Pre Building Condition Survey Report

Name and Address of Structure :	Choti Chopar to Badi Chopar (Down Line)
---------------------------------	---

Name of the Project	Contract JMRC-UG1B “Design and Construction of Tunnel between Chandpole and Badi Chouper and reverse line by Shield TBM, Underground Metro Stations at Choti Chouper and Badi Chouper by Cut and Cover Methods on East West Corridor of Jaipur Metro Rail Corporation Limited .”	
Owner :

Pre Building Condition Survey Report Choti Chopar to Badi Chopar (Down Line)

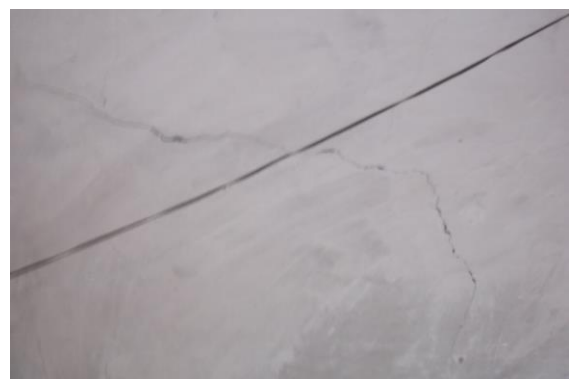
Photo 12
Inclined Crack on Roof of Varanda of Shop No. 380, Ground Floor
Approx. Width = 0.6mm, Approx. Length = 1.8m.
Distance from = Leftside External Column Backsidem, Height from Floor = 3.3m

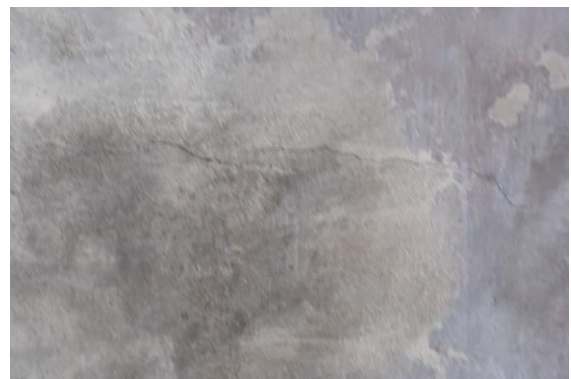
Photo 16A

Inclined Crack on Wall No. 1 of Near Staircase, Basement
Approx. Width = 1.5mm, Approx. Length = 1.3m.
Distance from Wall no. 4 = 0.4m, Height from Floor = 1m.

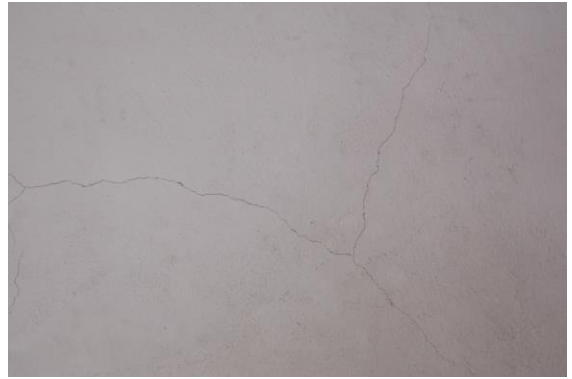
Peeling of Plaster on Roof of Part A of Shop No.260 of Ground Floor
