Pre Building Condition Survey Report

Name and Address of Structure :	Choti Chopar to Badi Chopar (UP Line)
---------------------------------	---------------------------------------

Name of the Project	Contract JMRC-UG1B “Design and Construction of Tunnel between Chandpole and Badi Chouper and reverse line by Shield TBM, Underground Metro Stations at Choti Chouper and Badi Chouper by Cut and Cover Methods on East West Corridor of Jaipur Metro Rail Corporation Limited .”	
Owner :

Shoping Complex - Shop No. 169-188
Tripolia Bazar
Jaipur
Unique ID: CC BC UP 0001

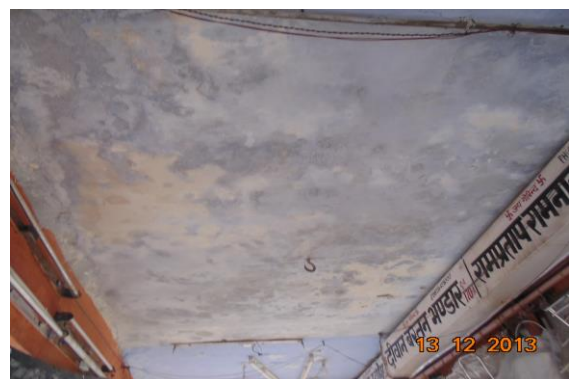
Photo 34
Damaged Portion on Floor of Varanda S.No.170A of Ground Floor

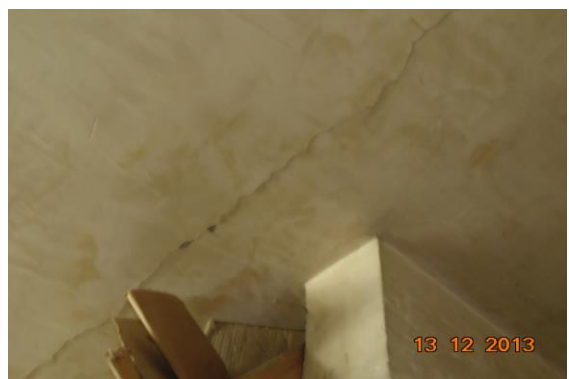
Photo 76

Plaster Crack on Floor of Part 2 of Shop No. 182, Upper Ground Floor

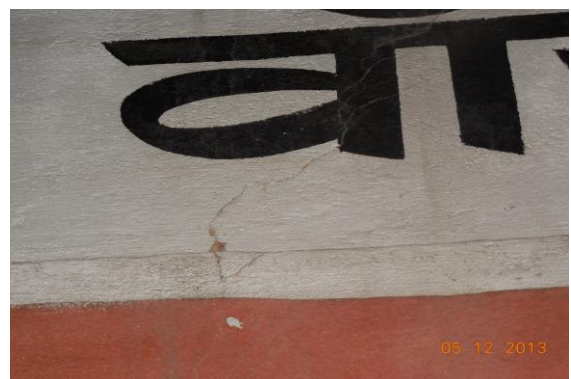
Inclined Crack on Roof of Varanda of Shop, Ground Floor Approx. Width
= 5mm, Approx. Length = 2.9m. Distance from Right side External
Column = 0m, Height from Floor = 3m.

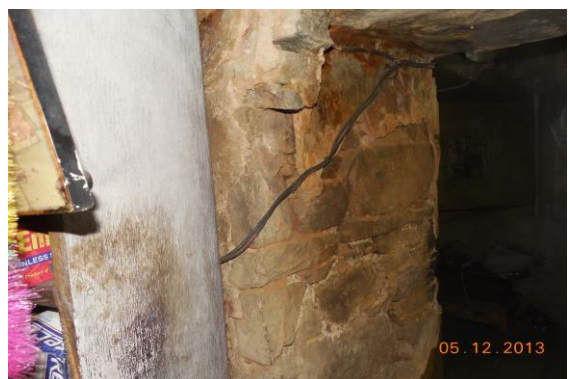
Photo 60
Peeling of Plaster on Roof of Part B of Shop of Ground Floor

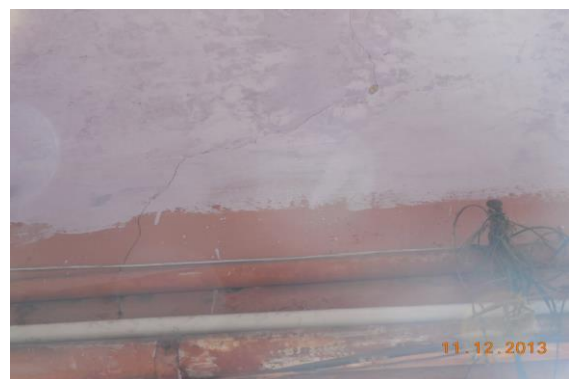
Photo 23
Horizontal Crack on Roof of Shop No.151, Ground Floor
Approx. Width = 0.4mm, Approx. Length = 2.15m.
Distance from Wall No.1 = 0.35m, Height from Floor = 2.5m.

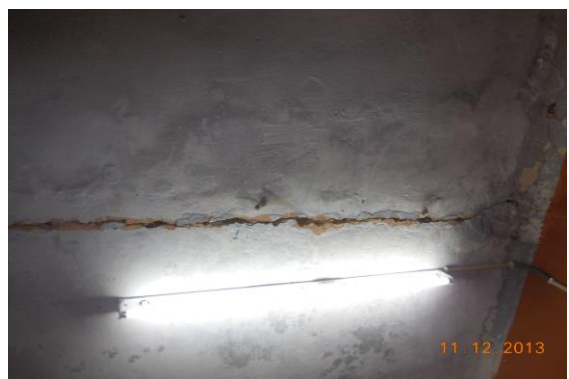
Photo 104
Peeling of Plaster on Wall No. 2 of Part B of Shop No.167 of Ground Floor

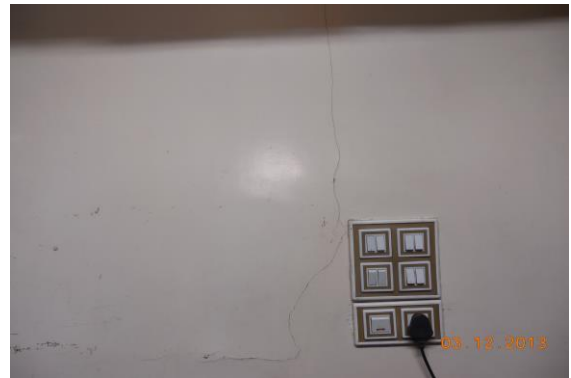
Inclined Crack on Wall No. 1 of Hall No. 6, Poornima Handicrafts, First Floor, Approx. Width = 0.8mm, Approx. Length = 1.8m. Distance from Wall No.3 = 1.5m, Height from Floor = 1.9m.

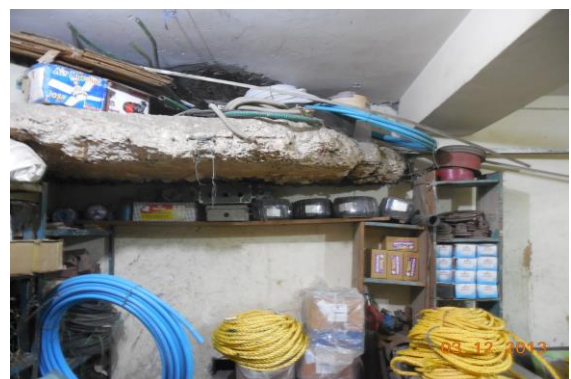
Photo 109
Peeling of Plaster on Wall No. 3 of Shop No. E 144 of Ground Floor

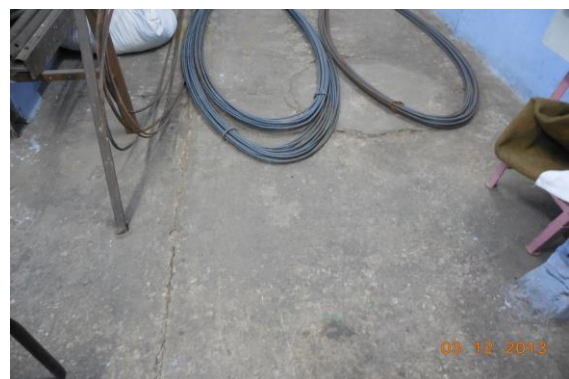
Photo 115
Peeling of Plaster on Roof of Part A of Shop No. D 53, Ground Floor

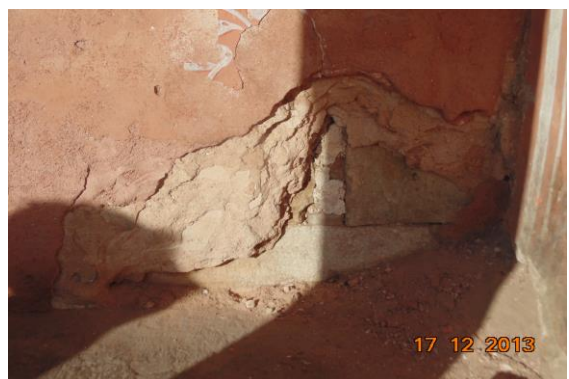
Photo 17
Damaged Portion on Wall No. 4 of Historical Gate No.2 of Ground Floor

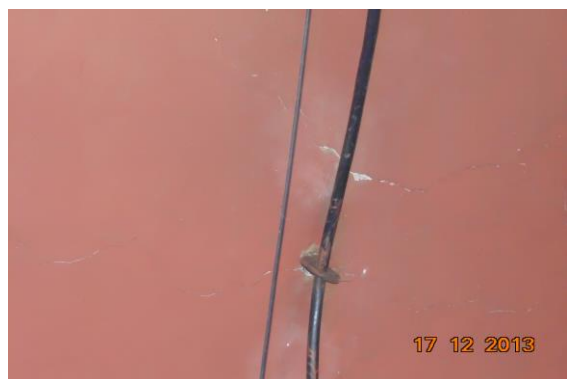
Damaged Portion on Roof of Passage of Historical Gate No.2, Ground Floor

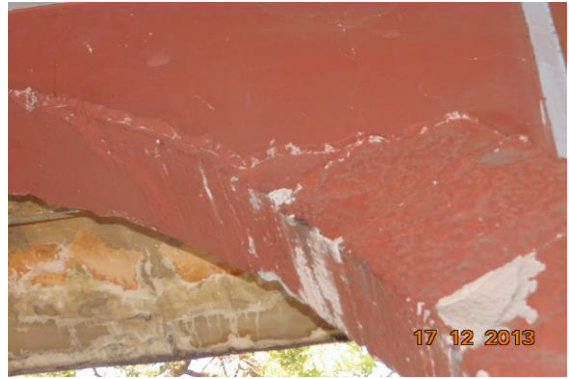
Damaged Portion on Roof of Passage of Historical Gate No.2, Ground Floor

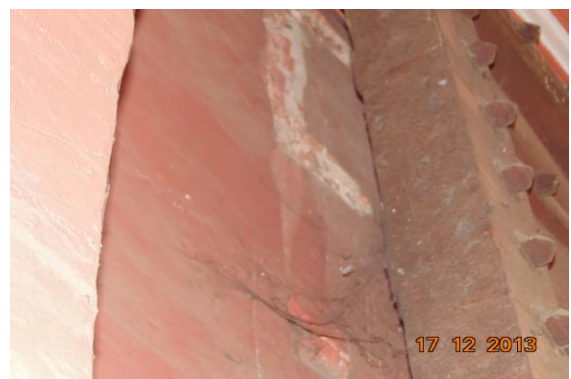
Damaged Portion on Wall No. 2 of Passage of Historical Gate No.2,
Ground Floor

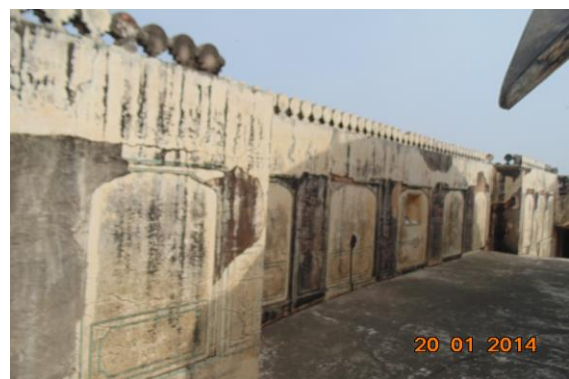
Photo 148
Peeling of Plaster on Wall No. 2 of Minarets of Tripoliya Gate, Terrace

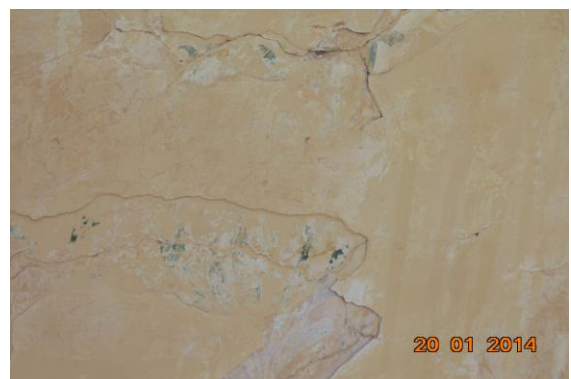
Damaged Portion on Wall No. 2 & Shade of Minarets of Tripoliya Gate, Terrace

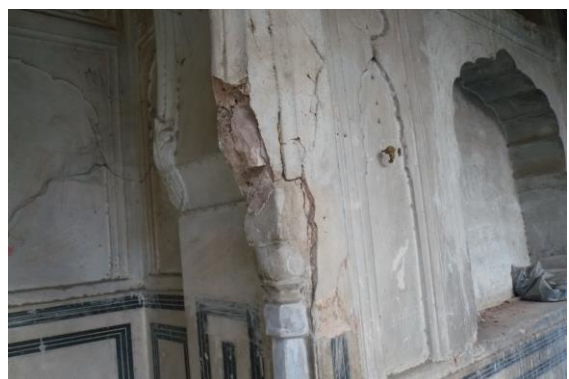
Photo 27
Damaged Portion on Wall No. 4 of Varanda No.4 of Ground Floor

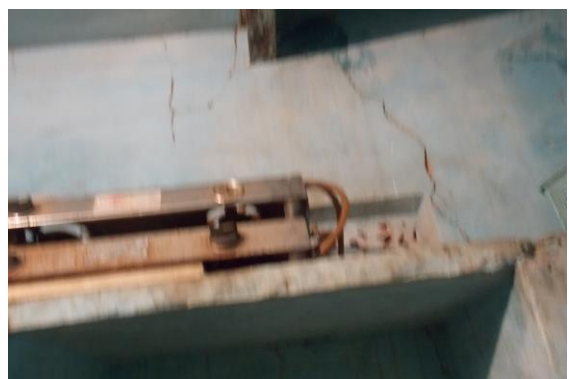
Photo 5
Inclined Crack on Roof of Kitchen, Ground Floor
Approx. Width = 0.35mm, Approx. Length = 1.7m.
Distance from Wall no.3 = 0m, Height from Floor = 3m.

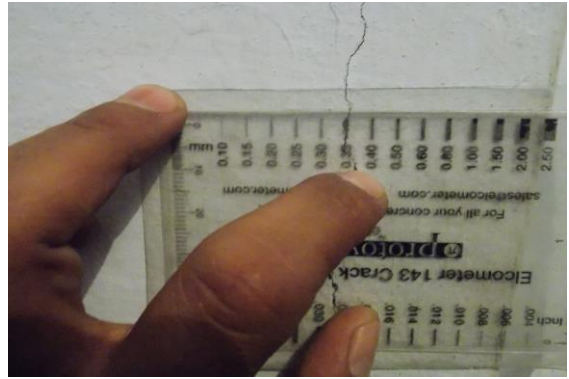
Vertical Crack on Wall No. 3 of Kitchen,
Approx. Width = 0.35mm, Approx. Length = 1m.
Distance from Wall No.2 = 0.92m, Height from Floor = 0.86m.

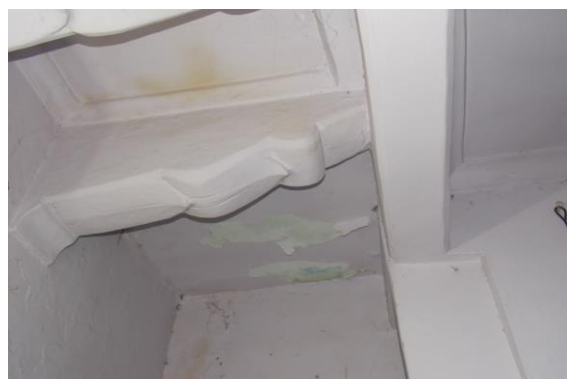
Photo 16
Plaster Crack on Roof & Beam of Room No. 3 of Navleshwar Temple,
Ground Floor

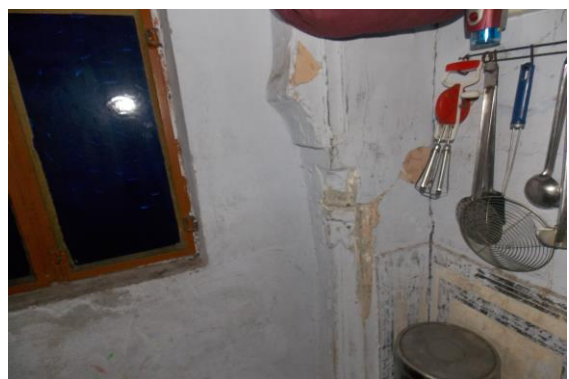
Plaster Crack on Wall No. 4 of Room No. 3 of Navleshwar Temple, First floor

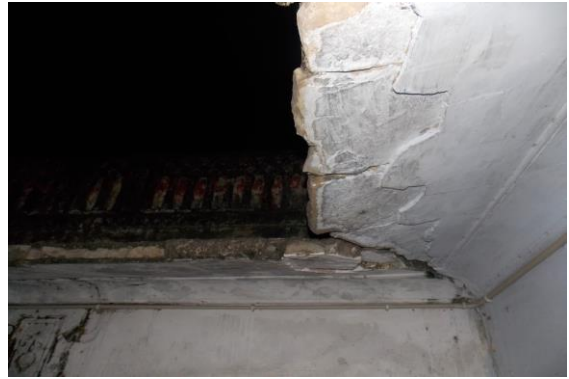
Photo 60
Damaged Portion on Roof & Shade of Open Sky of First floor

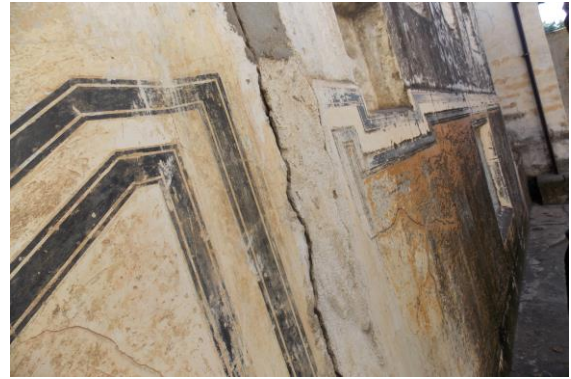
Inclined Crack on Wall No. 3 of Open Area 1, Second Floor
Approx. Width = 2.5mm, Approx. Length = 3m.
Distance from W2 = 0.25m, Height from Floor = 0.2m.

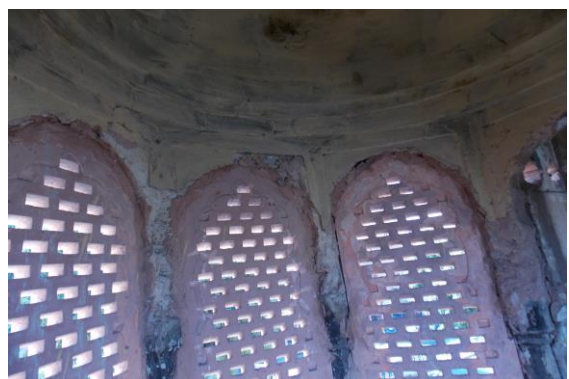
Damaged Portion on Wall No. 4 of Tinset 1 of Second Floor

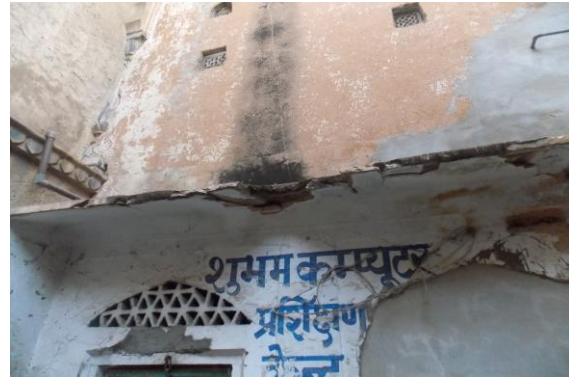
Damaged Portion on Sunshade of Open Area 1 of Ground Floor

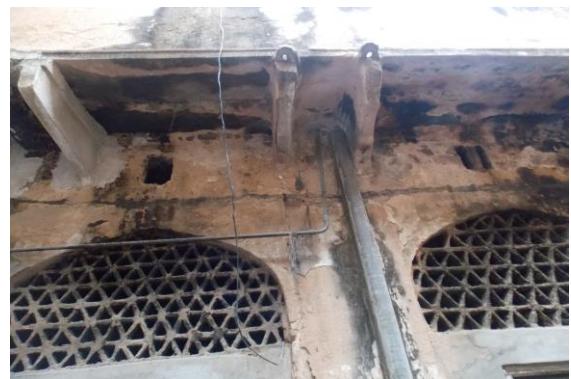
Peeling of Plaster on Wall No. 4 of Open Area 1 of Ground Floor

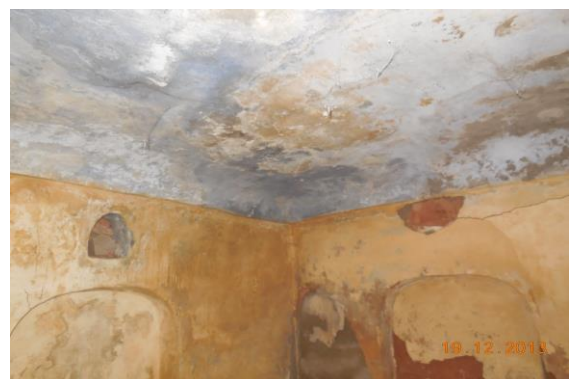
Photo 107
Plaster Crack on Wall No. 1 & 3 of Open Sky of Ground Floor

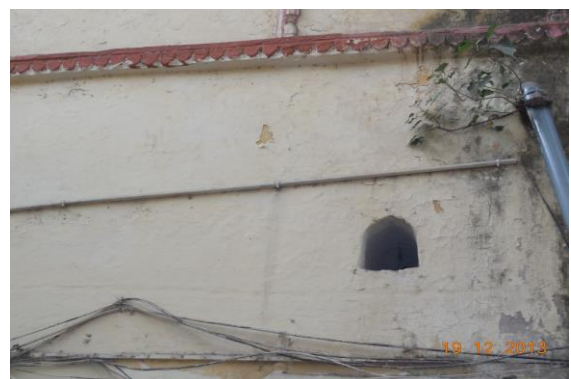
Photo 119
Peeling of Plaster on External Wall of of Lower First Floor

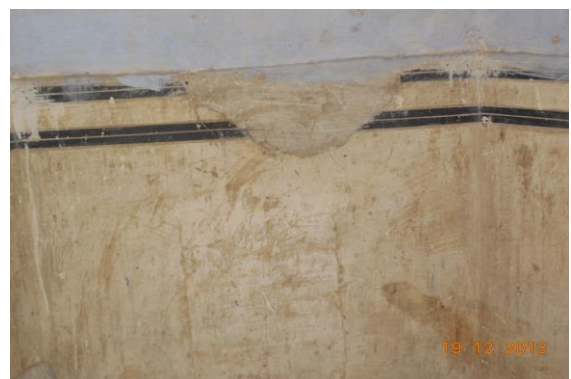
Photo 149
Exposed Reinforcement on Roof & 2 of Tomb No.2 of First Floor

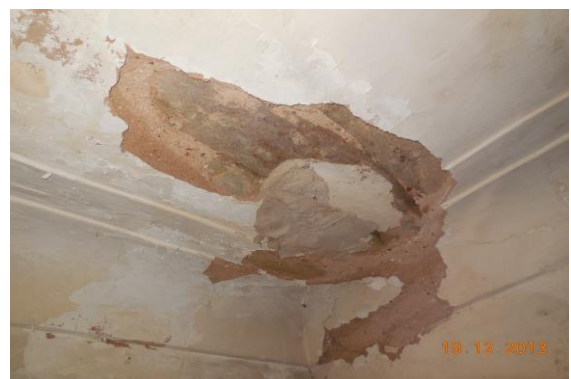
Damaged Portion on Wall No. 3 of Staircase Area of First Floor
