Pre Building Condition Survey Report

Name and Address of Structure :	Badi Chopar Station Area
---------------------------------	--------------------------

Name of the Project	Contract JMRC-UG1B “Design and Construction of Tunnel between Chandpole and Badi Chouper and reverse line by Shield TBM, Underground Metro Stations at Choti Chouper and Badi Chouper by Cut and Cover Methods on East West Corridor of Jaipur Metro Rail Corporation Limited .”	
Owner :

Pre - Condition Building Survey for Construction of Underground Stations from Chandpole to Bari Chouper and reversal line

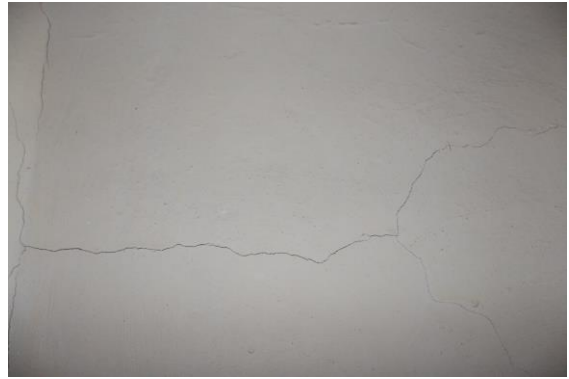
Inclined Crack on Wall No. 4 of Passage 1, Part A1 Upper Ground Floor
Approx. Width = 0.6mm, Approx. Length = 2m. Distance from Wall No. 2 = 1.5m, Height from Floor = 0m.

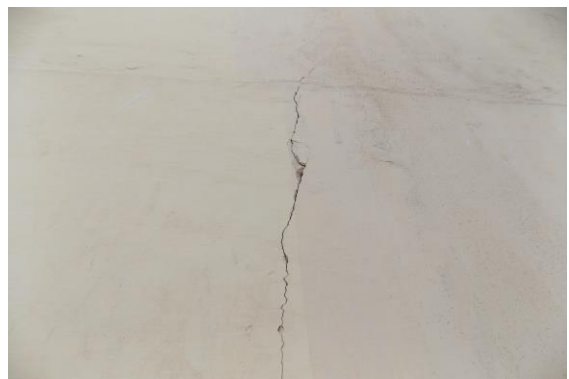
Inclined Crack on Wall No. 2 of Minaret 3, Part A1 Upper Ground Floor
Approx. Width = 0.5mm, Approx. Length = 4.8m. Distance from = m, Height from Floor = 0m.

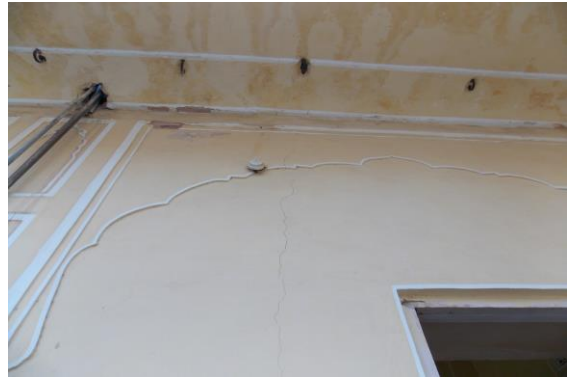
Inclined Crack on Wall No. 4 of Open Area Part A 1, Part A1 Upper Ground Floor Approx. Width = 0.8mm, Approx. Length = 1.3m. Distance from Wall No. 1 = 6.5m, Height from Floor = 1.1m.

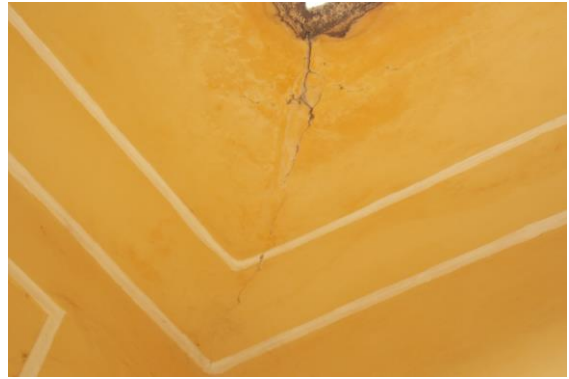
Inclined Crack on Wall No. 4 & Sunshade of Open Area, Part A2 Upper Ground Floor Approx. Width = 1mm, Approx. Length = 2.5m. Distance from Wall No. 1 = 2.3m, Height from Floor = 2m.

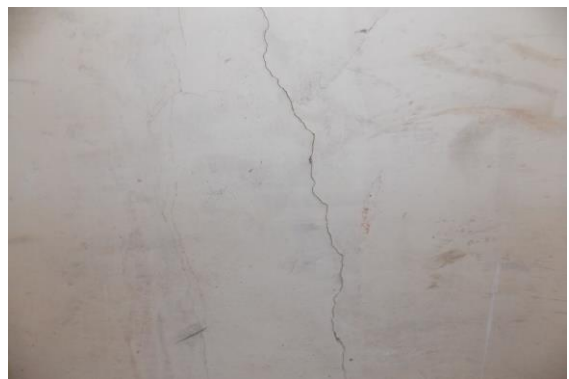
Inclined Crack on Wall No. 3 of Gallery 2, Part A2 Upper Ground Floor Approx. Width = 0.4mm, Approx. Length = 1.35m. Distance from Wall No. 1 = 10.4m, Height from Floor = 1.67m.

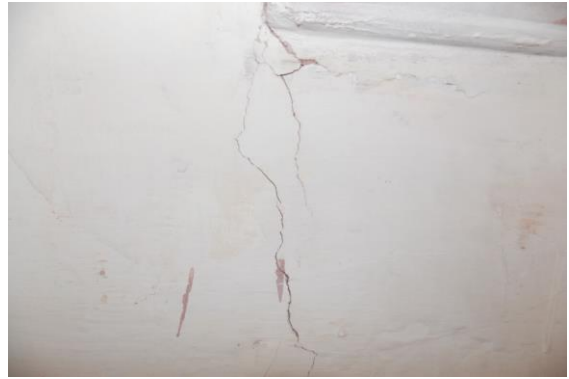
Inclined Crack on Wall No. 3 of Gallery 2, Part A2 Upper Ground Floor
Approx. Width = 0.6mm, Approx. Length = 1m. Distance from Wall No. 1 = 11.1m, Height from Floor = 0m.

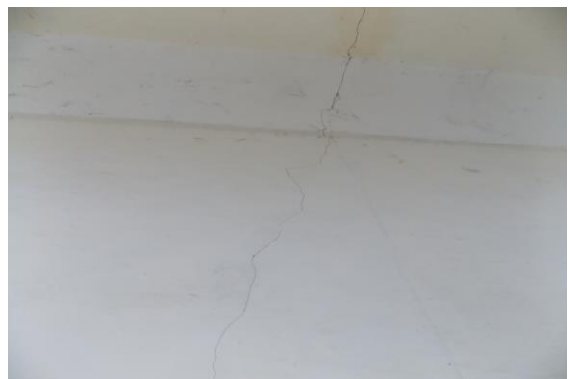
Inclined Crack on Wall No. 3 of Gallery 2, Part A2 Upper Ground Floor
Approx. Width = 0.4mm, Approx. Length = 2.2m. Distance from Wall No. 1 = 10.5m, Height from Floor = 0.5m.

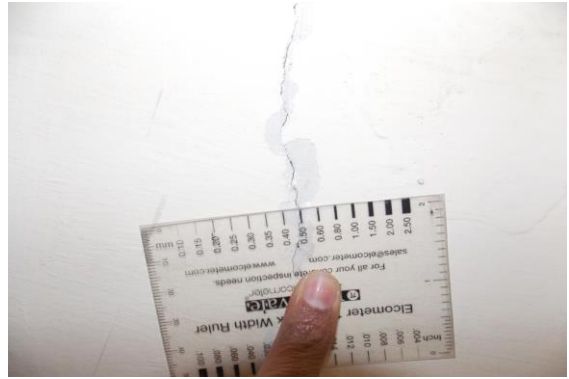
Inclined Crack on Wall No. 4 of Gallery 2, Part A2 Upper Ground Floor
Approx. Width = 0.5mm, Approx. Length = 1.5m. Distance from Wall No. 1 = 12.2m, Height from Floor = 0m.

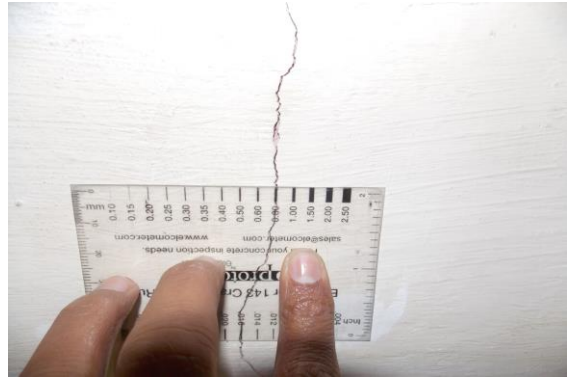
Inclined Crack on Wall No. 1 of Gallery 4, Part A2 Upper Ground Floor
Approx. Width = 0.8mm, Approx. Length = 1.3m. Distance from Wall No. 3 = 3.8m, Height from Floor = 0m.

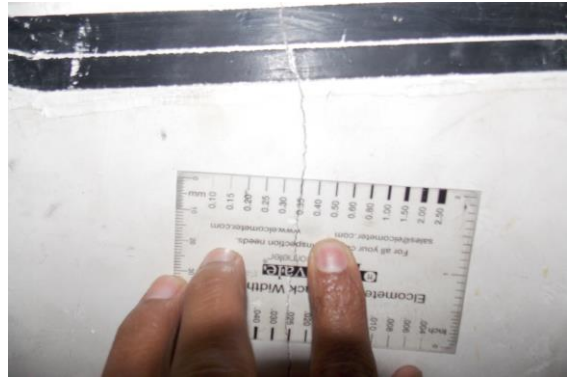
Inclined Crack on Wall No. 1 of Gallery 4, Part A2 Upper Ground Floor
Approx. Width = 0.35mm, Approx. Length = 2m. Distance from Wall No. 4 = 1.3m, Height from Floor = 0m.

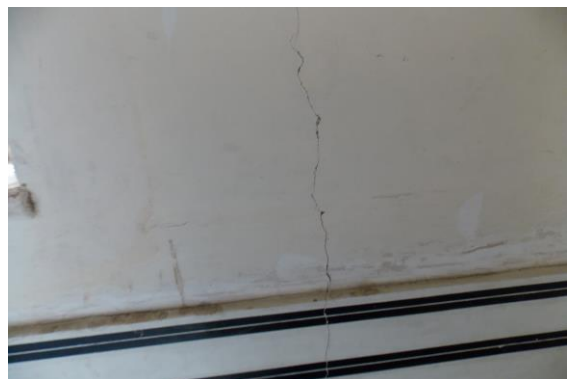
Inclined Crack on Wall No. 1 of Gallery 6, Part A2 Upper Ground Floor
Approx. Width = 0.3mm, Approx. Length = 2.5m. Distance from Wall No. 2 = 1.45m, Height from Floor = 0m.

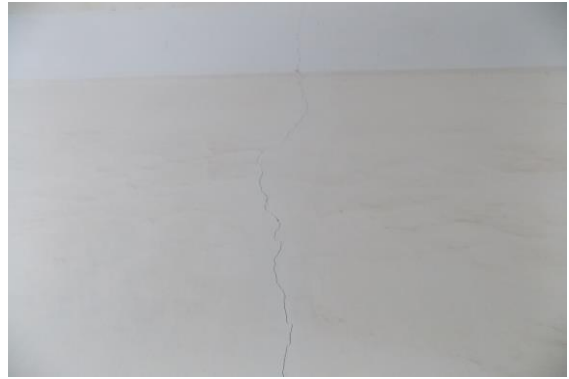
Inclined Crack on Wall No. 3 of Gallery 6, Part A2 Upper Ground Floor
Approx. Width = 0.5mm.

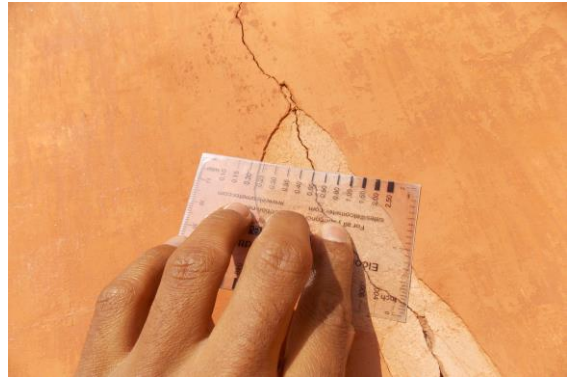
Inclined Crack on Wall No. 4 of Open Area 1, Terrace of (A2+B2) Open Area Approx. Width = 0.5mm, Approx. Length = 5m. Distance from Wall No. 1 = 5.5m, Height from Floor = 1m.

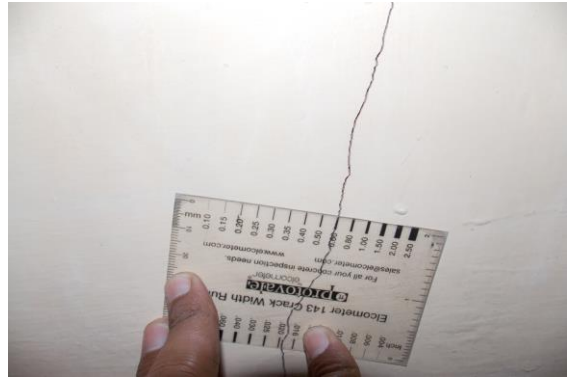
Inclined Crack on Wall No. 4 of Gallery 2, Terrace of (A2+B2) Open Area Approx. Width = 0.6mm, Approx. Length = 2m. Distance from Wall No. 2 = 4m, Height from Floor = 0m.

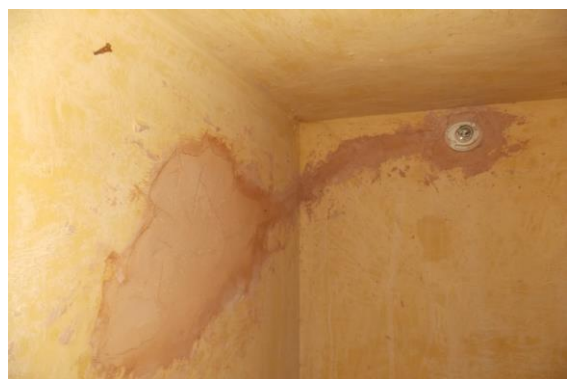
Peeling of Plaster on Wall No. 4 of Room No. 1 of Part A1 Upper Ground Floor

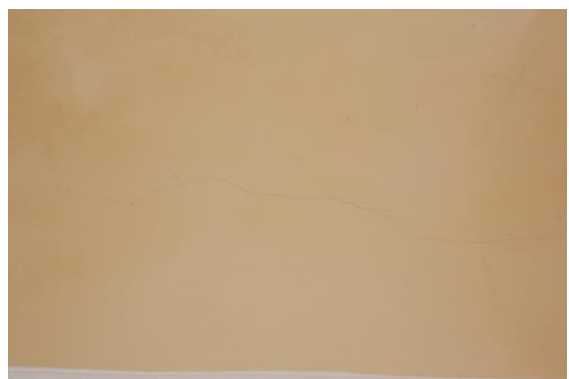
Photo 108
Peeling of Plaster on Wall No. 1 of Vrandha 4 of Part A1 Upper Ground
Floor

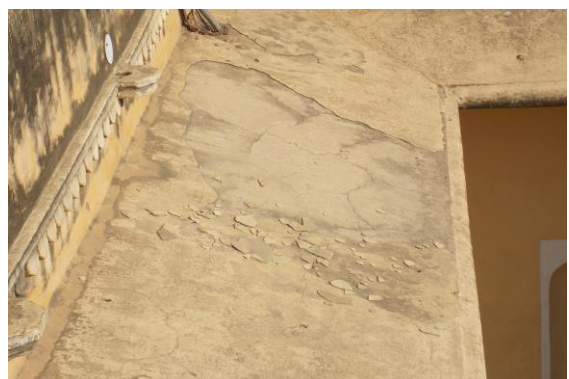
Photo 252
Dampness/Seepage on Wall No. 1 of Open Area 2 of Terrace of (A2+B2) Open Area

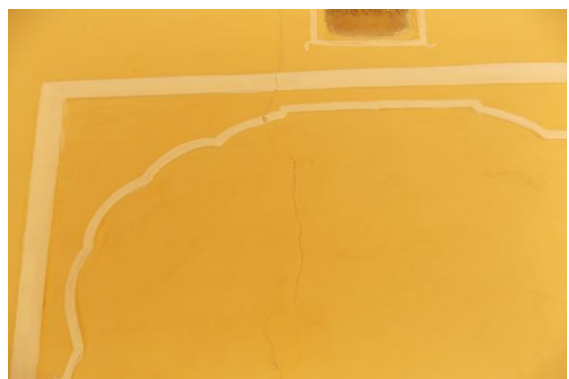
Peeling of Plaster on Roof & 4 of Vrandra of Terrace of (A2+B2) Open Area

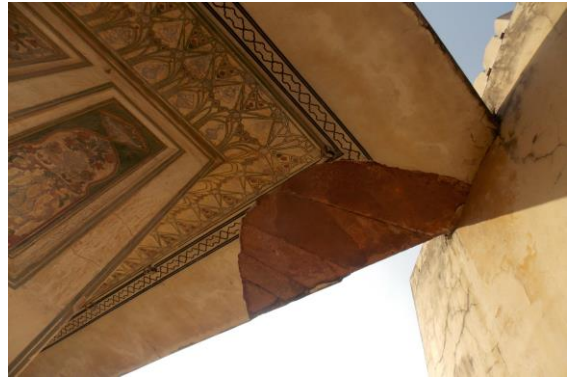
Photo 284
Plaster Crack on Wall No. 1 of Terrace of (A2+B2) Open Area

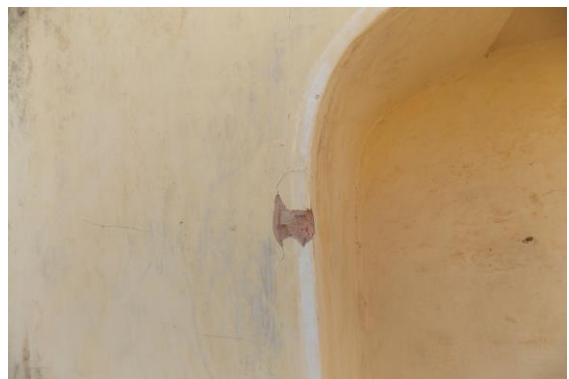
Photo 288
Plaster Crack on Wall No. 4 of Open Area 6 of Terrace of (A2+B2) Open Area

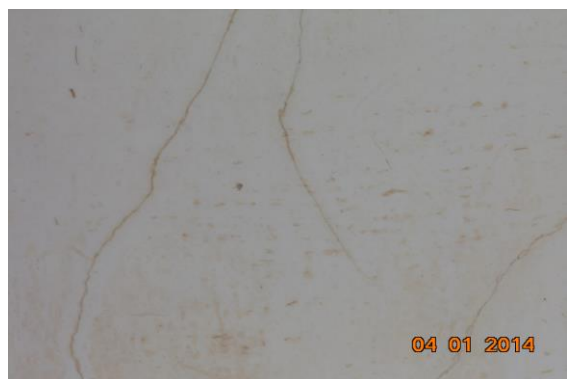
Peeling of Plaster on Wall No. 2 of Outer wall of main door of Part B1 Upper Ground Floor

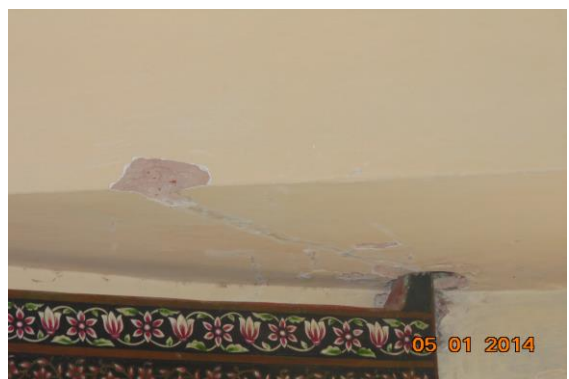
Damaged Portion on Wall No. 4 of Room No. 9B of Part B1 Upper Ground Floor

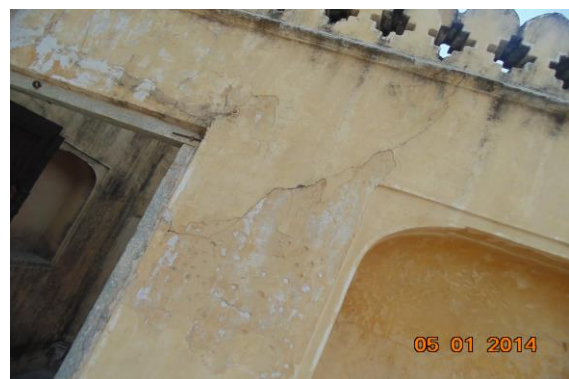
Photo 396
Plaster Crack on Wall No. 1 of Open Area 5 of Part B1 First Floor

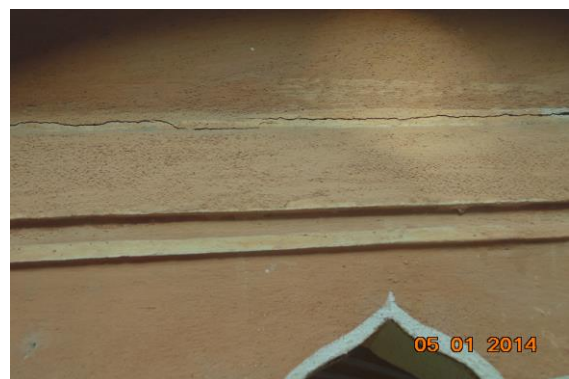
Photo 408
Dampness/Seepage on Wall No. 2 of Open Area 1 Shade of Part B1 Second Floor

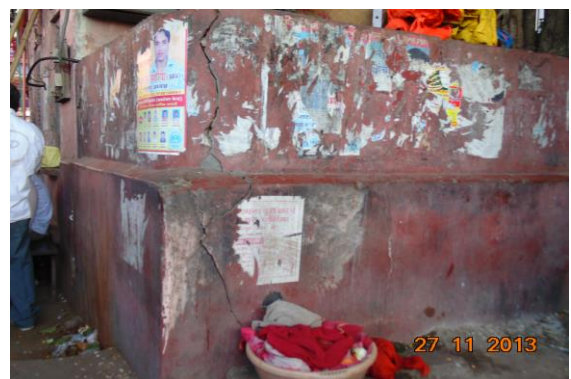
Photo 5
Peeling of Plaster on External Wall No. 4 of Ground Floor

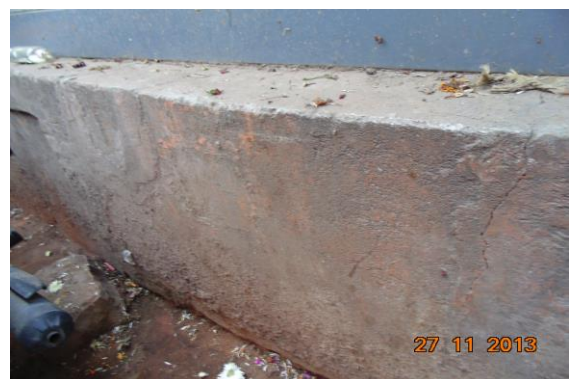
Photo 5
Peeling of Plaster on Platform of Transformer of Ground Floor
