### Pre Building Condition Survey Report

Name and Address of Structure :	Badi Chopar to Ramp Area (UP Line)
---------------------------------	------------------------------------

Name of the Project	<b>Contract JMRC-UG1B</b> “Design and Construction of Tunnel between Chandpole and Badi Chouper and reverse line by Shield TBM, Underground Metro Stations at Choti Chouper and Badi Chouper by Cut and Cover Methods on East West Corridor of Jaipur Metro Rail Corporation Limited .”	
Owner :

Pre Building Condition Survey Report Badi Chopar to Ramp Area (UP Line)

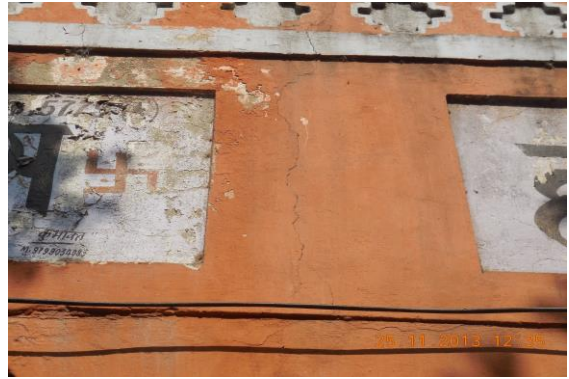
Photo 56

Horizontal Crack on Roof of Varanda of Shop No.365, Ground Floor  
Approx. Width = 0.8mm, Approx. Length = 3.2m. Distance from  
Rightside External Column = 0m, Height from Floor = 2.8m.

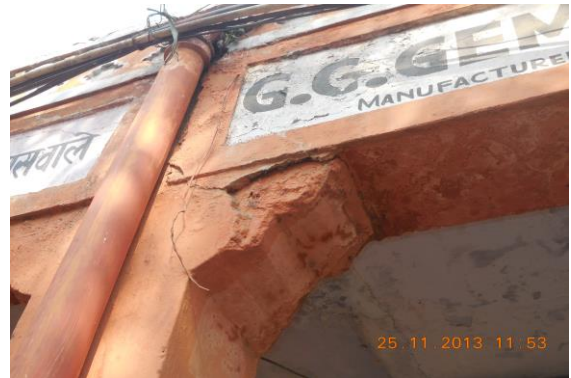
Photo 80

Damaged Portion on Beam of Varanda of Shop No.371 of Ground Floor

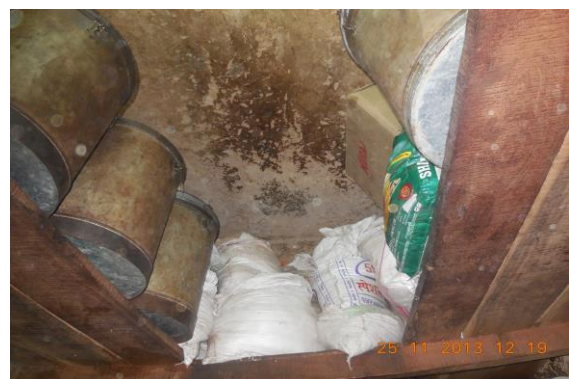
Photo 89  
Peeling of Plaster on Roof of Room No. 2 of Ground Floor

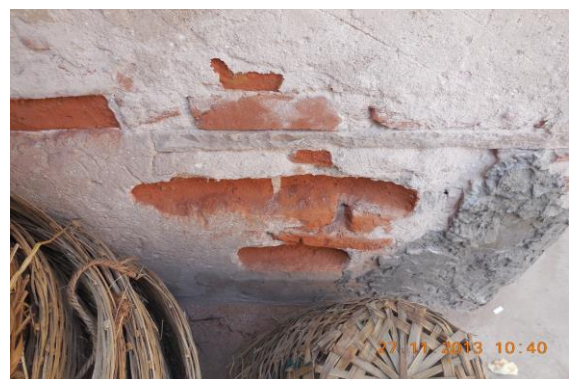
Photo 67  
Damaged Portion on Wall No. 3 of Entrance Open Area of First Floor

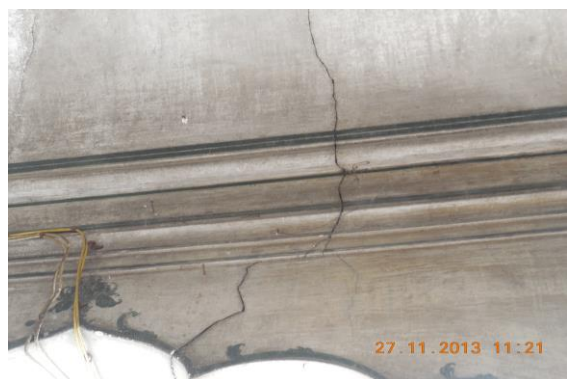
Photo 91  
Plaster Crack on Wall No. 1, 4 & Roof of Varanda of First Floor

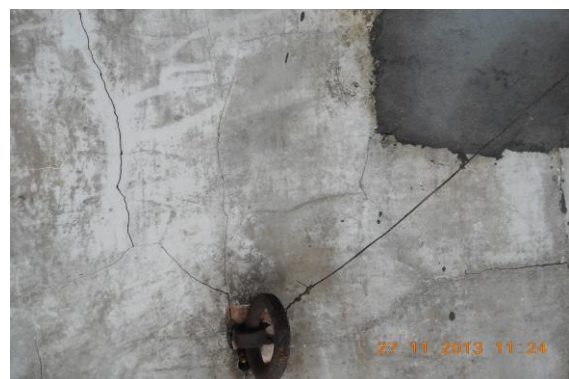
Photo 97  
Plaster Crack on Wall No. 1, 4 & Roof of Varanda of First Floor

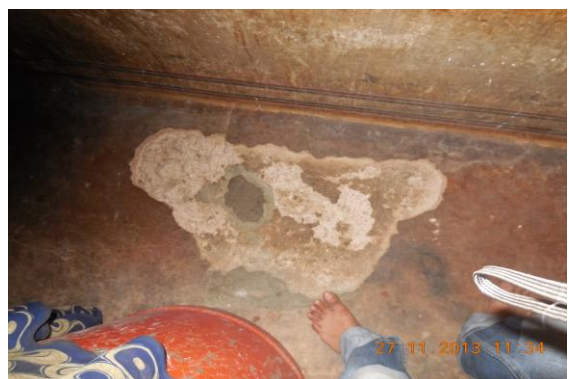
Photo 103  
Peeling of Plaster on Roof of Stair 2 of First Floor

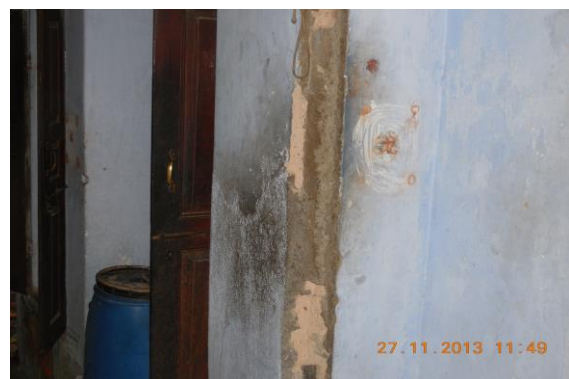
Photo 121  
Damaged Portion on Roof of Room No. 3 of First Floor

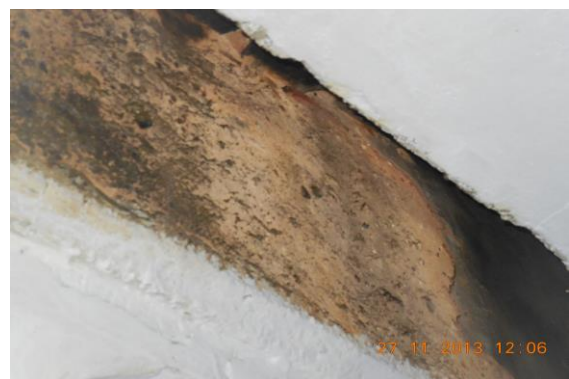
Photo 139  
Dampness/Seepage on Wall No. 1 & Roof of Room No. 2 of Second Floor

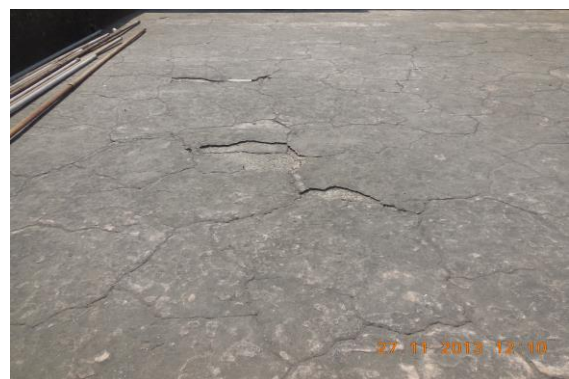
Photo 146

Damaged Portion on Roof of Stair 4 of Second Floor

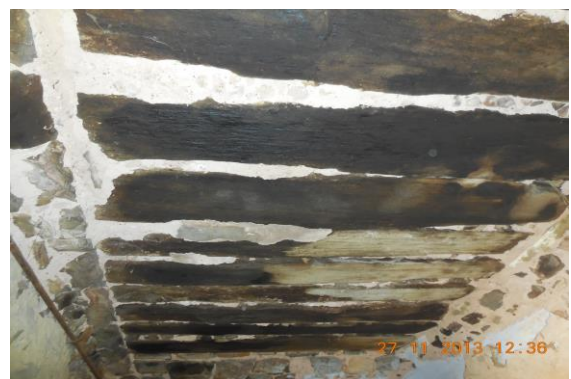
Photo 157  
Damaged Portion on Roof of Varanda 1 of Ground Floor

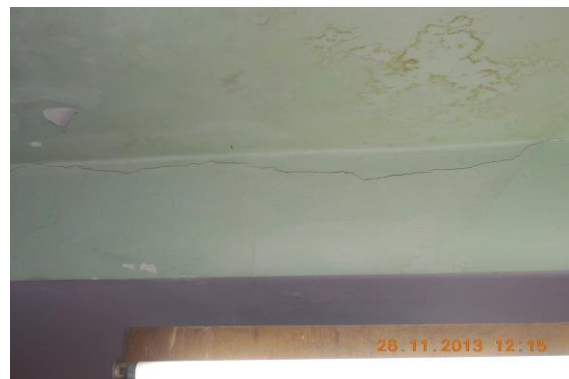
Photo 4  
Horizontal Crack on Wall No. 3 of Part B of Shop no.349, Ground Floor  
Approx. Width = 0.6mm, Approx. Length = 2.3m. Distance from Wall no.2 = 0m, Height from Floor = 3m.

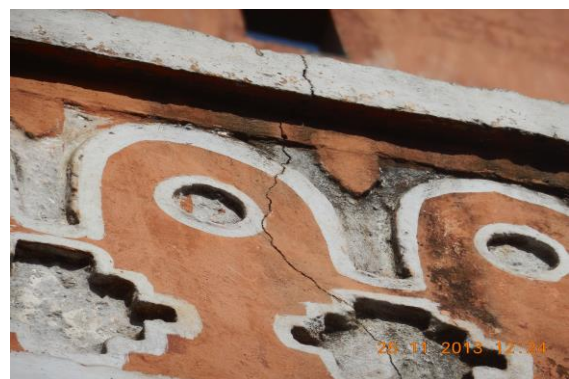
Photo 5  
Inclined Crack on Outer Wall & Leftside External Wall of Varanda of Shop no.349, Ground Floor Approx. Width = 0.35mm, Approx. Length = 1.3m. Distance from Leftside External Column = 0m, Height from Floor = 2.8m

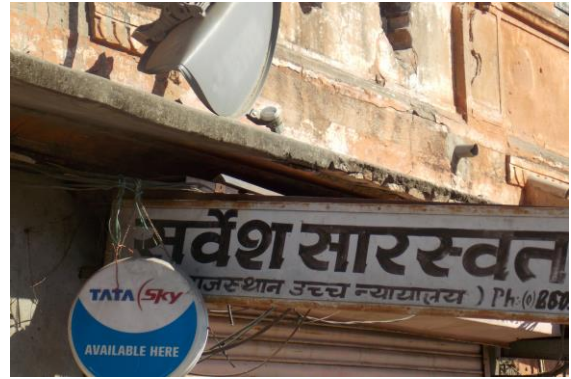
Photo 124

Damaged Portion on Wall No. 3 & Sunshade of Front Wall Shade of House No. 2144, First Floor

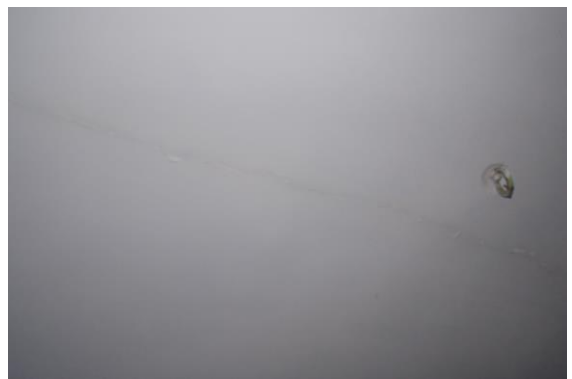
Photo 218

Peeling of Plaster on Roof of Passage 1, Part C of House No. 2144, First Floor

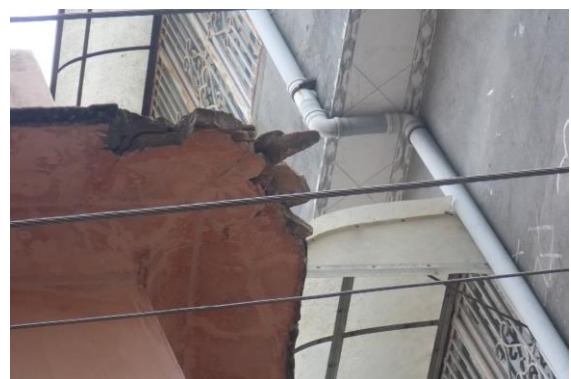
Photo 136

Peeling of Plaster on Outer Wall of External Façade of Part B of House No.2193, Ground Floor
