JAIPUR METRO Jaipur Metro Rail Corporation

Pre - Condition Building Survey for Construction of Underground Stations from Chandpole to Bari Chouper and reversal line

Shop No.18
Chandpole Bazaar
Jaipur
Unique ID:CP CC UP 0008/18

Report Number: AIMIL/ESG/JMCEC/CP CC UP 0008-18/01, Rev. 00, Dated: July 2014

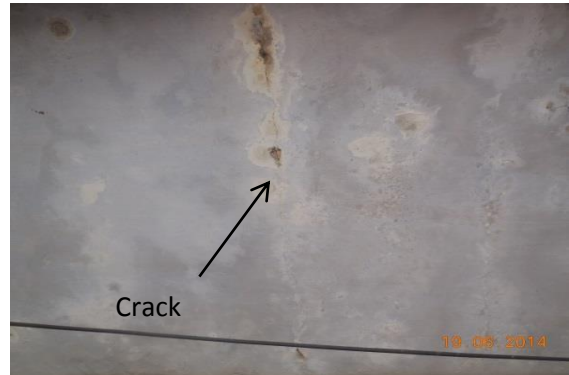
Photo 2

Horizontal Crack on Roof of Vrandah of Shop No.18, Ground Floor, Approx. Width = 0.20mm, Approx. Length = 2.0m. Distance from Left Column = 1.50m, Height from Floor = 3.0m.

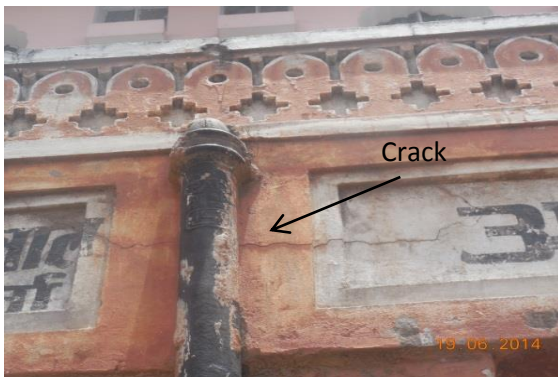
Photo 3

Inclined Crack on Left Column of Vrandah of Shop No.18, Ground Floor, Approx. Width = 0.50mm, Approx. Length = 1.10m. Distance from Left Column = 0m, Height from Floor = 2.70m.

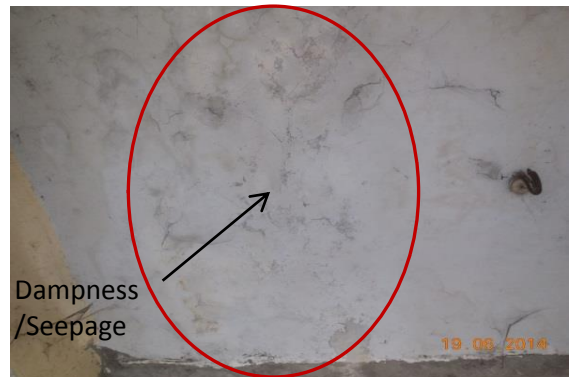
Photo 4

Dampness/Seepage on Roof of Shop No. 18, Ground Floor

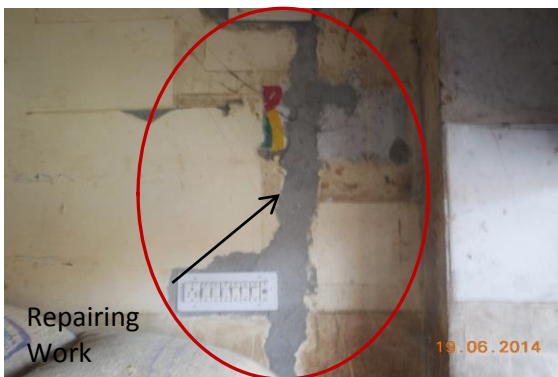
Photo 5

Repairing Work on Wall No.2 of Shop No. 18, Ground Floor

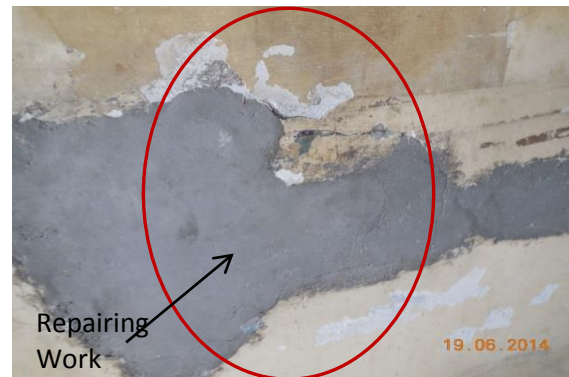
Photo 6

Repairing Work on Wall No.1 of Shop No. 18, Ground Floor

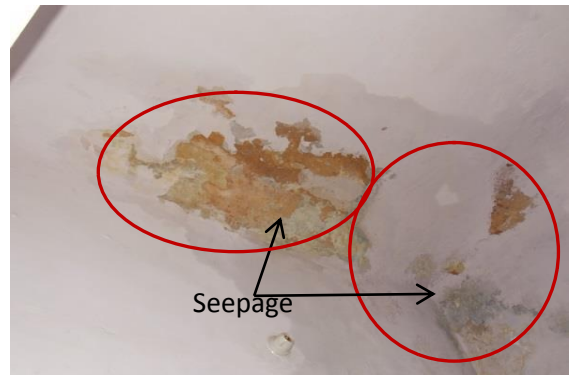
Photo 2
Seepage on Roof of Part-C of Shop No.72
Ground Floor

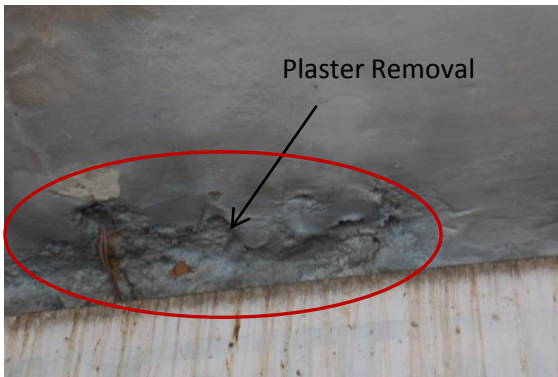
Photo 7
Plaster Removal on Roof of Varandah of Shop No.72
Ground Floor

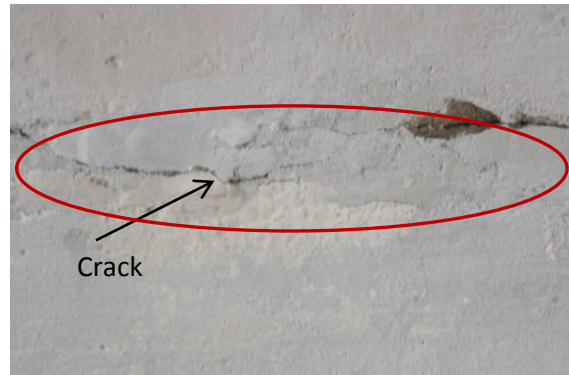
Photo 4

Horizontal Crack on Varandah Roof of Shop No. 153, Ground Floor, Approx. Width = 1.0mm, Approx. Length = 2.50m. Distance from Right Column = 0m, Height from Floor = 3.0m.

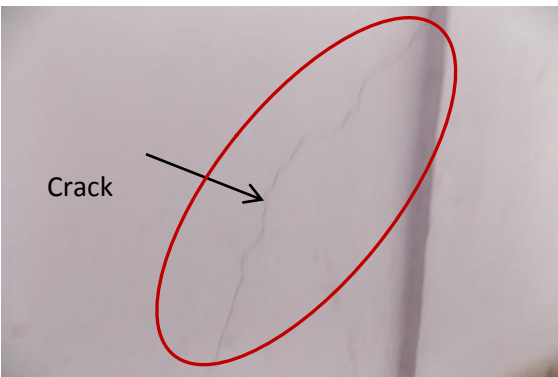
Photo 5

Inclined Crack on Wall No. 4 of Shop No. 153, Upper Ground Floor, Approx. Width = 0.35mm, Approx. Length = 1.8m. Distance from Wall No. 1 = 1.50m, Height from Floor = 0m.

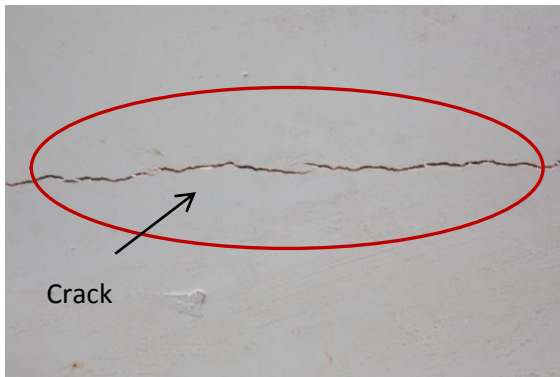
Photo 5A

Horizontal Crack on Beam at Entry gate of Part A of Shop No. 163, Ground Floor, Approx. Width = 1.20mm, Approx. Length = 2.0m. Distance from Wall No. 2 = 0m, Height from Floor = 2.50m.

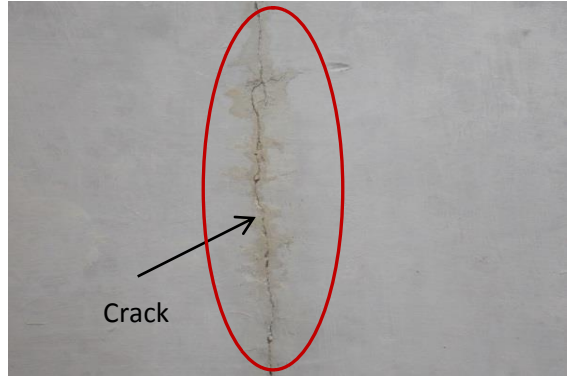
Photo 2

Horizontal Crack on Roof of Varandah of Shop No. 153, Ground Floor, Approx. Width = 0.25mm, Approx. Length = 2.0m. Distance from Left Column = 0m, Height from Floor = 3.0m.

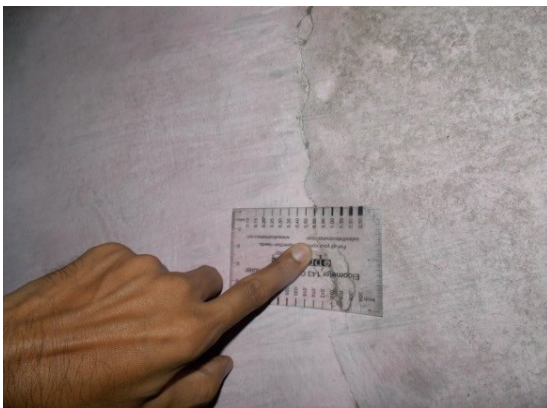
Photo 16B

Horizontal Crack on Wall no.3 of Staircase SF to Terrace of House above Shop No.59, Approx. Width=0.6mm, Approx. Length=1.4m. Distance from Wall No.2= 1.0m, Height from Floor = 0.3m.

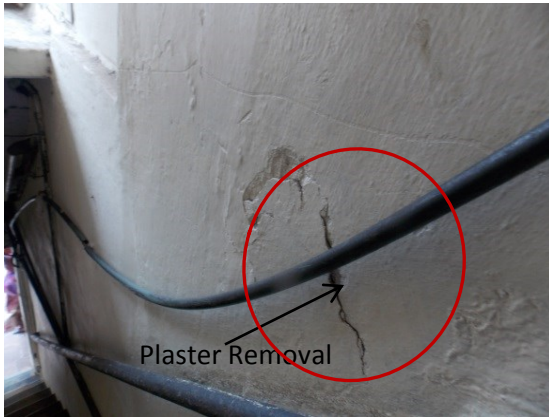
Photo 20
Plaster Removal on Wall No.1 of Stair of H.above Shop No.59,
First floor

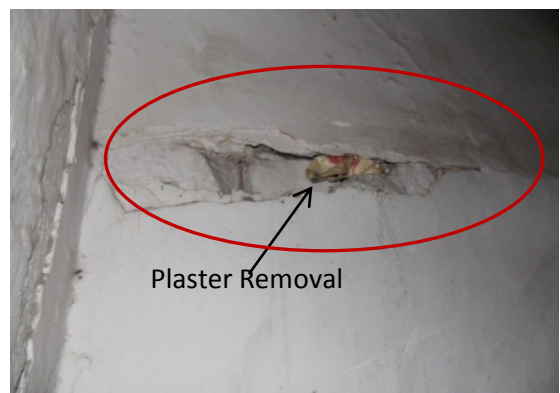
Photo 23B
Plaster Removal on Wall No.1 of Gallery of above Shop No.59,
First floor

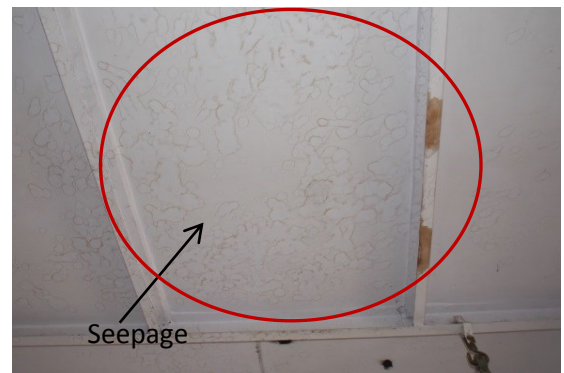
Photo 40
Seepage on Roof of Hall No.1 (Second Floor)
