Pre - Condition Building Survey for Construction of Underground Stations from Chandpole to Bari Chouper and reversal line

Hind Hotel
Choura Rasta
Jaipur
Unique ID:CC-BC/DL/0029

Report Number: AIMIL/ESG/JMCEC/CC-BC/DL/0029-294-286-GF-SF, Rev. 00, Dated: AUGUST 2014

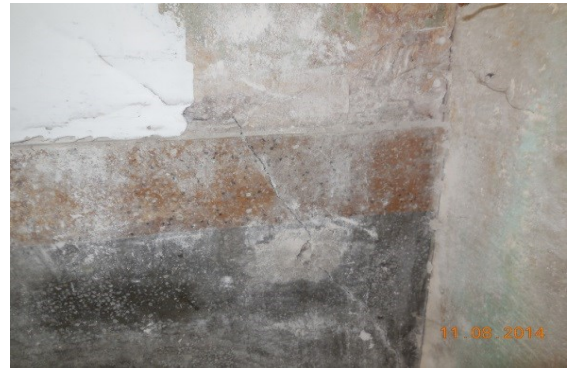
Photo 6A
Inclined Crack on Wall No.2 of Passage of Hind Hotel, Ground floor, Approx. Width=1.5mm, Approx.Length=2.5m. Distance from Wall No.4=2.2m, Height from Floor=1.0m.

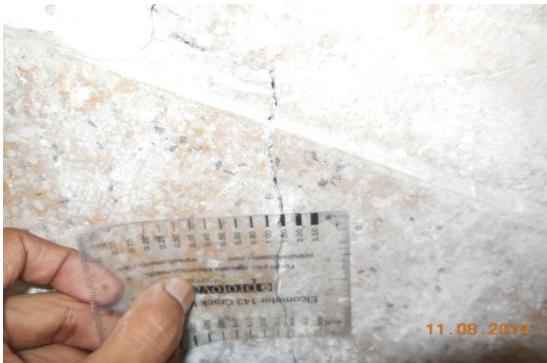
Photo 6B

Inclined Crack on Wall No.2 of Passage of Hind Hotel, Ground floor, Approx. Width=1.5mm, Approx.Length=2.5m. Distance from Wall No.4=2.2m, Height from Floor=1.0m.

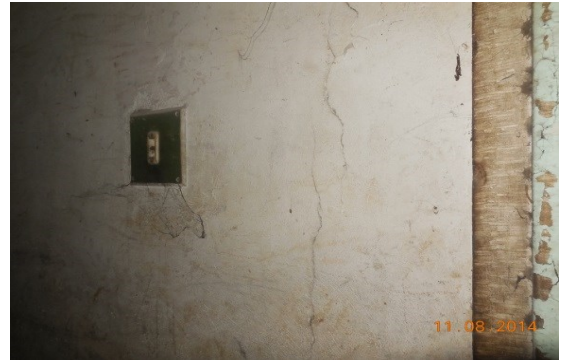
Photo 7A

Inclined Crack on Wall No.2 of Passage of Hind Hotel, First floor, Approx. Width=1.0mm, Approx.Length=1.8m. Distance from Wall No.3=0.25m, Height from Floor=0.0m.

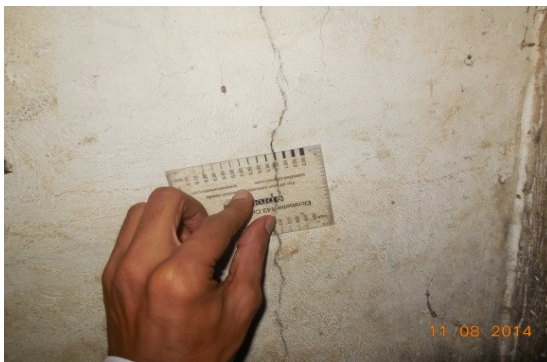
Photo 7B

Inclined Crack on Wall No.2 of Passage of Hind Hotel, First floor, Approx. Width=1.0mm, Approx.Length=1.8m. Distance from Wall No.3=0.25m, Height from Floor=0.0m.

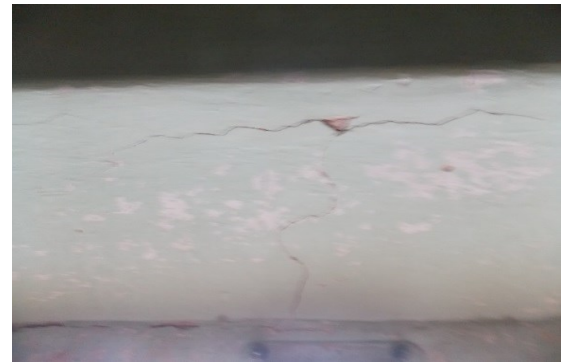
Photo 8A

Inclined Crack on Wall No.3 of Room No. 7 of Hind Hotel, First floor, Approx. Width=0.8mm, Approx.Length=1.0m. Distance from Wall No.2=1.3m, Height from Floor=1.8m.

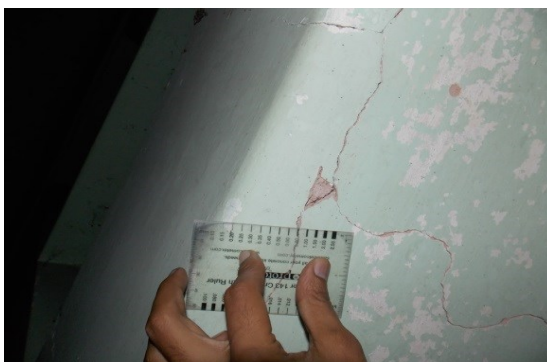
Photo 8B

Inclined Crack on Wall No.3 of Room No. 7 of Hind Hotel, First floor, Approx. Width=0.8mm, Approx.Length=1.0m. Distance from Wall No.2=1.3m, Height from Floor=1.8m.

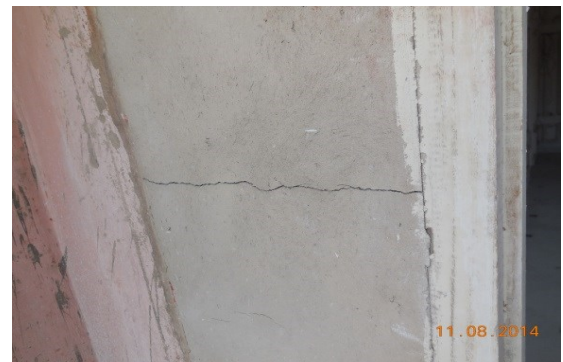
Photo 9A

Horizontal Crack on Wall No.3 of Balcony of Hind Hotel, Second floor, Approx. Width=1.5mm, Approx.Length=0.25m. Distance from Wall No.2=0.15m, Height from Floor=1.3m.

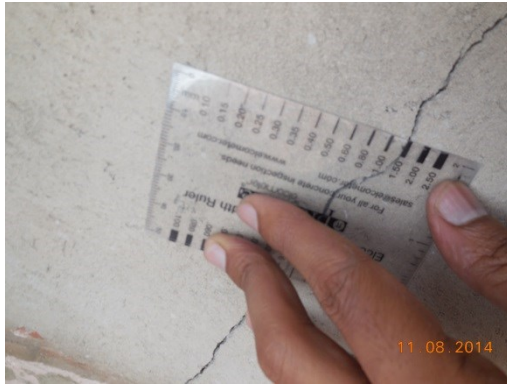
Photo 9B

Horizontal Crack on Wall No.3 of Balcony of Hind Hotel, Second floor, Approx. Width=1.5mm, Approx.Length=0.25m. Distance from Wall No.2=0.15m, Height from Floor=1.3m.

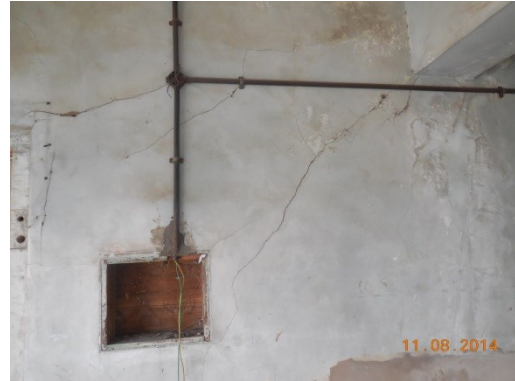
Photo 10A

Inclind Crack on Wall No.4 of Varanda No. 2 of Hind Hotel, Third floor, Approx. Width=1.5mm, Approx.Length=4.0m. Distance from Wall No.1=0.0m, Height from Floor=1.3m.

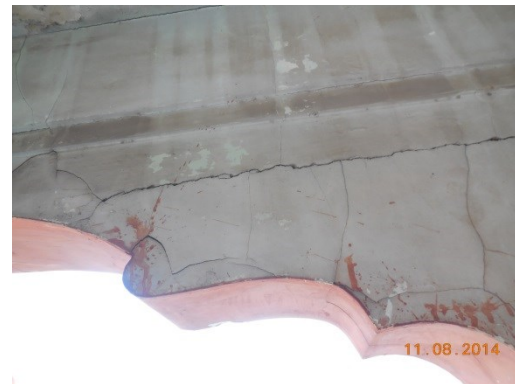
Photo 11A

Inclind Crack on Wall No.2 of Varanda No. 3 of Hind Hotel, Third floor, Approx. Width=2.5mm, Approx.Length=3.0m. Distance from Wall No.3=0.0m, Height from Floor=2.0m.

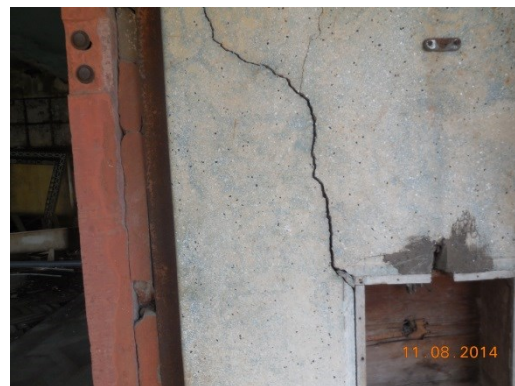
Photo 12A

Inclind Crack on Wall No.1 of Varanda No. 3 of Hind Hotel, Third floor, Approx. Width=2.5mm, Approx.Length=1.8m. Distance from Wall No.4=0.3m, Height from Floor=1.5m.

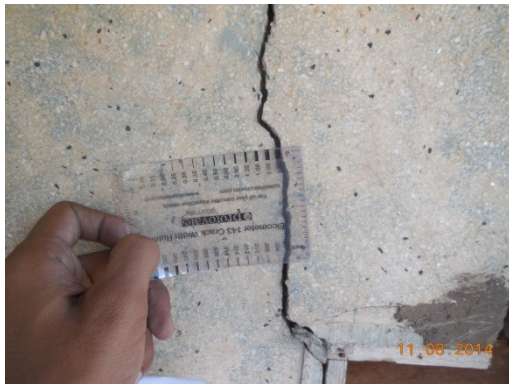
Photo 12B

Inclind Crack on Wall No.1 of Varanda No. 3 of Hind Hotel, Third floor, Approx. Width=2.5mm, Approx.Length=1.8m. Distance from Wall No.4=0.3m, Height from Floor=1.5m.

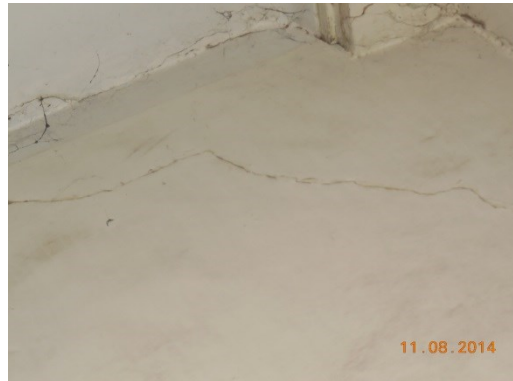
Photo 13

Inclind Crack on Wall No.1 to Roof of Room No. 3 of Hind Hotel, First floor, Approx. Width=0.8mm, Approx.Length=3.0m. Distance from Wall No.4=0.0m, Height from Floor=2.6m.

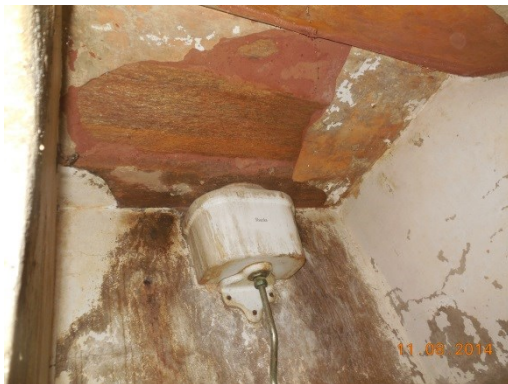
Photo 14

Plaster Removal on Roof of Toilet of Hind Hotel, Ground Floor

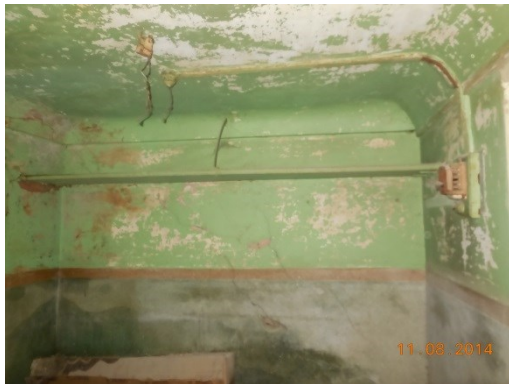
Photo 18

Seepage on All Walls of Room No. 2 of Hind Hotel, Ground Floor

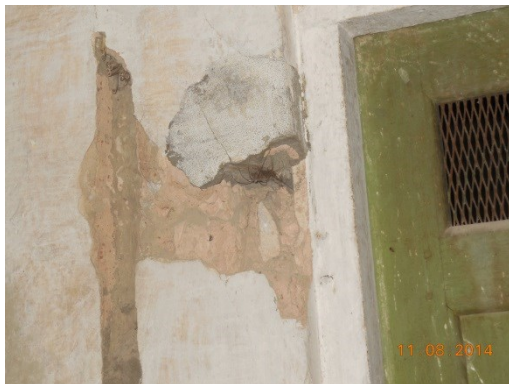
Photo 24

Plaster Removal on Wall No. 4 of Room No. 5 of Hind Hotel, Ground Floor

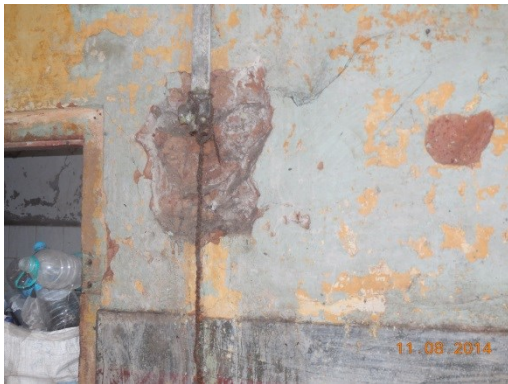
Photo 36

Plaster Removal on Wall No. 3 of Courtyard of Hind Hotel, Ground Floor

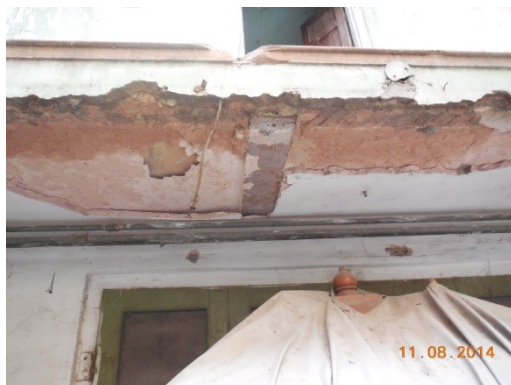
Photo 40

Damage on Shade of Courtyard of Hind Hotel, Ground Floor

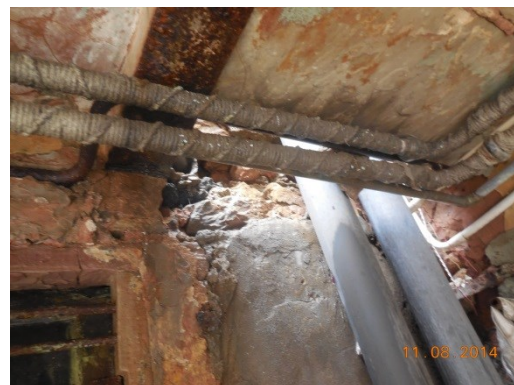
Photo 41

Plaster Removal on Roof of Staircase of Hind Hotel, Ground Floor

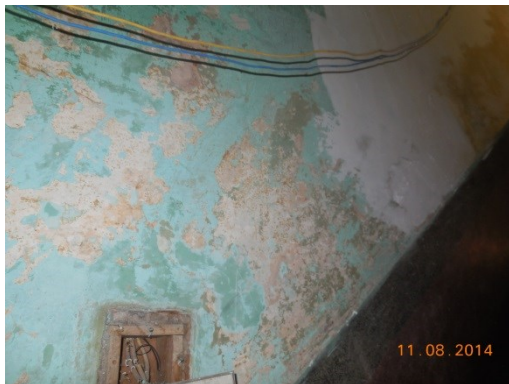
Photo 42

Seepage on Wall No. 1 of Staircase of Hind Hotel, Ground floor

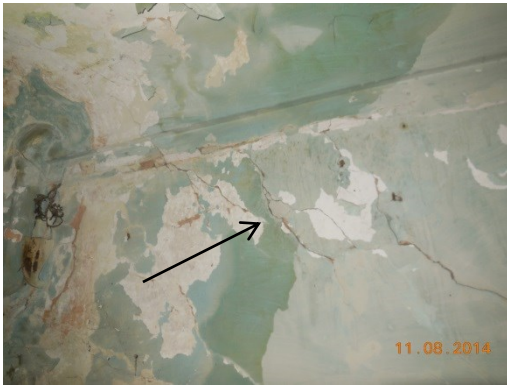
Photo 48

Plaster Removal on Wall No.1 of Room No. 1 of Hind Hotel, Mazzanin Floor

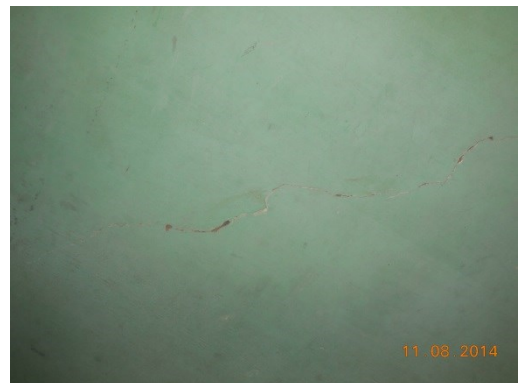
Photo 57

Plaster Crack on Wall No. 2 of Room No. 5 of Hind Hotel, Mazzanine Floor

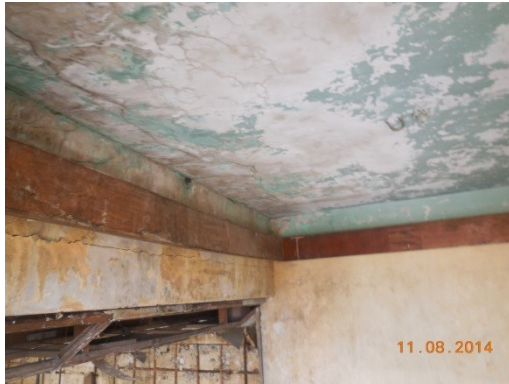
Photo 60

Plaster Removal on Wall No. 1 of Lobby of Hind Hotel, Mazzanin Floor

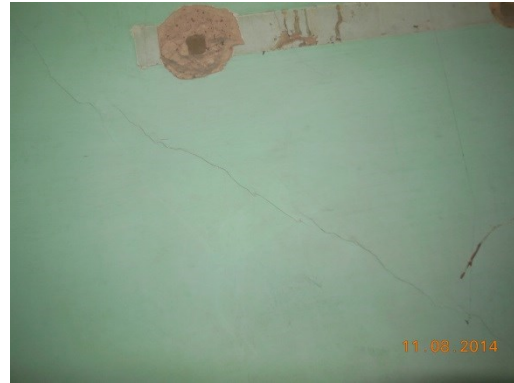
Photo 63

Plaster Crack on Wall No.4 of Room No.6 of Hind Hotel, Mazzanine Floor

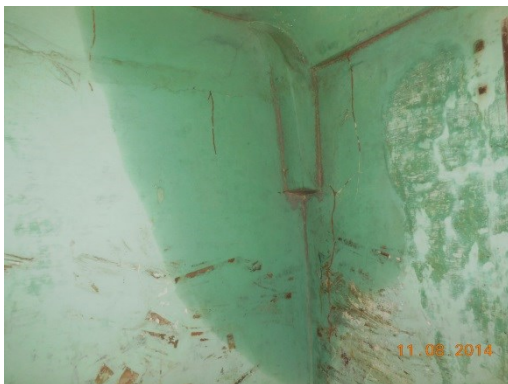
Photo 64

Seepage on Wall No. 2 & 3 of Room No.6 of Hind Hotel, Mazzanine Floor

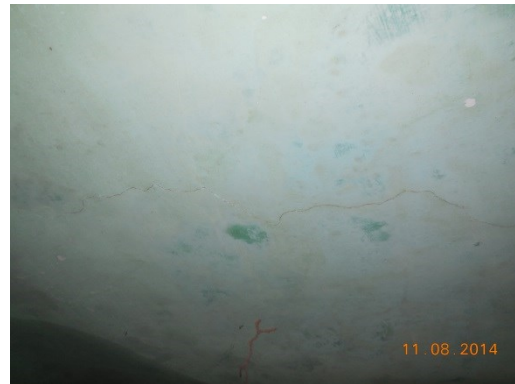
Photo 65

Plaster Crack on Roof of Room No.6 of Hind Hotel, Mazzanine Floor

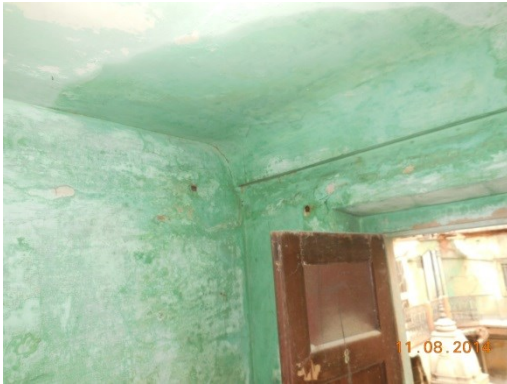
Photo 66

Seepage on Wall No.2 & 3 of Room No.7 of Hind Hotel,
Mazzanine Floor

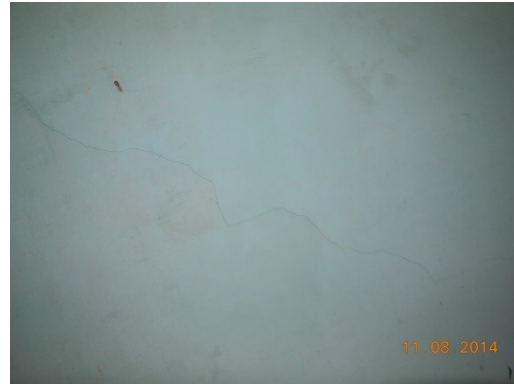
Photo 67

Plaster Crack on Wall No.1 of Room No.7 of Hind Hotel,
Mazzanine Floor

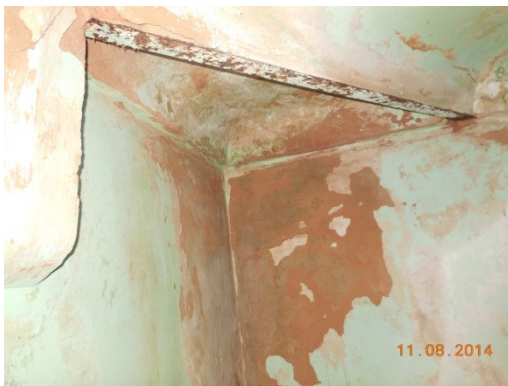
Photo 68

Seepage on Wall No. 2,3 & Roof of Room No.8 of Hind Hotel,
Mazzanine Floor

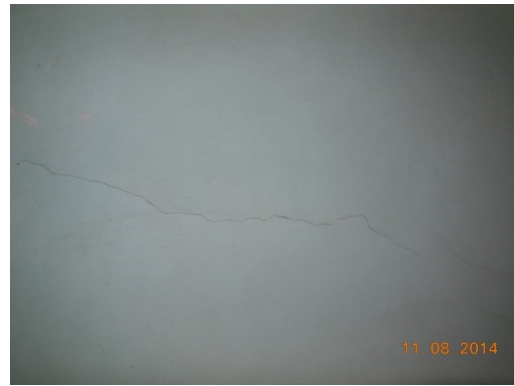
Photo 69

Plaster Crack on Wall No.1 of Room No.8 of Hind Hotel,
Mazzanine Floor

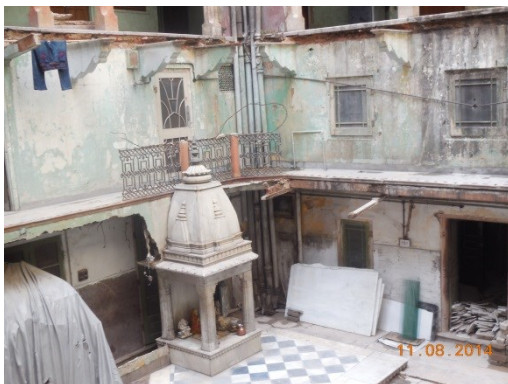
Photo 70

Damage on Railing of Corridor of Hind Hotel, Mazzanine Floor

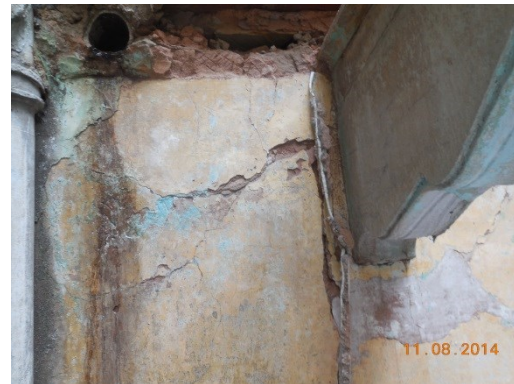
Photo 71

Damage on Wall No.1 of Corridor of Hind Hotel, Mazzanine Floor

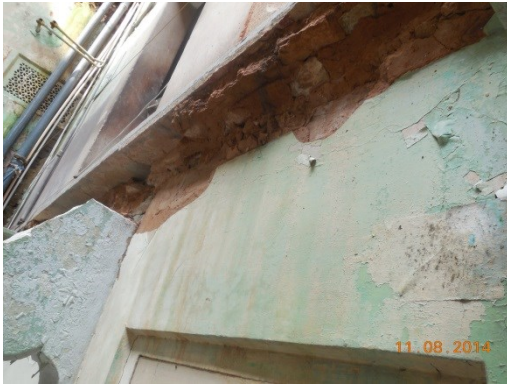
Photo 72

Damage on Wall No.3 of Corridor of Hind Hotel, Mezzanine Floor

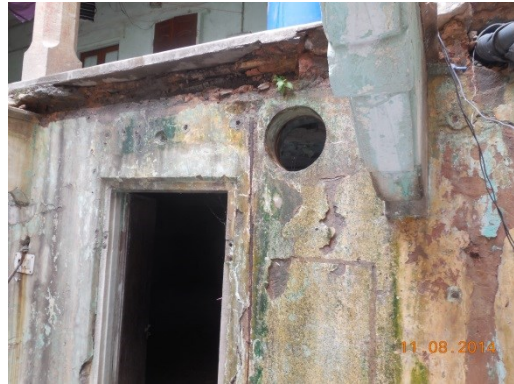
Photo 73

Seepage on Wall No.2 of Corridor of Hind Hotel, Mezzanine Floor

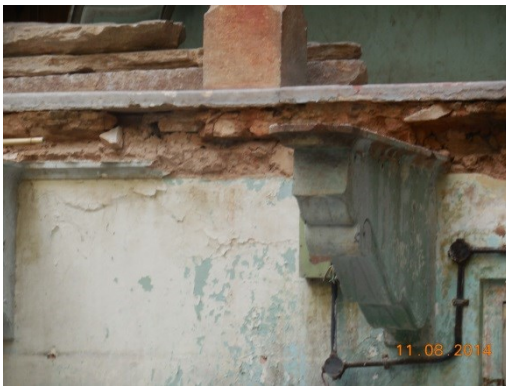
Photo 74

Damage on Wall No.4 of Corridor of Hind Hotel, Mezzanine Floor

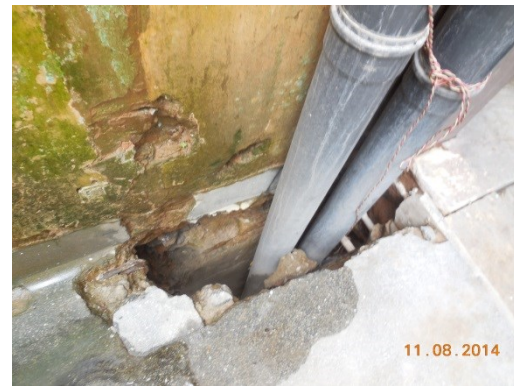
Photo 75

Damage on Floor of Corridor of Hind Hotel, Mezzanine Floor

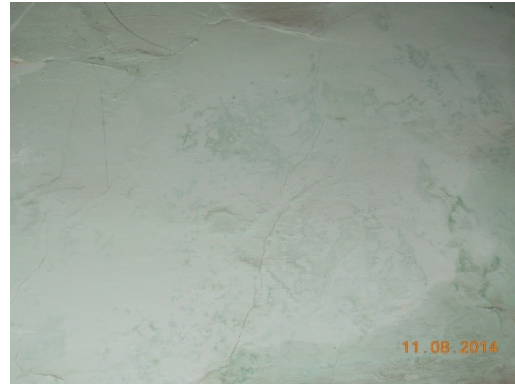
Photo 79

Plaster Crack on Wall No. 3 of Varanda No. 3 of Hind Hotel, First Floor

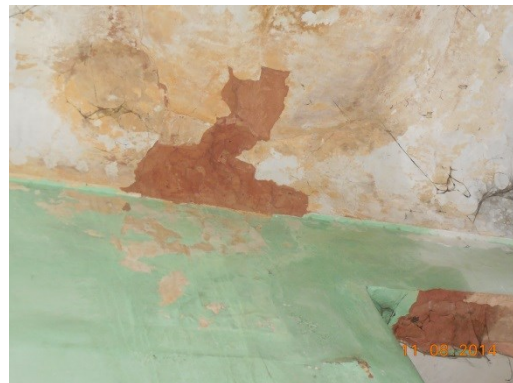
Photo 87

Plaster Crack on Roof of Varanda No. 4 of Hind Hotel,,
First Floor

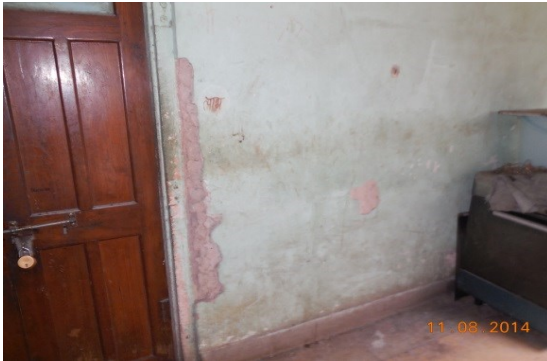
Photo 90

Plaster Removal on Wall No. 4 of Varanda No. 4 of Hind Hotel, First Floor

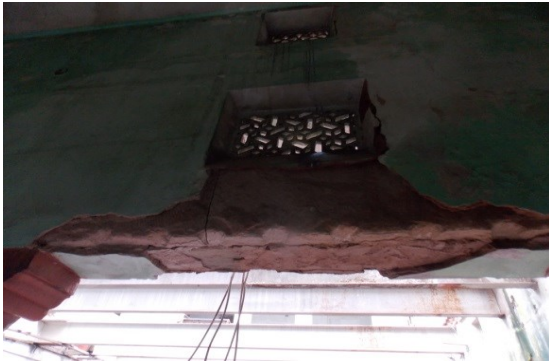
Photo 96

Plaster Removal on Wall No. 2 of Varanda No. 2 of Hind Hotel, First Floor

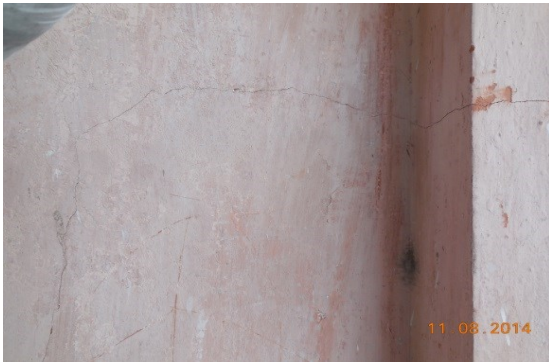
Photo 98

Plaster Crack on Wall No. 1 of Balcony of Room No. 3 of Hind Hotel, Second Floor

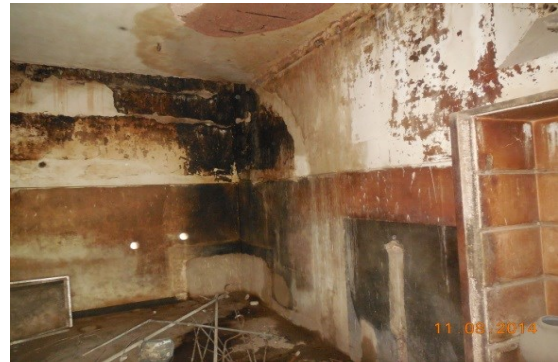
Photo 99

Seepage on Wall No. 2 & 4 of Room No. 7 of Hind Hotel, Second Floor

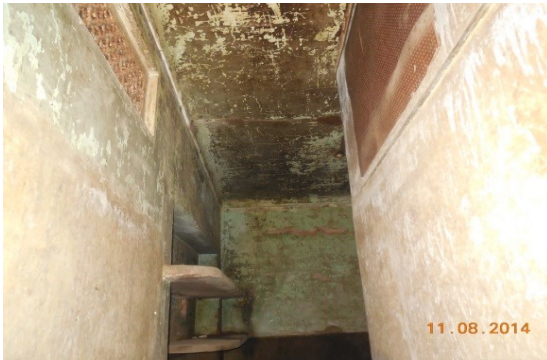
Photo 102
Seepage on All Walls & Roof of Toilet & Bath of Room No.7,
Second Floor

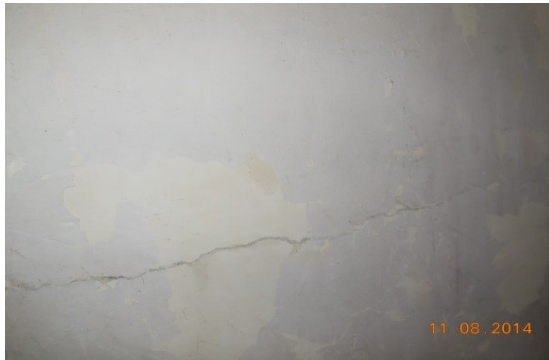
Photo 108

Peeling of Plaster on Wall No. 6 of Room No. 13 of Hind Hotel, Second Floor

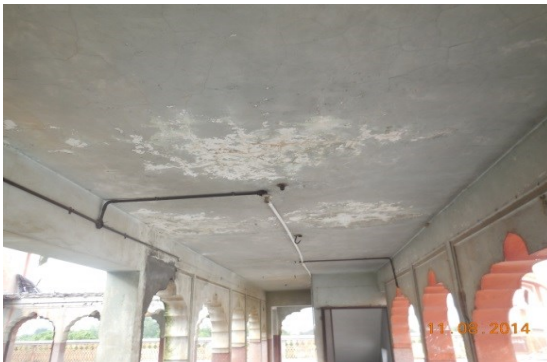
Photo 114
Seepage on Roof of Varanda No. 1 of Hind Hotel,
Third Floor

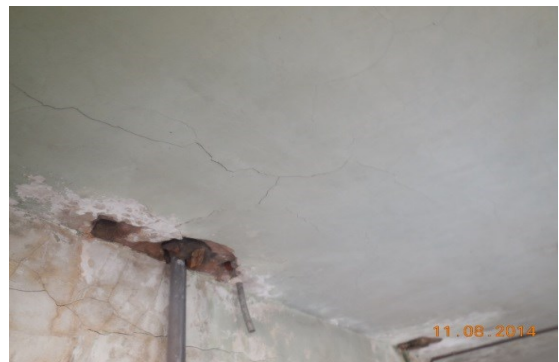
Photo 115
Plaster Crack on Roof of Varanda No. 2 of Hind Hotel,
Third Floor

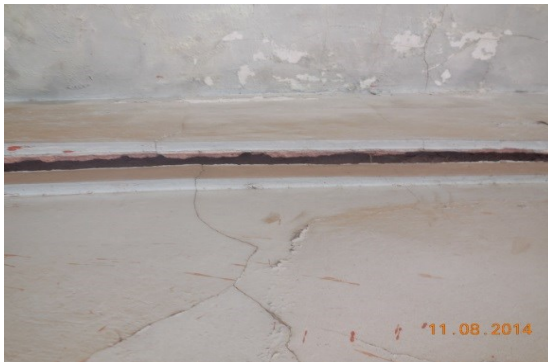
Photo 116
Plaster Removal on Wall No.4 of Varanda No. 3 of Hind Hotel
Third Floor

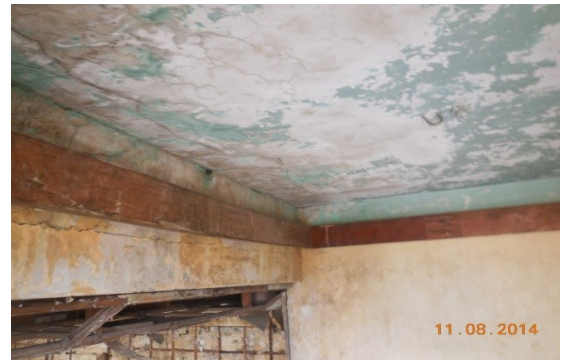
Photo 119
Seepage on Roof of Room No. 1 of Hind Hotel,
Terrace

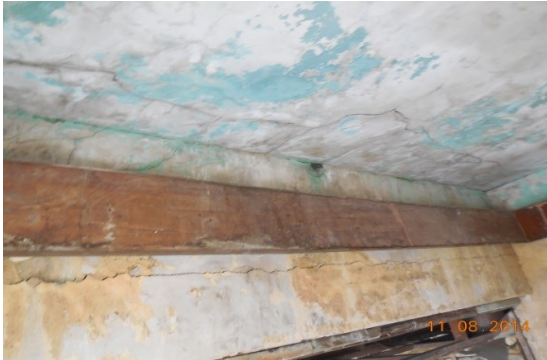
Photo 120
Damage on Wall No.2 & 3 of Room No. 1 of Hind Hotel, Terrace

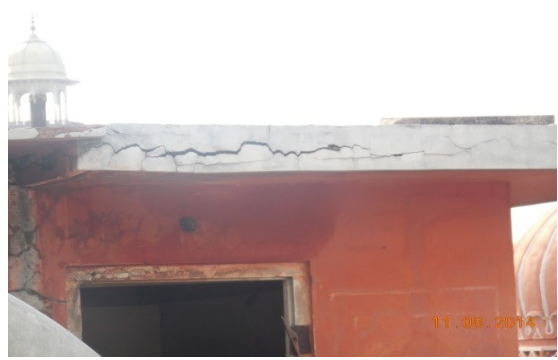
Photo 121
Damage on Shade of Room No. 1 of Hind Hotel, Terrace

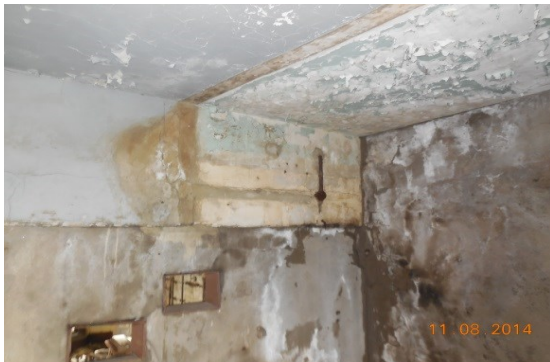
Photo 122
Seepage on All Walls & Roof of Room No. 2 of Hind Hotel, Terrace

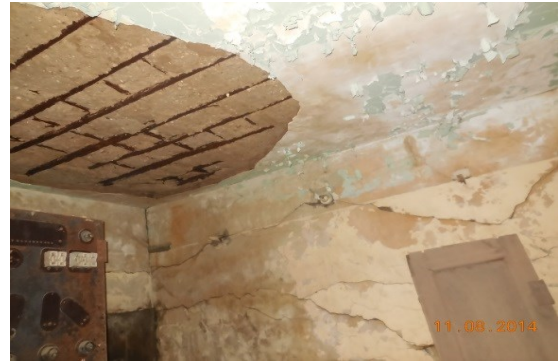
Photo 123
Damage on Wall No. 4 & Roof of Room No. 3 of Hind Hotel, Terrace

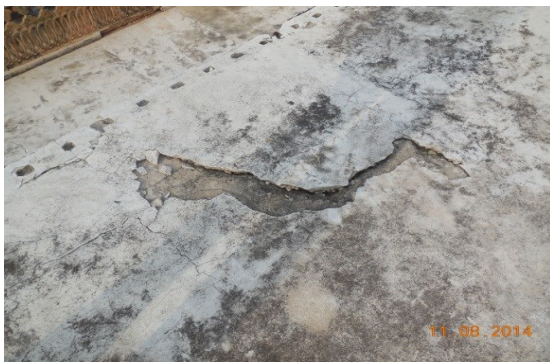
Photo 124
Damage on Floor of Terrace of Hind Hotel

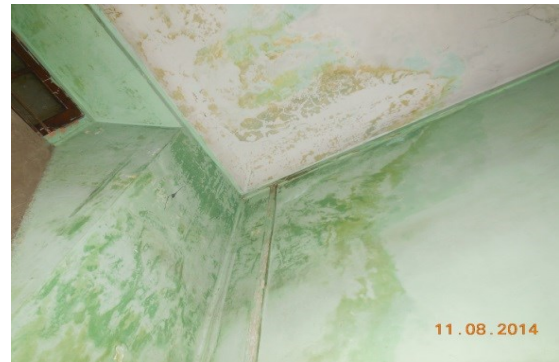
Photo 125
Seepage on Wall No. 1 & Roof of Room No. 2 of Hind Hotel,
First Floor

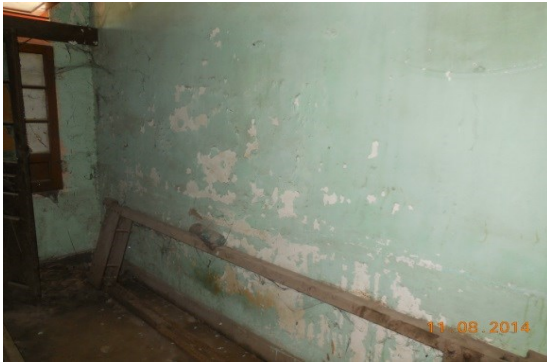
Photo 126

Peeling of Plaster on Wall No. 2 of Room No. 2 of Hind Hotel, First Floor

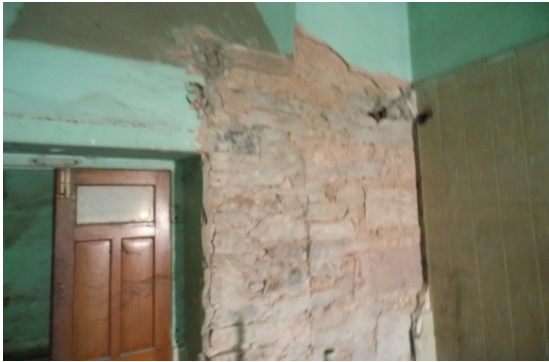
Photo 132

Plaster Removal on Wall No. 3 of Room No. 5 of Hind Hotel, First Floor

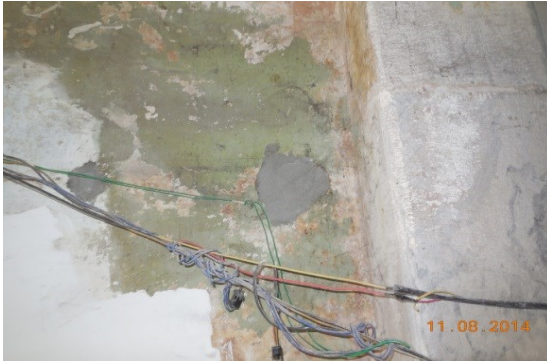
Photo 138

Repair Work on Wall No. 2 of of Passage of Hind Hotel,
Ground Floor

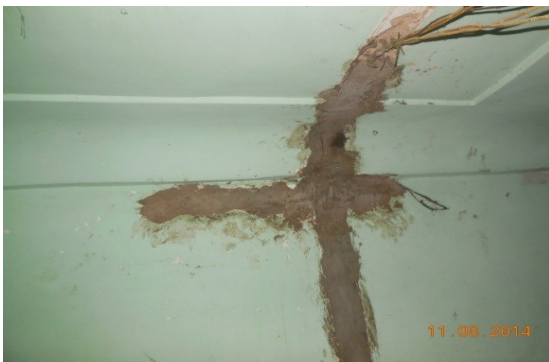
Photo 142

Repair Work on Wall No. 4 & Roof of Room No. 3 of Hind Hotel,
Mazzanin Floor
