Pre - Condition Building Survey for Construction of Underground Stations from Chandpole to Bari Chouper and reversal line

Shops
Chandpol Bazar
Jaipur
Unique ID: CP-CC-DL-0151

Report Number: AIMIL/ESG/JMCEC/CP-CC-DL-0151/03/Verandah, Rev. 02, Dated: October, 2014

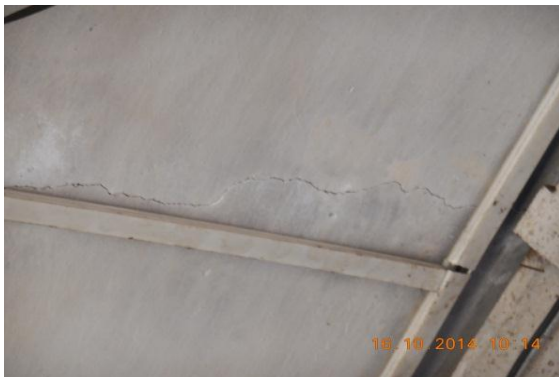
Photo 17
Horizontal Crack on Roof of Varanda of Shop No.263,(G. Floor)
Approx. Width = 0.25mm, Approx.Length = 2.0m.
Distance from R.Int.Col. =1.80m, Height from Floor =2.80m.

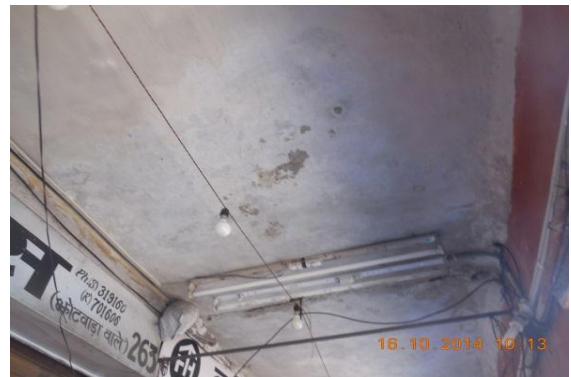
Photo 18
Dampness/Seepage on Roof of Verandah of S.No.263,
Ground Floor

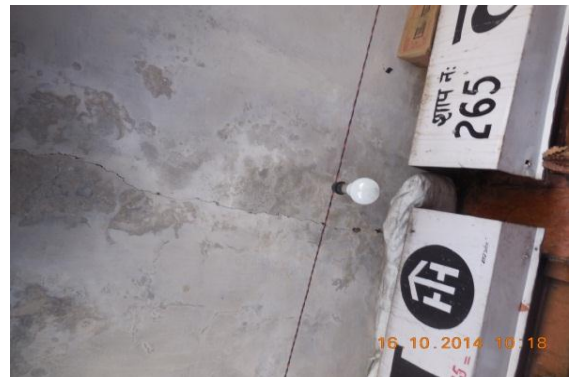
Photo 22

Inclined Crack on Roof & R.Int.Col. of Verandah of S.No.264, (G.F.),
Approx. Width = 0.80mm, Approx.Length = 2.60m.
Distance from R.Int.Col. = 0m, Height from Floor = 2.80m.

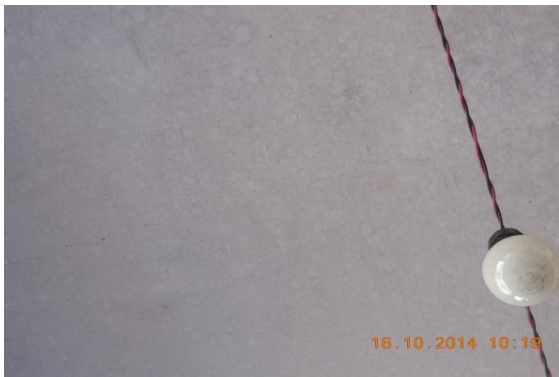
Photo 27

Plaster Crack on Roof of Verandah of S.No.265, Ground Floor

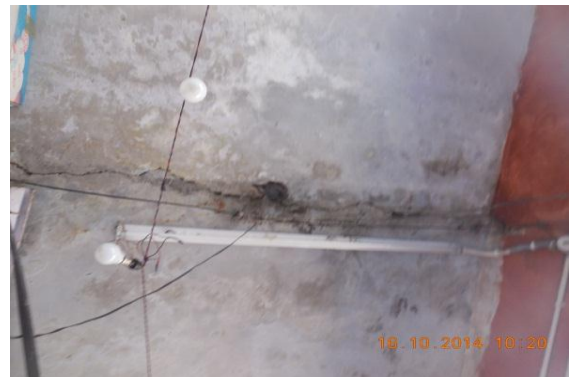
Photo 28

Horizontal Crack on Roof of Verandah of S.No.266, (G.F.), Approx. Width = 1.50mm, Approx.Length = 2.0m. Distance from L.Ext.Col. = 0m, Height from Floor = 2.80m.

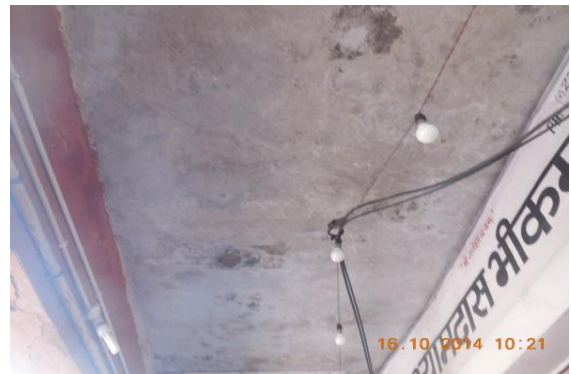
Photo 30

Dampness/Seepage on Roof of Verandah of S.No.266, Ground Floor

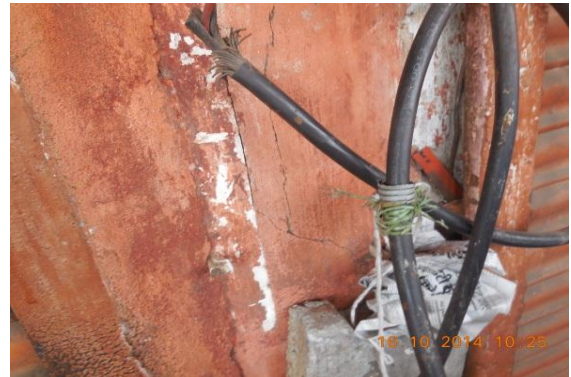
Photo 32
Inclined Crack on Left Int. Col. of Verandah of S.No.267, (G.F.),
Approx. Width = 0.25mm, Approx.Length = 1.0m.
Distance from L.Int.Col. = 0m, Height from Floor = 0.60m.

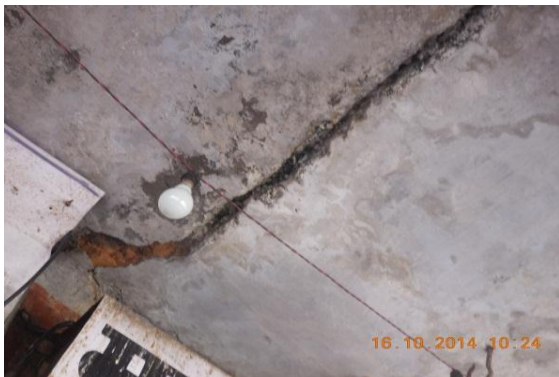
Photo 33
Plaster Removal on Roof of Verandah of S.No.267,
Ground Floor

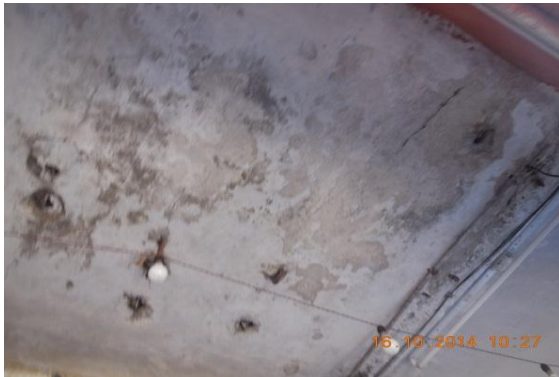
Photo 37
Dampness/Seepage on Roof of Verandah of S.No.268,
Ground Floor

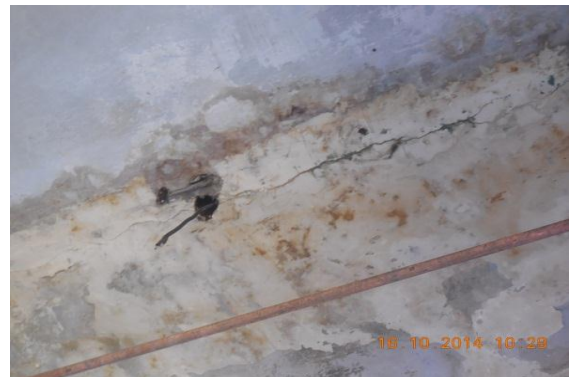
Photo 40
Horizontal Crack on Roof of Verandah of S.No.270,(G. Floor)
Approx. Width = 0.25mm, Approx.Length = 2.0m.
Distance from L.Ext.Col. =0m, Height from Floor =2.80m.

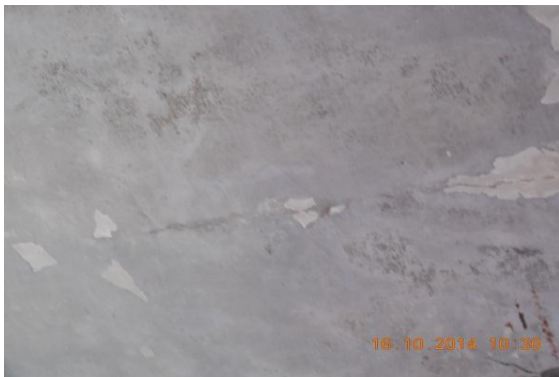
Photo 41
Horizontal Crack on Roof of Verandah of S.No.270,(G. Floor)
Approx. Width = 0.15mm, Approx.Length = 2.0m.
Distance from L.Ext.Col. =1.10m, Height from Floor =2.80m.

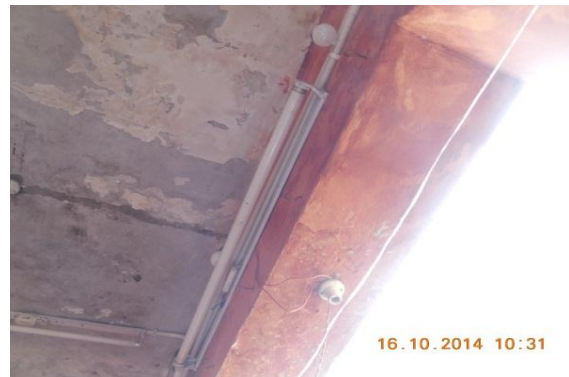
Photo 42
Dampness/Seepage on Ext. Beam & Roof of Verandah of S.No.270,G.
Floor

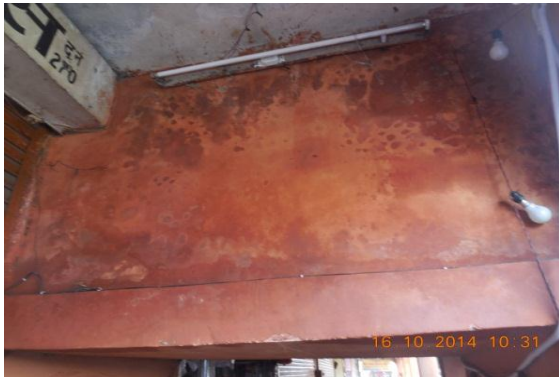
Photo 43

Dampness/Seepage on Wall No.2 of Verandah of S.No.270, Ground Floor

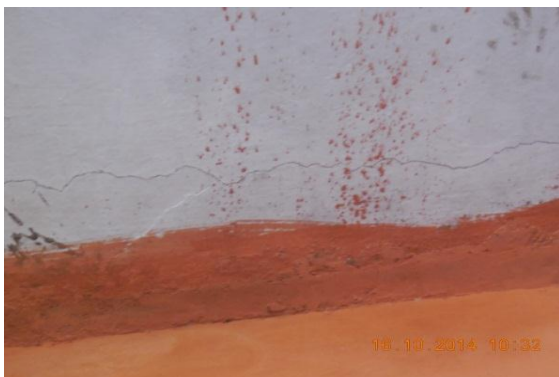
Photo 45

Horizontal Crack on Roof of Varanda of S.No.271,(G.F.)
Approx. Width = 0.40mm, Approx.Length = 2.0m.
Distance from L.Ext.Col. = 0m, Height from Floor = 2.8m.

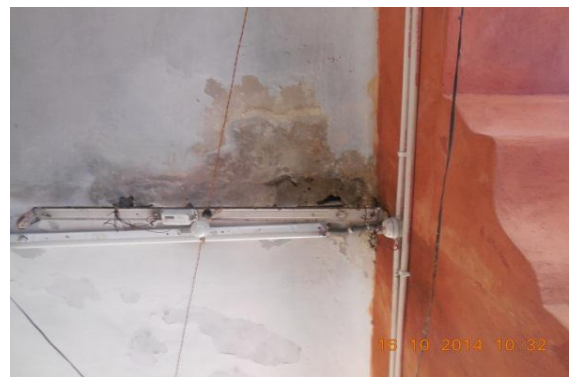
Photo 46

Dampness/Seepage on Roof of Verandah of S.No.271, Ground Floor

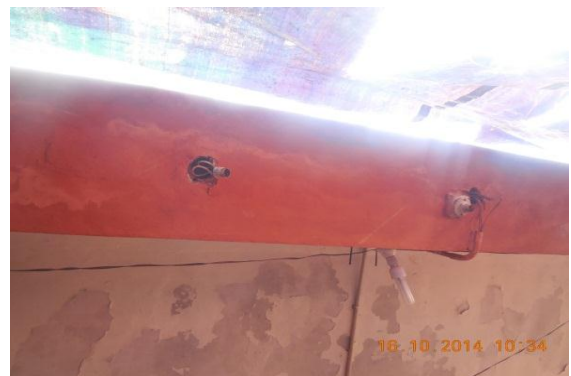
Photo 48

Peeling of Plaster on Roof of Verandah of S.No.272, Ground Floor

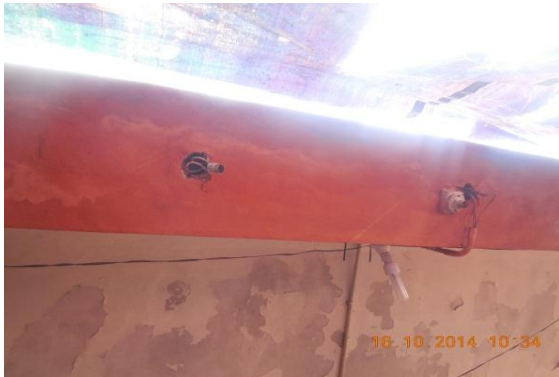
Photo 49
Dampness/Seepage on Ext. Beam of Verandah of S.No.272,
Ground Floor

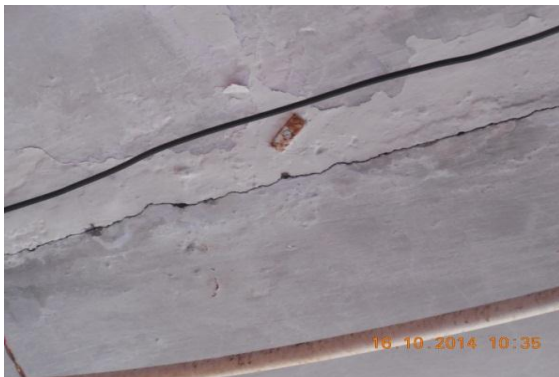
Photo 51
Horizontal Crack on Roof of Verandah of S.No.273,(G.F.)
Approx. Width = 1.0mm, Approx.Length = 2.0m.
Distance from L.Ext.Col. =0m, Height from Floor =2.8m.

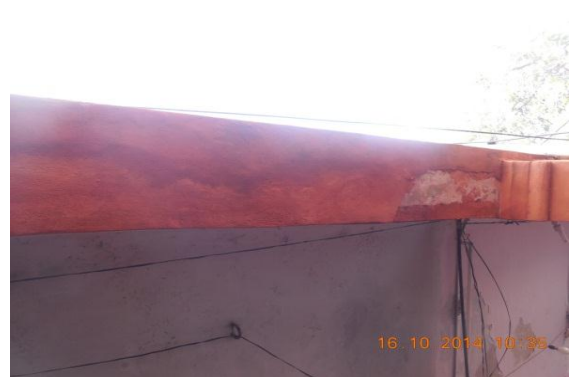
Photo 52
Dampness/Seepage on Ext.Beam of Verandah of S.No.273,, Ground
Floor

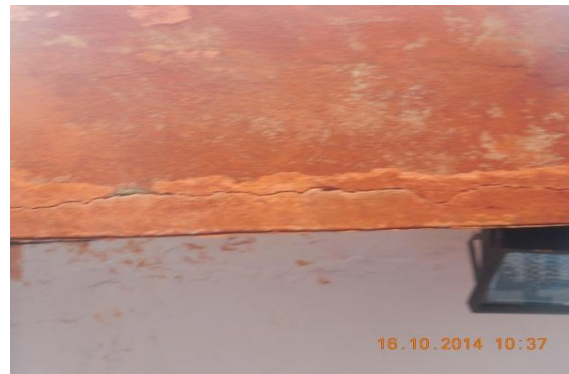
Photo 54
Horizontal Crack on Ext.Beam of Verandah of S.No.274,(G.F.)
Approx. Width = 0.80mm, Approx.Length = 1.50m.
Distance from R.Ext.Col. =0.40m, Height from Floor =2.0m.

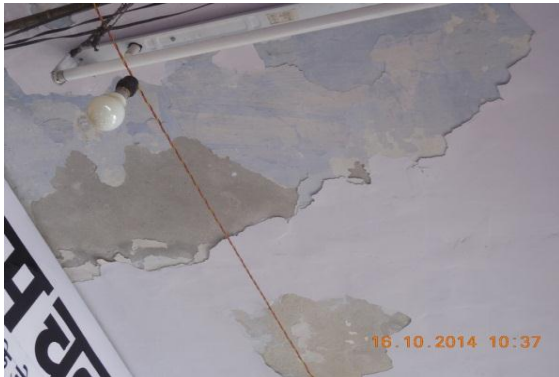
Photo 55

Peeling of Plaster on Roof of Verandah of S.No.274, Ground Floor

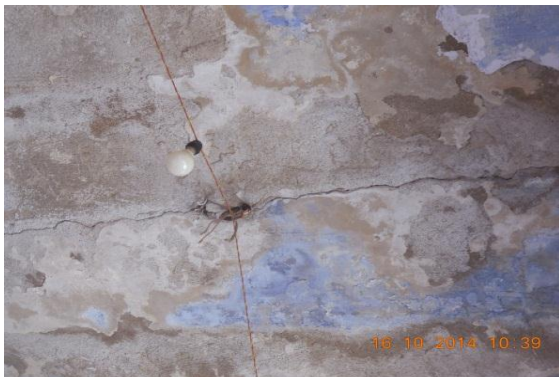
Photo 57

Horizontal Crack on Roof of Verandah of S.No.275, Ground Floor
Approx. Width = 0.40mm, Approx.Length = 2.0m.
Distance from R.Int.Col. = 1.20m, Height from Floor = 2.8m.

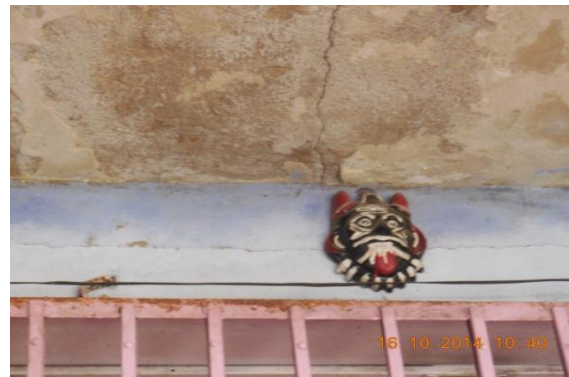
Photo 58

Horizontal Crack on Int. Beam of Verandah of S.No.275, G.Floor
Approx. Width = 0.35mm, Approx.Length = 3.0m.
Distance from L.Int.Col. = 1.20m, Height from Floor = 2.7m.

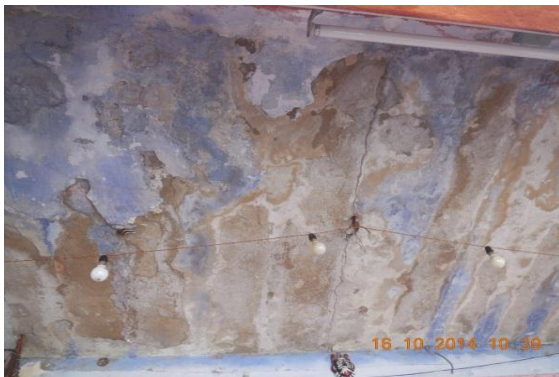
Photo 59

Dampness/Seepage on Roof of Verandah of S.No.275, Ground Floor

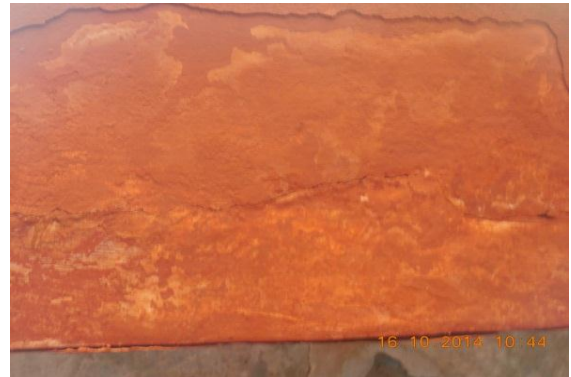
Photo 62

Horizontal Crack on Ext.Beam of Verandah of S.No.276,G. Floor
Approx. Width =0.40mm, Approx.Length = 2.0m.
Distance from R.Ext. Col. =0.50m, Height from Floor =2.5m.

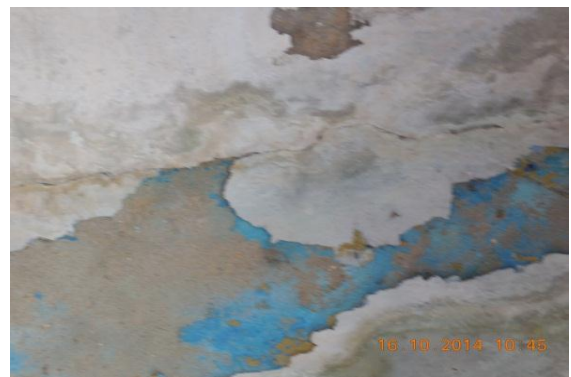
Photo 64

Horizontal Crack on Roof of Verandah of S.No.276,Ground Floor
Approx. Width =0.40mm, Approx.Length = 2.0m.
Distance from R.Ext. Col. =0.35m, Height from Floor =2.5m.

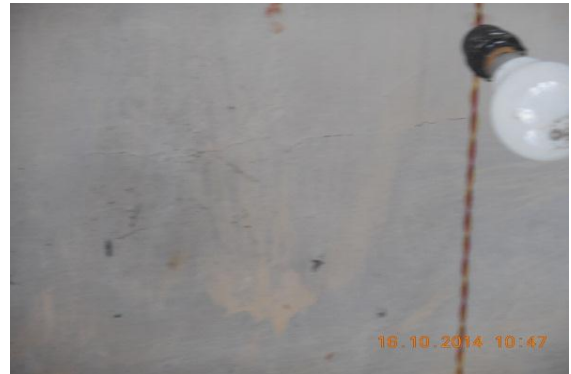
Photo 68

Horizontal Crack on Roof of Verandah of S.No.277,Ground Floor
Approx. Width =0.15mm, Approx.Length = 2.0m.
Distance from L.Int. Col. =0m, Height from Floor =2.8m.

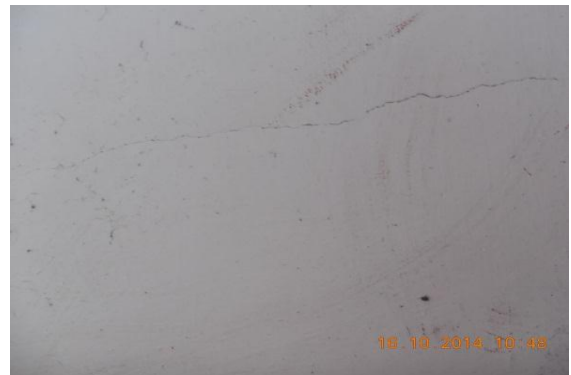
Photo 70

Plaster Crack on Roof of Verandah of S.No.277,Ground Floor

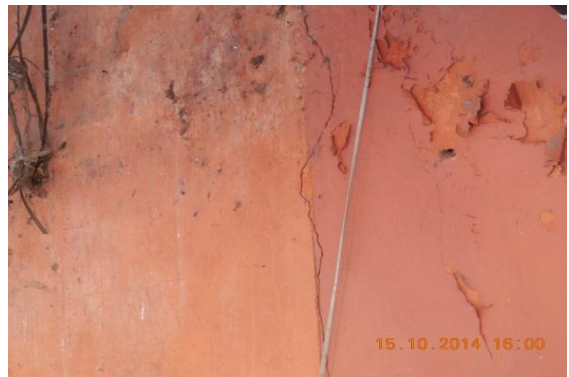
Photo 36
Inclined Crack on Wall No.4 of Varanda of Shop No.241,(G. Floor)
Approx. Width = 1.0mm, Approx.Length = 1.30m.
Distance from Entry Gate =1.10m, Height from Floor =1.50m.

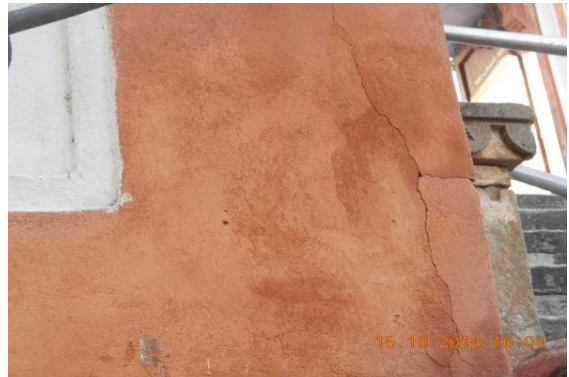
Photo 38

Inclined Crack on Right Ext.Col of Varanda of S.No.242,,(G. Floor)
Approx. Width = 0.8mm, Approx.Length = 1.20m.
Distance from R.Ext.Col. =0m, Height from Floor =2.0m.

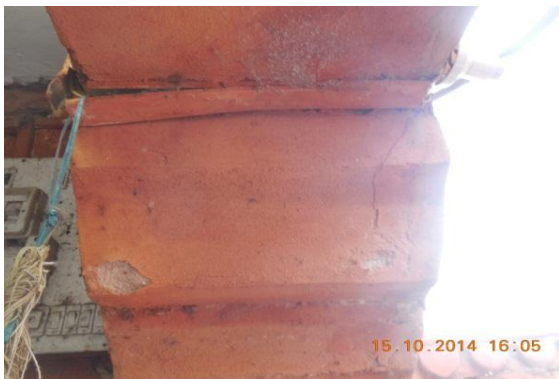
Photo 39

Inclined Crack on Ext. Beam of Varanda of S.No.242,(G. Floor)
Approx. Width = 0.6mm, Approx.Length = 0.30m.
Distance from R.Ext.Col. =0.2m, Height from Floor =2.0m.

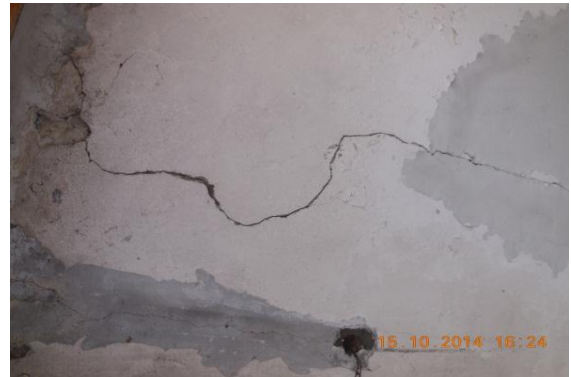
Photo 61

Inclined Crack on Roof of Varanda of S.No.246,Ground Floor
Approx. Width =2.0mm, Approx.Length = 2.0m.
Distance from L.Ext. Col. =0.50m, Height from Floor =2.8m.

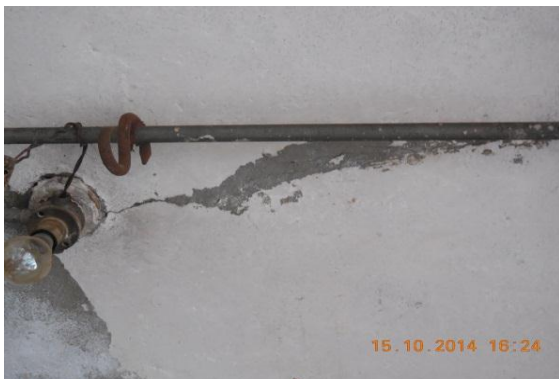
Photo 62

Horizontal Crack on Roof of Varanda of S.No.246,Ground Floor
Approx. Width = 0.40mm, Approx.Length = 1.80m.
Distance from R.Ext. Col. =0.80m, Height from Floor =2.8m.

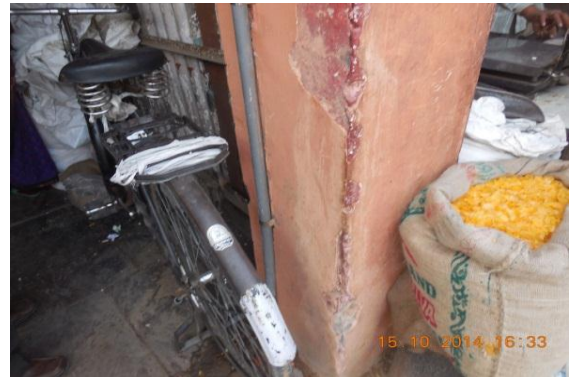
Photo 67

Plaster Removal on Right Ext.Col. of Varanda of S.No.246, Ground Floor

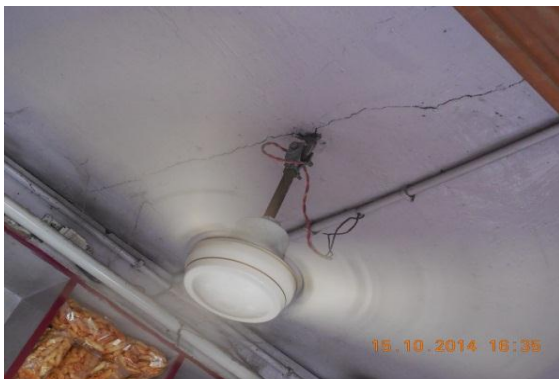
Photo 68

Horizontal Crack on Roof of Varanda of S.No.247, Ground Floor
Approx. Width = 1.0mm, Approx.Length = 1.80m.
Distance from R.Ext. Col. = 0.80m, Height from Floor = 2.8m.

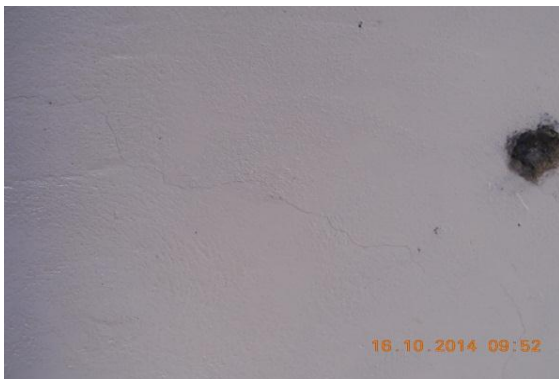
Photo 85

Plaster Crack on Roof of Verandah of S.No.252, Ground Floor

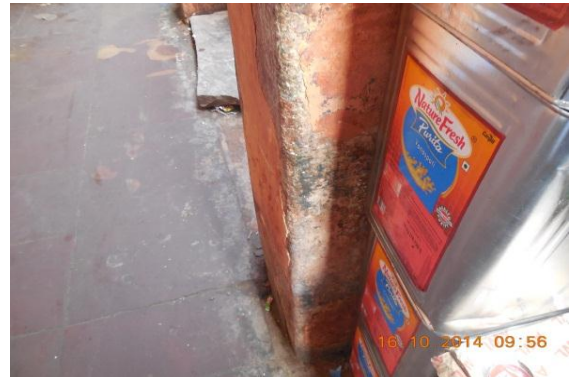
Photo 96

Plaster Crack on Left Ext.Col of Verandah of S.No.254, Ground Floor

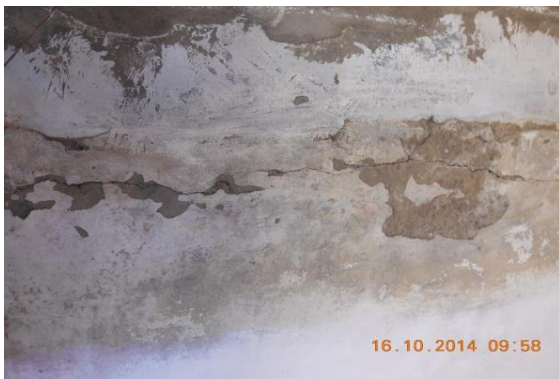
Photo 97

Horizontal Crack on Roof of Verandah of S.No.255, G.Floor
Approx. Width = 1.0mm, Approx.Length = 1.80m.
Distance from L.Ext. Col. = 0m, Height from Floor = 2.8m.

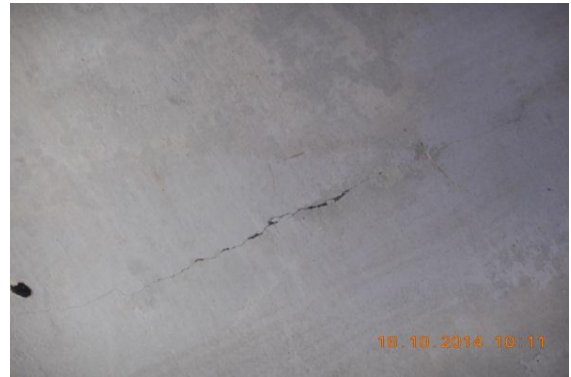
Photo 119
Plaster Crack on Roof of Verandah of S.No.262,
Ground Floor
