**JAIPUR METRO Jaipur Metro Rail Corporation**

Pre - Condition Building Survey for Construction of Underground Stations from Chandpole to Bari Chouper and reversal line

Shops  
Chandpol Bazar  
Jaipur  
Unique ID: CP-CC-UP-0071

Report Number: AIMIL/ESG/JMCEC/CP-CC-UP-0071/02/Verandah, Rev. 02, Dated: October, 2014

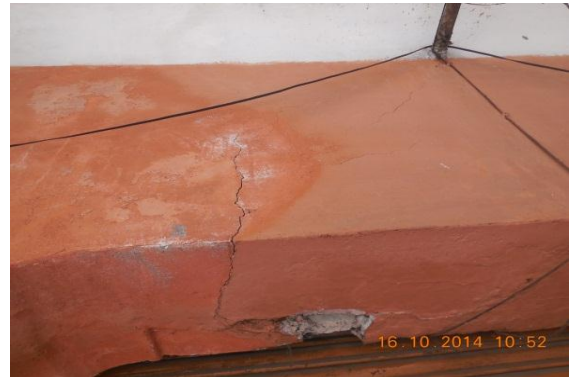
Photo 8  
Horizontal Crack on Int. Beam of Verandah of S.No.189,(G. Floor)  
Approx. Width = 2.0mm, Approx.Length = 1.4m.  
Distance from L.Int.Col. =0.50m, Height from Floor =2.10m.

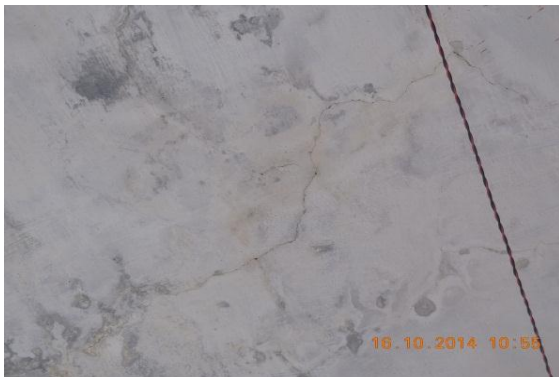
Photo 9  
Horizontal Crack on Roof of Verandah of S.No.189,(G. Floor)  
Approx. Width = 0.15mm, Approx.Length = 1.5m.  
Distance from Wall No.3 =0m, Height from Floor =2.50m.

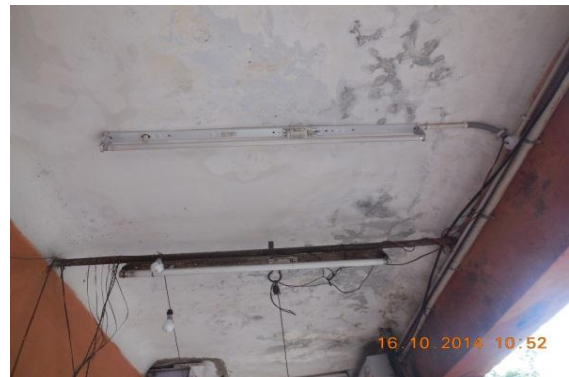
Photo 10  
Dampness/Seepage on Roof of Verandah of S.No.189,  
Ground Floor

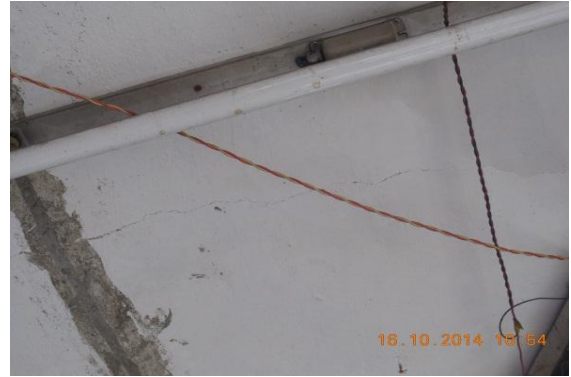
Photo 14

Horizontal Crack on Roof of Verandah of S.No.190,(G. Floor)  
Approx. Width = 0.15mm, Approx.Length = 2.0m.  
Distance from Ext. Beam =0m, Height from Floor =2.80m.

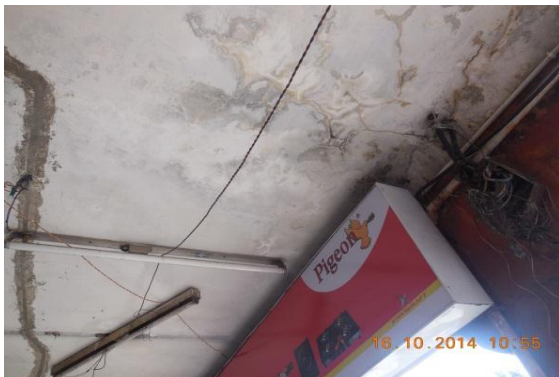
Photo 15

Dampness/Seepage on Roof of Verandah of S.No.190,  
Ground Floor

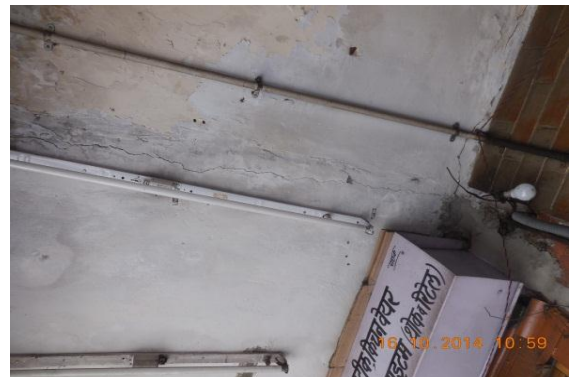
Photo 16A

Horizontal Crack on Roof of Verandah of S.No.191,(G. Floor)  
Approx. Width = 0.25mm, Approx.Length = 4.0m.  
Distance from L.Ext.Col. =0m, Height from Floor =2.80m.

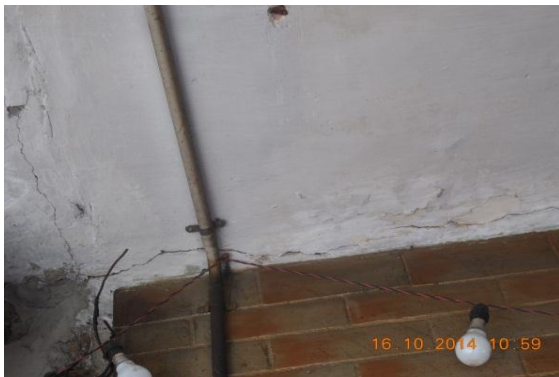
Photo 16B

Horizontal Crack on Roof of Verandah of S.No.191,(G. Floor)  
Approx. Width = 0.25mm, Approx.Length = 4.0m.  
Distance from L.Ext.Col. =0m, Height from Floor =2.80m.

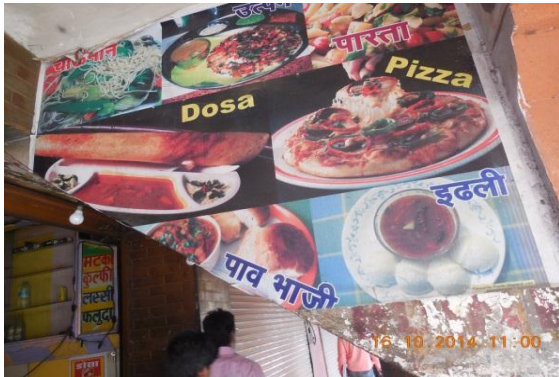
Photo 18

Covered with Plastic Cover, Wall No.2 of Verandah of S.No.191,  
Ground Floor

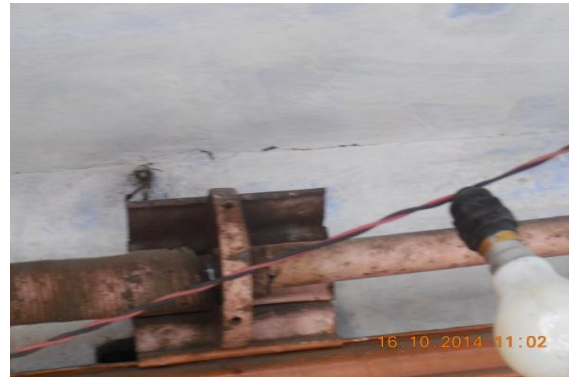
Photo 19

Horizontal Crack on Int. Beam of Verandah of S.No.192,(G.F.)  
Approx. Width = 0.25mm, Approx.Length = 2.30m.  
Distance from Left Int.Col.=0.0m, Height from Floor =2.80m.

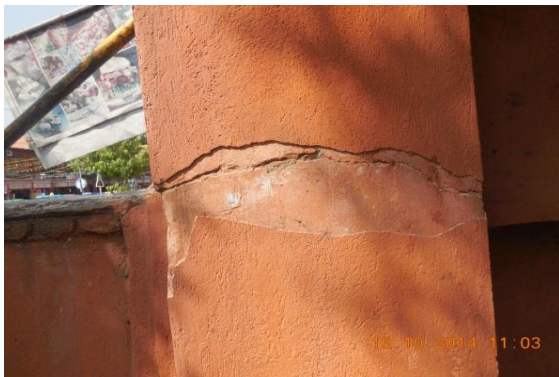
Photo 20

Horizontal Crack on Left Ext.Col. of Verandah of S.No.192,(G.F.)  
Approx. Width = 0.25mm, Approx.Length = 0.40m.  
Distance from Left Ext.Col.=0.0m, Height from Floor =1.60m.

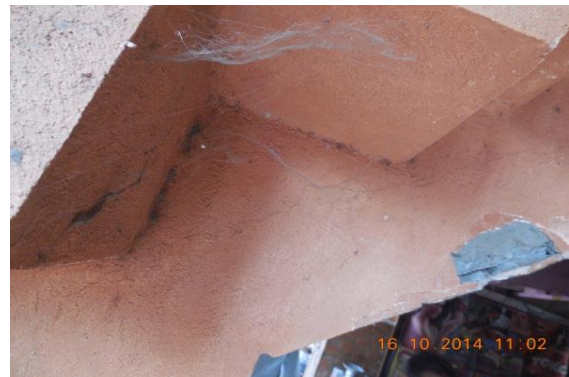
Photo 23

| Summary of Defects Other Than Crack | | | |
|---|---|---|---|
| 8 | Wall No.1 of Verandah of S.No.192,Ground Floor | Plaster Crack | 23 |

Plaster Crack on Wall No.1 of Verandah of S.No.192,  
Ground Floor

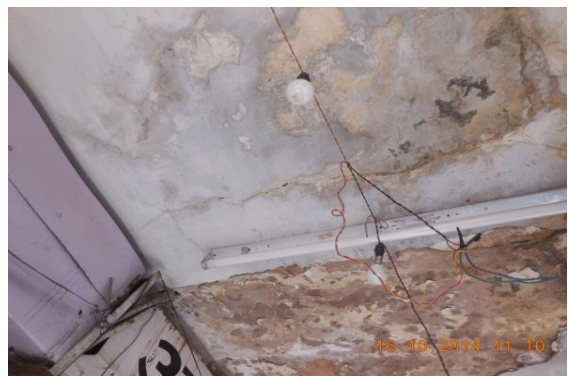
Photo 29  
Horizontal Crack on Roof of Verandah of S.No.194,(G.F.), Approx.  
Width = 0.25mm, Approx.Length = 2.10m.  
Distance from R.Ext.Col. =0m, Height from Floor =2.80m.

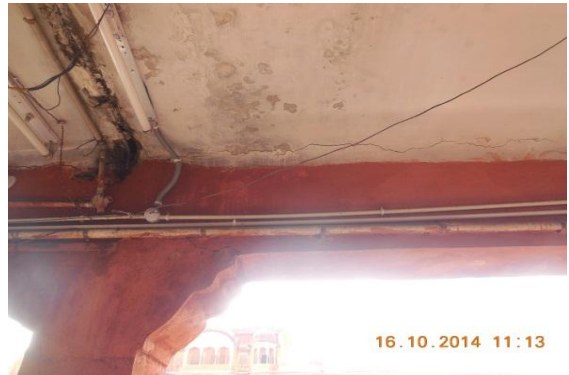
Photo 35

Inclined Crack on Roof & Beam of Verandah of S.No.195, (G.F.),  
Approx. Width = 1.50mm, Approx.Length = 3.0m.  
Distance from Left Ext.Col. = 0m, Height from Floor = 2.80m.

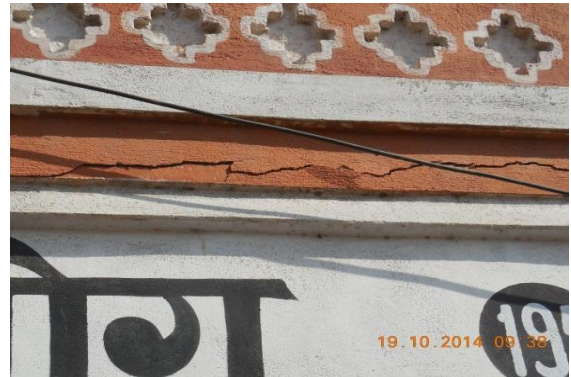
Photo 37A

Horizontal Crack on Outer Ext.Beam of Verandah of  
S.No.195&196, (G.F.), Approx. Width=2.0mm, Approx.Length=4.0m.  
Distance from Right Ext.Col. = 0m, Height from Floor = 2.50m.

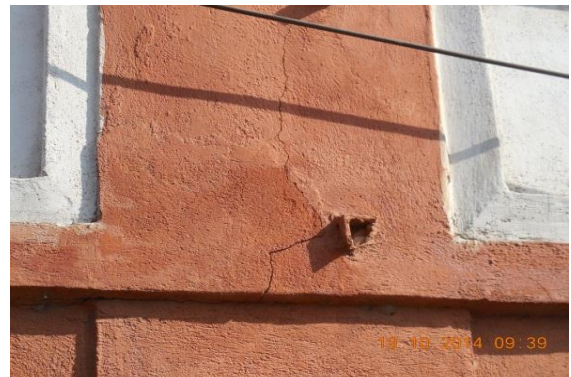
Photo 38

Inclined Crack on Outer R.Ext.Col. of Verandah of S.No.195, (G.F.),  
Approx. Width = 1.0mm, Approx.Length = 0.70m.  
Distance from R.Ext. Col. = 0m, Height from Floor = 2.0m.

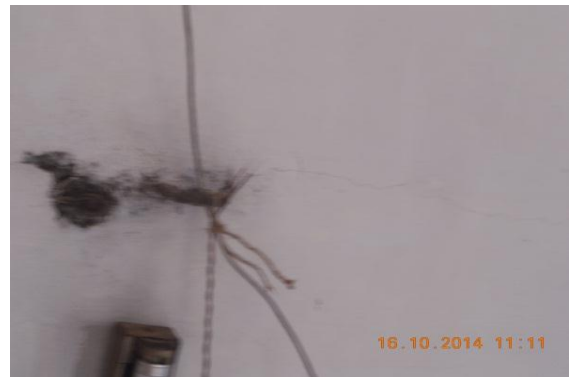
Photo 40

| Summary of Defects Other Than Crack | | | |
|---|---|---|---|
| 18 | Roof of Verandah of S.No.195,G.Floor | Plaster Crack | 40 |

Plaster Crack on Roof of Verandah of S.No.195,  
Ground Floor

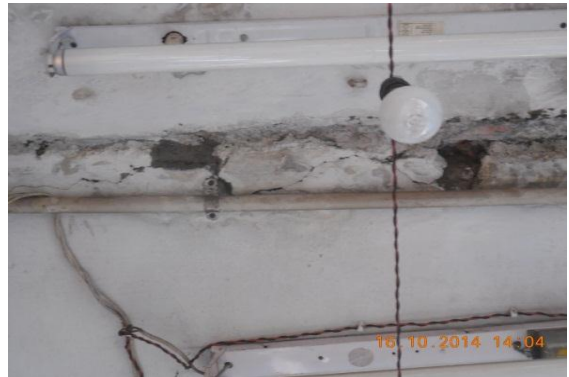
Photo 8

Horizontal Crack on Roof of Verandah of S.No.196,(G. Floor)  
Approx. Width = 0.35mm, Approx.Length = 1.8m.  
Distance from L.Ext.Col. =1.8m, Height from Floor =2.8m.

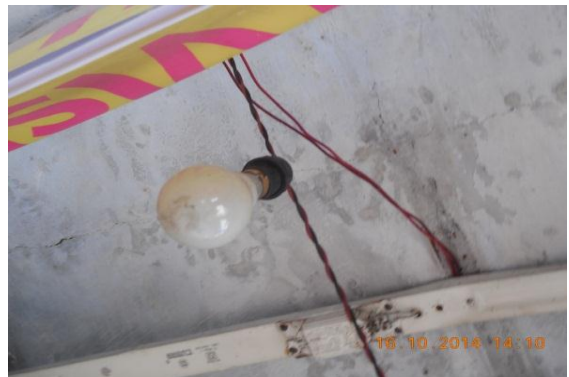
Photo 10

Horizontal Crack on Roof of Veranda of Ganpati Guest House,(GF)  
Approx. Width = 0.25mm, Approx.Length = 1.8m.  
Distance from L.Ext.Col. =0.4m, Height from Floor =2.5m.

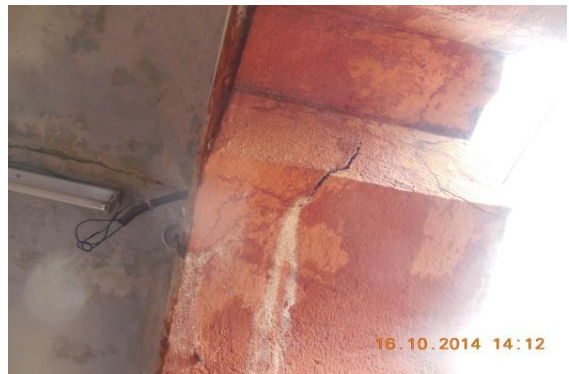
Photo 12

Inclined Crack on Ext. Beam of Veranda of Ganpati G. House,(GF)  
Approx. Width = 2.0mm, Approx.Length = 0.15m.  
Distance from Right Ext. Col. = 0m, Height from Floor =2.20m.

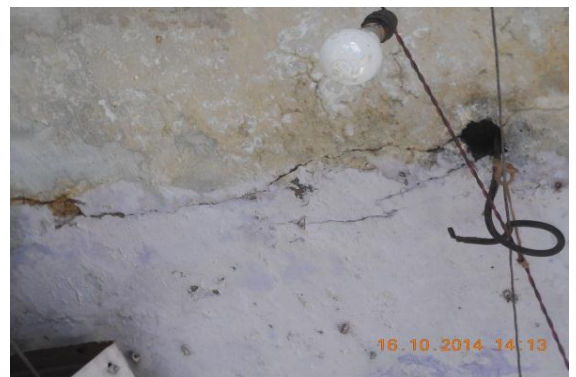
Photo 16

Horizontal Crack on Roof of Verandah of S.No.198,(G. Floor)  
Approx. Width = 0.50mm, Approx.Length = 2.0m.  
Distance from R.Ext.Col. =0m, Height from Floor =2.80m.

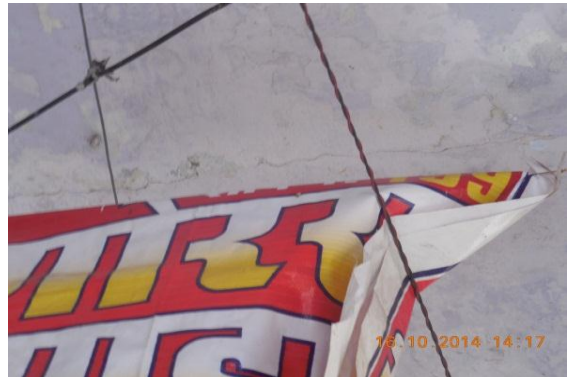
Photo 20

| Summary of Defects Other Than Crack | | | |
|---|--|---|---|
| 5 | Roof of Verandah of S.No.199,Ground Floor | Plaster Crack | 20 |

Plaster Crack on Roof of Verandah of S.No.199,  
Ground Floor

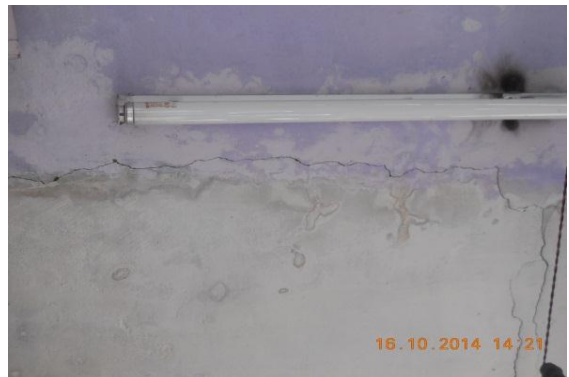
Photo 24A

Horizontal Crack on Roof of Verandah of S.No.200,(G.F.),      Approx.  
Width = 1.0mm, Approx.Length = 2.80m.  
Distance from L.Ext.Col. =0.1m, Height from Floor =2.80m.

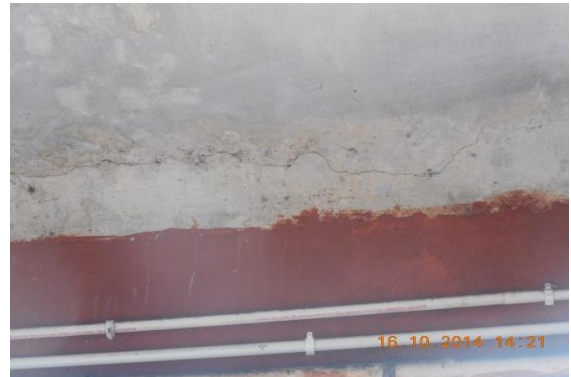
Photo 25

Horizontal Crack on Ext.Beam & Roof of Verandah of S.No.200, GF  
Approx. Width = 0.40mm, Approx.Length = 2.10m.  
Distance from R.Ext.Col. = 0m, Height from Floor = 2.80m.

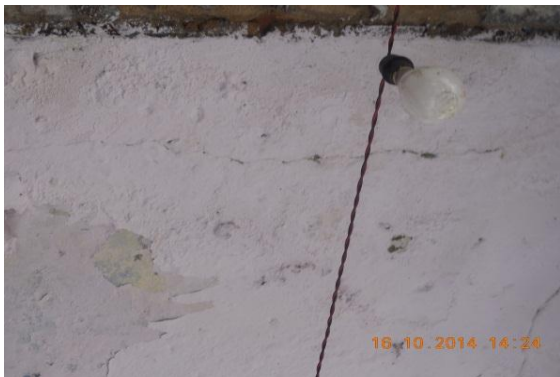
Photo 3  
Horizontal Crack on Roof of Verandah of S.No.201, (G. Floor)  
Approx. Width = 0.15mm, Approx.Length = 2.0m.  
Distance from L.Ext.Col. = 0m, Height from Floor = 2.80m.

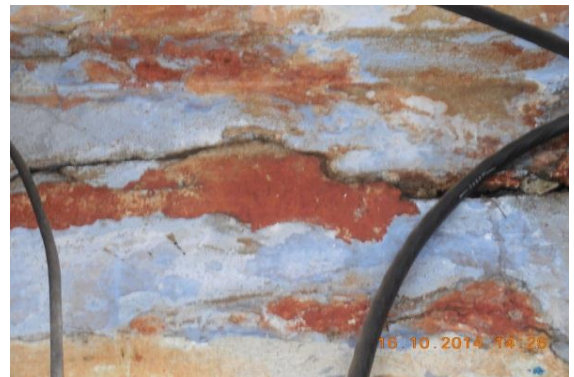
Photo 4  
Inclined Crack on L.Int.Col. of Verandah of S.No.201, (G. Floor)  
Approx. Width = 0.50mm, Approx.Length = 0.80m.  
Distance from L.Int.Col. = 0m, Height from Floor = 2.50m.

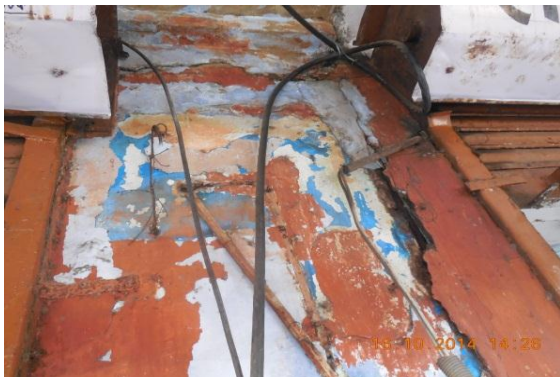
Photo 5  
Dampness/Seepage on Left Int. Col. of Verandah of S.No.201,  
Ground Floor

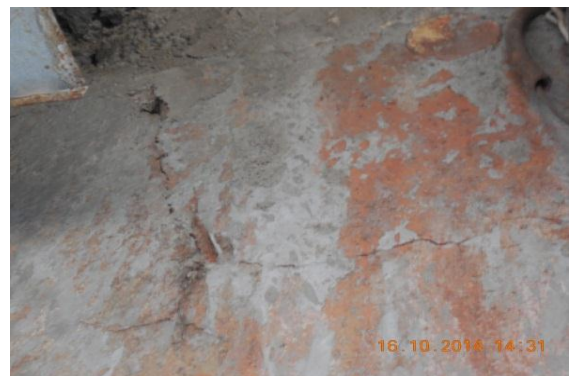
Photo 6  
Inclined Crack on Left Int. Col. of Verandah of S.No.204,(G.F.)  
Approx. Width = 0.60mm, Approx.Length = 0.70m.  
Distance from L.Side Wall =0m, Height from Floor =2.20m.

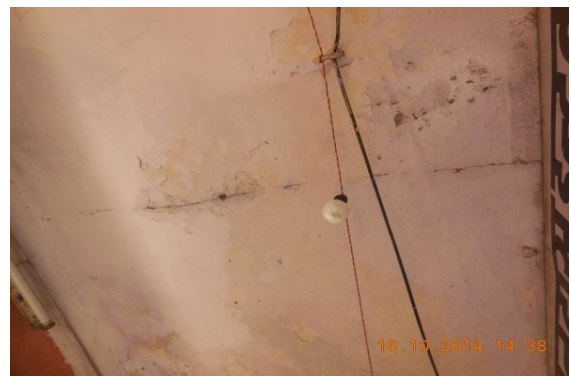
Photo 12  
Horizontal Crack on Roof of Verandah of S.No.206,(G. Floor)  
Approx. Width = 0.35mm, Approx.Length = 2.0m.  
Distance from Right Ext. Col. =1.80m, Height from Floor =2.80m.

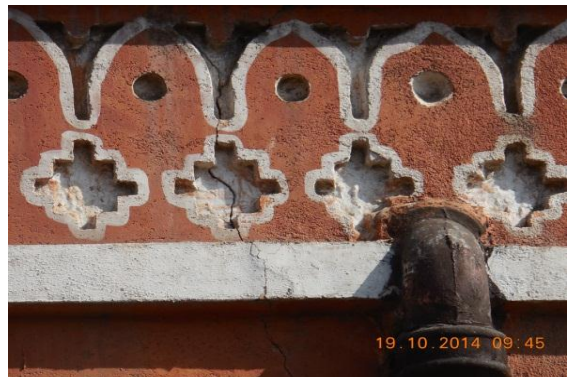
Photo 16A  
Inclined Crack on Outer L.Ext.Col. of Verandah of S.No.207(G.F)  
Approx. Width = 1.50mm, Approx.Length = 1.0m.  
Distance from L.Ext.Col. = 0m, Height from Floor = 2.70m.

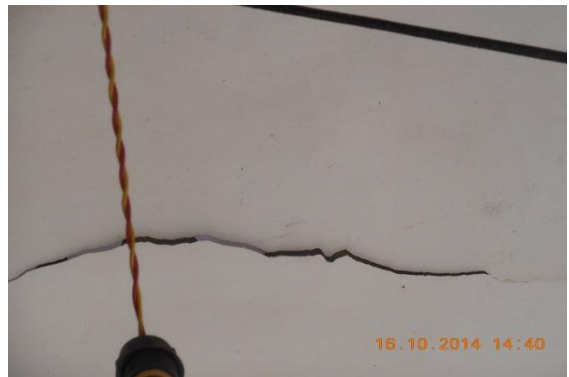
Photo 17  
Peeling of Plaster on Roof of Verandah of S.No.207,  
Ground Floor

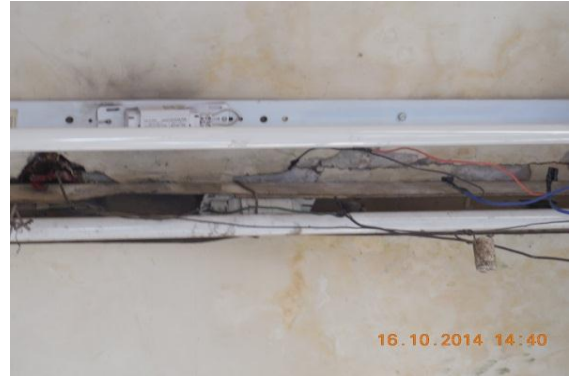
**Photo 19**  
Horizontal Crack on Roof of Verandah of S.No.208,(G.F.)  
Approx. Width = 0.80mm, Approx.Length = 2.0m.  
Distance from Left Ext.Col.=0.0m, Height from Floor =2.80m.

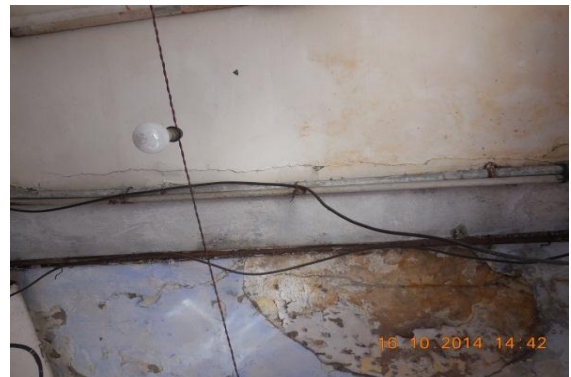
**Photo 21A**  
Inclined Crack on Roof & Right.Int.Col.of Verandah of S.No.208,GF  
Approx. Width = 0.80mm, Approx.Length = 0.80m.  
Distance from Right Ext.Col.=0.0m, Height from Floor =2.0m.

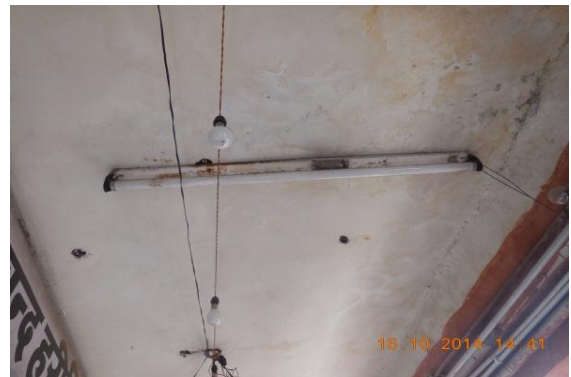
**Photo 22**  
Dampness/Seepage on Roof of Verandah of S.No.208,  
Ground Floor

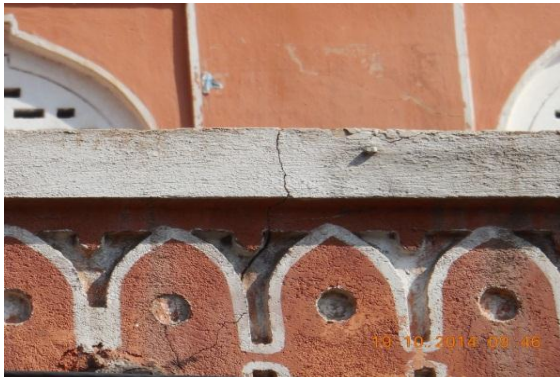
Photo 29

Horizontal Crack on Outer L.Ext.Col. of Verandah of S.No.210, GF  
Approx. Width = 1.0mm, Approx.Length = 0.30m.  
Distance from L.Ext.Col. = 0m, Height from Floor = 2.90m.

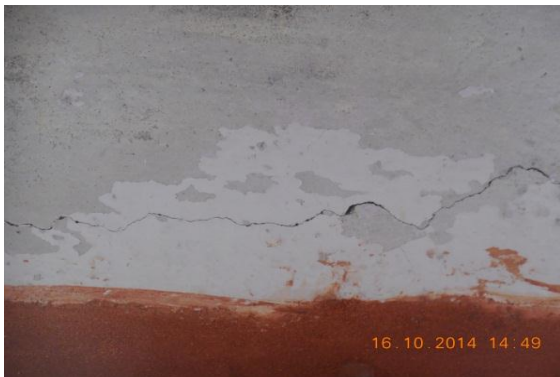
Photo 31

Horizontal Crack on Roof of Verandah of S.No.211, (G.F.),  
Width = 0.80mm, Approx.Length = 2.0m.  
Distance from R.Ext.Col. = 0m, Height from Floor = 2.80m.

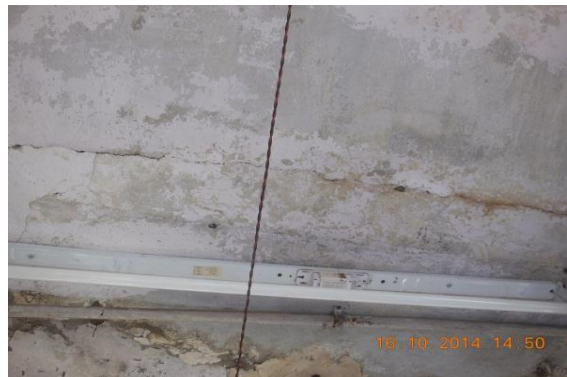
Photo 32

Horizontal Crack on Roof of Verandah of S.No.211, (G.F.),  
Width = 1.0mm, Approx.Length = 1.80m.  
Distance from R.Ext.Col. = 0m, Height from Floor = 2.80m.

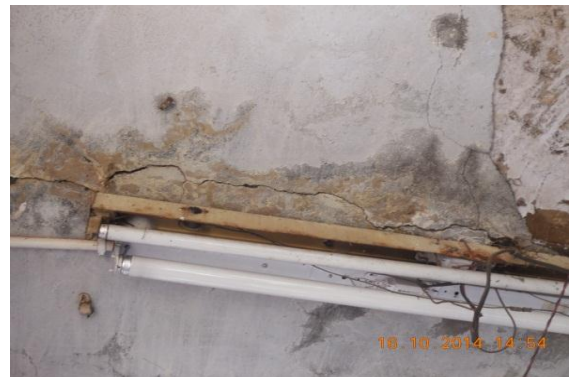
**Photo 44**  
Horizontal Crack on Roof of Verandah of S.No.214,(G.F.), Approx.  
Width = 2.0mm, Approx.Length = 2.0m.  
Distance from Left Ext.Col. =0m, Height from Floor =2.80m.

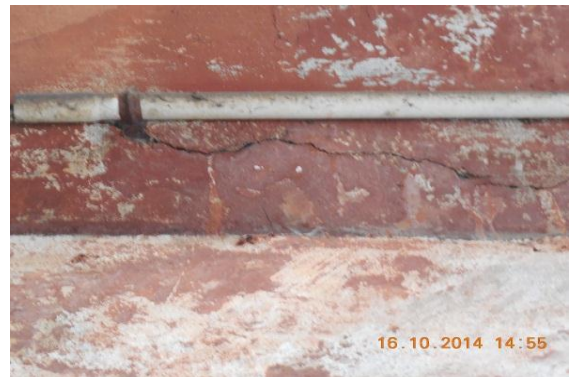
**Photo 46**  
Horizontal Crack on Roof of Verandah of S.No.214,(G.F.), Approx.  
Width = 1.0mm, Approx.Length = 2.0m.  
Distance from Right Ext.Col. =0m, Height from Floor =2.80m.
