Pre - Condition Building Survey for Construction of Underground Stations from Chandpole to Bari Chouper and reversal line

Shop No.362-363
Choti Choper
Jaipur
Unique ID: CC-BC-DL-0008

Report Number: AIMIL/ESG/JMCEC/CC-BC-DL-0008/02/Verandah, Rev. 02, Dated: October, 2014

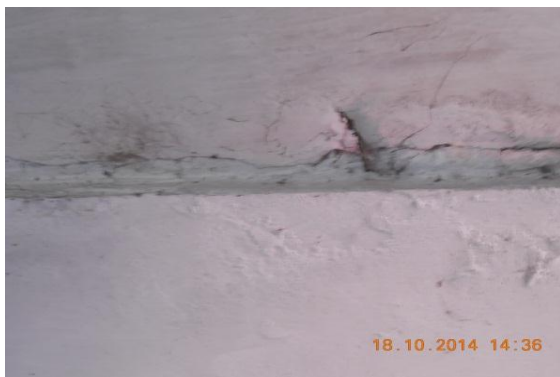
Photo 3
Horizontal Crack on Roof of Verandah of S.No.362,(G. Floor)
Approx. Width = 0.60mm, Approx.Length = 2.50m.
Distance from Left Ext.Col. =0m, Height from Floor =2.80m.

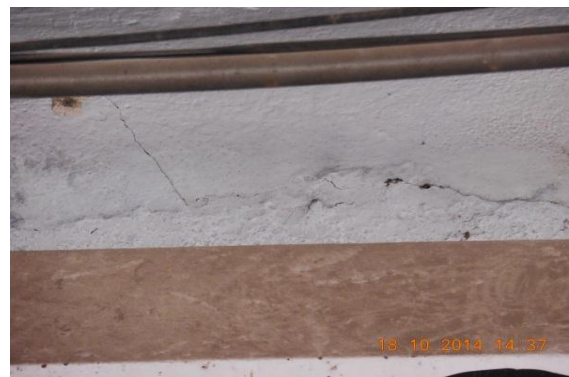
Photo 4
Horizontal Crack on Int.Beam of Verandah of S.No.362,(G. Floor)
Approx. Width = 1.50mm, Approx.Length = 2.0m.
Distance from Right Int.Beam =0m, Height from Floor =2.70m.

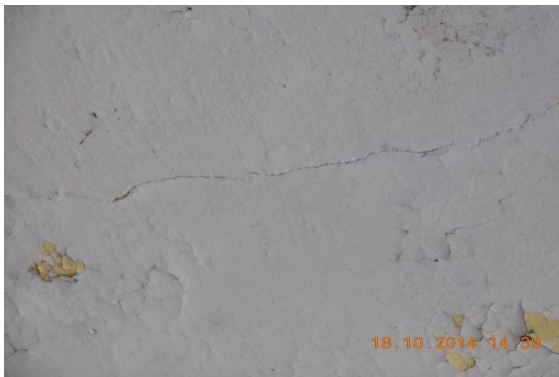
Photo 9

Horizontal Crack on Roof of Verandah of S.No.363, (G. Floor)
Approx. Width = 0.25mm, Approx.Length = 1.50m.
Distance from Right Ext.Col. =1.50m, Height from Floor =2.80m.

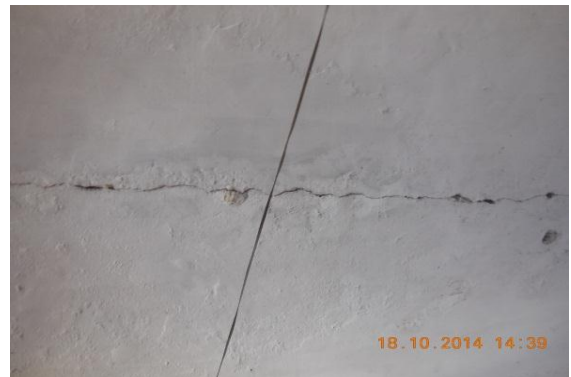
Photo 10

Horizontal Crack on Roof of Verandah of S.No.363, (G.Floor)
Approx. Width = 3.0mm, Approx.Length = 2.50m.
Distance from Right Ext.Col. =0.60m, Height from Floor =2.80m.

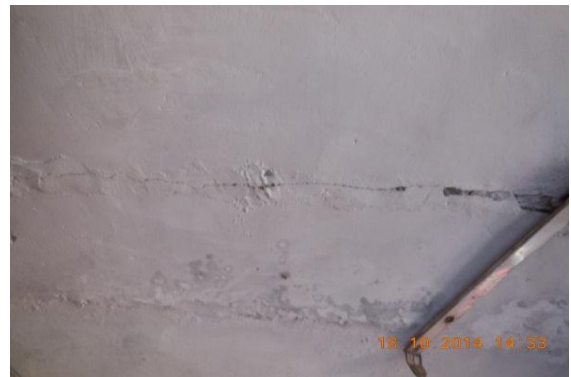
Photo 4
Horizontal Crack on Roof of Verandah of S.No.359, (G. Floor)
Approx. Width = 2.0mm, Approx.Length = 2.50m.
Distance from Right Ext.Col. = 0m, Height from Floor = 2.80m.

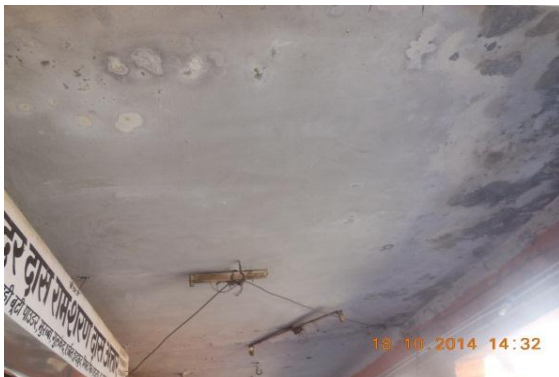
Photo 5
Dampness/Seepage on Roof of Verandah of S.No.359,
Ground Floor

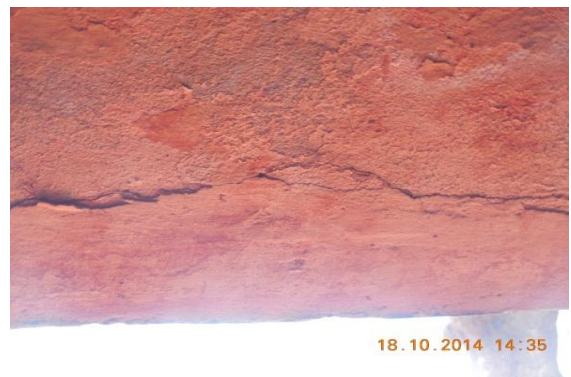
Photo 10

Horizontal Crack on Roof of Verandah of S.No.361A & 361B,(G.F)
Approx. Width = 0.80mm, Approx.Length = 0.70m.
Distance from Left Ext.Col. =0.50m, Height from Floor =2.30m.

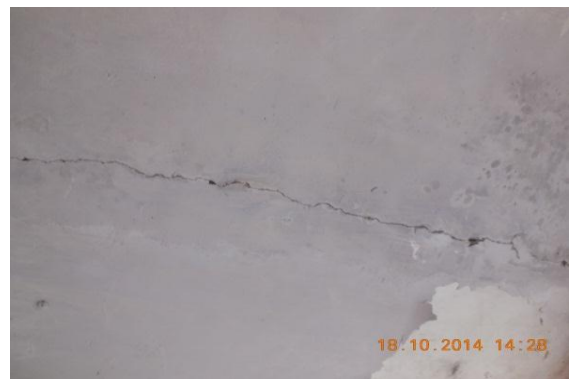
Photo 4
Horizontal Crack on Roof of Verandah of S.No.356, (G. Floor)
Approx. Width = 1.50mm, Approx.Length = 2.50m.
Distance from Left Ext.Col. = 0m, Height from Floor = 2.80m.

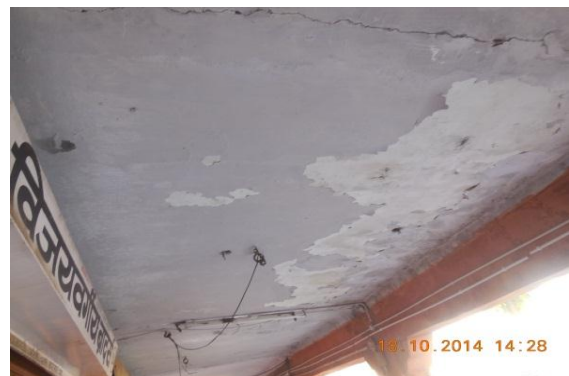
Photo 6
Dampness/Seepage on Roof of Verandah of S.No.356,
Ground Floor

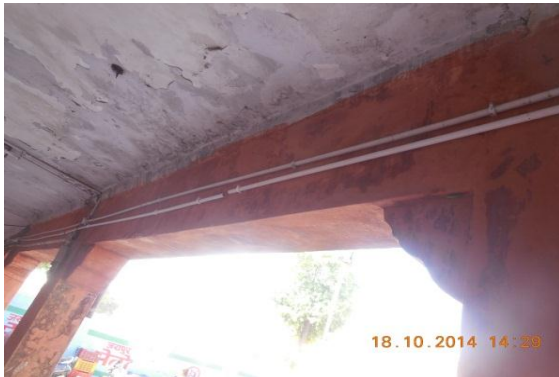
Photo 7
Dampness/Seepage on Ext.Beam of Verandah of S.No.356,
Ground Floor

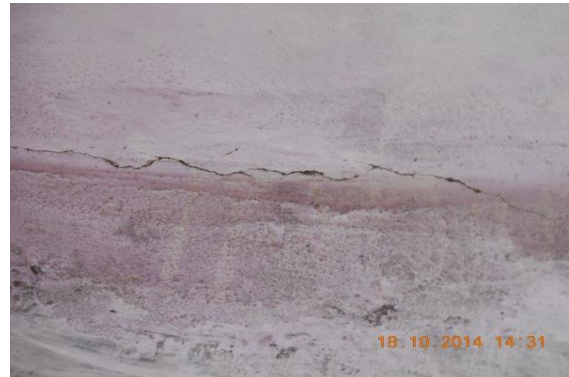
Photo 8
Horizontal Crack on Roof of Verandah of S.No.357, (G. Floor)
Approx. Width = 1.0mm, Approx.Length = 2.50m.
Distance from Right Ext.Col. = 0m, Height from Floor = 2.80m.

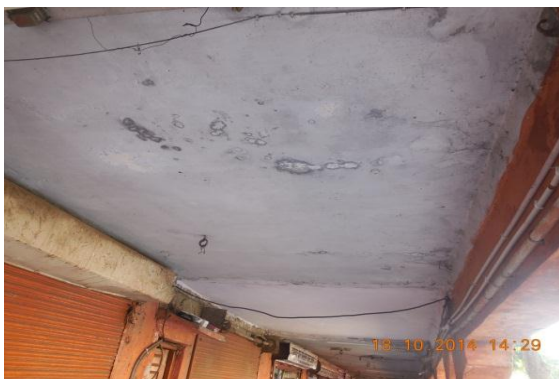
Photo 9
Dampness/Seepage on Roof of Verandah of S.No.357,
Ground Floor

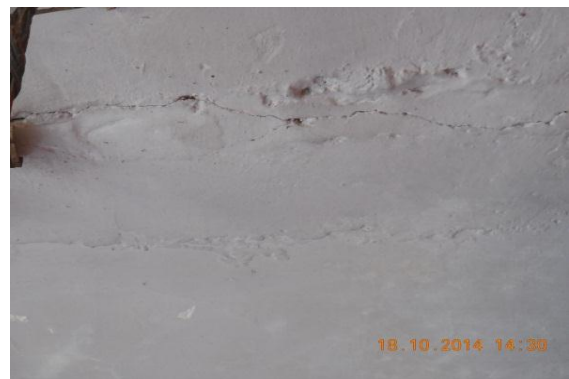
Photo 10
Plaster Crack on Roof of Verandah of S.No.357,
Ground Floor

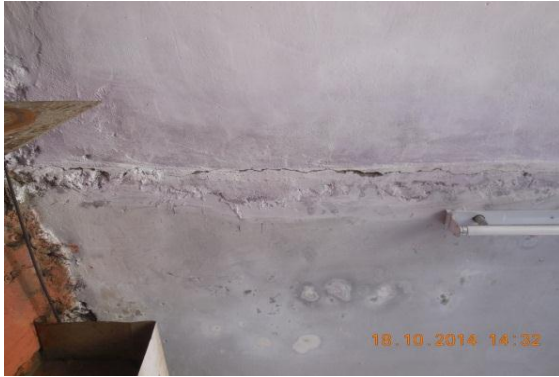
Photo 13

Horizontal Crack on Roof of Verandah of S.No.358,(G. Floor)
Approx. Width = 2.50mm, Approx.Length = 2.50m.
Distance from Right Ext.Col. =0m, Height from Floor =2.80m.

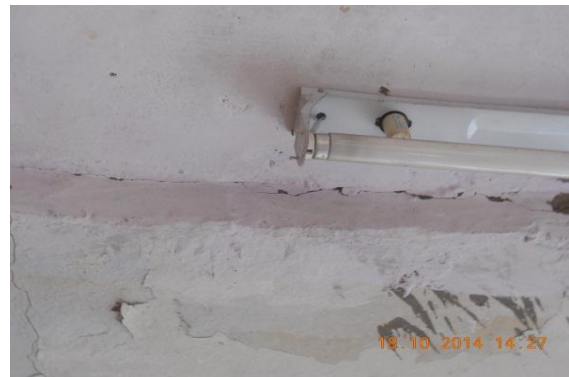
Photo 4
Horizontal Crack on Roof of Verandah of S.No.354, (G. Floor)
Approx. Width = 0.80mm, Approx.Length = 2.50m.
Distance from Right Ext.Col. = 0m, Height from Floor = 2.80m.

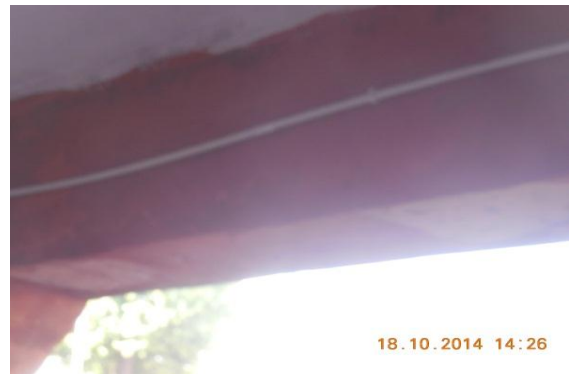
Photo 6
Dampness/Seepage on Ext.Beam of Verandah of S.No.354,
Ground Floor

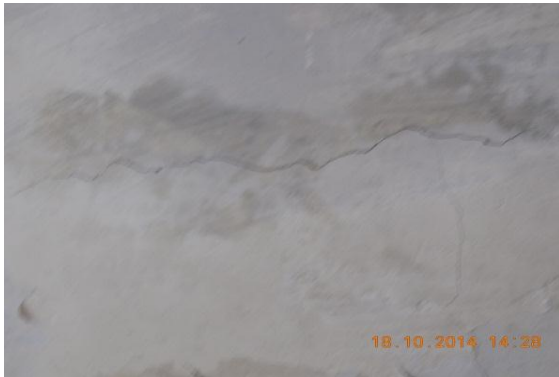
Photo 7

Horizontal Crack on Roof of Verandah of S.No.355,(G. Floor)
Approx. Width = 0.50mm, Approx.Length = 2.50m.
Distance from Right Ext.Col. =0.20m, Height from Floor =2.80m.

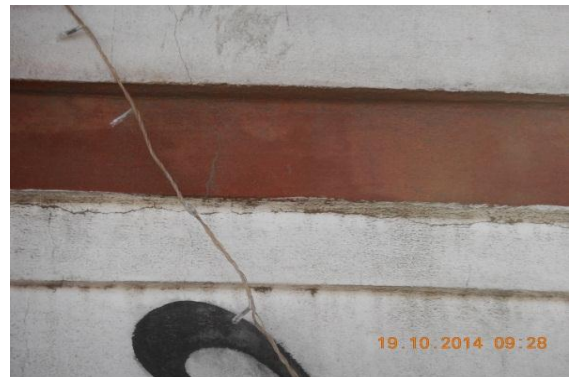
Photo 3B
Horizontal Crack on Outer Ext.Beam of Verandah of S.No.353,GF
Approx. Width = 0.50mm, Approx.Length = 3.0m.
Distance from Left Ext.Col. = 0m, Height from Floor = 2.50m.

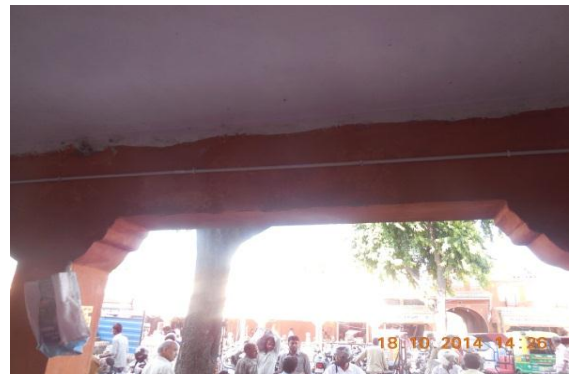
Photo 5
Dampness/Seepage on Ext.Beam of Verandah of S.No.353,
Ground Floor

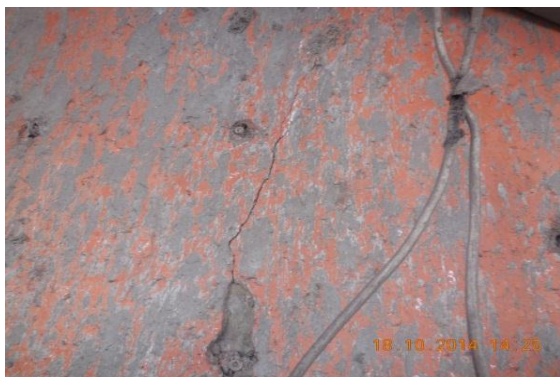
Photo 3A
Inclined Crack on Right Int. Col. of Verandah of S.No.352,GF
Approx. Width = 1.0mm, Approx.Length = 1.0m.
Distance from Right Int.Col. =0m, Height from Floor =1.60m.

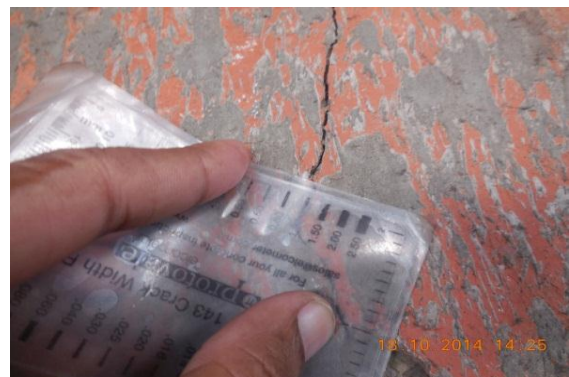
Photo 3B
Inclined Crack on Right Int. Col. of Verandah of S.No.352,GF
Approx. Width = 1.0mm, Approx.Length = 1.0m.
Distance from Right Int.Col. =0m, Height from Floor =1.60m.

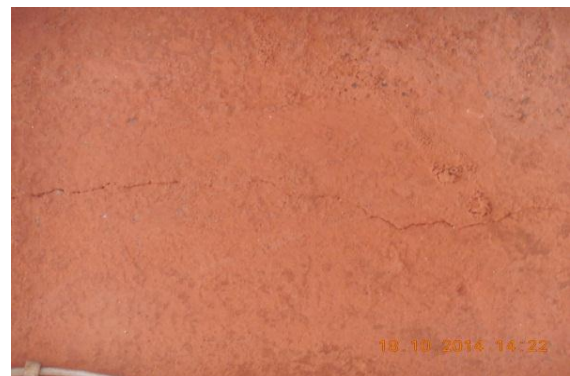
Photo 6
Plaster Crack on Left Ext.Beam of Verandah of S.No.350, Ground Floor

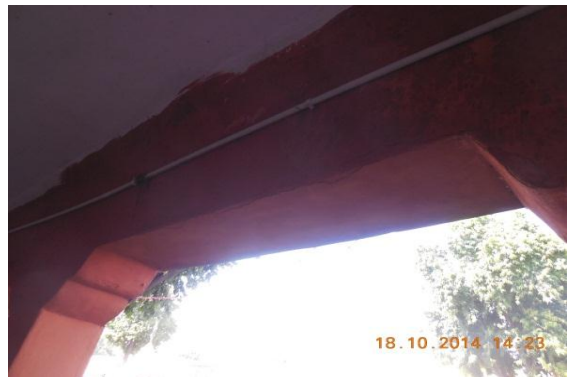
Photo 10
Peeling of Plaster on Ext.Beam of Verandah of S.No.351,
Ground Floor

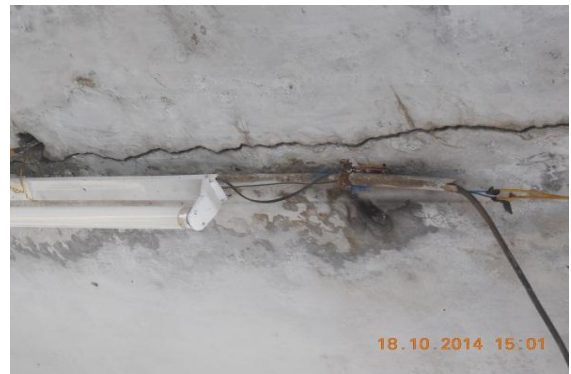
Photo 12
Horizontal Crack on Roof of Verandah of S.No.372,GF
Approx. Width =15.0mm, Approx.Length = 2.50m.
Distance from R.Ext.Col. = 0m, Height from Floor =2.80m.

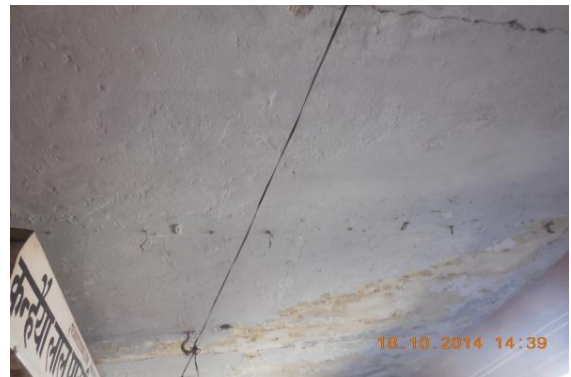
Photo 10
Dampness/Seepage on Roof of Verandah of S.No.364A & 364B,
Ground Floor

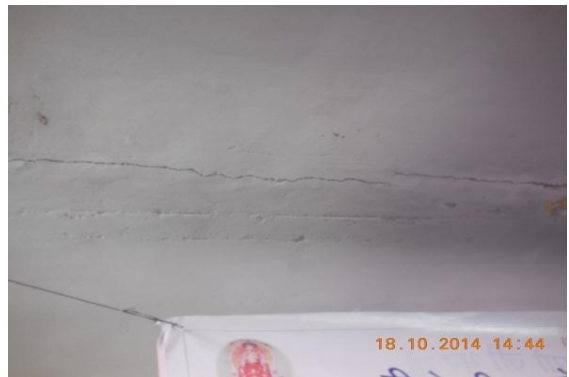
Photo 18
Horizontal Crack on Roof of Verandah of S.No.366,GF
Approx. Width =2.50mm, Approx.Length = 2.50m.
Distance from R.Ext.Col. = 0m, Height from Floor =2.80m.

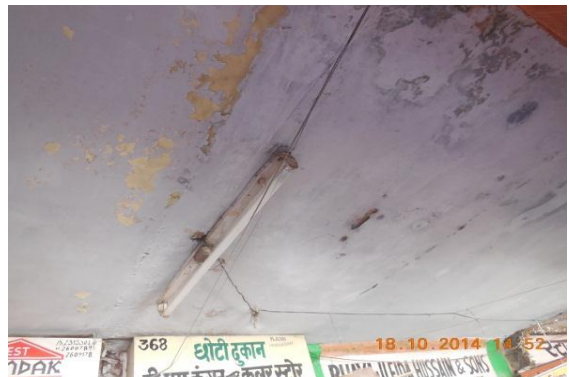
Photo 24
Dampness/ Seepage on Roof of Verandah of S.No.368,
Ground Floor

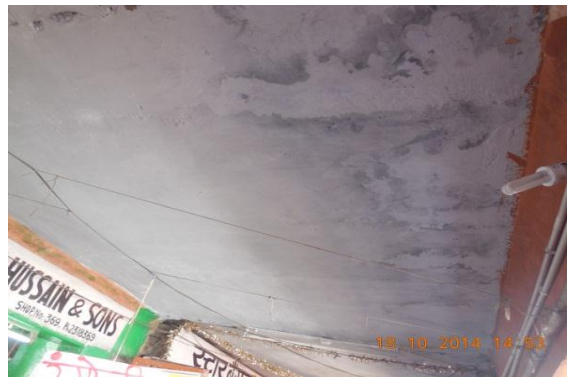
Photo 28
Dampness/Seepage on Roof of Verandah of S.No.369,
Ground Floor

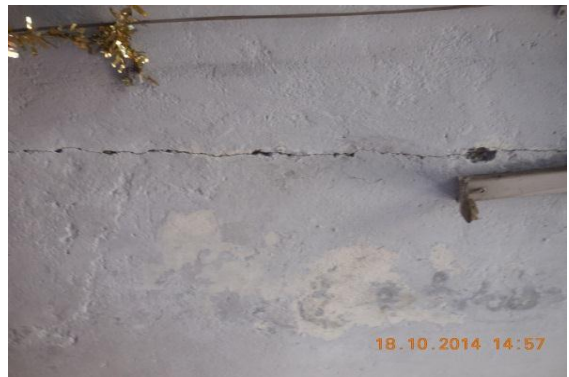
Photo 30
Horizontal Crack on Roof of Verandah of S.No.370&370A,GF
Approx. Width = 3.0mm, Approx.Length = 2.50m.
Distance from L.Ext.Col. = 0m, Height from Floor = 2.80m.
