Pre - Condition Building Survey for Construction of Underground Stations from Chandpole to Bari Chouper and reversal line

Shops
Choti Chopar
Jaipur
Unique ID: CC-BC-UP-0001

Report Number: AIMIL/ESG/JMCEC/CC-BC-UP-0001/03/Verandah, Rev. 02, Dated: October, 2014

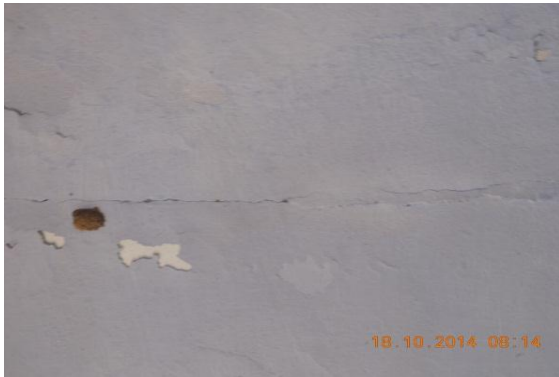
Photo 37

Horizontal Crack on Roof of Varanda of S.No.2, (G. Floor)
Approx. Width = 0.5mm, Approx.Length = 3.0m.
Distance from R.Ext.Col. =0.50m, Height from Floor =2.90m.

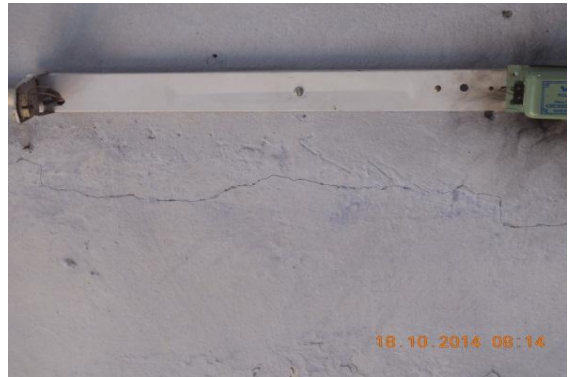
Photo 38

Horizontal Crack on Roof of Varanda of S.No.2, (G. Floor)
Approx. Width = 0.25mm, Approx.Length = 3.0m.
Distance from R.Ext.Col. =0m, Height from Floor =2.90m.

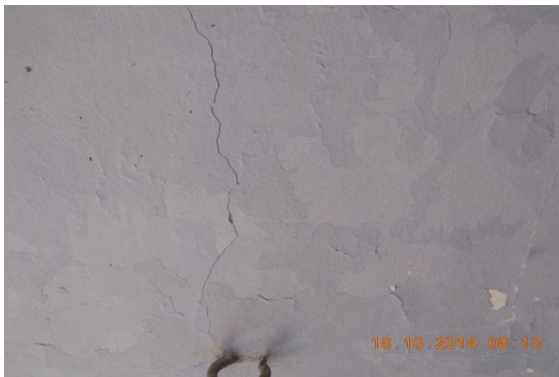
Photo 39

Plaster Crack on Roof of Varanda of S.No.2,
Ground Floor

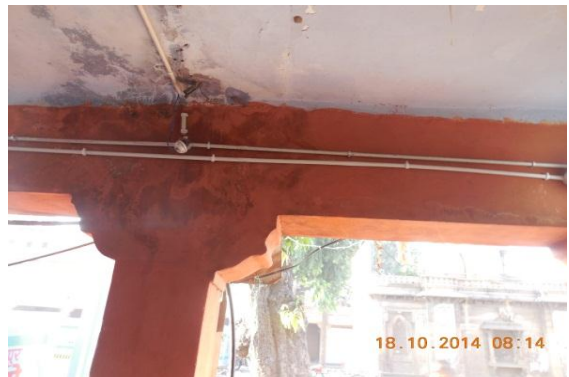
Photo 40

Dampness/Seepage on Ext.Beam of Varanda of S.No.2,
Ground Floor

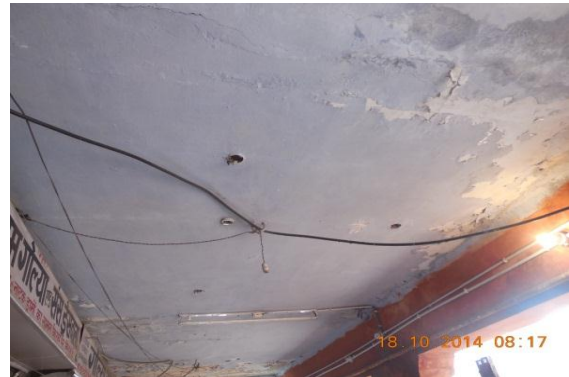
Photo 44

Dampness/Seepage on Roof of Varanda of S.No.4,
Ground Floor

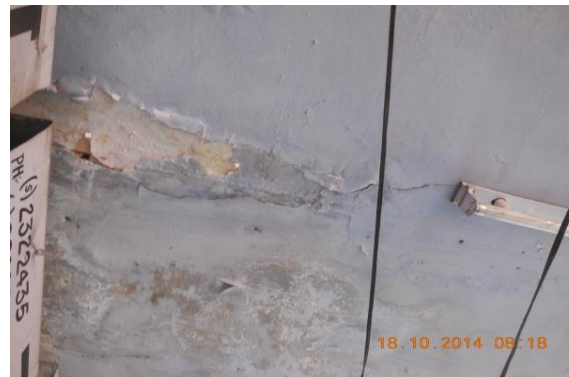
Photo 46

Horizontal Crack on Roof of Varanda of S.No.5,(G. Floor)
Approx. Width = 1.50mm, Approx.Length = 3.0m.
Distance from L.Ext.Col. =0m, Height from Floor =2.90m.

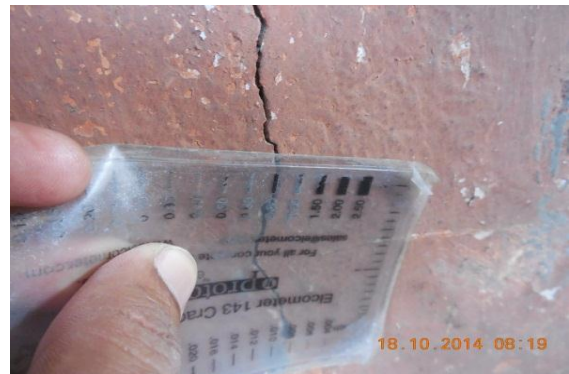
Photo 47B

Inclined Crack on Left Int.Col. of Verandah of S.No.5,(G.F.)
Approx. Width = 0.80mm, Approx.Length = 0.6m.
Distance from L.Int.Col. =0m, Height from Floor =0.30m.

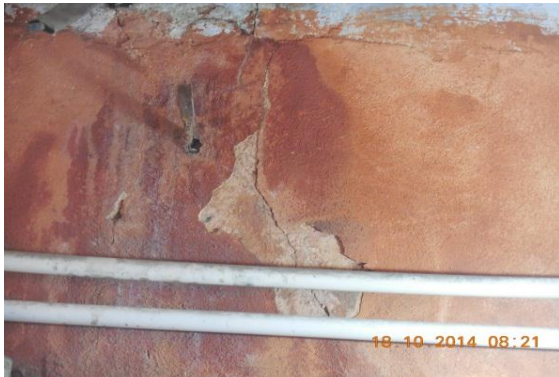
Photo 48A

Inclined Crack on Roof & Left Ext.Col. of Verandah of S.No.5,(G.F.
Approx. Width = 1.50mm, Approx.Length = 3.60m.
Distance from R.Ext.Col. =0m, Height from Floor =2.80m.

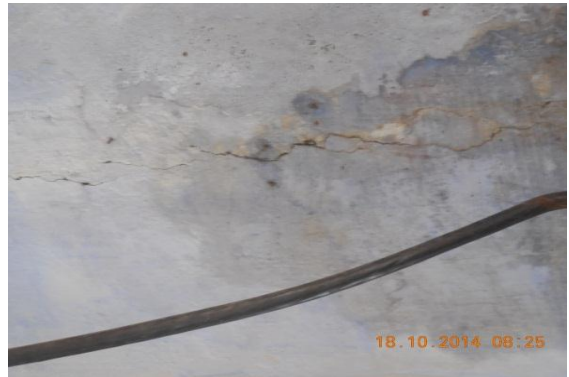
Photo 48B

Inclined Crack on Roof & Left Ext.Col. of Verandah of S.No.5,(G.F.
Approx. Width = 1.50mm, Approx.Length = 3.60m.
Distance from R.Ext.Col. =0m, Height from Floor =2.80m.

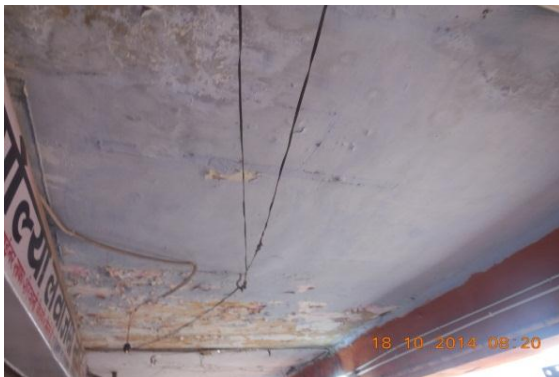
Photo 49

Dampness/Seepage on Roof of Varanda of S.No.5,
Ground Floor

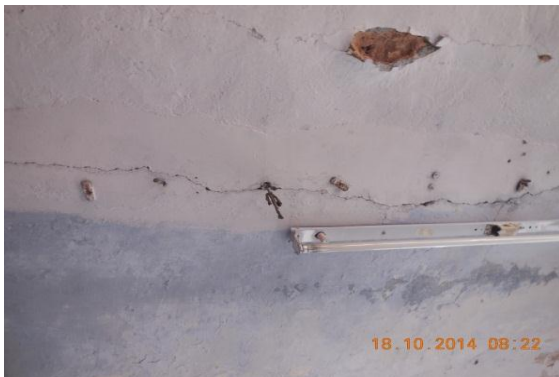
Photo 51

Horizontal Crack on Roof of Verandah of S.No.6A & 6B,(G. Floor)
Approx. Width = 2.0mm, Approx.Length = 3.0m.
Distance from R.Ext.Col. =0m, Height from Floor =2.80m.

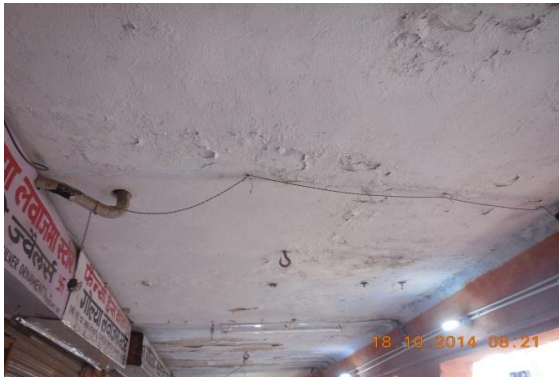
Photo 53

Dampness/Seepage on Roof of Varanda of S.No.6A & 6B,
Ground Floor

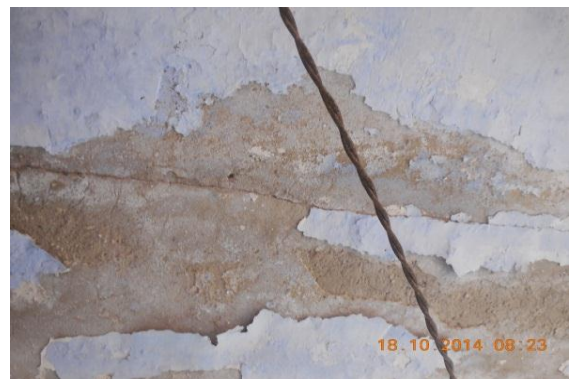
Photo 56

Horizontal Crack on Roof of Varanda of S.No.7,Ground Floor
Approx. Width = 1.0mm, Approx.Length = 2.60m.
Distance from L.Ext. Col. =1.0m, Height from Floor =2.8m.

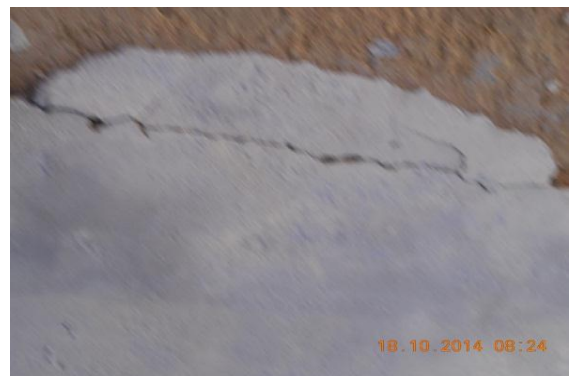
Photo 58

Horizontal Crack on Roof of Varanda of S.No.7,Ground Floor
Approx. Width = 2.0mm, Approx.Length = 2.90m.
Distance from R.Ext. Col. =0.30m, Height from Floor =2.8m.

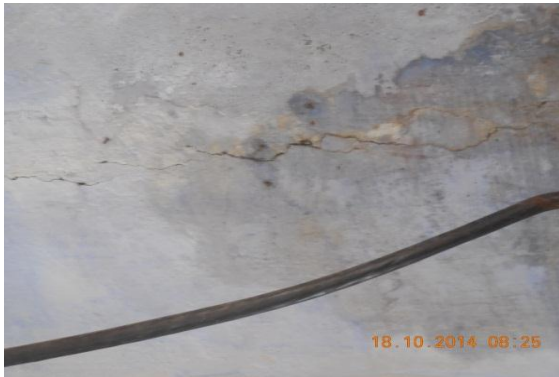
Photo 59

Horizontal Crack on Roof of Varanda of S.No.7, Ground Floor
Approx. Width = 0.80mm, Approx.Length = 1.50m.
Distance from R.Ext. Col. = 0m, Height from Floor = 2.8m.

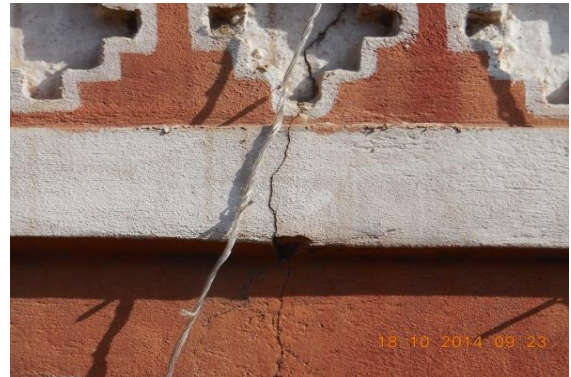
Photo 60

Inclined Crack on Outer Left Ext.Col. of Varanda of S.No.7, G.Floor
Approx. Width = 1.0mm, Approx.Length = 1.80m.
Distance from L.Ext. Col. = 0m, Height from Floor = 2.20m.

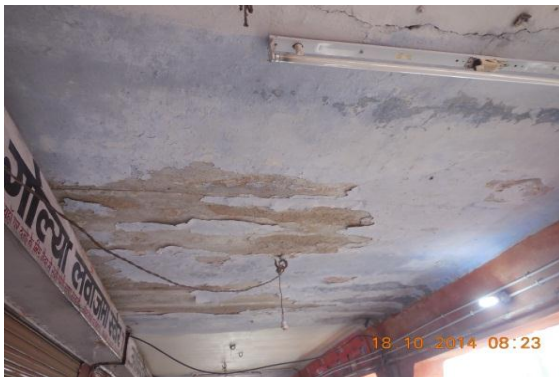
Photo 61

Dampness/Seepage on Roof of Verandah of S.No.7,
Ground Floor

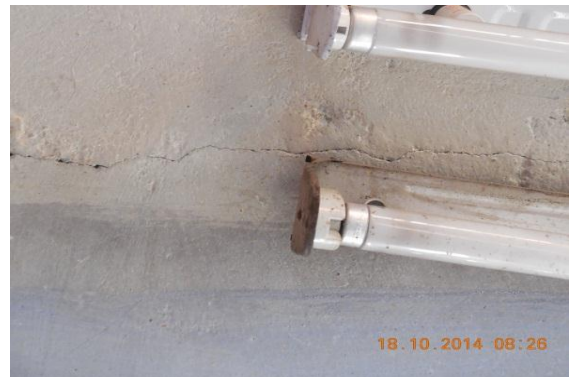
Photo 64

Horizontal Crack on Roof of Verandah of S.No.8, Ground Floor
Approx. Width = 0.50mm, Approx.Length = 2.90m.
Distance from R.Ext. Col. = 0m, Height from Floor = 2.80m.

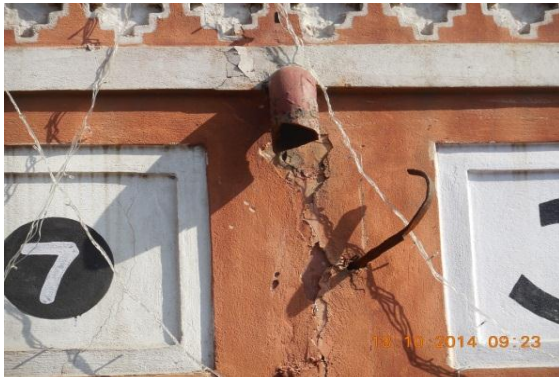
Photo 65

Inclined Crack on Outer Left Ext.Col. of Verandah of S.No.8,G.F.
Approx. Width = 1.0mm, Approx.Length = 2.10m.
Distance from L.Ext. Col. =0m, Height from Floor =2.0m.

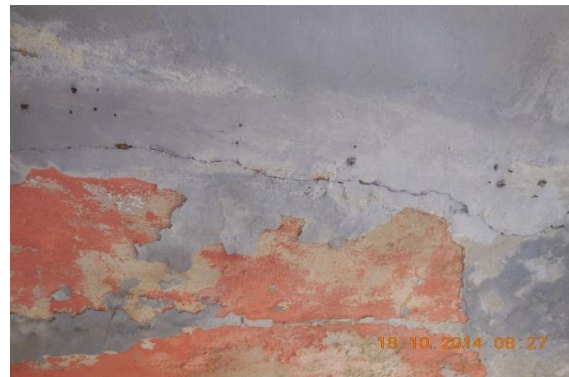
Photo 68

Horizontal Crack on Roof of Verandah of S.No.10,G.F.
Approx. Width = 1.50mm, Approx.Length = 2.90m.
Distance from L.Ext. Col. =0m, Height from Floor =2.80m.

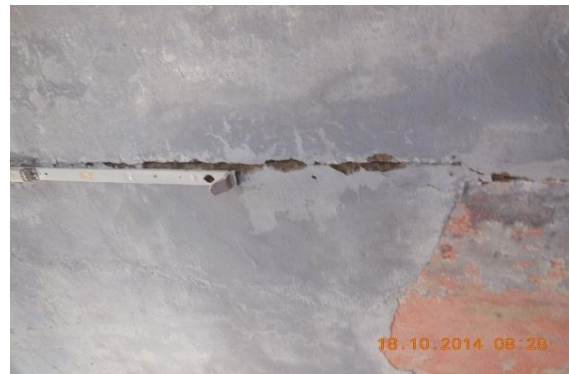
Photo 70

Horizontal Crack on Roof of Verandah of S.No.10,G.F.
Approx. Width = 2.50mm, Approx.Length = 2.90m.
Distance from R.Ext. Col. =0m, Height from Floor =2.80m.

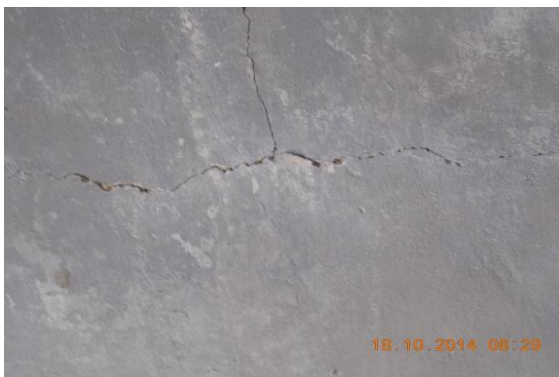
Photo 73

Horizontal Crack on Roof of Verandah of S.No.11, G.F.
Approx. Width = 0.50mm, Approx.Length = 3.50m.
Distance from R.Ext. Col. = 0.50m, Height from Floor = 2.80m.

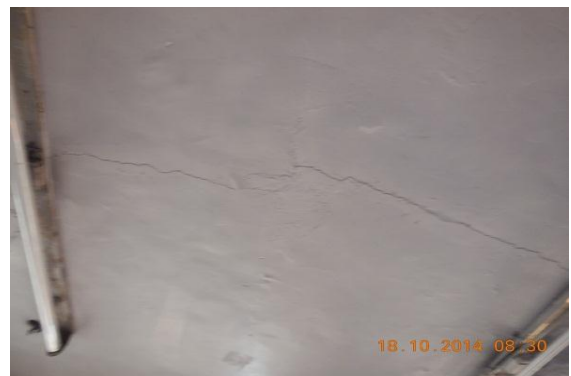
Photo 76A

Horizontal Crack on Roof of Verandah of S.No.12, G.F.
Approx. Width = 1.0mm, Approx.Length = 4.50m.
Distance from L.Ext. Col. = 1.60m, Height from Floor = 2.80m.

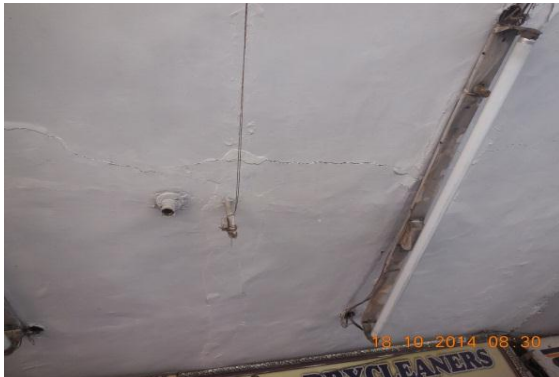
Photo 76B

Horizontal Crack on Roof of Verandah of S.No.12,G.F.
Approx. Width = 1.0mm, Approx.Length = 4.50m.
Distance from L.Ext. Col. =1.60m, Height from Floor =2.80m.

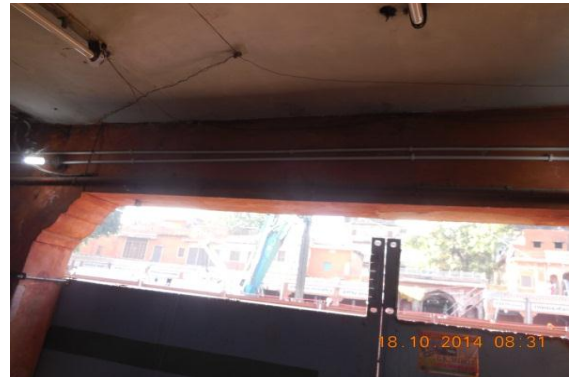
Photo 77

Dampness/Seepage on Ext.Beam of Verandah of S.No.12,
Ground Floor

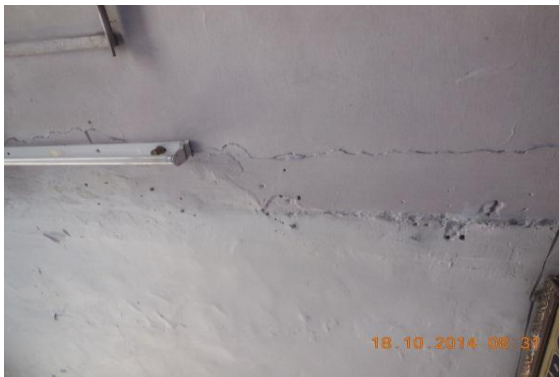
Photo 78

Horizontal Crack on Roof of Verandah of S.No.13,G.F.
Approx. Width = 0.60mm, Approx.Length = 3.0m.
Distance from L.Ext. Col. =0m, Height from Floor =2.80m.

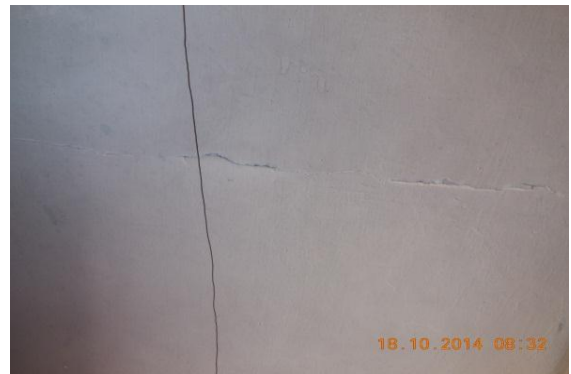
Photo 81

Plaster Crack on Roof of Verandah of S.No.13,
Ground Floor

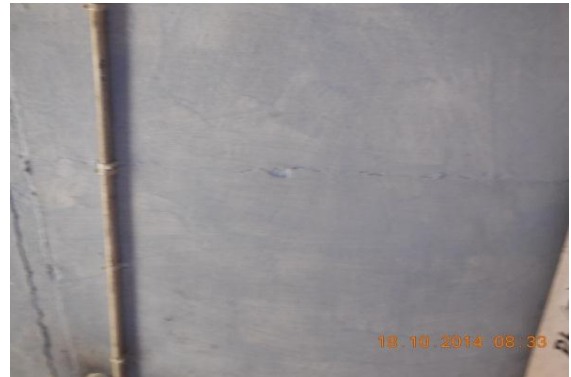
Photo 83

Horizontal Crack on Roof of Verandah of S.No.14A & 14B,G.F.
Approx. Width = 0.35mm, Approx.Length = 2.90m.
Distance from L.Ext. Col. =1.40m, Height from Floor =2.80m.

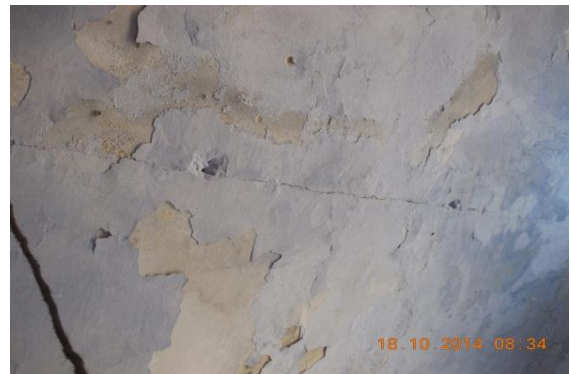
Photo 87

Horizontal Crack on Roof of Verandah of S.No.15,G.F.
Approx. Width = 0.25mm, Approx.Length = 2.90m.
Distance from L.Ext. Col. =1.40m, Height from Floor =2.80m.

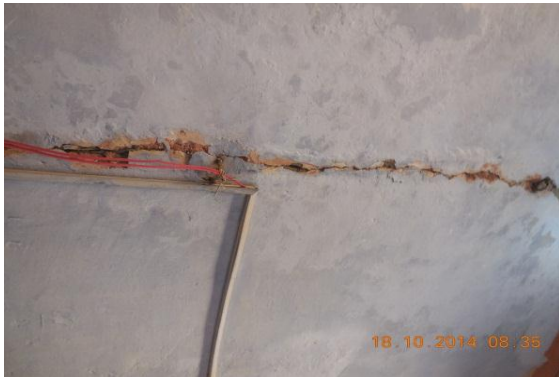
Photo 88

Horizontal Crack on Roof of Verandah of S.No.15,G.F.
Approx. Width = 5.0mm, Approx.Length = 3.50m.
Distance from R.Ext. Col. =0m, Height from Floor =2.80m.

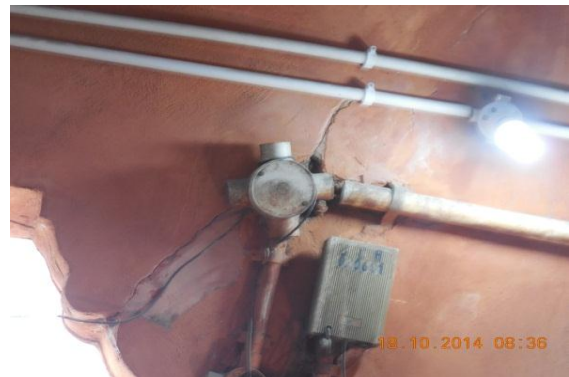
Photo 91

Inclined Crack on L.Ext.Col. of Verandah of S.No.16,G.F.
Approx. Width = 2.0mm, Approx.Length = 1.0m.
Distance from L.Ext. Col. =0m, Height from Floor =2.20m.

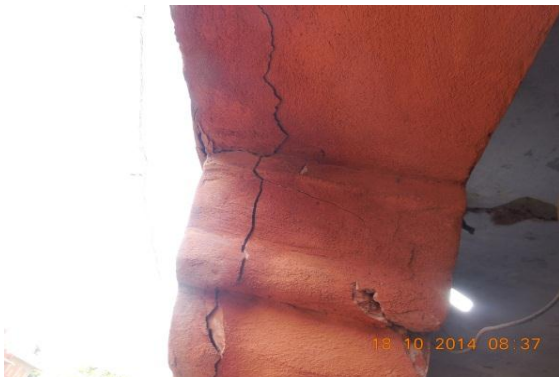
Photo 92

Inclined Crack on Ext.Beam&L.Ext.Col. of Verandah of S.No.16,G.F
Approx. Width = 5.0mm, Approx.Length = 0.80m.
Distance from L.Ext. Col. =0m, Height from Floor =2.0m.

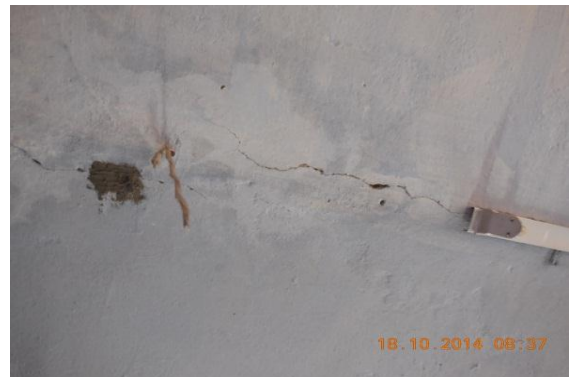
Photo 93

Horizontal Crack on Roof of Verandah of S.No.16,G.F.
Approx. Width = 1.50mm, Approx.Length = 3.0m.
Distance from R.Ext. Col. =0m, Height from Floor =2.80m.

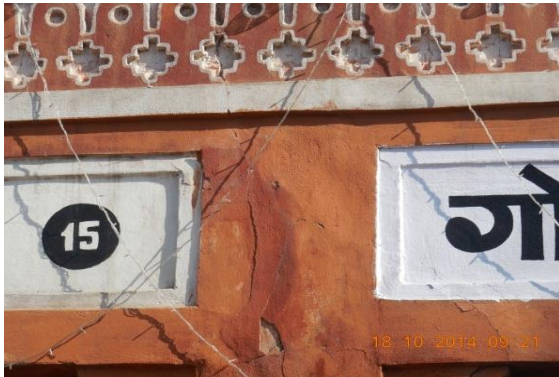
Photo 94

Inclined Crack on Outer L.Ext.Col. of Verandah of S.No.16, G.F.
Approx. Width = 2.50mm, Approx.Length = 3.0m.
Distance from L.Ext. Col. = 0m, Height from Floor = 2.20m.

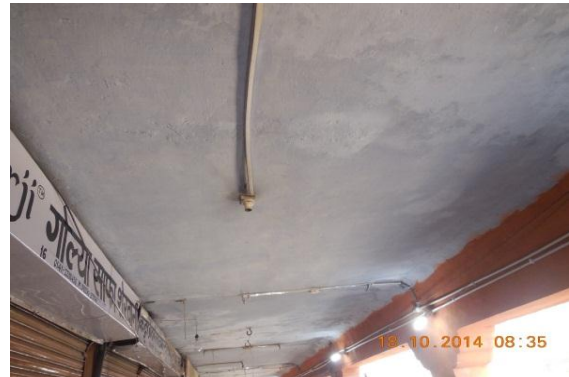
Photo 95

Dampness/Seepage on Roof of Verandah of S.No.16, Ground Floor

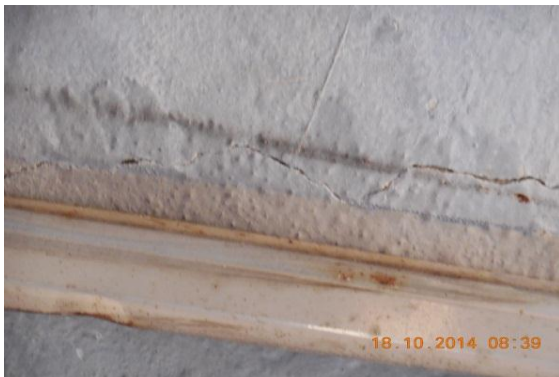
Photo 96

Horizontal Crack on Roof of Verandah of S.No.17A & 17B, G.F.
Approx. Width = 0.25mm, Approx.Length = 2.90m.
Distance from R.Ext. Col. = 0.20m, Height from Floor = 2.80m.

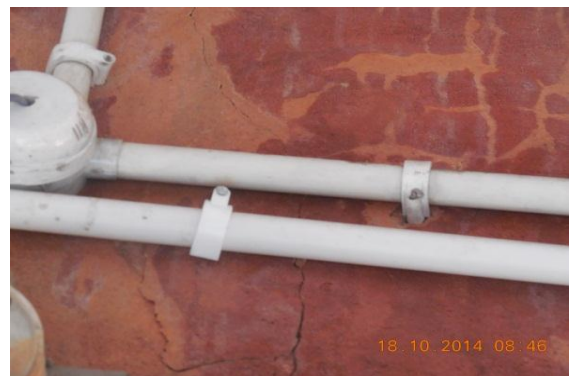
Photo 116B
Horizontal Crack on Roof & L.Ext.Col.of Verandah of S.No.22,G.F.
Approx. Width = 1.0mm, Approx.Length = 3.50m.
Distance from L.Ext. Col. =0m, Height from Floor =2.80m.

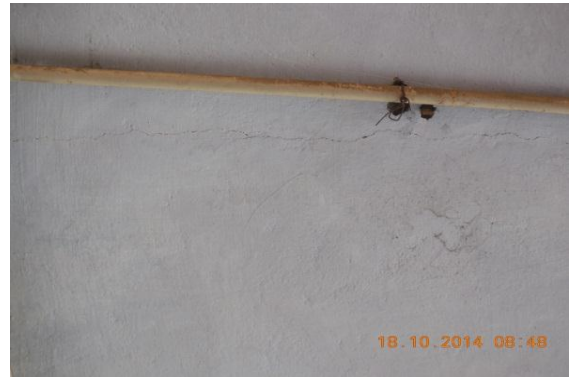
Photo 124
Plaster Crack on Roof of Verandah of S.No.24,
Ground Floor

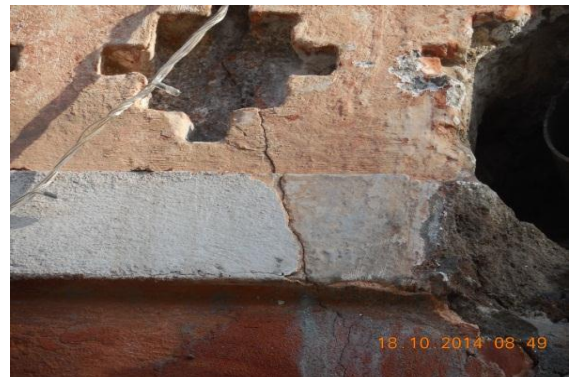
Photo 126
Inclined Crack on Outer L.Ext.Col. of Verandah of S.No.25, G.F.
Approx. Width = 0.60mm, Approx.Length = 0.80m.
Distance from L.Ext. Col. = 0m, Height from Floor = 3.10m.

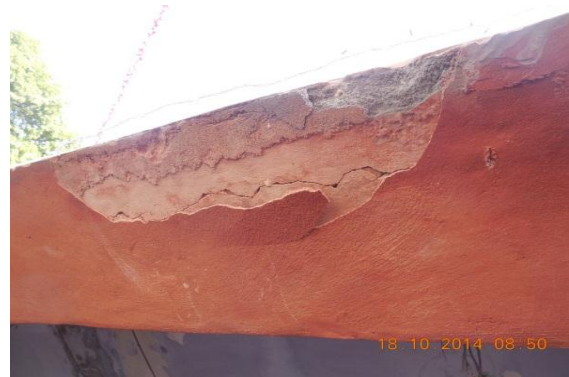
Photo 128
Plaster Removal on Ext. Beam of Verandah of S.No.25,
Ground Floor

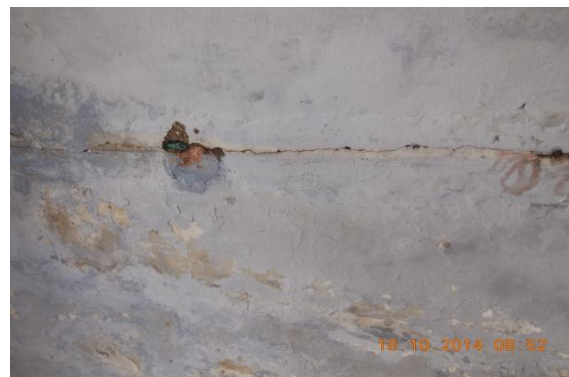
Photo 132
Horizontal Crack on Roof of Verandah of S.No.26, G.F.
Approx. Width = 1.50mm, Approx.Length = 2.90m.
Distance from R.Ext. Col. = 0m, Height from Floor = 2.80m.

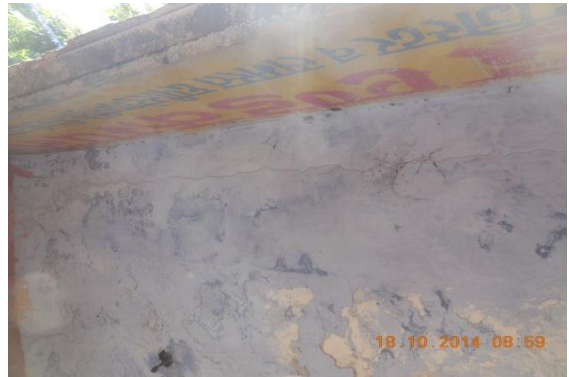
Photo 153

Plaster Crack on Roof of Verandah of S.No.30,
Ground Floor
