Pre Building Condition Survey Report

Name of the Project	Contract JMRC-UG1B "Design and Construction of Tunnel between Chandpole and Badi Chouper and reverse line by Shield TBM, Underground Metro Stations at Choti Chouper and Badi Chouper by Cut and Cover Methods on East West Corridor of Jaipur Metro Rail Corporation Limited ."		
Owner :	JAIPUR METRO	Jaipur Metro Rail Corporation	
Contractor :	VUV	Continental Engineering Corporation	
Survey Agency :	Aimil I Instrumentation	tion & Technologies

Pre Building Condition Survey Report Chand Pole to Choti Chopar (UP Line)

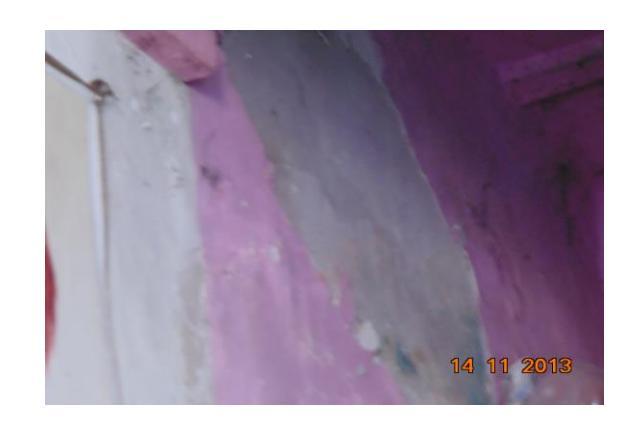
Photo 10 Peeling of Plaster on Wall No. 4 of Billu Saloon of Ground Floor

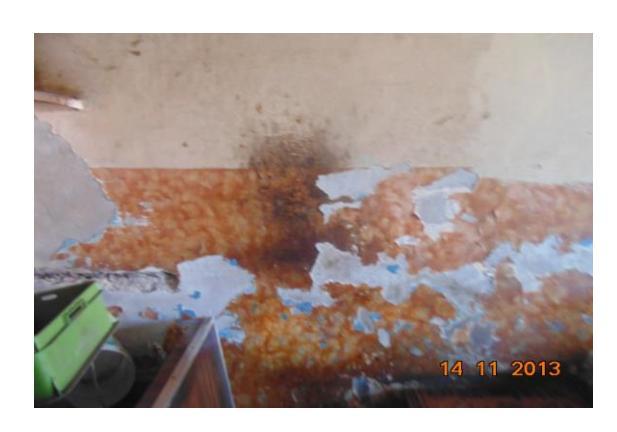
Photo 9 Damaged Portion on Backside Wall of Shop No. 11 & 12 of Ground Floor

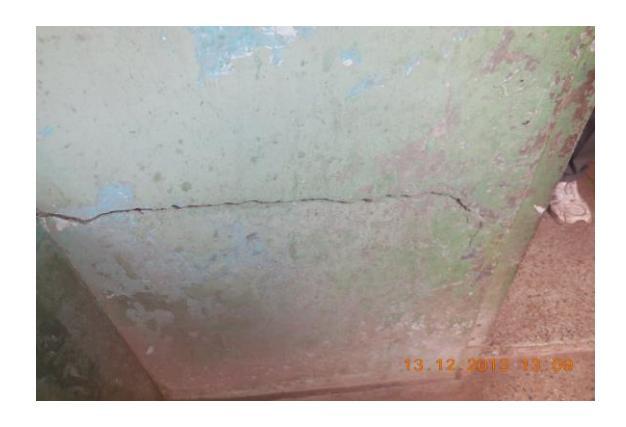
Photo 13 Horizontal Crack on Room, First Floor, Approx. Width = 250mm, Approx. Length = 0.8m. Distance from Wall No. 1 = 0.8m, Height from Floor = 0.5m.

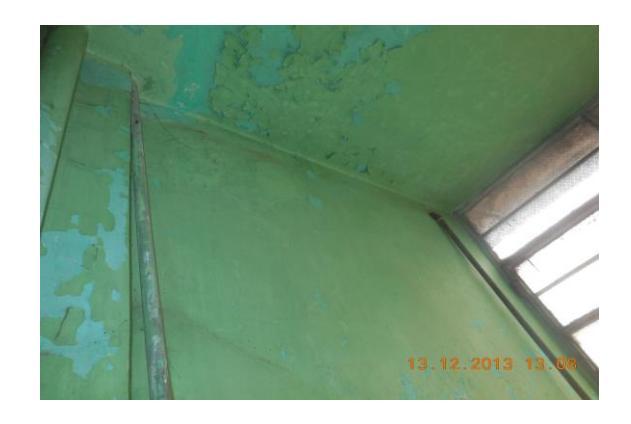
Photo 30 Peeling of Plaster on Wall No. 1 & Roof of Bathroom of First Floor

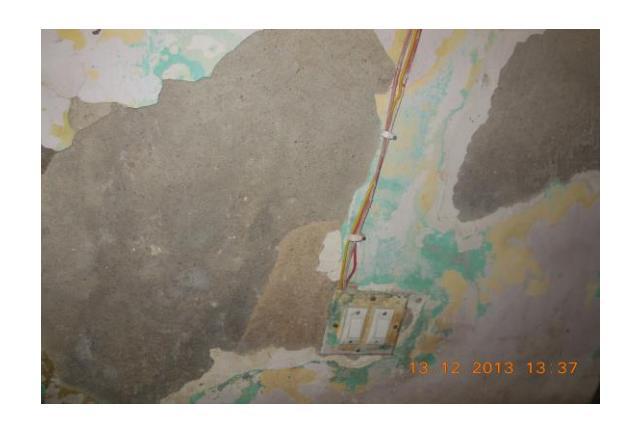
Photo 60 Peeling of Plaster on Bathroom of Third Floor

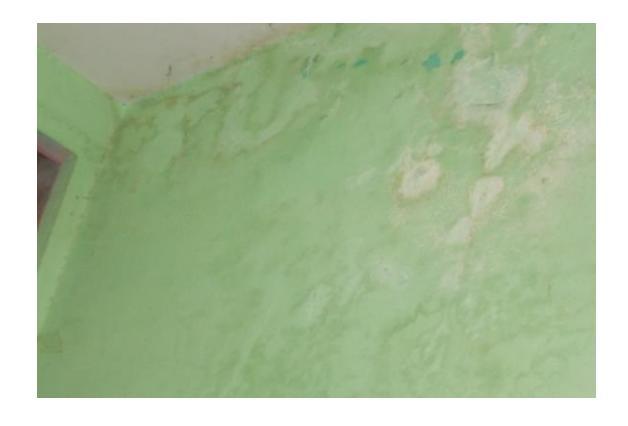
Photo 72 Dampness/Seepage on House No. Special D 5 of Ground Floor

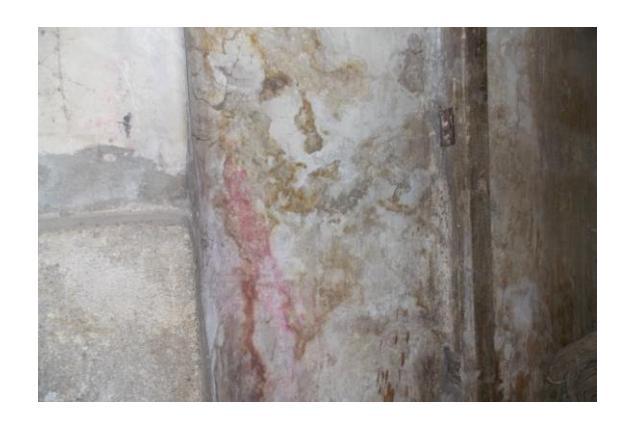
Photo 84 Dampness/Seepage on Stair Case of Basement

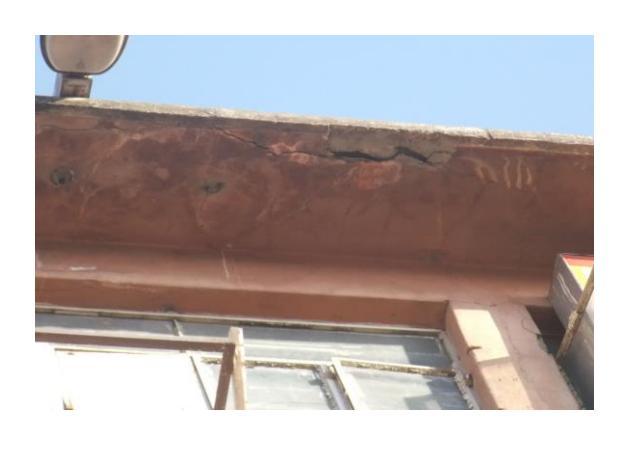
Photo 93 Damaged Portion on Floor of Electrical Hazard Sunshade of Third Floor

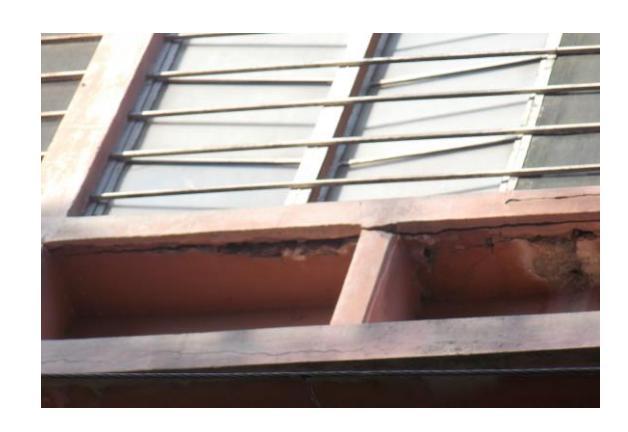
Photo 98 Damaged Portion on Floor of Electrical Hazard of Third Floor

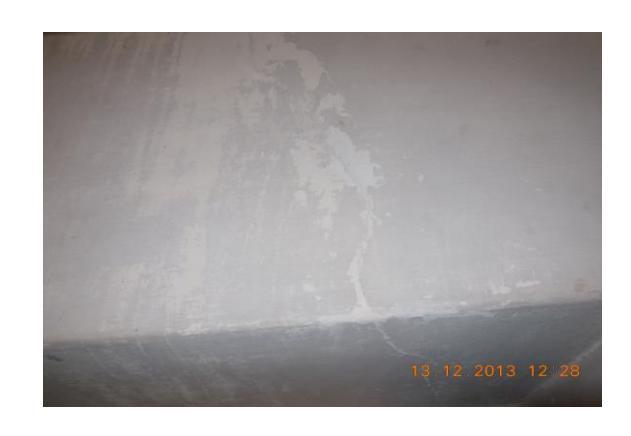
Photo 8 Horizontal Crack on Roof of Hall No. 1, Second Floor, Approx. Width = 0.15mm, Approx. Length = 0.8m. Distance from W1 = 1.6m, Height from Floor = 1.7m.

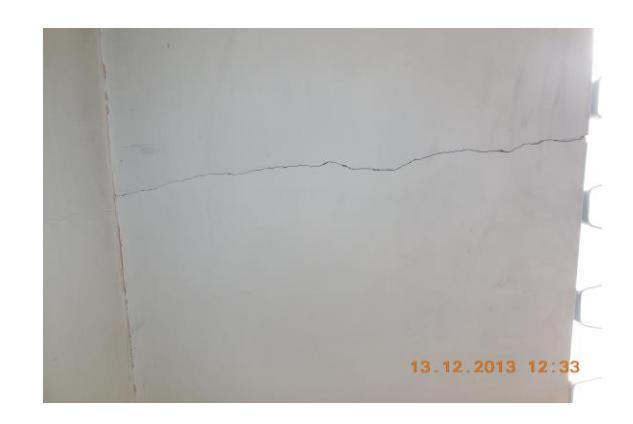
Photo 1 Horizontal Crack on Roof of Room No. 1, Approx. Width = 0.4mm, Approx. Length = 0.5m. Distance from W1 = 0m, Height from Floor = 1.5m.

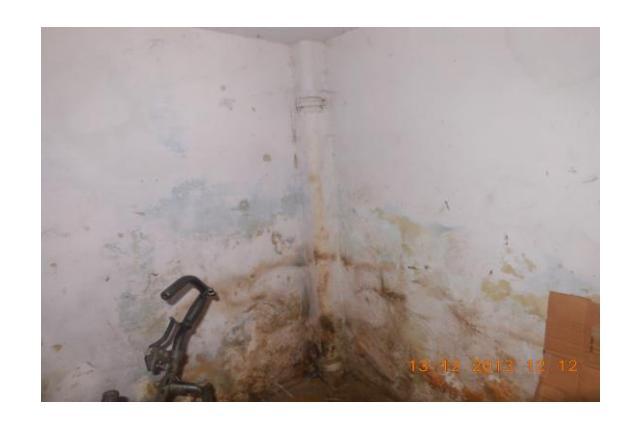
Photo 15 Plaster Crack on Shop-JK Msale & Food Production of Ground Floor

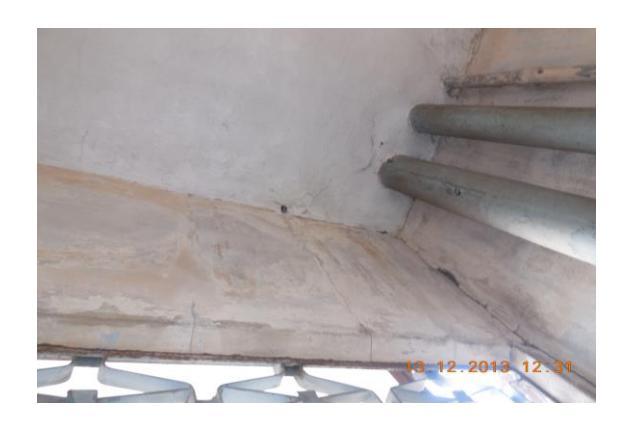
Photo 38 Peeling of Plaster on Roof of Balcony of Second Floor

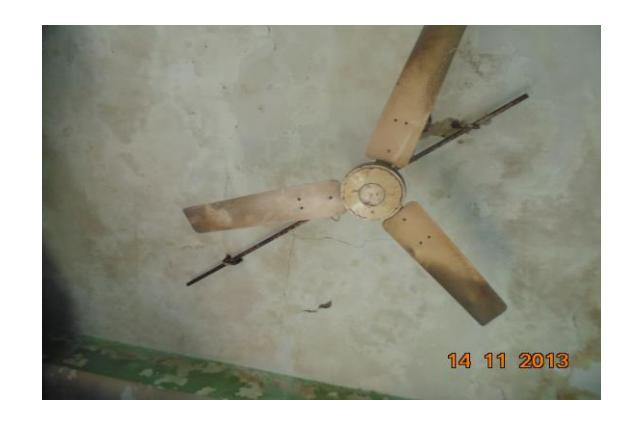
Photo 35 Damaged Portion on Roof of Room No. 3 of House No. D-1, Second Floor

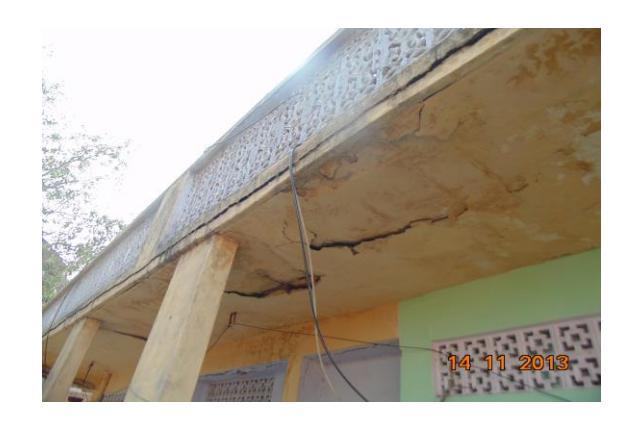
Photo 42 Damaged Portion on Shade of Varanda 3 of House No. D-1, Second Floor

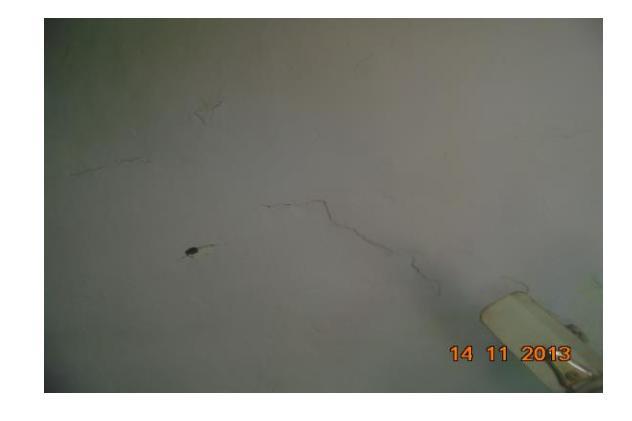
Photo 46 Damaged Portion on Roof of Balcony 2 of House No. D-1, Second Floor

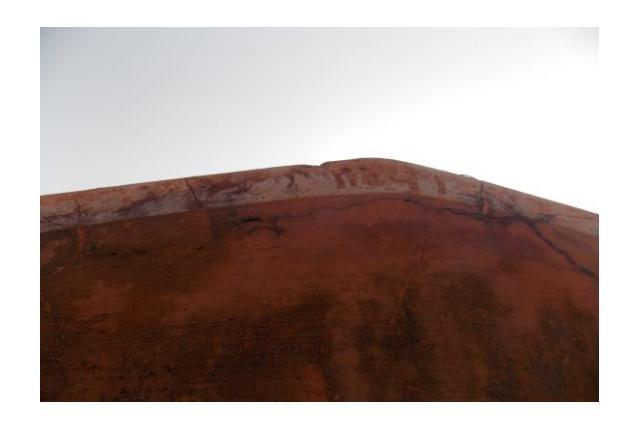
Photo 23 Plaster Crack on of L/s Vertical Slab No.2 of Terrace of G/F (L/S Compound Wall)

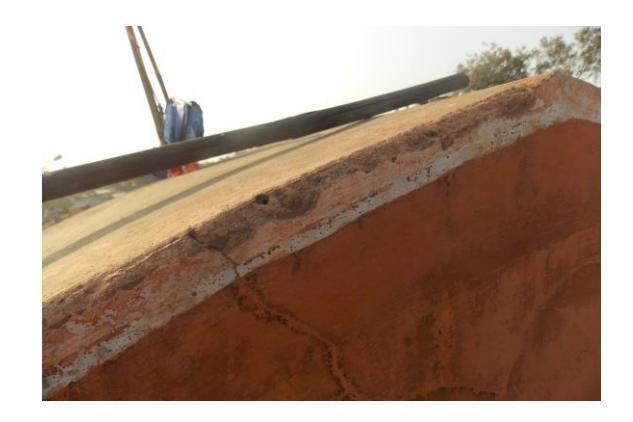
Photo 29 Plaster Crack on of L/s Vertical Slab No.7 of Terrace of G/F (L/S Compound Wall)

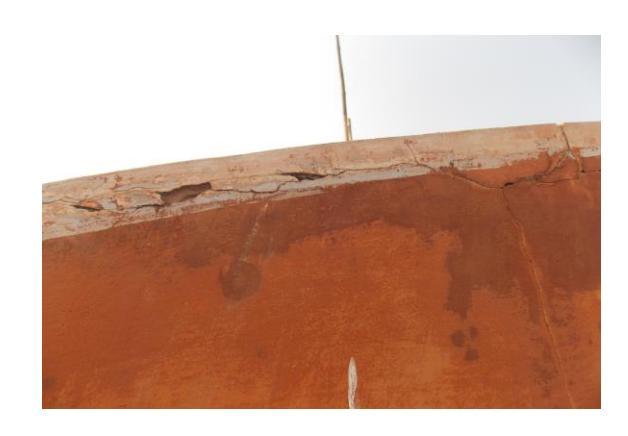
Photo 30 Plaster Crack on of L/s Vertical Slab No.9 of Terrace of G/F (L/S Compound Wall)

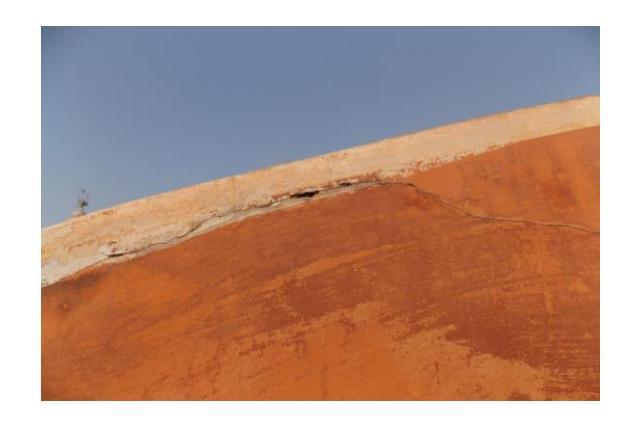
Photo 35 Plaster Crack on of L/s Vertical Slab No.18 of Terrace of G/F (L/S Compound Wall)

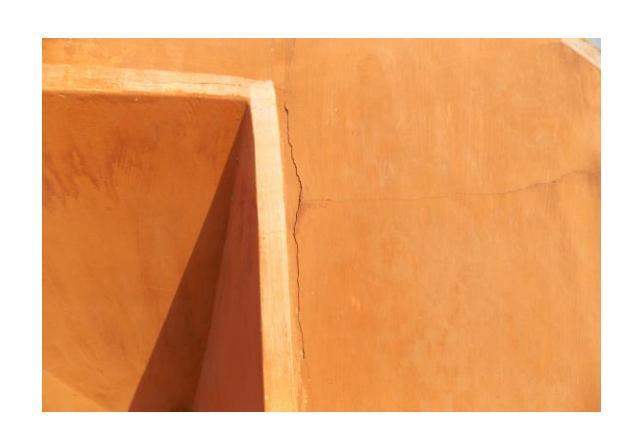
Photo 36 Plaster Crack on of L/s Vertical Slab No.19 of Terrace of G/F (L/S Compound Wall)

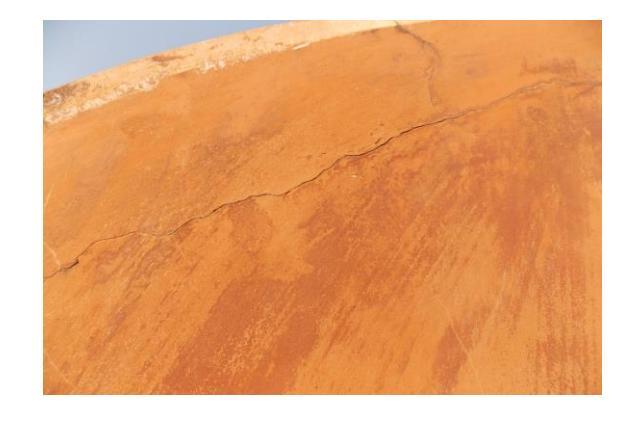
Photo 41 Plaster Crack on of L/s Vertical Slab No.35 of Terrace of G/F (L/S Compound Wall)

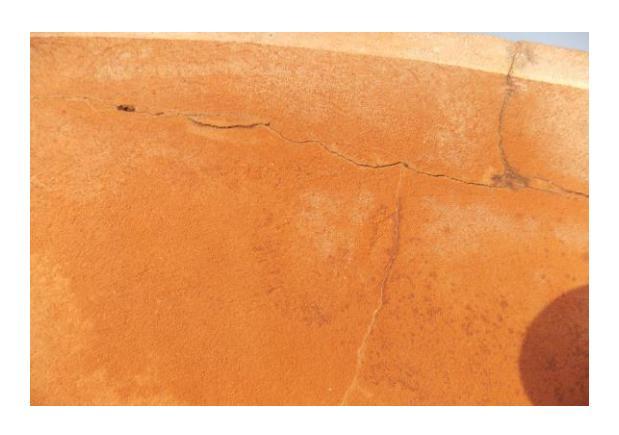
Photo 42 Plaster Crack on of L/s Vertical Slab No.38 of Terrace of G/F (L/S Compound Wall)

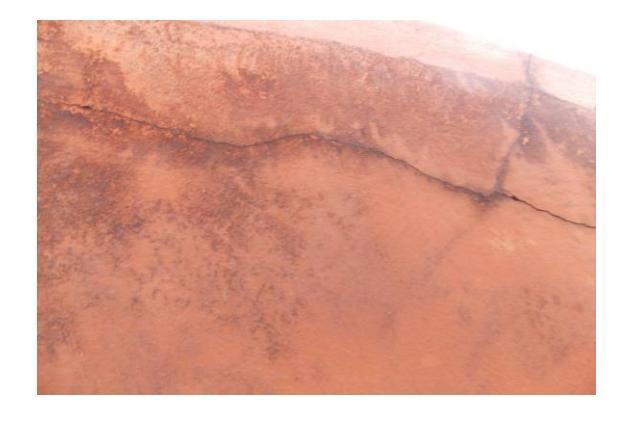
Photo 53 Plaster Crack on of L/s Vertical Slab No.55 of Terrace of G/F (L/S Compound Wall)

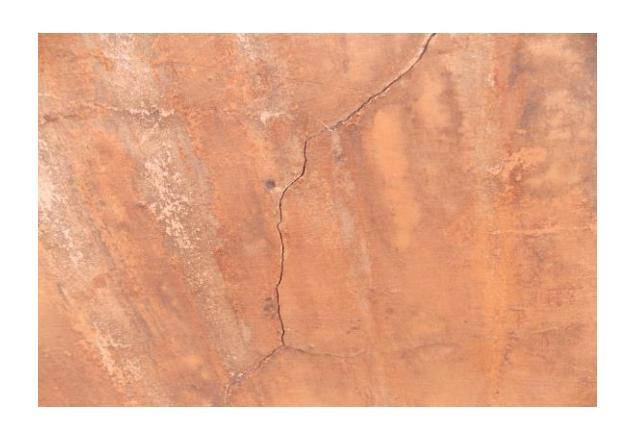
Photo 54 Plaster Crack on of L/s Vertical Slab No.57 of Terrace of G/F (L/S Compound Wall)

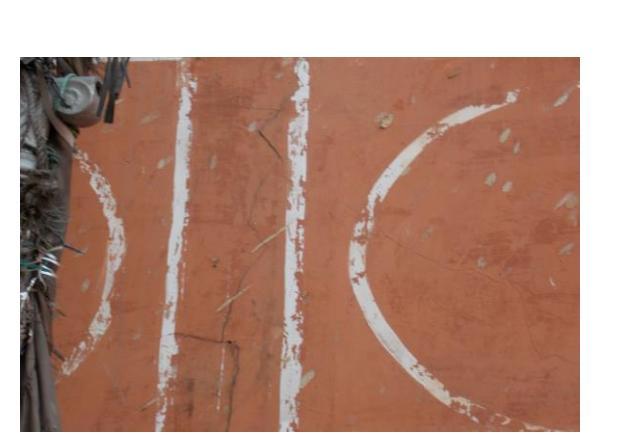
Photo 92 Plaster Crack on Vertical Slab no.14&15

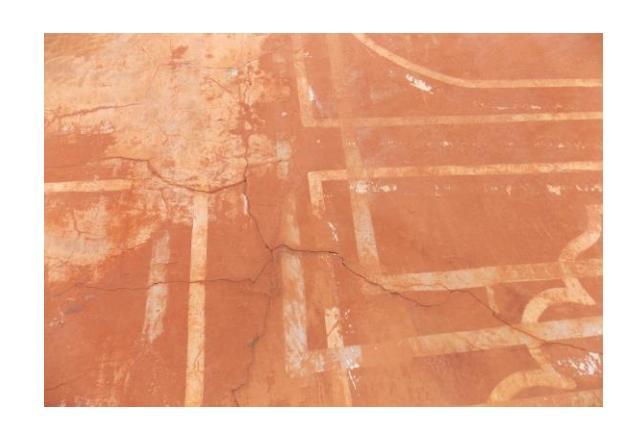
Photo 53 Plaster Crack on External F/F (Open Area Gallery of Terrace of G/F (R/S Compound Wall)

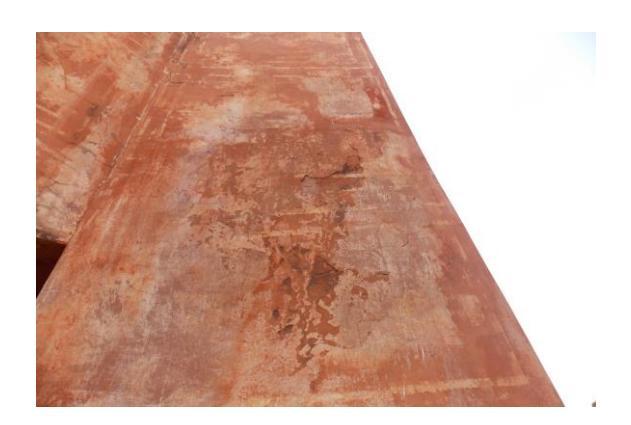
Photo 55 Plaster Crack on External F/F (Open Area Gallery of Terrace of G/F (R/S Compound Wall)

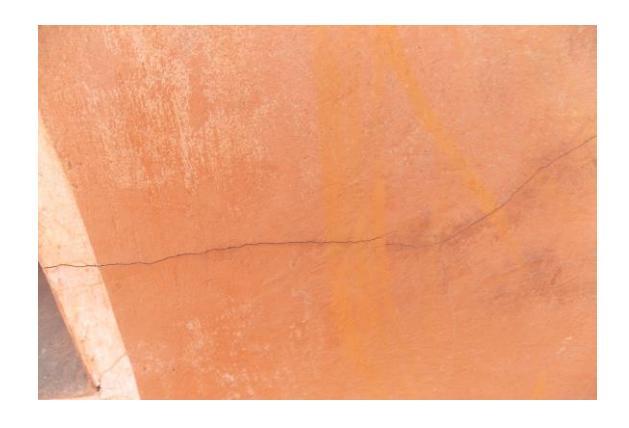
Photo 58 Plaster Crack on L/s Vertical Slab no. 3 of Terrace of G/F (R/S Compound Wall)

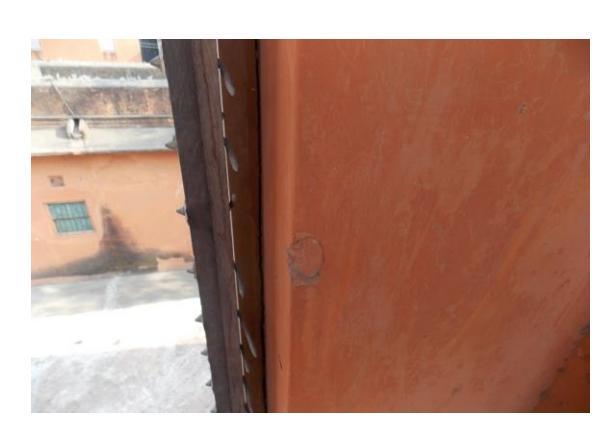
Photo 59 Peeling of Plaster on L/s Vertical Slab no. 4 of Terrace of G/F (R/S Compound Wall)

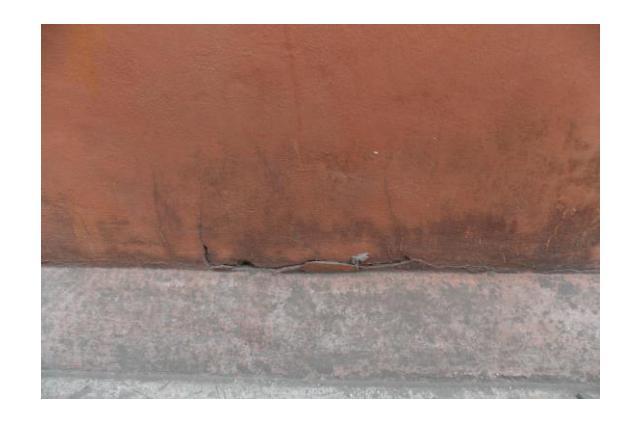
Photo 64 Peeling of Plaster on R/s Vertical Slab No. 39 of Terrace of G/F (R/S Compound Wall)
