Pre - Condition Building Survey for Construction of Underground Stations from from Chandpole to Bari Chouper and reversal line

Shop No 5RS Ramganj Bazaar Jaipur Unique ID:BC-RA/UP/0006

Report Number: AIMIL/ESG/JMCEC/BC-RA/UP/0006-5RS /01, Rev. 00, Dated: June 2014

Shop No 23,24,25 & 26 335-338,Ramganj Bazaar Jaipur Unique ID:BC-RA/UP/0008

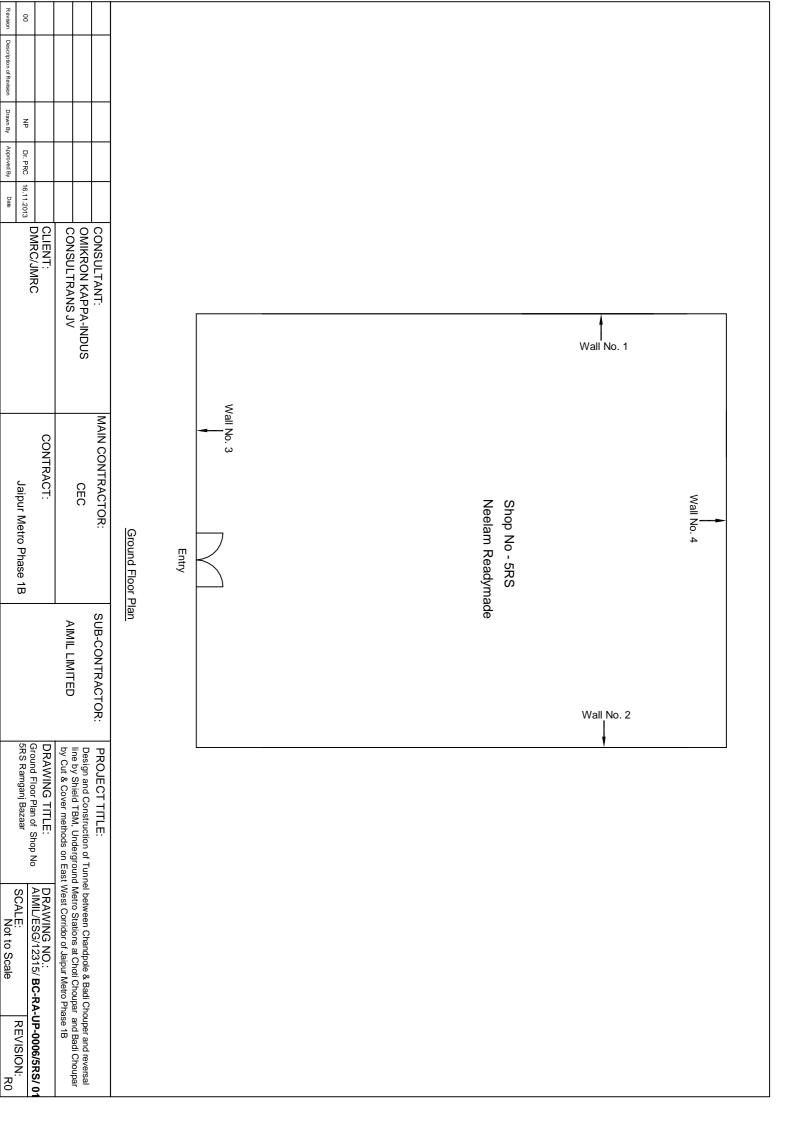
Photo 1
Stone Damage on Outer Wall of Shop No. 5RS, Ground floor

Photo 2
Covered with Materials, All Walls of Shop No. 5RS, Ground floor

$\frac{\text{Photo 3}}{\text{Covered with wooden Ceiling, Roof of Shop No. 5RS, Ground floor}}$

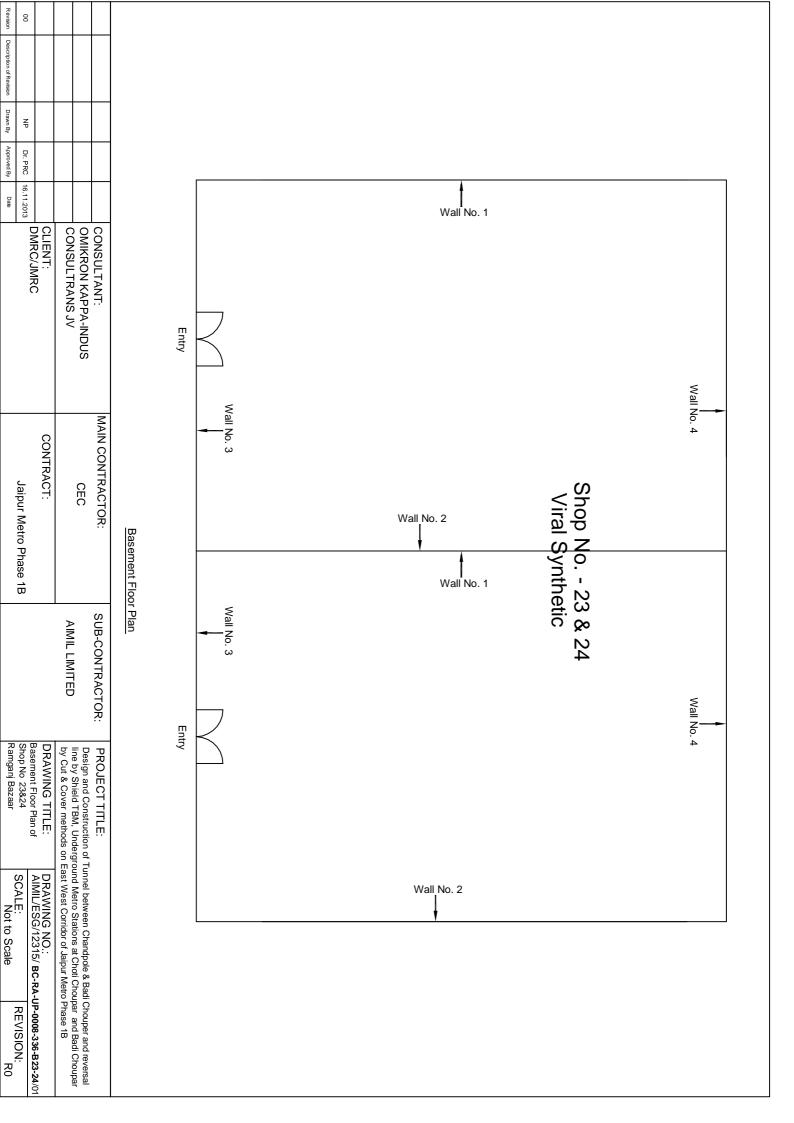
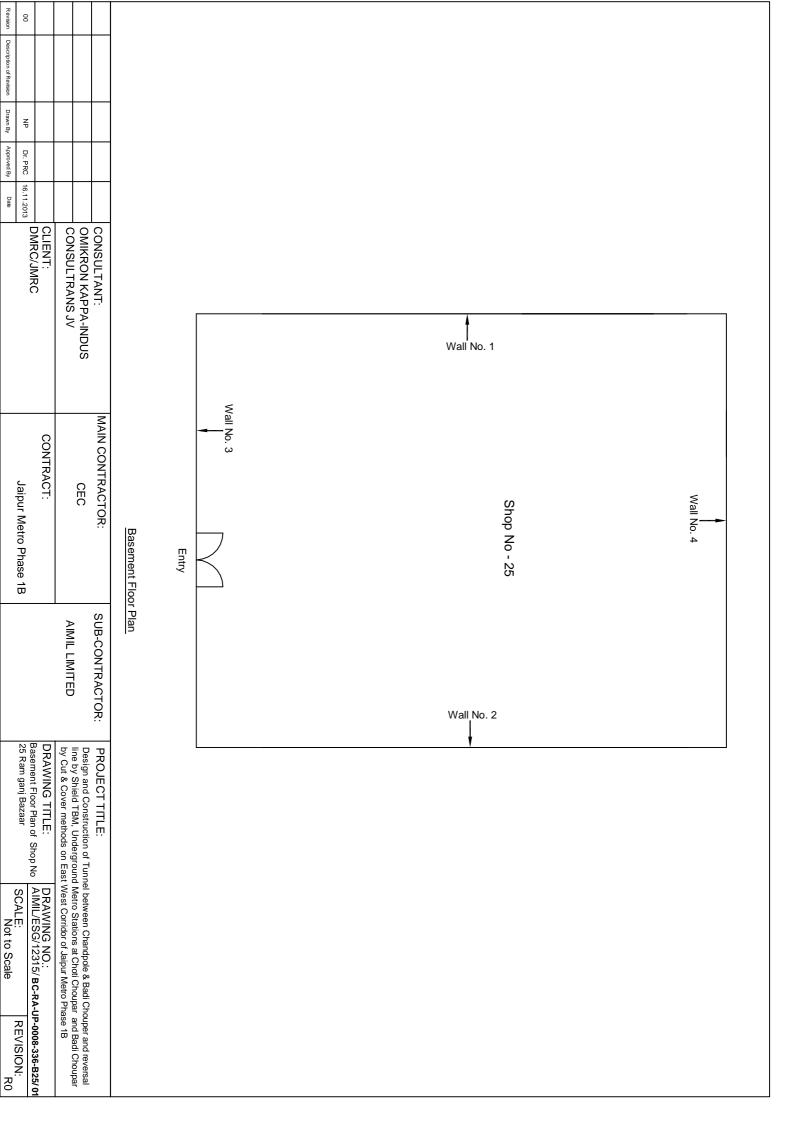
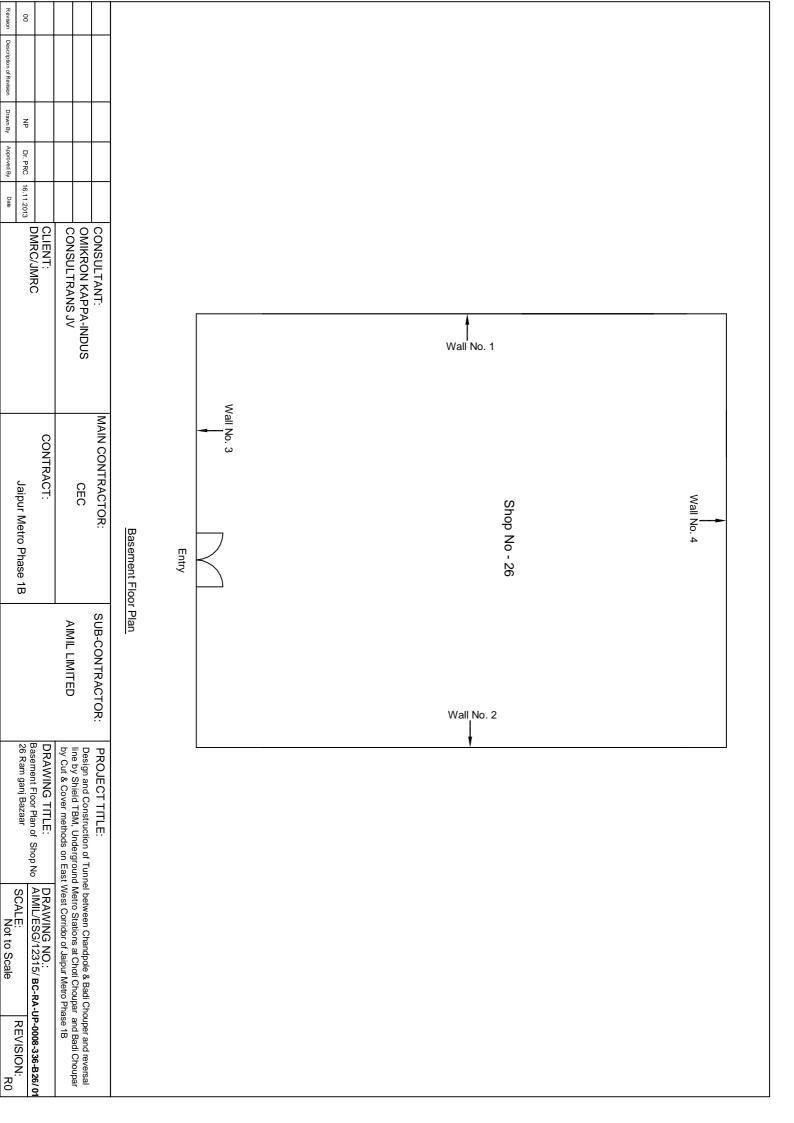
Photo 1 Main View of Shop No. 25, Viral Synthetic, Basement

Photo 2
Main View of Shop No. 26, Radhalaxmi Enterprises, Basement

Photo 3

Dampness/Seepage on Wall No.1 of Shop No. 25, Viral Synthetic,

Photo 4
Covered with Materials, Wall No. 4 of Shop No. 25,
Synthetic, Basement

Photo 5
Covered with Materials, All Walls of Shop No. 23 & 24,Basement

Photo 6
Covered with Materials, All Walls of Shop No.26, Basement
