Pre Building Condition Survey Report

Name and Address of Structure :	Choti Chopar to Badi Chopar (Down Line)
---------------------------------	---

Name of the Project	Contract JMRC-UG1B “Design and Construction of Tunnel between Chandpole and Badi Chouper and reverse line by Shield TBM, Underground Metro Stations at Choti Chouper and Badi Chouper by Cut and Cover Methods on East West Corridor of Jaipur Metro Rail Corporation Limited .”	
Owner :

Pre Building Condition Survey Report Choti Chopar to Badi Chopar (Down Line)

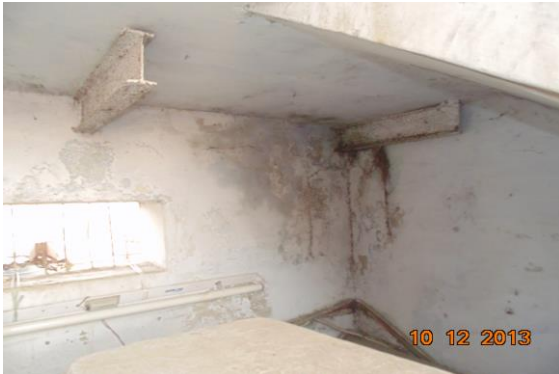
Photo 150
Dampness/Seepage on Wall No. 1, 2 & 4 of Staircase FF to SF of Second Floor
