### Pre Building Condition Survey Report

Name and Address of Structure :	Badi Chopar to Ramp Area (UP Line)
---------------------------------	------------------------------------

Name of the Project	<b>Contract JMRC-UG1B</b> “Design and Construction of Tunnel between Chandpole and Badi Chouper and reverse line by Shield TBM, Underground Metro Stations at Choti Chouper and Badi Chouper by Cut and Cover Methods on East West Corridor of Jaipur Metro Rail Corporation Limited .”	
Owner :

Pre Building Condition Survey Report Badi Chopar to Ramp Area (UP Line)

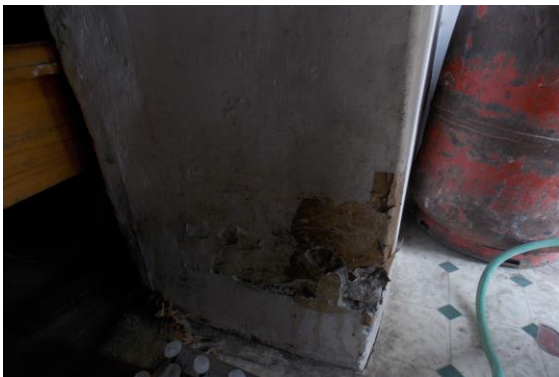
Photo 9  
Peeling of Plaster on Wall No. 2 of Hall No. 1 of House No. 2414 First Floor

Summary of Defects Other Than Crack			
Defect ID	Location	Description	Photo No.
1	Wall No. 1 Hall No. 1 House No. 2414 First Floor	Peeling of Plaster	8
2	Wall No. 2 Hall No. 1 House No. 2414 First Floor	Peeling of Plaster	9
3	Wall No. 1 Hall No. 2 House No. 2414 First Floor	Peeling of Plaster	10
4	Wall No. 6 Hall No. 2 House No. 2414 First Floor	Peeling of Plaster	11
5	Wall No. 1 Room No. 1 House No. 2414 First Floor	Peeling of Plaster	12
6	Roof Room No. 1 House No. 2414 First Floor	Peeling of Plaster	13
7	Wall No. 1 Stair FF to SF House No. 2414 First Floor	Peeling of Plaster	14
8	Wall No. 4 Stair FF to SF House No. 2414 First Floor	Peeling of Plaster	15
9	Roof Hall No. 1 House No. 2414 Second Floor	Peeling of Plaster	16
10	Wall No. 2, 4 & 6 Room No. 1 House No. 2414 Second Floor	Dampness/Seepage	17
11	Hall No. 1 House No. 2414 Second Floor	Damaged Portion	18
12	Hall No. 1 House No. 2414 Second Floor	Damaged Portion	19
