Pre Building Condition Survey Report

Name and Address of Structure :	Badi Chopar to Ramp Area (Down Line)
---------------------------------	--------------------------------------

Name of the Project	Contract JMRC-UG1B “Design and Construction of Tunnel between Chandpole and Badi Chouper and reverse line by Shield TBM, Underground Metro Stations at Choti Chouper and Badi Chouper by Cut and Cover Methods on East West Corridor of Jaipur Metro Rail Corporation Limited .”	
Owner :

Pre - Condition Building Survey for Construction of Underground Stations from Chandpole to Bari Chouper and reversal line

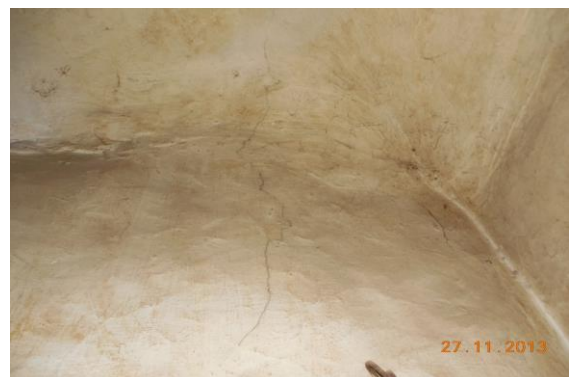
Photo 24
Inclined Crack on Wall No. 1 & Roof of Part C, Ground Floor
Approx. Width = 1.5mm, Approx. Length = 1m.
Distance from Wall No. 3 = 0.6m, Height from Floor = 1.5m.

Summary of Cracks						
Defect ID	Location	Orientation	Appx. Width (mm)	Appx. Length (m)	Category	Photo No.
1	Wall No. 1 & Roof Part C Ground Floor	Inclined	1.5	1	Slight	24
2	Roof Shop No. 8, Part D Ground Floor	Inclined	0.6	1	Very Slight	25, 25A
3	Varandah Col Shop No. 12, Ground Floor	Inclined	0.5	1.5	Very Slight	26
4	Varandah Col Shop No. 12, Ground Floor	Inclined	0.6	0.4	Very Slight	27

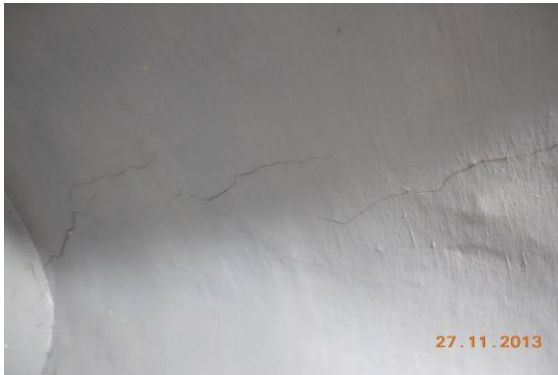
Photo 25

Inclined Crack on Roof of Shop No. 8, Part D, Ground Floor
Approx. Width = 0.6mm, Approx. Length = 1m.
Distance from Wall No. 4 = 0.1m, Height from Floor = 1.5m.

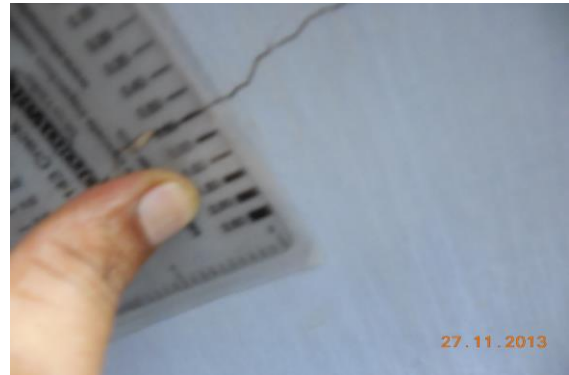
Photo 25A

Inclined Crack on Roof of Shop No. 8, Part D, Ground Floor
Approx. Width = 0.6mm, Approx. Length = 1m.
Distance from Wall No. 4 = 0.1m, Height from Floor = 1.5m.

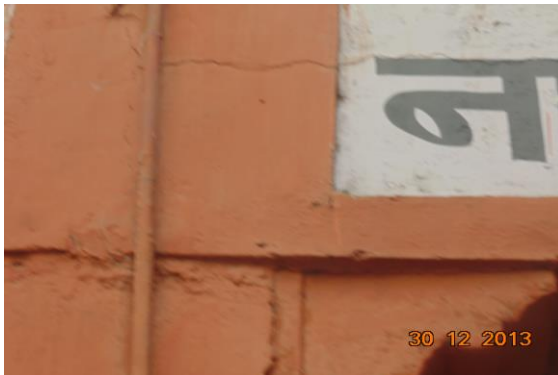
Photo 26

Inclined Crack on of Varandah Col, Shop No. 12, Ground Floor
Approx. Width = 0.5mm, Approx. Length = 1.5m.
Distance from Left External Col = 0m, Height from Floor = 2m.

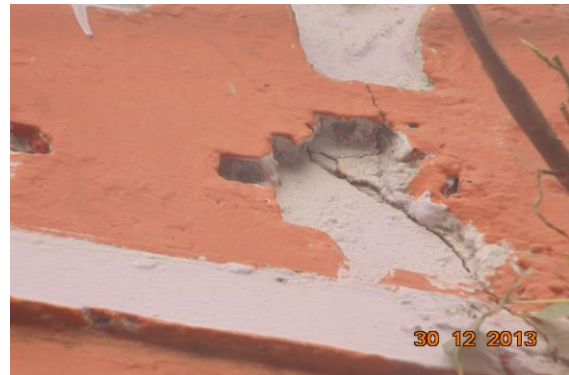
Photo 27

Inclined Crack on of Varandah Col, Shop No. 12, Ground Floor
Approx. Width = 0.6mm, Approx. Length = 0.4m.
Distance from Right External Col = 0m, Height from Floor = 3m.

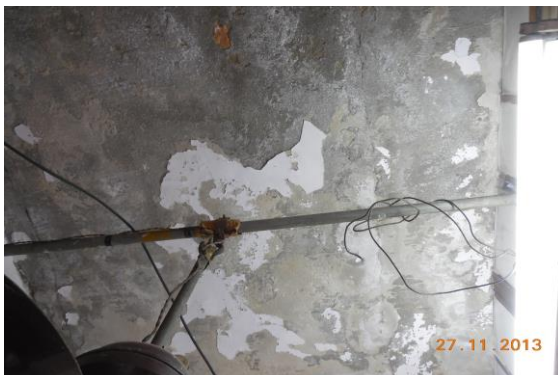
Photo 28

Peeling of Plaster on Roof of Shop No. 11B of Ground Floor

Summary of Defects Other Than Crack			
Defect ID	Location	Description	Photo No.
5	Roof Shop No. 11B Ground Floor	Peeling of Plaster	28
6	Wall No. 4 & Roof Part C Ground Floor	Peeling of Plaster	29
7	Wall No. 3 Part C Ground Floor	Peeling of Plaster	30
8	Roof Varanda of Shop No. 15A Ground Floor	Peeling of Plaster	31
9	Wall No. 4 & Roof Shop No. 5, Part C Ground Floor	Peeling of Plaster	32
10	Wall No. 2 Shop No. 5, Part C Ground Floor	Peeling of Plaster	33
11	Wall No. 3 Shop No. 5, Part C Ground Floor	Peeling of Plaster	34
12	Wall No. 1 Shop No. 5, Part C Ground Floor	Peeling of Plaster	35
13	Roof Shop No. 5, Part B Ground Floor	Peeling of Plaster	36
14	Wall No. 2 & Roof Shop No. 5, Part A Ground Floor	Peeling of Plaster	37
15	Wall No. 3 Shop No. 5, Part A Ground Floor	Peeling of Plaster	38
16	Wall No. 3 Shop No. 5, Part A Ground Floor	Peeling of Plaster	39
17	Wall No. 1 & 3 Shop No. 6 Ground Floor	Peeling of Plaster	40

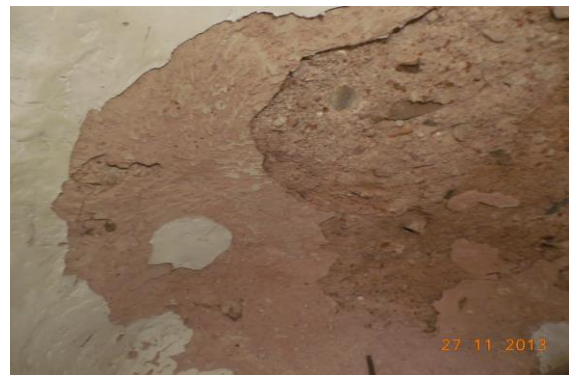
Photo 29

Peeling of Plaster on Wall No. 4 & Roof of Part C of Ground Floor

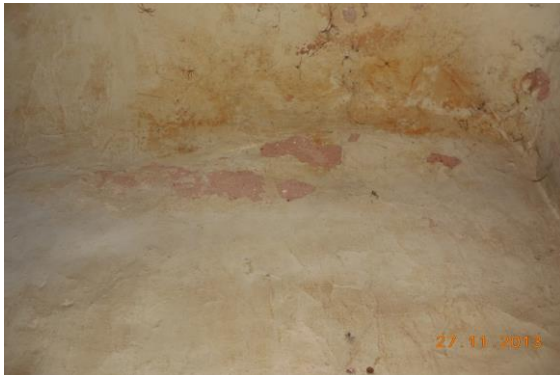
Photo 30

Peeling of Plaster on Wall No. 3 of Part C of Ground Floor

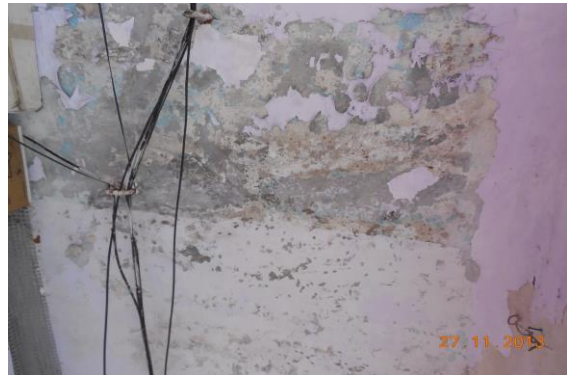
Photo 31

Peeling of Plaster on Roof of Varanda of Shop No. 15A of Ground Floor

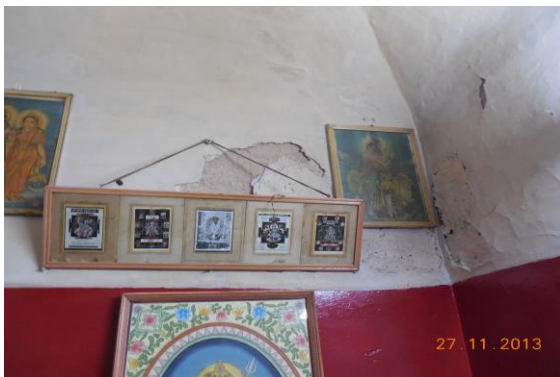
Photo 32

Peeling of Plaster on Wall No. 4 & Roof of Shop No. 5, Part C of Ground Floor

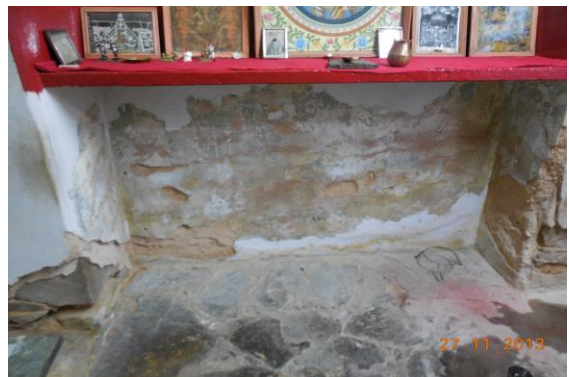
Photo 33

Peeling of Plaster on Wall No. 2 of Shop No. 5, Part C of Ground Floor

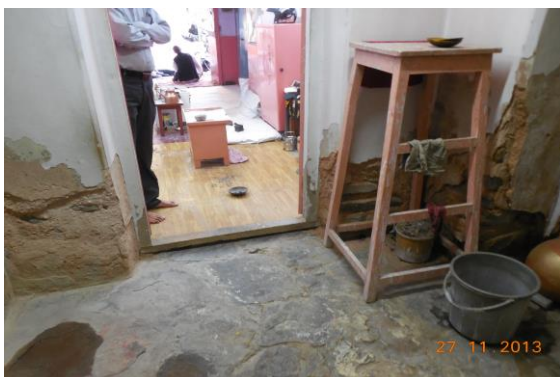
Photo 34

Peeling of Plaster on Wall No. 3 of Shop No. 5, Part C of Ground Floor

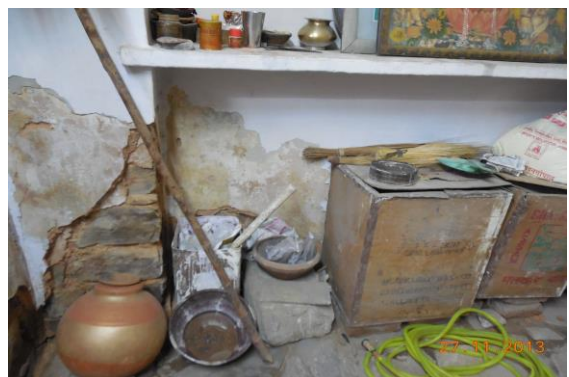
Photo 35

Peeling of Plaster on Wall No. 1 of Shop No. 5, Part C of Ground Floor

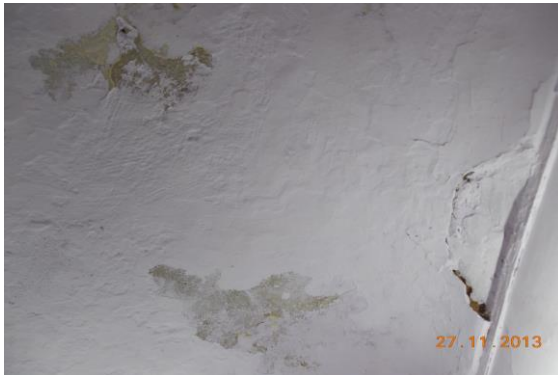
Photo 36

Peeling of Plaster on Roof of Shop No. 5, Part B of Ground Floor

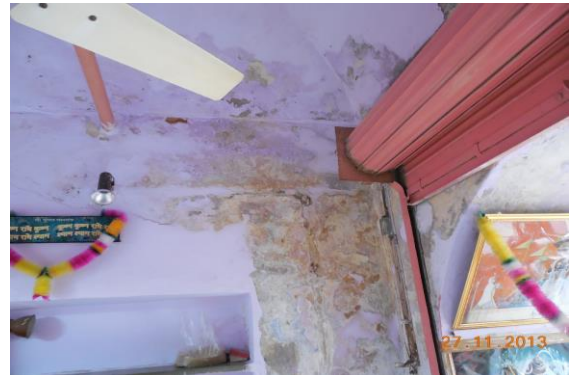
Photo 37

Peeling of Plaster on Wall No. 2 & Roof of Shop No. 5, Part A of Ground Floor

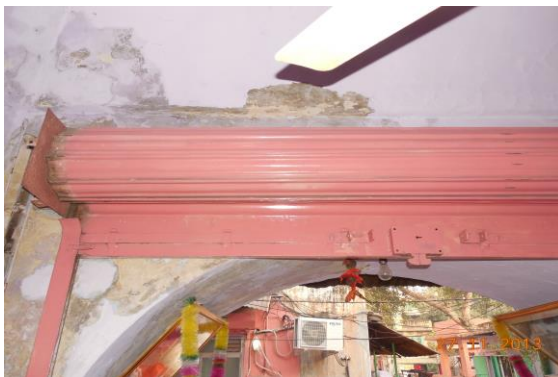
Photo 38

Peeling of Plaster on Wall No. 3 of Shop No. 5, Part A of Ground Floor

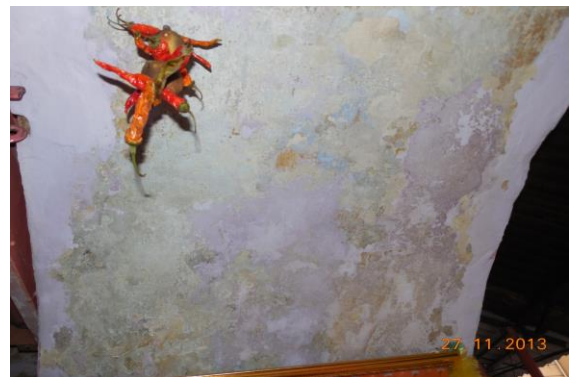
Photo 39

Peeling of Plaster on Wall No. 3 of Shop No. 5, Part A of Ground Floor

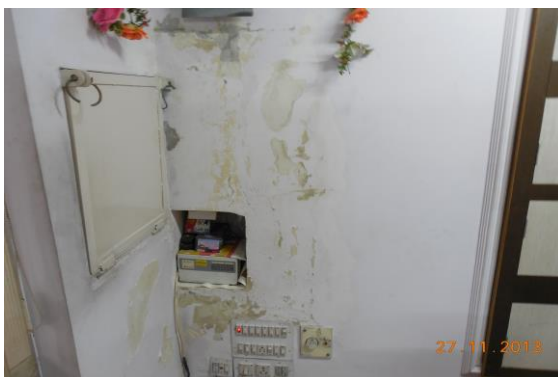
Photo 40

Peeling of Plaster on Wall No. 1 & 3 of Shop No. 6 of Ground Floor

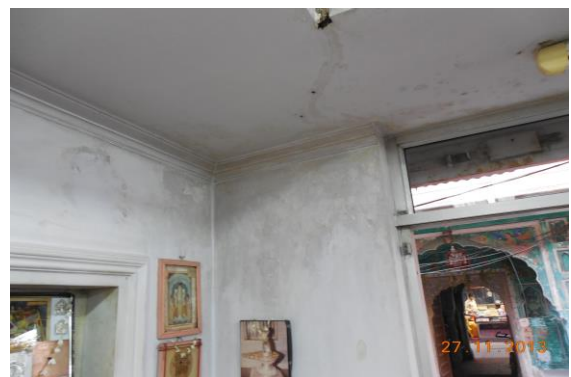
Photo 41

Dampness/Seepage on Wall No. 2 & 3 of Shop No. 7 of Ground Floor

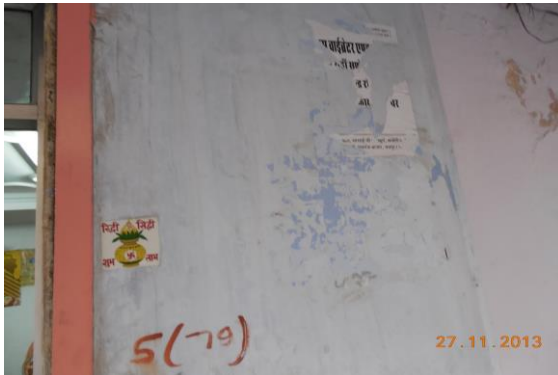
Photo 42

Dampness/Seepage on Wall No. 4 of Varanda of Ground Floor

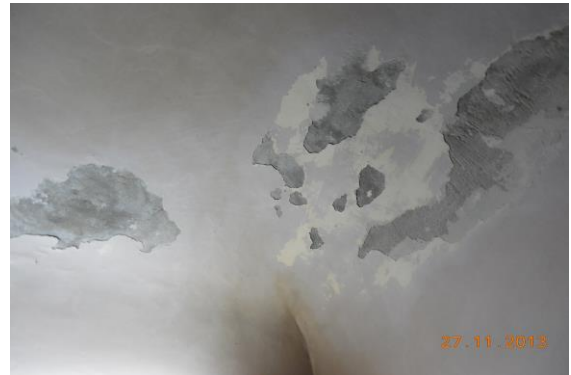
Photo 43

Peeling of Plaster on Roof of Shop No. 8 of Ground Floor

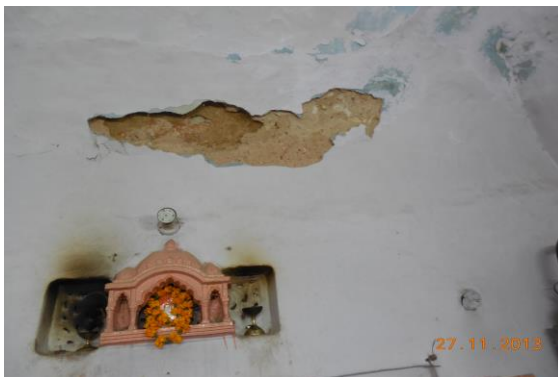
Photo 44

Peeling of Plaster on Wall No. 4 of Shop No. 8, Part B of Ground Floor

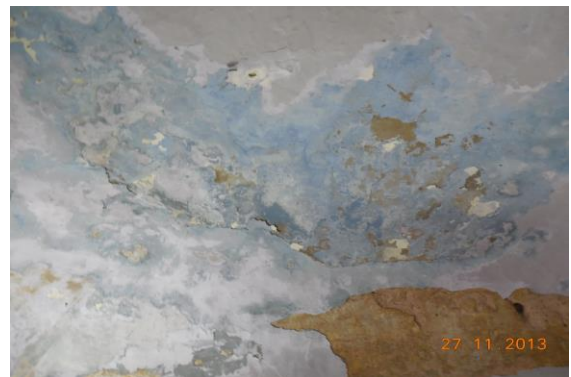
Photo 45

Dampness/Seepage on Roof of Shop No. 8, Part B of Ground Floor

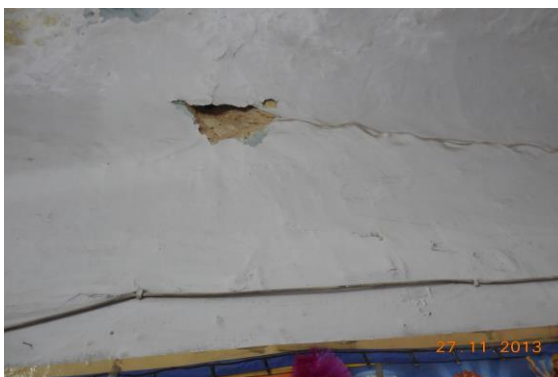
Photo 46

Peeling of Plaster on Wall No. 2 of Shop No. 8, Part A of Ground Floor

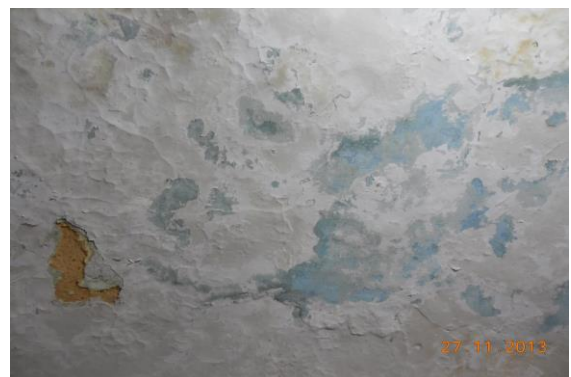
Photo 47

Dampness/Seepage on Roof of Shop No. 8, Part A of Ground Floor

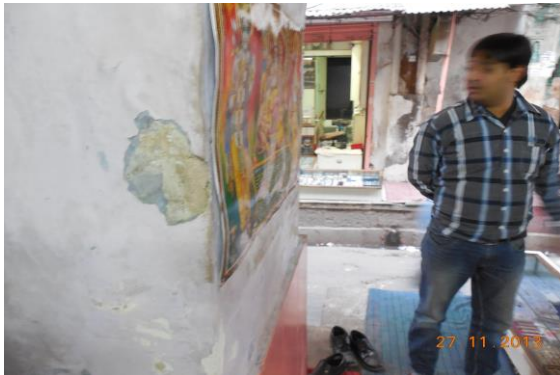
Photo 48

Peeling of Plaster on Wall No. 3 of Shop No. 8, Part A of Ground Floor

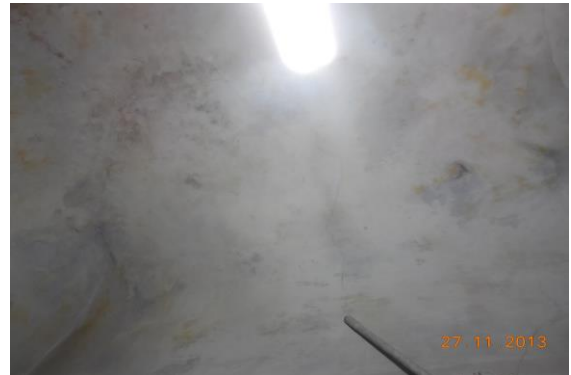
Photo 49

Dampness/Seepage on Roof of Shop No. 8, Part D of Ground Floor

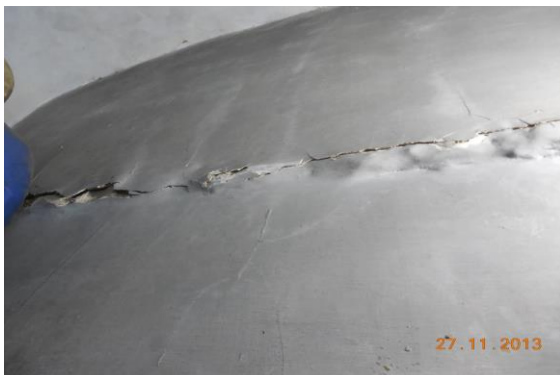
Photo 50

Peeling of Plaster on Wall No. 3 of Shop No. 8, Part D of Ground Floor

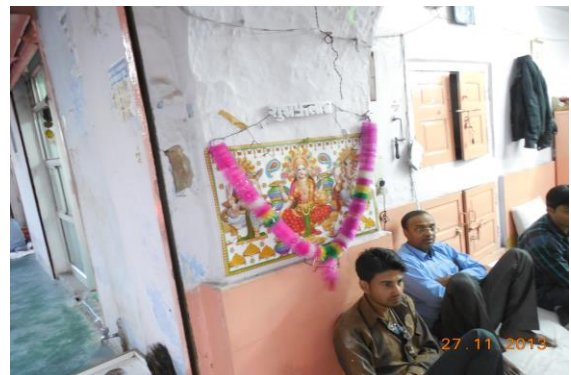
Photo 51

Peeling of Plaster on Wall No. 1 of Shop No. 8, Part A of Ground Floor

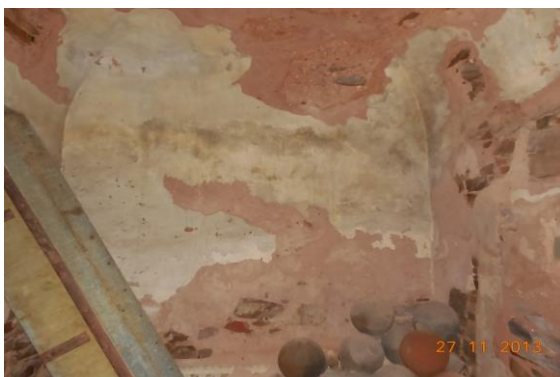
Photo 52

Peeling of Plaster on Wall No. 4 of Piyau, Part B of Ground Floor

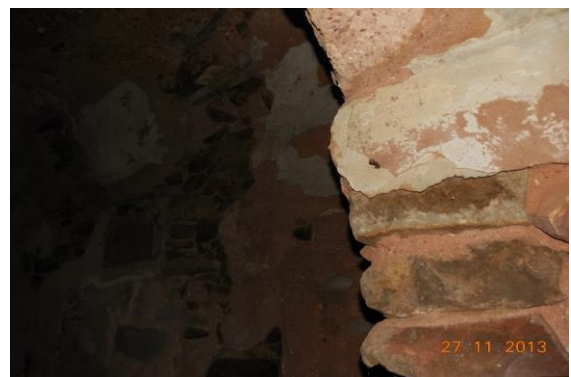
Photo 53

Peeling of Plaster on Wall No. 2 of Piyau, Part B of Ground Floor

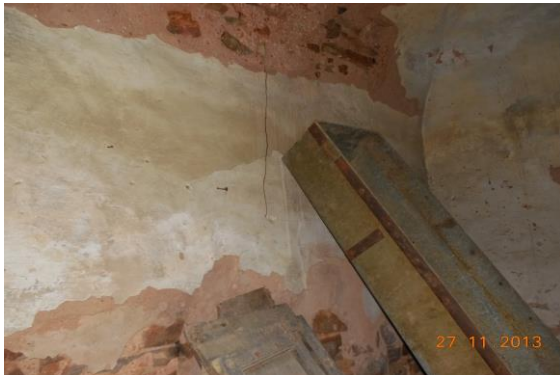
Photo 54

Peeling of Plaster on Wall No. 1 of Piyau, Part B of Ground Floor

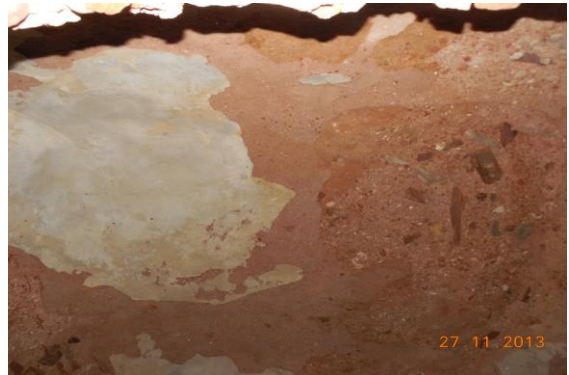
Photo 55

Peeling of Plaster on Roof of Piyau, Part B of Ground Floor

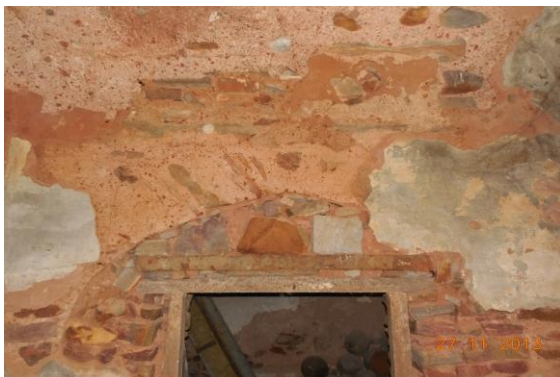
Photo 56

Peeling of Plaster on Wall No. 4 of Piyau, Part A of Ground Floor

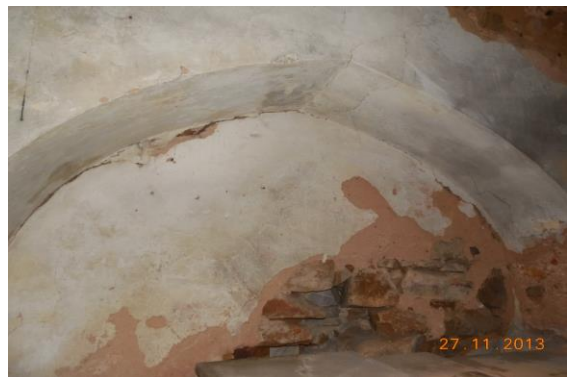
Photo 57

Peeling of Plaster on Wall No. 1 of Piyau, Part A of Ground Floor

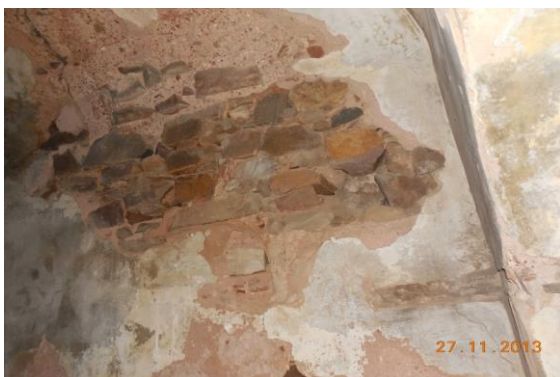
Photo 58

Peeling of Plaster on Wall No. 2 of Piyau, Part A of Ground Floor

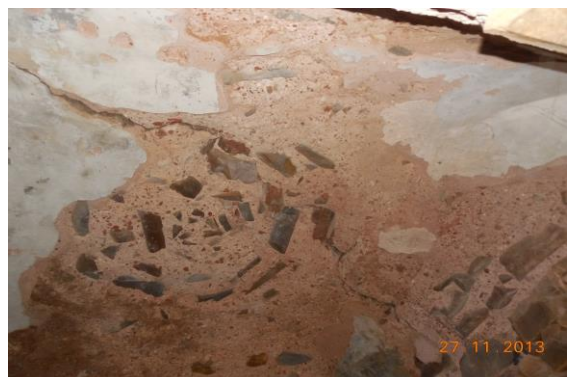
Photo 59

Peeling of Plaster on Roof of Piyau, Part A of Ground Floor

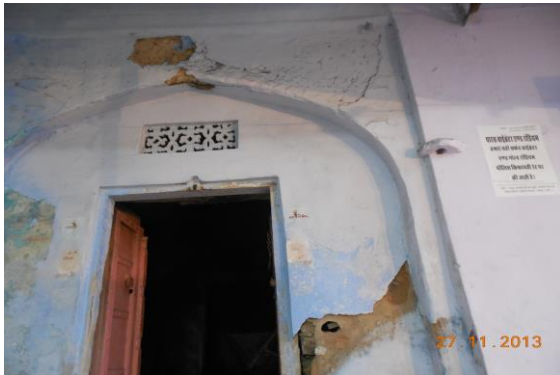
Photo 60

Peeling of Plaster on Front Wall of Piyau, Part A of Ground Floor

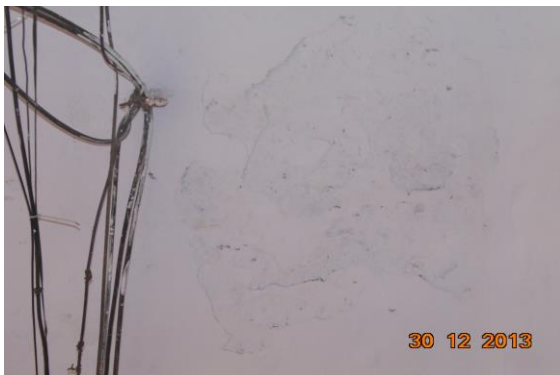
Photo 62

Peeling of Plaster on Varandah Roof of Shop No. A11, Ground Floor

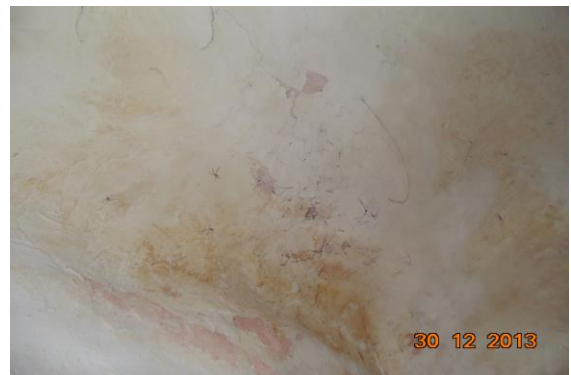
Photo 63

Peeling of Plaster on Room No. 1 of Ground Floor

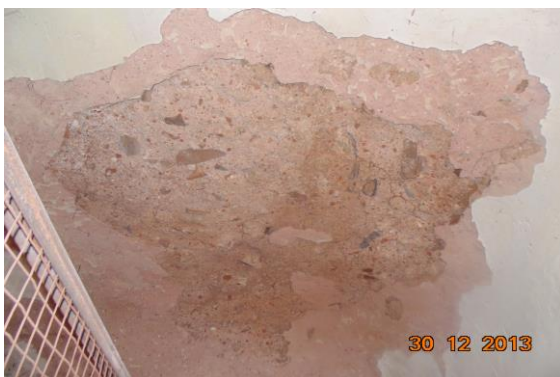
Photo 64

Peeling of Plaster on Room No. 2 of Ground Floor

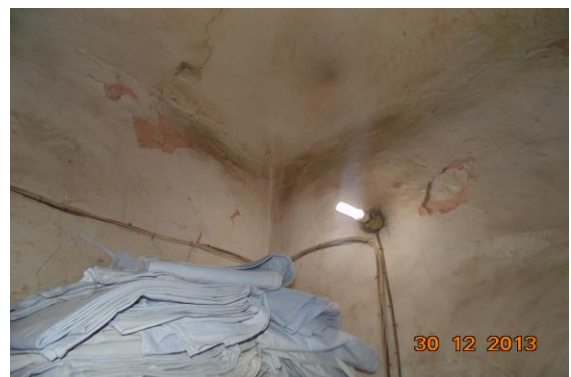
Photo 65

Peeling of Plaster on Wall No. 1 & 3 of Room No. 1 of Ground Floor

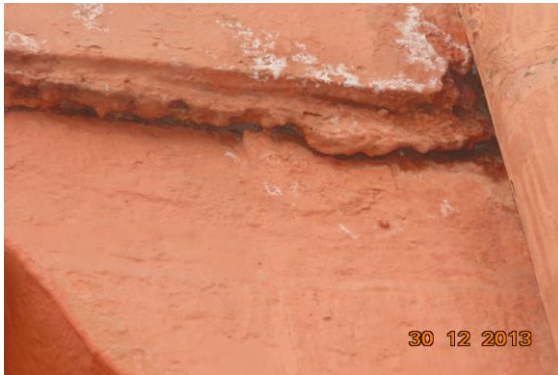
Photo 66

Peeling of Plaster on Right External Col of Shop No. 12, Ground Floor

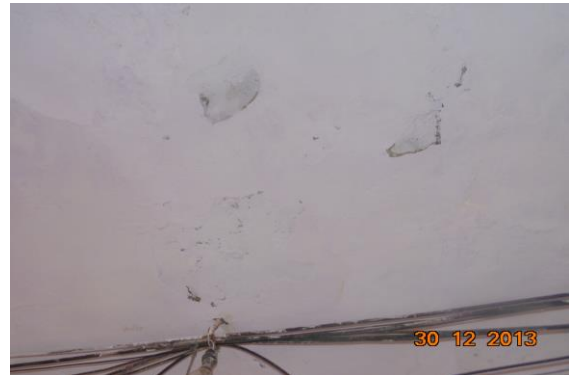
Photo 67

Peeling of Plaster on Varandah Roof of Shop No. 12, Ground Floor

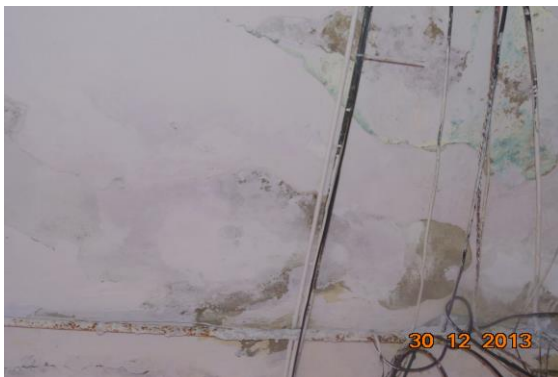
Photo 68

Peeling of Plaster on Varandah Roof of Shop No. 12, Ground Floor

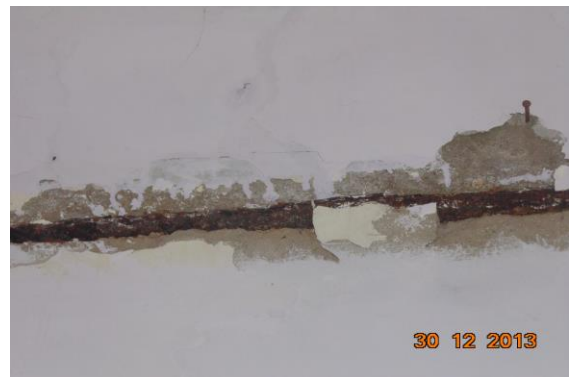
Photo 69

Exposed Reinforcement on Varandah Beam of Shop No. 12, Ground Floor

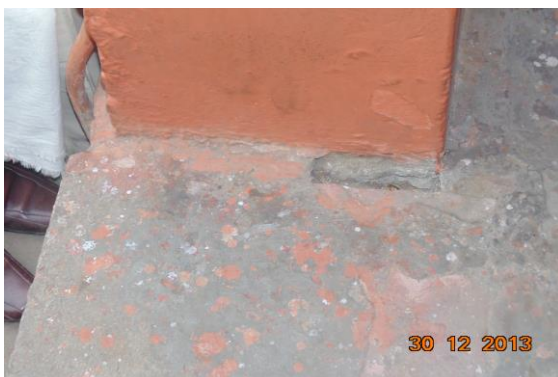
Photo 70

Peeling of Plaster on Varandah Floor of Shop No. 12, Ground Floor

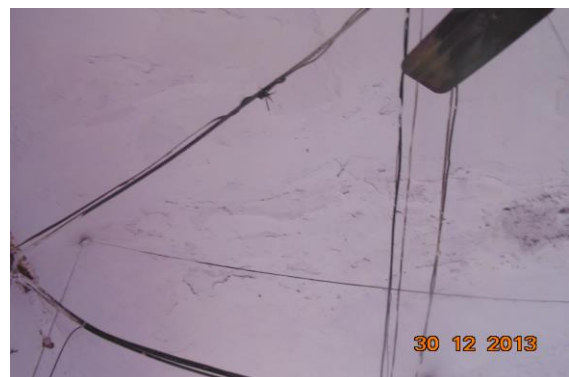
Photo 71

Peeling of Plaster on Roof of Varanda of Shop No. B10, Ground Floor

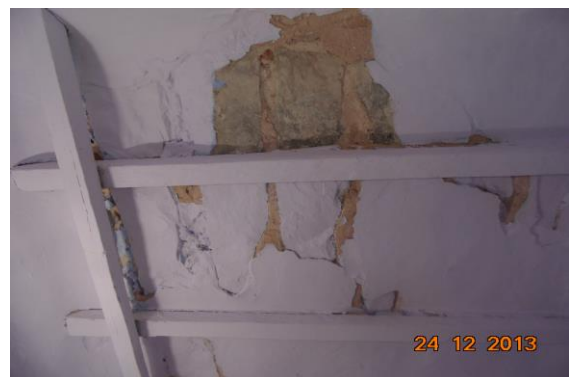
Photo 6
Peeling of Plaster on Roof of Part B of Shop No.20 of Ground Floor

Summary of Defects Other Than Crack			
Defect ID	Location	Description	Photo No.
1	Roof Part B of Shop No.20 Ground Floor	Peeling of Plaster	6
2	Wall No. 1 & 3 Part B of Shop No.20 Ground Floor	Peeling of Plaster	7
3	Wall No. 4 Part B of Shop No.20 Ground Floor	Peeling of Plaster	8
4	Wall No. 4 Part B of Shop No.20 Ground Floor	Peeling of Plaster	9
5	Wall No. 2 Part B of Shop No.20 Ground Floor	Peeling of Plaster	10
6	Roof Part C of Shop No.20 Ground Floor	Peeling of Plaster	11
7	Wall No. 3 Part C of Shop No.20 Ground Floor	Peeling of Plaster	12
8	Wall No. 3 Part C of Shop No.20 Ground Floor	Peeling of Plaster	13
9	Wall No. 1 & Roof House Above Shop No.20 First Floor	Dampness/Seepage	14
10	Roof Room No. 1 House Above Shop No.20, First Floor	Peeling of Plaster	15
11	Wall No.2 & Roof Room No. 2 House Above Shop No.20, First Floor	Peeling of Plaster	16
12	Roof Room No. 3 House Above Shop No.20, First Floor	Peeling of Plaster	17

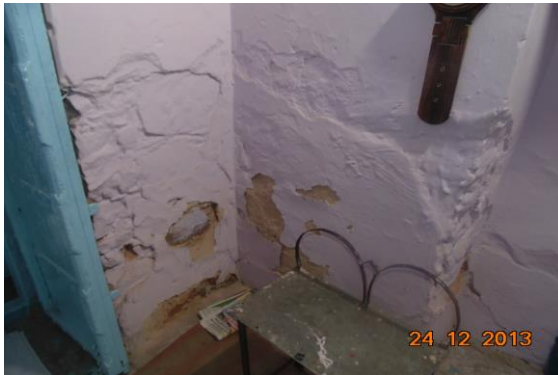
Photo 7

Peeling of Plaster on Wall No. 1 & 3 of Part B of Shop No.20 of Ground Floor

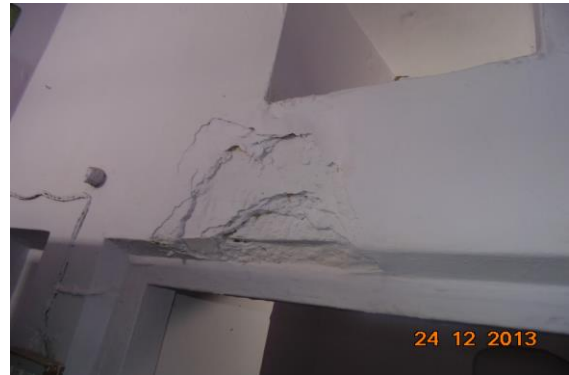
Photo 8

Peeling of Plaster on Wall No. 4 of Part B of Shop No.20 of Ground Floor

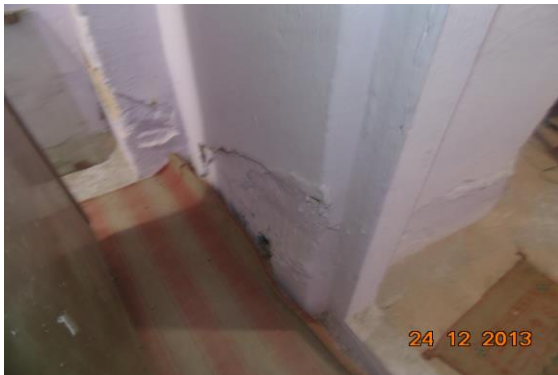
Photo 9

Peeling of Plaster on Wall No. 4 of Part B of Shop No.20 of Ground Floor

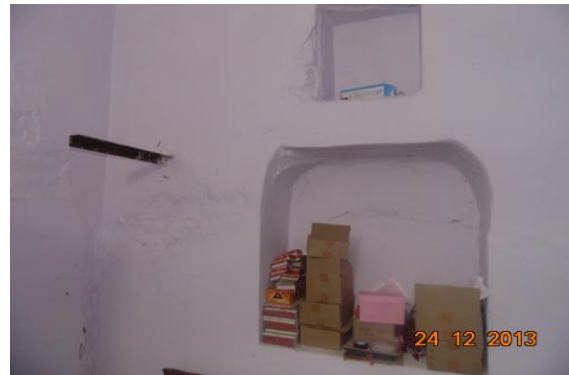
Photo 10

Peeling of Plaster on Wall No. 2 of Part B of Shop No.20 of Ground Floor

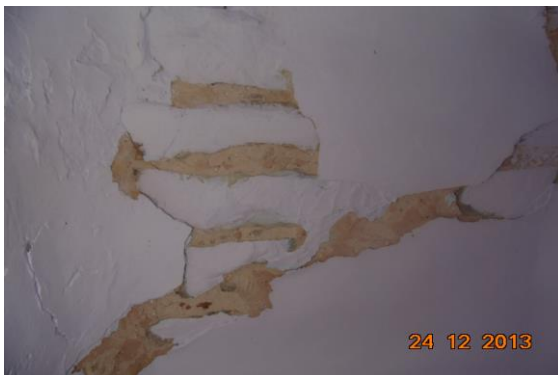
Photo 11

Peeling of Plaster on Roof of Part C of Shop No.20 of Ground Floor

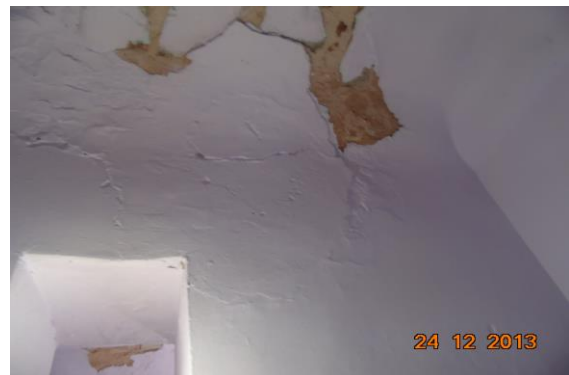
Photo 12

Peeling of Plaster on Wall No. 3 of Part C of Shop No.20 of Ground Floor

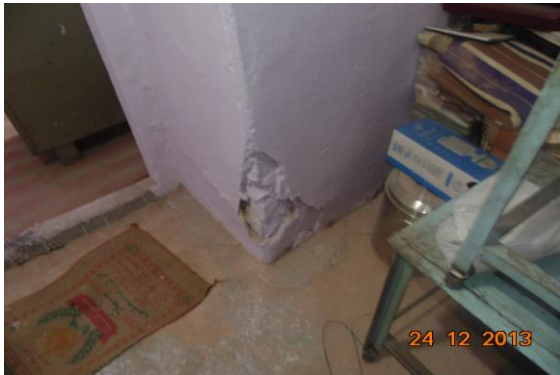
Photo 13

Peeling of Plaster on Wall No. 3 of Part C of Shop No.20 of Ground Floor

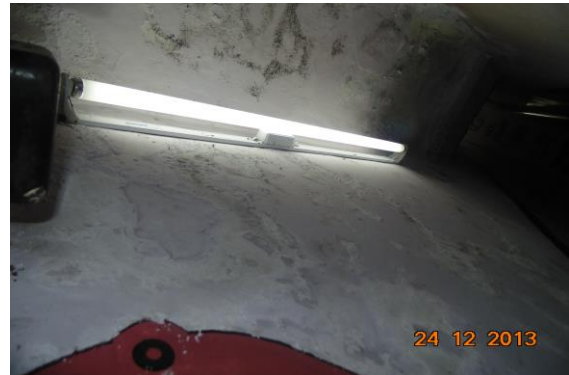
Photo 14

Dampness/Seepage on Wall No. 1 & Roof of House Above Shop No.20 of First Floor

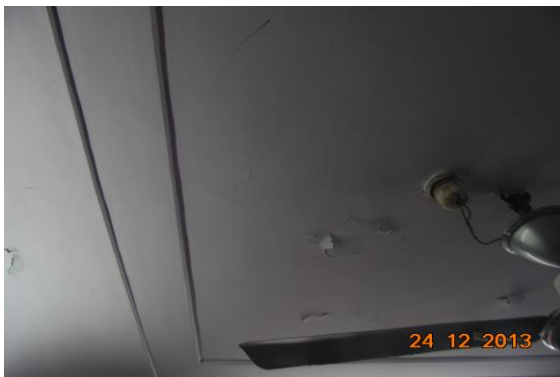
Photo 15

Peeling of Plaster on Roof of Room No. 1 of House Above Shop No.20, First Floor

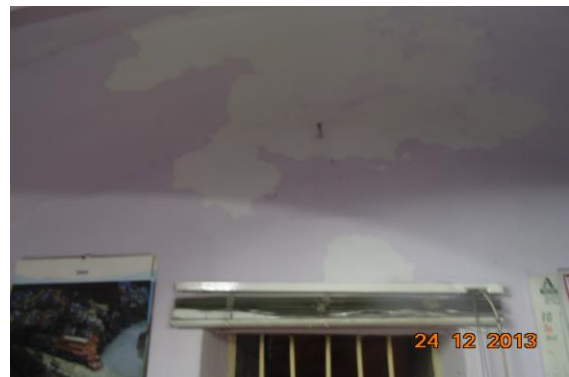
Photo 16

Peeling of Plaster on Wall No. 2 & Roof of Room No. 2 of House Above Shop No.20, First Floor

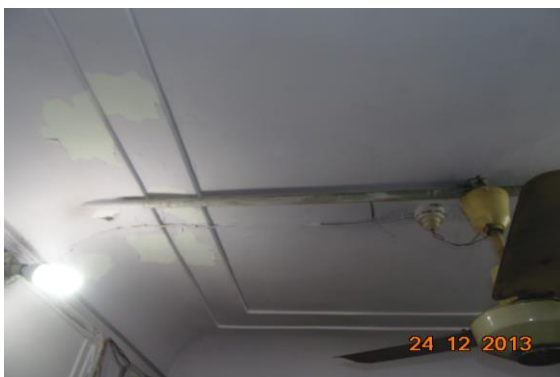
Photo 17

Peeling of Plaster on Roof of Room No. 3 of House Above Shop No.20, First Floor

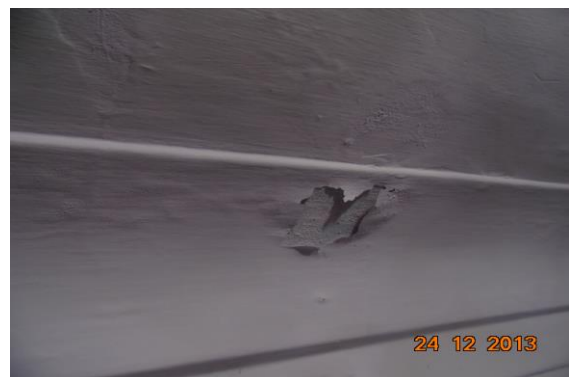
Photo 18

Peeling of Plaster on Roof of Balcony of First Floor

13	Roof Balcony First Floor	Peeling of Plaster	18
14	Sun Shade & FrontSide House Above Shop No.20 First Floor	Damaged Portion	19
15	Sun Shade & FrontSide House Above Shop No.20 First Floor	Damaged Portion	20
16	Sun Shade & Rightside House Above Shop No.20 First Floor	Damaged Portion	21
17	Rightside Wall House Above Shop No.20 First Floor	Peeling of Plaster	22
18	Wall No. 3 Staircase First Floor to Second Floor	Peeling of Plaster	23
19	Wall No. 1 First Floor to Second Floor Staircase	Peeling of Plaster	24
20	Wall No. 4 Room No. 1 House Above Shop No.20, First Floor	Peeling of Plaster	25
21	Wall No. 3, Roof of Room No. 1 House Above Shop No.20, First Floor	Dampness/Seepage	26
22	Wall No. 4 House Above Shop No.20 Terrace	Peeling of Plaster	27
23	Wall No. 4 House Above Shop No.20 Terrace	Peeling of Plaster	28
24	Wall No. 3 House Above Shop No.20 Terrace	Peeling of Plaster	29
25	Wall No. 1 Staircase SF to Terrace	Peeling of Plaster	30

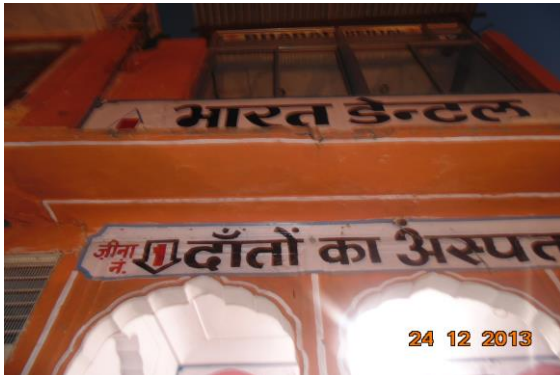
Photo 19

Damaged Portion on Sun Shade & FrontSide of House Above Shop No.20 of First Floor

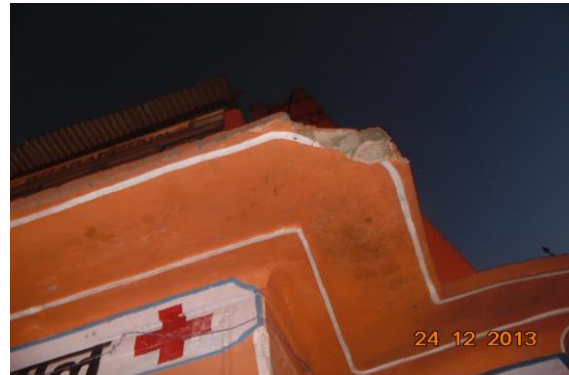
Photo 20

Damaged Portion on Sun Shade & FrontSide of House Above Shop No.20 of First Floor

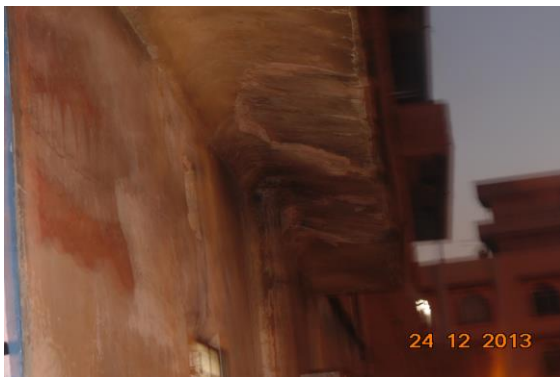
Photo 21

Damaged Portion on Sun Shade & Rightside of House Above Shop No.20 of First Floor

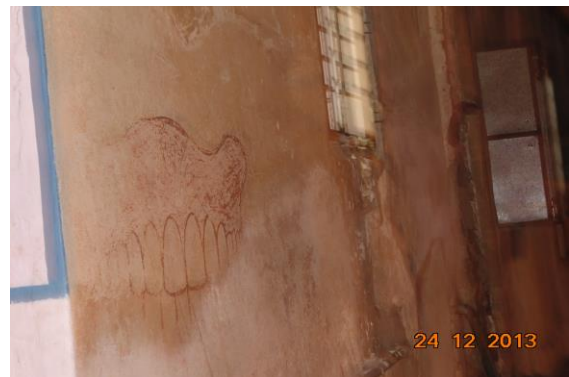
Photo 22

Peeling of Plaster on Rightside Wall of House Above Shop No.20 of First Floor

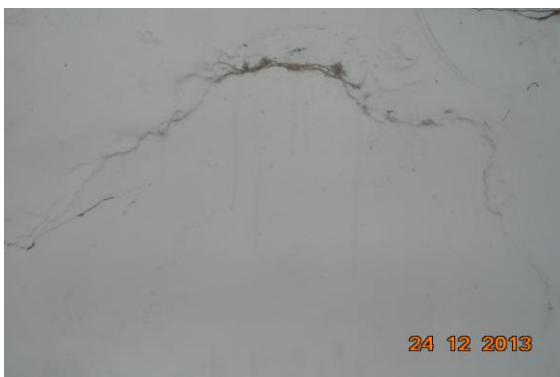
Photo 23

Peeling of Plaster on Wall No. 3 of First Floor to Second Floor Staircase

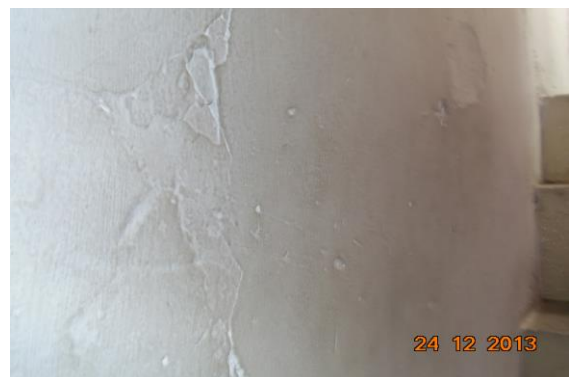
Photo 24

Peeling of Plaster on Wall No. 1 of First Floor to Second Floor Staircase

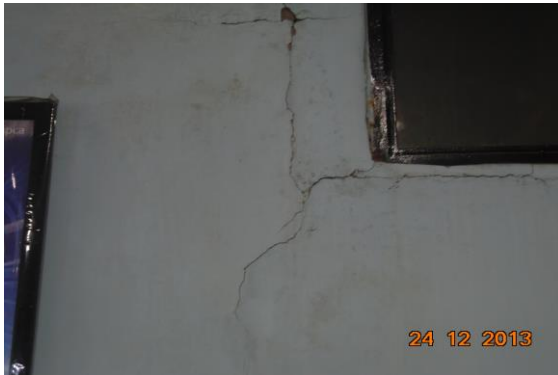
Photo 25

Peeling of Plaster on Wall No. 4 of Room No. 1 of House Above Shop No.20, First Floor

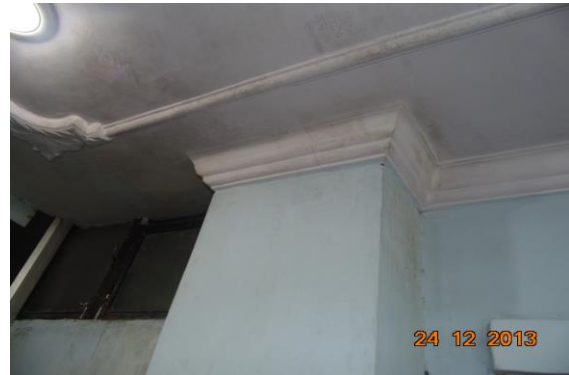
Photo 26

Dampness/Seepage on Wall No. 3, Roof of Room No. 1 of House Above Shop No.20, First Floor

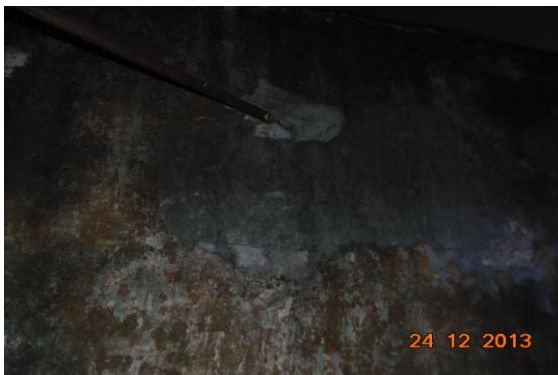
Photo 27

Peeling of Plaster on Wall No. 4 of House Above Shop No.20 of Terrace

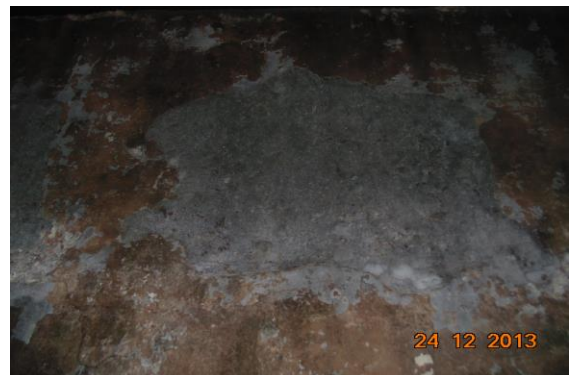
Photo 28

Peeling of Plaster on Wall No. 4 of House Above Shop No.20 of Terrace

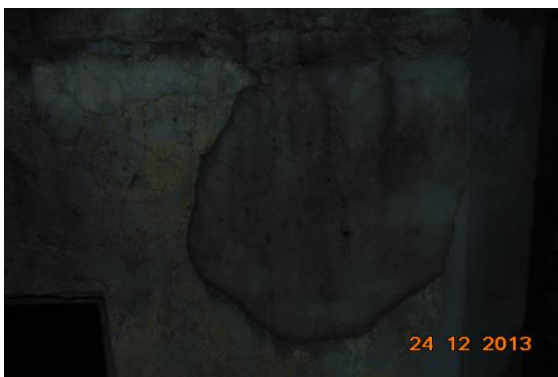
Photo 29

Peeling of Plaster on Wall No. 3 of House Above Shop No.20 of Terrace

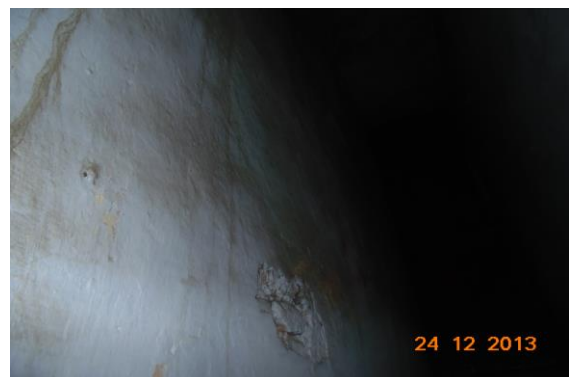
Photo 30

Peeling of Plaster on Wall No. 1 of Staircase SF to Terrace

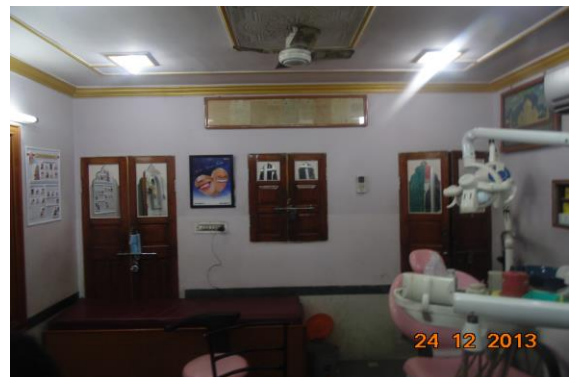
Photo 4
View of Room No.2, First Floor

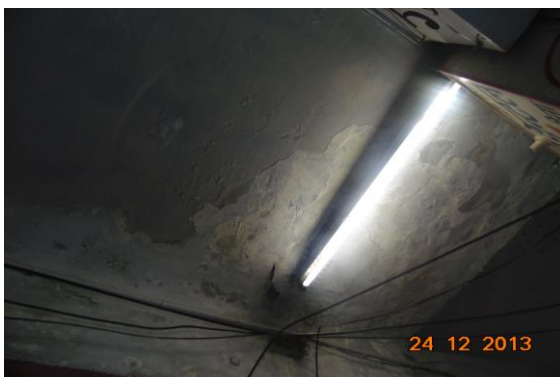
Photo 5
Dampness/Seepage on Roof of Varanda of Shop No.21 of Ground Floor

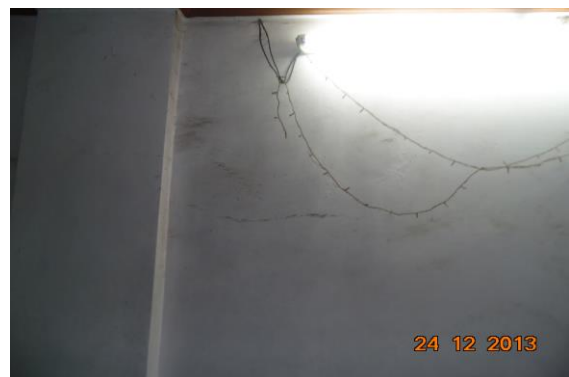
Photo 6
Dampness/Seepage on Wall No. 3 of Room No. 1 of Second Floor

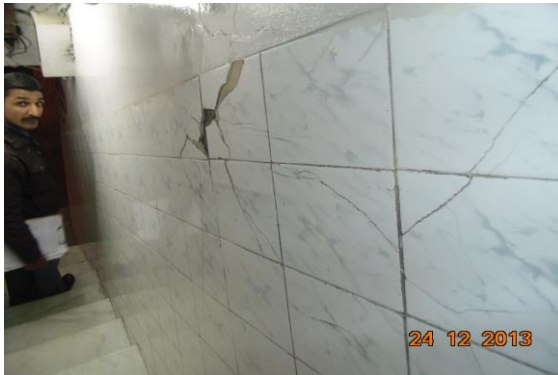
Photo 7

Damaged Portion on Wall No. 1 of Staircase Ground Floor to First Floor

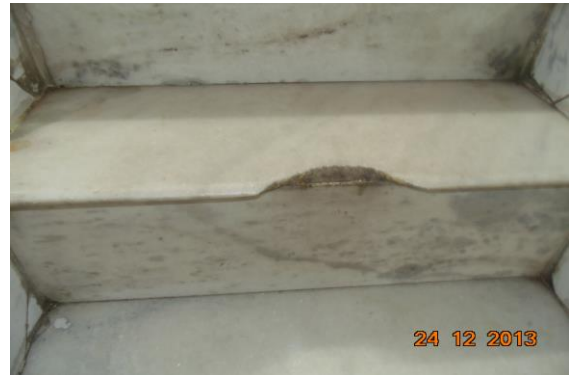
Photo 8

Damaged Portion on Steps of Staircase Ground Floor to First Floor

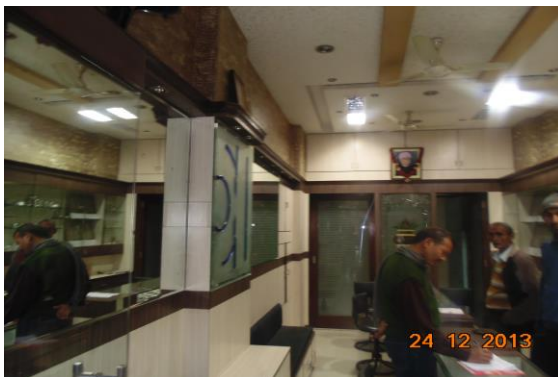
Photo 9

Wall No. 1 & 4 of Part A of Shop No.21 of Ground Floor Covered With Wooden Work

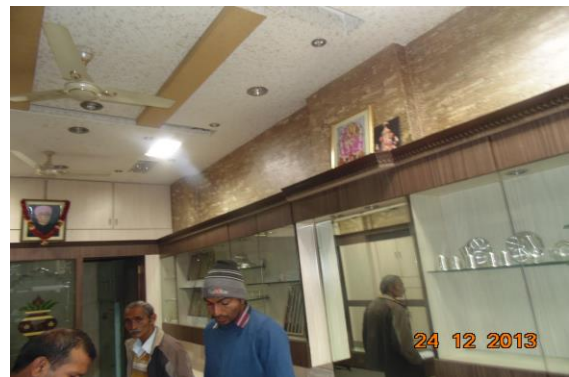
Photo 10

Wall No. 2 & 4 of Part A of Shop No.21 of Ground Floor Covered With Wooden Work

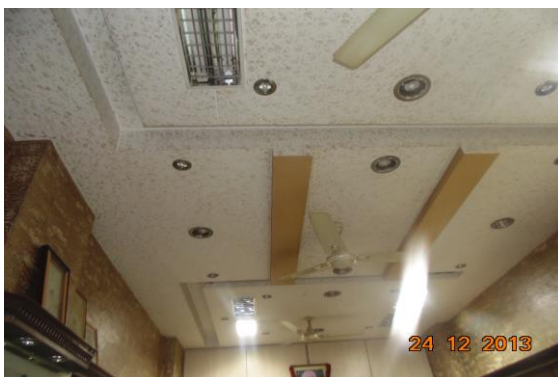
Photo 11

Roof of Part A of Shop No.21 of Ground Floor Covered With Falls Ceiling

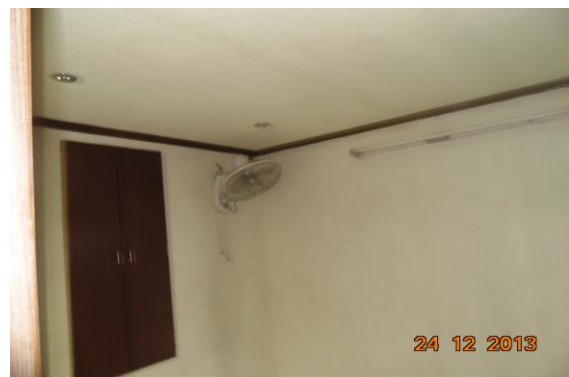
Photo 12

Wall No. 4 of Part A of Shop No.21 of Ground Floor Covered With Wooden Work

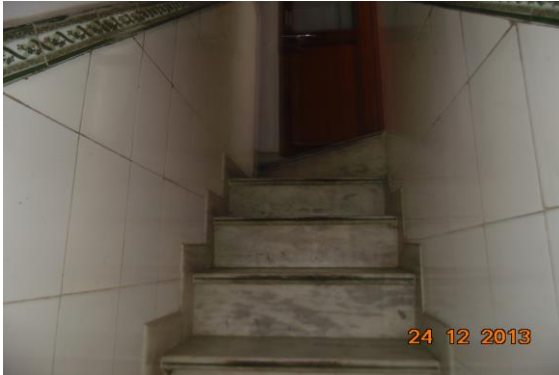
Photo 13

Wall No. 1 & 2 of Staircase First Floor to Second Floor Covered With Material

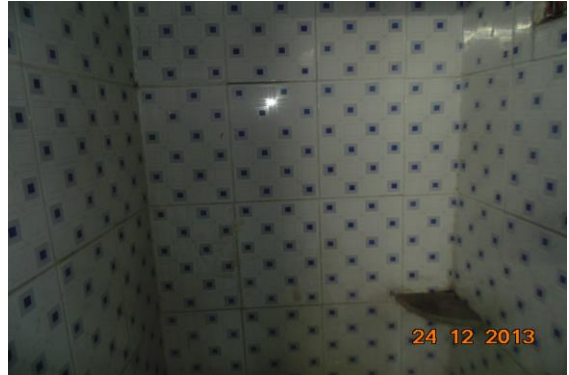
Photo 14

Bathroom of Second Floor Covered With Tiles

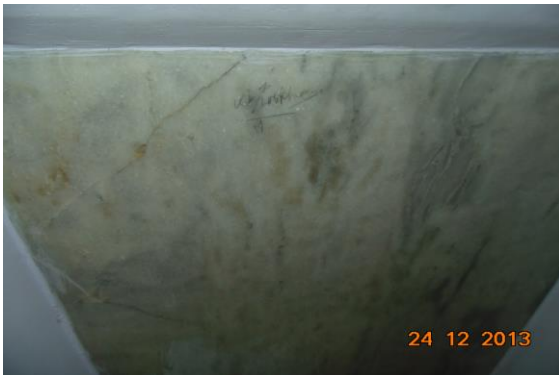
Photo 15

Roof of Staircase First Floor to Second Floor Covered With Marble

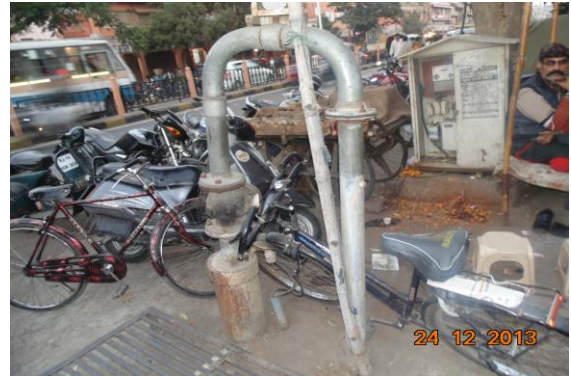
Photo 2
View of Borewell, Ground Floor

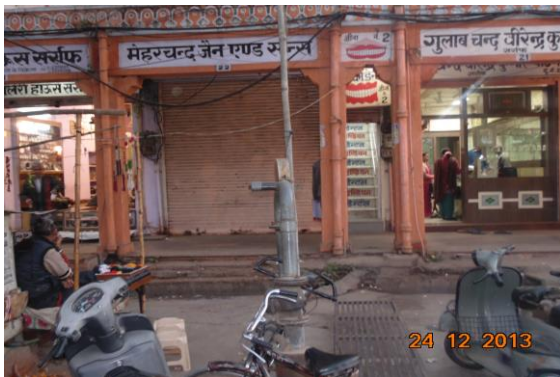
Photo 3
View of Borewell, Ground Floor

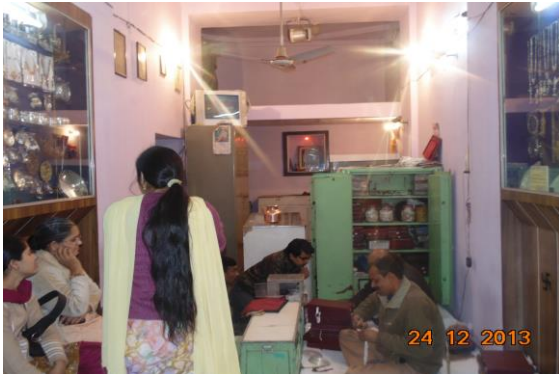
Photo 4
Inclined Crack on Wall No. 2 of Staircase Ground Floor to First Floor of House No.339, Ground Floor Approx. Width = 0.5mm, Approx. Length = 2m. Distance from = m, Height from Floor = m.

The average width of cracks is 0.5mm and average length of cracks is 2m. The maximum crack width is 0.5mm and minimum width is 0.5mm.

Summary of Cracks						
Defect ID	Location	Orientation	Appx. Width (mm)	Appx. Length (m)	Category	Photo No.
1	Wall No. 2 Stairecase Ground Floor to First Floor of House No.339 Ground Floor	Inclined	0.5	2	Very Slight	4, 4A

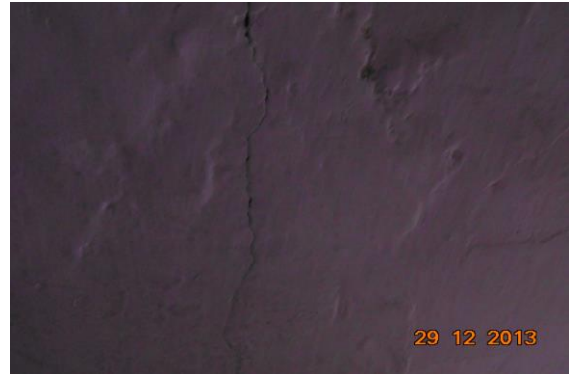
Photo 4A
Inclined Crack on Wall No. 2 of Staircase Ground Floor to First Floor of House No.339, Ground Floor Approx. Width = 0.5mm, Approx. Length = 2m. Distance from = m, Height from Floor = m.

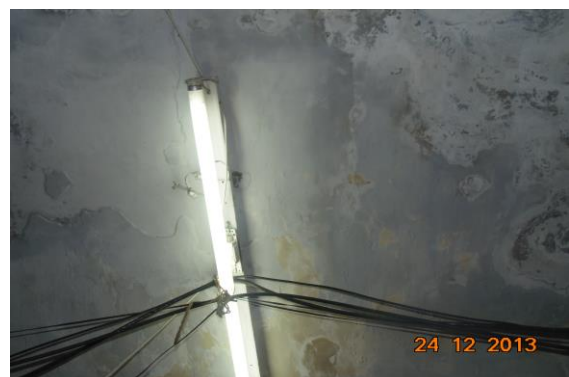
Photo 6
Dampness/Seepage on Roof of Shop No.23 of Ground Floor

Summary of Defects Other Than Crack			
Defect ID	Location	Description	Photo No.
2	Roof Varanda of Shop No.23 Ground Floor	Dampness/Seepage	5
3	Roof Shop No.23 Ground Floor	Dampness/Seepage	6
4	Roof Varanda of House No. 339 First Floor	Dampness/Seepage	7
5	Wall No. 2 Varanda of House No. 339 First Floor	Peeling of Plaster	8
6	Wall No. Floor Room No. 1 House No. 339,First Floor	Damaged Portion	9
7	Roof Room No. 1 House No. 339,First Floor	Dampness/Seepage	10
8	Wall No. 2 Passage 2 of House No.339 Second Floor	Peeling of Plaster	11
9	Roof Passage 2 of House No.339 Second Floor	Peeling of Plaster	12
10	Wall No. 3 & 4 Kitchen of House No.339 Second Floor	Peeling of Plaster	13
11	Roof & Wall No. 2 & 4 of Room No. 1 House No. 339,Second Floor	Dampness/Seepage	14
12	Wall No. 4 Room No. 2 House No. 339,Second Floor	Peeling of Plaster	15
13	Roof & Wall No. 1 of Room No. 1 House No. 339,Third Floor	Dampness/Seepage	16

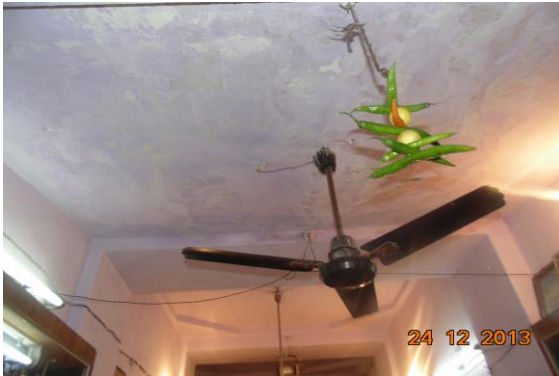
Photo 7
Dampness/Seepage on Roof of Varanda of House No. 339 of First Floor
