Pre Building Condition Survey Report

Name and Address of Structure :	Badi Chopar to Ramp Area (Down Line)
---------------------------------	--------------------------------------

Name of the Project	Contract JMRC-UG1B “Design and Construction of Tunnel between Chandpole and Badi Chouper and reverse line by Shield TBM, Underground Metro Stations at Choti Chouper and Badi Chouper by Cut and Cover Methods on East West Corridor of Jaipur Metro Rail Corporation Limited .”	
Owner :

Pre - Condition Building Survey for Construction of Underground Stations from Chandpole to Bari Chouper and reversal line

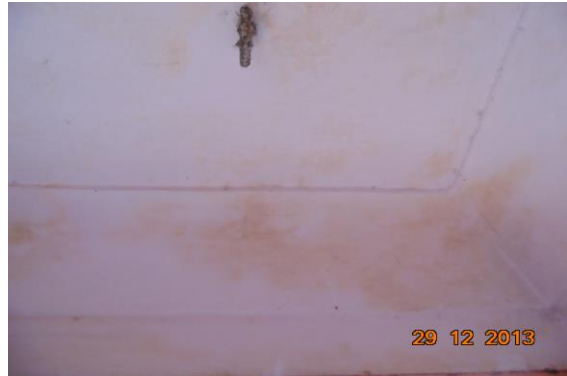
Photo 8
Peeling of Plaster on Wall No. 2 of Varanda of House No. 339 of First Floor

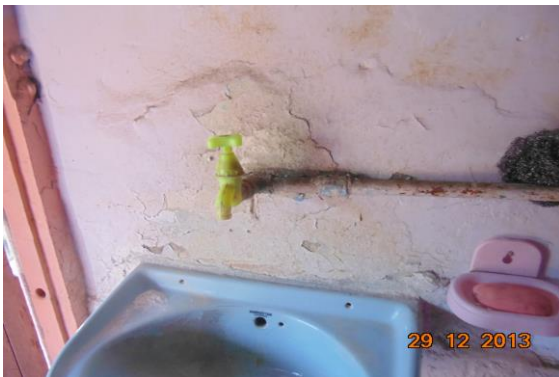
Photo 9
Damaged Portion on Wall No. Floor of Room No. 1 of House No. 339, First Floor

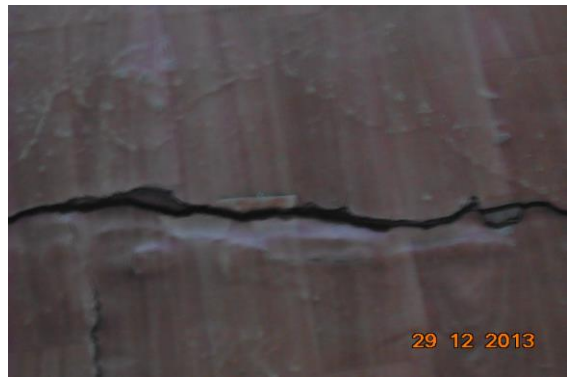
Photo 10
Dampness/Seepage on Roof of Room No. 1 of House No. 339, First Floor

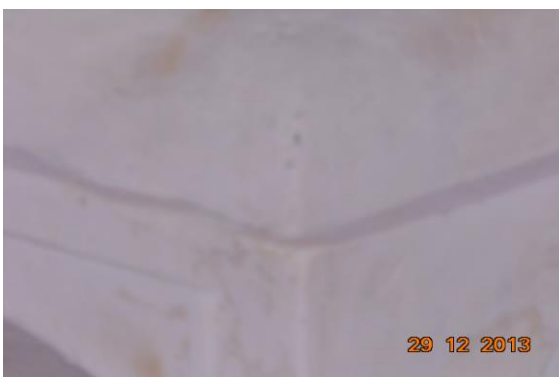
Photo 11
Peeling of Plaster on Wall No. 2 of Passage 2 of House No.339 of Second Floor

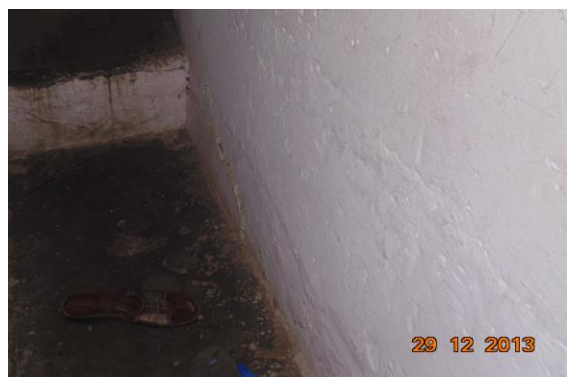
Photo 12

Peeling of Plaster on Roof of Passage 2 of House No.339 of Second Floor

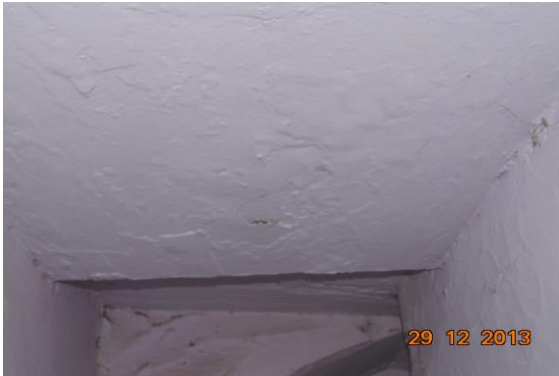
Photo 13

Peeling of Plaster on Wall No. 3 & 4 of Kitchen of House No.339 of Second Floor

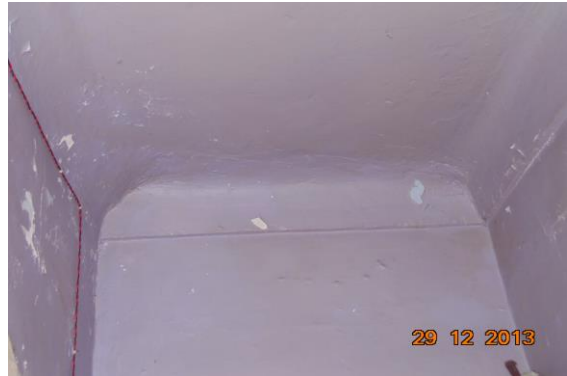
Photo 14

Dampness/Seepage on Roof & Wall No. 2 & 4 of Room No. 1 of House No. 339, Second Floor

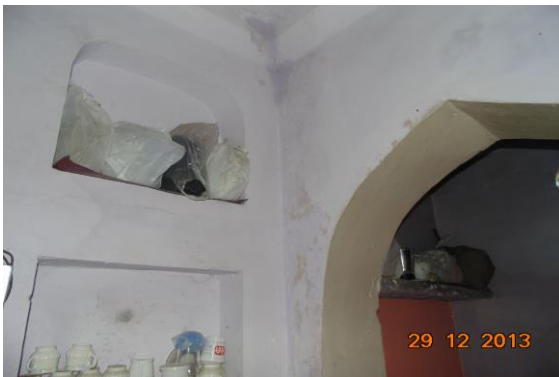
Photo 15

Peeling of Plaster on Wall No. 4 of Room No. 2 of House No. 339, Second Floor

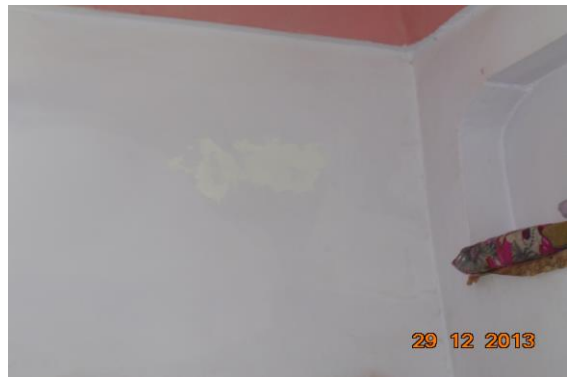
Photo 16

Dampness/Seepage on Wall No. 1 & Roof of Room No. 1 of House No. 339, Third Floor

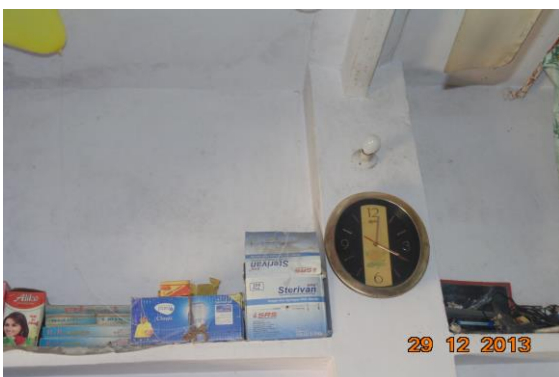
Photo 17

Dampness/Seepage on Wall No. 2 & 3 of House No. 339 of Third Floor

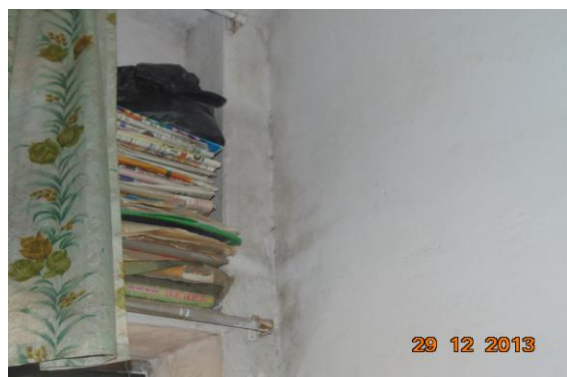
Photo 18
Dampness/Seepage on Wall No. 2 & 4 of Third Floor

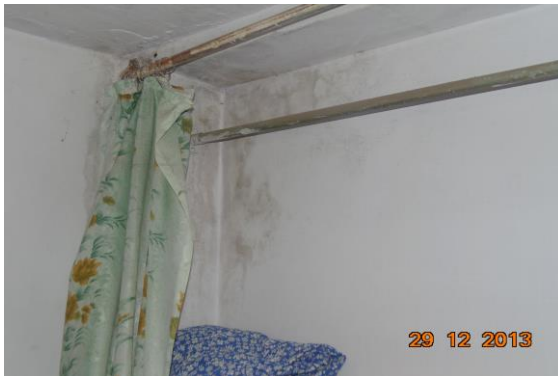
Photo 19
Dampness/Seepage on Roof of Toilet No. 1 of House No. 339, Third Floor

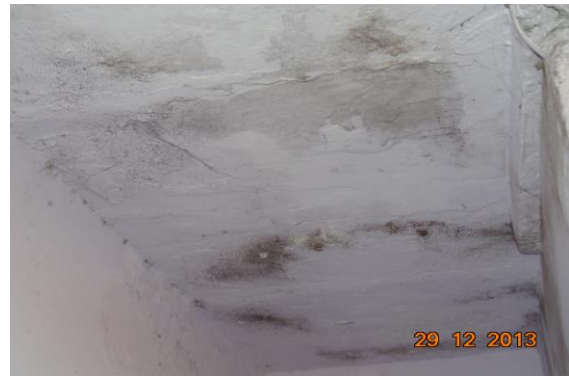
Photo 20
Dampness/Seepage on Wall No. 1 of Toilet No. 1 of House No. 339, Third Floor

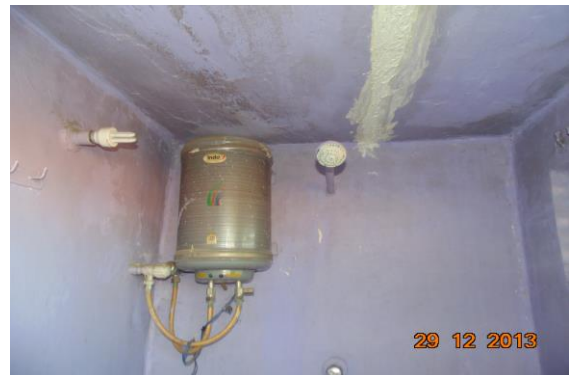
Photo 21
Dampness/Seepage on Wall No. 1 & Roof of Bathroom of House No. 339, Third Floor

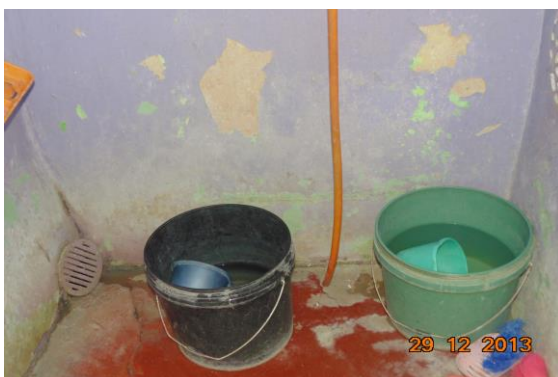
Photo 22
Peeling of Plaster on Wall No. 1, 2 & 4 of Bathroom of House No. 339, Third Floor

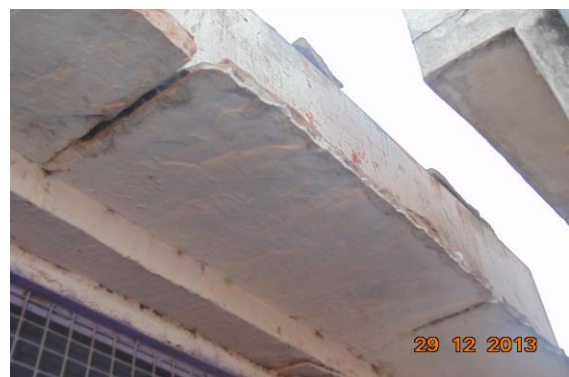
Photo 23
Damaged Portion on Wall No. 3 & Sunshade of Toilet No. 1 of House No. 339, Third Floor

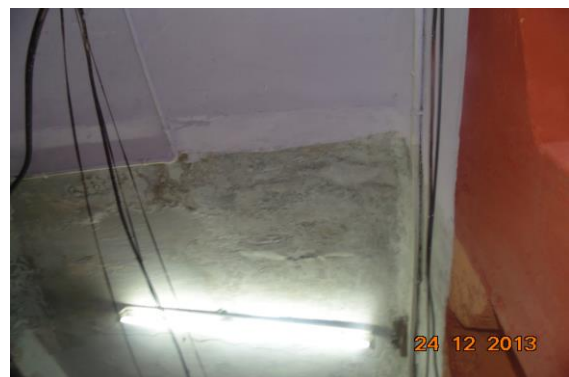
Photo 6
Dampness/Seepage on Roof of Varanda of Shop No.25 of Ground Floor

Summary of Defects Other Than Crack			
Defect ID	Location	Description	Photo No.
1	Roof Varanda of Shop No.25 Ground Floor	Dampness/Seepage	6
2	Roof Varanda of Shop No.25A Ground Floor	Dampness/Seepage	7

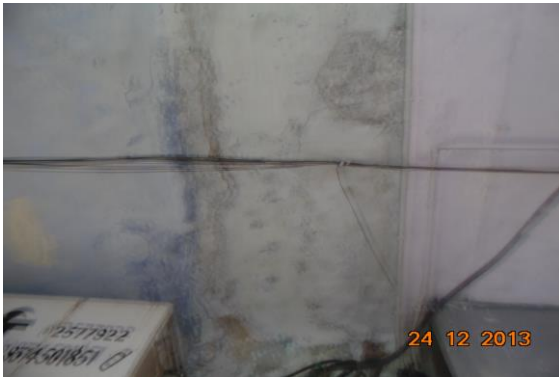
Photo 7

Dampness/Seepage on Roof of Varanda of Shop No.25A of Ground Floor

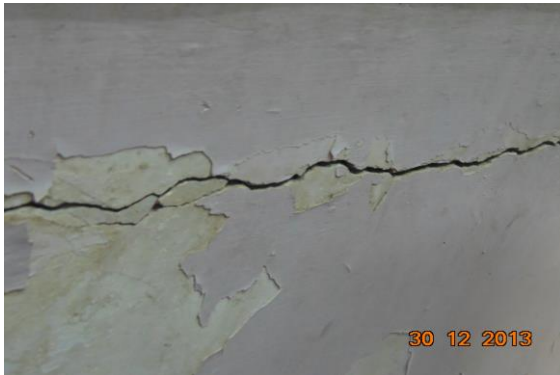
Photo 7

Inclined Crack on Wall No. 2 of Stair GF to FF, House No. 333
Approx. Width = 5mm, Approx. Length = 2m.
Distance from Stair Step = 0m, Height from Floor = 0.1m.

Summary of Cracks						
Defect ID	Location	Orientation	Appx. Width (mm)	Appx. Length (m)	Category	Photo No.
1	Wall No. 2 Stair GF to FF House No. 333 Fifth Floor	Inclined	5	2	Moderate	7, 7A

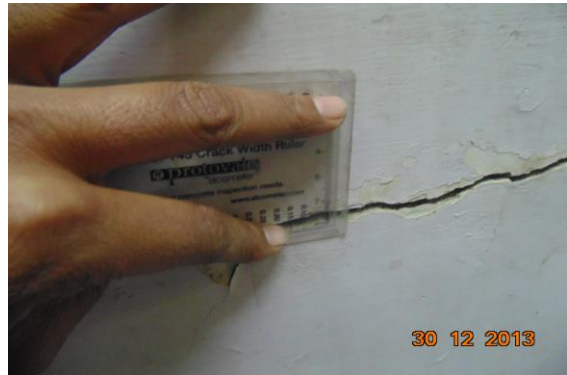
Photo 7A

Inclined Crack on Wall No. 2 of Stair GF to FF, House No. 333
Approx. Width = 5mm, Approx. Length = 2m.
Distance from Stair Step = 0m, Height from Floor = 0.1m.

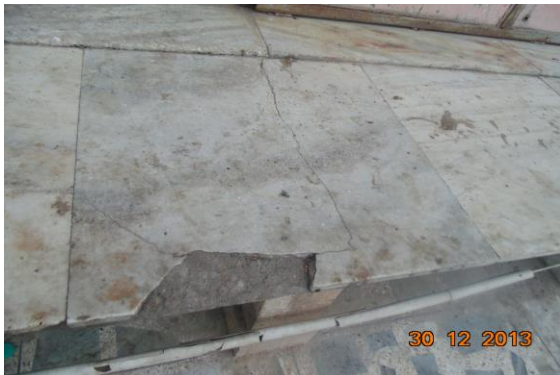
Photo 8

Damaged Portion on Varandah Open of House No. 333 First Floor

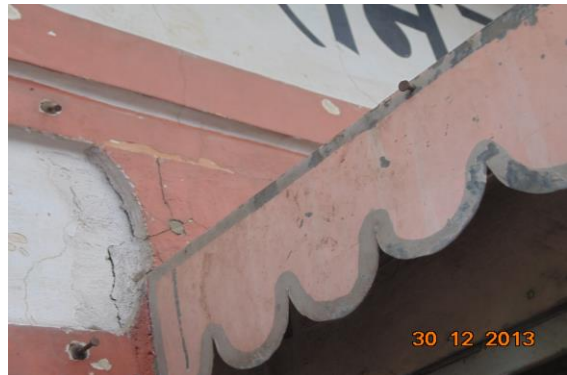
Photo 9

Peeling of Plaster on Front Side Wall of Varandah of House No. 333
First Floor

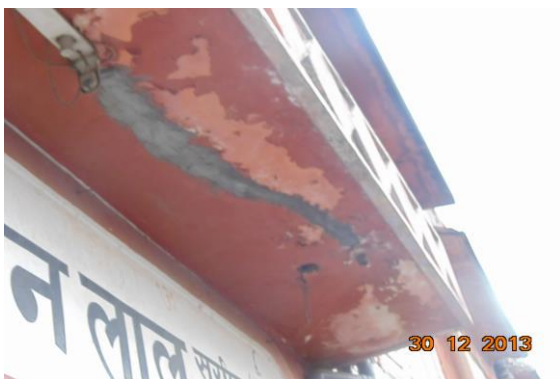
Photo 10

Peeling of Plaster on Front Side Wall of Varandah Shed of House No.
333 First Floor

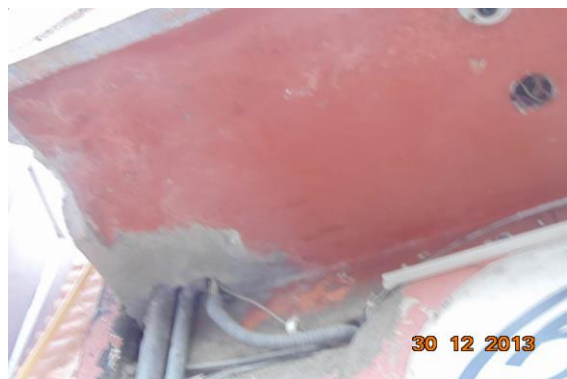
Photo 11

Peeling of Plaster on Front Side Wall of Varandah Shed of House No.
333 First Floor

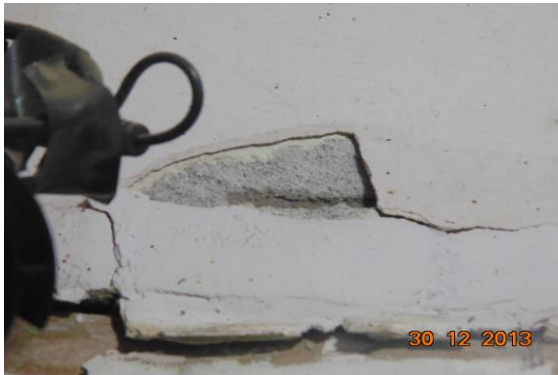
Photo 12

Damaged Portion on Wall No. 7 of Passage of House No. 333 First Floor

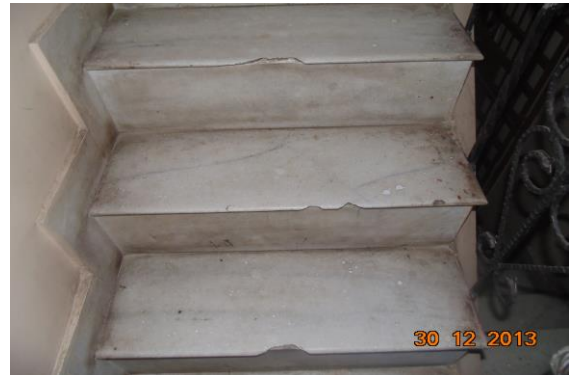
Photo 13

Damaged Portion on Stair Steps FF to SF of House No. 333

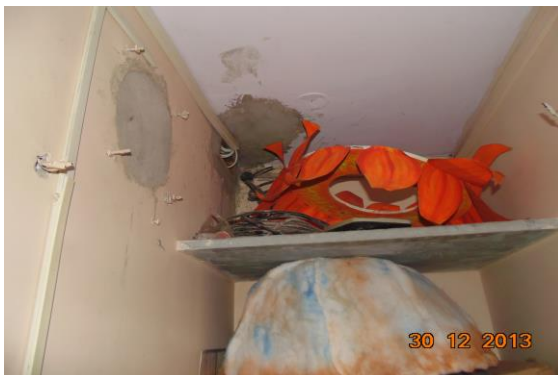
Photo 14

Peeling of Plaster on Wall No. 1 & Roof of Store of House No. 333 Second Floor

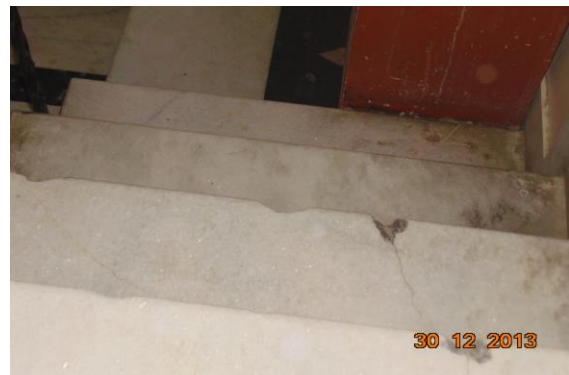
Photo 15

Damaged Portion on Stair Steps SF to TF of House No. 333

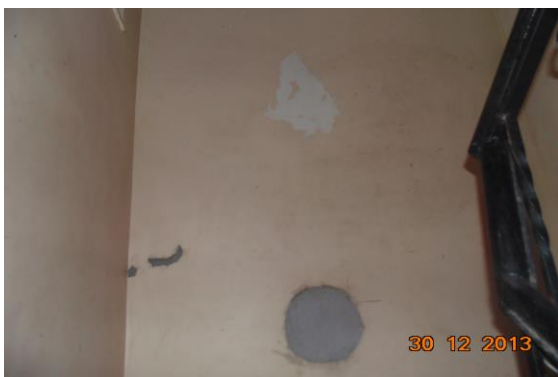
Photo 16

Peeling of Plaster on Wall No. 4 of Stair SF to TF of House No. 333

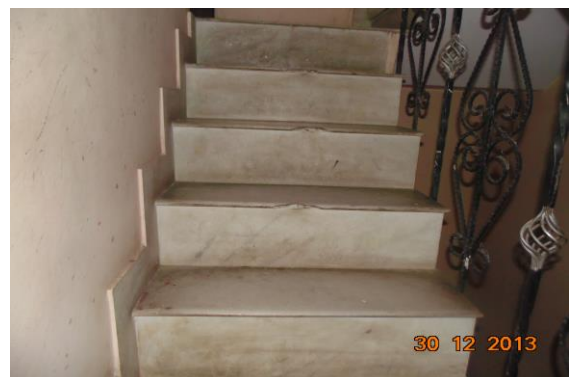
Photo 17

Damaged Portion on Stair Steps SF to TF of House No. 333

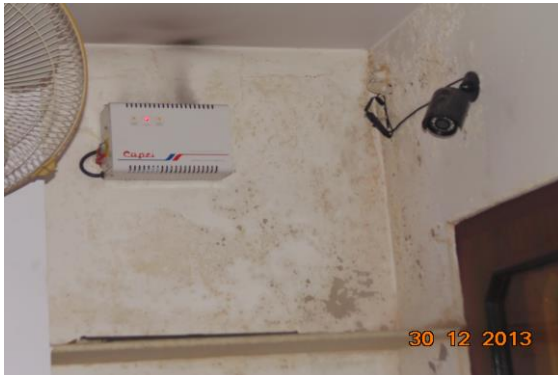
Photo 18

Dampness/Seepage on Wall No. 1 of Hall No. 1 of House No. 333 Third Floor

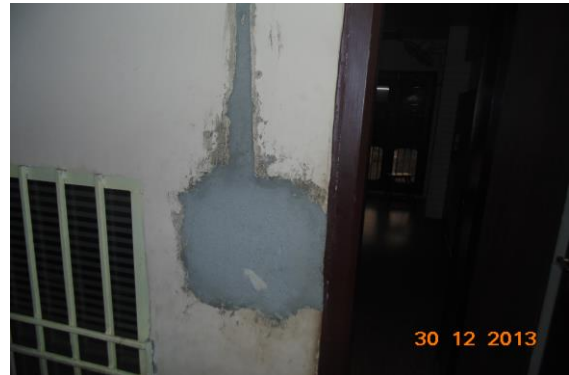
Photo 19

Peeling of Plaster on Wall No. 1 of Stair of House No. 333 Third Floor

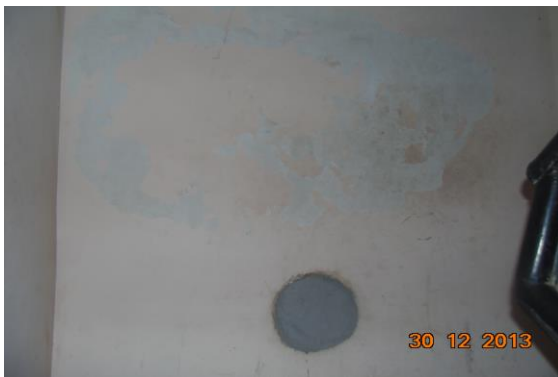
Photo 20

Peeling of Plaster on Wall No. 2 of Stair TF to 4Th Floor of House No. 333

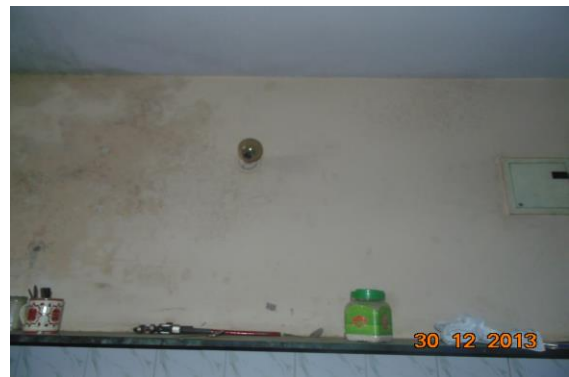
Photo 21

Dampness/Seepage on Wall No. 2 of Kitchen of House No. 333 Fourth Floor

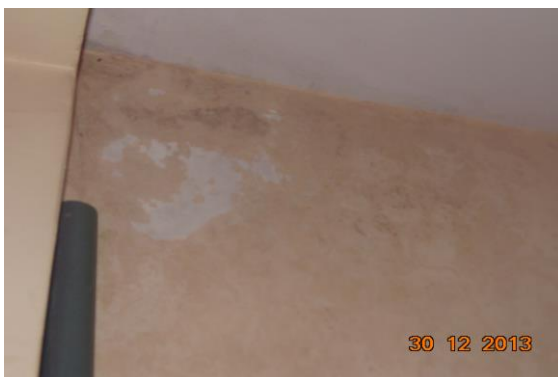
Photo 22

Dampness/Seepage on Wall No. 2 of Kitchen of House No. 333 Fourth Floor

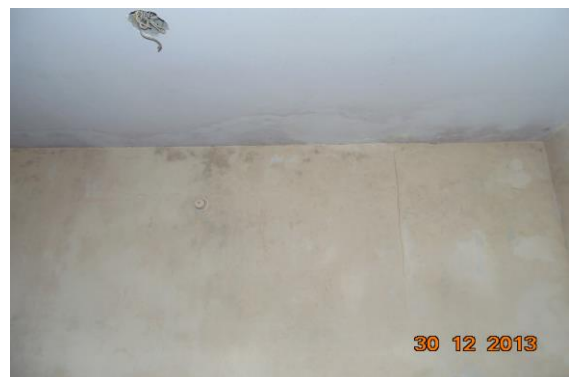
Photo 23

Dampness/Seepage on Wall No. 1, 4 & Roof of Kitchen of House No. 333 Fourth Floor

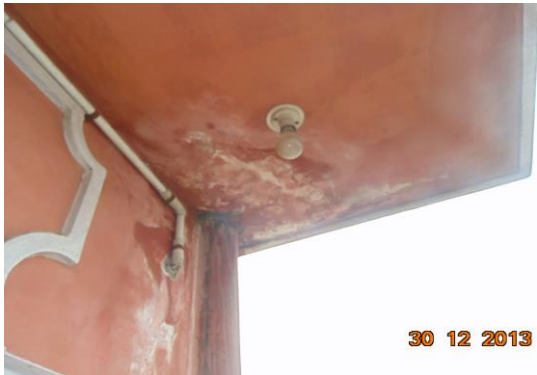
Photo 24

Dampness/Seepage on Balcony Shed of House No. 333 Fourth Floor

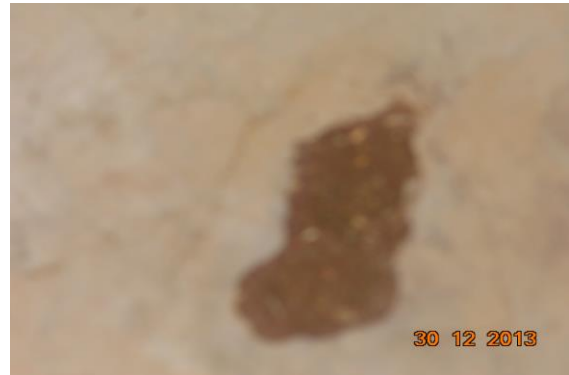
Photo 25

Peeling of Plaster on Balcony Floor of House No. 333 Fourth Floor

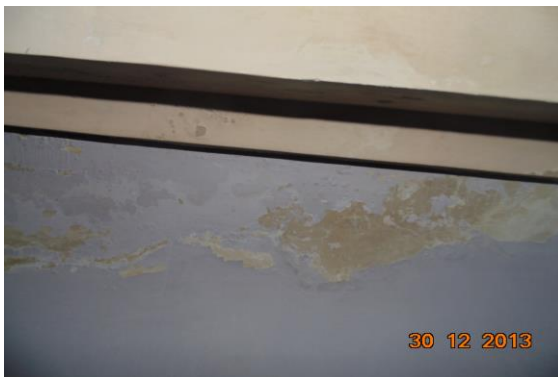
Photo 26

Dampness/Seepage on Roof of Passage of House No. 333 Fifth Floor

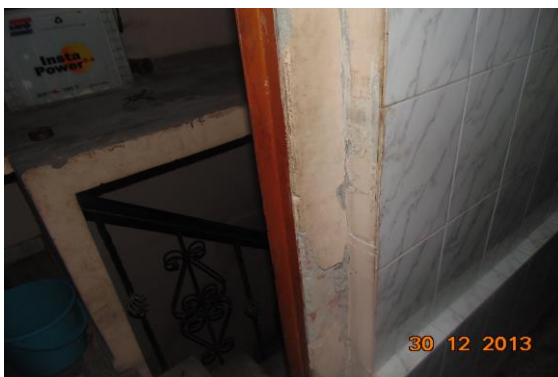
Photo 27

Peeling of Plaster on Wall No. 2 of Stair GF to FF of House No. 333

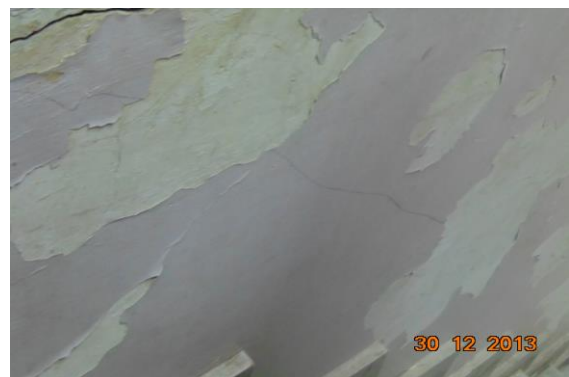
Photo 28

Peeling of Plaster on Wall No. 3 of Passage of House No. 333

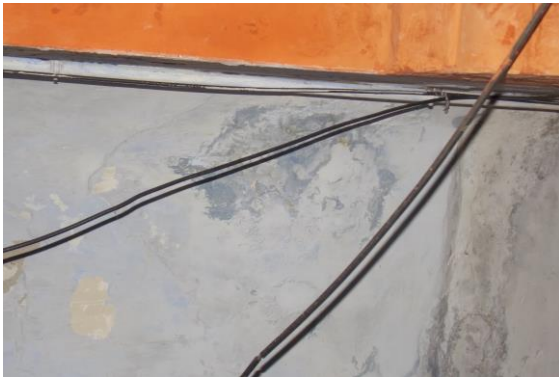
Photo 29

Peeling of Plaster on Wall No. 2 of Stair GF to FF of House No. 333

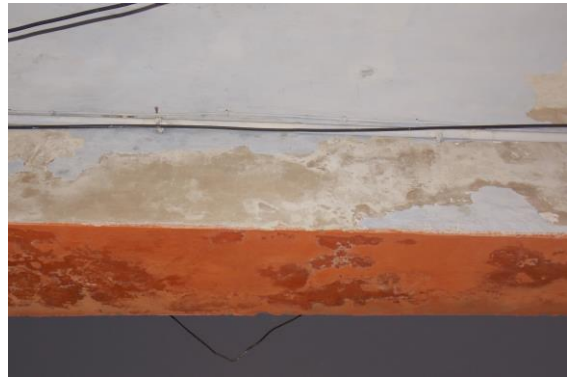
Photo 30

Dampness/Seepage on Roof of Varanda of Shop No.26 of Ground Floor

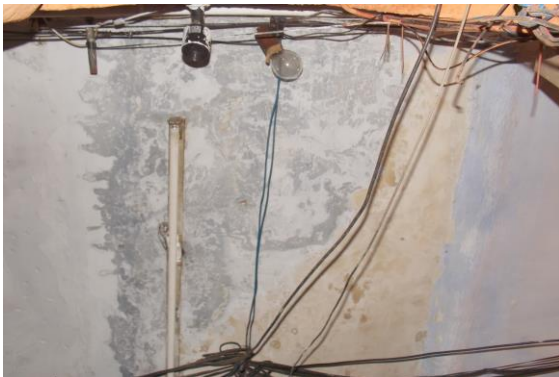
Photo 31

Dampness/Seepage on Wall No. Beam of Varanda of Shop No.26 of Ground Floor

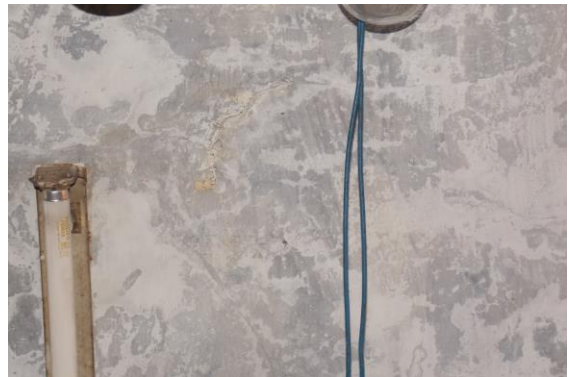
Photo 32

Dampness/Seepage on Roof of Varanda of Shop No.26B of Ground Floor

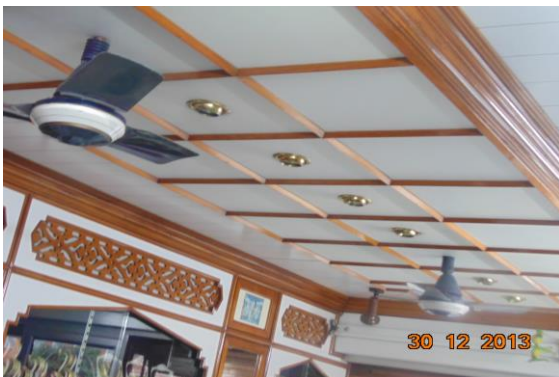
Photo 33

Peeling of Plaster on Roof of Varanda of Shop No.26B of Ground Floor

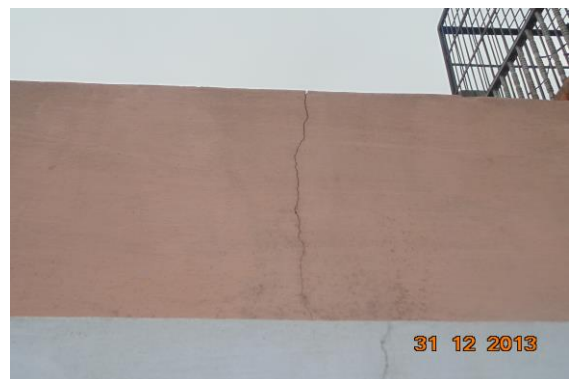
Photo 6
Inclined Crack on Wall No. 3 of Terrace
Approx. Width = 1mm, Approx. Length = 0.4m.
Distance from Wall No. 1 = 1m, Height from Floor = 2.2m.

Summary of Cracks						
Defect ID	Location	Orientation	Appx. Width (mm)	Appx. Length (m)	Category	Photo No.
1	Wall No. 3 Stair Terrace Floor	Inclined	1	0.4	Slight	6

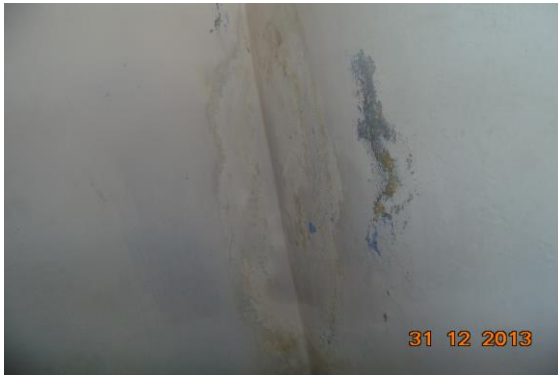
Photo 7
Dampness/Seepage on Wall No. 1 of Stair SF to TF

Summary of Defects Other Than Crack			
Defect ID	Location	Description	Photo No.
2	Wall No. 1 Stair SF to TF	Dampness/Seepage	7
3	Hall No. 1 Third Floor	Dampness/Seepage	8
4	Wall No. 1, 3, 4 & Roof Stair TF to Fourth Floor	Dampness/Seepage	9
5	Wall No. 1 Hall No. 1 Fourth Floor	Dampness/Seepage	10
6	Wall No. 2 Hall No. 1 Fourth Floor	Peeling of Plaster	11
7	Wall No. 3 Hall No. 1 Fourth Floor	Dampness/Seepage	12
8	Wall No. 3 Hall No. 1 Fourth Floor	Dampness/Seepage	13
9	Wall No. 1 Stair Fourth Floor to Terrace	Dampness/Seepage	14
10	Wall No. 1 & 2 Stair GF to FF	Dampness/Seepage	15
11	Roof Varanda of Shop No.27 Ground Floor	Peeling of Plaster	16
12	Beam Varanda of Shop No.27 Ground Floor	Peeling of Plaster	17

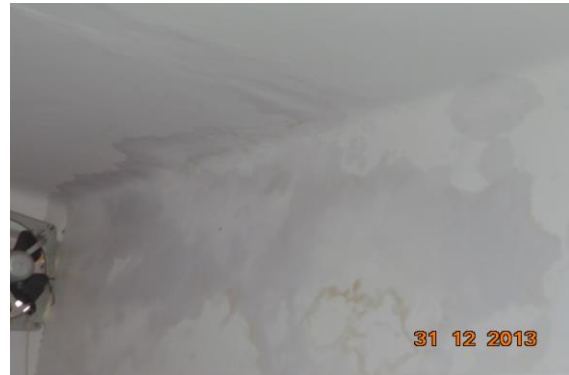
Photo 8
Dampness/Seepage on Hall No. 1 of Third Floor

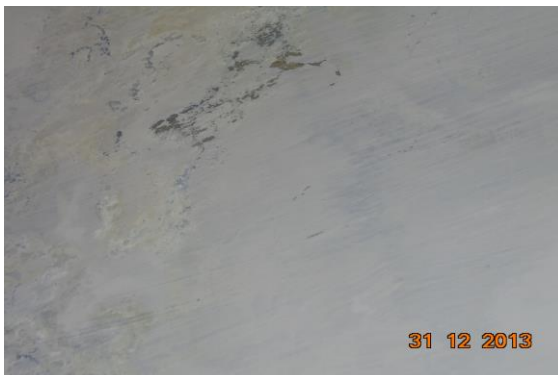
Photo 9
Dampness/Seepage on Wall No. 1, 3, 4 & Roof of Stair TF to Fourth Floor

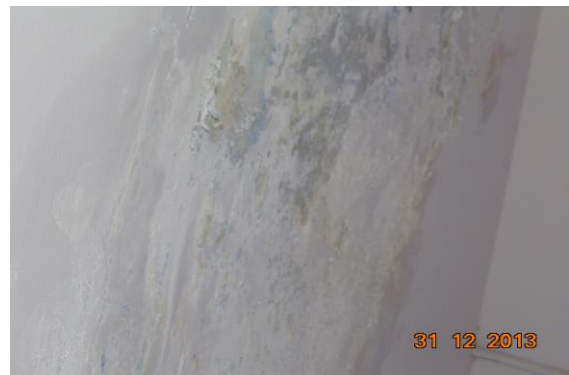
Photo 10
Dampness/Seepage on Wall No. 1 of Hall No. 1 of Fourth Floor

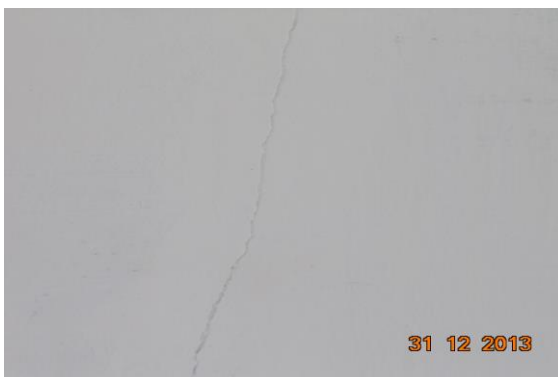
Photo 11
Peeling of Plaster on Wall No. 2 of Hall No. 1 of Fourth Floor

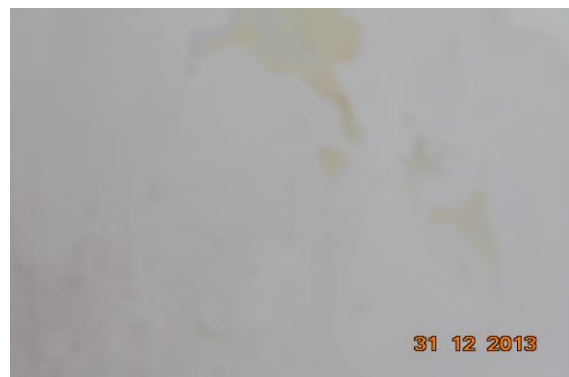
Photo 12
Dampness/Seepage on Wall No. 3 of Hall No. 1 of Fourth Floor

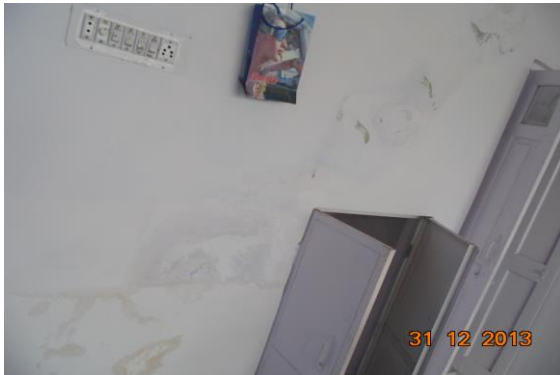
Photo 13

Dampness/Seepage on Wall No. 3 of Hall No. 1 of Fourth Floor

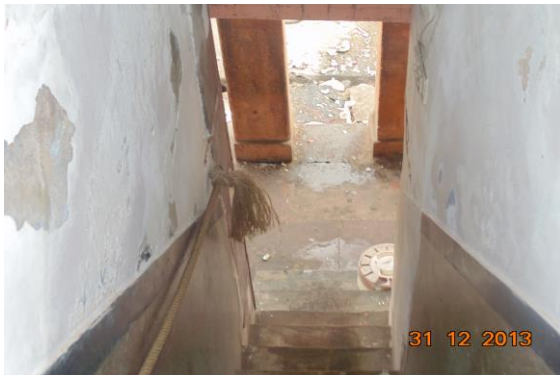
Photo 14

Dampness/Seepage on Wall No. 1 of Stair Fourth Floor to Terrace

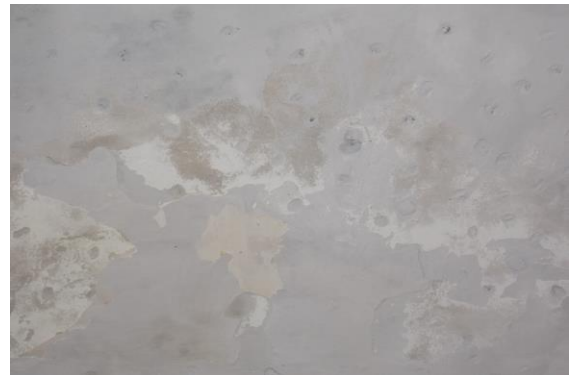
Photo 15

Dampness/Seepage on Wall No. 1 & 2 of Stair GF to FF

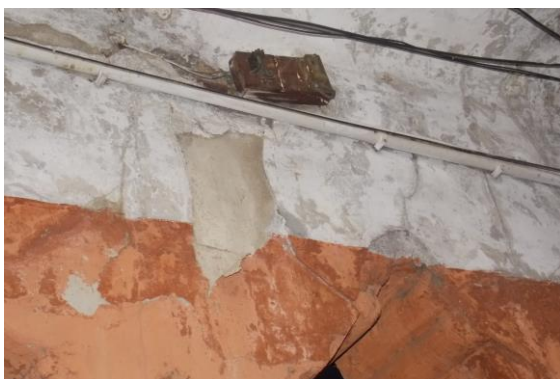
Photo 16

Peeling of Plaster on Roof of Varanda of Shop No.27 of Ground Floor

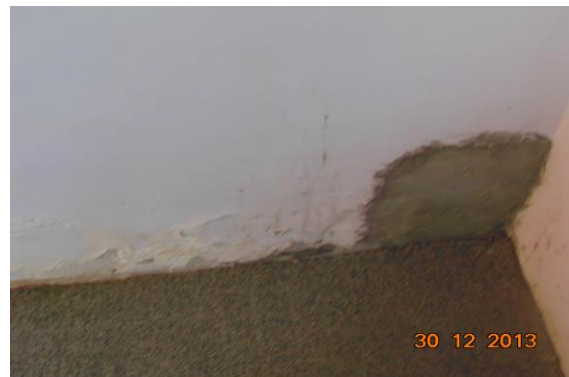
Photo 4
Peeling of Plaster on Wall No. 2 of Room No. 2 of House No. 329 First Floor

Summary of Defects Other Than Crack			
Defect ID	Location	Description	Photo No.
1	Wall No. 2 Room No. 2 House No. 329 First Floor	Peeling of Plaster	4
2	Stair Step FF to SF House No. 329 First Floor	Damaged Portion	5
3	Wall No. 1 & 4 Stair SF to TF House No. 329 Second Floor	Peeling of Plaster	6
4	Wall No. 1 Room No. 1 House No. 329 Third Floor	Damaged Portion	7
5	Beam Varanda of Shop No.28 Ground Floor	Peeling of Plaster	8
6	Roof Varanda of Shop No.28 Ground Floor	Peeling of Plaster	9
7	Roof Shop No.28 Ground Floor	Peeling of Plaster	10

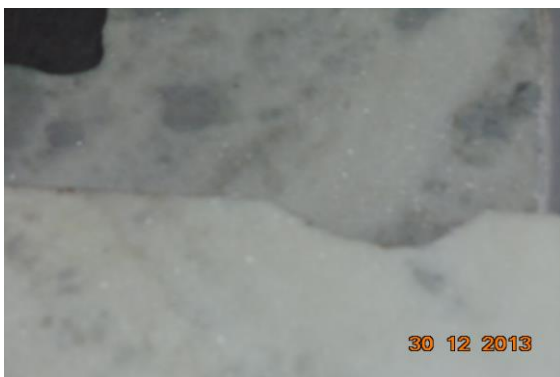
Photo 5
Damaged Portion on Stair Step FF to SF of House No. 329

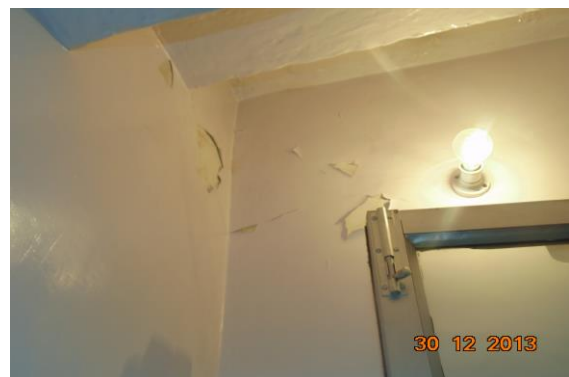
Photo 6
Peeling of Plaster on Wall No. 1 & 4 of Stair SF to TF of House No. 329

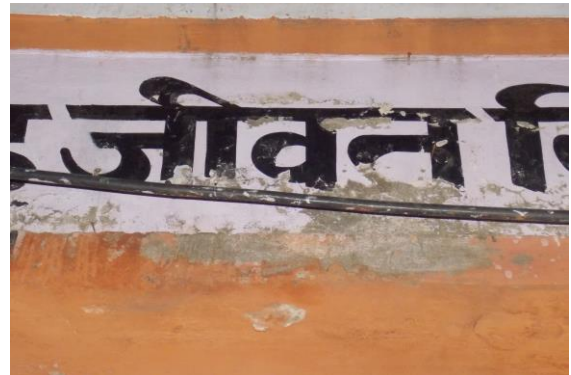
Photo 8

Peeling of Plaster on Beam of Varanda of Shop No.28 of Ground Floor

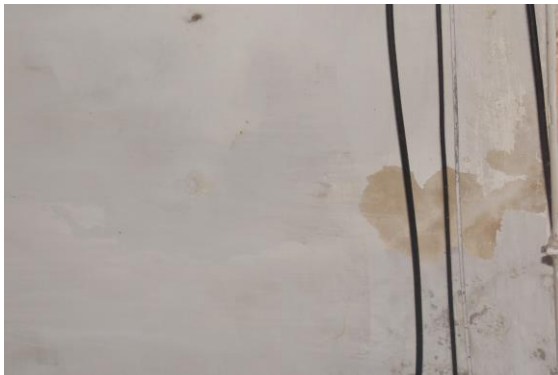
Photo 9

Peeling of Plaster on Roof of Varanda of Shop No.28 of Ground Floor

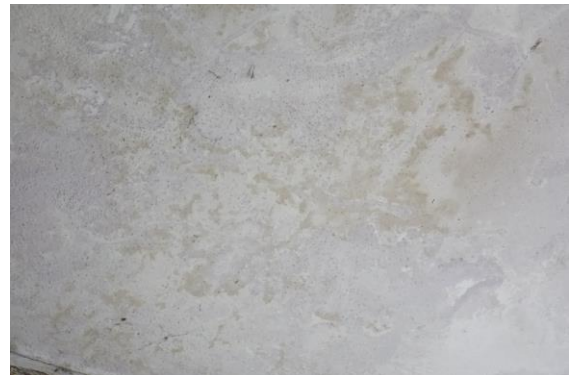
Photo 10

Peeling of Plaster on Roof of Shop No.28 of Ground Floor

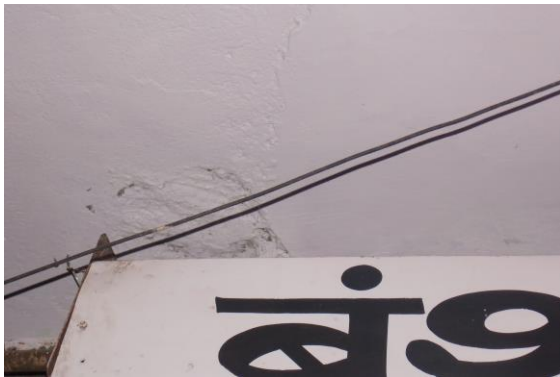
Photo 3
Peeling of Plaster on Roof of Varanda of Shop No.29 of Ground Floor

Summary of Defects Other Than Crack			
Defect ID	Location	Description	Photo No.
1	Roof Varanda of Shop No.29 Ground Floor	Peeling of Plaster	3
2	Wall No. 1 Shop No.29 Ground Floor	Dampness/Seepage	4

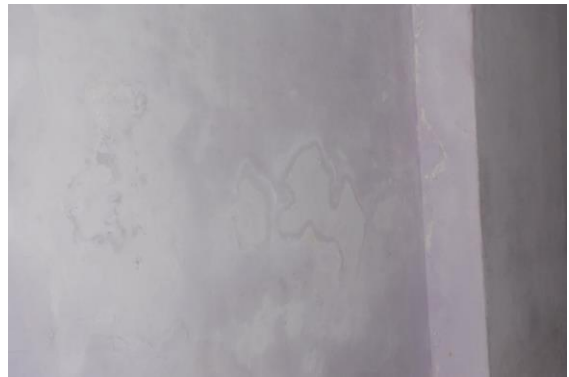
Photo 4
Dampness/Seepage on Wall No. 1 of Shop No.29 of Ground Floor

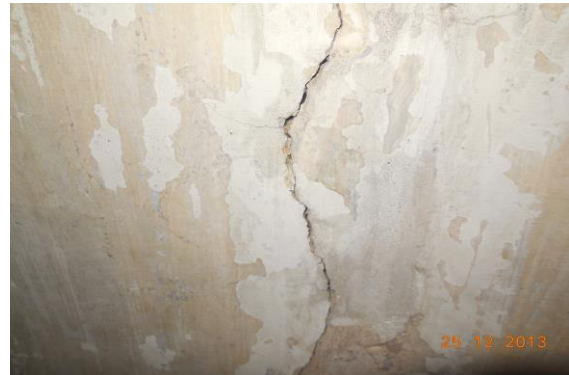
Photo 2
Vertical Crack on Wall No. 2 of Staircase Ground Floor to First Floor
Approx. Width = 3mm, Approx. Length = 1.8m.
Distance from Wall No.3 = 2m, Height from Floor = 0m.

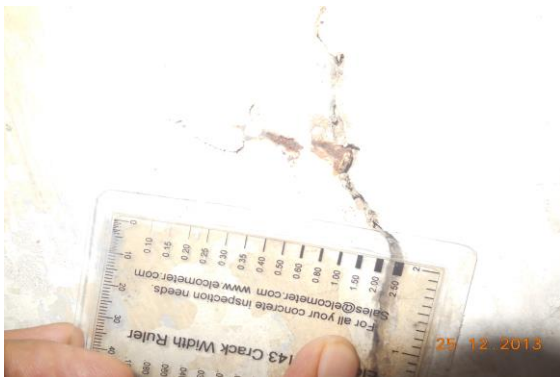
Photo 2A
Vertical Crack on Wall No. 2 of Staircase Ground Floor to First Floor
Approx. Width = 3mm, Approx. Length = 1.8m.
Distance from Wall No.3 = 2m, Height from Floor = 0m.

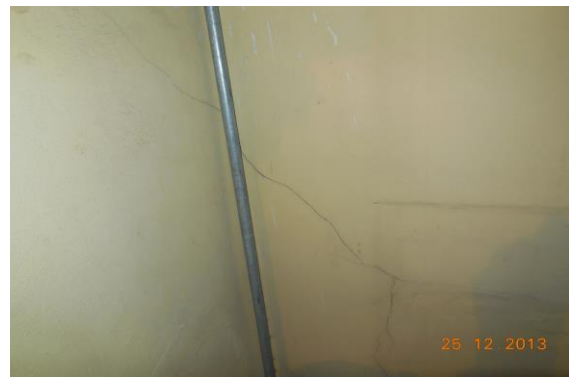
Photo 3
Inclined Crack on Wall No. 1 & 4 of Hall No. 1, First Floor
Approx. Width = 0.6mm, Approx. Length = 2m.
Distance from Corner Wall No.1 = 4m, Height from Floor = 0m.

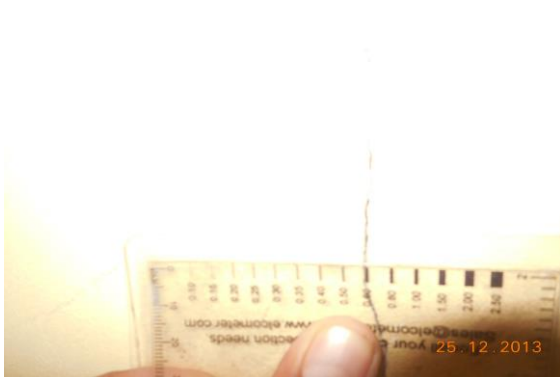
Photo 3A
Inclined Crack on Wall No. 1 & 4 of Hall No. 1, First Floor
Approx. Width = 0.6mm, Approx. Length = 2m.
Distance from Corner Wall No.1 = 4m, Height from Floor = 0m.

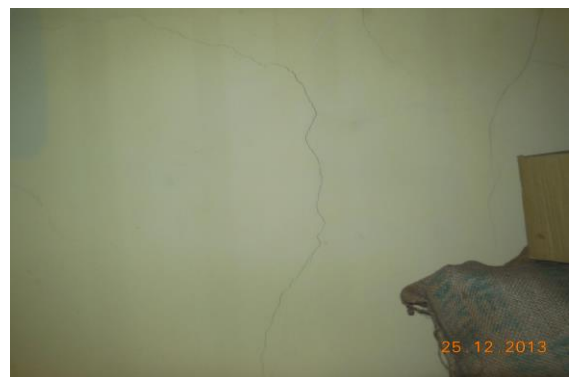
Photo 4
Inclined Crack on Wall No. 1 of Part A of Shop No.30, First Floor
Approx. Width = 0.6mm, Approx. Length = 2.3m.
Distance from Wall No.3 = 1.2m, Height from Floor = 0m.

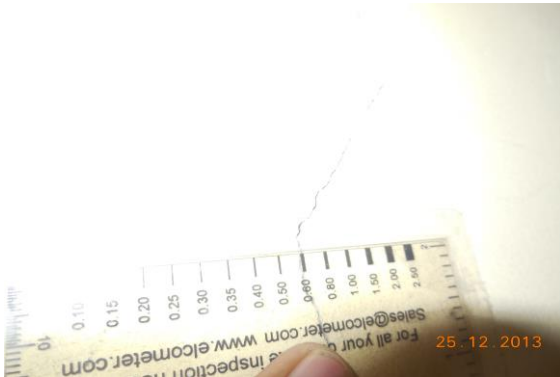
Photo 4A

Inclined Crack on Wall No. 1 of Part A of Shop No.30, First Floor
Approx. Width = 0.6mm, Approx. Length = 2.3m.
Distance from Wall No.3 = 1.2m, Height from Floor = 0m.

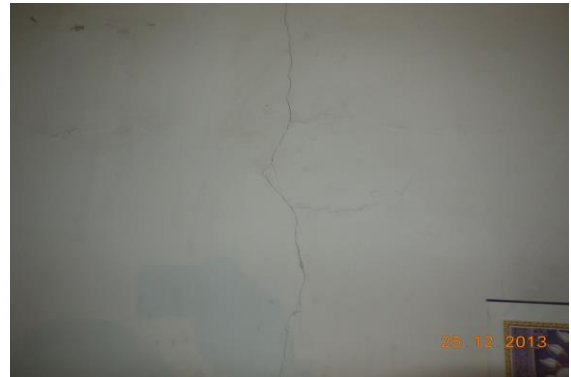
Photo 5

Vertical Crack on Wall No. 4 of Part A of Shop No.30, First Floor
Approx. Width = 0.5mm, Approx. Length = 2m.
Distance from Wall No.1 = 1m, Height from Floor = 0m.

Summary of Cracks						
Defect ID	Location	Orientation	Appx. Width (mm)	Appx. Length (m)	Category	Photo No.
1	Wall No. 2 Staircase Ground Floor to First Floor	Vertical	3	1.8	Slight	2, 2A
2	Wall No. 1 & 4 Hall No. 1 First Floor	Inclined	0.6	2	Very Slight	3, 3A
3	Wall No. 1 Part A of Shop No.30 First Floor	Inclined	0.6	2.3	Very Slight	4, 4A
4	Wall No. 4 Part A of Shop No.30 First Floor	Vertical	0.5	2	Very Slight	5, 5A
5	Wall No. 2 & 4 Part A of Shop No.30 First Floor	Vertical	1	2	Slight	6, 6A
6	Wall No. 1 Part A of Shop No.30 First Floor	Inclined	0.4	1.3	Very Slight	7
7	Wall No. 2 Balcony First Floor	Vertical	1	1.5	Slight	8, 8A
8	Wall No. 1 Open Sky Varanda Second Floor	Inclined	0.5	1.3	Very Slight	9, 9A
9	Wall No. 1 Open Sky Varanda Second Floor	Inclined	0.5	3	Very Slight	10, 10A
10	Wall No. 4 Second Floor	Inclined	0.6	1.25	Very Slight	11, 11A
11	Wall No. 4 Second Floor	Inclined	0.8	2	Very Slight	12
12	Wall No. 1 Staircase area Third Floor	Inclined	0.4	2	Very Slight	13, 13A

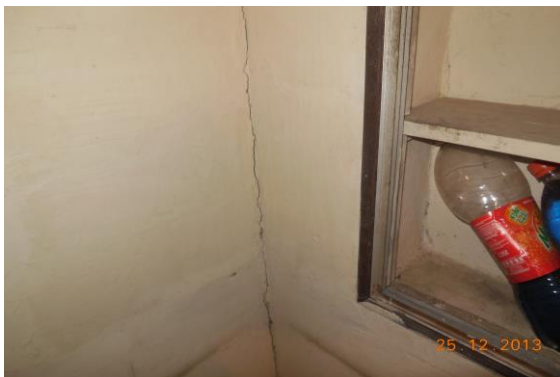
Photo 6

Vertical Crack on Wall No. 2 & 4 of Part A of Shop No.30, First Floor
Approx. Width = 1mm, Approx. Length = 2m.
Distance from = Corner Wall No.2 & 4m, Height from Floor = 0m.

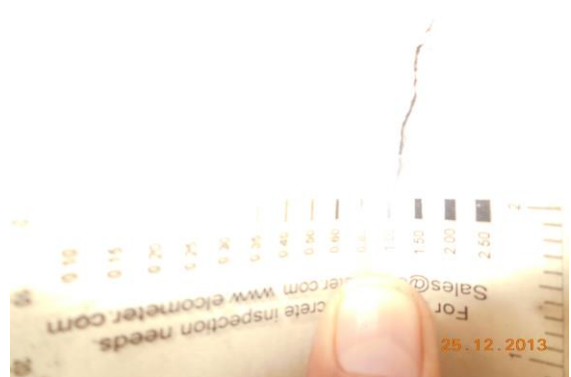
Photo 6A

Vertical Crack on Wall No. 2 & 4 of Part A of Shop No.30, First Floor
Approx. Width = 1mm, Approx. Length = 2m.
Distance from = Corner Wall No.2 & 4m, Height from Floor = 0m.

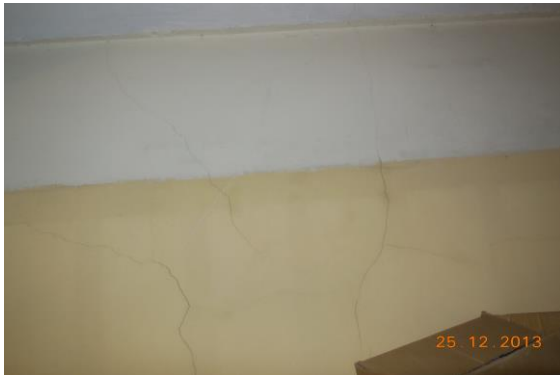
Photo 7

Inclined Crack on Wall No. 1 of Part A of Shop No.30, First Floor
Approx. Width = 0.4mm, Approx. Length = 1.3m.
Distance from Wall No.4 = 1m, Height from Floor = 1.5m.

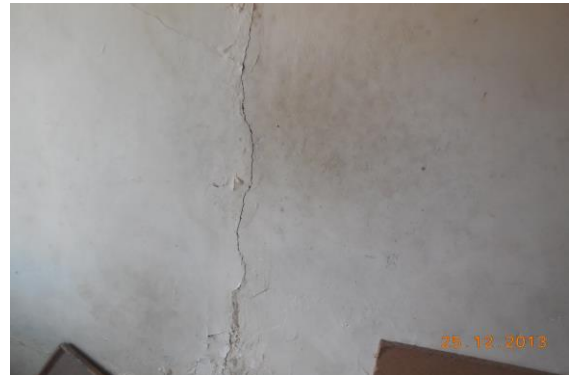
Photo 8

Vertical Crack on Wall No. 2 of Balcony, First Floor
Approx. Width = 1mm, Approx. Length = 1.5m.
Distance from Wall No.3 = 0m, Height from Floor = 0m.

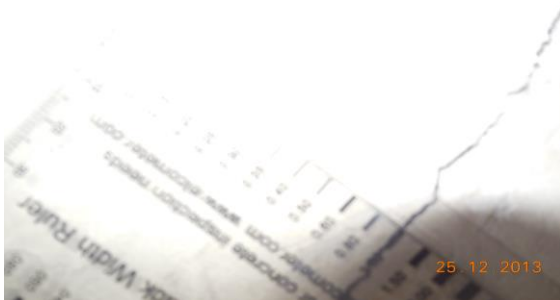
Photo 8A

Vertical Crack on Wall No. 2 of Balcony, First Floor
Approx. Width = 1mm, Approx. Length = 1.5m.
Distance from Wall No.3 = 0m, Height from Floor = 0m.

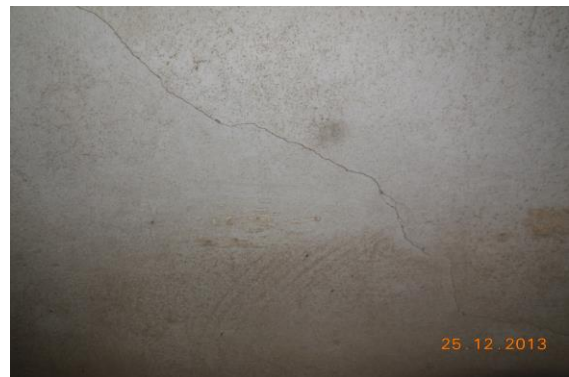
Photo 9

Inclined Crack on Wall No. 1 of Open Sky Varanda, Second Floor
Approx. Width = 0.5mm, Approx. Length = 1.3m.
Distance from Wall no.3 = 0m, Height from Floor = 0m.

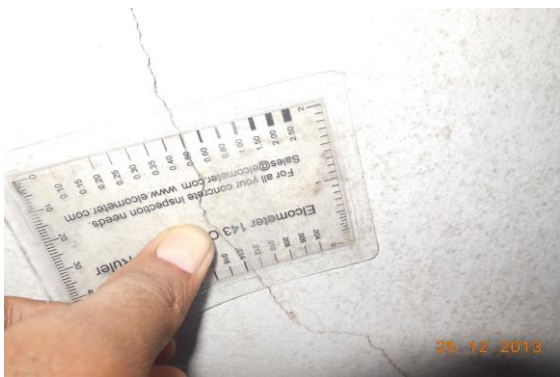
Photo 9A

Inclined Crack on Wall No. 1 of Open Sky Varanda, Second Floor
Approx. Width = 0.5mm, Approx. Length = 1.3m.
Distance from Wall no.3 = 0m, Height from Floor = 0m.

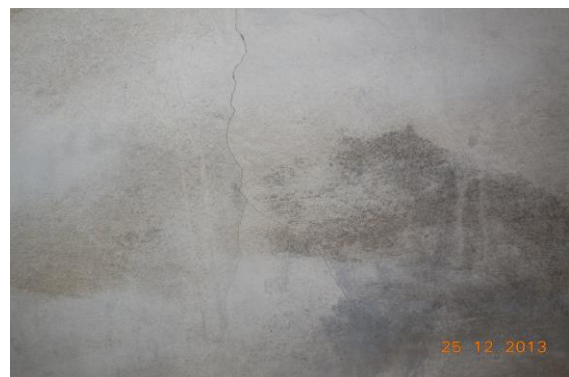
Photo 10

Inclined Crack on Wall No. 1 of Open Sky Varanda, Second Floor
Approx. Width = 0.5mm, Approx. Length = 3m.
Distance from Wall No.3 = 1.5m, Height from Floor = 0m.

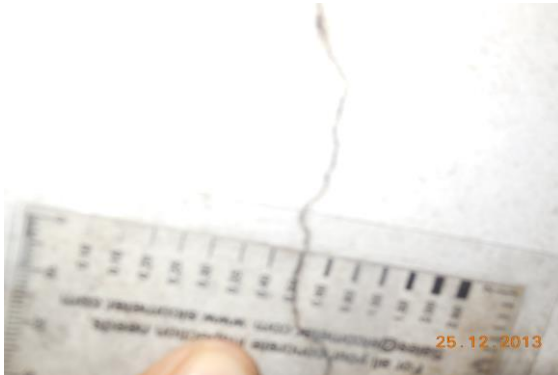
Photo 10A

Inclined Crack on Wall No. 1 of Open Sky Varanda, Second Floor
Approx. Width = 0.5mm, Approx. Length = 3m.
Distance from Wall No.3 = 1.5m, Height from Floor = 0m.

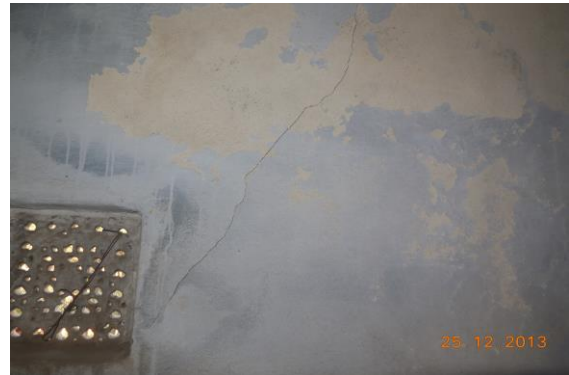
Photo 11

Inclined Crack on Wall No. 4 of Second Floor
Approx. Width = 0.6mm, Approx. Length = 1.25m.
Distance from Wall No.1 = 0.1m, Height from Floor = 1.2m.

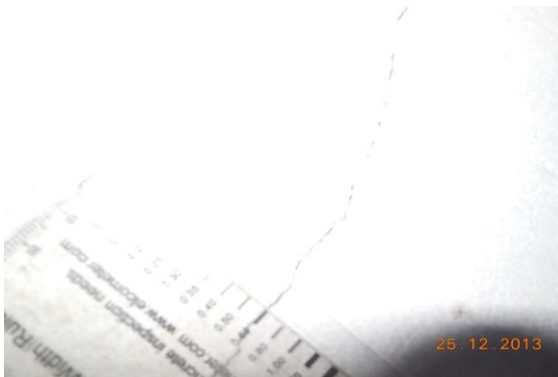
Photo 11A

Inclined Crack on Wall No. 4 of Second Floor
Approx. Width = 0.6mm, Approx. Length = 1.25m.
Distance from Wall No.1 = 0.1m, Height from Floor = 1.2m.

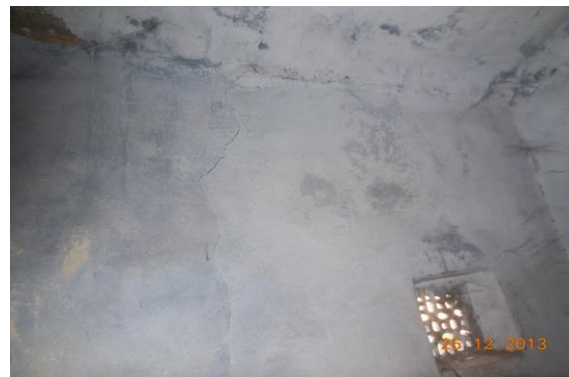
Photo 12

Inclined Crack on Wall No. 4 of Second Floor
Approx. Width = 0.8mm, Approx. Length = 2m.
Distance from Wall No.2 = 1.1m, Height from Floor = 1.2m.

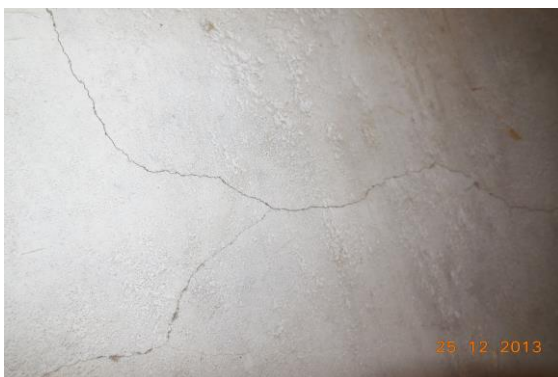
Photo 13

Inclined Crack on Wall No. 1 of Staircase area, Third Floor
Approx. Width = 0.4mm, Approx. Length = 2m.
Distance from Wall No.3 = 0.8m, Height from Floor = 0m.

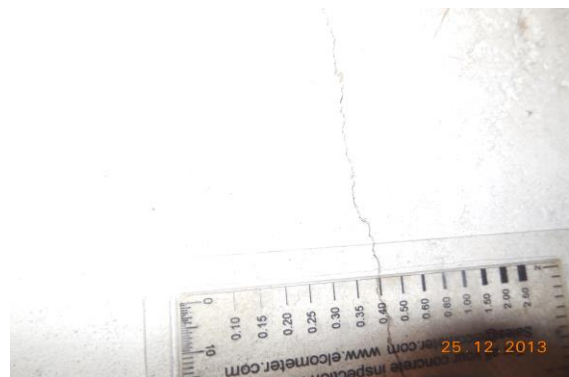
Photo 13A

Inclined Crack on Wall No. 1 of Staircase area, Third Floor
Approx. Width = 0.4mm, Approx. Length = 2m.
Distance from Wall No.3 = 0.8m, Height from Floor = 0m.

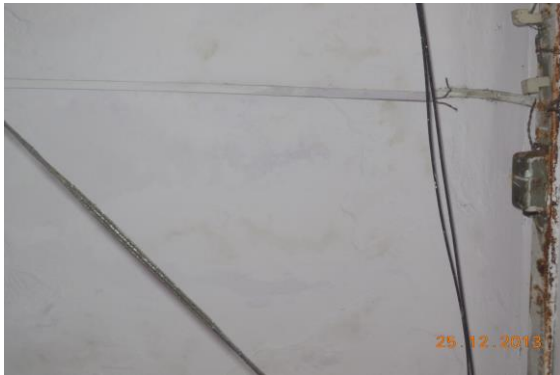
Photo 14

Dampness/Seepage on Roof of Varanda of Shop No.30 of Ground Floor

Summary of Defects Other Than Crack			
Defect ID	Location	Description	Photo No.
13	Roof Varanda of Shop No.30 Ground Floor	Dampness/Seepage	14
14	Wall No. 4 Shop No.30 Ground Floor	Dampness/Seepage	15
15	Wall No. 1 Staircase Ground Floor to First Floor	Dampness/Seepage	16
16	Wall No. 1 Staircase Ground Floor to First Floor	Dampness/Seepage	17
17	Wall No. 2 Staircase Ground Floor to First Floor	Peeling of Plaster	18
18	Roof Staircase Ground Floor to First Floor	Peeling of Plaster	19
19	Wall No. 4 Staircase Ground Floor to First Floor	Peeling of Plaster	20
20	Wall No. 2 & Roof Hall No. 1 First Floor	Dampness/Seepage	21
21	Wall No. 4 Part A of Shop No.30 First Floor	Peeling of Plaster	22
22	Wall No. 2 & Roof Hall No. 1 First Floor	Dampness/Seepage	23
23	Roof Balcony First Floor	Peeling of Plaster	24
24	Wall No. 4 & Roof Balcony First Floor	Dampness/Seepage	25
25	Shade Part-II First Floor	Peeling of Plaster	26

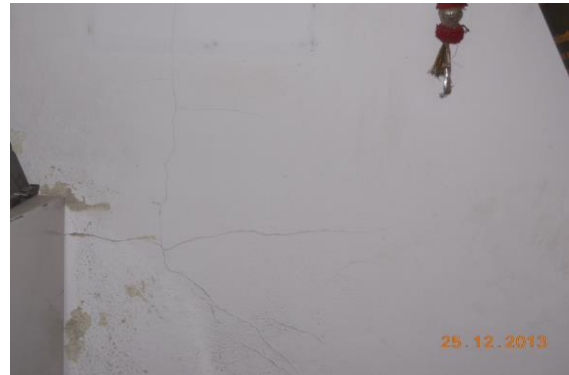
Photo 15

Dampness/Seepage on Wall No. 4 of Shop No.30 of Ground Floor

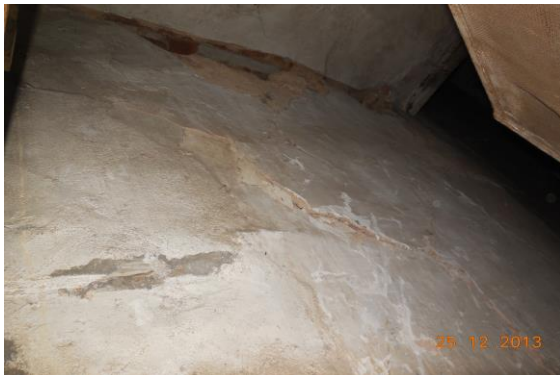
Photo 16

Dampness/Seepage on Wall No. 1 of Staircase Ground Floor to First Floor

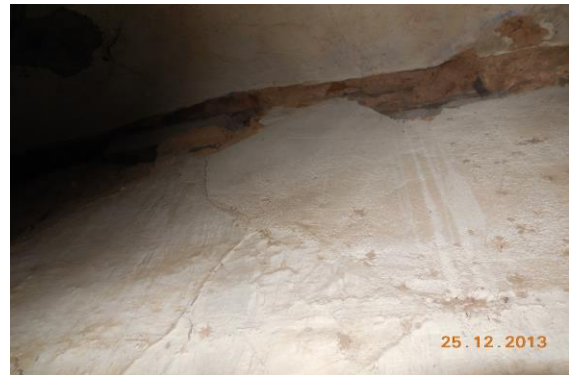
Photo 17

Dampness/Seepage on Wall No. 1 of Staircase Ground Floor to First Floor
