Pre Building Condition Survey Report

Name and Address of Structure :	Badi Chopar to Ramp Area (Down Line)
---------------------------------	--------------------------------------

Name of the Project	Contract JMRC-UG1B “Design and Construction of Tunnel between Chandpole and Badi Chouper and reverse line by Shield TBM, Underground Metro Stations at Choti Chouper and Badi Chouper by Cut and Cover Methods on East West Corridor of Jaipur Metro Rail Corporation Limited .”	
Owner :

Pre - Condition Building Survey for Construction of Underground Stations from Chandpole to Bari Chouper and reversal line

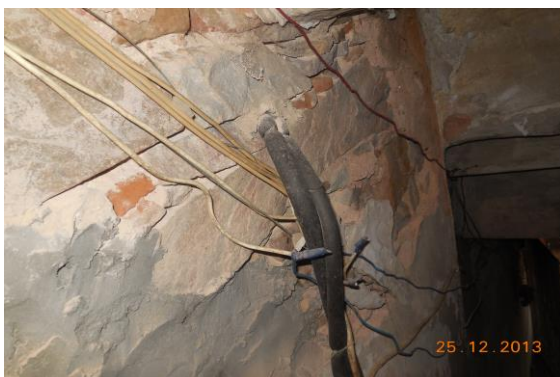
Photo 18

Peeling of Plaster on Wall No. 2 of Staircase Ground Floor to First Floor

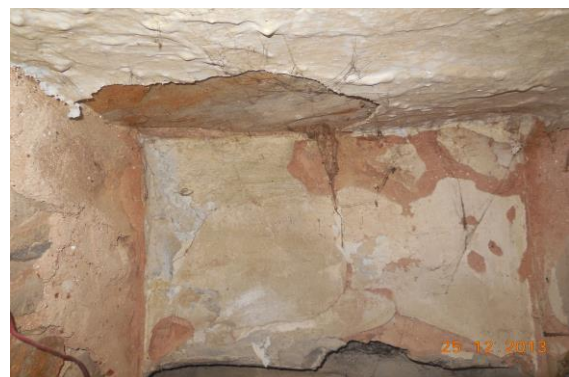
Photo 19

Peeling of Plaster on Roof of Staircase Ground Floor to First Floor

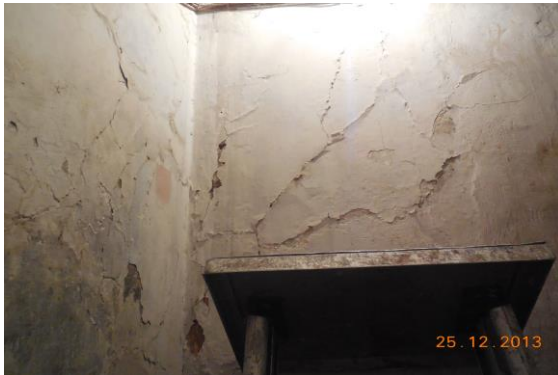
Photo 20

Peeling of Plaster on Wall No. 4 of Staircase Ground Floor to First Floor

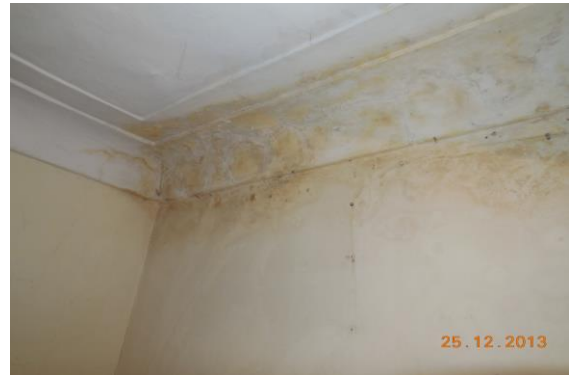
Photo 21

Dampness/Seepage on Wall No. 2 & Roof of Hall No. 1 of First Floor

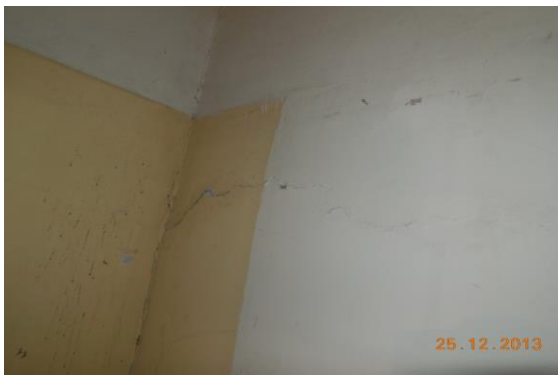
Photo 22

Peeling of Plaster on Wall No. 4 of Part A of Shop No.30 of First Floor

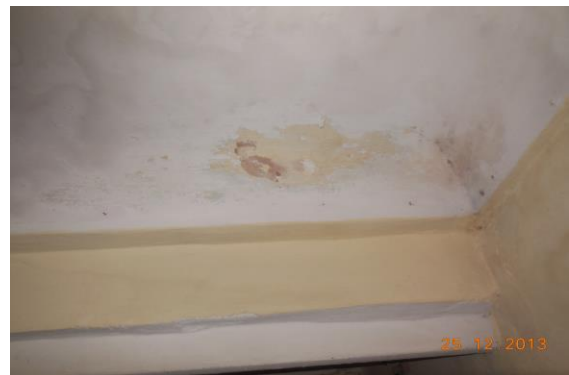
Photo 23

Dampness/Seepage on Wall No. 2 & Roof of Hall No. 1 of First Floor

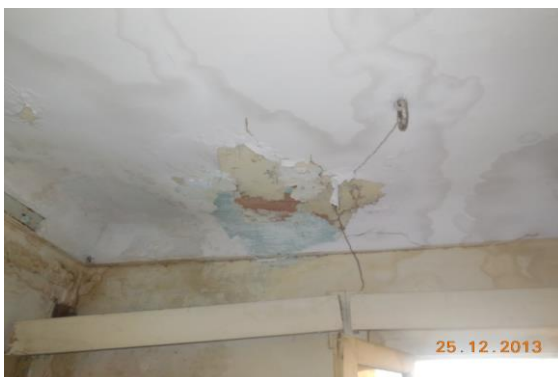
Photo 24

Peeling of Plaster on Roof of Balcony of First Floor

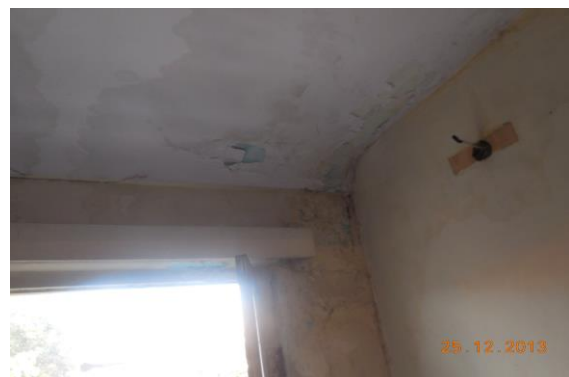
Photo 25

Dampness/Seepage on Wall No. 4 & Roof of Balcony of First Floor

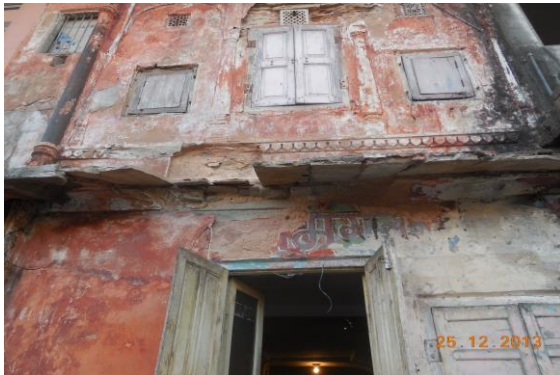
Photo 26
Peeling of Plaster on Shade of Part-II of First Floor

Summary of Defects Other Than Crack			
Defect ID	Location	Description	Photo No.
13	Roof Varanda of Shop No.30 Ground Floor	Dampness/Seepage	14
14	Wall No. 4 Shop No.30 Ground Floor	Dampness/Seepage	15
15	Wall No. 1 Staircase Ground Floor to First Floor	Dampness/Seepage	16
16	Wall No. 1 Staircase Ground Floor to First Floor	Dampness/Seepage	17
17	Wall No. 2 Staircase Ground Floor to First Floor	Peeling of Plaster	18
18	Roof Staircase Ground Floor to First Floor	Peeling of Plaster	19
19	Wall No. 4 Staircase Ground Floor to First Floor	Peeling of Plaster	20
20	Wall No. 2 & Roof Hall No. 1 First Floor	Dampness/Seepage	21
21	Wall No. 4 Part A of Shop No.30 First Floor	Peeling of Plaster	22
22	Wall No. 2 & Roof Hall No. 1 First Floor	Dampness/Seepage	23
23	Roof Balcony First Floor	Peeling of Plaster	24
24	Wall No. 4 & Roof Balcony First Floor	Dampness/Seepage	25
25	Shade Part-II First Floor	Peeling of Plaster	26

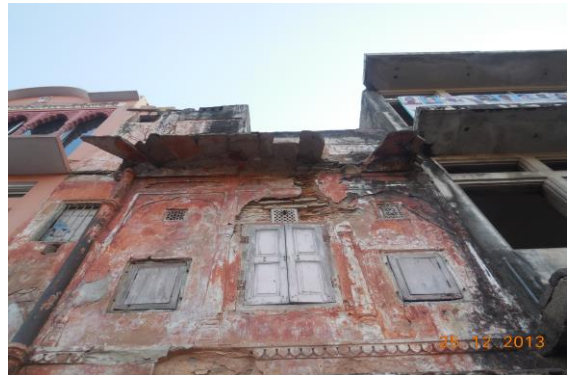
Photo 27
Peeling of Plaster on Shade of Part-II of First Floor

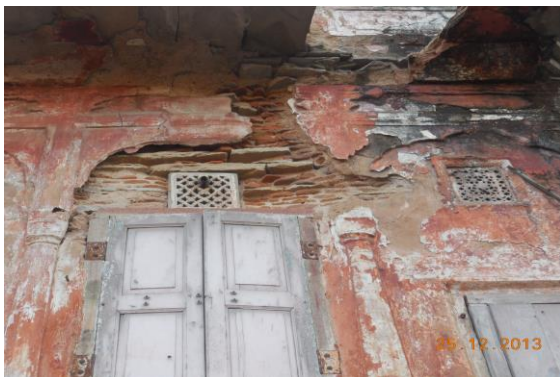
Photo 28
Peeling of Plaster on Outer Wall of Part-II of First Floor

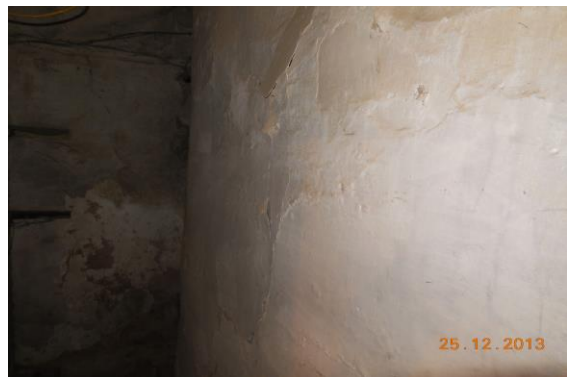
Photo 29
Peeling of Plaster on Wall No. 3 of Passage of First Floor

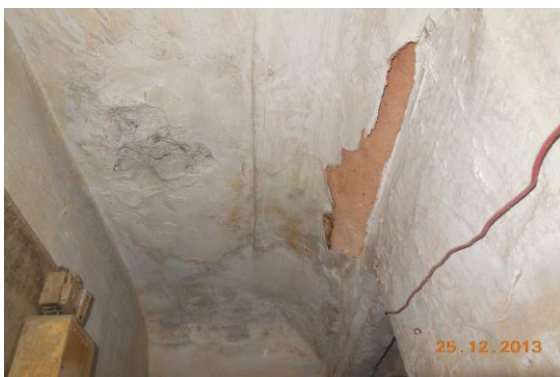
Photo 30
Peeling of Plaster on Roof of Passage of First Floor

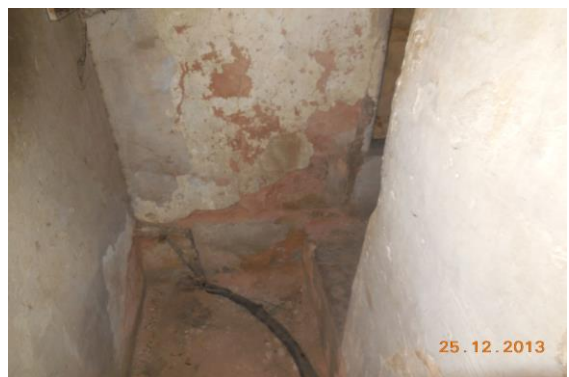
Photo 31
Dampness/Seepage on Staircase First Floor to Second Floor

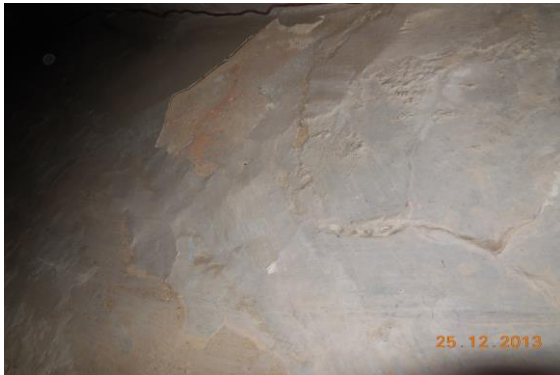
Photo 32
Dampness/Seepage on of Staircase First Floor to Second Floor

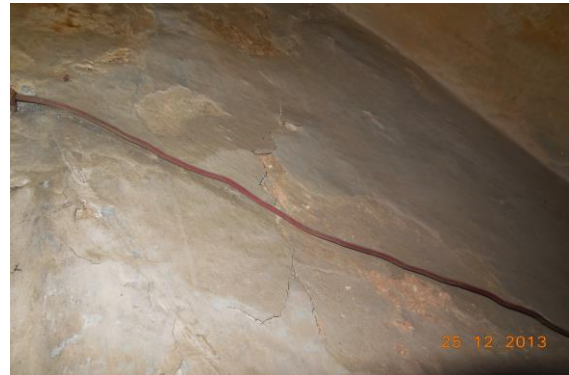
Photo 33
Peeling of Plaster on Wall No. 2 of Staircase First Floor to Second Floor

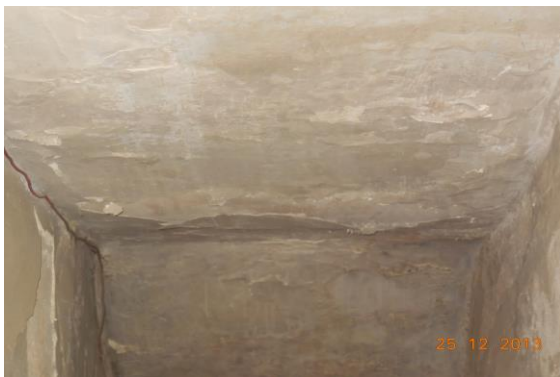
Photo 34
Peeling of Plaster on Wall No. 1 of Room No. 1 of Second Floor

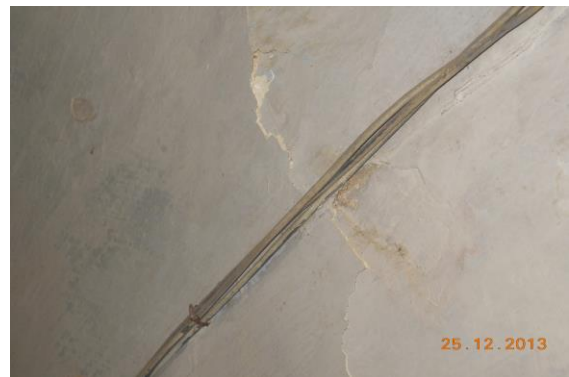
Photo 35
Peeling of Plaster on Wall No. 1 of Room No. 1 of Second Floor

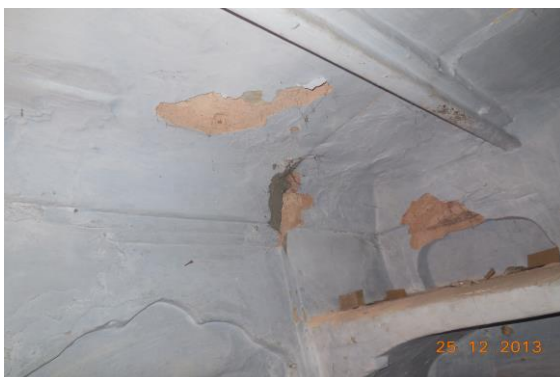
Photo 36
Peeling of Plaster on Wall No. 3 & Roof of Room No. 1 of Second Floor

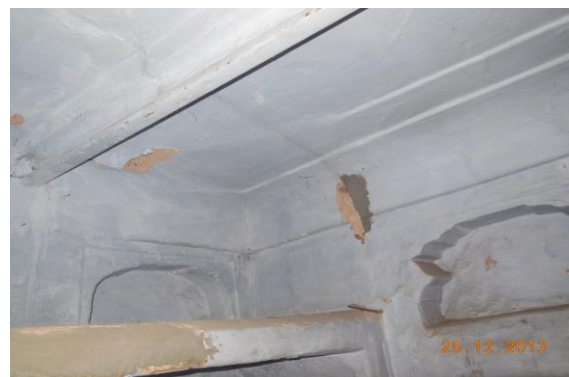
Photo 37
Peeling of Plaster on Wall No. 4 & Roof of Room No. 1 of Second Floor

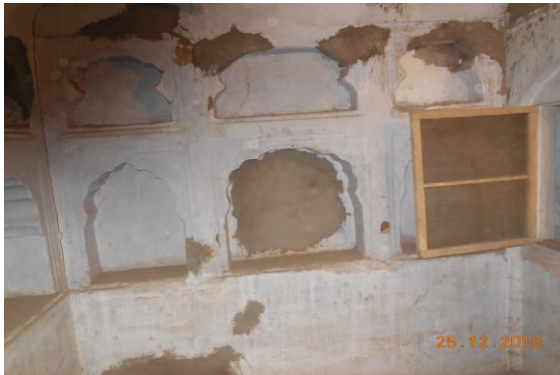
Photo 38

Peeling of Plaster on Wall No. 2 of Room No. 1 of Second Floor

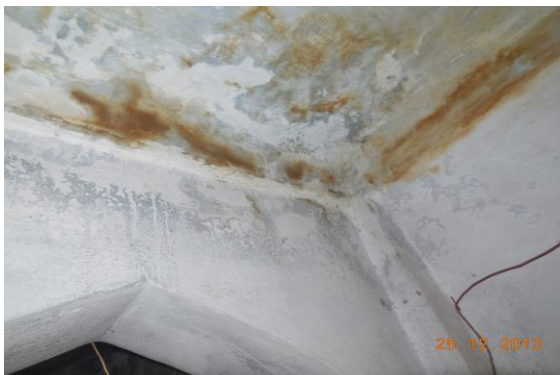
Photo 39

Dampness/Seepage on Wall No. 2 & Roof of Lobby of Second Floor

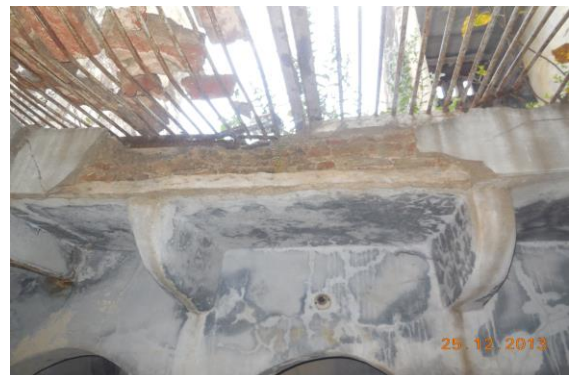
Photo 40

Dampness/Seepage on Wall No. 3 & Roof of Lobby of Second Floor

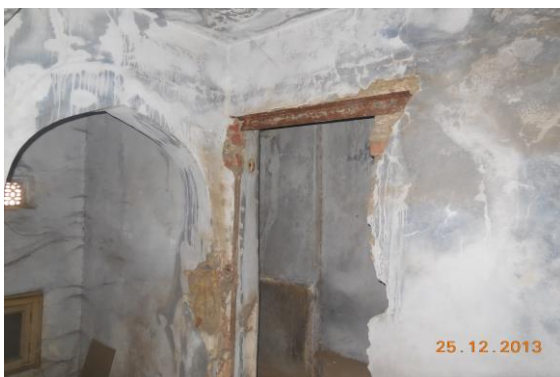
Photo 41

Peeling of Plaster on Roof of Open Sky Varanda of Second Floor

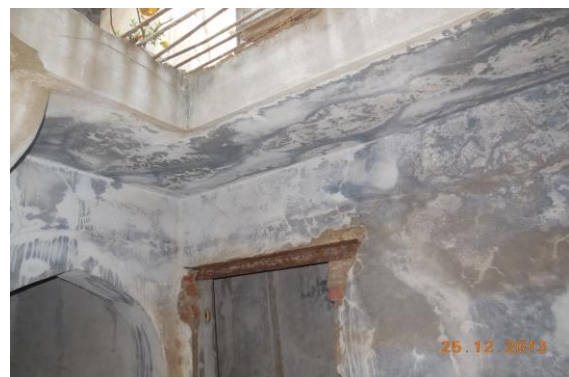
Photo 42

Peeling of Plaster on Wall No. 4 & 2 of Open Sky Varanda of Second Floor

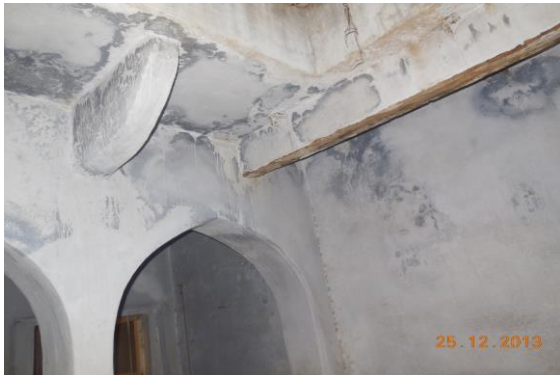
Photo 44

Dampness/Seepage on Wall No. 3 & 1 of Open Sky Varanda of Second Floor

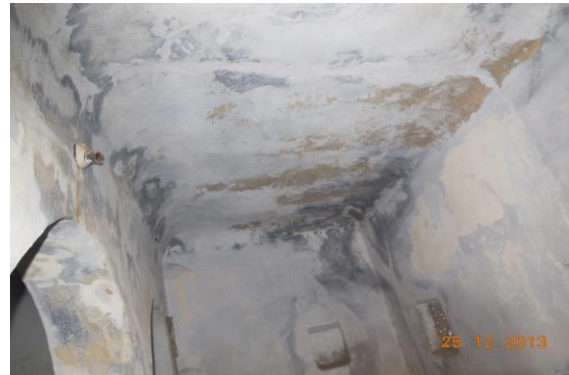
Photo 45

Dampness/Seepage on All Walls & Roof of Balcony of Second Floor

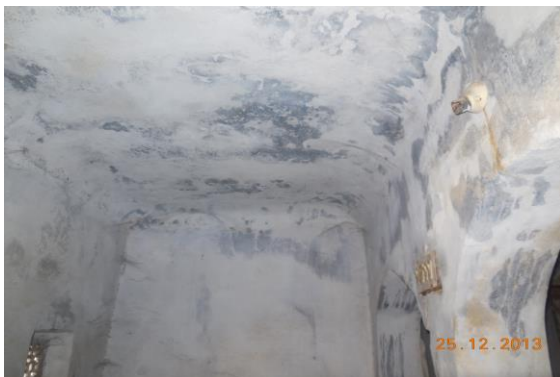
Photo 46

Dampness/Seepage on All Walls & Roof of Balcony of Second Floor

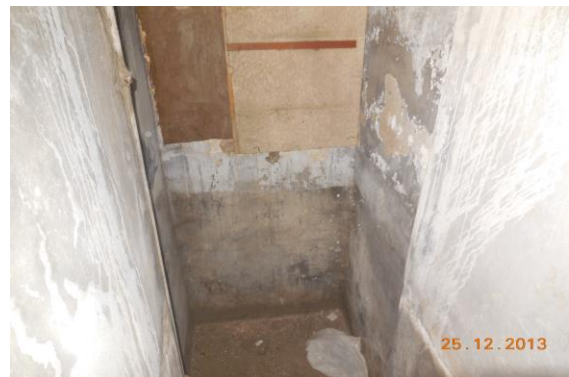
Photo 47

Dampness/Seepage on Wall No. 3 of Staircase area of Third Floor

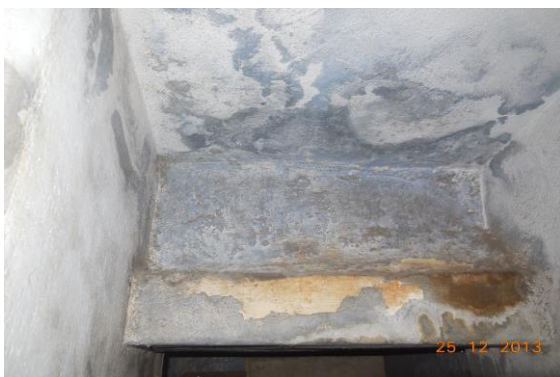
Photo 48

Dampness/Seepage on Wall No. 3 of Staircase area of Third Floor

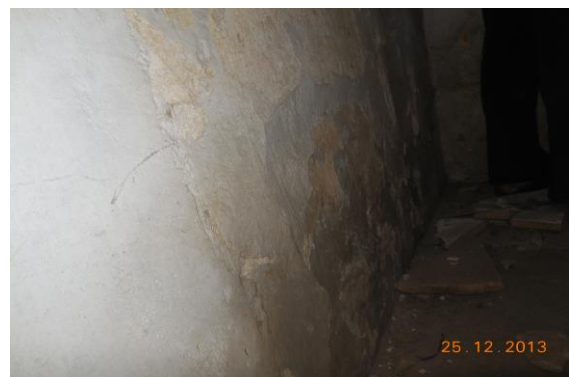
Photo 49

Peeling of Plaster on Wall No. 1 of Staircase area of Third Floor

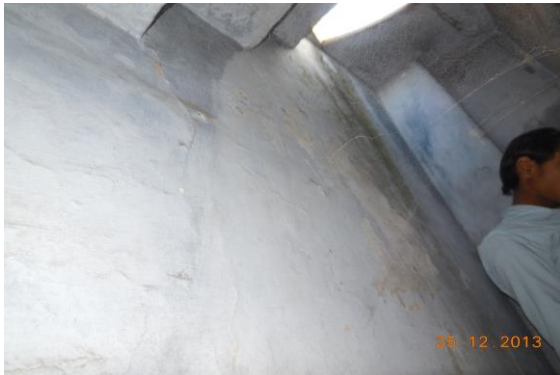
Photo 50

Peeling of Plaster on Wall No. 2 of Staircase area of Third Floor

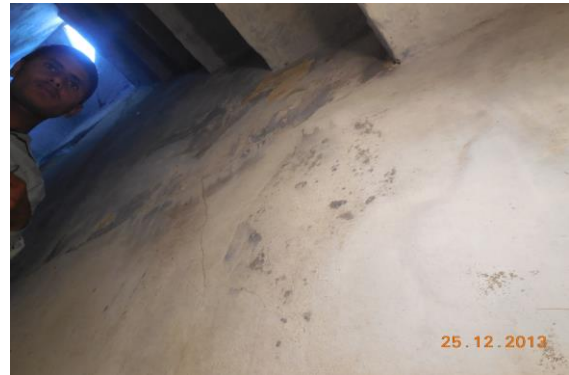
Photo 51

Dampness/Seepage on Toilet No. 1 of First Floor

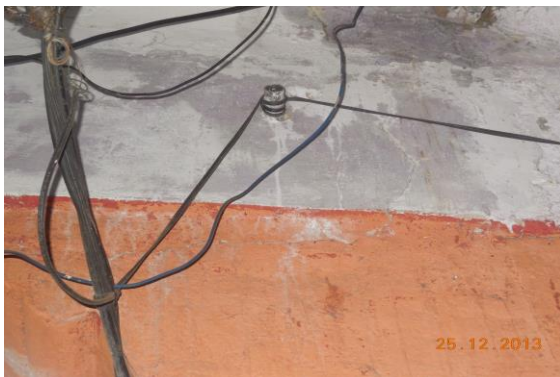
Photo 3
Inclined Crack on Backside & Leftside External Column of Shop No.31, Ground Floor
Approx. Width = 0.8mm, Approx. Length = 0.8m.
Distance from Leftside External Column = Backside Height from Floor

Summary of Cracks						
Defect ID	Location	Orientation	Appx. Width (mm)	Appx. Length (m)	Category	Photo No.
1	Backside & Leftside External Column Shop No.31 Ground Floor	Inclined	0.8	0.8	Very Slight	3
2	Backside & Leftside External Column Shop No.31 Ground Floor	Horizontal	0.5	2	Very Slight	4

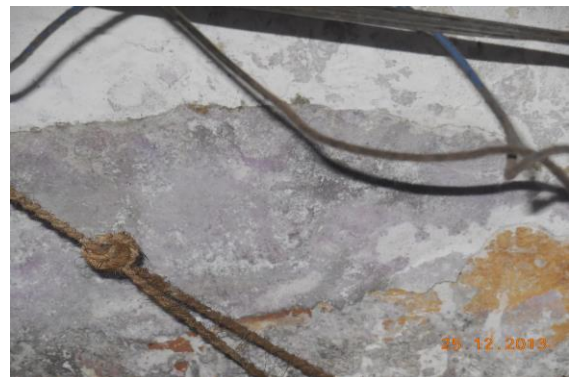
Photo 4
Horizontal Crack on Backside & Leftside External Column of Shop No.31, Ground Floor
Approx. Width = 0.5mm, Approx. Length = 2m.
Distance from Leftside External Column = Backside Height from Floor

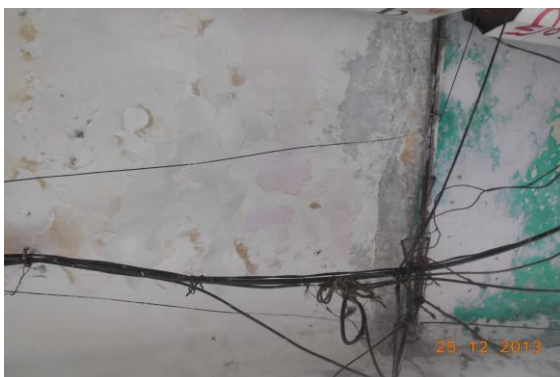
Photo 5
Dampness/Seepage on Roof of Shop No.31 of Ground Floor

Summary of Defects Other Than Crack			
Defect ID	Location	Description	Photo No.
3	Roof Shop No.31 Ground Floor	Dampness/Seepage	5

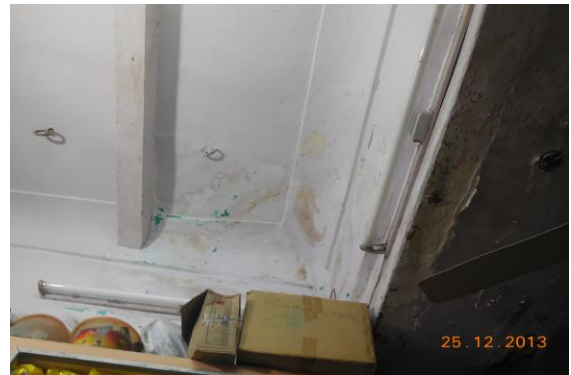
Photo 4
Dampness/Seepage on Roof of Shop No.32 of Ground Floor

Summary of Defects Other Than Crack			
Defect ID	Location	Description	Photo No.
1	Roof Shop No.32 Ground Floor	Dampness/Seepage	4
2	Wall No. 3 Part-II of Shop No.32 Ground Floor	Peeling of Plaster	5
3	Roof Shop No.32 Ground Floor	Dampness/Seepage	6
4	Beam Shop No.32 Ground Floor	Peeling of Plaster	7

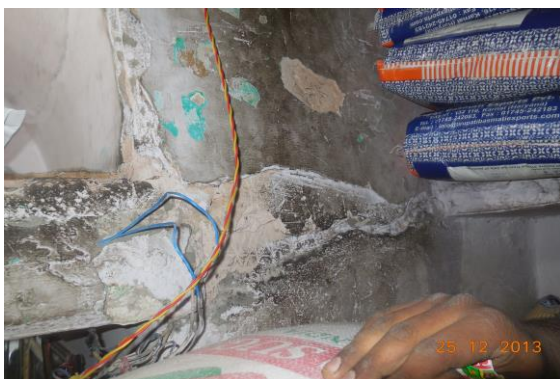
Photo 5
Peeling of Plaster on Wall No. 3 of Part-II of Shop No.32 of Ground Floor

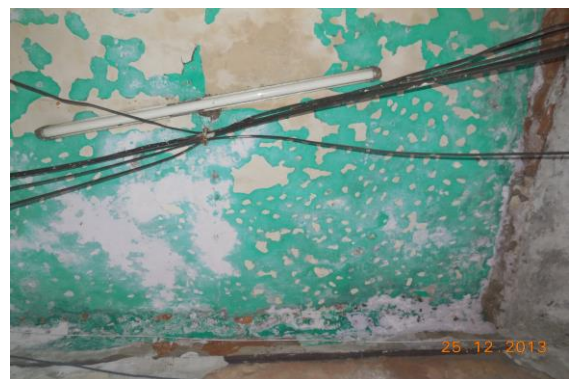
Photo 6
Dampness/Seepage on Roof of Shop No.32 of Ground Floor

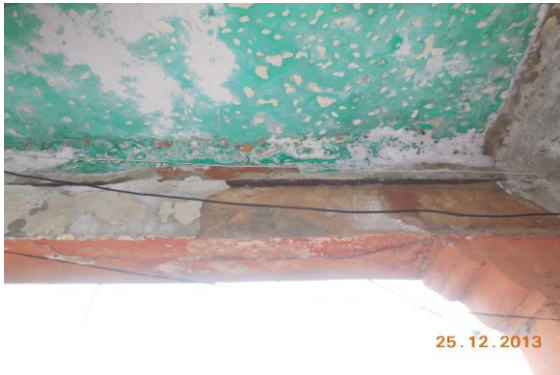
Photo 7

Peeling of Plaster on Beam of Shop No.32 of Ground Floor

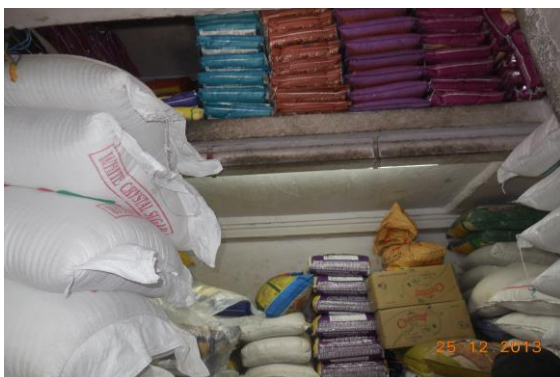
Photo 10

Wall No. 4 of Shop No.32 of Ground Floor Covered With Material

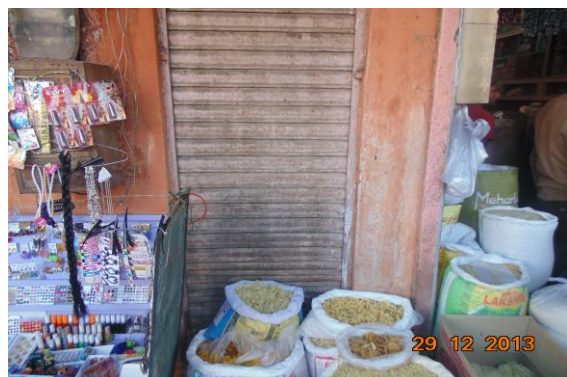
Photo 11

Wall No. 1, 2 & 4 of Part-II of Shop No.32 of Ground Floor Covered With Material

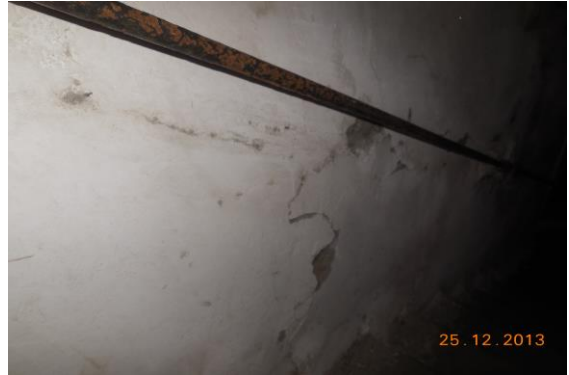
Photo 2
Vertical Crack on Wall No. 1 of Staircase Ground To First Floor
Approx. Width = 1mm, Approx. Length = 1.5m.
Distance from Wall No.4 = 0.9m, Height from Floor = 0m.

Summary of Cracks						
Defect ID	Location	Orientation	Appx. Width (mm)	Appx. Length (m)	Category	Photo No.
1	Wall No. 1 Staircase Ground To First Floor	Vertical	1	1.5	Slight	2, 2A
2	Wall No. 4 Room No. 2 First Floor	Inclined	1	2	Slight	3, 3A
3	Wall No. 3 Room No. 2 First Floor	Horizontal	0.3	0.7	Very Slight	4, 4A
4	Wall No. 2 & 3 Room No. 1 Third Floor	Vertical	1	2	Slight	5
5	Staircase Area Third Floor to Terrace	Inclined	0.6	2.5	Very Slight	6, 6A

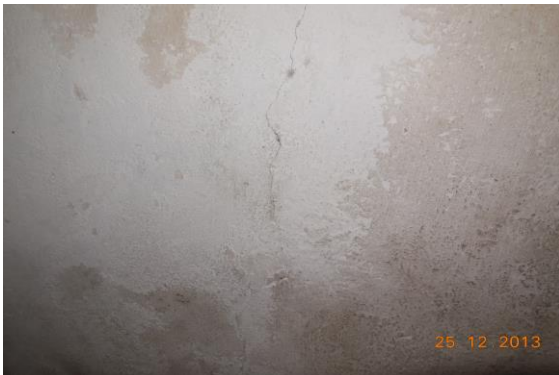
Photo 2A
Vertical Crack on Wall No. 1 of Staircase Ground To First Floor
Approx. Width = 1mm, Approx. Length = 1.5m.
Distance from Wall No.4 = 0.9m, Height from Floor = 0m.

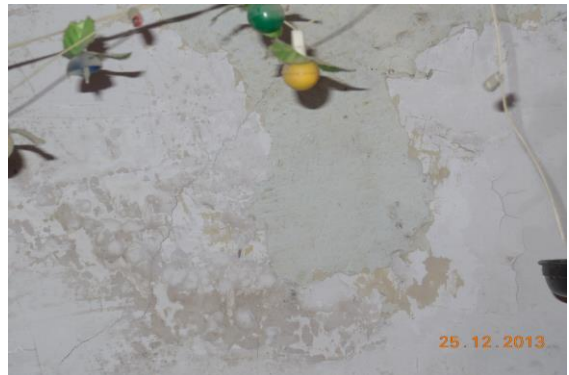
Photo 3
Inclined Crack on Wall No. 4 of Room No. 2, First Floor
Approx. Width = 1mm, Approx. Length = 2m.
Distance from Wall No.2 = 0.3m, Height from Floor = 0m.

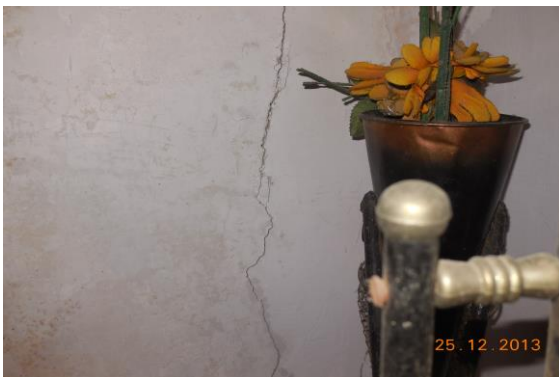
Photo 3A
Inclined Crack on Wall No. 4 of Room No. 2, First Floor
Approx. Width = 1mm, Approx. Length = 2m.
Distance from Wall No.2 = 0.3m, Height from Floor = 0m.

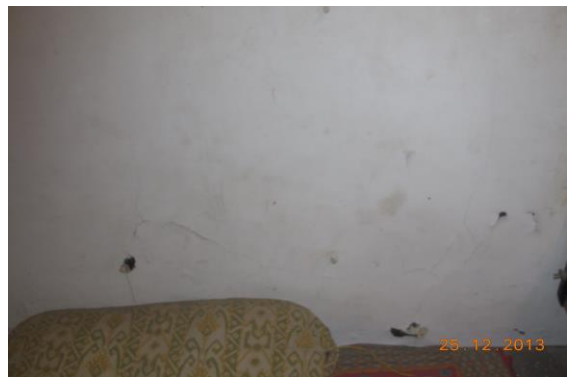
Photo 4
Horizontal Crack on Wall No. 3 of Room No. 2, First Floor
Approx. Width = 0.3mm, Approx. Length = 0.7m.
Distance from Wall No.1 = 0.85m, Height from Floor = 1.6m.

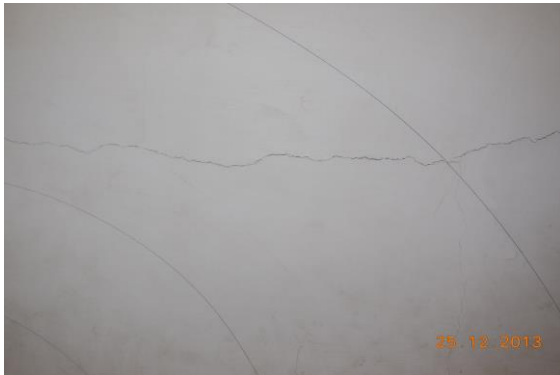
Photo 4A

Horizontal Crack on Wall No. 3 of Room No. 2, First Floor
Approx. Width = 0.3mm, Approx. Length = 0.7m.
Distance from Wall No.1 = 0.85m, Height from Floor = 1.6m.

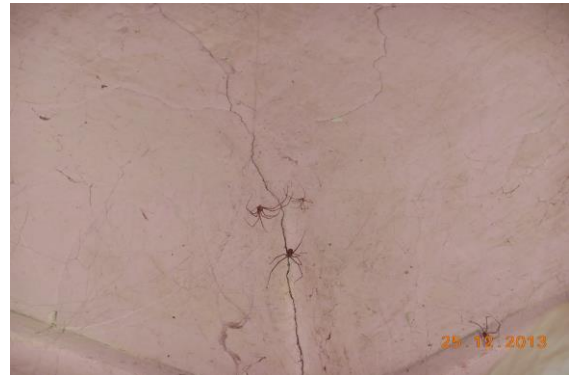
Photo 5

Vertical Crack on Wall No. 2 & 3 of Room No. 1, Third Floor
Approx. Width = 1mm, Approx. Length = 2m.
Distance from = m, Height from Floor = m.

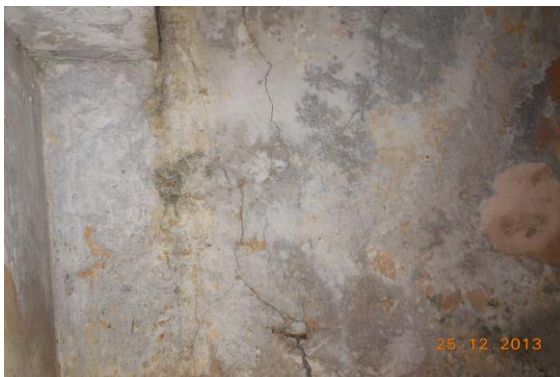
Photo 6

Inclined Crack on Staircase Area Third Floor to Terrace
Approx. Width = 0.6mm, Approx. Length = 2.5m.
Distance from Wall No.3 = 1.7m, Height from Floor = 0m.

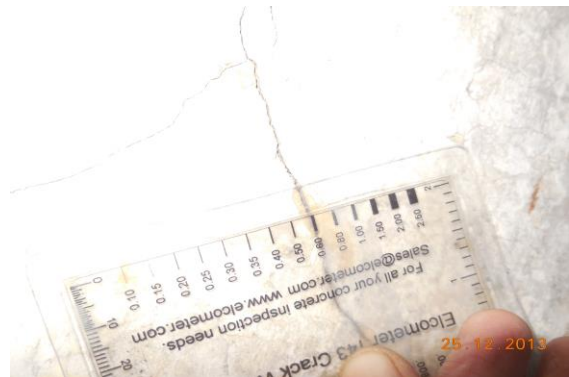
Photo 6A

Inclined Crack on of Staircase Area Third Floor to Terrace
Approx. Width = 0.6mm, Approx. Length = 2.5m.
Distance from Wall No.3 = 1.7m, Height from Floor = 0m.

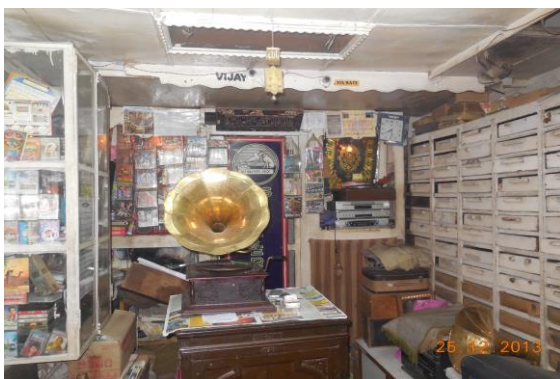
Photo 7

Dampness/Seepage on Roof of Shop No.33 of Ground Floor

Summary of Defects Other Than Crack			
Defect ID	Location	Description	Photo No.
6	Roof Shop No.33 Ground Floor	Dampness/Seepage	7
7	Wall No. 4 & Roof Shop No.33 Ground Floor	Dampness/Seepage	8
8	Wall No. 1 Staircase Ground To First Floor	Dampness/Seepage	9
9	Wall No. 2 Staircase Ground To First Floor	Dampness/Seepage	10
10	Roof Staircase Ground To First Floor	Peeling of Plaster	11
11	Wall No. 2 Staircase Ground To First Floor	Peeling of Plaster	12
12	Wall No. 4 Room No. 2 First Floor	Dampness/Seepage	13
13	Wall No. 4 Room No. 2 First Floor	Peeling of Plaster	14
14	Roof Balcony First Floor	Dampness/Seepage	15
15	Wall No. 1 & 3 Balcony First Floor	Dampness/Seepage	16
16	Wall No. 2 Balcony First Floor	Peeling of Plaster	17
17	Wall No. 3 Balcony First Floor	Peeling of Plaster	18
18	Wall No. 1 Staircase First Floor to Second Floor	Dampness/Seepage	19
19	Wall No. 1 Staircase First Floor to Second Floor	Peeling of Plaster	20

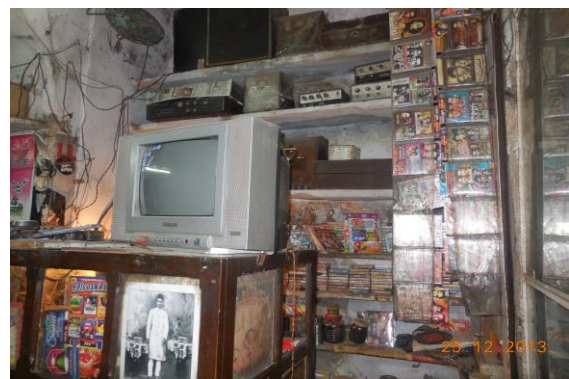
Photo 8

Dampness/Seepage on Wall No. 4 & Roof of Shop No.33 of Ground Floor

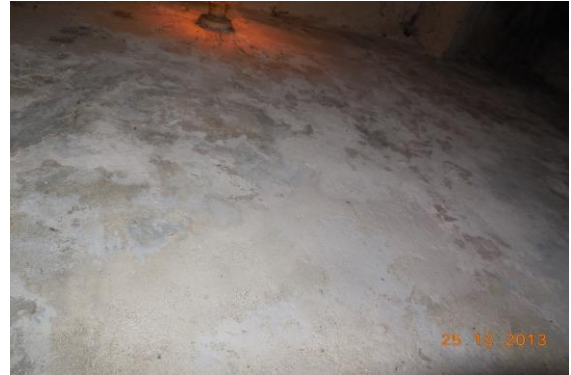
Photo 10

Dampness/Seepage on Wall No. 2 of Staircase Ground To First Floor

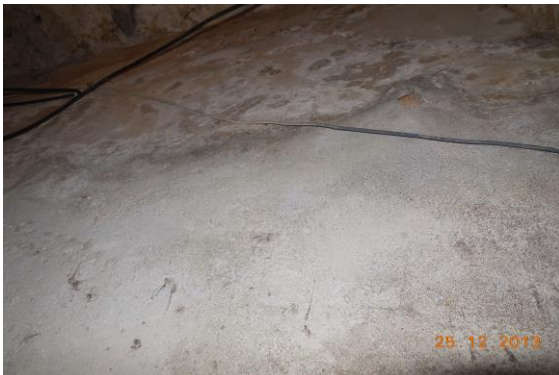
Photo 11

Peeling of Plaster on Roof of Staircase Ground To First Floor

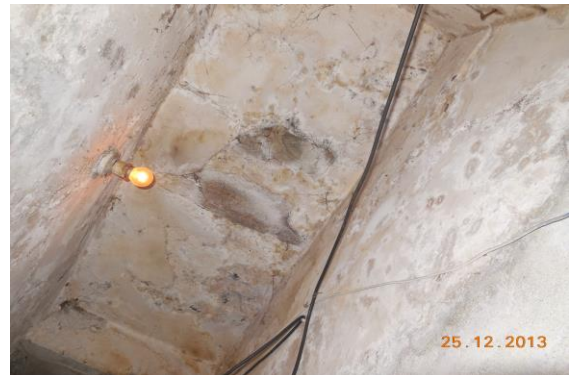
Photo 12

Peeling of Plaster on Wall No. 2 of Staircase Ground To First Floor

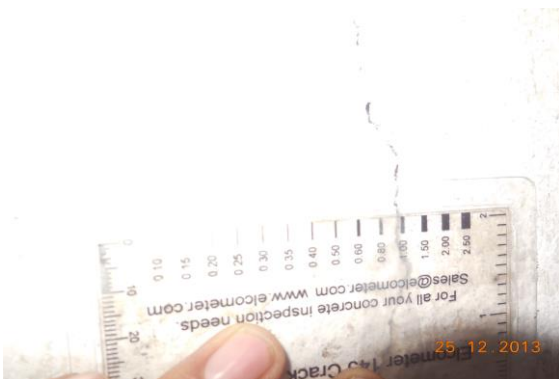
Photo 13

Dampness/Seepage on Wall No. 4 of Room No. 2 of First Floor

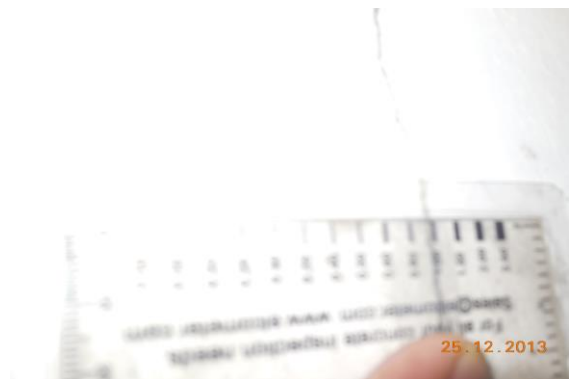
Photo 14

Peeling of Plaster on Wall No. 4 of Room No. 2 of First Floor

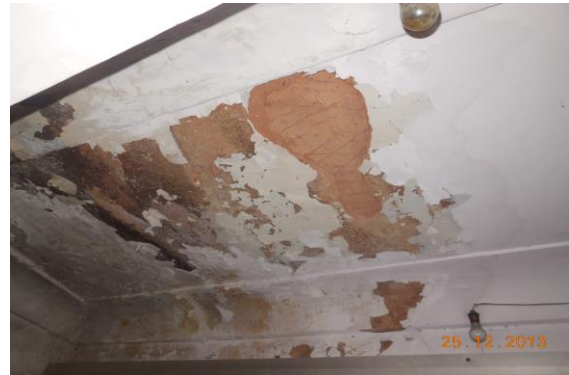
Photo 16

Dampness/Seepage on Wall No. 1 & 3 of Balcony of First Floor

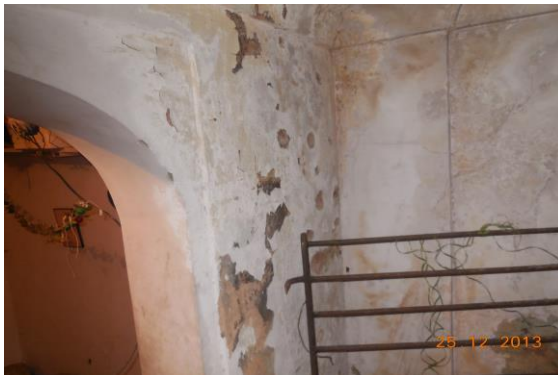
Photo 17

Peeling of Plaster on Wall No. 2 of Balcony of First Floor

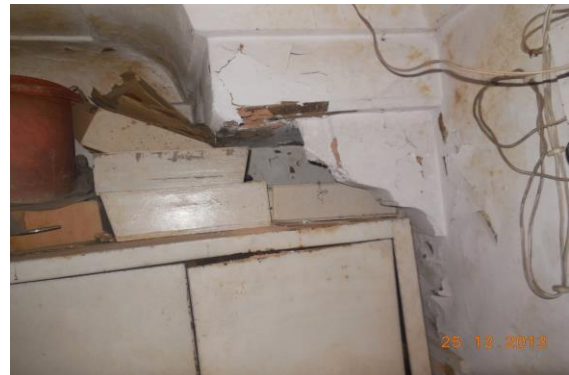
Photo 18

Peeling of Plaster on Wall No. 3 of Balcony of First Floor

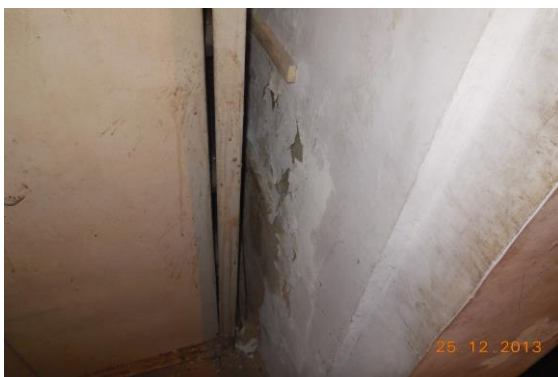
Photo 19

Dampness/Seepage on Wall No. 1 of Staircase First Floor to Second Floor

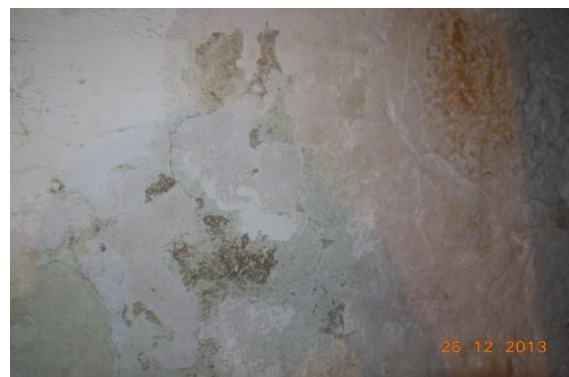
Photo 20

Peeling of Plaster on Wall No. 1 of Staircase First Floor to Second Floor

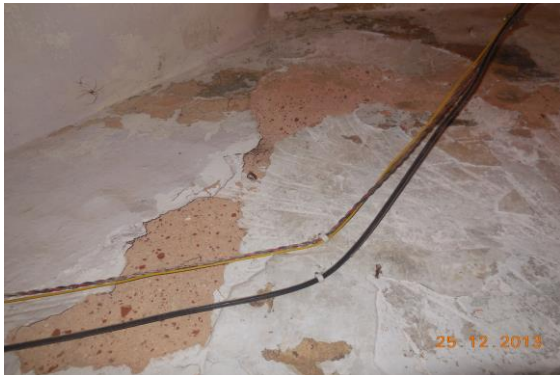
Photo 21

Dampness/Seepage on Wall No. 1, 4 & Roof of Staircase First Floor to Second Floor

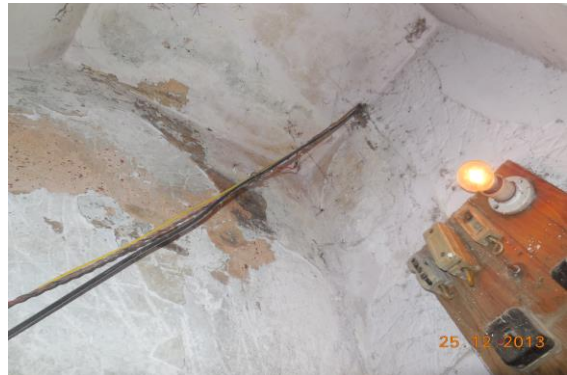
Photo 22

Peeling of Plaster on Roof of Staircase First Floor to Second Floor

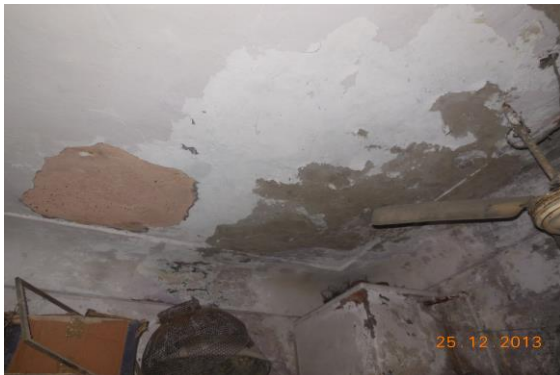
Photo 23

Peeling of Plaster on Wall No. 4 of Staircase First Floor to Second Floor

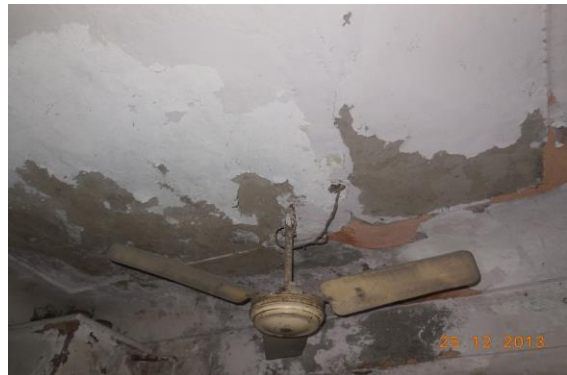
Photo 24

Dampness/Seepage on Wall No. 4 of Staircase First Floor to Second Floor

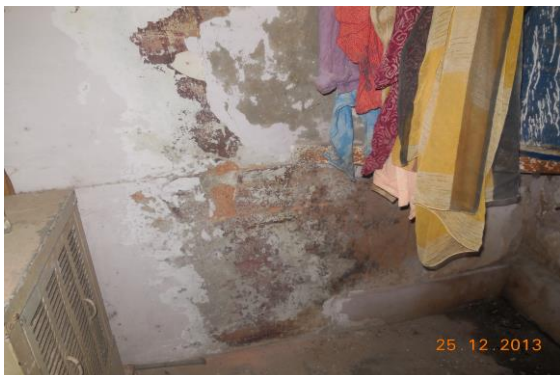
Photo 25

Dampness/Seepage on Wall No. 2 & 4 of Second Floor

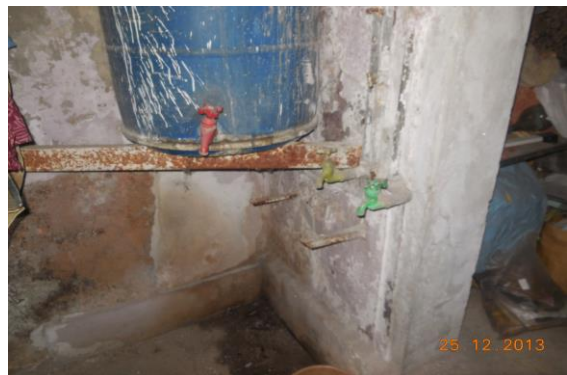
Photo 26

Dampness/Seepage on Roof of Balcony of Second Floor

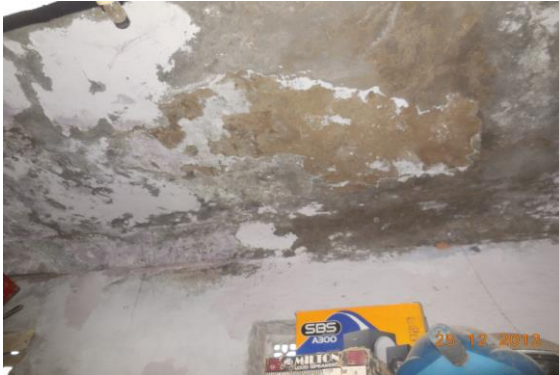
Photo 27

Dampness/Seepage on Wall No. 3 of Balcony of Second Floor

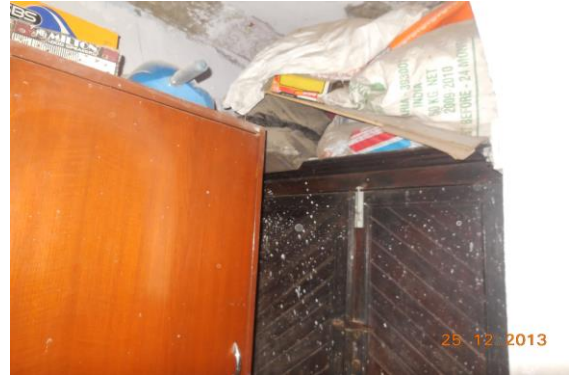
Photo 28

Dampness/Seepage on Wall No. 3 of Store of Second Floor

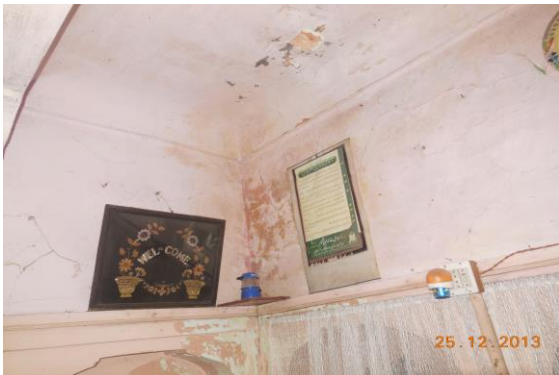
Photo 29

Peeling of Plaster on Wall No. 1, 4 & Roof of Room No. 1 of Third Floor

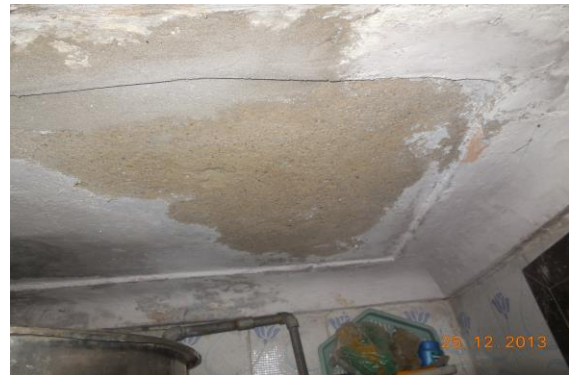
Photo 30

Peeling of Plaster on Roof of Bathroom of Third Floor

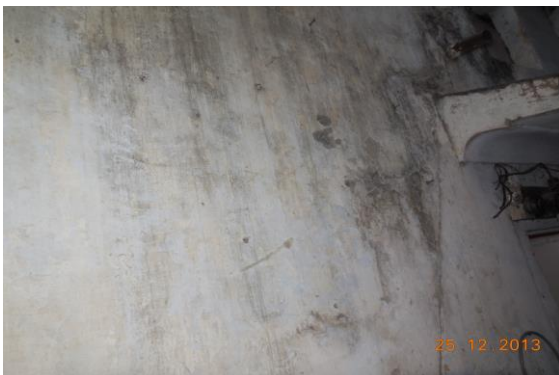
Photo 31

Dampness/Seepage on Wall No. 3 of Balcony of Third Floor

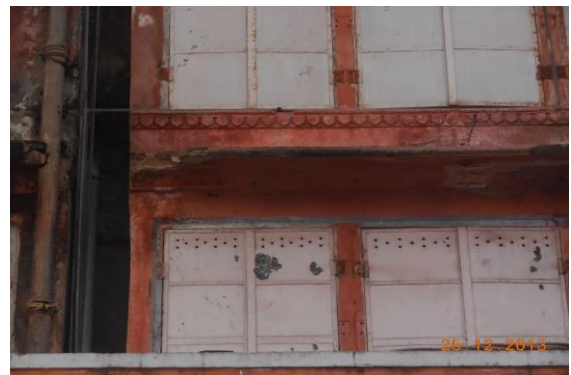
Photo 32

Peeling of Plaster on Wall No. Shade of House No.319 Above Shop No.33 of First Floor

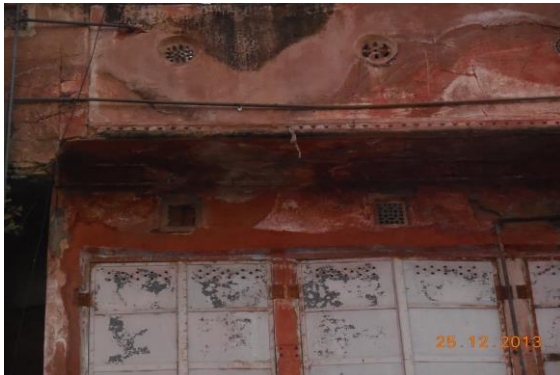
Photo 33

Peeling of Plaster on Wall No. 319 Above Shop No.33 of Second Floor

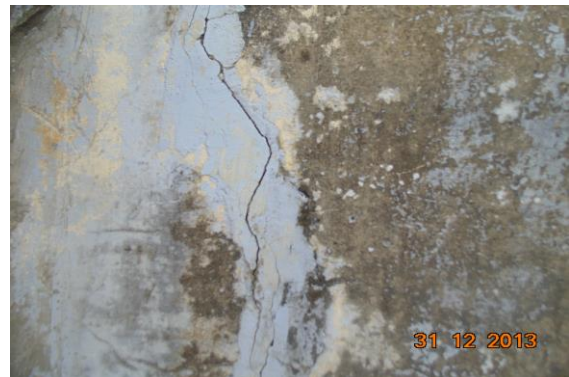
Photo 4
Inclined Crack on Wall No. 5 of Open Area 1, Terrace, Approx. Width = 4mm, Approx. Length = 3m.
Distance from Wall No. 2 = 1.1m, Height from Floor = 0m.

Summary of Cracks						
Defect ID	Location	Orientation	Appx. Width (mm)	Appx. Length (m)	Category	Photo No.
1	Wall No. 5 Open Area 1 Terrace	Inclined	4	3	Slight	4, 4A
2	Wall No. 5 Open Area Terrace	Vertical	5	2	Moderate	5
3	Wall No. 5 Open Area Terrace	Inclined	2	1	Slight	6
4	Wall No. 4 Bathroom Second Floor	Inclined	1	0.3	Slight	7
5	Wall No. 4 Open Area Second Floor	Horizontal	0.3	1.5	Very Slight	8, 8A

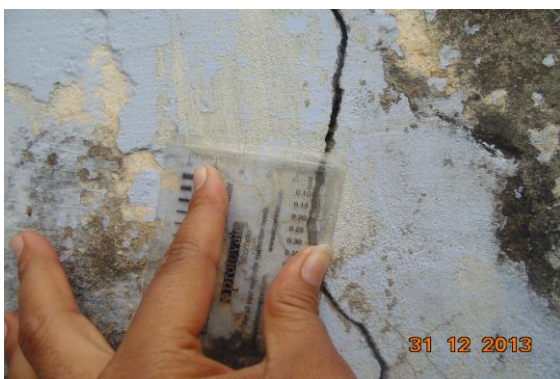
Photo 4A
Inclined Crack on Wall No. 5 of Open Area 1, Terrace, Approx. Width = 4mm, Approx. Length = 3m.
Distance from Wall No. 2 = 1.1m, Height from Floor = 0m.

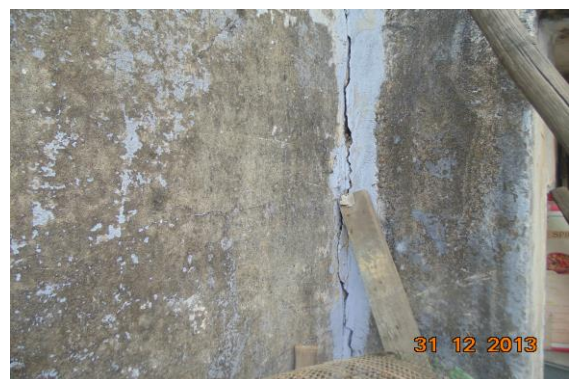
Photo 5
Vertical Crack on Wall No. 5 of Open Area, Terrace, Approx. Width = 5mm, Approx. Length = 2m.
Distance from = m, Height from Floor = m.

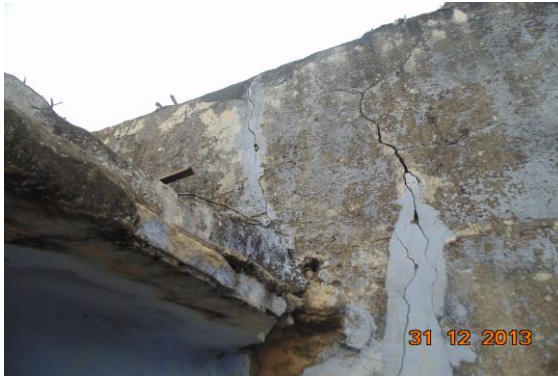
Photo 6

Inclined Crack on Wall No. 5 of Open Area, Terrace, Approx. Width = 2mm, Approx. Length = 1m.
Distance from Wall No. 2 = 2m, Height from Floor = 2m.

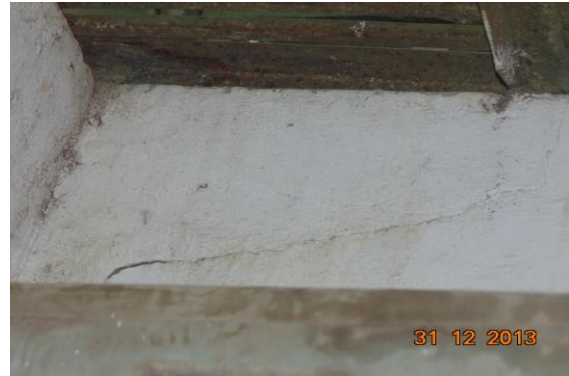
Photo 7

Inclined Crack on Wall No. 4 of Bathroom, Second Floor, Approx. Width = 1mm, Approx. Length = 0.3m.
Distance from Wall No. 1 = 0.8m, Height from Floor = 2.1m.

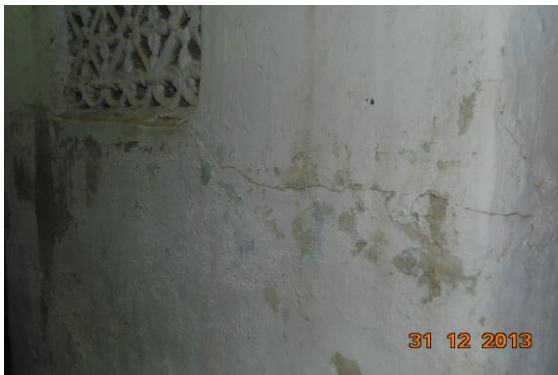
Photo 8

Horizontal Crack on Wall No. 4 of Open Area, Second Floor, Approx. Width = 0.3mm, Approx. Length = 1.5m.
Distance from Wall No. 1 = 0.8m, Height from Floor = 1.5m.

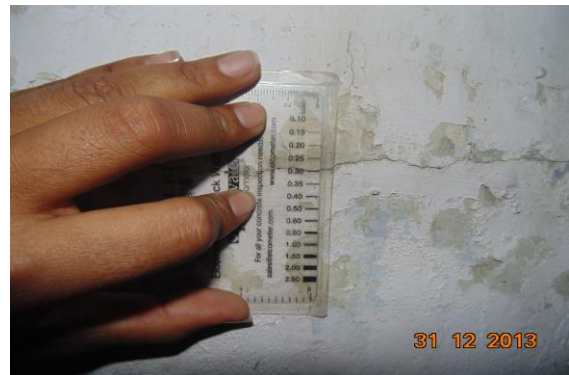
Photo 8A

Horizontal Crack on Wall No. 4 of Open Area, Second Floor, Approx. Width = 0.3mm, Approx. Length = 1.5m.
Distance from Wall No. 1 = 0.8m, Height from Floor = 1.5m.

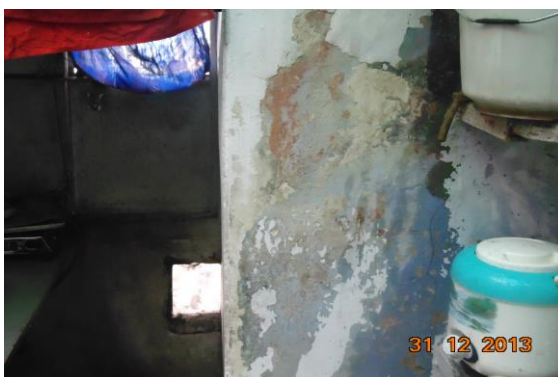
Photo 9

Peeling of Plaster on Wall No. 2 of Open Area of Third Floor

Summary of Defects Other Than Crack			
Defect ID	Location	Description	Photo No.
6	Wall No. 2 Open Area Third Floor	Peeling of Plaster	9
7	Wall No. 3 Third Floor	Peeling of Plaster	10
8	Wall No. 1 Third Floor	Peeling of Plaster	11
9	Wall No. 4 Third Floor	Peeling of Plaster	12
10	Roof Toilet No. 1 Third Floor	Dampness/Seepage	13
11	Wall No. 1 Toilet No. 1 Third Floor	Dampness/Seepage	14
12	Wall No. 2 Room No. 1 Third Floor	Dampness/Seepage	15
13	Wall No. 1 Room No. 1 Third Floor	Dampness/Seepage	16
14	Roof Room No. 1 Third Floor	Dampness/Seepage	17
15	Wall No. 3 Room No. 1 Third Floor	Peeling of Plaster	18
16	Floor Open Area 1 Terrace	Peeling of Plaster	19
17	Wall No. 4 Open Area 1 Terrace	Peeling of Plaster	20
18	Store Room Shed Terrace	Damaged Portion	21
19	Wall No. 2 Terrace	Peeling of Plaster	22
20	Wall No. 2 Stair SF to TF Terrace	Peeling of Plaster	23
21	Wall No. 1 Terrace	Peeling of Plaster	24
22	Wall No. 2 Terrace	Peeling of Plaster	25

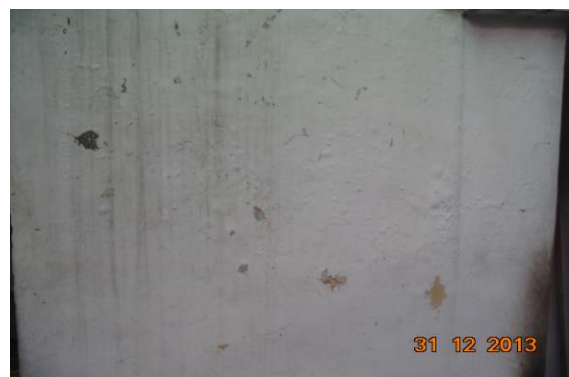
Photo 10

Peeling of Plaster on Wall No. 3 of Third Floor

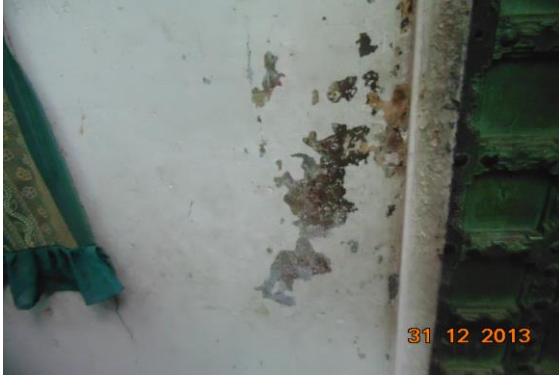
Photo 11
Peeling of Plaster on Wall No. 1 of Third Floor

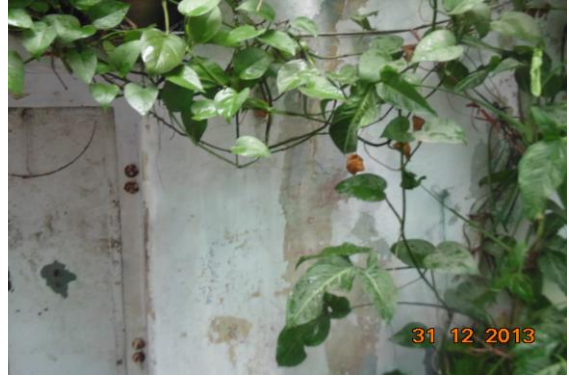
Photo 12
Peeling of Plaster on Wall No. 4 of Third Floor

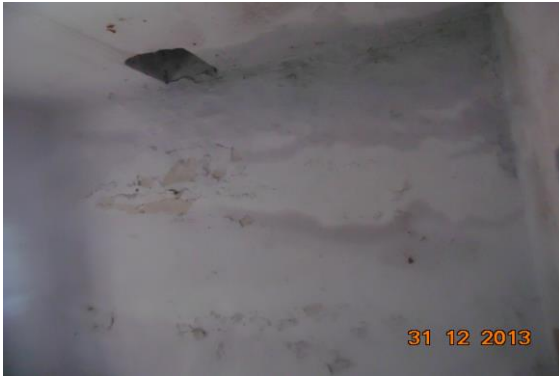
Photo 13
Dampness/Seepage on Roof of Toilet No. 1 of Third Floor

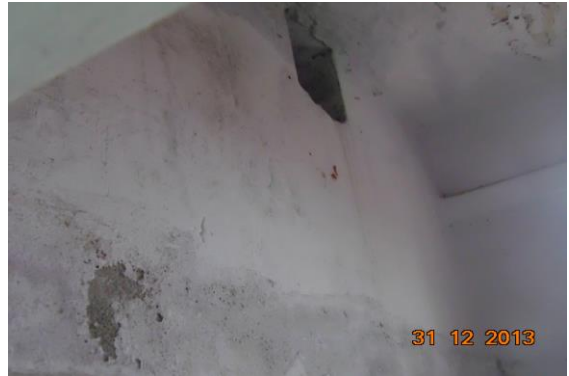
Photo 14
Dampness/Seepage on Wall No. 1 of Toilet No. 1 of Third Floor

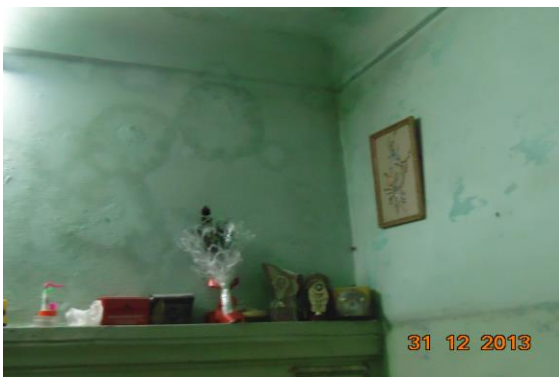
Photo 15
Dampness/Seepage on Wall No. 2 of Room No. 1 of Third Floor
