Pre Building Condition Survey Report

Name and Address of Structure :	Badi Chopar to Ramp Area (Down Line)
---------------------------------	--------------------------------------

Name of the Project	Contract JMRC-UG1B “Design and Construction of Tunnel between Chandpole and Badi Chouper and reverse line by Shield TBM, Underground Metro Stations at Choti Chouper and Badi Chouper by Cut and Cover Methods on East West Corridor of Jaipur Metro Rail Corporation Limited .”	
Owner :

Pre - Condition Building Survey for Construction of Underground Stations from Chandpole to Bari Chouper and reversal line

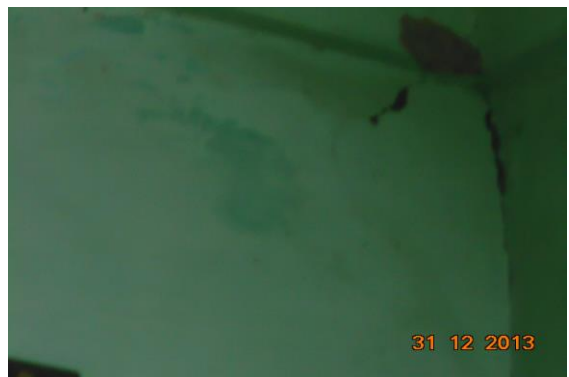
Photo 16
Dampness/Seepage on Wall No. 1 of Room No. 1 of Third Floor

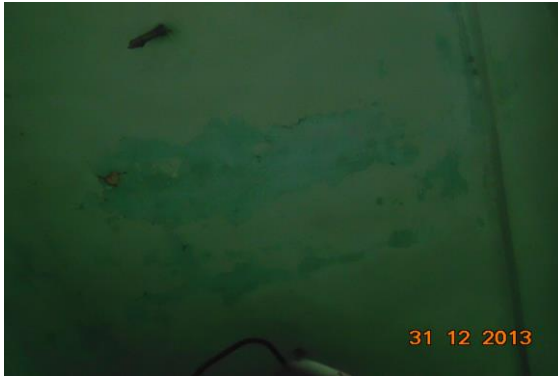
Photo 17

Dampness/Seepage on Roof of Room No. 1 of Third Floor

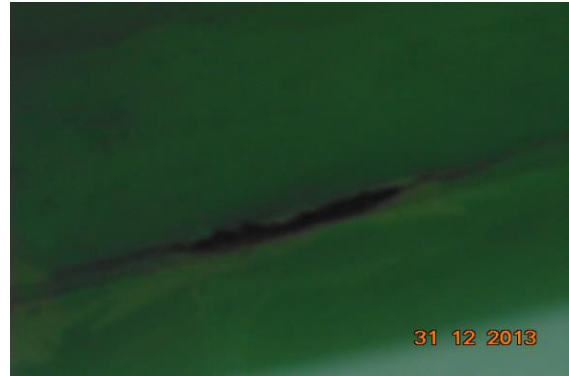
Photo 18

Peeling of Plaster on Wall No. 3 of Room No. 1 of Third Floor

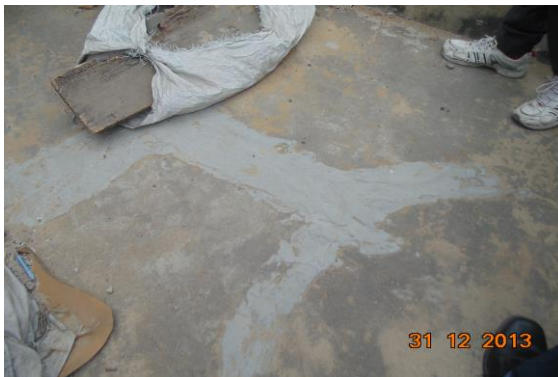
Photo 19

Peeling of Plaster on Floor of Open Area 1 of Terrace

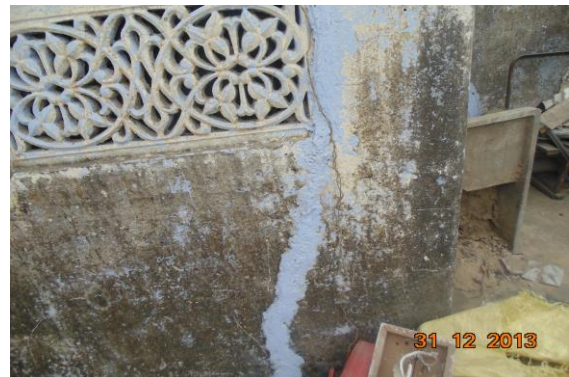
Photo 20

Peeling of Plaster on Wall No. 4 of Open Area 1 of Terrace

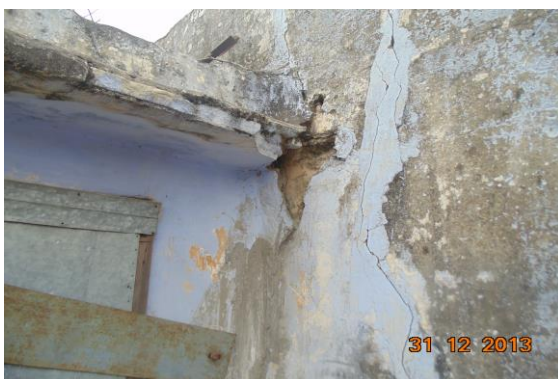
Photo 21

Damaged Portion on Store Room Shed of Terrace

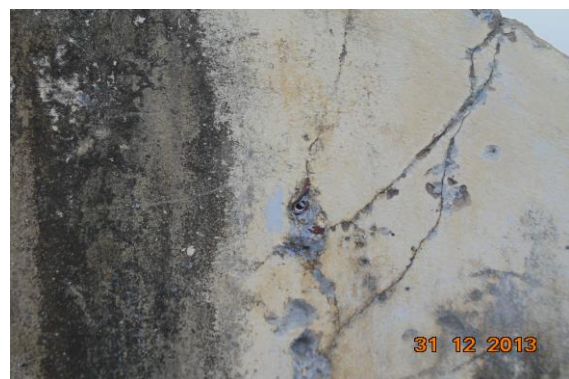
Photo 22

Peeling of Plaster on Wall No. 2 of Terrace

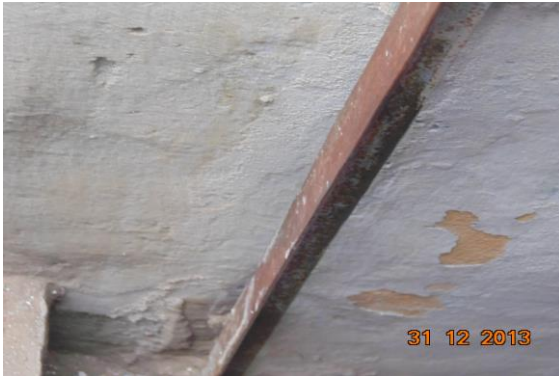
Photo 23
Peeling of Plaster on Wall No. 2 of Stair SF to TF of Terrace

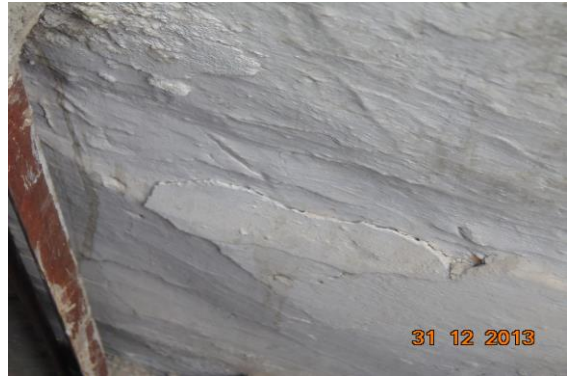
Photo 24
Peeling of Plaster on Wall No. 1 of Terrace

Summary of Defects Other Than Crack			
Defect ID	Location	Description	Photo No.
6	Wall No. 2 Open Area Third Floor	Peeling of Plaster	9
7	Wall No. 3 Third Floor	Peeling of Plaster	10
8	Wall No. 1 Third Floor	Peeling of Plaster	11
9	Wall No. 4 Third Floor	Peeling of Plaster	12
10	Roof Toilet No. 1 Third Floor	Dampness/Seepage	13
11	Wall No. 1 Toilet No. 1 Third Floor	Dampness/Seepage	14
12	Wall No. 2 Room No. 1 Third Floor	Dampness/Seepage	15
13	Wall No. 1 Room No. 1 Third Floor	Dampness/Seepage	16
14	Roof Room No. 1 Third Floor	Dampness/Seepage	17
15	Wall No. 3 Room No. 1 Third Floor	Peeling of Plaster	18
16	Floor Open Area 1 Terrace	Peeling of Plaster	19
17	Wall No. 4 Open Area 1 Terrace	Peeling of Plaster	20
18	Store Room Shed Terrace	Damaged Portion	21
19	Wall No. 2 Terrace	Peeling of Plaster	22
20	Wall No. 2 Stair SF to TF Terrace	Peeling of Plaster	23
21	Wall No. 1 Terrace	Peeling of Plaster	24
22	Wall No. 2 Terrace	Peeling of Plaster	25

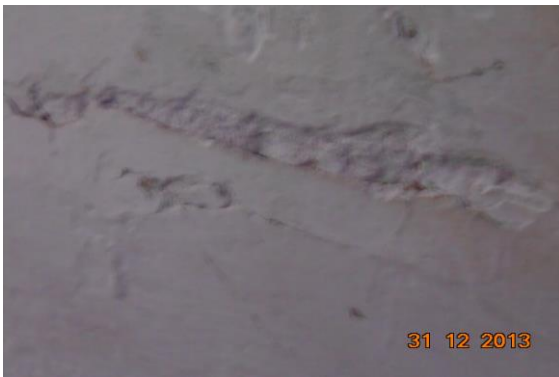
Photo 25
Peeling of Plaster on Wall No. 2 of Terrace

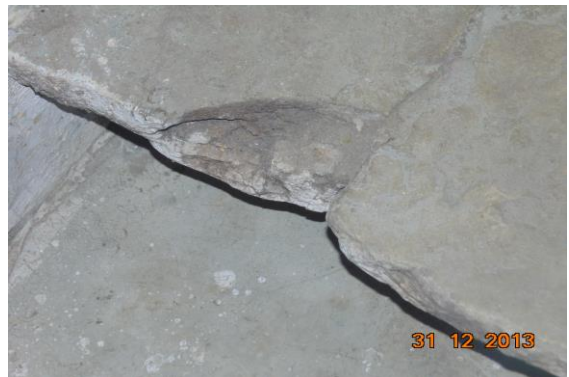
Photo 26
Damaged Portion on Stair Step of Second Floor

23	Stair Step Second Floor	Damaged Portion	26
24	Wall No. 4 Lobby Second Floor	Dampness/Seepage	27
25	Wall No. 1 Lobby Second Floor	Dampness/Seepage	28
26	Wall No. 3 Second Floor	Peeling of Plaster	29
27	Wall No. 4 Second Floor	Peeling of Plaster	30
28	Wall No. 4 & Roof Bathroom No. 1 Second Floor	Dampness/Seepage	31
29	Wall No. 2 Lobby Shed Second Floor	Dampness/Seepage	32
30	Wall No. 4 & Roof Room No. 2 Second Floor	Dampness/Seepage	33
31	Wall No. 4 & Roof Room No. 1 Second Floor	Dampness/Seepage	34
32	Wall No. 3 Room No. 1 Second Floor	Peeling of Plaster	35
33	Roof Room No. 1 Second Floor	Peeling of Plaster	36
34	Wall No. 2 Room No. 1 Second Floor	Peeling of Plaster	37
35	Wall No. 1 Room No. 1 Second Floor	Peeling of Plaster	38
36	Wall No. 2 Stair FF to SF	Peeling of Plaster	39
37	Wall No. 1 Second Floor	Peeling of Plaster	40
38	Wall No. 5 & Roof Lobby First Floor	Dampness/Seepage	41
39	Wall No. 1 & Roof First Floor	Dampness/Seepage	42

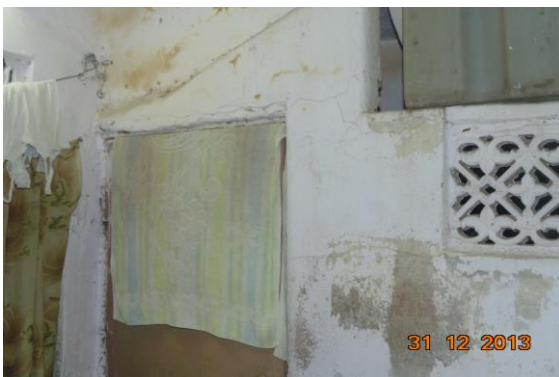
Photo 27
Dampness/Seepage on Wall No. 4 of Lobby of Second Floor

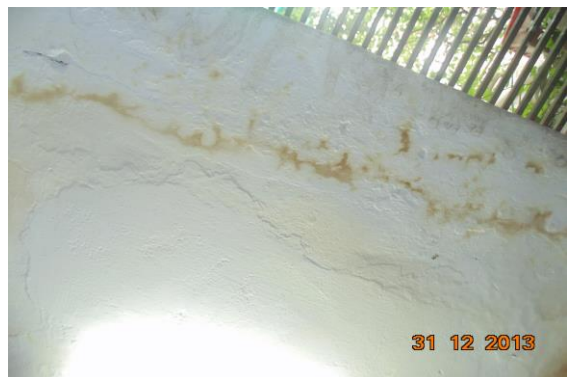
Photo 28
Dampness/Seepage on Wall No. 1 of Lobby of Second Floor

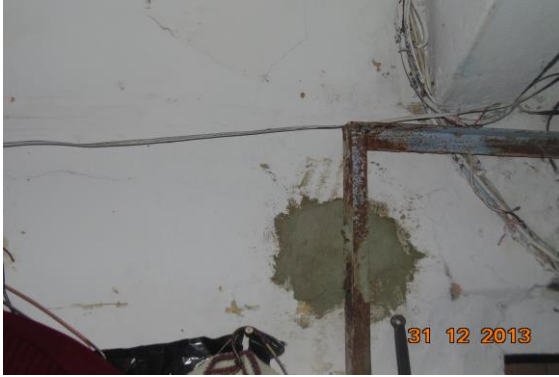
Photo 29
Peeling of Plaster on Wall No. 3 of Second Floor

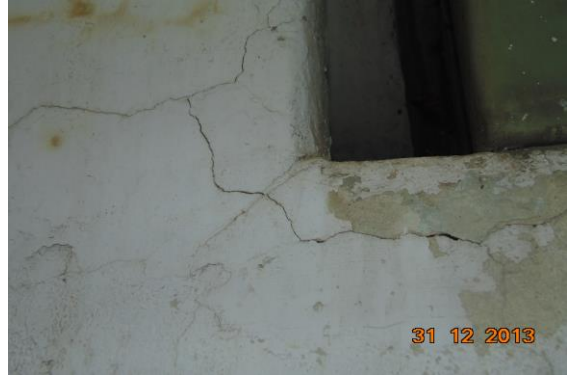
Photo 30
Peeling of Plaster on Wall No. 4 of Second Floor

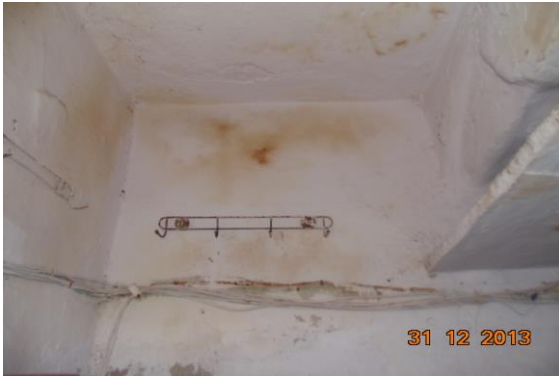
Photo 31
Dampness/Seepage on Wall No. 4 & Roof of Bathroom of Second Floor

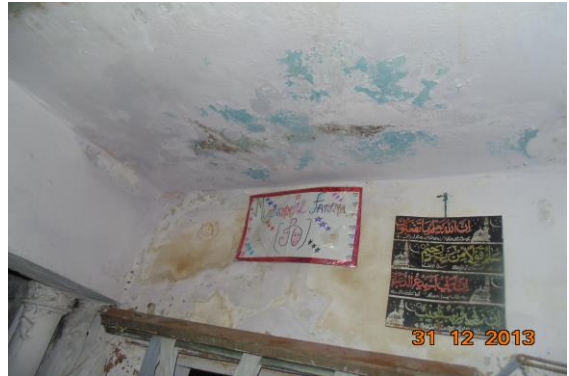
Photo 32
Dampness/Seepage on Wall No. 2 of Lobby Shed of Second Floor

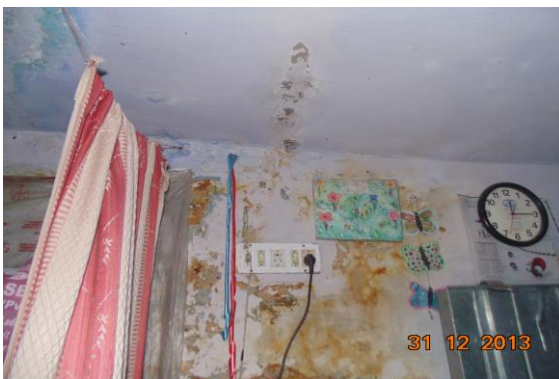
Photo 33
Dampness/Seepage on Wall No. 4 & Roof of Room No. 2 of Second Floor

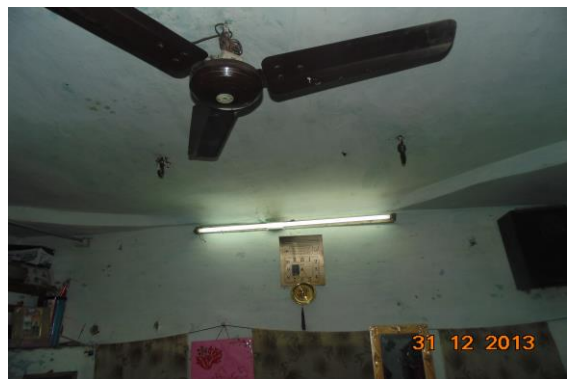
Photo 34
Dampness/Seepage on Wall No. 4 & Roof of Room No. 1 of Second Floor

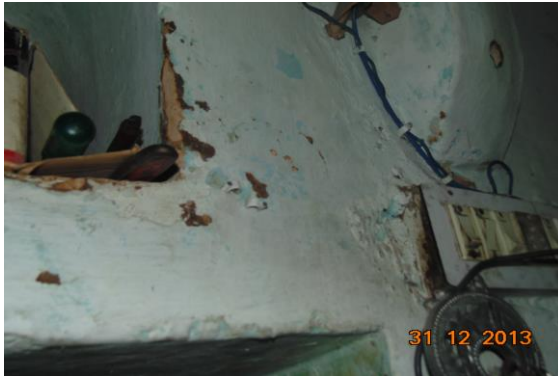
Photo 35

Peeling of Plaster on Wall No. 3 of Room No. 1 of Second Floor

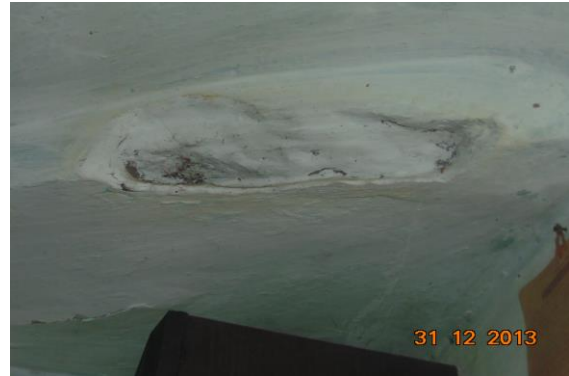
Photo 36

Peeling of Plaster on Roof of Room No. 1 of Second Floor

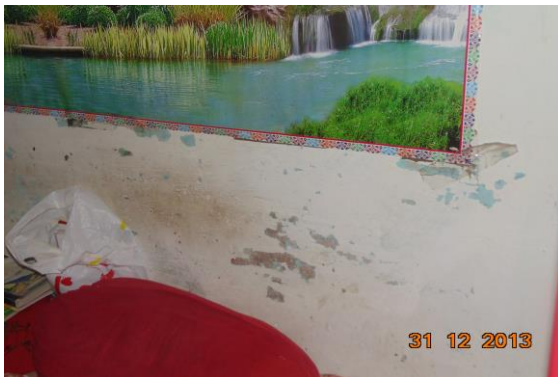
Photo 37

Peeling of Plaster on Wall No. 2 of Room No. 1 of Second Floor

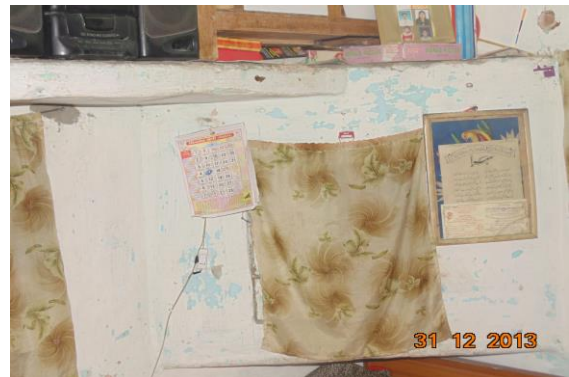
Photo 38

Peeling of Plaster on Wall No. 1 of Room No. 1 of Second Floor

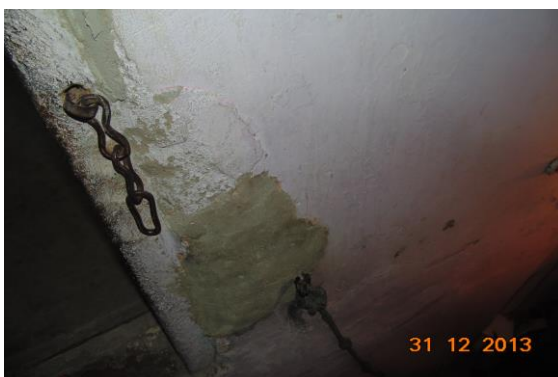
Photo 39

Peeling of Plaster on Wall No. 2 of Stair FF to SF

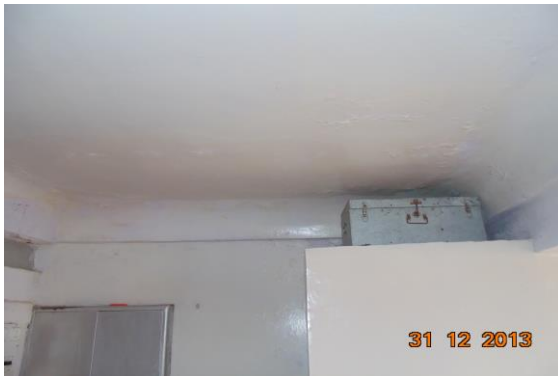
Photo 41
Dampness/Seepage on Wall No. 5 & Roof of Lobby of First Floor

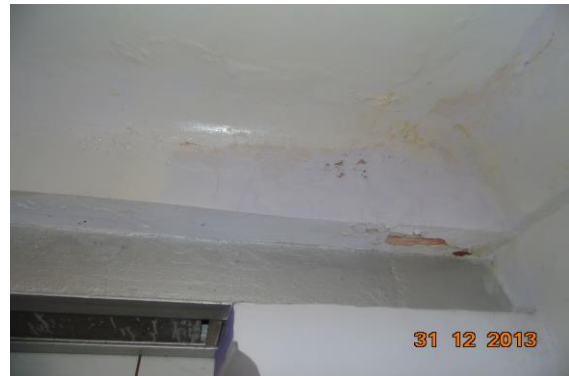
Photo 42
Dampness/Seepage on Wall No. 1 & Roof of First Floor

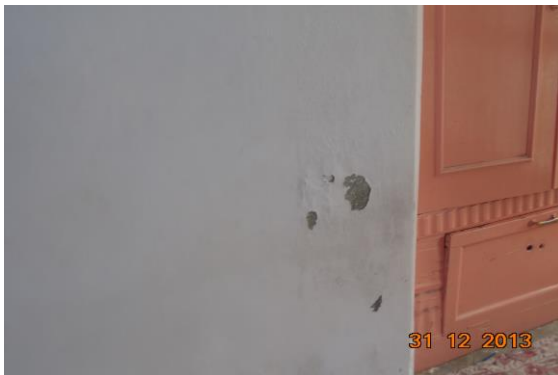
Photo 43
Dampness/Seepage on Wall No. 4 of First Floor

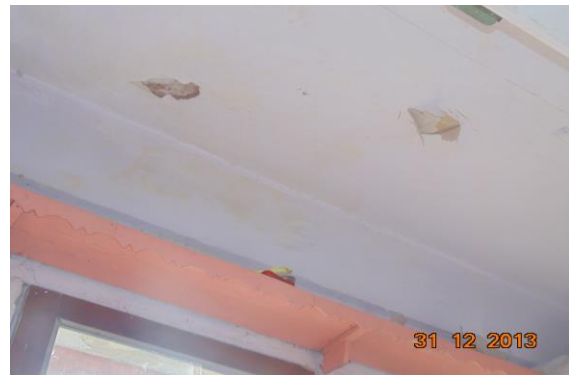
Photo 44
Dampness/Seepage on Wall No. 4 of Varanda of First Floor

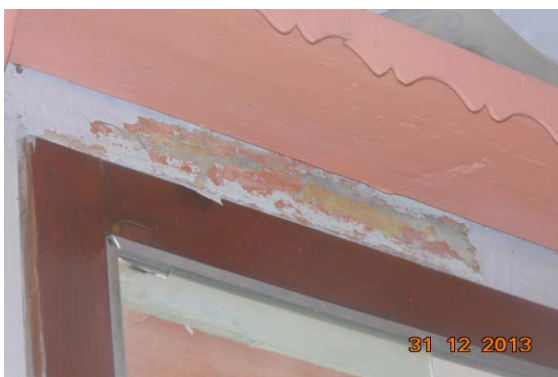
Photo 45
Peeling of Plaster on Wall No. 4 of First Floor

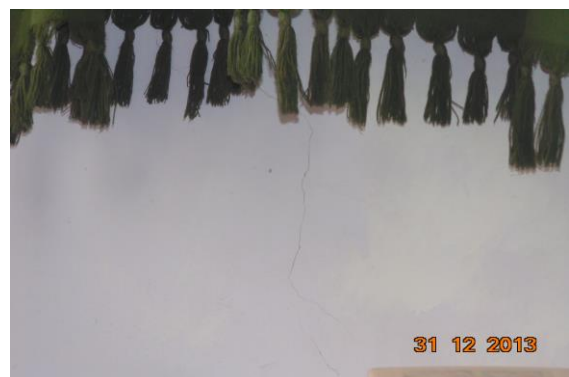
Photo 46
Peeling of Plaster on Wall No. 2 of First Floor

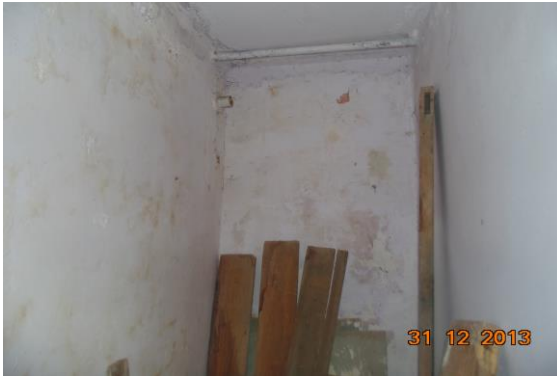
Photo 47

Dampness/Seepage on Wall No. 1, 4 & Roof of Toilet No. 1 of First Floor

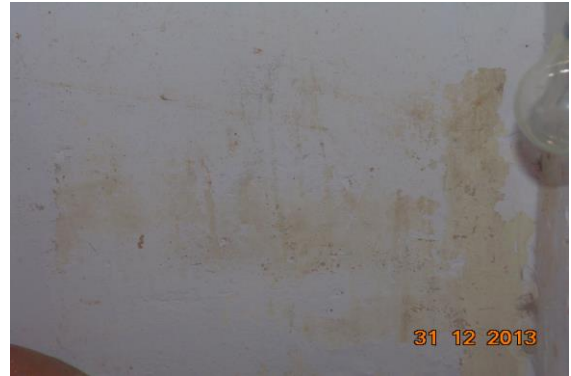
Photo 48

Peeling of Plaster on Wall No. 4 of Store of First Floor

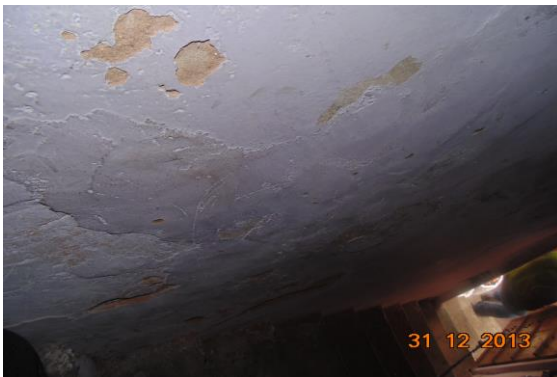
Photo 49

Peeling of Plaster on Wall No. 2 of Stair GF to FF

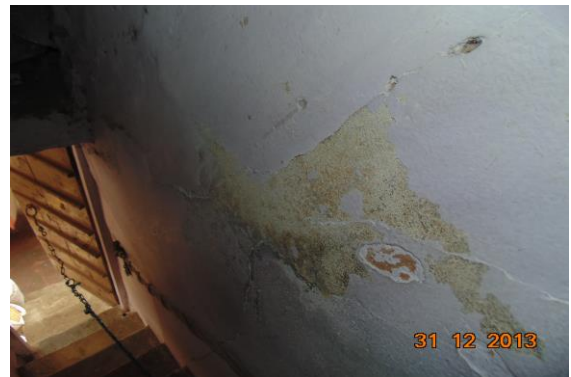
Photo 50

Peeling of Plaster on Wall No. 1 of First Floor

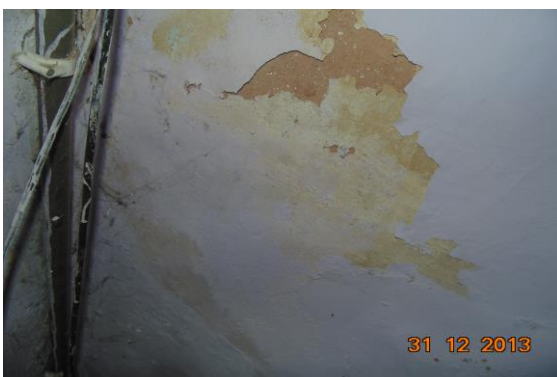
Photo 51

Peeling of Plaster on Roof of First Floor

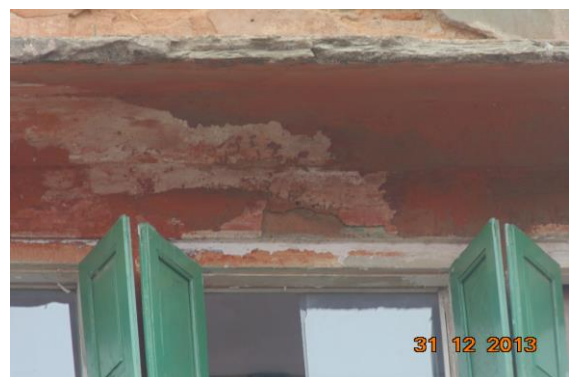
Photo 52

Peeling of Plaster on Outer Wall of First Floor

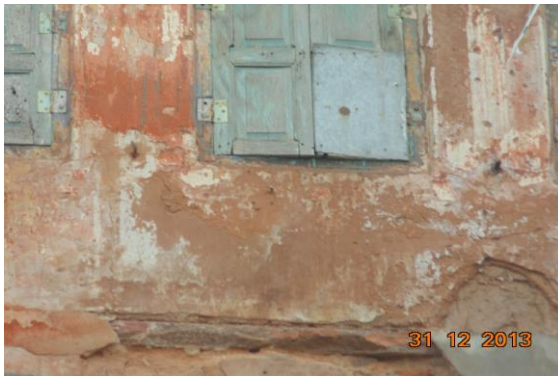
Photo 53
Peeling of Plaster on Outer Wall of Second Floor

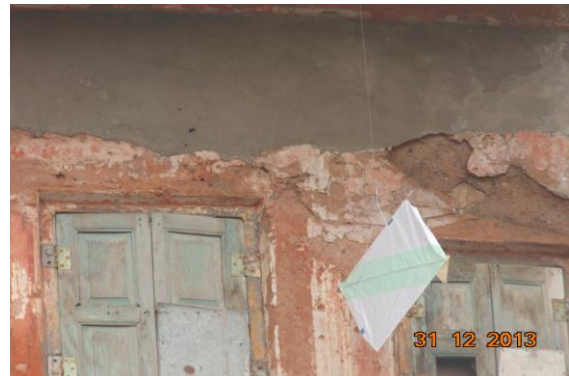
Photo 54
Peeling of Plaster on Outer Wall of Second Floor

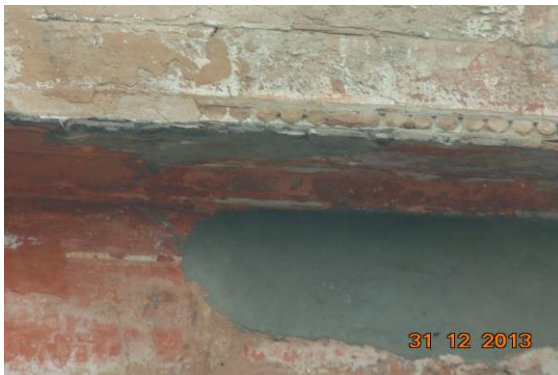
Photo 55
Peeling of Plaster on Shed of Second Floor

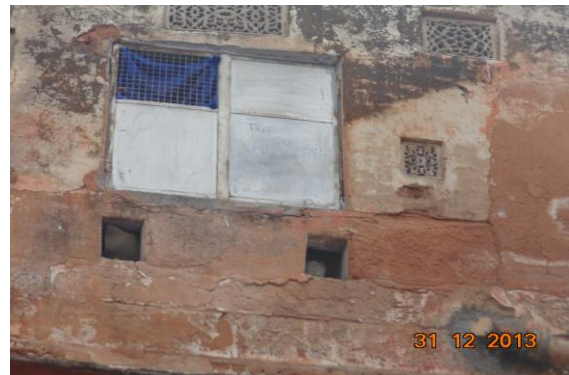
Photo 56
Dampness/Seepage on Outer Wall of Third Floor

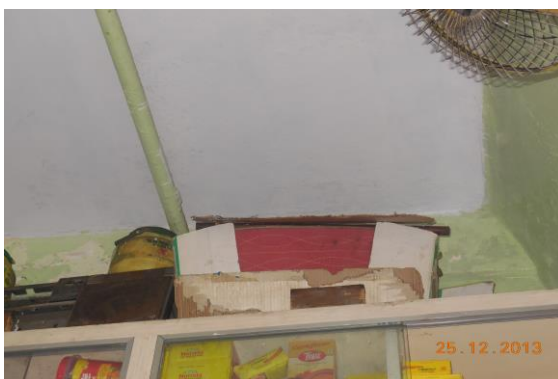
Photo 57
Peeling of Plaster on Wall No. 2 of Shop No.34 of Ground Floor

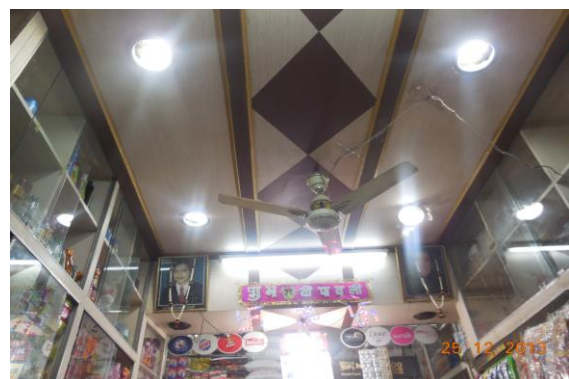
Photo 58
Peeling of Plaster on Roof of Shop No.34 of Ground Floor

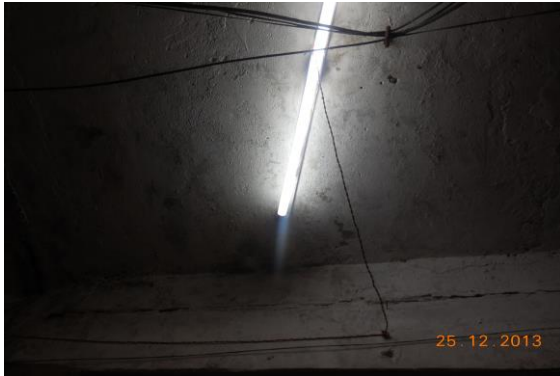
Photo 59
Dampness/Seepage on Roof of Shop No.34 of Ground Floor

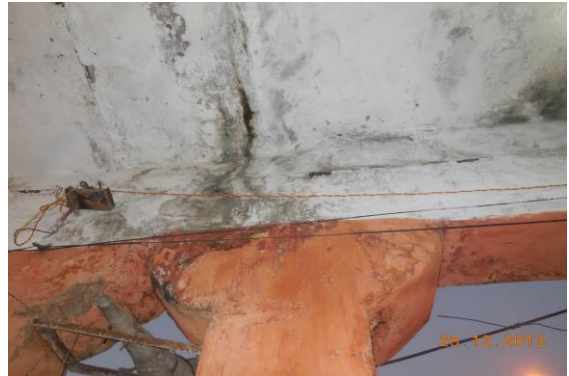
Photo 60
Dampness/Seepage on Roof of Shop No.34 of Ground Floor

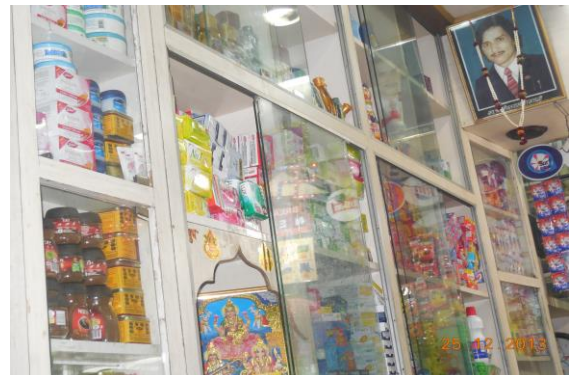
Photo 68
Wall No. 1 of Shop No.34 of Ground Floor Covered With Material

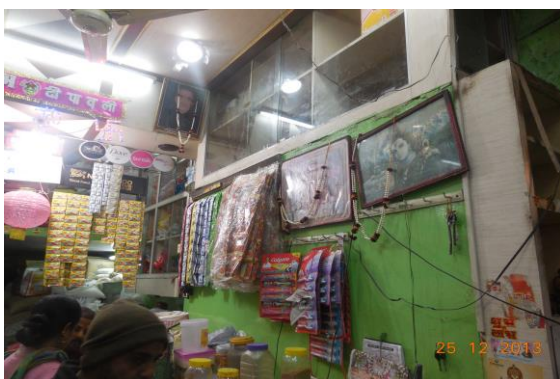
Photo 69
Wall No. 2 of Shop No.34 of Ground Floor Covered With Material

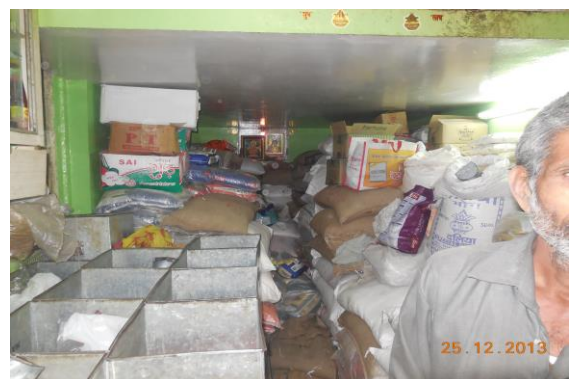
Photo 70
Wall No. 4 of Shop No.34 of Ground Floor Covered With Material

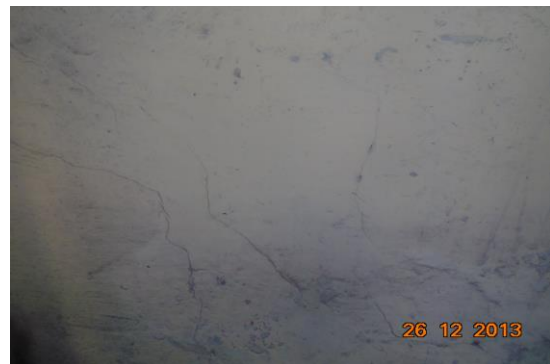
Photo 4

Inclined Crack on Wall No. 4 of Kitchen, Third Floor
Approx. Width = 0.5mm, Approx. Length = 2m.

Summary of Cracks						
Defect ID	Location	Orientation	Appx. Width (mm)	Appx. Length (m)	Category	Photo No.
1	Wall No. 4 Kitchen Third Floor	Inclined	0.5	2	Very Slight	4
2	Wall No. 3 Lobby Third Floor	Inclined	3	3	Slight	5
3	Outer wall No.3 Store Third Floor	Inclined	2	2	Slight	6, 6A
4	Wall No. 4 & Roof Balcony Second Floor	Inclined	0.25	0.6	Very Slight	7, 7A
5	Roof Lobby Second Floor	Inclined	0.6	2	Very Slight	8
6	Wall No. 4 Lobby Second Floor	Vertical	2.5	0.5	Slight	9, 9A
7	Wall No. 2 Staircase GF to FF	Inclined	1	1	Slight	10
8	Roof Varanda of Shop No. 35 Ground Floor	Horizontal	3	2.5	Slight	11

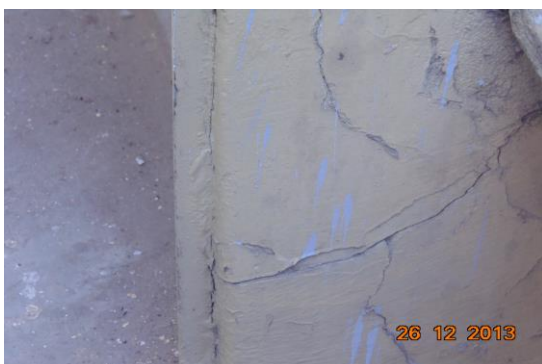
Photo 5

Inclined Crack on Wall No. 3 of Lobby, Third Floor
Approx. Width = 3mm, Approx. Length = 3m.

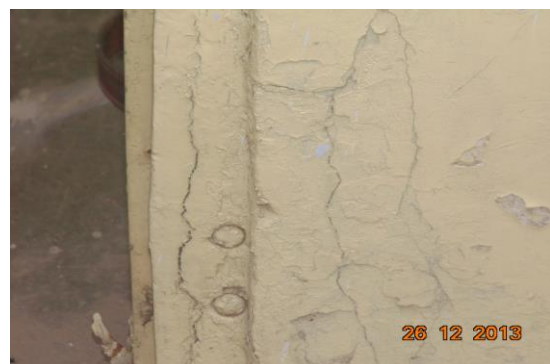
Photo 6

Inclined Crack on Outer wall No.3 of Store, Third Floor
Approx. Width = 2mm, Approx. Length = 2m.

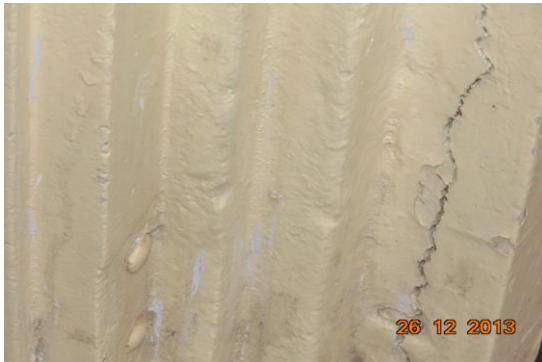
Photo 6A

Inclined Crack on Outer wall No.3 of Store, Third Floor
Approx. Width = 2mm, Approx. Length = 2m.

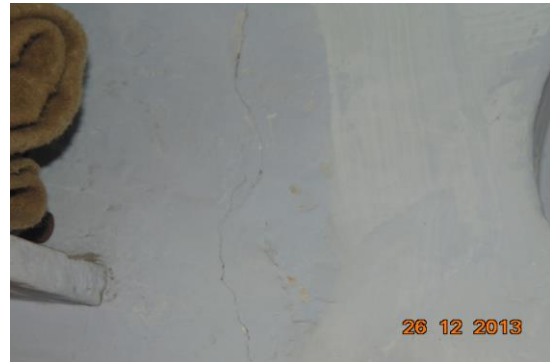
Photo 7

Inclined Crack on Wall No. 4 & Roof of Balcony, Second Floor
Approx. Width = 0.25mm, Approx. Length = 0.6m.
Distance from Wall No.1 = 0.8m, Height from Floor = 1.8m.

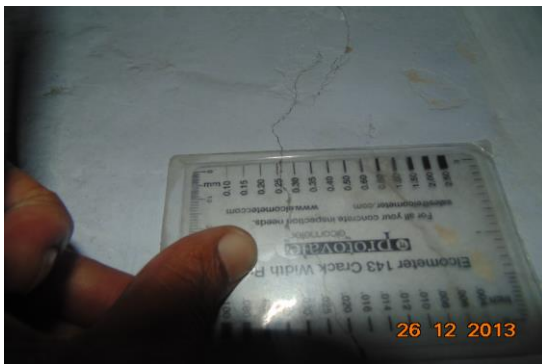
Photo 7A

Inclined Crack on Wall No. 4 & Roof of Balcony, Second Floor
Approx. Width = 0.25mm, Approx. Length = 0.6m.
Distance from Wall No.1 = 0.8m, Height from Floor = 1.8m.

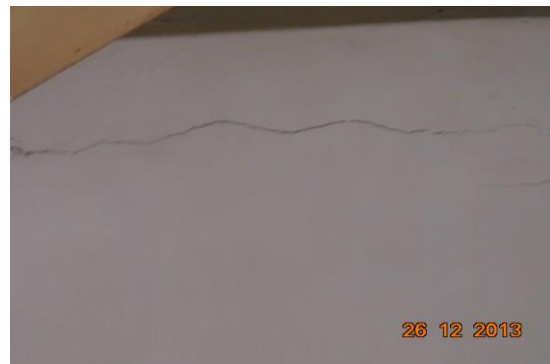
Photo 8

Inclined Crack on Roof of Lobby, Second Floor
Approx. Width = 0.6mm, Approx. Length = 2m.
Distance from Wall no.1 = 0m, Height from Floor = 2m.

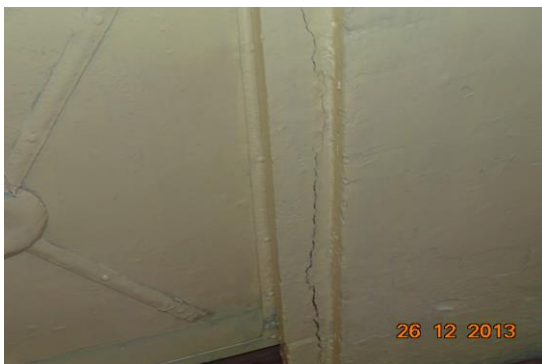
Photo 9

Vertical Crack on Wall No. 4 of Lobby, Second Floor
Approx. Width = 2.5mm, Approx. Length = 0.5m.
Distance from Wall No.1 = 0.9m, Height from Floor = 0m.

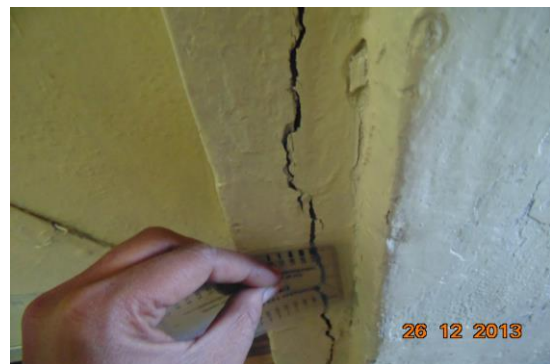
Photo 9A

Vertical Crack on Wall No. 4 of Lobby, Second Floor
Approx. Width = 2.5mm, Approx. Length = 0.5m.
Distance from Wall No.1 = 0.9m, Height from Floor = 0m.

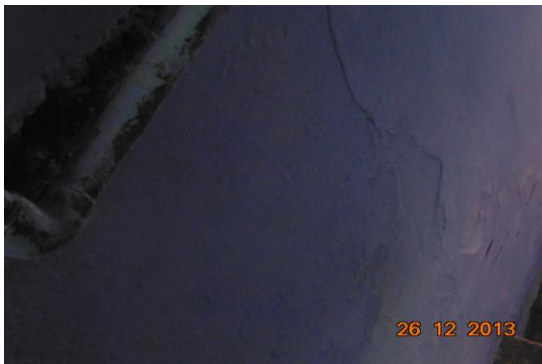
Photo 10
Inclined Crack on Wall No. 2 of Staircase GF to FF,
Approx. Width = 1mm, Approx. Length = 1m.

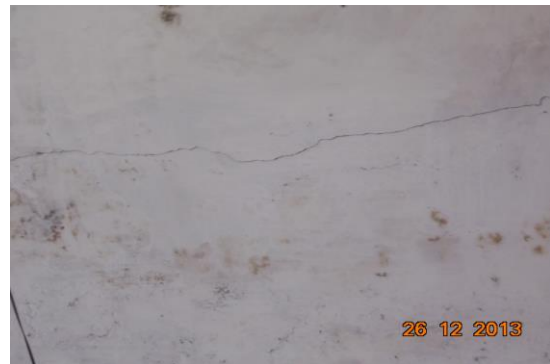
Photo 11
Horizontal Crack on Roof of Varanda of Shop No. 35, Ground Floor
Approx. Width = 3mm, Approx. Length = 2.5m.
Distance from Right side External Column = 0m, Height from Floor = 3m.

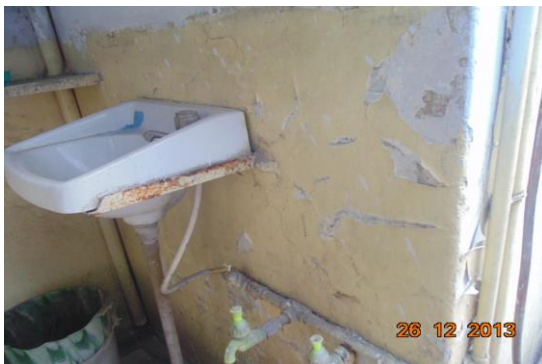
Photo 12
Peeling of Plaster on Wall No. 2 of Lobby of Third Floor

Summary of Defects Other Than Crack			
Defect ID	Location	Description	Photo No.
9	Wall No. 2 Lobby Third Floor	Peeling of Plaster	12
10	Wall No. 1 & 4 Kitchen Third Floor	Dampness/Seepage	13
11	Roof Kitchen Third Floor	Dampness/Seepage	14
12	Roof Kitchen Third Floor	Dampness/Seepage	15
13	Wall No. 1 & 3 Kitchen Third Floor	Dampness/Seepage	16
14	Wall No. 2 & 3 Kitchen Third Floor	Dampness/Seepage	17
15	Wall No. 4 Kitchen Third Floor	Dampness/Seepage	18
16	Roof Store Third Floor	Dampness/Seepage	19
17	Wall No. 3 & Roof Store Third Floor	Dampness/Seepage	20
18	Wall No. 4 & Roof Store Third Floor	Dampness/Seepage	21
19	Wall No. 2 & 3 Room No. 1 Third Floor	Dampness/Seepage	22
20	Wall No. 1 & 4 Room No. 1 Third Floor	Dampness/Seepage	23
21	Wall No. 3 Room No. 1 Third Floor	Dampness/Seepage	24
22	Wall No. 1 Staircase Area Third Floor	Peeling of Plaster	25
23	Wall No. 1 Staircase Area	Peeling of Plaster	26
24	Roof Balcony Second Floor	Dampness/Seepage	27

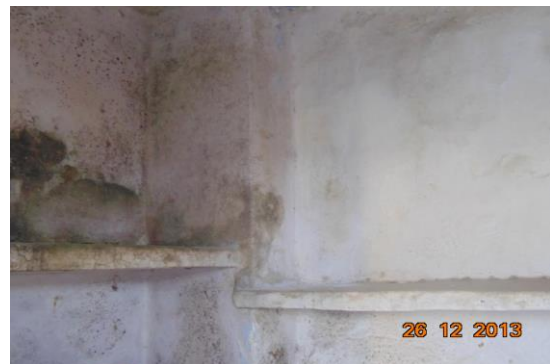
Photo 13
Dampness/Seepage on Wall No. 1 & 4 of Kitchen of Third Floor

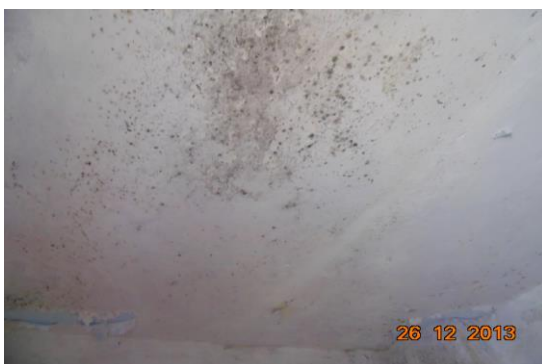
Photo 14
Dampness/Seepage on Roof of Kitchen of Third Floor

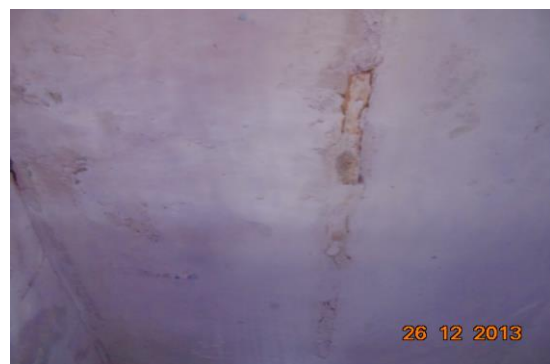
Photo 15
Dampness/Seepage on Roof of Kitchen of Third Floor

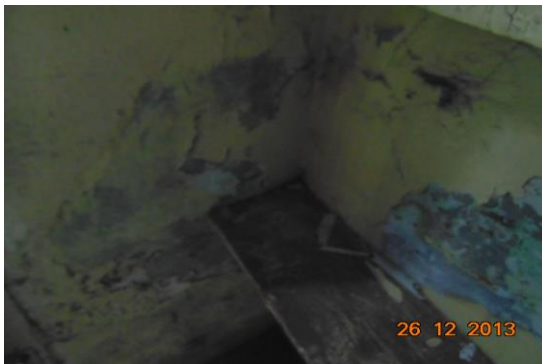
Photo 16

Dampness/Seepage on Wall No. 1 & 3 of Kitchen of Third Floor

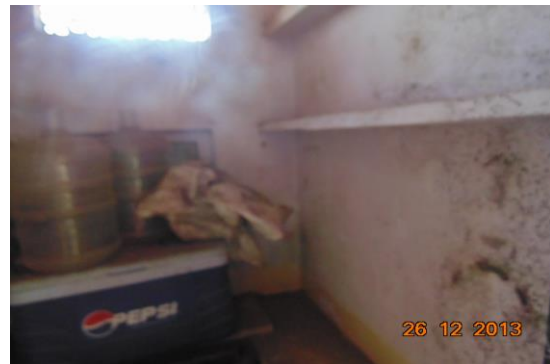
Photo 17

Dampness/Seepage on Wall No. 2 & 3 of Kitchen of Third Floor

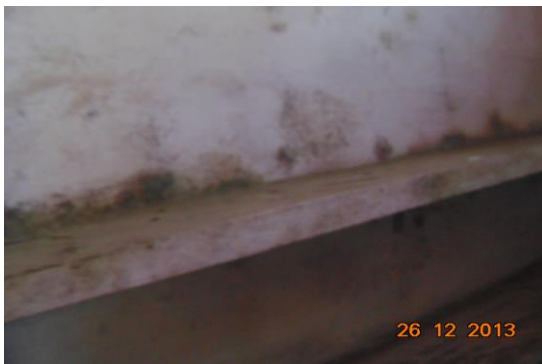
Photo 18

Dampness/Seepage on Wall No. 4 of Kitchen of Third Floor

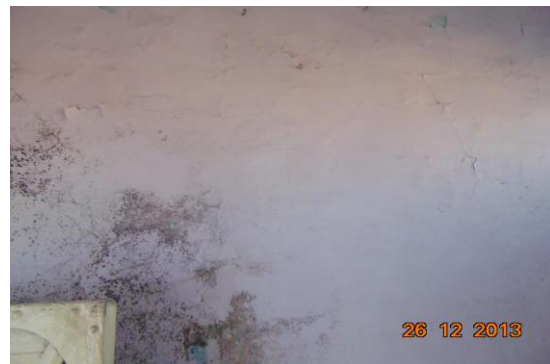
Photo 19

Dampness/Seepage on Roof of Store of Third Floor

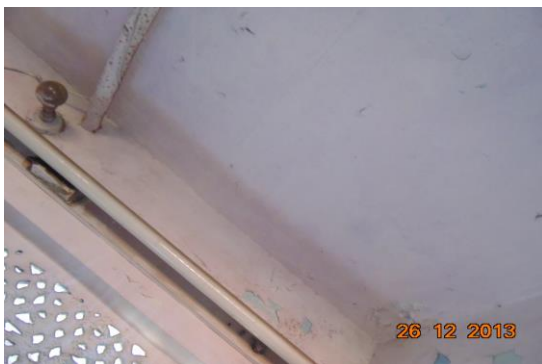
Photo 20

Dampness/Seepage on Wall No. 3 & Roof of Store of Third Floor

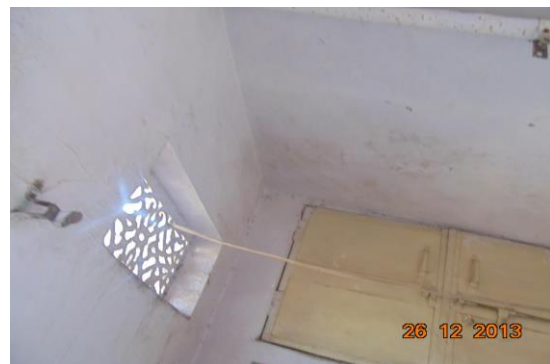
Photo 21

Dampness/Seepage on Wall No. 4 & Roof of Store of Third Floor

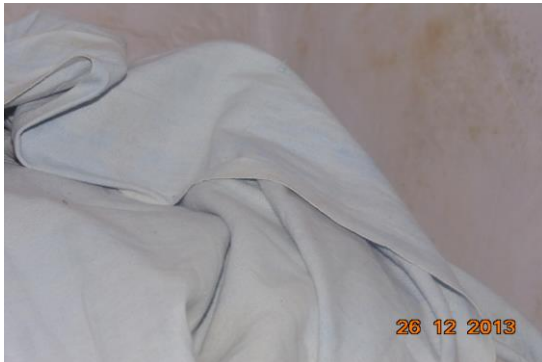
Photo 22

Dampness/Seepage on Wall No. 2 & 3 of Room No. 1 of Third Floor

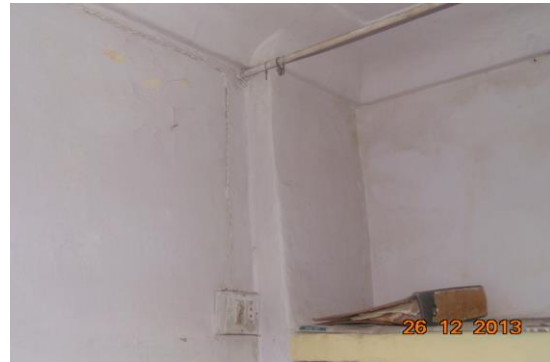
Photo 23

Dampness/Seepage on Wall No. 1 & 4 of Room No. 1 of Third Floor

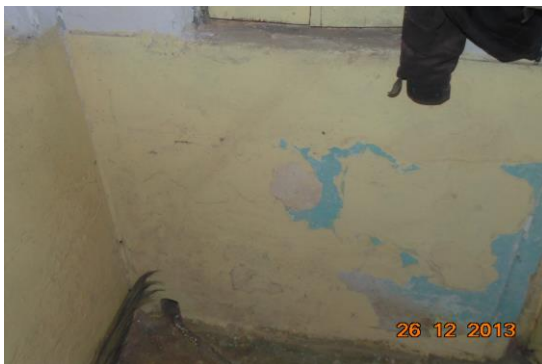
Photo 24

Dampness/Seepage on Wall No. 3 of Room No. 1 of Third Floor

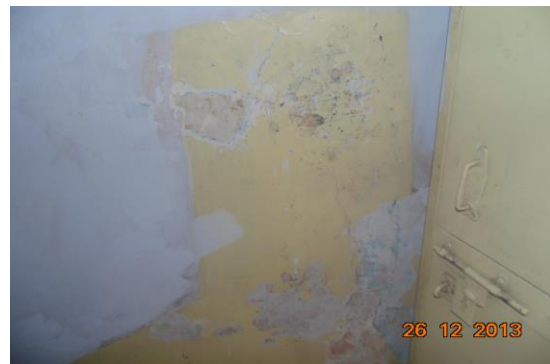
Photo 25

Peeling of Plaster on Wall No. 1 of Staircase Area of Third Floor

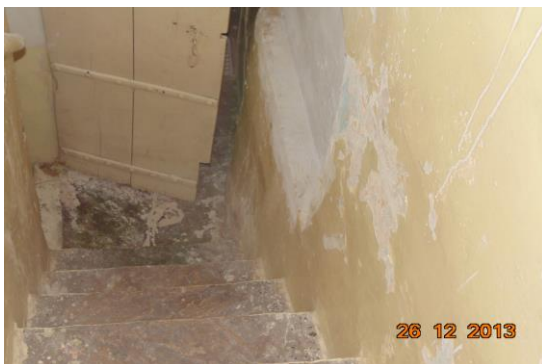
Photo 26

Peeling of Plaster on Wall No. 1 of Staircase Area

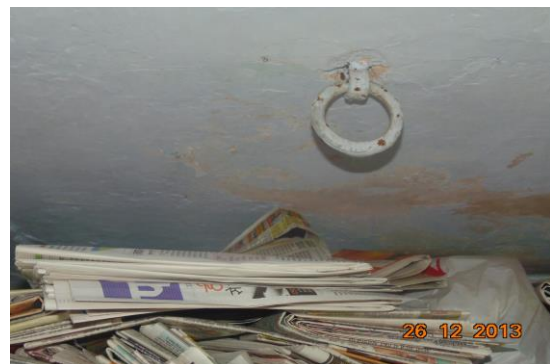
Photo 27

Dampness/Seepage on Roof of Balcony of Second Floor

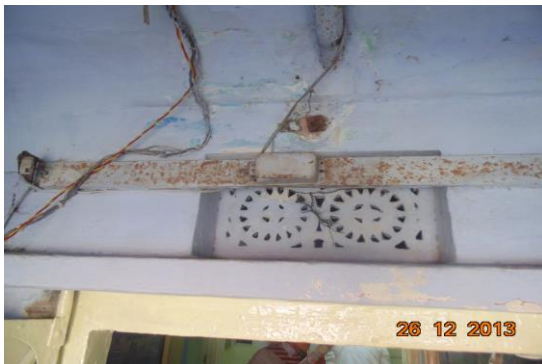
Photo 28

Dampness/Seepage on Wall No. 3 of Balcony of Second Floor

25	Wall No. 3 Balcony Second Floor	Dampness/Seepage	28
26	Wall No. 3 Balcony Second Floor	Dampness/Seepage	29
27	Wall No. 3 Balcony Second Floor	Dampness/Seepage	30
28	Wall No. 4 Lobby Second Floor	Peeling of Plaster	31
29	Wall No. 3 Lobby Second Floor	Peeling of Plaster	32
30	Wall No. 4 Bathroom Second Floor	Peeling of Plaster	33
31	Wall No. 1, 3 & 4 Staircase FF to SF	Peeling of Plaster	34
32	Outer wall Shade Second Floor	Damaged Portion	35
33	Outerwall Shade Third Floor	Damaged Portion	36
34	Beam & Left side External Column Varanda of Shop No. 35 Ground Floor	Peeling of Plaster	37
35	Roof Varanda of Shop No. 35 Ground Floor	Peeling of Plaster	38

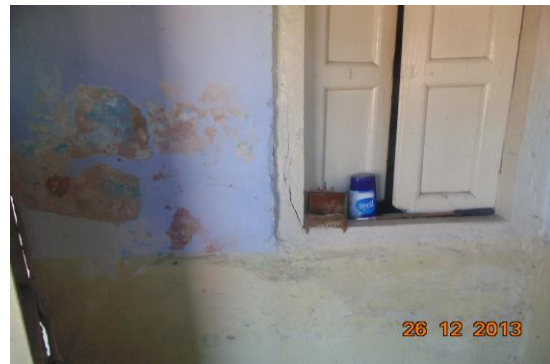
Photo 29

Dampness/Seepage on Wall No. 3 of Balcony of Second Floor

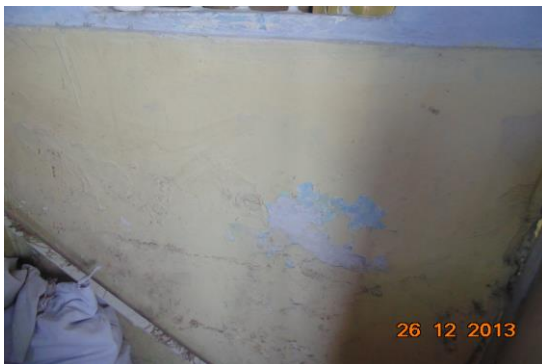
Photo 30

Dampness/Seepage on Wall No. 3 of Balcony of Second Floor

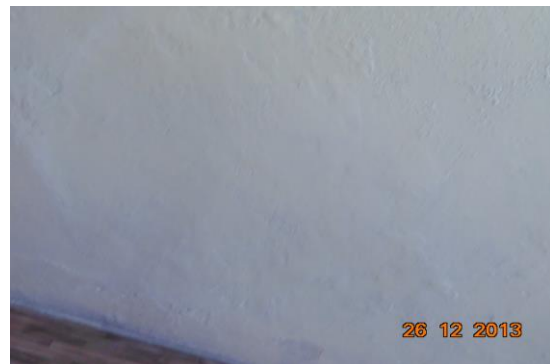
Photo 31

Peeling of Plaster on Wall No. 4 of Lobby of Second Floor

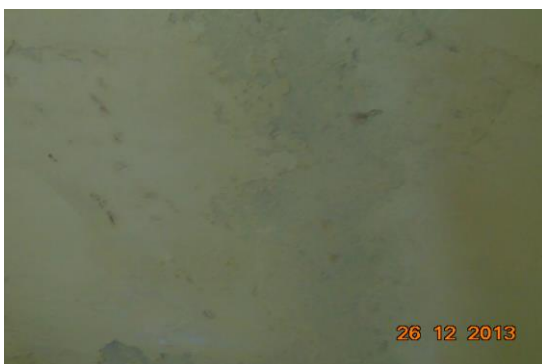
Photo 32

Peeling of Plaster on Wall No. 3 of Lobby of Second Floor

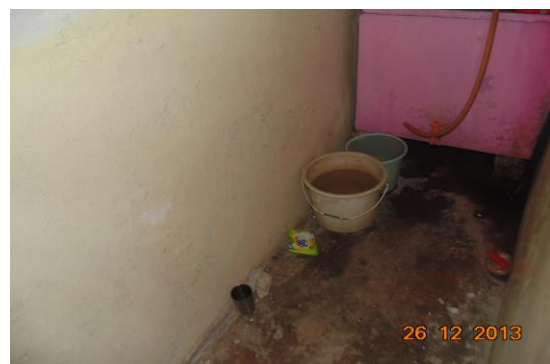
Photo 33

Peeling of Plaster on Wall No. 4 of Bathroom of Second Floor

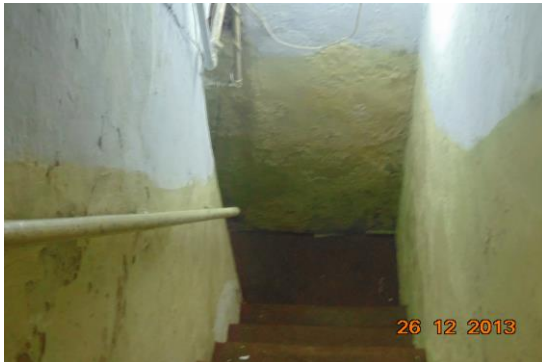
Photo 34

Peeling of Plaster on Wall No. 1, 3 & 4 of Staircase FF to SF

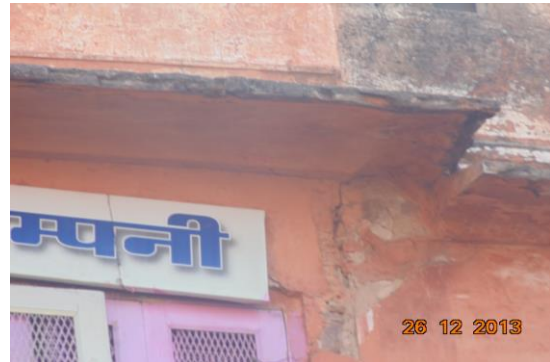
Photo 35

Damaged Portion on outer wall Shade of Second Floor

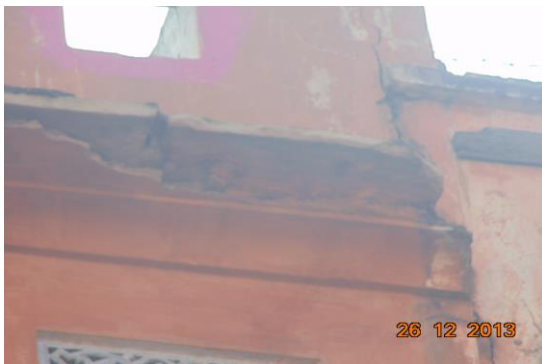
Photo 36

Damaged Portion on outerwall Shade of Third Floor

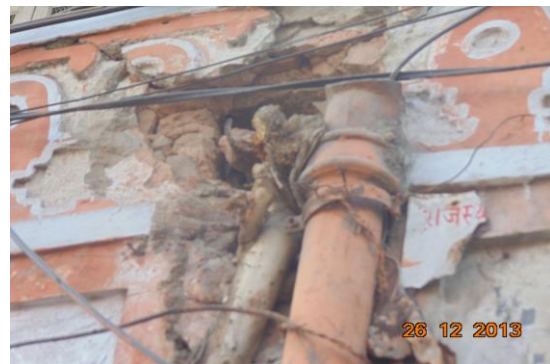
Photo 37

Peeling of Plaster on Beam & Left side External Column of Varanda of Shop No. 35 of Ground Floor

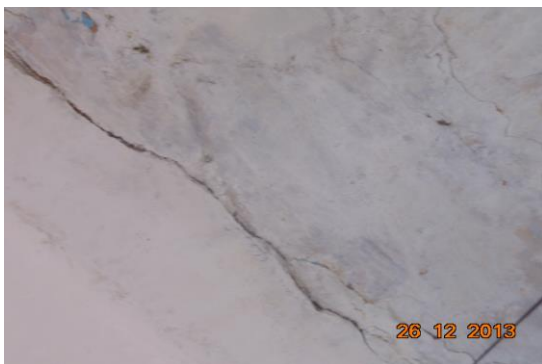
Photo 38

Peeling of Plaster on Roof of Varanda of Shop No. 35 of Ground Floor

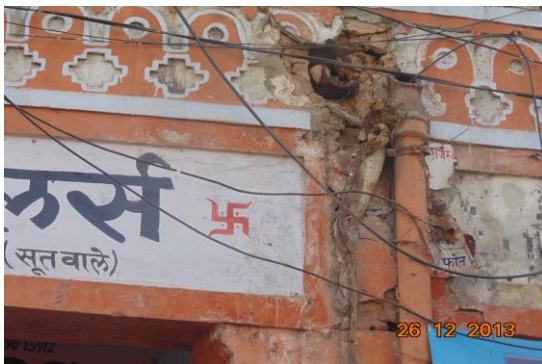
Photo 3

Damaged Portion on Right side External Column of Varanda of Shop No.36, Ground Floor

Summary of Defects Other Than Crack			
Defect ID	Location	Description	Photo No.
1	Right side External Column Varanda Shop No.36, Ground Floor	Damaged Portion	3
2	Right side External Column Varanda Shop No.36, Ground Floor	Damaged Portion	4
3	Roof Varanda Shop No.36, Ground Floor	Peeling of Plaster	5
4	Internal Beam Varanda Shop No.36, Ground Floor	Dampness/Seepage	6
5	Roof Varanda Shop No.36, Ground Floor	Peeling of Plaster	7

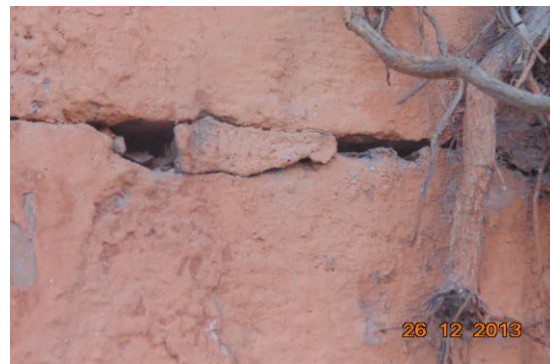
Photo 4

Damaged Portion on Right side External Column of Varanda of Shop No.36, Ground Floor

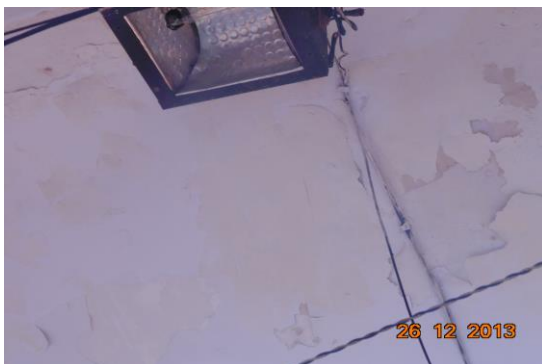
Photo 5

Peeling of Plaster on Roof of Varanda of Shop No.36, Ground Floor

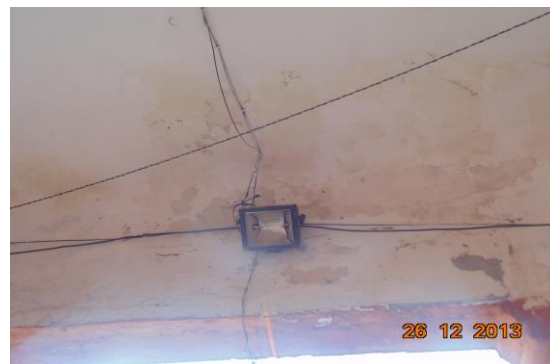
Photo 6

Dampness/Seepage on Internal Beam of Varanda of Shop No.36, Ground Floor

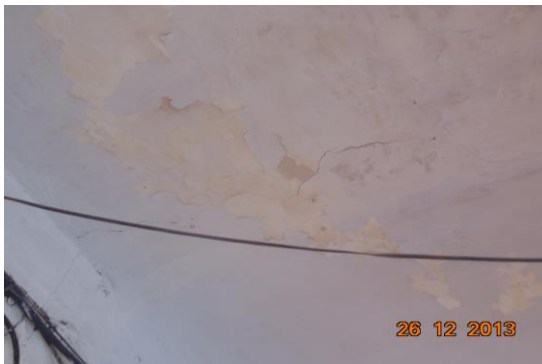
Photo 7

Peeling of Plaster on Roof of Varanda of Shop No.36, Ground Floor

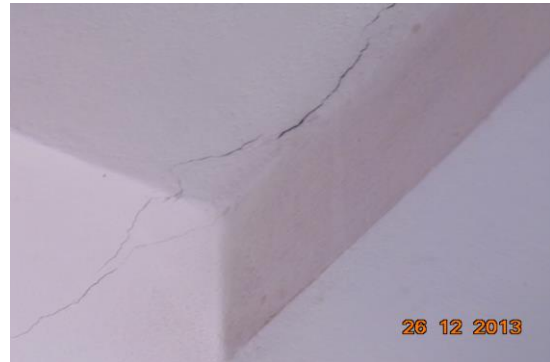
Photo 8
Inclined Crack on Wall No. 1 & Roof of Staircase, Second Floor
Approx. Width = 0.6mm, Approx. Length = 1m.
Distance from Wall no.2 = 1m, Height from Floor = 2.5m.

Summary of Cracks						
Defect ID	Location	Orientation	Appx. Width (mm)	Appx. Length (m)	Category	Photo No.
1	Wall No. 1 & Roof Staircase Second Floor	Inclined	0.6	1	Very Slight	8
2	Wall No. 4 Hall No. 1 Second Floor	Inclined	0.3	1	Very Slight	9
3	Wall No. 2 Hall No. 1 Second Floor	Inclined	0.3	1	Very Slight	10, 10A
4	Wall No. 1 & Roof Hall No. 1 Second Floor	Inclined	2	1	Slight	11, 11A
5	Roof Room No. 1 Third Floor	Inclined	2	1	Slight	12
6	Roof Bathroom Third Floor	Horizontal	1	0.5	Slight	13
7	Roof Bathroom Third Floor	Horizontal	1	0.5	Slight	14
8	Roof Bathroom Third Floor	Horizontal	0.8	0.5	Very Slight	15
9	Floor Staircase Third Floor	Inclined	1	1	Slight	16
10	Wall No. 1 Staircase SF to TF Second Floor	Inclined	1	1	Slight	17
11	Wall No. 2 Staircase FF to SF First Floor	Vertical	0.5	2	Very Slight	18
12	Wall No. 2 Staircase GF to FF Ground Floor	Inclined	0.3	2	Very Slight	19
13	Wall No. 1 Staircase GF to FF Ground Floor	Inclined	0.5	2	Very Slight	20

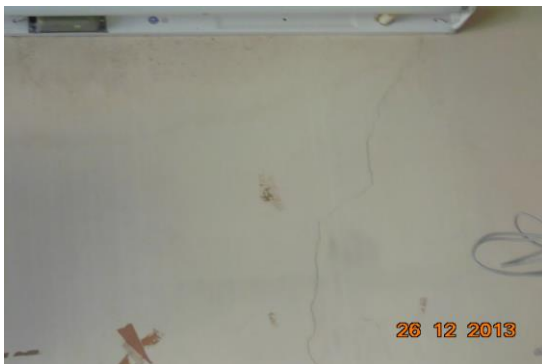
Photo 9
Inclined Crack on Wall No. 4 of Hall No. 1, Second Floor
Approx. Width = 0.3mm, Approx. Length = 1m.

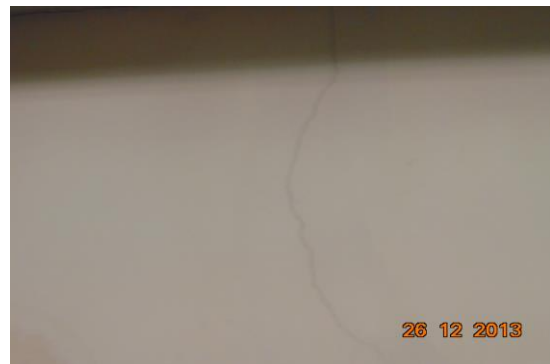
Photo 10
Inclined Crack on Wall No. 2 of Hall No. 1, Second Floor
Approx. Width = 0.3mm, Approx. Length = 1m.
