Pre Building Condition Survey Report

Name and Address of Structure :	Badi Chopar to Ramp Area (Down Line)
---------------------------------	--------------------------------------

Name of the Project	Contract JMRC-UG1B “Design and Construction of Tunnel between Chandpole and Badi Chouper and reverse line by Shield TBM, Underground Metro Stations at Choti Chouper and Badi Chouper by Cut and Cover Methods on East West Corridor of Jaipur Metro Rail Corporation Limited .”	
Owner :

Pre - Condition Building Survey for Construction of Underground Stations from Chandpole to Bari Chouper and reversal line

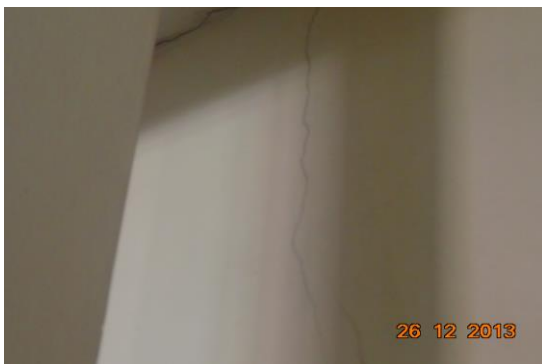
Photo 10A
Inclined Crack on Wall No. 2 of Hall No. 1, Second Floor
Approx. Width = 0.3mm, Approx. Length = 1m.

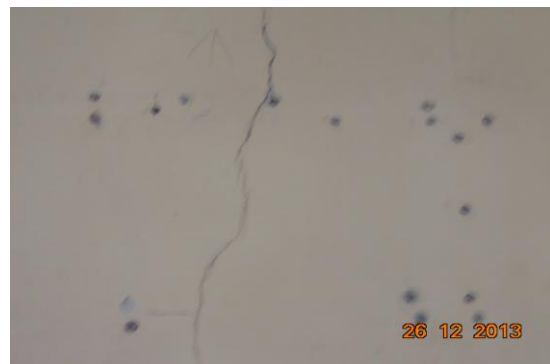
Photo 10A
Inclined Crack on Wall No. 2 of Hall No. 1, Second Floor
Approx. Width = 0.3mm, Approx. Length = 1m.

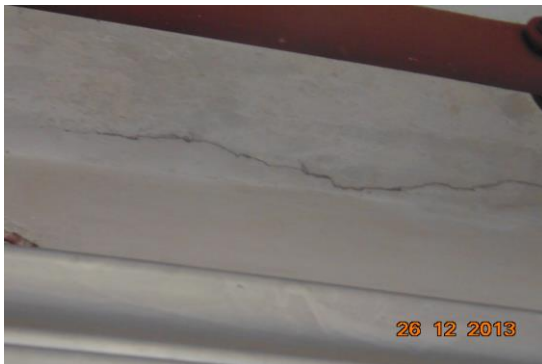
Photo 11

Inclined Crack on Wall No. 1 & Roof of Hall No. 1, Second Floor
Approx. Width = 2mm, Approx. Length = 1m.

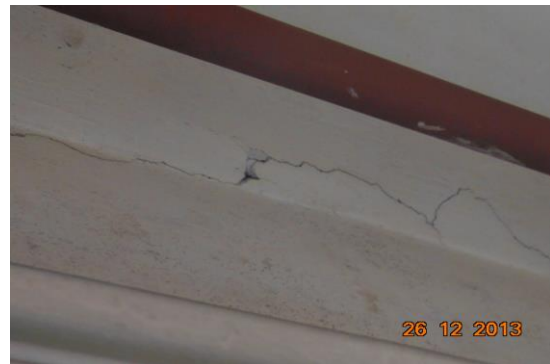
Photo 11A

Inclined Crack on Wall No. 1 & Roof of Hall No. 1, Second Floor
Approx. Width = 2mm, Approx. Length = 1m.

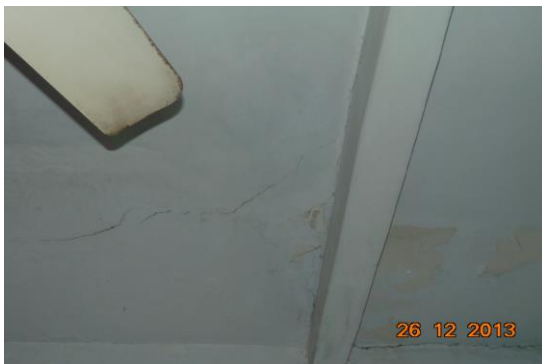
Photo 12

Inclined Crack on Roof of Room No. 1, Third Floor
Approx. Width = 2mm, Approx. Length = 1m.

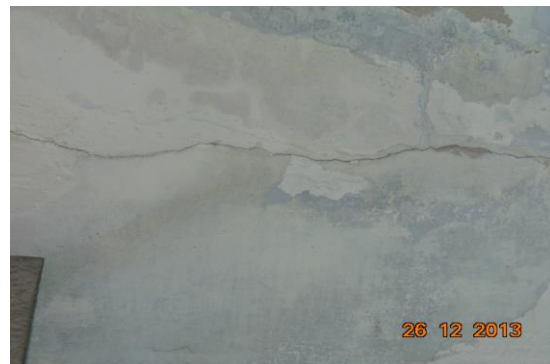
Photo 13

Horizontal Crack on Roof of Bathroom Third Floor
Approx. Width = 1mm, Approx. Length = 0.5m.
Distance from Wall no.3 = 0m, Height from Floor = 2.5m.

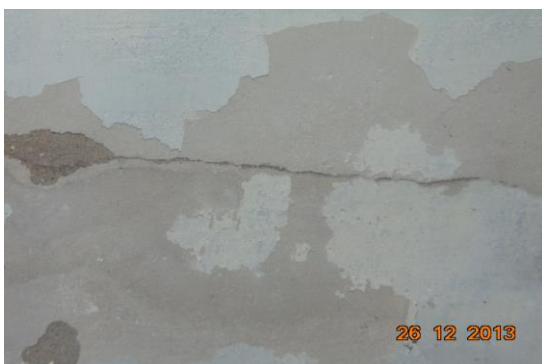
Photo 14

Horizontal Crack on Roof of Bathroom Third Floor
Approx. Width = 1mm, Approx. Length = 0.5m.
Distance from Wall no.4 = 0m, Height from Floor = 2.5m.

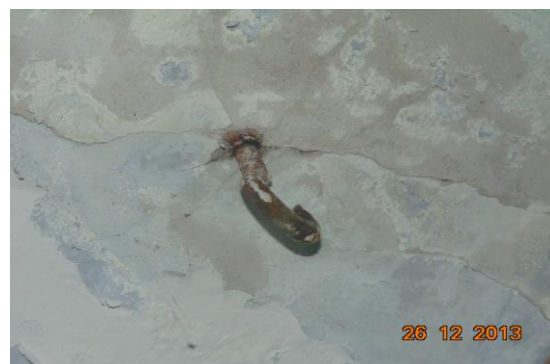
Photo 15

Horizontal Crack on Roof of Bathroom Third Floor
Approx. Width = 0.8mm, Approx. Length = 0.5m.
Distance from Wall No.4 = 0m, Height from Floor = 2.5m.

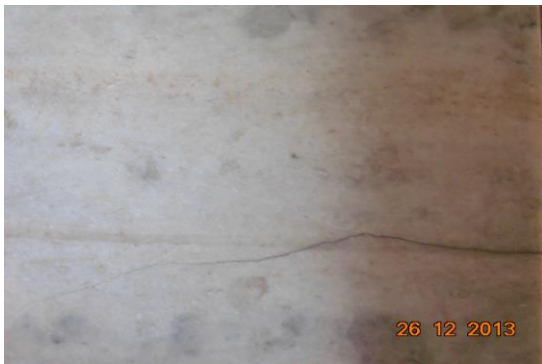
Photo 16
Inclined Crack on Floor of Staircase, Third Floor
Approx. Width = 1mm, Approx. Length = 1m.

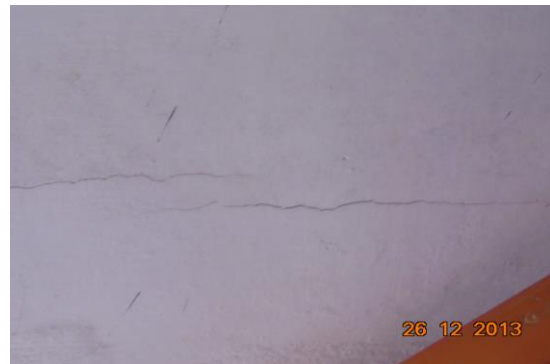
Photo 17
Inclined Crack on Wall No. 1 of Staircase SF to TF, Second Floor
Approx. Width = 1mm, Approx. Length = 1m.

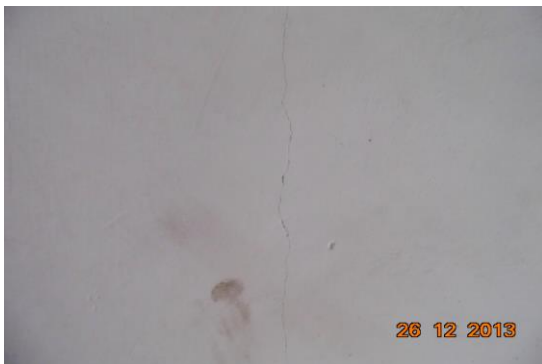
Photo 18
Vertical Crack on Wall No. 2 of Staircase FF to SF, First Floor
Approx. Width = 0.5mm, Approx. Length = 2m.

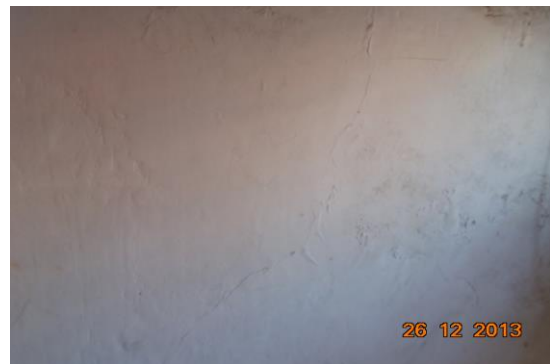
Photo 19
Inclined Crack on Wall No. 2 of Staircase GF to FF, Ground Floor
Approx. Width = 0.3mm, Approx. Length = 2m.

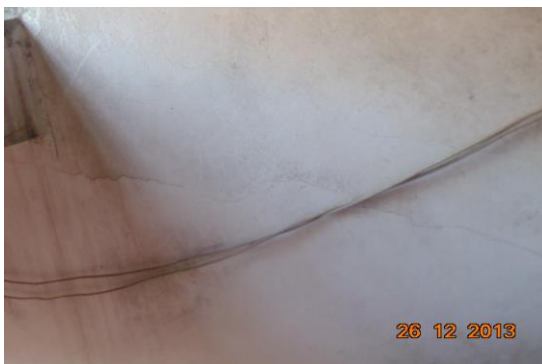
Photo 20
Inclined Crack on Wall No. 1 of Staircase GF to FF, Ground Floor
Approx. Width = 0.5mm, Approx. Length = 2m.

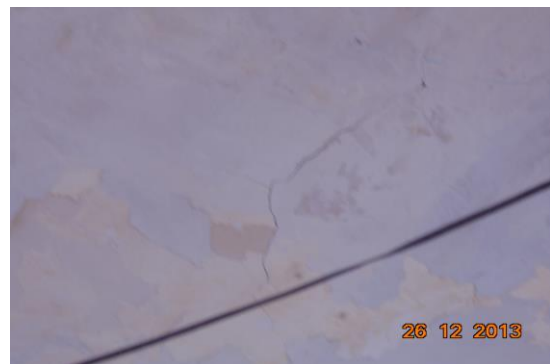
Photo 21
Inclined Crack on Roof of Varanda, Shop No. 37, Ground Floor
Approx. Width = 1mm, Approx. Length = 1m.

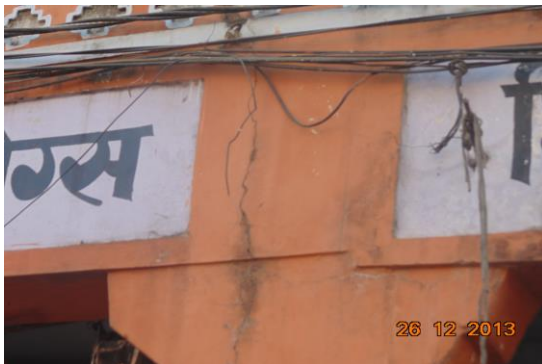
Photo 22

Inclined Crack on Left side External Column of Varanda, Shop No. 39, Ground Floor

Approx. Width = 1mm, Approx. Length = 2m.

Distance from Left side External Column = 0m. Height from Floor = 1m.

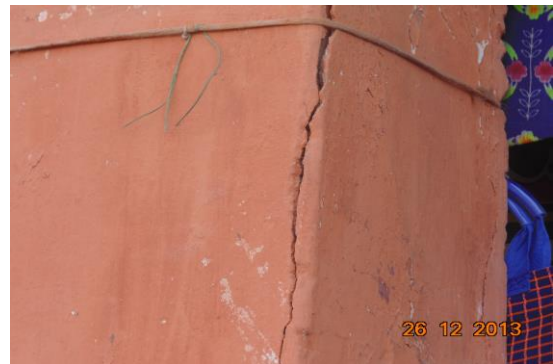
Photo 23

Vertical Crack on Left side External Column of Varanda, Shop No. 39, Ground Floor

Approx. Width = 5mm, Approx. Length = 1m.

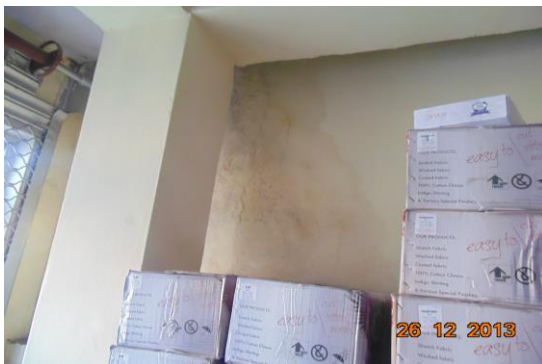
Photo 24

Dampness/Seepage on Wall No. 4 of Hall No. 1 of First Floor

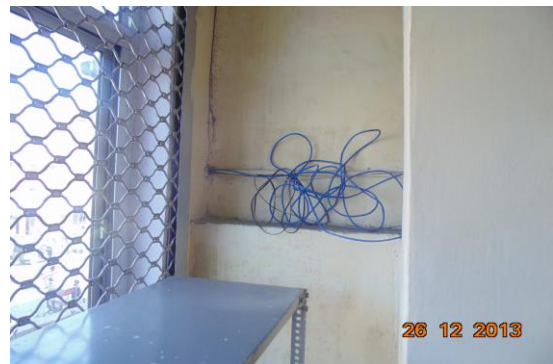
Photo 25

Dampness/Seepage on Wall No. 4 of Hall No. 1 of First Floor

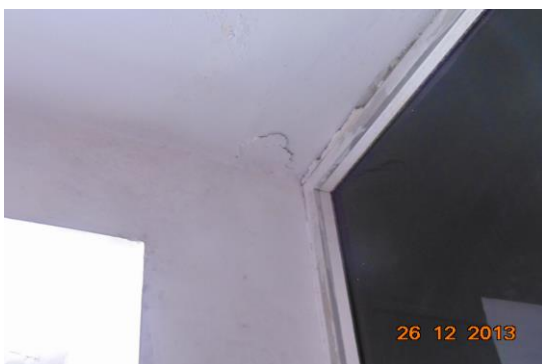
Photo 26

Dampness/Seepage on Roof & 4 of Lobby of Second Floor

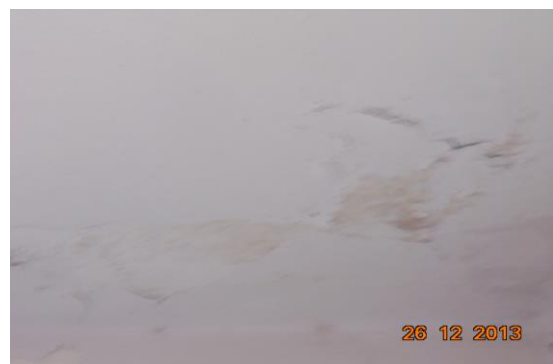
Photo 27

Dampness/Seepage on Roof of Staircase of Second Floor

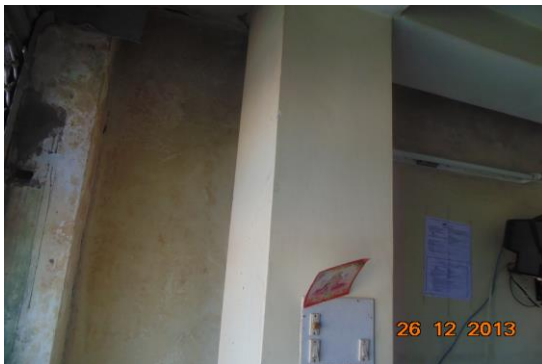
Photo 28

Dampness/Seepage on Wall No. 4 of Hall No. 1 of Second Floor

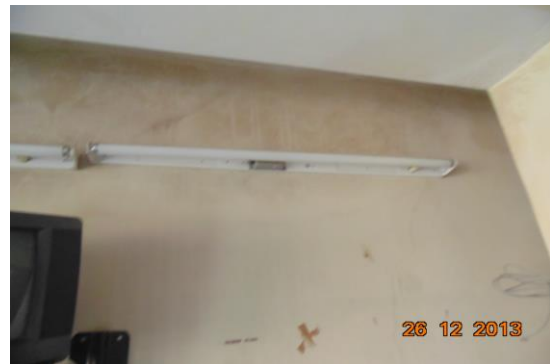
Photo 29

Dampness/Seepage on Wall No. 4 of Hall No. 1 of Second Floor

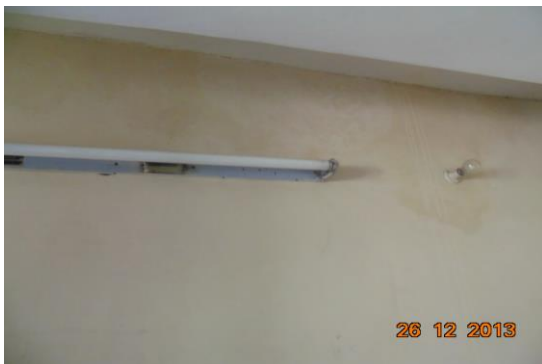
Photo 30

Dampness/Seepage on Wall No. 4 of Hall No. 1 of Second Floor

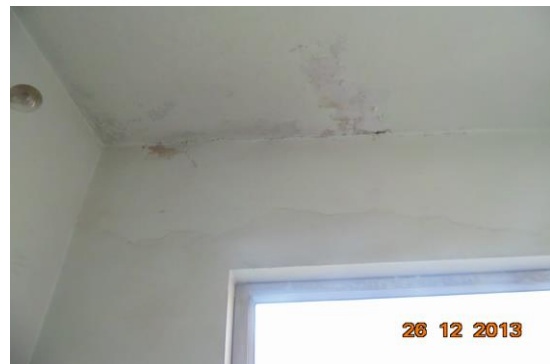
Photo 31

Dampness/Seepage on Wall No. 4 & Roof of Toilet No. 1 of Second Floor

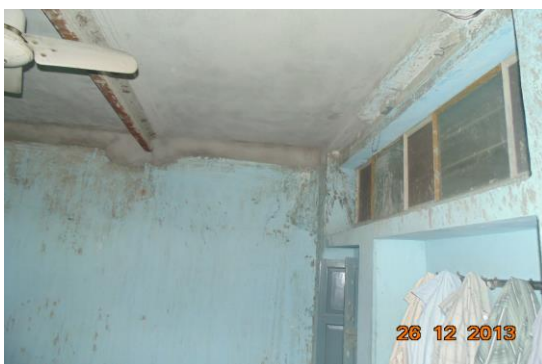
Photo 32

Dampness/Seepage on Wall No. 2 & 3 of Room No. 2 of Third Floor

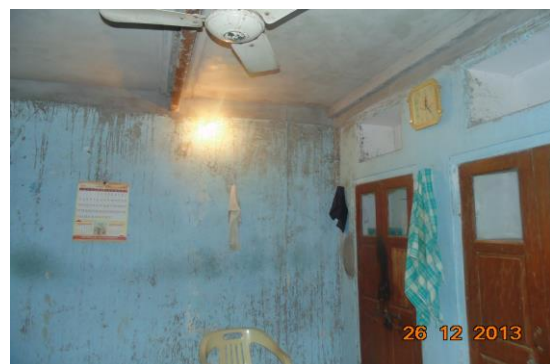
Photo 33

Dampness/Seepage on Wall No. 1 & 4 of Room No. 2 of Third Floor

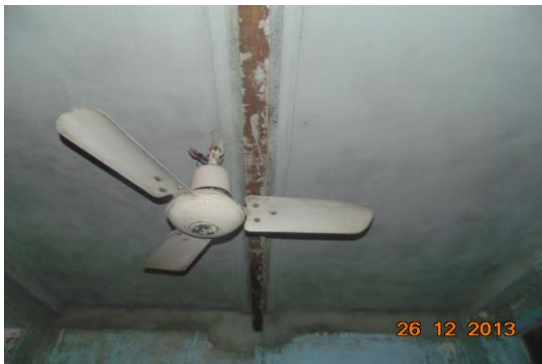
Photo 34
Peeling of Plaster on Roof of Room No. 2 of Third Floor

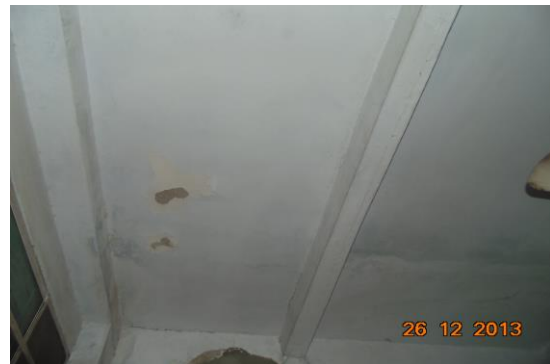
Photo 35
Peeling of Plaster on Roof of Room No. 1 of Third Floor

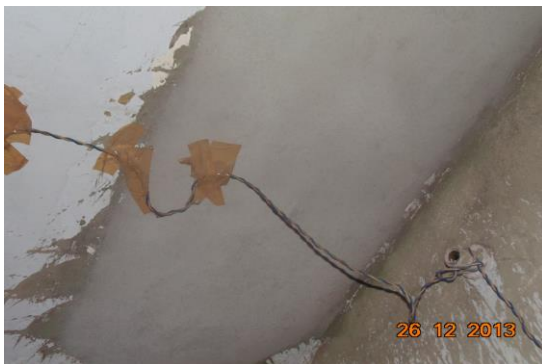
Photo 36
Peeling of Plaster on Roof of Room No. 1 of Third Floor

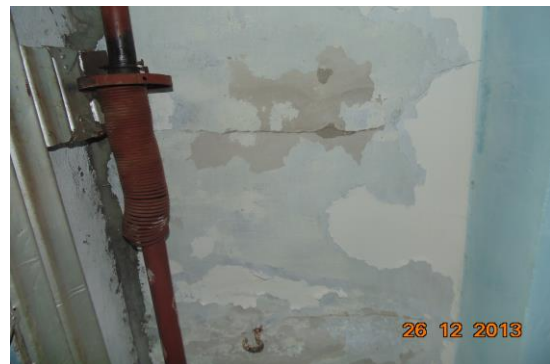
Photo 37
Dampness/Seepage on Roof of Bathroom of Third Floor

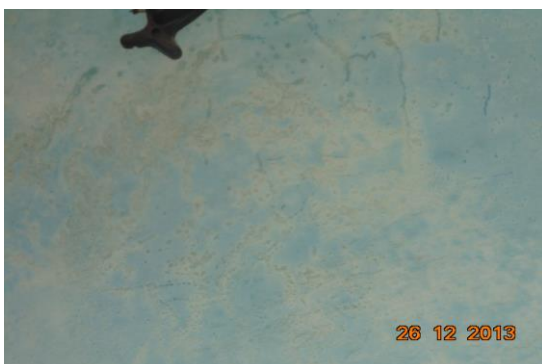
Photo 38
Dampness/Seepage on Wall No. 2 of Bathroom of Third Floor

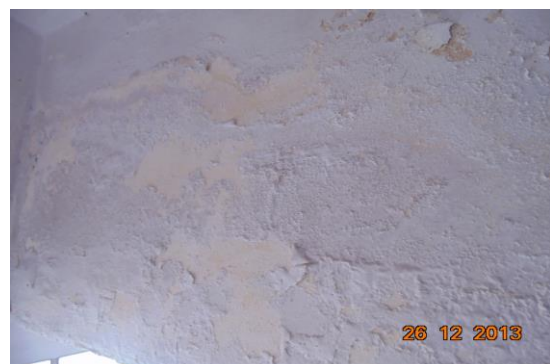
Photo 39
Dampness/Seepage on Wall No. 1 of Staircase SF to TF of Second Floor

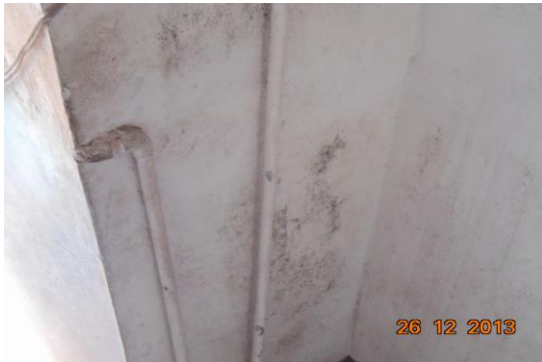
Photo 40

Dampness/Seepage on Wall No. 1 of Staircase GF to FF of Ground Floor

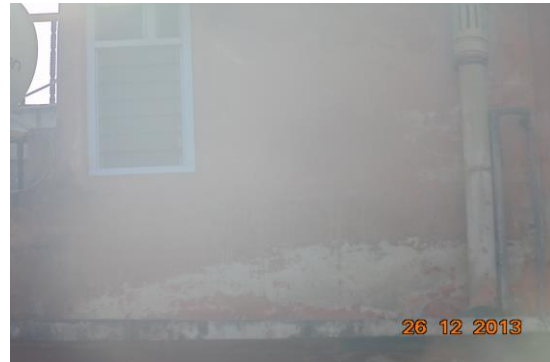
Photo 41

Dampness/Seepage on Front side Wall of Building of Second Floor

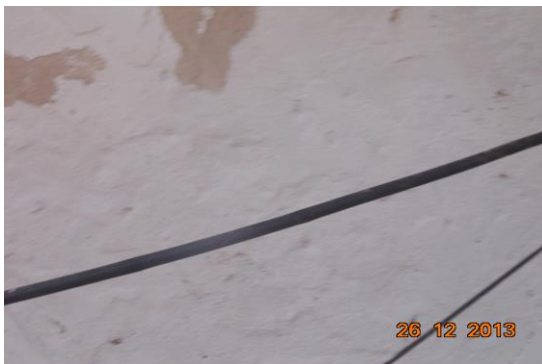
Photo 42

Dampness/Seepage on Roof of Varanda of Shop No. 37, Ground Floor

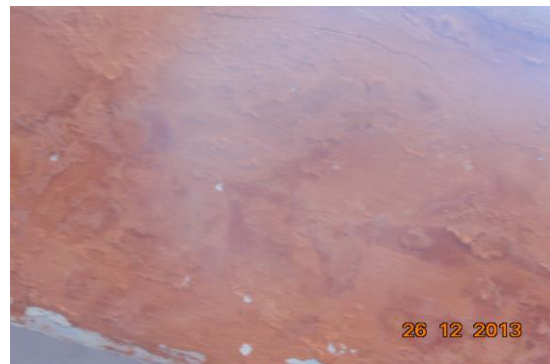
Photo 43

Peeling of Plaster on Beam of Varanda of Shop No. 39, Ground Floor

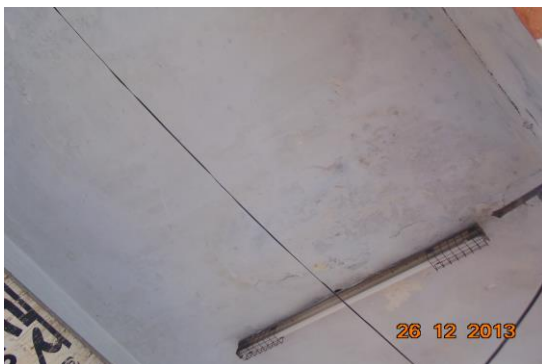
Photo 44

Dampness/Seepage on Roof of Varanda of Shop No. 39, Ground Floor

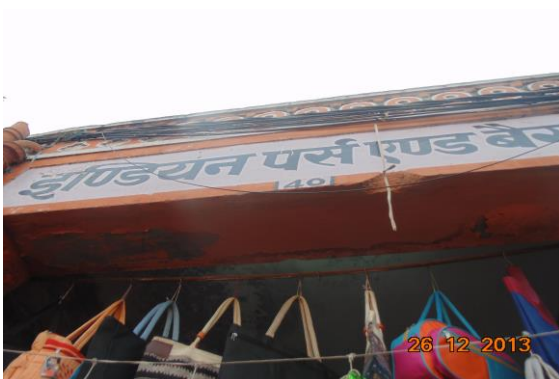
Photo 5
Horizontal Crack on Beam of Varanda, Shop No.40, Ground Floor,
Approx. Width = 10mm, Approx. Length = 2m.
Distance from = m, Height from Floor = m.

Summary of Cracks						
Defect ID	Location	Orientation	Appx. Width (mm)	Appx. Length (m)	Category	Photo No.
1	Beam Varanda Shop No.40, Ground Floor	Horizontal	10	2	Moderate	5
2	Roof Varanda Shop No.40, Ground Floor	Horizontal	1	2.5	Slight	6
3	Roof Varanda Shop No.40, Ground Floor	Inclined	0.3	2	Very Slight	7

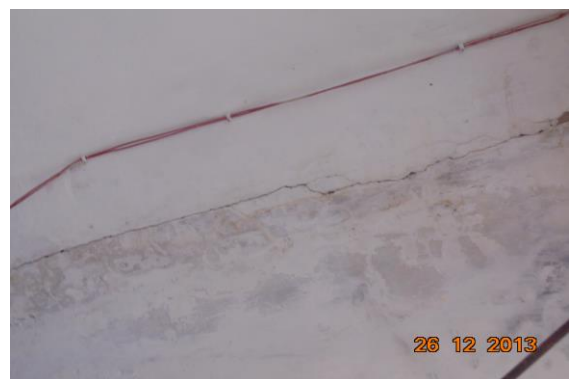
Photo 6
Horizontal Crack on Roof of Varanda, Shop No. 40, Ground Floor,
Approx. Width = 1mm, Approx. Length = 2.5m.
Distance from = m, Height from Floor = m.

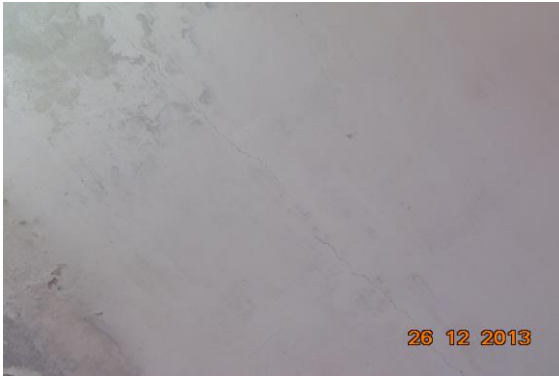
Photo 7

Inclined Crack on Roof of Varanda, Shop No. 40, Ground Floor, Approx.
Width = 0.3mm, Approx. Length = 2m.
Distance from = m, Height from Floor = m.

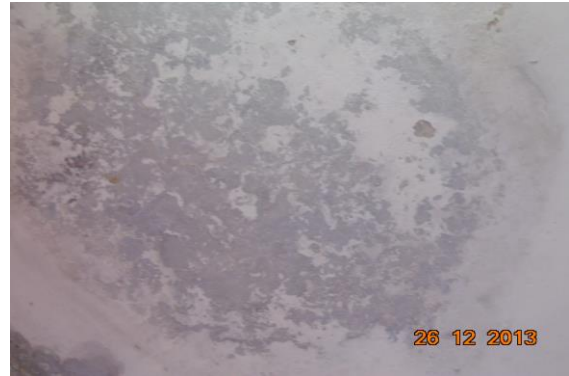
Photo 8

Dampness/Seepage on Roof of Varanda of Shop No.40, Ground Floor

Summary of Defects Other Than Crack			
Defect ID	Location	Description	Photo No.
4	Roof Varanda Shop No.40, Ground Floor	Dampness/Seepage	8
5	Roof Shop No.40 Ground Floor	Peeling of Plaster	9
6	Wall No. 4 & Roof Room No. 1 First Floor	Dampness/Seepage	10
7	Wall No. 2 Room No. 2 First Floor	Peeling of Plaster	11
8	Roof Room No. 1 Second Floor	Peeling of Plaster	12
9	Roof Varanda Second Floor	Dampness/Seepage	13
10	Roof Varanda Second Floor	Dampness/Seepage	14
11	Wall No. 1 Second Floor	Dampness/Seepage	15
12	Wall No. 4 Second Floor	Peeling of Plaster	16
13	Wall No. 2 & 4 Room No. 2 Second Floor	Peeling of Plaster	17
14	Wall No. 1, 2 & Roof Stair SF to TF Second Floor	Peeling of Plaster	18
15	Roof Second Floor	Dampness/Seepage	19
16	Room No. 1 Third Floor	Damaged Portion	20
17	Wall No. 1, 2 & Roof Bathroom No. 1 Third Floor	Dampness/Seepage	21
18	Wall No. 1, 4, 2 & Roof Toilet No. 1 Third Floor	Dampness/Seepage	22

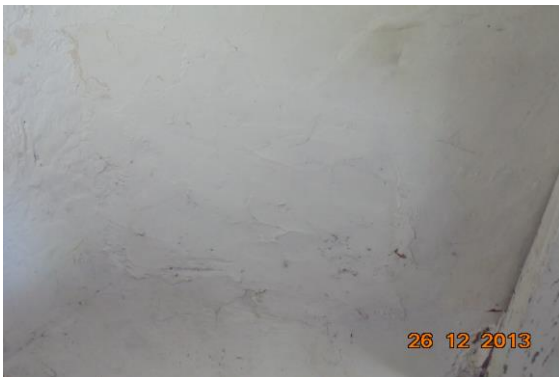
Photo 9

Peeling of Plaster on Roof of Shop No.40 of Ground Floor

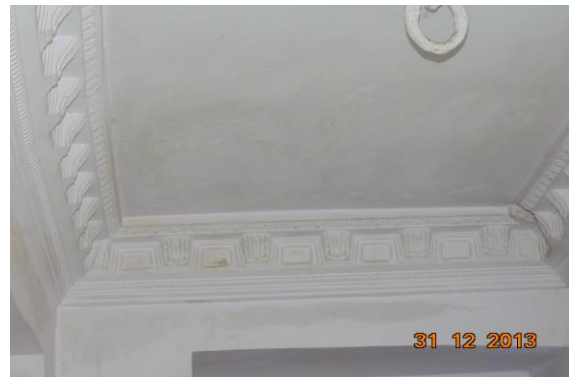
Photo 10

Dampness/Seepage on Wall No. 4 & Roof of Room No. 1 of First Floor

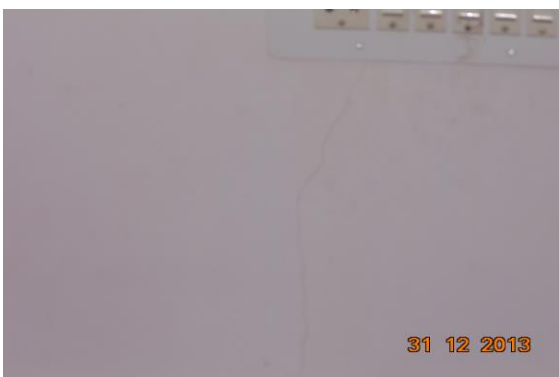
Photo 11

Peeling of Plaster on Wall No. 2 of Room No. 2 of First Floor

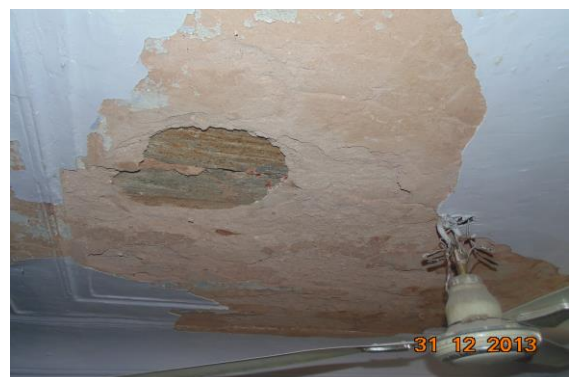
Photo 12

Peeling of Plaster on Roof of Room No. 1 of Second Floor

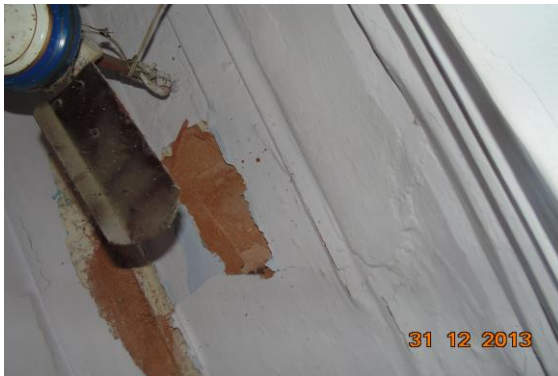
Photo 13
Dampness/Seepage on Roof of Varanda of Second Floor

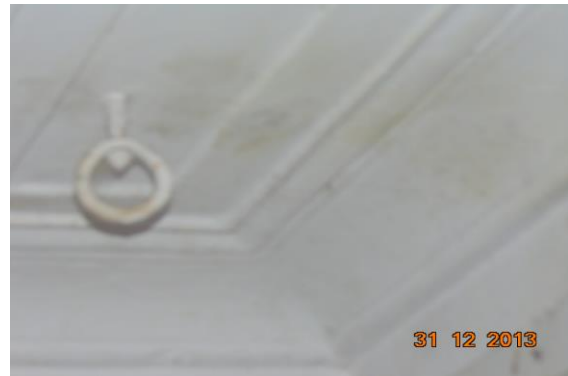
Photo 14
Dampness/Seepage on Roof of Varanda of Second Floor

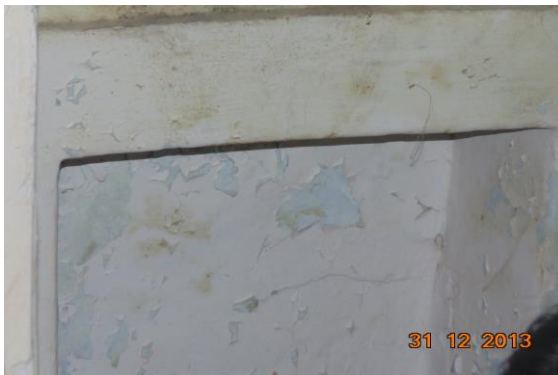
Photo 15
Dampness/Seepage on Wall No. 1 of Second Floor

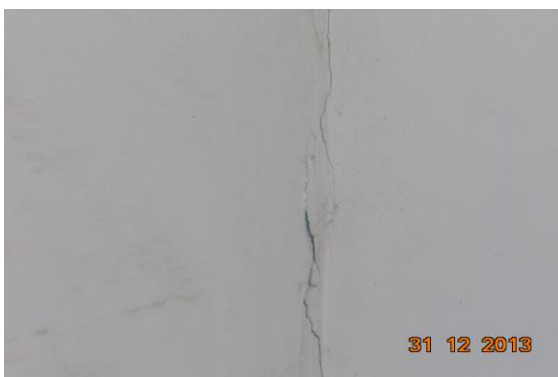
Photo 17
Peeling of Plaster on Wall No. 2 & 4 of Room No. 2 of Second Floor

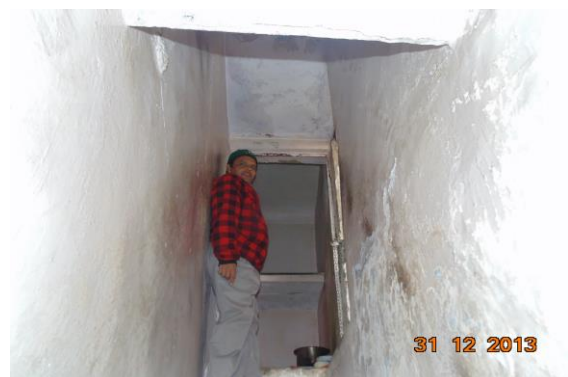
Photo 18
Peeling of Plaster on Wall No. 1, 2 & Roof of Stair SF to TF of Second Floor

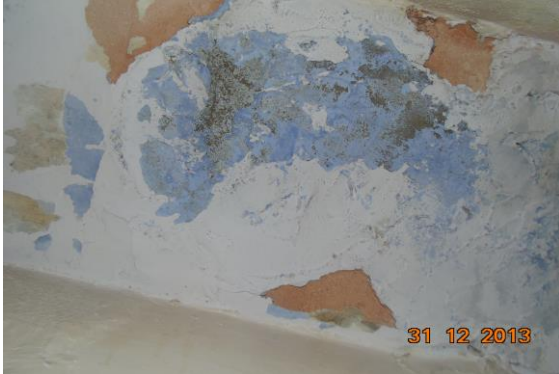
Photo 19
Dampness/Seepage on Roof of Second Floor

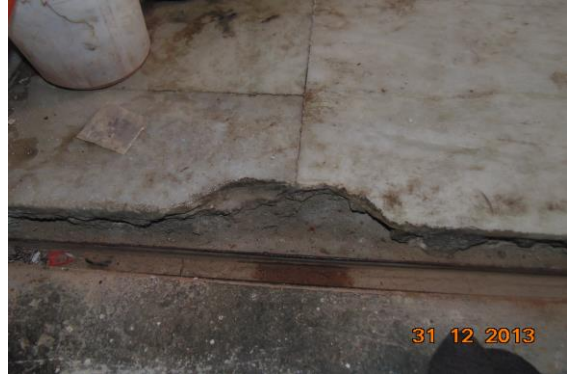
Photo 20
Damaged Portion on Room No. 1 of Third Floor

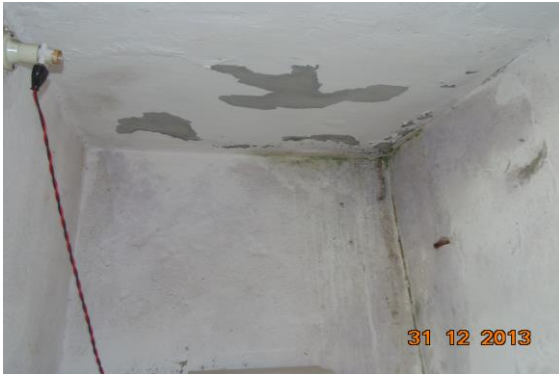
Photo 21
Dampness/Seepage on Wall No. 1, 2 & Roof of Bathroom No. 1 Third Floor

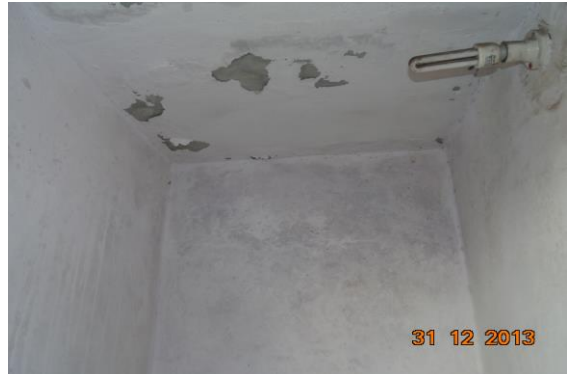
Photo 22
Dampness/Seepage on Wall No. 1, 4, 2 & Roof of Toilet No. 1 of Third Floor

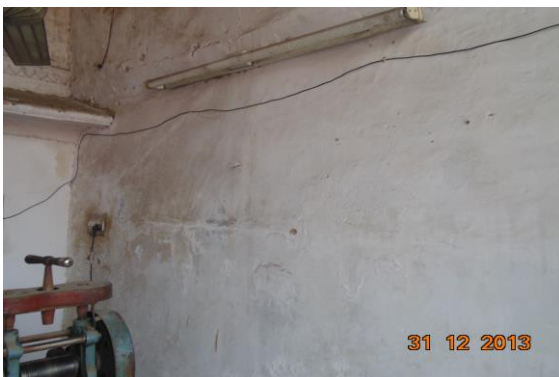
Photo 23
Dampness/Seepage on Wall No. 4 of Room No. 1 of Third Floor

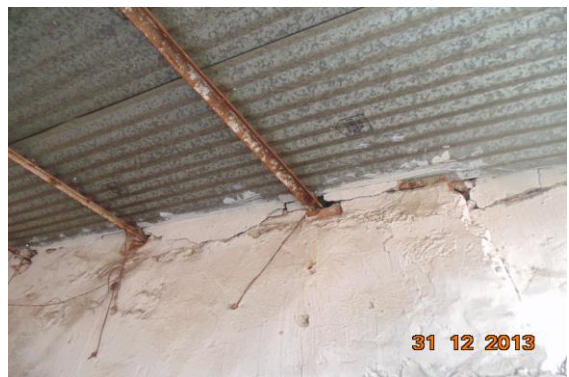
Photo 24
Peeling of Plaster on Room No. 1 of Third Floor

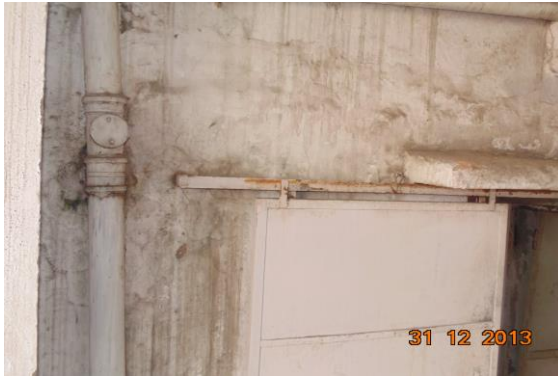
Photo 25
Dampness/Seepage on Wall No. 3 of Room No. 1 of Third Floor

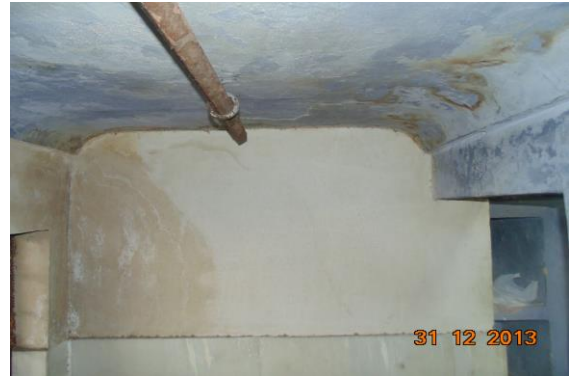
Photo 26
Dampness/Seepage on Wall No. 1, 3, 4 & Roof of Room No. 2 of Third Floor

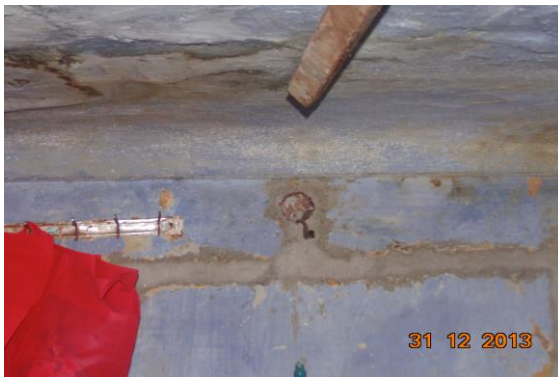
Photo 27
Dampness/Seepage on Wall No. 2 & Roof of Room No. 2 of Third Floor

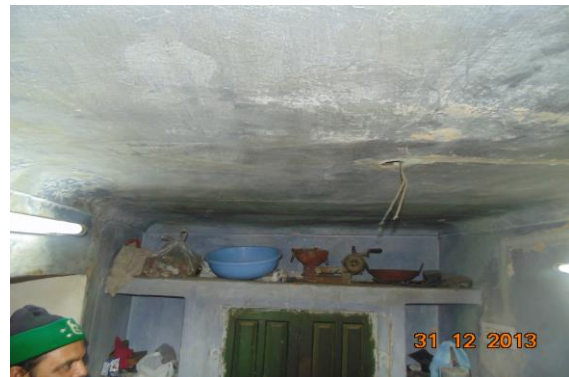
Photo 28
Dampness/Seepage on Wall No. 1, 4 & Roof of Room No. 2 of Third Floor

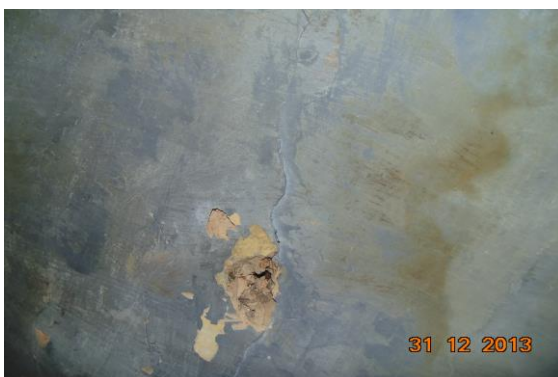
Photo 29
Peeling of Plaster on Roof of Room No. 2 of Third Floor

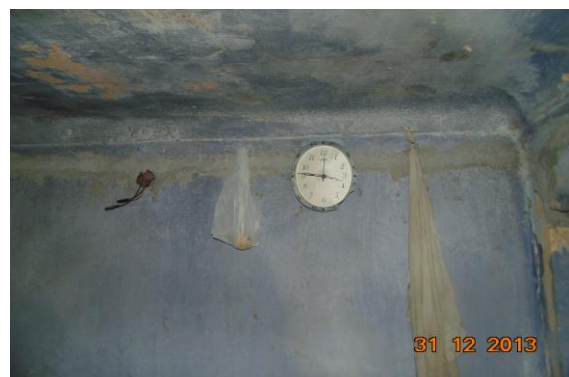
Photo 30
Peeling of Plaster on Wall No. 2 of Room No. 2 of Third Floor

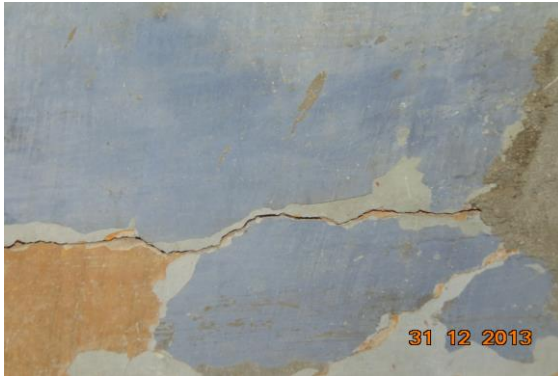
Photo 31
Peeling of Plaster on Wall No. 2 of Room No. 1 of Third Floor

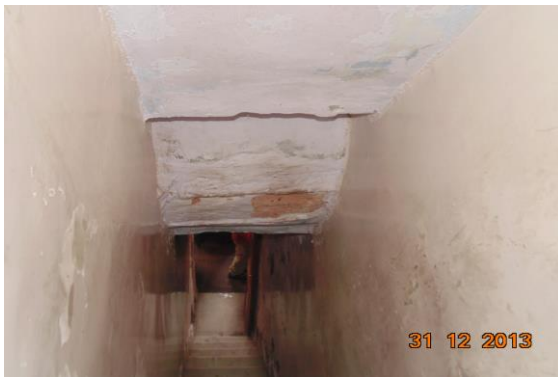
Photo 33
Dampness/Seepage on Wall No. 1, 2 & Roof of Stair GF to FF of Third Floor

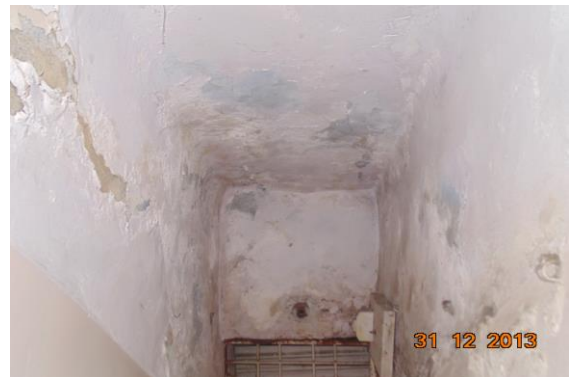
Photo 34
Dampness/Seepage on Wall No. 1, 2 & Roof of Stair GF to FF of Third Floor

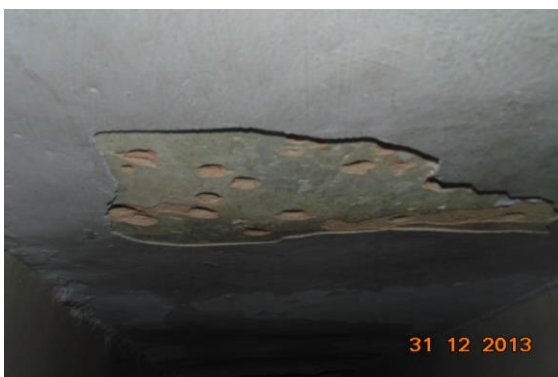
Photo 35
Peeling of Plaster on Roof of Third Floor

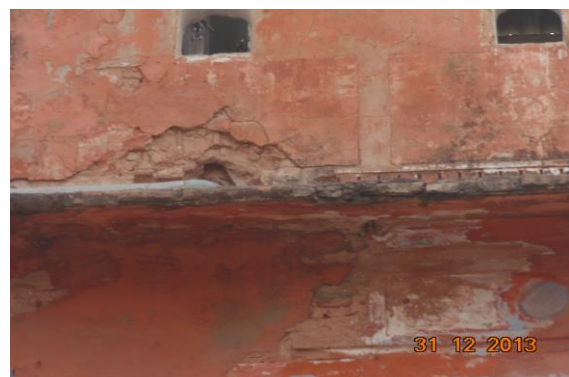
Photo 36
Damaged Portion on Outer Wall of SF External Hazard

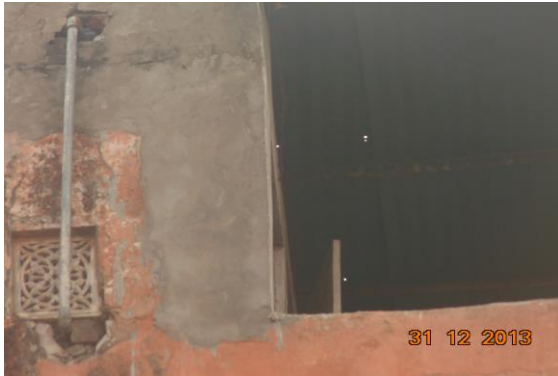
Photo 37
Peeling of Plaster on Outer Wall of Third Floor

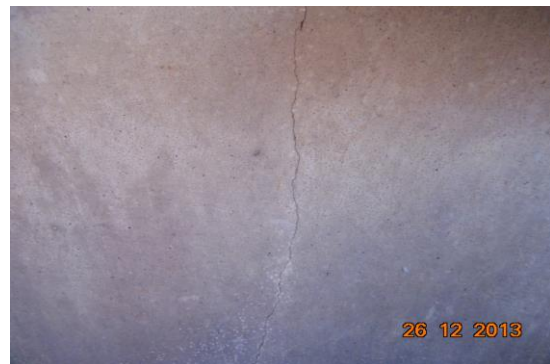
Photo 4
Inclined Crack on Wall No. 4 of Lobby, First Floor
Approx. Width = 0.25mm, Approx. Length = 0.7m.
Distance from Wall No.1 = 1.5m, Height from Floor = 0.05m.

Summary of Cracks						
Defect ID	Location	Orientation	Appx. Width (mm)	Appx. Length (m)	Category	Photo No.
1	Wall No. 4 Lobby First Floor	Inclined	0.25	0.7	Very Slight	4, 4A
2	Wall No. 4 Lobby Second Floor	Inclined	0.35	1	Very Slight	5, 5A
3	Wall No. 4 Open Sky External Façade	Inclined	4	2	Slight	6
4	Shade Open Sky External Façade	Horizontal	5	1	Moderate	7
5	Beam Left Side Shop No.41 Ground Floor	Inclined	0.9	1	Very Slight	8
6	Beam Rightside Shop No.41 Ground Floor	Inclined	1	2	Slight	9
7	Roof Varanda Shop No.41, Ground Floor	Inclined	5	2	Moderate	10

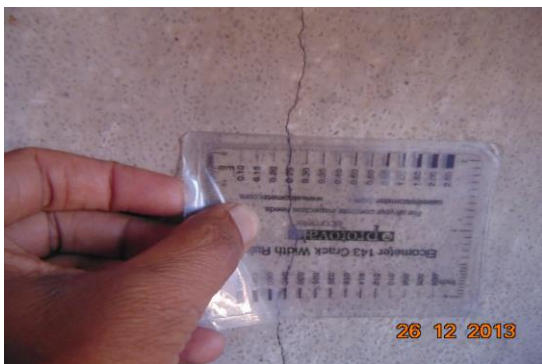
Photo 4A
Inclined Crack on Wall No. 4 of Lobby, First Floor
Approx. Width = 0.25mm, Approx. Length = 0.7m.
Distance from Wall No.1 = 1.5m, Height from Floor = 0.05m.

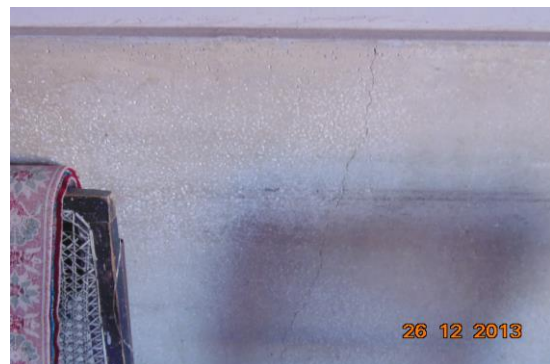
Photo 5
Inclined Crack on Wall No. 4 of Lobby, Second Floor
Approx. Width = 0.35mm, Approx. Length = 1m.
Distance from Wall No.1 = 1.5m, Height from Floor = 0m.

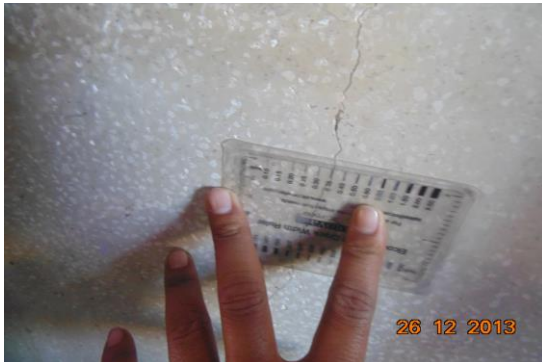
Photo 5A

Inclined Crack on Wall No. 4 of Lobby, Second Floor
Approx. Width = 0.35mm, Approx. Length = 1m.
Distance from Wall No.1 = 1.5m, Height from Floor = 0m.

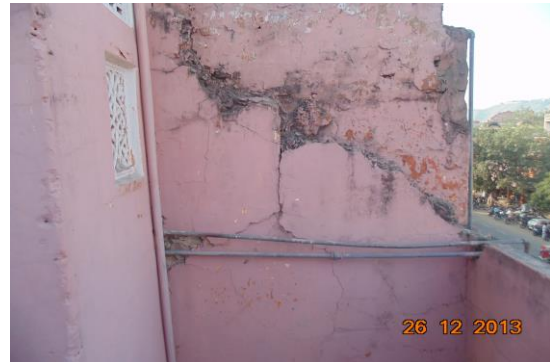
Photo 6

Inclined Crack on Wall No. 4 of Open Sky, External Façade
Approx. Width = 4mm, Approx. Length = 2m.

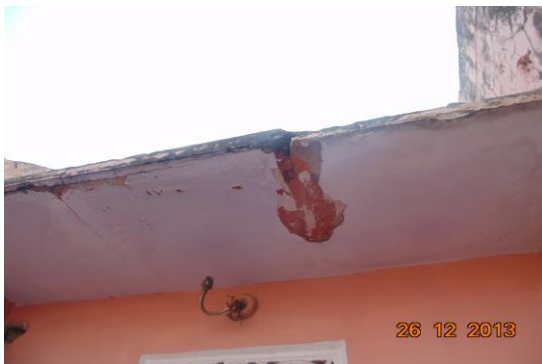
Photo 7

Horizontal Crack on Shade of Open Sky, External Façade
Approx. Width = 5mm, Approx. Length = 1m.

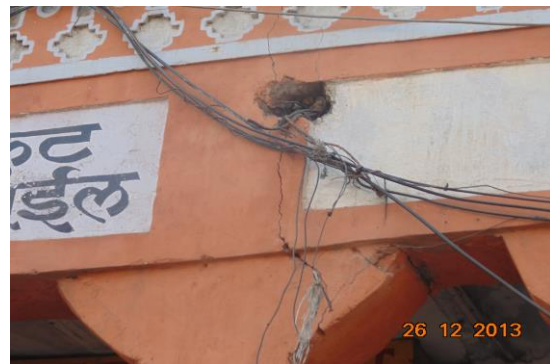
Photo 8

Inclined Crack on Beam Left Side of Shop No.41, Ground Floor
Approx. Width = 0.9mm, Approx. Length = 1m.
Distance from = Leftside external Columnn, Height from Floor = 3m.

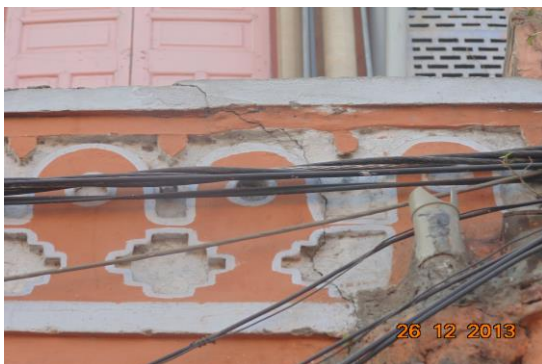
Photo 9

Inclined Crack on Beam Rightside of Shop No.41, Ground Floor
Approx. Width = 1mm, Approx. Length = 2m.
Distance from = Rightside External Columnn, Height from Floor = 3m.

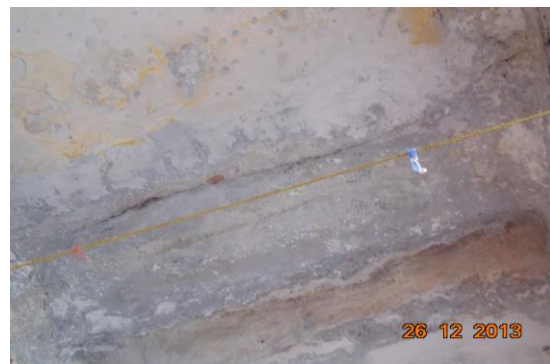
Photo 10

Inclined Crack on Roof of Varanda, Shop No.41, Ground Floor
Approx. Width = 5mm, Approx. Length = 2m

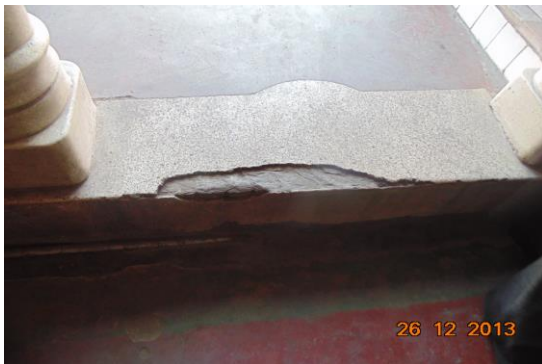
Photo 11
Damaged Portion on Floor of Varanda of First Floor

Summary of Defects Other Than Crack			
Defect ID	Location	Description	Photo No.
8	Floor Varanda First Floor	Damaged Portion	11
9	Roof Varanda First Floor	Peeling of Plaster	12
10	Wall No. 4 Lobby First Floor	Peeling of Plaster	13
11	Roof Lobby Second Floor	Peeling of Plaster	14
12	Wall No. 2 & 3 Lobby Second Floor	Peeling of Plaster	15
13	Steps Staircase SF to TF Second Floor	Damaged Portion	16
14	Wall No. 3 Open Sky External Façade	Damaged Portion	17
15	Wall No. 3 Open Sky External Façade	Peeling of Plaster	18
16	Roof Toilet No. 1 External Façade	Peeling of Plaster	19
17	Wall No. 4 & Shade Open Sky External Façade	Peeling of Plaster	20
18	Wall No. 2 Room No. 1 External Façade	Peeling of Plaster	21
19	Roof Room No. 1 External Façade	Peeling of Plaster	22
20	Roof Staircase GF to FF	Peeling of Plaster	23
21	Wall No. 1 Staircase GF to FF	Damaged Portion	24
22	Wall No. 2 & Roof Staircase GF to FF	Damaged Portion	25

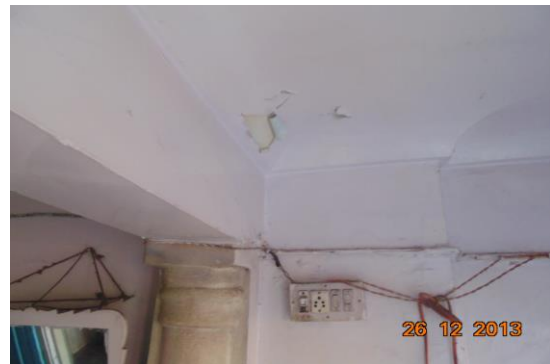
Photo 12
Peeling of Plaster on Roof of Varanda of First Floor

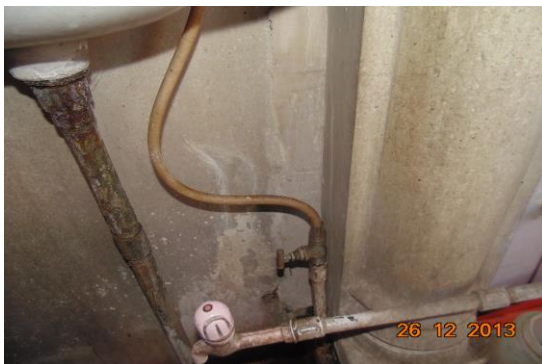
Photo 13
Peeling of Plaster on Wall No. 4 of Lobby of First Floor

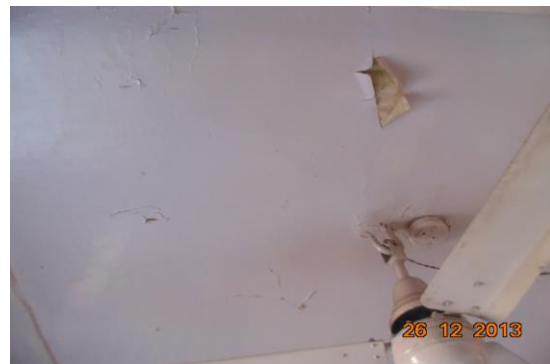
Photo 14
Peeling of Plaster on Roof of Lobby of Second Floor

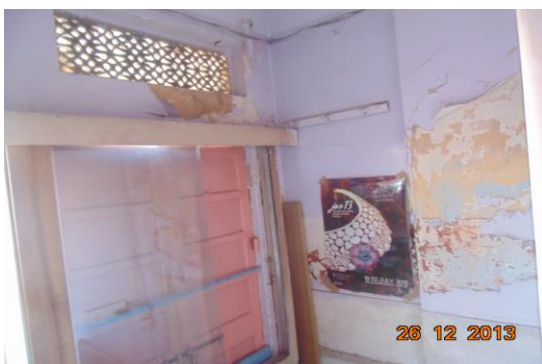
Photo 15
Peeling of Plaster on Wall No. 2 & 3 of Lobby of Second Floor

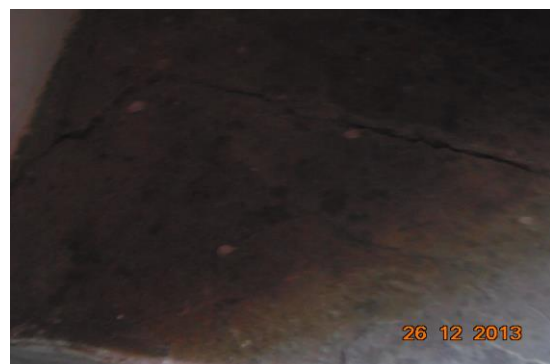
Photo 16
Damaged Portion on Steps of Staircase SF to TF of Second Floor

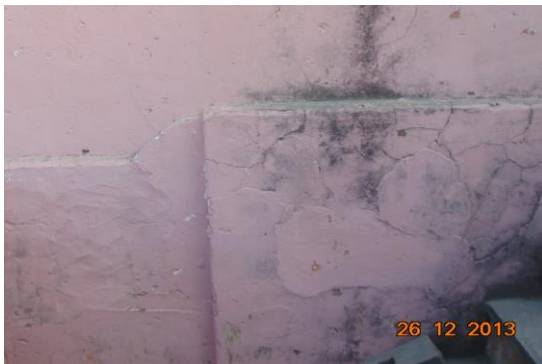
Photo 17
Damaged Portion on Wall No. 3 of Open Sky of External Façade

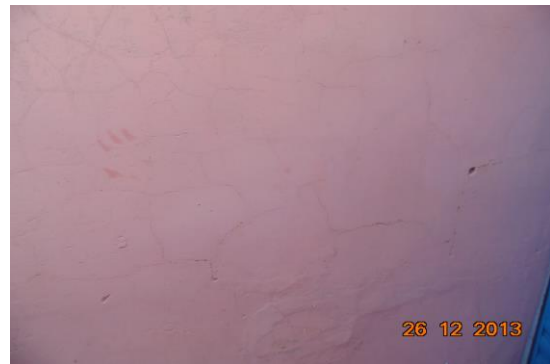
Photo 18
Peeling of Plaster on Wall No. 3 of Open Sky of External Façade

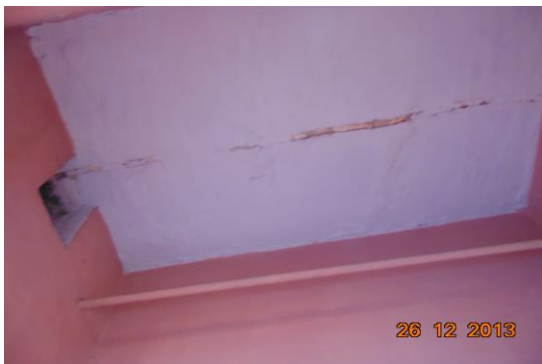
Photo 19
Peeling of Plaster on Roof of Toilet No. 1 of External Façade

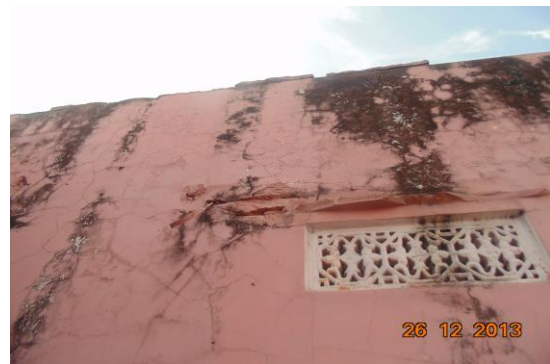
Photo 20
Peeling of Plaster on Wall No. 4 & Shade of Open Sky of External Façade

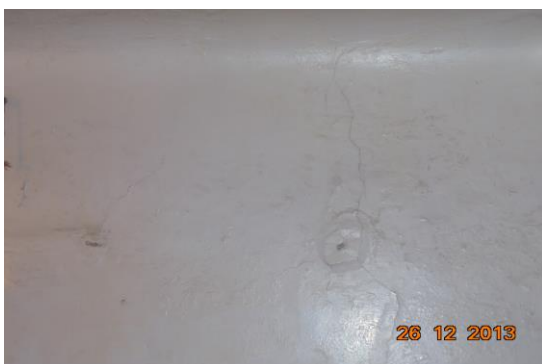
Photo 21
Peeling of Plaster on Wall No. 2 of Room No. 1 of External Façade

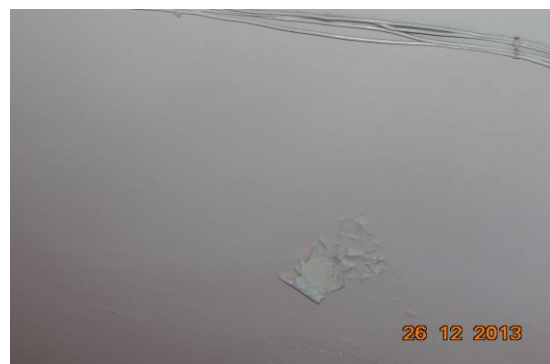
Photo 22
Peeling of Plaster on Roof of Room No. 1 of External Façade

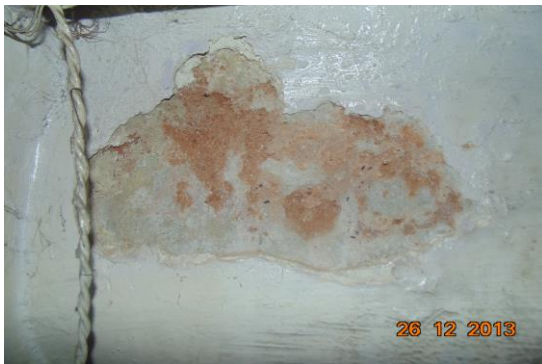
Photo 23
Peeling of Plaster on Roof of Staircase GF to FF

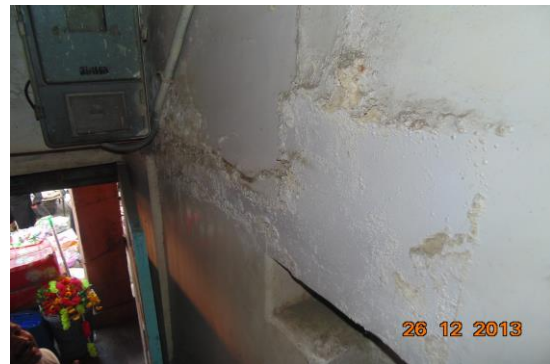
Photo 24
Damaged Portion on Wall No. 1 of Staircase GF to FF

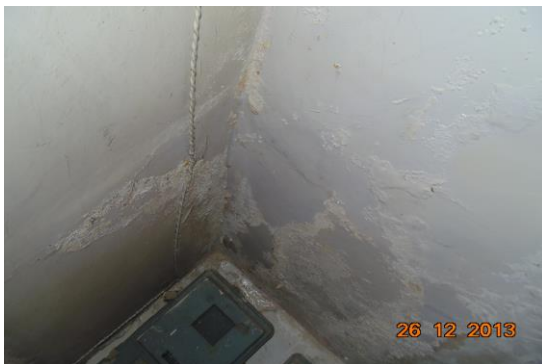
Photo 25
Damaged Portion on Wall No. 2 & Roof of Staircase GF to FF of

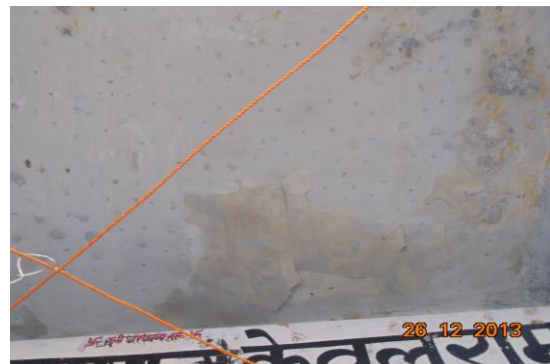
Photo 26
Peeling of Plaster on Roof of Varanda of Shop No.41, Ground Floor

23	Roof Varanda Shop No.41, Ground Floor	Peeling of Plaster	26
24	Roof Part B of Shop No.42 Ground Floor	Damaged Portion	27

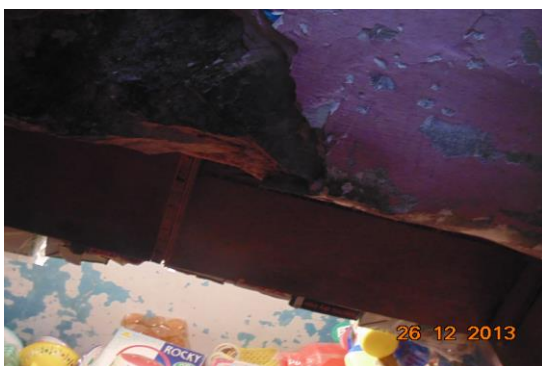
Photo 27
Damaged Portion on Roof of Part B of Shop No.42 of Ground Floor

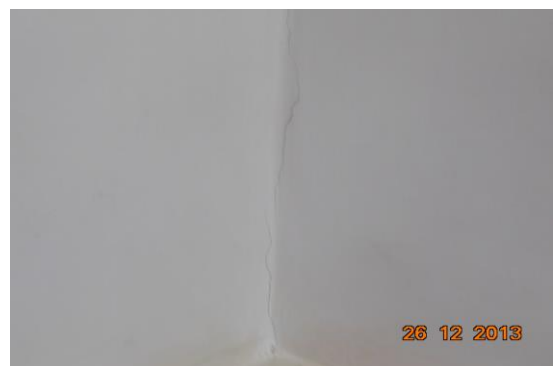
Photo 6

Peeling of Plaster on Wall No. 2, 4 & Corner of Room No. 1 of First Floor

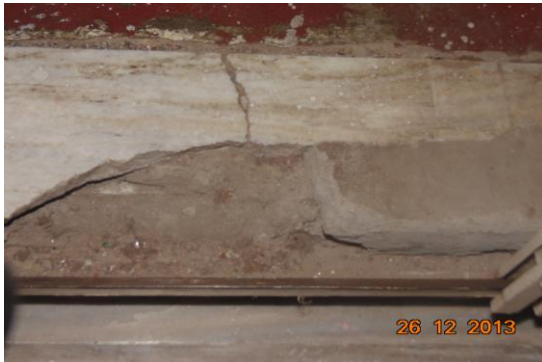
Photo 7

Peeling of Plaster on Floor & Entry Gate of Hall No. 1 of Second Floor
