Pre Building Condition Survey Report

Name and Address of Structure :	Badi Chopar to Ramp Area (Down Line)
---------------------------------	--------------------------------------

Name of the Project	Contract JMRC-UG1B “Design and Construction of Tunnel between Chandpole and Badi Chouper and reverse line by Shield TBM, Underground Metro Stations at Choti Chouper and Badi Chouper by Cut and Cover Methods on East West Corridor of Jaipur Metro Rail Corporation Limited .”	
Owner :

Pre - Condition Building Survey for Construction of Underground Stations from Chandpole to Bari Chouper and reversal line

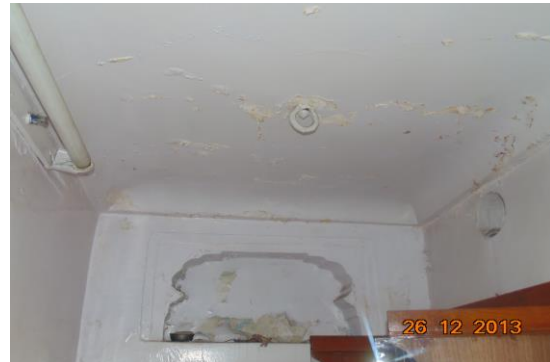
Photo 8

Dampness/Seepage on Wall No. 2, 4 & Roof of Hall No. 1 of Second Floor

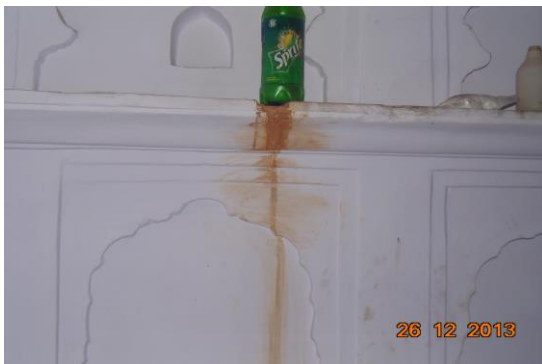
Photo 9

Peeling of Plaster on Wall No. 1 & Shade of H.NO.302 of Second Floor

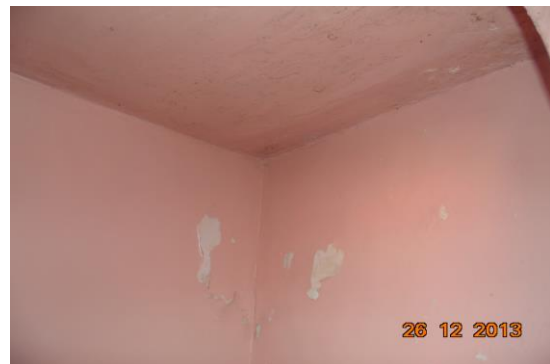
Photo 10

Peeling of Plaster on Wall No. 2 & 4 of Bathroom of Third Floor

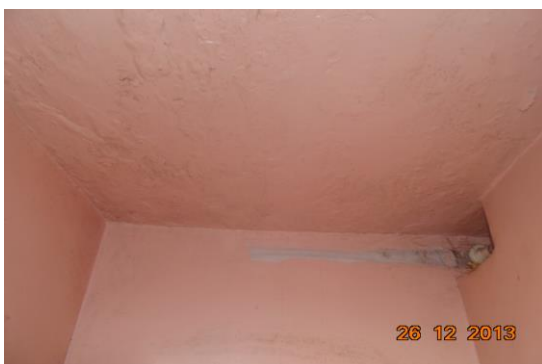
Photo 11

Dampness/Seepage on Roof of Toilet No. 1 of Third Floor

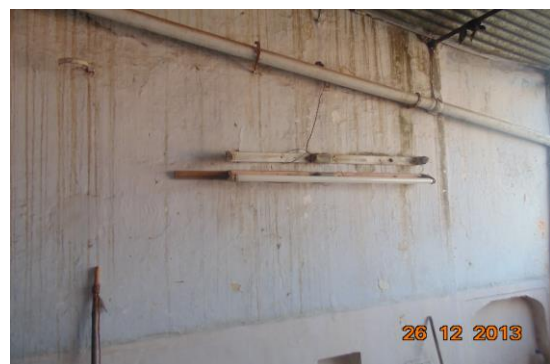
Photo 12

Dampness/Seepage on Wall No. 4 of Hall No. 1 of Third Floor

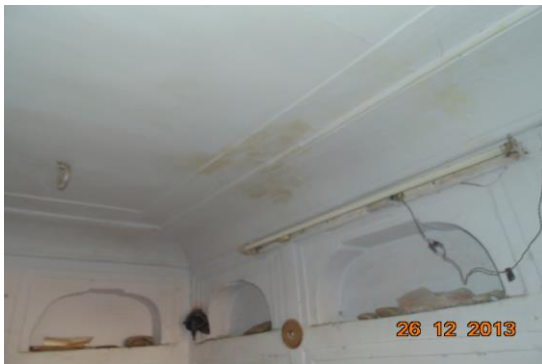
Photo 13
Dampness/Seepage on Roof of Room No. 1 of Third Floor

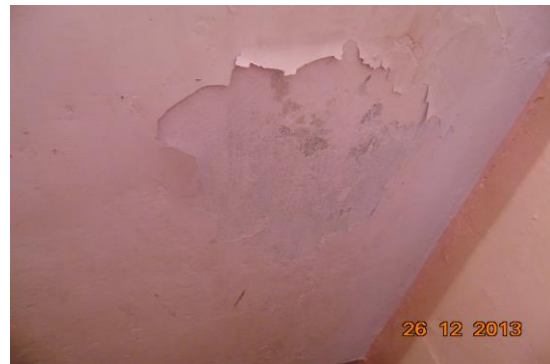
Photo 14
Peeling of Plaster on Roof of H.NO.302 of Third Floor

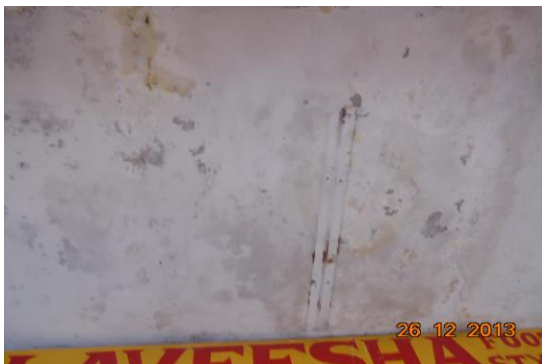
Photo 15
Peeling of Plaster on Roof of Varanda of Shop No.42, Ground Floor

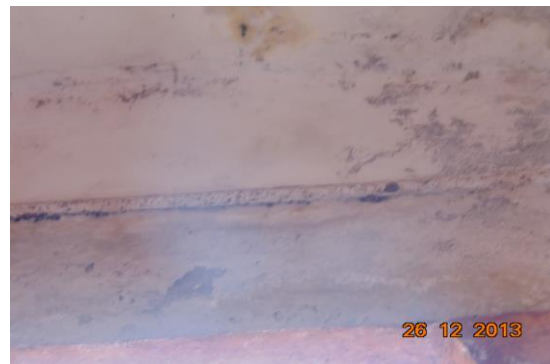
Photo 16
Dampness/Seepage on Beam of Varanda of Shop No.42, Ground Floor

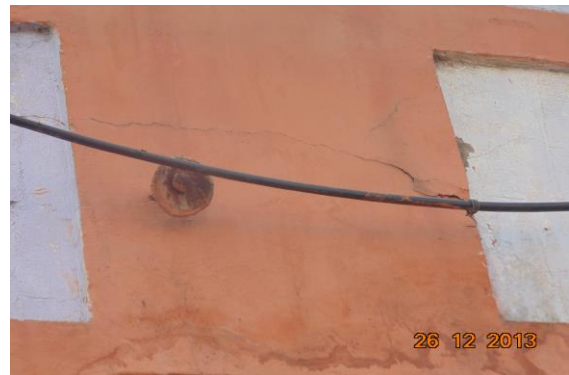
Photo 4

Inclined Crack on Outside Beam of Varanda of Shop No.43, Ground Floor Approx. Width = 0.5mm, Approx. Length = 1m. Distance from = m, Height from Floor = m.

Summary of Cracks						
Defect ID	Location	Orientation	Appx. Width (mm)	Appx. Length (m)	Category	Photo No.
1	Outside Beam Varanda of Shop No.43 Ground Floor	Inclined	0.5	1	Very Slight	4
2	Roof Varanda of Shop No.43 Ground Floor	Horizontal	0.4	2	Very Slight	5

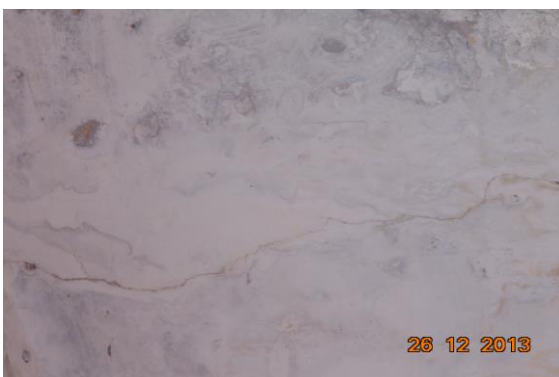
Photo 5

Horizontal Crack on Roof of Varanda of Shop No.43, Ground Floor Approx. Width = 0.4mm, Approx. Length = 2m. Distance from Leftside External Column = 0m, Height from Floor = 3m.

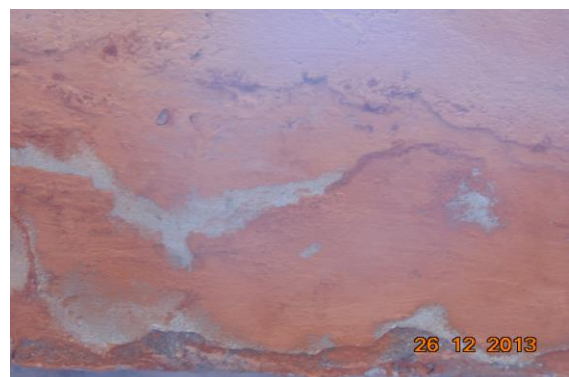
Photo 6

Dampness/Seepage on Beam of Varanda of Shop No.43 of Ground Floor

Summary of Defects Other Than Crack			
Defect ID	Location	Description	Photo No.
3	Beam Varanda of Shop No.43 Ground Floor	Dampness/Seepage	6
4	Roof Varanda of Shop No.43 Ground Floor	Dampness/Seepage	7

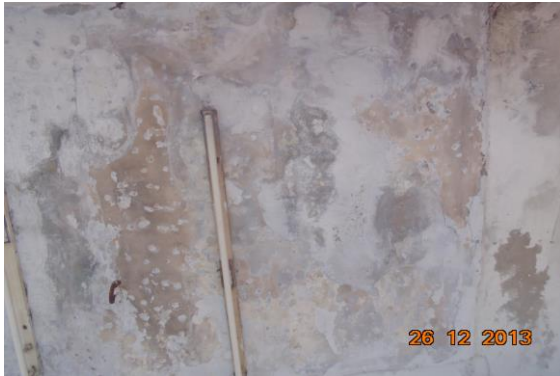
Photo 7

Dampness/Seepage on Roof of Varanda of Shop No.43 of Ground Floor All Walls of Part A of Shop No.43 of Ground Floor Covered with Material

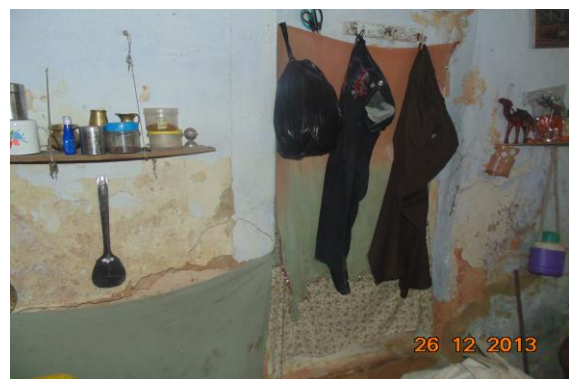
Photo 10
Inclined Crack on Wall No. 1 of Kitchen, First Floor
Approx. Width = 2mm, Approx. Length = 2m.
Distance from = m, Height from Floor = m.

Summary of Cracks						
Defect ID	Location	Orientation	Appx. Width (mm)	Appx. Length (m)	Category	9, 9A
1	Wall No. 1 Kitchen First Floor	Inclined	2	2	Slight	10
2	Wall No. 1 Kitchen First Floor	Inclined	0.3	1	Very Slight	11, 11A
3	Roof Kitchen First Floor	Inclined	1	2	Slight	12, 12A
4	Wall No. Leftside Shade front wall H.no.299 First Floor	Inclined	10	1	Moderate	13

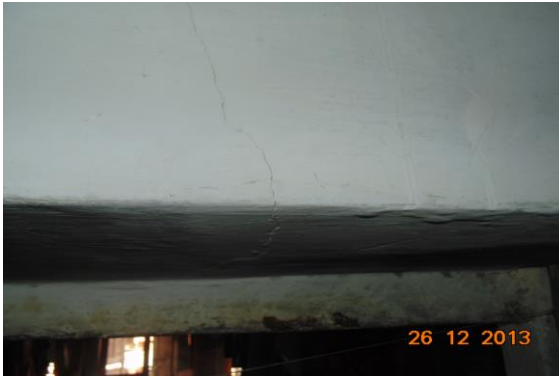
Photo 11

Inclined Crack on Wall No. 1 of Kitchen, First Floor
Approx. Width = 0.3mm, Approx. Length = 1m.
Distance from Wall No.1 = 1.5m, Height from Floor = 1.9m.

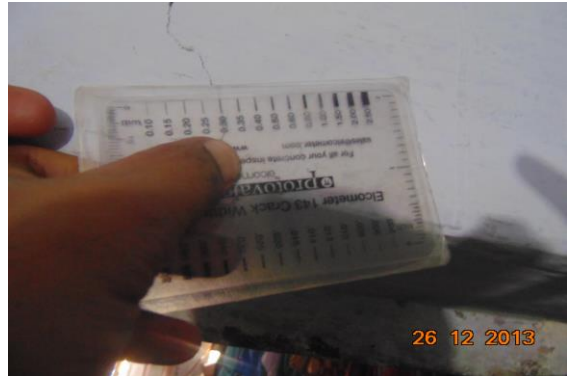
Photo 11A

Inclined Crack on Wall No. 1 of Kitchen, First Floor
Approx. Width = 0.3mm, Approx. Length = 1m.
Distance from Wall No.1 = 1.5m, Height from Floor = 1.9m.

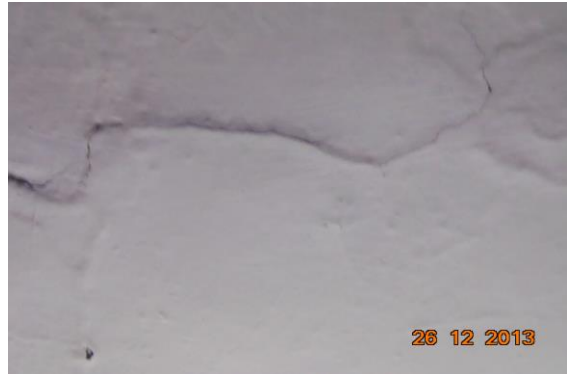
Photo 12A

Inclined Crack on Roof of Kitchen, First Floor
Approx. Width = 1mm, Approx. Length = 2m.
Distance from = m, Height from Floor = m.

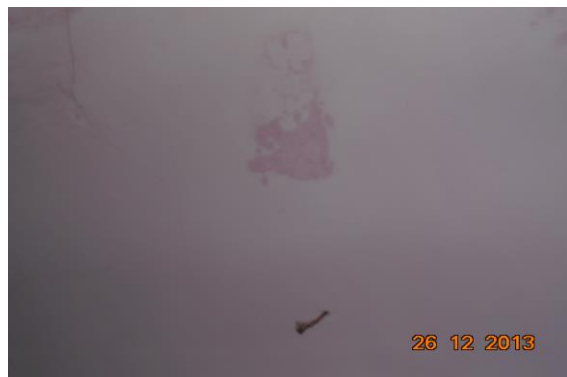
Photo 12A

Inclined Crack on Roof of Kitchen, First Floor
Approx. Width = 1mm, Approx. Length = 2m.
Distance from = m, Height from Floor = m.

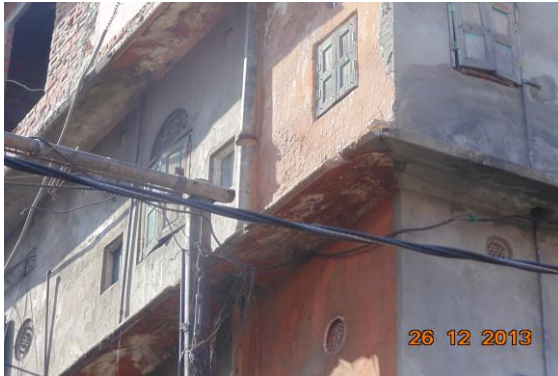
PHOTO 13

Inclined Crack on Wall No. Leftside Shade front wall of H.no.299, First Floor

Approx. Width = 10mm, Approx. Length = 1m.
Distance from = m. Height from Floor = m.

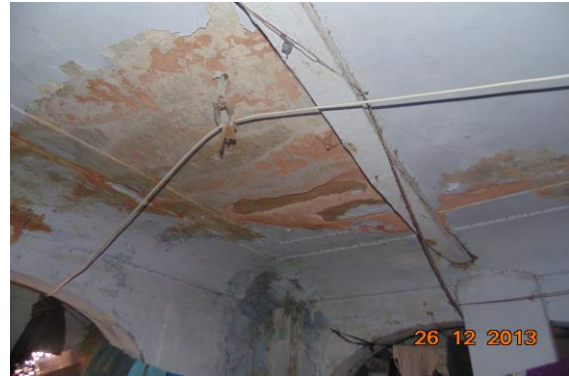
Photo 14

Damaged Portion on Roof of Lobby of First Floor

Summary of Defects Other Than Crack			
Defect ID	Location	Description	Photo No.
5	Roof Lobby First Floor	Damaged Portion	14
6	Wall No. 1, 4 & Roof Lobby First Floor	Dampness/Seepage	15
7	Wall No. 2 & 4 Lobby First Floor	Damaged Portion	16
8	Wall No. 1 Passage First Floor	Peeling of Plaster	17
9	Wall No. 4 Passage First Floor	Peeling of Plaster	18
10	Roof Passage First Floor	Peeling of Plaster	19
11	Roof Varanda First Floor	Damaged Portion	20
12	Wall No. 4 Varanda First Floor	Damaged Portion	21
13	Wall No. Floor Kitchen First Floor	Peeling of Plaster	22
14	Roof Kitchen First Floor	Peeling of Plaster	23
15	Wall No. 4 Kitchen First Floor	Peeling of Plaster	24
16	Roof Lobby Second Floor	Peeling of Plaster	25
17	Wall No. 1 & 4 Lobby Second Floor	Peeling of Plaster	26
18	Wall No. 2 Varanda Second Floor	Dampness/Seepage	27
19	Roof Varanda Second Floor	Dampness/Seepage	28
20	Wall No. 1, 3 & Roof Kitchen Second Floor	Dampness/Seepage	29

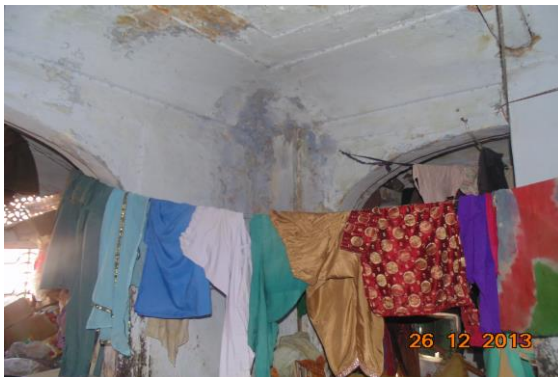
Photo 15

Dampness/Seepage on Wall No. 1, 4 & Roof of Lobby of First Floor

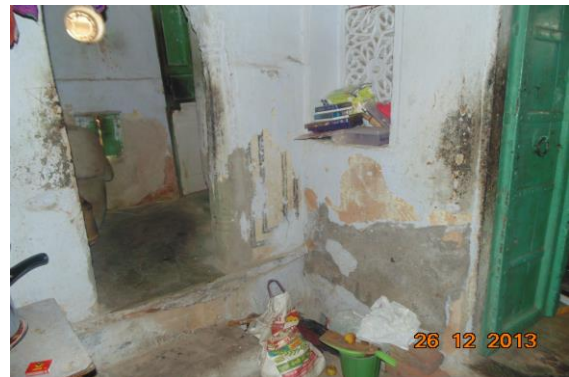
Photo 16

Damaged Portion on Wall No. 2 & 4 of Lobby of First Floor

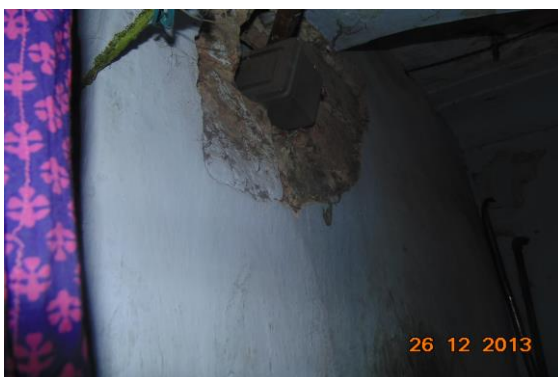
Photo 17

Peeling of Plaster on Wall No. 1 of Passage of First Floor

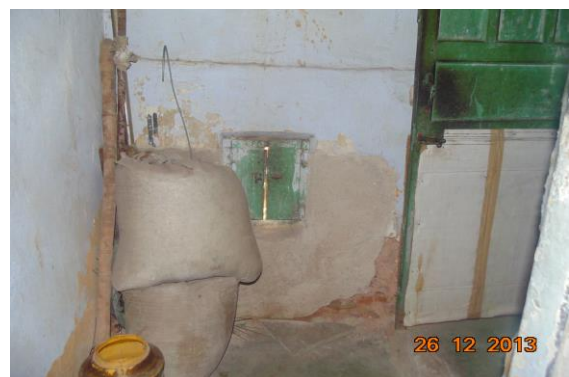
Photo 18

Peeling of Plaster on Wall No. 4 of Passage of First Floor

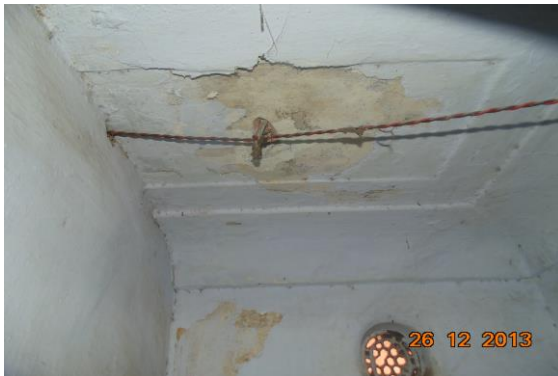
Photo 19
Peeling of Plaster on Roof of Passage of First Floor

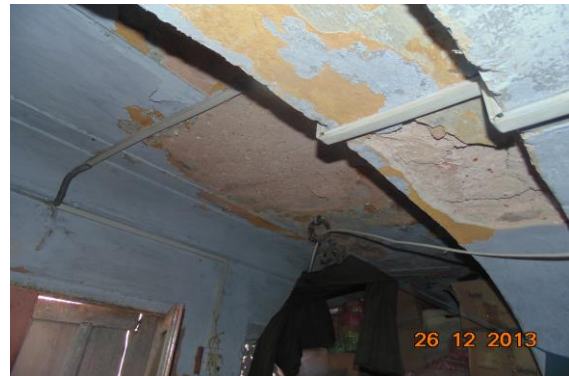
Photo 20
Damaged Portion on Roof of Varanda of First Floor

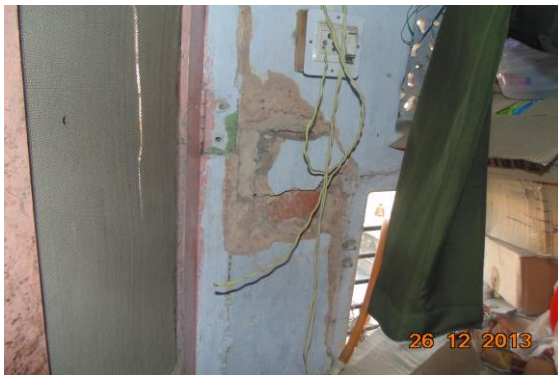
Photo 21
Damaged Portion on Wall No. 4 of Varanda of First Floor

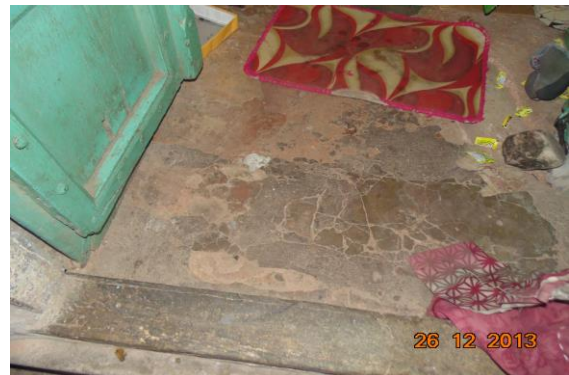
Photo 22
Peeling of Plaster on Wall No. Floor of Kitchen of First Floor

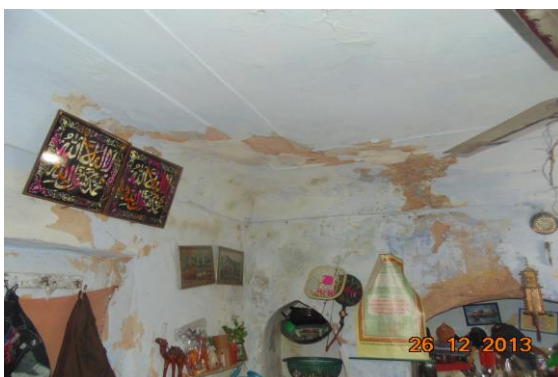
Photo 23
Peeling of Plaster on Roof of Kitchen of First Floor

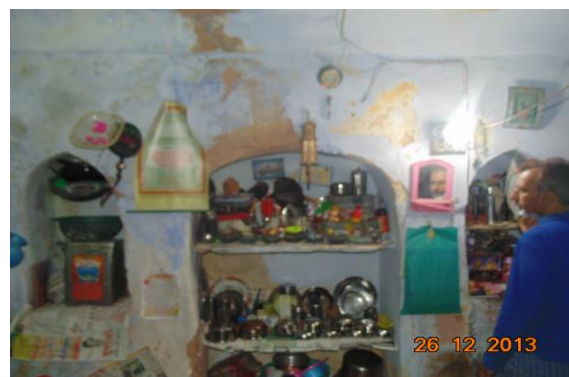
Photo 24
Peeling of Plaster on Wall No. 4 of Kitchen of First Floor

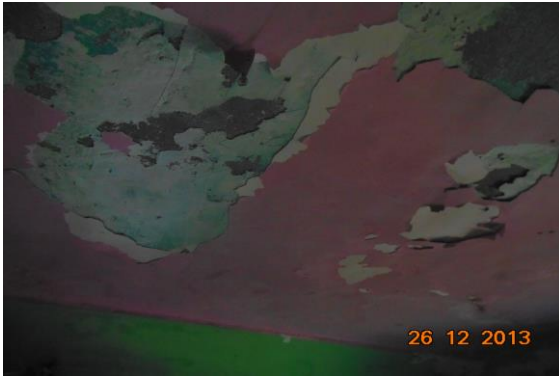
Photo 25
Peeling of Plaster on Roof of Lobby of Second Floor

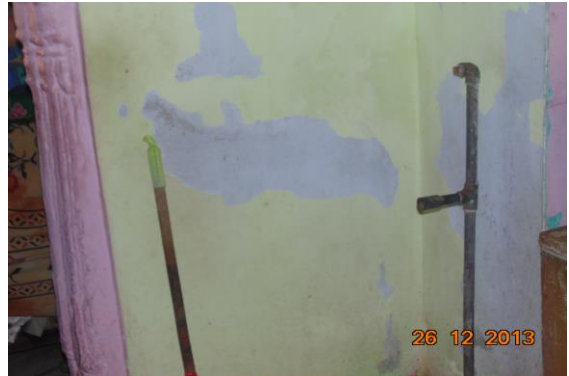
Photo 26
Peeling of Plaster on Wall No. 1 & 4 of Lobby of Second Floor

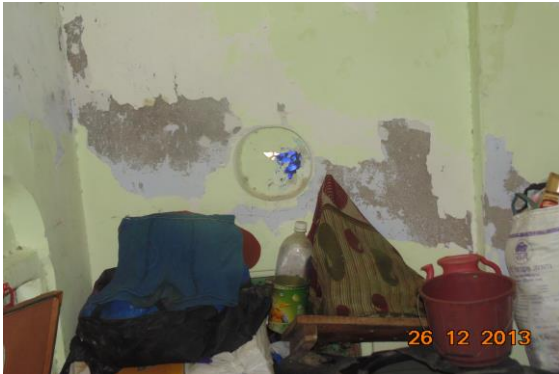
Photo 27
Dampness/Seepage on Wall No. 2 of Varanda of Second Floor

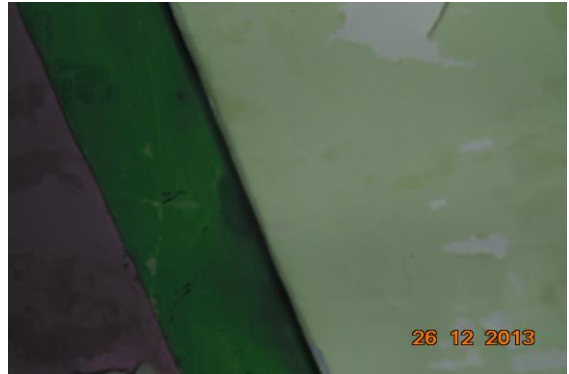
Photo 28
Dampness/Seepage on Roof of Varanda of Second Floor

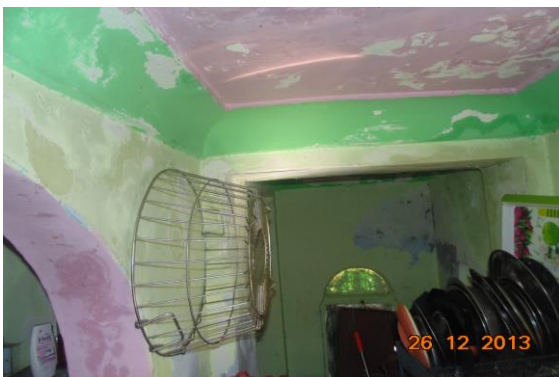
Photo 29
Dampness/Seepage on Wall No. 1, 3 & Roof of Kitchen of Second Floor

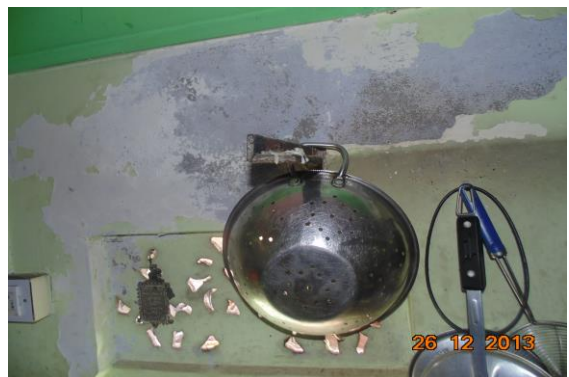
Photo 30
Dampness/Seepage on Wall No. 4 of Kitchen of Second Floor

21	Wall No. 4 Kitchen Second Floor	Dampness/Seepage	30
22	Wall No. 4 Room No. 1 Second Floor	Dampness/Seepage	31
23	Wall No. 1 Room No. 1 Second Floor	Dampness/Seepage	32
24	Wall No. Wall No. Staircase FF to SF Second Floor	Peeling of Plaster	33
25	Roof Staircase FF to SF Second Floor	Peeling of Plaster	34
26	Wall No. Front Wall H.no.299 Second Floor	Damaged Portion	35

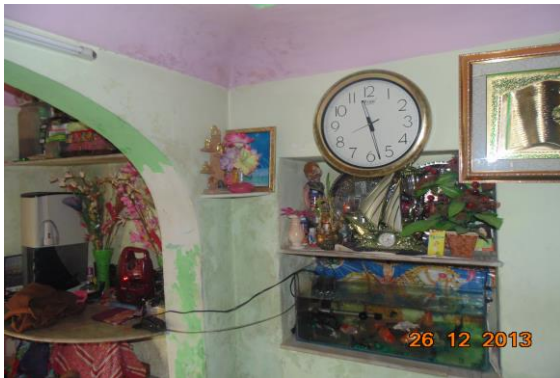
Photo 31

Dampness/Seepage on Wall No. 4 of Room No. 1 of Second Floor

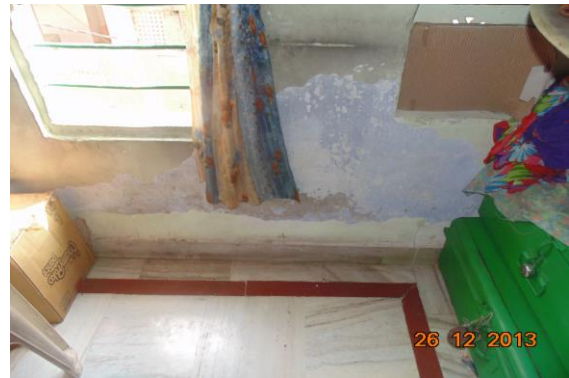
Photo 32

Dampness/Seepage on Wall No. 1 of Room No. 1 of Second Floor

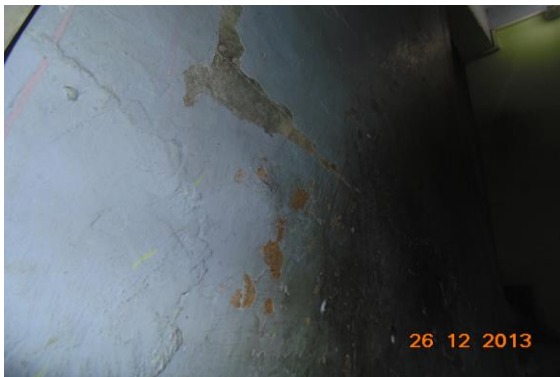
Photo 33

Peeling of Plaster on Wall No. of Staircase FF to SF of Second Floor

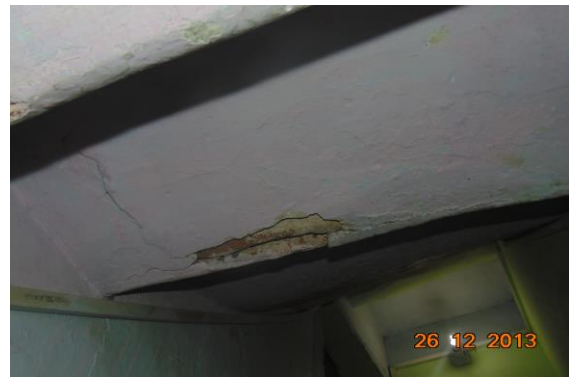
Photo 34

Peeling of Plaster on Roof of Staircase FF to SF of Second Floor

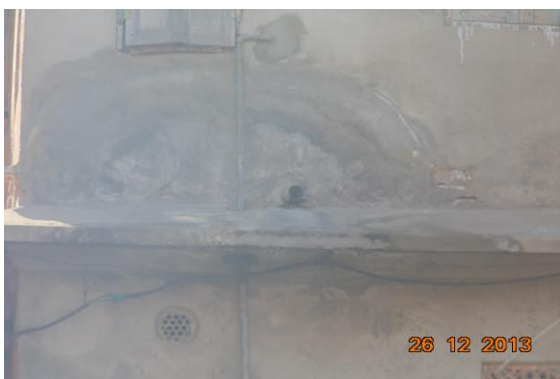
Photo 35

Damaged Portion on Wall No. Front Wall of H.no.299 of Second Floor

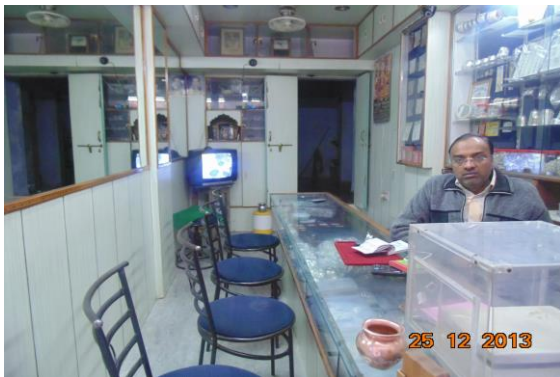
Photo 3
All Walls of Shop No. 2 of Ground Floor Covered with Wooden

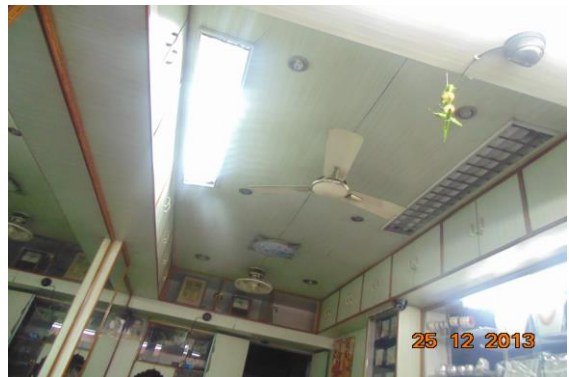
Photo 4
Roof of Shop No. 2 of Ground Floor Covered with False Ceiling

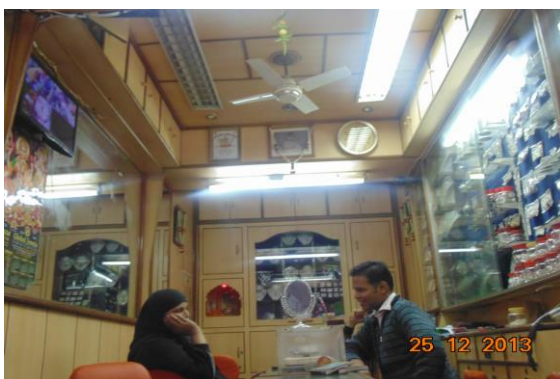
Photo 5
Roof & All Walls of Shop No. 1 of Ground Floor Covered with Wooden

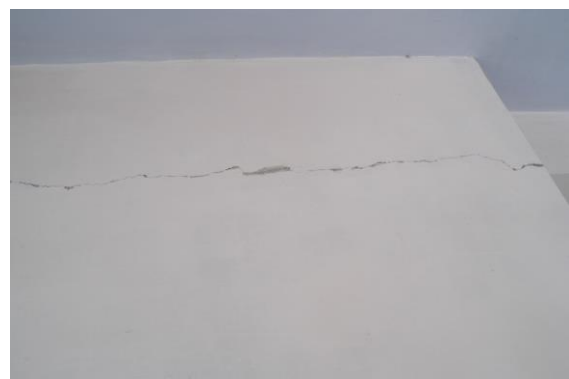
Photo 24
Horizontal Crack on Wall No. 1 of Room No. 1, Part B of House No. 347, Fourth Floor, Approx. Width = 0.4mm, Approx. Length = 1.3m. Distance from Wall No. 4 = 0.6m, Height from Floor = 2.1m.

Summary of Cracks						
Defect ID	Location	Orientation	Appx. Width (mm)	Appx. Length (m)	Category	Photo No.
1	Wall No. 1 Room No. 1 Part B of House No. 347, Fourth Floor	Horizontal	0.4	1.3	Very Slight	24
2	Wall No. 1 Room No. 1 Part B of House No. 347, Fourth Floor	Horizontal	0.35	0.6	Very Slight	25
3	Wall No. 4 Room No. 1 Part B of House No. 347, Fourth Floor	Inclined	0.2	2.5	Very Slight	26, 26A
4	Wall No. 2 Staircase First Floor to Second Floor First Floor	Horizontal	0.5	0.8	Very Slight	27, 27A
5	Backside Wall Part C of House No. 347 First Floor	Inclined	0.5	2	Very Slight	28
6	Backside Wall Part C of House No. 347 First Floor	Inclined	0.5	2	Very Slight	29
7	Wall No. 2 Hall No. 1 Ground Floor	Inclined	0.3	1	Very Slight	30, 30A

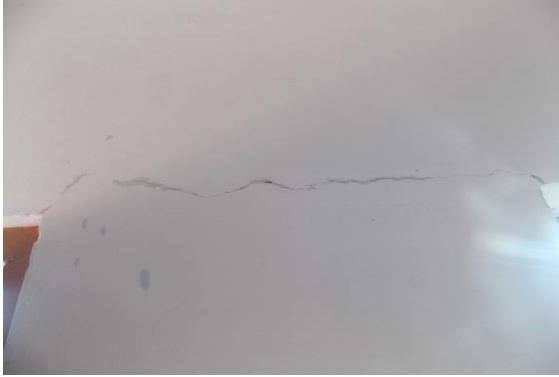
Photo 25

Horizontal Crack on Wall No. 1 of Room No. 1, Part B of House No. 347, Fourth Floor, Approx. Width = 0.35mm, Approx. Length = 0.6m. Distance from Wall No. 1 = 1m, Height from Floor = 2.7m.

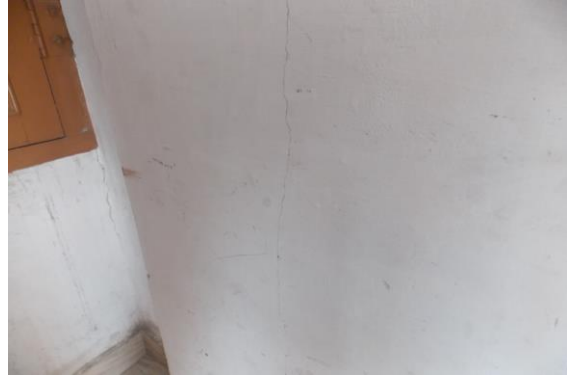
Photo 26

Inclined Crack on Wall No. 4 of Room No. 1, Part B of House No. 347, Fourth Floor, Approx. Width = 0.2mm, Approx. Length = 2.5m. Distance from Wall No. 5 = 0.3m, Height from Floor = 0m.

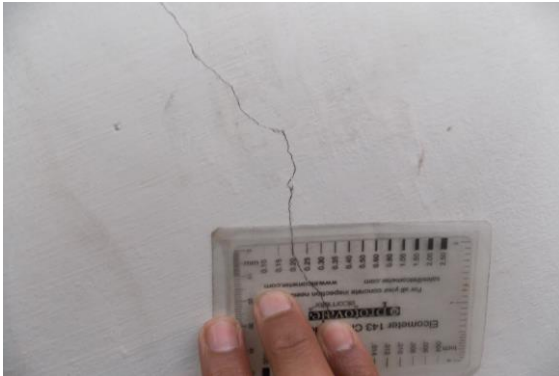
Photo 26A

Inclined Crack on Wall No. 4 of Room No. 1, Part B of House No. 347, Fourth Floor, Approx. Width = 0.2mm, Approx. Length = 2.5m. Distance from Wall No. 5 = 0.3m, Height from Floor = 0m.

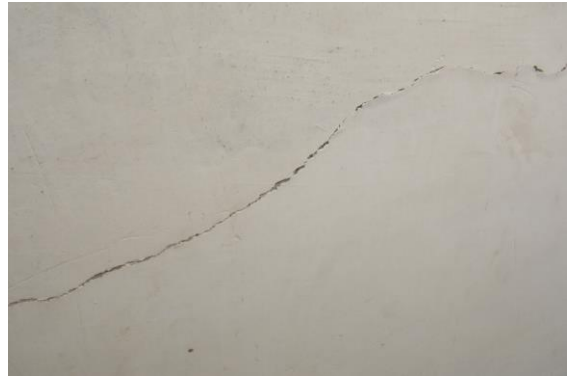
Photo 27

Horizontal Crack on Wall No. 2 of Staircase First Floor to Second Floor, First Floor, Approx. Width = 0.5mm, Approx. Length = 0.8m. Distance from Wall No. 4 = 0.9m, Height from Floor = 0.1m.

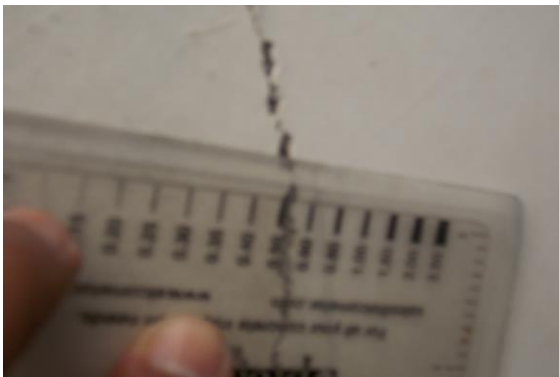
Photo 27A

Horizontal Crack on Wall No. 2 of Staircase First Floor to Second Floor, First Floor, Approx. Width = 0.5mm, Approx. Length = 0.8m. Distance from Wall No. 4 = 0.9m, Height from Floor = 0.1m.

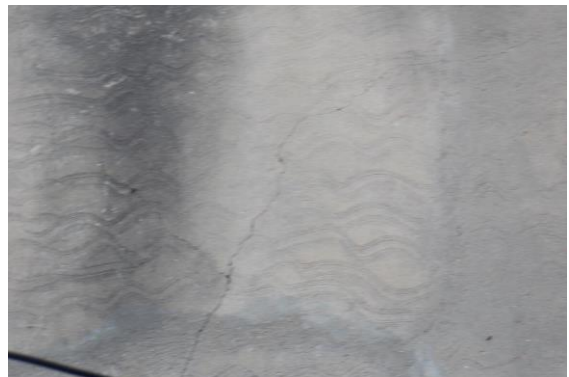
Photo 28

Inclined Crack on Backside Wall of Part C of House No. 347, First Floor, Approx. Width = 0.5mm, Approx. Length = 2m.

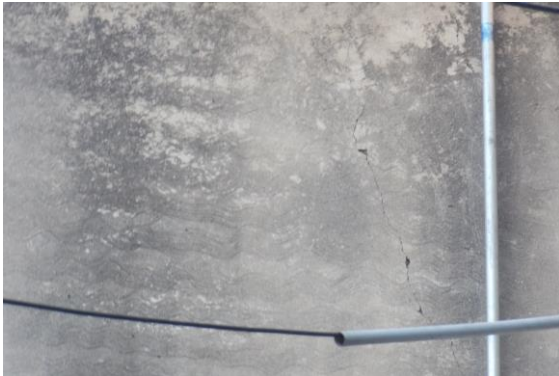
Photo 29

Inclined Crack on Backside Wall of Part C of House No. 347, First Floor, Approx. Width = 0.5mm, Approx. Length = 2m.

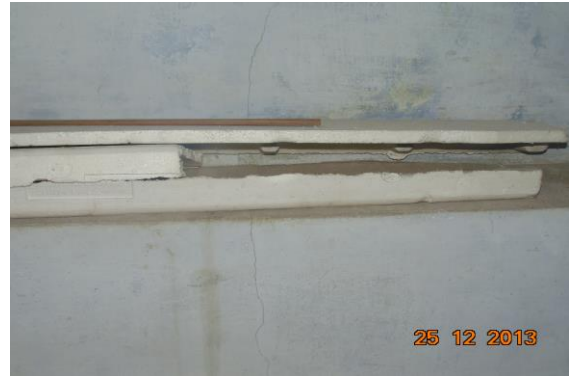
Photo 30

Inclined Crack on Wall No. 2 of Hall No. 1, Ground Floor, Approx. Width = 0.3mm, Approx. Length = 1m. Distance from Wall No. 3 = 0.5m, Height from Floor = 0.5m.

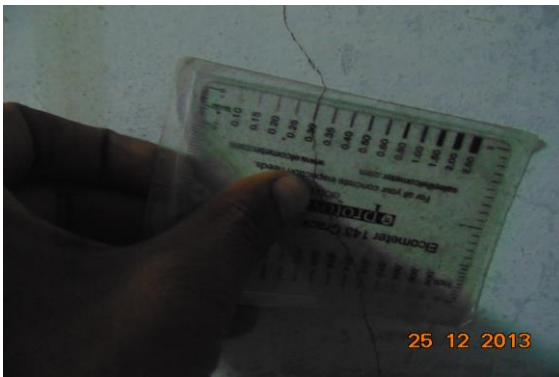
Photo 30A

Inclined Crack on Wall No. 2 of Hall No. 1, Ground Floor, Approx. Width = 0.3mm, Approx. Length = 1m. Distance from Wall No. 3 = 0.5m, Height from Floor = 0.5m.

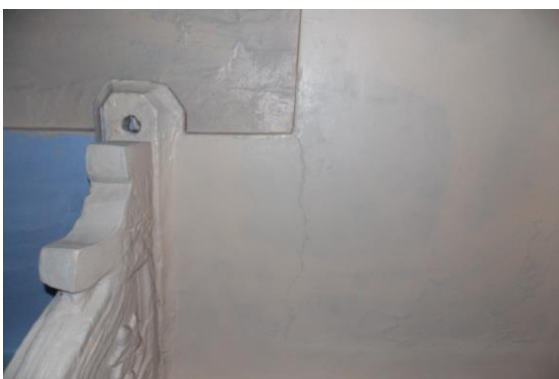
Photo 32

Peeling of Plaster on Roof of Open Sky of First Floor

Summary of Defects Other Than Crack			
Defect ID	Location	Description	Photo No.
8	Wall No. 1 Open Sky First Floor	Peeling of Plaster	31
9	Roof Open Sky First Floor	Peeling of Plaster	32
10	Wall No. 1 Staircase First Floor to Second Floor First Floor	Peeling of Plaster	33
11	Wall No. 4 Staircase First Floor to Second Floor First Floor	Peeling of Plaster	34
12	Roof Room No. 2 Part B of House No. 347, Second Floor	Peeling of Plaster	35
13	Wall No. 4 Open Sky Second Floor	Peeling of Plaster	36
14	Wall No. 3 Balcony Second Floor	Peeling of Plaster	37
15	Wall No. 3 Room No. 1 Part B of House No. 347, Third Floor	Peeling of Plaster	38
16	Wall No. 1 Lobby Ground Floor	Peeling of Plaster	39
17	Wall No. 3 Lobby Ground Floor	Peeling of Plaster	40
18	Wall No. 5 Lobby Ground Floor	Peeling of Plaster	41
19	Wall No. 6 Lobby Ground Floor	Peeling of Plaster	42
20	Wall No. 1 Staircase Ground Floor To First Floor Ground Floor	Peeling of Plaster	43

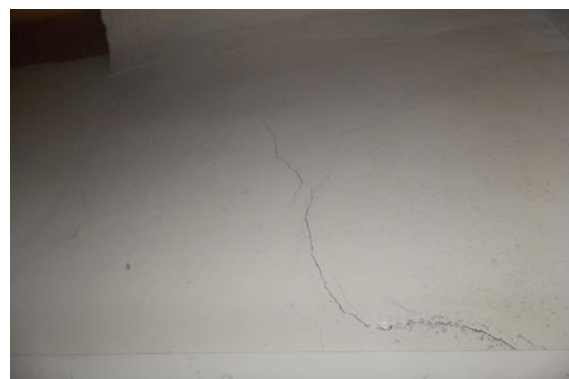
Photo 33

Peeling of Plaster on Wall No. 1 of Staircase First Floor to Second Floor of First Floor

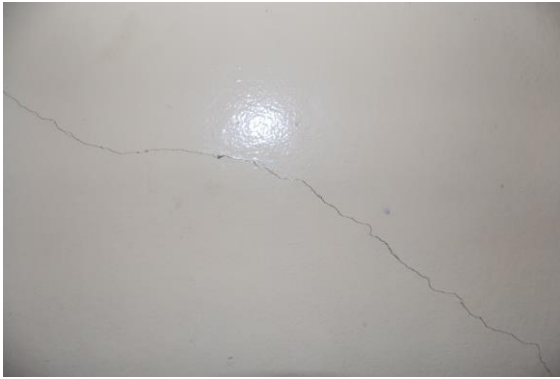
Photo 34

Peeling of Plaster on Wall No. 4 of Staircase First Floor to Second Floor of First Floor

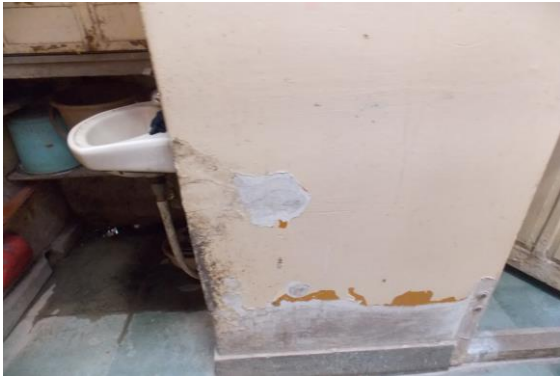
Photo 36

Peeling of Plaster on Wall No. 4 of Open Sky of Second Floor

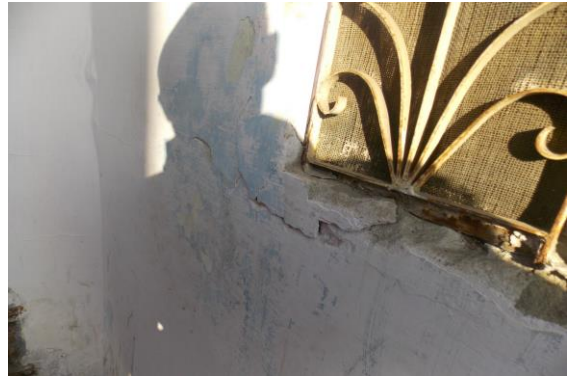
Photo 37

Peeling of Plaster on Wall No. 3 of Balcony of Second Floor

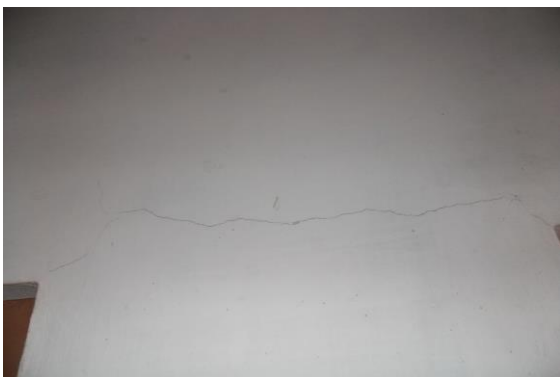
Photo 38

Peeling of Plaster on Wall No. 3 of Room No. 1 of Part B of House No. 347, Third Floor

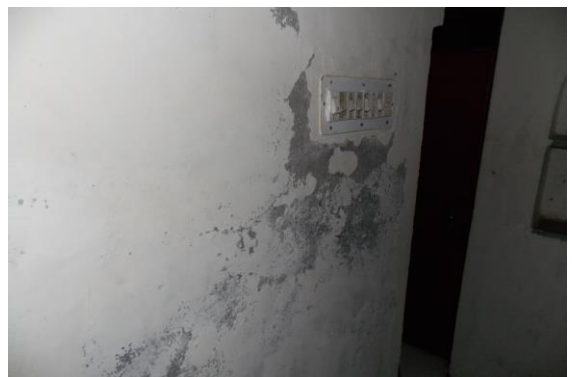
Photo 39

Peeling of Plaster on Wall No. 1 of Lobby of Ground Floor

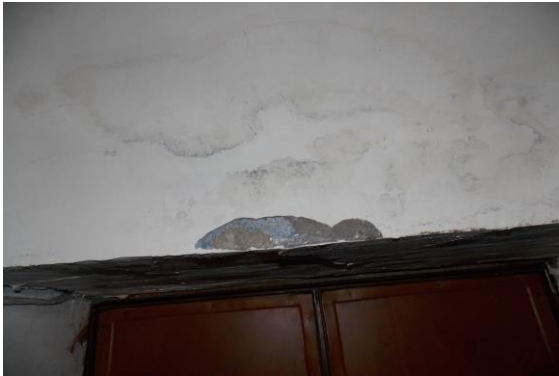
Photo 40
Peeling of Plaster on Wall No. 3 of Lobby of Ground Floor

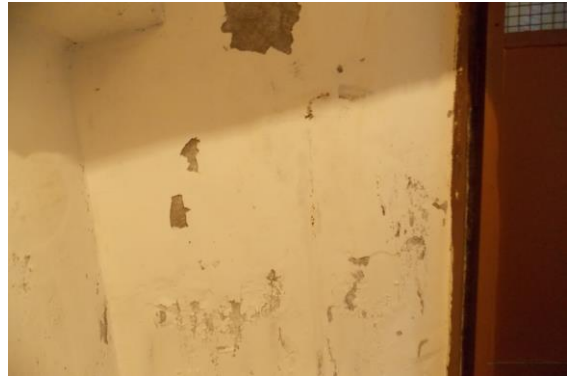
Photo 41
Peeling of Plaster on Wall No. 5 of Lobby of Ground Floor

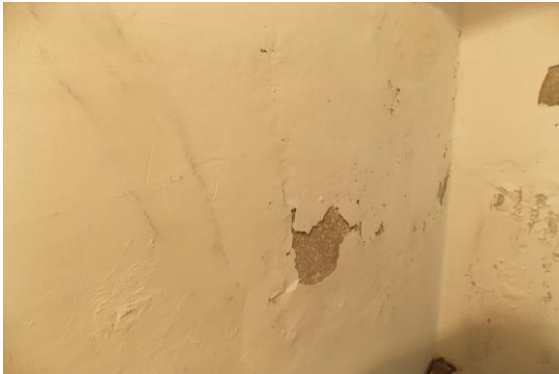
Photo 42
Peeling of Plaster on Wall No. 6 of Lobby of Ground Floor

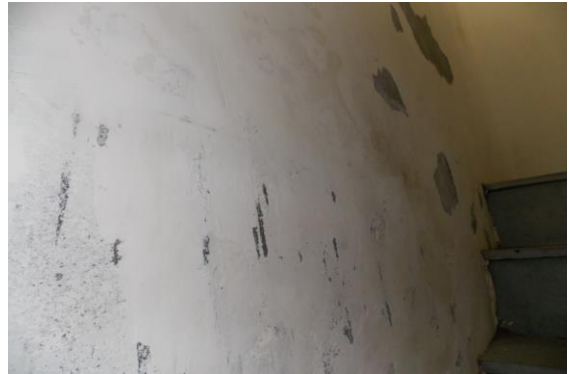
Photo 43
Peeling of Plaster on Wall No. 1 of Staircase Ground Floor To First Floor of Ground Floor

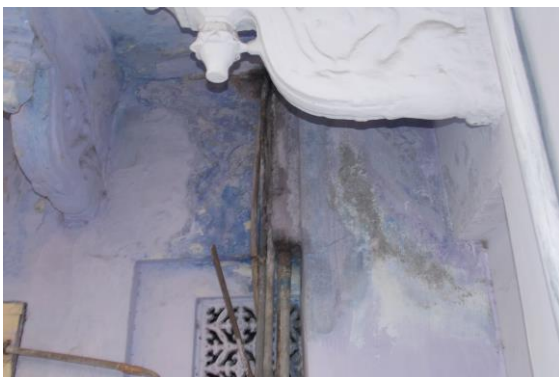
Photo 44
Dampness/Seepage on Wall No. 2 of Balcony of First Floor

21	Wall No. 2 Balcony First Floor	Dampness/Seepage	44
22	Wall No. 3 Staircase First Floor to Second Floor First Floor	Dampness/Seepage	45
23	Floor Part C of House No. 347 Second Floor	Peeling of Plaster	46
24	Right-side View Part C of House No. 347 First Floor	Damaged Portion	47
25	Rightside View Part C of House No. 347 First Floor	Peeling of Plaster	48
26	External Wall Murlidhar Tulsiram Shop Ground Floor	Peeling of Plaster	49
27	External Wall Murlidhar Tulsiram Shop Ground Floor	Peeling of Plaster	50
28	Wall No. 2 Murlidhar Tulsiram Shop Ground Floor	Peeling of Plaster	51
29	Wall No. 4 Murlidhar Tulsiram Shop	Peeling of Plaster	52
30	Wall No. 2 & 4 Murlidhar Tulsiram Shop	Peeling of Plaster	53
31	Roof Murlidhar Tulsiram Shop	Peeling of Plaster	54
32	Roof Part A Shop No. 4, Ground Floor	Peeling of Plaster	55
33	Wall No. 4 Part A Shop No. 4, Ground Floor	Peeling of Plaster	56
34	Roof Lobby No. 1 House No. 347 Part A, Ground Floor	Peeling of Plaster	57

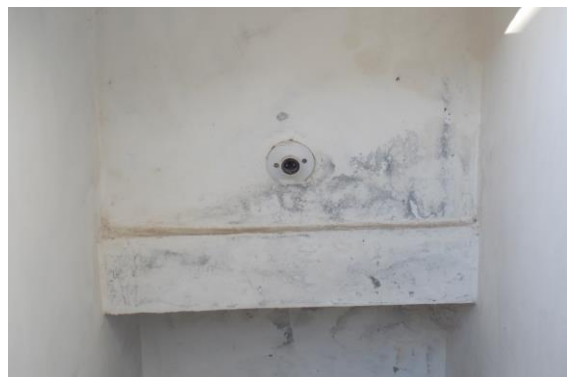
Photo 45
Dampness/Seepage on Wall No. 3 of Staircase First Floor to Second Floor of First Floor

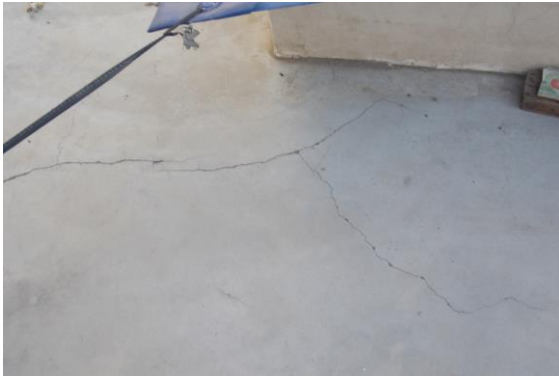
Photo 46

Peeling of Plaster on Floor of Part C of House No. 347 of Second Floor

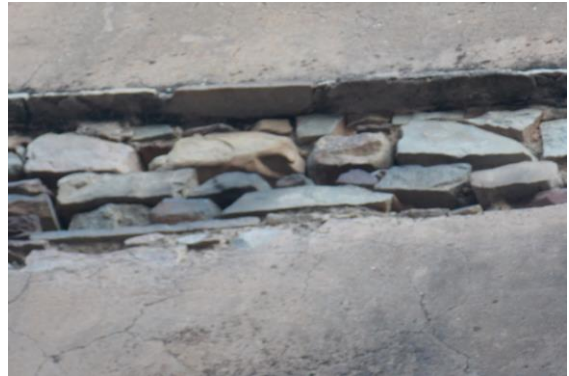
Photo 47

Damaged Portion on Rightside View of Part C of House No. 347 of First Floor

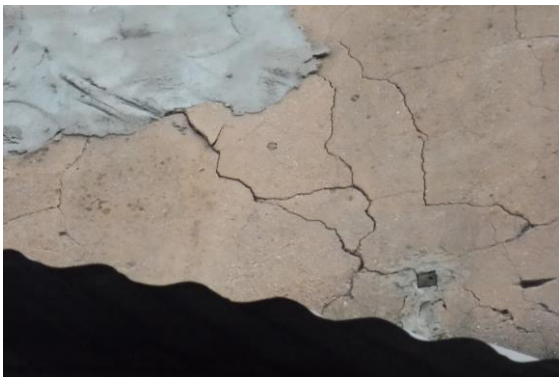
Photo 48

Peeling of Plaster on Rightside View of Part C of House No. 347 of First Floor

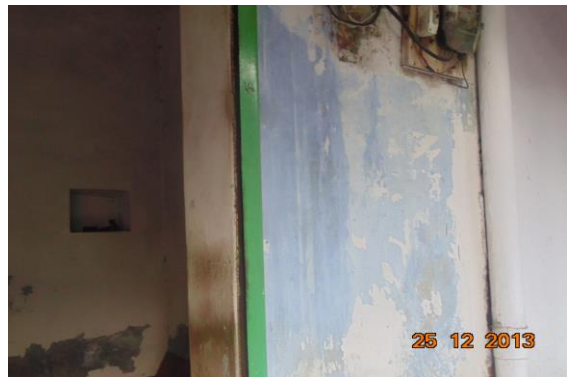
Photo 49

Peeling of Plaster on External Wall of Murlidhar Tulsiram Shop of Ground Floor

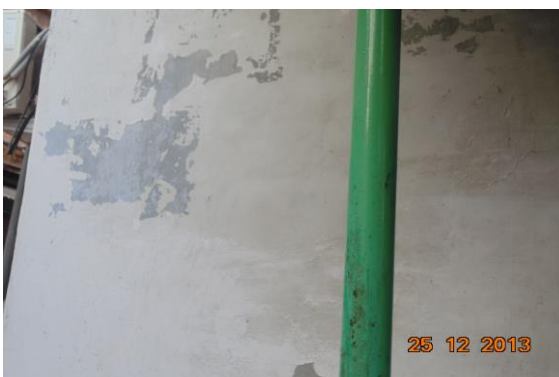
Photo 50

Peeling of Plaster on External Wall of Murlidhar Tulsiram Shop of Ground Floor

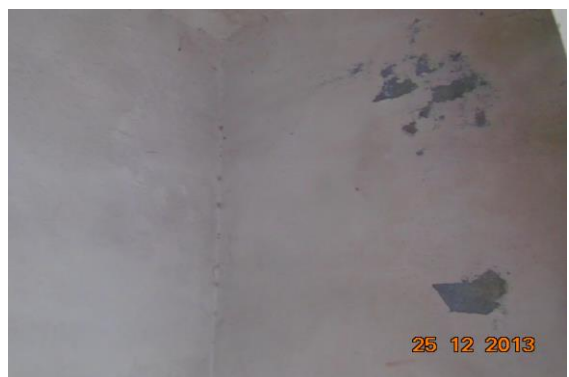
Photo 51

Peeling of Plaster on Wall No. 2 of Murlidhar Tulsiram Shop of Ground Floor

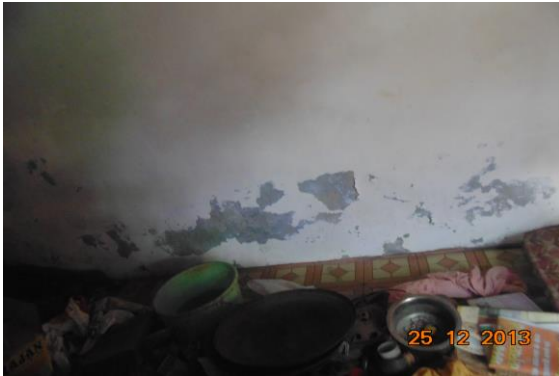
Photo 52

Peeling of Plaster on Wall No. 4 of Murlidhar Tulsiram Shop of

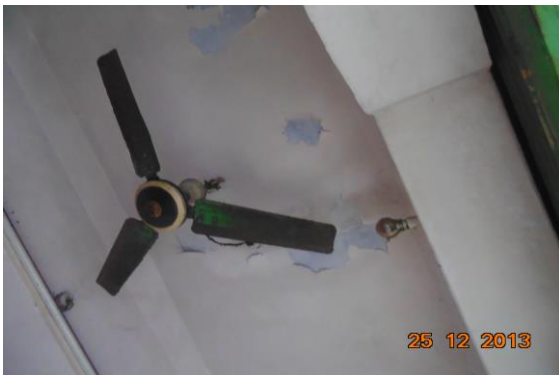
Photo 54

Peeling of Plaster on Roof of Murlidhar Tulsiram Shop of

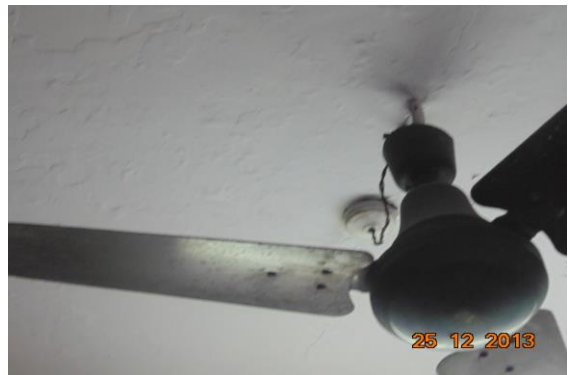
Photo 55

Peeling of Plaster on Roof of Part A of Shop No. 4, Ground Floor

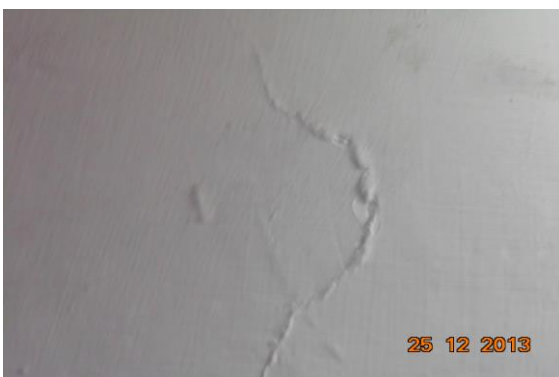
Photo 56

Peeling of Plaster on Wall No. 4 of Part A of Shop No. 4, Ground Floor

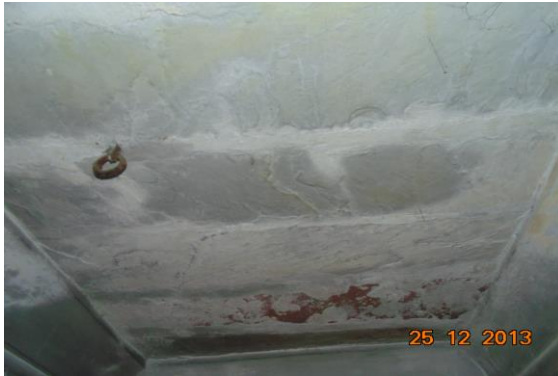
Photo 58

Dampness/Seepage on Roof of Lobby No. 2 of House No. 347 Part A, Ground Floor

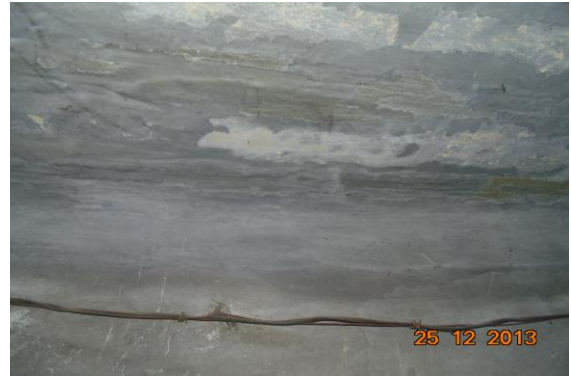
Photo 59

Dampness/Seepage on Roof of Lobby No. 2 of House No. 347 Part A, Ground Floor

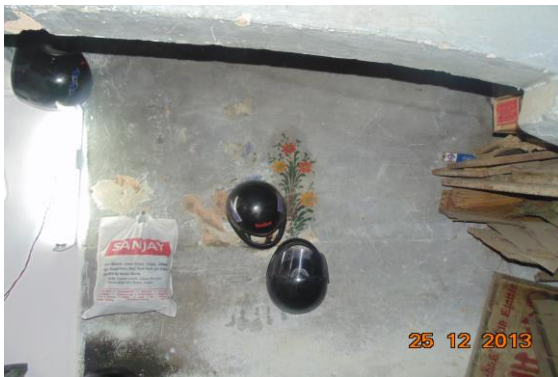
Photo 60

Dampness/Seepage on Wall No. 2 of Lobby No. 2 of House No. 347 Part A, Ground Floor

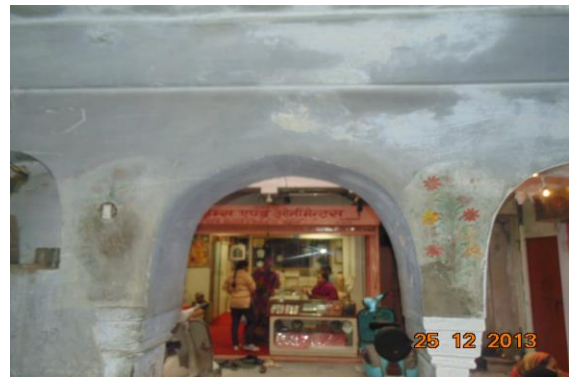
Photo 61

Dampness/Seepage on Wall No. 4 & Roof of Lobby No. 2 of House No. 347 Part A, Ground Floor

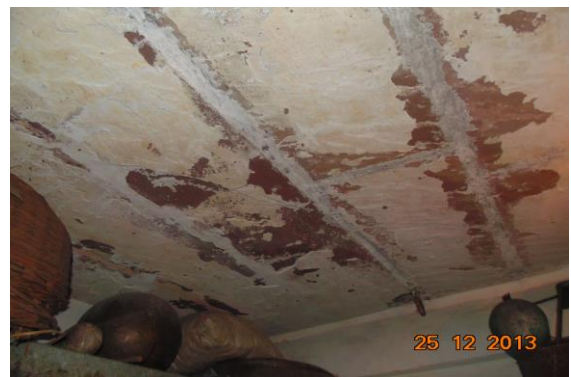
Photo 63

Dampness/Seepage on Roof of Room No. 2 of House No. 347 Part A, Ground Floor

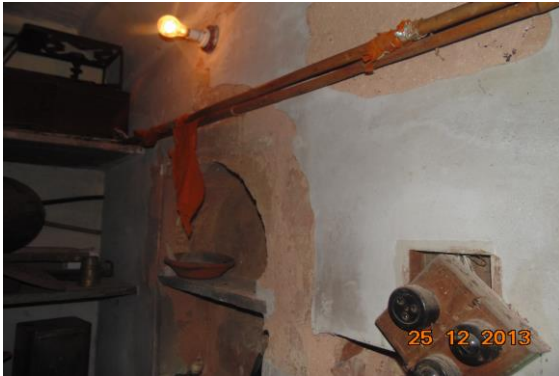
Photo 64

Peeling of Plaster on Wall No. 2 of Room No. 2 of House No. 347 Part A, Ground Floor

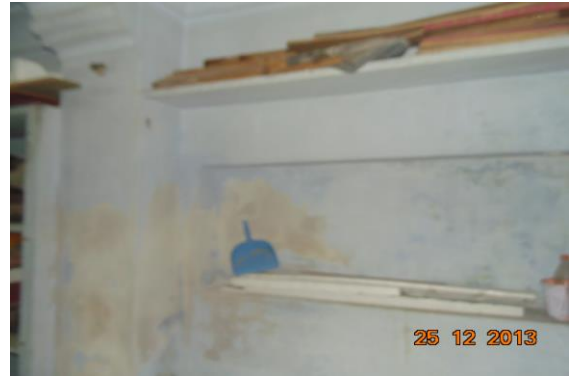
Photo 65

Dampness/Seepage on Wall No. 2 of Hall No. 1 of House No. 347 Part A, Ground Floor

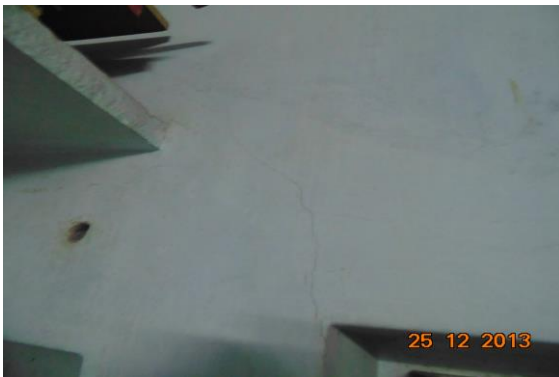
Photo 66

Plaster Crack on Wall No. 3 of Hall No. 1 of House No. 347 Part A, Ground Floor

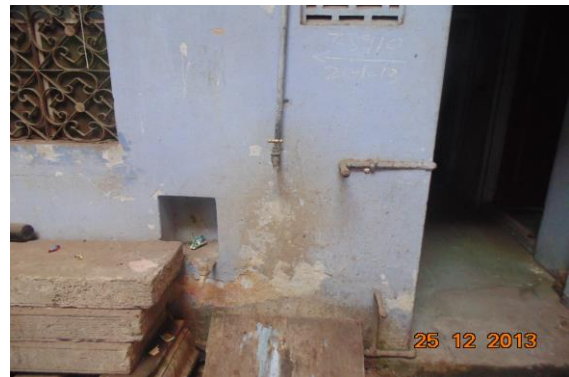
Photo 67

Dampness/Seepage on Wall No. 1 of Open Sky Area of House No. 347 Part A, Ground Floor

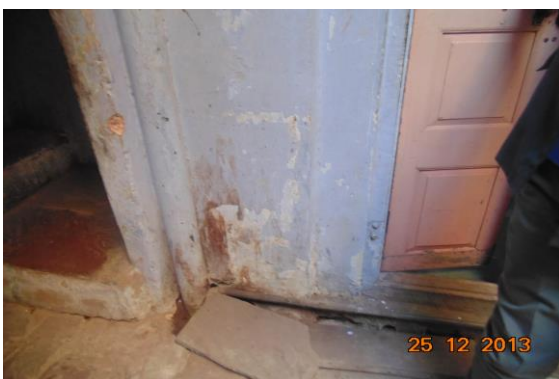
Photo 68

Dampness/Seepage on Wall No. 1 of Open Sky Area of House No. 347 Part A, Ground Floor

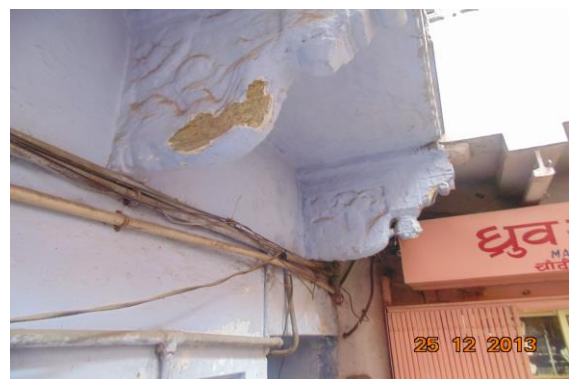
Photo 69

Peeling of Plaster on Wall No. 1 & Shade of Open Sky Area of House No. 347 Part A, Ground Floor

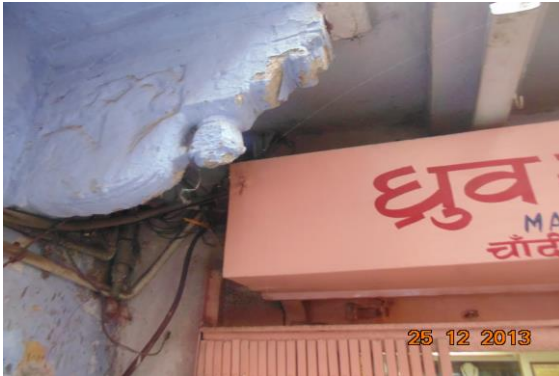
Photo 70

Dampness/Seepage on Wall No. 1 & Shade of Open Sky Area of House No. 347 Part A, Ground Floor

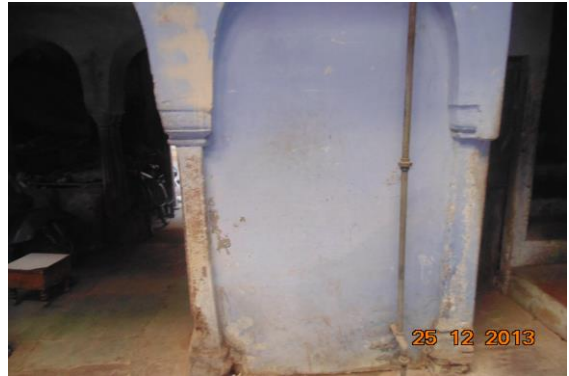
Photo 71

Dampness/Seepage on Wall No. 3 of Open Sky Area of House No. 347 Part A, Ground Floor
