Pre Building Condition Survey Report

Name and Address of Structure :	Badi Chopar to Ramp Area (Down Line)
---------------------------------	--------------------------------------

Name of the Project	Contract JMRC-UG1B “Design and Construction of Tunnel between Chandpole and Badi Chouper and reverse line by Shield TBM, Underground Metro Stations at Choti Chouper and Badi Chouper by Cut and Cover Methods on East West Corridor of Jaipur Metro Rail Corporation Limited .”	
Owner :

Pre - Condition Building Survey for Construction of Underground Stations from Chandpole to Bari Chouper and reversal line

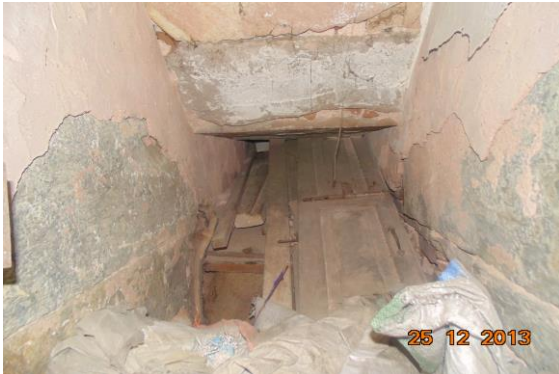
Photo 72

Dampness/Seepage on Wall No. 2, Roof & 1 of Store of House No. 347 Part A, Ground Floor

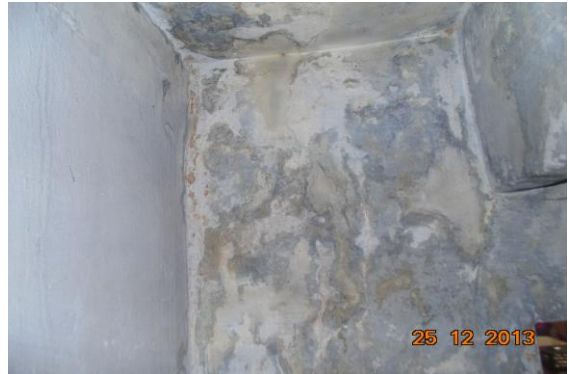
Photo 73

Dampness/Seepage on Wall No. 2 & Roof of Stair of House No. 347 Part A, Ground Floor to First Floor

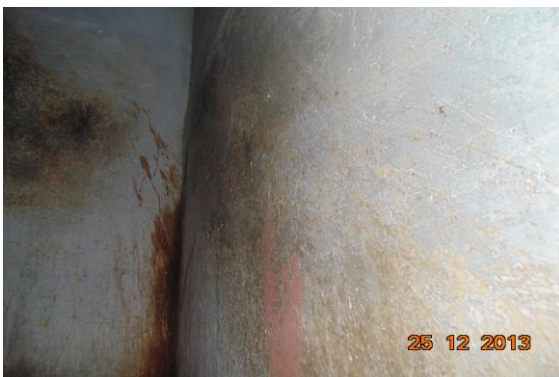
Photo 74

Dampness/Seepage on Wall No. 2 & Roof of Stair of House No. 347 Part A, Ground Floor to First Floor

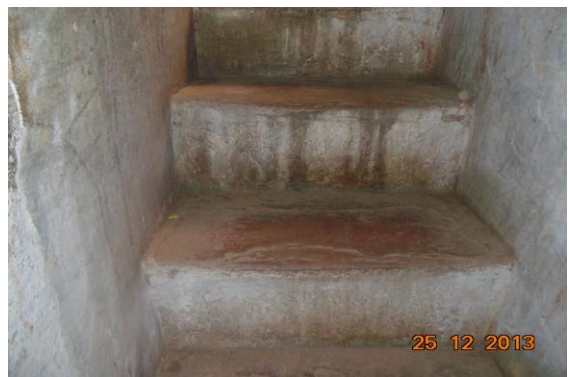
Photo 75

Peeling of Plaster on Wall No. Steps of Stair of House No. 347 Part A, Ground Floor to First Floor

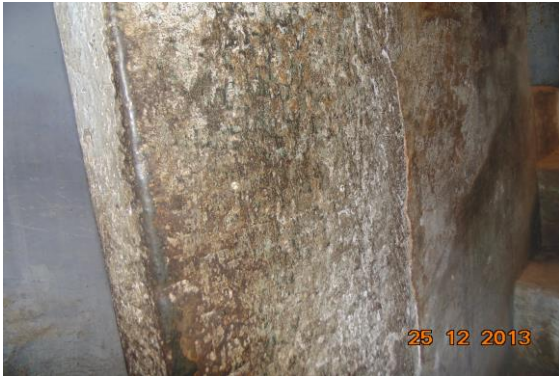
Photo 76

Peeling of Plaster on Wall No. 1 of Stair of House No. 347 Part A, Ground Floor to First Floor

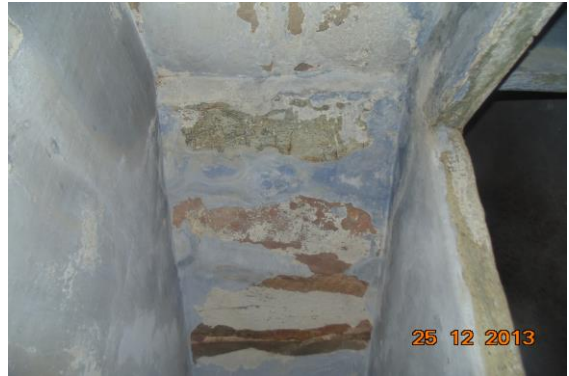
Photo 77

Dampness/Seepage on Wall No. 1, 2 & Roof of Stair of House No. 347 Part A, Ground Floor to First Floor

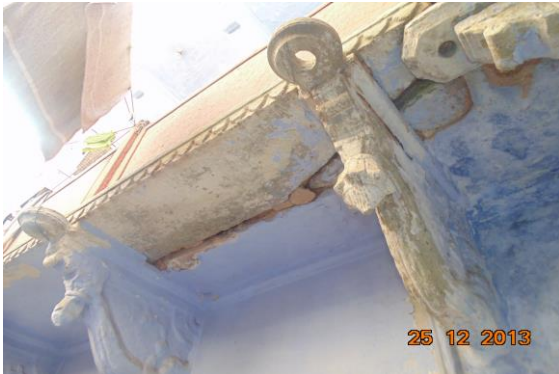
Photo 78

Peeling of Plaster on Shade of Open Sky Area Balcony of House No. 347 Part A, First Floor

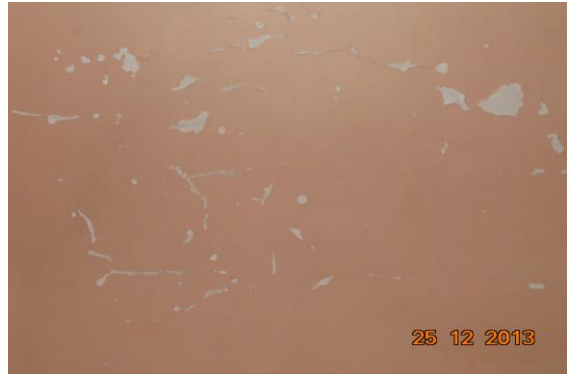
Photo 79

Peeling of Plaster on Wall No. 1 of Hall No. 1 of House No. 347 Part A, First Floor

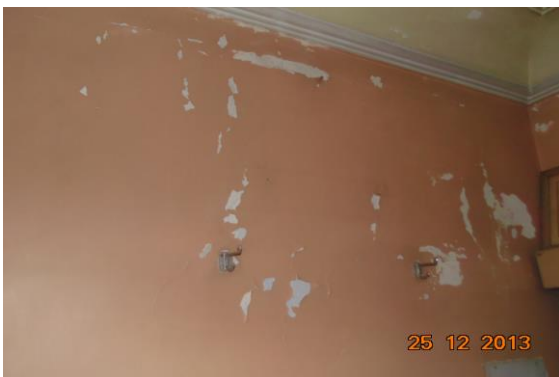
Photo 80

Peeling of Plaster on Wall No. 2 of Hall No. 1 of House No. 347 Part A, First Floor

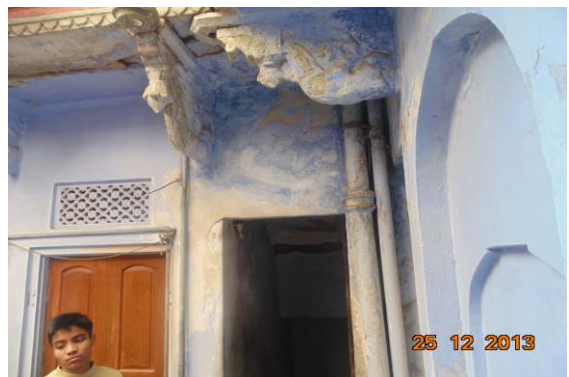
Photo 81

Dampness/Seepage on Wall No. 3, 2 & Roof of Open Sky Area of House No. 347 Part A, First Floor

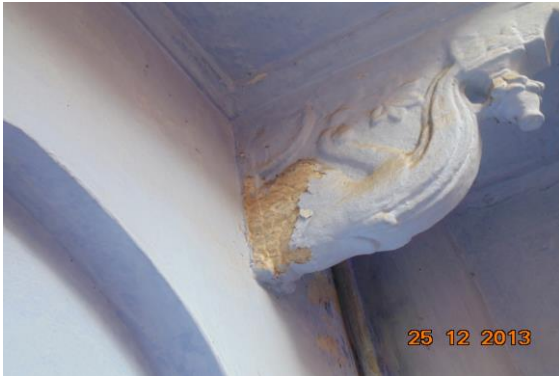
Photo 82

Dampness/Seepage on Wall No. 1 & Shade of Open Sky Area of House No. 347 Part A, First Floor

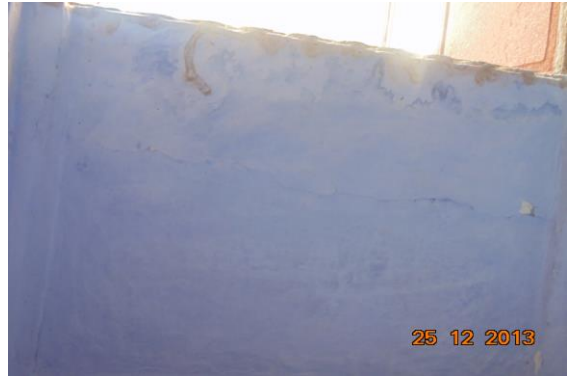
Photo 83

Dampness/Seepage on Wall No. 1 & Shade of Open Sky Area of House No. 347 Part A, First Floor

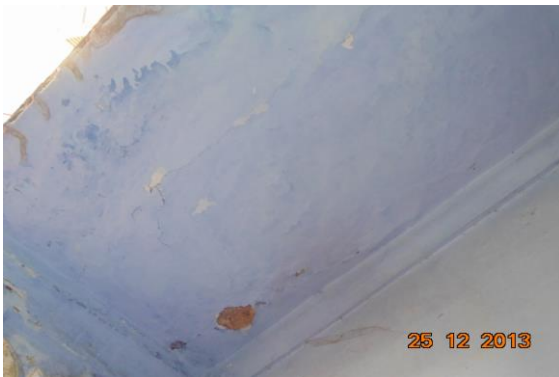
Photo 84

Dampness/Seepage on Wall No. 1 & Shade of Open Sky Area of House No. 347 Part A, First Floor

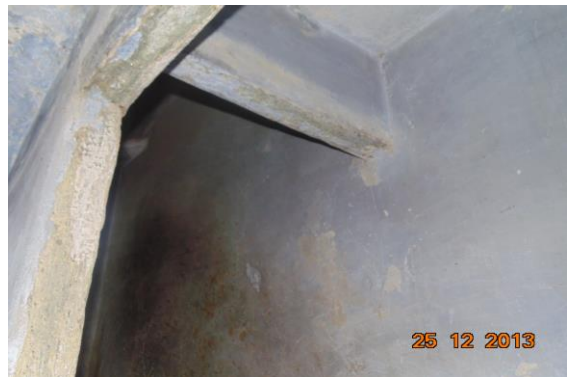
Photo 85

Dampness/Seepage on Wall No. 1, 2 & Roof of Stair of House No. 347 Part A, First Floor to Second Floor

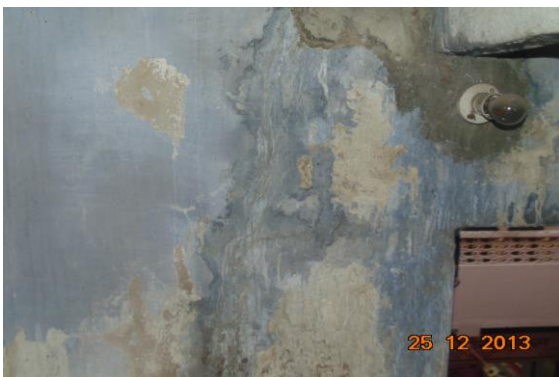
Photo 86

Dampness/Seepage on Wall No. 2 of Stair of House No. 347 Part A, First Floor to Second Floor

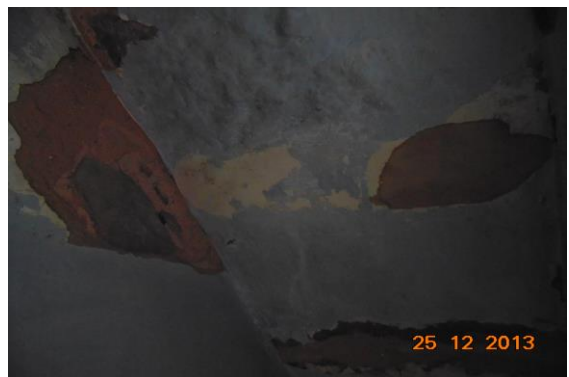
Photo 87

Dampness/Seepage on Wall No. 2 & Roof of Stair of House No. 347 Part A, First Floor to Second Floor

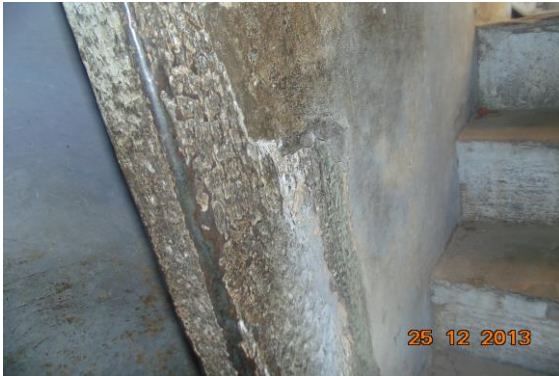
Photo 88

Peeling of Plaster on Wall No. 1 of Stair of House No. 347 Part A, First Floor to Second Floor

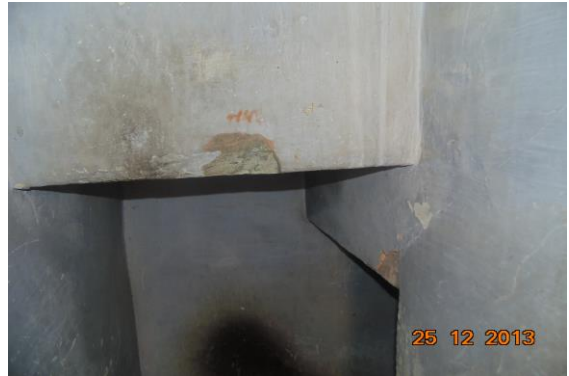
Photo 89

Peeling of Plaster on Wall No. 1 & Roof of Stair of House No. 347 Part A, First Floor to Second Floor

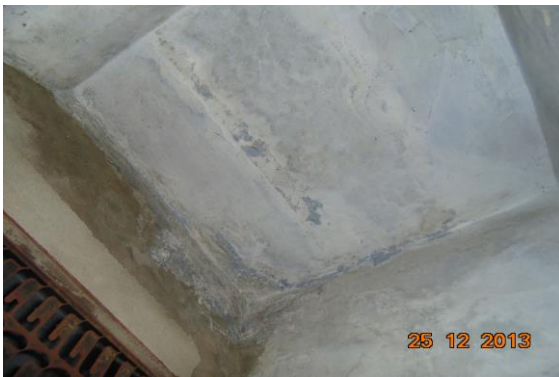
Photo 90

Dampness/Seepage on Wall No. 1, 2, 3 & Roof of Stair of House No. 347 Part A, First Floor to Second Floor

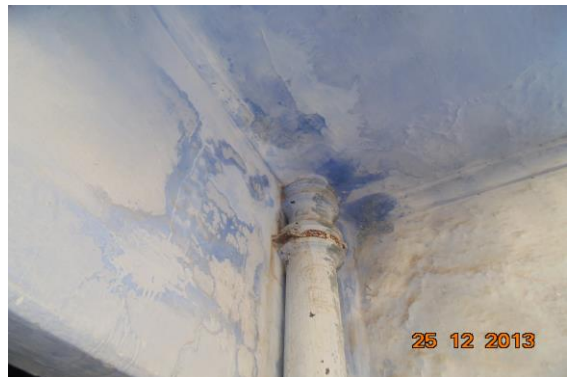
Photo 91

Dampness/Seepage on Wall No. 1, 3 & Shade of Open Sky Area of House No. 347 Part A, Second Floor

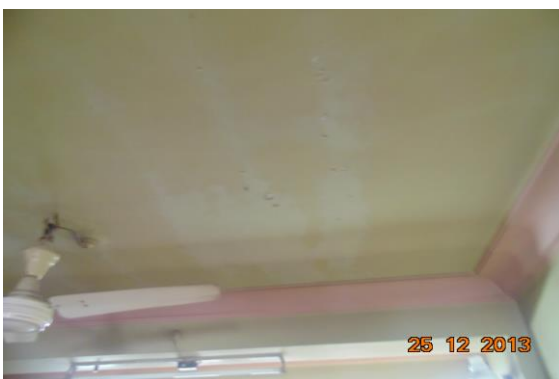
Photo 92

Dampness/Seepage on Roof of Hall No. 1 of House No. 347 Part A, Second Floor

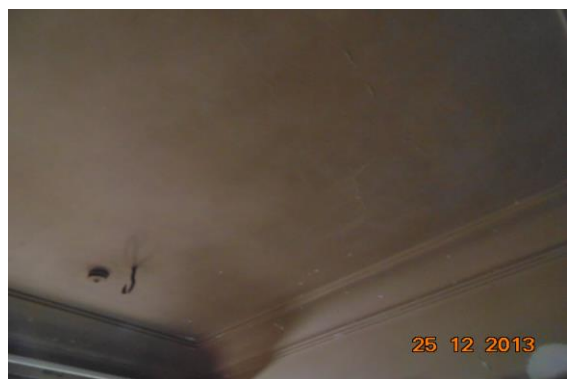
Photo 93

Dampness/Seepage on Roof of Kitchen of House No. 347 Part A, Second Floor

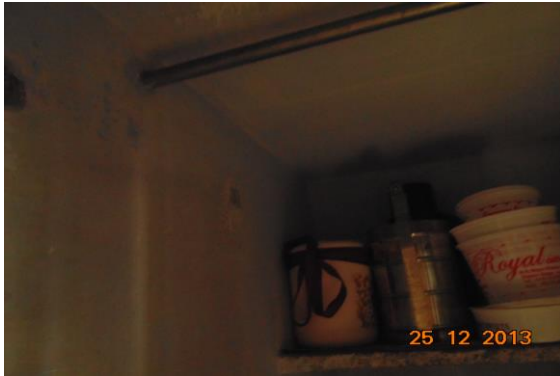
Photo 94

Dampness/Seepage on Wall No. 1 & Roof of Store of House No. 347 Part A, Second Floor

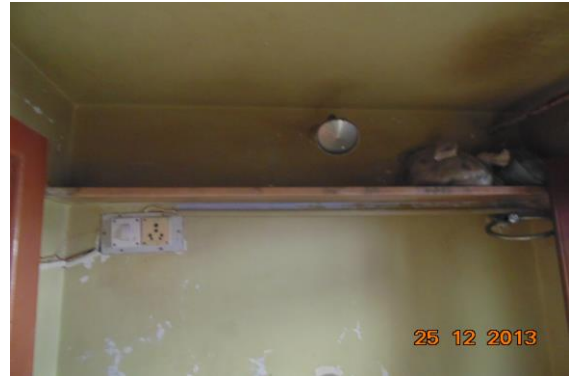
Photo 95

Dampness/Seepage on Wall No. 4 & Roof of Bathroom No. of House No. 347 Part A, Second Floor

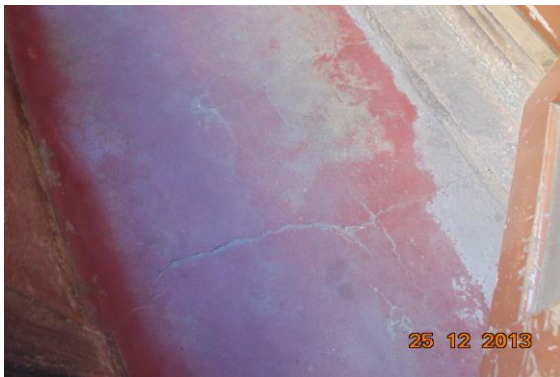
Photo 96

Plaster Crack on Floor of Balcony No. 3 of House No. 347 Part A, Second Floor

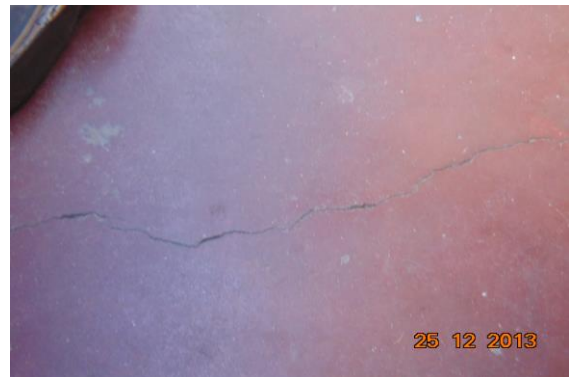
Photo 97

Plaster Crack on Floor of Balcony No. 3 of House No. 347 Part A, Second Floor

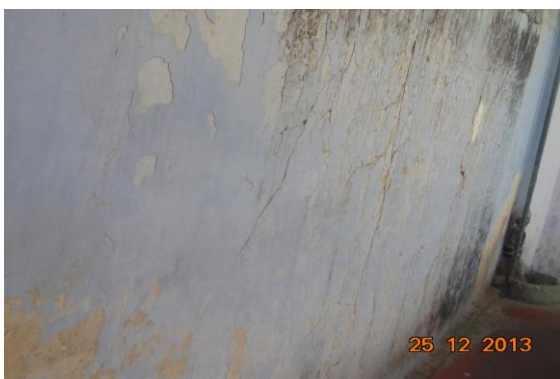
Photo 98

Dampness/Seepage on Wall No. 1 of Open Sky Area of House No. 347 Part A, Second Floor

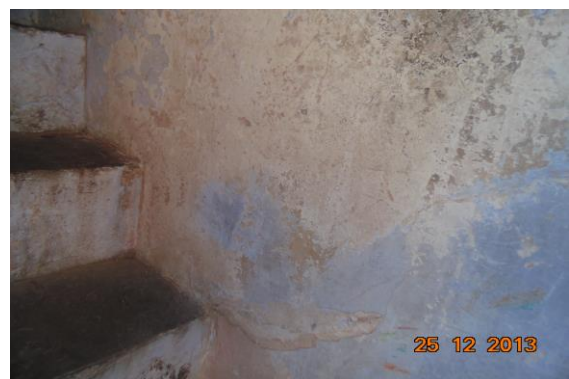
Photo 99

Dampness/Seepage on Wall No. 2 of Stair of House No. 347 Part A, Second Floor to Terrace Floor

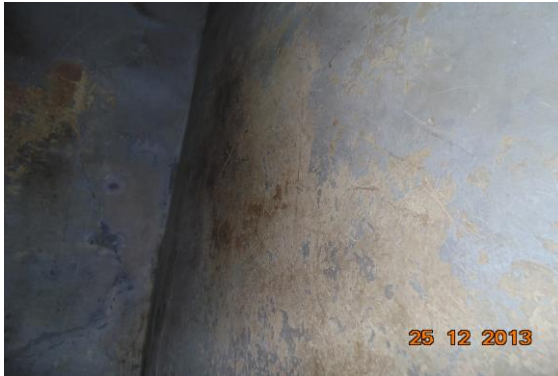
Photo 100

Dampness/Seepage on Wall No. 2 of Stair of House No. 347 Part A,
Second Floor to Terrace Floor

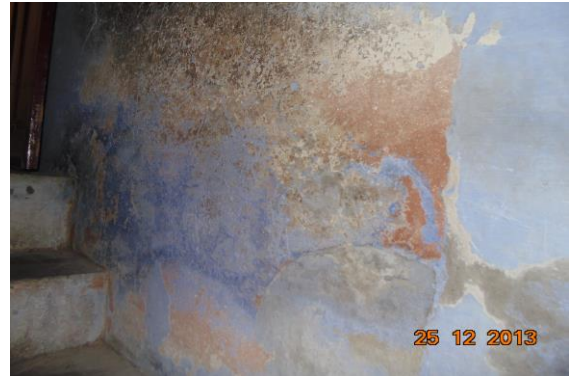
Photo 101

Peeling of Plaster on Wall No. 2 of Stair of House No. 347 Part A,
Second Floor to Terrace Floor

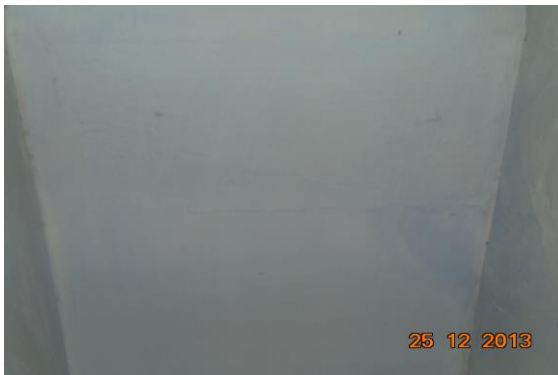
Photo 102

Plaster Crack on Roof of Stair of House No. 347 Part A, Second Floor to
Terrace Floor

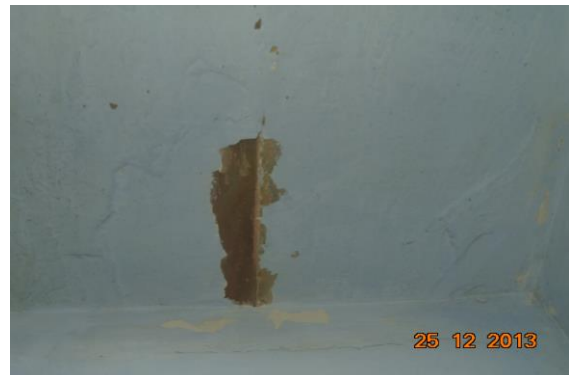
Photo 103

Peeling of Plaster on Roof of Stair of House No. 347 Part A, Second
Floor to Terrace Floor

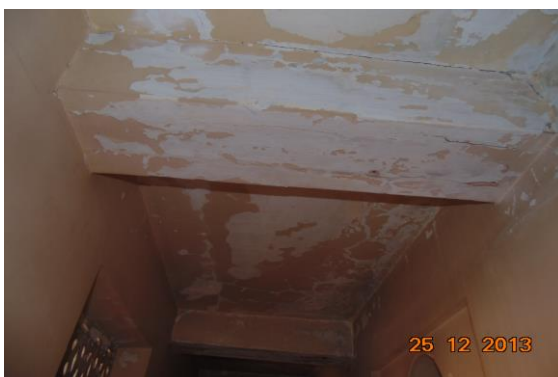
Photo 104

Peeling of Plaster on Roof of Passage of House No. 347 Part A, Second
Floor

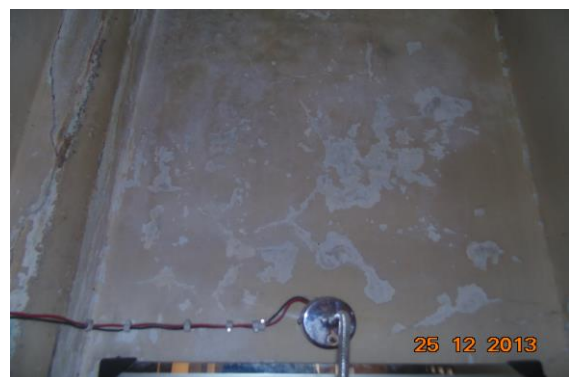
Photo 105

Peeling of Plaster on Wall No. 1 of Passage of House No. 347 Part A,
Second Floor

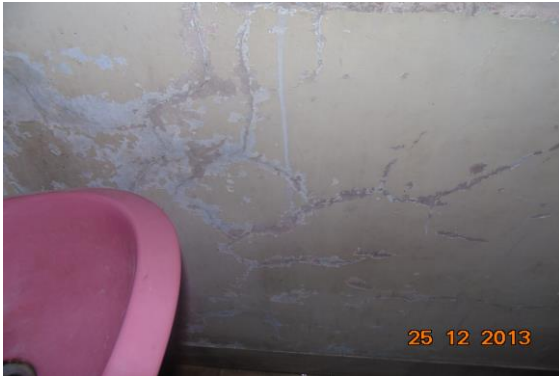
Photo 106
Plaster Crack on Wall No. 4 of Passage of House No. 347 Part A,
Second Floor

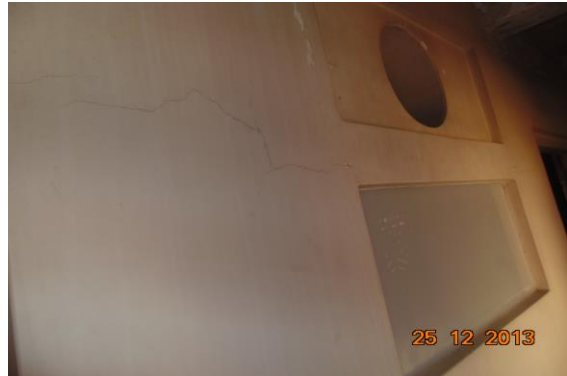
Photo 107
Plaster Crack on Wall No. 3 of Passage of House No. 347 Part A,
Second Floor

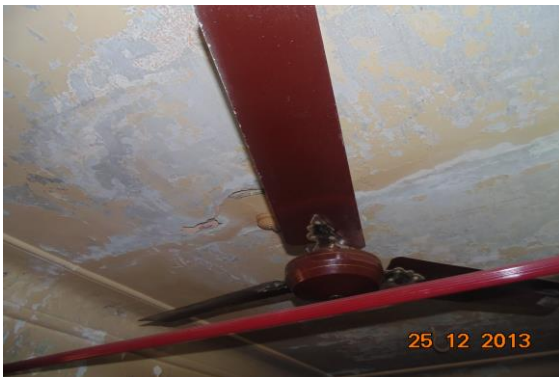
Photo 108
Plaster Crack on Roof of Lobby of House No. 347 Part A, Second Floor

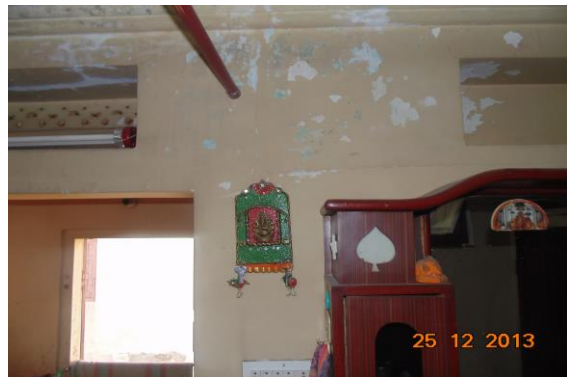
Photo 109
Plaster Crack on Wall No. 3 of Lobby of House No. 347 Part A, Second
Floor

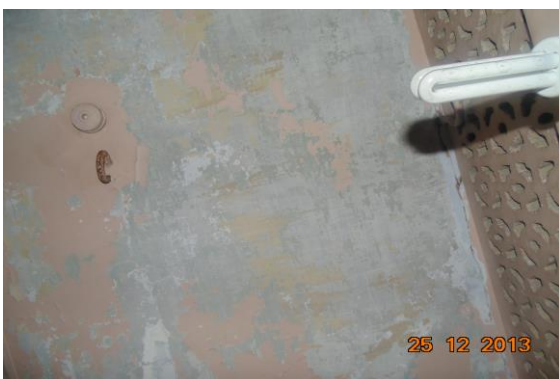
Photo 110
Peeling of Plaster on Roof of Toilet No. 1 of House No. 347 Part A,
Second Floor

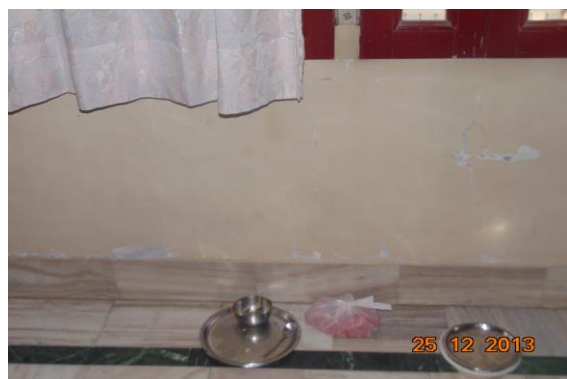
Photo 111
Peeling of Plaster on Wall No. 4 of Hall No. 1 of House No. 347 Part A,
Second Floor

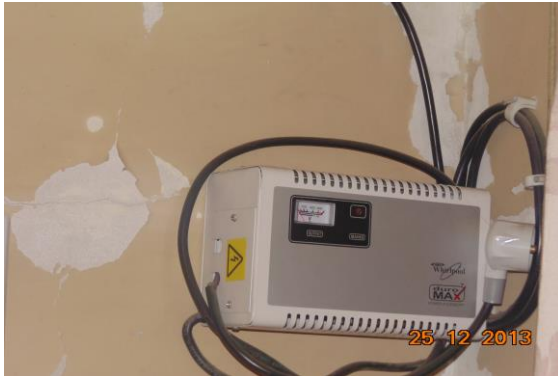
Photo 112

Peeling of Plaster on Wall No. 1 & 4 of Hall No. 1 of House No. 347 Part A, Second Floor

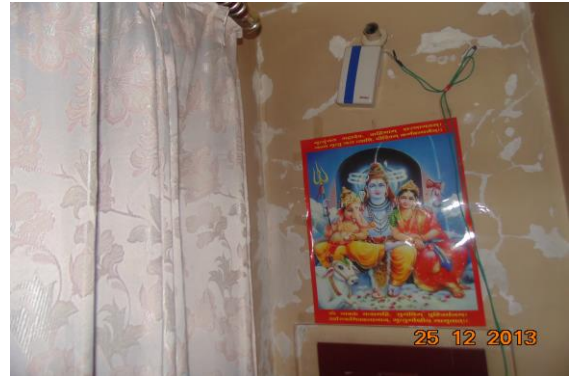
Photo 113

Peeling of Plaster on Wall No. 2 & 4 of Hall No. 1 of House No. 347 Part A, Second Floor

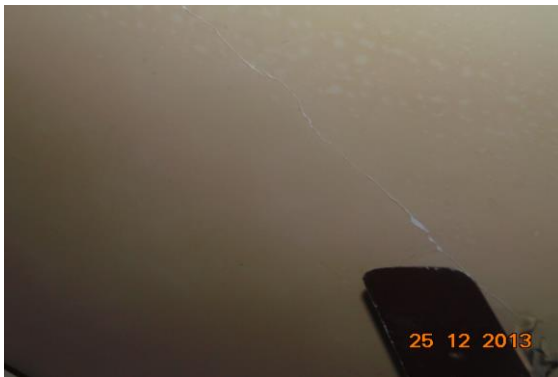
Photo 114

Plaster Crack on Roof of Hall No. 1 of House No. 347 Part A, Second Floor

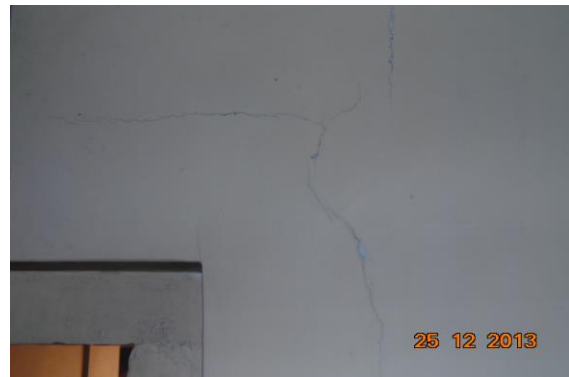
Photo 115

Plaster Crack on Wall No. 3 of Hall No. 1 of House No. 347 Part A, Second Floor

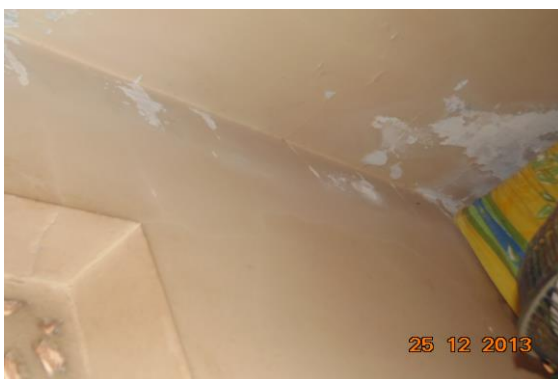
Photo 116

Peeling of Plaster on Wall No. 1 & Roof of Store of House No. 347 Part A, Second Floor

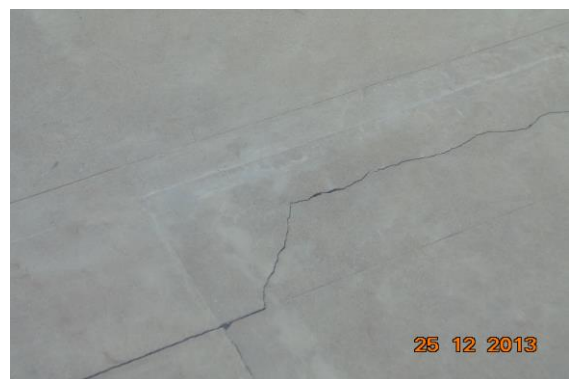
Photo 117

Peeling of Plaster on Floor of House No. 347 of Terrace

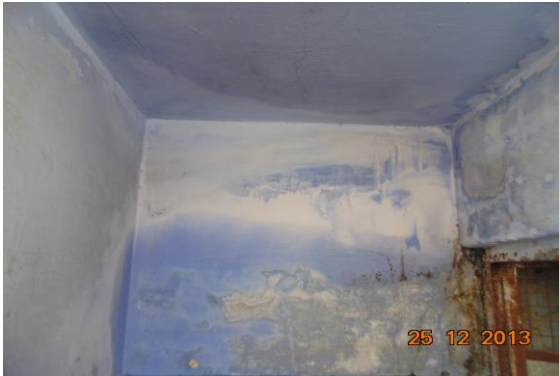
Photo 118

Dampness/Seepage on Wall No. 1, 2, 3 & Roof of House No. 347 of Terrace

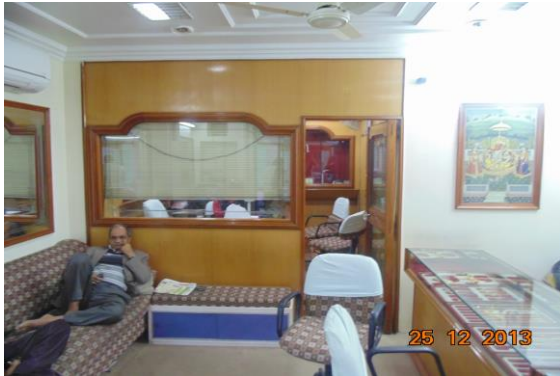
Photo 8
Horizontal Crack on Wall No. 1 of Room No. 1, Fourth Floor, Approx.
Width = 0.4mm, Approx. Length = 1.3m.
Distance from Wall No. 4 = 0.6m, Height from Floor = 2.1m.

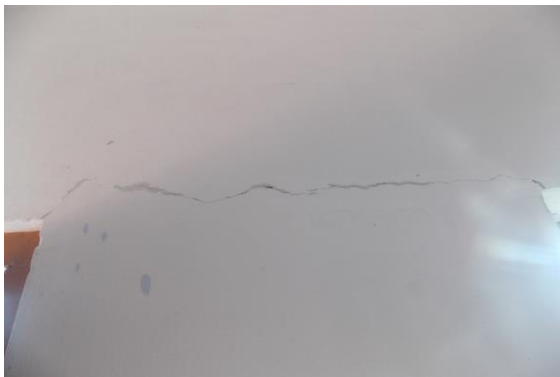
Photo 9
Horizontal Crack on Wall No. 1 of Room No. 1, Fourth Floor, Approx.
Width = 0.35mm, Approx. Length = 0.6m.
Distance from Wall No. 1 = 1m, Height from Floor = 2.7m.

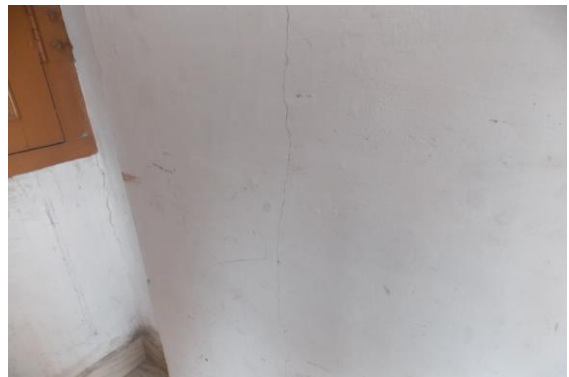
Photo 10
Inclined Crack on Wall No. 4 of Room No. 1, Fourth Floor, Approx.
Width = 0.2mm, Approx. Length = 2.5m.
Distance from Wall No. 5 = 0.3m, Height from Floor = 0m.

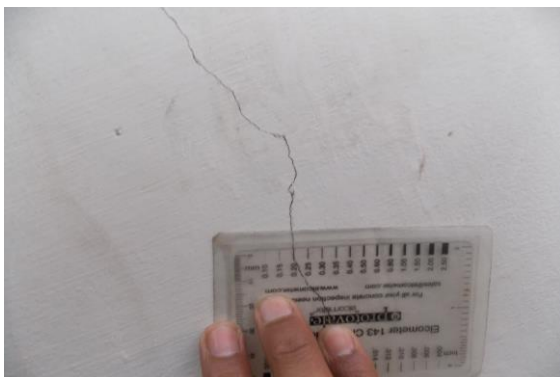
Photo 11
Inclined Crack on Wall No. 4 of Room No. 1, Fourth Floor, Approx.
Width = 0.2mm, Approx. Length = 2.5m.
Distance from Wall No. 5 = 0.3m, Height from Floor = 0m.

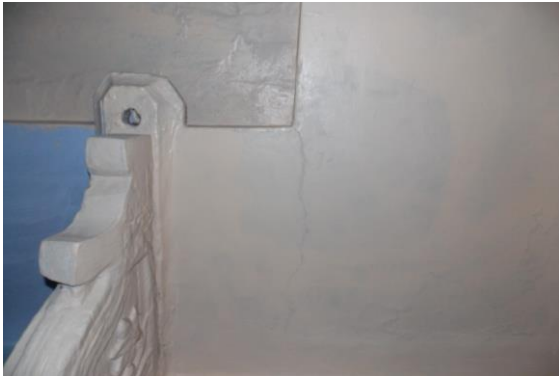
Photo 13
Peeling of Plaster on Roof of Open Sky of First Floor

Summary of Defects Other Than Crack			
Defect ID	Location	Description	Photo No.
5	Wall No. 1 Open Sky First Floor	Peeling of Plaster	12
6	Roof Open Sky First Floor	Peeling of Plaster	13
7	Wall No. 1 Staircase First Floor to Second Floor First Floor	Peeling of Plaster	14
8	Wall No. 4 Staircase First Floor to Second Floor First Floor	Peeling of Plaster	15
9	Roof Room No. 2 Second Floor	Peeling of Plaster	16
10	Wall No. 4 Open Sky Second Floor	Peeling of Plaster	17
11	Wall No. 3 Balcony Second Floor	Peeling of Plaster	18
12	Wall No. 3 Room No. 1 Third Floor	Peeling of Plaster	19

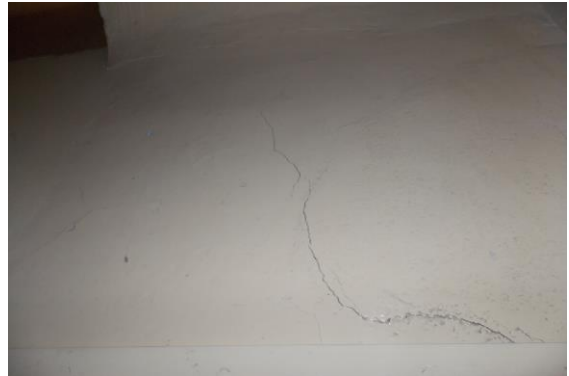
Photo 14
Peeling of Plaster on Wall No. 1 of Staircase First Floor to Second Floor of First Floor

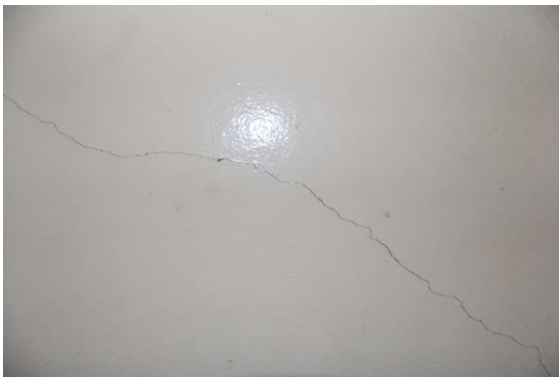
Photo 15
Peeling of Plaster on Wall No. 4 of Staircase First Floor to Second Floor of First Floor

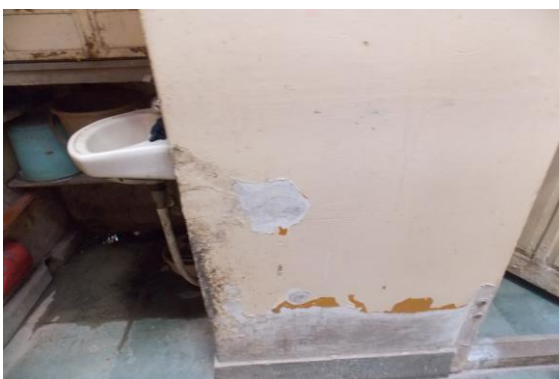
Photo 17
Peeling of Plaster on Wall No. 4 of Open Sky of Second Floor

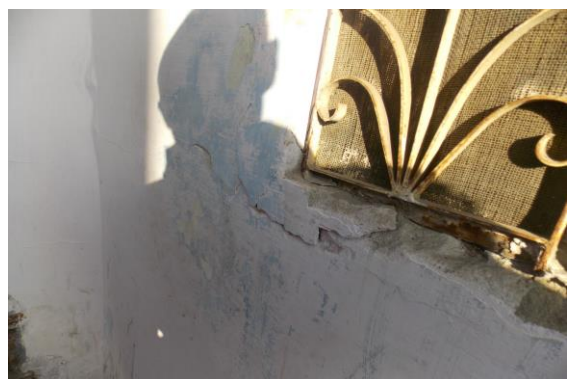
Photo 18
Peeling of Plaster on Wall No. 3 of Balcony of Second Floor

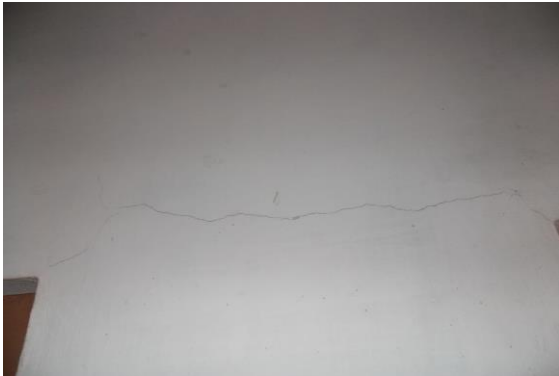
Photo 19

Peeling of Plaster on Wall No. 3 of Room No. 1 of Third Floor

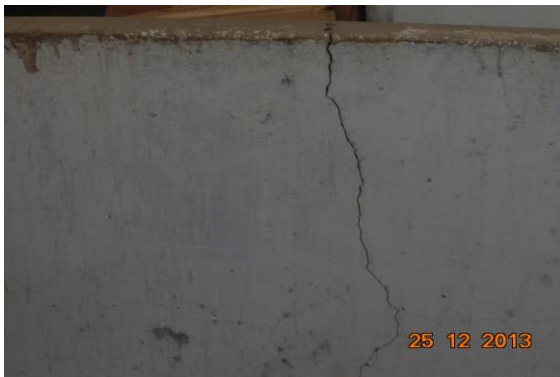
Photo 21
Vertical Crack on Wall No. 1 of Open Sky, First Floor, Approx. Width = 2mm, Approx. Length = 1m.
Distance from Wall No.4 = 2.5m, Height from Floor = 0m.

Summary of Cracks						
Defect ID	Location	Orientation	Appx. Width (mm)	Appx. Length (m)	Category	Photo No.
1	Wall No. 1 Open Sky First Floor	Vertical	2	1	Slight	21, 21A
2	Parapet wall no.1 & Floor Balcony No.4 First Floor	Inclined	0.6	0.8	Very Slight	22, 22A
3	Wall No. 4 & Floor Room No. 3 Jain Dharamshala, Second Floor	Inclined	1.5	3	Slight	23, 23A
4	Shade Balcony No.3 Second Floor	Inclined	2.5	1	Slight	24
5	Outerwall No.3 Room No. 3 Jain Dharamshala, Second Floor	Inclined	1	1.5	Slight	25
6	Parapet wall no.3 Open Sky Second Floor	Vertical	1.5	1	Slight	26, 26A
7	Wall No. 3 Jain Dharamshala Terrace	Inclined	0.8	1	Very Slight	27, 27A
8	Wall No. 1 Jain Dharamshala Terrace	Inclined	7	2	Moderate	28
9	Wall No. 2 Jain Dharamshala Terrace	Inclined	0.6	0.9	Very Slight	29, 29A
10	Wall No. 2 & 3 Jain Dharamshala Terrace	Inclined	5	5	Moderate	30
11	Wall No. 2 Jain Dharamshala Terrace	Inclined	1	1	Slight	31, 31A

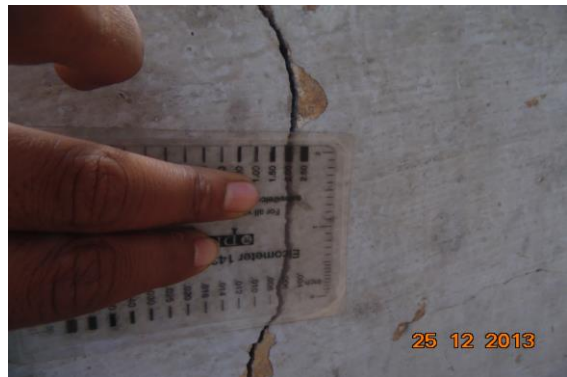
Photo 21A
Vertical Crack on Wall No. 1 of Open Sky, First Floor, Approx. Width = 2mm, Approx. Length = 1m.
Distance from Wall No.4 = 2.5m, Height from Floor = 0m.

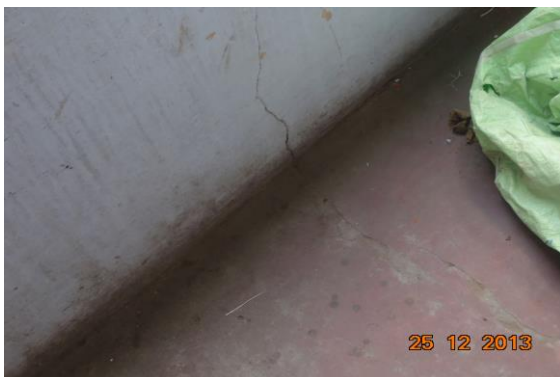
Photo 22
Inclined Crack on Parapet wall no.1 & Floor of Balcony No.4, First Floor
Approx. Width = 0.6mm, Approx. Length = 0.8m.
Distance from Wall No.3 = 1.5m, Height from Floor = 0m.

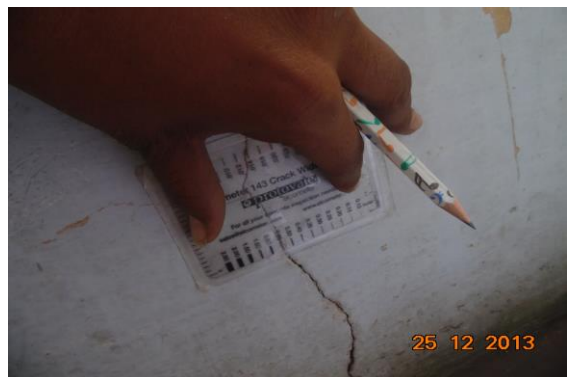
Photo 22A
Inclined Crack on Parapet wall no.1 & Floor of Balcony No.4, First Floor
Approx. Width = 0.6mm, Approx. Length = 0.8m.
Distance from Wall No.3 = 1.5m, Height from Floor = 0m.

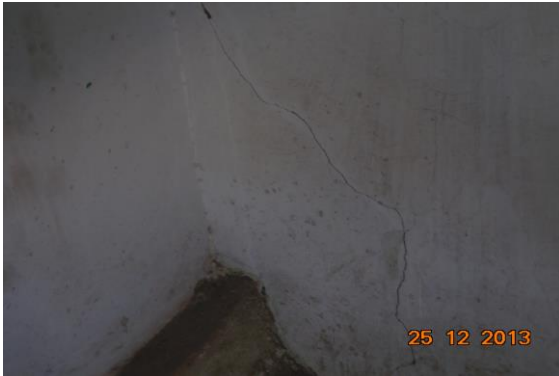
PHOTO 23

Inclined Crack on Wall No. 4 & Floor of Room No. 3, Jain Dharamshala, Second Floor

Approx. Width = 1.5mm, Approx. Length = 3m.
Distance from Wall No.3 = 0m Height from Floor = 0m.

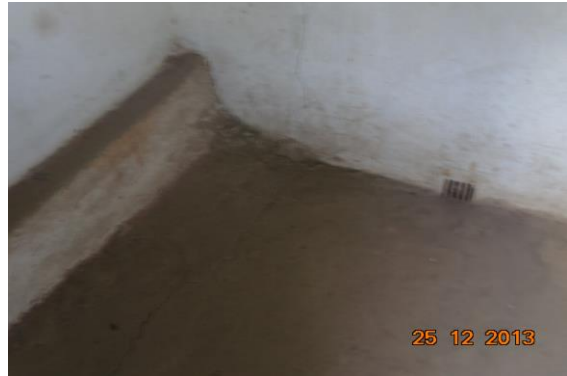
PHOTO 23A

Approx. Width = 1.5mm, Approx. Length = 3m.
Distance from Wall No.3 = 0m Height from Floor = 0m.

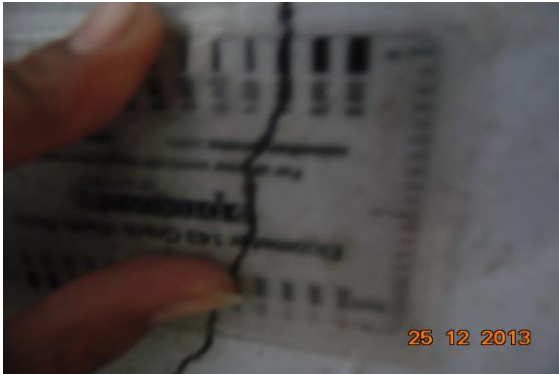
PHOTO 23A

Inclined Crack on Wall No. 4 & Floor of Room No. 3, Jain Dharamshala, Second Floor

Approx. Width = 1.5mm, Approx. Length = 3m.
Distance from Wall No.3 = 0m Height from Floor = 0m

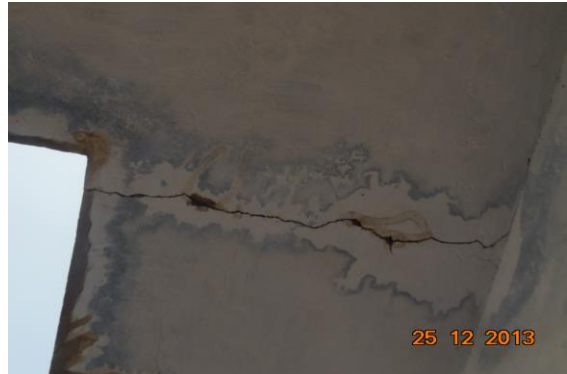
Photo 24

Inclined Crack on Shade of Balcony No.3, Second Floor, Approx. Width = 2.5mm, Approx. Length = 1m.
Distance from Wall No. 1 = 1m, Height from Floor = 0m.

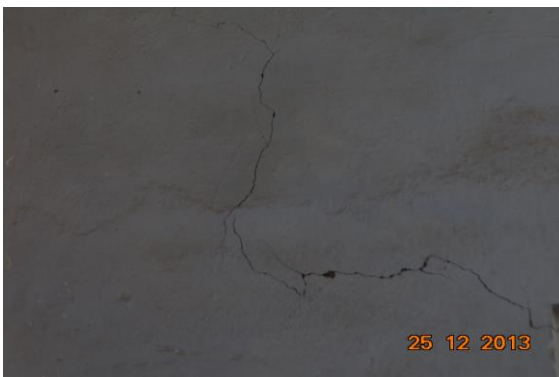
Photo 25

Inclined Crack on Outerwall No.3 of Room No. 3, Jain Dharamshala, Second Floor, Approx. Width = 1mm, Approx. Length = 1.5m.
Distance from Balcony No.1 = 1m, Height from Floor = 2.2m.

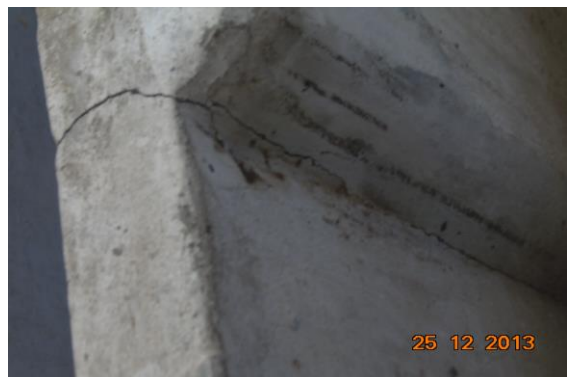
Photo 26

Vertical Crack on Parapet wall no.3 of Open Sky, Second Floor, Approx. Width = 1.5mm, Approx. Length = 1m.
Distance from Balcony No.1 = 1.2m, Height from Floor = 0m.

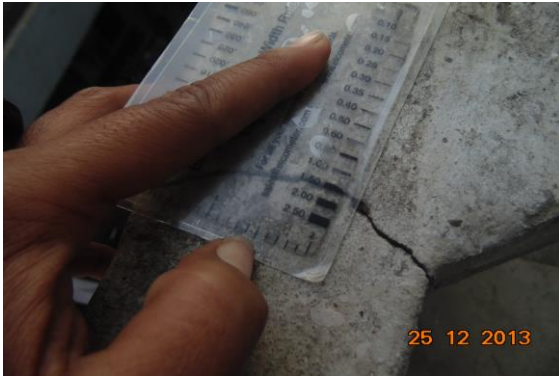
Photo 26A

Vertical Crack on Parapet wall no.3 of Open Sky, Second Floor, Approx.
Width = 1.5mm, Approx. Length = 1m.
Distance from Balcony No.1 = 1.2m, Height from Floor = 0m.

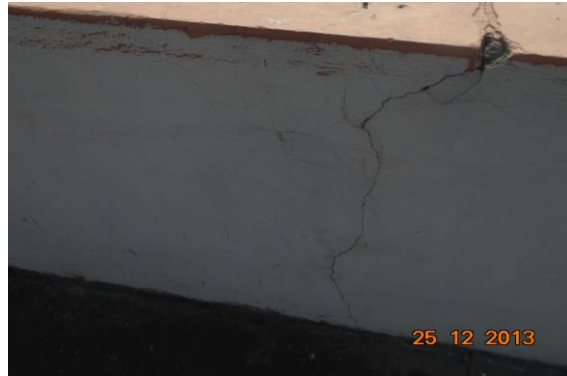
Photo 27

Inclined Crack on Wall No. 3 of Jain Dharamshala, Terrace, Approx.
Width = 0.8mm, Approx. Length = 1m.
Distance from Wall No.2 = 5m, Height from Floor = 0m.

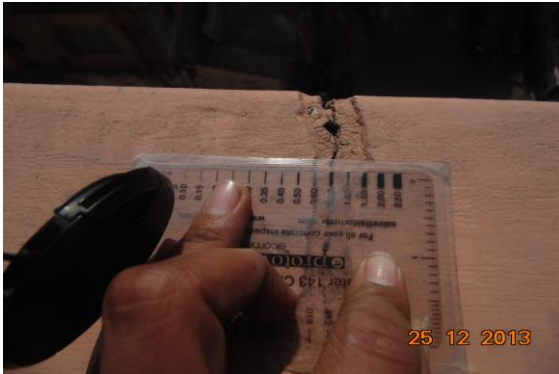
Photo 27A

Inclined Crack on Wall No. 3 of Jain Dharamshala, Terrace, Approx.
Width = 0.8mm, Approx. Length = 1m.
Distance from Wall No.2 = 5m, Height from Floor = 0m.

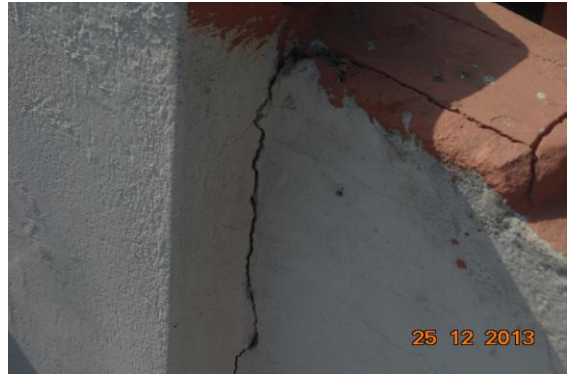
Photo 28

Inclined Crack on Wall No. 1 of Jain Dharamshala, Terrace, Approx.
Width = 7mm, Approx. Length = 2m.
Distance from = m, Height from Floor = m.

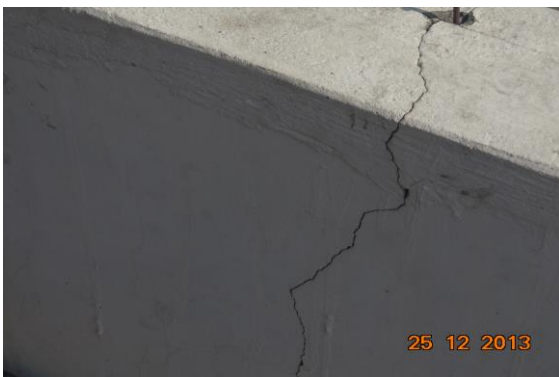
Photo 29

Inclined Crack on Wall No. 2 of Jain Dharamshala, Terrace, Approx.
Width = 0.6mm, Approx. Length = 0.9m.
Distance from Wall No.3 = 7m, Height from Floor = 0m.

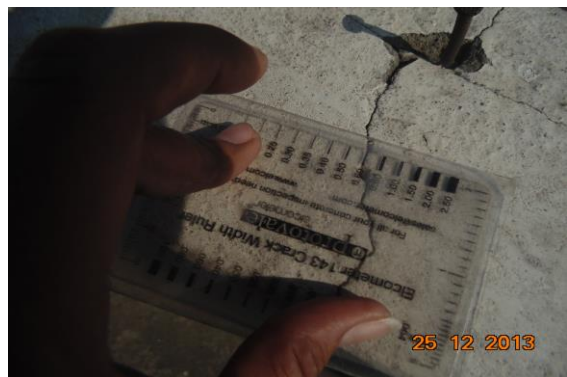
Photo 29A

Inclined Crack on Wall No. 2 of Jain Dharamshala, Terrace, Approx.
Width = 0.6mm, Approx. Length = 0.9m.
Distance from Wall No.3 = 7m, Height from Floor = 0m.

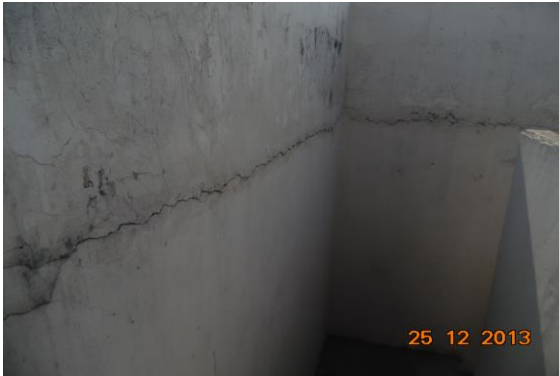
Photo 30

Inclined Crack on Wall No. 2 & 3 of Jain Dharamshala, Terrace, Approx.
Width = 5mm, Approx. Length = 5m.
Distance from = m, Height from Floor = m.

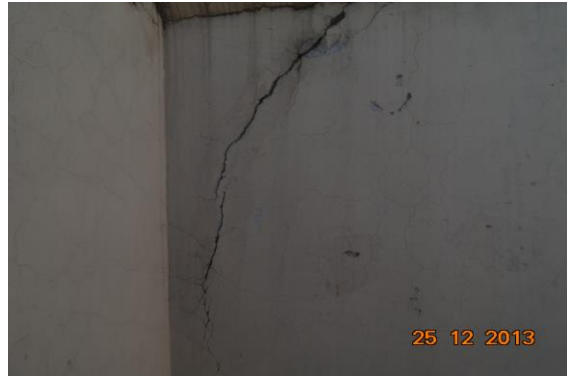
Photo 31

Inclined Crack on Wall No. 2 of Jain Dharamshala, Terrace, Approx.
Width = 1mm, Approx. Length = 1m.
Distance from Wall No.4 = 0.5m, Height from Floor = 1m.

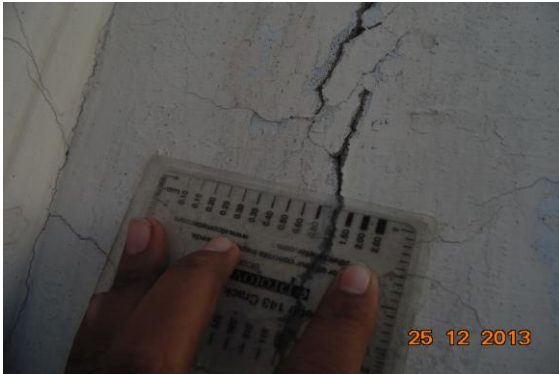
Photo 31A

Inclined Crack on Wall No. 2 of Jain Dharamshala, Terrace, Approx.
Width = 1mm, Approx. Length = 1m.
Distance from Wall No.4 = 0.5m, Height from Floor = 1m.

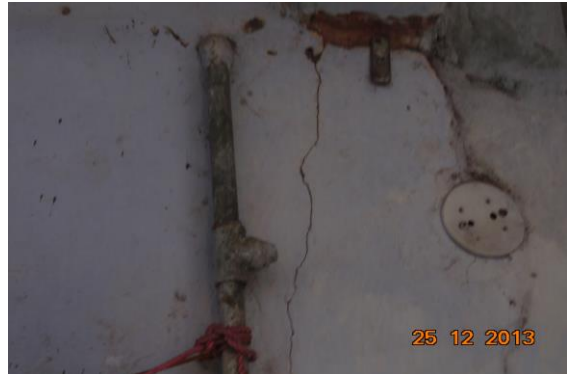
Photo 32

Inclined Crack on Wall No. 4 of Jain Dharamshala, Ground Floor,
Approx. Width = 0.6mm, Approx. Length = 0.4m.
Distance from Wall No. 2 = 1.5m, Height from Floor = 2m.

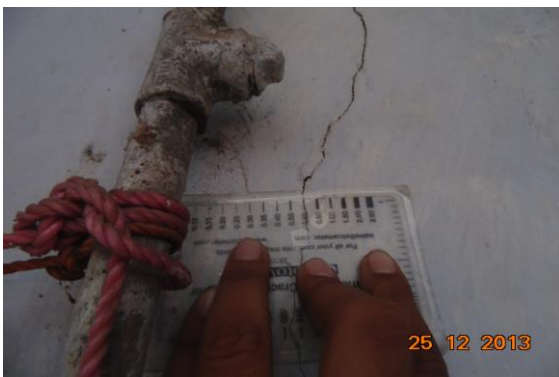
Photo 32A

Inclined Crack on Wall No. 4 of Jain Dharamshala, Ground Floor,
Approx. Width = 0.6mm, Approx. Length = 0.4m.
Distance from Wall No. 2 = 1.5m, Height from Floor = 2m.

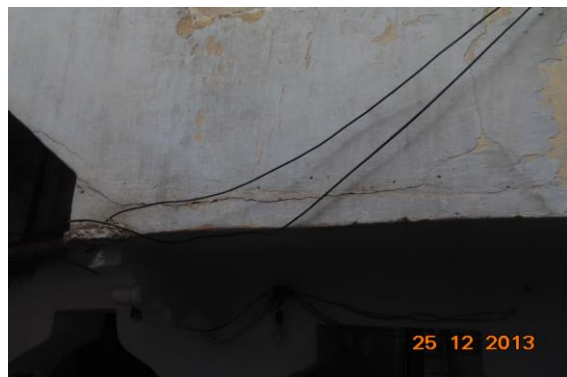
Photo 33

Horizontal Crack on Wall No. 1 of Jain Dharamshala, Ground Floor,
Approx. Width = 1mm, Approx. Length = 1.5m.
Distance from Wall No. 3 = 1.8m, Height from Floor = 2.2m.

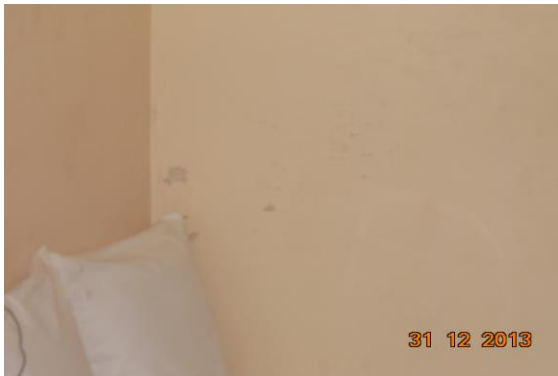
Photo 34

Peeling of Plaster on Wall No. 3 of Part C of Shop No. 3, Ground Floor

Summary of Defects Other Than Crack			
Defect ID	Location	Description	Photo No.
14	Wall No. 3 Part C Shop No. 3, Ground Floor	Peeling of Plaster	34
15	Wall No. 2 Staircase Area First Floor	Plaster Crack	35
16	Wall No. 4 Staircase Area First Floor	Dampness/Seepage	36
17	Roof Lobby First Floor	Dampness/Seepage	37
18	Wall No. 2 Lobby First Floor	Plaster Crack	38
19	Wall No. 4 Bathroom No. 1 Jain Dharamshala, First Floor	Dampness/Seepage	39
20	Wall No. 1 & Roof Hall No. 1 Jain Dharamshala, First Floor	Dampness/Seepage	40
21	Roof Room No. 6 Jain Dharamshala, First Floor	Dampness/Seepage	41
22	Wall No. 4 Room No. 6 Jain Dharamshala, First Floor	Dampness/Seepage	42
23	Wall No. 3 Hall No. 2 Jain Dharamshala, First Floor	Peeling of Plaster	43
24	Roof Hall No. 2 Jain Dharamshala, First Floor	Plaster Crack	44
25	Wall No. 1 Room No. 3 Jain Dharamshala, First Floor	Peeling of Plaster	45
26	Wall No. 2 Room No. 3 Jain Dharamshala, First Floor	Damaged Portion	46

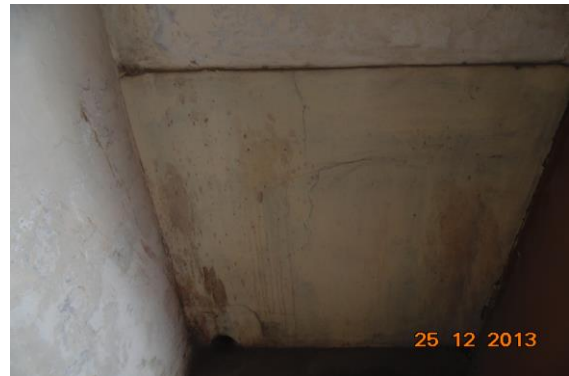
Photo 35

Plaster Crack on Wall No. 2 of Staircase Area of First Floor

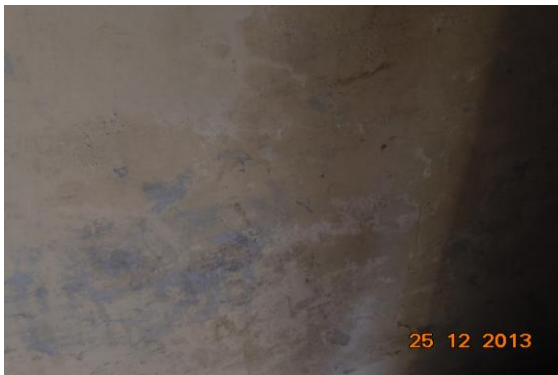
Photo 36

Dampness/Seepage on Wall No. 4 of Staircase Area of First Floor

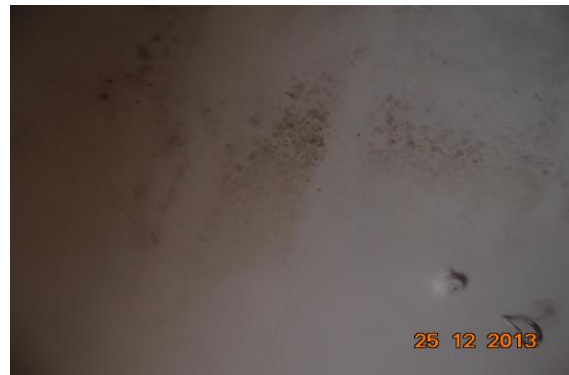
Photo 37

Dampness/Seepage on Roof of Lobby of First Floor

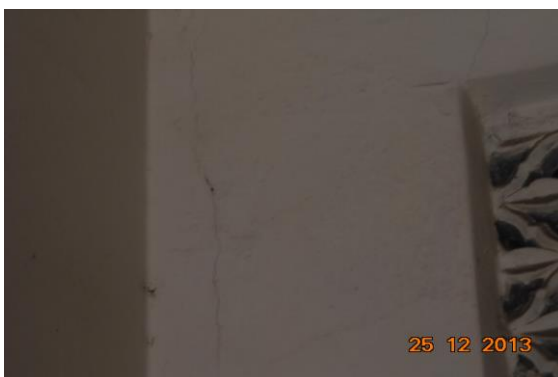
Photo 38

Plaster Crack on Wall No. 2 of Lobby of First Floor

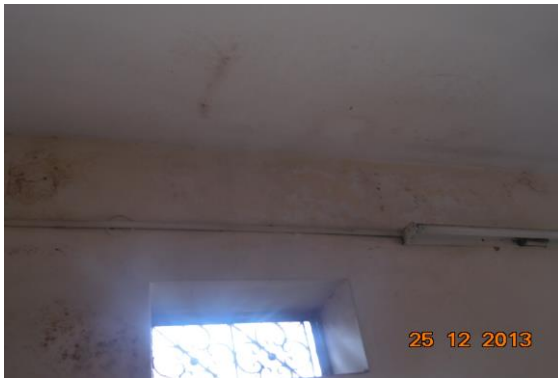
Photo 40

Dampness/Seepage on Wall No. 1 & Roof of Hall No. 1 of Jain Dharamshala, First Floor

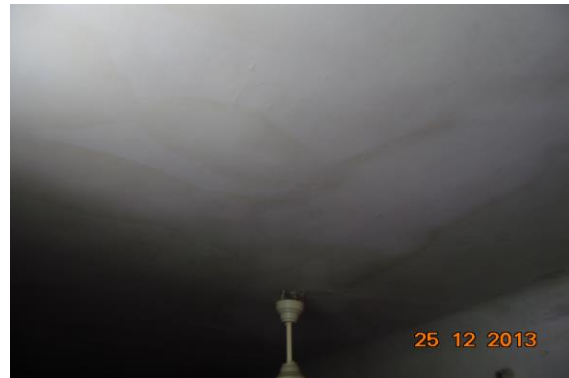
Photo 41

Dampness/Seepage on Roof of Room No. 6 of Jain Dharamshala, First Floor

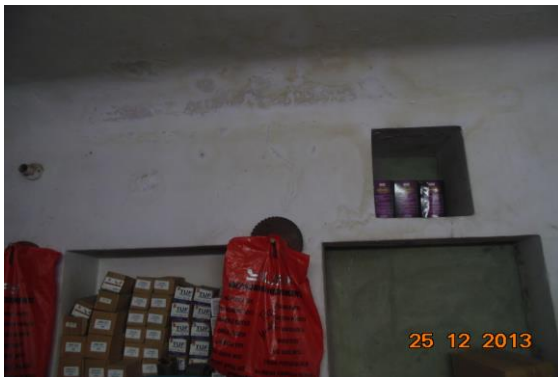
Photo 42

Dampness/Seepage on Wall No. 4 of Room No. 6 of Jain Dharamshala, First Floor

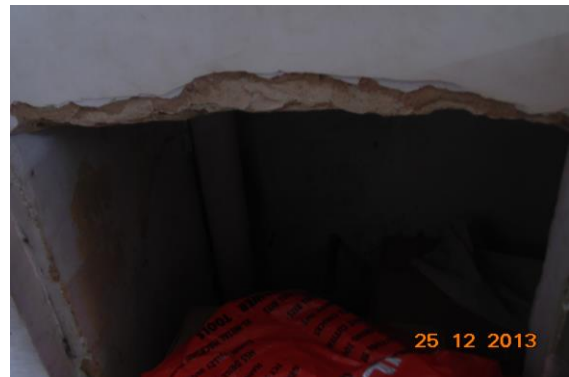
Photo 43

Peeling of Plaster on Wall No. 3 of Hall No. 2 of Jain Dharamshala, First Floor

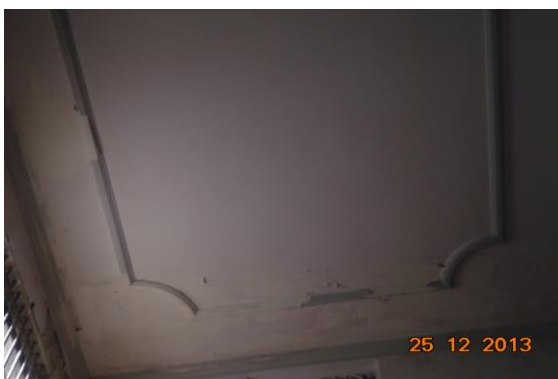
Photo 44

Plaster Crack on Roof of Hall No. 2 of Jain Dharamshala, First Floor

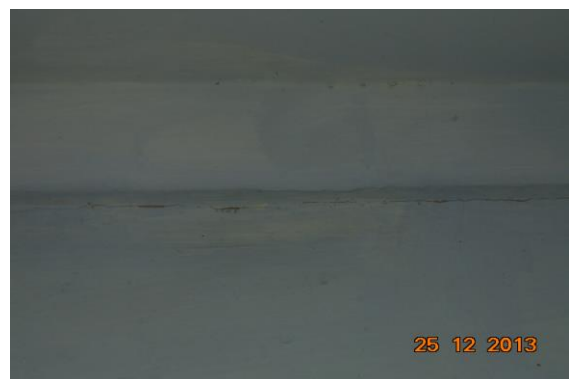
Photo 45

Peeling of Plaster on Wall No. 1 of Room No. 3 of Jain Dharamshala, First Floor
