Pre Building Condition Survey Report

Name and Address of Structure :	Badi Chopar to Ramp Area (Down Line)
---------------------------------	--------------------------------------

Name of the Project	Contract JMRC-UG1B “Design and Construction of Tunnel between Chandpole and Badi Chouper and reverse line by Shield TBM, Underground Metro Stations at Choti Chouper and Badi Chouper by Cut and Cover Methods on East West Corridor of Jaipur Metro Rail Corporation Limited .”	
Owner :

Pre - Condition Building Survey for Construction of Underground Stations from Chandpole to Bari Chouper and reversal line

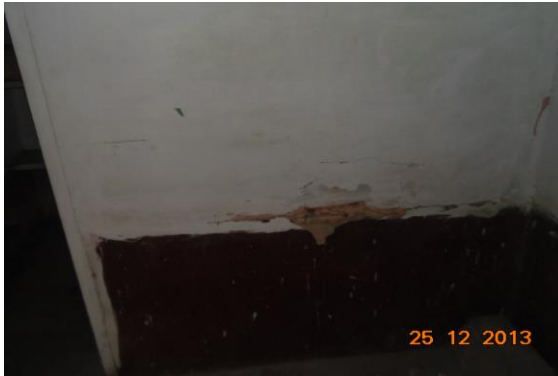
Photo 46

Damaged Portion on Wall No. 2 of Room No. 3 of Jain Dharamshala, First Floor

Summary of Defects Other Than Crack			
Defect ID	Location	Description	Photo No.
14	Wall No. 3 Part C Shop No. 3, Ground Floor	Peeling of Plaster	34
15	Wall No. 2 Staircase Area First Floor	Plaster Crack	35
16	Wall No. 4 Staircase Area First Floor	Dampness/Seepage	36
17	Roof Lobby First Floor	Dampness/Seepage	37
18	Wall No. 2 Lobby First Floor	Plaster Crack	38
19	Wall No. 4 Bathroom No. 1 Jain Dharamshala, First Floor	Dampness/Seepage	39
20	Wall No. 1 & Roof Hall No. 1 Jain Dharamshala, First Floor	Dampness/Seepage	40
21	Roof Room No. 6 Jain Dharamshala, First Floor	Dampness/Seepage	41
22	Wall No. 4 Room No. 6 Jain Dharamshala, First Floor	Dampness/Seepage	42
23	Wall No. 3 Hall No. 2 Jain Dharamshala, First Floor	Peeling of Plaster	43
24	Roof Hall No. 2 Jain Dharamshala, First Floor	Plaster Crack	44
25	Wall No. 1 Room No. 3 Jain Dharamshala, First Floor	Peeling of Plaster	45
26	Wall No. 2 Room No. 3 Jain Dharamshala, First Floor	Damaged Portion	46

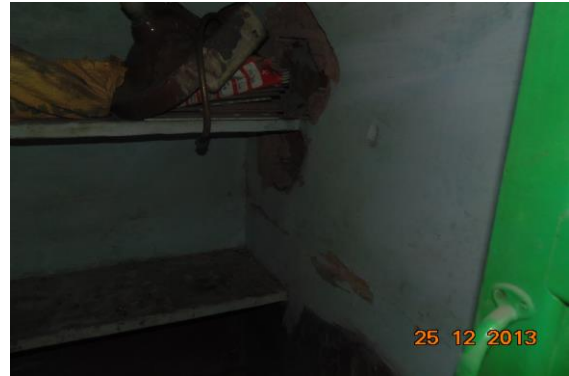
Photo 47

Peeling of Plaster on Wall No. 2 of Store No.1 of First Floor

27	Wall No. 2 Store No.1 First Floor	Peeling of Plaster	47
28	Shade Balcony First Floor	Damaged Portion	48
29	Wall No. 1 Balcony First Floor	Damaged Portion	49
30	Wall No. 4 Balcony No.4 First Floor	Dampness/Seepage	50
31	Shade Balcony No.4 First Floor	Damaged Portion	51
32	Wall No. 1 Balcony No.2 First Floor	Peeling of Plaster	52
33	Outerwall No.3 Toilet No. 1 Jain Dharamshala, First Floor	Dampness/Seepage	53
34	Shade Balcony No.5 First Floor	Plaster Crack	54
35	Wall No. 4 Room No. 2 Jain Dharamshala, Second Floor	Peeling of Plaster	55
36	Outerwall No.3 Room No. 2 Jain Dharamshala, Second Floor	Peeling of Plaster	56

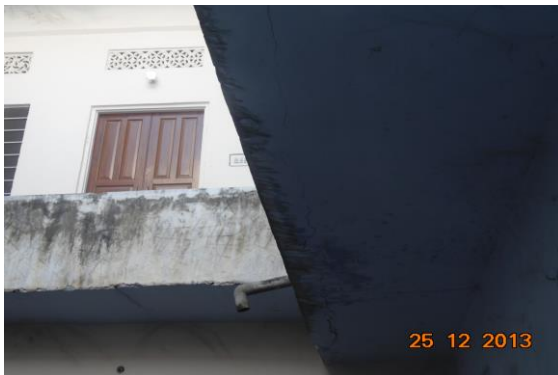
Photo 48

Damaged Portion on Shade of Balcony of First Floor

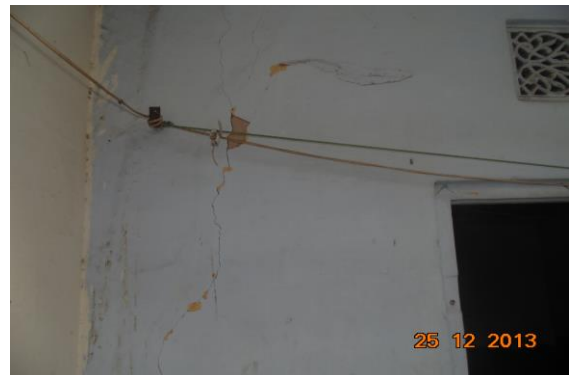
Photo 49

Damaged Portion on Wall No. 1 of Balcony of First Floor

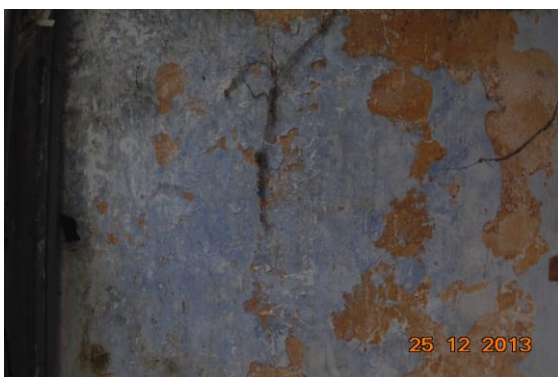
Photo 50

Dampness/Seepage on Wall No. 4 of Balcony No.4 of First Floor

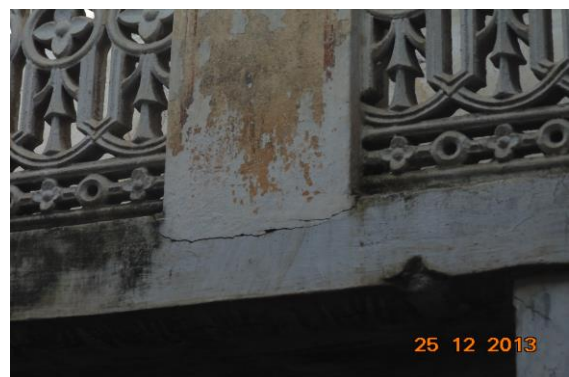
Photo 51

Damaged Portion on Shade of Balcony No.4 of First Floor

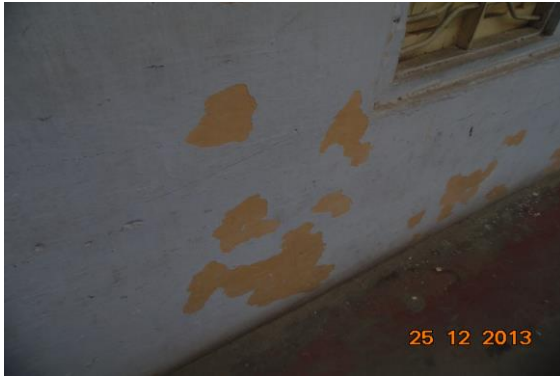
Photo 52

Peeling of Plaster on Wall No. 1 of Balcony No.2 of First Floor

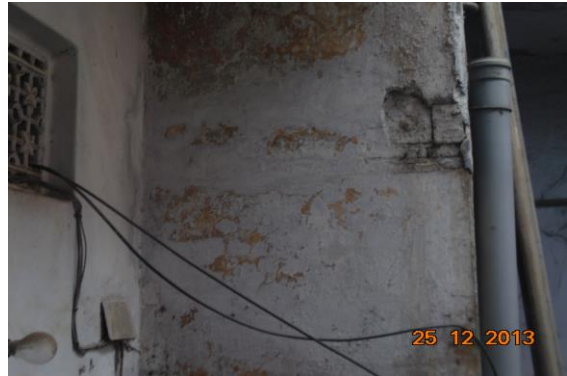
Photo 53

Dampness/Seepage on Outerwall No.3 of Toilet No. 1 of Jain Dharamshala, First Floor

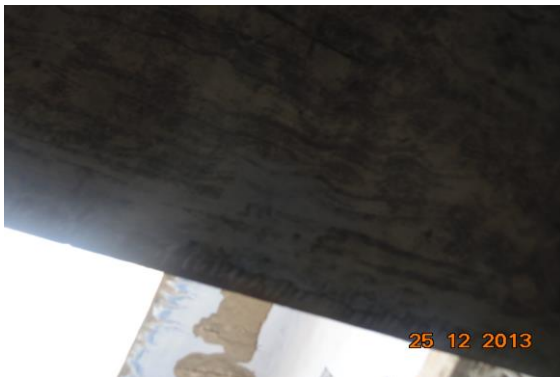
Photo 54

Plaster Crack on Shade of Balcony No.5 of First Floor

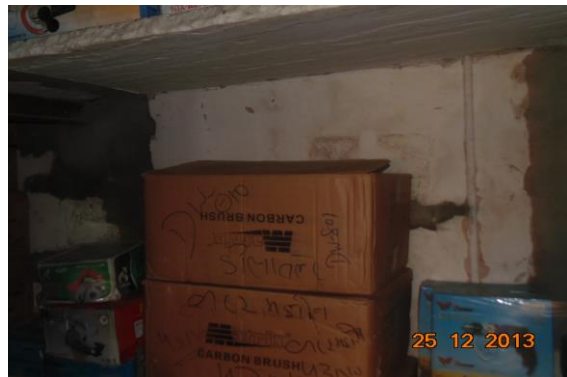
Photo 55

Peeling of Plaster on Wall No. 4 of Room No. 2 of Jain Dharamshala, Second Floor

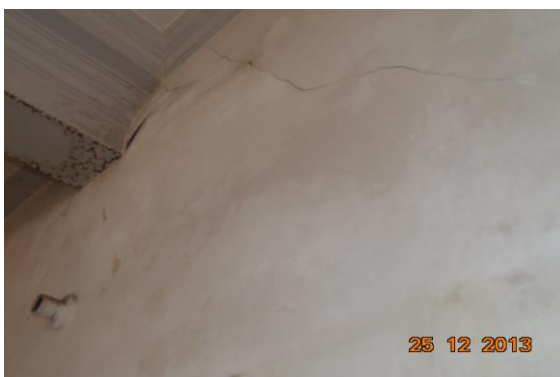
Photo 56

Peeling of Plaster on Outerwall No.3 of Room No. 2 of Jain Dharamshala, Second Floor

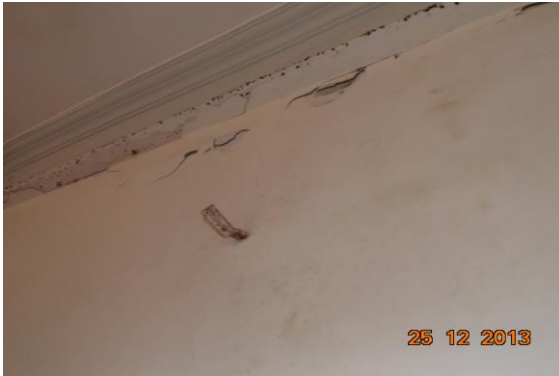
Photo 58

Dampness/Seepage on Wall No. 4 of Balcony No.2 of Second Floor

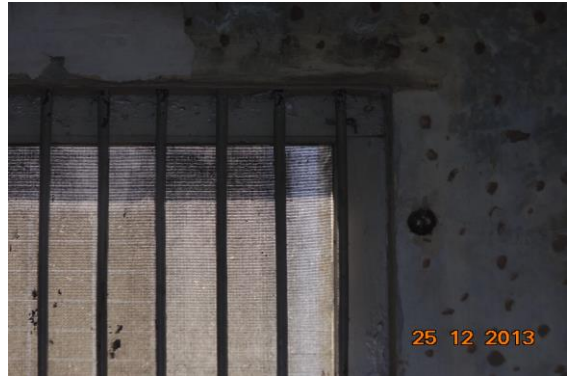
Photo 59

Dampness/Seepage on Wall No. 3 of Hall No. 2 of Jain Dharamshala, Second Floor

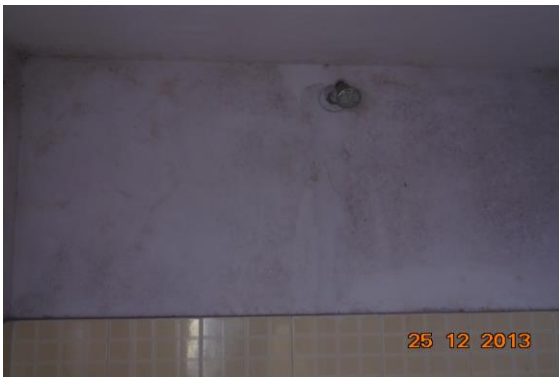
Photo 60

Dampness/Seepage on Wall No. 4 of Bathroom No. 1 of Jain Dharamshala, Second Floor

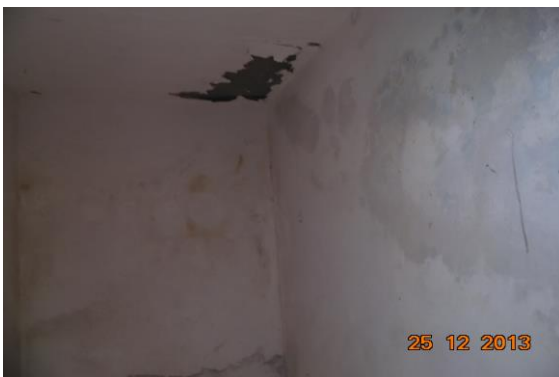
Photo 62

Dampness/Seepage on Wall No. 2, 4 & Roof of Jain Dharamshala of Second Floor

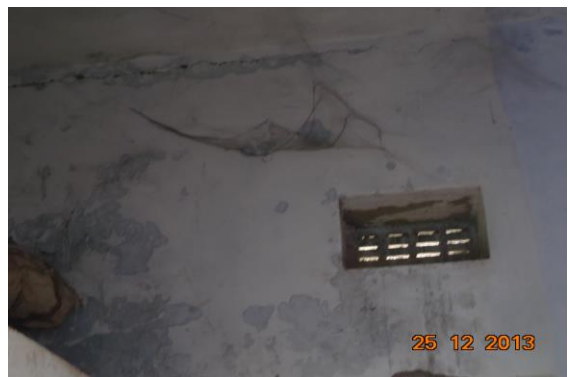
Photo 63

Dampness/Seepage on Wall No. 4 of Passage No.1 of Second Floor

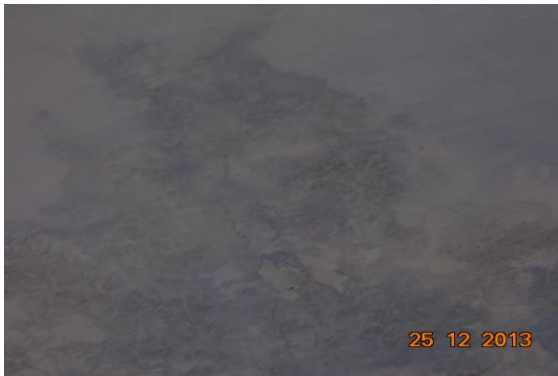
Photo 64

Dampness/Seepage on Roof of Staircase First Floor to second floor of Second Floor

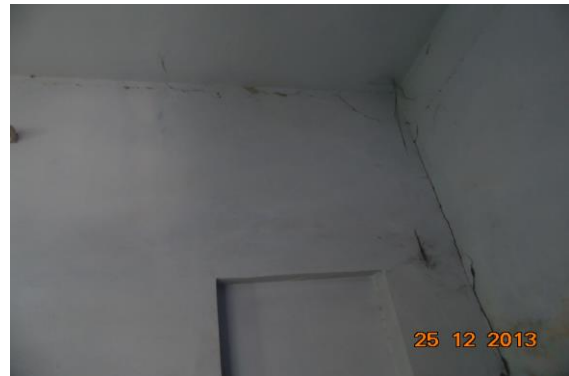
Photo 65

Peeling of Plaster on Wall No. 2 & 4 of Room No. 3 of Jain Dharamshala, Second Floor

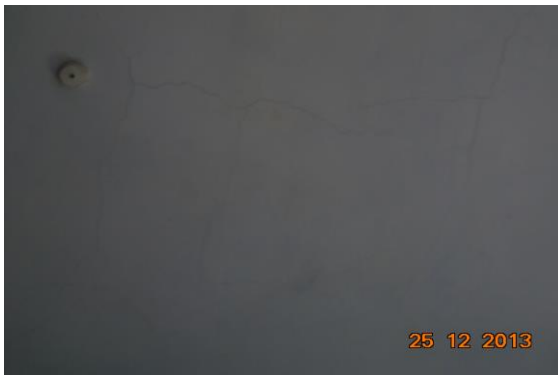
Photo 66

Plaster Crack on Roof of Room No. 3 of Jain Dharamshala, Second Floor

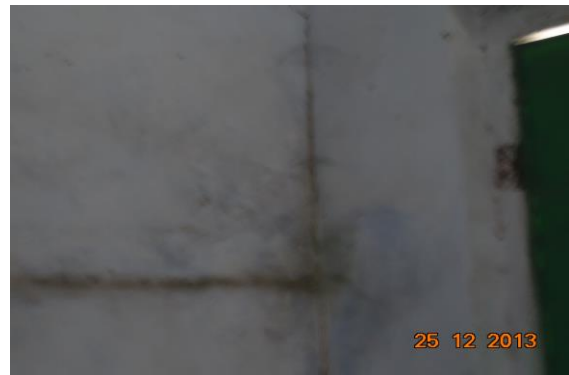
Photo 67

Dampness/Seepage on Wall No. 2 & 3 of Room No. 3 of Jain Dharamshala, Second Floor

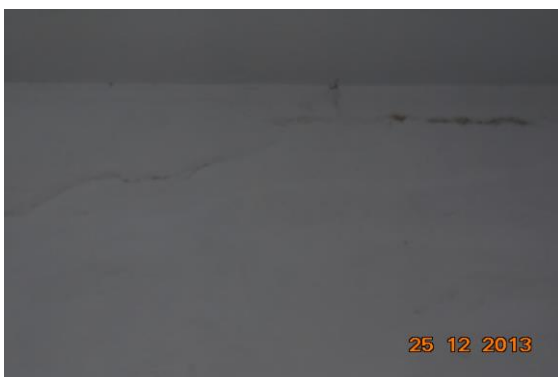
Photo 68

Peeling of Plaster on Wall No. 2 of Room No. 3 of Jain Dharamshala, Second Floor

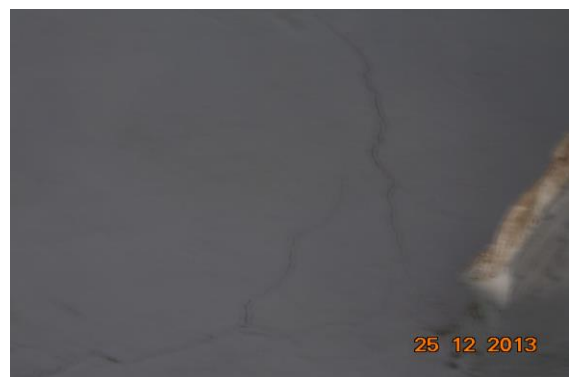
Photo 69

Plaster Crack on Wall No. 3 of Room No. 3 of Jain Dharamshala, Second Floor

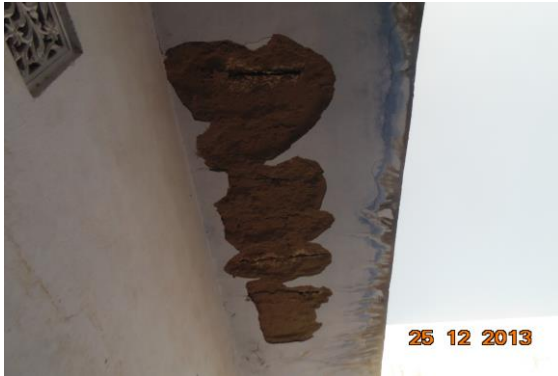
Photo 70
Damaged Portion on Shade of Balcony No.4 of Second Floor

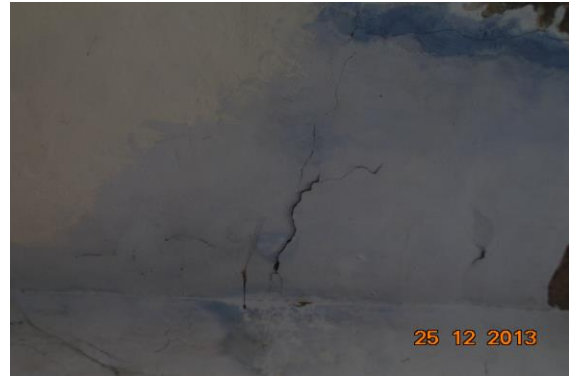
Photo 71
Damaged Portion on Shade of Balcony No.4 of Second Floor

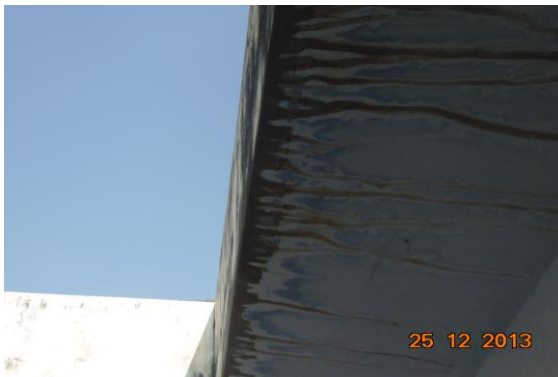
Photo 72
Dampness/Seepage on Shade of Balcony No.3 of Second Floor

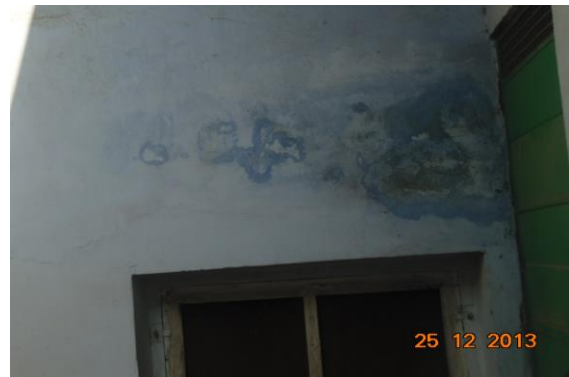
Photo 73
Dampness/Seepage on Wall No. 2 of Balcony No.2 of Second Floor

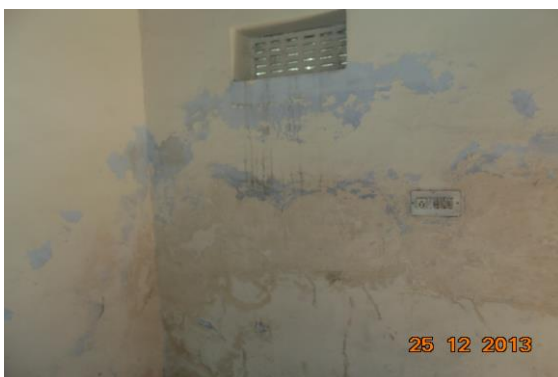
Photo 74
Dampness/Seepage on Wall No. 2 & 4 of Lobby of Second Floor

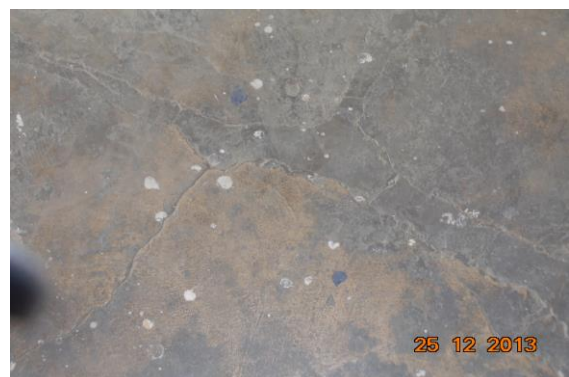
Photo 75
Plaster Crack on Floor of Hall No. 1 of Jain Dharamshala, Second Floor

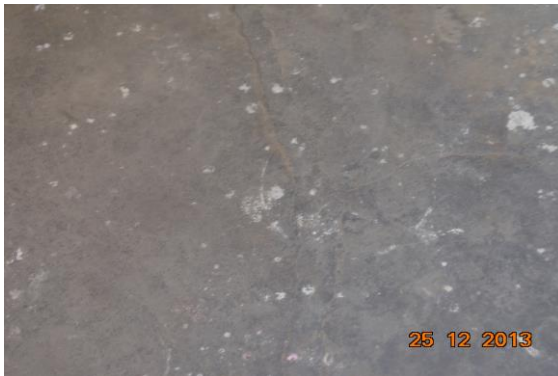
Photo 76

Plaster Crack on Floor of Hall No. 1 of Jain Dharamshala, Second Floor

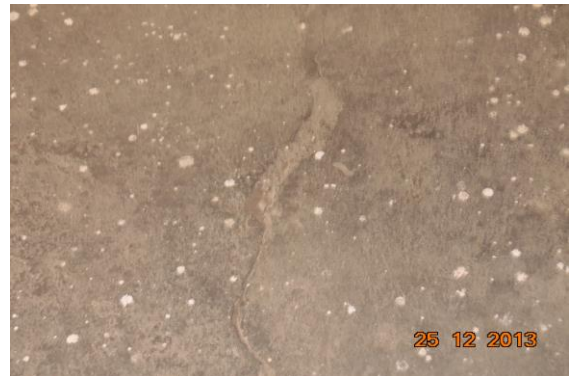
Photo 77

Plaster Crack on Floor of Hall No. 1 of Jain Dharamshala, Second Floor

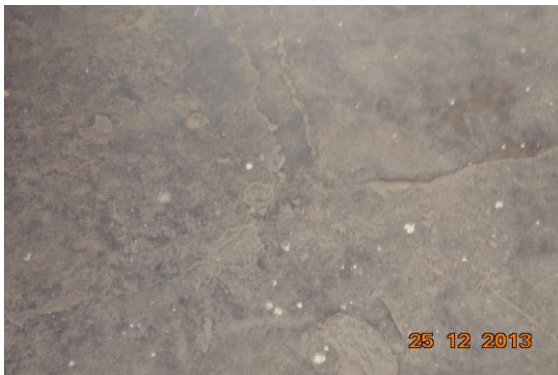
Photo 78

Plaster Crack on Floor of Hall No. 1 of Jain Dharamshala, Second Floor

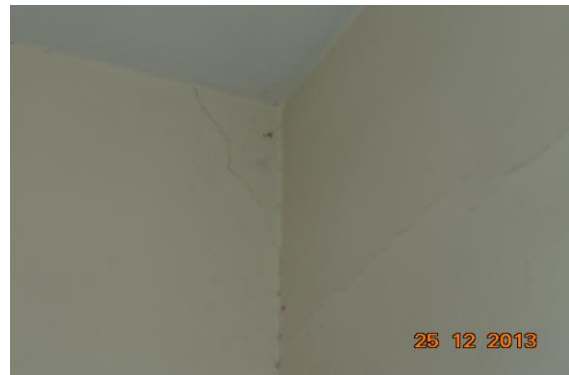
Photo 79

Peeling of Plaster on Wall No. 1 & 5 of Hall No. 1 of Jain Dharamshala, Second Floor

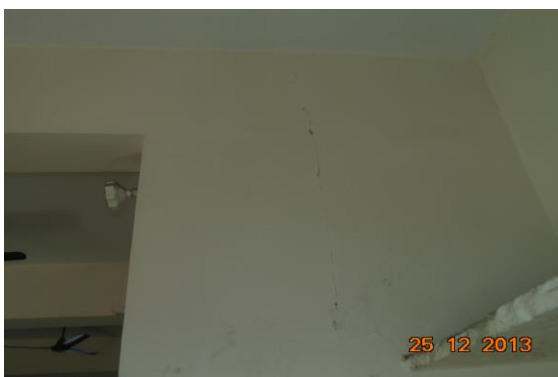
Photo 80

Peeling of Plaster on Wall No. 6 of Hall No. 1 of Jain Dharamshala, Second Floor

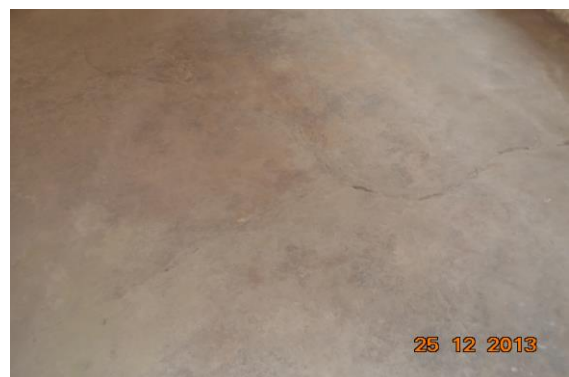
Photo 81

Plaster Crack on Floor of Room No. 4 of Jain Dharamshala, Second Floor

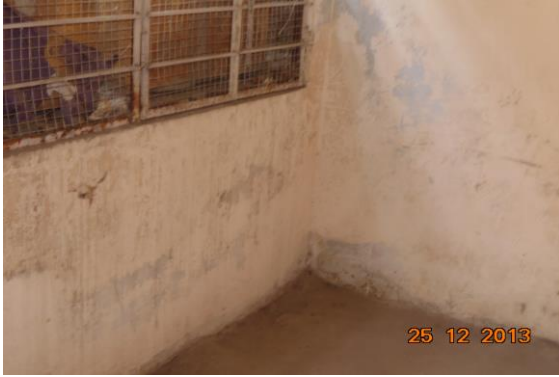
Photo 82

Dampness/Seepage on Wall No. 2 & 4 of Room No. 4 of Jain Dharamshala, Second Floor

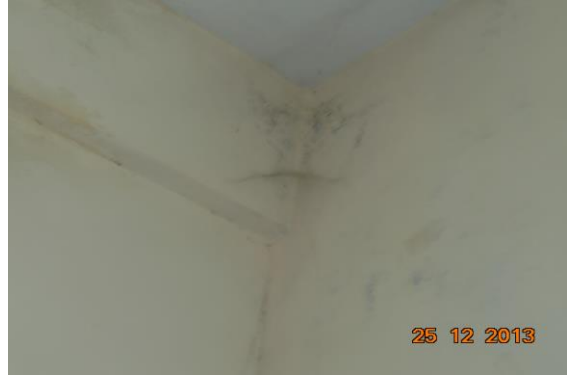
Photo 83

Dampness/Seepage on Wall No. 1 & 4 of Room No. 4 of Jain Dharamshala, Second Floor

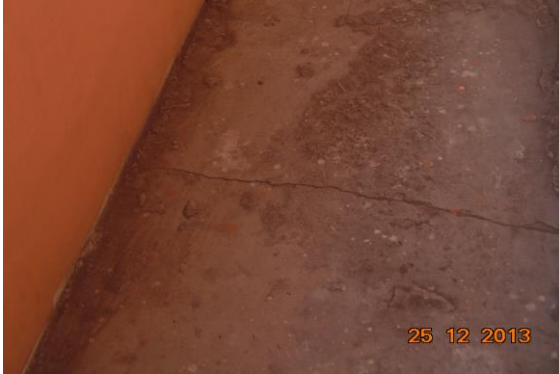
Photo 84

Plaster Crack on Floor of Balcony No.1 of Second Floor

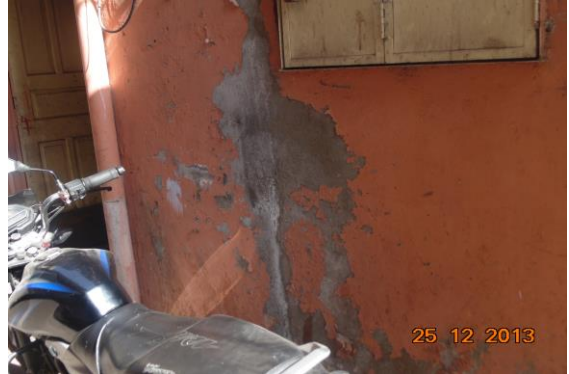
Photo 85

Peeling of Plaster on Right Hand Side of Jain Dharamshala of Ground Floor

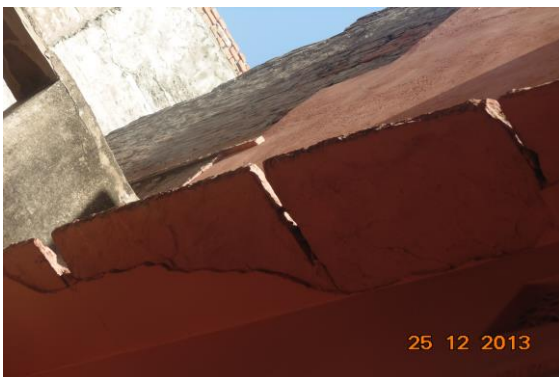
Photo 86

Damaged Portion on SunShade of Jain Dharamshala of First Floor

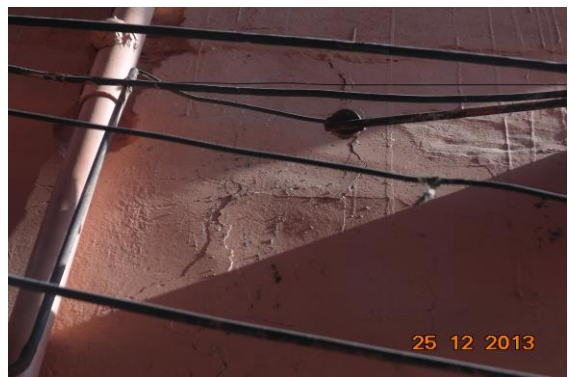
Photo 87

Damaged Portion on Lefthand side Wall of Jain Dharamshala of First Floor

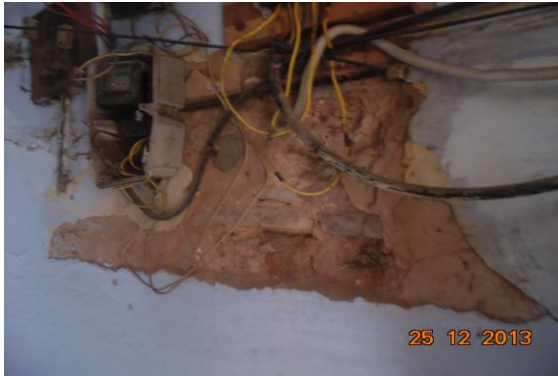
Photo 88

Peeling of Plaster on Wall No. 2 of Lobby of Ground Floor

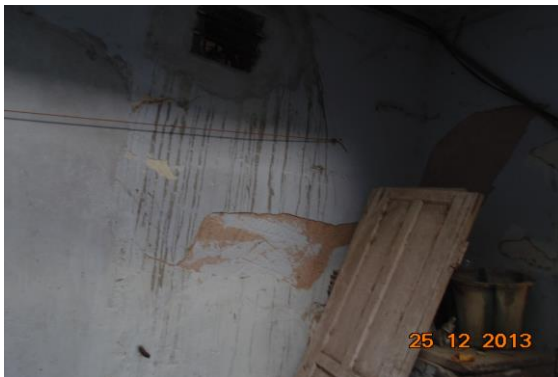
Photo 89

Peeling of Plaster on Wall No. 4 of Lobby of Ground Floor

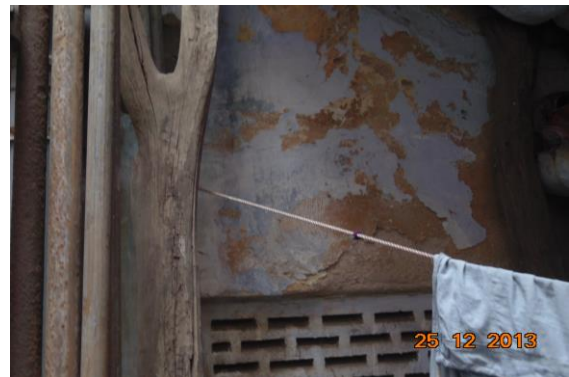
Photo 90

Peeling of Plaster on Wall No. 2 & 3 of Open Sky of Ground Floor

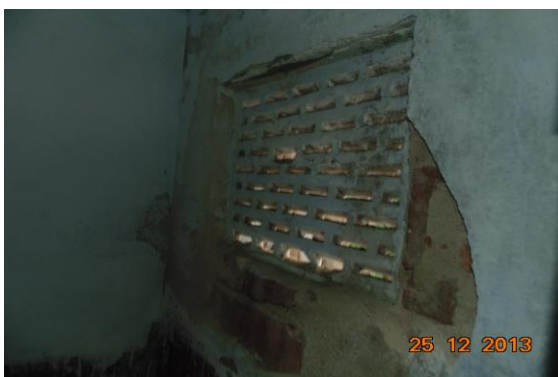
Photo 91

Peeling of Plaster on Wall No. 1 of Open Sky of Ground Floor

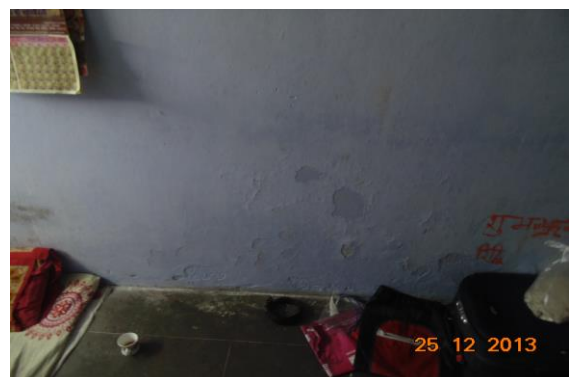
Photo 92

Peeling of Plaster on Wall No. 2 of Toilet No. 1 of Jain Dharamshala, Ground Floor

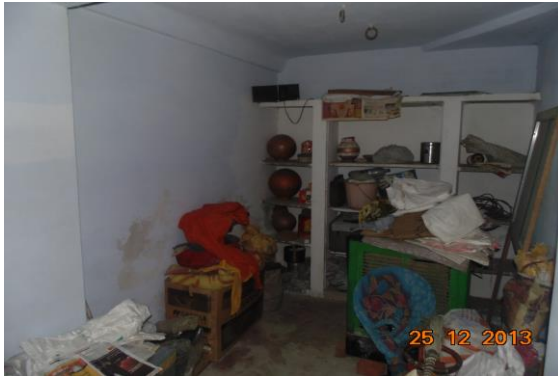
Photo 93

Peeling of Plaster on Wall No. 4 of Room No. 3 of Jain Dharamshala, Ground Floor

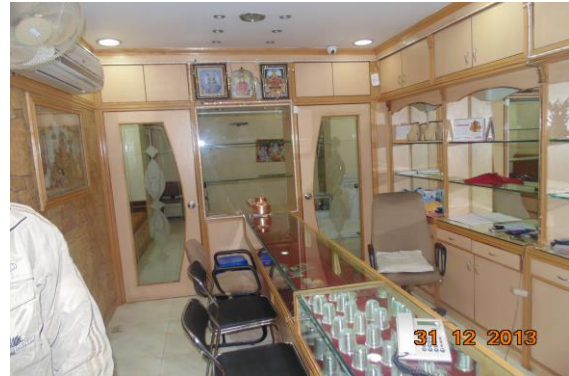
Photo 94

Peeling of Plaster on Wall No. 4 of Room No. 2 of Jain Dharamshala, Ground Floor

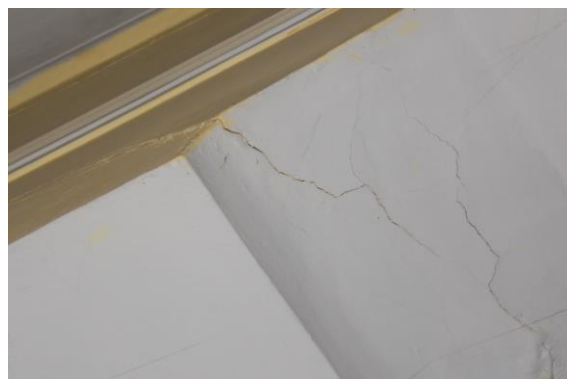
Photo 12
Inclined Crack on Roof of Varanda, First Floor
Approx. Width = 2mm, Approx. Length = 1m.
Distance from Wall No.3 = 0.8m, Height from Floor = 3m.

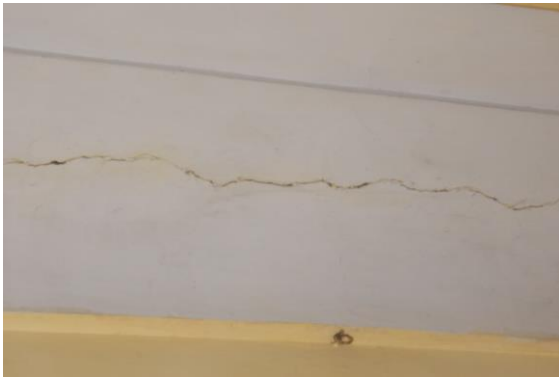
Photo 13
Horizontal Crack on Roof of Varanda, First Floor
Approx. Width = 2.5mm, Approx. Length = 2m.
Distance from Wall No.3 = 0.15m, Height from Floor = 6m.

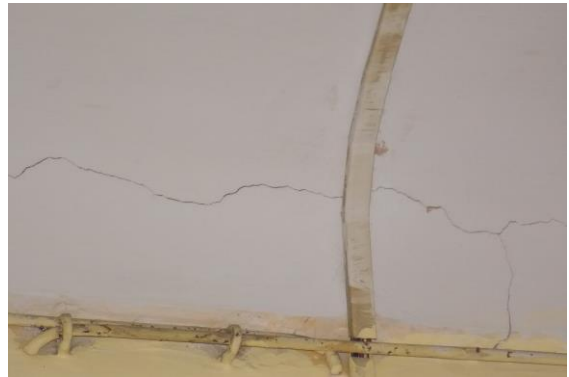
Photo 14
Horizontal Crack on Roof of Varanda No.2, First Floor
Approx. Width = 0.6mm, Approx. Length = 1m.
Distance from Wall No.3 = 4.8m, Height from Floor = 3.5m.

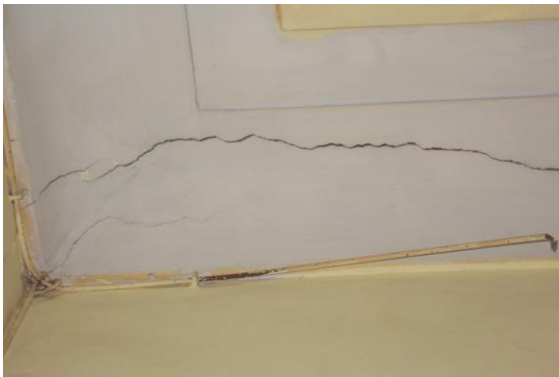
Photo 15
Horizontal Crack on Wall No. 1 of Varanda No.2, First Floor
Approx. Width = 3mm, Approx. Length = 1.5m.
Distance from Wall No.1 = 0.15m, Height from Floor = 3.5m.

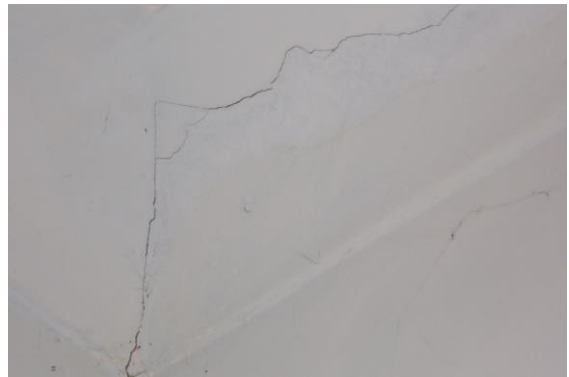
Photo 16
Inclined Crack on Wall No. 2, 4 & Roof of Room No. 2, First Floor
Approx. Width = 0.8mm, Approx. Length = 1.2m.
Distance from = Corner Wall no.2 & 4m, Height from Floor = 3m.

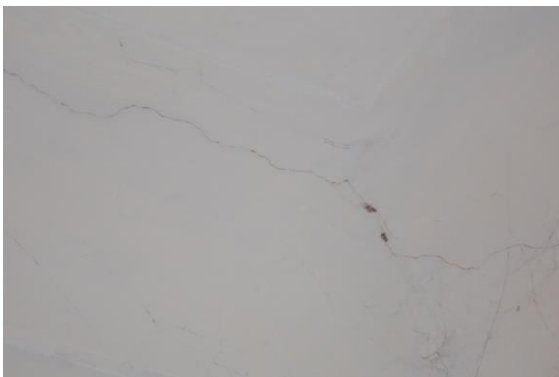
Photo 17
Inclined Crack on Wall No. 4 & Roof of Room No. 2, First Floor
Approx. Width = 0.6mm, Approx. Length = 3m.
Distance from Wall No.1 = 0.4m, Height from Floor = 2.5m.

Summary of Cracks						
Defect ID	Location	Orientation	Appx. Width (mm)	Appx. Length (m)	Category	Photo No.
1	Roof Varanda First Floor	Inclined	2	1	Slight	12
2	Roof Varanda First Floor	Horizontal	2.5	2	Slight	13
3	Roof Varanda No.2 First Floor	Horizontal	0.6	1	Very Slight	14
4	Wall No. 1 Varanda No.2 First Floor	Horizontal	3	1.5	Slight	15
5	Wall No. 2, 4 & Roof Room No. 2 First Floor	Inclined	0.8	1.2	Very Slight	16
6	Wall No. 4 & Roof Room No. 2 First Floor	Inclined	0.6	3	Very Slight	17
7	Roof Varanda No.3 First Floor	Horizontal	1	1.5	Slight	18
8	Roof Varanda No.3 First Floor	Inclined	2.5	6	Slight	19, 19A
9	Roof Varanda No.3 First Floor	Horizontal	1	2	Slight	20
10	Wall No. 4 & Roof Open Sky First Floor	Horizontal	0.5	2	Very Slight	21
11	Wall No. 2 & Roof Open Sky First Floor	Horizontal	1.5	0.7	Slight	22
12	Roof Open Sky First Floor	Horizontal	1.5	1.3	Slight	23
13	Wall No. 3 Open Sky First Floor	Horizontal	0.6	0.8	Very Slight	24

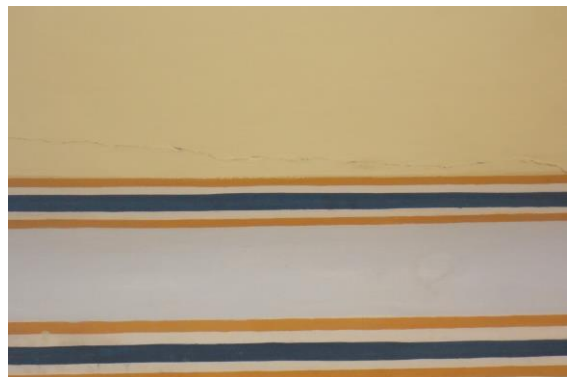
Photo 18
Horizontal Crack on Roof of Varanda No.3, First Floor
Approx. Width = 1mm, Approx. Length = 1.5m.
Distance from Wall No.3 = 0.3m, Height from Floor = 4m.

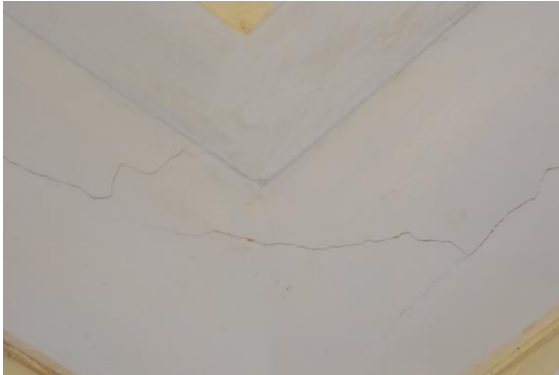
Photo 19

Inclined Crack on Roof of Varanda No.3, First Floor
Approx. Width = 2.5mm, Approx. Length = 6m.
Distance from Wall No.3 = 1.5m, Height from Floor = 3m.

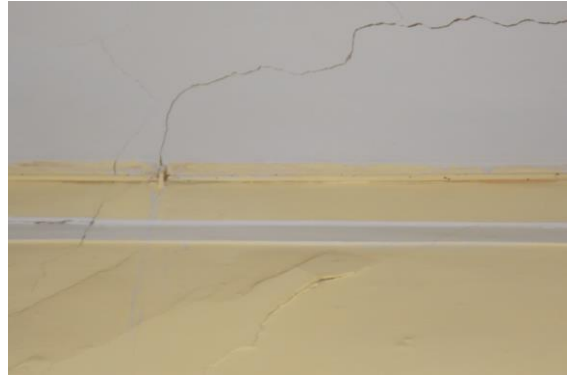
Photo 19A

Inclined Crack on Roof of Varanda No.3, First Floor
Approx. Width = 2.5mm, Approx. Length = 6m.
Distance from Wall No.3 = 1.5m, Height from Floor = 3m.

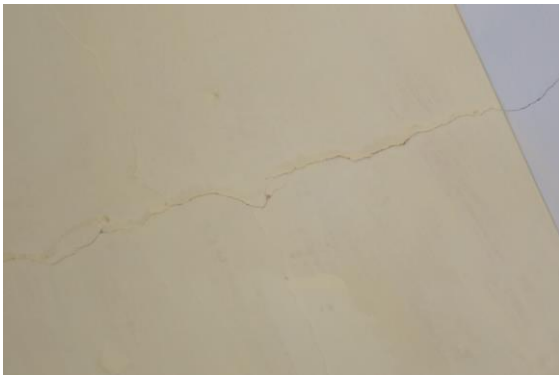
Photo 20

Horizontal Crack on Roof of Varanda No.3, First Floor
Approx. Width = 1mm, Approx. Length = 2m.
Distance from Wall No.1 = 1.6m, Height from Floor = 3.5m.

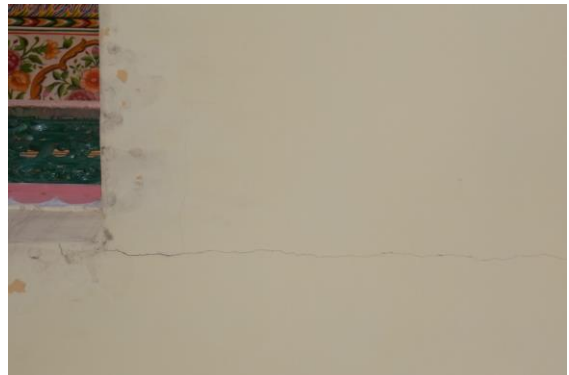
Photo 21

Horizontal Crack on Wall No. 4 & Roof of Open Sky, First Floor
Approx. Width = 0.5mm, Approx. Length = 2m.
Distance from Wall No.1 = 1m, Height from Floor = 3m.

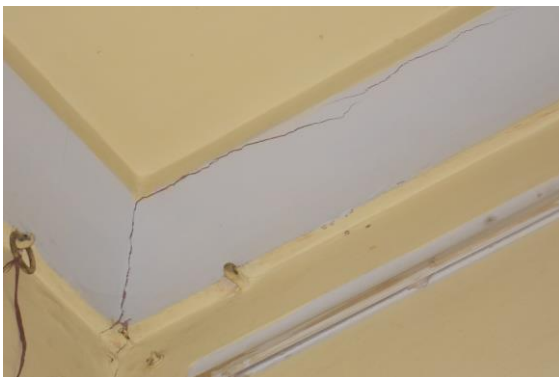
Photo 22

Horizontal Crack on Wall No. 2 & Roof of Open Sky, First Floor
Approx. Width = 1.5mm, Approx. Length = 0.7m.
Distance from Wall No.2 = 0.1m, Height from Floor = 3.5m.

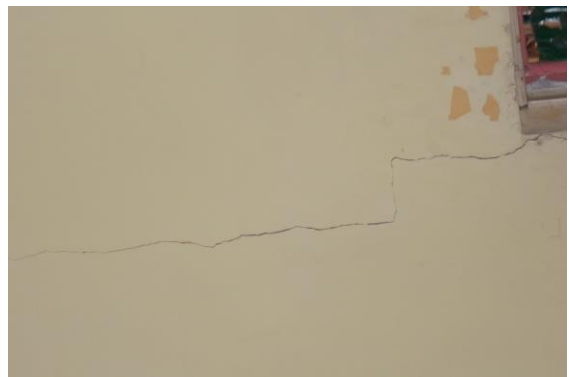
Photo 23

Horizontal Crack on Roof of Open Sky, First Floor
Approx. Width = 1.5mm, Approx. Length = 1.3m.
Distance from Wall No.2 = 0.8m, Height from Floor = 3.5m.

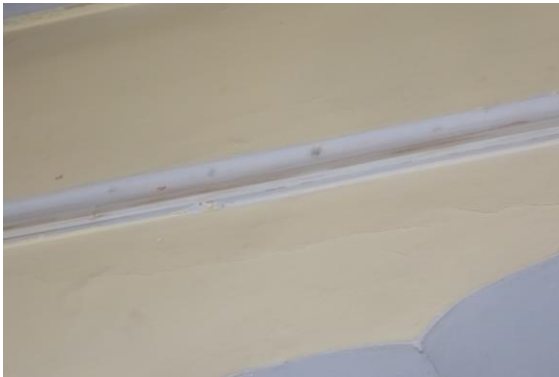
Photo 24

Horizontal Crack on Wall No. 3 of Open Sky, First Floor
Approx. Width = 0.6mm, Approx. Length = 0.8m.
Distance from Wall No.2 = 0.5m, Height from Floor = 3m.

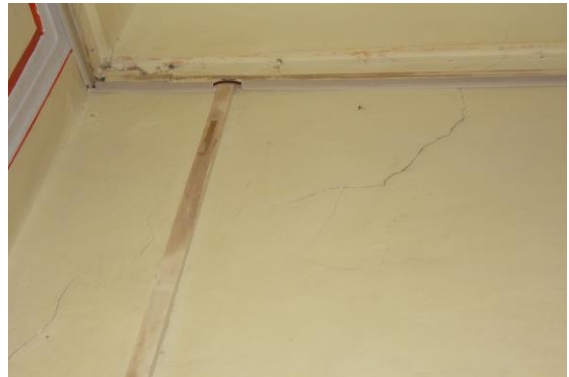
Photo 25

Inclined Crack on Wall No. 3 of Lobby, First Floor
Approx. Width = 0.5mm, Approx. Length = 1.3m.
Distance from Wall No.2 = 0.02m, Height from Floor = 2.2m.

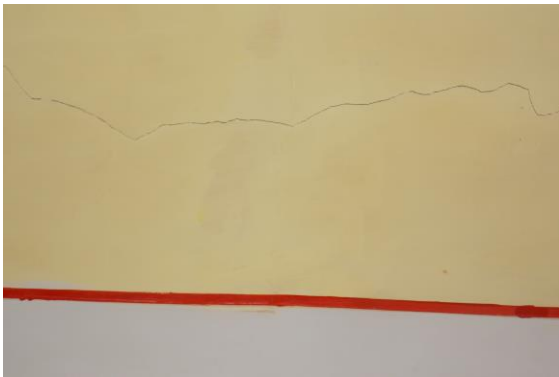
Photo 26

Inclined Crack on Roof of Lobby, First Floor
Approx. Width = 1mm, Approx. Length = 3.5m.
Distance from Wall No.4 = 2.5m, Height from Floor = 3m.

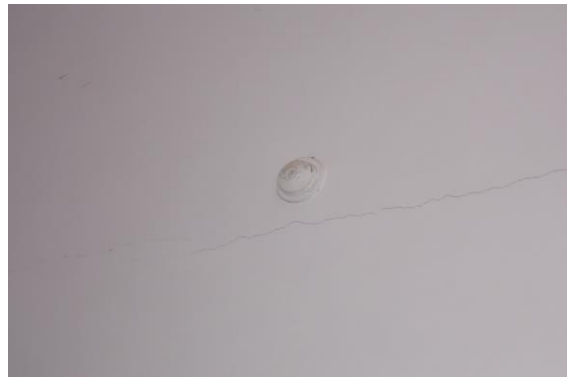
Photo 27

Horizontal Crack on Wall No. 2 of Kitchen, First Floor
Approx. Width = 0.35mm, Approx. Length = 1.8m.
Distance from Wall No.3 = 0m, Height from Floor = 2.3m.

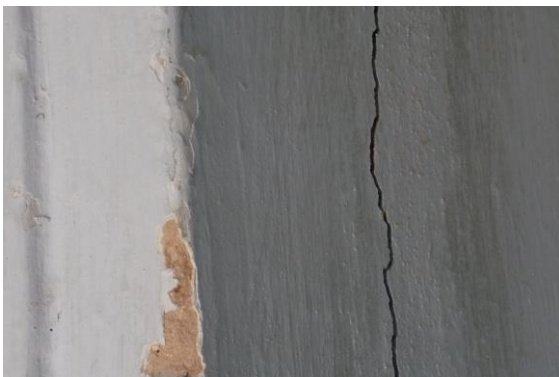
Photo 28

Inclined Crack on Wall No. 1 of Lobby, Second Floor
Approx. Width = 2mm, Approx. Length = 1.5m.
Distance from Wall No.3 = 0.5m, Height from Floor = 0.4m.

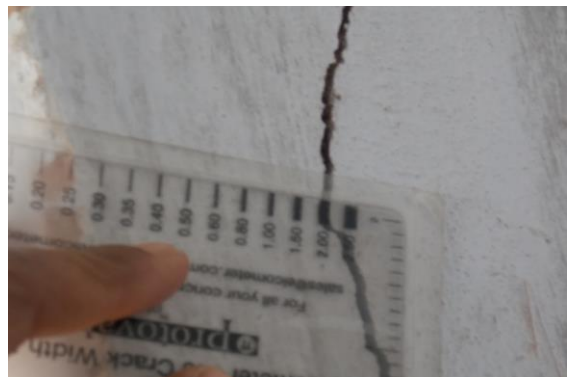
Photo 28A

Inclined Crack on Wall No. 1 of Lobby, Second Floor
Approx. Width = 2mm, Approx. Length = 1.5m.
Distance from Wall No.3 = 0.5m, Height from Floor = 0.4m.

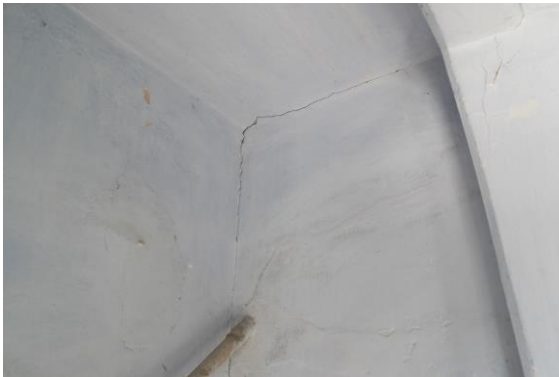
PHOTO 29

Inclined Crack on Wall No. 1 & 4 of Staircase First Floor to Second Floor

Approx. Width = 1.5mm, Approx. Length = 2.2m.
Distance from = Corner Wall No 1 & 4m Height from Floor = 0.2m

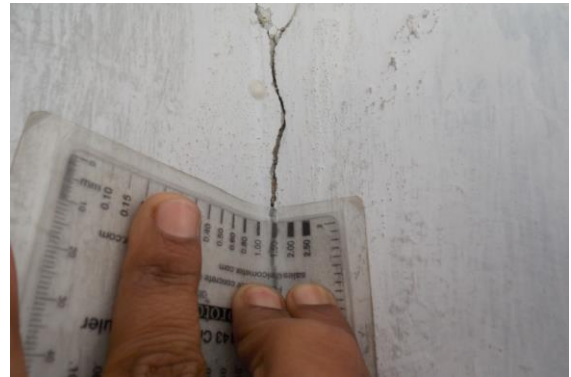
PHOTO 29A

Inclined Crack on Wall No. 1 & 4 of Staircase First Floor to Second Floor

Approx. Width = 1.5mm, Approx. Length = 2.2m.
Distance from = Corner Wall No 1 & 4m Height from Floor = 0.2m

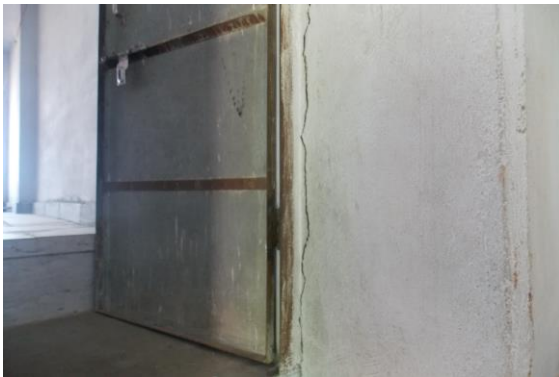
Photo 30

Inclined Crack on Wall No. 2 of Hall No. 1, Second Floor

Approx. Width = 5mm, Approx. Length = 2m.
Distance from Wall No.3 = 0.1m, Height from Floor = 0m.

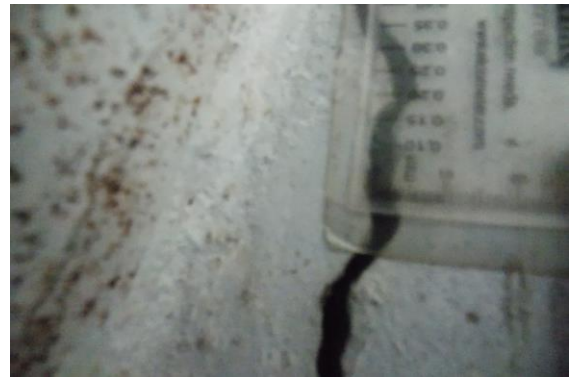
Photo 30A

Inclined Crack on Wall No. 2 of Hall No. 1, Second Floor

Approx. Width = 5mm, Approx. Length = 2m.
Distance from Wall No.3 = 0.1m, Height from Floor = 0m.

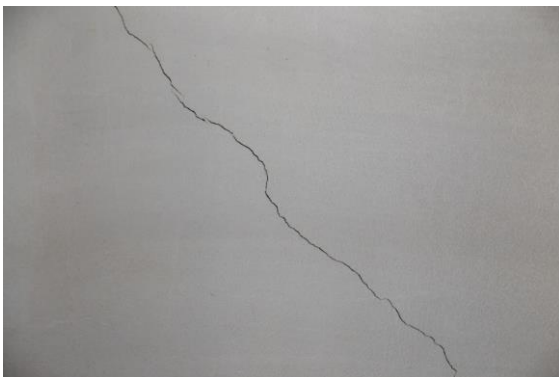
Photo 31

Inclined Crack on Wall No. 2 of Hall No. 1, Second Floor
Approx. Width = 0.8mm, Approx. Length = 2.5m.
Distance from Wall No.3 = 0.05m, Height from Floor = 0.6m.

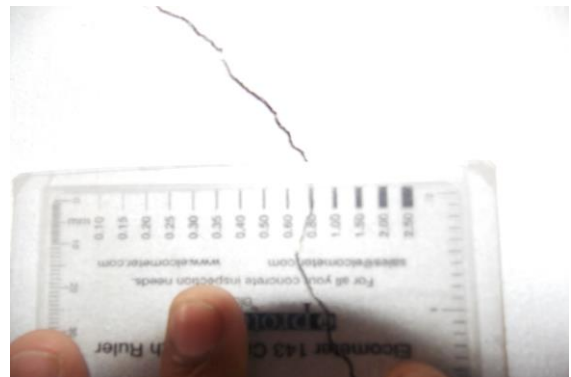
Photo 31A

Inclined Crack on Wall No. 2 of Hall No. 1, Second Floor
Approx. Width = 0.8mm, Approx. Length = 2.5m.
Distance from Wall No.3 = 0.05m, Height from Floor = 0.6m.

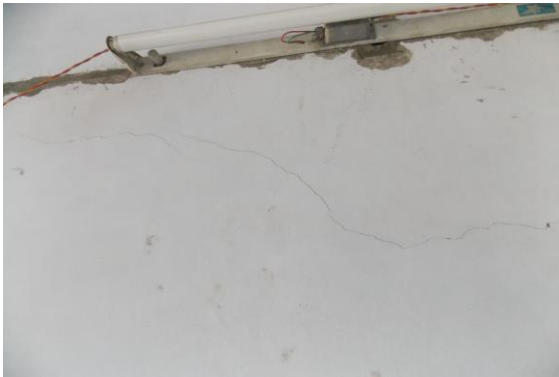
Photo 32

Inclined Crack on Wall No. 2 of Hall No. 1, Second Floor
Approx. Width = 0.35mm, Approx. Length = 3.2m.
Distance from Wall No.3 = 0.8m, Height from Floor = 1.1m.

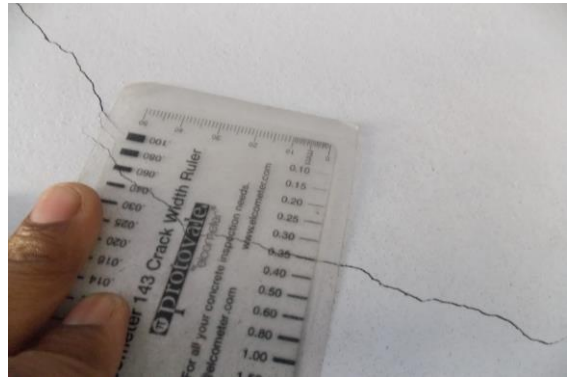
Photo 32A

Inclined Crack on Wall No. 2 of Hall No. 1, Second Floor
Approx. Width = 0.35mm, Approx. Length = 3.2m.
Distance from Wall No.3 = 0.8m, Height from Floor = 1.1m.

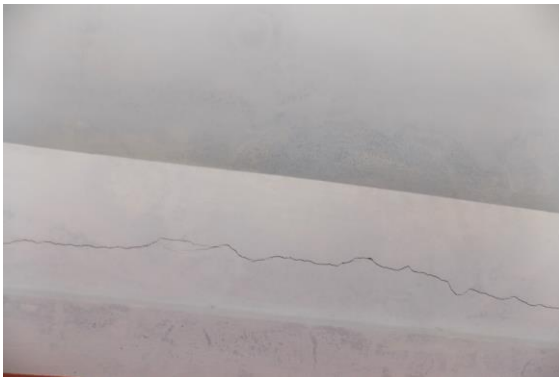
Photo 33

Horizontal Crack on Roof of Hall No. 1, Second Floor
Approx. Width = 1mm, Approx. Length = 2.6m.
Distance from Wall No.1 = 0.4m, Height from Floor = 2.2m.

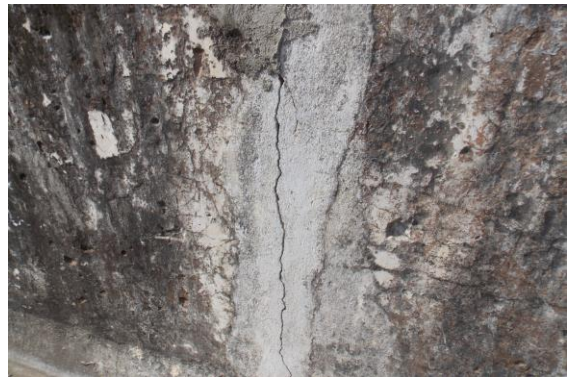
Photo 34

Vertical Crack on Wall No. 2 of Open Sky, Second Floor
Approx. Width = 2.5mm, Approx. Length = 1.2m.
Distance from Wall No.4 = 6m, Height from Floor = 0m.

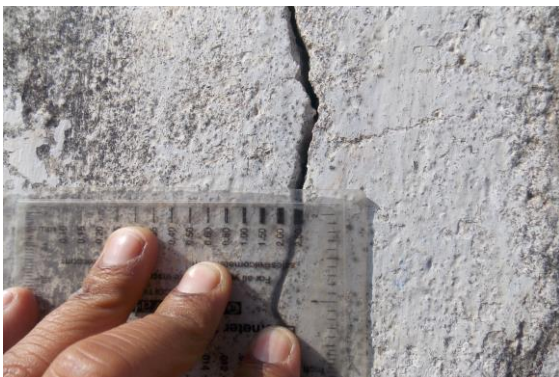
Photo 34A

Vertical Crack on Wall No. 2 of Open Sky, Second Floor
Approx. Width = 2.5mm, Approx. Length = 1.2m.
Distance from Wall No.4 = 6m, Height from Floor = 0m.

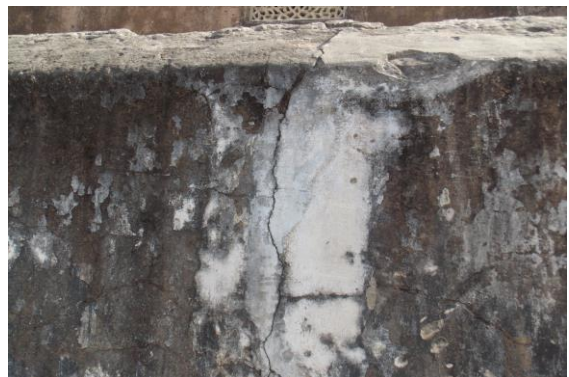
Photo 35

Inclined Crack on Wall No. 5 of Open Sky, Second Floor
Approx. Width = 1.5mm, Approx. Length = 3.2m.
Distance from Wall No.4 = 6m, Height from Floor = 0m.

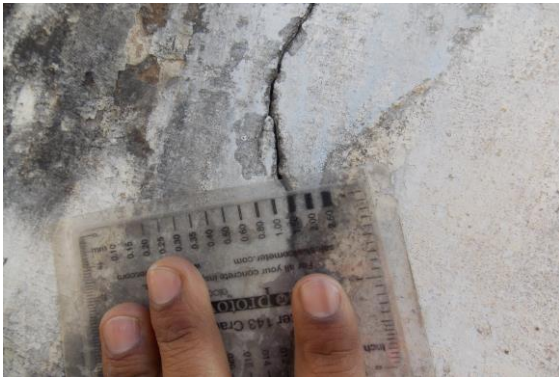
Photo 35A

Inclined Crack on Wall No. 5 of Open Sky, Second Floor
Approx. Width = 1.5mm, Approx. Length = 3.2m.
Distance from Wall No.4 = 6m, Height from Floor = 0m.

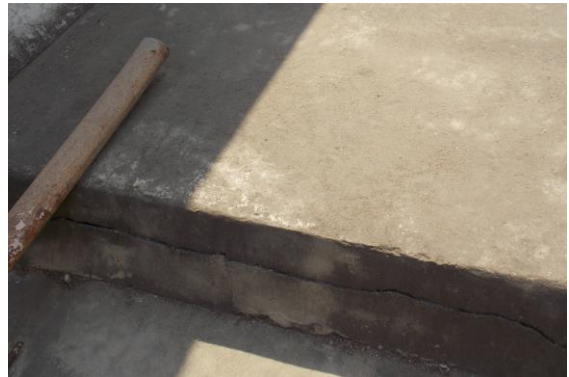
Photo 35A

Inclined Crack on Wall No. 5 of Open Sky, Second Floor
Approx. Width = 1.5mm, Approx. Length = 3.2m.
Distance from Wall No.4 = 6m, Height from Floor = 0m.

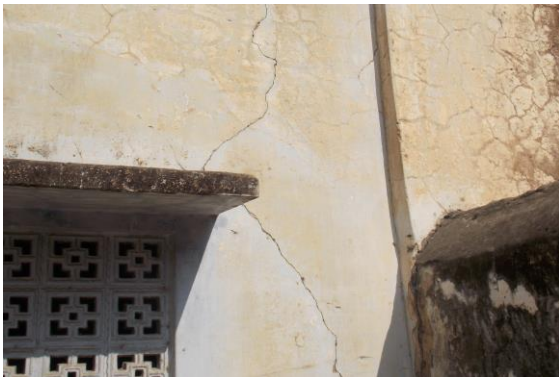
Photo 36

Inclined Crack on Wall No. 6 of Open Sky, Second Floor
Approx. Width = 2mm, Approx. Length = 3.2m.
Distance from Wall No.5 = 0.15m, Height from Floor = 0m.

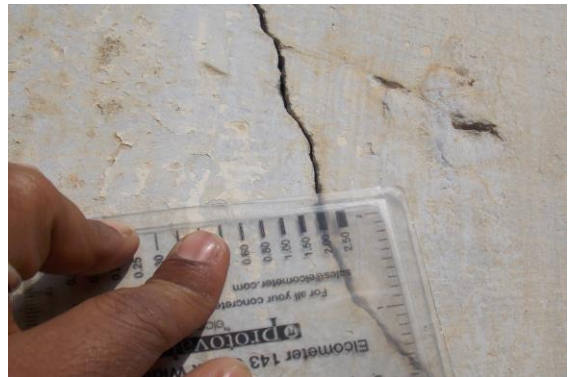
Photo 36A

Inclined Crack on Wall No. 6 of Open Sky, Second Floor
Approx. Width = 2mm, Approx. Length = 3.2m.
Distance from Wall No.5 = 0.15m, Height from Floor = 0m.

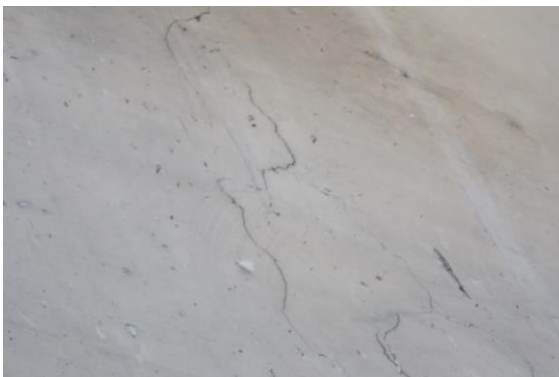
Photo 37

Inclined Crack on Right handside of Digamber Jain, First Floor
Approx. Width = 10mm, Approx. Length = 3.3m.
Distance from Wall No.4 = 1.6m, Height from Floor = 2.5m.

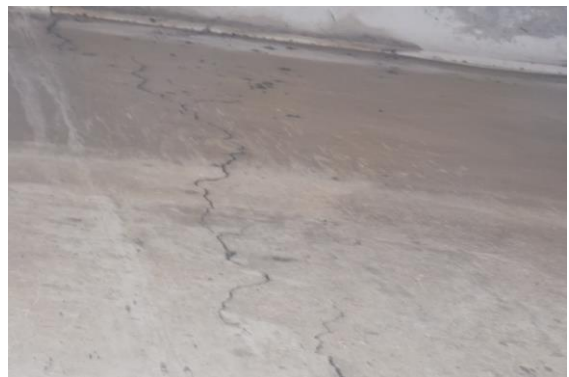
Photo 38

Inclined Crack on Right handside Wall of Digamber Jain, Ground Floor
Approx. Width = 5mm, Approx. Length = 4m.
Distance from Wall No.4 = 7m, Height from Floor = 2.1m.

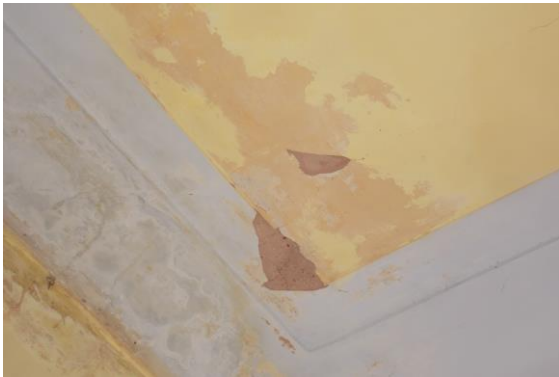
Photo 39

Peeling of Plaster on Roof of Varanda of First Floor

Summary of Defects Other Than Crack			
Defect ID	Location	Description	Photo No.
28	Roof Varanda First Floor	Peeling of Plaster	39
29	Wall No. 1 Varanda First Floor	Peeling of Plaster	40
30	Wall No. 1 & Roof Varanda First Floor	Dampness/Seepage	41
31	Roof Varanda First Floor	Peeling of Plaster	42
32	Wall No. 3 Varanda First Floor	Peeling of Plaster	43
33	Wall No. 4 Varanda No.2 First Floor	Peeling of Plaster	44
34	Roof Varanda No.2 First Floor	Peeling of Plaster	45
35	Wall No. 4 Room No. 3 First Floor	Peeling of Plaster	46
36	Wall No. 1 Room No. 2 First Floor	Peeling of Plaster	47
37	Wall No. 4 Room No. 2 First Floor	Peeling of Plaster	48
38	Wall No. Floor Varanda No.2 First Floor	Peeling of Plaster	49
39	Wall No. Floor Varanda No.2 First Floor	Peeling of Plaster	50

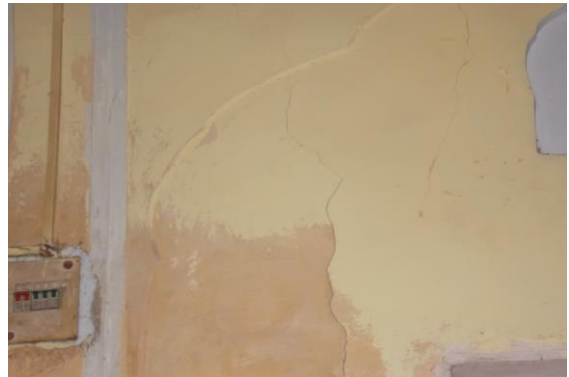
Photo 40

Peeling of Plaster on Wall No. 1 of Varanda of First Floor

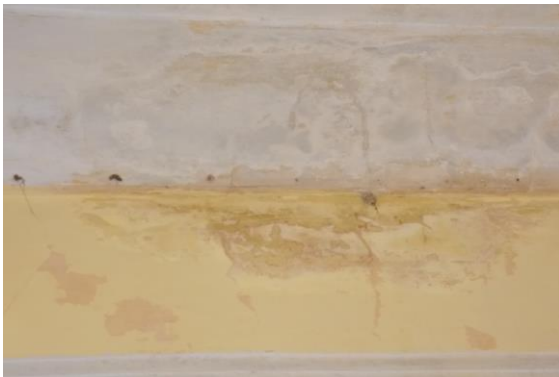
Photo 41

Dampness/Seepage on Wall No. 1 & Roof of Varanda of First Floor

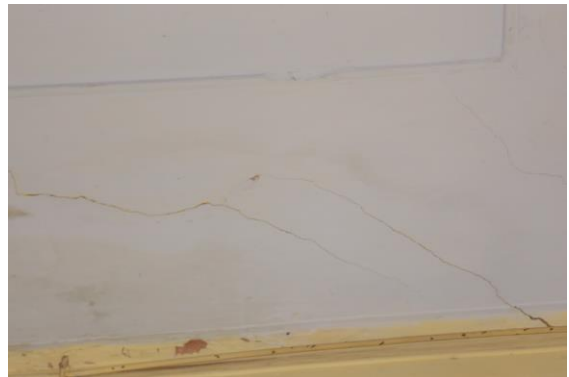
Photo 42

Peeling of Plaster on Roof of Varanda of First Floor

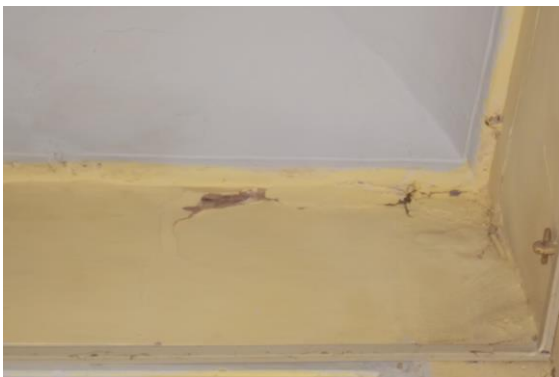
Photo 43

Peeling of Plaster on Wall No. 3 of Varanda of First Floor
