Pre Building Condition Survey Report

Name and Address of Structure :	Badi Chopar to Ramp Area (Down Line)
---------------------------------	--------------------------------------

Name of the Project	Contract JMRC-UG1B “Design and Construction of Tunnel between Chandpole and Badi Chouper and reverse line by Shield TBM, Underground Metro Stations at Choti Chouper and Badi Chouper by Cut and Cover Methods on East West Corridor of Jaipur Metro Rail Corporation Limited .”	
Owner :

Pre - Condition Building Survey for Construction of Underground Stations from Chandpole to Bari Chouper and reversal line

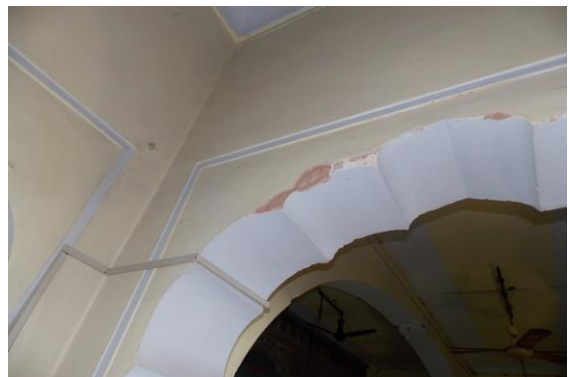
Photo 44

Peeling of Plaster on Wall No. 4 of Varanda No.2 of First Floor

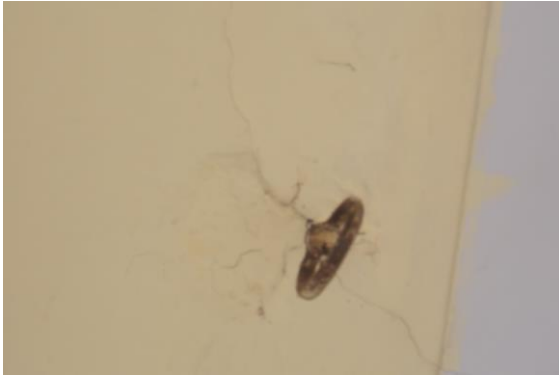
Photo 45
Peeling of Plaster on Roof of Varanda No.2 of First Floor

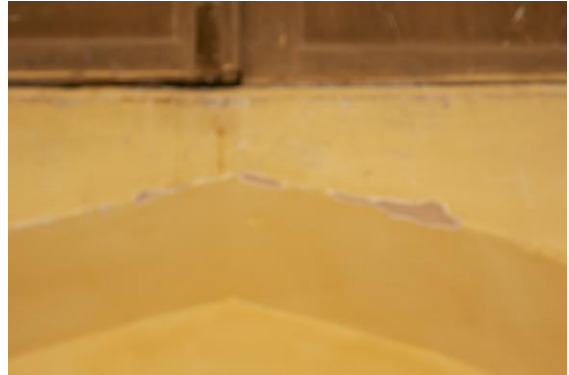
Photo 46
Peeling of Plaster on Wall No. 4 of Room No. 3 of First Floor

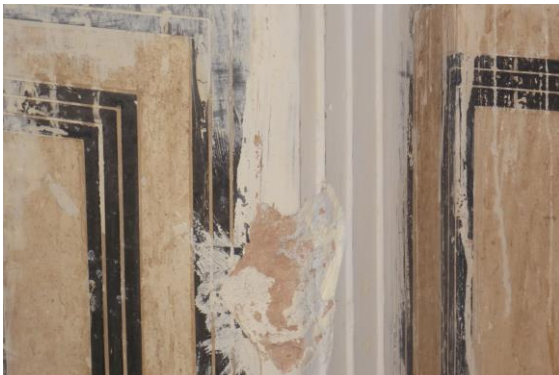
Photo 47
Peeling of Plaster on Wall No. 1 of Room No. 2 of First Floor

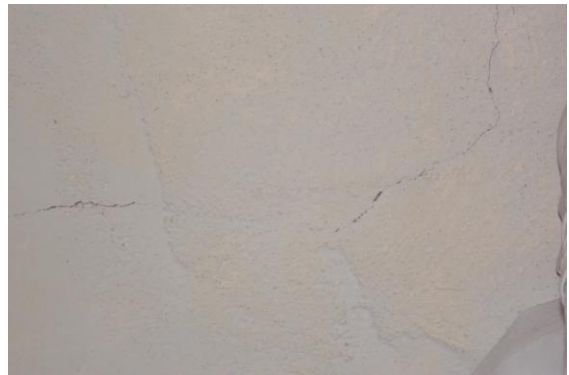
Photo 48
Peeling of Plaster on Wall No. 4 of Room No. 2 of First Floor

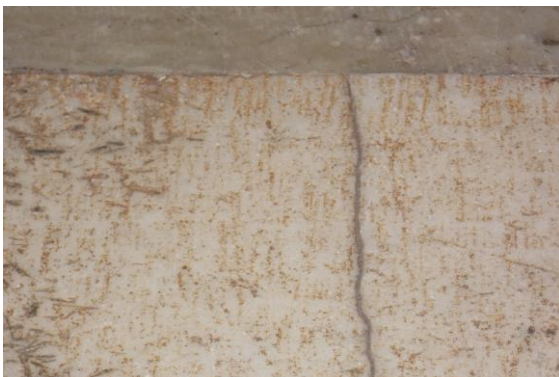
Photo 49
Peeling of Plaster on Floor of Varanda No.2 of First Floor

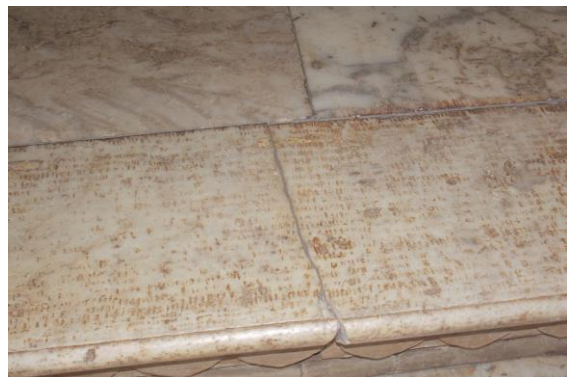
Photo 50
Peeling of Plaster on Floor of Varanda No.2 of First Floor

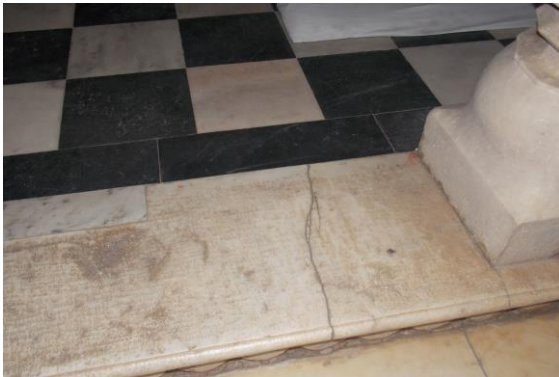
Photo 51

Peeling of Plaster on Floor of Varanda No.3 of First Floor

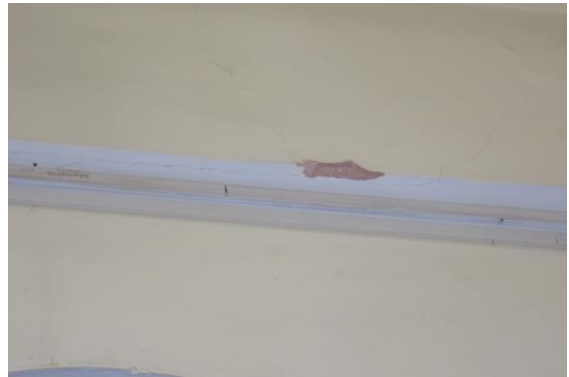
Photo 52

Peeling of Plaster on Wall No. 1 of Open Sky of First Floor

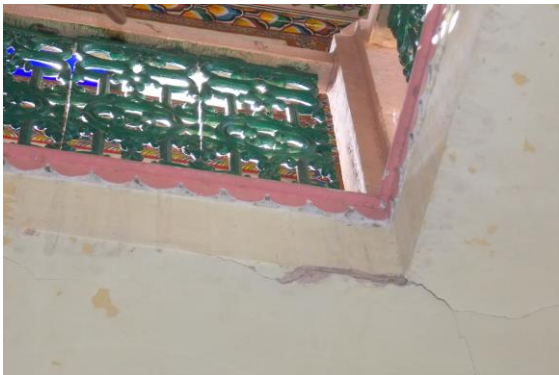
Photo 53

Peeling of Plaster on Roof of Open Sky of First Floor

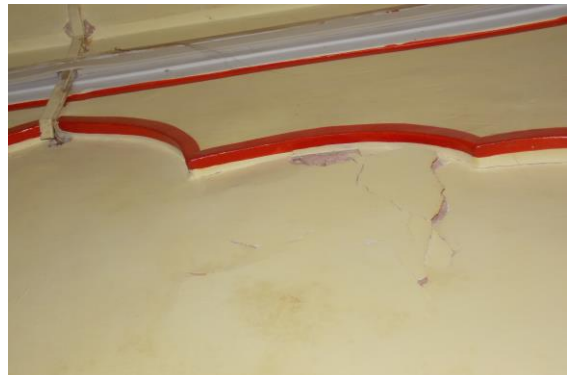
Photo 54

Peeling of Plaster on Wall No. 2 of Lobby of First Floor

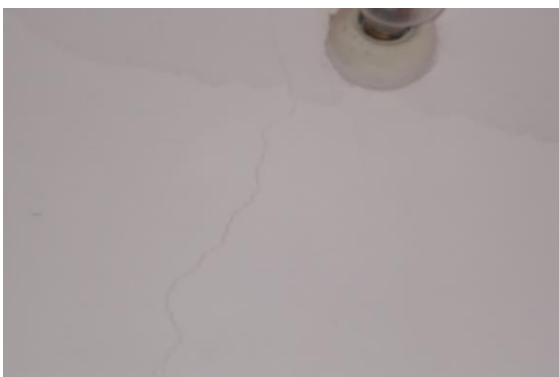
Photo 55

Peeling of Plaster on Wall No. 4 of Kitchen of First Floor

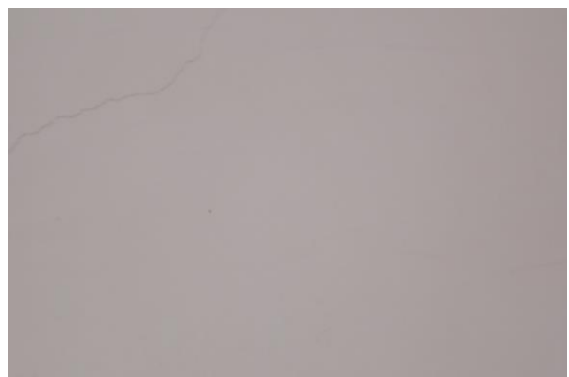
Photo 56

Peeling of Plaster on Wall No. 4 of Kitchen of First Floor

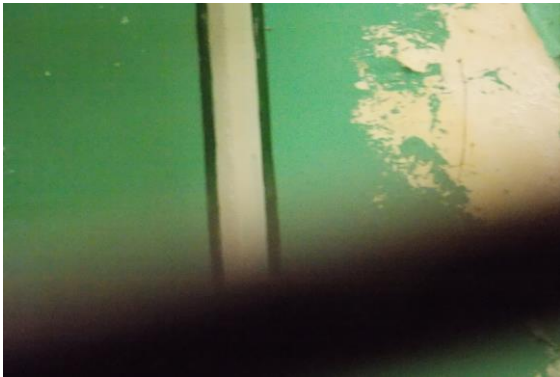
Photo 57

Peeling of Plaster on Roof of Temple No.3 of First Floor

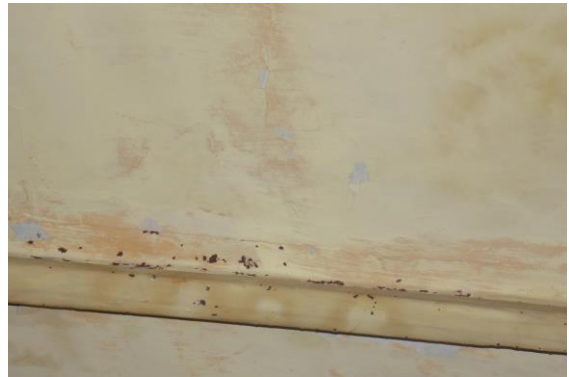
Photo 58

Dampness/Seepage on Roof of Lobby of First Floor

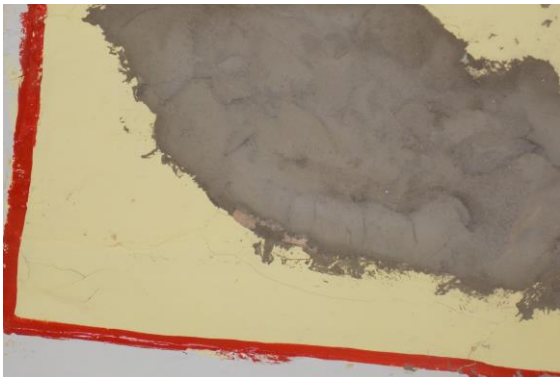
Photo 59

Dampness/Seepage on Roof of Lobby of First Floor

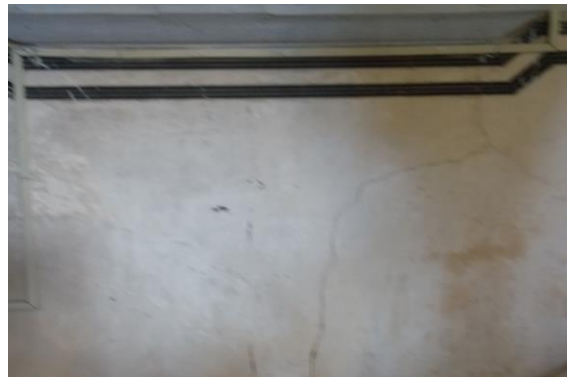
Photo 60

Peeling of Plaster on Wall No. 1 of Staircase First Floor to Second Floor

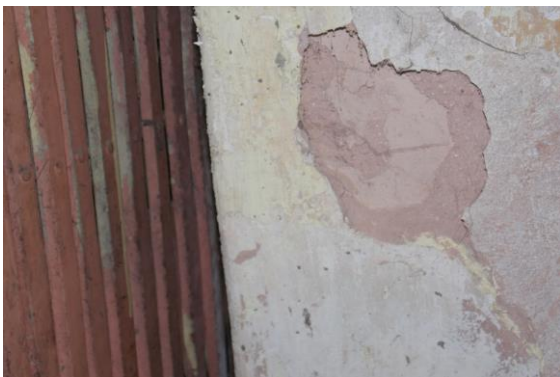
Photo 61

Peeling of Plaster on Wall No. 2 of Staircase First Floor to Second Floor

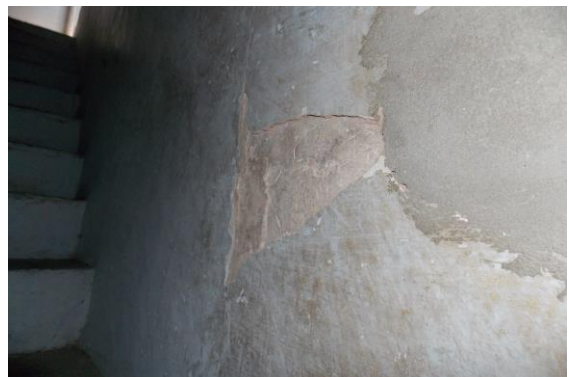
Photo 62

Peeling of Plaster on Wall No. 1 of Staircase First Floor to Second Floor

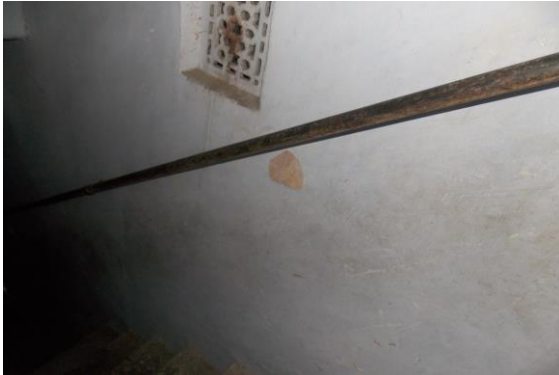
Photo 63

Peeling of Plaster on Wall No. 1 of Staircase First Floor to Second Floor

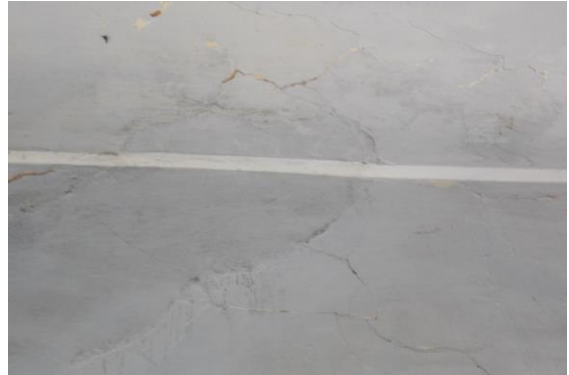
Photo 64

Peeling of Plaster on Roof & 3 of Lobby of Second Floor

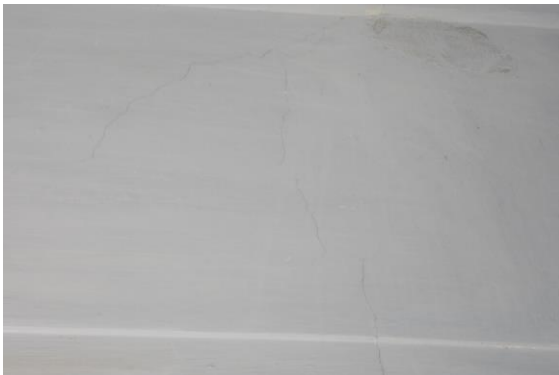
Photo 65

Peeling of Plaster on Wall No. 1 of Lobby of Second Floor

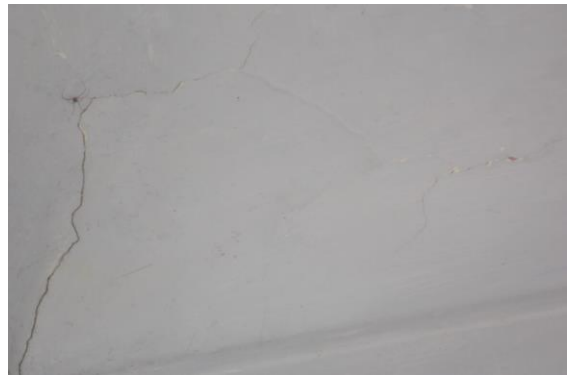
Photo 66

Peeling of Plaster on Wall No. 1 & 4 of Lobby of Second Floor

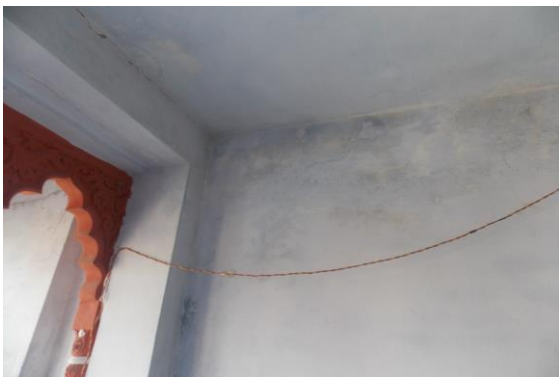
Photo 67

Dampness/Seepage on Wall No. 2 of Hall No. 1 of Second Floor

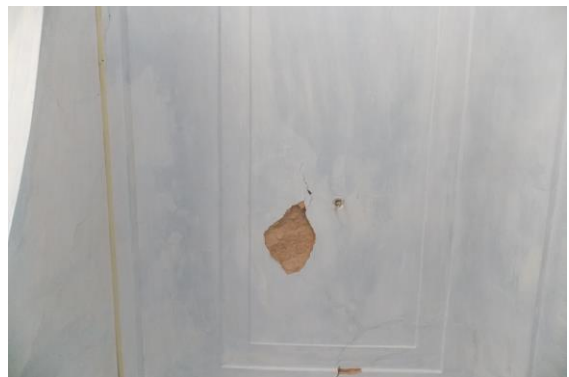
Photo 68

Peeling of Plaster on Roof of Hall No. 2 of Second Floor

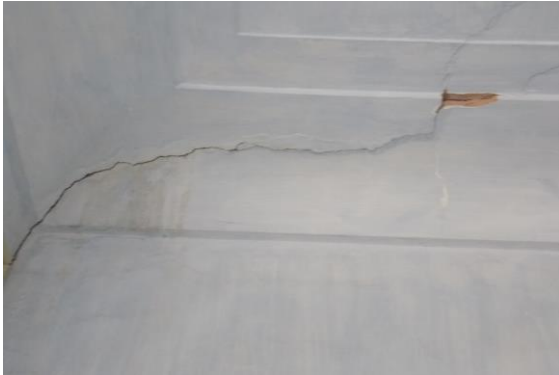
Photo 69
Damaged Portion on Roof of Hall No. 2 of Second Floor

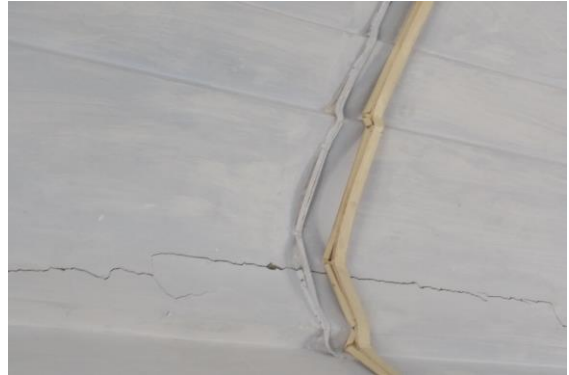
Photo 70
Damaged Portion on Roof of Hall No. 2 of Second Floor

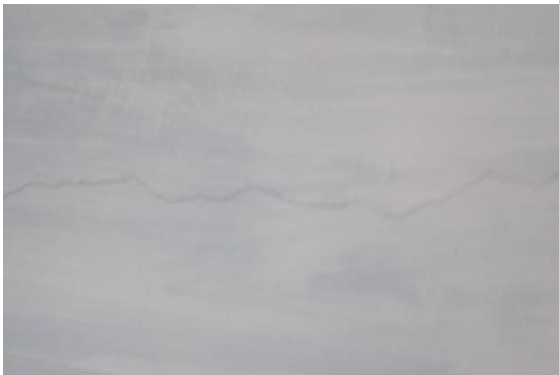
Photo 71
Peeling of Plaster on Roof of Hall No. 2 of Second Floor

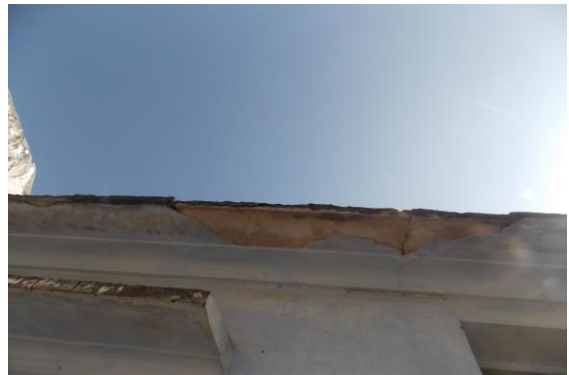
Photo 72
Peeling of Plaster on Sun Shade of Digamber Jain of Second Floor

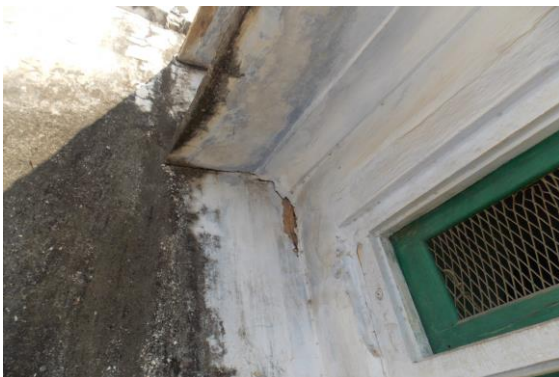
Photo 73
Peeling of Plaster on Wall No. 3 of Open Sky of Second Floor

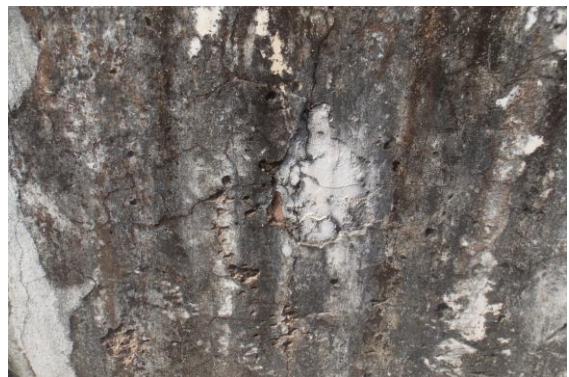
Photo 74
Peeling of Plaster on Wall No. 2 of Open Sky of Second Floor

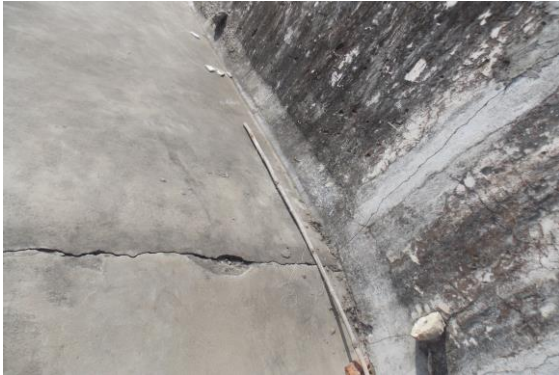
Photo 75
Peeling of Plaster on Floor of Open Sky of Second Floor

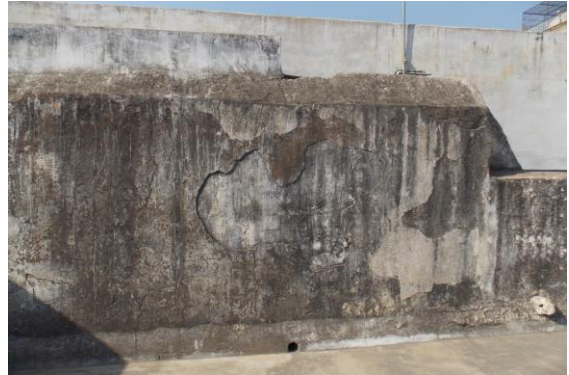
Photo 76
Peeling of Plaster on Wall No. 2 of Open Sky of Second Floor

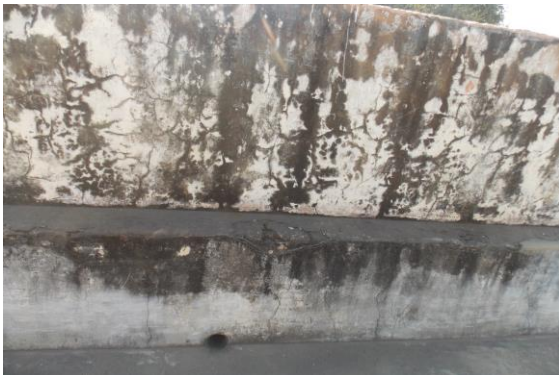
Photo 77
Peeling of Plaster on Wall No. 4 of Open Sky of Second Floor

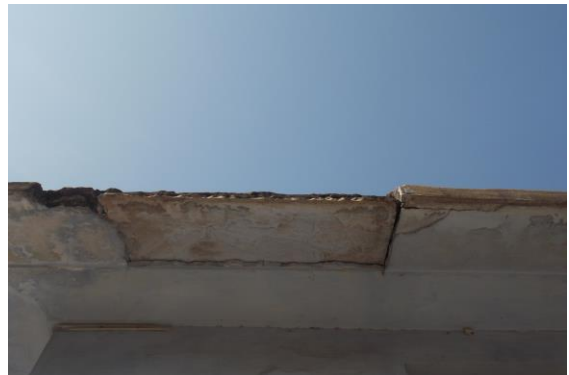
Photo 78
Peeling of Plaster on Wall No. 7 & Sun Shade of Open Sky of Second Floor

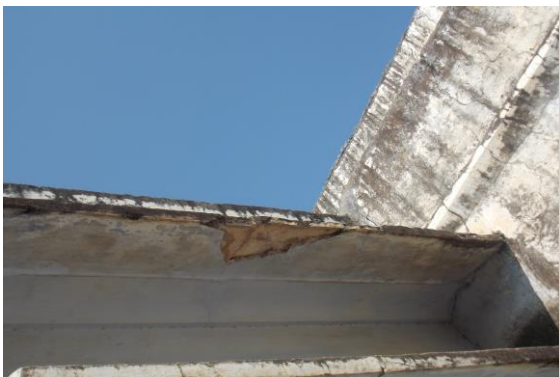
Photo 79
Peeling of Plaster on Wall No. 7 & Sun Shade of Open Sky of Second Floor

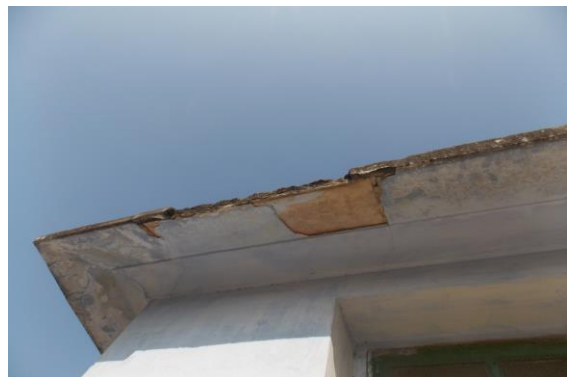
Photo 80
Peeling of Plaster on Wall No. 8 & Sun Shade of Open Sky of Second Floor

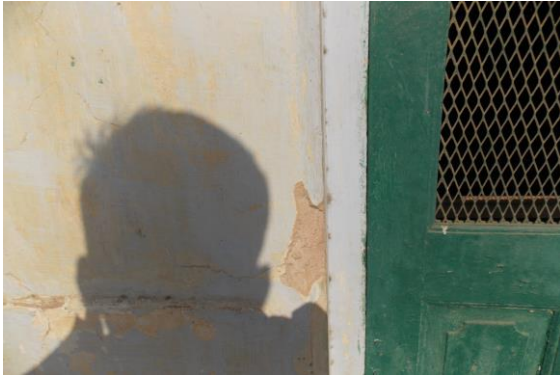
Photo 81

Peeling of Plaster on Wall No. 8 of Open Sky of Second Floor

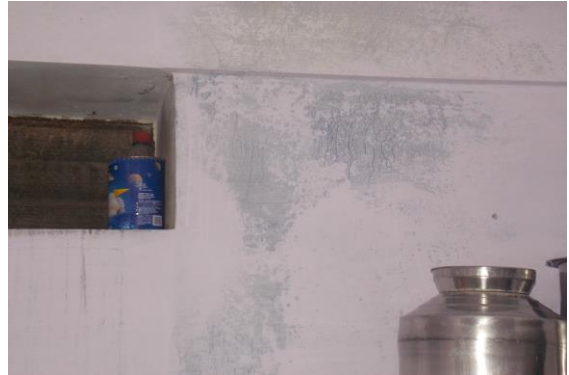
Photo 82

Dampness/Seepage on Wall No. 4 of Room No. 3 of Third Floor

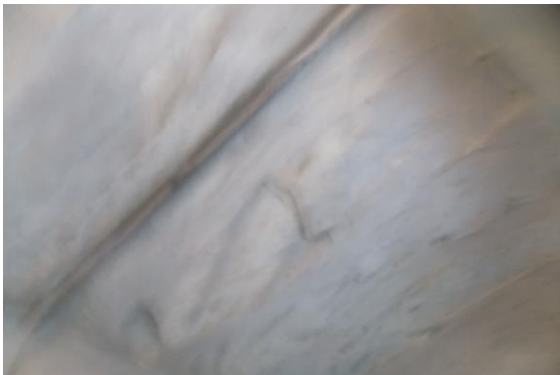
Photo 83

Peeling of Plaster on Roof of Shop No.8 of Ground Floor

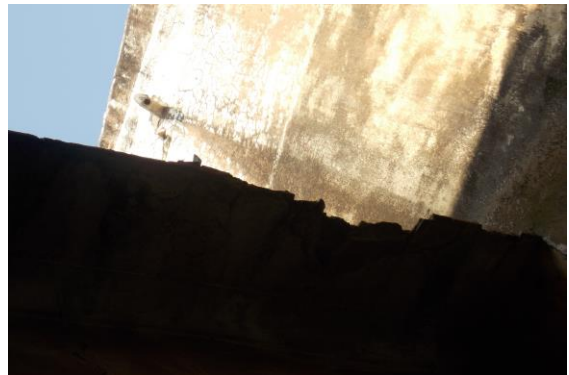
Photo 84

Damaged Portion on Sun Shade of Digamber Jain of First Floor

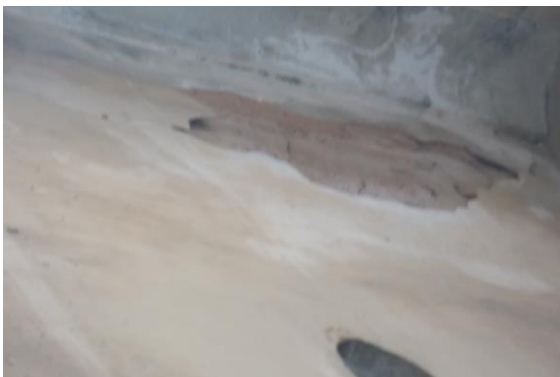
Photo 85

Peeling of Plaster on Right handside of Digamber Jain of First Floor

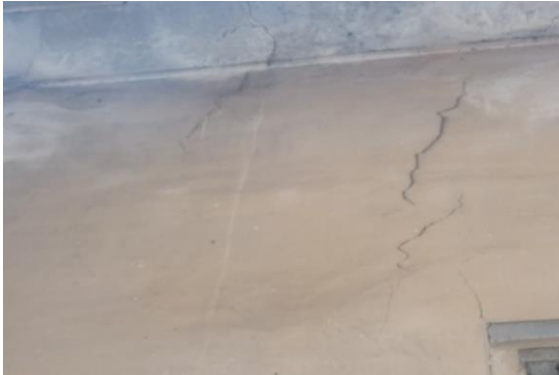
Photo 87

Damaged Portion on Right handside of Digamber Jain of First Floor

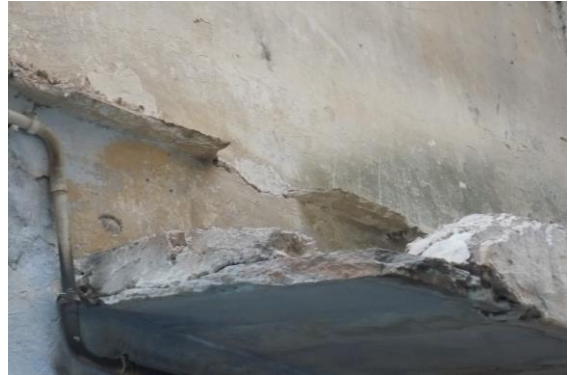
Photo 88

Damaged Portion on Sun Shade of Digamber Jain of Ground Floor

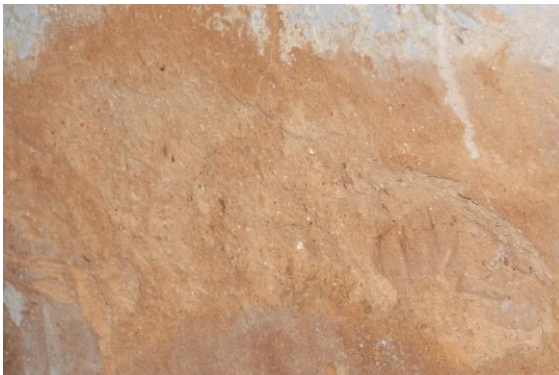
Photo 89

Peeling of Plaster on Right handside Wall of Digamber Jain of Ground Floor

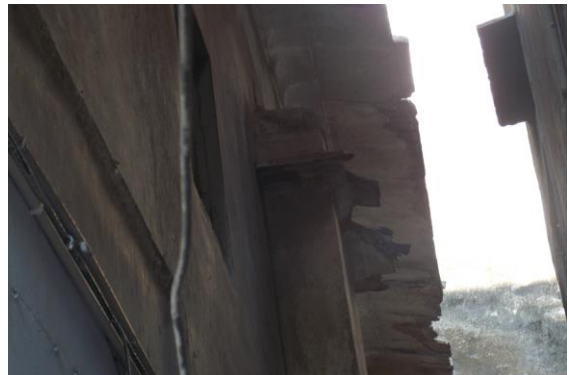
Photo 90

Damaged Portion on Sun Shade Window of Digamber Jain of Ground Floor

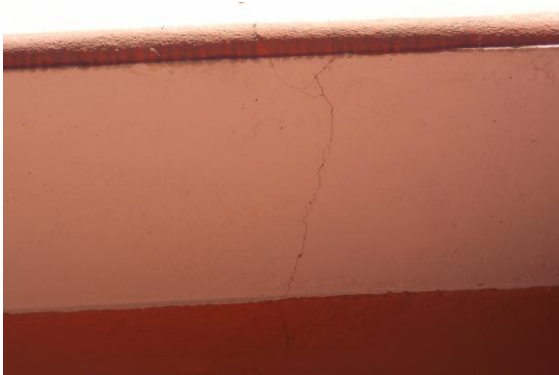
Photo 91

Peeling of Plaster on Sun Shade & Frontside of Digamber Jain of First Floor

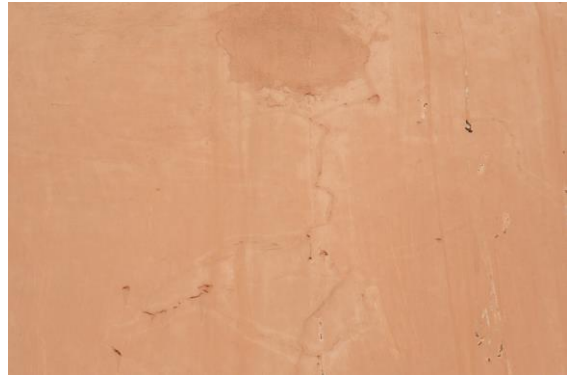
Photo 92

Dampness/Seepage on Frontside Wall of Digamber Jain of First Floor

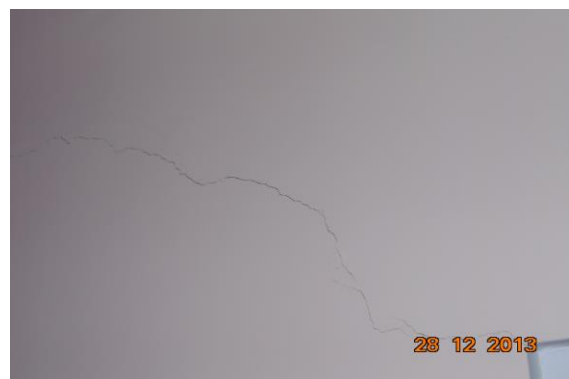
Photo 6
Inclined Crack on Wall No. 4 of Room No. 5, H.No.284,First floor
Approx. Width = 0.5mm, Approx. Length = 1.2m.
Distance from Wall No.1 = 1.6m, Height from Floor = 17m.

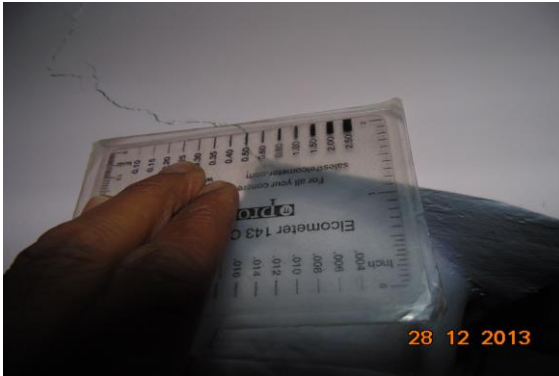
Photo 6A

Inclined Crack on Wall No. 4 of Room No. 5, H.No.284, First floor
Approx. Width = 0.5mm, Approx. Length = 1.2m.
Distance from Wall No.1 = 1.6m, Height from Floor = 17m.

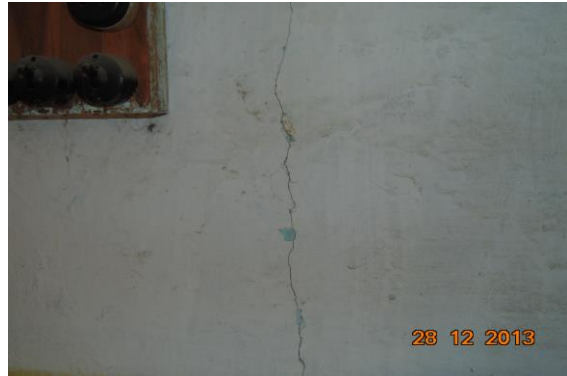
Photo 7

Inclined Crack on Wall No. 2 of H.No.284, Second floor
Approx. Width = 0.4mm, Approx. Length = 2.5m.
Distance from Wall No.3 = 0.7m, Height from Floor = 0m.

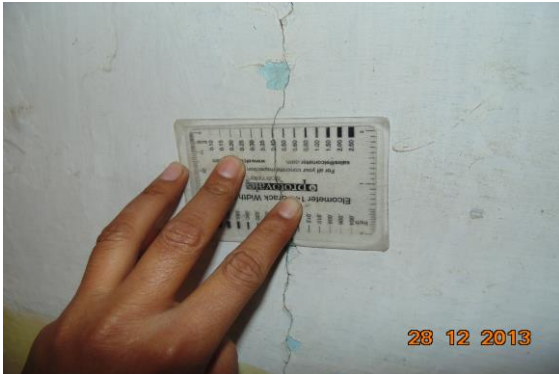
Photo 7A

Inclined Crack on Wall No. 2 of H.No.284, Second floor
Approx. Width = 0.4mm, Approx. Length = 2.5m.
Distance from Wall No.3 = 0.7m, Height from Floor = 0m.

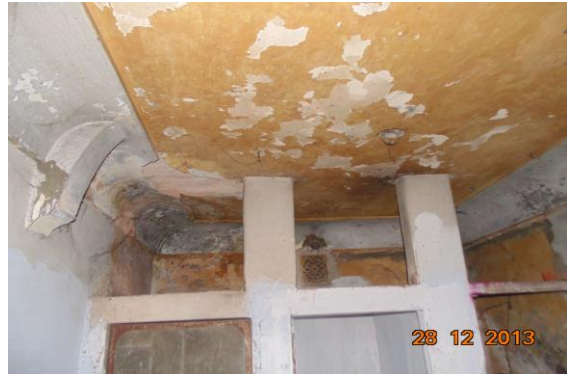
Photo 8

Dampness/Seepage on Roof of Lobby 1 of House No. 284 of Ground Floor

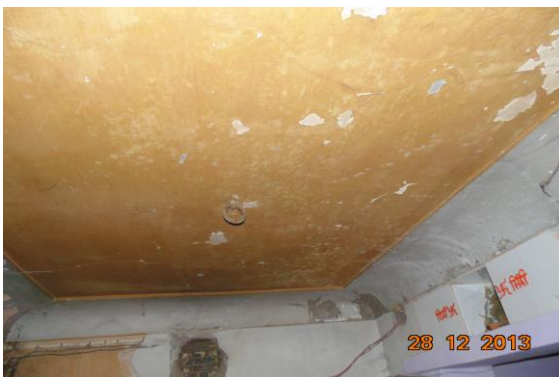
Photo 9

Dampness/Seepage on Roof of Lobby 1 of House No. 284 of Ground Floor

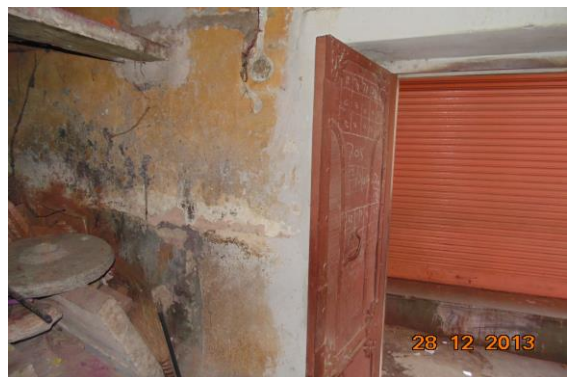
Photo 10

Dampness/Seepage on Wall No. 3 of Lobby 1 of House No. 284 of Ground Floor

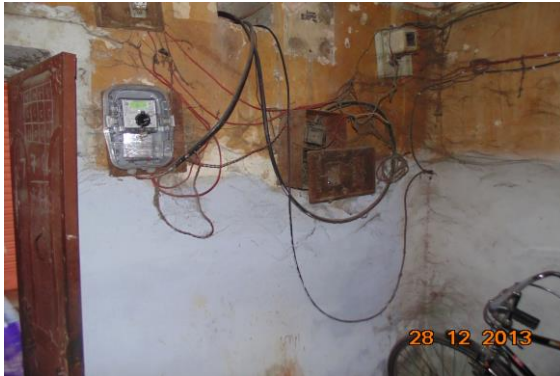
Photo 11

Dampness/Seepage on Wall No. 3 of Lobby 1 of House No. 284 of Ground Floor

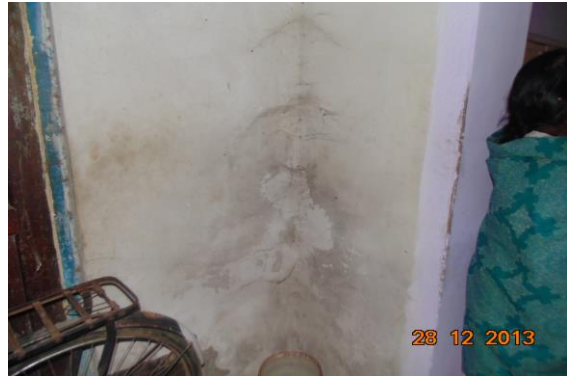
Photo 12

Dampness/Seepage on Wall No. 1 & 4 of Lobby 1 of House No. 284 of Ground Floor

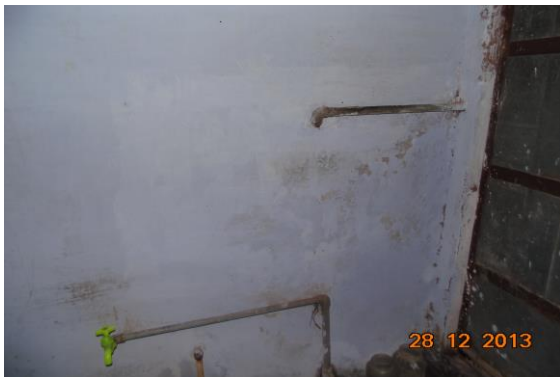
Photo 13

Dampness/Seepage on Wall No. 4 of Lobby 1 of House No. 284 of Ground Floor

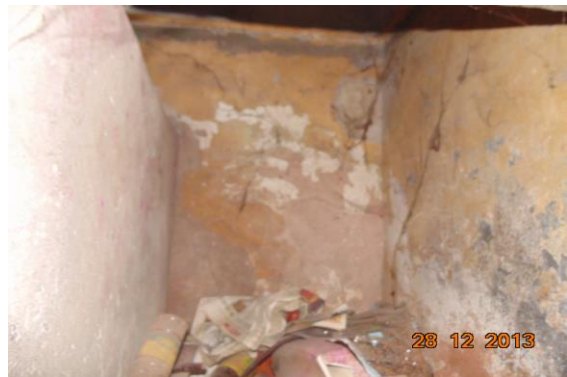
Photo 14

Dampness/Seepage on Wall No. 2 of Lobby 1 of House No. 284 of Ground Floor

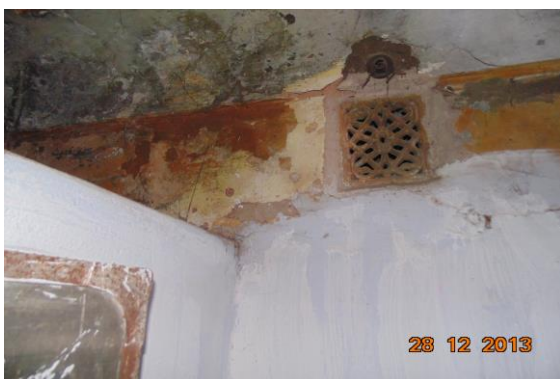
Photo 15

Dampness/Seepage on Wall No. 2 of Lobby 1 of House No. 284 of Ground Floor

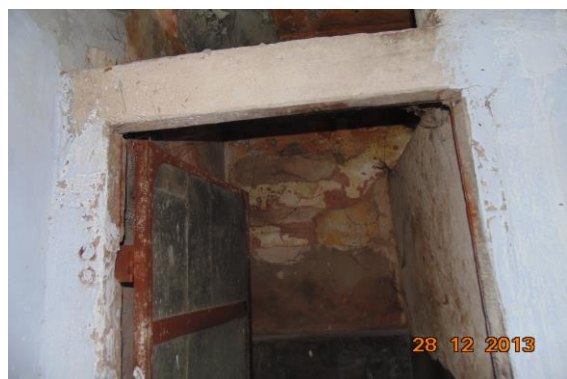
Photo 16

Peeling of Plaster on Wall No. 2 & 4 of Toilet No. 2 of H.No.284,Ground Floor

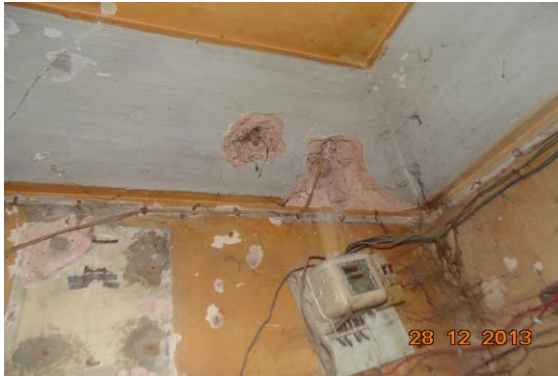
Photo 17

Damaged Portion on Roof of Lobby of House No. 284 of Ground Floor

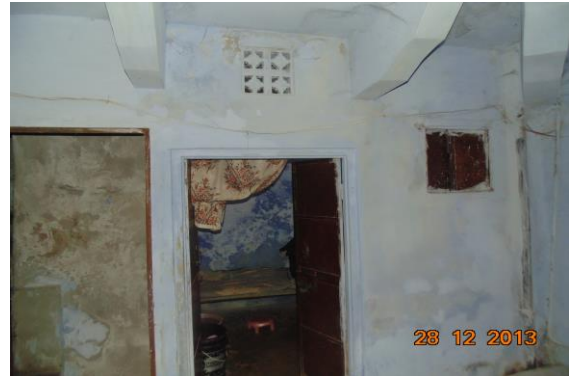
Photo 18

Dampness/Seepage on Wall No. 2 of Sky Open of House No. 284 of Ground Floor

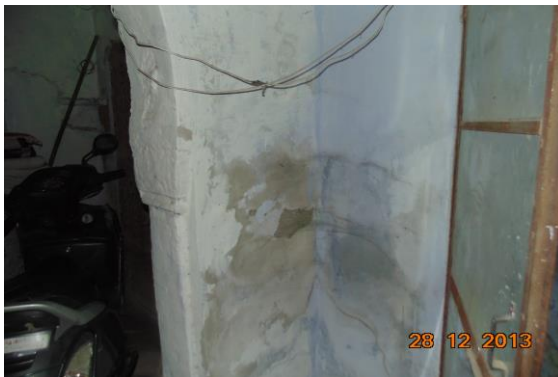
Photo 19

Dampness/Seepage on Wall No. 2 & 4 of Sky Open of House No. 284 of Ground Floor

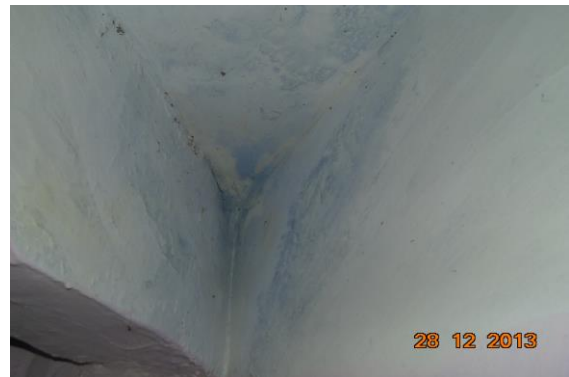
Photo 20

Dampness/Seepage on Wall No. 4 & Roof of Sky Open of House No. 284 of Ground Floor

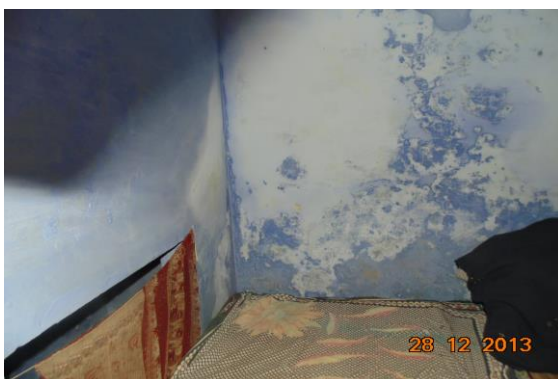
Photo 21

Dampness/Seepage on Wall No. 1 & 4 of Room No. 6 of H.No.284, Ground Floor

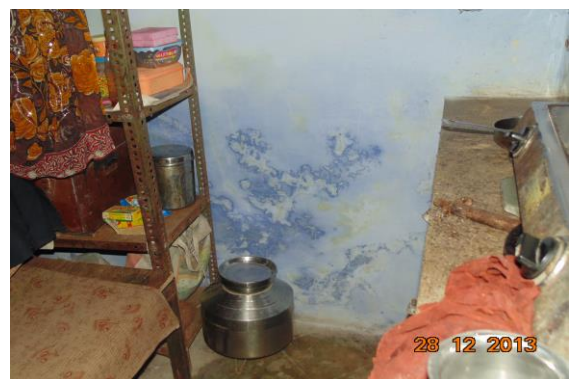
Photo 22

Dampness/Seepage on Wall No. 2 of Room No. 6 of H.No.284, Ground Floor

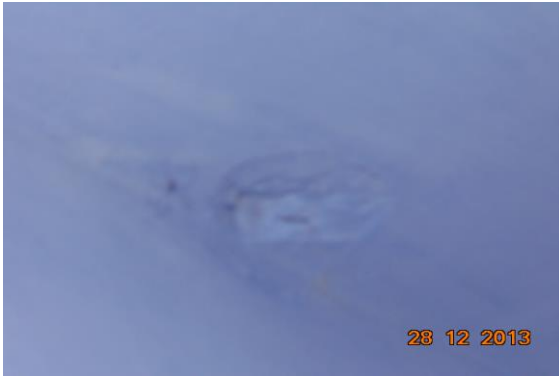
Photo 23

Peeling of Plaster on Roof of Room No. 6 of H.No.284,Ground Floor

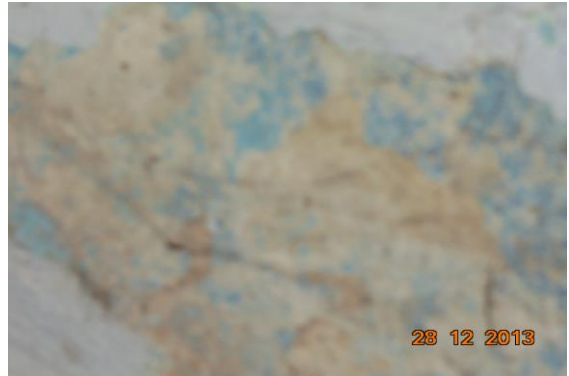
Photo 24

Dampness/Seepage on Wall No. 2 of Room No. 5 of H.No.284,Ground Floor

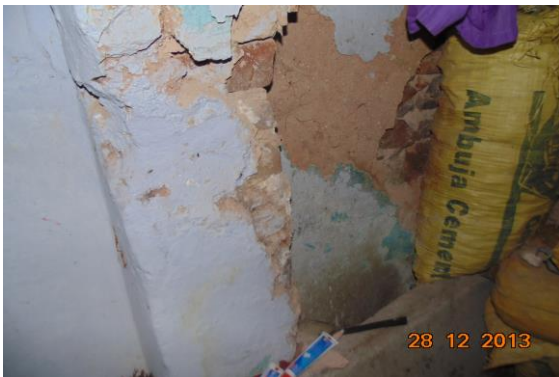
Photo 25

Dampness/Seepage on Wall No. 3 of Room No. 5 of H.No.284,Ground Floor

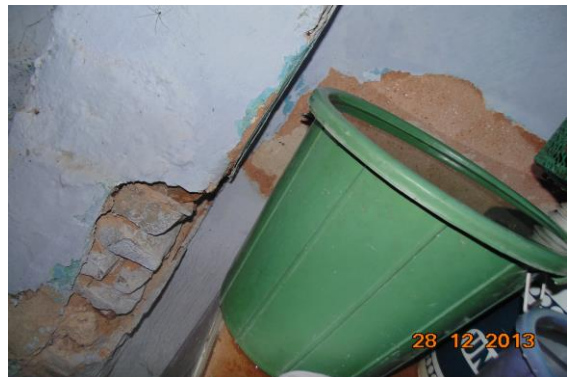
Photo 26

Peeling of Plaster on Wall No. 1 & 4 of Varanda of House No. 284 of Ground Floor

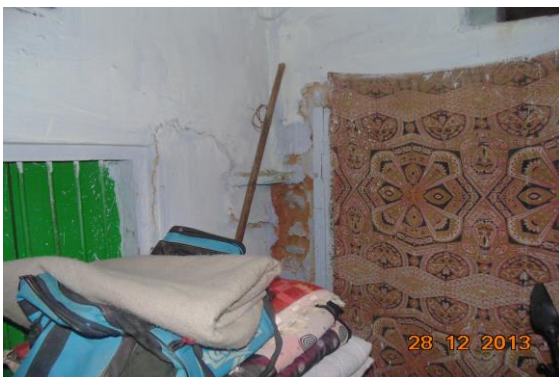
Photo 27

Peeling of Plaster on Wall No. 2 & 4 of Varanda of House No. 284 of Ground Floor

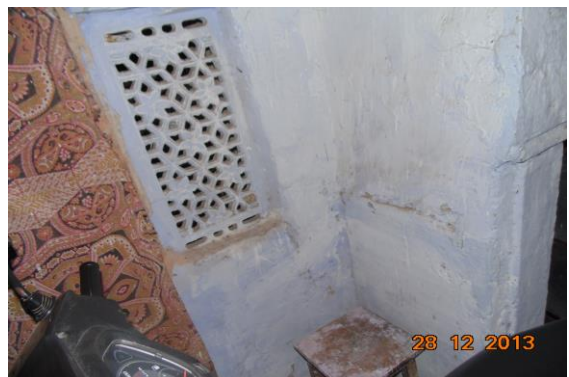
Photo 28

Peeling of Plaster on Wall No. 2 & 3 of Varanda of House No. 284 of Ground Floor

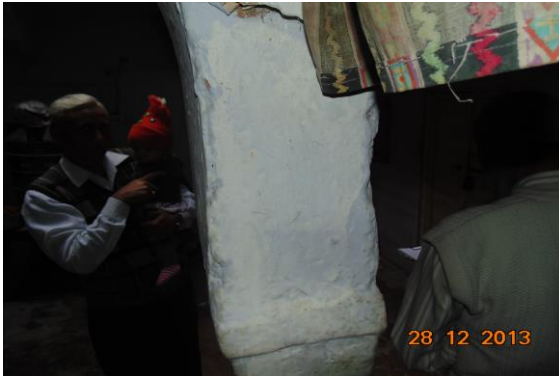
Photo 29

Peeling of Plaster on Wall No. 2 & 3 of Varanda of House No. 284 of Ground Floor

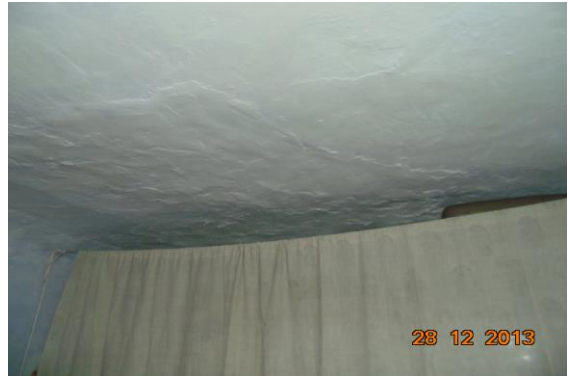
Photo 30

Peeling of Plaster on Roof of Room No. 1 of H.No.284,Ground Floor

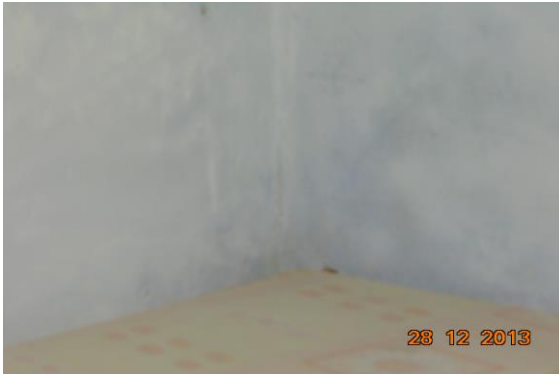
Photo 31

Dampness/Seepage on Wall No. 2 & 4 of Room No. 1 of H.No.284,Ground Floor

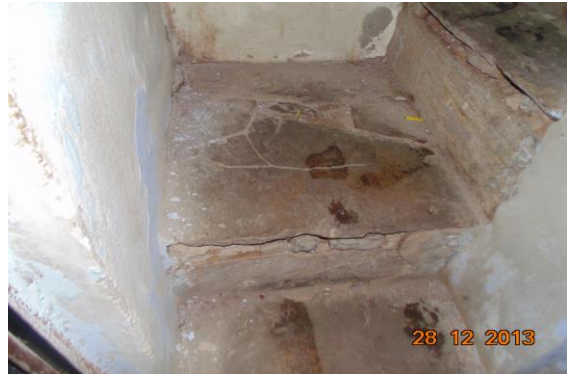
Photo 32

Damaged Portion on Steps of Staircase GF-FF of House No. 284 of Ground Floor

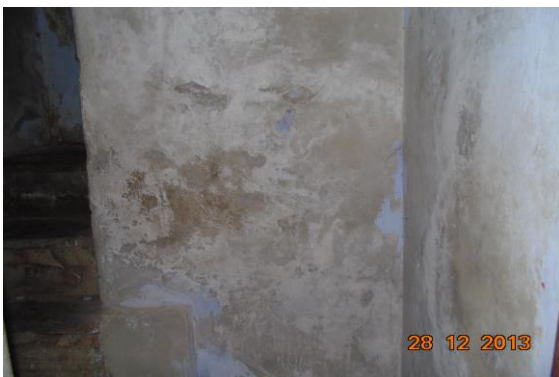
Photo 33

Dampness/Seepage on All Wall & Roof of Staircase GF-FF Steps of House No. 284 of Ground Floor

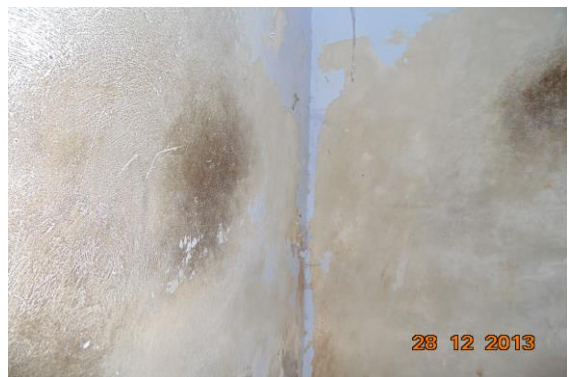
Photo 34

Dampness/Seepage on All Wall & Roof of Staircase GF-FF Steps of House No. 284 of Ground Floor

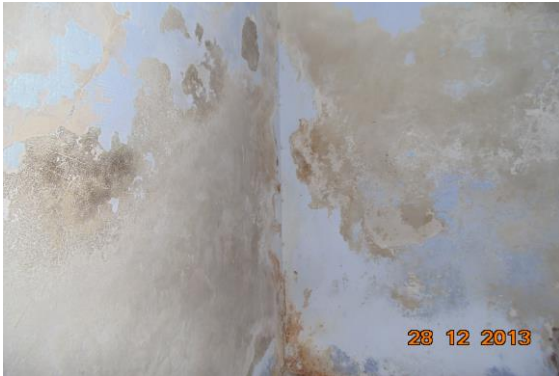
Photo 35

Dampness/Seepage on All Wall & Roof of Staircase GF-FF Steps of House No. 284 of Ground Floor

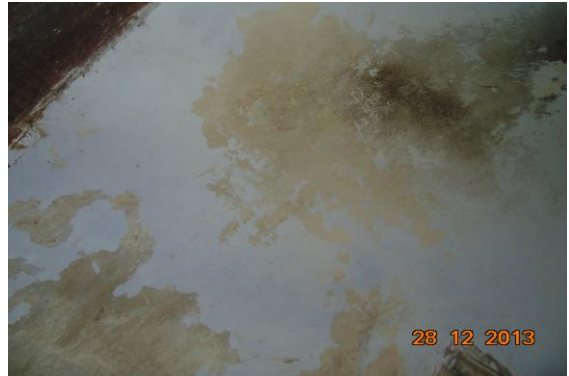
Photo 36

Dampness/Seepage on All Wall & Roof of Staircase GF-FF Steps of House No. 284 of Ground Floor

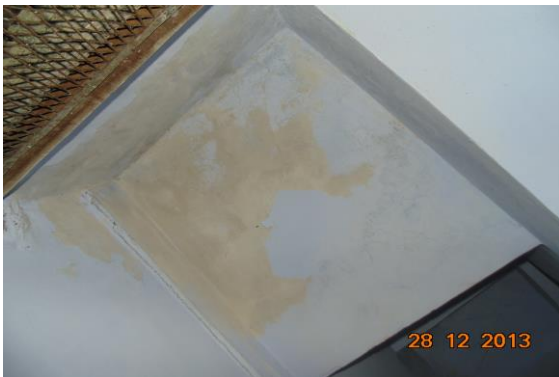
Photo 37

Dampness/Seepage on All Wall & Roof of Staircase GF-FF Steps of House No. 284 of Ground Floor

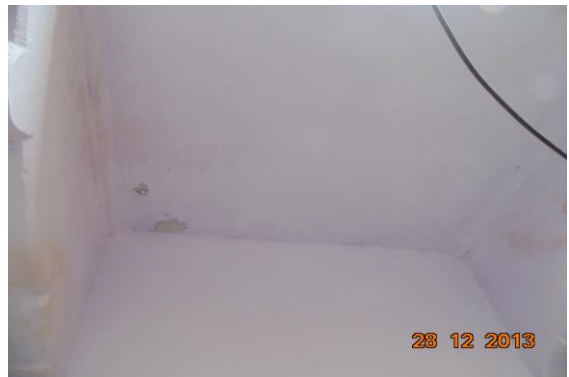
Photo 38

Dampness/Seepage on Wall No. 3 & Sunshade of Sky Open Lobby of House No. 284 of First floor

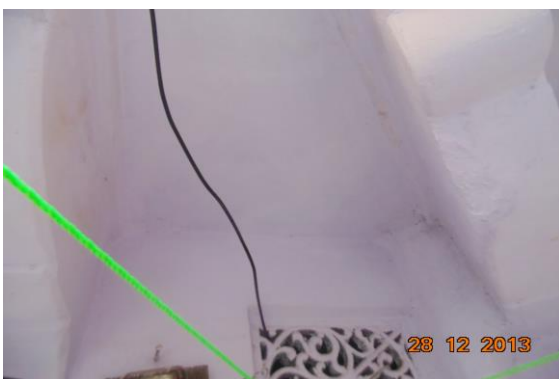
Photo 39

Dampness/Seepage on Wall No. 3 & Sunshade of Sky Open Lobby of House No. 284 of First floor

34	Wall No. 3 & Sunshade Sky Open Lobby of House No. 284 First floor	Dampness/Seepage	39
35	Wall No. 3 & Sunshade Sky Open Lobby of House No. 284 First floor	Dampness/Seepage	40
36	Wall No. 1 & Sunshade Sky Open Lobby of House No. 284 First floor	Dampness/Seepage	41
37	Floor Room No. 3 H.No.284,First floor	Damaged Portion	42
38	Wall No. 4 Room No. 4 H.No.284,First floor	Peeling of Plaster	43
39	Roof Room No. 4 H.No.284,First floor	Dampness/Seepage	44
40	Wall No. 3 Room No. 4 H.No.284,First floor	Peeling of Plaster	45
41	Staircase Step FF-SF of House No. 284 First floor	Damaged Portion	46
42	All Wall Staircase FF-SF of House No. 284 First floor	Dampness/Seepage	47
43	All Wall Staircase FF-SF of House No. 284 First floor	Dampness/Seepage	48
44	All Wall Staircase FF-SF of House No. 284 First floor	Dampness/Seepage	49
45	All Wall Staircase FF-SF of House No. 284 First floor	Dampness/Seepage	50
46	All Wall Staircase FF-SF of House No. 284 First floor	Dampness/Seepage	51

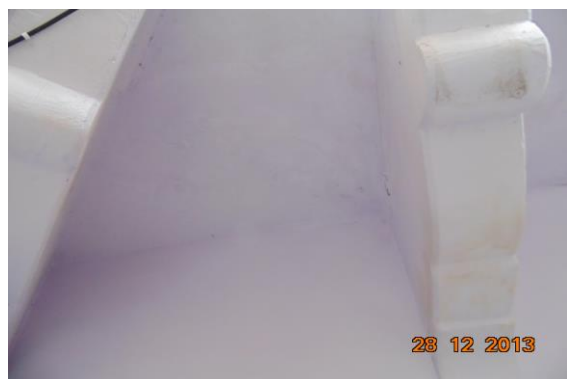
Photo 40

Dampness/Seepage on Wall No. 3 & Sunshade of Sky Open Lobby of House No. 284 of First floor

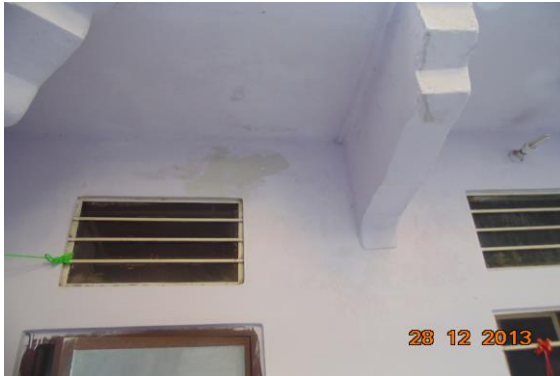
Photo 41

Dampness/Seepage on Wall No. 1 & Sunshade of Sky Open Lobby of House No. 284 of First floor

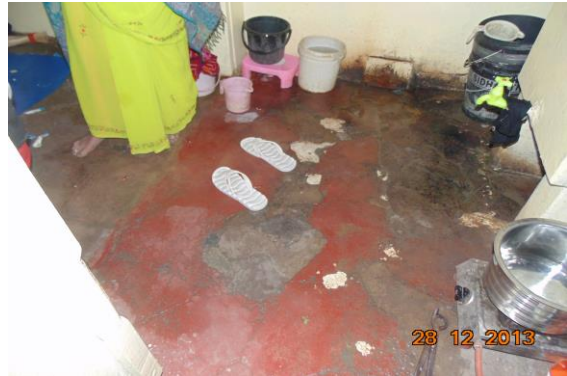
Photo 42

Damaged Portion on Floor of Room No. 3 of H.No.284, First floor

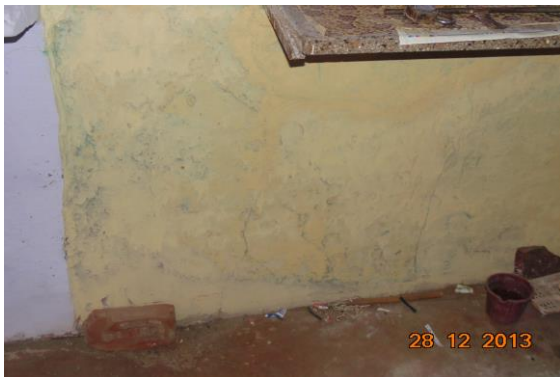
Photo 43

Peeling of Plaster on Wall No. 4 of Room No. 4 of H.No.284, First floor

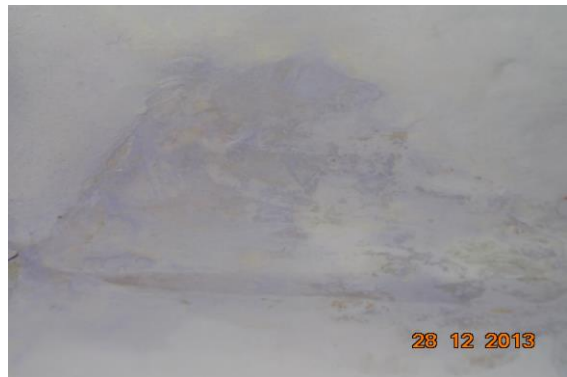
Photo 44

Dampness/Seepage on Roof of Room No. 4 of H.No.284, First floor

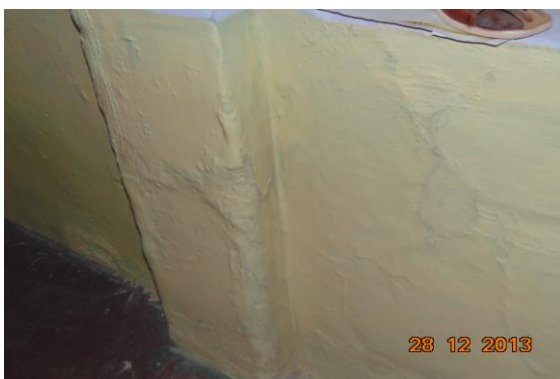
Photo 45

Peeling of Plaster on Wall No. 3 of Room No. 4 of H.No.284, First floor

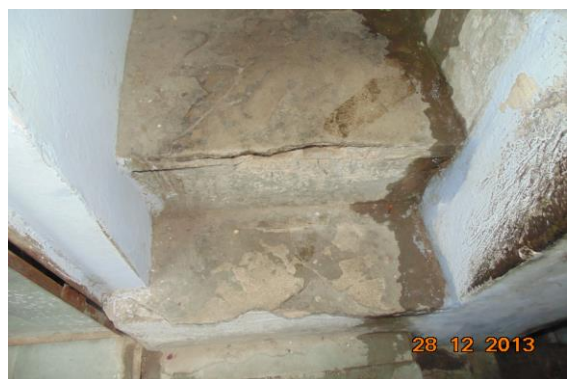
Photo 46

Damaged Portion on Staircase Step FF-SF of House No. 284 of First floor

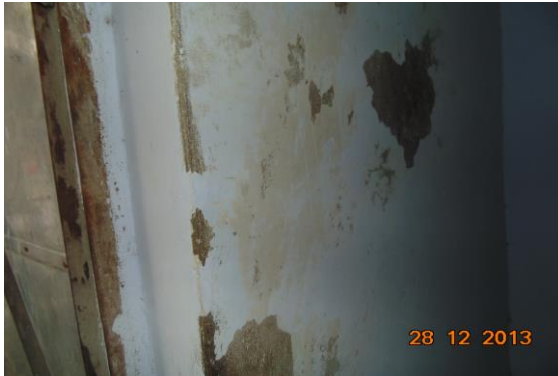
Photo 47

Dampness/Seepage on All Wall of Staircase FF-SF of House No. 284 of First floor

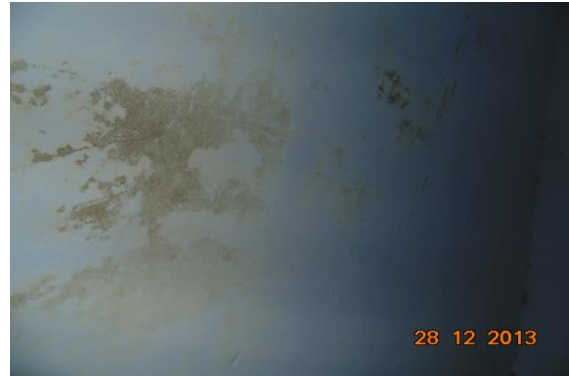
Photo 48

Dampness/Seepage on All Wall of Staircase FF-SF of House No. 284 of First floor

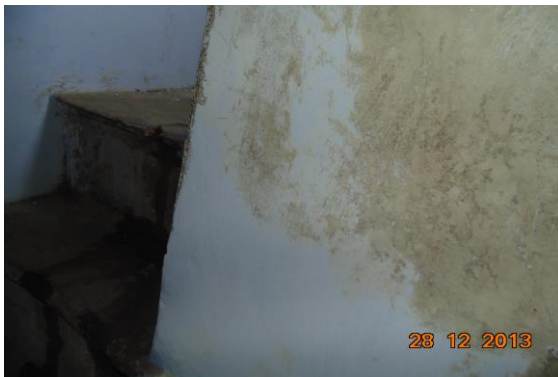
Photo 49

Dampness/Seepage on All Wall of Staircase FF-SF of House No. 284 of First floor

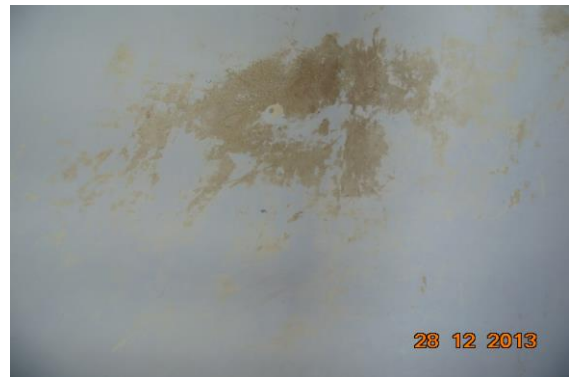
Photo 50

Dampness/Seepage on All Wall of Staircase FF-SF of House No. 284 of First floor
