Pre Building Condition Survey Report

Name and Address of Structure :	Badi Chopar to Ramp Area (Down Line)
---------------------------------	--------------------------------------

Name of the Project	Contract JMRC-UG1B “Design and Construction of Tunnel between Chandpole and Badi Chouper and reverse line by Shield TBM, Underground Metro Stations at Choti Chouper and Badi Chouper by Cut and Cover Methods on East West Corridor of Jaipur Metro Rail Corporation Limited .”	
Owner :

Pre - Condition Building Survey for Construction of Underground Stations from Chandpole to Bari Chouper and reversal line

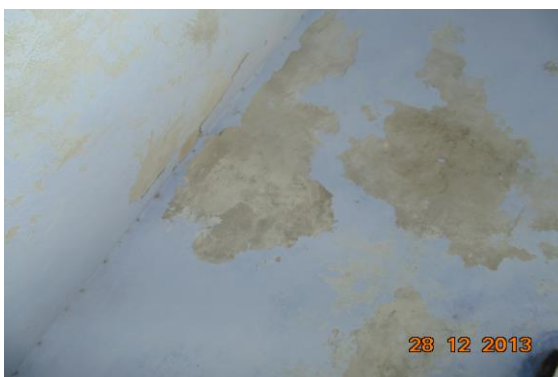
Photo 51

Dampness/Seepage on All Wall of Staircase FF-SF of House No. 284 of First floor

34	Wall No. 3 & Sunshade Sky Open Lobby of House No. 284 First floor	Dampness/Seepage	39
35	Wall No. 3 & Sunshade Sky Open Lobby of House No. 284 First floor	Dampness/Seepage	40
36	Wall No. 1 & Sunshade Sky Open Lobby of House No. 284 First floor	Dampness/Seepage	41
37	Floor Room No. 3 H.No.284,First floor	Damaged Portion	42
38	Wall No. 4 Room No. 4 H.No.284,First floor	Peeling of Plaster	43
39	Roof Room No. 4 H.No.284,First floor	Dampness/Seepage	44
40	Wall No. 3 Room No. 4 H.No.284,First floor	Peeling of Plaster	45
41	Staircase Step FF-SF of House No. 284 First floor	Damaged Portion	46
42	All Wall Staircase FF-SF of House No. 284 First floor	Dampness/Seepage	47
43	All Wall Staircase FF-SF of House No. 284 First floor	Dampness/Seepage	48
44	All Wall Staircase FF-SF of House No. 284 First floor	Dampness/Seepage	49
45	All Wall Staircase FF-SF of House No. 284 First floor	Dampness/Seepage	50
46	All Wall Staircase FF-SF of House No. 284 First floor	Dampness/Seepage	51

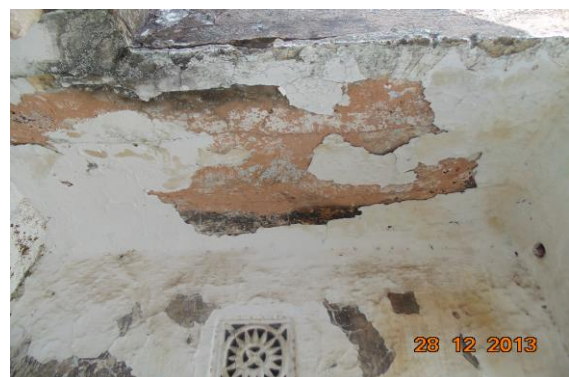
Photo 52

Dampness/Seepage on Wall No. 1 & Sunshade of Sky Open Lobby 2 of House No. 284 of Second floor

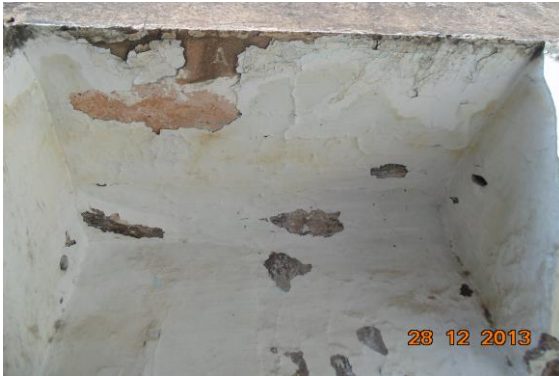
Photo 53

Dampness/Seepage on Wall No. 1 & Sunshade of Sky Open Lobby 2 of House No. 284 of Second floor

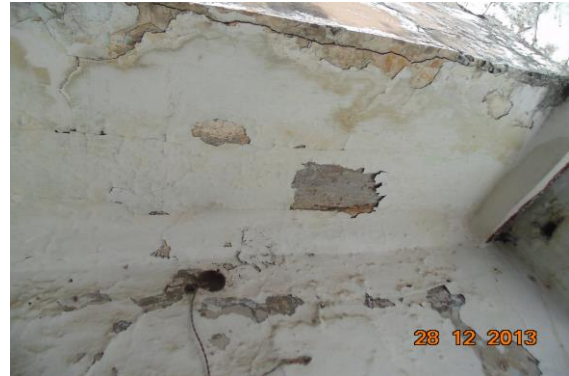
Photo 54

Dampness/Seepage on Wall No. 1 & Sunshade of Sky Open Lobby 2 of House No. 284 of Second floor

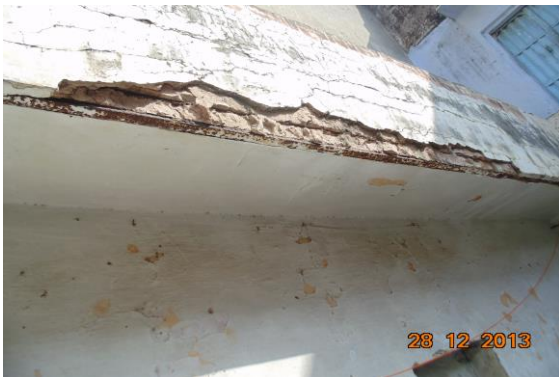
Photo 55

Dampness/Seepage on Wall No. 4 & Sunshade of Sky Open Lobby 2 of House No. 284 of Second floor

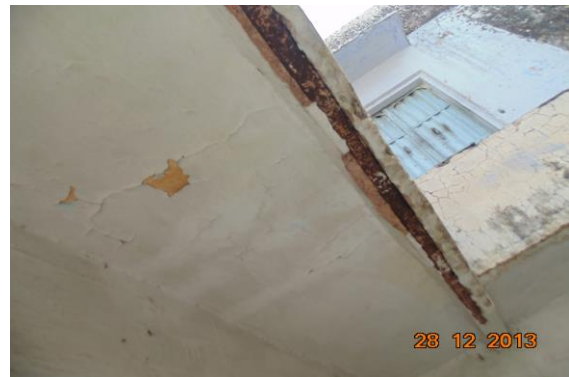
Photo 56

Dampness/Seepage on Wall No. 4 & Sunshade of Sky Open Lobby 2 of House No. 284 of Second floor

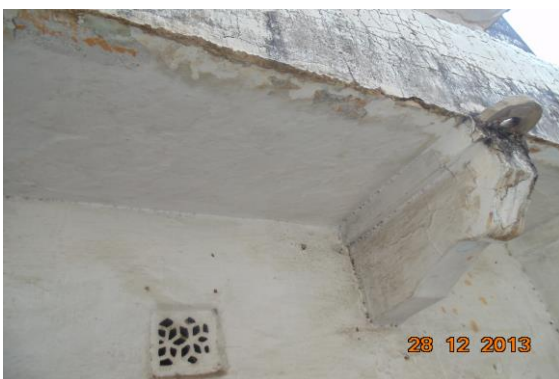
Photo 57

Dampness/Seepage on Wall No. 2 & Sunshade of Sky Open Lobby 2 of House No. 284 of Second floor

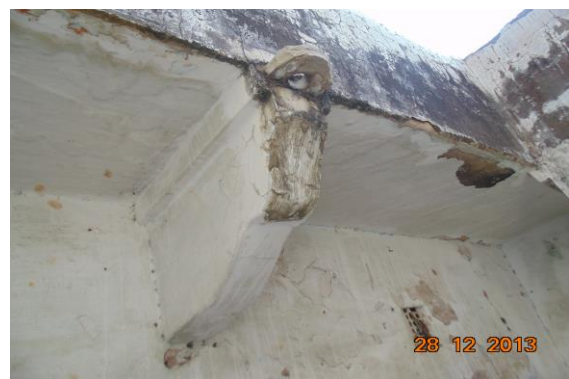
Photo 58

Dampness/Seepage on Wall No. 2 & Sunshade of Sky Open Lobby 2 of House No. 284 of Second floor

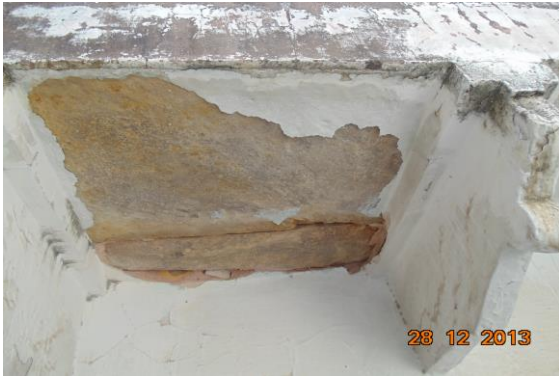
Photo 59

Dampness/Seepage on Wall No. 3 & Sunshade of Sky Open Lobby 2 of House No. 284 of Second floor

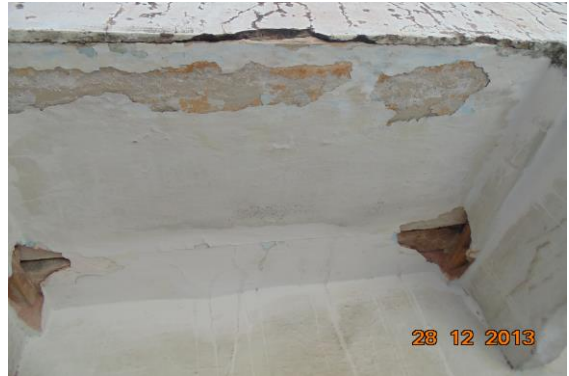
Photo 60

Dampness/Seepage on Wall No. 3 & Sunshade of Sky Open Lobby 2 of House No. 284 of Second floor

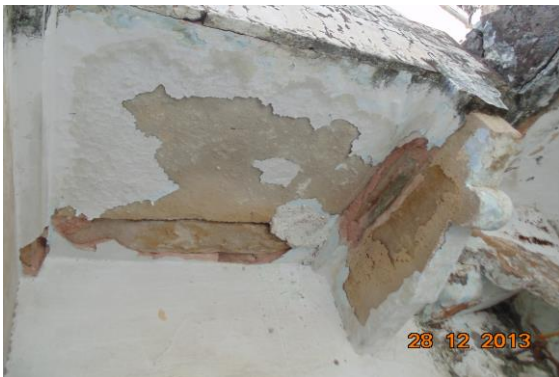
Photo 61

Dampness/Seepage on Wall No. 3 & Sunshade of Sky Open Lobby 2 of House No. 284 of Second floor

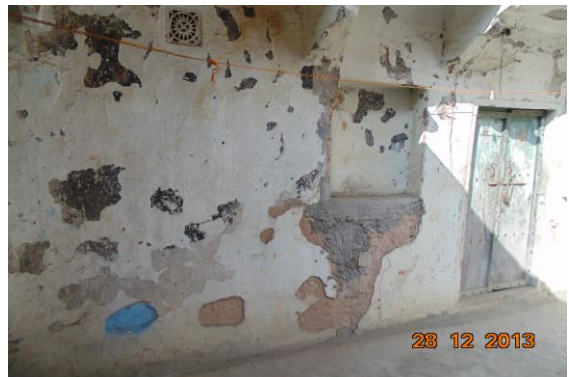
Photo 62

Dampness/Seepage on Wall No. 1 of Sky Open Lobby 2 of House No. 284 of Second floor

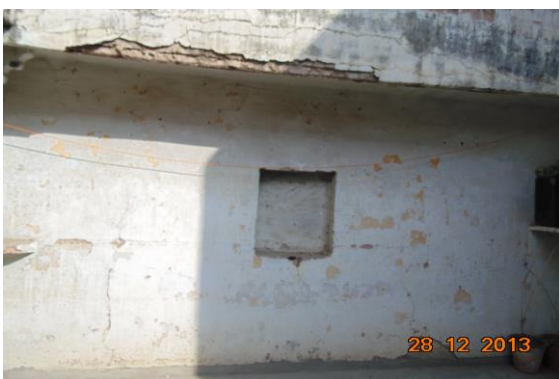
Photo 63

Dampness/Seepage on Wall No. 4 of Sky Open Lobby 2 of House No. 284 of Second floor

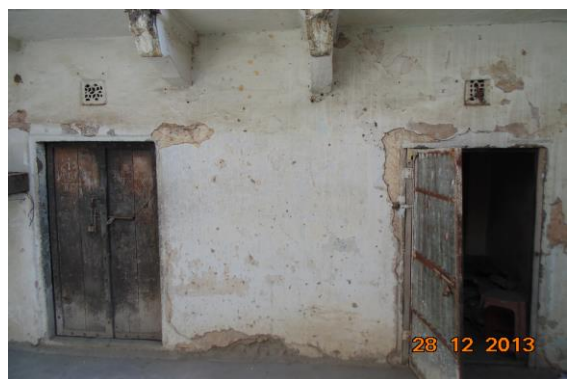
Photo 64

Dampness/Seepage on Wall No. 2 of Sky Open Lobby 2 of House No. 284 of Second floor

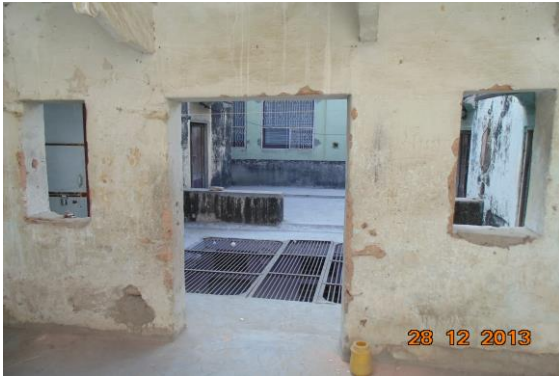
Photo 65

Dampness/Seepage on Wall No. 3 of Sky Open Lobby 2 of House No. 284 of Second floor

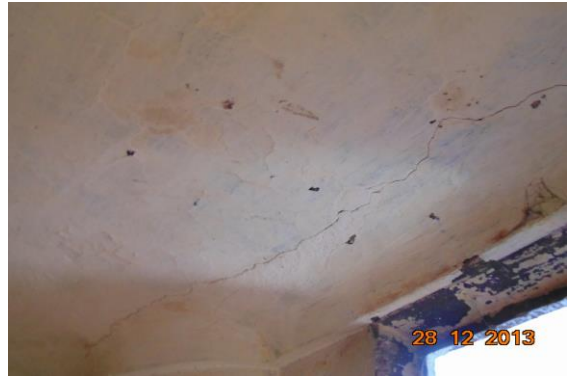
Photo 66

Plaster Crack on Roof of Room No. 3 of H.No.284, Second floor

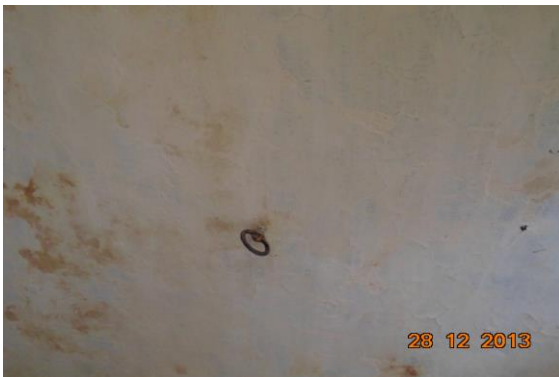
Photo 67

Dampness/Seepage on Roof of Room No. 3 of H.No.284, Second floor

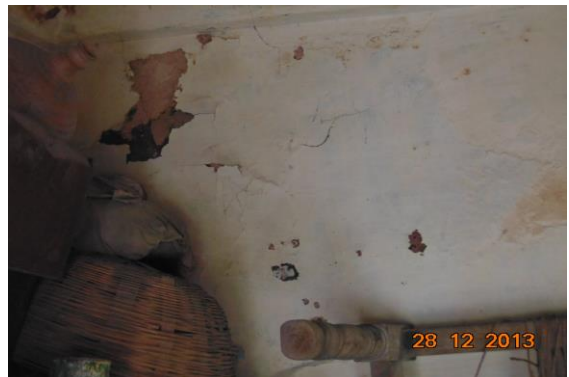
Photo 68

Dampness/Seepage on Wall No. 4 of Room No. 3 of H.No.284, Second floor

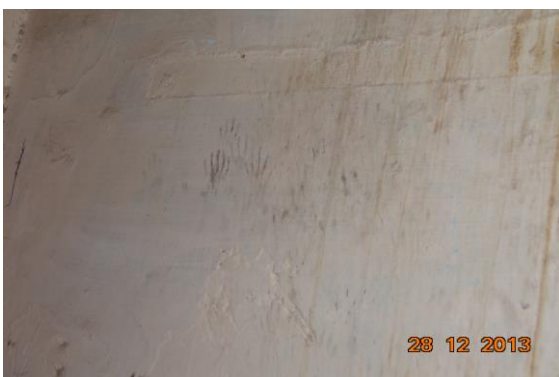
Photo 69

Dampness/Seepage on Wall No. 2 of Room No. 3 of H.No.284, Second floor

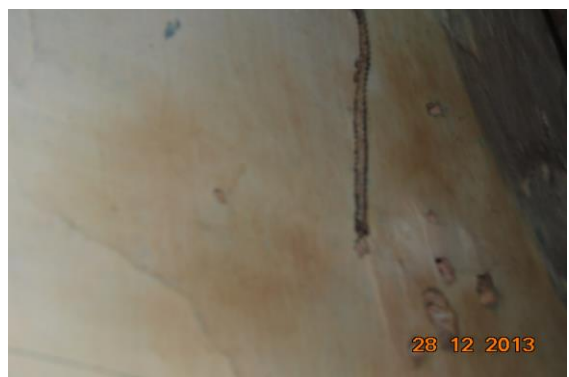
Photo 70

Dampness/Seepage on Wall No. 3 of Room No. 3 of H.No.284, Second floor

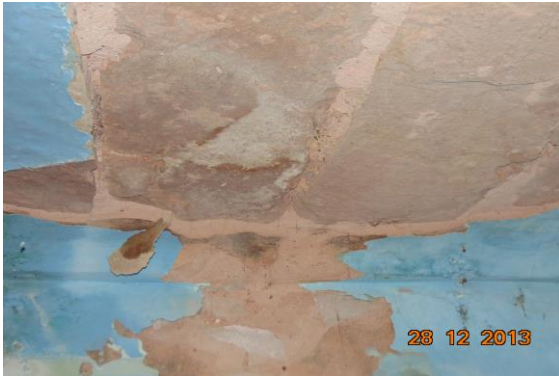
Photo 71

Peeling of Plaster on Wall No. 4 & Roof of Room No. 2 of H.No.284, Second floor

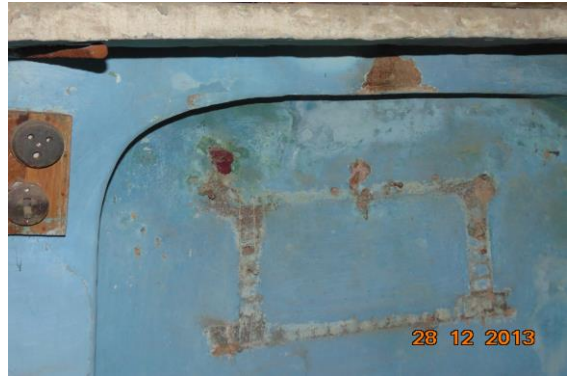
Photo 72

Dampness/Seepage on Wall No. 1 of Room No. 2 of H.No.284, Second floor

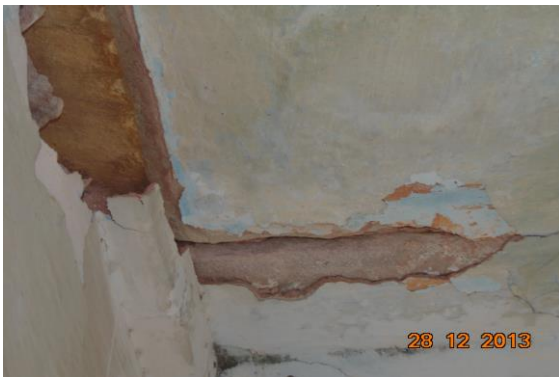
Photo 73

Damaged Portion on Wall No. 2 & Sunshade of Sky Open Lobby 1 of House No. 284 of Second floor

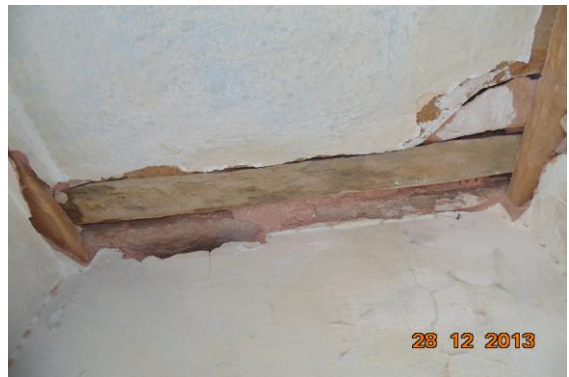
Photo 74

Damaged Portion on Wall No. 2 & Sunshade of Sky Open Lobby 1 of House No. 284 of Second floor

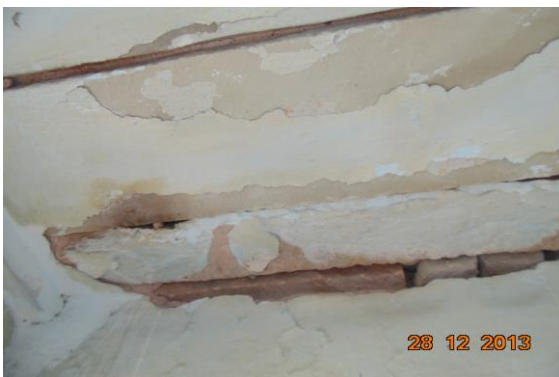
Photo 75

Damaged Portion on Wall No. 2 & Sunshade of Sky Open Lobby 1 of House No. 284 of Second floor

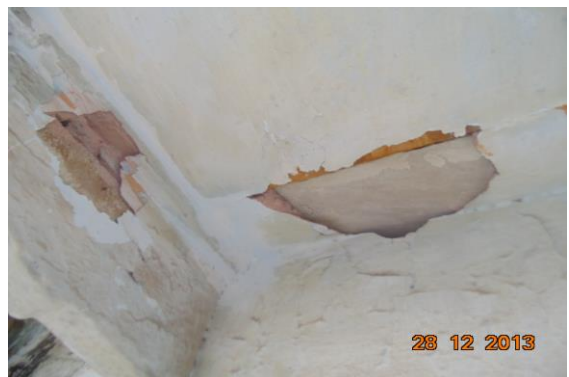
Photo 76

Damaged Portion on Wall No. 2 & Sunshade of Sky Open Lobby 1 of House No. 284 of Second floor

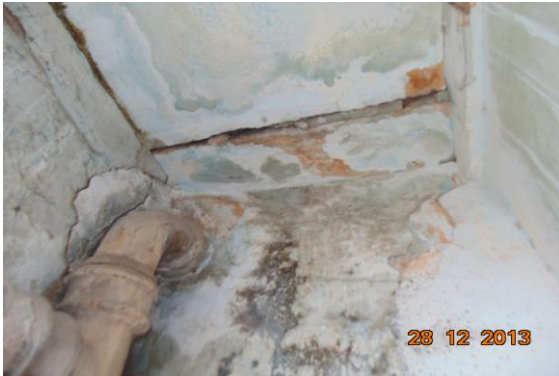
Photo 77

Damaged Portion on Wall No. 2 & Sunshade of Sky Open Lobby 1 of House No. 284 of Second floor

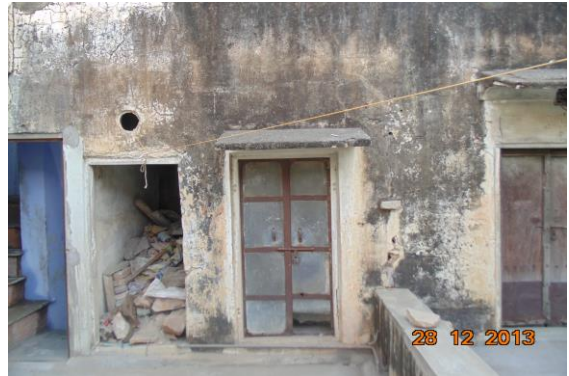
Photo 78

Dampness/Seepage on Wall No. 3 of Sky Open Lobby 1 of House No. 284 of Second floor

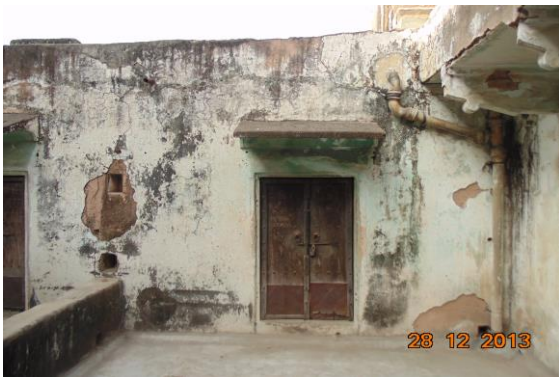
Photo 79

Dampness/Seepage on Wall No. 4 of Sky Open Lobby 1 of House No. 284 of Second floor

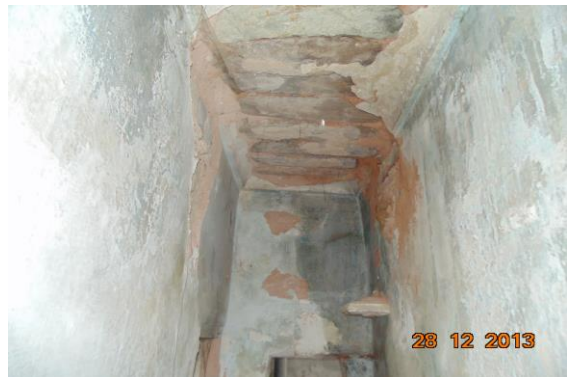
Photo 80

Peeling of Plaster on Wall No. 1, 2, 4 & Roof of Store Room of House No. 284 of Second floor

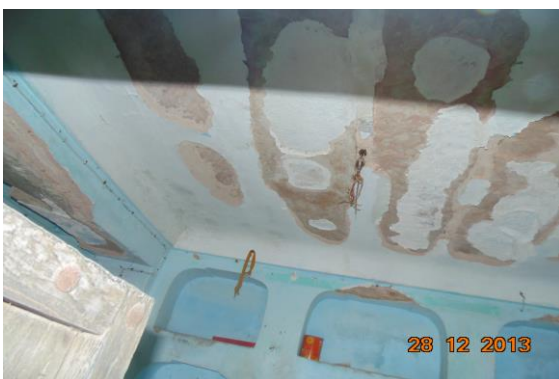
Photo 81

Peeling of Plaster on Roof of Room No. 7 of H.No.284,Second floor

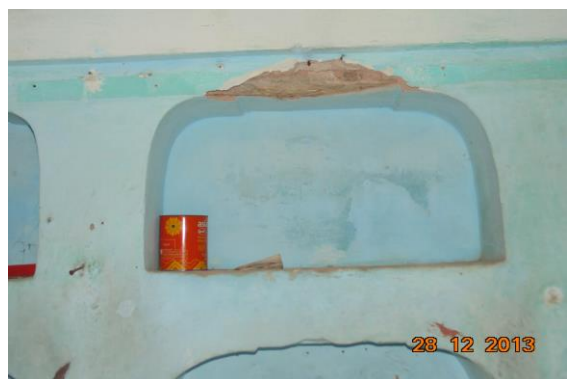
Photo 82

Peeling of Plaster on Wall No. 4 of Room No. 7 of H.No.284,Second floor

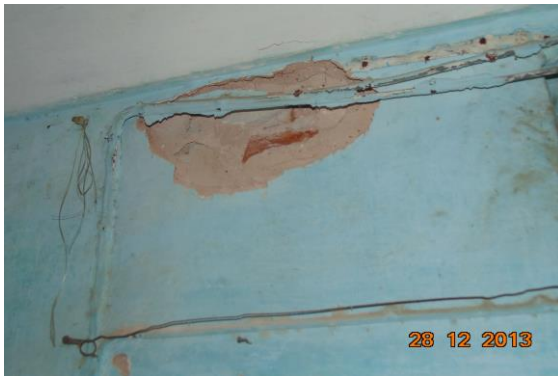
Photo 83

Peeling of Plaster on Wall No. 3 of Room No. 7 of H.No.284, Second floor

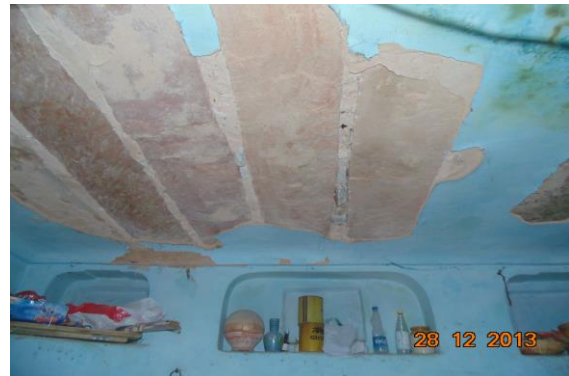
Photo 84

Peeling of Plaster on Roof of Room No. 6 of H.No.284, Second floor

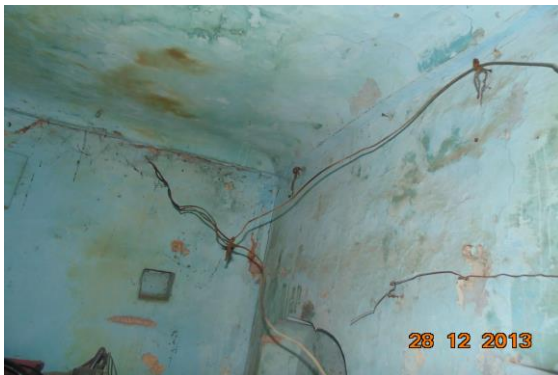
Photo 85

Dampness/Seepage on Wall No. 2 & 3 of Room No. 6 of H.No.284, Second floor

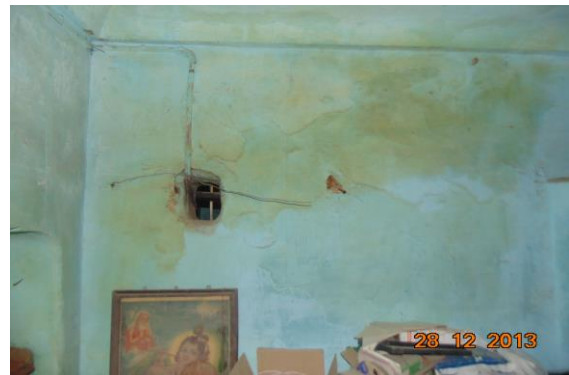
Photo 86

Dampness/Seepage on Wall No. 1 of Room No. 6 of H.No.284, Second floor

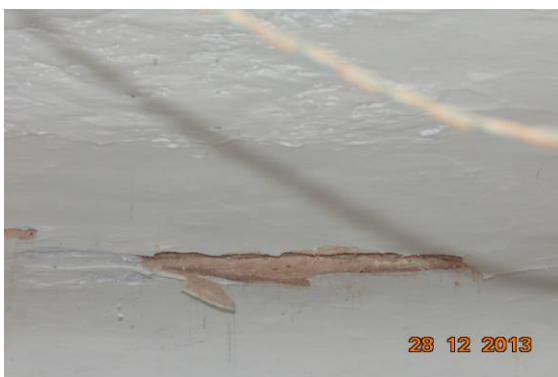
Photo 87

Peeling of Plaster on Roof of Room No. 1 of H.No.284, Second floor

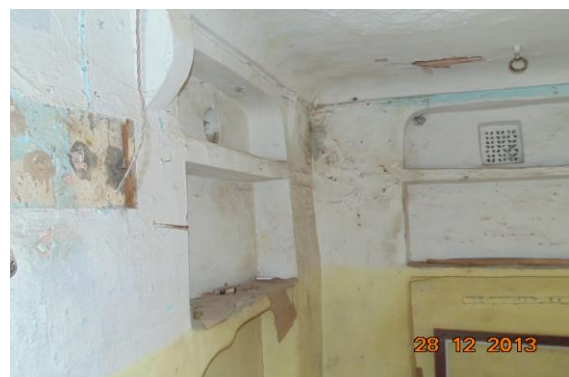
Photo 88

Dampness/Seepage on Wall No. 1 & 3 of Room No. 1 of H.No.284, Second floor

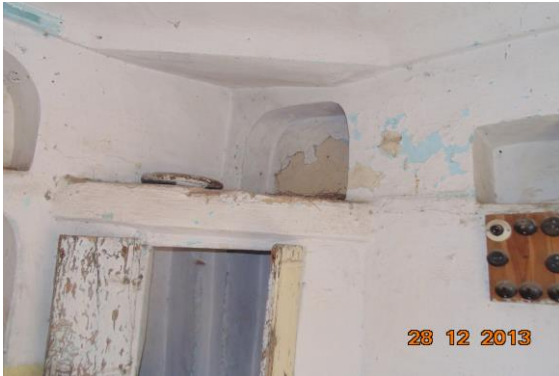
Photo 89

Dampness/Seepage on Wall No. 2 & 4 of Room No. 1 of H.No.284, Second floor

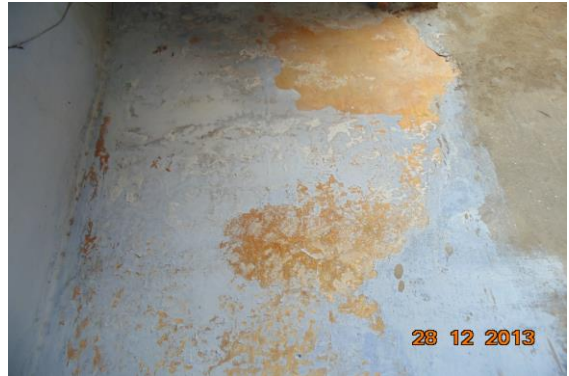
Photo 90

Dampness/Seepage on All Wall of Staircase SF-TF of House No. 284 of Second floor

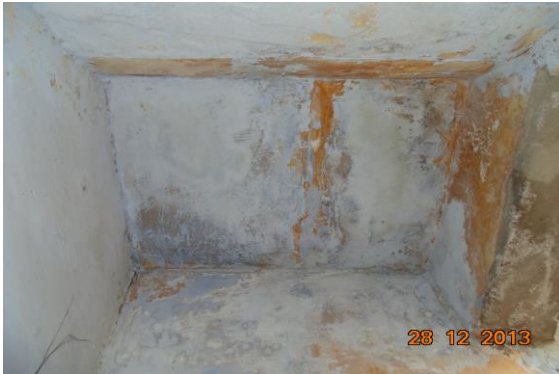
Photo 91

Dampness/Seepage on All Wall of Staircase SF-TF of House No. 284 of Second floor

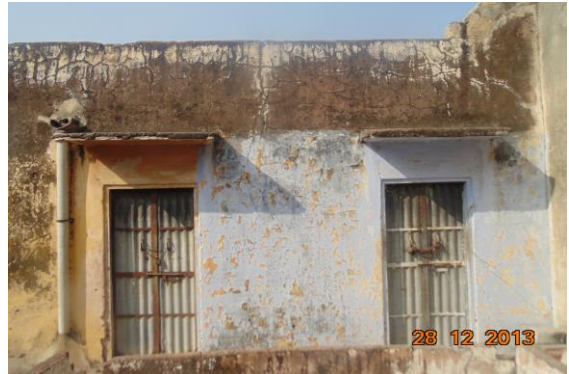
Photo 92

Dampness/Seepage on Wall No. 4 of Sky Open Lobby of House No. 284 of Third floor

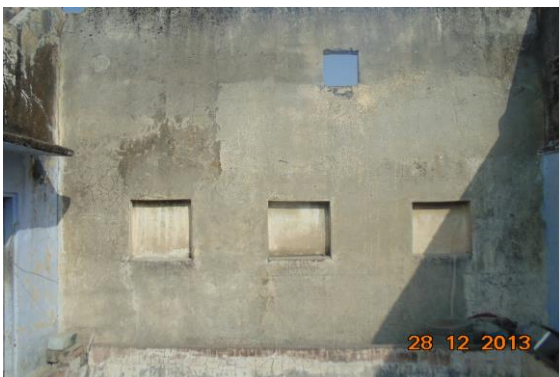
Photo 93

Dampness/Seepage on Wall No. 2 of Sky Open Lobby of House No. 284 of Third floor

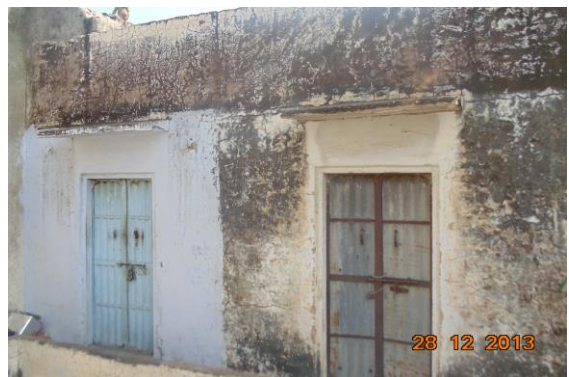
Photo 94

Dampness/Seepage on Wall No. 3 of Sky Open Lobby of House No. 284 of Third floor

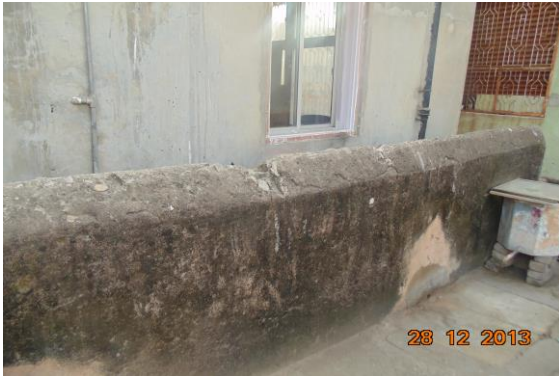
Photo 95

Peeling of Plaster on Wall No. 1 of Passage 1 of House No. 284 of Third floor

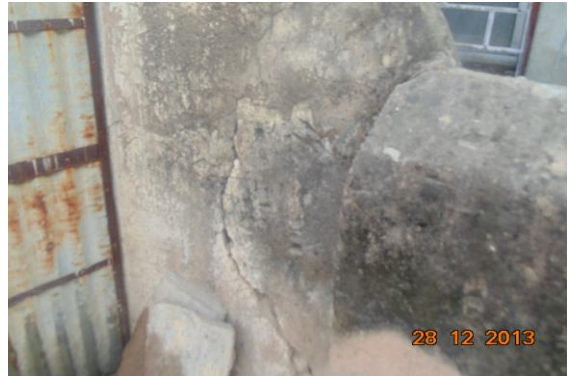
Photo 96

Peeling of Plaster on Wall No. 1 of Passage 1 of House No. 284 of Third floor

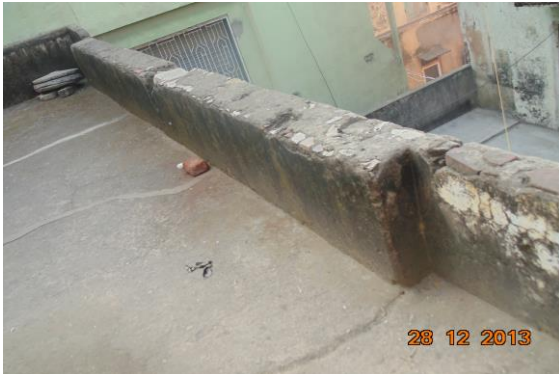
Photo 97

Peeling of Plaster on Wall No. 2 of Passage 1 of House No. 284 of Third floor

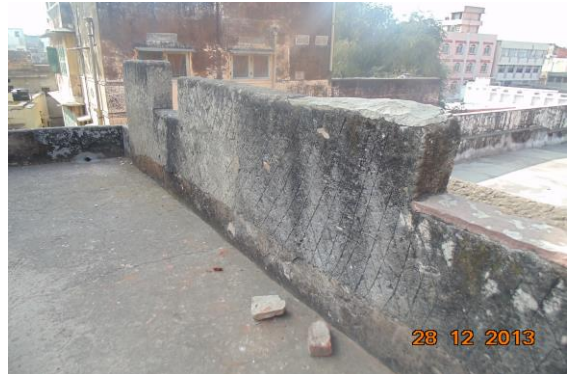
Photo 98

Peeling of Plaster on Wall No. 2 of Passage 2 of House No. 284 of Third floor

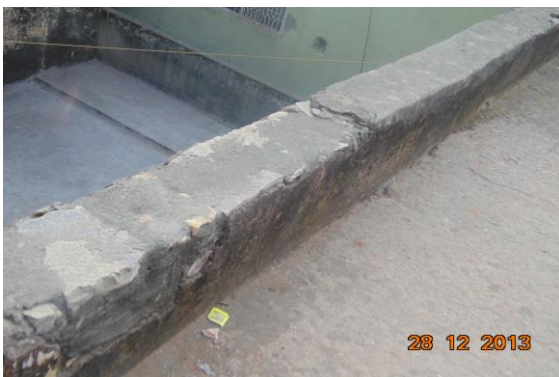
Photo 99

Peeling of Plaster on Wall No. 1 of Passage 2 of House No. 284 of Third floor

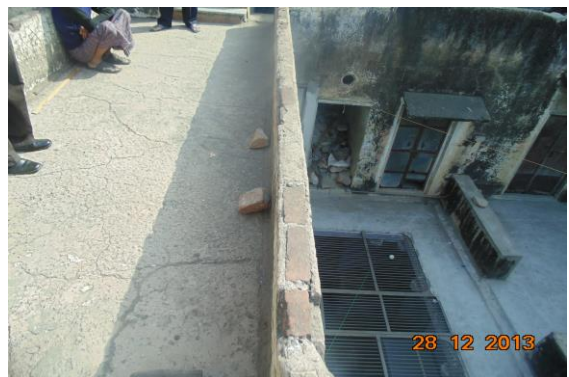
Photo 100

Peeling of Plaster on Wall No. 1 of Sky Open Lobby of House No. 284 of Third floor

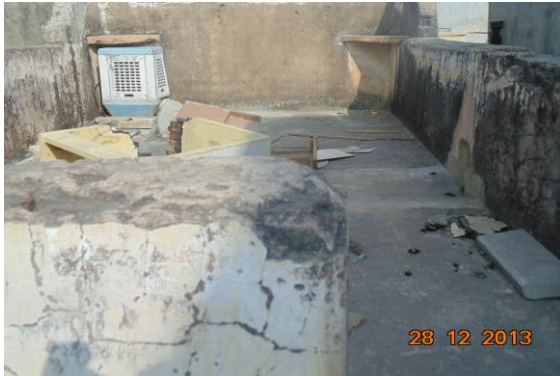
Photo 101

Peeling of Plaster on All Wall & Floor of Terrace 1 of House No. 284 of Terrace

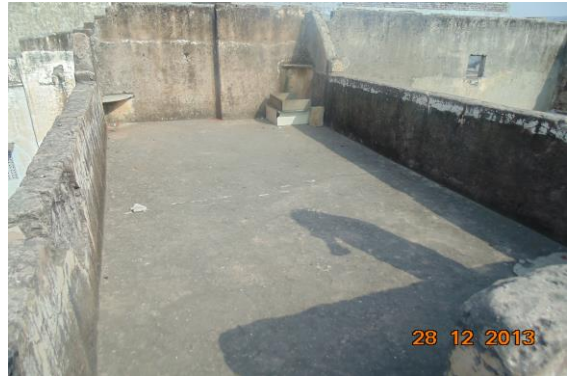
Photo 102

Peeling of Plaster on All Wall of Terrace 2 of House No. 284 of Terrace

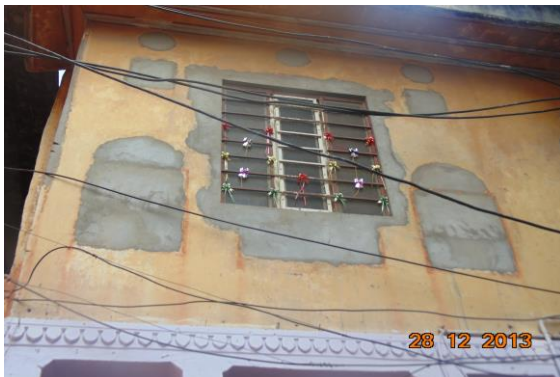
Photo 103

Peeling of Plaster on Wall No. 3 of External Façade of House No. 284 of First floor

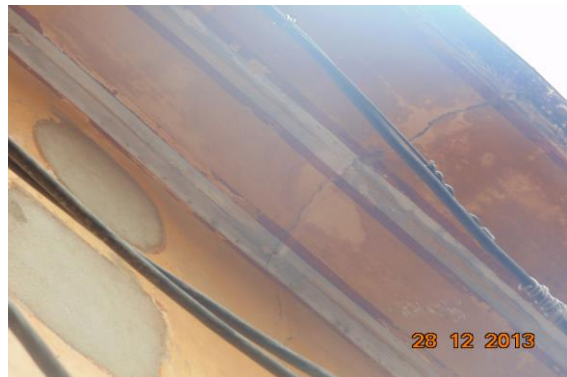
Photo 104

Plaster Crack on Wall No. 3 & Sunshade of External Façade of House No. 284 of First floor

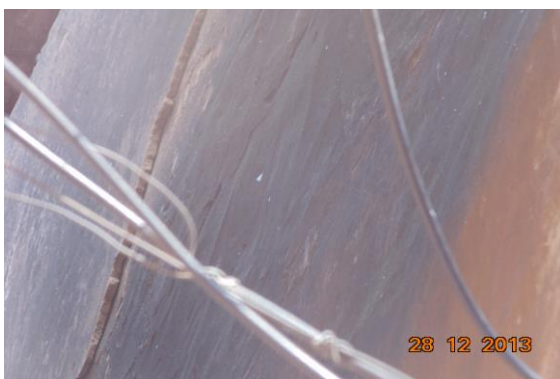
Photo 105

Peeling of Plaster on Wall No. 1 of Left Side Wall of House No. 284 of Second floor

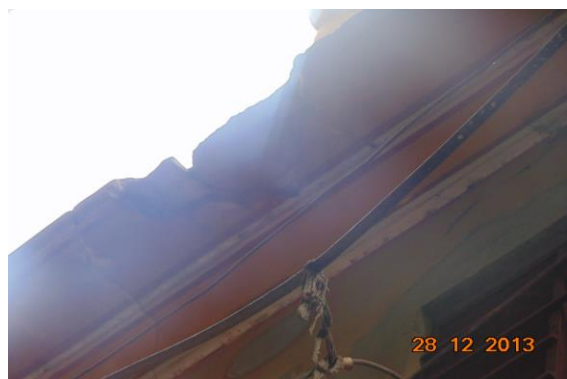
Photo 106

Damaged Portion on Wall No. 3 & Sunshade of H.No.284 of First floor

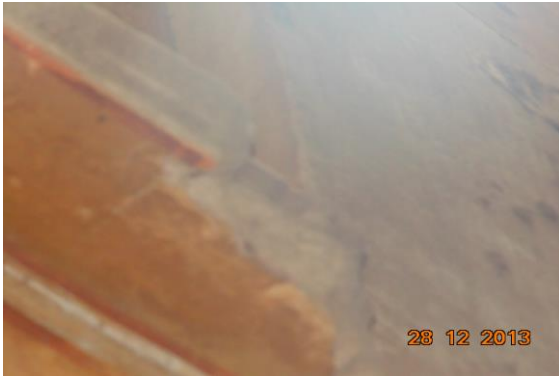
Photo 107

Damaged Portion on Wall No. 2 & Sunshade of Right Side Wall of House No. 284 of First floor

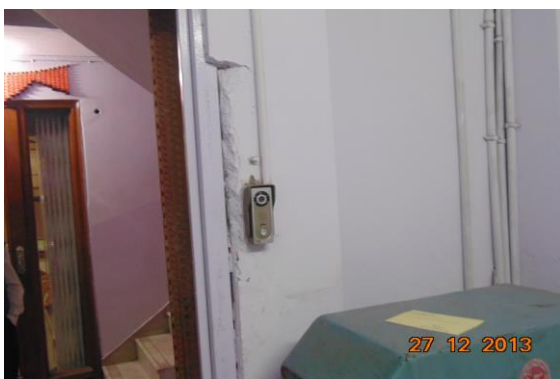
Photo 5
Peeling of Plaster on Wall No. 4 of Passage of Ground Floor

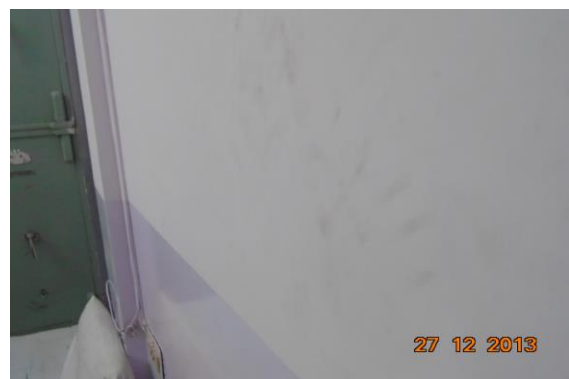
Photo 6
Dampness/Seepage on Wall No. 1 of Shop of Ground Floor

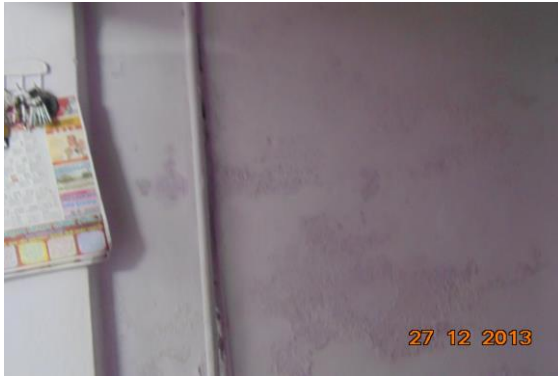
Photo 7

Dampness/Seepage on Wall No. 4 of Room No. 2 of Ground Floor

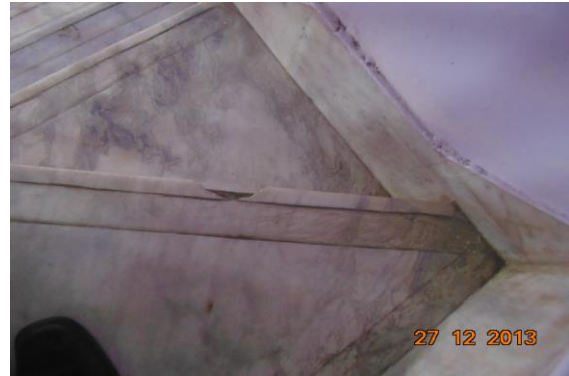
Photo 8

Peeling of Plaster on Step of Staircase GF to FF of

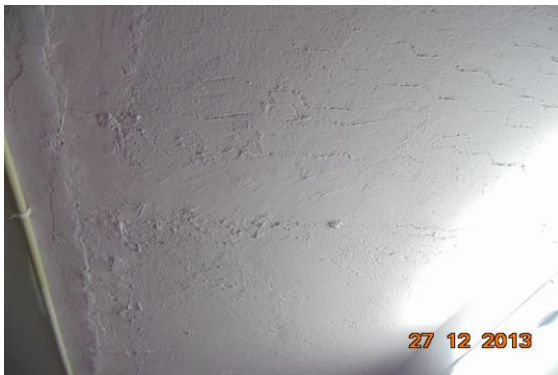
Photo 9

Dampness/Seepage on Roof of Lobby of First Floor

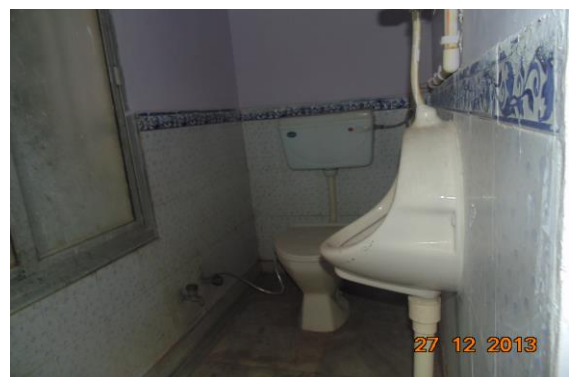
Photo 18
Bottom Portion of Toilet No. 1 of Third Floor

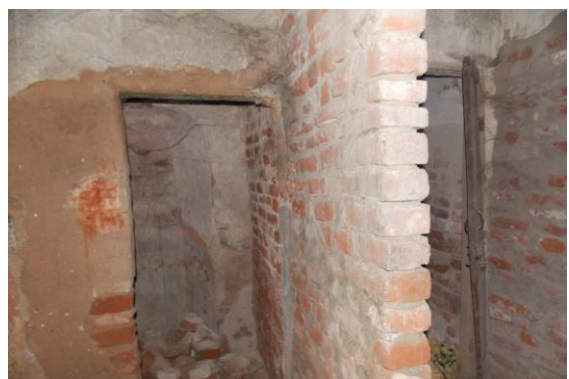
Photo 6
Damaged Portion on All Walls of H.No.286 of Ground Floor

Summary of Defects Other Than Crack			
Defect ID	Location	Description	Photo No.
1	All Walls H.No.286 Ground Floor	Damaged Portion	6
2	All Walls H.No.286 Ground Floor	Damaged Portion	7
3	All Walls H.No.286 Ground Floor	Damaged Portion	8
4	All Walls H.No.286 Ground Floor	Damaged Portion	9
5	All Walls H.No.286 Ground Floor	Damaged Portion	10
6	All Walls H.No.286 Ground Floor	Damaged Portion	11
7	All Walls H.No.286 Ground Floor	Damaged Portion	12
8	All Walls H.No.287 Ground Floor	Damaged Portion	13
9	All Walls H.No.287 Ground Floor	Damaged Portion	14
10	All Walls H.No.287 Ground Floor	Damaged Portion	15
11	All Walls H.No.287 Ground Floor	Damaged Portion	16
12	All Walls H.No.287 Ground Floor	Damaged Portion	17
13	Wall No. 3 Passage, H.No.287 Ground Floor	Damaged Portion	18
14	Wall No. 4 & Roof Passage, H.No.287 Ground Floor	Damaged Portion	19
15	Wall No. 2 & Roof Passage, H.No.287 Ground Floor	Damaged Portion	20

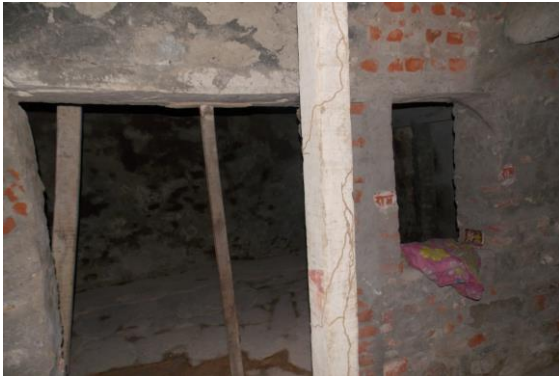
Photo 7

Damaged Portion on All Walls of H.No.286 of Ground Floor

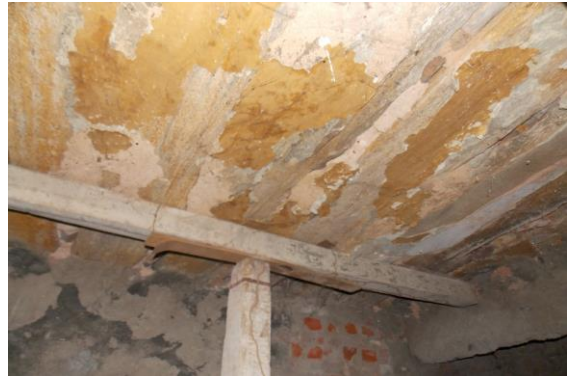
Photo 8

Damaged Portion on All Walls of H.No.286 of Ground Floor

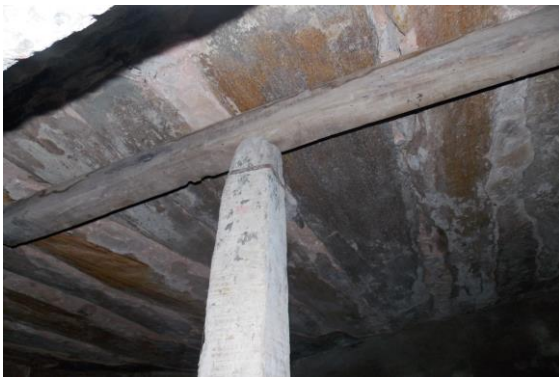
Photo 9

Damaged Portion on All Walls of H.No.286 of Ground Floor

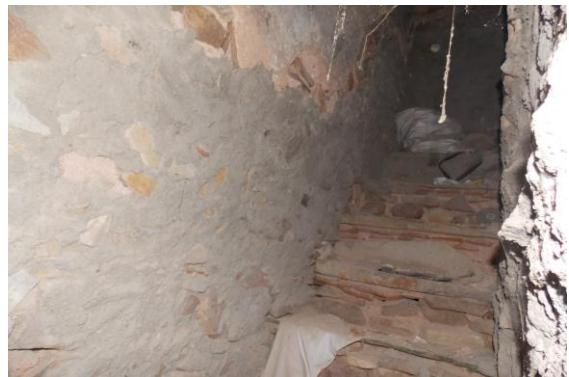
Photo 10

Damaged Portion on All Walls of H.No.286 of Ground Floor

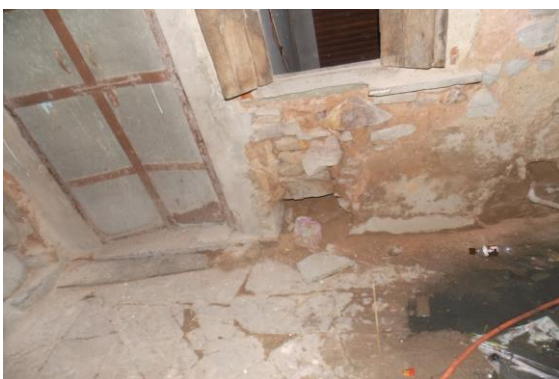
Photo 11

Damaged Portion on All Walls of H.No.286 of Ground Floor

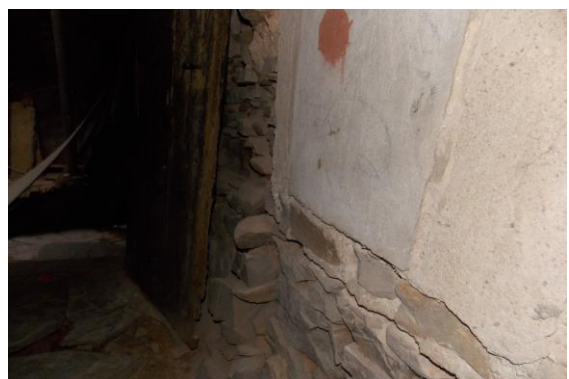
Photo 12

Damaged Portion on All Walls of H.No.286 of Ground Floor

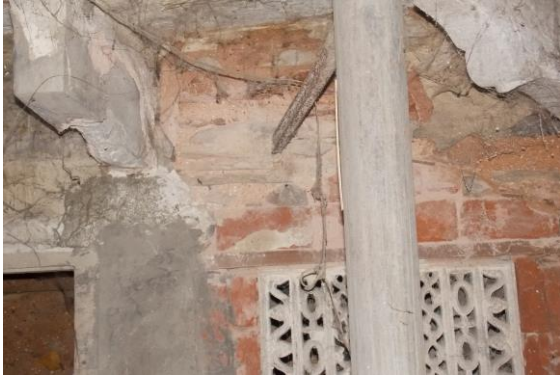
Photo 13

Damaged Portion on All Walls of H.No.287 of Ground Floor

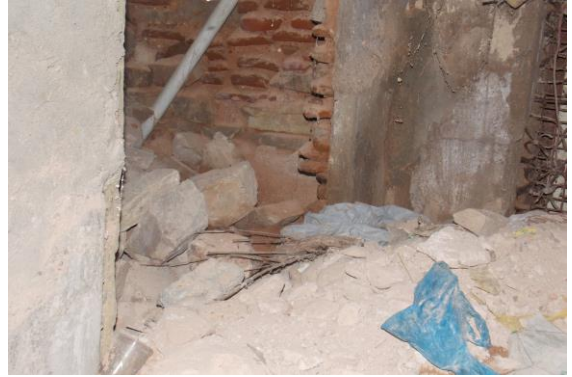
Photo 14

Damaged Portion on All Walls of H.No.287 of Ground Floor

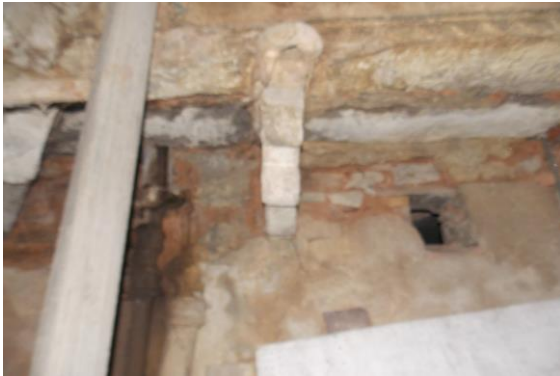
Photo 15

Damaged Portion on All Walls of H.No.287 of Ground Floor

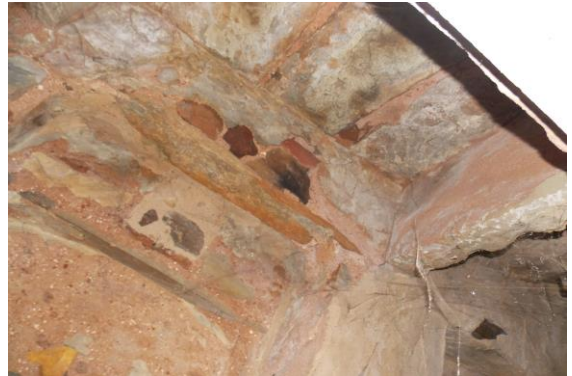
Photo 16

Damaged Portion on All Walls of H.No.287 of Ground Floor

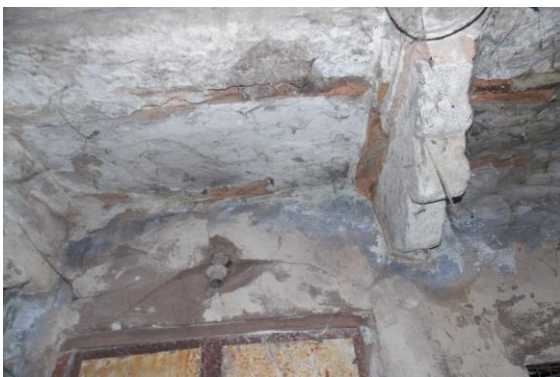
Photo 17

Damaged Portion on All Walls of H.No.287 of Ground Floor

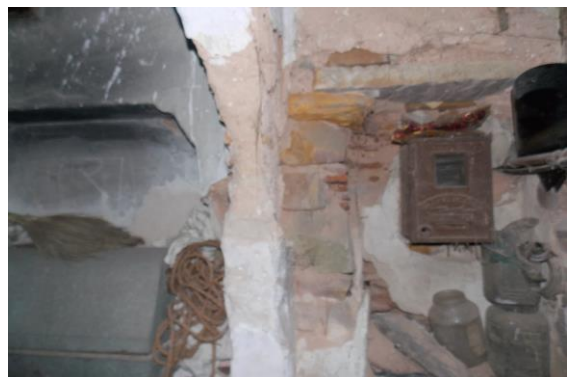
Photo 18

Damaged Portion on Wall No. 3 of Passage, H.No.287 of Ground Floor

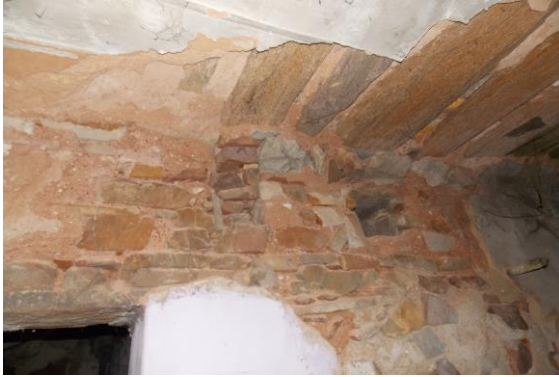
Photo 19

Damaged Portion on Wall No. 4 & Roof of Passage, H.No.287 of Ground Floor

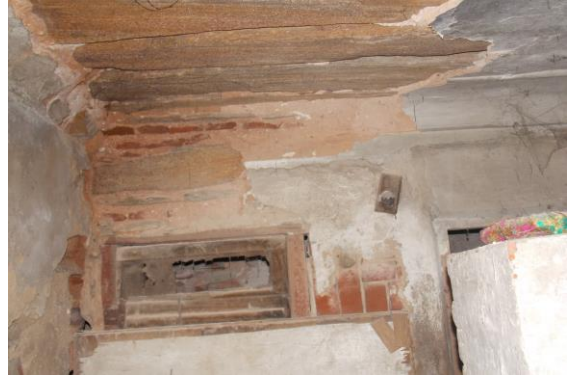
Photo 20

Damaged Portion on Wall No. 2 & Roof of Passage, H.No.287 of Ground Floor

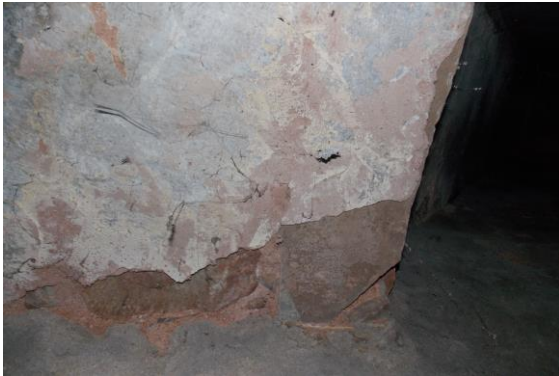
Photo 21

Damaged Portion on Roof of Staircase GF to FF, H.No.287 of Ground Floor

16	Roof Staircase GF to FF, H.No.287 Ground Floor	Damaged Portion	21
17	Wall No. 3 Staircase GF to FF, H.No.287 Ground Floor	Damaged Portion	22
18	Wall No. 1 Staircase GF to FF, H.No.287 Ground Floor	Damaged Portion	23
19	Wall No. 4 Staircase GF to FF, H.No.287 Ground Floor	Damaged Portion	24
20	Wall No. 2 Staircase GF to FF, H.No.287 Ground Floor	Damaged Portion	25
21	Wall No. 4 Room No. 1 First Floor	Damaged Portion	26
22	Wall No. 2 Room No. 1 First Floor	Damaged Portion	27
23	Roof Room No. 2 First Floor	Damaged Portion	28
24	Wall No. 1 Room No. 2 First Floor	Damaged Portion	29
25	Wall No. 3 Room No. 2 First Floor	Damaged Portion	30
26	Wall No. All Walls & Roofs Passage First Floor	Damaged Portion	31
27	All Walls & Roofs H.No.286 First Floor	Damaged Portion	32
28	All Walls & Roofs H.No.286 First Floor	Damaged Portion	33
29	All Walls & Roofs H.No.286 First Floor	Damaged Portion	34
30	All Walls & Roofs H.No.286 First Floor	Damaged Portion	35

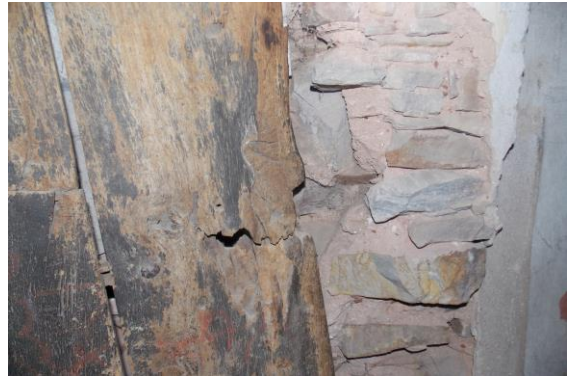
Photo 22

Damaged Portion on Wall No. 3 of Staircase GF to FF, H.No.287 of Ground Floor

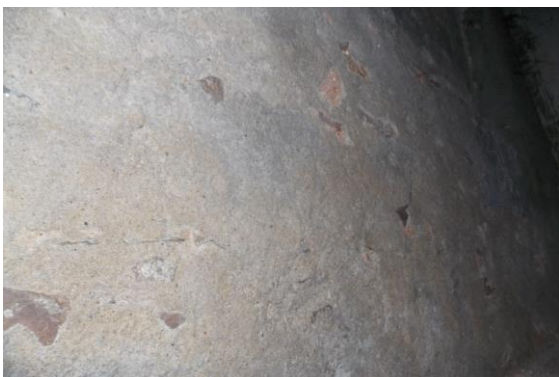
Photo 23

Damaged Portion on Wall No. 1 of Staircase GF to FF, H.No.287 of Ground Floor

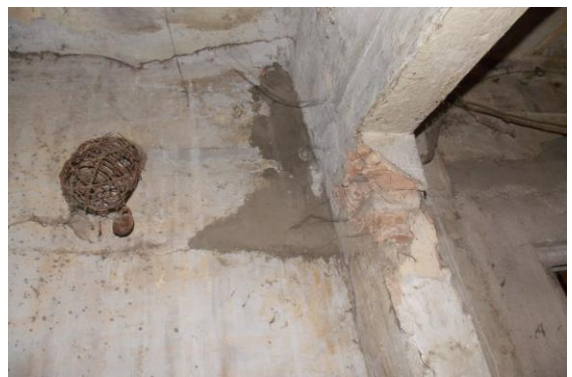
Photo 24

Damaged Portion on Wall No. 4 of Staircase GF to FF, H.No.287 of Ground Floor

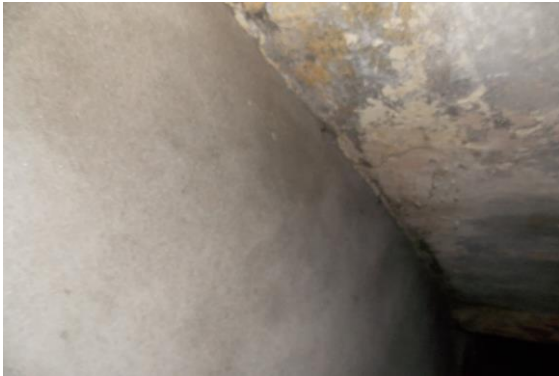
Photo 25

Damaged Portion on Wall No. 2 of Staircase GF to FF, H.No.287 of Ground Floor

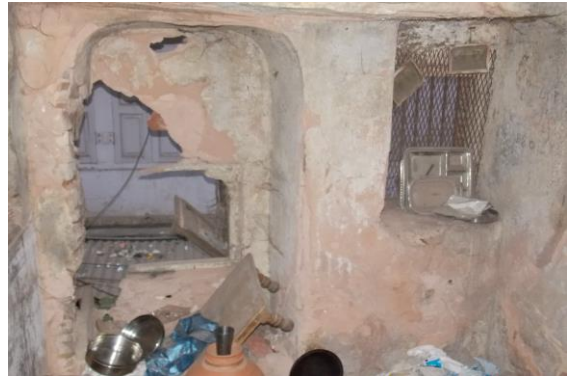
Photo 26

Damaged Portion on Wall No. 4 of Room No. 1 of First Floor

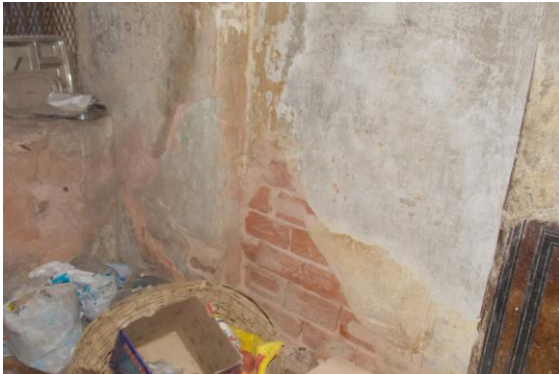
Photo 27

Damaged Portion on Wall No. 2 of Room No. 1 of First Floor

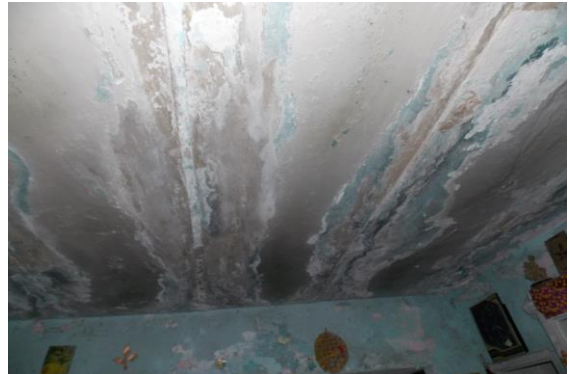
Photo 28

Damaged Portion on Roof of Room No. 2 of First Floor

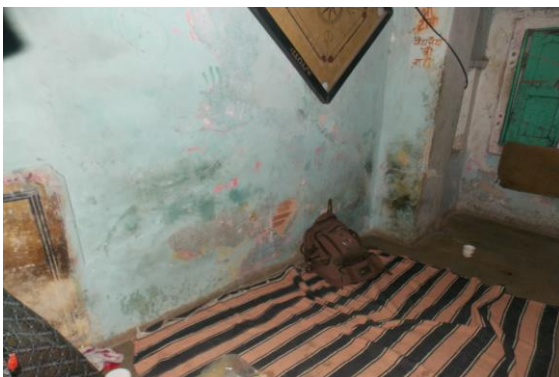
Photo 29

Damaged Portion on Wall No. 1 of Room No. 2 of First Floor

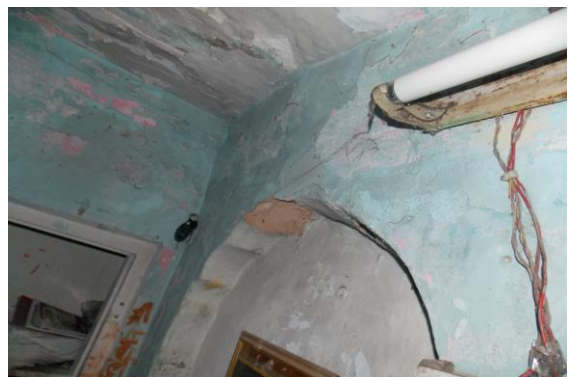
Photo 30

Damaged Portion on Wall No. 3 of Room No. 2 of First Floor

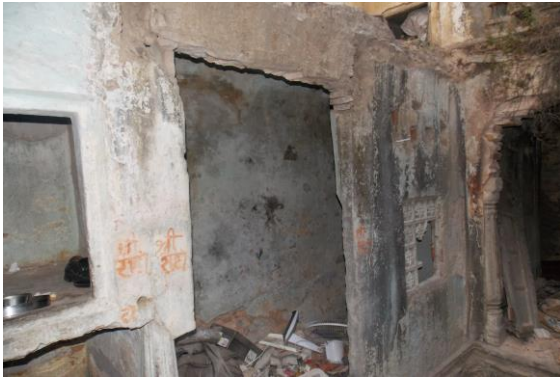
Photo 31

Damaged Portion on All Walls & Roofs of Passage of First Floor

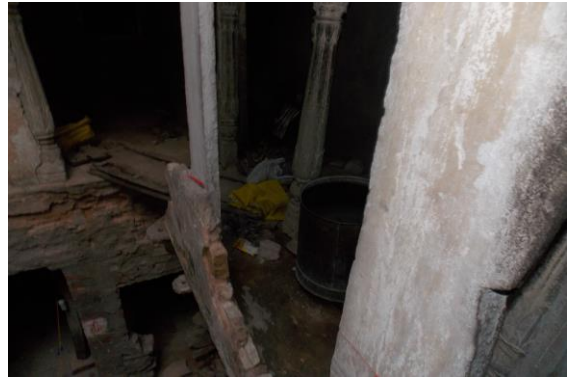
Photo 32

Damaged Portion on All Walls & Roofs of H.No.286 of First Floor

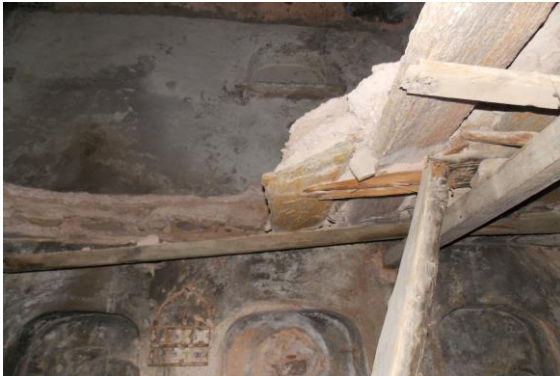
Photo 33

Damaged Portion on All Walls & Roofs of H.No.286 of First Floor

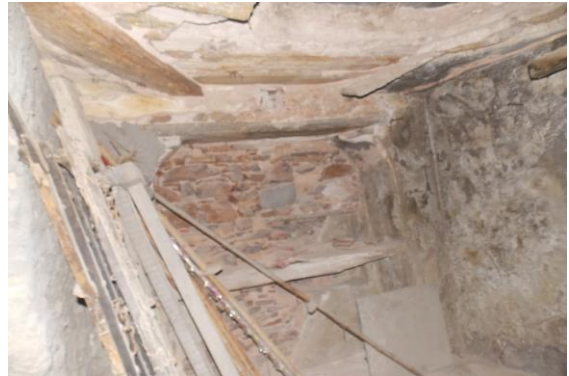
Photo 34

Damaged Portion on All Walls & Roofs of H.No.286 of First Floor

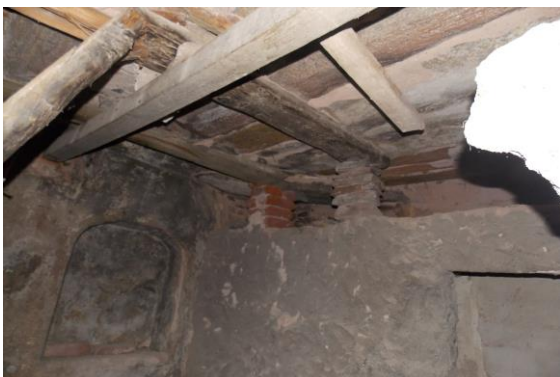
Photo 35

Damaged Portion on All Walls & Roofs of H.No.286 of First Floor
