Pre Building Condition Survey Report

Name and Address of Structure :	Badi Chopar to Ramp Area (Down Line)
---------------------------------	--------------------------------------

Name of the Project	Contract JMRC-UG1B “Design and Construction of Tunnel between Chandpole and Badi Chouper and reverse line by Shield TBM, Underground Metro Stations at Choti Chouper and Badi Chouper by Cut and Cover Methods on East West Corridor of Jaipur Metro Rail Corporation Limited .”	
Owner :

Pre - Condition Building Survey for Construction of Underground Stations from Chandpole to Bari Chouper and reversal line

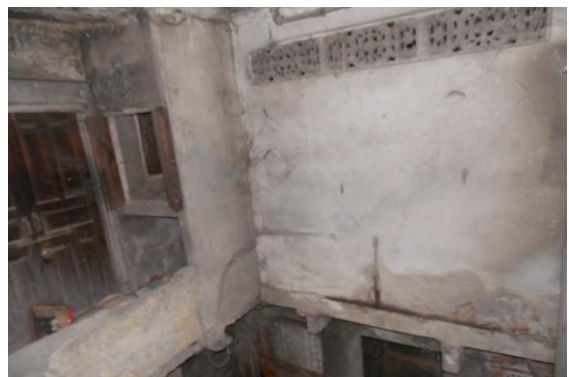
Photo 36

Damaged Portion on Open Area, H.No.287 of First Floor

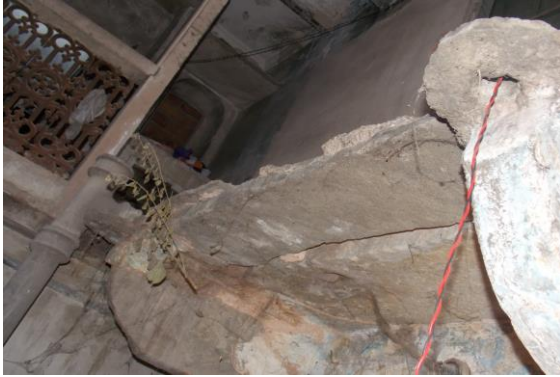
Photo 37

Damaged Portion on Wall No. 2 & Roof of Open Area, H.No.287 of First Floor

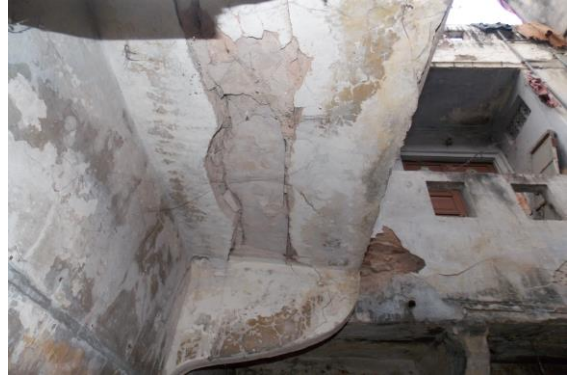
Photo 38

Damaged Portion on Wall No. 3 of Open Area, H.No.287 of First Floor

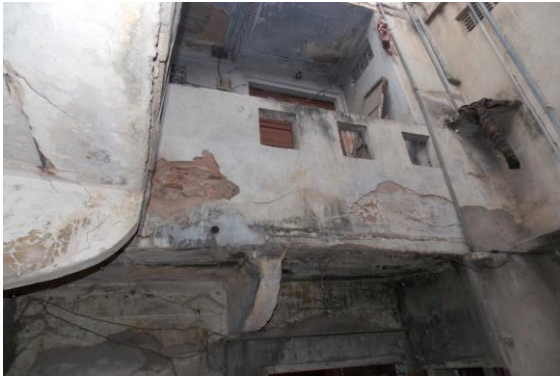
Photo 39

Damaged Portion on Wall No. 1 of Open Area, H.No.287 of First Floor

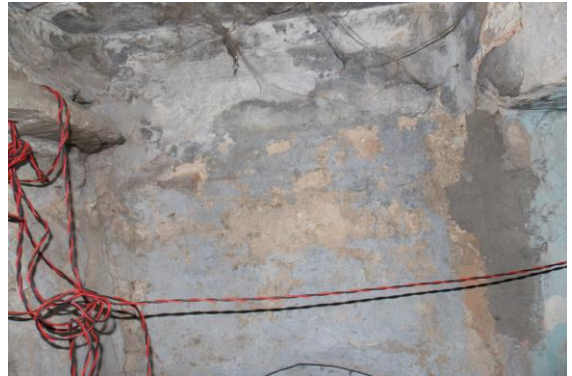
Photo 40

Damaged Portion on Wall No. 3 of Staircase FF to SF, H.No.287 of First Floor

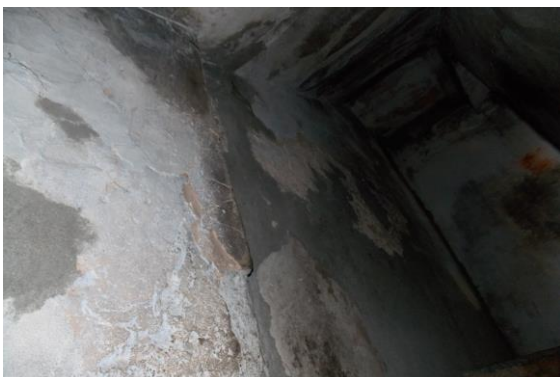
Photo 41

Damaged Portion on Wall No. 1 of Staircase FF to SF, H.No.287 of First Floor

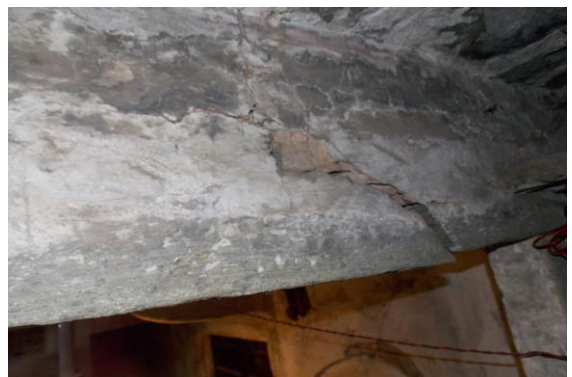
Photo 42

Damaged Portion on Wall No. 2 of Staircase FF to SF, H.No.287 of First Floor

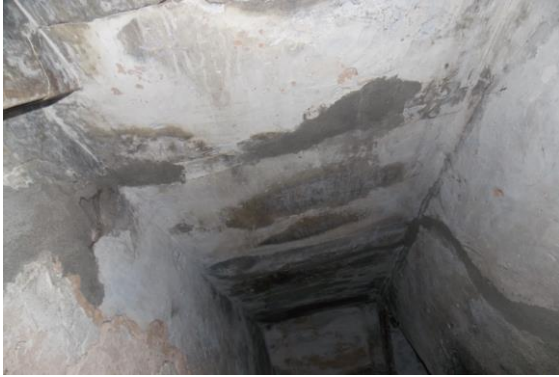
Photo 43

Damaged Portion on Roof of Staircase FF to SF, H.No.287 of First Floor

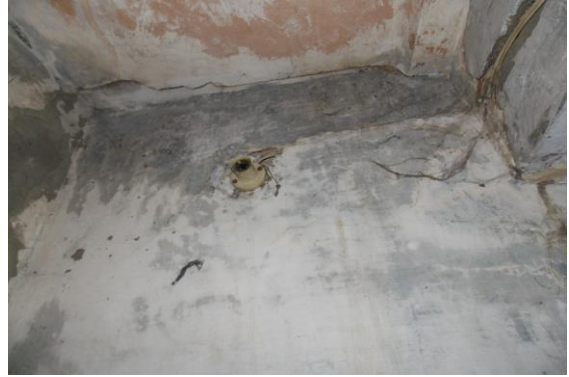
Photo 44

Damaged Portion on Wall No. 4 of Staircase FF to SF, H.No.287 of First Floor

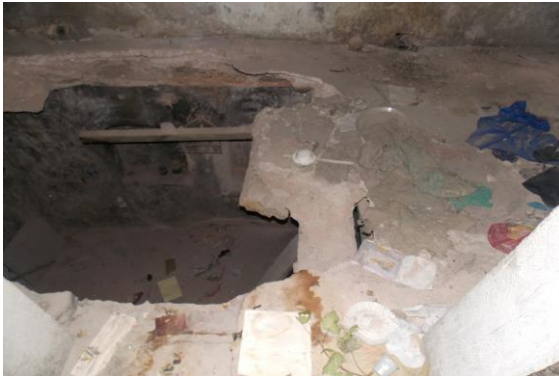
Photo 45

Damaged Portion on Floor of Room No. 2 of Second Floor

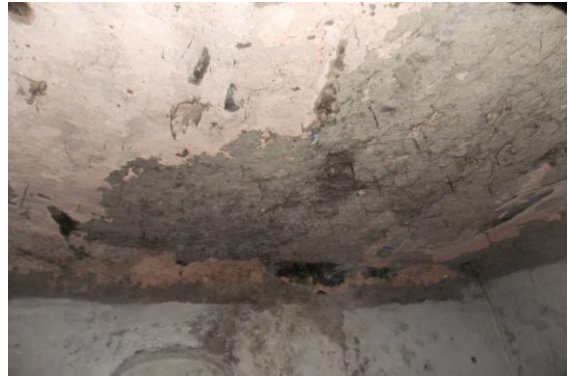
Photo 46

Damaged Portion on Roof of Room No. 2 of Second Floor

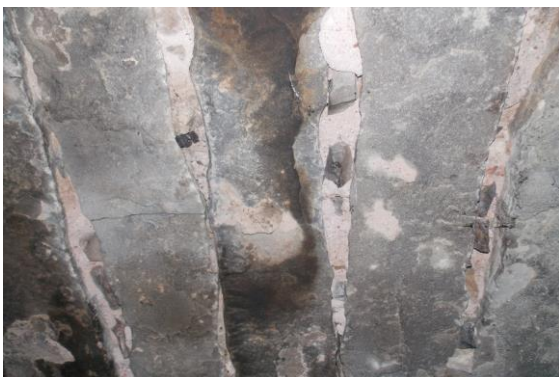
Photo 47

Damaged Portion on Roof of Varanda, H.No.286 of Second Floor

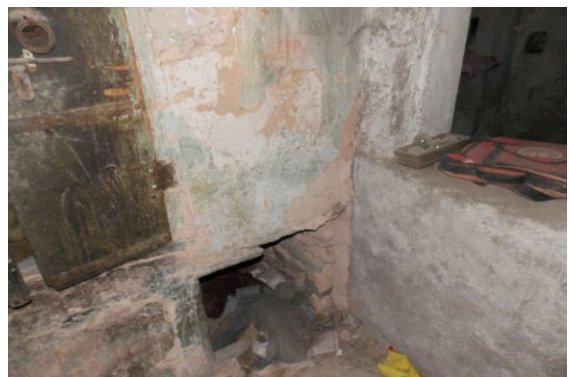
Photo 48

Damaged Portion on Wall No. 1 of Varanda, H.No.286 of Second Floor

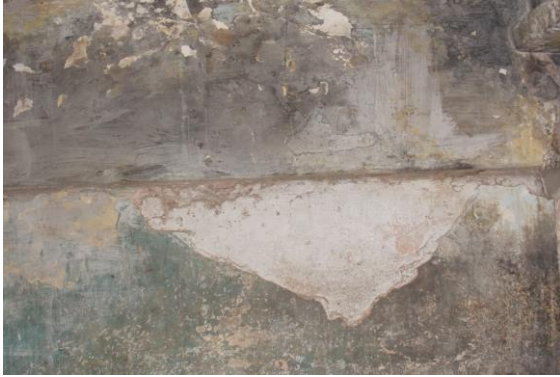
Photo 49

Damaged Portion on Wall No. 2 of Varanda, H.No.286 of Second Floor

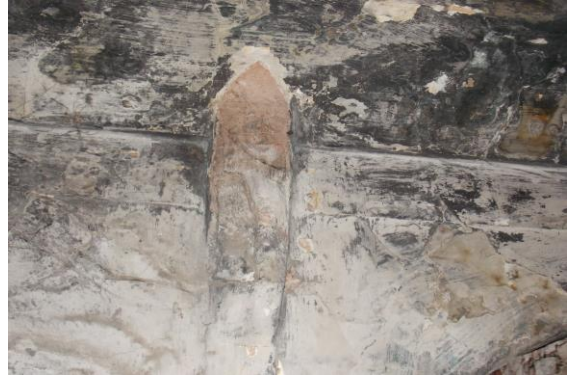
Photo 50

Damaged Portion on Wall No. 3 of Varanda, H.No.286 of Second Floor

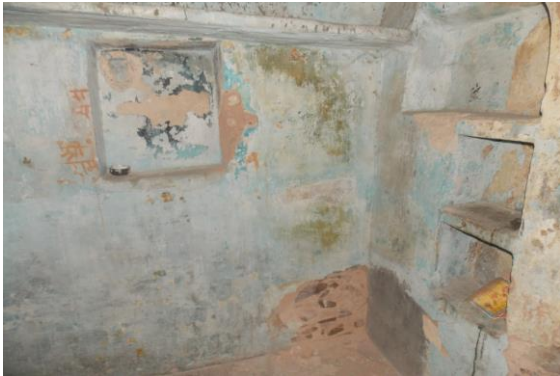
Photo 51

Damaged Portion on Wall No. 4 of Room No. 1 of Second Floor

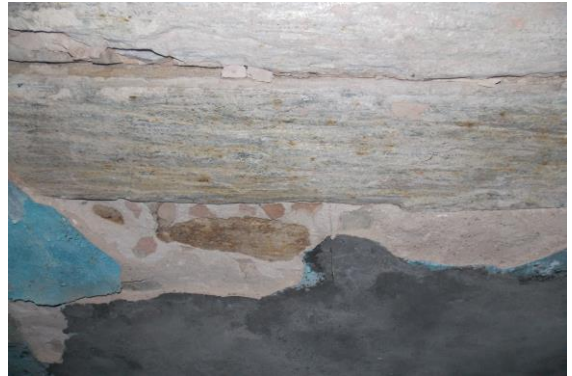
Photo 52

Damaged Portion on Roof of Room No. 1 of Second Floor

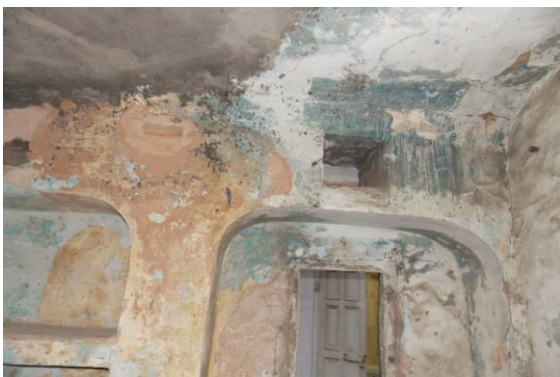
Photo 53

Damaged Portion on Wall No. 2 of Room No. 1 of Second Floor

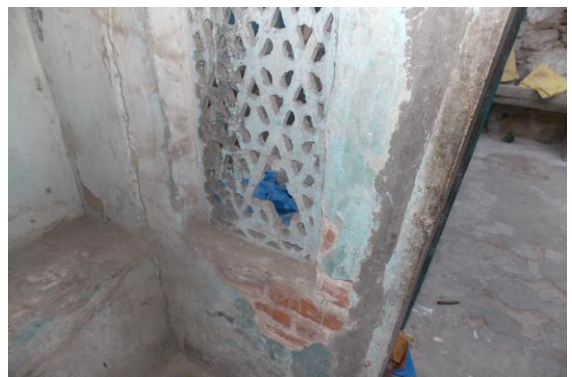
Photo 54

Damaged Portion on Wall No. 3 of Room No. 1 of Second Floor

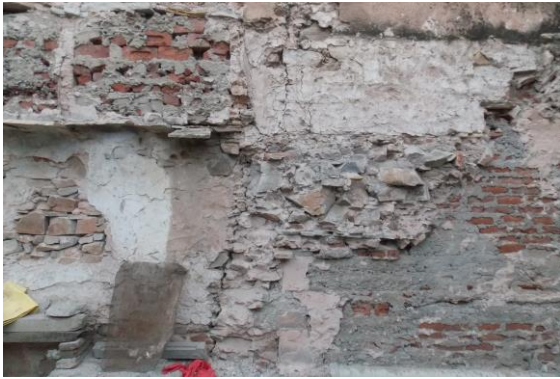
Photo 55

Damaged Portion on Wall No. 4 of Open Sky, H.No.286 of Second Floor

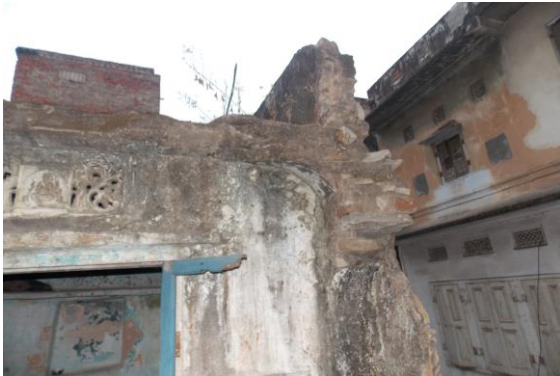
Photo 57

Damaged Portion on Outside Wall of Room No. 1 of Second Floor

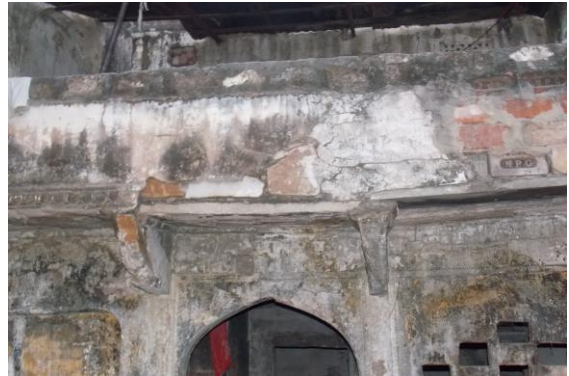
Photo 58

Damaged Portion on Wall No. 2 of Open Sky, H.No.286 of Second Floor

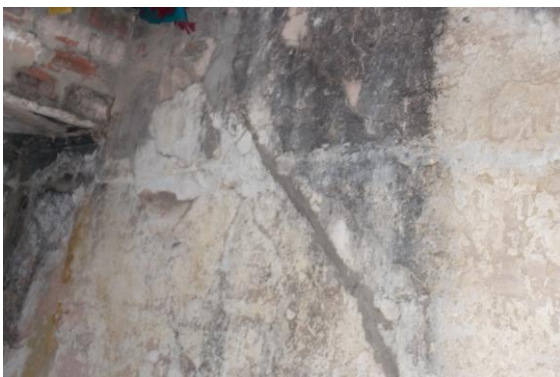
Photo 59

Damaged Portion on Wall No. 3 of Open Sky, H.No.286 of Second Floor

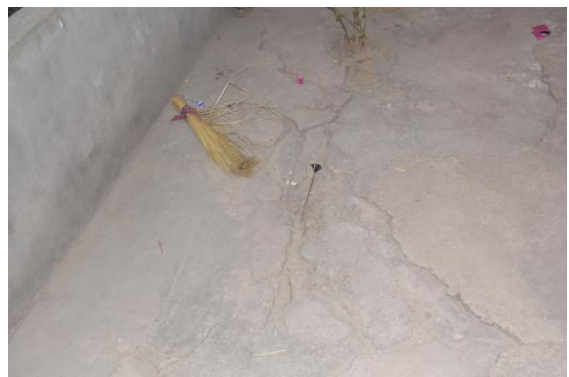
Photo 60

Damaged Portion on Floor of Open Sky, H.No.286 of Second Floor

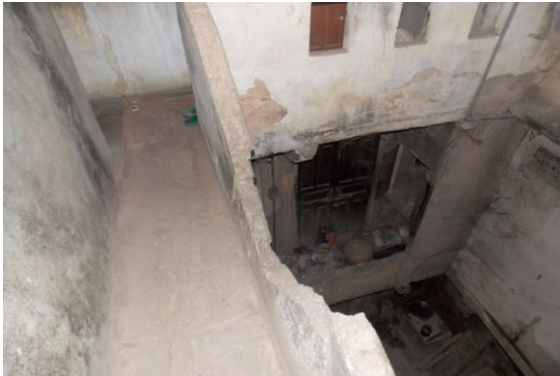
Photo 61
Peeling of Plaster on Wall No. 3 of Balcony of Second Floor

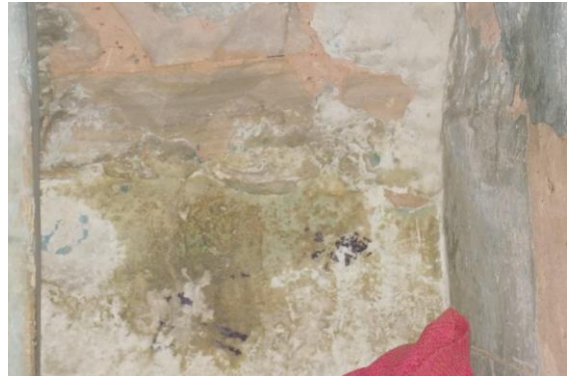
Photo 62
Damaged Portion on Wall No. 4 of Room No. 2 of Second Floor

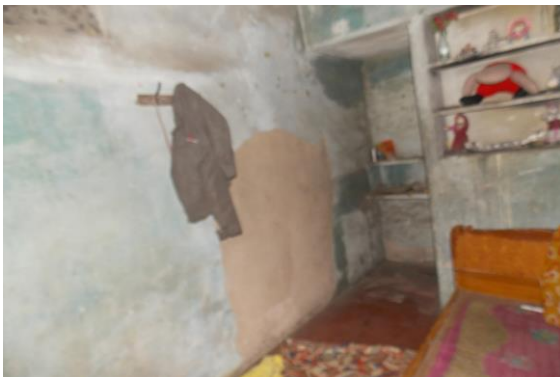
Photo 63
Damaged Portion on Wall No. 1 of Room No. 2 of Second Floor

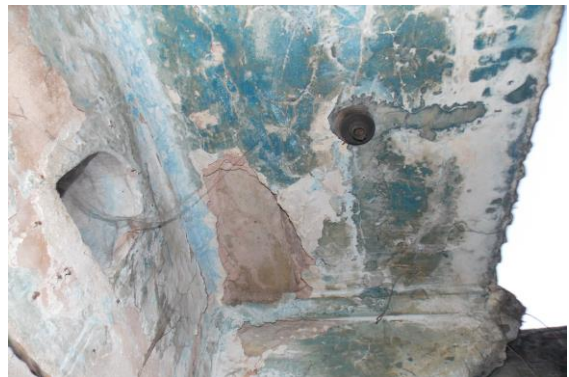
Photo 64
Damaged Portion on Roof of Balcony, H.No.287 of Second Floor

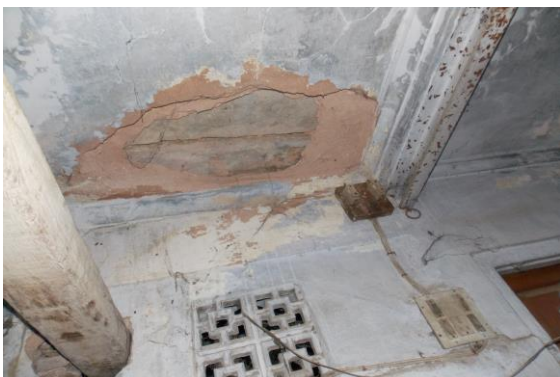
Photo 65
Damaged Portion on Roof of Balcony, H.No.287 of Second Floor

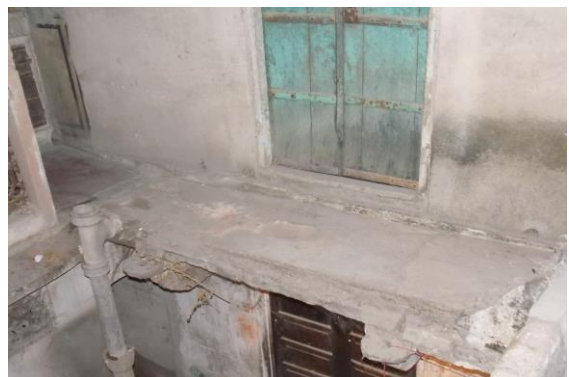
Photo 66
Damaged Portion on Wall No. 2 of Balcony, H.No.287 of Second Floor

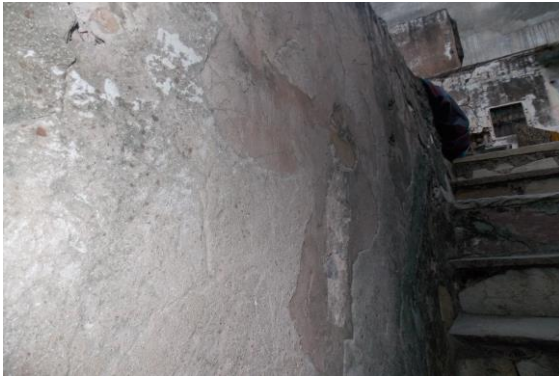
Photo 67

Damaged Portion on Wall No. 1 of Staircase SF to TF of Second Floor

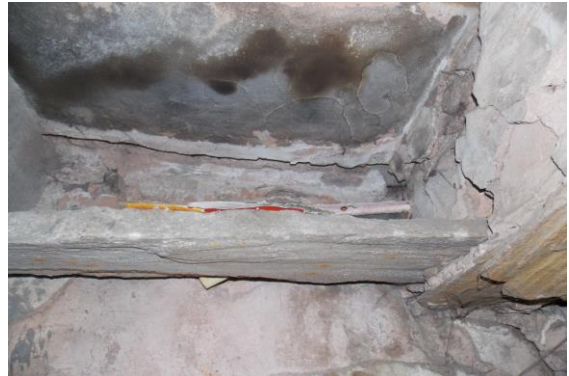
Photo 68

Damaged Portion on Wall No. 3 & Roof of Staircase SF to TF of Second Floor

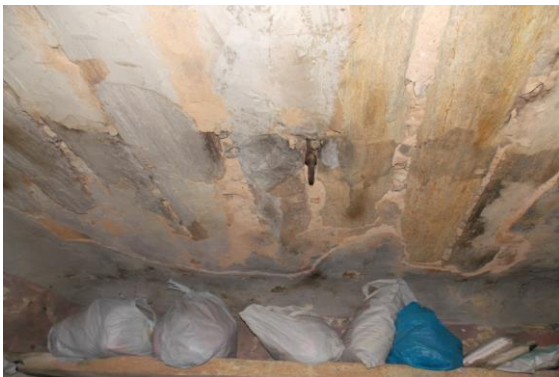
Photo 69

Damaged Portion on Roof of Room No. 1 of Third Floor

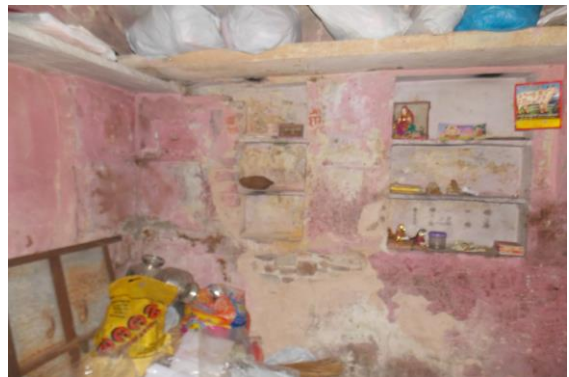
Photo 70

Damaged Portion on Wall No. 1 & 4 of Room No. 1 of Third Floor

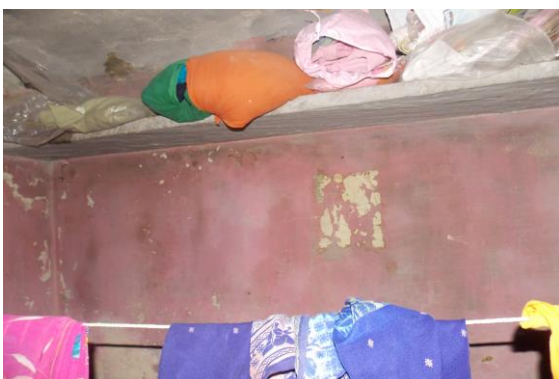
Photo 71

Damaged Portion on Wall No. 2 of Room No. 1 of Third Floor

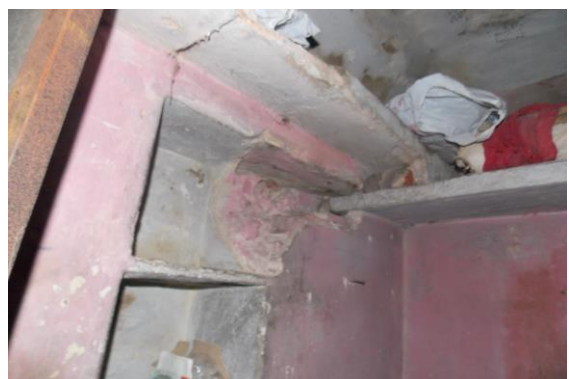
Photo 72

Damaged Portion on Wall No. 3 of Room No. 1 of Third Floor

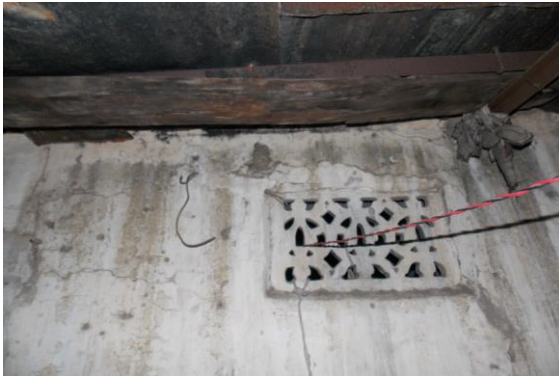
Photo 73
Damaged Portion on Outside Wall of Room No. 1 of Third Floor

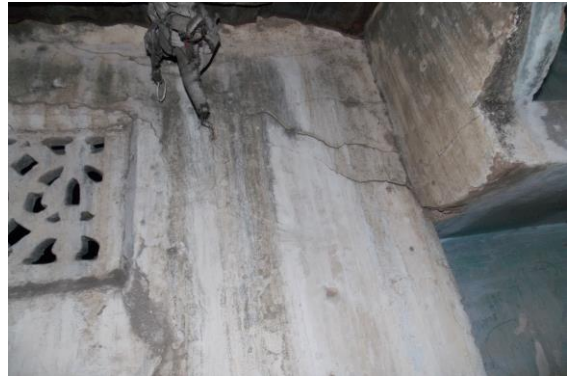
Photo 74
Damaged Portion on Outside Wall of Room No. 1 of Third Floor

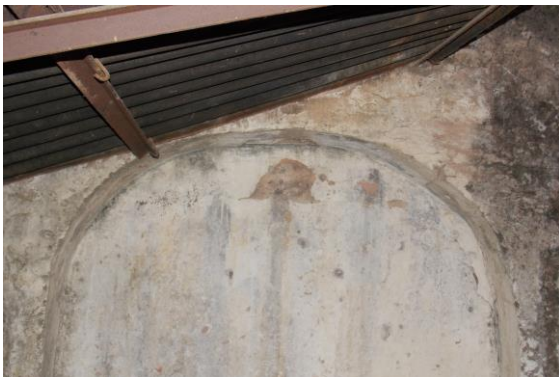
Photo 75
Damaged Portion on Wall No. 4 of Open Area No.1 of Third Floor

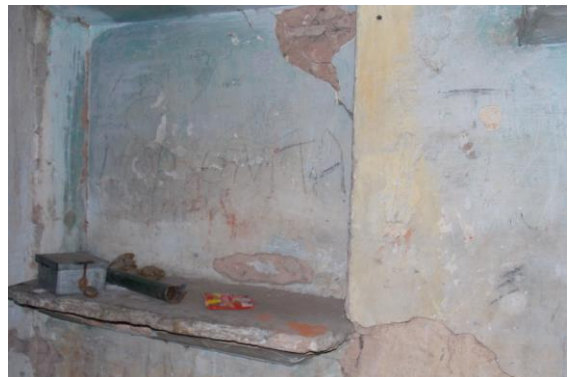
Photo 76
Damaged Portion on Wall No. 4 of Open Area No.1 of Third Floor

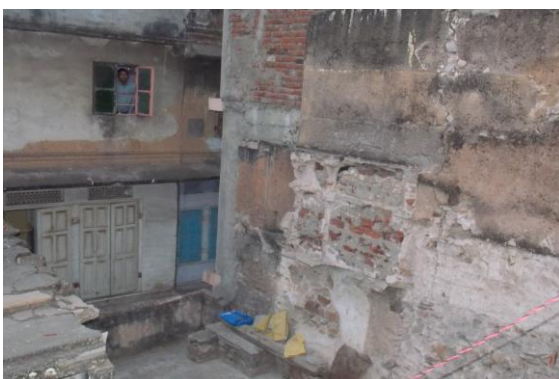
Photo 77
Damaged Portion on All Walls of Open Area No.2 of Third Floor

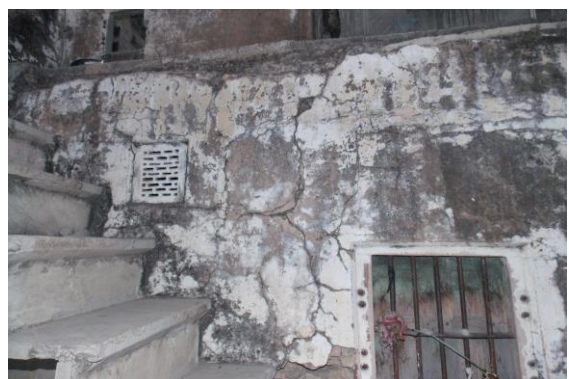
Photo 78
Damaged Portion on Outside Wall of Room No. 2 of Third Floor

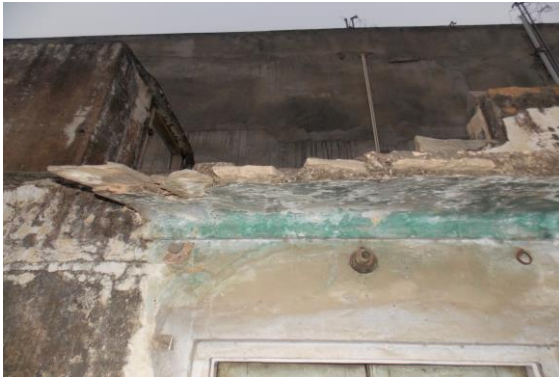
Photo 79
Damaged Portion on SunShade of Room No. 2 of Third Floor

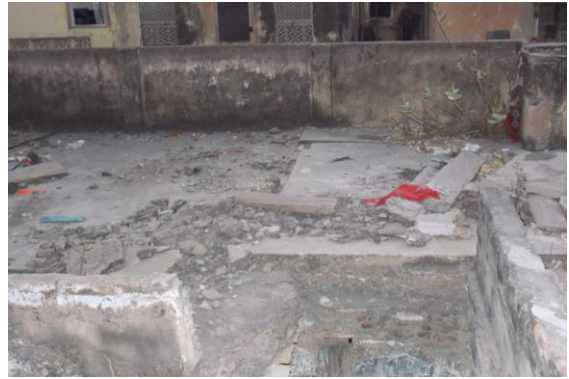
Photo 80
Damaged Portion on Open Area No.3 of Third Floor

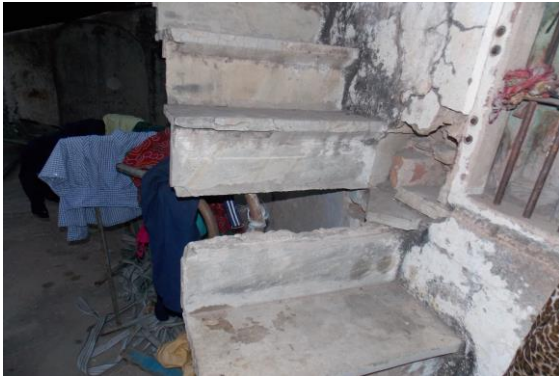
Photo 81
Damaged Portion on Steps of Staircase TF to Terrace of

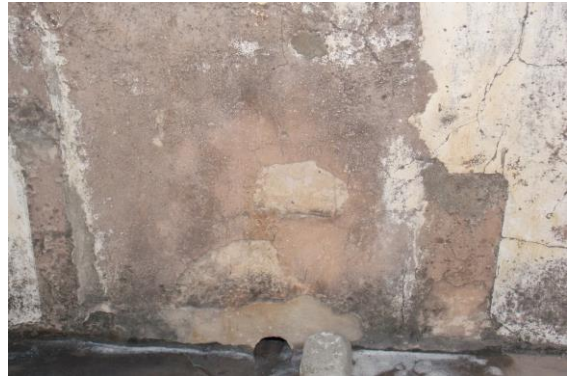
Photo 82
Damaged Portion on All Walls of H.No.287 of Terrace

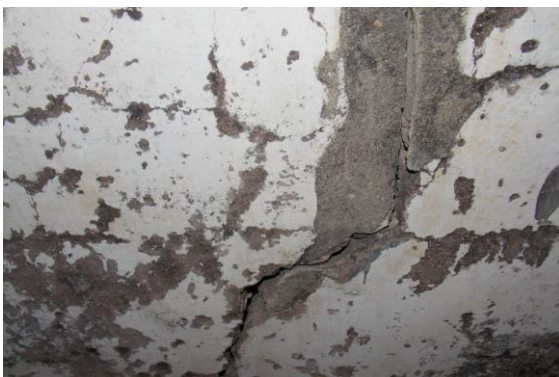
Photo 83
Damaged Portion on All Walls of H.No.287 of Terrace

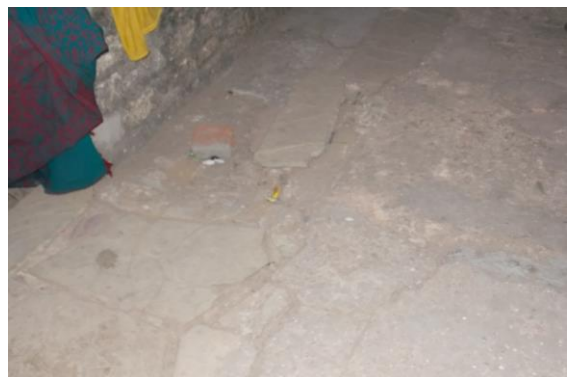
Photo 84
Damaged Portion on Floor of Open Area No.1 of Terrace

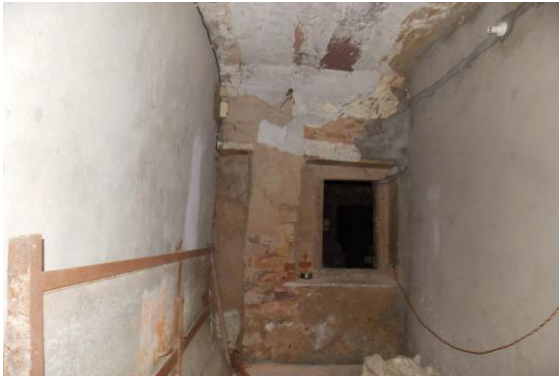
Photo 85
Peeling of Plaster on Wall No. 4 of Shop of Ground Floor

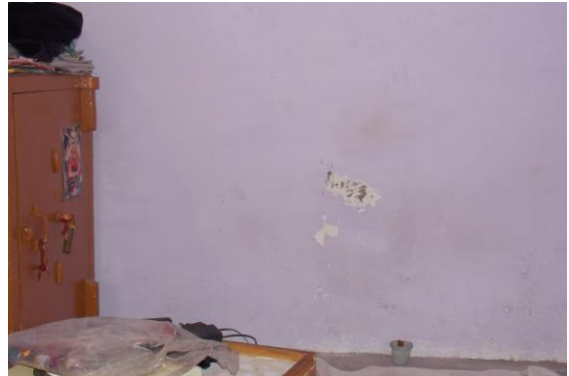
Photo 86
Peeling of Plaster on Wall No. 4 of Shop No.2 of Ground Floor

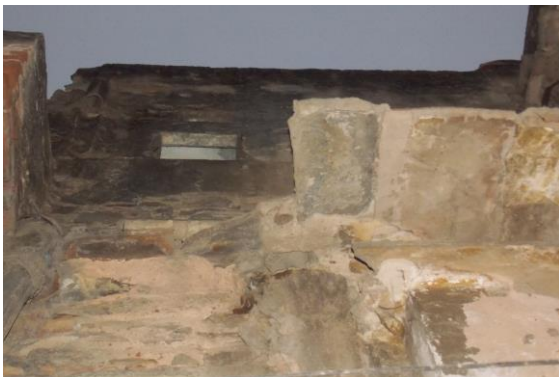
Photo 87
Peeling of Plaster on Outer wall of H.No.286 of Ground Floor

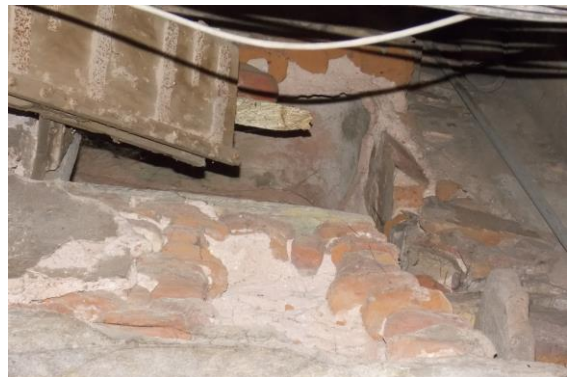
Photo 88
Peeling of Plaster on Outer wall of H.No.286 of Ground Floor

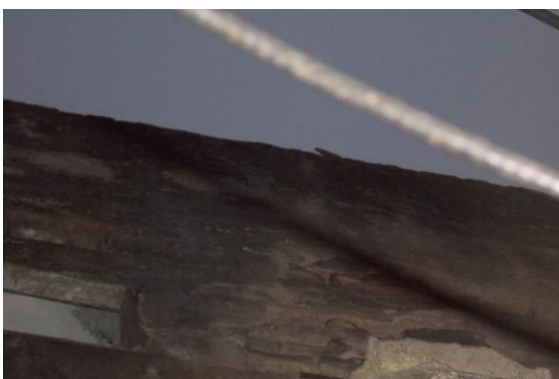
Photo 89
Peeling of Plaster on Outer wall of H.No.286 of Ground Floor

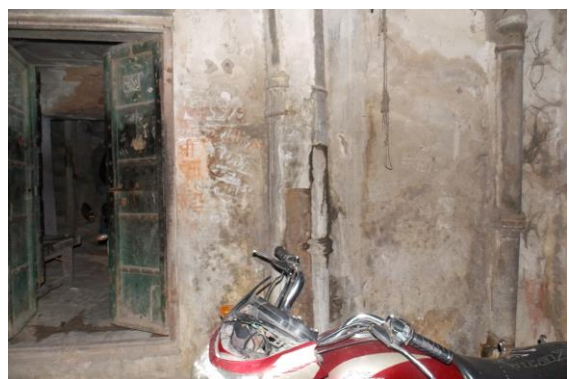
Photo 90
Peeling of Plaster on Outer wall of Building of Ground Floor

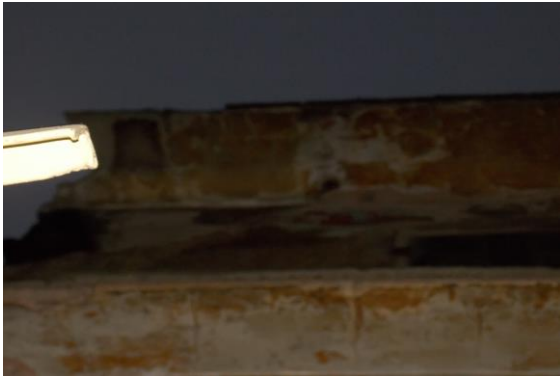
Photo 91
Peeling of Plaster on SunShade of Building of Second Floor

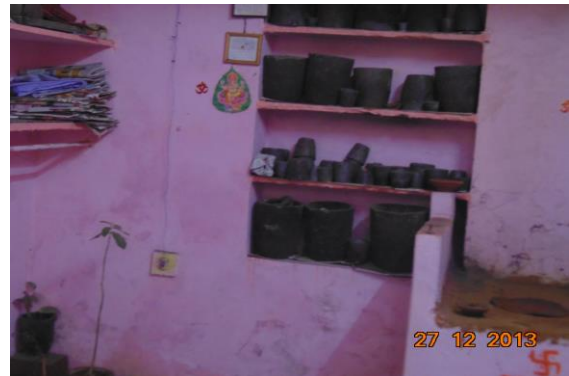
Photo 2
Dampness/Seepage on Wall No. 4 of Shop of Ground Floor

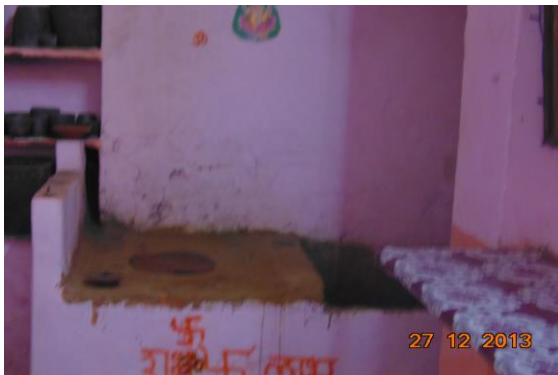
Photo 3
Dampness/Seepage on Wall No. 4 of Shop of Ground Floor

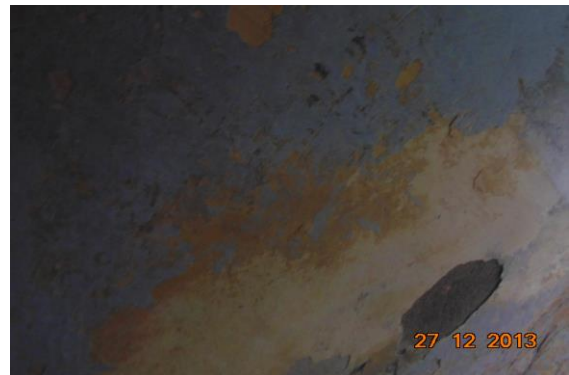
Photo 4
Dampness/Seepage on Wall No. 2 of Staircase GF to FF of Ground Floor

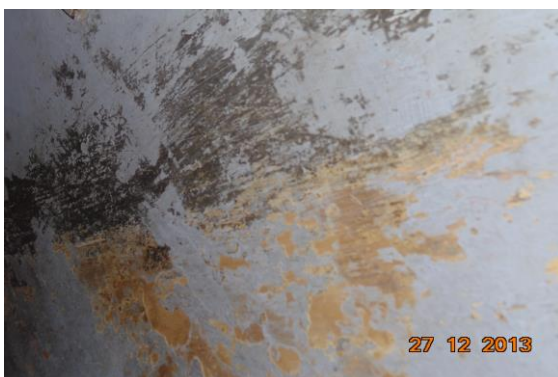
Photo 5
Dampness/Seepage on Wall No. 1 of Staircase GF to FF of Ground Floor

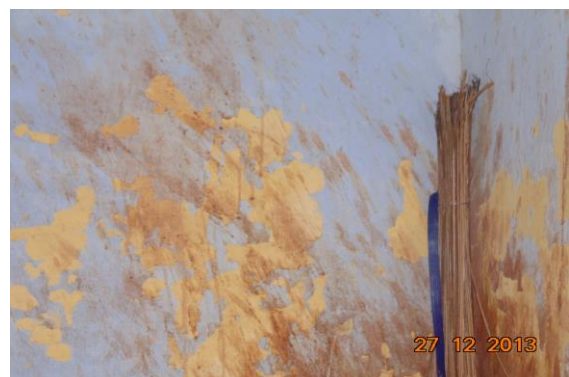
Photo 6
Dampness/Seepage on Wall No. 2 & 4 of Staircase GF to FF of Ground Floor

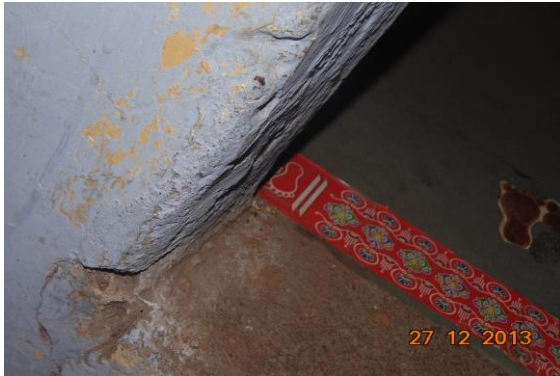
Photo 7

Damaged Portion on Wall No. 1 of Staircase GF to FF of Ground Floor

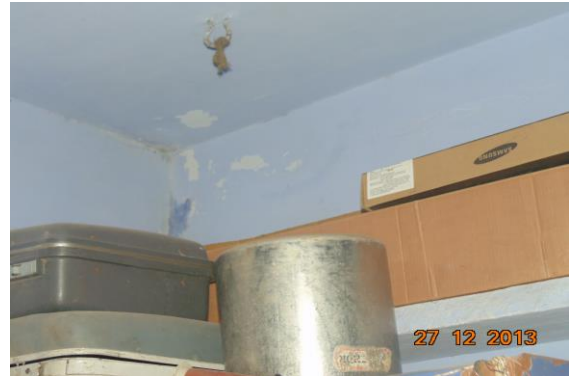
Photo 8

Dampness/Seepage on Wall No. 4 & Roof of Room No. 1 of First Floor

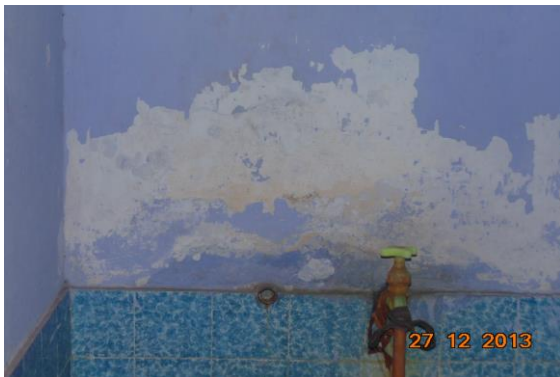
Photo 9

Peeling of Plaster on Wall No. 1 of Toilet No. 1 of First Floor

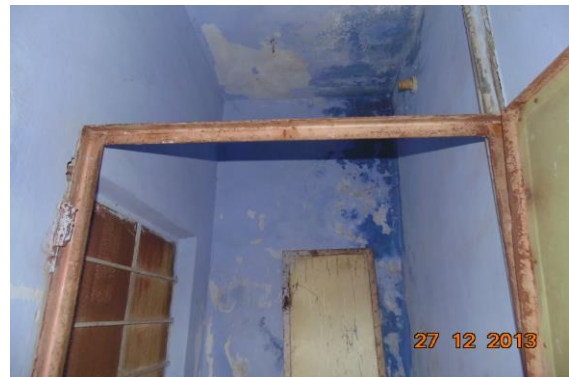
Photo 10

Peeling of Plaster on Wall No. 3, 4 & Roof of Toilet No. 1 of First Floor

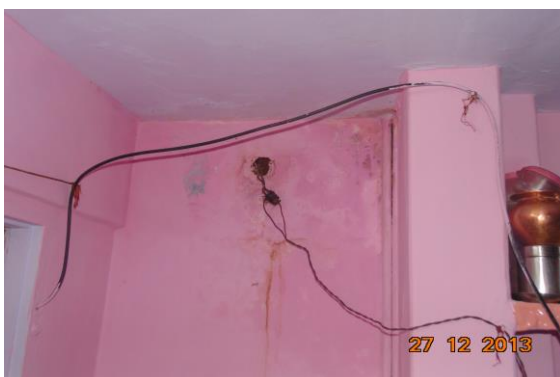
Photo 11

Dampness/Seepage on Wall No. 4 of Toilet No. 1 of Second Floor

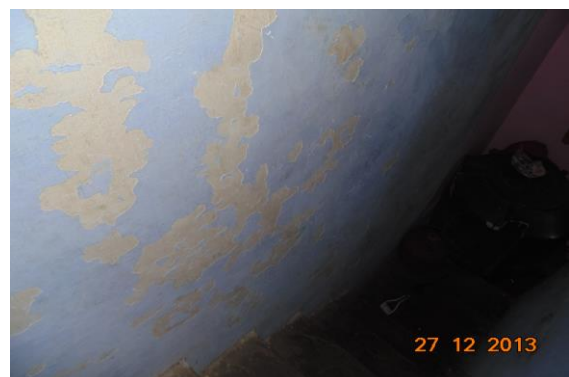
Photo 12

Peeling of Plaster on Wall No. 2 of Staircase FF to SF of Second Floor

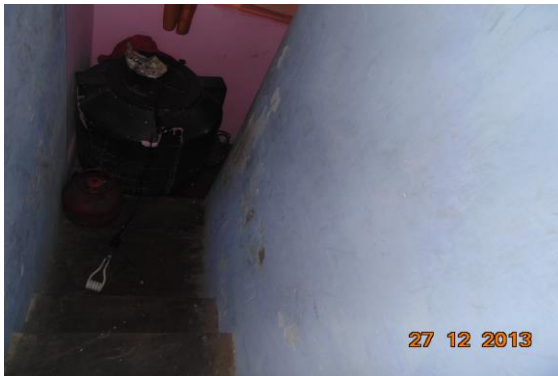
Photo 13

Peeling of Plaster on Wall No. 1 of Staircase FF to SF of Second Floor

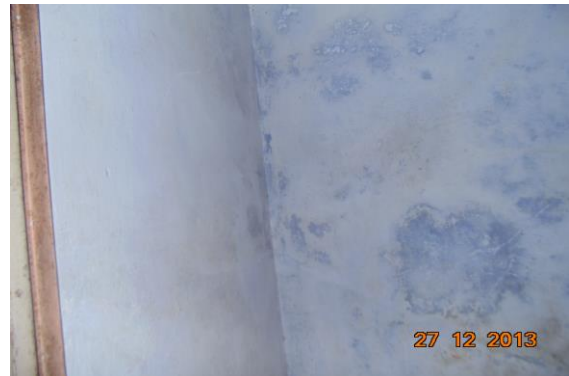
Photo 14

Dampness/Seepage on Wall No. 2 of Staircase FF to SF of Second Floor

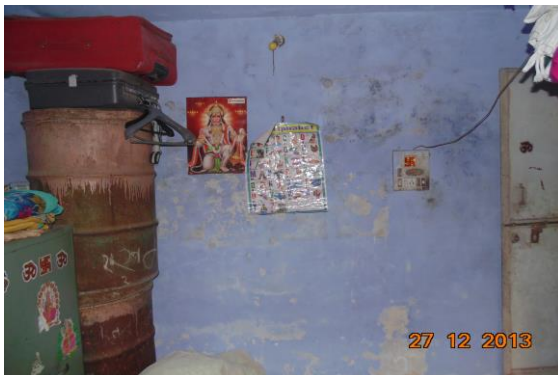
Photo 15

Dampness/Seepage on Wall No. 2 of Toilet No. 1 of Third Floor

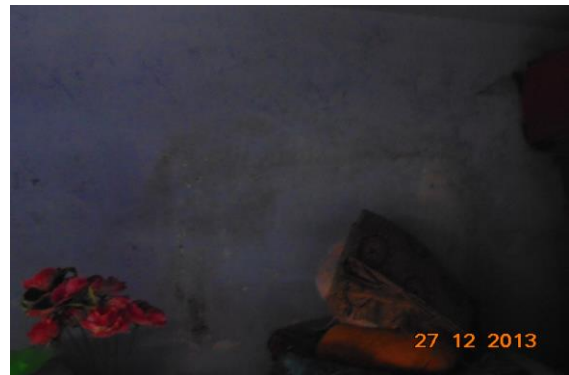
Photo 16

Dampness/Seepage on Wall No. 4 of Toilet No. 1 of Third Floor

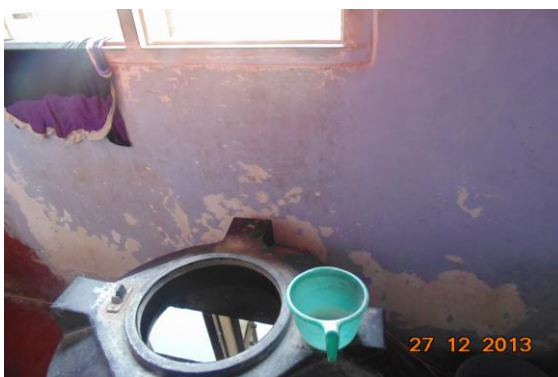
Photo 17

Peeling of Plaster on Wall No. 4 of Toilet No. 1 of Third Floor

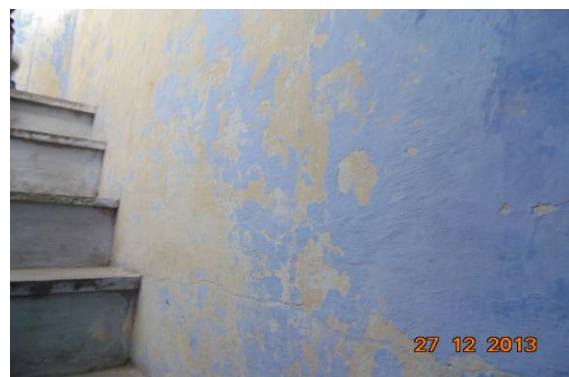
Photo 18

Peeling of Plaster on Wall No. 2 of Staircase TF to Fourth of Third Floor

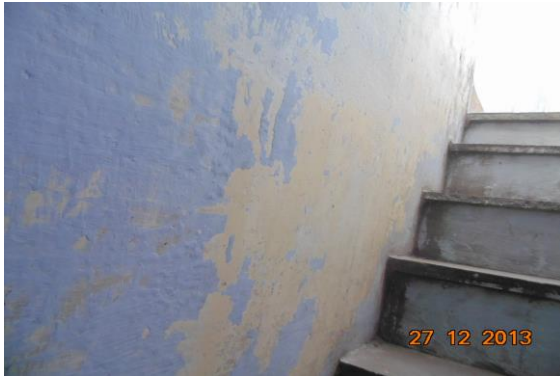
Photo 19

Peeling of Plaster on Wall No. 1 of Staircase TF to Fourth of Third Floor

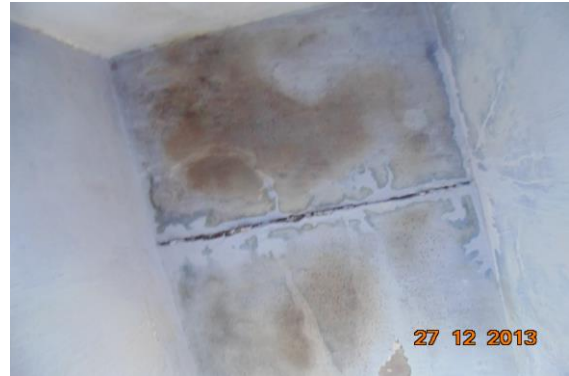
Photo 20

Damaged Portion on Roof of Staircase TF to Fourth of Third Floor

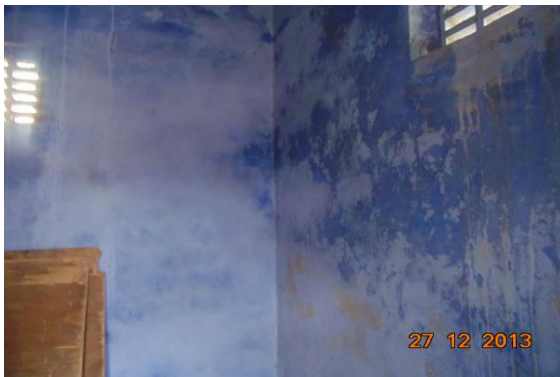
Photo 21

Dampness/Seepage on Wall No. 2 & 4 of Room No. 1 of Fourth Floor

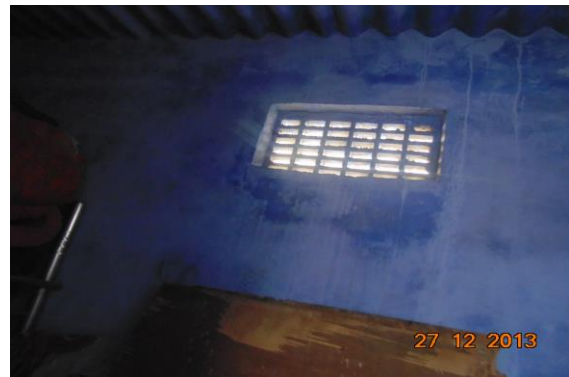
Photo 22

Dampness/Seepage on Wall No. 2 & 4 of Room No. 1 of Fourth Floor

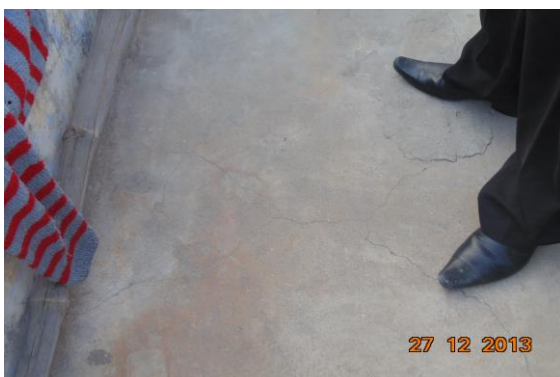
Photo 23

Peeling of Plaster on Floor of Room No. 1 of Fourth Floor

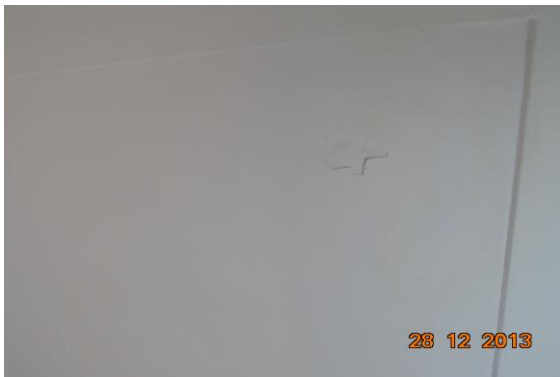
Photo 9
Peeling of Plaster on Room No. 2 of House No.289, First Floor

Summary of Defects Other Than Crack			
Defect ID	Location	Description	Photo No.
1	Room No. 2 House No.289,First Floor	Peeling of Plaster	9
2	Roof Balcony of House No.289 First Floor	Dampness/Seepage	10
3	Wall No. 1 & 4 Staircase FF-Terrace of House No.289 First Floor	Dampness/Seepage	11
4	Wall No. 1 & 3 Staircase FF-Terrace of House No.289 First Floor	Dampness/Seepage	12
5	Wall No. 3 House No.289 Ground Floor	Dampness/Seepage	13
6	Floor Temple Ground Floor	Damaged Portion	14

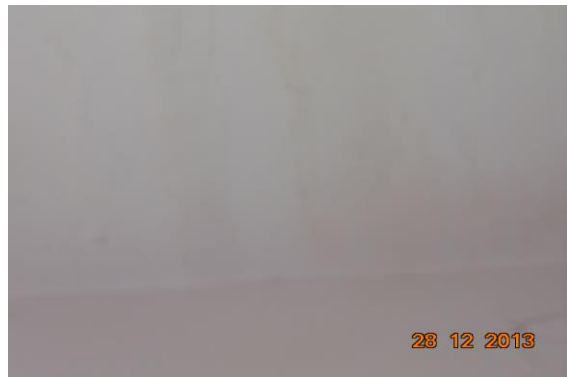
Photo 10
Dampness/Seepage on Roof of Balcony of House No.289 of First Floor

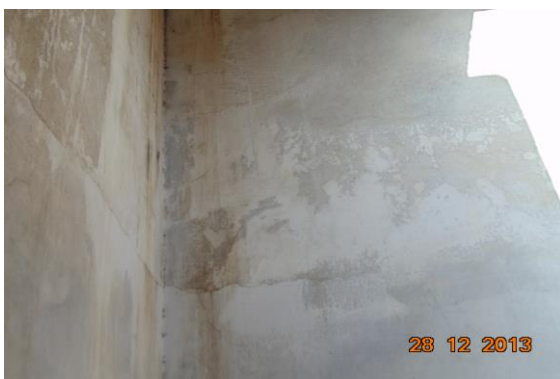
Photo 11
Dampness/Seepage on Wall No. 1 & 4 of Staircase FF-Terrace of House No.289 of First Floor

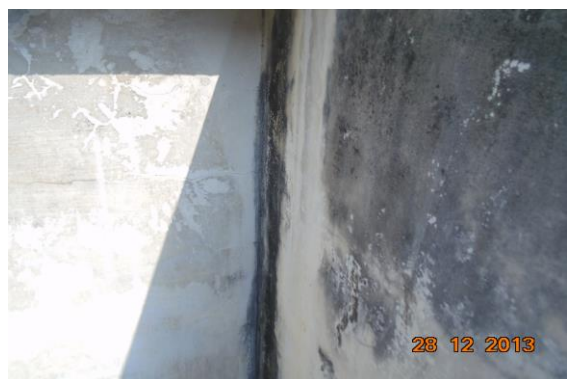
Photo 12
Dampness/Seepage on Wall No. 1 & 3 of Staircase FF-Terrace of House No.289 of First Floor

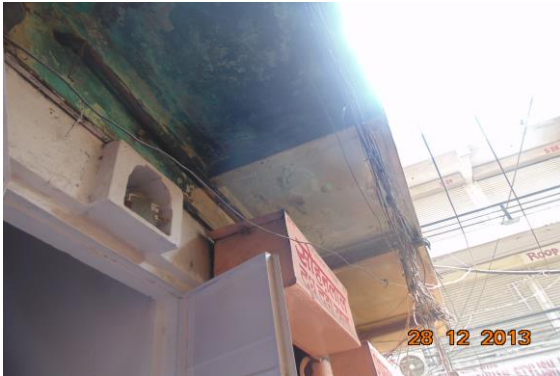
Photo 13
Dampness/Seepage on Wall No. 3 of House No.289 of Ground Floor

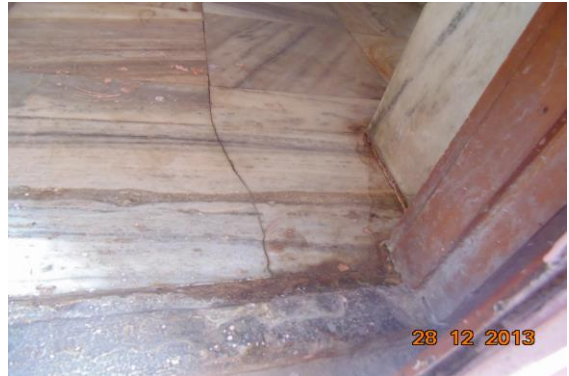
Photo 14
Damaged Portion on Floor of Temple of Ground Floor

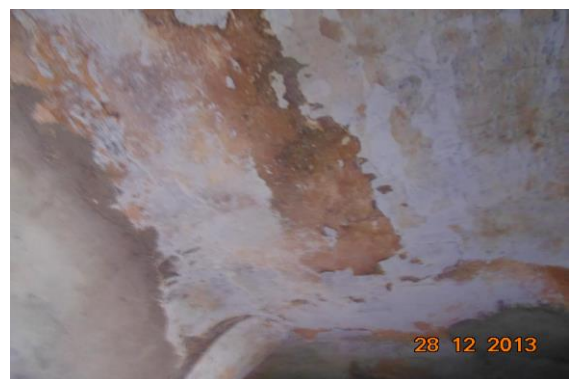
Photo 6
Dampness/Seepage on Roof of Passage of House No 290 & 291 of Ground Floor

Summary of Defects Other Than Crack			
Defect ID	Location	Description	Photo No.
1	Roof Passage of House No 290 & 291 Ground Floor	Dampness/Seepage	6
2	Roof Passage of House No 290 & 291 Ground Floor	Dampness/Seepage	7
3	Wall No. 4 Passage of House No 290 & 291 Ground Floor	Peeling of Plaster	8
4	Wall No. 2 Passage of House No 290 & 291 Ground Floor	Peeling of Plaster	9
5	Wall No. 1 Passage of House No 290 & 291 Ground Floor	Peeling of Plaster	10
6	Wall No. 3 Passage of House No 290 & 291 Ground Floor	Dampness/Seepage	11
7	Wall No. 4 & Sun Shade Open Sky Lobby of House No 290 & 291 Ground Floor	Dampness/Seepage	12
8	Wall No. 4 & Sun Shade Open Sky Lobby of House No 290 & 291 Ground Floor	Dampness/Seepage	13
9	Wall No. 2 & Sun Shade Open Sky Lobby of House No 290 & 291 Ground Floor	Dampness/Seepage	14
10	Wall No. 3 & Sun Shade Open Sky Lobby of House No 290 & 291 Ground Floor	Dampness/Seepage	15
11	Wall No. 4 Open Sky Lobby of House No 290 & 291 Ground Floor	Dampness/Seepage	16

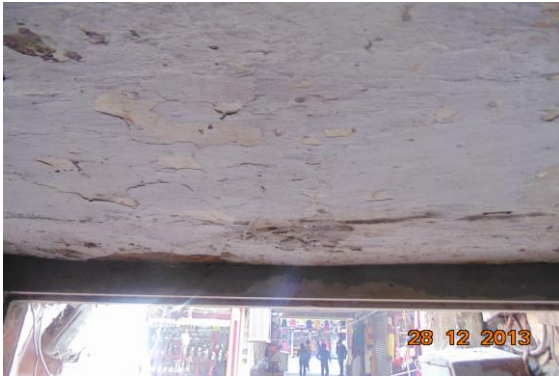
Photo 7

Dampness/Seepage on Roof of Passage of House No 290 & 291 of Ground Floor

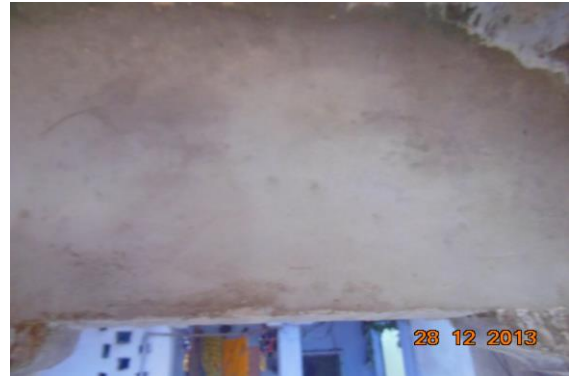
Photo 8

Peeling of Plaster on Wall No. 4 of Passage of House No 290 & 291 of Ground Floor

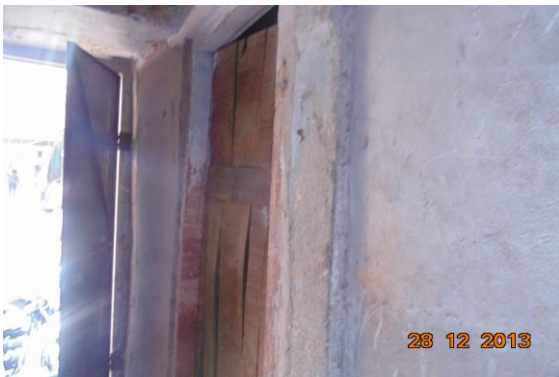
Photo 9

Peeling of Plaster on Wall No. 2 of Passage of House No 290 & 291 of Ground Floor

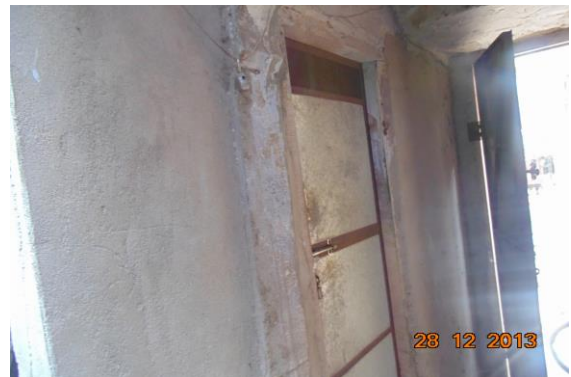
Photo 10

Peeling of Plaster on Wall No. 1 of Passage of House No 290 & 291 of Ground Floor

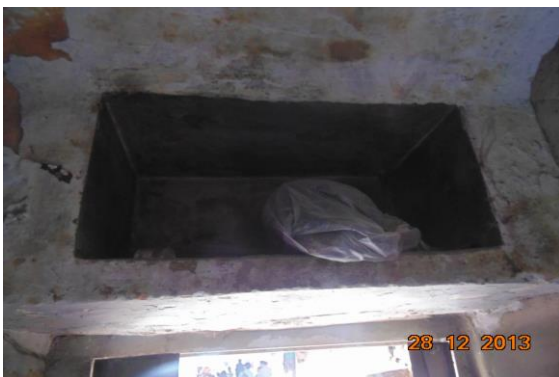
Photo 11

Dampness/Seepage on Wall No. 3 of Passage of House No 290 & 291 of Ground Floor

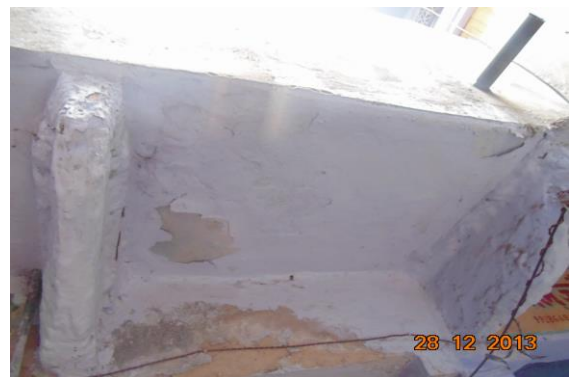
Photo 12

Dampness/Seepage on Wall No. 4 & Sun Shade of Open Sky Lobby of House No 290 & 291 of Ground Floor

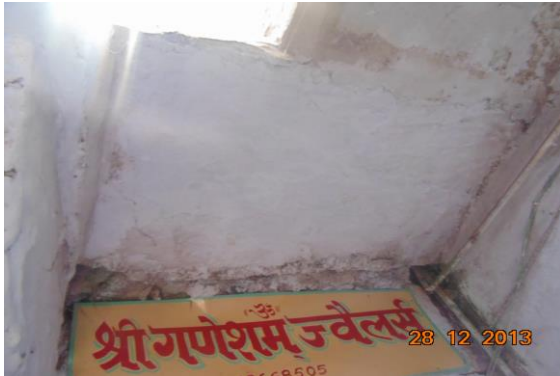
Photo 13

Dampness/Seepage on Wall No. 4 & Sun Shade of Open Sky Lobby of House No 290 & 291 of Ground Floor

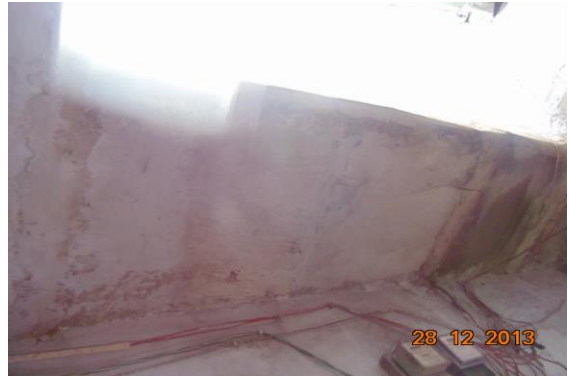
Photo 14

Dampness/Seepage on Wall No. 2 & Sun Shade of Open Sky Lobby of House No 290 & 291 of Ground Floor

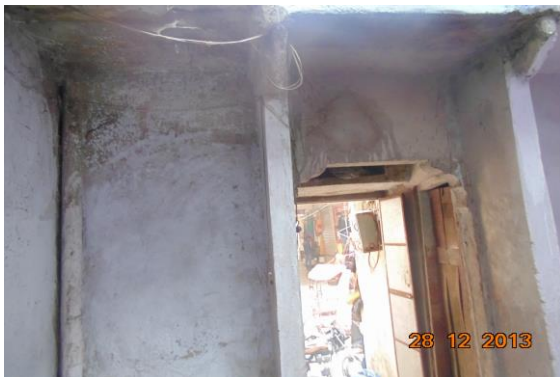
Photo 15

Dampness/Seepage on Wall No. 3 & Sun Shade of Open Sky Lobby of House No 290 & 291 of Ground Floor

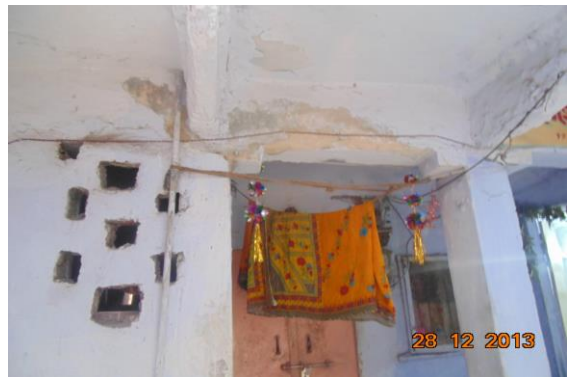
Photo 16

Dampness/Seepage on Wall No. 4 of Open Sky Lobby of House No 290 & 291 of Ground Floor

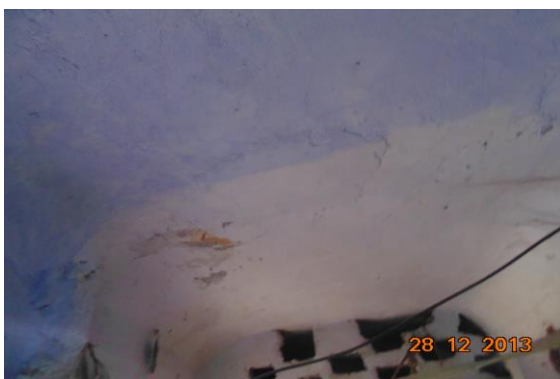
Photo 17

Dampness/Seepage on Roof of Varanda of House No 290 & 291 of Ground Floor

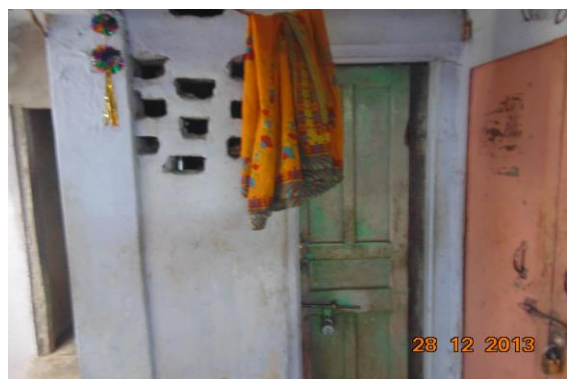
Photo 18

Dampness/Seepage on Wall No. 1 of Varanda of House No 290 & 291 of Ground Floor
