Pre Building Condition Survey Report

Name and Address of Structure :	Badi Chopar to Ramp Area (Down Line)
---------------------------------	--------------------------------------

Name of the Project	Contract JMRC-UG1B “Design and Construction of Tunnel between Chandpole and Badi Chouper and reverse line by Shield TBM, Underground Metro Stations at Choti Chouper and Badi Chouper by Cut and Cover Methods on East West Corridor of Jaipur Metro Rail Corporation Limited .”	
Owner :

Pre - Condition Building Survey for Construction of Underground Stations from Chandpole to Bari Chouper and reversal line

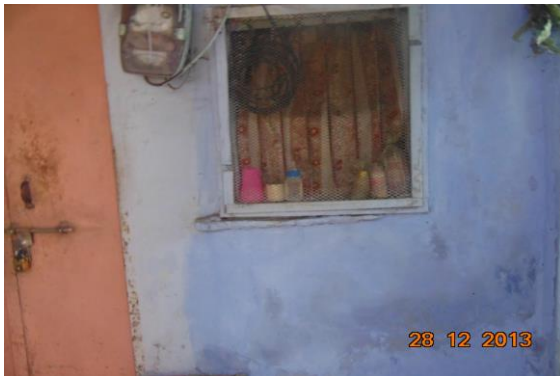
Photo 19

Dampness/Seepage on Wall No. 4 of Varanda of House No 290 & 291 of Ground Floor

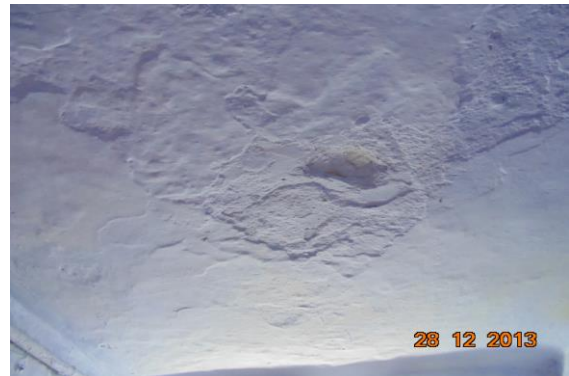
Photo 20

Dampness/Seepage on Roof of Room No. 2 of House No 290 & 291, Ground Floor

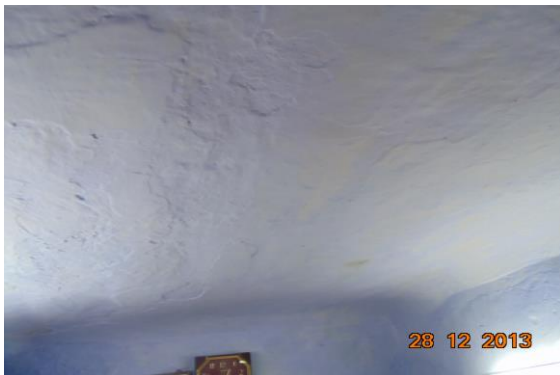
Photo 21

Dampness/Seepage on Wall No. 4 of Room No. 2 of House No 290 & 291, Ground Floor

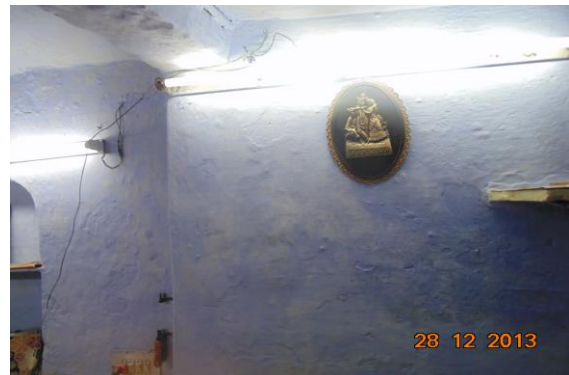
Photo 22

Dampness/Seepage on Wall No. 1 of Room No. 2 of House No 290 & 291, Ground Floor

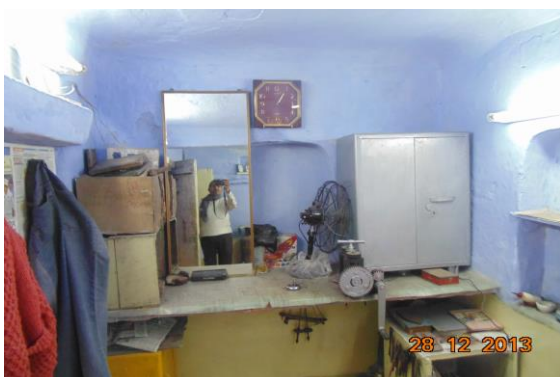
Photo 23

Dampness/Seepage on Wall No. 2 of Room No. 2 of House No 290 & 291, Ground Floor

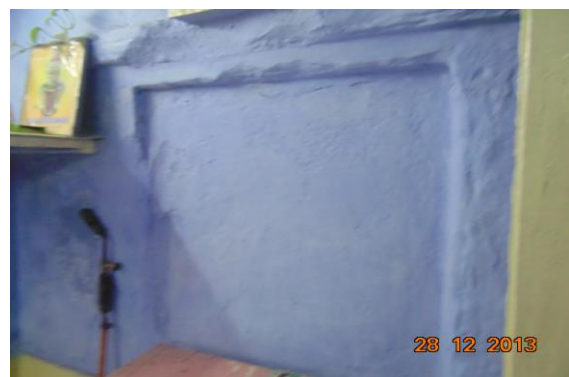
Photo 24

Dampness/Seepage on Wall No. 3 of Room No. 2 of House No 290 & 291, Ground Floor

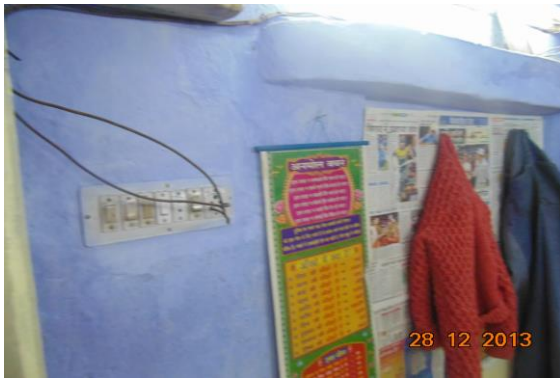
Photo 25

Dampness/Seepage on Wall No. 4 of Room No. 3 of House No 290 & 291, Ground Floor

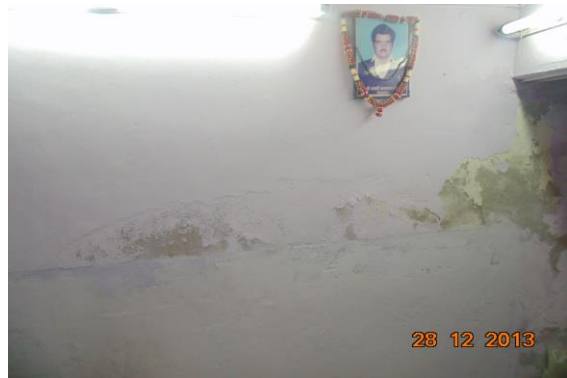
Photo 26

Dampness/Seepage on Wall No. 2 of Room No. 3 of House No 290 & 291, Ground Floor

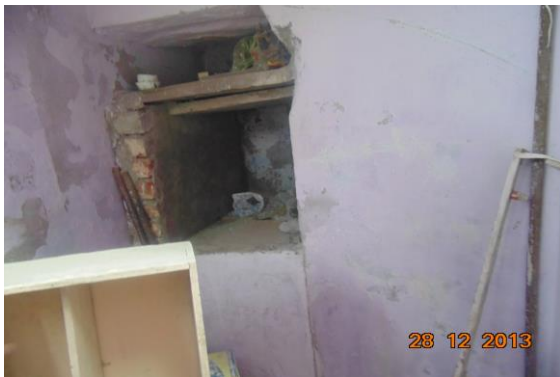
Photo 27

Dampness/Seepage on Wall No. 3 & Roof of Room No. 3 of House No 290 & 291, Ground Floor

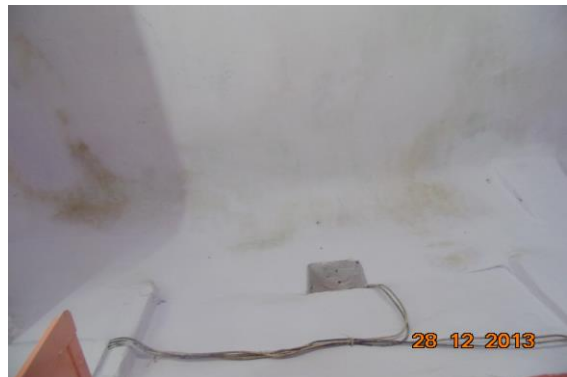
Photo 28

Peeling of Plaster on Wall No. 1 & 4 of Staire Case Gf-Ff of House No 290 & 291 of Ground Floor

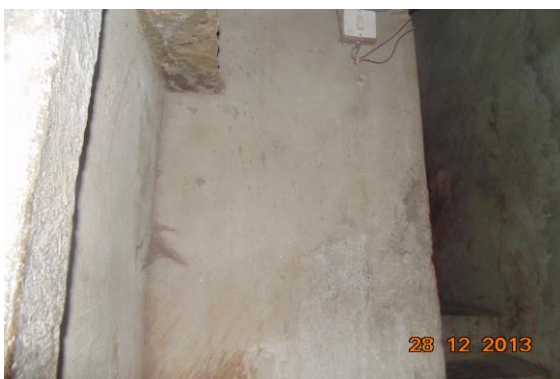
Photo 29

Damaged Portion on of Staire Case Gf-Ff Steps of House No 290 & 291 of Ground Floor

24	Staire Case Gf-Ff Steps of House No 290 & 291 Ground Floor	Damaged Portion	29
25	Wall No. 2 Staire Case Gf-Ff of House No 290 & 291 Ground Floor	Peeling of Plaster	30
26	Roof Staire Case Gf-Ff of House No 290 & 291 Ground Floor	Dampness/Seepage	31
27	Wall No. 1 & Sun Shade Sky Open Lobby of House No 290 & 291 First Floor	Dampness/Seepage	32
28	Wall No. 3 Sky Open Lobby of House No 290 & 291 First Floor	Dampness/Seepage	33

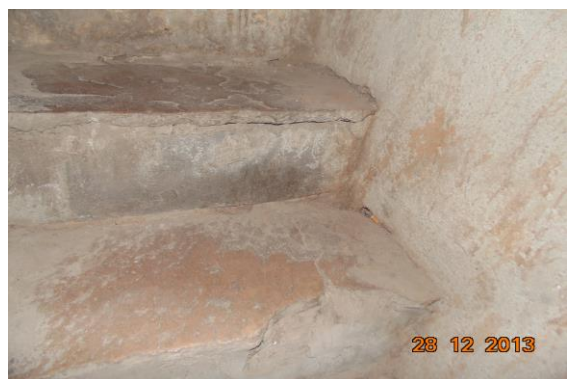
Photo 30

Peeling of Plaster on Wall No. 2 of Staire Case Gf-Ff of House No 290 & 291 of Ground Floor

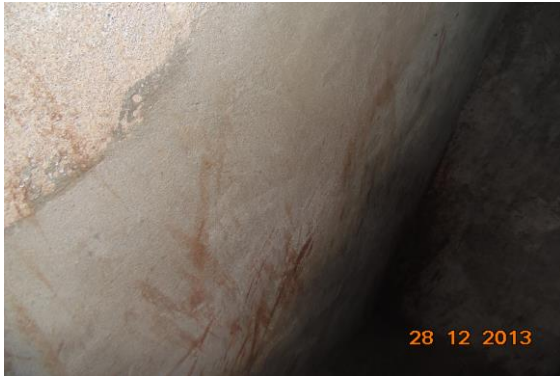
Photo 31

Dampness/Seepage on Roof of Staire Case Gf-Ff of House No 290 & 291 of Ground Floor

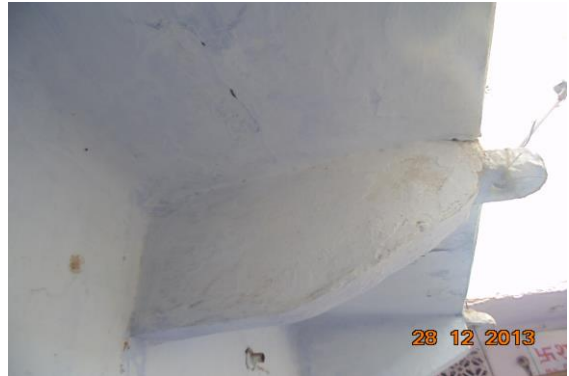
Photo 32

Dampness/Seepage on Wall No. 1 & Sun Shade of Sky Open Lobby of House No 290 & 291 of First Floor

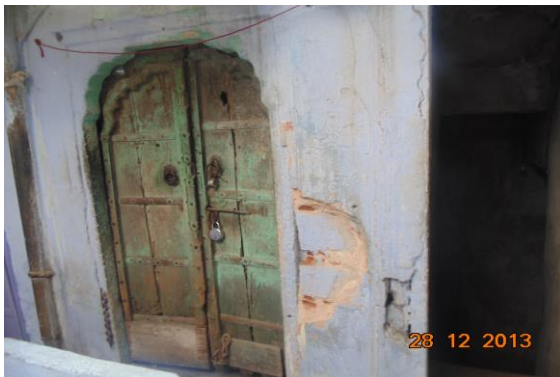
Photo 33

Dampness/Seepage on Wall No. 3 of Sky Open Lobby of House No 290 & 291 of First Floor

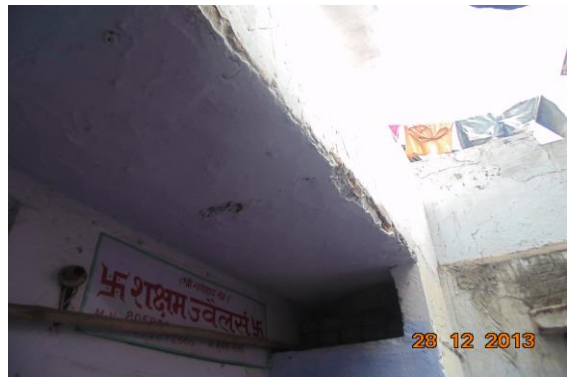
Photo 34

Peeling of Plaster on Wall No. 4 & Sun Shade of Sky Open Lobby of House No 290 & 291 of First Floor

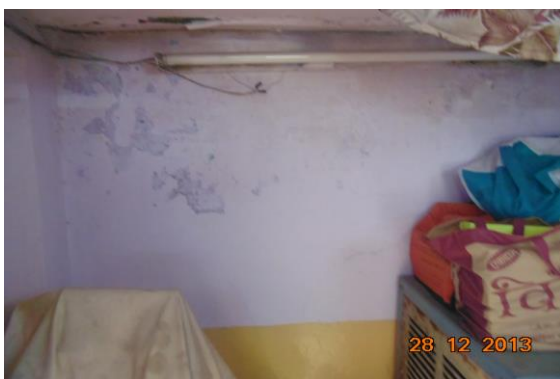
Photo 35

Dampness/Seepage on Wall No. 1 of Room No. 2 of House No 290 & 291, First Floor

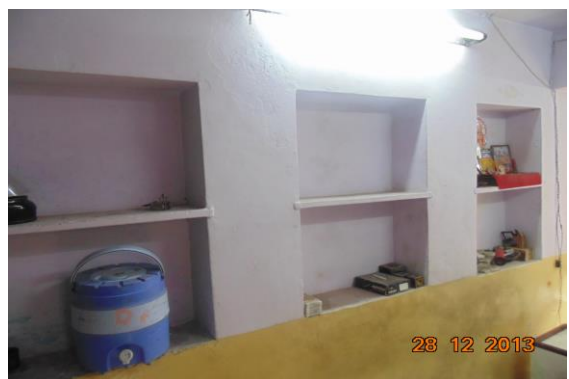
Photo 36

Dampness/Seepage on Wall No. 4 of Room No. 2 of House No 290 & 291, First Floor

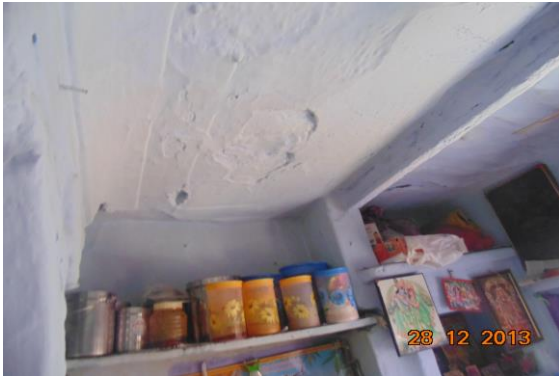
Photo 37

Peeling of Plaster on Roof of Room No. 3 of House No 290 & 291, First Floor

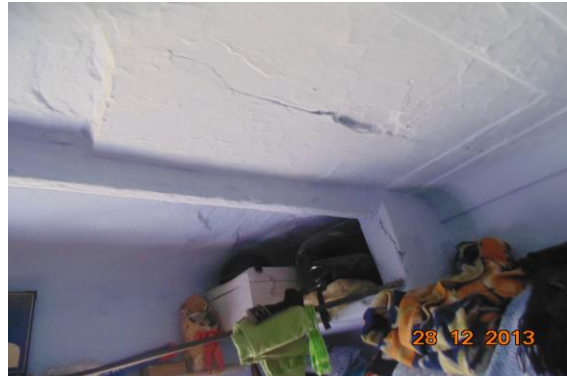
Photo 38

Peeling of Plaster on Roof of Room No. 3 of House No 290 & 291, First Floor

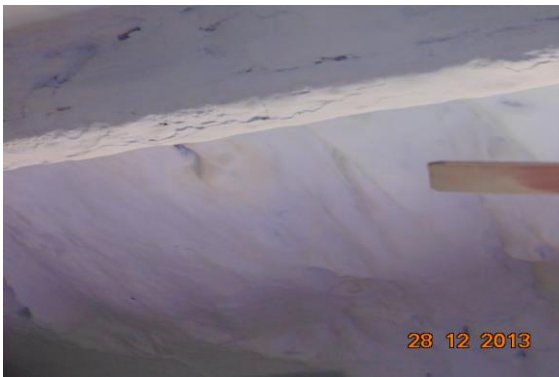
Photo 39

Peeling of Plaster on Roof of Room No. 3 of House No 290 & 291, First Floor

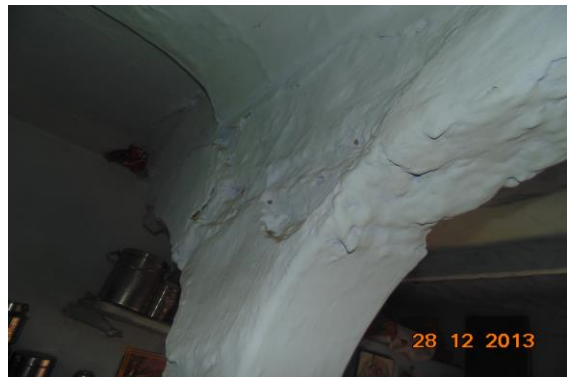
Photo 40

Peeling of Plaster on Wall No. 2 of Passage of House No 290 & 291 of First Floor

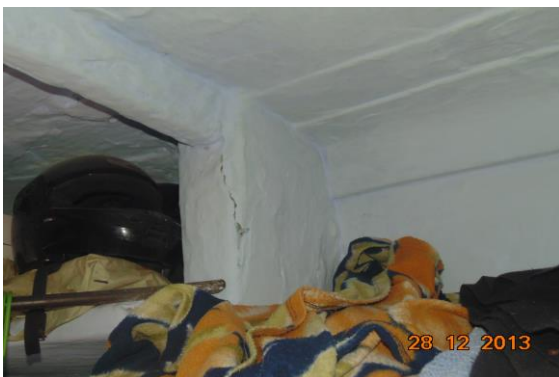
Photo 41

Plaster Crack on Wall No. 2 of Room No. 3 of House No 290 & 291, First Floor

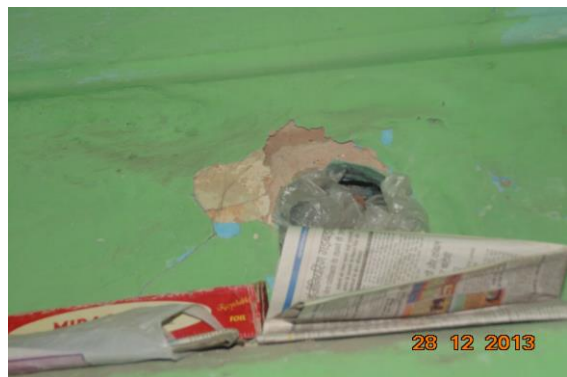
Photo 42

Peeling of Plaster on Wall No. 4 of Room No. 4 of House No 290 & 291, First Floor

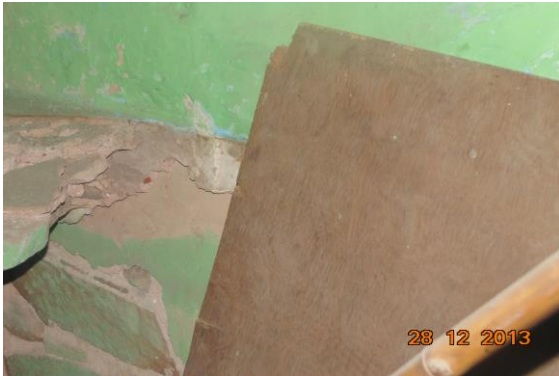
Photo 43

Damaged Portion on Wall No. 2, 3 & Roof of Room No. 4 of House No 290 & 291, First Floor

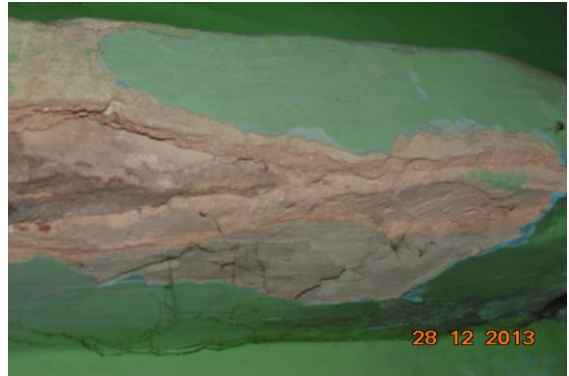
Photo 44

Damaged Portion on Wall No. 2, 3 & Roof of Room No. 4 of House No 290 & 291, First Floor

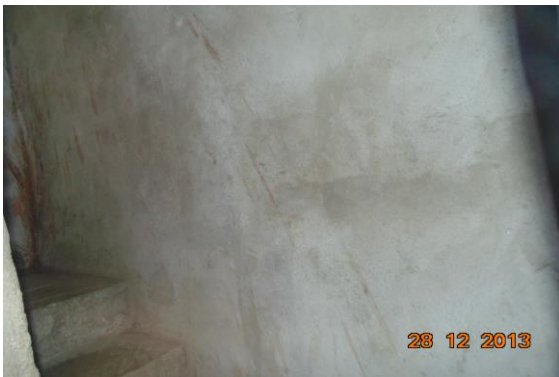
Photo 45

Peeling of Plaster on Wall No. 2 & 3 of Staire Case Ff-Sf of House No 290 & 291 of First Floor

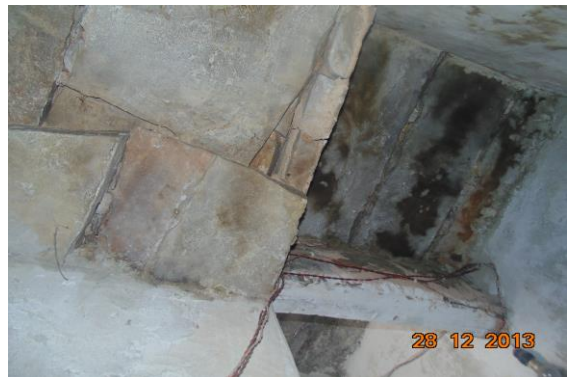
Photo 46

Damaged Portion on Roof of Staire Case Ff-Sf of House No 290 & 291 of First Floor

41	Roof Staire Case Ff-Sf of House No 290 & 291 First Floor	Damaged Portion	46
42	Wall No. 4 Sky Open Lobby of House No 290 & 291 Second Floor	Plaster Crack	47
43	Wall No. 1 Sky Open Lobby of House No 290 & 291 Second Floor	Dampness/Seepage	48
44	Wall No. 3 Sky Open Lobby of House No 290 & 291 Second Floor	Peeling of Plaster	49
45	Floor Sky Open Lobby of House No 290 & 291 Second Floor	Plaster Crack	50
46	External Façade Front Side of House No 290 & 291 First Floor	Damaged Portion	51
47	External Façade Front Side of House No 290 & 291 First Floor	Damaged Portion	52
48	Main Gate Shade of House No 290 & 291 Ground Floor	Damaged Portion	53

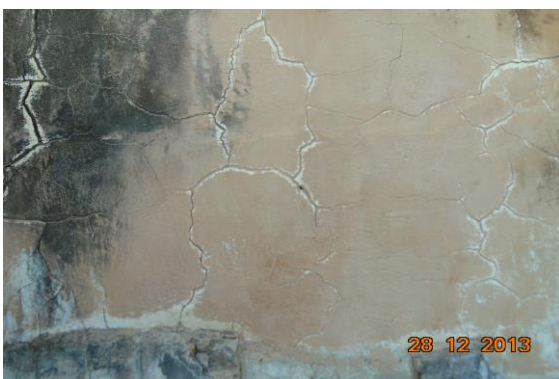
Photo 47

Plaster Crack on Wall No. 4 of Sky Open Lobby of House No 290 & 291 of Second Floor

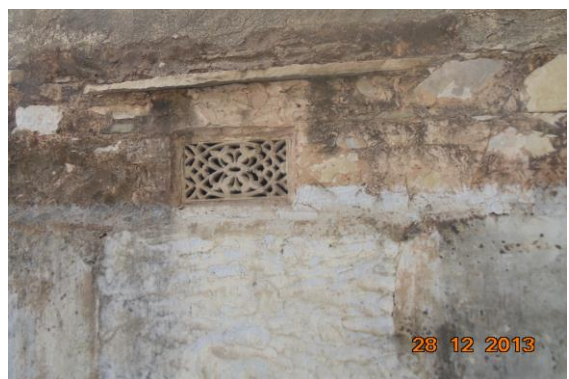
Photo 48

Dampness/Seepage on Wall No. 1 of Sky Open Lobby of House No 290 & 291 of Second Floor

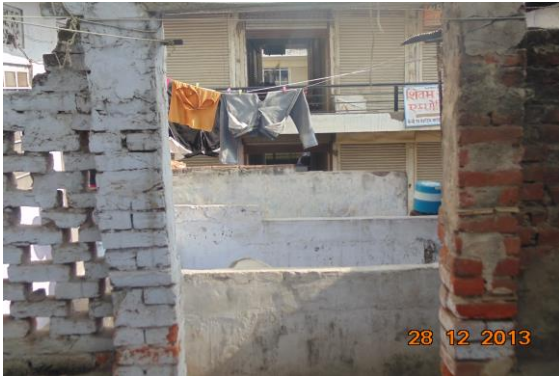
Photo 49

Peeling of Plaster on Wall No. 3 of Sky Open Lobby of House No 290 & 291 of Second Floor

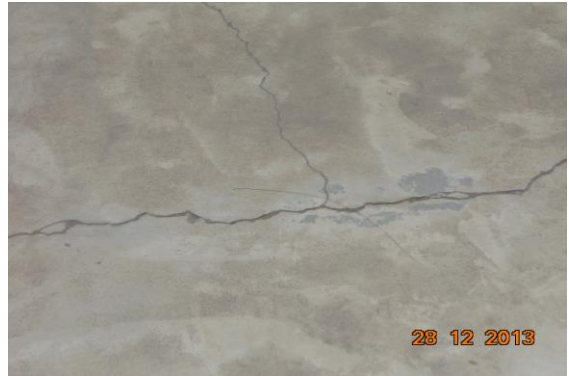
Photo 50

Plaster Crack on Floor of Sky Open Lobby of House No 290 & 291 of Second Floor

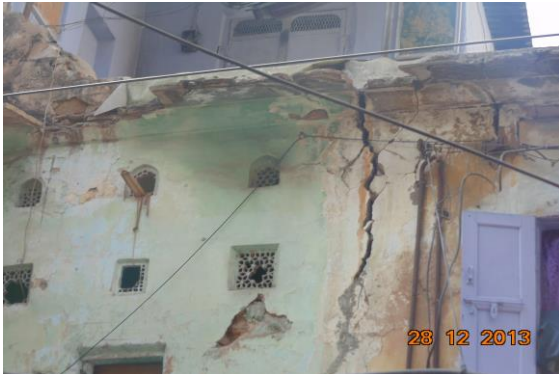
Photo 51

Damaged Portion on External Façade Front Side of House No 290 & 291 of First Floor

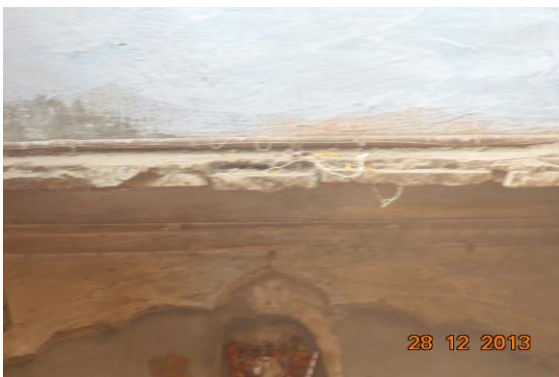
Photo 52

Damaged Portion on External Façade Front Side of House No 290 & 291 of First Floor

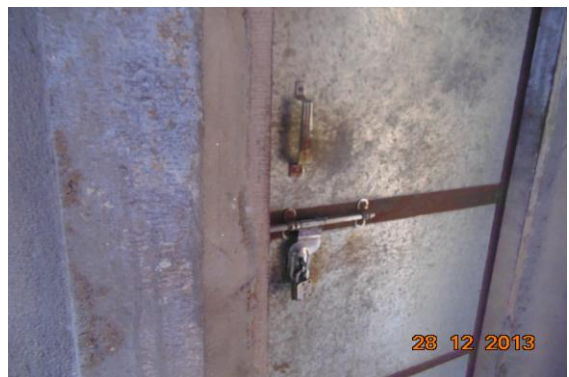
Photo 53

Damaged Portion on Main Gate Shade of House No 290 & 291 of Ground Floor

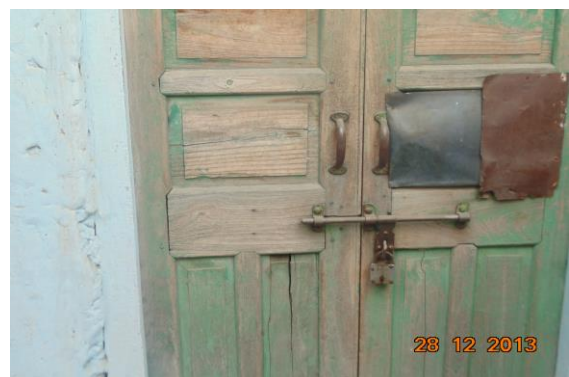
Photo 59
Wall No. 2 of Room No. 3 of House No 290 & 291, First Floor

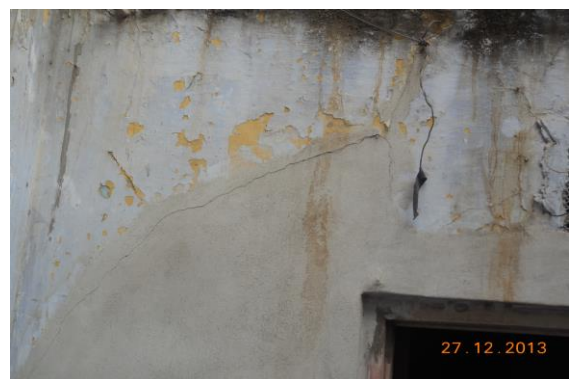
Photo 36
Inclined Crack on Wall No. 2 of Open Varanda, Second Floor
Approx. Width = 0.5mm, Approx. Length = 1.5m.
Distance from Wall no.4 = 0m, Height from Floor = 1.5m.

Summary of Cracks						
Defect ID	Location	Orientation	Appx. Width (mm)	Appx. Length (m)	Category	Photo No.
1	Wall No. 2 Open Varanda Second Floor	Inclined	0.5	1.5	Very Slight	36, 36A
2	Wall No. 4 Open Varanda Second Floor	Inclined	0.3	4	Very Slight	37, 37A
3	Wall No. 4 Open Varanda Second Floor	Inclined	0.4	1.5	Very Slight	38, 38A
4	Roof Room No. 1 Third Floor	Horizontal	0.6	1.4	Very Slight	39
5	Roof Room No. 1 Third Floor	Horizontal	0.5	2	Very Slight	40
6	Roof Room No. 1 Third Floor	Horizontal	0.35	1.5	Very Slight	41
7	Roof Room No. 1 Third Floor	Horizontal	0.4	1.7	Very Slight	42
8	Wall No. 1 Room No. 1 Third Floor	Vertical	0.35	2.5	Very Slight	43, 43A
9	Wall No. 2 Room No. 1 Third Floor	Inclined	0.5	0.4	Very Slight	44, 44A
10	Wall No. 3 Store No.1 Third Floor	Vertical	0.25	0.6	Very Slight	45, 45A
11	Wall No. 3 Lobby No.2 Third Floor	Vertical	0.4	1.8	Very Slight	46, 46A
12	Wall No. 2 Kitchen Third Floor	Horizontal	0.35	2.4	Very Slight	47

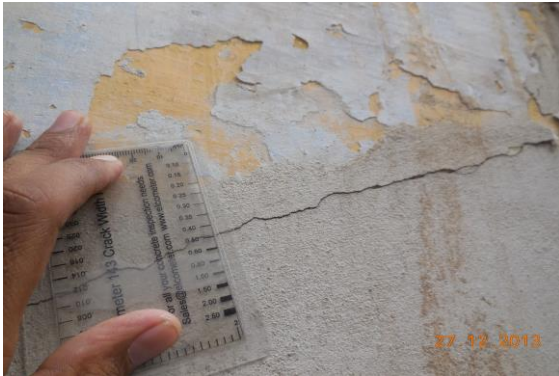
Photo 36A

Inclined Crack on Wall No. 2 of Open Varanda, Second Floor
Approx. Width = 0.5mm, Approx. Length = 1.5m.
Distance from Wall no.4 = 0m, Height from Floor = 1.5m.

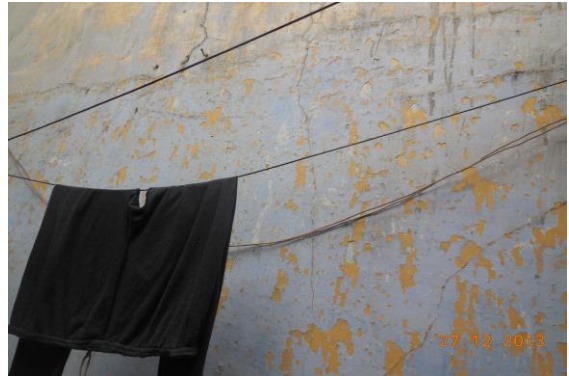
Photo 37

Inclined Crack on Wall No. 4 of Open Varanda, Second Floor
Approx. Width = 0.3mm, Approx. Length = 4m.
Distance from Wall No.1 = 1m, Height from Floor = 0.5m.

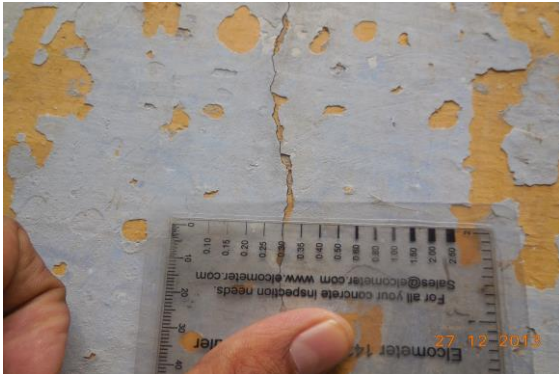
Photo 37A

Inclined Crack on Wall No. 4 of Open Varanda, Second Floor
Approx. Width = 0.3mm, Approx. Length = 4m.
Distance from Wall No.1 = 1m, Height from Floor = 0.5m.

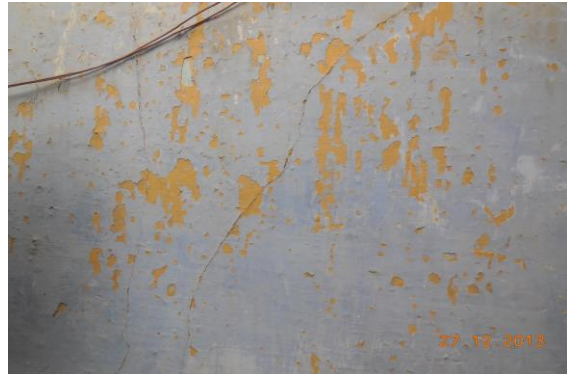
Photo 38

Inclined Crack on Wall No. 4 of Open Varanda, Second Floor
Approx. Width = 0.4mm, Approx. Length = 1.5m.
Distance from Wall No.2 = 0.8m, Height from Floor = 1.5m.

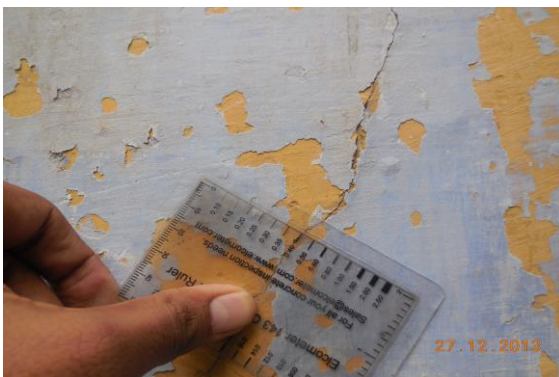
Photo 38A

Inclined Crack on Wall No. 4 of Open Varanda, Second Floor
Approx. Width = 0.4mm, Approx. Length = 1.5m.
Distance from Wall No.2 = 0.8m, Height from Floor = 1.5m.

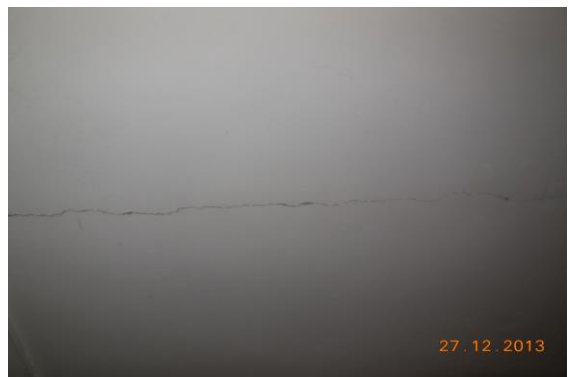
Photo 39

Horizontal Crack on Roof of Room No. 1, Third Floor
Approx. Width = 0.6mm, Approx. Length = 1.4m.
Distance from Wall no.1 = 1.5m, Height from Floor = 2.5m.

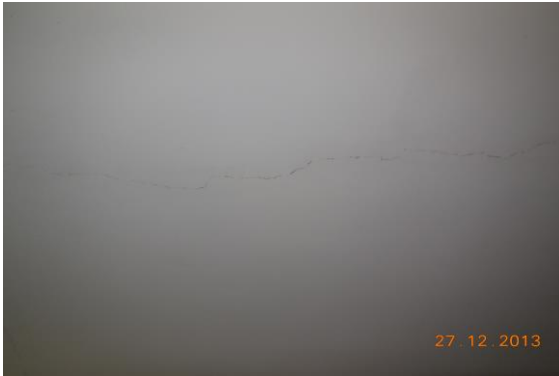
Photo 40

Horizontal Crack on Roof of Room No. 1, Third Floor
Approx. Width = 0.5mm, Approx. Length = 2m.
Distance from Wall No.2 = 1.2m, Height from Floor = 2.5m.

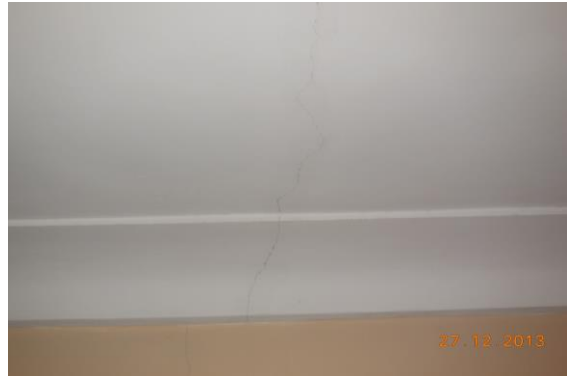
Photo 41

Horizontal Crack on Roof of Room No. 1, Third Floor
Approx. Width = 0.35mm, Approx. Length = 1.5m.
Distance from Wall no.2 = 0.8m, Height from Floor = 2.5m.

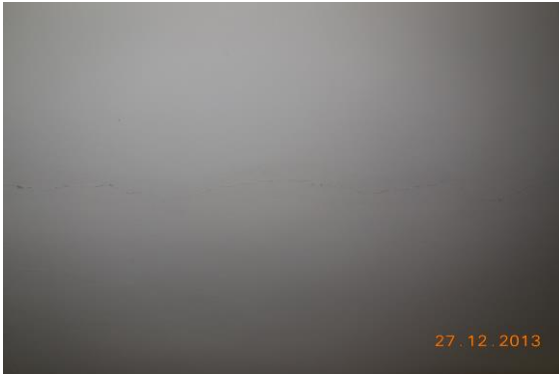
Photo 42

Horizontal Crack on Roof of Room No. 1, Third Floor
Approx. Width = 0.4mm, Approx. Length = 1.7m.
Distance from Wall No.2 = 1.6m, Height from Floor = 2.5m.

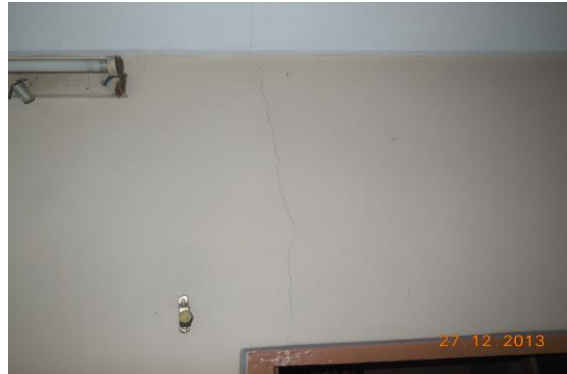
Photo 43

Vertical Crack on Wall No. 1 of Room No. 1, Third Floor
Approx. Width = 0.35mm, Approx. Length = 2.5m.
Distance from Wall No.4 = 1.5m, Height from Floor = 1.8m.

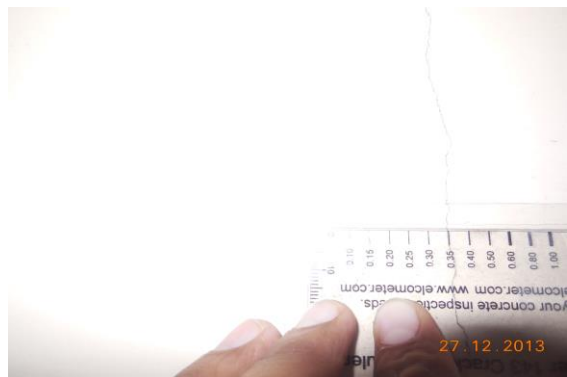
Photo 43A

Vertical Crack on Wall No. 1 of Room No. 1, Third Floor
Approx. Width = 0.35mm, Approx. Length = 2.5m.
Distance from Wall No.4 = 1.5m, Height from Floor = 1.8m.

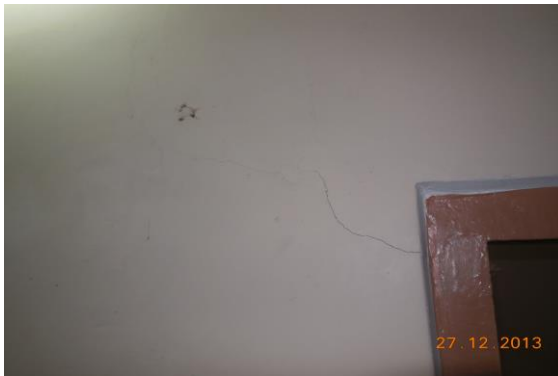
Photo 44

Inclined Crack on Wall No. 2 of Room No. 1, Third Floor
Approx. Width = 0.5mm, Approx. Length = 0.4m.
Distance from Wall no.3 = 1.7m, Height from Floor = 1.8m.

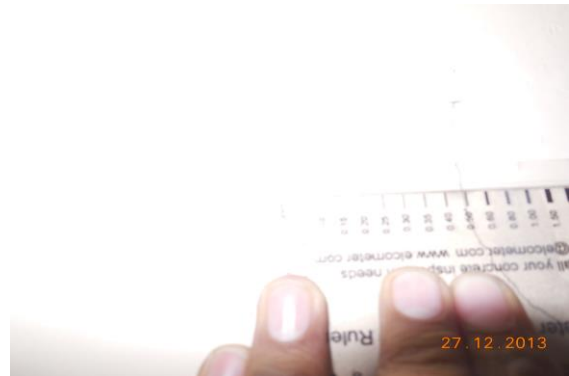
Photo 44A

Inclined Crack on Wall No. 2 of Room No. 1, Third Floor
Approx. Width = 0.5mm, Approx. Length = 0.4m.
Distance from Wall no.3 = 1.7m, Height from Floor = 1.8m.

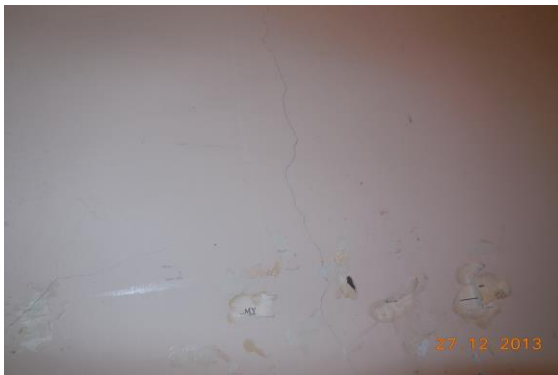
Photo 45

Vertical Crack on Wall No. 3 of Store No.1, Third Floor
Approx. Width = 0.25mm, Approx. Length = 0.6m.
Distance from Wall no.1 = 0.4m, Height from Floor = 1.8m.

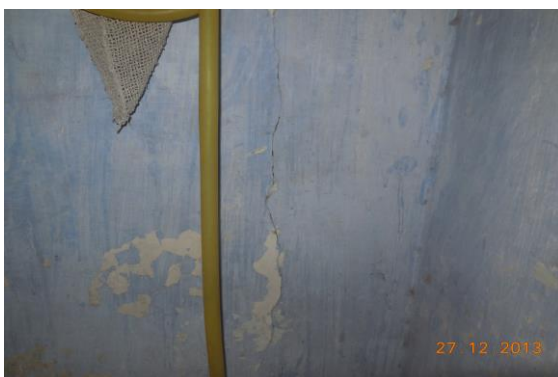
Photo 46

Vertical Crack on Wall No. 3 of Lobby No.2, Third Floor
Approx. Width = 0.4mm, Approx. Length = 1.8m.
Distance from Wall no.1 = 0.2m, Height from Floor = 0m.

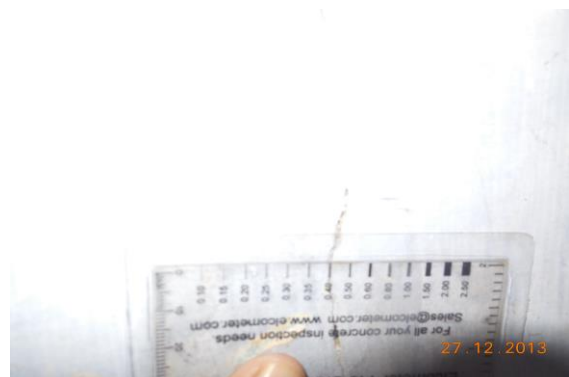
Photo 46A

Vertical Crack on Wall No. 3 of Lobby No.2, Third Floor
Approx. Width = 0.4mm, Approx. Length = 1.8m.
Distance from Wall no.1 = 0.2m, Height from Floor = 0m.

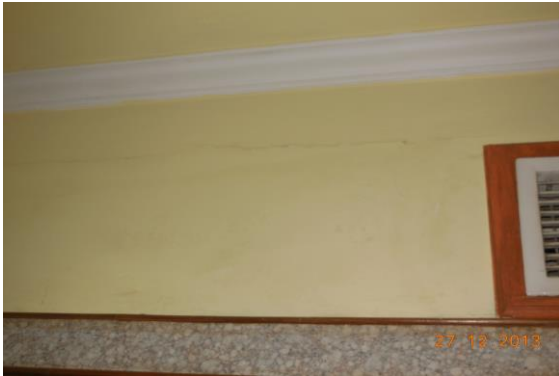
Photo 47

Horizontal Crack on Wall No. 2 of Kitchen, Third Floor
Approx. Width = 0.35mm, Approx. Length = 2.4m.
Distance from Wall no.4 = 0m, Height from Floor = 2.5m.

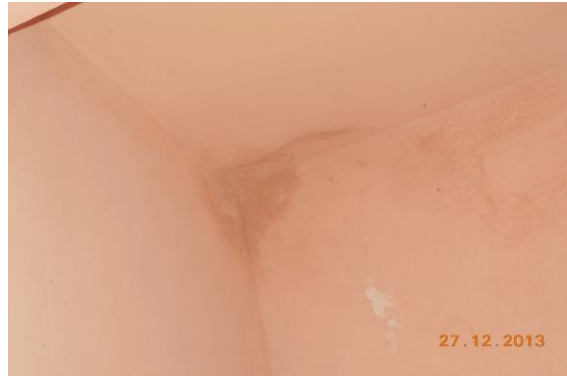
Photo 48

Dampness/Seepage on Wall No. 1 & 4 of Toilet No. 2 of Ground Floor

Summary of Defects Other Than Crack			
Defect ID	Location	Description	Photo No.
13	Wall No. 1 & 4 Toilet No. 2 Ground Floor	Dampness/Seepage	48
14	Wall No. 1, 3 & Roof Varanda Ground Floor	Dampness/Seepage	49
15	Outer Wall Kohtari Ground Floor	Damaged Portion	50
16	Wall No. 4 Kohtari Ground Floor	Damaged Portion	51
17	Wall No. 2 Kohtari Ground Floor	Damaged Portion	52
18	Roof Kohtari Ground Floor	Damaged Portion	53
19	Outer Wall Kohtari Ground Floor	Damaged Portion	54
20	Roof Passage Ground Floor	Damaged Portion	55
21	Roof Varanda Ground Floor	Damaged Portion	56
22	Outer Wall Toilet No. 2 Ground Floor	Dampness/Seepage	57
23	Outer Wall Shop No.1 Ground Floor	Peeling of Plaster	58
24	Wall No. 2 Passage Ground Floor	Peeling of Plaster	59
25	Roof Passage Ground Floor	Peeling of Plaster	60
26	Wall No. 1 Room No. 2 First Floor	Dampness/Seepage	61
27	Wall No. 2 & 4 Room No. 3 First Floor	Dampness/Seepage	62
28	Wall No. 1 & 4 Toilet No. 1 First Floor	Dampness/Seepage	63

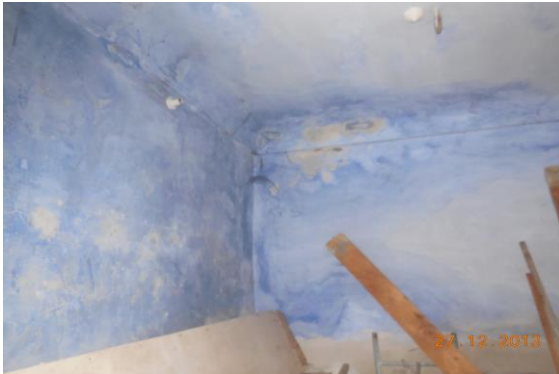
Photo 49

Dampness/Seepage on Wall No. 1, 3 & Roof of Varanda of Ground Floor

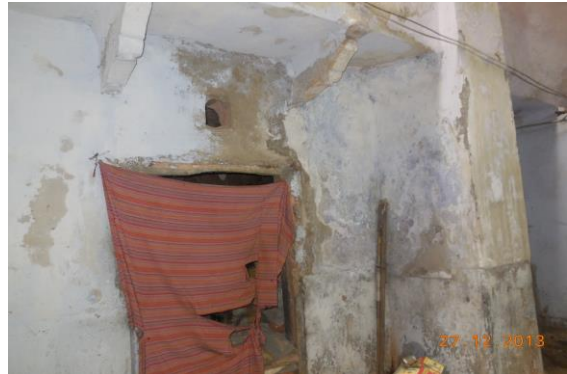
Photo 50

Damaged Portion on Outer Wall of Kohtari of Ground Floor

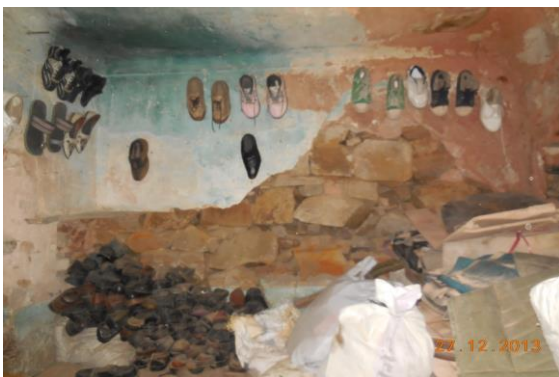
Photo 51

Damaged Portion on Wall No. 4 of Kohtari of Ground Floor

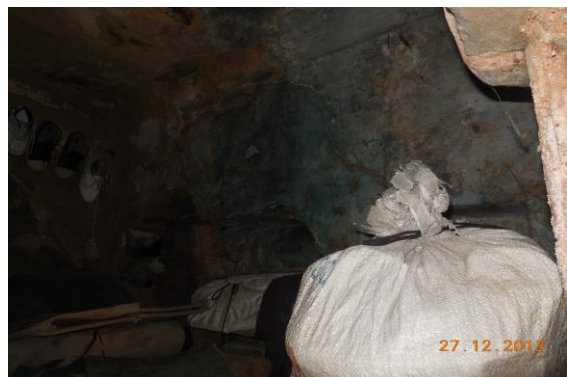
Photo 52

Damaged Portion on Wall No. 2 of Kohtari of Ground Floor

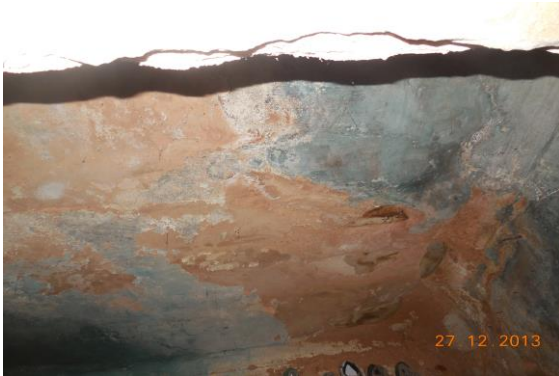
Photo 53
Damaged Portion on Roof of Kohtari of Ground Floor

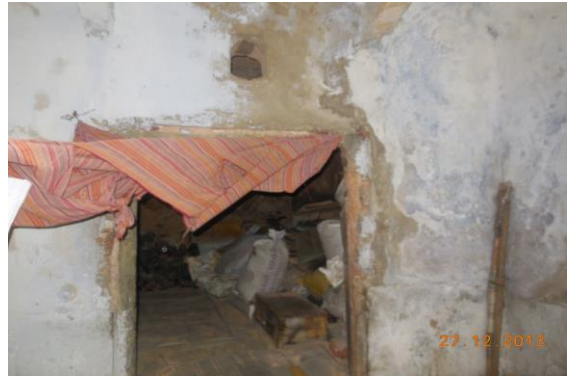
Photo 54
Damaged Portion on Outer Wall of Kohtari of Ground Floor

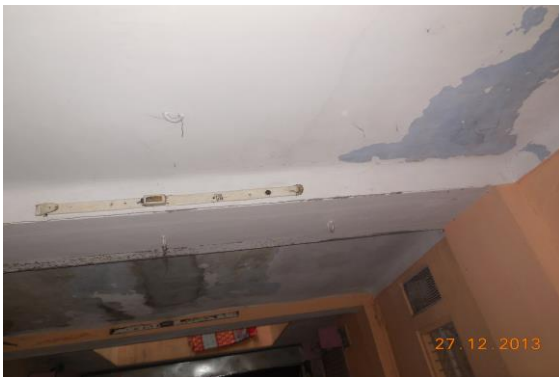
Photo 55
Damaged Portion on Roof of Passage of Ground Floor

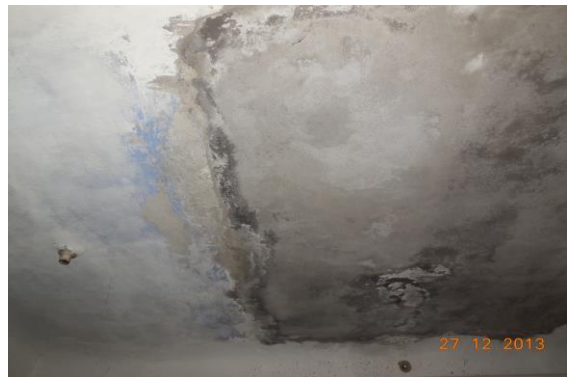
Photo 56
Damaged Portion on Roof of Varanda of Ground Floor

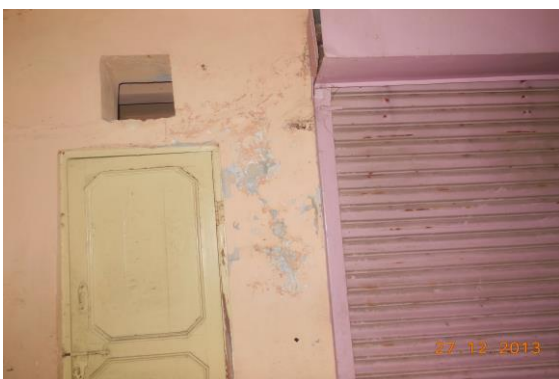
Photo 57
Dampness/Seepage on Outer Wall of Toilet No. 2 of Ground Floor

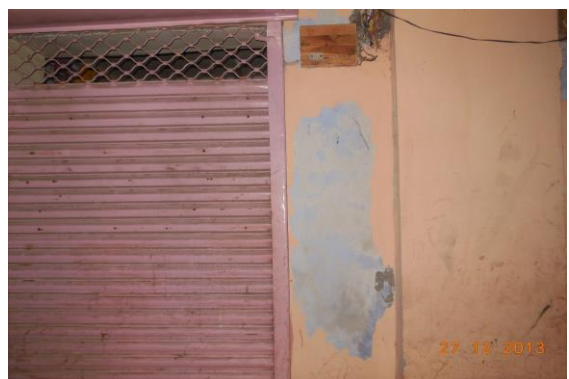
Photo 58
Peeling of Plaster on Outer Wall of Shop No.1 of Ground Floor

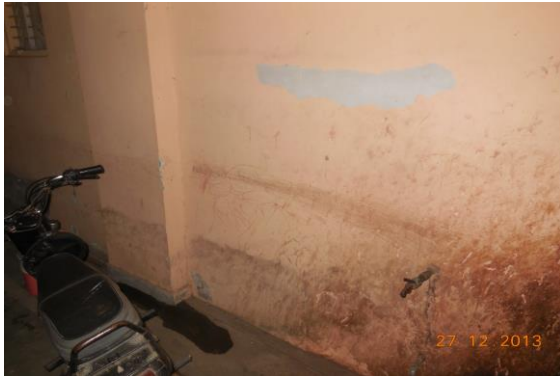
Photo 59

Peeling of Plaster on Wall No. 2 of Passage of Ground Floor

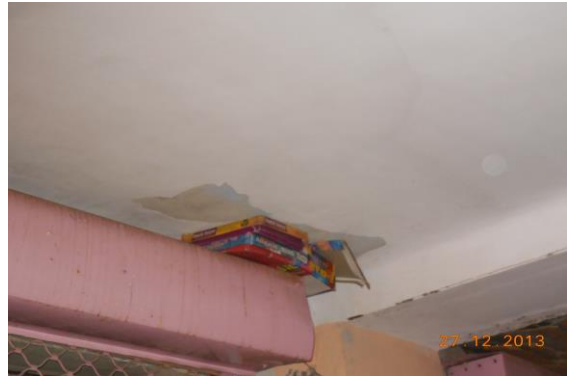
Photo 60

Peeling of Plaster on Roof of Passage of Ground Floor

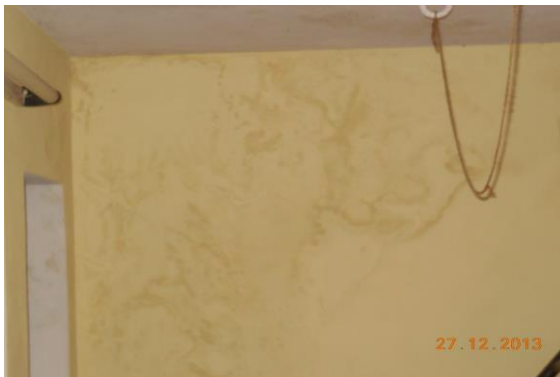
Photo 61

Dampness/Seepage on Wall No. 1 of Room No. 2 of First Floor

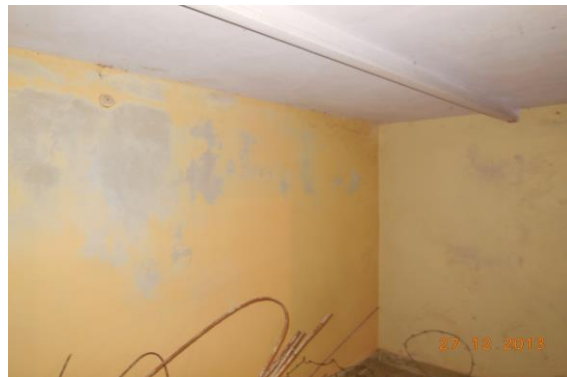
Photo 62

Dampness/Seepage on Wall No. 2 & 4 of Room No. 3 of First Floor

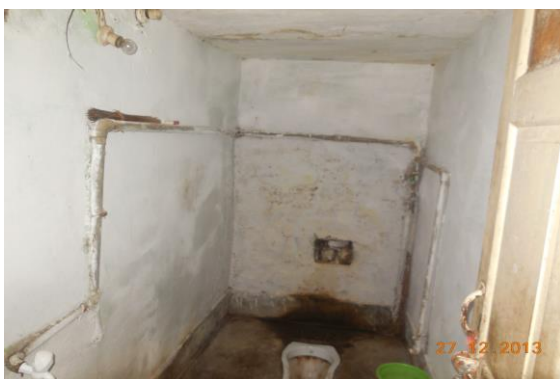
Photo 63

Dampness/Seepage on Wall No. 1 & 4 of Toilet No. 1 of First Floor

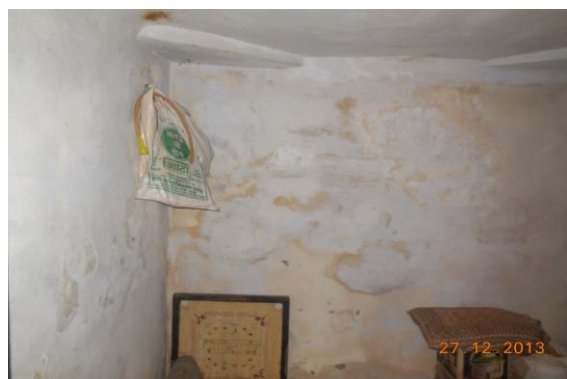
Photo 64

Dampness/Seepage on Wall No. 1 & 4 of Store of First Floor

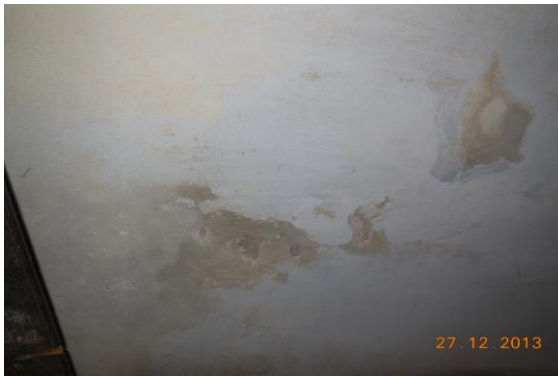
Photo 65
Peeling of Plaster on Wall No. 1 of Store of First Floor

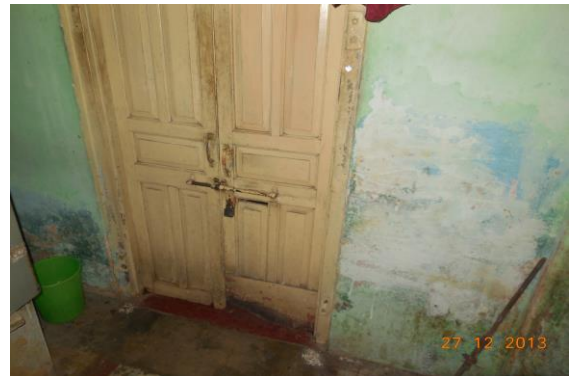
Photo 66
Dampness/Seepage on Wall No. 1 of Varanda No.1 of First Floor

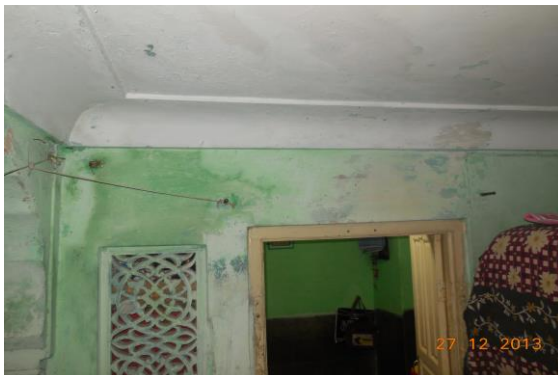
Photo 67
Dampness/Seepage on Wall No. 1 of Varanda No.1 of First Floor

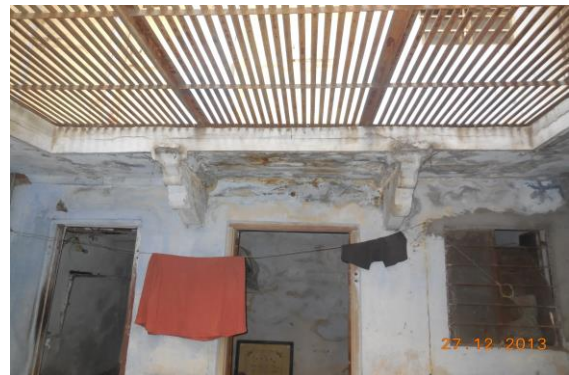
Photo 68
Dampness/Seepage on Wall No. 4 & Roof of Open To sky area of First Floor

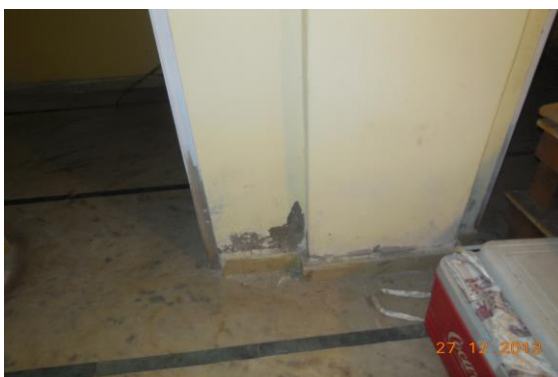
Photo 69
Peeling of Plaster on Wall No. 2 of Room No. 1 of First Floor

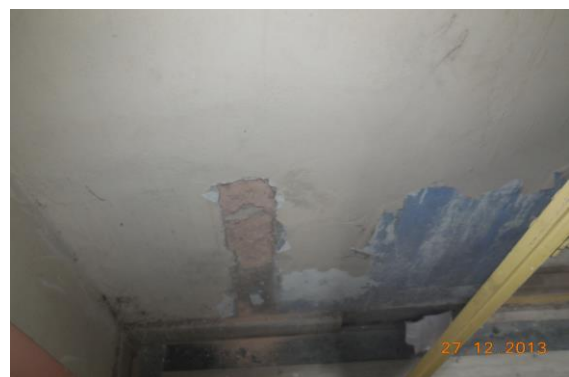
Photo 70
Damaged Portion on Wall No. 3 of Open To Sky of First Floor

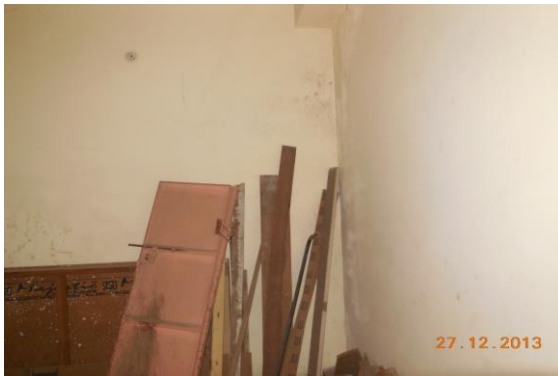
Photo 71
Dampness/Seepage on Wall No. 2 & 4 of Shop of First Floor

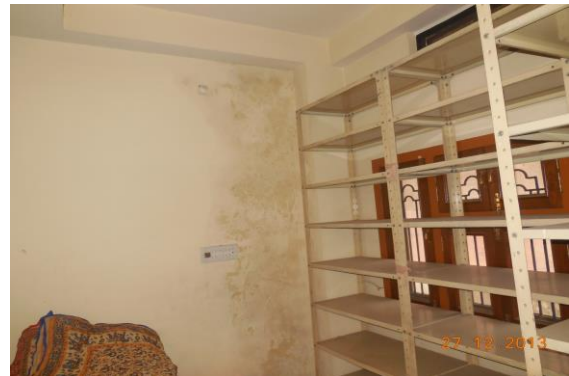
Photo 72
Dampness/Seepage on Wall No. 1 of Hall No. 1 of First Floor

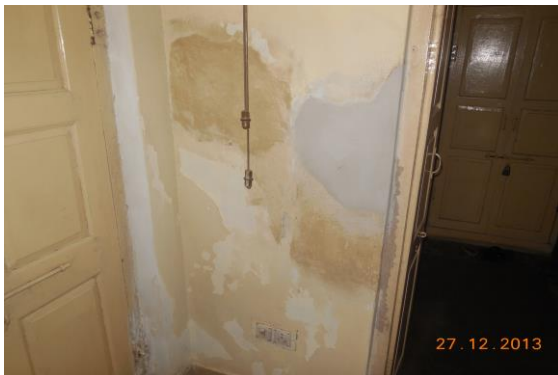
Photo 73
Dampness/Seepage on Wall No. 1 of Room No. 1 of Second Floor

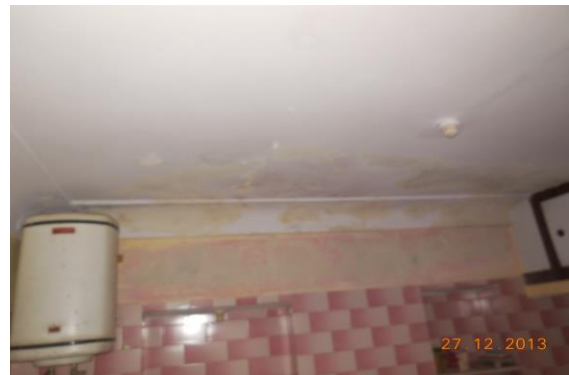
Photo 74
Dampness/Seepage on Wall No. 4 & Roof of Bathroom No. of Second Floor

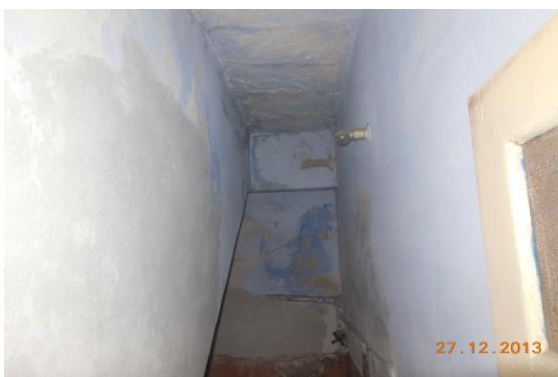
Photo 75
Dampness/Seepage on All walls of Toilet No. 2 of Second Floor

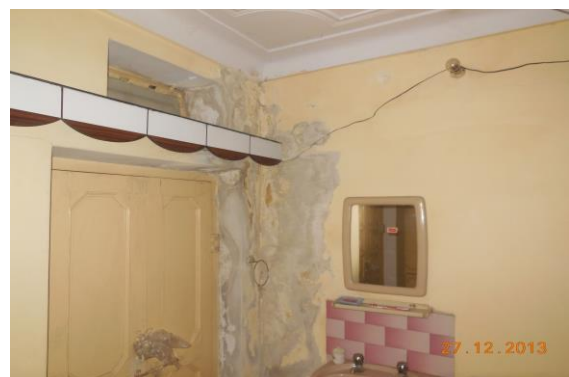
Photo 76
Dampness/Seepage on Wall No. 1 & 3 of Room No. 4 of Second Floor

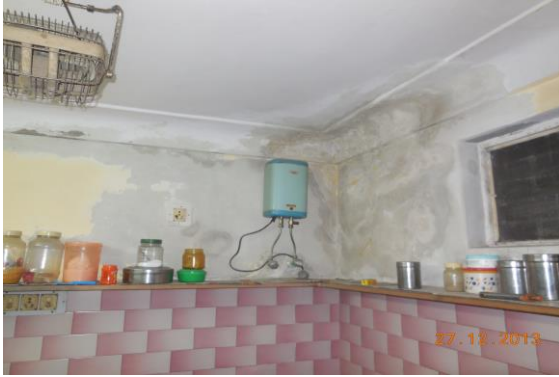
Photo 77

Dampness/Seepage on Wall No. 2 & 4 of Kitchen of Second Floor

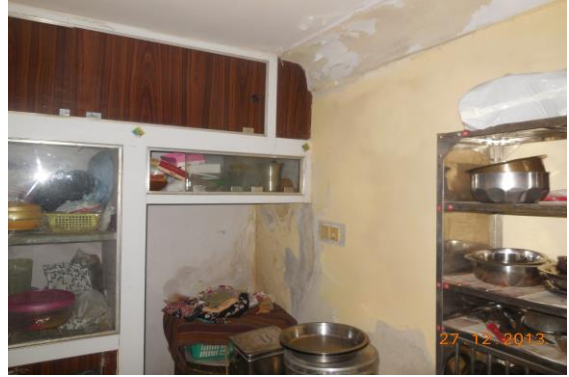
Photo 78

Dampness/Seepage on Wall No. 1, 4 & Roof of Kitchen of Second Floor

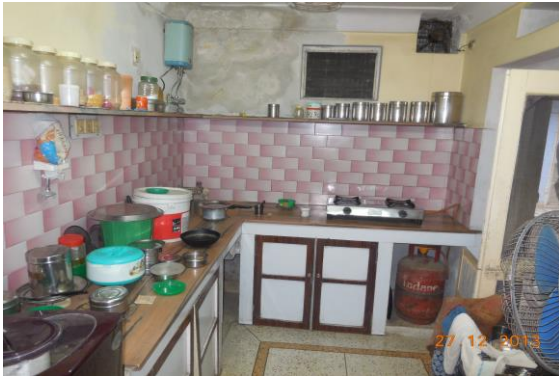
Photo 79

Dampness/Seepage on Wall No. 1 & 4 of Kitchen of Second Floor

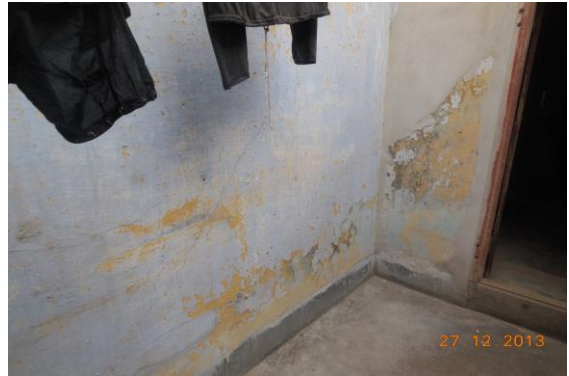
Photo 80

Peeling of Plaster on Wall No. 2 & 1 of Open Varanda of Second Floor

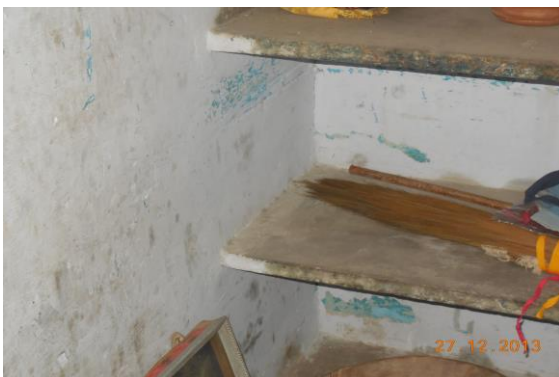
Photo 81

Dampness/Seepage on Wall No. 2 & 4 of Store of Second Floor

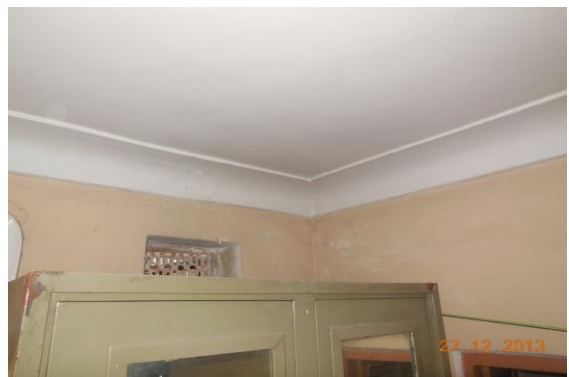
Photo 82

Dampness/Seepage on Wall No. 1 & 3 of Room No. 1 of Third Floor

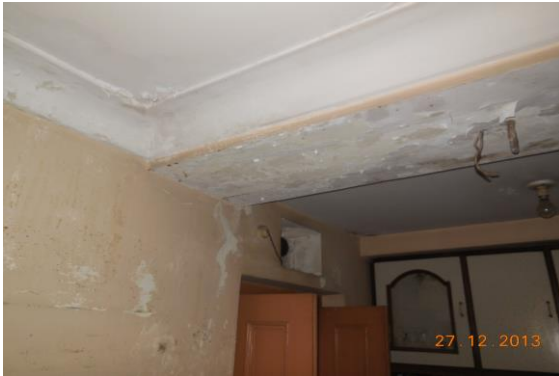
Photo 83

Dampness/Seepage on Wall No. 3 & Roof of Kitchen of Third Floor

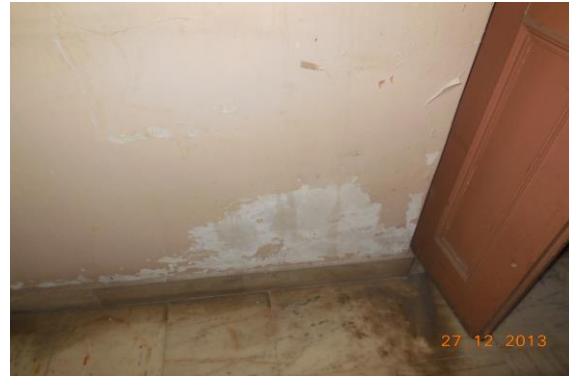
Photo 84

Dampness/Seepage on Wall No. 3 of Kitchen of Third Floor

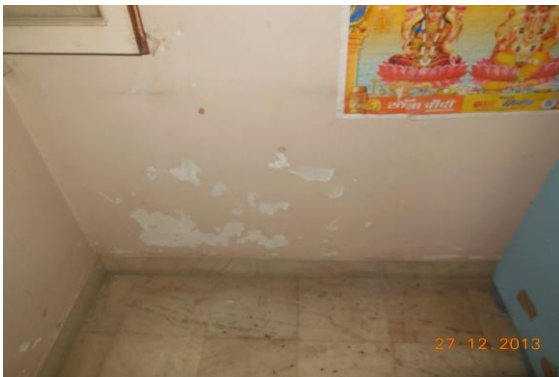
Photo 85

Dampness/Seepage on Wall No. 2 of Kitchen of Third Floor
