Pre Building Condition Survey Report

Name and Address of Structure :	Badi Chopar to Ramp Area (Down Line)
---------------------------------	--------------------------------------

Name of the Project	Contract JMRC-UG1B “Design and Construction of Tunnel between Chandpole and Badi Chouper and reverse line by Shield TBM, Underground Metro Stations at Choti Chouper and Badi Chouper by Cut and Cover Methods on East West Corridor of Jaipur Metro Rail Corporation Limited .”	
Owner :

Pre - Condition Building Survey for Construction of Underground Stations from Chandpole to Bari Chouper and reversal line

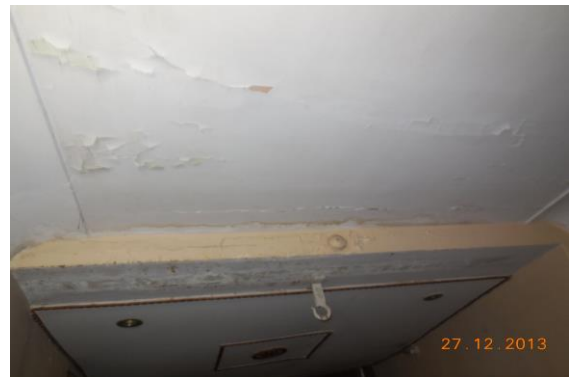
Photo 86

Peeling of Plaster on Roof of Room No. 2 of Third Floor

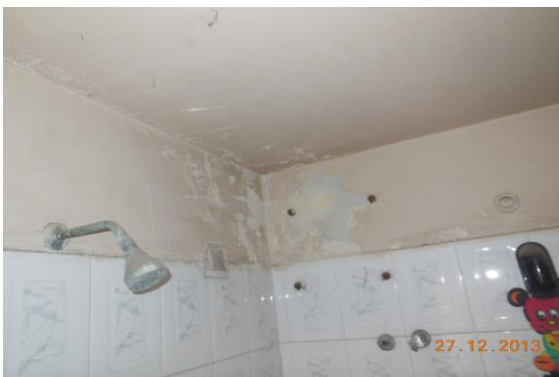
Photo 87

Dampness/Seepage on Wall No. 1, 4 & Roof of Toilet No. 1 of Third Floor

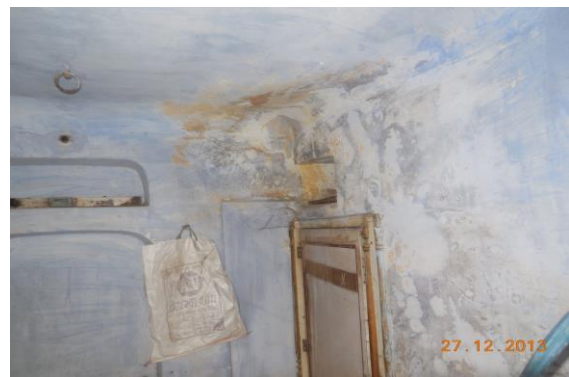
Photo 88

Dampness/Seepage on Wall No. 2, 4 & Roof of Lobby No.2 of Third Floor

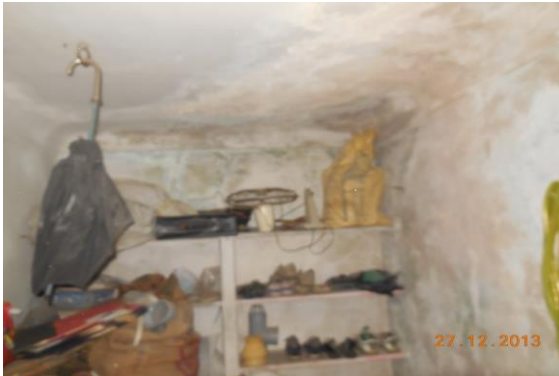
Photo 89

Dampness/Seepage on Wall No. 2, 4 & Roof of Lobby No.2 of Third Floor

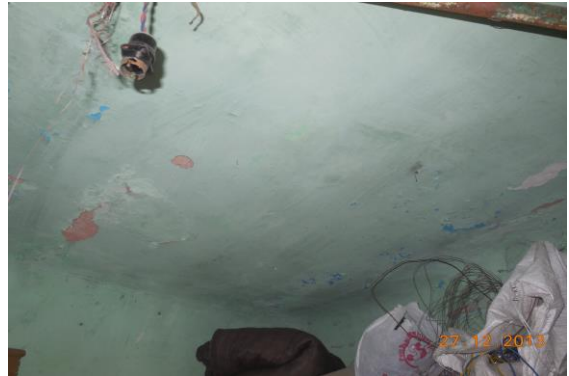
Photo 90

Peeling of Plaster on Roof of Store No.2 of Third Floor

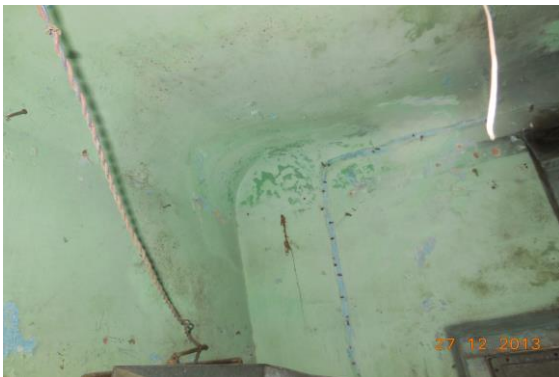
Photo 91

Dampness/Seepage on Wall No. 1, 3 & Roof of Store No.3 of Third Floor

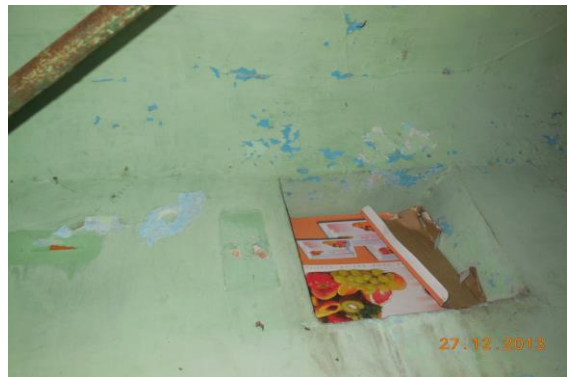
Photo 92

Peeling of Plaster on Wall No. 2 of Store No.3 of Third Floor

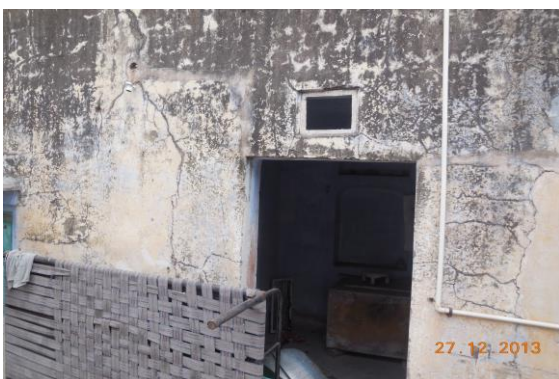
Photo 93

Peeling of Plaster on Wall No. 2 of Open Area of Third Floor

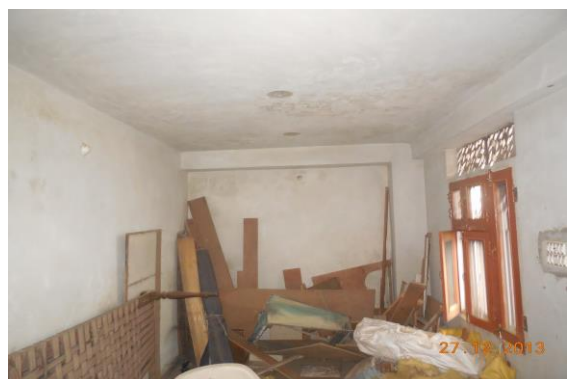
Photo 94

Dampness/Seepage on Roof of Store No.2 of Terrace

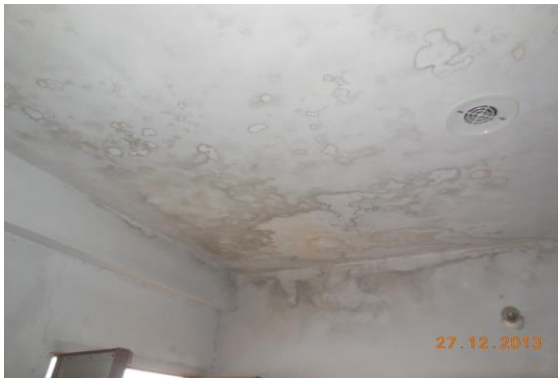
Photo 95
Dampness/Seepage on Wall No. 1 & Roof of Store No.2 of Terrace

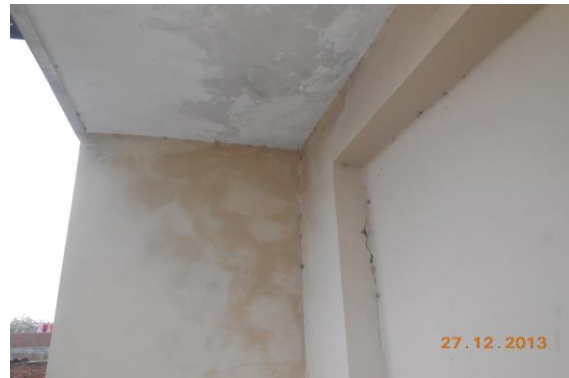
Photo 96
Dampness/Seepage on Wall No. RHS outer Wall of Open Area of Terrace

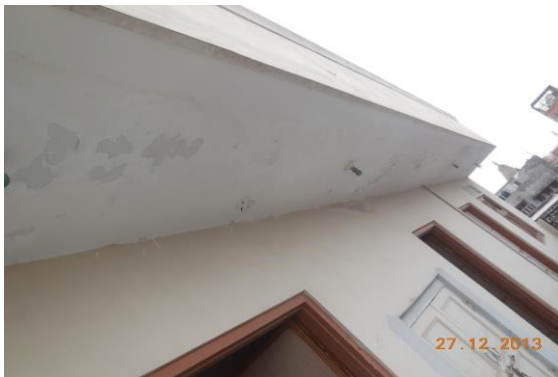
Photo 97
Dampness/Seepage on Wall No. Mumty Shade of Open Area of Terrace

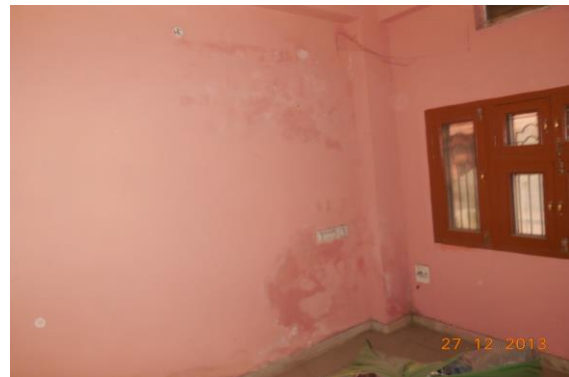
Photo 98
Dampness/Seepage on Wall No. 4 & 2 of Room No. 2 of Second Floor

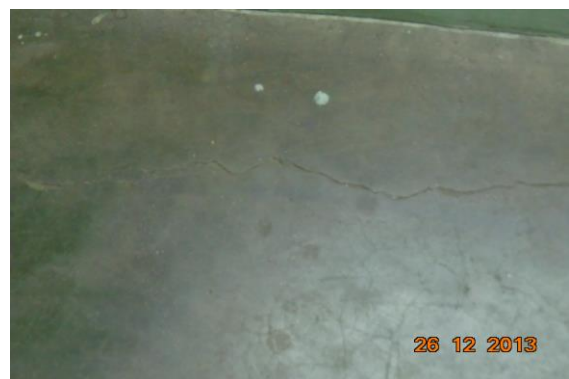
Photo 6
Inclined Crack on Floor of Room No. 2, First Floor, Approx. Width = 0.3mm, Approx. Length = 2m. , Height from Floor = m.

Summary of Cracks						
Defect ID	Location	Orientation	Appx. Width (mm)	Appx. Length (m)	Category	Photo No.
1	Floor Room No. 2 First Floor	Inclined	0.3	2	Very Slight	6
2	Roof Room No. 1 First Floor	Inclined	0.3	1	Very Slight	7
3	Roof Toilet No. 1 First Floor	Horizontal	1	1	Slight	8
4	Wall No. 3 Gallery First Floor	Inclined	2	1	Slight	9
5	Wall No. 1 & Roof Hall No. 1 Second Floor	Vertical	1.5	1.5	Slight	10, 10A
6	Wall No. 2 Passage Second Floor	Inclined	2.5	1	Slight	11, 11A
7	Wall No. 4 Hall No. 1 Third Floor	Inclined	2	2	Slight	12, 12A
8	Wall No. 4 Hall No. 1 Third Floor	Inclined	0.8	1	Very Slight	13, 13A
9	Wall No. 4 Hall No. 1 Third Floor	Inclined	1	2	Slight	14, 14A
10	Wall No. 2 Hall No. 1 Third Floor	Horizontal	0.8	0.3	Very Slight	15, 15A
11	Roof Varanda Shop No. 47, Ground Floor	Inclined	1	1	Slight	16

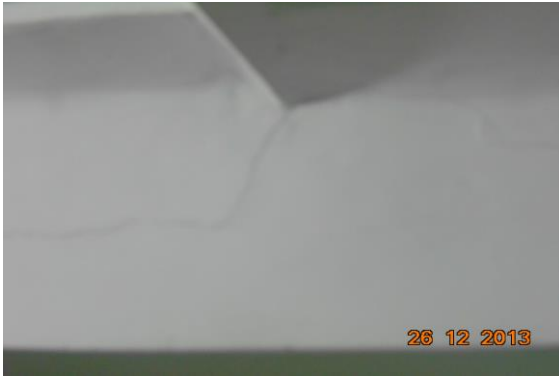
Photo 7

Inclined Crack on Roof of Room No. 1, First Floor, Approx. Width = 0.3mm, Approx. Length = 1m.
 , Height from Floor = m.

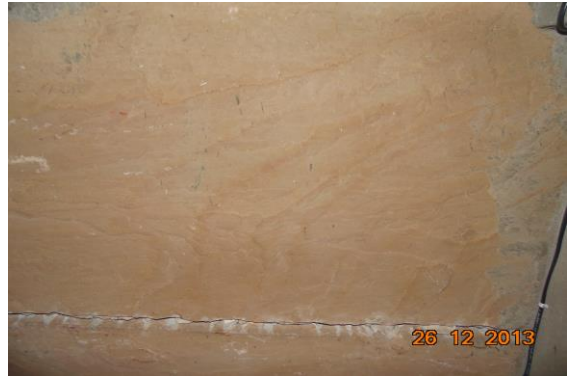
Photo 8

Horizontal Crack on Roof of Toilet No. 1, First Floor, Approx. Width = 1mm, Approx. Length = 1m.
 , Height from Floor = m.

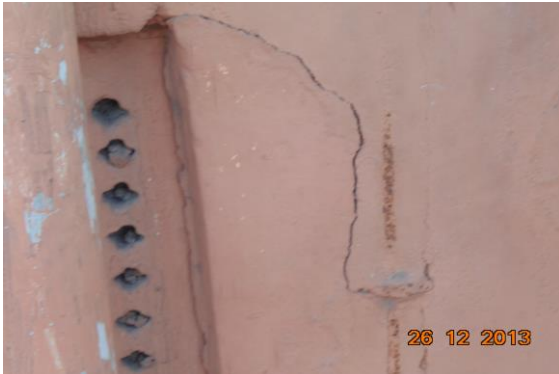
Photo 9

Inclined Crack on Wall No. 3 of Gallery, First Floor, Approx. Width = 2mm, Approx. Length = 1m.
 , Height from Floor = m.

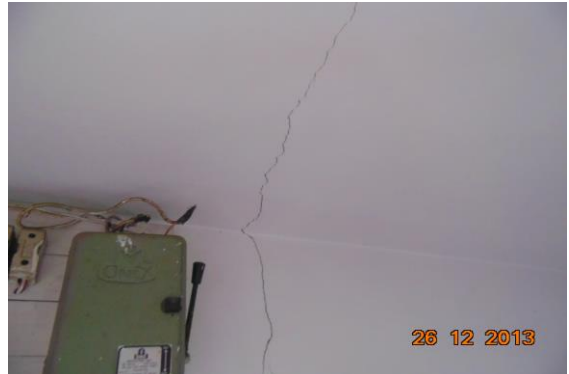
Photo 10

Vertical Crack on Wall No. 1 & Roof of Hall No. 1, Second Floor, Approx. Width = 1.5mm, Approx. Length = 1.5m.
 Distance from Wall No. 3 = 1m, Height from Floor = 1.7m.

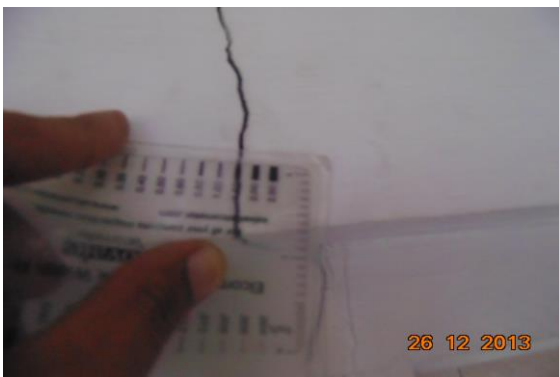
Photo 10A

Vertical Crack on Wall No. 1 & Roof of Hall No. 1, Second Floor, Approx. Width = 1.5mm, Approx. Length = 1.5m.
 Distance from Wall No. 3 = 1m, Height from Floor = 1.7m.

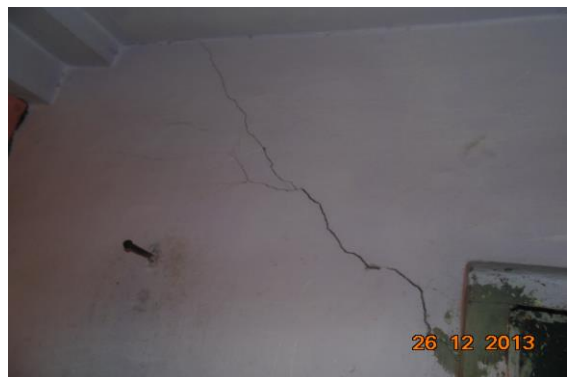
Photo 11

Inclined Crack on Wall No. 2 of Passage, Second Floor, Approx. Width = 2.5mm, Approx. Length = 1m.
 Distance from Wall No. 3 = 1.05m, Height from Floor = 1.7m.

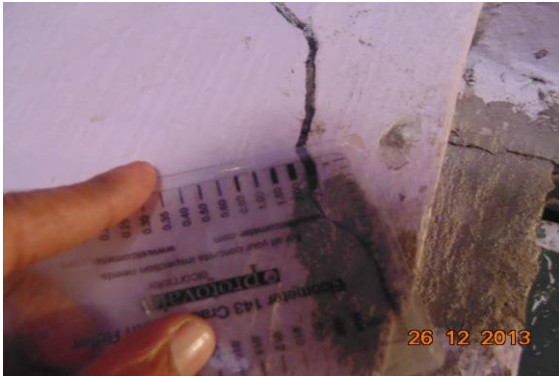
Photo 11A

Inclined Crack on Wall No. 2 of Passage, Second Floor, Approx. Width = 2.5mm, Approx. Length = 1m.
Distance from Wall No. 3 = 1.05m, Height from Floor = 1.7m.

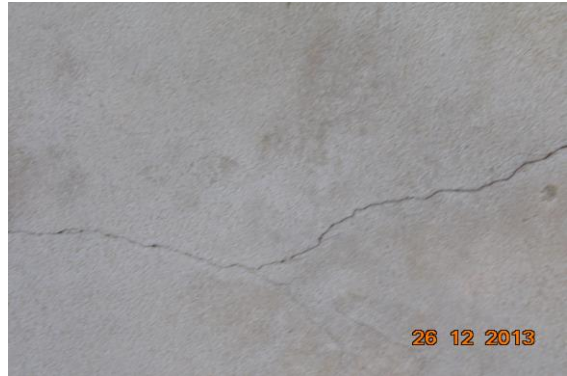
Photo 12

Inclined Crack on Wall No. 4 of Hall No. 1, Third Floor, Approx. Width = 2mm, Approx. Length = 2m.
, Height from Floor = m.

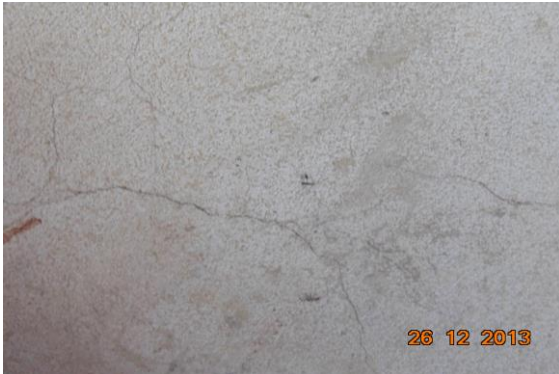
Photo 12A

Inclined Crack on Wall No. 4 of Hall No. 1, Third Floor, Approx. Width = 2mm, Approx. Length = 2m.
, Height from Floor = m.

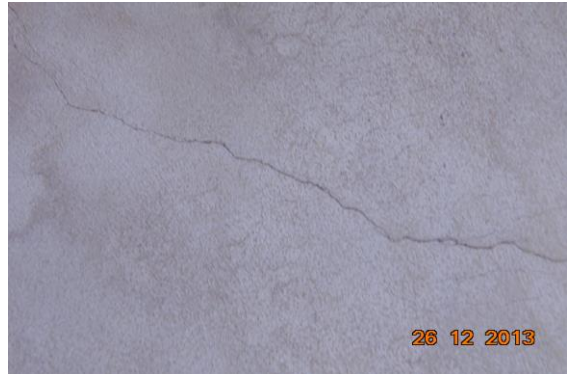
Photo 12A

Inclined Crack on Wall No. 4 of Hall No. 1, Third Floor, Approx. Width = 2mm, Approx. Length = 2m.
, Height from Floor = m.

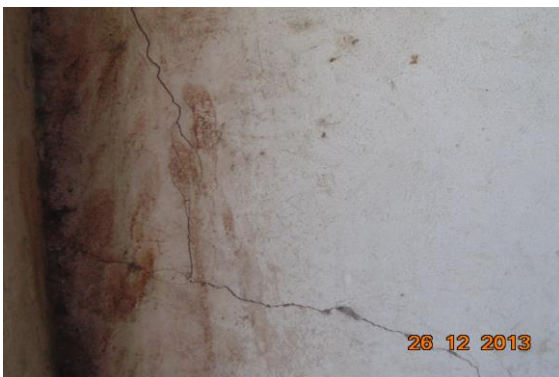
Photo 13

Inclined Crack on Wall No. 4 of Hall No. 1, Third Floor, Approx. Width = 0.8mm, Approx. Length = 1m.
Distance from Wall no. 1 = 1.1m, Height from Floor = 0.15m.

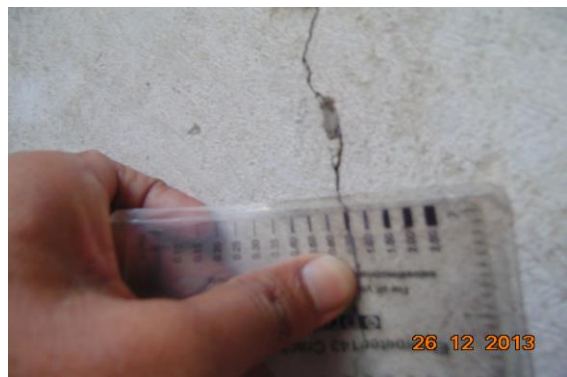
Photo 13A

Inclined Crack on Wall No. 4 of Hall No. 1, Third Floor, Approx. Width = 0.8mm, Approx. Length = 1m.
Distance from Wall no. 1 = 1.1m, Height from Floor = 0.15m.

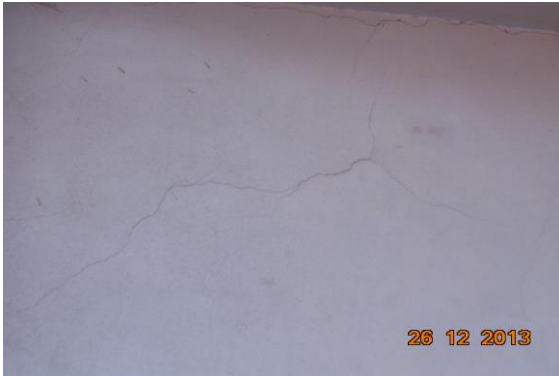
Photo 14

Inclined Crack on Wall No. 4 of Hall No. 1, Third Floor, Approx. Width = 1mm, Approx. Length = 2m.
Height from Floor = m.

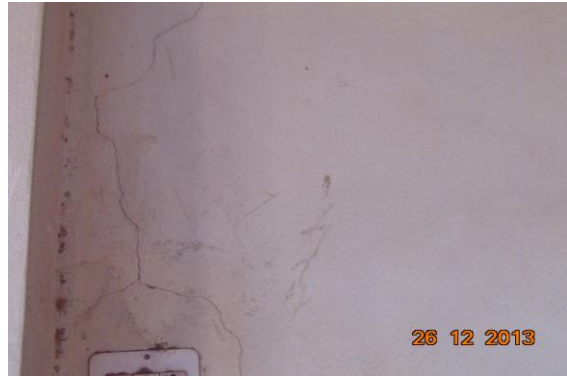
Photo 14A

Inclined Crack on Wall No. 4 of Hall No. 1, Third Floor, Approx. Width = 1mm, Approx. Length = 2m.
Height from Floor = m.

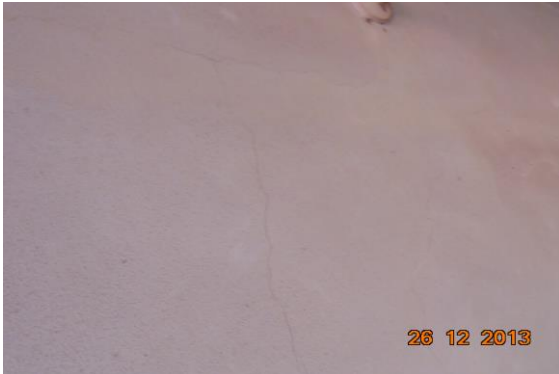
Photo 14A

Inclined Crack on Wall No. 4 of Hall No. 1, Third Floor, Approx. Width = 1mm, Approx. Length = 2m.
Height from Floor = m.

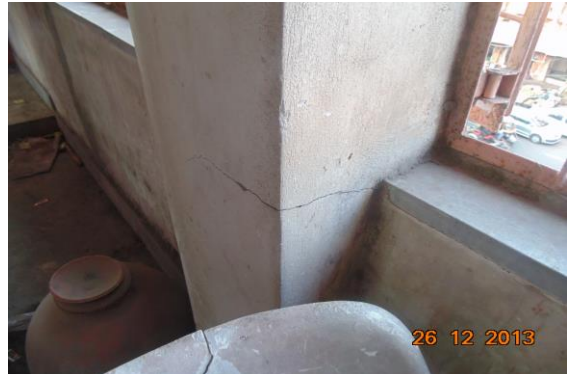
Photo 15

Horizontal Crack on Wall No. 2 of Hall No. 1, Third Floor, Approx. Width = 0.8mm, Approx. Length = 0.3m.
Distance from Wall no.3 = 2m, Height from Floor = 0.8m.

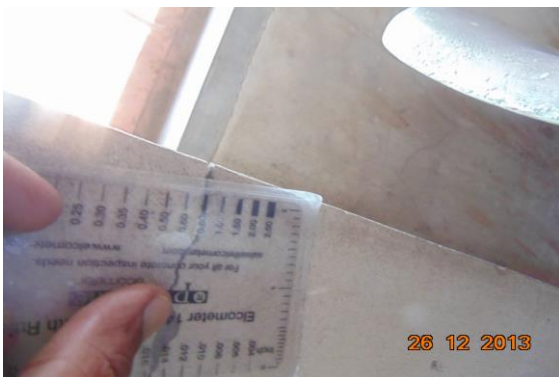
Photo 15A

Horizontal Crack on Wall No. 2 of Hall No. 1, Third Floor, Approx. Width = 0.8mm, Approx. Length = 0.3m.
Distance from Wall no.3 = 2m, Height from Floor = 0.8m.

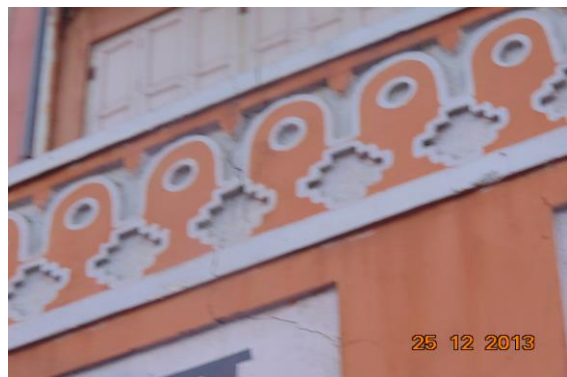
Photo 16

Inclined Crack on Roof of Veranda, Shop No. 47, Ground Floor, Approx. Width = 1mm, Approx. Length = 1m.
Distance from Left Internal Column = 1.2m, Height from Floor = 3m.

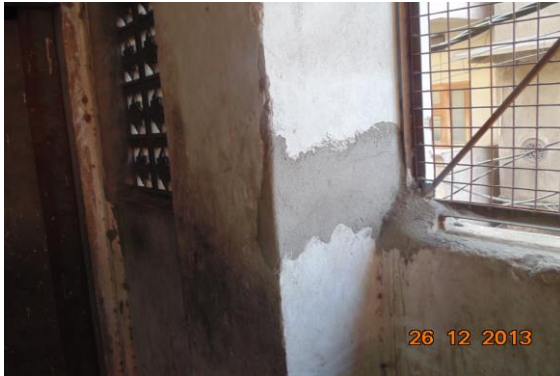
Photo 17
Damaged Portion on Wall No. 4 of Passage of First Floor

Summary of Defects Other Than Crack			
Defect ID	Location	Description	Photo No.
12	Wall No. 4 Passage First Floor	Damaged Portion	17
13	Wall No. 3 Gallery First Floor	Damaged Portion	18
14	Wall No. 3 Gallery First Floor	Damaged Portion	19
15	Shade Gallery First Floor	Peeling of Plaster	20
16	Roof Passage Second Floor	Dampness/Seepage	21
17	Wall No. 1 Passage Second Floor	Dampness/Seepage	22
18	Outer wall No.3 Store Second Floor	Damaged Portion	23
19	Wall No. 2 Hall No. 1 Third Floor	Dampness/Seepage	24
20	Wall No. 1 Lobby Second Floor	Peeling of Plaster	25
21	Steps Staircase Area Second Floor	Damaged Portion	26
22	Wall No. 4 Staircase Area First Floor	Peeling of Plaster	27
23	Roof Varanda Shop No. 46,Ground Floor	Peeling of Plaster	28
24	Roof Varanda Shop No. 47,Ground Floor	Peeling of Plaster	29
25	Beam Varanda Shop No. 47,Ground Floor	Peeling of Plaster	30
26	Roof Shop No. 47 Upper Ground Floor	Peeling of Plaster	31

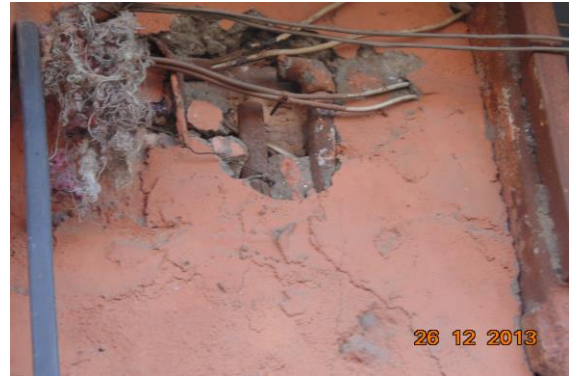
Photo 18
Damaged Portion on Wall No. 3 of Gallery of First Floor

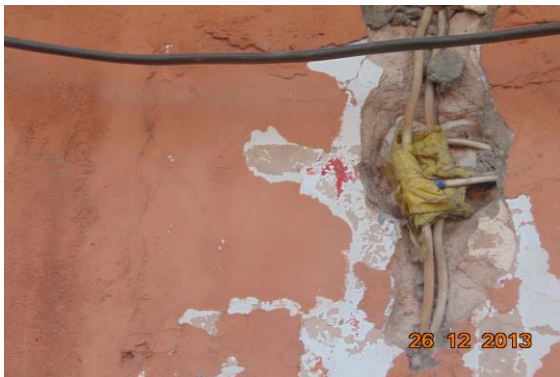
Photo 19
Damaged Portion on Wall No. 3 of Gallery of First Floor

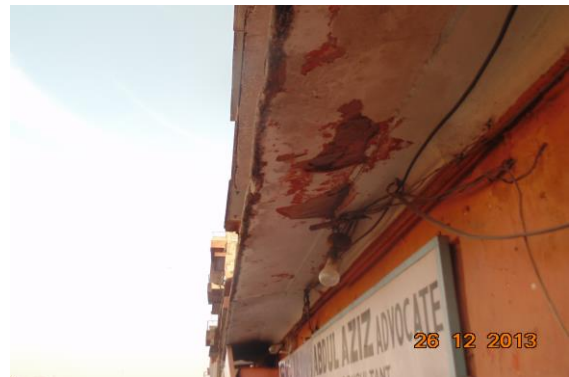
Photo 20
Peeling of Plaster on Shade of Gallery of First Floor

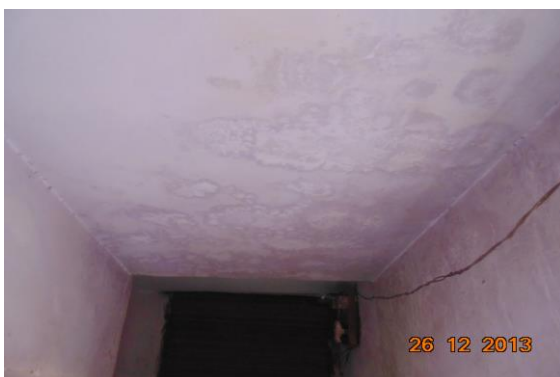
Photo 21
Dampness/Seepage on Roof of Passage of Second Floor

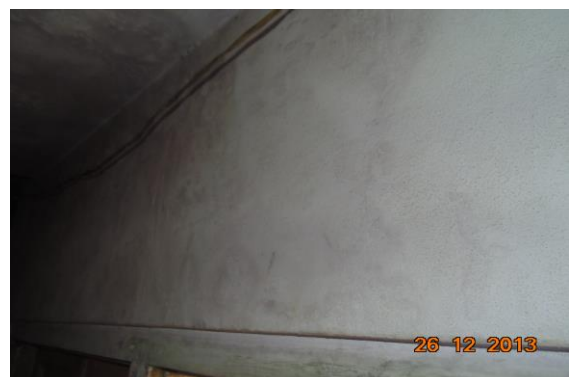
Photo 22
Dampness/Seepage on Wall No. 1 of Passage of Second Floor

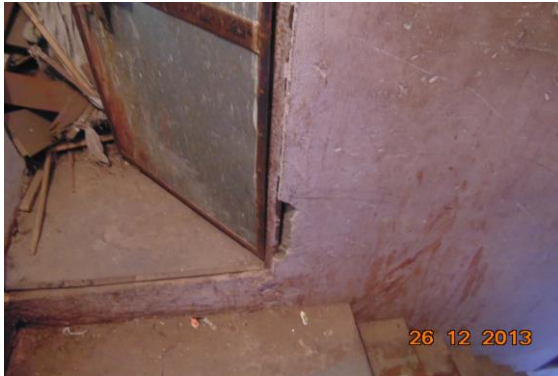
Photo 23
Damaged Portion on Outer wall No.3 of Store of Second Floor

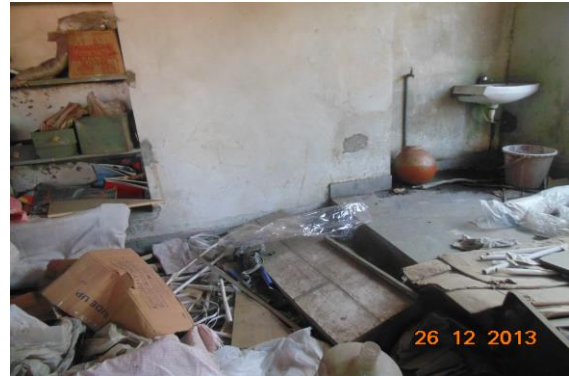
Photo 24
Dampness/Seepage on Wall No. 2 of Hall No. 1 of Third Floor

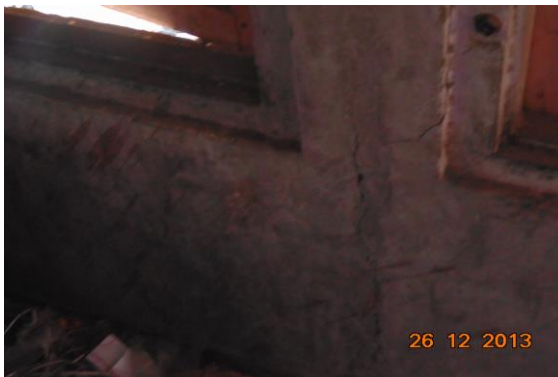
Photo 25
Peeling of Plaster on Wall No. 1 of Lobby of Second Floor

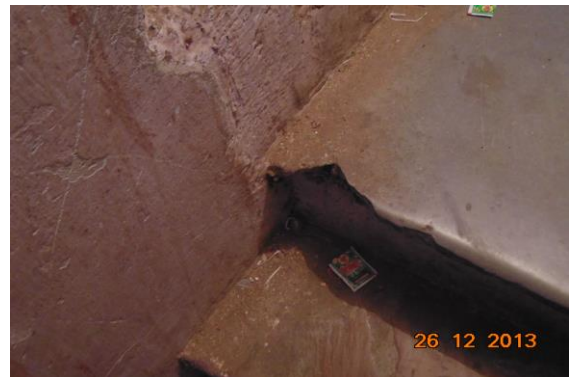
Photo 26
Damaged Portion on Steps of Staircase Area of Second Floor

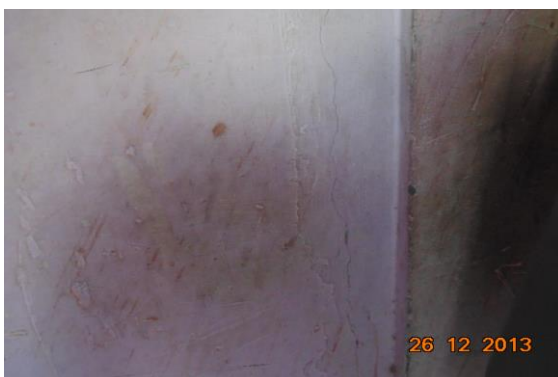
Photo 27
Peeling of Plaster on Wall No. 4 of Staircase Area of First Floor

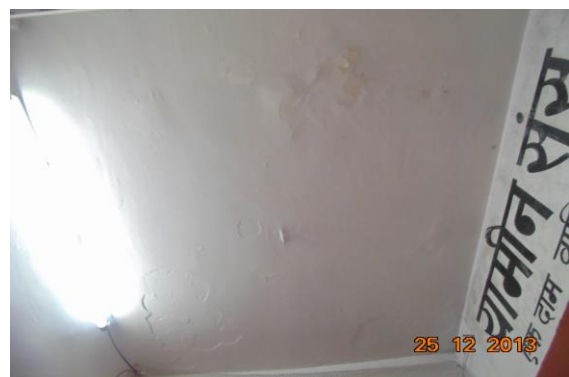
Photo 28
Peeling of Plaster on Roof of Varanda of Shop No. 46, Ground Floor

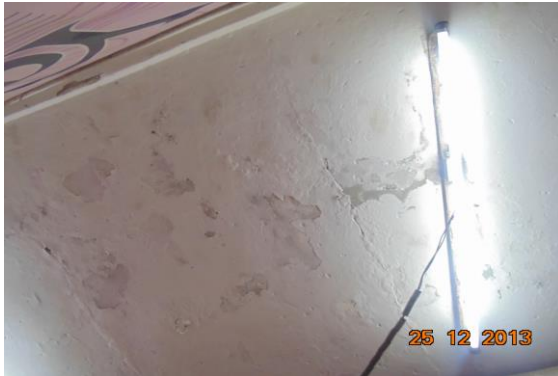
Photo 29

Peeling of Plaster on Roof of Varanda of Shop No. 47, Ground Floor

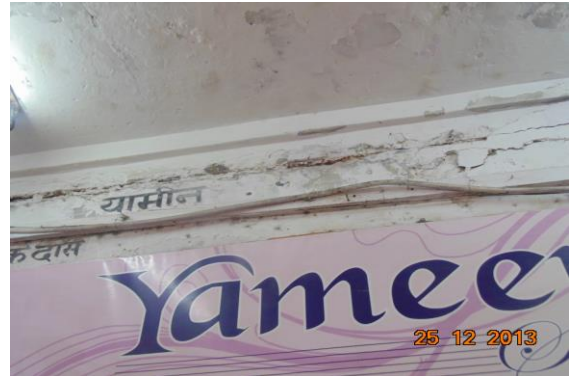
Photo 30

Peeling of Plaster on Beam of Varanda of Shop No. 47, Ground Floor

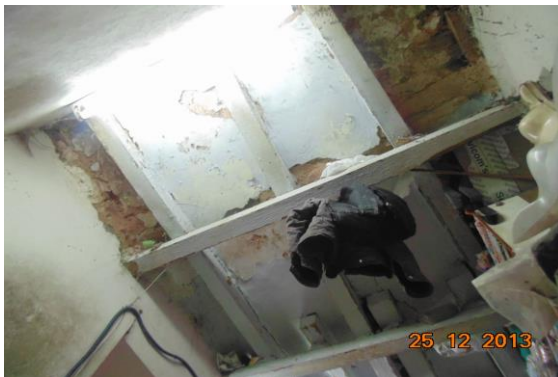
Photo 31

Peeling of Plaster on Roof of Shop No. 47 of Upper Ground Floor

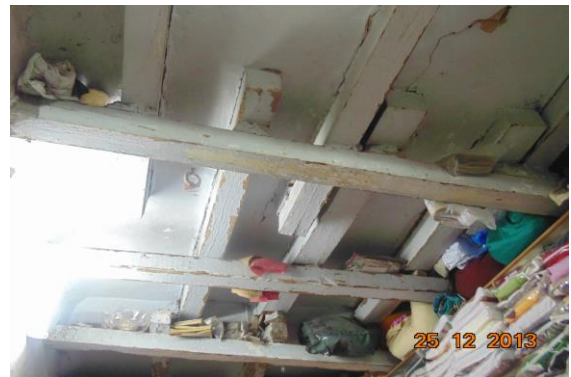
Photo 32

Peeling of Plaster on Roof of Shop No. 47 of Upper Ground Floor

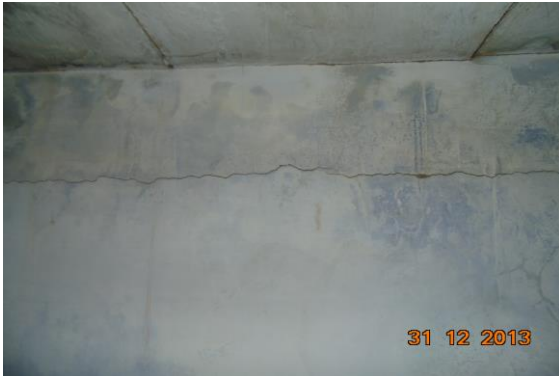
Photo 7

Horizontal Crack on Wall No. 2 of , Fifth Floor, Approx. Width = 1.5mm,
Approx. Length = 2.5m.
Distance from Wall No. 3 = 1m, Height from Floor = 1.5m.

Summary of Cracks						
Defect ID	Location	Orientation	Appx. Width (mm)	Appx. Length (m)	Category	Photo No.
1	Wall No. 2 Fifth Floor	Horizontal	1.5	2.5	Slight	7, 7A
2	Outer Wall No. 3 Room No. 1 Terrace	Horizontal	0.5	2.5	Very Slight	8
3	Roof Varanda Shop No. 49, Ground Floor	Horizontal	10	2.5	Moderate	9

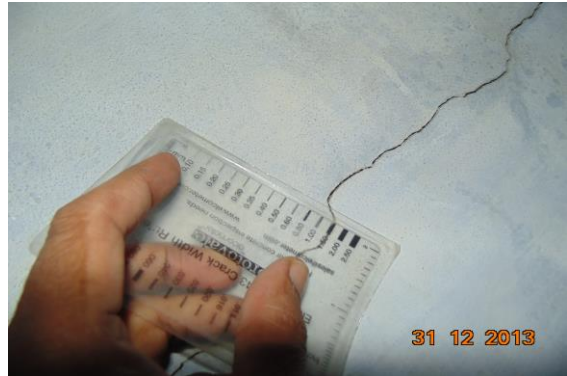
Photo 7A

Horizontal Crack on Wall No. 2 of , Fifth Floor, Approx. Width = 1.5mm,
Approx. Length = 2.5m.
Distance from Wall No. 3 = 1m, Height from Floor = 1.5m.

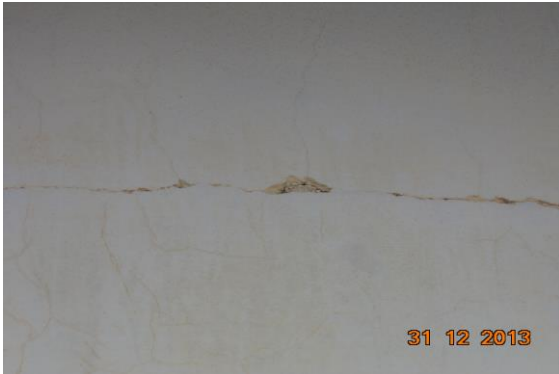
Photo 8

Horizontal Crack on Outer Wall No. 3 of Room No. 1, Terrace, Approx.
Width = 0.5mm, Approx. Length = 2.5m.
Distance from Wall No. 1 = 0m, Height from Floor = 2.5m.

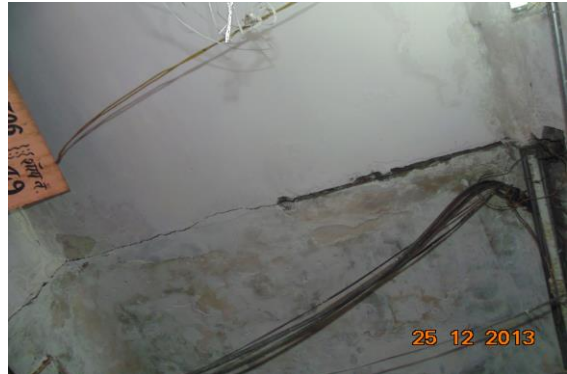
Photo 9

Horizontal Crack on Roof of Varanda, Shop No. 49, Ground
Floor, Approx. Width = 10mm, Approx. Length = 2.5m.
Distance from Right External Column = 0m, Height from Floor = 3m.

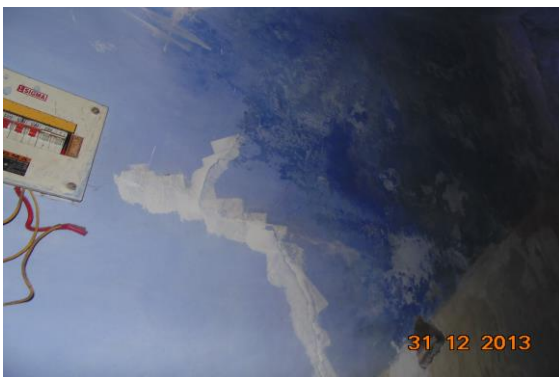
Photo 10

Dampness/Seepage on Wall No. 1 of Stair SF to TF

Summary of Defects Other Than Crack			
Defect ID	Location	Description	Photo No.
4	Wall No. 1 Stair SF to TF	Dampness/Seepage	10
5	Wall No. 1 Stair SF to TF	Dampness/Seepage	11
6	Wall No. 4 Stair SF to TF	Dampness/Seepage	12
7	Wall No. 4 Stair SF to TF	Dampness/Seepage	13
8	Roof Stair TF to 4Th Floor	Dampness/Seepage	14
9	Wall No. 4 & 1 Stair TF to 4Th Floor	Dampness/Seepage	15
10	Wall No. 4 Room No. 1 Fourth Floor	Peeling of Plaster	16
11	Wall No. 4 Room No. 1 Fourth Floor	Peeling of Plaster	17
12	Wall No. 1 Room No. 1 Fourth Floor	Dampness/Seepage	18
13	Wall No. 4 Room No. 1 Fourth Floor	Peeling of Plaster	19
14	Wall No. 1 & 4 Room No. 2 Fourth Floor	Dampness/Seepage	20
15	Roof Toilet No. 1 Fourth Floor	Dampness/Seepage	21
16	Wall No. 4 Fourth Floor	Dampness/Seepage	22
17	Wall No. 2 Fourth Floor	Dampness/Seepage	23
18	Wall No. 1 Fourth Floor	Dampness/Seepage	24
19	Wall No. 1, 4 & 2 Room No. 2 Third Floor	Dampness/Seepage	25

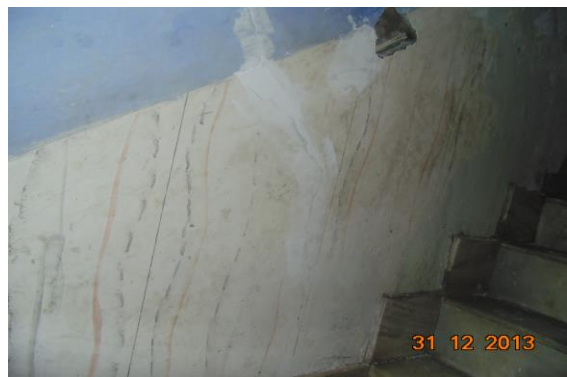
Photo 11

Dampness/Seepage on Wall No. 1 of Stair SF to TF

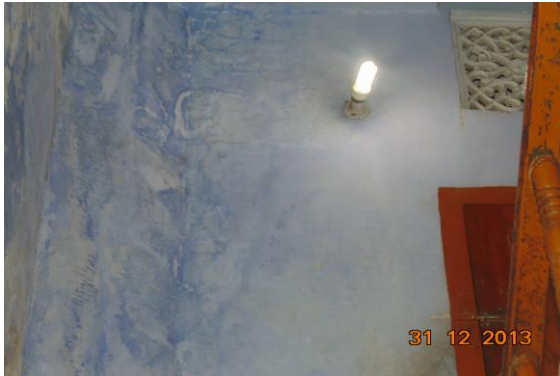
Photo 12
Dampness/Seepage on Wall No. 4 of Stair SF to TF

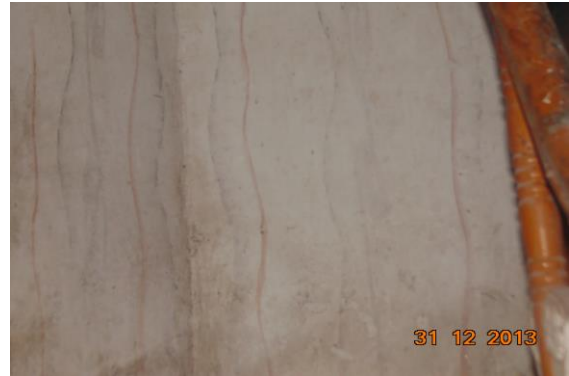
Photo 13
Dampness/Seepage on Wall No. 4 of Stair SF to TF

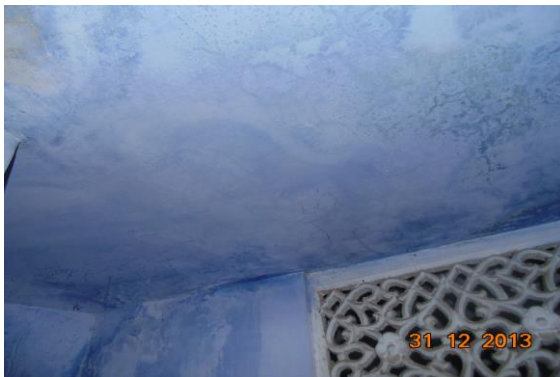
Photo 14
Dampness/Seepage on Roof of Stair TF to 4Th Floor

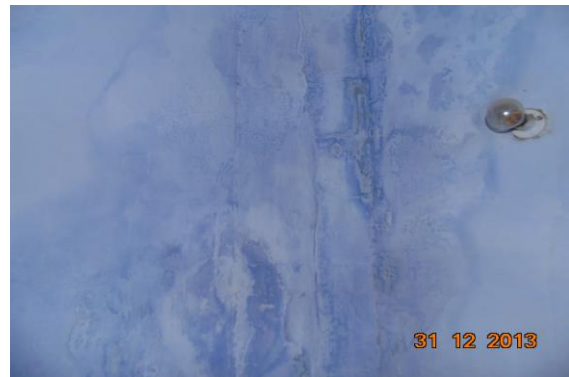
Photo 15
Dampness/Seepage on Wall No. 4 & 1 of Stair TF to 4Th Floor

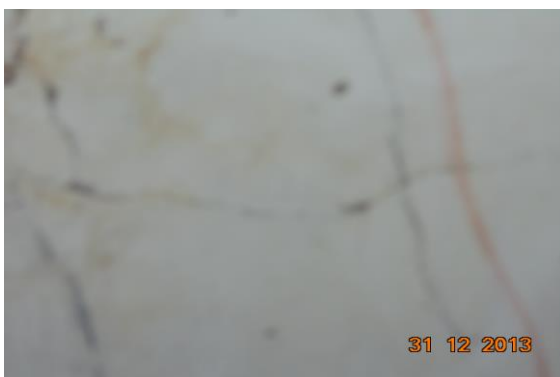
Photo 16
Peeling of Plaster on Wall No. 4 of Room No. 1 of Fourth Floor

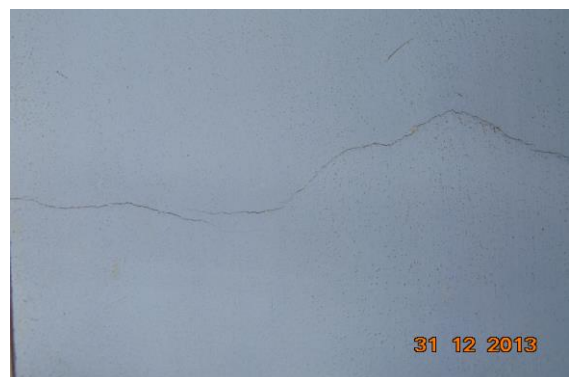
Photo 17
Peeling of Plaster on Wall No. 4 of Room No. 1 of Fourth Floor

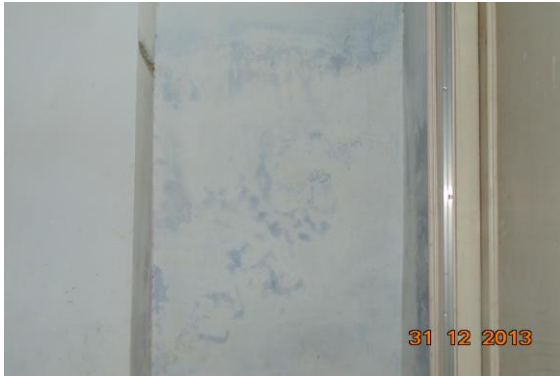
Photo 18

Dampness/Seepage on Wall No. 1 of Room No. 1 of Fourth Floor

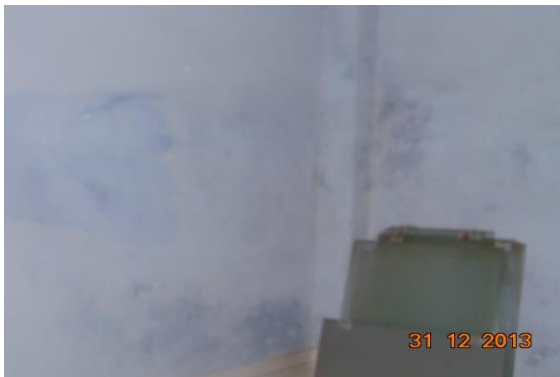
Photo 19

Peeling of Plaster on Wall No. 4 of Room No. 1 of Fourth Floor

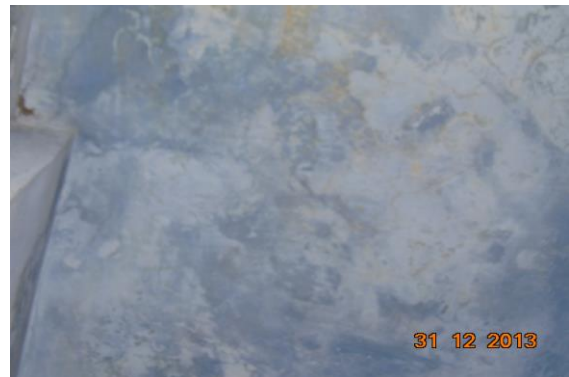
Photo 20

Dampness/Seepage on Wall No. 1 & 4 of Room No. 2 of Fourth Floor

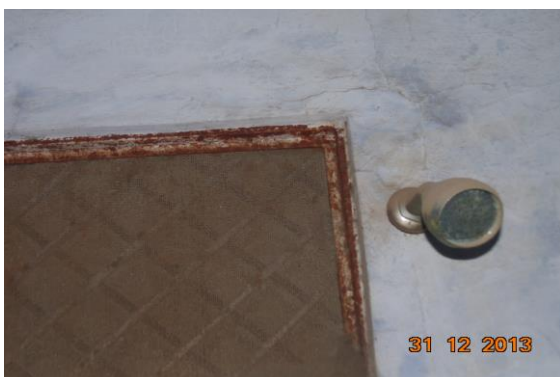
Photo 21

Dampness/Seepage on Roof of Toilet No. 1 of Fourth Floor

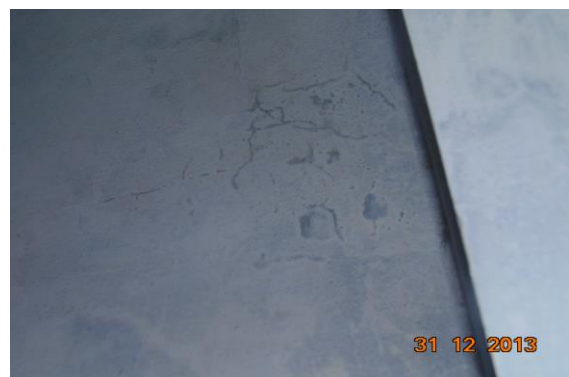
Photo 22

Dampness/Seepage on Wall No. 4 of Fourth Floor

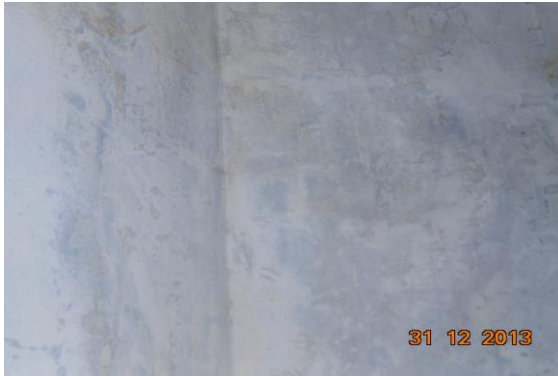
Photo 24
Dampness/Seepage on Wall No. 1 of Fourth Floor

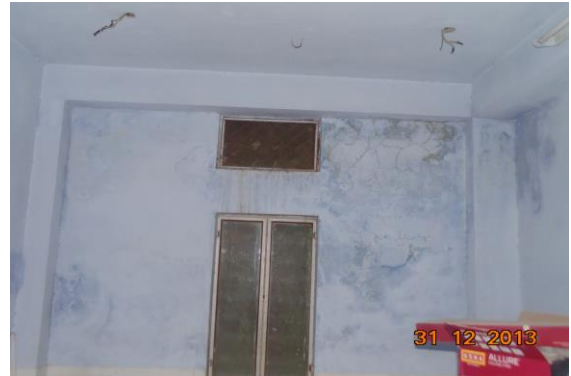
Photo 25
Dampness/Seepage on Wall No. 1, 4 & 2 of Room No. 2 of Third Floor

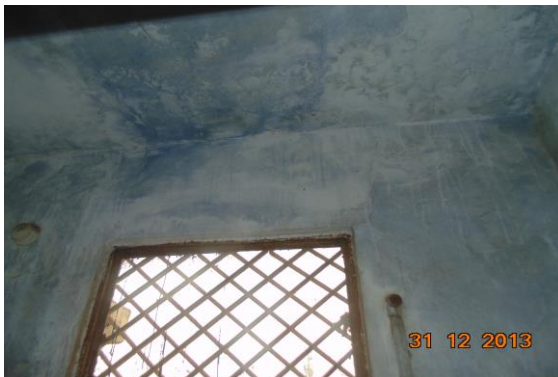
Photo 26
Dampness/Seepage on Wall No. 4 & Roof of Toilet No. 1 of Fifth Floor

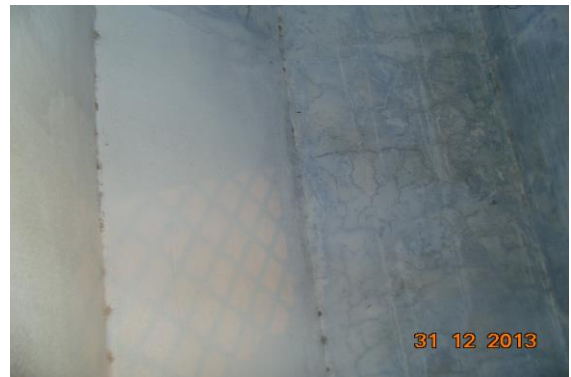
Photo 27
Dampness/Seepage on Wall No. 1 of Fifth Floor

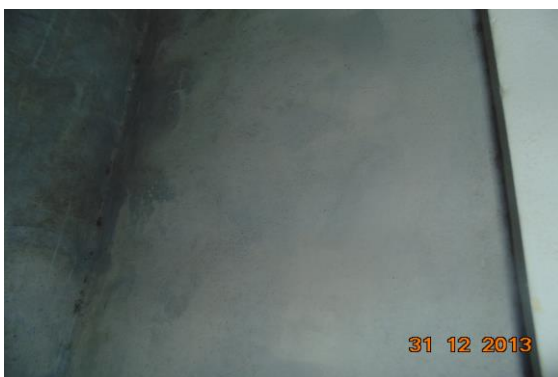
Photo 28
Dampness/Seepage on Wall No. 2 of Fifth Floor

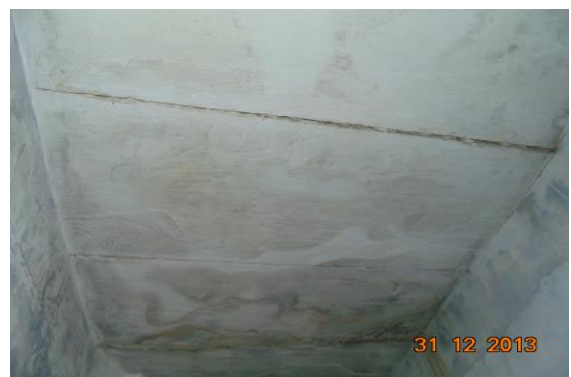
Photo 29
Dampness/Seepage on Roof of Stair 5Th Floor To Terrace

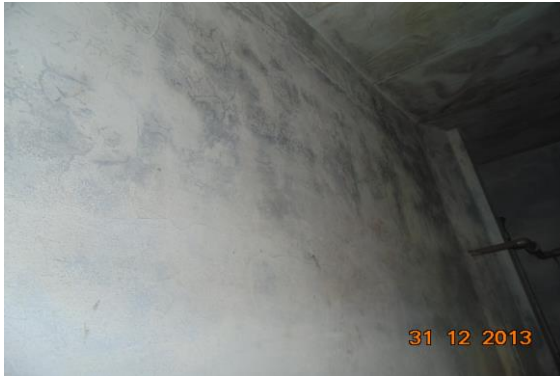
Photo 30
Dampness/Seepage on Wall No. 1 of Fifth Floor

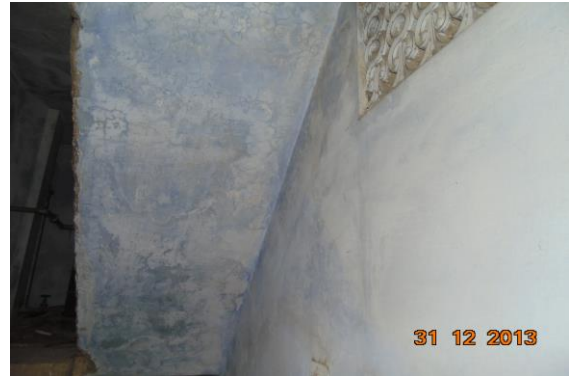
Photo 31
Dampness/Seepage on Wall No. 2 & Roof of Fifth Floor

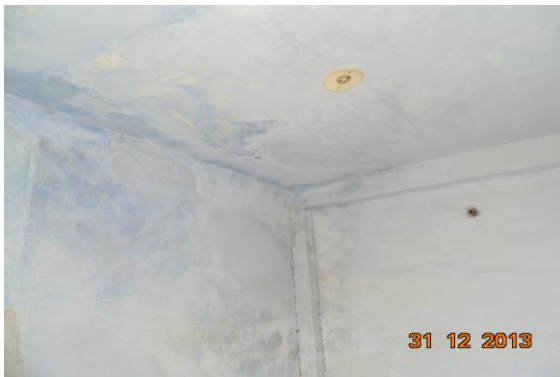
Photo 32
Dampness/Seepage on Wall No. 1, 4 & Roof of Room No. 1 of Terrace

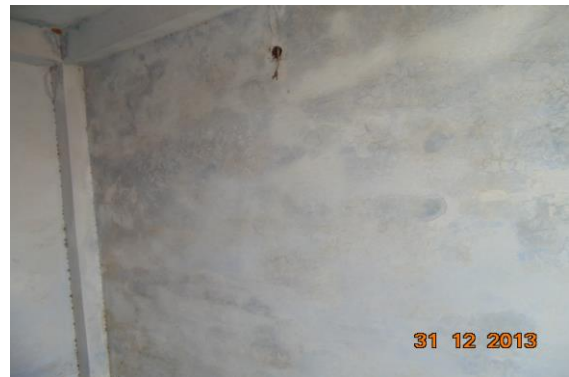
Photo 33
Dampness/Seepage on Wall No. 2 of Room No. 1 of Terrace

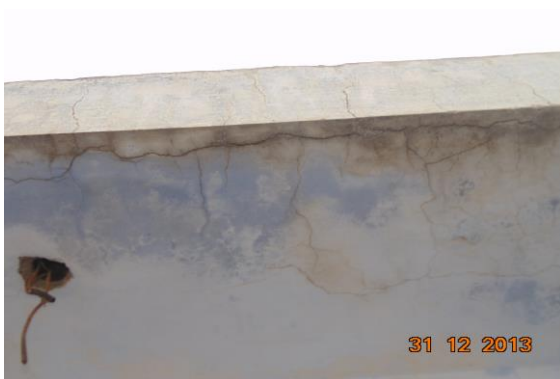
Photo 34
Dampness/Seepage on Wall No. 3 of Room No. 1 of Terrace

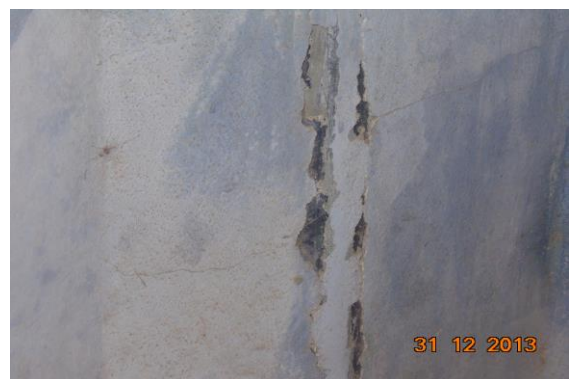
Photo 35
Peeling of Plaster on Wall No. 1 of Stair 5Th Floor To Terrace of Terrace

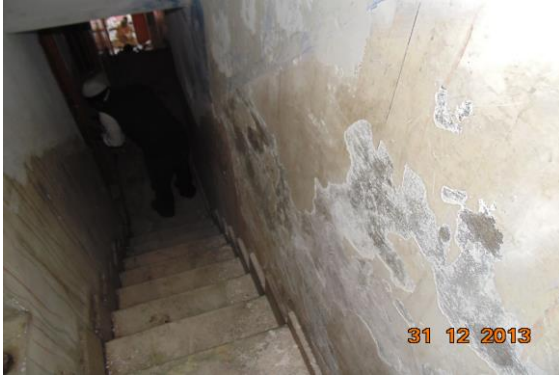
Photo 36
Dampness/Seepage on Wall No. 1 of Stair FF to SF

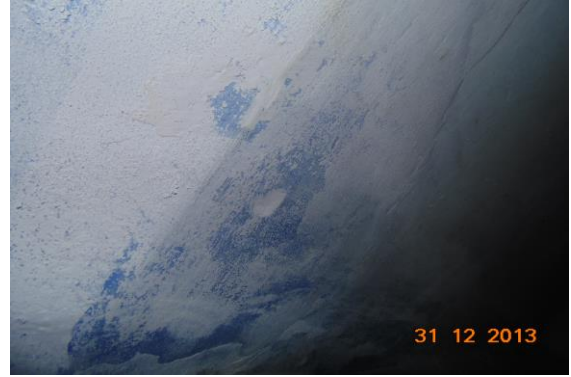
Photo 37
Dampness/Seepage on Roof of Terrace

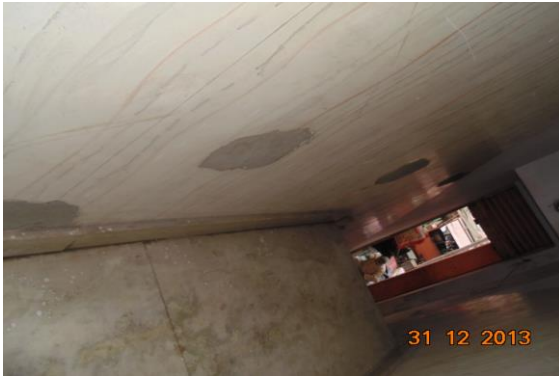
Photo 38
Peeling of Plaster on Wall No. 2 of Stair GF to FF

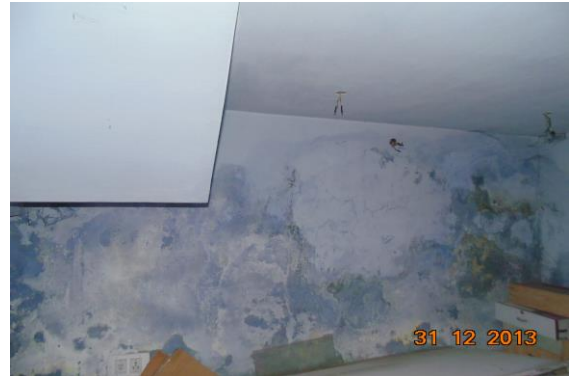
Photo 39
Dampness/Seepage on Wall No. 1 of Hall No. 1 of First Floor

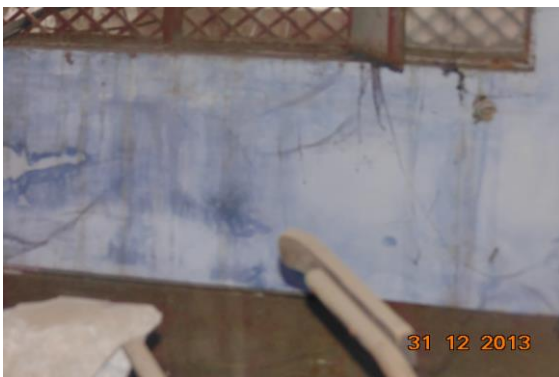
Photo 40
Dampness/Seepage on Wall No. 2 of First Floor

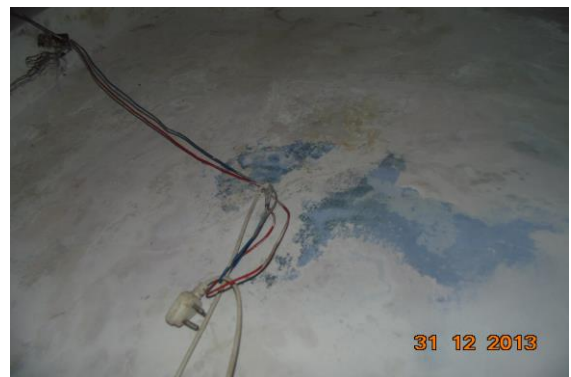
Photo 41
Dampness/Seepage on Wall No. 1 of Stair GF to FF

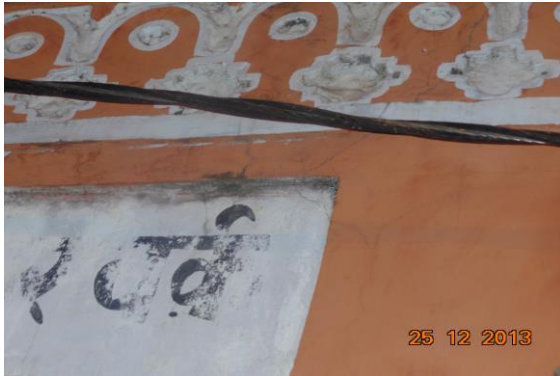
Photo 42
Peeling of Plaster on Beam of Varanda of Shop No. 49, Ground Floor

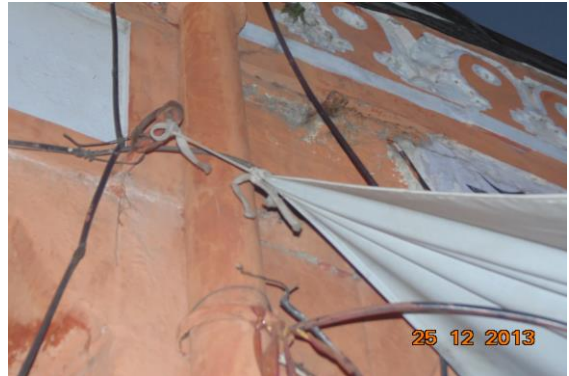
Photo 43
Damaged Portion on Right external Column of Varanda of Shop No. 49, Ground Floor

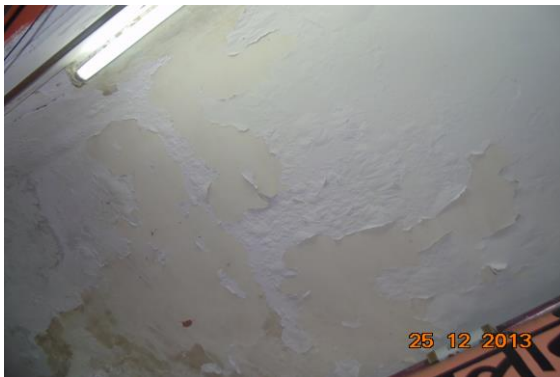
Photo 44
Dampness/Seepage on Roof of Varanda of Shop No. 49, Ground Floor

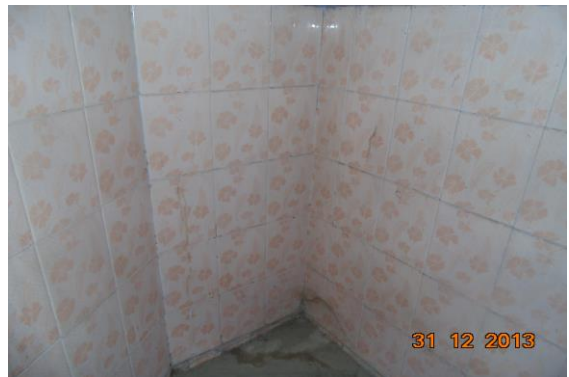
Photo 45
Wall No. 1, 3 & 4 of Fifth Floor Covered with Tiles

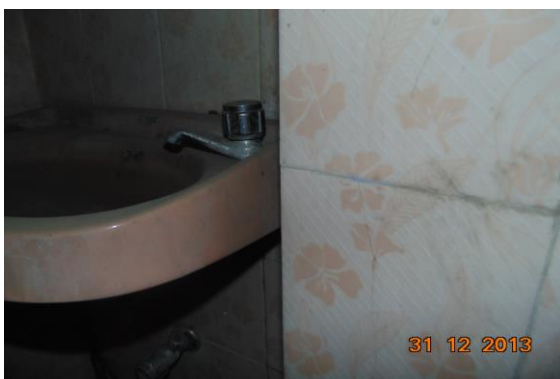
Photo 46
Wall No. 2 of Fifth Floor Covered with Tiles

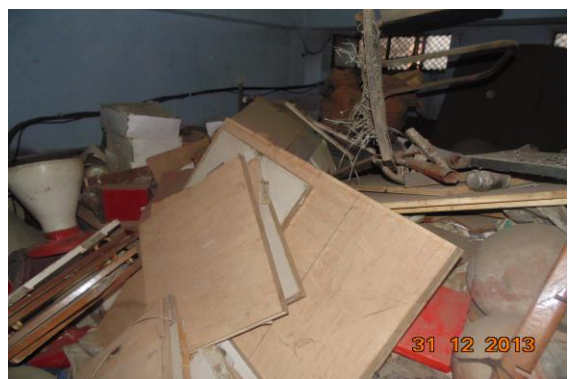
Photo 47
All Walls of First Floor Covered with Material

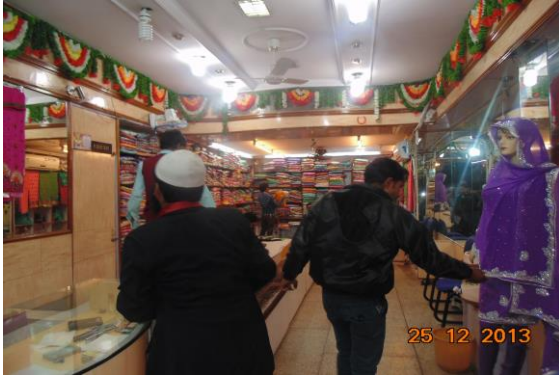
Photo 48

All Walls of Shop No. 49 of Ground Floor Covered with Materials.

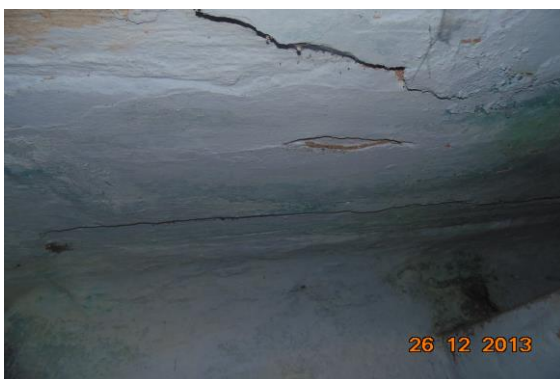
Photo 5
Inclined Crack on Roof of Toilet No. 1, First Floor, Approx. Width = 3mm, Approx. Length = 1m, Height from Floor = m.

Summary of Cracks						
Defect ID	Location	Orientation	Appx. Width (mm)	Appx. Length (m)	Category	Photo No.
1	Roof Toilet No. 1 First Floor	Inclined	3	1	Slight	5
2	Wall No. 1 Lobby Second Floor	Inclined	0.6	0.8	Very Slight	6, 6A
3	Wall No. 1 Lobby Second Floor	Inclined	1.5	0.4	Slight	7, 7A
4	Wall No. 4 Lobby Open Sky Fourth Floor	Inclined	2	1	Slight	8
5	Wall No. 1 Lobby Open Sky Fourth Floor	Inclined	2	2	Slight	9, 9A
6	front side Staircase GF to FF Ground Floor	Inclined	2	1	Slight	10
7	Roof Varanda Shop No. 50, Ground Floor	Horizontal	0.6	2.5	Very Slight	11
