Pre Building Condition Survey Report

Name and Address of Structure :	Badi Chopar to Ramp Area (Down Line)
---------------------------------	--------------------------------------

Name of the Project	Contract JMRC-UG1B “Design and Construction of Tunnel between Chandpole and Badi Chouper and reverse line by Shield TBM, Underground Metro Stations at Choti Chouper and Badi Chouper by Cut and Cover Methods on East West Corridor of Jaipur Metro Rail Corporation Limited .”	
Owner :

Pre - Condition Building Survey for Construction of Underground Stations from Chandpole to Bari Chouper and reversal line

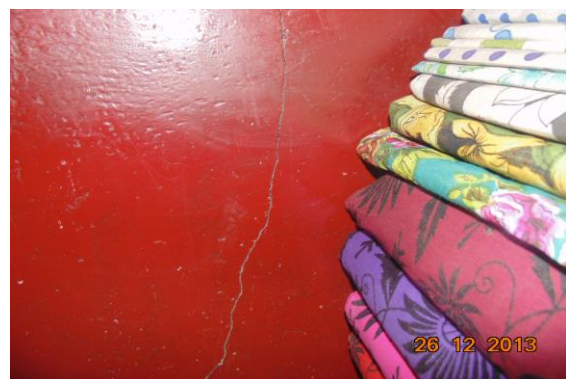
Photo 6
Inclined Crack on Wall No. 1 of Lobby, Second Floor, Approx. Width = 0.6mm, Approx. Length = 0.8m, Distance from Wall No. 3 = 1.1m, Height from Floor = 0m.

Summary of Cracks						
Defect ID	Location	Orientation	Appx. Width (mm)	Appx. Length (m)	Category	Photo No.
1	Roof Toilet No. 1 First Floor	Inclined	3	1	Slight	5
2	Wall No. 1 Lobby Second Floor	Inclined	0.6	0.8	Very Slight	6, 6A
3	Wall No. 1 Lobby Second Floor	Inclined	1.5	0.4	Slight	7, 7A
4	Wall No. 4 Lobby Open Sky Fourth Floor	Inclined	2	1	Slight	8
5	Wall No. 1 Lobby Open Sky Fourth Floor	Inclined	2	2	Slight	9, 9A
6	front side Staircase GF to FF Ground Floor	Inclined	2	1	Slight	10
7	Roof Varanda Shop No. 50, Ground Floor	Horizontal	0.6	2.5	Very Slight	11

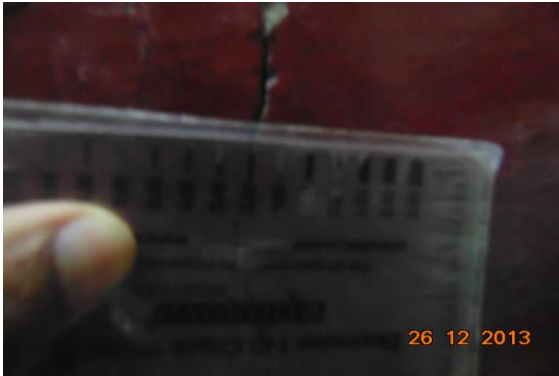
Photo 6A

Inclined Crack on Wall No. 1 of Lobby, Second Floor, Approx. Width = 0.6mm, Approx. Length = 0.8m.
Distance from Wall No. 3 = 1.1m, Height from Floor = 0m.

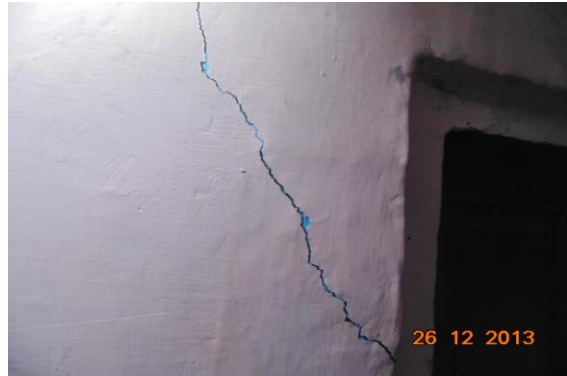
Photo 7

Inclined Crack on Wall No. 1 of Lobby, Second Floor, Approx. Width = 1.5mm, Approx. Length = 0.4m.
Distance from Wall No. 3 = 2m, Height from Floor = 1.5m.

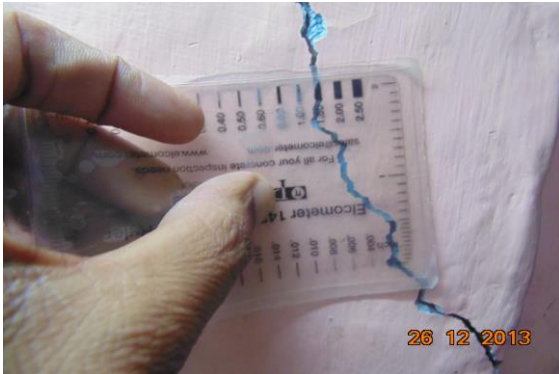
Photo 7A

Inclined Crack on Wall No. 1 of Lobby, Second Floor, Approx. Width = 1.5mm, Approx. Length = 0.4m.
Distance from Wall No. 3 = 2m, Height from Floor = 1.5m.

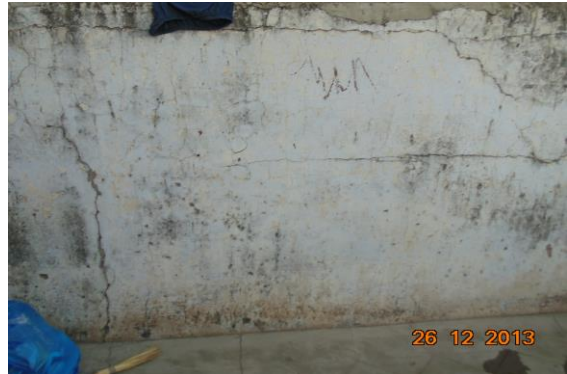
Photo 8

Inclined Crack on Wall No. 4 of Lobby Open Sky, Fourth Floor, Approx. Width = 2mm, Approx. Length = 1m.
, Height from Floor = m.

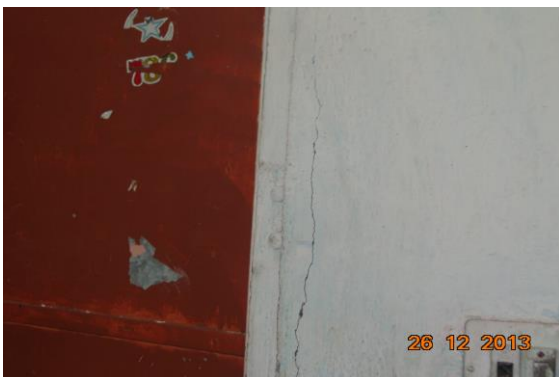
Photo 9

Inclined Crack on Wall No. 1 of Lobby Open Sky, Fourth Floor, Approx. Width = 2mm, Approx. Length = 2m.
, Height from Floor = m.

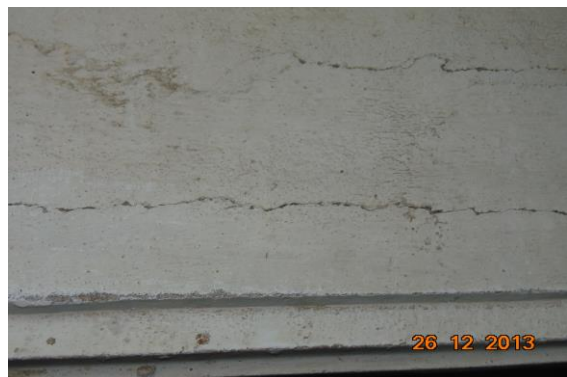
Photo 9A

Inclined Crack on Wall No. 1 of Lobby Open Sky, Fourth Floor, Approx. Width = 2mm, Approx. Length = 2m.
, Height from Floor = m.

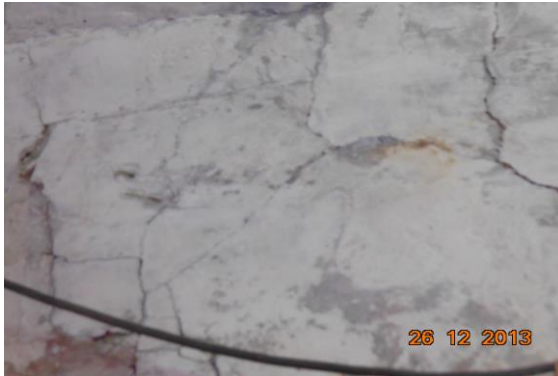
Photo 10
Inclined Crack on front side of Staircase GF to FF, Ground Floor, Approx. Width = 2mm, Approx. Length = 1m.
, Height from Floor = m.

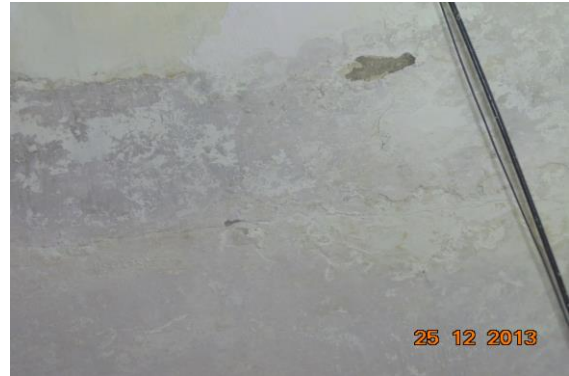
Photo 11
Horizontal Crack on Roof of Varanda, Shop No. 50, Ground Floor, Approx. Width = 0.6mm, Approx. Length = 2.5m.
Distance from Right External Column = 0m, Height from Floor = 3m.

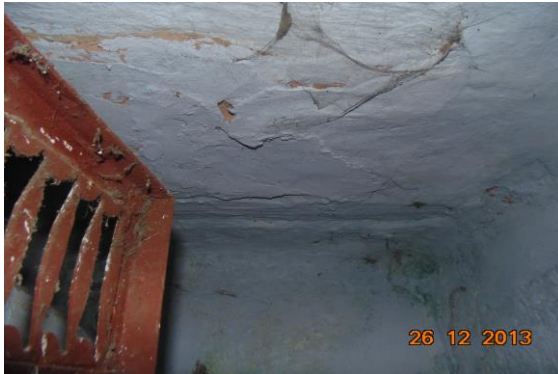
Photo 12
Damaged Portion on Roof of Toilet No. 2 of First Floor

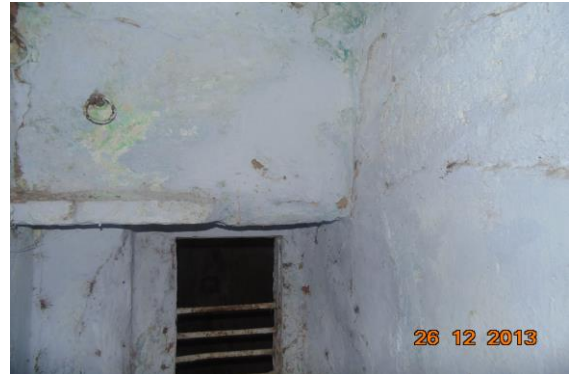
Photo 13
Dampness/Seepage on Wall No. 2 & 4 of Toilet No. 2 of First Floor

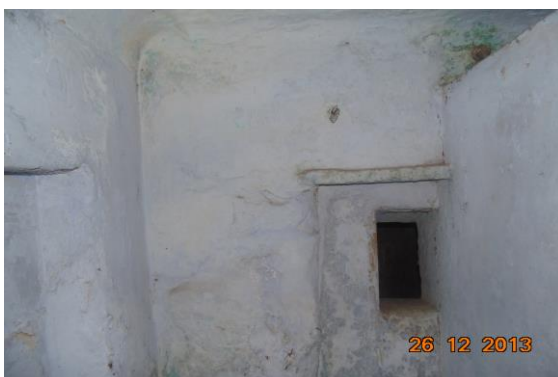
Photo 14
Dampness/Seepage on Wall No. 1, 2 & 4 of Toilet No. 1 of First Floor

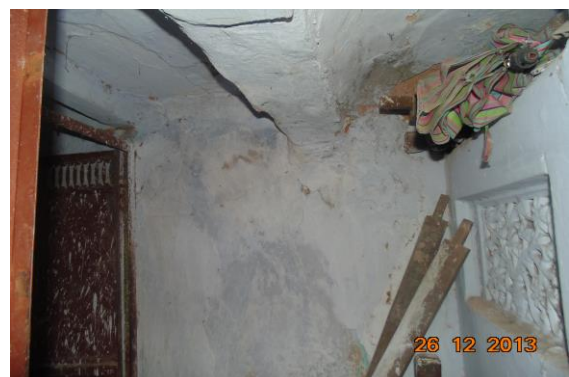
Photo 15
Dampness/Seepage on Wall No. 2 & Roof of Passage of First Floor

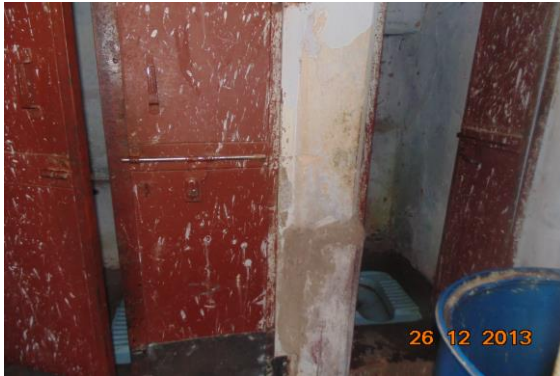
Photo 16

Damaged Portion on Outer Wall of Toilet No. 2 & 3 of First Floor

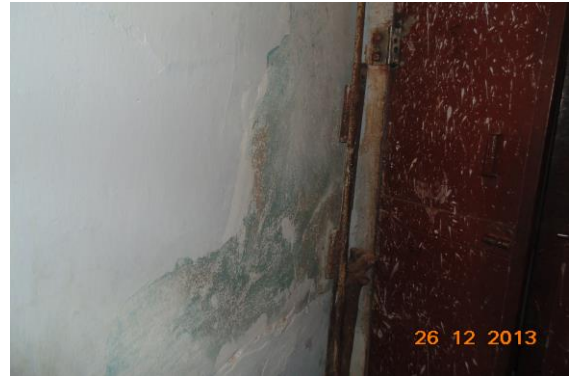
Photo 17

Dampness/Seepage on Wall No. 2 of Passage of First Floor

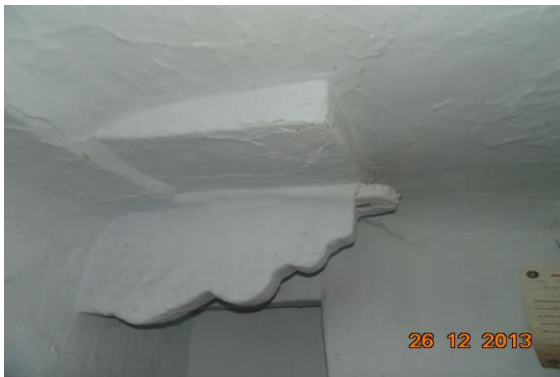
Photo 18

Peeling of Plaster on Roof of Lobby of First Floor

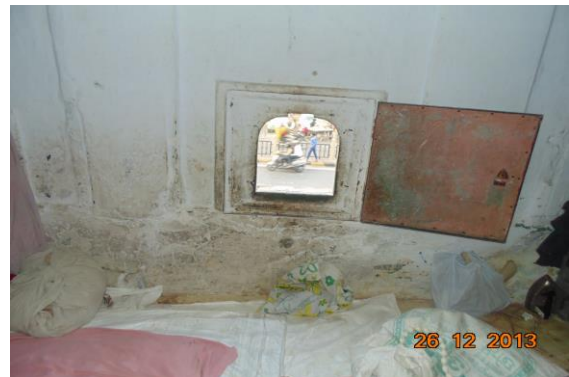
Photo 19

Dampness/Seepage on Wall No. 4 of Varanda of First Floor

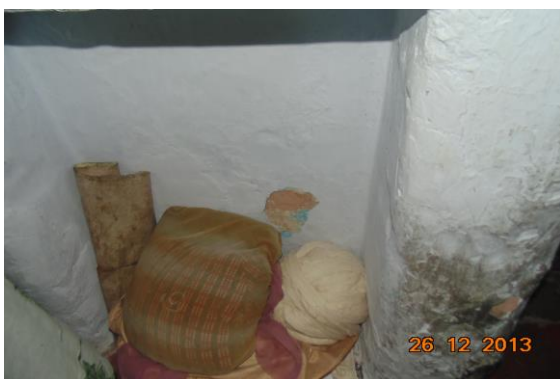
Photo 20

Peeling of Plaster on Wall No. 1 of Lobby of First Floor

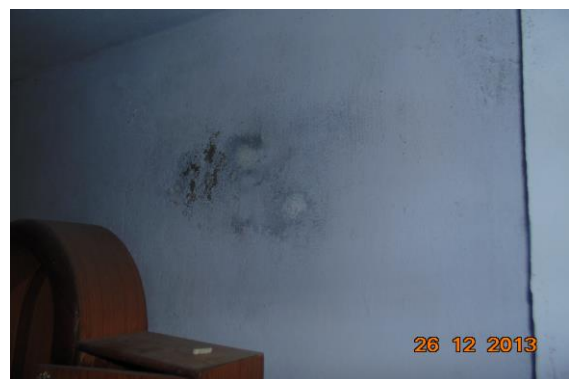
Photo 21

Dampness/Seepage on Wall No. 2 of Room No. 1 of First Floor

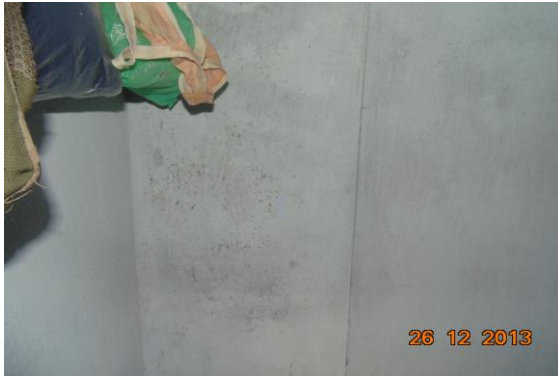
Photo 22
Dampness/Seepage on Wall No. 4 of Room No. 1 of First Floor

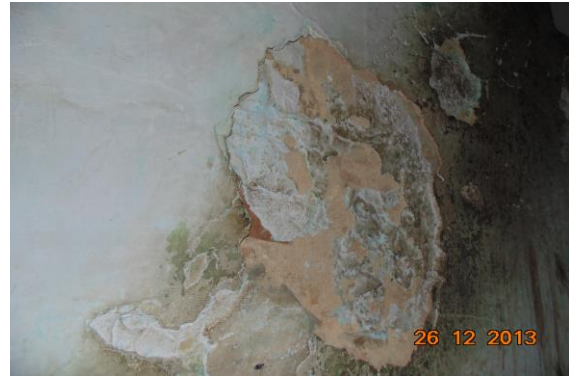
Photo 23
Damaged Portion on Wall No. 1 of Staircase FF to SF of First Floor

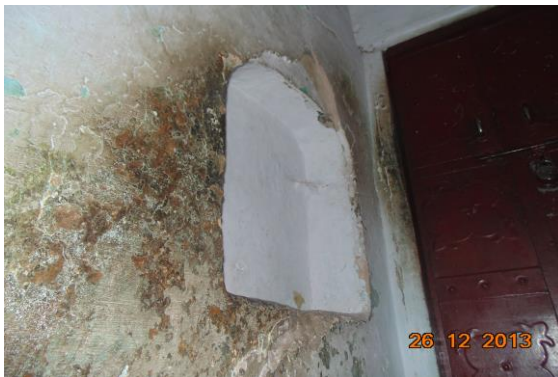
Photo 24
Damaged Portion on Wall No. 1 of Staircase FF to SF of First Floor

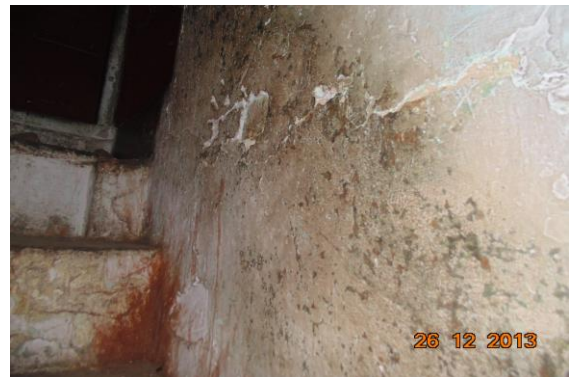
Photo 25
Dampness/Seepage on Wall No. 2 of Staircase FF to SF of First Floor

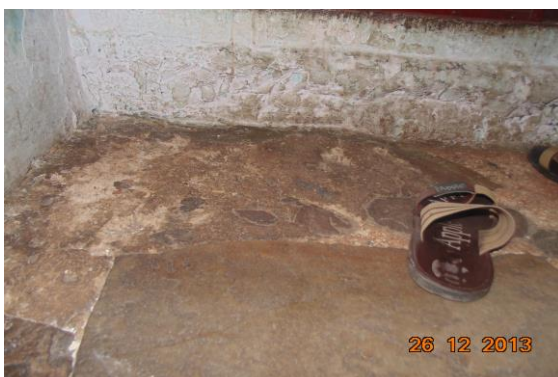
Photo 26
Peeling of Plaster on Steps of Staircase FF to SF of First Floor

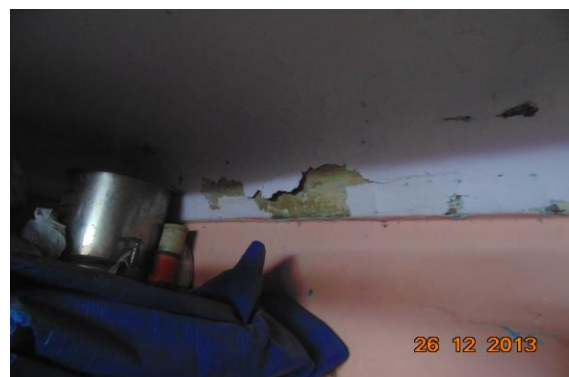
Photo 27
Peeling of Plaster on Roof of Lobby of Second Floor

23	Roof Lobby Second Floor	Peeling of Plaster	27
24	Wall No. 2, 3 & 4 Staircase SF to TF Second Floor	Dampness/Seepage	28
25	Roof Staircase SF to TF Second Floor	Peeling of Plaster	29
26	Wall No. 1 & 4 Room No. 1 Third Floor	Peeling of Plaster	30
27	Wall No. 2 Room No. 1 Third Floor	Peeling of Plaster	31
28	Roof Room No. 1 Third Floor	Peeling of Plaster	32
29	Wall No. 1, 2, 4 & Roof Room No. 2 Third Floor	Dampness/Seepage	33
30	Wall No. 1 Lobby Third Floor	Peeling of Plaster	34
31	Wall No. 4 Lobby Third Floor	Peeling of Plaster	35
32	Steps Staircase Area Third Floor	Damaged Portion	36
33	Wall No. 1, 3 & 4 Staircase Area TF to Fourth Third Floor	Dampness/Seepage	37
34	Wall No. 1 & 4 Room No. 1 Fourth Floor	Dampness/Seepage	38
35	Roof Room No. 2 Fourth Floor	Dampness/Seepage	39
36	Wall No. 2 & 4 Room No. 2 Fourth Floor	Dampness/Seepage	40
37	Wall No. 1 Room No. 2 Fourth Floor	Peeling of Plaster	41
38	Roof Room No. 2 Fourth Floor	Peeling of Plaster	42

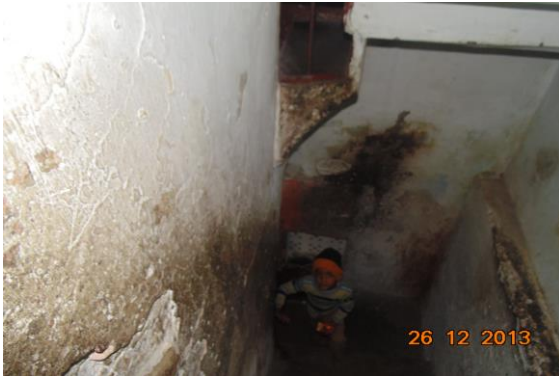
Photo 28
Dampness/Seepage on Wall No. 2, 3 & 4 of Staircase SF to TF of Second Floor

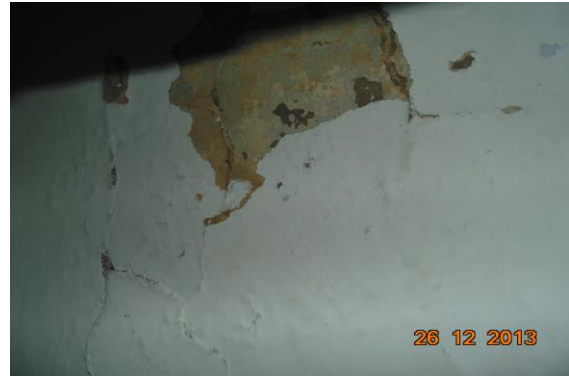
Photo 29
Peeling of Plaster on Roof of Staircase SF to TF of Second Floor

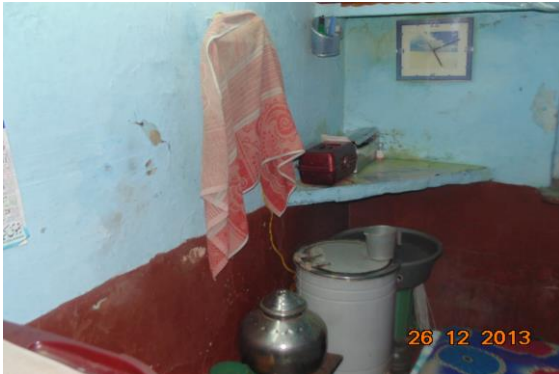
Photo 30
Peeling of Plaster on Wall No. 1 & 4 of Room No. 1 of Third Floor

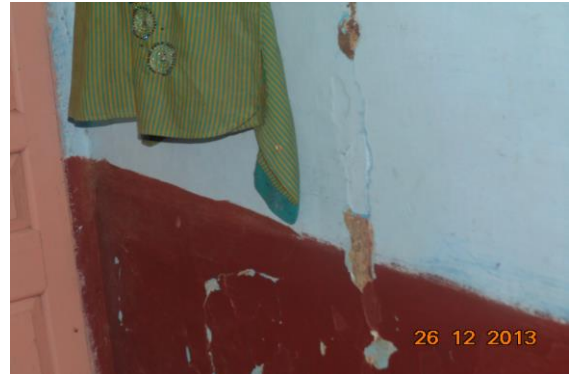
Photo 31
Peeling of Plaster on Wall No. 2 of Room No. 1 of Third Floor

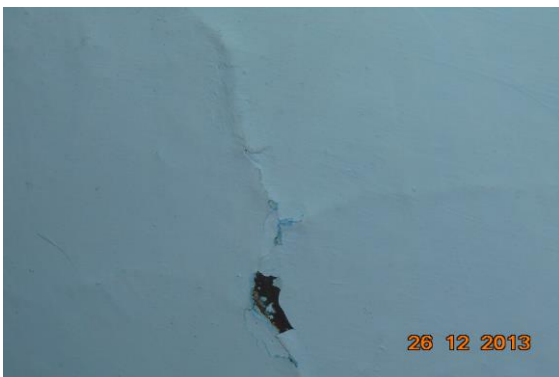
Photo 32
Peeling of Plaster on Roof of Room No. 1 of Third Floor

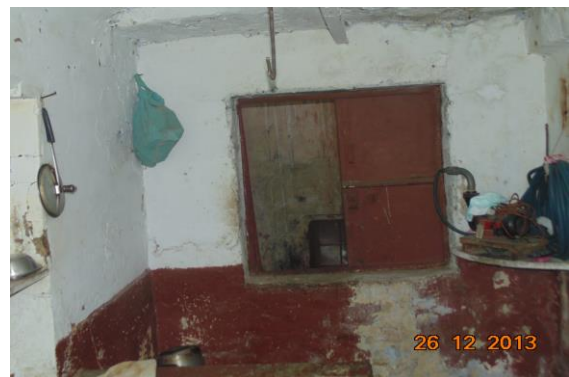
Photo 33
Dampness/Seepage on Wall No. 1, 2, 4 & Roof of Room No. 2 of Third Floor

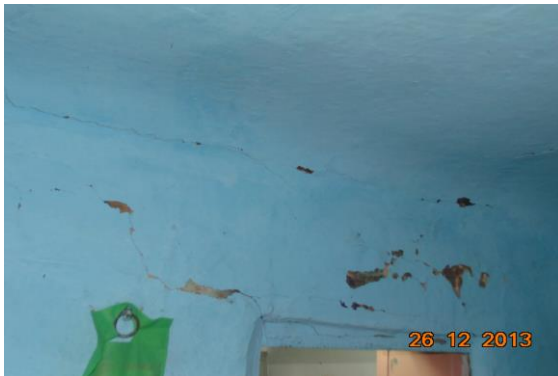
Photo 34
Peeling of Plaster on Wall No. 1 of Lobby of Third Floor

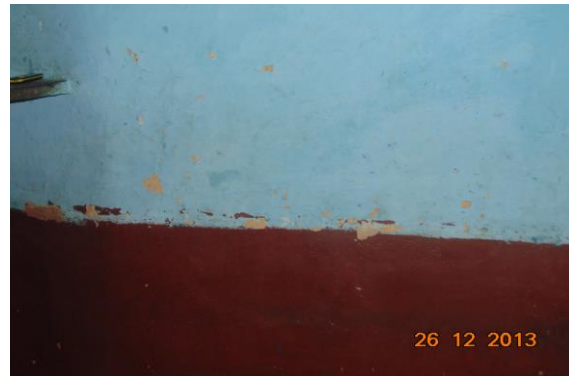
Photo 35
Peeling of Plaster on Wall No. 4 of Lobby of Third Floor

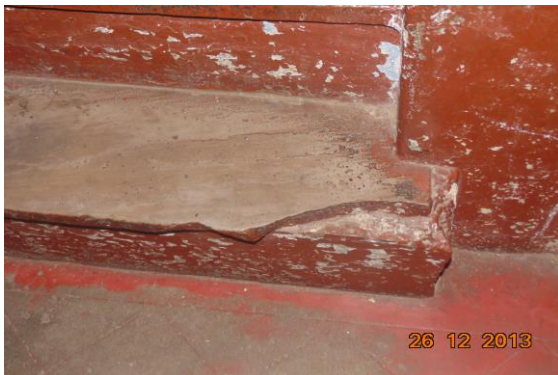
Photo 36
Damaged Portion on Steps of Staircase Area of Third Floor

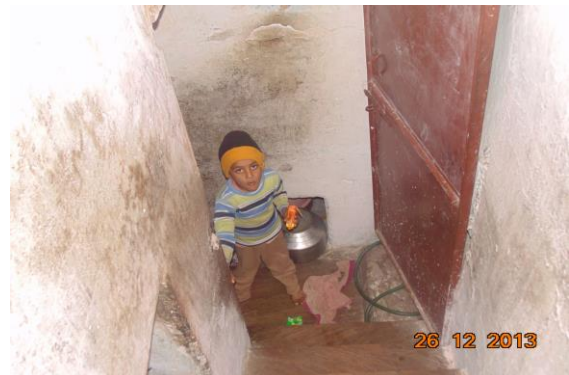
Photo 37
Dampness/Seepage on Wall No. 1, 3 & 4 of Staircase Area TF to Fourth of Third Floor

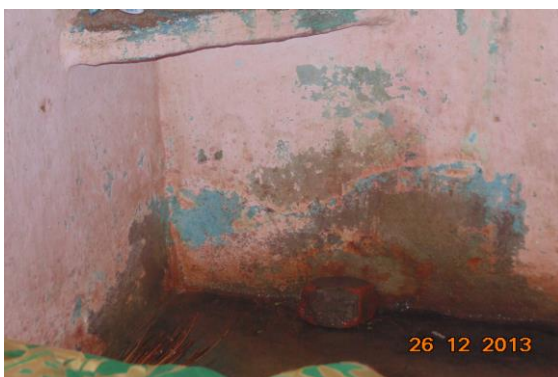
Photo 38
Dampness/Seepage on Wall No. 1 & 4 of Room No. 1 of Fourth Floor

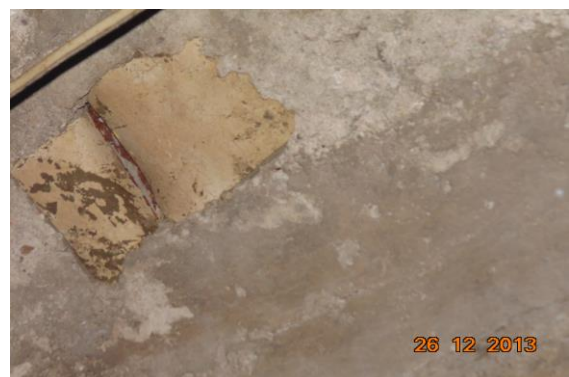
Photo 39
Dampness/Seepage on Roof of Room No. 2 of Fourth Floor

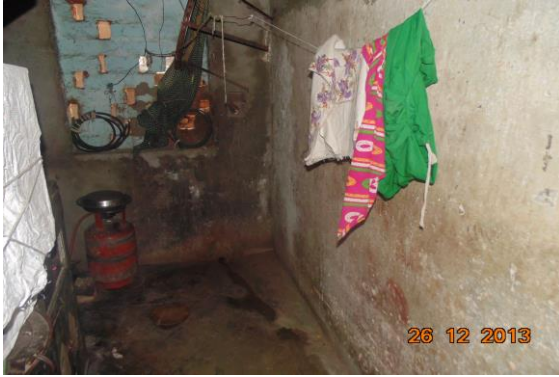
Photo 40
Dampness/Seepage on Wall No. 2 & 4 of Room No. 2 of Fourth Floor

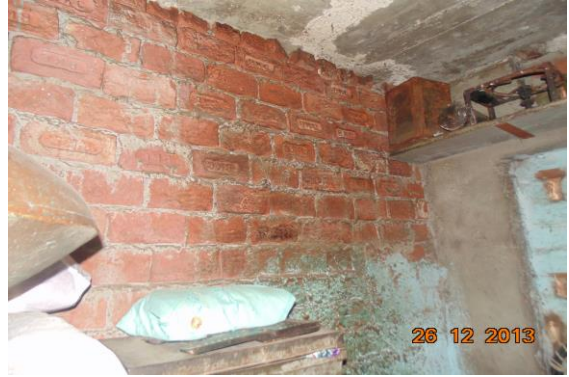
Photo 41
Peeling of Plaster on Wall No. 1 of Room No. 2 of Fourth Floor

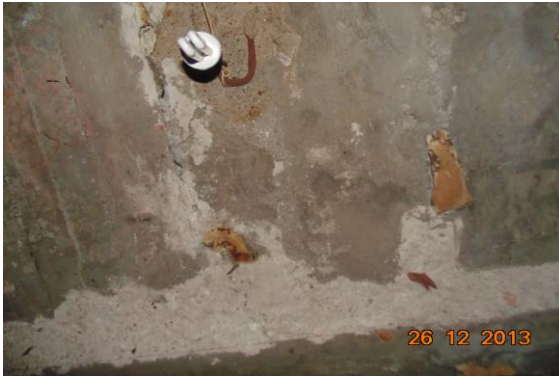
Photo 42
Peeling of Plaster on Roof of Room No. 2 of Fourth Floor

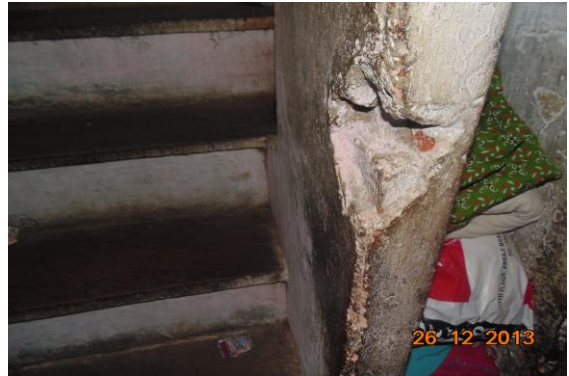
Photo 43
Damaged Portion on Wall No. 2 of Staircase TF to Fourth Floor of

39	Wall No. 2 Staircase TF to Fourth Floor	Damaged Portion	43

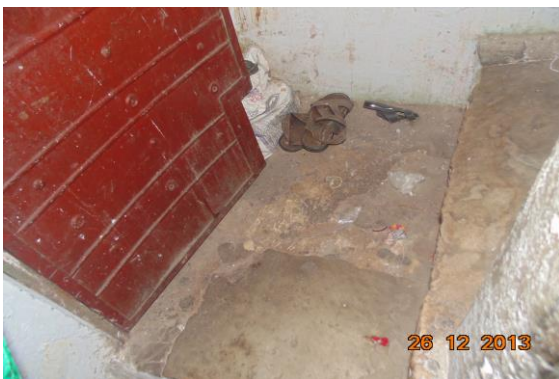
Photo 44
Peeling of Plaster on Wall of Staircase FF of First Floor

40	Wall of Staircase FF First Floor	Peeling of Plaster	44
41	Wall No. 2 Staircase GF to FF Ground Floor	Peeling of Plaster	45
42	Wall No. 1 Staircase GF to FF Ground Floor	Peeling of Plaster	46
43	Roof Staircase GF to FF Ground Floor	Peeling of Plaster	47
44	Steps Staircase GF to FF Ground Floor	Damaged Portion	48
45	Front side Shade H.No.479 First Floor	Peeling of Plaster	49
46	Front side Shade H.No.480 Third Floor	Peeling of Plaster	50
47	Beam Varanda Shop No. 50, Ground Floor	Damaged Portion	51
48	Roof Varanda Shop No. 50, Ground Floor	Dampness/Seepage	52
49	All Walls Shop No. 50, Ground Floor	Damaged Portion	53

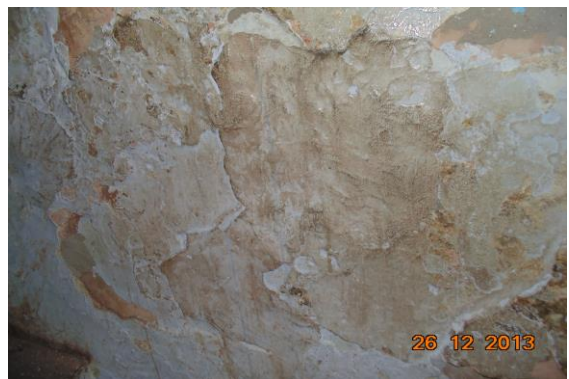
Photo 45
Peeling of Plaster on Wall No. 2 of Staircase GF to FF of Ground Floor

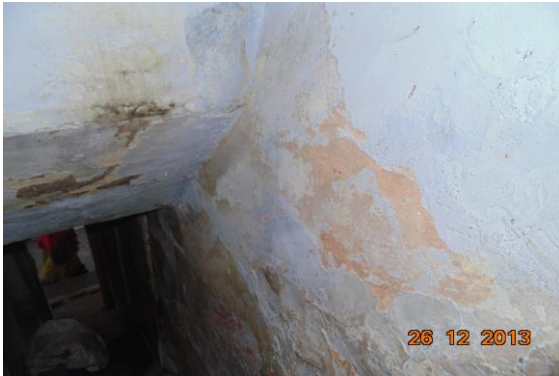
Photo 46

Peeling of Plaster on Wall No. 1 of Staircase GF to FF of Ground Floor

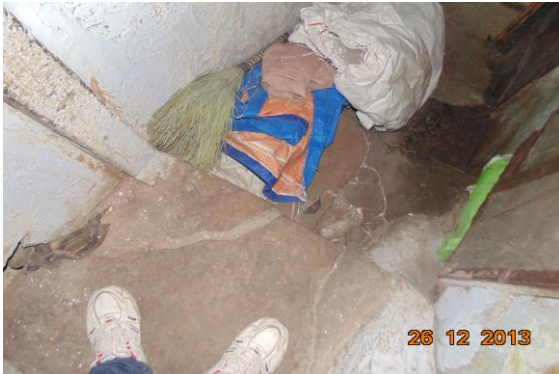
Photo 47

Peeling of Plaster on Roof of Staircase GF to FF of Ground Floor

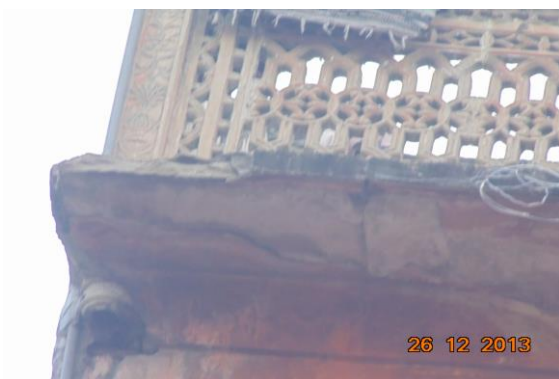
Photo 49

Peeling of Plaster on Front side Shade of H.No.479 of First Floor

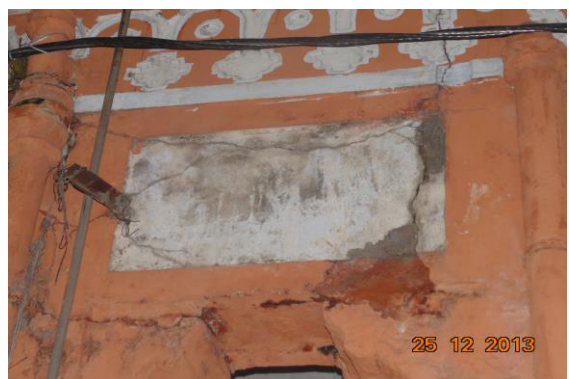
Photo 50

Peeling of Plaster on Wall No. Front side Shade of H.No.480 of Third Floor

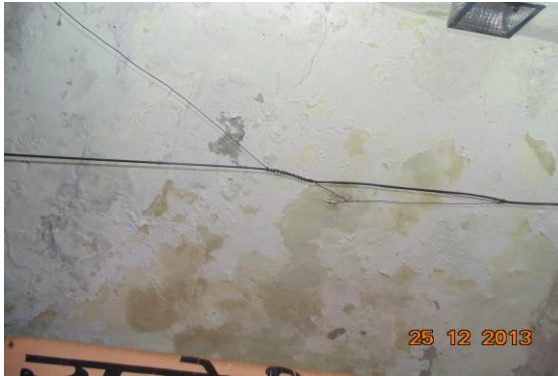
Photo 52

Dampness/Seepage on Roof of Varanda of Shop No. 50, Ground Floor

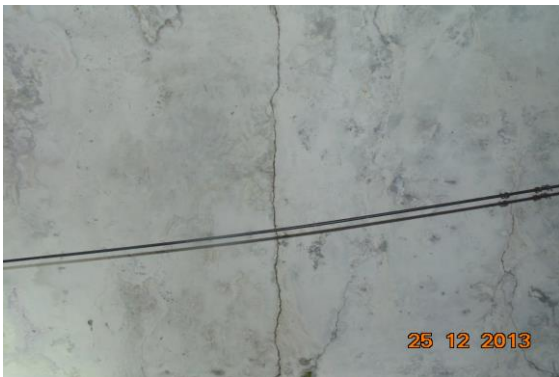
Photo 3

Horizontal Crack on Roof of Varanda, Shop No. 51, Ground Floor, Approx. Width = 3mm, Approx. Length = 2.5m. Distance from Right External Column = 0m, Height from Floor = 3m.

Summary of Cracks						
Defect ID	Location	Orientation	Appx. Width (mm)	Appx. Length (m)	Category	Photo No.
1	Roof Varanda Shop No. 51, Ground Floor	Horizontal	3	2.5	Slight	3

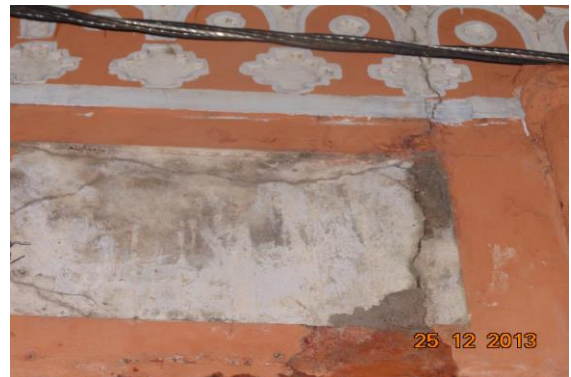
Photo 4

Damaged Portion on Beam of Varanda of Shop No. 51, Ground Floor

Summary of Defects Other Than Crack			
Defect ID	Location	Description	Photo No.
2	Beam Varanda Shop No. 51, Ground Floor	Damaged Portion	4
3	Wall No. 4 Varanda Shop No. 51, Ground Floor	Damaged Portion	5
4	Roof Varanda Shop No. 51, Ground Floor	Dampness/Seepage	6
5	Roof Part A Shop No. 51, Ground Floor	Peeling of Plaster	7
6	Roof Part A Shop No. 51, Ground Floor	Peeling of Plaster	8
7	Roof Part A Shop No. 51, Ground Floor	Peeling of Plaster	9
8	Wall No. 1 Part A Shop No. 51, Ground Floor	Dampness/Seepage	10
9	Wall No. 1 Part A Shop No. 51, Ground Floor	Dampness/Seepage	11
10	Wall No. 2 Part A Shop No. 51, Ground Floor	Plaster Crack	12
11	Wall No. 2 Part A Shop No. 51, Ground Floor	Plaster Crack	13
12	Wall No. 4 Part A Shop No. 51, Ground Floor	Peeling of Plaster	14
13	Roof Part B Shop No. 51, Ground Floor	Peeling of Plaster	15
14	Wall No. 4 Part B Shop No. 51, Ground Floor	Dampness/Seepage	16
15	Wall No. 2 Part A Shop No. 51, Ground Floor	Damaged Portion	17

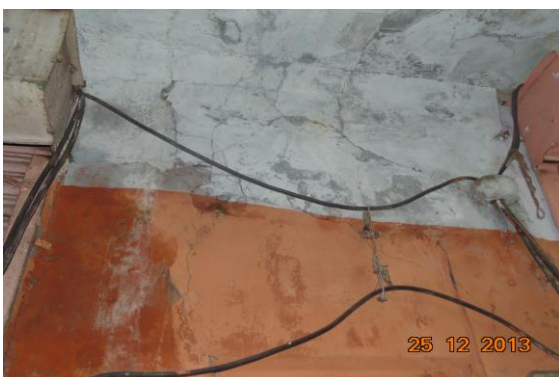
Photo 5

Damaged Portion on Wall No. 4 of Varanda of Shop No. 51, Ground Floor

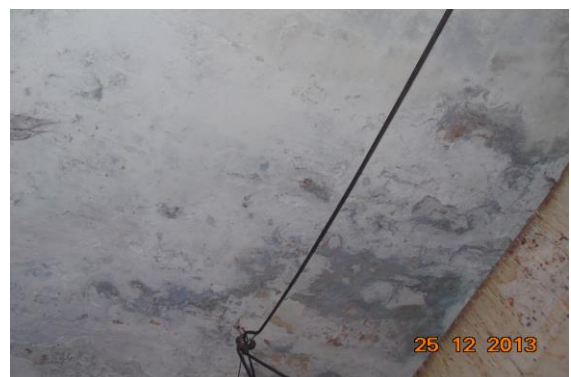
Photo 6

Dampness/Seepage on Roof of Varanda of Shop No. 51, Ground Floor

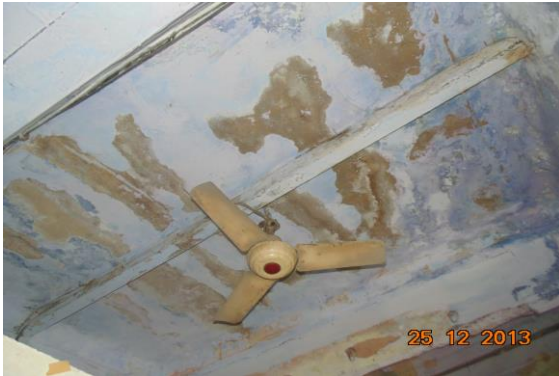
Photo 7

Peeling of Plaster on Roof of Part A of Shop No. 51, Ground Floor

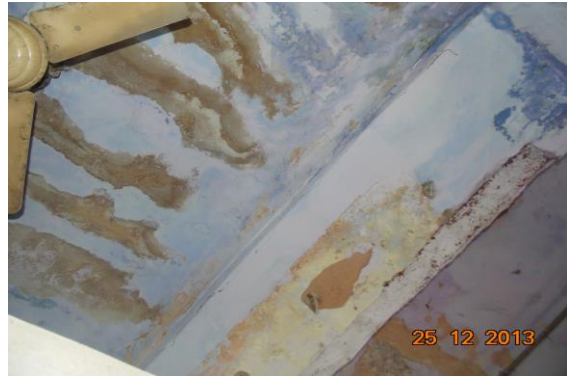
Photo 8

Peeling of Plaster on Roof of Part A of Shop No. 51, Ground Floor

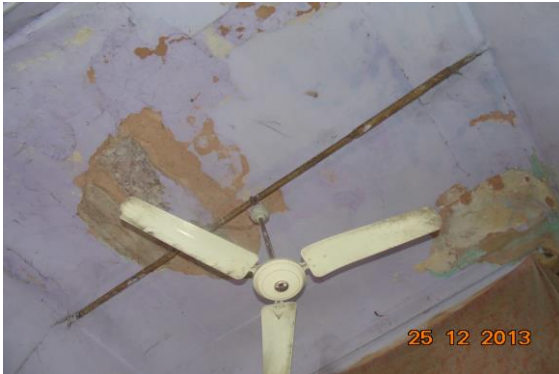
Photo 9

Peeling of Plaster on Roof of Part A of Shop No. 51, Ground Floor

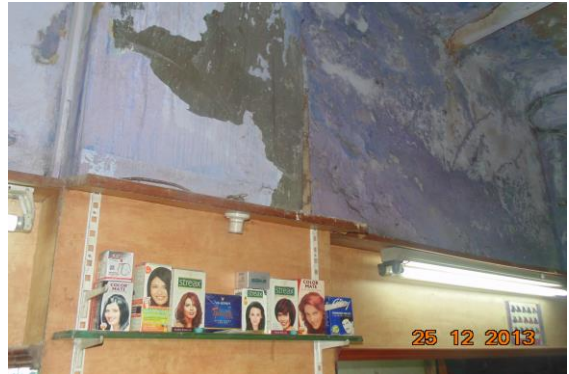
Photo 10

Dampness/Seepage on Wall No. 1 of Part A of Shop No. 51, Ground Floor

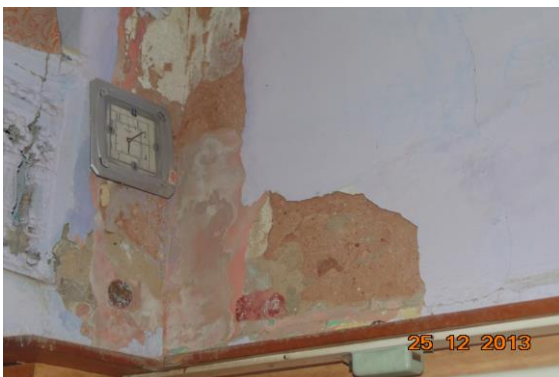
Photo 11

Dampness/Seepage on Wall No. 1 of Part A of Shop No. 51, Ground Floor

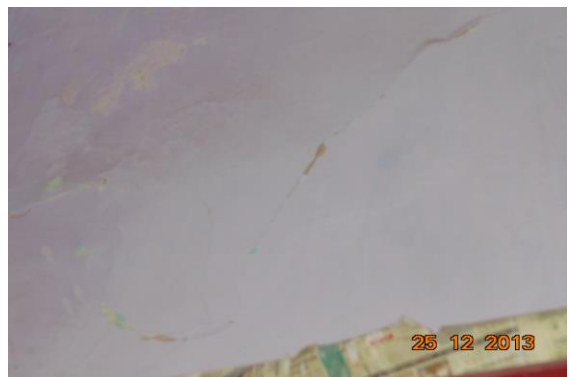
Photo 12

Plaster Crack on Wall No. 2 of Part A of Shop No. 51, Ground Floor

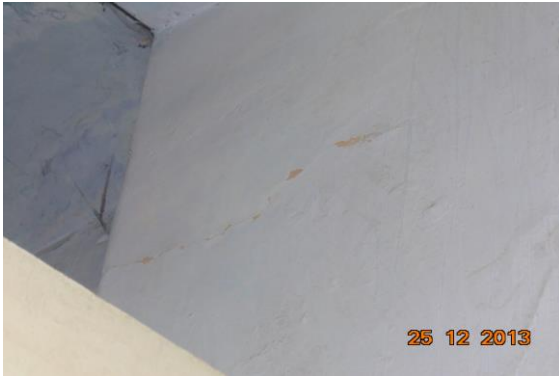
Photo 13

Plaster Crack on Wall No. 2 of Part A of Shop No. 51, Ground Floor

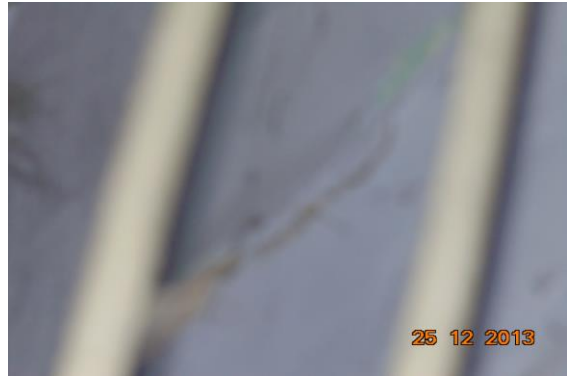
Photo 14

Peeling of Plaster on Wall No. 4 of Part A of Shop No. 51, Ground Floor

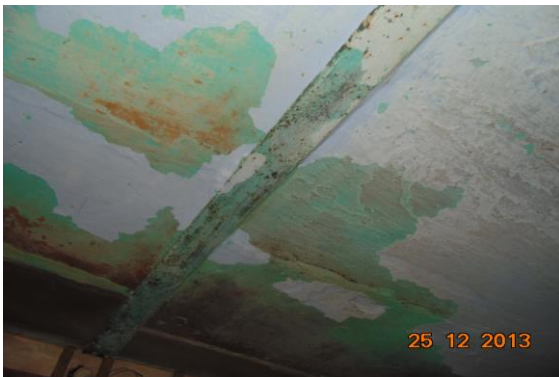
Photo 15

Peeling of Plaster on Roof of Part B of Shop No. 51, Ground Floor

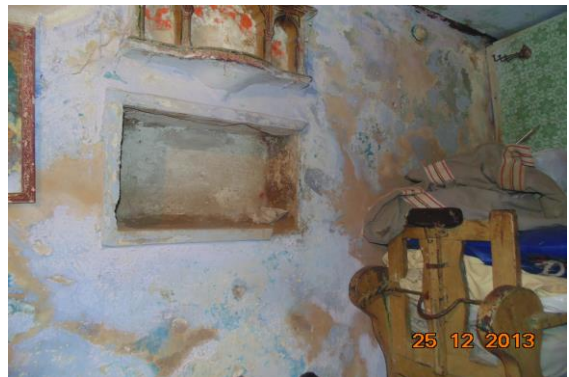
Photo 16

Dampness/Seepage on Wall No. 4 of Part B of Shop No. 51, Ground Floor

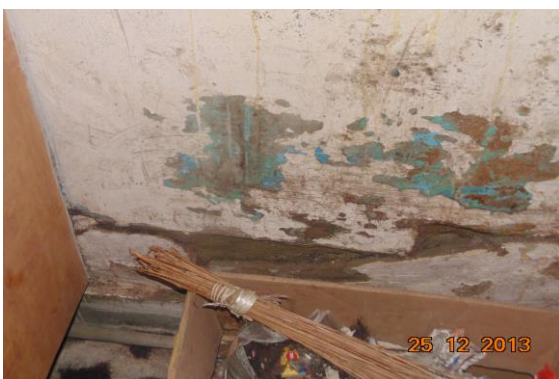
Photo 17

Damaged Portion on Wall No. 2 of Part A of Shop No. 51, Ground Floor

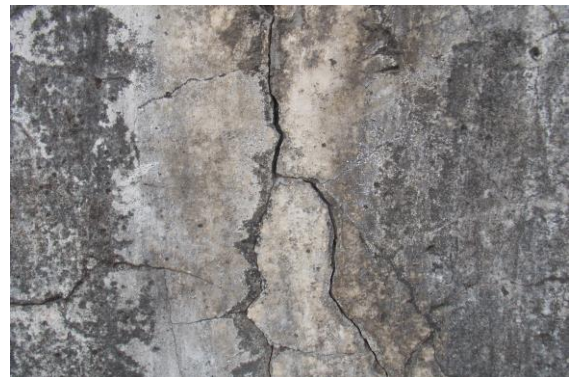
Photo 4
Inclined Crack on Wall No. 4 of Open Area, Third Floor, Approx. Width = 4mm, Approx. Length = 2m.
Distance from Wall No. 2 = 0.2m, Height from Floor = 0m.

Summary of Cracks						
Defect ID	Location	Orientation	Appx. Width (mm)	Appx. Length (m)	Category	Photo No.
1	Wall No. 4 Open Area Third Floor	Inclined	4	2	Slight	4, 4A
2	Wall No. 4 & Floor Varandah Second Floor	Inclined	1	1.3	Slight	5, 5A

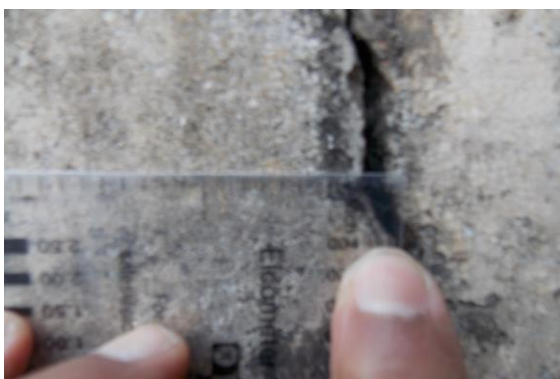
Photo 4A
Inclined Crack on Wall No. 4 of Open Area, Third Floor, Approx. Width = 4mm, Approx. Length = 2m.
Distance from Wall No. 2 = 0.2m, Height from Floor = 0m.

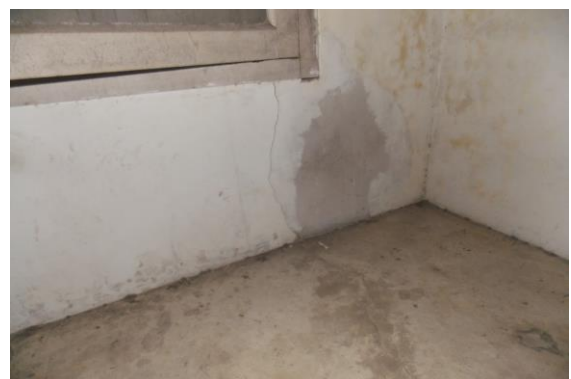
Photo 5
Inclined Crack on Floor & Wall No. 4 of Varandah, Second Floor, Approx. Width = 1mm, Approx. Length = 1.3m.
Distance from Wall No. 2 = 0.8m, Height from Floor = 0m.

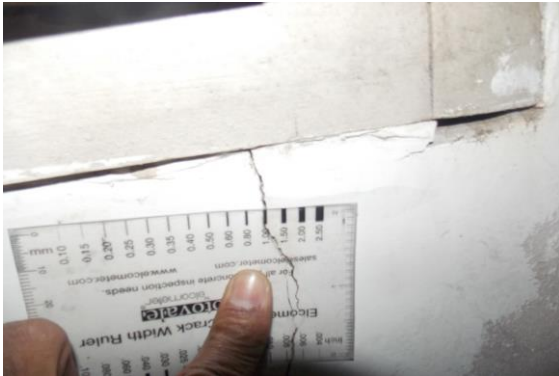
Photo 5A

Inclined Crack on Floor & Wall No. 4 of Varandah, Second Floor,
Approx. Width = 1mm, Approx. Length = 1.3m.
Distance from Wall No. 2 = 0.8m, Height from Floor = 0m.

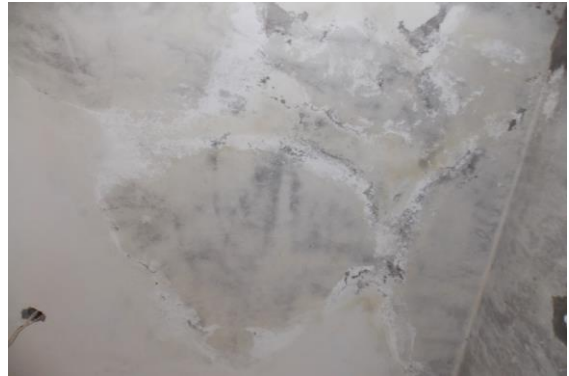
Photo 6

Dampness/Seepage on Roof of Room No. 1 of Third Floor

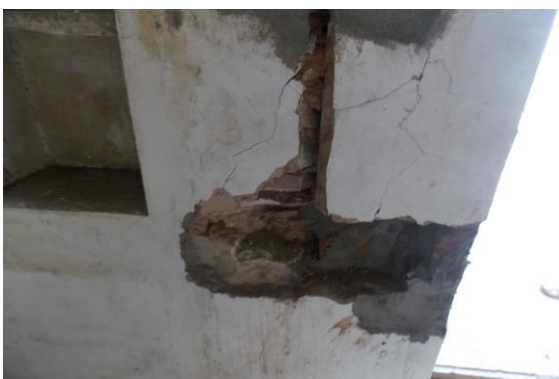
Photo 8

Plaster Crack on Floor of Room No. 1 of Third Floor

Summary of Defects Other Than Crack			
Defect ID	Location	Description	Photo No.
3	Roof Room No. 1 Third Floor	Dampness/Seepage	6
4	Wall No. 3 Room No. 1 Third Floor	Plaster Crack	7
5	Floor Room No. 1 Third Floor	Plaster Crack	8
6	Wall No. 3 Room No. 1 Third Floor	Plaster Crack	9
7	Wall No. 2 Open Area Third Floor	Plaster Crack	10
8	Wall No. 4 Open Area Third Floor	Plaster Crack	11
9	Wall No. 4 & Roof Stair SF to TF Third Floor	Peeling of Plaster	12
10	Wall No. 1 & 4 Varandah Second Floor	Peeling of Plaster	13
11	Wall No. 2 & 3 Varandah Second Floor	Peeling of Plaster	14
12	Floor Varandah Second Floor	Peeling of Plaster	15
13	Wall No. 1 Lobby Second Floor	Peeling of Plaster	16
14	Wall No. 4 Lobby Second Floor	Peeling of Plaster	17
15	Wall No. 2 Lobby Second Floor	Peeling of Plaster	18
16	Wall No. 3 Lobby Second Floor	Peeling of Plaster	19
17	Roof Lobby Second Floor	Peeling of Plaster	20
18	Wall No. 1 & 3 Room No. 1 Second Floor	Peeling of Plaster	21

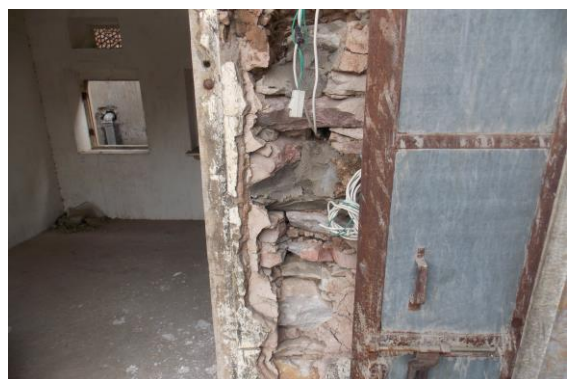
Photo 9

Plaster Crack on Wall No. 3 of Room No. 1 of Third Floor

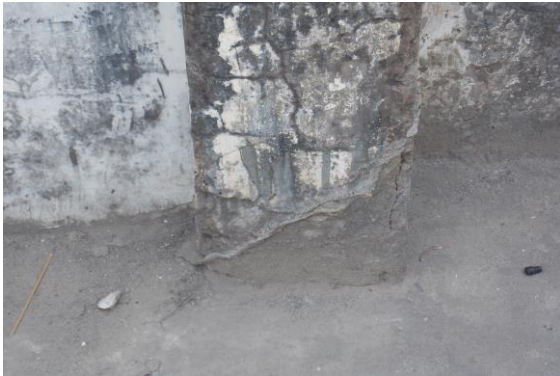
Photo 11
Plaster Crack on Wall No. 4 of Open Area of Third Floor

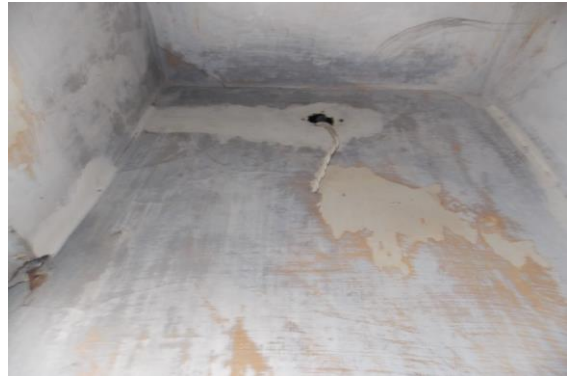
Photo 12
Peeling of Plaster on Roof & 4 of Stair SF to TF of Third Floor

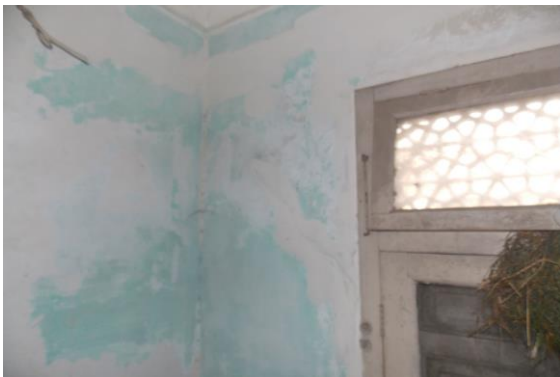
Photo 13
Peeling of Plaster on Wall No. 1 & 4 of Varanda of Second Floor

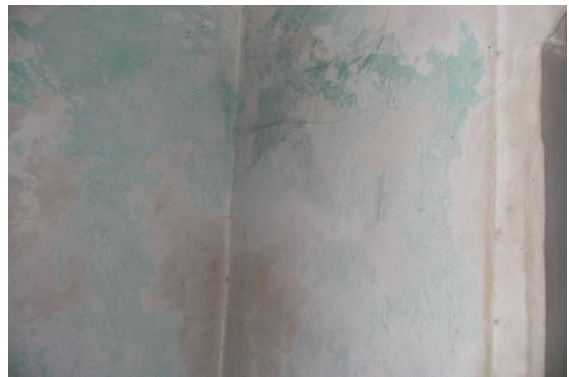
Photo 14
Peeling of Plaster on Wall No. 2 & 3 of Varanda of Second Floor

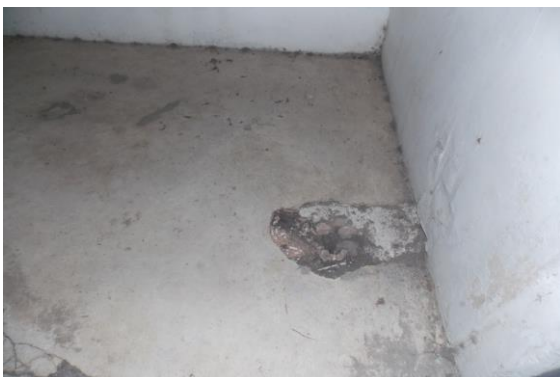
Photo 15
Peeling of Plaster on Floor of Varanda of Second Floor

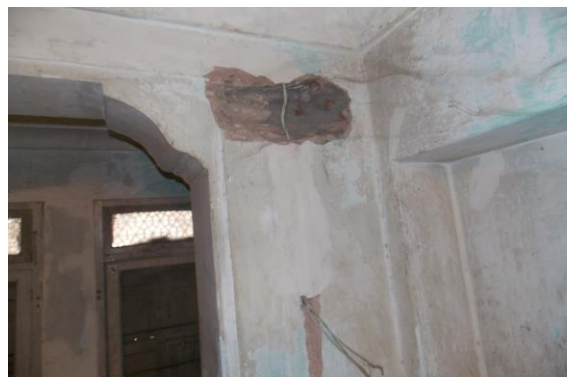
Photo 16
Peeling of Plaster on Wall No. 1 of Lobby of Second Floor

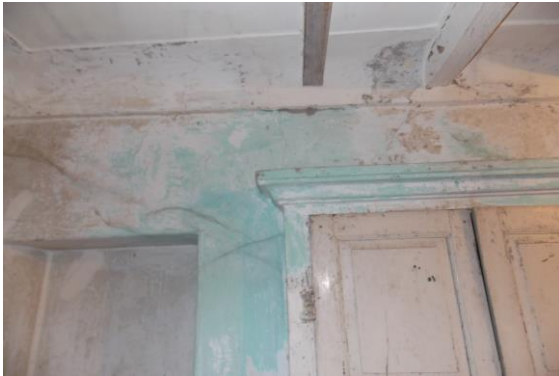
Photo 17

Peeling of Plaster on Wall No. 4 of Lobby of Second Floor

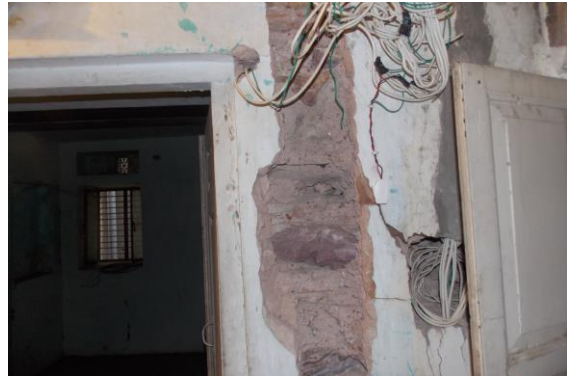
Photo 18

Peeling of Plaster on Wall No. 2 of Lobby of Second Floor

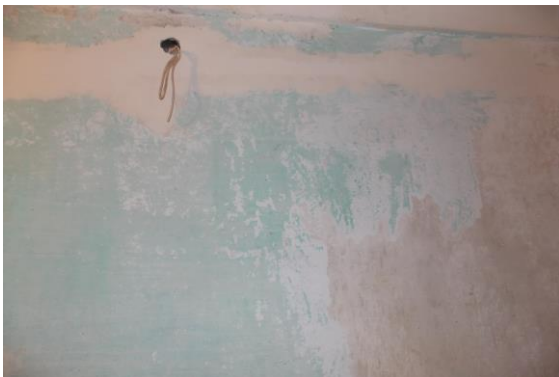
Photo 19

Peeling of Plaster on Wall No. 3 of Lobby of Second Floor

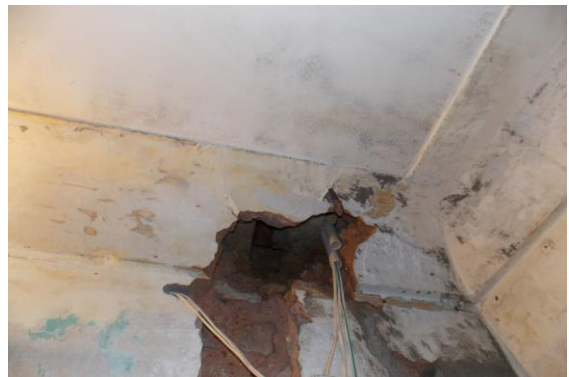
Photo 20

Peeling of Plaster on Roof of Lobby of Second Floor

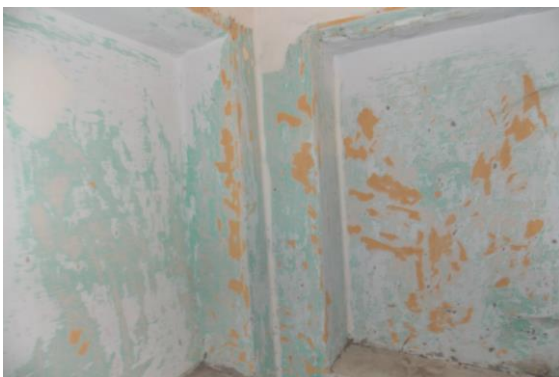
Photo 21

Peeling of Plaster on Wall No. 1 & 3 of Room No. 1 of Second Floor

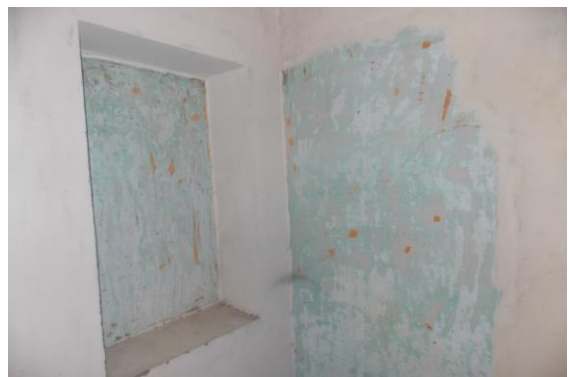
Photo 22

Peeling of Plaster on Wall No. 2 & 3 of Lobby of Second Floor

19	Wall No. 2 & 3 Lobby Second Floor	Peeling of Plaster	22
20	Wall No. 3 Lobby Second Floor	Plaster Crack	23
21	Wall No. 1 & 4 Stair FF to SF Second Floor	Dampness/Seepage	24
22	Wall No. 1 & 4 Varandah First Floor	Dampness/Seepage	25
23	Wall No. 2, 3 & 4 Varandah First Floor	Dampness/Seepage	26
24	Wall No. 4 Varandah First Floor	Plaster Crack	27
25	Floor Varandah First Floor	Plaster Crack	28
26	Wall No. 1 Lobby First Floor	Peeling of Plaster	29
27	Wall No. 4 Lobby First Floor	Plaster Crack	30
28	Wall No. 2 Lobby First Floor	Peeling of Plaster	31
29	Roof Lobby First Floor	Peeling of Plaster	32
30	Wall No. 3 Lobby First Floor	Peeling of Plaster	33
31	Roof Room No. 1 First Floor	Dampness/Seepage	34
32	Wall No. 1 & 3 Room No. 1 First Floor	Peeling of Plaster	35
33	Wall No. 2 & 3 Room No. 1 First Floor	Peeling of Plaster	36
34	Floor Room No. 1 First Floor	Peeling of Plaster	37
35	All Walls Toilet No. 1 First Floor	Peeling of Plaster	38

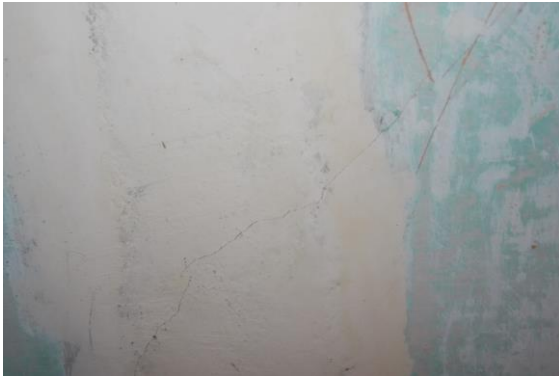
Photo 23
Plaster Crack on Wall No. 3 of Lobby of Second Floor

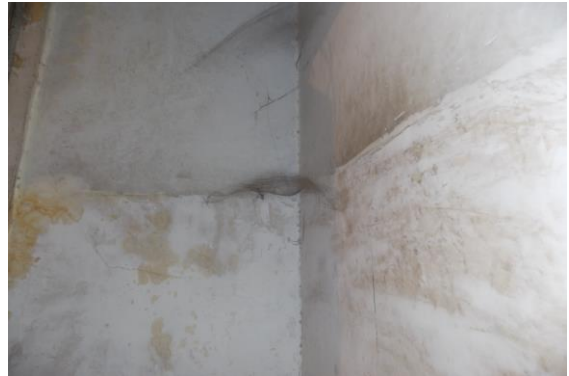
Photo 24
Dampness/Seepage on Wall No. 1 & 4 of Stair FF to SF of Second Floor

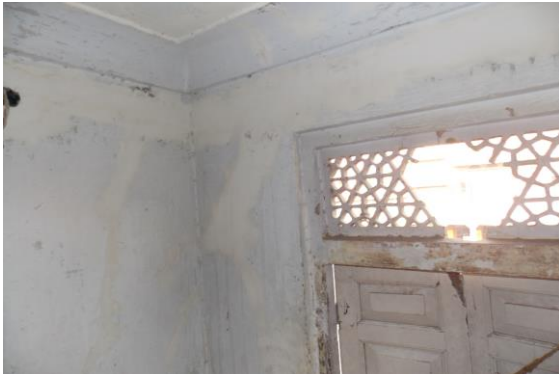
Photo 25
Dampness/Seepage on Wall No. 1 & 4 of Varanda of First Floor

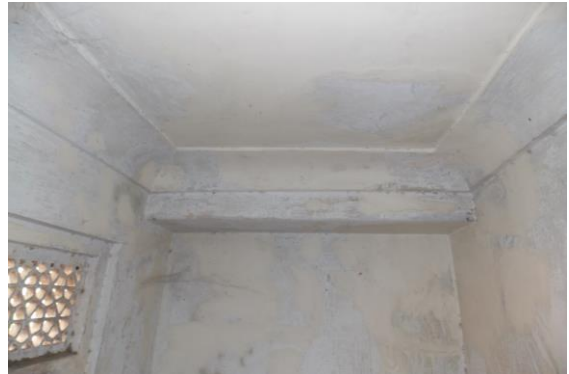
Photo 26
Dampness/Seepage on Wall No. 2, 3 & 4 of Varanda of First Floor

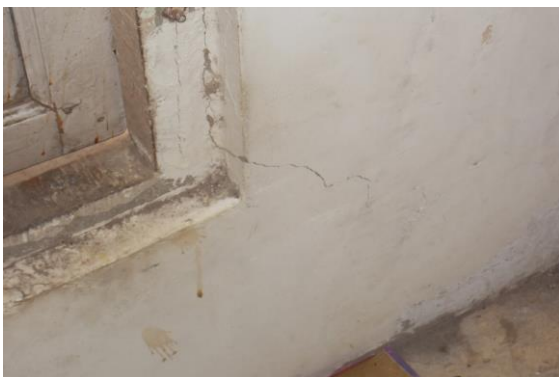
Photo 27
Plaster Crack on Wall No. 4 of Varanda of First Floor

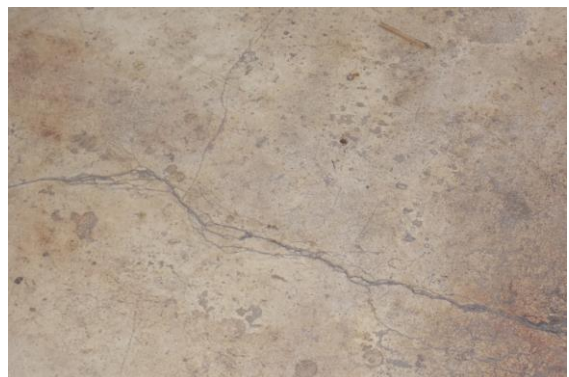
Photo 28
Plaster Crack on Floor of Varanda of First Floor

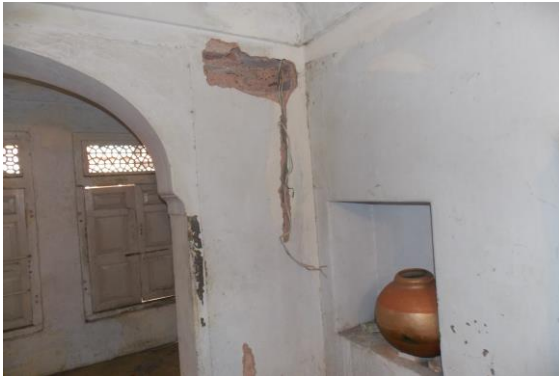
Photo 29
Peeling of Plaster on Wall No. 1 of Lobby of First Floor

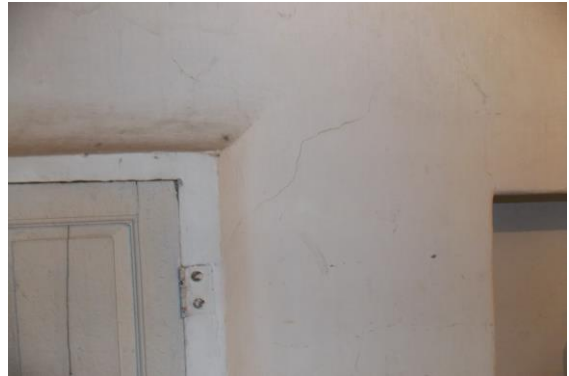
Photo 30
Plaster Crack on Wall No. 4 of Lobby of First Floor
