Pre Building Condition Survey Report

Name and Address of Structure :	Badi Chopar to Ramp Area (Down Line)
---------------------------------	--------------------------------------

Name of the Project	Contract JMRC-UG1B “Design and Construction of Tunnel between Chandpole and Badi Chouper and reverse line by Shield TBM, Underground Metro Stations at Choti Chouper and Badi Chouper by Cut and Cover Methods on East West Corridor of Jaipur Metro Rail Corporation Limited .”	
Owner :

Pre - Condition Building Survey for Construction of Underground Stations from Chandpole to Bari Chouper and reversal line

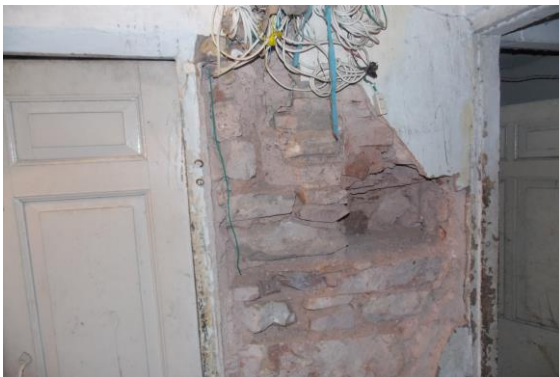
Photo 31
Peeling of Plaster on Wall No. 2 of Lobby of First Floor

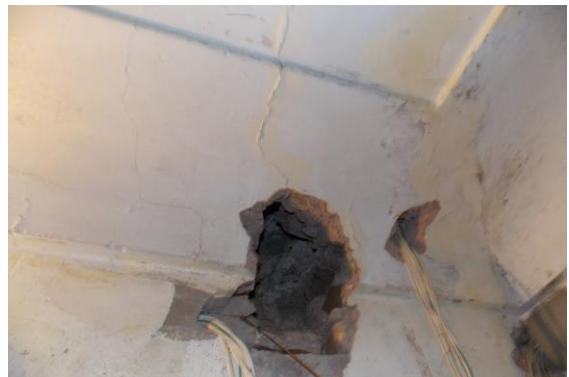
Photo 32
Peeling of Plaster on Roof of Lobby of First Floor

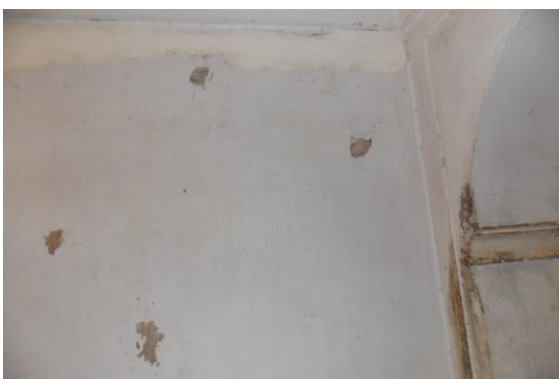
Photo 33
Peeling of Plaster on Wall No. 3 of Lobby of First Floor

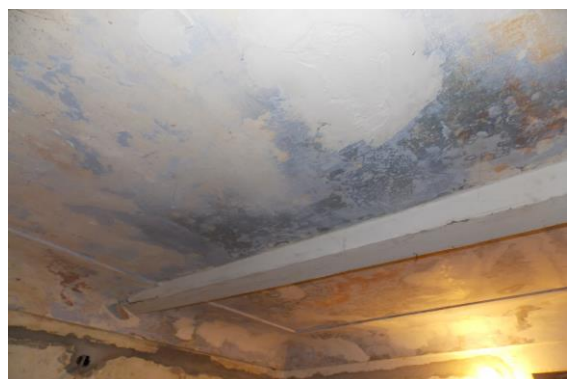
Photo 34
Dampness/Seepage on Roof of Room No. 1 of First Floor

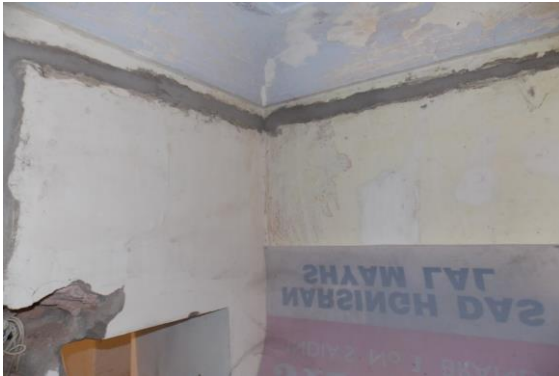
Photo 35

Peeling of Plaster on Wall No. 1 & 3 of Room No. 1 of First Floor

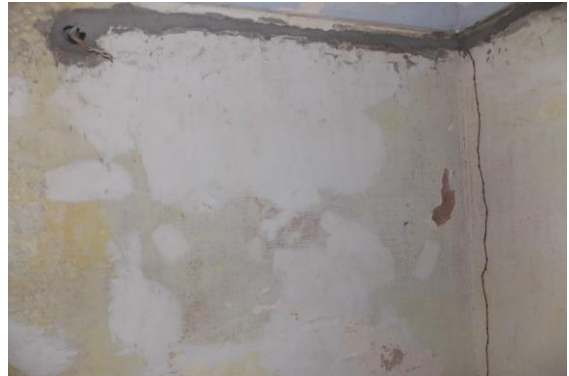
Photo 36

Peeling of Plaster on Wall No. 2 & 3 of Room No. 1 of First Floor

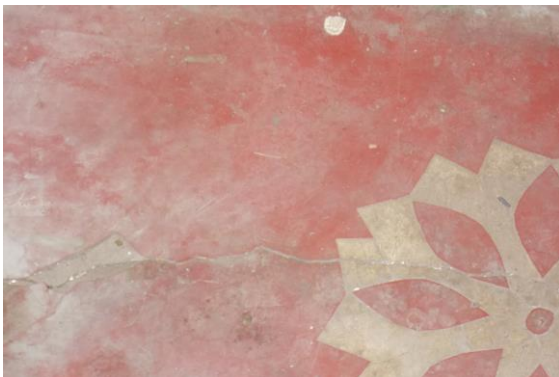
Photo 37

Peeling of Plaster on Floor of Room No. 1 of First Floor

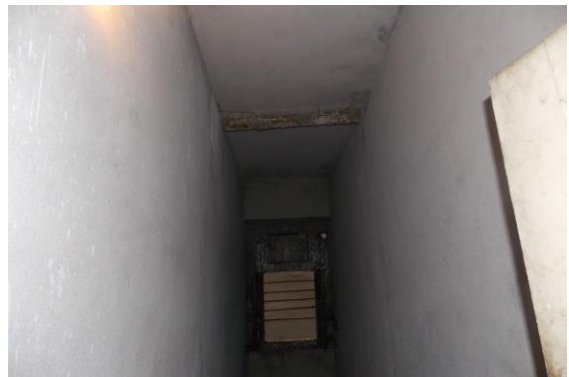
Photo 38

Peeling of Plaster on All Walls of Toilet No. 1 of First Floor

19	Wall No. 2 & 3 Lobby Second Floor	Peeling of Plaster	22
20	Wall No. 3 Lobby Second Floor	Plaster Crack	23
21	Wall No. 1 & 4 Stair FF to SF Second Floor	Dampness/Seepage	24
22	Wall No. 1 & 4 Varandah First Floor	Dampness/Seepage	25
23	Wall No. 2, 3 & 4 Varandah First Floor	Dampness/Seepage	26
24	Wall No. 4 Varandah First Floor	Plaster Crack	27
25	Floor Varandah First Floor	Plaster Crack	28
26	Wall No. 1 Lobby First Floor	Peeling of Plaster	29
27	Wall No. 4 Lobby First Floor	Plaster Crack	30
28	Wall No. 2 Lobby First Floor	Peeling of Plaster	31
29	Roof Lobby First Floor	Peeling of Plaster	32
30	Wall No. 3 Lobby First Floor	Peeling of Plaster	33
31	Roof Room No. 1 First Floor	Dampness/Seepage	34
32	Wall No. 1 & 3 Room No. 1 First Floor	Peeling of Plaster	35
33	Wall No. 2 & 3 Room No. 1 First Floor	Peeling of Plaster	36
34	Floor Room No. 1 First Floor	Peeling of Plaster	37
35	All Walls Toilet No. 1 First Floor	Peeling of Plaster	38

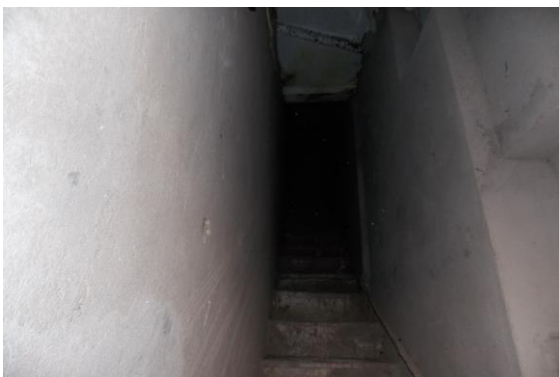
Photo 39

Peeling of Plaster on All Walls of Stair GF to FF of First Floor

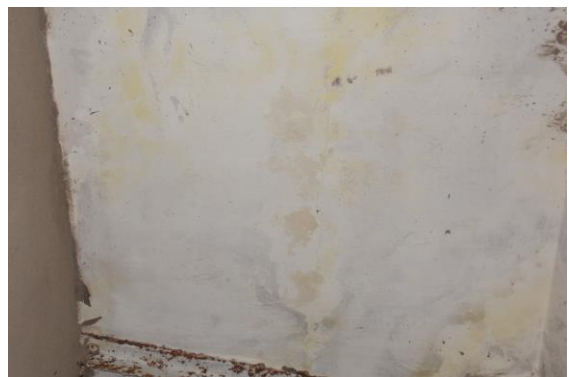
Photo 40

Dampness/Seepage on Roof of Stair GF to FF of First Floor

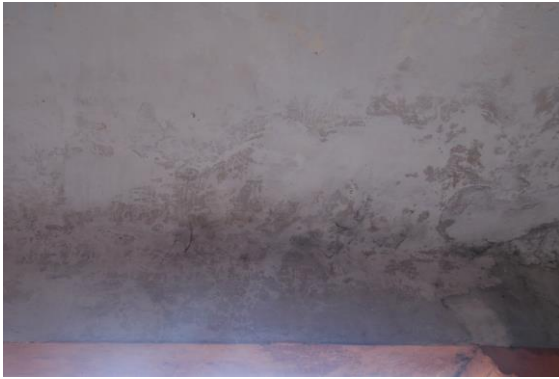
Photo 41

Dampness/Seepage on Roof of Varanda of Shop no. 52, Ground Floor

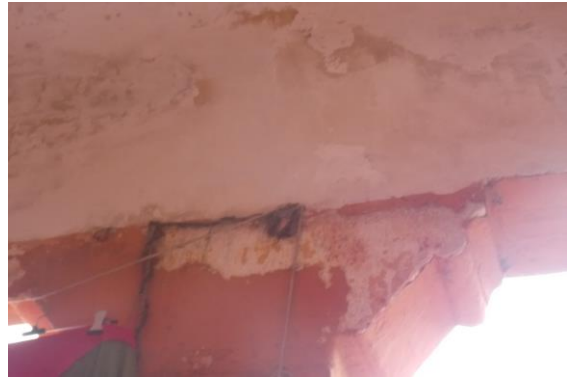
Photo 42

Peeling of Plaster on External Column of Varanda of Shop no. 52, Ground Floor

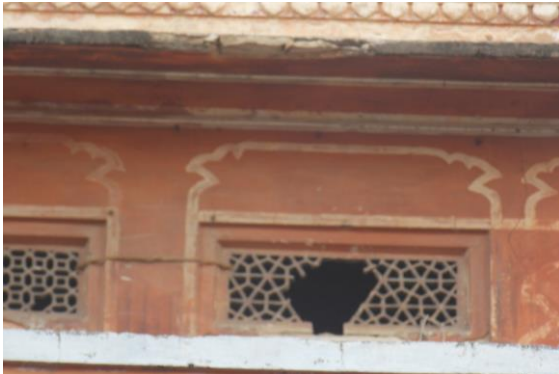
Photo 43

Peeling of Plaster on Outer Wall 3 of FF external façade

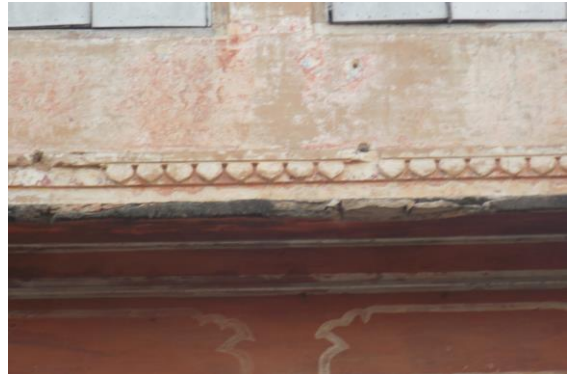
Photo 44

Peeling of Plaster on Shade of FF external façade

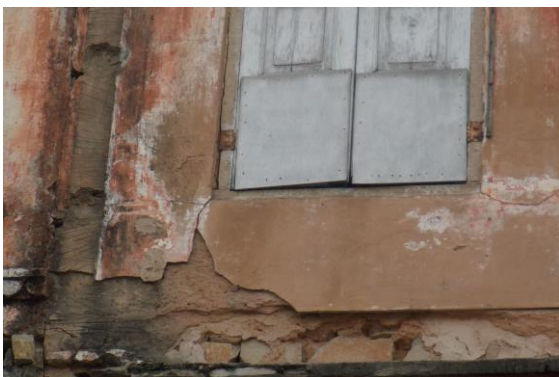
Photo 45

Peeling of Plaster on Outer Wall 3 of SF external façade

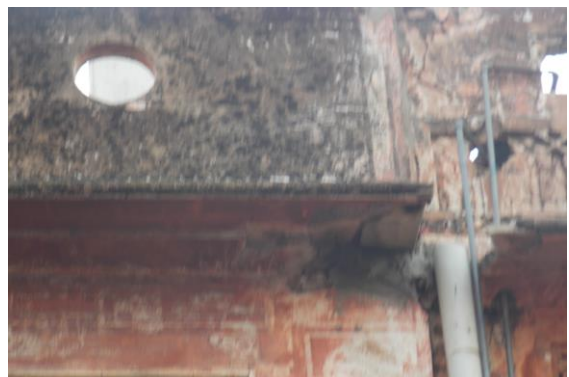
Photo 46

Peeling of Plaster on Shade of SF external façade

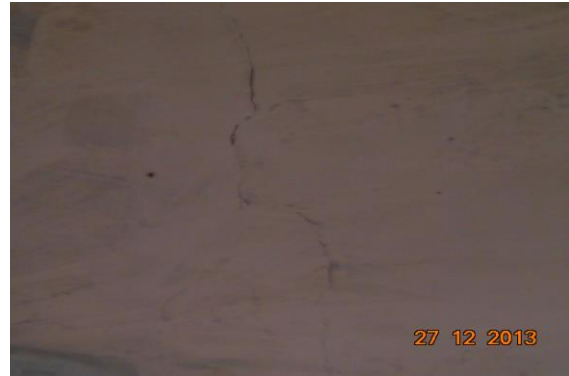
Photo 2
Horizontal Crack on Roof of Room No. 2, First Floor
Approx. Width = 0.8mm, Approx. Length = 2m.
Distance from Wall No.4 = 0m, Height from Floor = 2.1m.

Summary of Cracks						
Defect ID	Location	Orientation	Appx. Width (mm)	Appx. Length (m)	Category	Photo No.
1	Roof Room No. 2 First Floor	Horizontal	0.8	2	Very Slight	2, 2A
2	Roof Room No. 2 First Floor	Inclined	0.5	2	Very Slight	3
3	H.No.474 First Floor	Inclined	2	2	Slight	4
4	Wall No. 3 Room No. 2 First Floor	Inclined	2	1	Slight	5
5	JRoof & Entry Gate Room No. 2 First Floor	Inclined	5	2	Moderate	6
6	Wall No. 1 Lobby Second Floor	Inclined	0.3	1	Very Slight	7
7	Perapet wall Front side H.No.474 Terrace	Inclined	5	2	Moderate	8

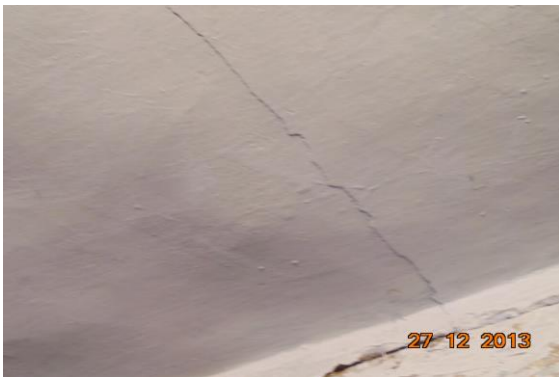
Photo 2A
Horizontal Crack on Roof of Room No. 2, First Floor
Approx. Width = 0.8mm, Approx. Length = 2m.
Distance from Wall No.4 = 0m, Height from Floor = 2.1m.

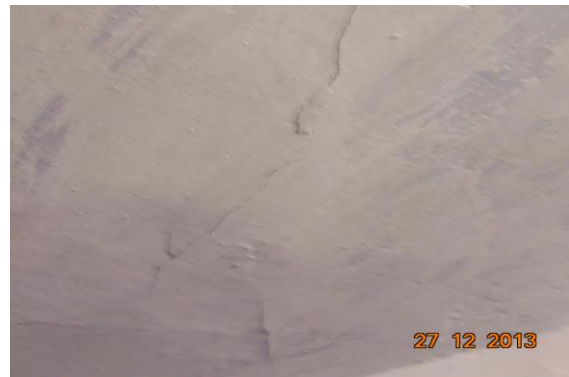
Photo 3
Inclined Crack on Roof of Room No. 2, First Floor
Approx. Width = 0.5mm, Approx. Length = 2m.

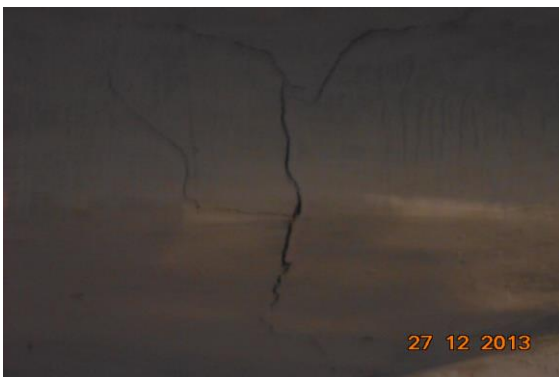
Photo 4
Inclined Crack on of H.No.474, First Floor
Approx. Width = 2mm, Approx. Length = 2m.

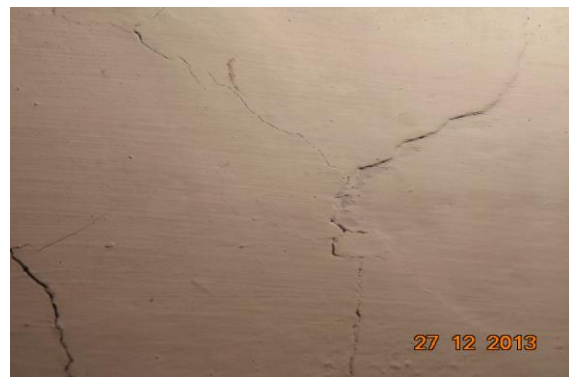
Photo 5
Inclined Crack on Wall No. 3 of Room No. 2, First Floor
Approx. Width = 2mm, Approx. Length = 1m.

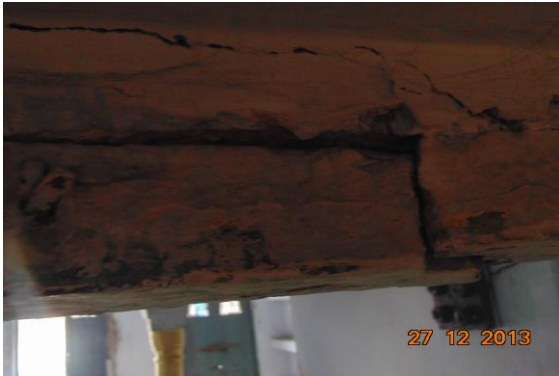
Photo 6

Inclined Crack on Roof & Entry Gate of Room No. 2, First Floor
Approx. Width = 5mm, Approx. Length = 2m.

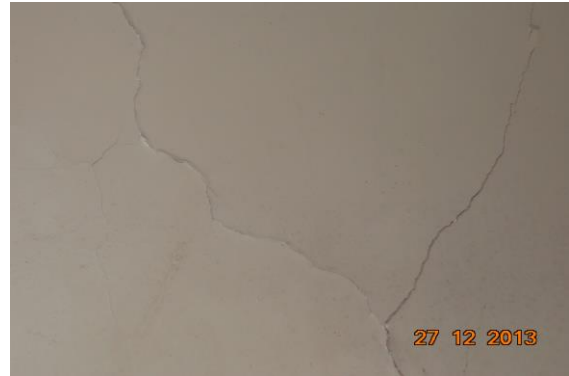
Photo 7

Inclined Crack on Wall No. 1 of Lobby, Second Floor
Approx. Width = 0.3mm, Approx. Length = 1m.

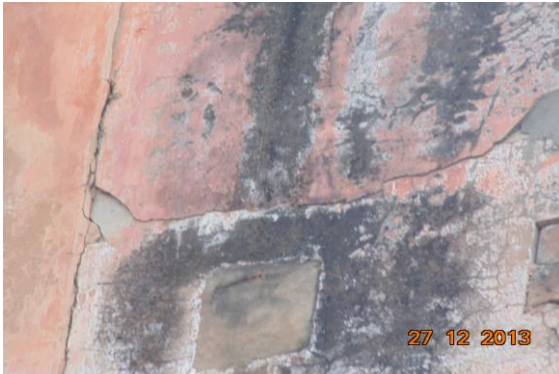
Photo 8

Inclined Crack on Perapet wall Front side of H.No.474, Terrace
Approx. Width = 5mm, Approx. Length = 2m.

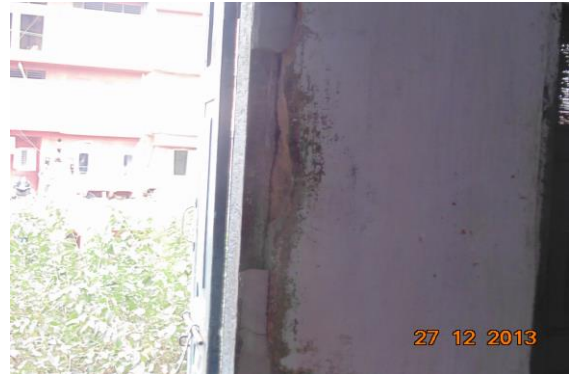
Photo 9

Peeling of Plaster on Wall No. 4 of Balcony of First Floor

Summary of Defects Other Than Crack			
Defect ID	Location	Description	Photo No.
8	Wall No. 4 Balcony First Floor	Peeling of Plaster	9
9	Roof Balcony First Floor	Peeling of Plaster	10
10	Wall No. 4 Balcony First Floor	Peeling of Plaster	11
11	Wall No. 3 & Top Pillar Balcony First Floor	Damaged Portion	12
12	Wall No. 1, 4 & Roof Lobby First Floor	Dampness/Seepage	13
13	Roof Lobby First Floor	Peeling of Plaster	14
14	Wall No. 4 Room No. 2 First Floor	Damaged Portion	15
15	Wall No. 1 Room No. 2 First Floor	Damaged Portion	16
16	Wall No. 2 Room No. 2 First Floor	Peeling of Plaster	17
17	Roof Room No. 2 First Floor	Dampness/Seepage	18
18	Wall No. 3 Room No. 2 First Floor	Damaged Portion	19
19	Wall No. 1 & 3 Room No. 2 First Floor	Damaged Portion	20
20	Roof Balcony Second Floor	Dampness/Seepage	21
21	Roof Balcony Second Floor	Dampness/Seepage	22
22	Wall No. 4 Balcony Second Floor	Dampness/Seepage	23
23	Wall No. 1 & 4 Balcony Second Floor	Dampness/Seepage	24

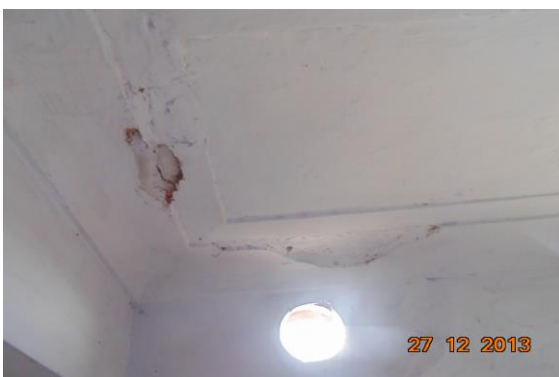
Photo 10

Peeling of Plaster on Roof of Balcony of First Floor

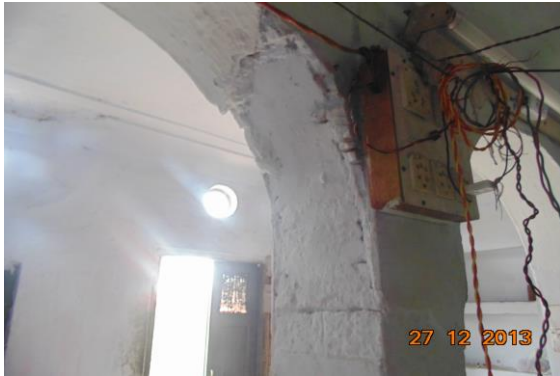
Photo 12

Damaged Portion on Wall No. 3 & Top Pillar of Balcony of First Floor

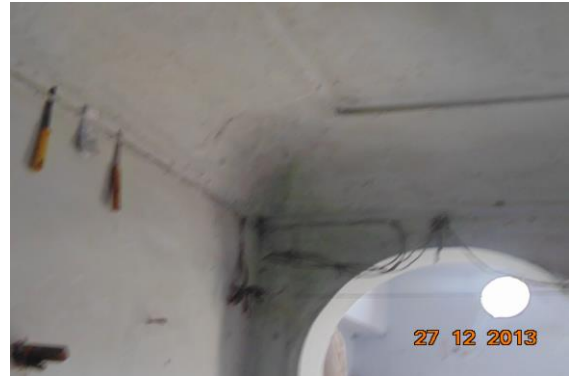
Photo 13

Dampness/Seepage on Wall No. 1, 4 & Roof of Lobby of First Floor

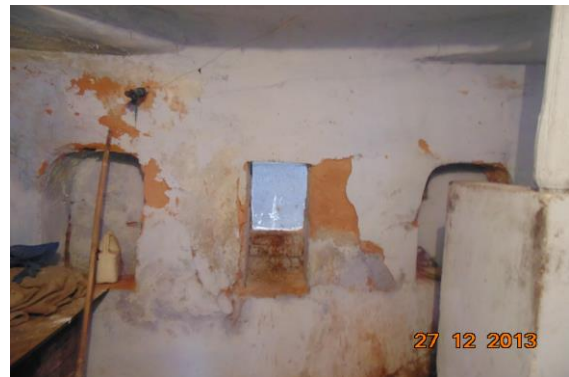
Photo 15

Damaged Portion on Wall No. 4 of Room No. 2 of First Floor

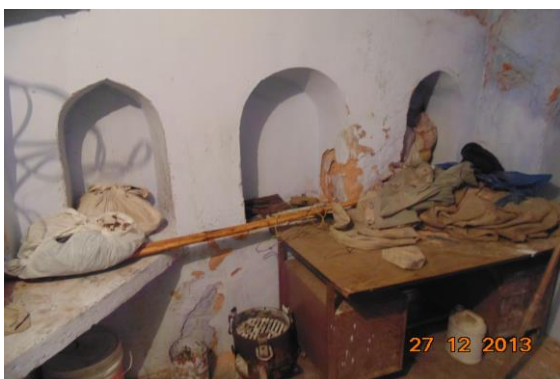
Photo 16

Damaged Portion on Wall No. 1 of Room No. 2 of First Floor

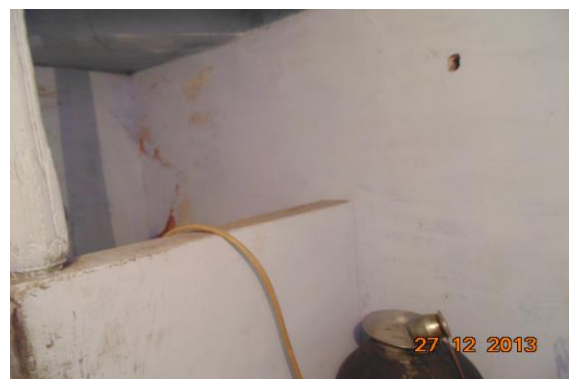
Photo 17

Peeling of Plaster on Wall No. 2 of Room No. 2 of First Floor

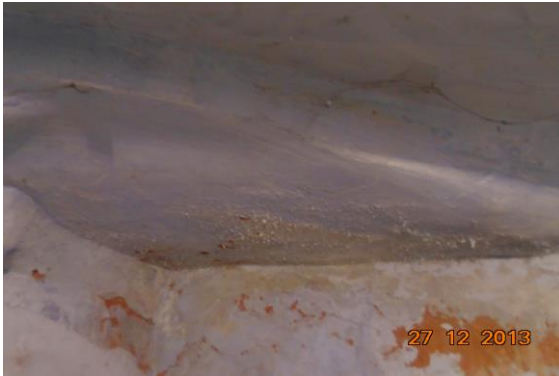
Photo 18
Dampness/Seepage on Roof of Room No. 2 of First Floor

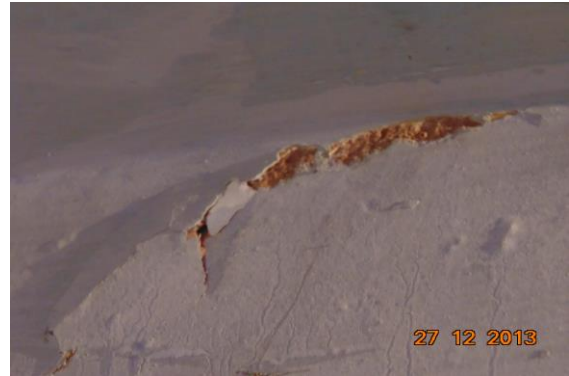
Photo 19
Damaged Portion on Wall No. 3 of Room No. 2 of First Floor

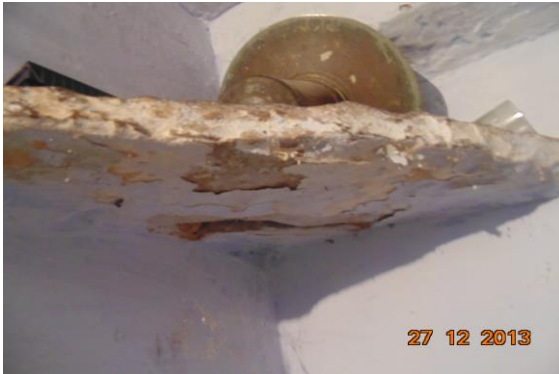
Photo 20
Damaged Portion on Wall No. 1 & 3 of Room No. 2 of First Floor

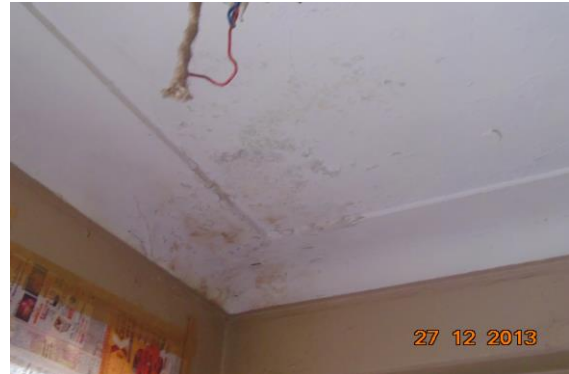
Photo 21
Dampness/Seepage on Roof of Balcony of Second Floor

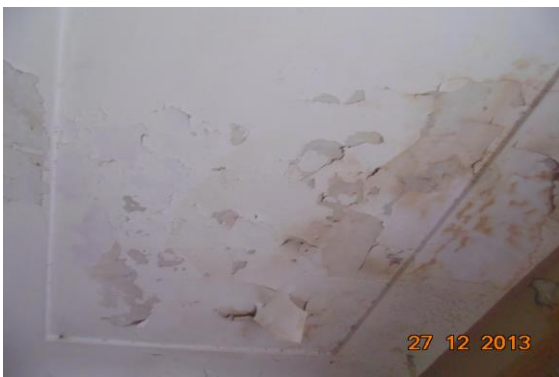
Photo 22
Dampness/Seepage on Roof of Balcony of Second Floor

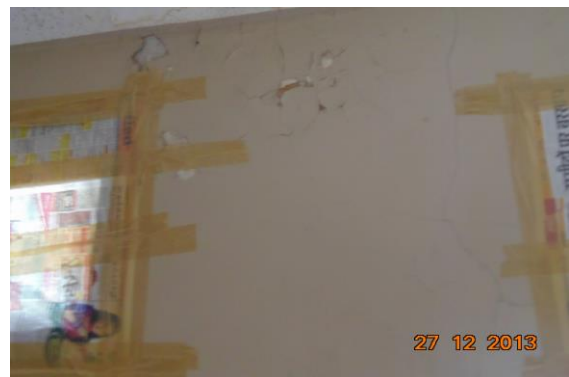
Photo 23
Dampness/Seepage on Wall No. 4 of Balcony of Second Floor

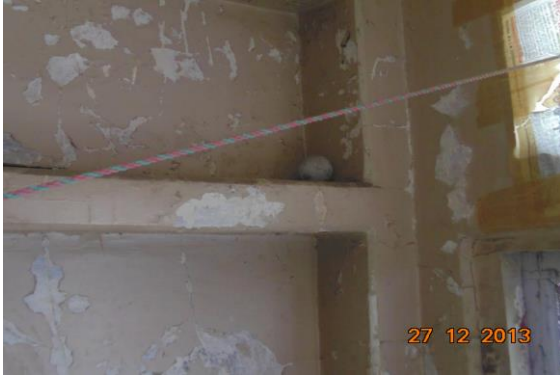
Photo 24

Dampness/Seepage on Wall No. 1 & 4 of Balcony of Second Floor

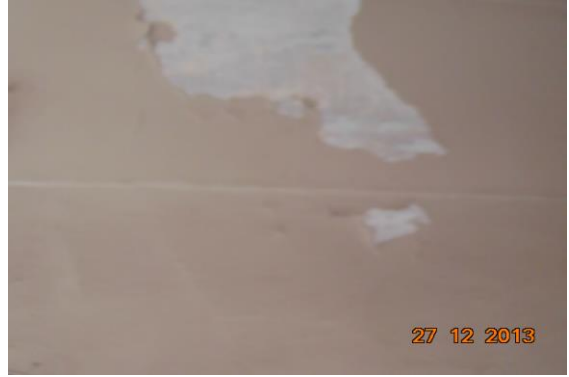
Photo 25

Dampness/Seepage on Wall No. 3 of Balcony of Second Floor

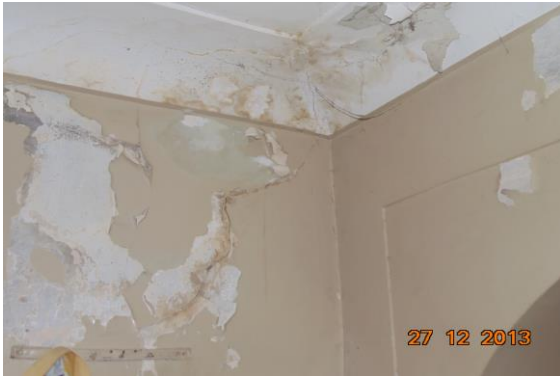
Photo 26

Dampness/Seepage on Wall No. 1, 4 & Roof of Lobby of Second Floor

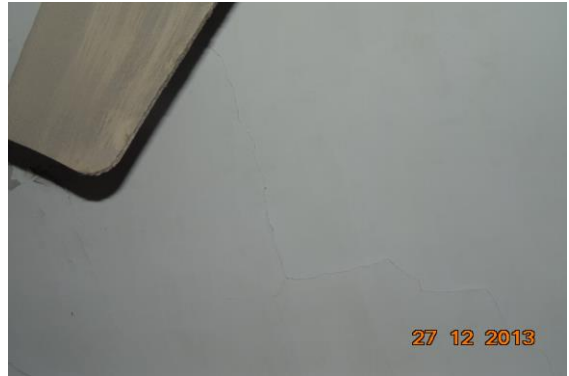
Photo 27

Dampness/Seepage on Wall No. 1, 4 & Roof of Lobby of Second Floor

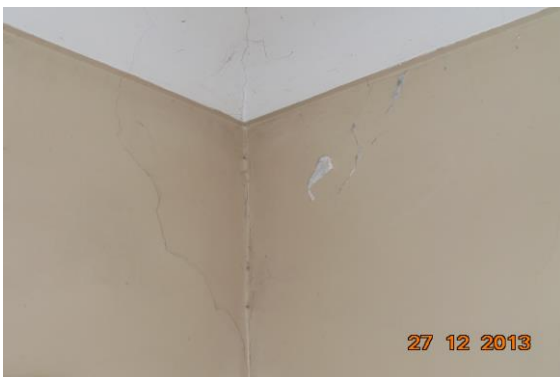
Photo 28

Peeling of Plaster on Wall No. 1 & 4 of Lobby of Second Floor

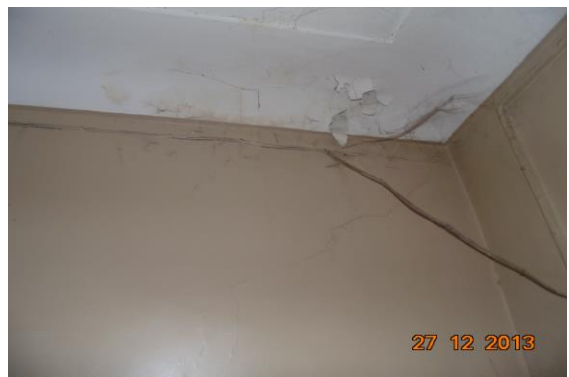
Photo 29

Peeling of Plaster on Wall No. 3 & Roof of Lobby of Second Floor

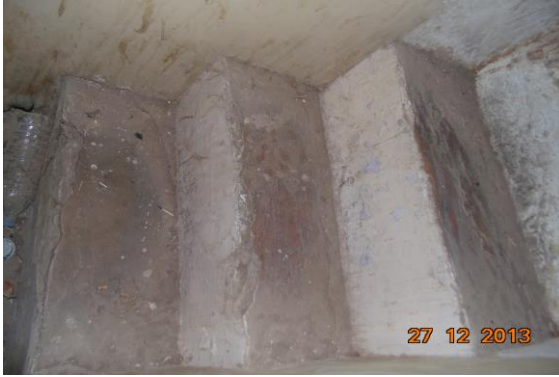
Photo 30
Damaged Portion on Steps of Staircase SF to Terrace of Terrace

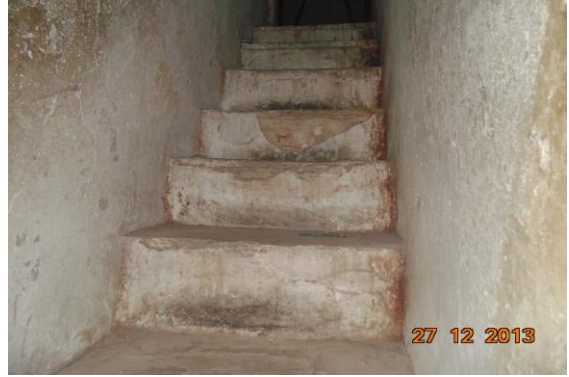
Photo 31
Damaged Portion on Steps of Staircase SF to Terrace of

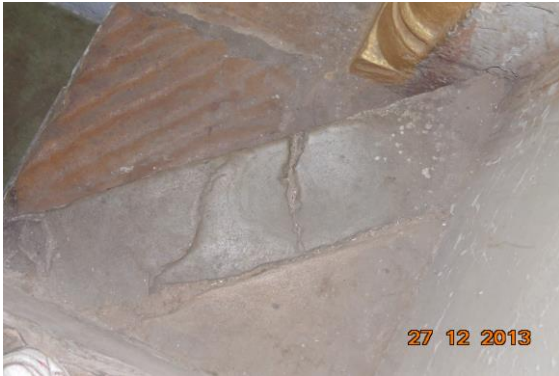
Photo 32
Damaged Portion on Steps of Staircase FF to SF of First Floor

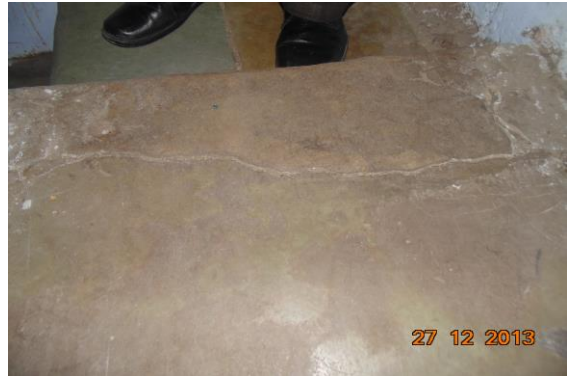
Photo 33
Damaged Portion on Floor & Entry Gate of Lobby of First Floor

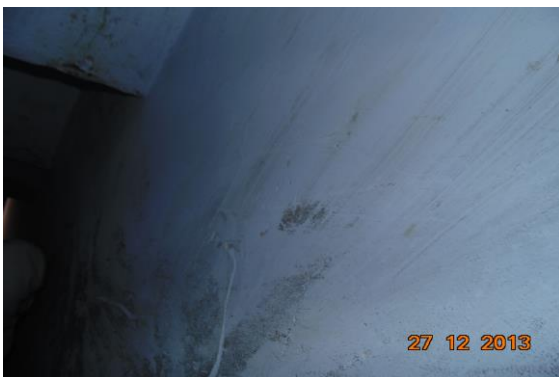
Photo 34
Peeling of Plaster on Wall No. 1 of Staircase GF to FF of First Floor

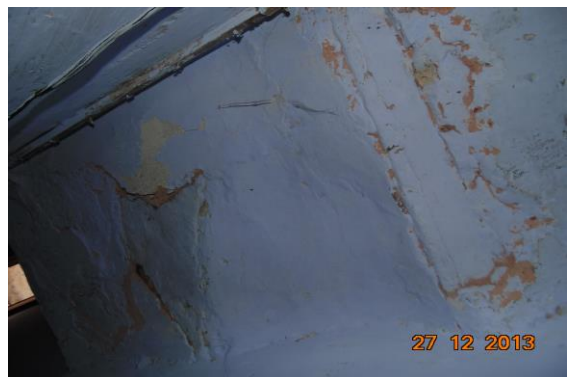
Photo 35
Damaged Portion on Roof of Staircase GF to FF of First Floor

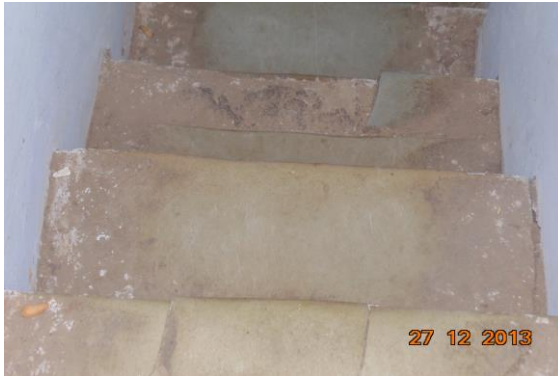
Photo 36

Peeling of Plaster on Steps of Staircase GF to FF of First Floor

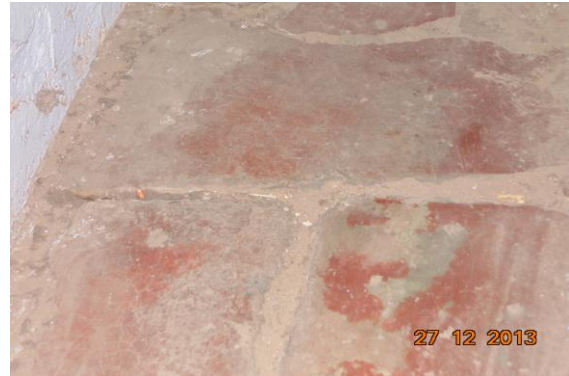
Photo 37

Peeling of Plaster on Steps of Staircase GF to FF of First Floor

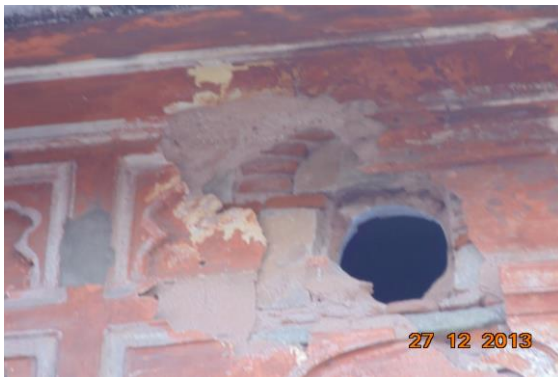
Photo 38

Damaged Portion on Outer front Wall of H.No.474 of First Floor

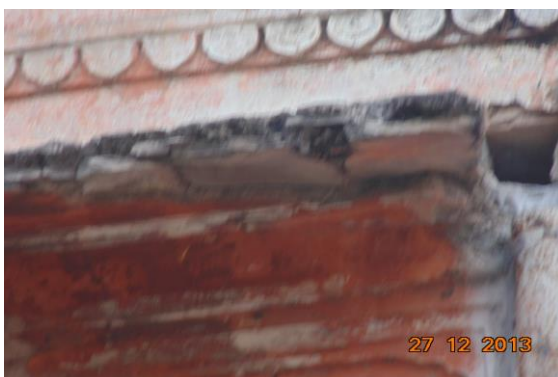
Photo 39

Damaged Portion on Front Wall shade of H.No.474 of Second Floor

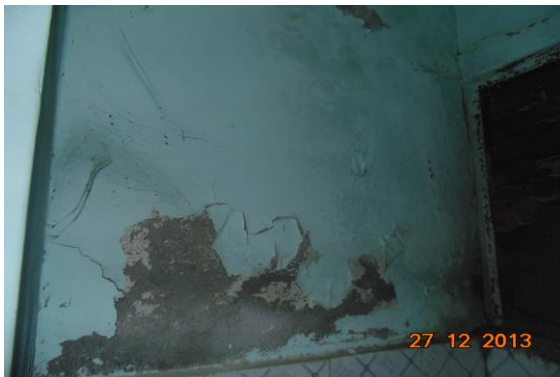
Photo 3
Dampness/Seepage on Wall No. 1 of Toilet No. 1 of House No.472, Second floor

Summary of Defects Other Than Crack			
Defect ID	Location	Description	Photo No.
1	Wall No. 1 Toilet No. 1 House No.472,Second floor	Dampness/Seepage	3
2	Roof Lobby of House No.472 Second floor	Peeling of Plaster	4
3	Wall No. 3 Lobby of House No.472 Second floor	Peeling of Plaster	5
4	Wall No. 2 Lobby of House No.472 Second floor	Dampness/Seepage	6
5	Wall No. 4 Lobby of House No.472 Second floor	Dampness/Seepage	7
6	Wall No. 1 Room No. 1 House No.472,Second floor	Dampness/Seepage	8
7	Wall No. 2 Room No. 1 House No.472,Second floor	Peeling of Plaster	9
8	Wall No. 2 & 4 Balcony of House No.472 Second floor	Dampness/Seepage	10
9	Varanda, Left External Col Shop No. 54, Ground Floor	Damaged Portion	11
10	Roof Varanda Shop No. 54, Ground Floor	Dampness/Seepage	12

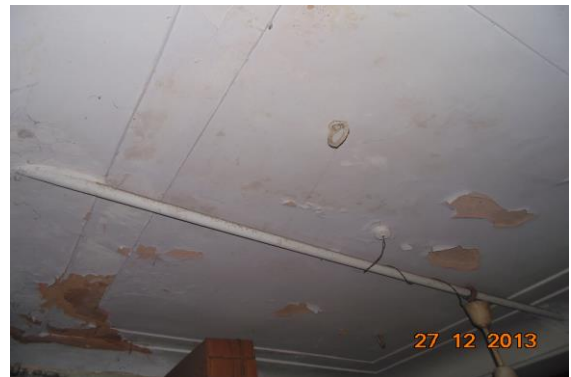
Photo 4
Peeling of Plaster on Roof of Lobby of House No.472 of Second floor

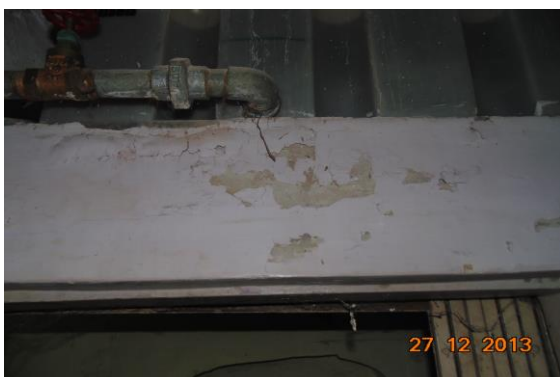
Photo 5
Peeling of Plaster on Wall No. 3 of Lobby of House No.472 of Second floor

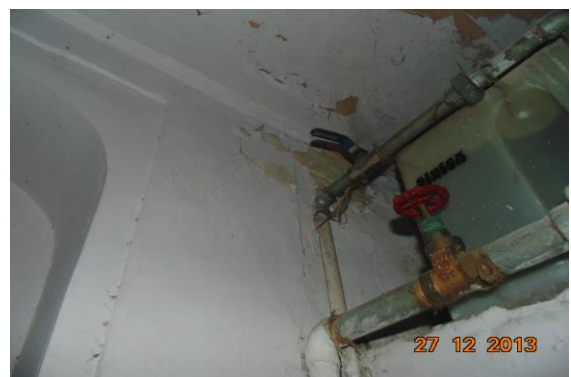
Photo 6
Dampness/Seepage on Wall No. 2 of Lobby of House No.472 of Second floor

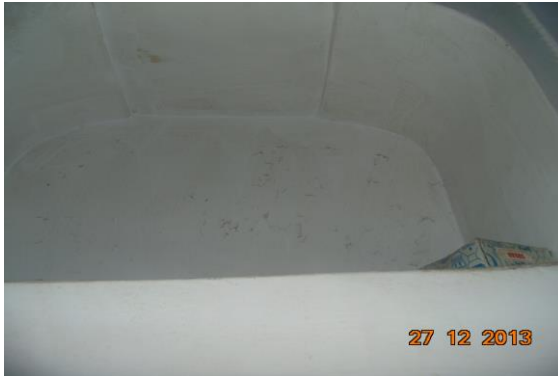
Photo 7

Dampness/Seepage on Wall No. 4 of Lobby of House No.472 of Second floor

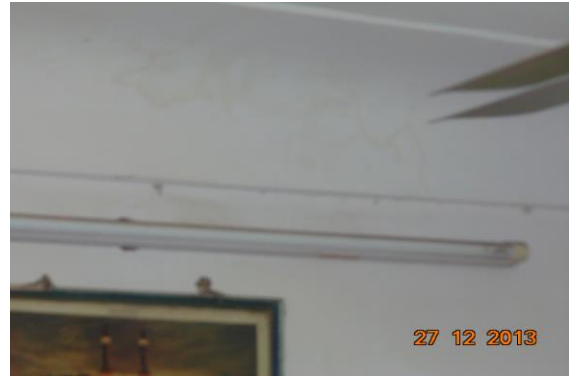
Photo 8

Dampness/Seepage on Wall No. 1 of Room No. 1 of House No.472, Second floor

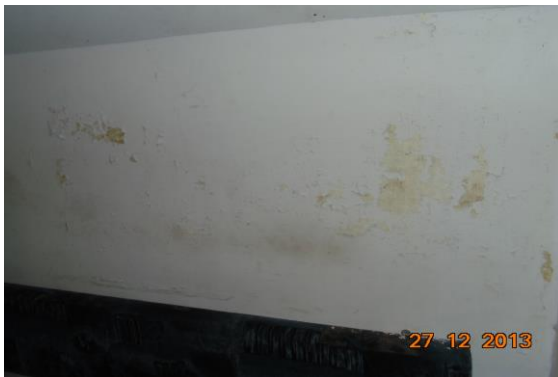
Photo 9

Peeling of Plaster on Wall No. 2 of Room No. 1 of House No.472, Second floor

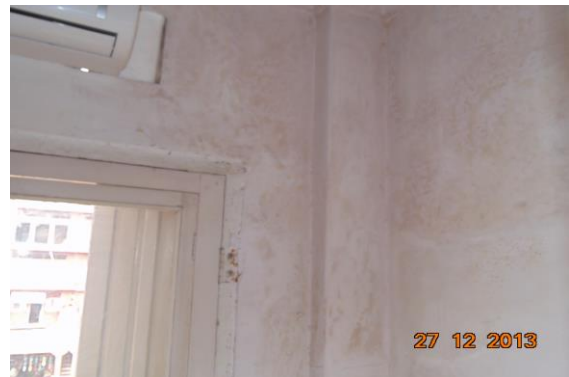
Photo 10

Dampness/Seepage on Wall No. 2 & 4 of Balcony of House No.472 of Second floor

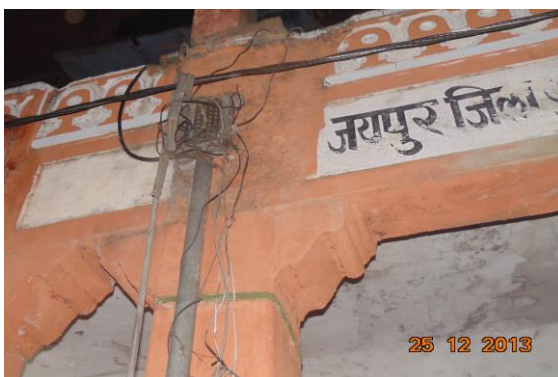
Photo 11

Damaged Portion on Varanda, Left External Col of Shop No. 54, Ground Floor

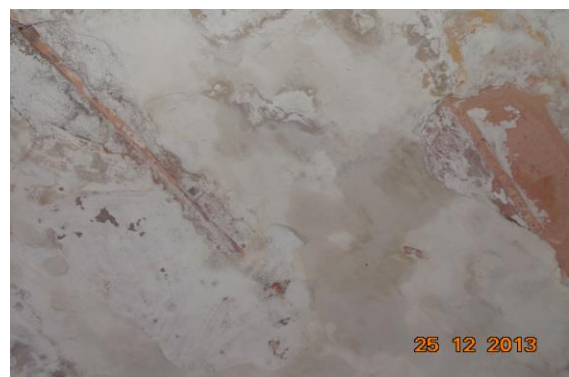
Photo 12

Dampness/Seepage on Roof of Varanda of Shop No. 54, Ground Floor

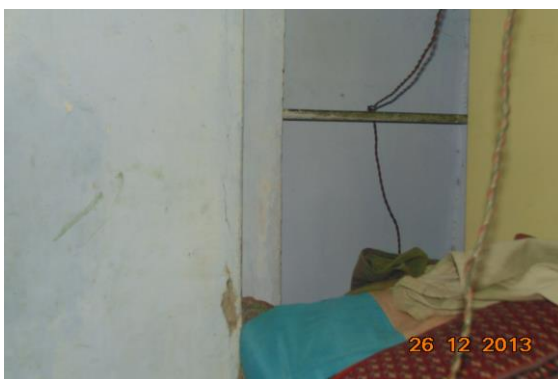
Photo 5
Peeling of Plaster on Room No. 1 of First Floor

Summary of Defects Other Than Crack			
Defect ID	Location	Description	Photo No.
1	Room No. 1 First Floor	Peeling of Plaster	5
2	Wall No. 4 & Roof Room No. 2 First Floor	Peeling of Plaster	6
3	Roof Passage First Floor	Dampness/Seepage	7
4	Roof Passage First Floor	Dampness/Seepage	8
5	Wall No. 1 Passage First Floor	Dampness/Seepage	9
6	Roof Room No. 2 Second Floor	Peeling of Plaster	10
7	Wall No. 4 & Roof Passage Second Floor	Dampness/Seepage	11
8	Wall No. 4 & Roof Passage Second Floor	Dampness/Seepage	12
9	Roof Room No. 1 Third Floor	Dampness/Seepage	13
10	Wall No. 2 Room No. 1 Third Floor	Dampness/Seepage	14
11	Wall No. 3 Room No. 1 Third Floor	Dampness/Seepage	15
12	Wall No. 4 Room No. 1 Third Floor	Dampness/Seepage	16
13	Roof Room No. 2 Third Floor	Dampness/Seepage	17
14	Wall No. 1 & 4 Room No. 2 Third Floor	Dampness/Seepage	18
15	Wall No. 2, 4 & Roof Toilet No. 1 Third Floor	Dampness/Seepage	19
16	Wall No. 1, 2, 4 & Roof Bathroom No. 1 Third Floor	Dampness/Seepage	20

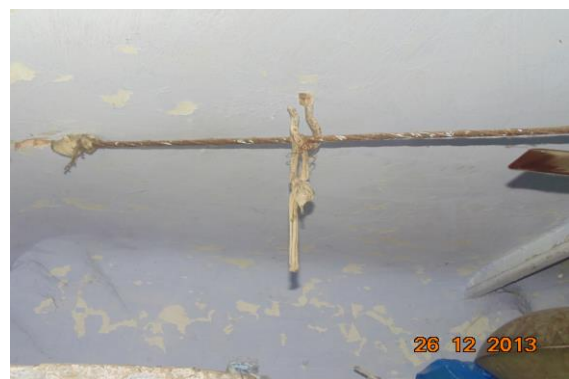
Photo 6
Peeling of Plaster on Wall No. 4 & Roof of Room No. 2 of First Floor

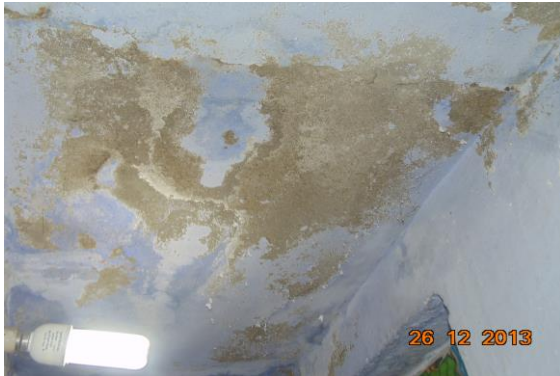
Photo 7
Dampness/Seepage on Roof of Passage of First Floor

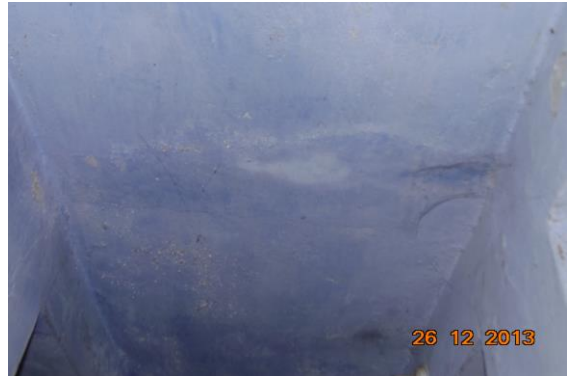
Photo 8
Dampness/Seepage on Roof of Passage of First Floor

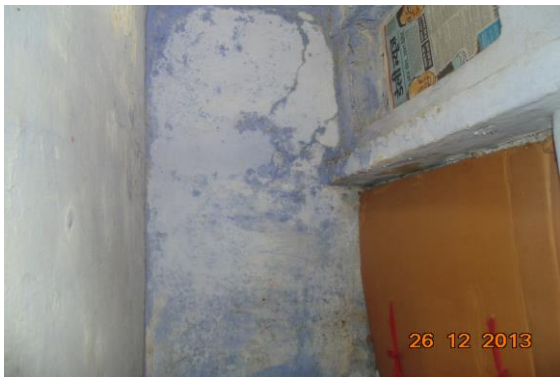
Photo 9
Dampness/Seepage on Wall No. 1 of Passage of First Floor

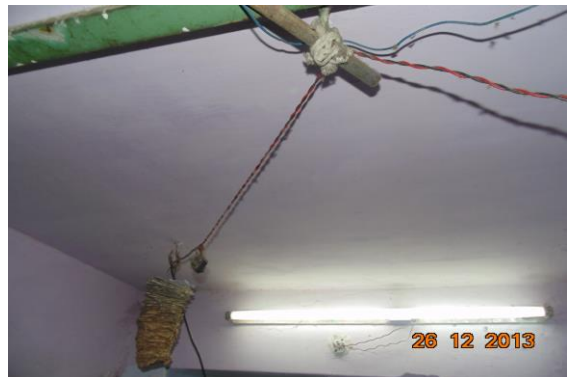
Photo 10
Peeling of Plaster on Roof of Room No. 2 of Second Floor

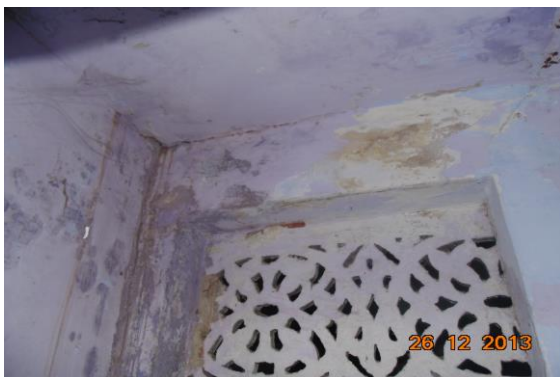
Photo 11
Dampness/Seepage on Wall No. 4 & Roof of Passage of Second Floor

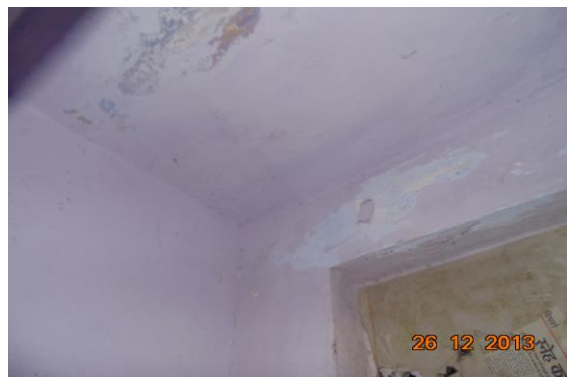
Photo 12
Dampness/Seepage on Wall No. 4 & Roof of Passage of Second Floor

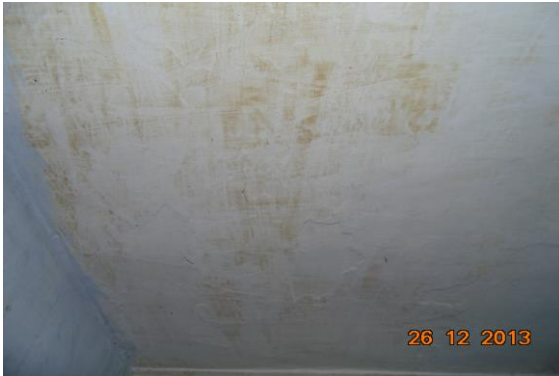
Photo 13
Dampness/Seepage on Roof of Room No. 1 of Third Floor

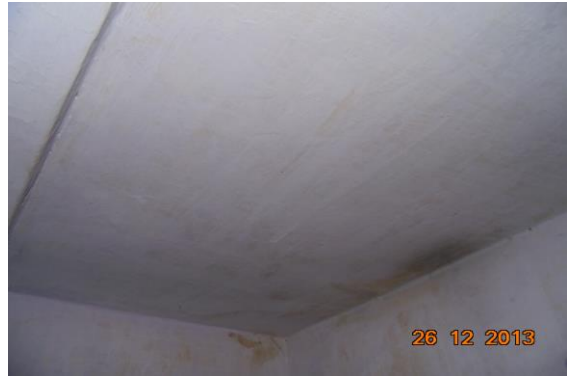
Photo 14
Dampness/Seepage on Wall No. 2 of Room No. 1 of Third Floor

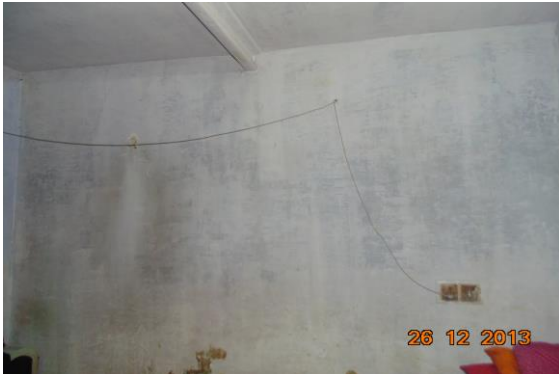
Photo 15
Dampness/Seepage on Wall No. 3 of Room No. 1 of Third Floor

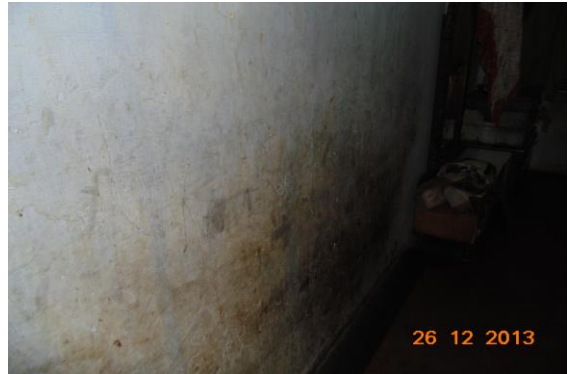
Photo 16
Dampness/Seepage on Wall No. 4 of Room No. 1 of Third Floor

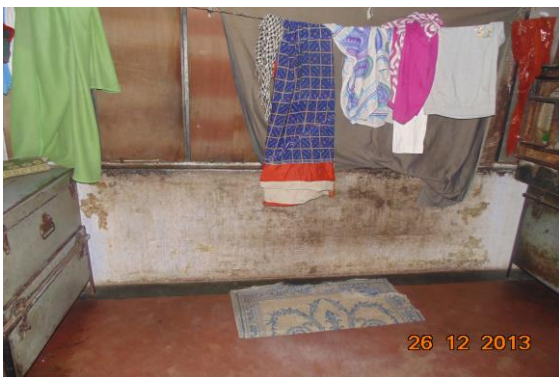
Photo 17
Dampness/Seepage on Roof of Room No. 2 of Third Floor

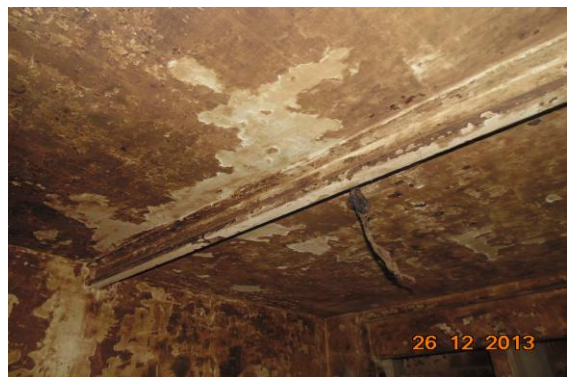
Photo 18
Dampness/Seepage on Wall No. 1 & 4 of Room No. 2 of Third Floor

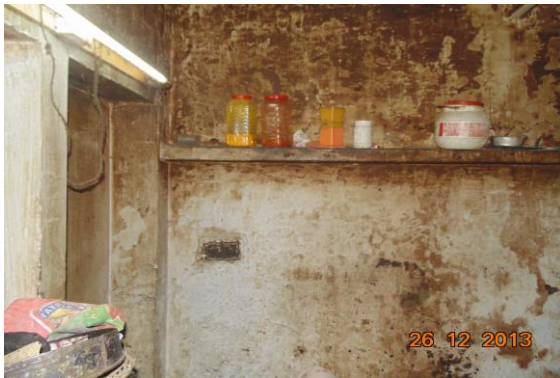
Photo 19

Dampness/Seepage on Wall No. 2, 4 & Roof of Toilet No. 1 of Third Floor

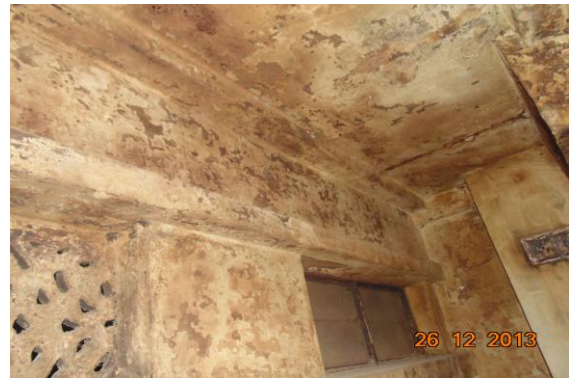
Photo 20

Dampness/Seepage on Wall No. 1, 2, 4 & Roof of Bathroom No. 1 of Third Floor

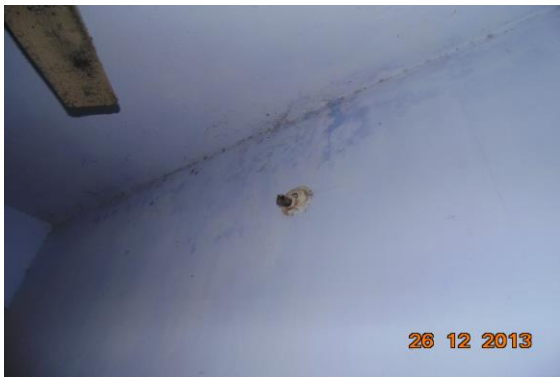
Photo 21

Dampness/Seepage on Wall No. 3 of Room No. 2 of Fourth Floor

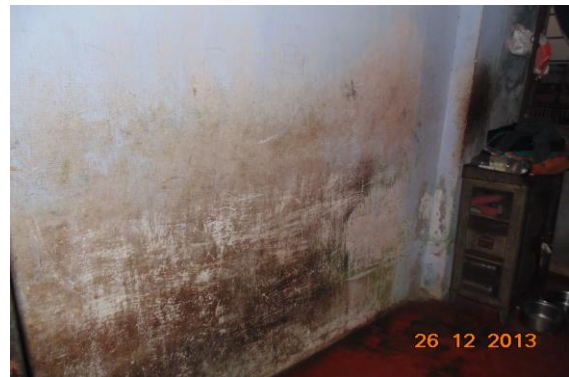
Photo 22

Dampness/Seepage on Wall No. 4 of Room No. 2 of Fourth Floor

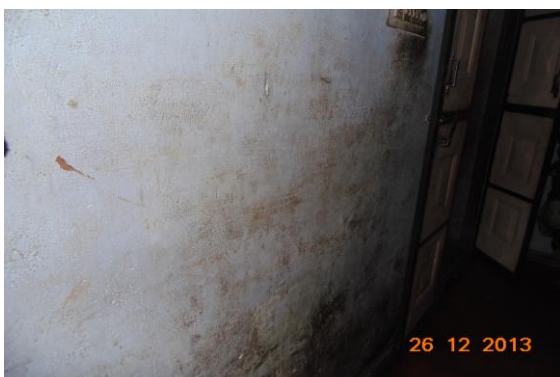
Photo 23

Dampness/Seepage on Wall No. 3 of Room No. 2 of Fourth Floor

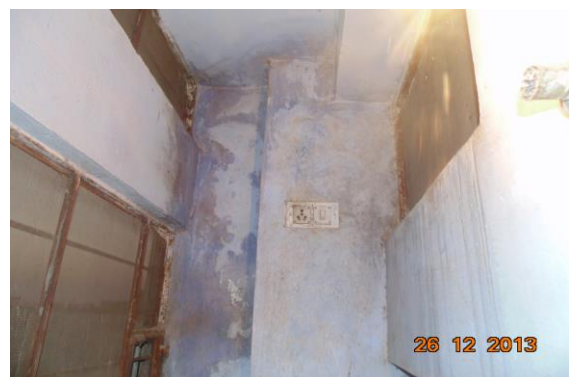
Photo 24

Dampness/Seepage on Wall No. 2 of Toilet No. 2 of Fourth Floor

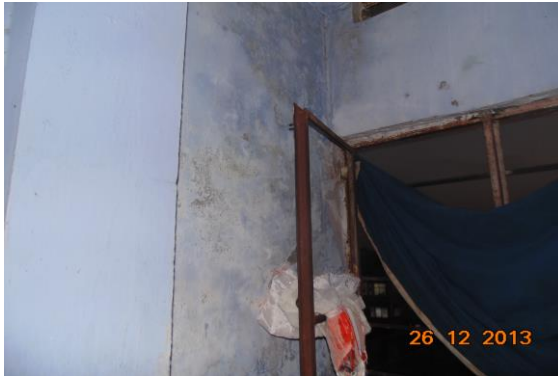
Photo 25
Dampness/Seepage on Wall No. 1 of Kitchen of Fourth Floor

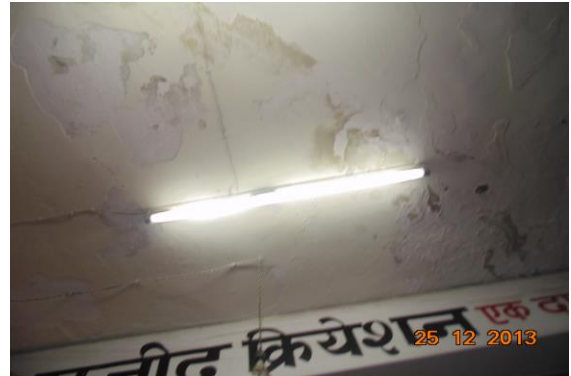
Photo 26
Dampness/Seepage on Roof of Varanda of Shop No. 55, Ground Floor

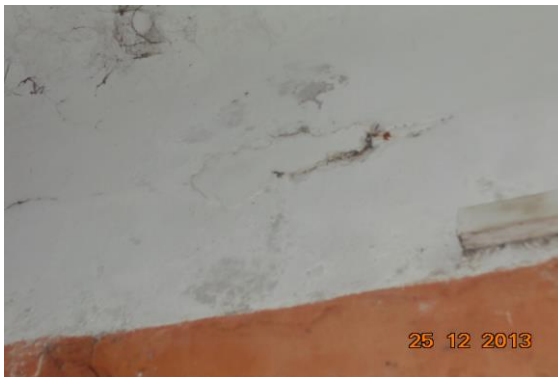
Photo 27
Peeling of Plaster on Beam of Varanda of Shop No. 55, Ground Floor

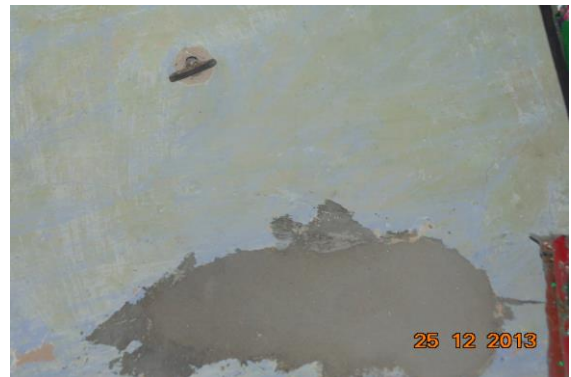
Photo 28
Peeling of Plaster on Roof of Shop No. 55 of Ground Floor

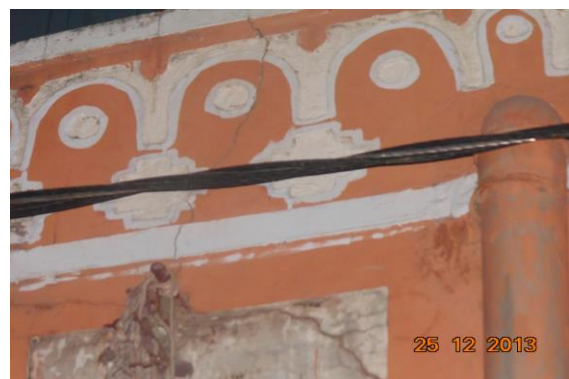
Photo 6
Inclined Crack on Beam of Varanda, Shop No. 56, Ground Floor, Approx.
Width = 1mm, Approx. Length = 1m.
Distance from Left External Col = 0m, Height from Floor = 3m.

Summary of Cracks						
Defect ID	Location	Orientation	Appx. Width (mm)	Appx. Length (m)	Category	Photo No.
1	Beam Varanda Shop No. 56, Ground Floor	Inclined	1	1	Slight	6
2	Roof Varanda Shop No. 56, Ground Floor	Inclined	2	5	Slight	7
3	Roof Varanda Shop No. 56, Ground Floor	Inclined	2	5	Slight	8
4	Wall No. 2 Shop No. 56 Ground Floor	Inclined	1	3	Slight	9

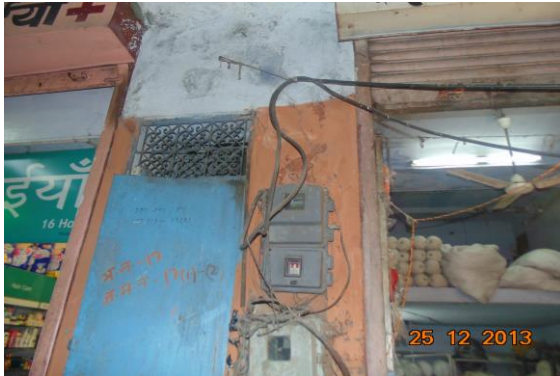
Photo 7

Inclined Crack on Roof of Varanda, Shop No. 56, Ground Floor, Approx.
Width = 2mm, Approx. Length = 5m.
Distance from Left Internal Col = 0m, Height from Floor = 0m.

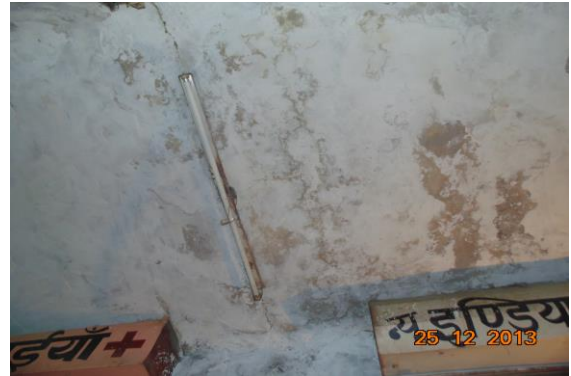
Photo 8

Inclined Crack on Roof of Varanda, Shop No. 56, Ground Floor, Approx.
Width = 2mm, Approx. Length = 5m.
Distance from Left Internal Col = 0m, Height from Floor = 0m.

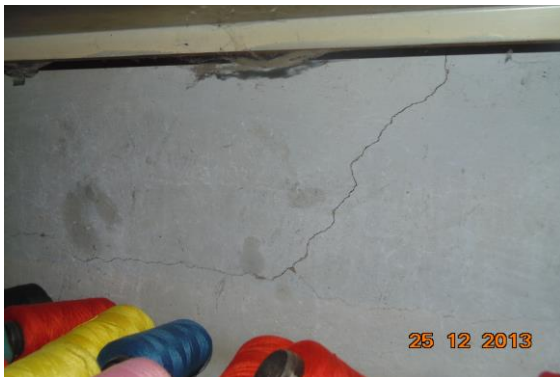
Photo 9

Inclined Crack on Wall No. 2 of Shop No. 56, Ground Floor, Approx.
Width = 1mm, Approx. Length = 3m.
Distance from Wall No. 3 = 0.6m, Height from Floor = 0.9m.
