Pre Building Condition Survey Report

Name and Address of Structure :	Badi Chopar to Ramp Area (Down Line)
---------------------------------	--------------------------------------

Name of the Project	Contract JMRC-UG1B “Design and Construction of Tunnel between Chandpole and Badi Chouper and reverse line by Shield TBM, Underground Metro Stations at Choti Chouper and Badi Chouper by Cut and Cover Methods on East West Corridor of Jaipur Metro Rail Corporation Limited .”	
Owner :

Pre - Condition Building Survey for Construction of Underground Stations from Chandpole to Bari Chouper and reversal line

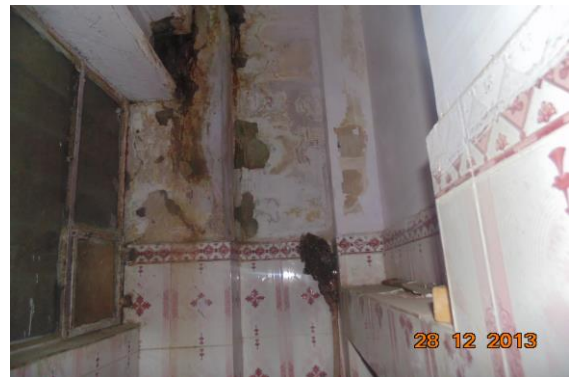
Photo 10

Dampness/Seepage on Wall No. 2 of Toilet No. 1 of House No. 468, First Floor

Summary of Defects Other Than Crack			
Defect ID	Location	Description	Photo No.
5	Wall No. 2 Toilet No. 1 House No. 468, First Floor	Dampness/Seepage	10
6	Wall No. 2, 4 & Roof Stair Case FF-SF of House No. 468 First Floor	Dampness/Seepage	11
7	Shade Balcony of House No. 468 Second Floor	Peeling of Plaster	12
8	Wall No. 2 Toilet No. 1 House No. 468, Second Floor	Dampness/Seepage	13
9	Wall No. 2, 3 & Roof Stair Case FF-SF of House No. 468 Second Floor	Dampness/Seepage	14
10	Wall No. 1, 4 & Roof Passage Of House No. 468 Second Floor	Dampness/Seepage	15
11	Wall No. 4 Stair Case TF-4Th F of House No. 468 Third Floor	Dampness/Seepage	16
12	Roof Passage Of House No. 468 4th Floor	Peeling of Plaster	17
13	Wall No. 2, 4 & Roof Stair Case 4th F-Terrace of House No. 468 4th Floor	Dampness/Seepage	18
14	Wall No. 2 Stair Case 4th F-Terrace of House No. 468 4th Floor	Dampness/Seepage	19
15	Wall No. 1, 2 & Roof Passage of House No. 468 Terrace	Dampness/Seepage	20

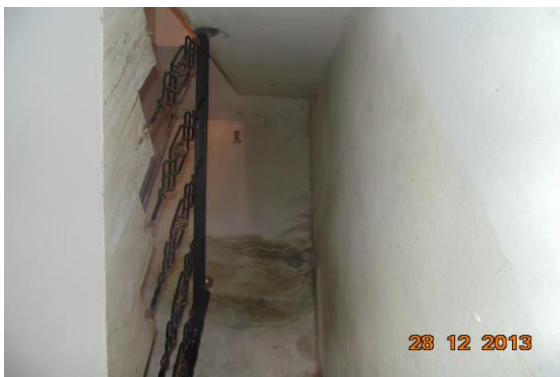
Photo 11

Dampness/Seepage on Wall No. 2, 4 & Roof of Stair Case FF-SF of House No. 468 of First Floor

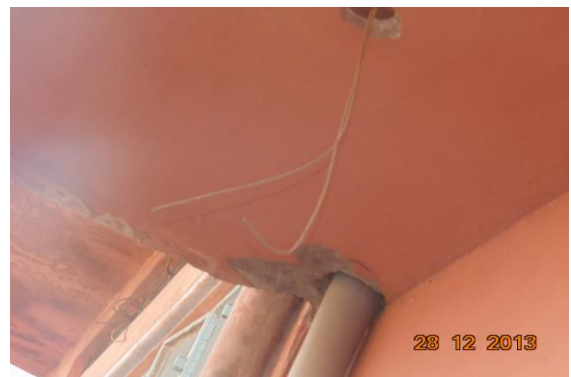
Photo 12

Peeling of Plaster on Shade of Balcony of House No. 468 of Second Floor

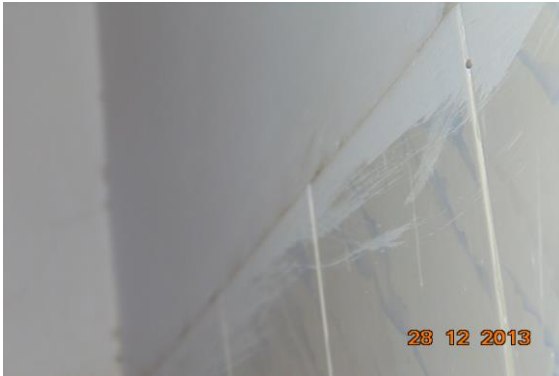
Photo 13

Dampness/Seepage on Wall No. 2 of Toilet No. 1 of House No. 468, Second Floor

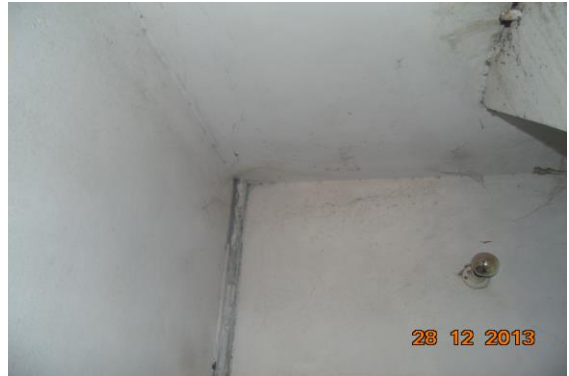
Photo 14

Dampness/Seepage on Wall No. 2, 3 & Roof of Stair Case FF-SF of House No. 468 of Second Floor

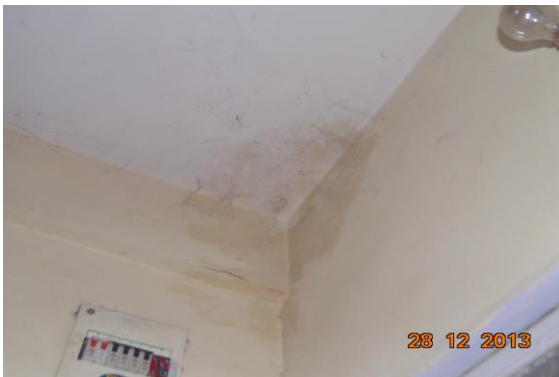
Photo 15

Dampness/Seepage on Wall No. 1, 4 & Roof of Passage Of House No. 468 of Second Floor

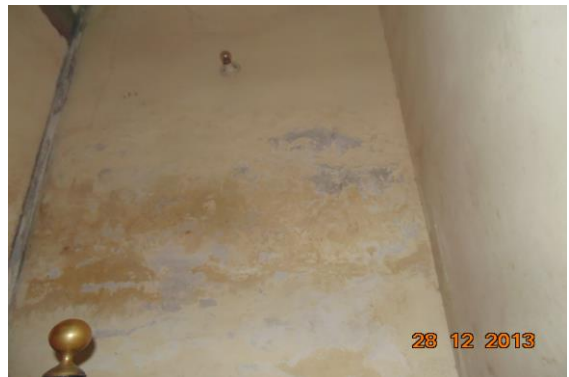
Photo 16

Dampness/Seepage on Wall No. 4 of Stair Case TF-4Th F of House No. 468 of Third Floor

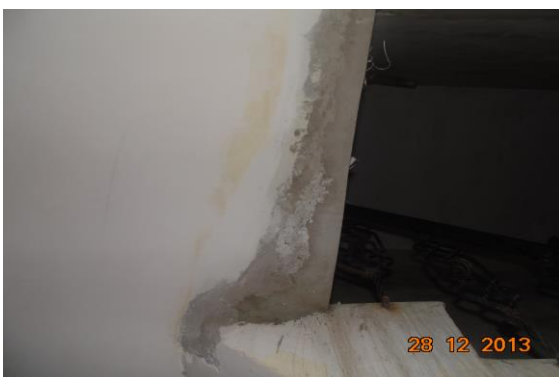
Photo 17

Peeling of Plaster on Roof of Passage of House No. 468 of 4th Floor

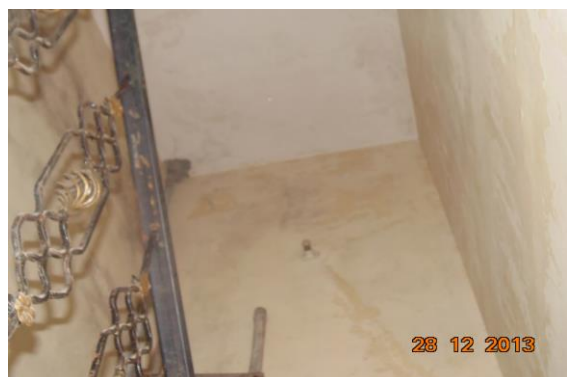
Photo 18

Dampness/Seepage on Wall No. 2, 4 & Roof of Stair Case 4th F-Terrace of House No. 468 of 4th Floor

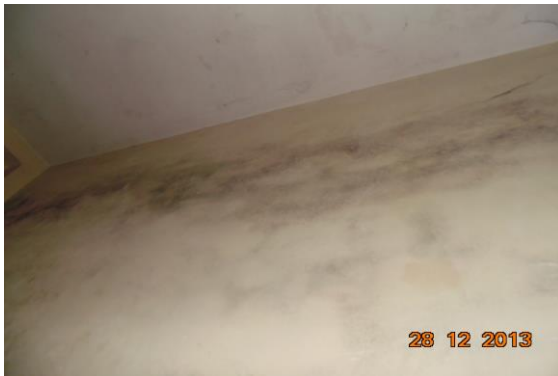
Photo 19

Dampness/Seepage on Wall No. 2 of Stair Case 4th F-Terrace of House No. 468 of 4th Floor

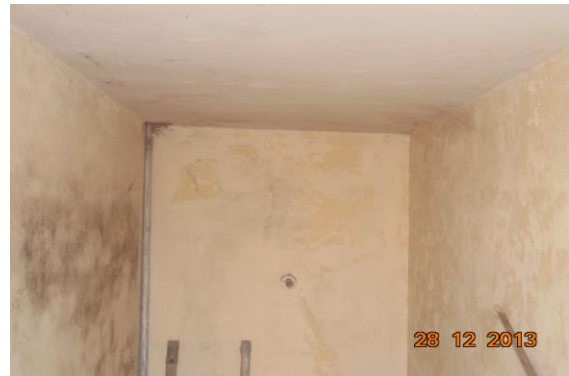
Photo 20

Dampness/Seepage on Wall No. 1, 2 & Roof of Passage of House No. 468 of Terrace

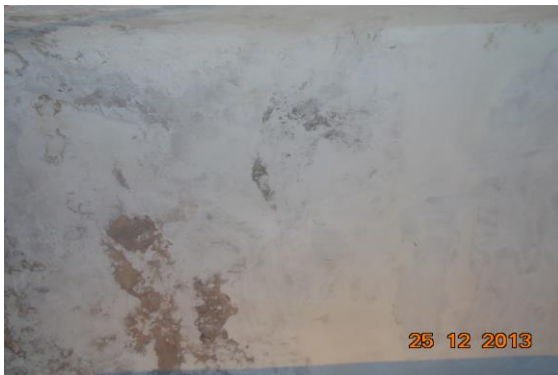
Photo 21

Dampness/Seepage on Roof of Varanda of Shop No. 56, Ground Floor

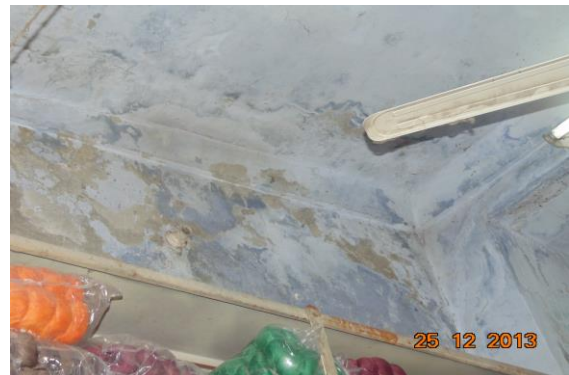
Photo 22

Dampness/Seepage on Roof & 1 of Shop No. 56 of Ground Floor

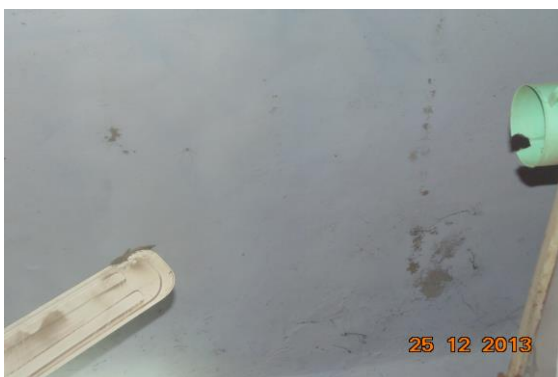
Photo 23

Peeling of Plaster on Roof of Shop No. 56 of Ground Floor

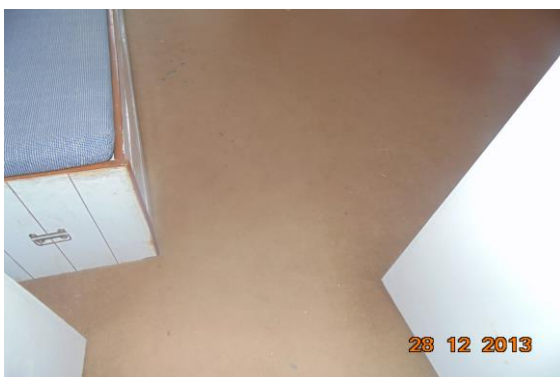
Photo 28

All Wall of Room No. 2 of House No. 468, First Floor 1/3 Portion Covered With Material

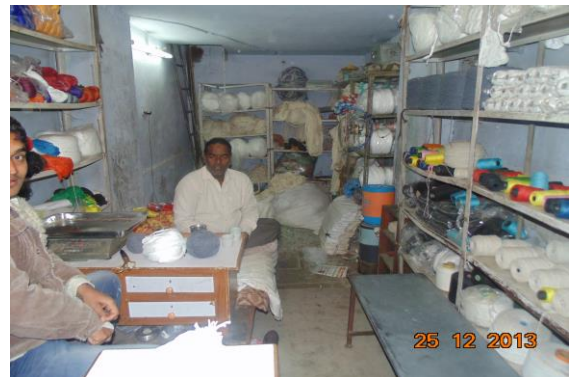
Photo 34
All Walls of Shop No. 56 of Ground Floor Covered with Material

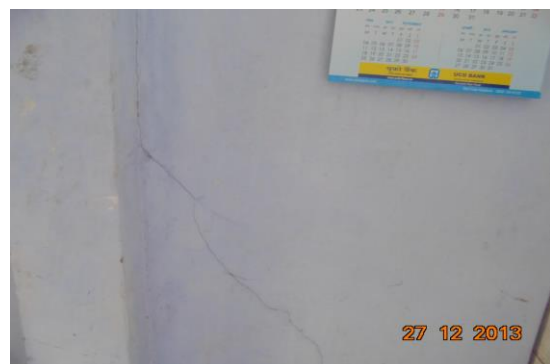
Photo 6
Inclined Crack on Wall No. 3 of Hall No. 1, First Floor
Approx. Width = 0.5mm, Approx. Length = 2m.
Distance from Wall no.1 = 3m, Height from Floor = 0.15m.

Summary of Cracks						
Defect ID	Location	Orientation	Appx. Width (mm)	Appx. Length (m)	Category	Photo No.
1	Wall No. 3 Hall No. 1 First Floor	Inclined	0.5	2	Very Slight	6, 6A
2	Wall No. 3 Hall No. 1 First Floor	Inclined	0.25	0.7	Very Slight	7, 7A
3	Roof Hall No. 1 First Floor	Inclined	0.5	2	Very Slight	8
4	Wall No. 3 Hall No. 1 First Floor	Inclined	0.5	2	Very Slight	9
5	Wall No. 4 Toilet No. 1 First Floor	Inclined	1	3	Slight	10
6	Wall No. 2 Room No. 1 Second Floor	Inclined	2	3	Slight	11
7	Wall No. 2 Room No. 2 Second Floor	Inclined	0.6	0.7	Very Slight	12, 12A
8	Wall No. 2 Room No. 2 Second Floor	Inclined	0.5	2	Very Slight	13
9	Wall No. 2 Room No. 2 Second Floor	Inclined	1	2	Slight	14
10	Roof Room No. 4 Third Floor	Inclined	1	2	Slight	15
11	Staircase Fourth to Fifth Floor	Inclined	1	1.5	Slight	16, 16A
12	Staircase Fourth to Fifth Floor	Inclined	1	3	Slight	17
13	Roof Room No. 1 Fifth Floor	Inclined	0.6	2	Very Slight	18

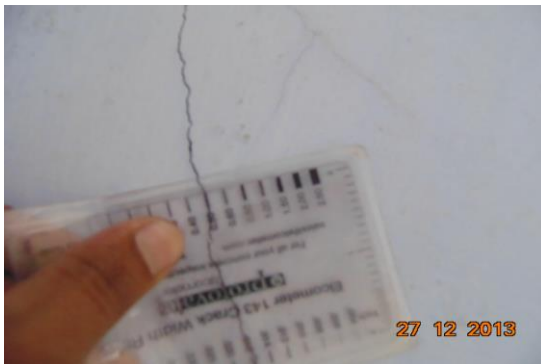
Photo 6A

Inclined Crack on Wall No. 3 of Hall No. 1, First Floor
Approx. Width = 0.5mm, Approx. Length = 2m.
Distance from Wall no.1 = 3m, Height from Floor = 0.15m.

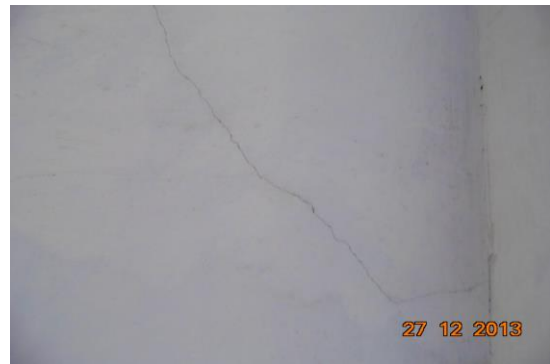
Photo 7

Inclined Crack on Wall No. 3 of Hall No. 1, First Floor
Approx. Width = 0.25mm, Approx. Length = 0.7m.
Distance from Wall No.1 = 3.6m, Height from Floor = 1.6m.

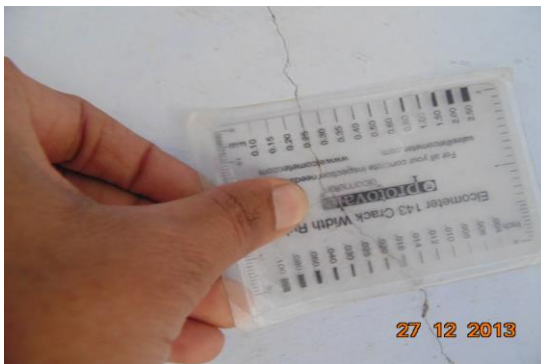
Photo 7A

Inclined Crack on Wall No. 3 of Hall No. 1, First Floor
Approx. Width = 0.25mm, Approx. Length = 0.7m.
Distance from Wall No.1 = 3.6m, Height from Floor = 1.6m.

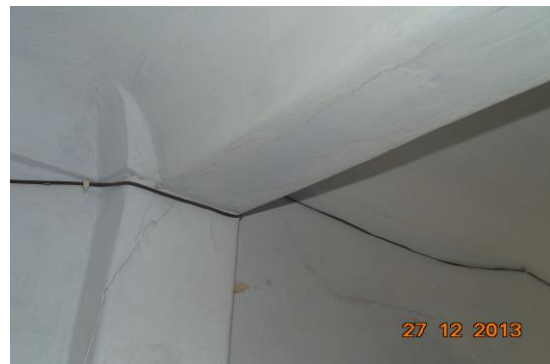
Photo 8

Inclined Crack on Roof of Hall No. 1, First Floor
Approx. Width = 0.5mm, Approx. Length = 2m.

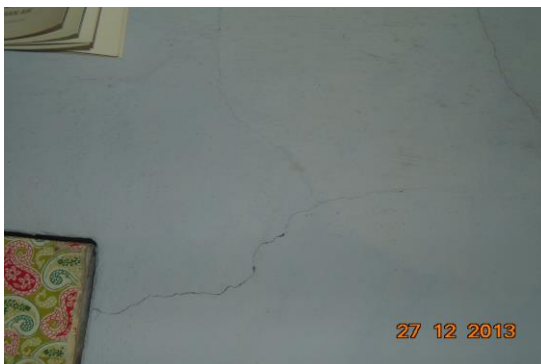
Photo 9

Inclined Crack on Wall No. 3 of Hall No. 1, First Floor
Approx. Width = 0.5mm, Approx. Length = 2m.

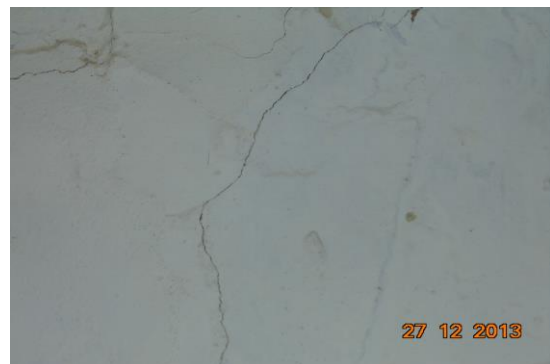
Photo 10

Inclined Crack on Wall No. 4 of Toilet No. 1, First Floor
Approx. Width = 1mm, Approx. Length = 3m.

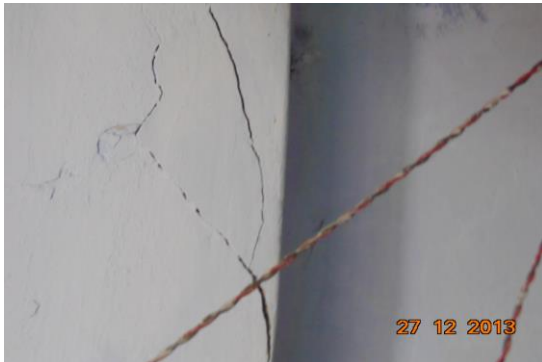
Photo 11

Inclined Crack on Wall No. 2 of Room No. 1, Second Floor
Approx. Width = 2mm, Approx. Length = 3m.

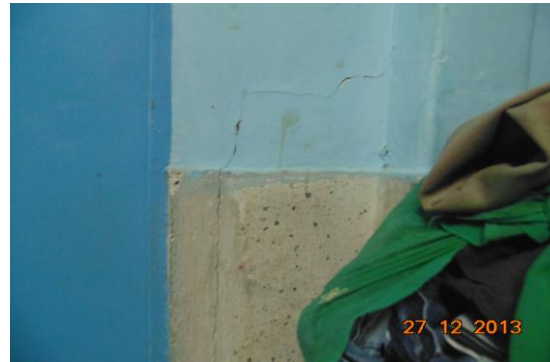
Photo 12

Inclined Crack on Wall No. 2 of Room No. 2, Second Floor
Approx. Width = 0.6mm, Approx. Length = 0.7m.
Distance from Wall No.4 = 0.9m, Height from Floor = 0m.

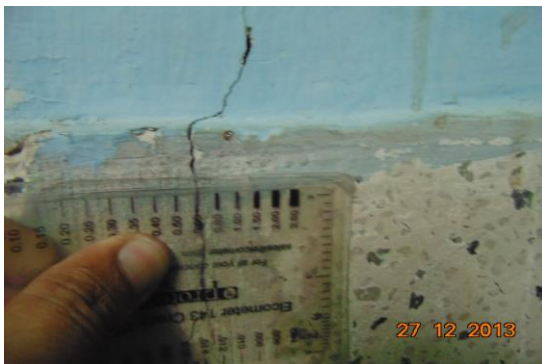
Photo 12A

Inclined Crack on Wall No. 2 of Room No. 2, Second Floor
Approx. Width = 0.6mm, Approx. Length = 0.7m.
Distance from Wall No.4 = 0.9m, Height from Floor = 0m.

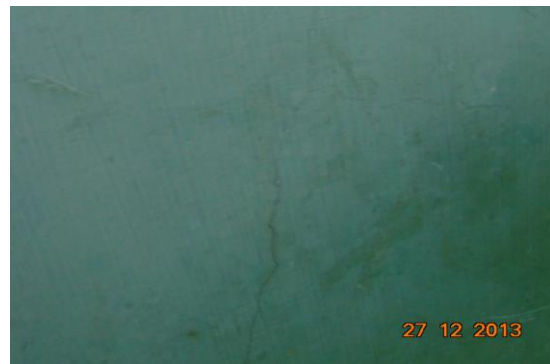
Photo 13

Inclined Crack on Wall No. 2 of Room No. 2, Second Floor
Approx. Width = 0.5mm, Approx. Length = 2m.

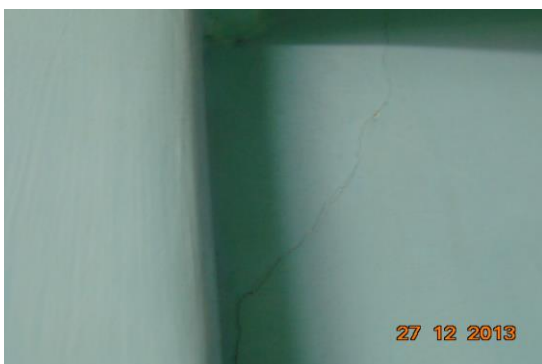
Photo 14

Inclined Crack on Wall No. 2 of Room No. 2, Second Floor
Approx. Width = 1mm, Approx. Length = 2m.

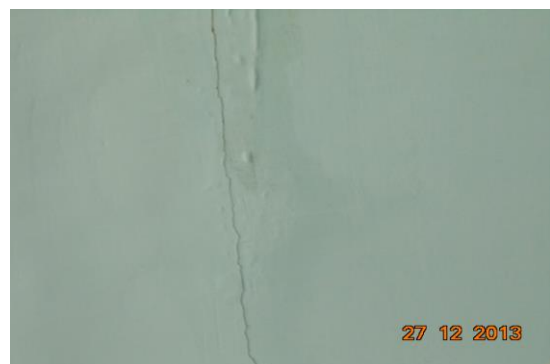
Photo 15

Inclined Crack on Roof of Room No. 4, Third Floor
Approx. Width = 1mm, Approx. Length = 2m.

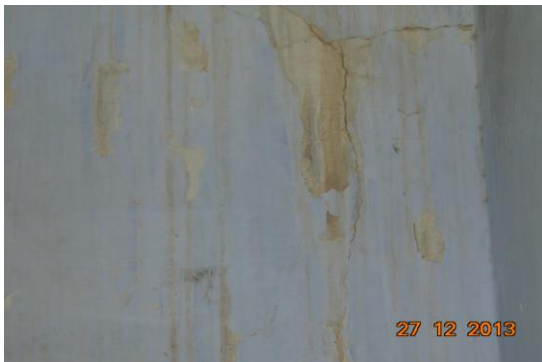
Photo 16

Inclined Crack on Staircase Fourth to Fifth Floor
Approx. Width = 1mm, Approx. Length = 1.5m.
Distance from Wall no.2 = 0m, Height from Floor = 0m.

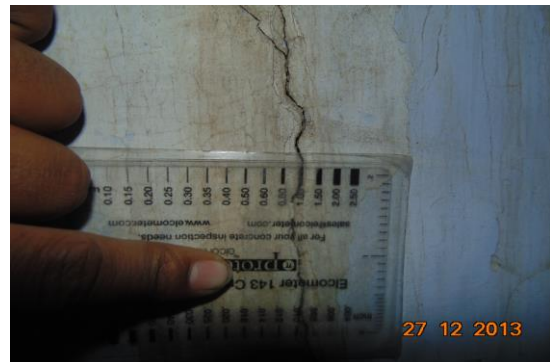
Photo 16A

Inclined Crack on Staircase Fourth to Fifth Floor
Approx. Width = 1mm, Approx. Length = 1.5m.
Distance from Wall no.2 = 0m, Height from Floor = 0m.

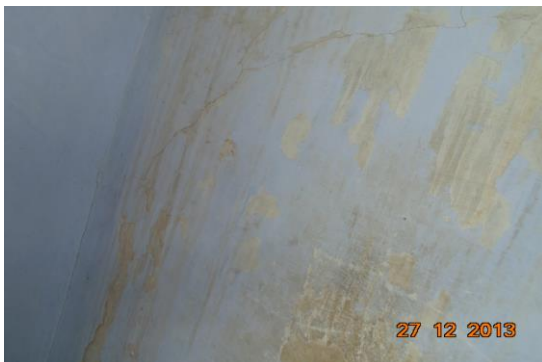
Photo 17

Inclined Crack on Staircase Fourth to Fifth Floor, Fourth Floor
Approx. Width = 1mm, Approx. Length = 3m.

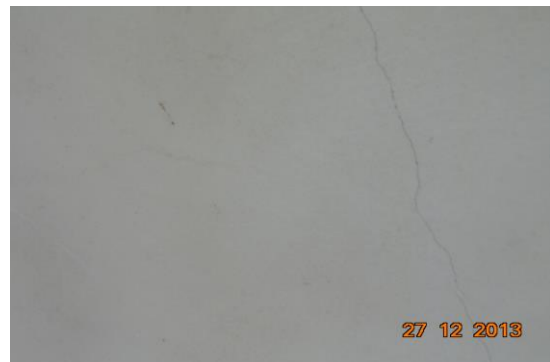
Photo 18

Inclined Crack on Roof of Room No. 1, Fifth Floor
Approx. Width = 0.6mm, Approx. Length = 2m.

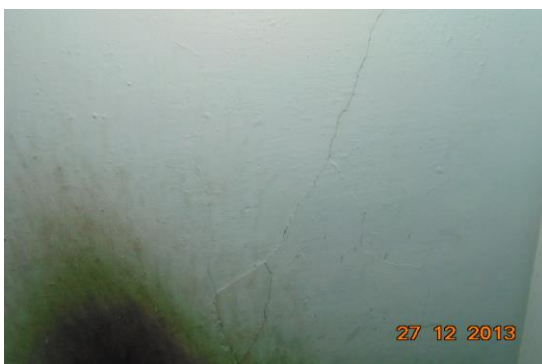
Photo 19

Inclined Crack on Wall No. 4 of Staircase SF to TF
Approx. Width = 1.5mm, Approx. Length = 2.5m.
Distance from Wall no.2 = 0.3m, Height from Floor = 0m.

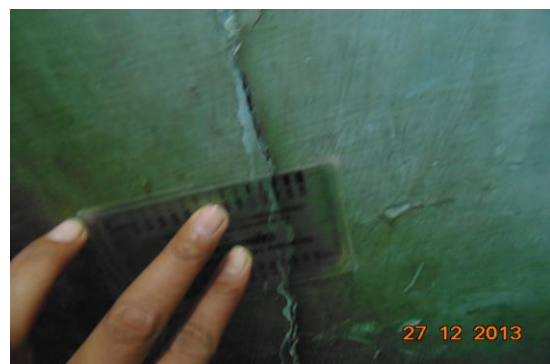
Photo 19A

Inclined Crack on Wall No. 4 of Staircase SF to TF
Approx. Width = 1.5mm, Approx. Length = 2.5m.
Distance from Wall no.2 = 0.3m, Height from Floor = 0m.

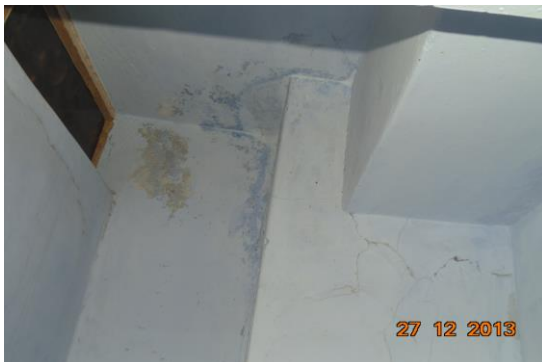
Photo 20
Inclined Crack on Wall No. 4 & Roof of Toilet No. 1, First Floor
Approx. Width = 1mm, Approx. Length = 2m.

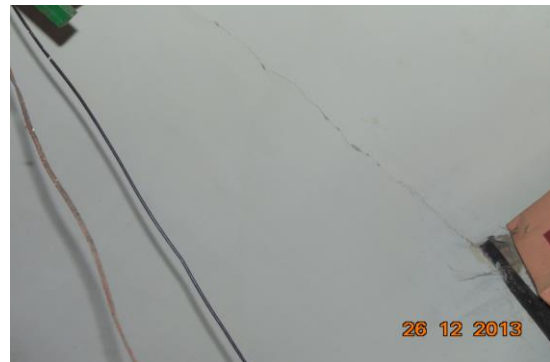
Photo 21
Horizontal Crack on Roof of Varanda, Shop No.57, Ground Floor
Approx. Width = 1mm, Approx. Length = 2.5m.
Distance from Left side External Column = 0m, Height from Floor = 3m.

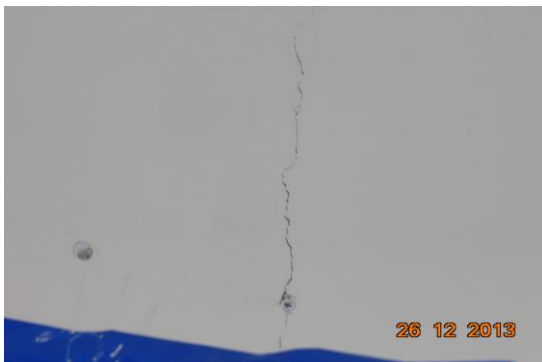
Photo 22
Inclined Crack on Wall No. 1 of Shop No.57, Ground Floor
Approx. Width = 0.5mm, Approx. Length = 1m.
Distance from = m, Height from Floor = m.

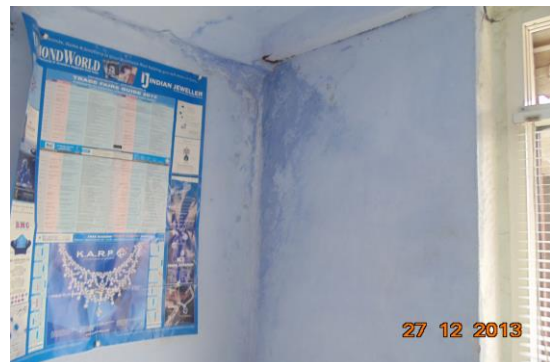
Photo 23
Dampness/Seepage on Wall No. 1 & 3 of Hall No. 1 of First Floor

Summary of Defects Other Than Crack			
Defect ID	Location	Description	Photo No.
18	Wall No. 1 & 3 Hall No. 1 First Floor	Dampness/Seepage	23
19	Wall No. 4 Hall No. 1 First Floor	Peeling of Plaster	24
20	Wall No. 4 Hall No. 1 First Floor	Dampness/Seepage	25
21	Wall No. 7 Hall No. 1 First Floor	Dampness/Seepage	26
22	Wall No. 4 & Roof Toilet No. 1 First Floor	Dampness/Seepage	27
23	Wall No. 4 Bathroom First Floor	Peeling of Plaster	28
24	Roof Room No. 1 Second Floor	Dampness/Seepage	29
25	Roof Room No. 1 Second Floor	Damaged Portion	30
26	Roof Room No. 1 Second Floor	Peeling of Plaster	31
27	Roof Room No. 1 Second Floor	Peeling of Plaster	32
28	Wall No. 2 Room No. 1 Second Floor	Dampness/Seepage	33
29	Wall No. 1 Room No. 2 Second Floor	Peeling of Plaster	34
30	Wall No. 1 Room No. 2 Second Floor	Damaged Portion	35
31	Roof Room No. 2 Second Floor	Peeling of Plaster	36
32	Wall No. 1, 4 & Roof Room No. 4 Third Floor	Dampness/Seepage	37

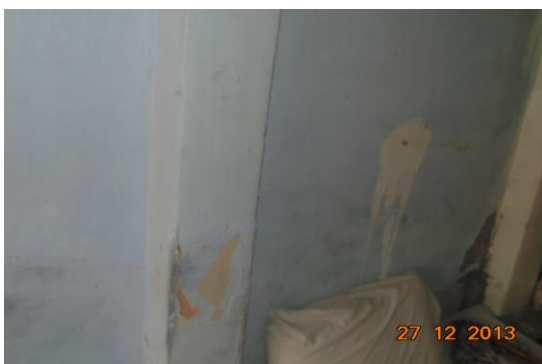
Photo 24
Peeling of Plaster on Wall No. 4 of Hall No. 1 of First Floor

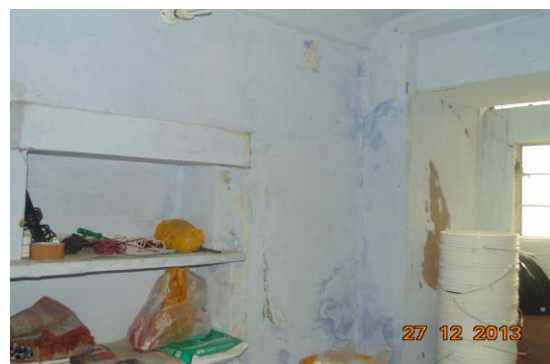
Photo 25
Dampness/Seepage on Wall No. 4 of Hall No. 1 of First Floor

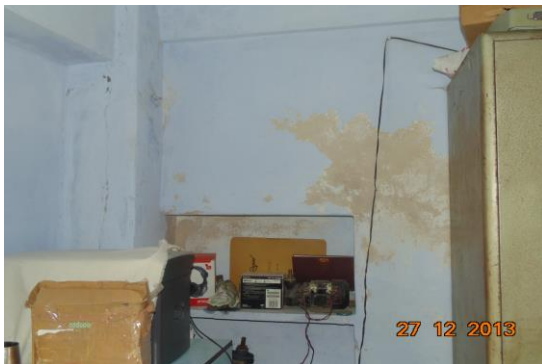
Photo 26
Dampness/Seepage on Wall No. 7 of Hall No. 1 of First Floor

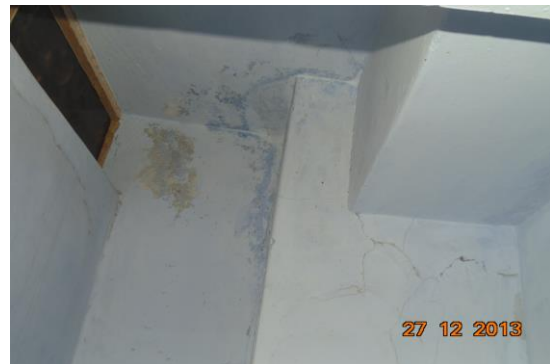
Photo 27
Dampness/Seepage on Wall No. 4 & Roof of Toilet No. 1 of First Floor

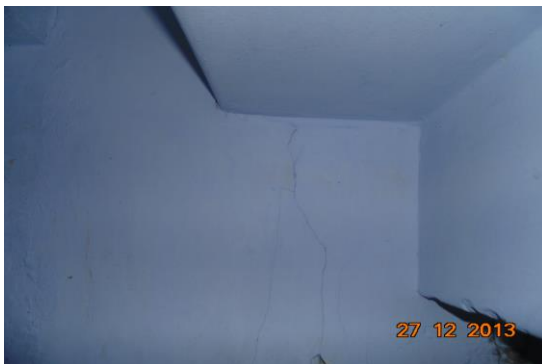
Photo 28
Peeling of Plaster on Wall No. 4 of Bathroom of First Floor

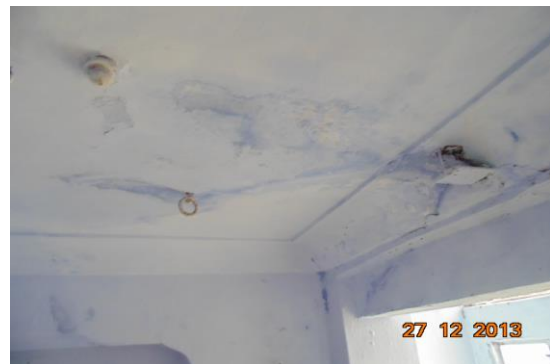
Photo 29
Dampness/Seepage on Roof of Room No. 1 of Second Floor

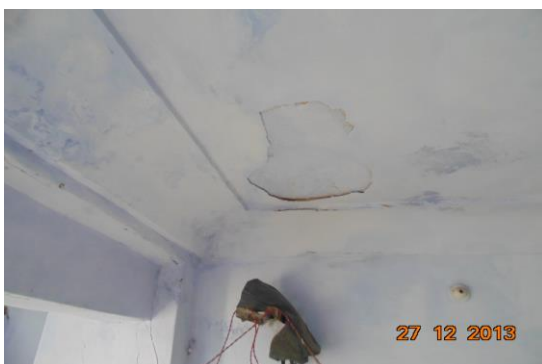
Photo 30
Damaged Portion on Roof of Room No. 1 of Second Floor

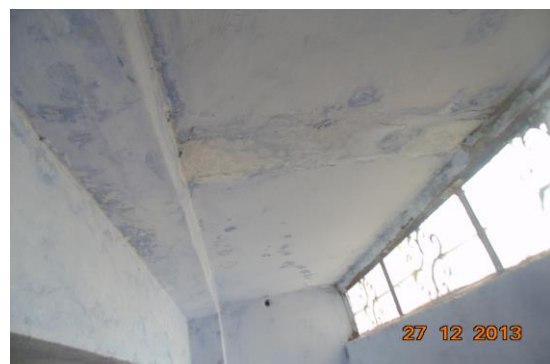
Photo 31
Peeling of Plaster on Roof of Room No. 1 of Second Floor

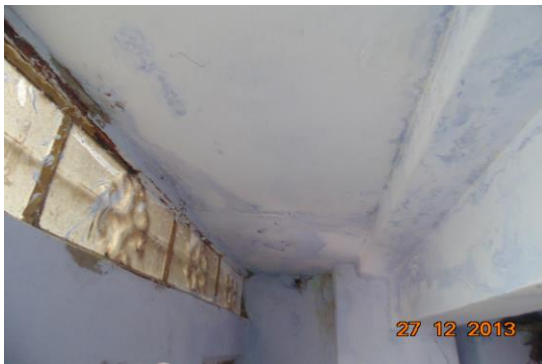
Photo 32
Peeling of Plaster on Roof of Room No. 1 of Second Floor

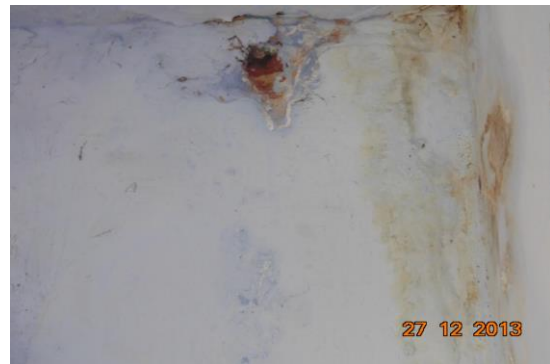
Photo 33
Dampness/Seepage on Wall No. 2 of Room No. 1 of Second Floor

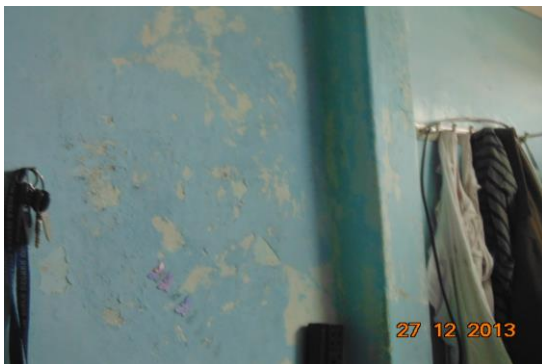
Photo 34
Peeling of Plaster on Wall No. 1 of Room No. 2 of Second Floor

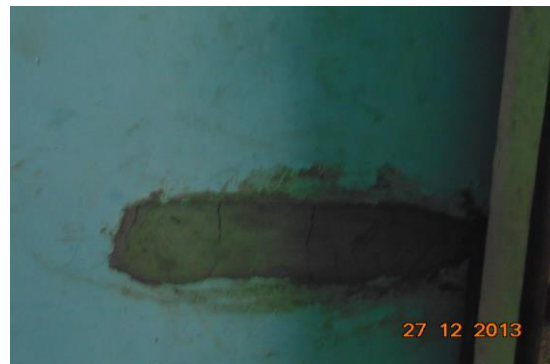
Photo 35
Damaged Portion on Wall No. 1 of Room No. 2 of Second Floor

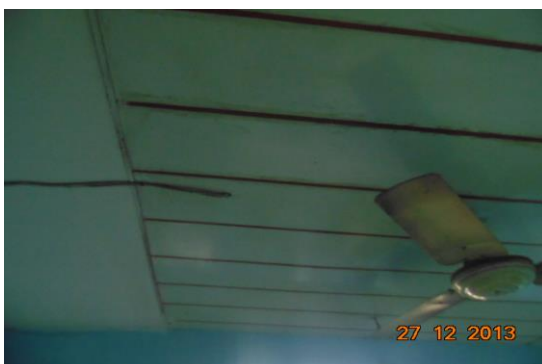
Photo 36
Peeling of Plaster on Roof of Room No. 2 of Second Floor

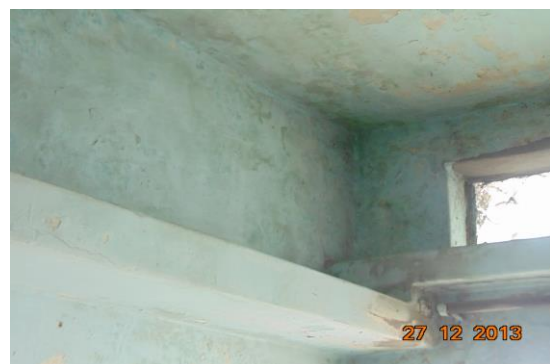
Photo 37
Dampness/Seepage on Wall No. 1, 4 & Roof of Room No. 4 of Third Floor

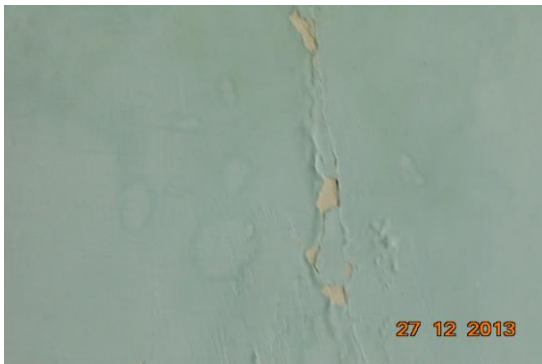
Photo 38

Peeling of Plaster on Wall No. 1 of Room No. 4 of Third Floor

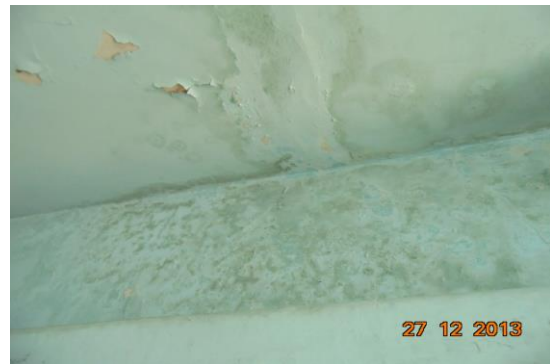
Photo 39

Dampness/Seepage on Wall No. 1 & Roof of Room No. 4 of Third Floor

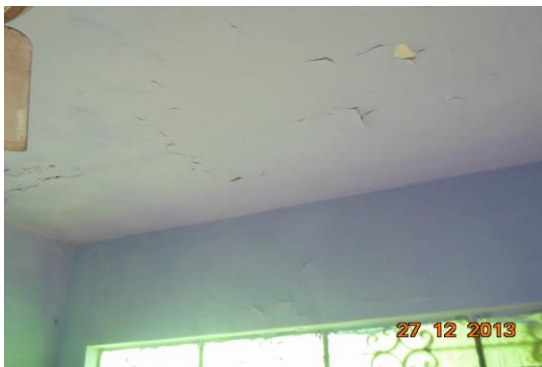
Photo 40

Peeling of Plaster on Wall No. 4 & Roof of Room No. 1 of Third Floor

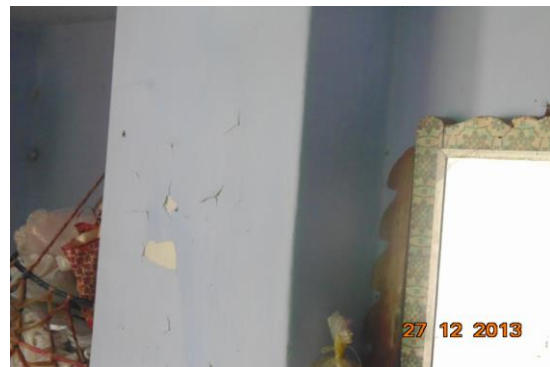
Photo 41

Peeling of Plaster on Wall No. 2 of Room No. 1 of Third Floor

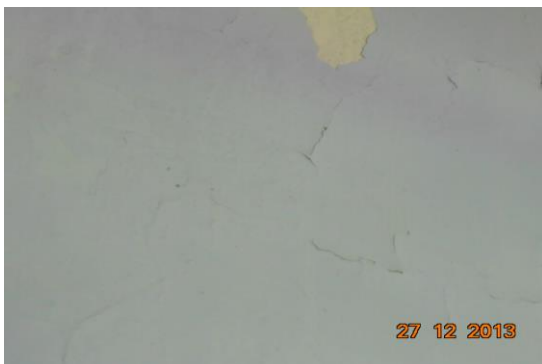
Photo 42

Peeling of Plaster on Wall No. 3 of Room No. 1 of Third Floor

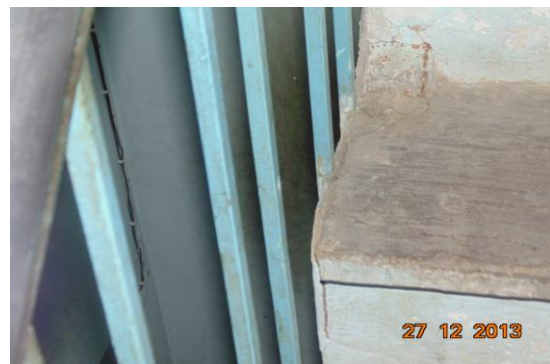
Photo 43

Damaged Portion on Step of Staircase TF to Fourth Floor of Third Floor

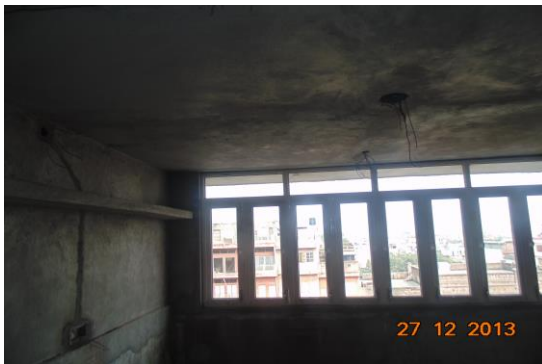
Photo 44

Peeling of Plaster on All walls of Room No. 1 of Fourth Floor

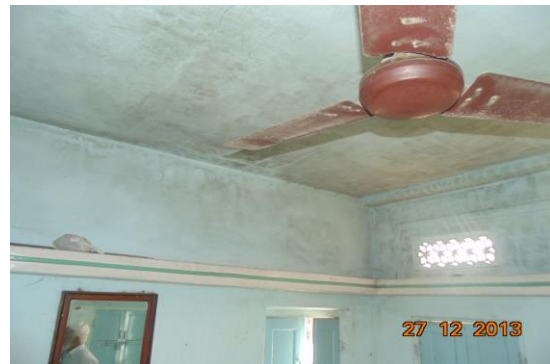
Photo 45

Dampness/Seepage on Wall No. 1, 4 & Roof of H.No.466 of Fourth Floor

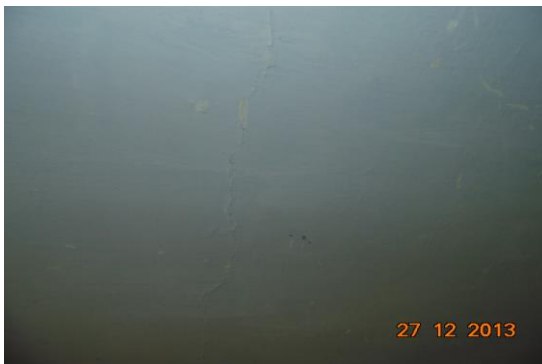
Photo 46

Peeling of Plaster on Roof of Staircase Fourth to Fifth Floor

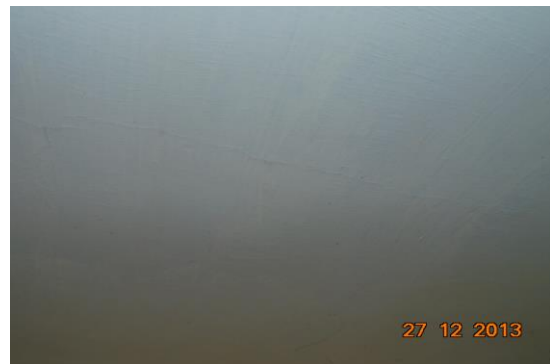
Photo 47

Peeling of Plaster on Roof of Staircase Fourth to Fifth Floor

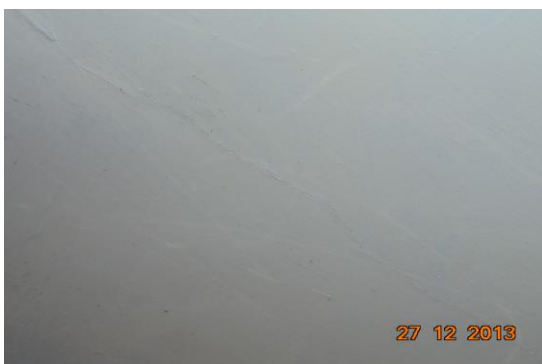
Photo 48

Peeling of Plaster on Roof of Staircase Fourth to Fifth Floor

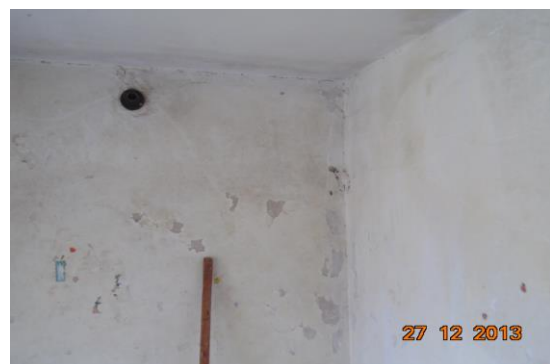
Photo 49

Dampness/Seepage on Wall No. 2 & 3 of Room No. 1 of Fifth Floor

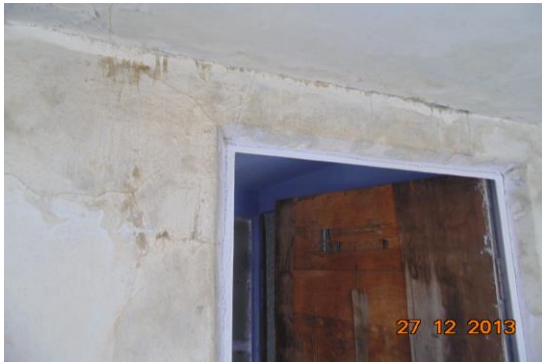
Photo 50
Dampness/Seepage on Wall No. 3 of Room No. 1 of Fifth Floor

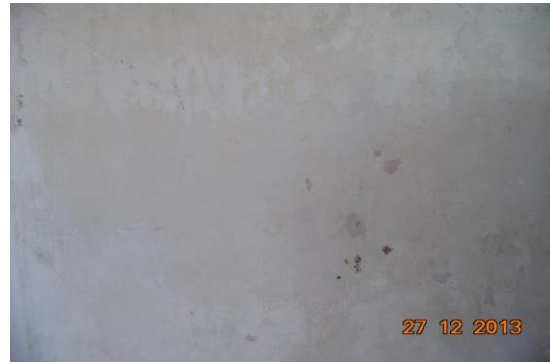
Photo 51
Dampness/Seepage on Wall No. 1 of Room No. 1 of Fifth Floor

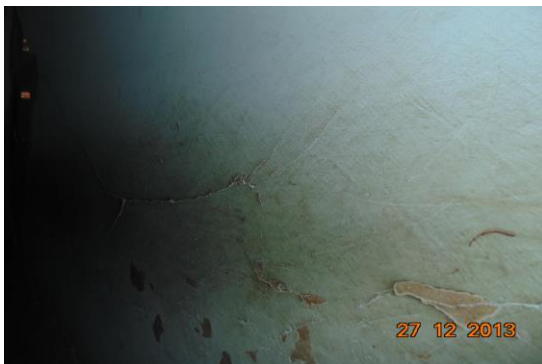
Photo 52
Peeling of Plaster on Staircase FF to SF

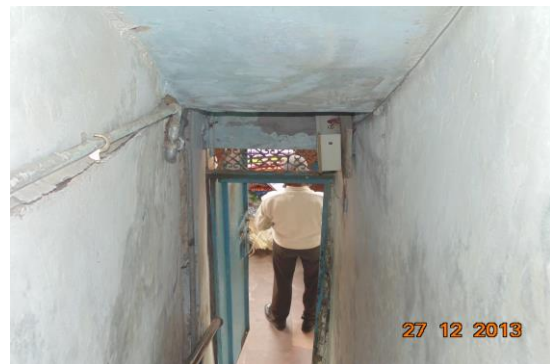
Photo 53
Dampness/Seepage on Wall No. 1, 2 & Roof of Staircase FF to GF

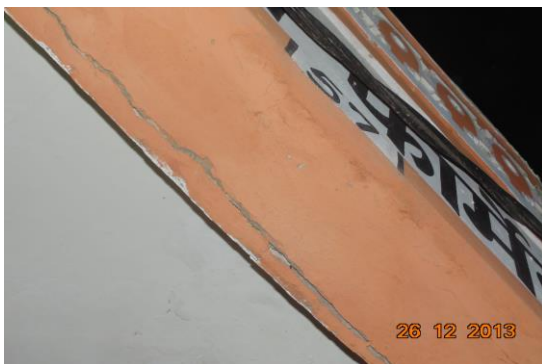
Photo 54
Peeling of Plaster on Beam of Varanda of Shop No.57, Ground Floor

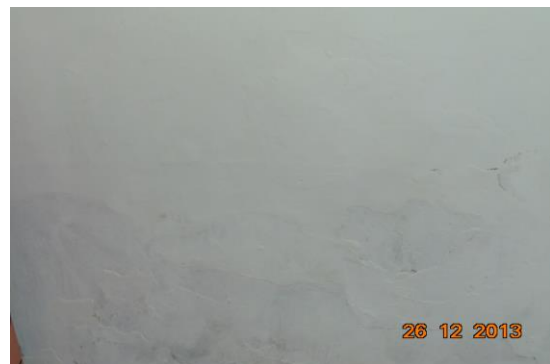
Photo 55
Peeling of Plaster on Roof of Varanda of Shop No.57, Ground Floor

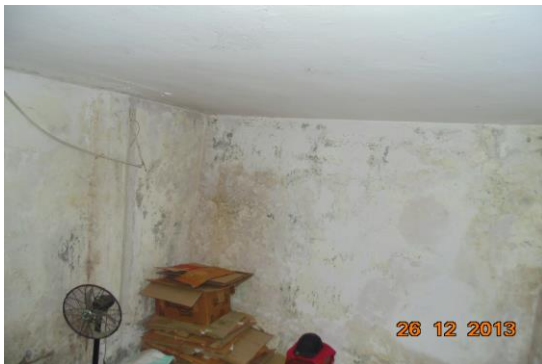
Photo 56

Dampness/Seepage on Wall No. 1, 4 & Roof of Shop No.57 of Ground Floor

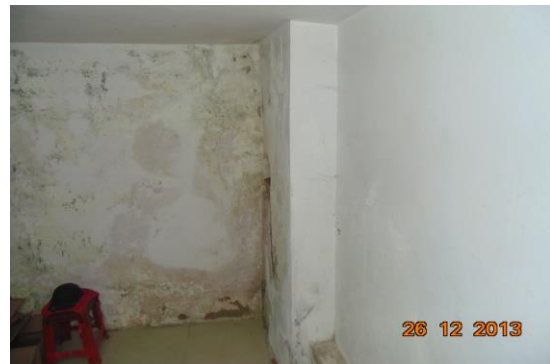
Photo 57

Dampness/Seepage on Wall No. 2 & 4 of Shop No.57 of Ground Floor

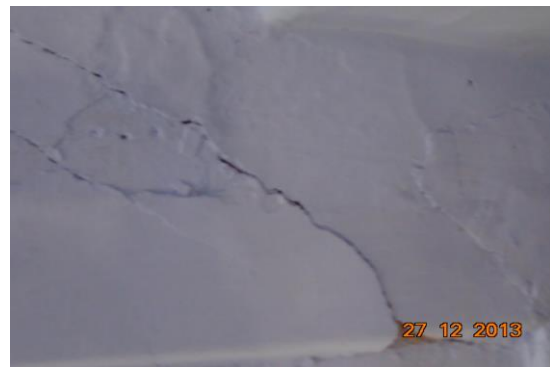
Photo 4

Inclined Crack on Wall No. 4 of Balcony, First Floor
Approx. Width = 10mm, Approx. Length = 3m.
Distance from = m, Height from Floor = m.

Summary of Cracks						
Defect ID	Location	Orientation	Appx. Width (mm)	Appx. Length (m)	Category	Photo No.
1	Wall No. 4 Balcony First Floor	Inclined	10	3	Moderate	4
2	Wall No. 4 Balcony First Floor	Inclined	1	2	Slight	5
3	Wall No. 3 Balcony First Floor	Inclined	15	2	Severe	6, 6A
4	Wall No. 3 First Floor	Inclined	10	2	Moderate	7
5	Wall No. 3 First Floor	Inclined	2	2	Slight	8
6	Wall No. 2 Lobby First Floor	Inclined	2.5	1.9	Slight	9, 9A
7	H. No.464 First Floor	Inclined	0.3	2	Very Slight	10
8	H. No.464 First Floor	Inclined	0.3	2	Very Slight	11
9	Wall No. 4 Room No. 1 H. No.464, Second Floor	Inclined	0.5	1	Very Slight	12
10	Roof & 4 Lobby Second Floor	Inclined	1	3	Slight	13
11	Wall No. 3 Lobby Second Floor	Inclined	0.3	1	Very Slight	14
12	Wall No. 4 & Tinshed Area H.No.464 Terrace	Inclined	0.5	1	Very Slight	15
13	Wall No. 3 & Tinshed Area H.No.464 Terrace	Inclined	2.5	1	Slight	16, 16A
14	Outer Wall & 3 H.No.464 Terrace	Inclined	2.5	1	Slight	17, 17A

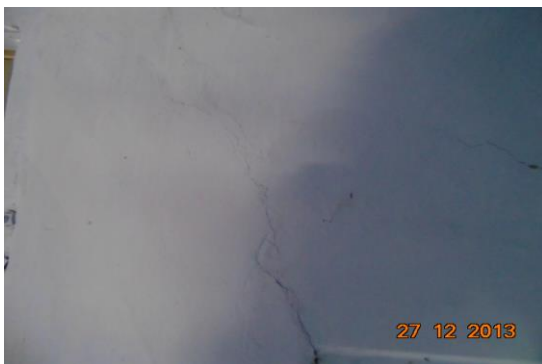
Photo 5

Inclined Crack on Wall No. 4 of Balcony, First Floor
Approx. Width = 1mm, Approx. Length = 2m.
Distance from = m, Height from Floor = m.

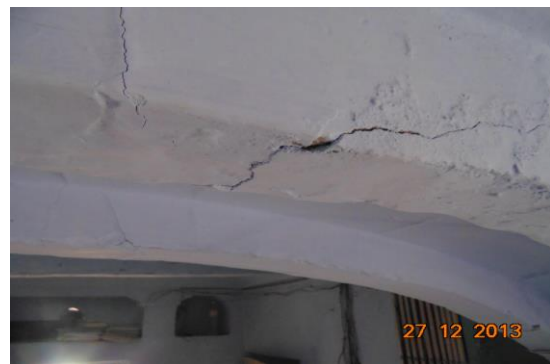
Photo 6

Inclined Crack on Wall No. 3 of Balcony, First Floor
Approx. Width = 15mm, Approx. Length = 2m.
Distance from = m, Height from Floor = m.

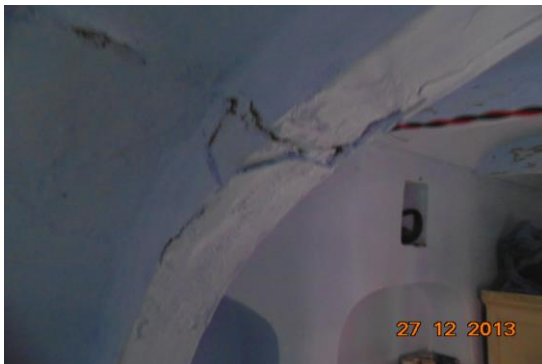
Photo 6A

Inclined Crack on Wall No. 3 of Balcony, First Floor
Approx. Width = 15mm, Approx. Length = 2m.
Distance from = m, Height from Floor = m.

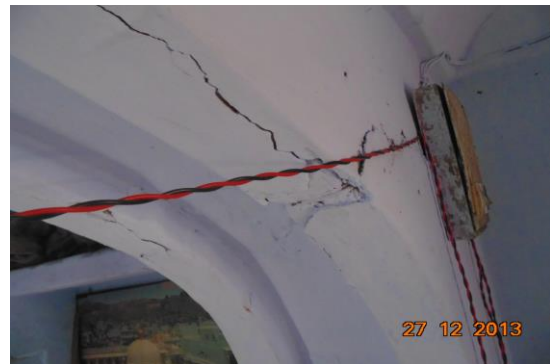
Photo 7

Inclined Crack on Wall No. 3 of , First Floor
Approx. Width = 10mm, Approx. Length = 2m.
Distance from = m, Height from Floor = m.

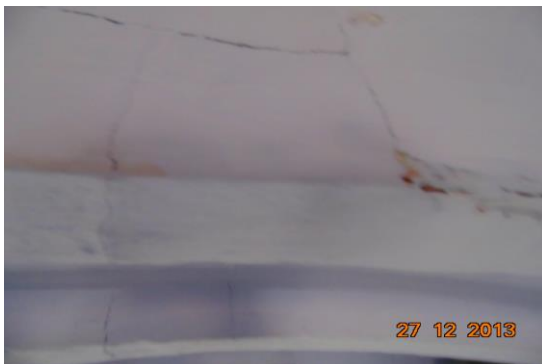
Photo 8

Inclined Crack on Wall No. 3 of , First Floor
Approx. Width = 2mm, Approx. Length = 2m.
Distance from = m, Height from Floor = m.

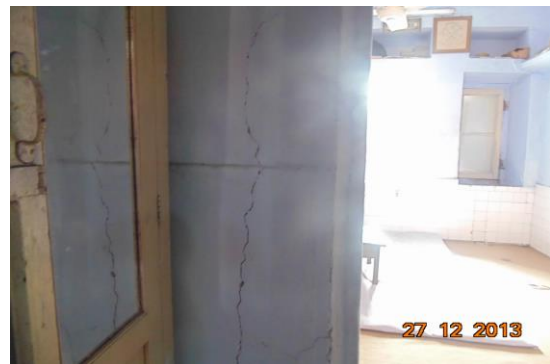
Photo 9

Inclined Crack on Wall No. 2 of Lobby, First Floor
Approx. Width = 2.5mm, Approx. Length = 1.9m.
Distance from Wall No.4 = 0.4m, Height from Floor = 0m.

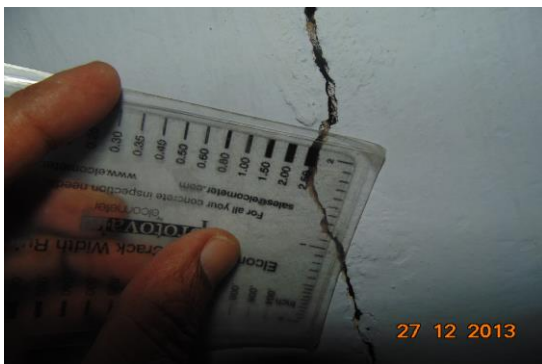
Photo 9A

Inclined Crack on Wall No. 2 of Lobby, First Floor
Approx. Width = 2.5mm, Approx. Length = 1.9m.
Distance from Wall No.4 = 0.4m, Height from Floor = 0m.

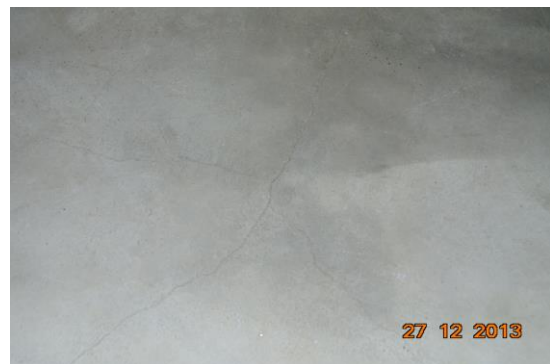
Photo 10

Inclined Crack on of H. No.464, First Floor
Approx. Width = 0.3mm, Approx. Length = 2m.
Distance from = m, Height from Floor = m.

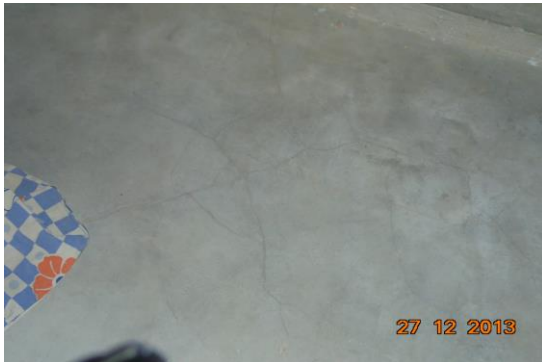
Photo 11

Inclined Crack on Wall No. 4 of Room No. 1, H. No.464, First Floor
Approx. Width = 0.3mm, Approx. Length = 2m.
Distance from = m, Height from Floor = m.

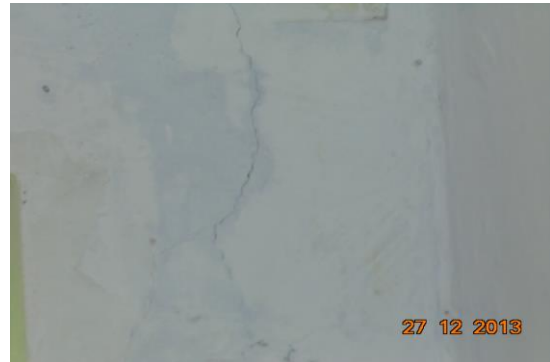
Photo 12

Inclined Crack on Wall No. 4 of Room No. 1, H. No.464, Second Floor
Approx. Width = 0.5mm, Approx. Length = 1m.
Distance from = m, Height from Floor = m.

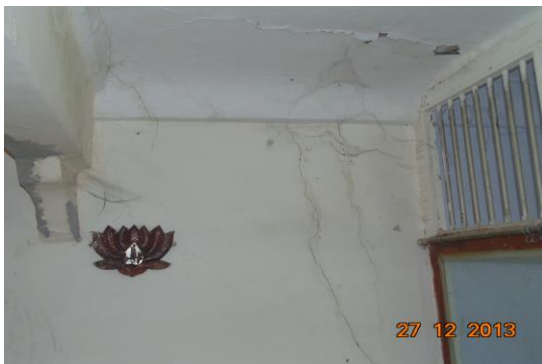
Photo 13

Inclined Crack on Wall No. Roof & 4 of Lobby, Second Floor
Approx. Width = 1mm, Approx. Length = 3m.
Distance from = m, Height from Floor = m.

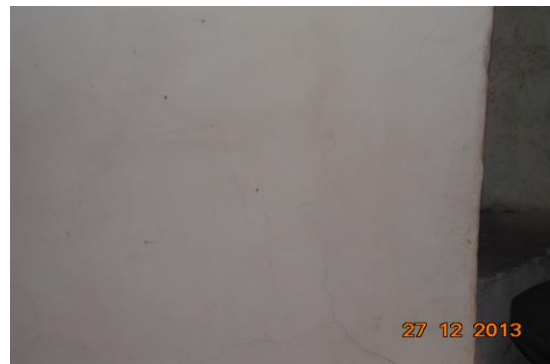
Photo 14

Inclined Crack on Wall No. 3 of Lobby, Second Floor
Approx. Width = 0.3mm, Approx. Length = 1m.
Distance from = m, Height from Floor = m.

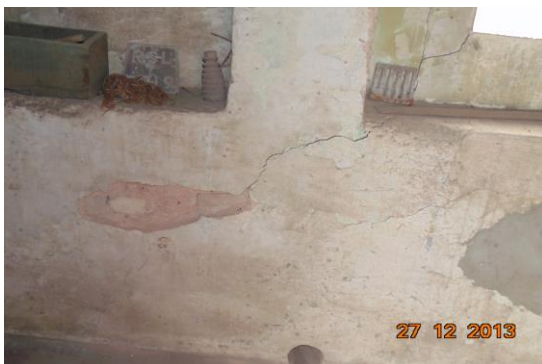
Photo 15

Inclined Crack on Wall No. 4 & Tinshed Area of H.No.464, Terrace
Approx. Width = 0.5mm, Approx. Length = 1m.
Distance from = m, Height from Floor = m.

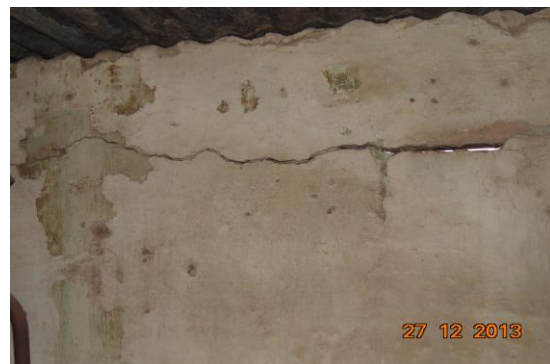
Photo 16

Inclined Crack on Wall No. 3 & Tinshed Area of H.No.464, Terrace
Approx. Width = 2.5mm, Approx. Length = 1m.
Distance from = m, Height from Floor = m.

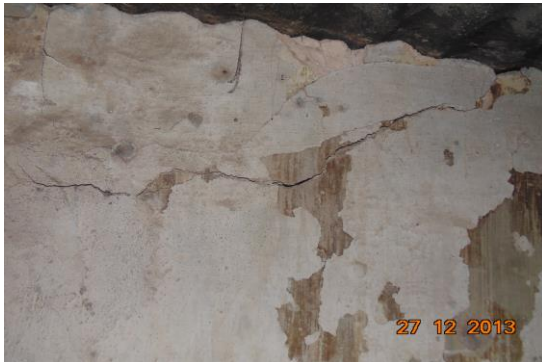
Photo 16A

Inclined Crack on Wall No. 3 & Tinshed Area of H.No.464, Terrace
Approx. Width = 2.5mm, Approx. Length = 1m.
Distance from = m, Height from Floor = m.

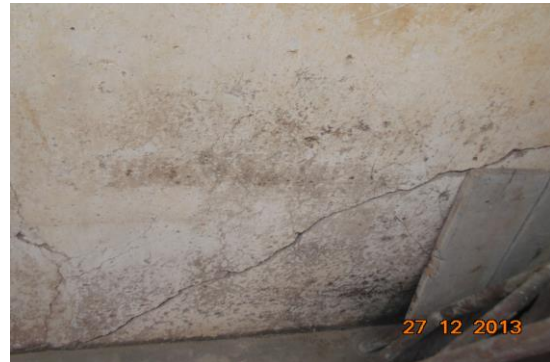
Photo 17

Inclined Crack on Wall No. Outer Wall & 3 of H.No.464, Terrace
Approx. Width = 2.5mm, Approx. Length = 1m.
Distance from = m, Height from Floor = m.

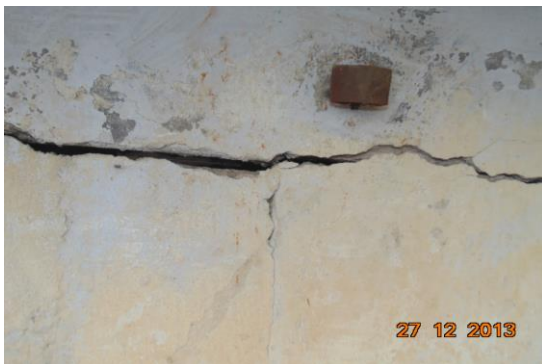
Photo 17A

Inclined Crack on Wall No. Outer Wall & 3 of H.No.464, Terrace
Approx. Width = 2.5mm, Approx. Length = 1m.
Distance from = m, Height from Floor = m.

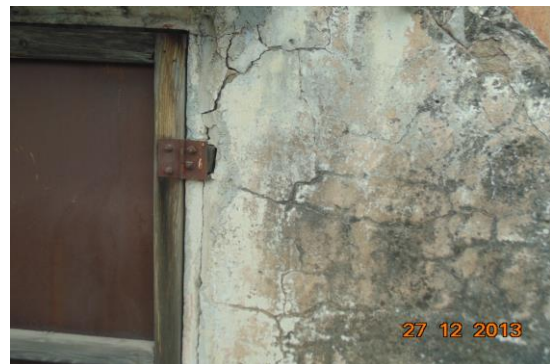
Photo 18

Inclined Crack on Wall No. 3 of Open Sky, Terrace
Approx. Width = 2mm, Approx. Length = 1m.
Distance from = m, Height from Floor = m.

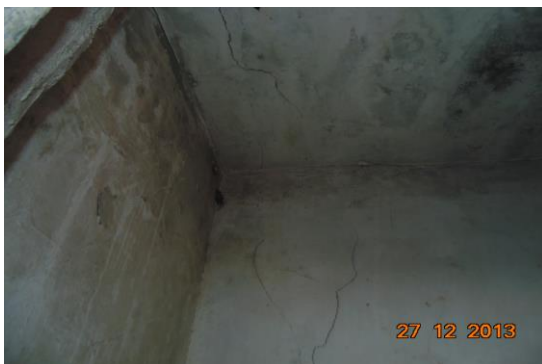
Photo 19

Inclined Crack on Wall No. 2 & Roof of Staircase TF to Terrace, Terrace
Approx. Width = 1mm, Approx. Length = 1m.
Distance from = m, Height from Floor = m.

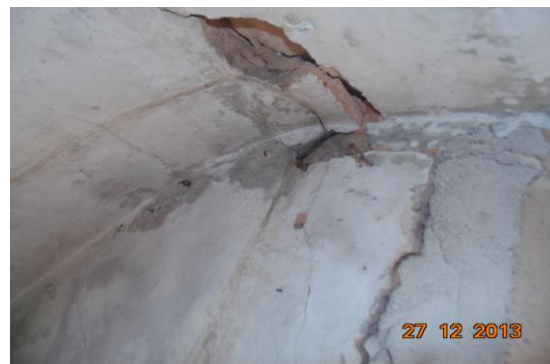
Photo 20

Inclined Crack on Wall No. 1 & Roof of Staircase TF to Terrace, Terrace
Approx. Width = 10mm, Approx. Length = 2m.
Distance from = m, Height from Floor = m.
