Pre Building Condition Survey Report

Name and Address of Structure :	Badi Chopar to Ramp Area (Down Line)
---------------------------------	--------------------------------------

Name of the Project	Contract JMRC-UG1B “Design and Construction of Tunnel between Chandpole and Badi Chouper and reverse line by Shield TBM, Underground Metro Stations at Choti Chouper and Badi Chouper by Cut and Cover Methods on East West Corridor of Jaipur Metro Rail Corporation Limited .”	
Owner :

Pre - Condition Building Survey for Construction of Underground Stations from Chandpole to Bari Chouper and reversal line

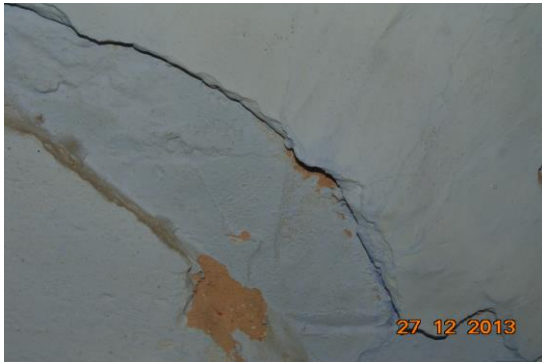
Photo 21

Inclined Crack on Wall No. 2 of Staircase GF to FF, Terrace
Approx. Width = 10mm, Approx. Length = 1m.
Distance from = m, Height from Floor = m.

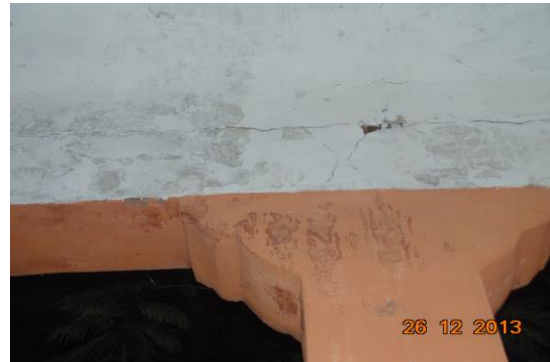
Photo 22

Inclined Crack on Wall No. Left side External Beam of Varanda, Shop No.58, Ground Floor
Approx. Width = 0.5mm, Approx. Length = 1m.
Distance from = m. Height from Floor = m.

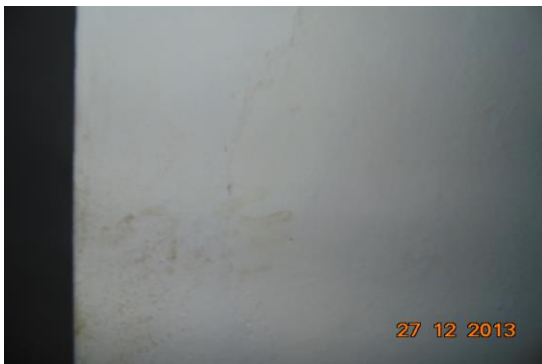
Photo 23

Peeling of Plaster on Wall No. 3 of Lobby of First Floor

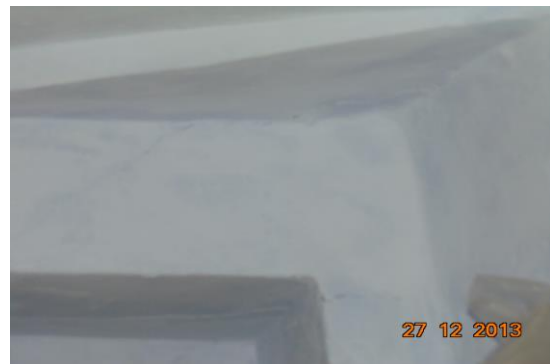
Photo 24

Peeling of Plaster on Wall No. 4 of Room No. 1 of First Floor

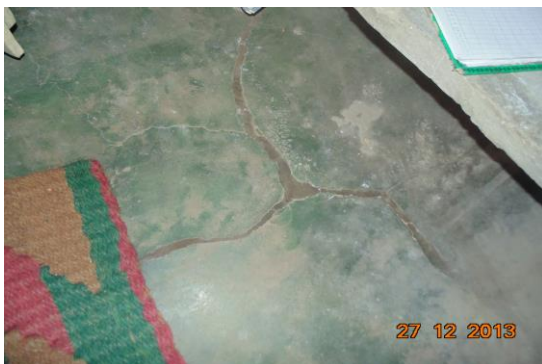
Photo 25

Peeling of Plaster on Wall No. Floor of Lobby of First Floor

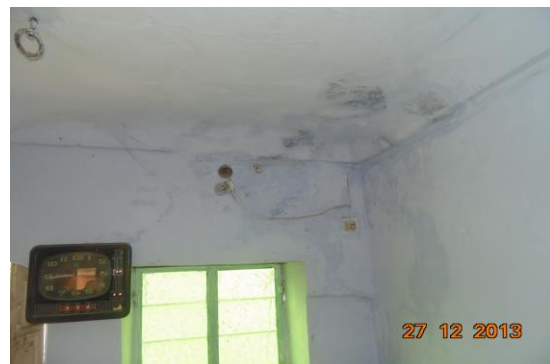
Photo 26

Dampness/Seepage on Wall No. 2, 4 & Roof of H. No.464 of Second Floor

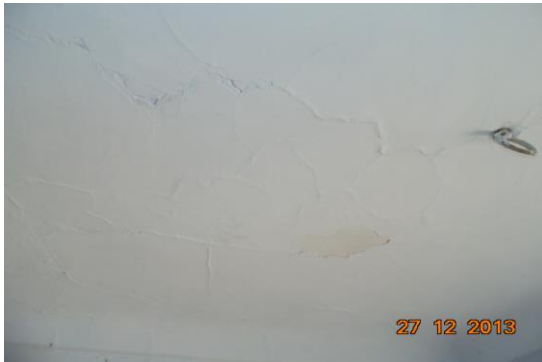
Photo 27

Peeling of Plaster on Roof of Room No. 1 of H. No.464, Second Floor

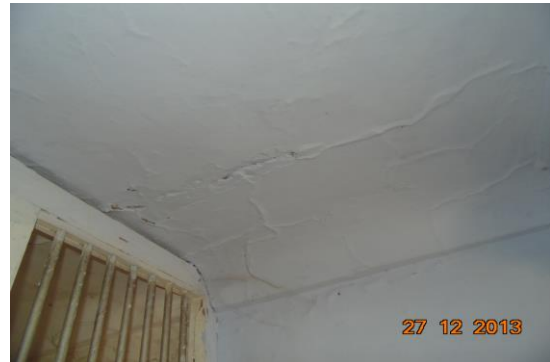
Photo 28

Peeling of Plaster on Roof of Room No. 1 of H. No.464, Second Floor

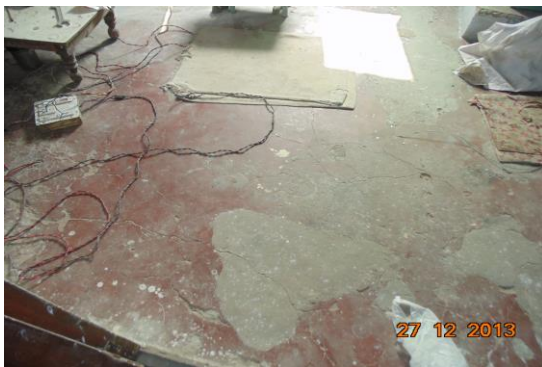
Photo 29

Peeling of Plaster on Wall No. Floor of Room No. 1 of H. No.464, Second Floor

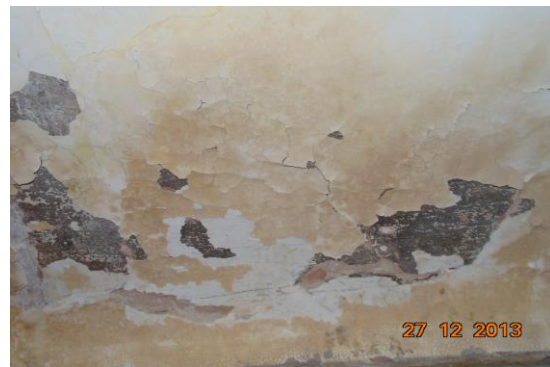
Photo 30

Dampness/Seepage on Wall No. Roof & 4 of Lobby of Second Floor

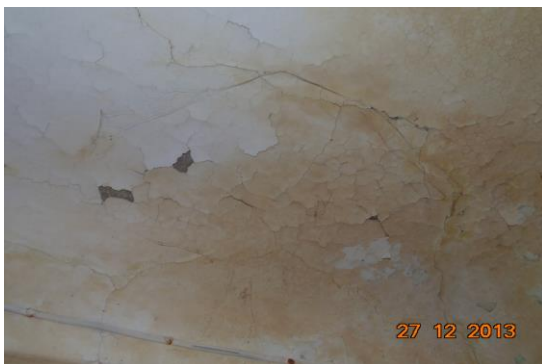
Photo 31

Dampness/Seepage on Wall No. Roof & 4 of Lobby of Second Floor

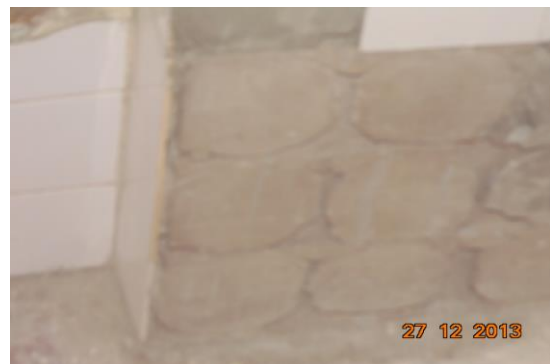
Photo 32

Damaged Portion on Wall No. 3 of Lobby of Second Floor

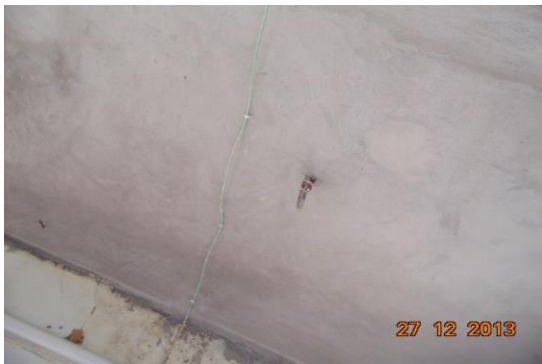
Photo 33

Peeling of Plaster on Roof of Varanda of Second Floor

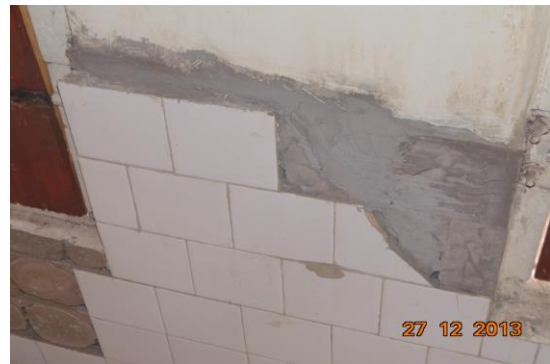
Photo 34

Damaged Portion on Wall No. 4 of Varanda of Second Floor

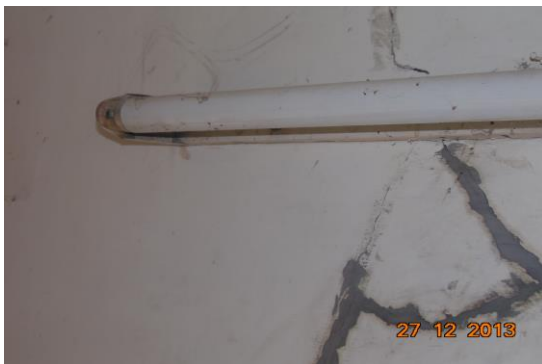
Photo 35

Peeling of Plaster on Wall No. 4 of Varanda of Second Floor

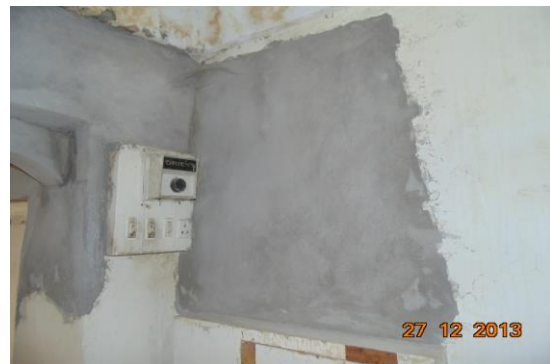
Photo 36

Damaged Portion on Wall No. 4 & 1 of Lobby of Second Floor

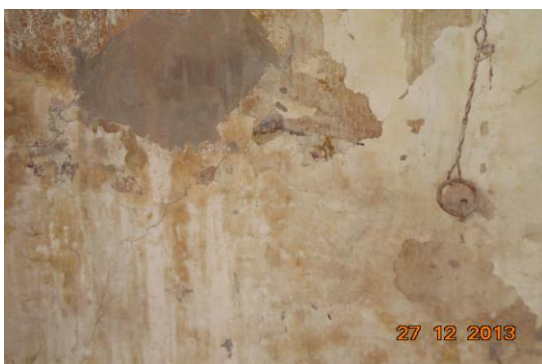
Photo 37

Peeling of Plaster on Wall No. 2 & Tinshed Area of H.No.464 of Terrace

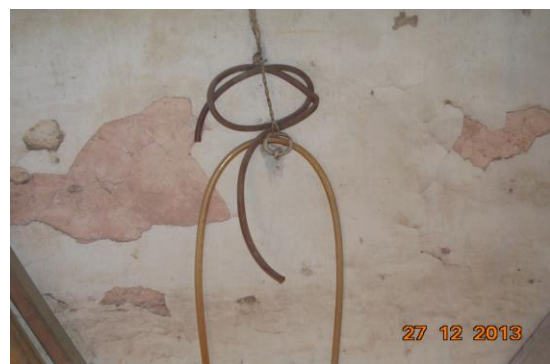
Photo 38

Peeling of Plaster on Wall No. 1 & Tinshed Area of H.No.464 of Terrace

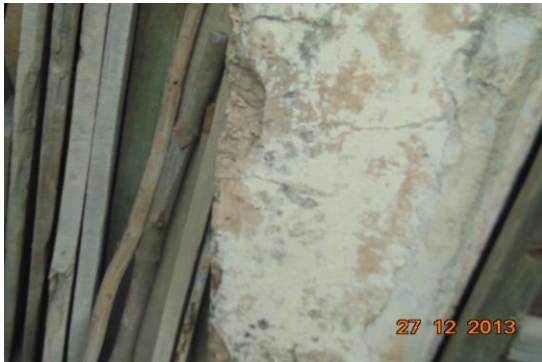
Photo 39

Damaged Portion on Wall No. 3 of Open Sky of Terrace

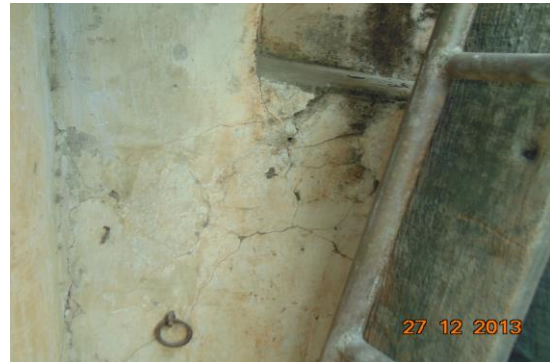
Photo 40

Damaged Portion on Wall No. 3 of Open Sky of Terrace

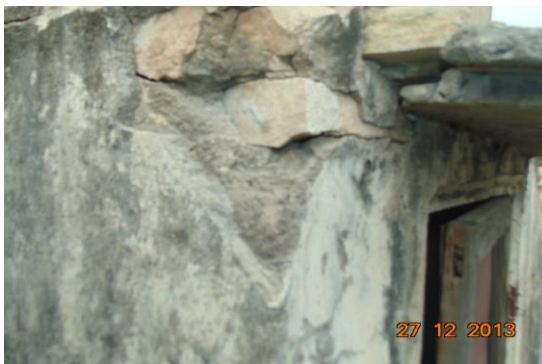
Photo 41

Damaged Portion on Wall No. 3 of Open Sky of Terrace

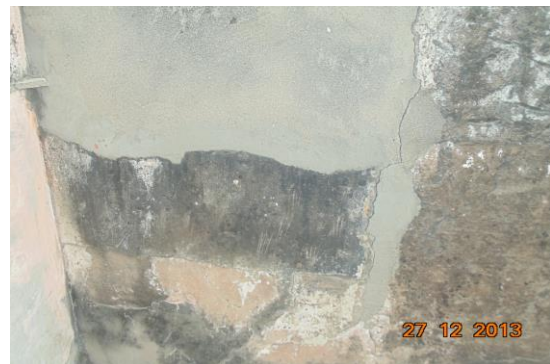
Photo 42

Damaged Portion on Wall No. 4 of Open Sky of Terrace

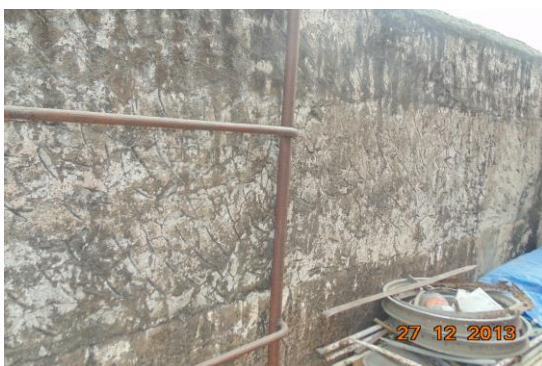
Photo 43

Peeling of Plaster on Wall No. 4 of Open Sky of Terrace

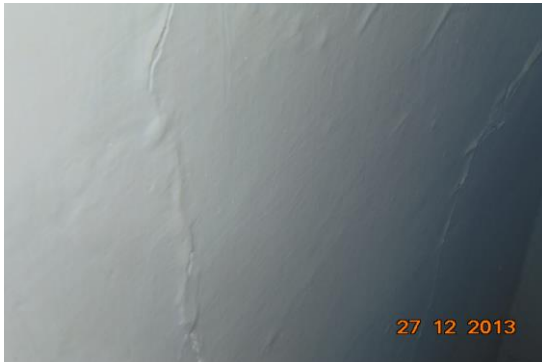
Photo 44

Peeling of Plaster on Wall No. 2 of Staircase TF to Terrace of Terrace

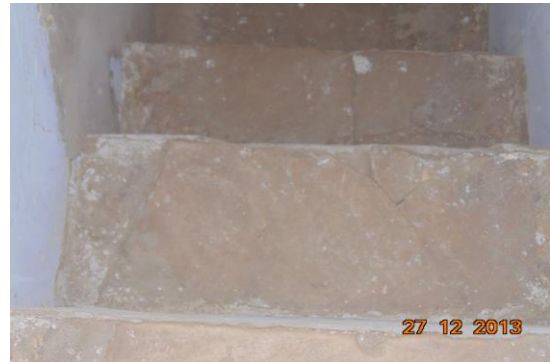
Photo 45

Peeling of Plaster on Wall No. 2 of Staircase SF to FF of Terrace

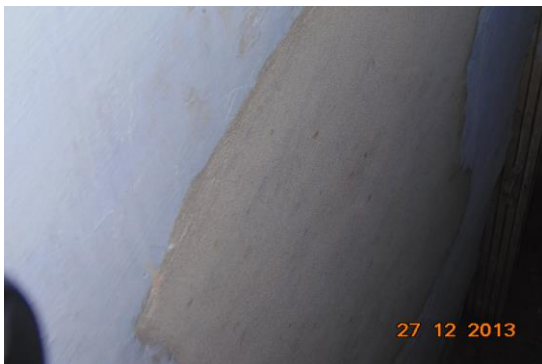
Photo 46

Peeling of Plaster on Wall No. Steps of Staircase GF to FF of Terrace

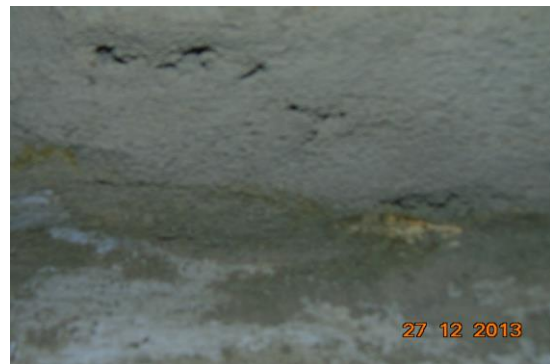
Photo 47

Peeling of Plaster on Wall No. Steps2 of Staircase GF to FF of Terrace

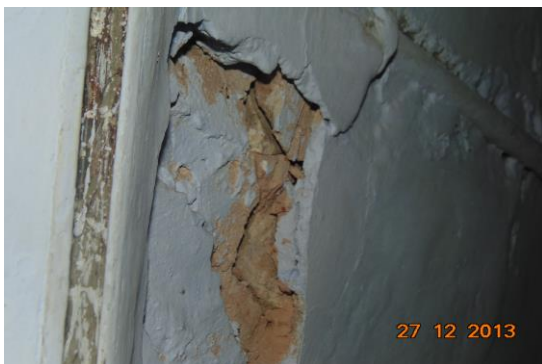
Photo 48

Peeling of Plaster on Wall No. 1 of Staircase GF to FF of Terrace

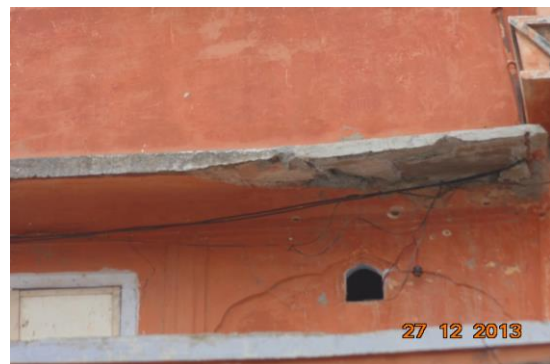
Photo 49

Damaged Portion on Wall No. 1 of Staircase GF to FF of Terrace

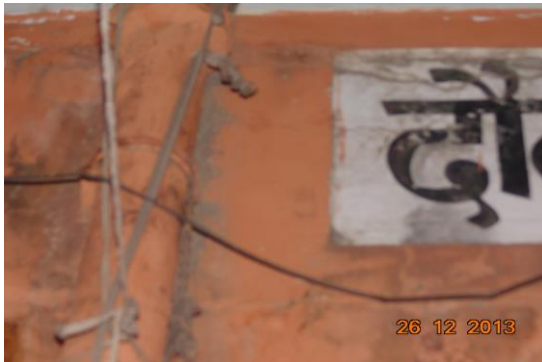
Photo 50

Damaged Portion on Wall No. Frontside Shade of of First Floor

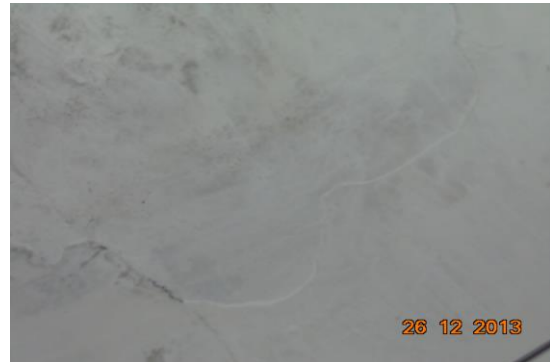
Photo 51

Peeling of Plaster on Wall No. Left side External Column of Varanda of Shop No.58, Ground Floor

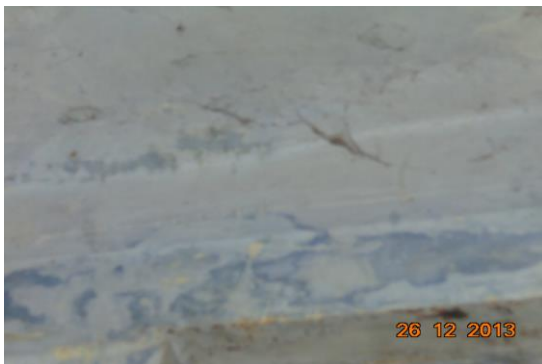
Photo 52

Peeling of Plaster on Roof of Varanda of Shop No.58, Ground Floor

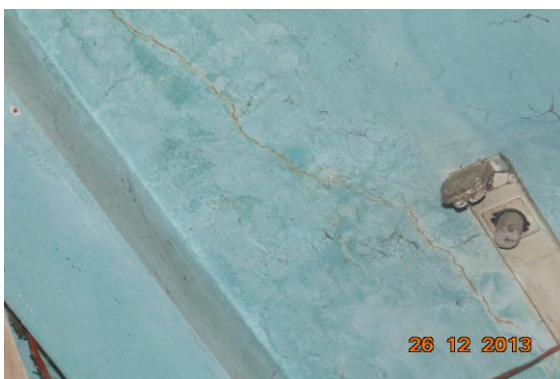
Photo 5
Inclined Crack on Roof of Shop No.59, Ground Floor
Approx. Width = 0.3mm, Approx. Length = 2m.

Summary of Cracks						
Defect ID	Location	Orientation	Appx. Width (mm)	Appx. Length (m)	Category	Photo No.
1	Roof Varanda Shop No.59, Ground Floor	Horizontal	0.7	2	Very Slight	4
2	Roof Shop No.59 Ground Floor	Inclined	0.3	2	Very Slight	5
3	Roof Varanda Shop No. 60, Ground Floor	Horizontal	2	2.5	Slight	6

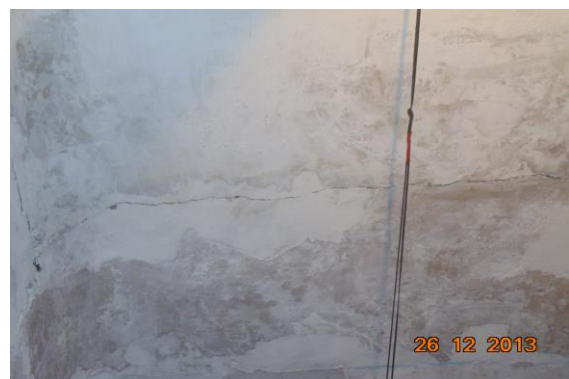
Photo 6
Horizontal Crack on Roof of Varanda, Shop No. 60, Ground Floor, Approx. Width = 2mm, Approx. Length = 2.5m. Distance from Left side External Column = 0m, Height from Floor = 3m.

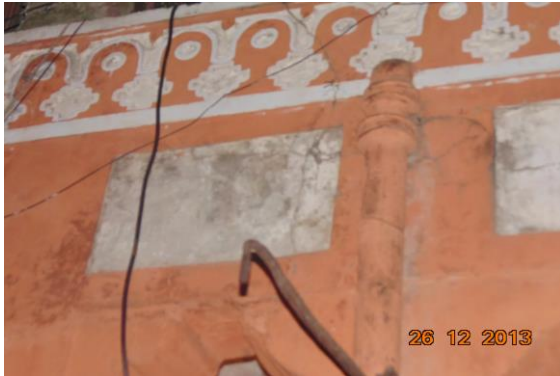
Photo 7

Peeling of Plaster on Left side External Column of Varanda of Shop No. 60, Ground Floor

Summary of Defects Other Than Crack			
Defect ID	Location	Description	Photo No.
4	Left side External Column Varanda Shop No. 60, Ground Floor	Peeling of Plaster	7
5	Roof	Dampness/Seepage	8

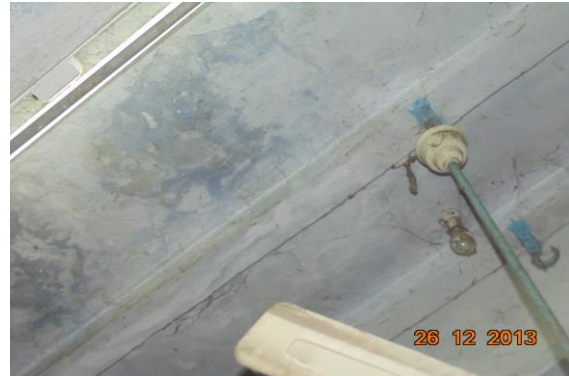
Photo 8

Dampness/Seepage on Roof

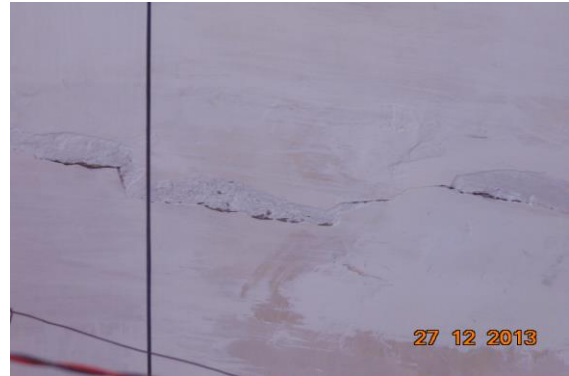
Photo 8

Inclined Crack on Roof of Shop No.63, Ground Floor Approx. Width = 0.9mm, Approx. Length = 2.5m. Distance from Leftside External Column = 0m, Height from Floor = 3m.

Summary of Cracks						
Defect ID	Location	Orientation	Appx. Width (mm)	Appx. Length (m)	Category	Photo No.
1	Roof Shop No.63 Ground Floor	Inclined	0.9	2.5	Very Slight	8
2	Roof Varanda Shop No.62, Ground Floor	Horizontal	1	2.5	Slight	9
3	Wall No. 2 Lobby First Floor	Inclined	2.5	0.6	Slight	10, 10A
4	Wall No. 2 First Floor	Inclined	2.5	0.5	Slight	11
5	Wall No. 1 First Floor	Horizontal	1.5	1.5	Slight	12
6	Wall No. 3 First Floor	Vertical	0.8	2	Very Slight	13, 13A
7	Wall No. 2 & 4 Hall No. 3 First Floor	Vertical	15	3	Severe	14
8	Roof Room No. 1 Third Floor	Horizontal	1.5	3.5	Slight	15
9	Roof Room No. 1 Third Floor	Horizontal	1	3.5	Slight	16
10	Roof Room No. 1 Third Floor	Horizontal	1.5	2.7	Slight	17
11	Wall No. 1 Hall No. 1 Third Floor	Inclined	12	2	Moderate	18, 18A

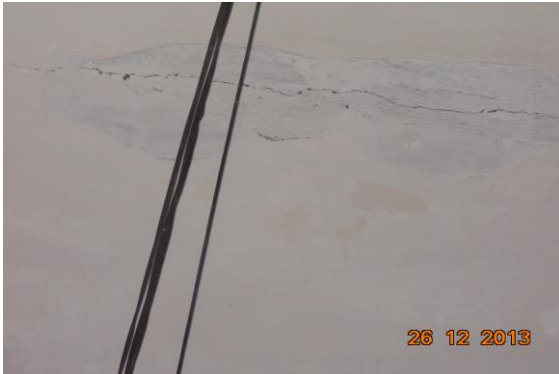
Photo 9

Horizontal Crack on Roof of Varanda, Shop No.62, Ground Floor Approx. Width = 1mm, Approx. Length = 2.5m. Distance from Left side External Column = 0m, Height from Floor = 3m.

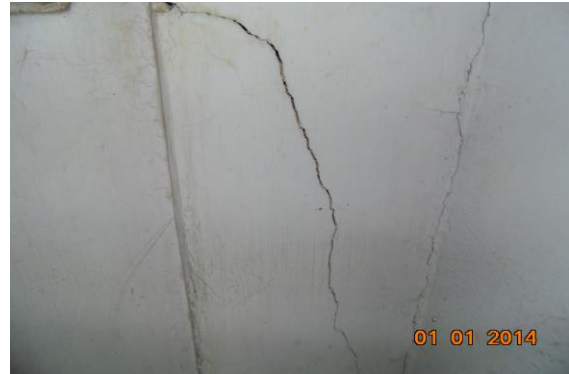
Photo 10

Inclined Crack on Wall No. 2 of Lobby, First Floor Approx. Width = 2.5mm, Approx. Length = 0.6m. Distance from Wall No. 3 = 0.05m, Height from Floor = 0.3m.

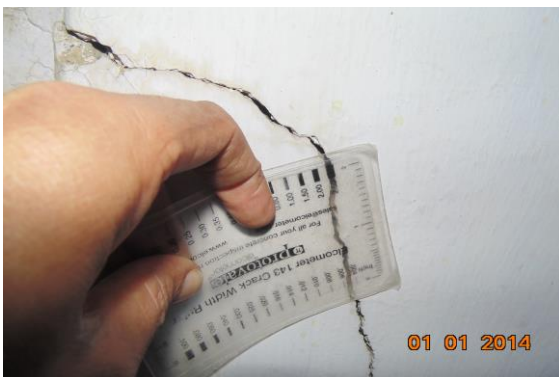
Photo 10A

Inclined Crack on Wall No. 2 of Lobby, First Floor, Approx. Width = 2.5mm, Approx. Length = 0.6m. Distance from Wall No. 3 = 0.05m, Height from Floor = 0.3m.

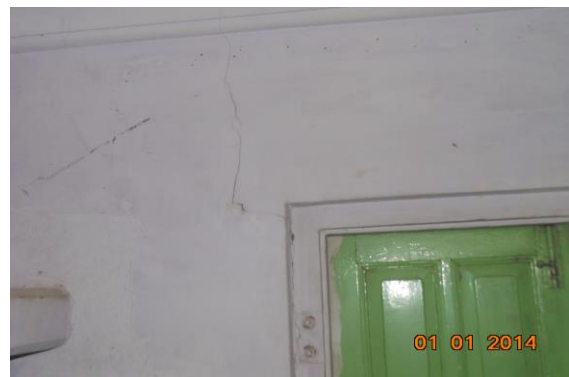
Photo 11

Inclined Crack on Wall No. 2 of , First Floor, Approx. Width = 2.5mm, Approx. Length = 0.5m. Distance from Wall No. 3 = 0.05m, Height from Floor = 2m.

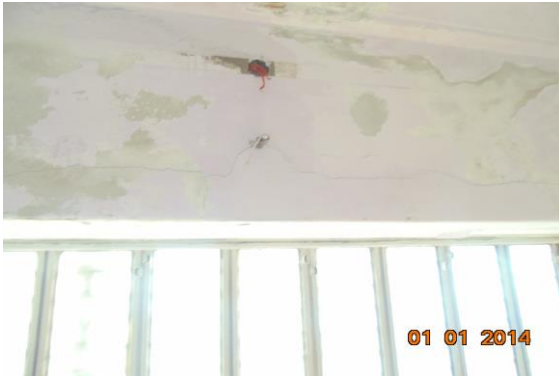
Photo 12

Horizontal Crack on Wall No. 1 of , First Floor, Approx. Width = 1.5mm,
Approx. Length = 1.5m.
Distance from Wall No. 4 = 0.2m, Height from Floor = 2m.

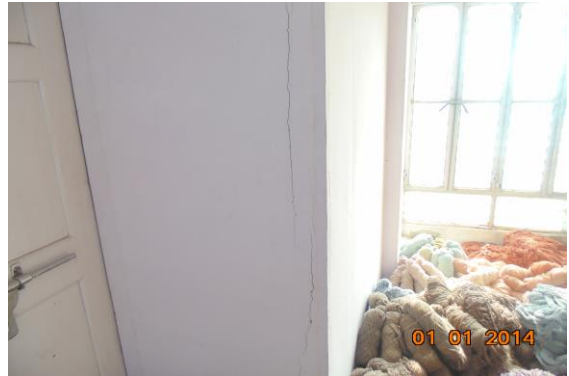
Photo 13

Vertical Crack on Wall No. 3 of , First Floor, Approx. Width = 0.8mm,
Approx. Length = 2m.
Distance from Wall No. 1 = 2m, Height from Floor = 0m.

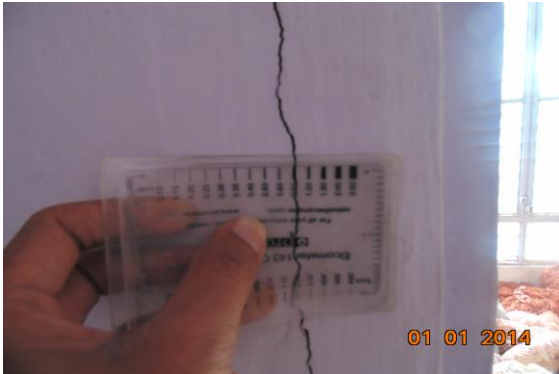
Photo 13A

Vertical Crack on Wall No. 3 of , First Floor, Approx. Width = 0.8mm,
Approx. Length = 2m.
Distance from w1 = 2m, Height from Floor = 0m.

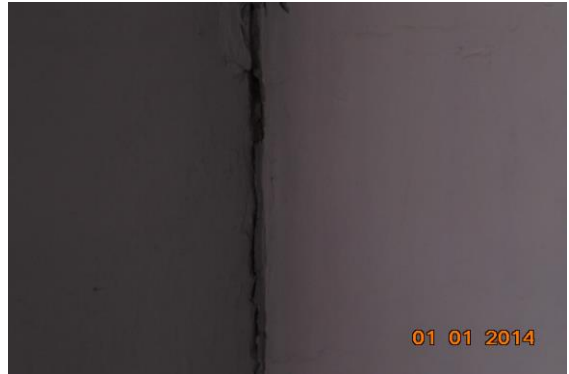
Photo 14

Vertical Crack on Wall No. 2 & 4 of Hall No. 3, First Floor, Approx. Width
= 15mm, Approx. Length = 3m.
Distance from = m, Height from Floor = m.

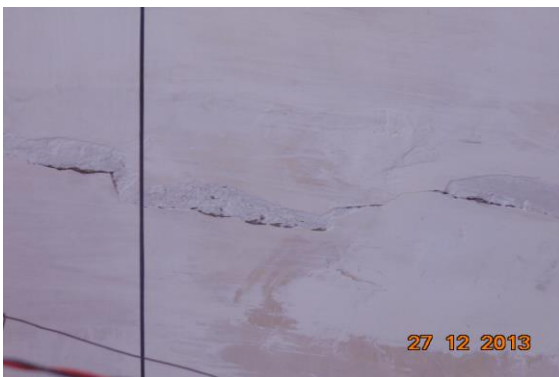
Photo 15

Horizontal Crack on Roof of Room No. 1, Third Floor, Approx. Width =
1.5mm, Approx. Length = 3.5m.
Distance from w2 = 1.6m, Height from Floor = 2.8m.

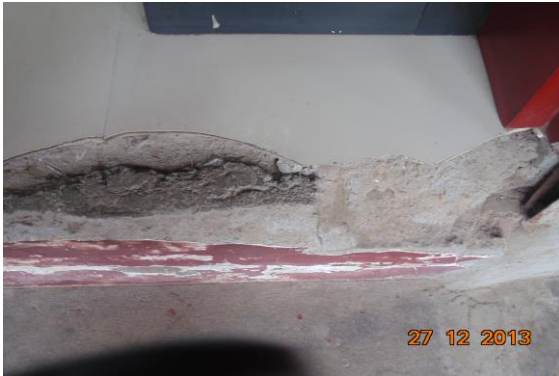
Photo 17

Horizontal Crack on Roof of Room No. 1, Third Floor, Approx. Width = 1.5mm, Approx. Length = 2.7m.
Distance from w2 = 3m, Height from Floor = 2.7m.

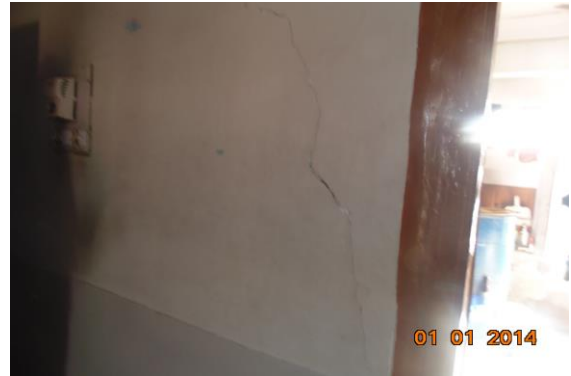
Photo 18

Inclined Crack on Wall No. 1 of Hall No. 1, Third Floor, Approx. Width = 12mm, Approx. Length = 2m.
Distance from w3 = 2m, Height from Floor = 1m.

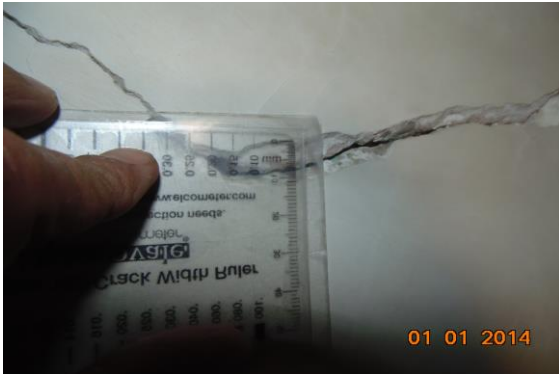
Photo 18A

Inclined Crack on Wall No. 1 of Hall No. 1, Third Floor, Approx. Width = 12mm, Approx. Length = 2m.
Distance from w3 = 2m, Height from Floor = 1m.

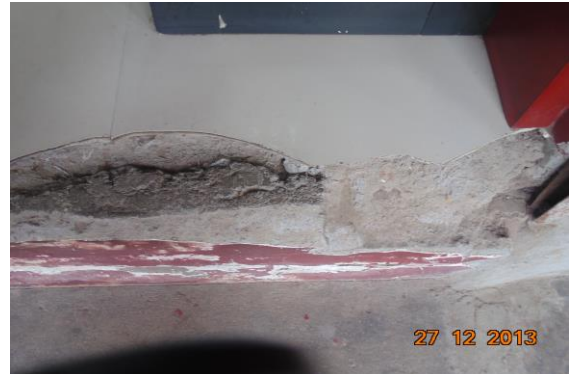
Photo 19

Peeling of Plaster on Outer Wall & Floor of Shop No.63 of Ground Floor

Summary of Defects Other Than Crack			
Defect ID	Location	Description	Photo No.
12	Outer Wall & Floor Shop No.63 Ground Floor	Peeling of Plaster	19
13	Outer Leftside External Column Shop No.64 Ground Floor	Peeling of Plaster	20
14	Floor Shop No.64 Ground Floor	Peeling of Plaster	21
15	Leftside External Column Beam Shop No.64 Ground Floor	Peeling of Plaster	22
16	Roof Shop No.64 Ground Floor	Dampness/Seepage	23
17	Beam Varanda Shop No.61, Ground Floor	Dampness/Seepage	24
18	Roof Varanda Shop No.61, Ground Floor	Dampness/Seepage	25
19	Wall No. 4 Shop No.62 Ground Floor	Dampness/Seepage	26
20	Roof Lobby 1 First Floor	Peeling of Plaster	27
21	Wall No. 3 First Floor	Peeling of Plaster	28
22	Roof & Wall No.3 First Floor	Plaster Crack	29
23	Floor First Floor	Plaster Crack	30
24	Roof & Wall No. 4 Hall No. 1 First Floor	Dampness/Seepage	31
25	Wall No. 2 First Floor	Dampness/Seepage	32
26	Wall No. 1 Hall No. 2 First Floor	Plaster Crack	33

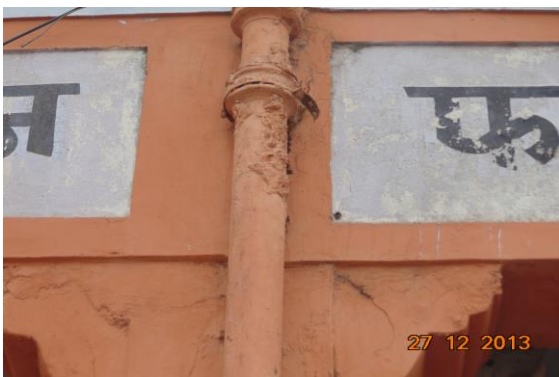
Photo 20

Peeling of Plaster on Outer Leftside External Column of Shop No.64 of Ground Floor

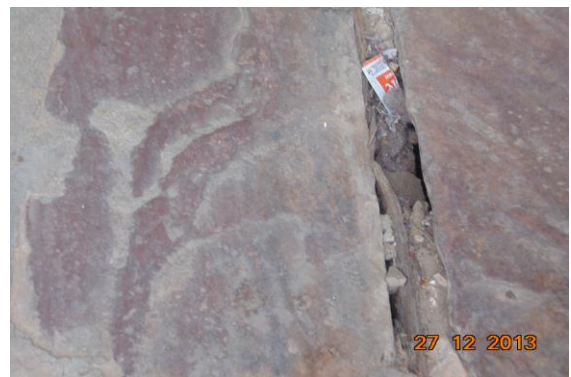
Photo 21

Peeling of Plaster on Floor of Shop No.64 of Ground Floor

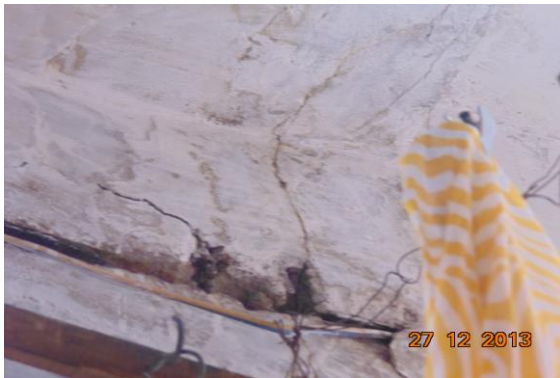
Photo 22

Peeling of Plaster on Leftside External Column Beam of Shop No.64 of Ground Floor

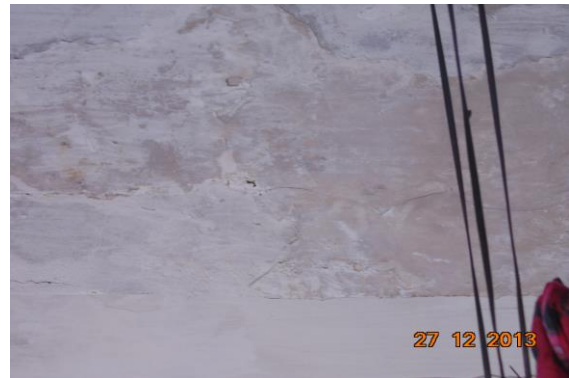
Photo 23

Dampness/Seepage on Roof of Shop No.64 of Ground Floor

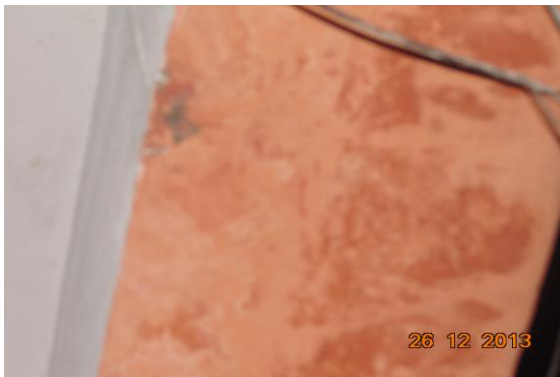
Photo 24

Dampness/Seepage on Beam of Varanda of Shop No.61, Ground Floor

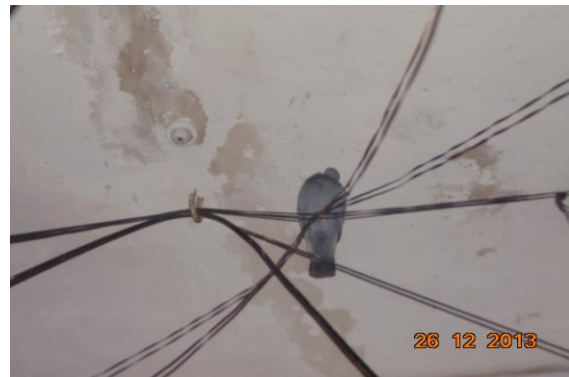
Photo 25

Dampness/Seepage on Roof of Varanda of Shop No.61, Ground Floor

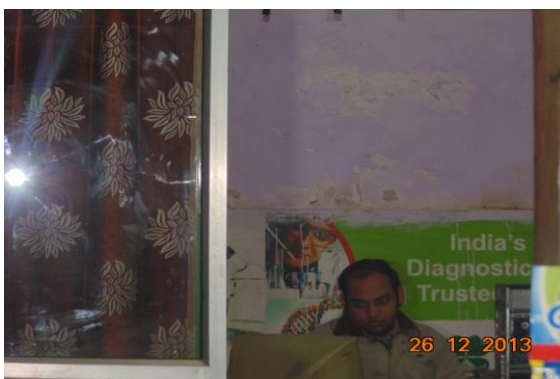
Photo 26

Dampness/Seepage on Wall No. 4 of Shop No.62 of Ground Floor

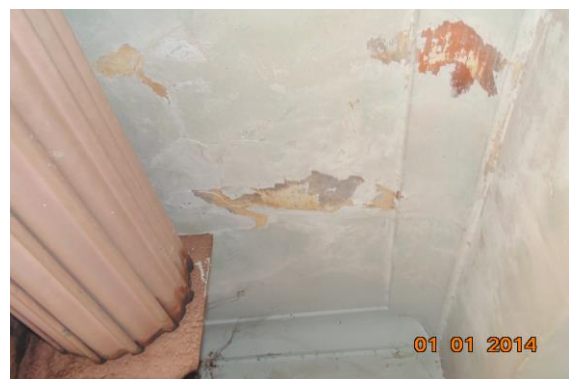
Photo 27

Peeling of Plaster on Roof of Lobby 1 of First Floor

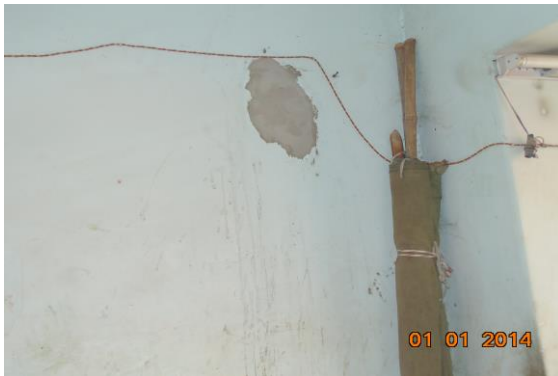
Photo 28
Peeling of Plaster on Wall No. 3 of First Floor

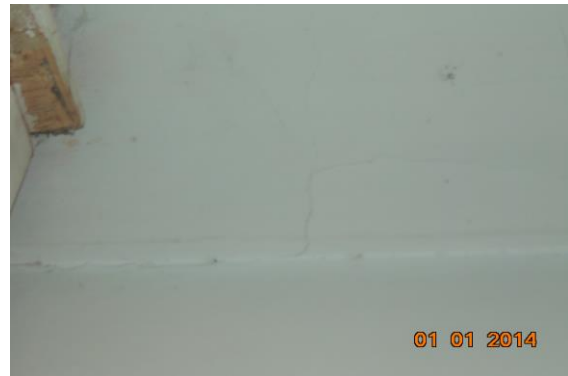
Photo 29
Plaster Crack on Roof & Wall No. 3 of First Floor

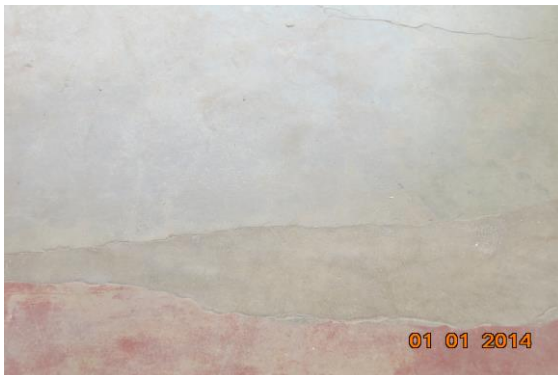
Photo 30
Plaster Crack on Floor of First Floor

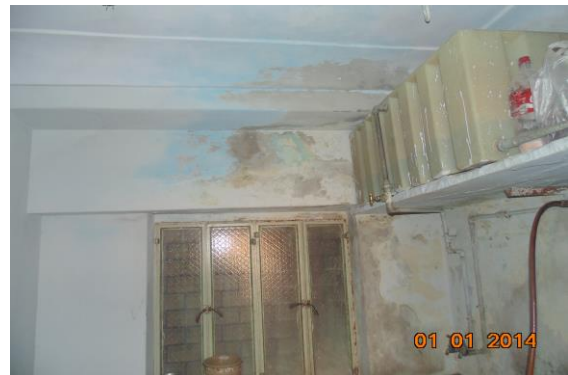
Photo 31
Dampness/Seepage on Roof & Wall No. 4 of Hall No. 1 of First Floor

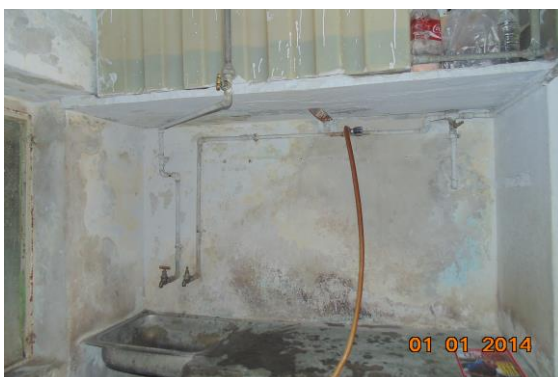
Photo 32
Dampness/Seepage on Wall No. 2 of First Floor

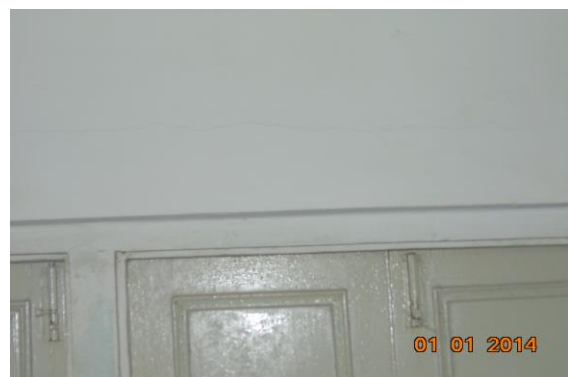
Photo 33
Plaster Crack on Wall No. 1 of Hall No. 2 of First Floor

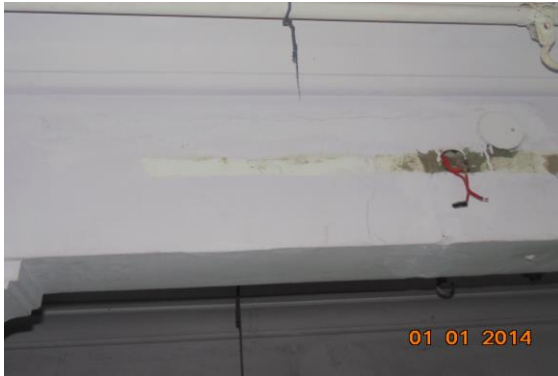
Photo 34
Plaster Crack on Roof of Lobby 2 of First Floor

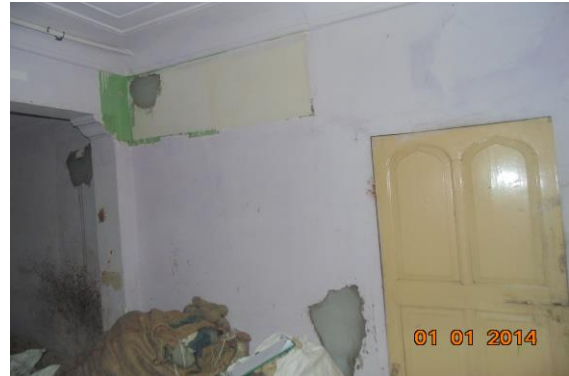
Photo 35
Peeling of Plaster on Wall No. 3 of First Floor

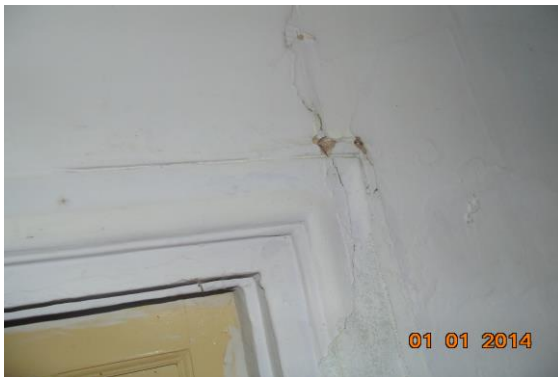
Photo 36
Plaster Crack on Wall No. 1 of First Floor

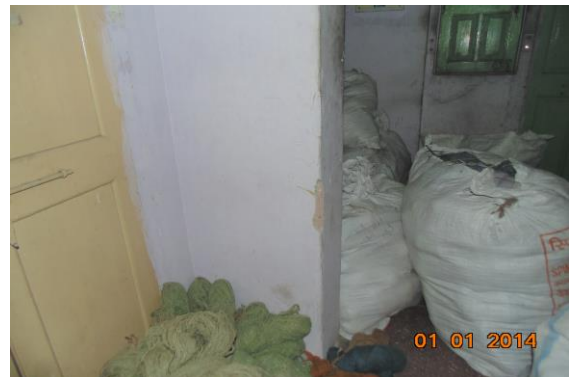
Photo 37
Peeling of Plaster on Wall No. 4 of First Floor

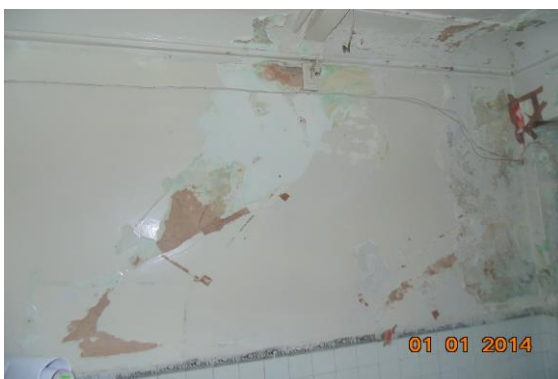
Photo 38
Dampness/Seepage on Wall No. 1 of Room No. 1 of First Floor

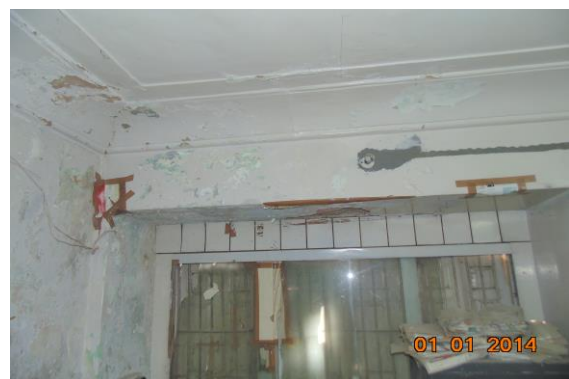
Photo 39
Dampness/Seepage on Roof & Wall No.4 of First Floor

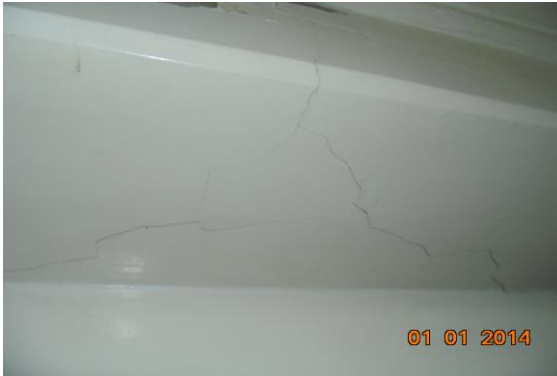
Photo 40
Plaster Crack on Roof of First Floor

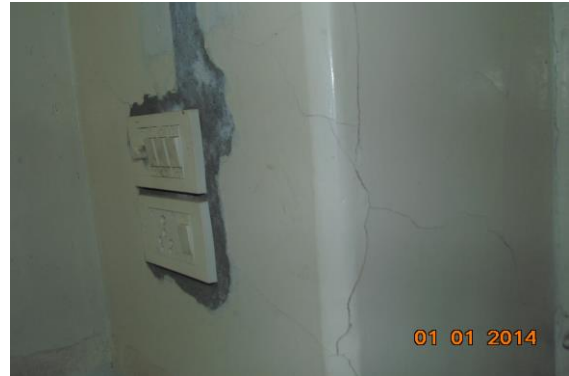
Photo 41
Plaster Crack on Wall No. 3 of First Floor

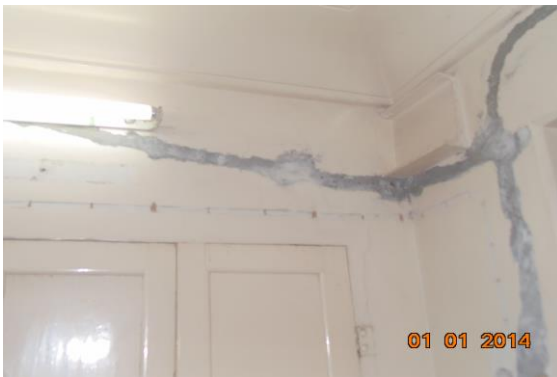
Photo 42
Plaster Crack on Wall No. 2 & 3 of Room No. 3 of First Floor

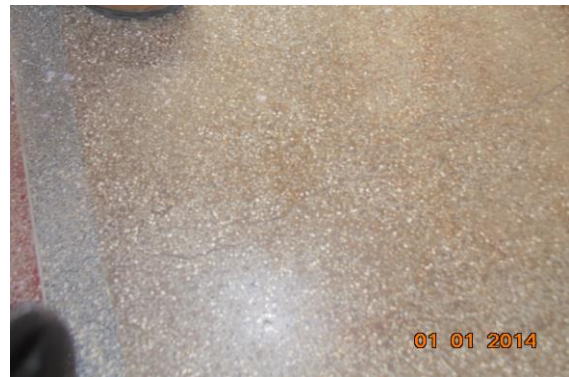
Photo 43
Plaster Crack on Floor of Hall No. 3 of First Floor

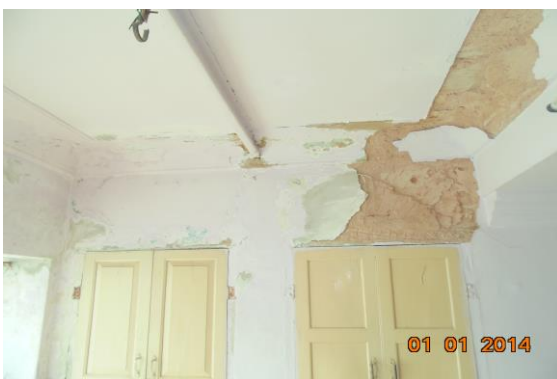
Photo 44
Peeling of Plaster on Roof & Wall No.4 of First Floor

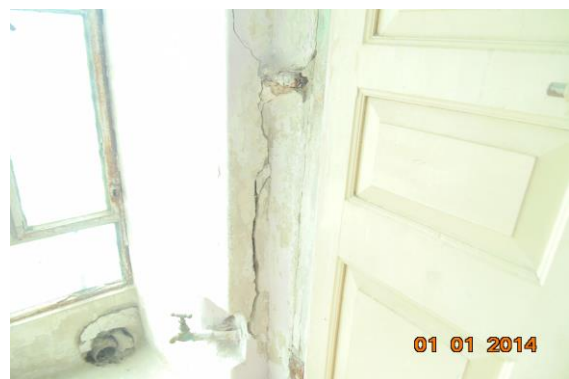
Photo 45
Peeling of Plaster on Wall No. 4 of First Floor

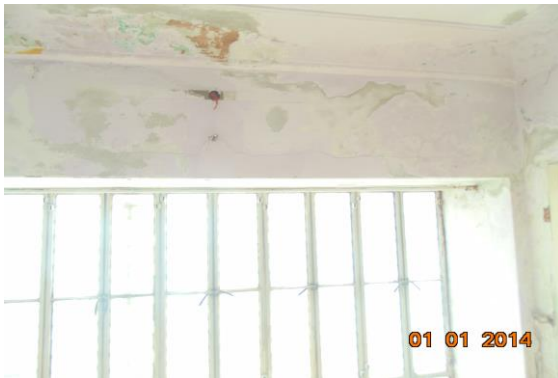
Photo 46
Dampness/Seepage on Roof, Wall No.1 & 4 of First Floor

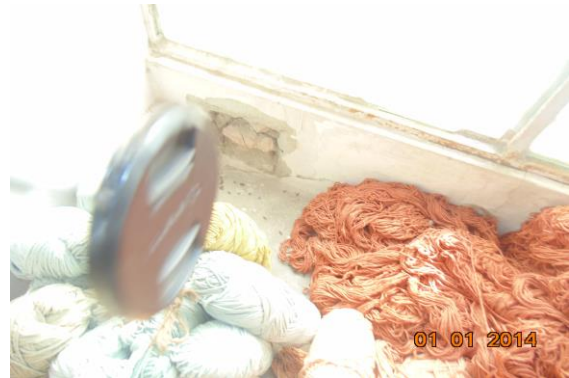
Photo 47
Peeling of Plaster on Wall No. 1 of First Floor

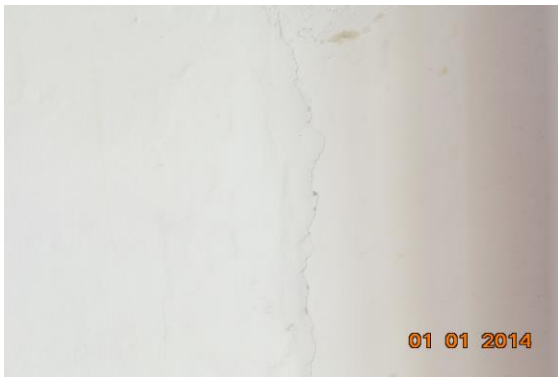
Photo 48
Plaster Crack on Wall No. 3 of First Floor

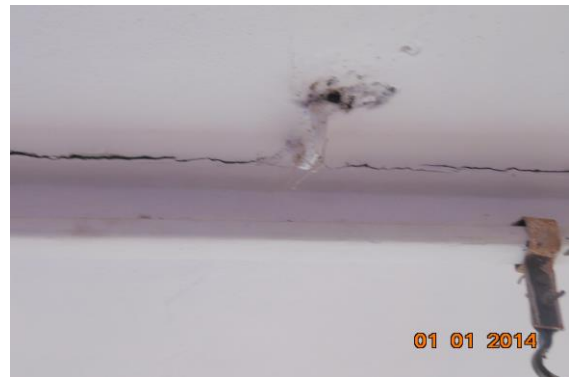
Photo 49
Plaster Crack on Roof of First Floor

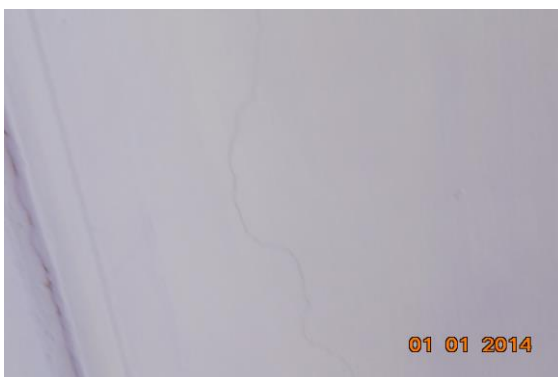
Photo 50
Plaster Crack on Roof of First Floor

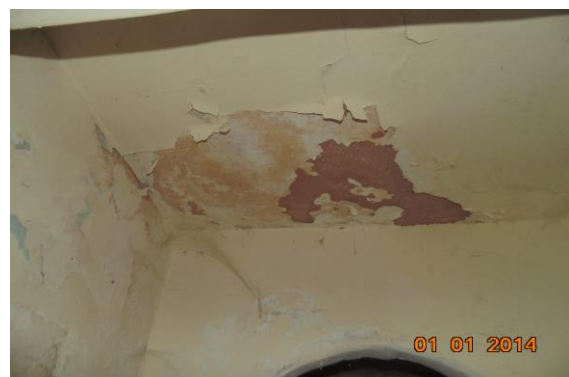
Photo 51
Dampness/Seepage on Roof of Toilet No. 1 of First Floor

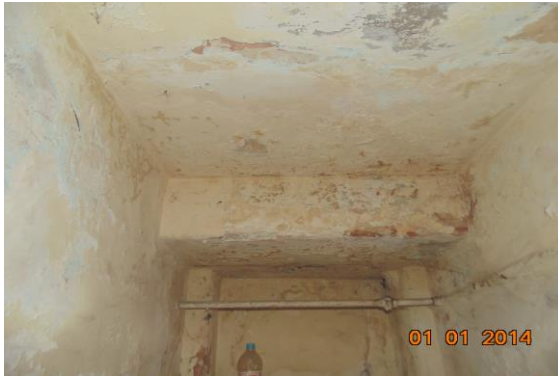
Photo 52
Dampness/Seepage on Roof of Toilet No. 1 of First Floor

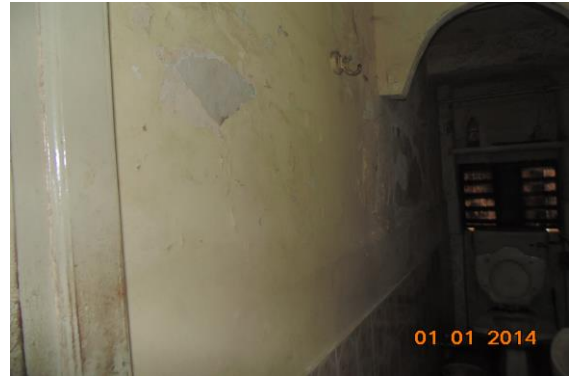
Photo 53
Dampness/Seepage on Wall No. 1 of First Floor

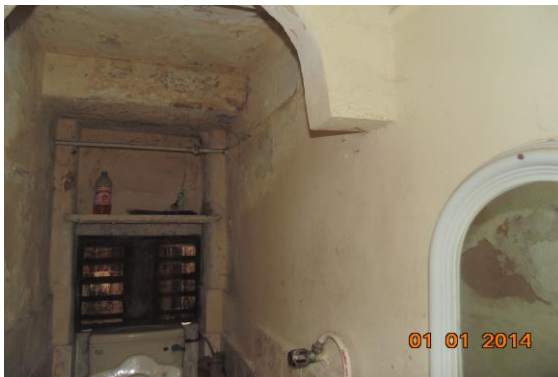
Photo 54
Dampness/Seepage on Wall No. 2 of First Floor

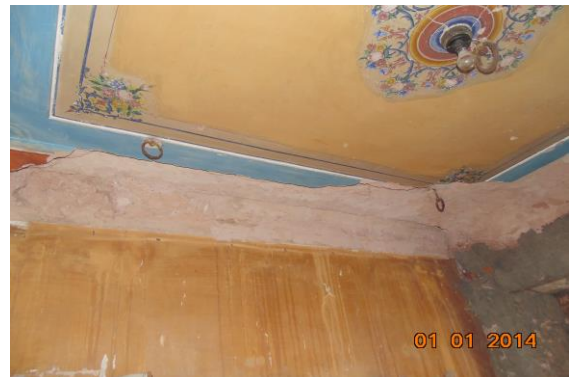
Photo 55
Damaged Portion on Roof of Lobby of Second Floor

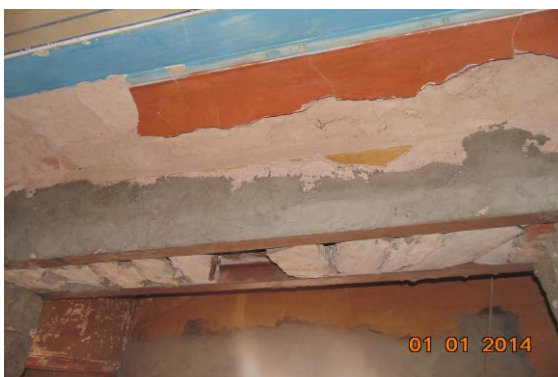
Photo 56
Damaged Portion on Roof of Lobby of Second Floor

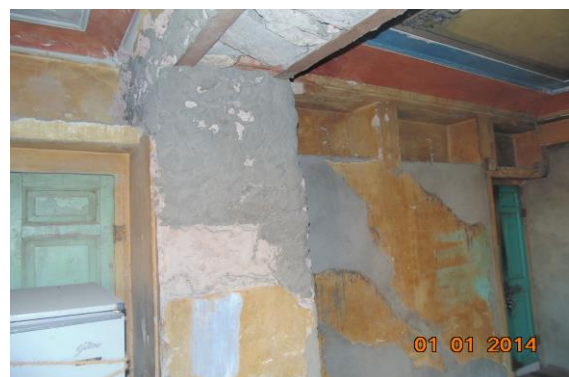
Photo 57
Peeling of Plaster on Wall No. 4 of Second Floor

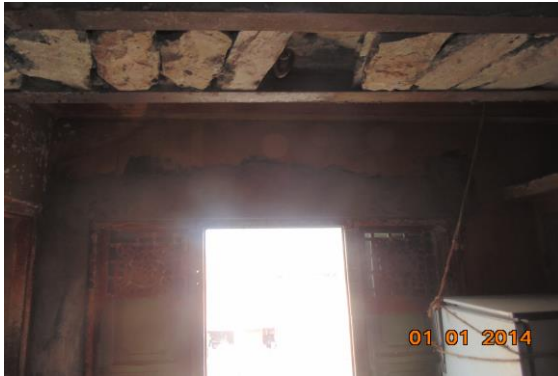
Photo 58
Peeling of Plaster on Wall No. 1 of Second Floor

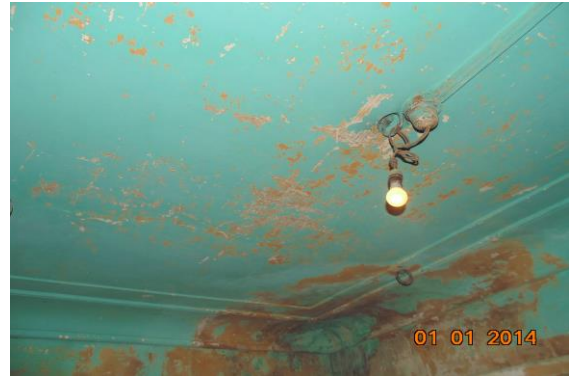
Photo 59
Dampness/Seepage on Roof of Toilet No. 1 of Second Floor

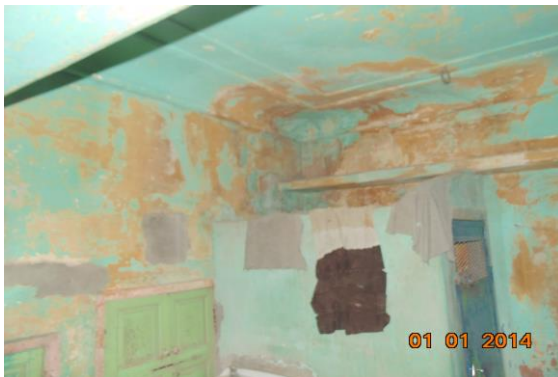
Photo 60
Dampness/Seepage on Wall No. 1 & 4 of Second Floor

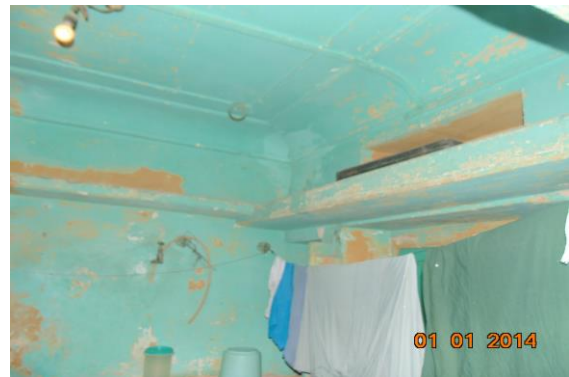
Photo 61
Dampness/Seepage on Wall No. 2 & 4 of Second Floor

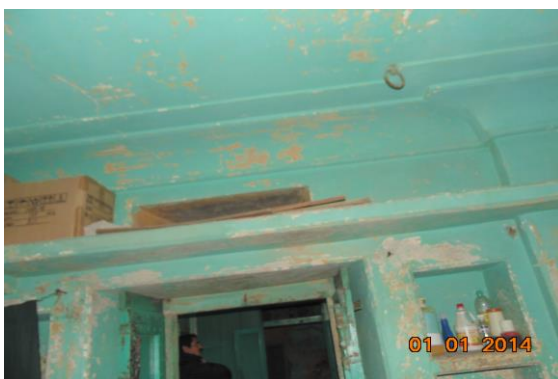
Photo 62
Dampness/Seepage on Wall No. 3 of Second Floor

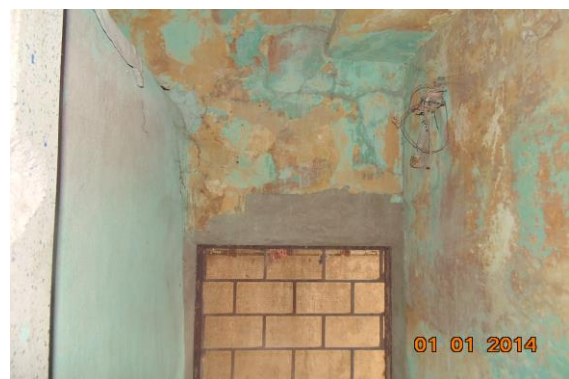
Photo 63
Dampness/Seepage on Wall No. 1, 2 & 4 of Second Floor

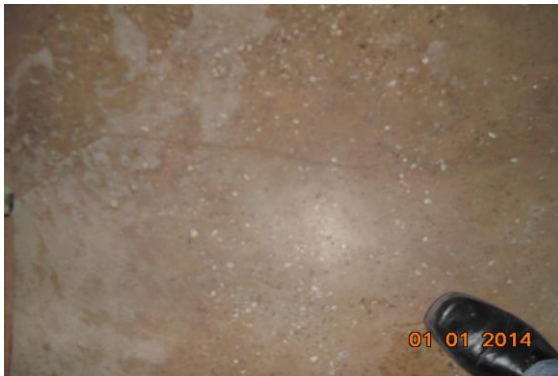
Photo 64
Plaster Crack on Floor of Second Floor

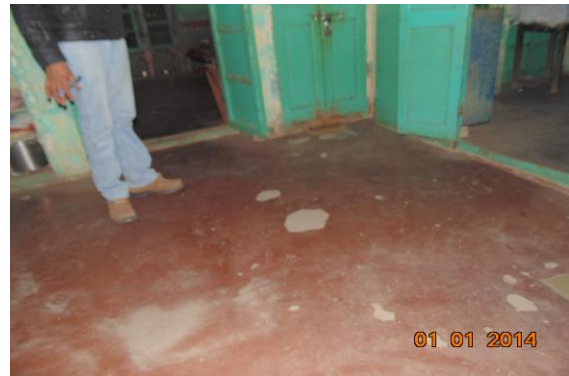
Photo 65
Peeling of Plaster on Floor of Room No. 1 of Second Floor
