Pre Building Condition Survey Report

Name and Address of Structure :	Badi Chopar to Ramp Area (Down Line)
---------------------------------	--------------------------------------

Name of the Project	Contract JMRC-UG1B “Design and Construction of Tunnel between Chandpole and Badi Chouper and reverse line by Shield TBM, Underground Metro Stations at Choti Chouper and Badi Chouper by Cut and Cover Methods on East West Corridor of Jaipur Metro Rail Corporation Limited .”	
Owner :

Pre - Condition Building Survey for Construction of Underground Stations from Chandpole to Bari Chouper and reversal line

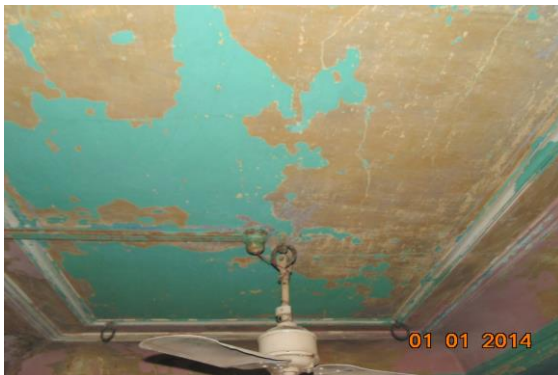
Photo 66
Dampness/Seepage on Roof of Second Floor

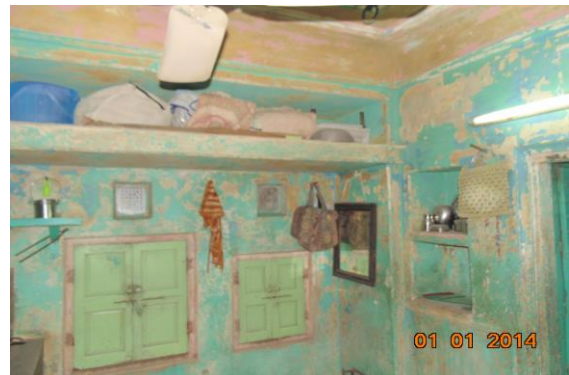
Photo 67
Dampness/Seepage on Wall No. 2 & 4 of Second Floor

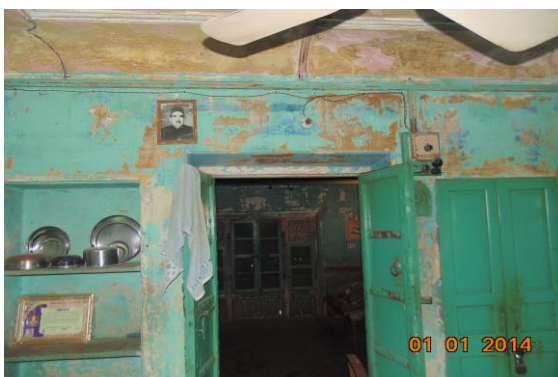
Photo 68
Dampness/Seepage on Wall No. 3 of Second Floor

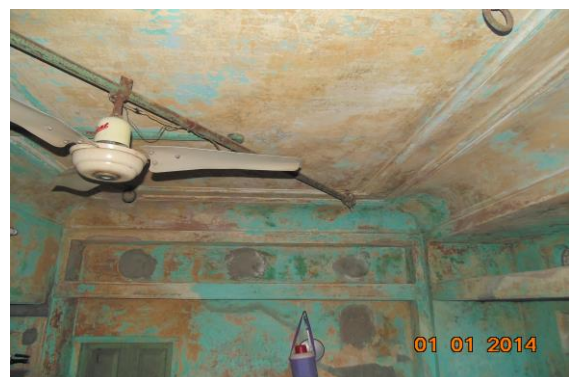
Photo 69
Dampness/Seepage on Roof & Wall No.4 of Room No. 2 of Second Floor

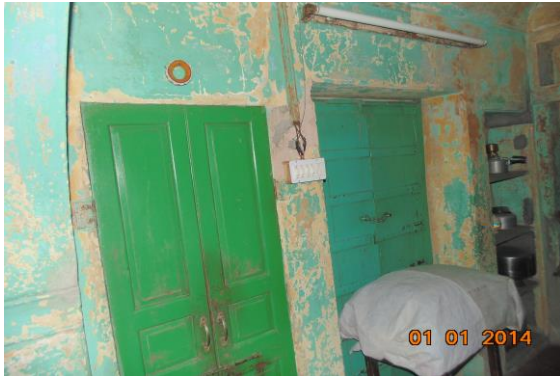
Photo 70
Dampness/Seepage on Wall No. 1 of Second Floor

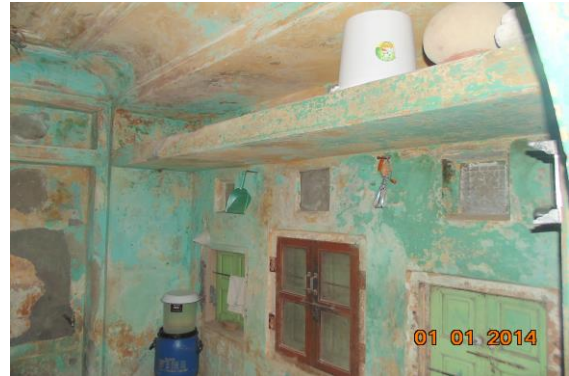
Photo 71
Dampness/Seepage on Wall No. 2 of Second Floor

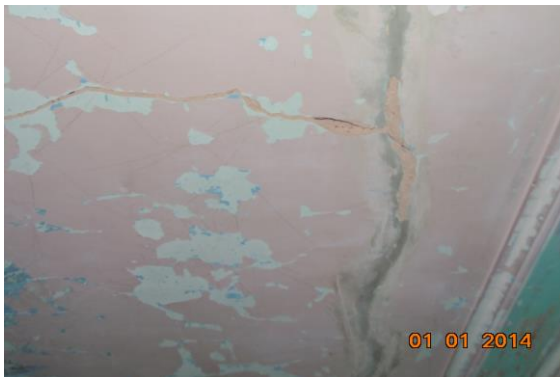
Photo 72
Peeling of Plaster on Roof of Hall No. 1 of Second Floor

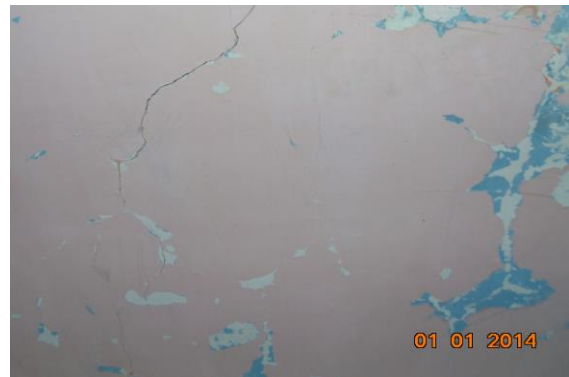
Photo 73
Peeling of Plaster on Roof of Hall No. 1 of Second Floor

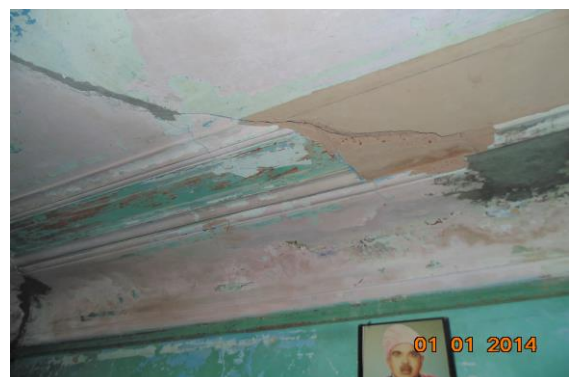
Photo 75
Peeling of Plaster on Roof of Hall No. 1 of Second Floor

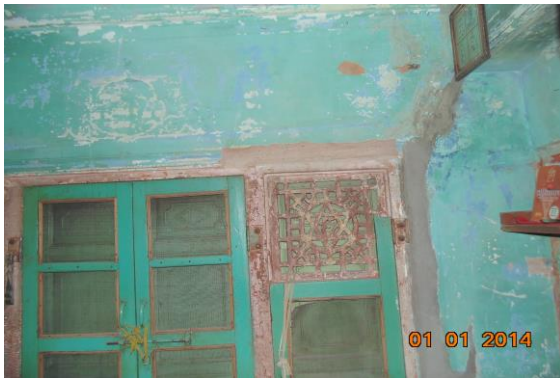
Photo 76
Peeling of Plaster on Wall No. 1 of Second Floor

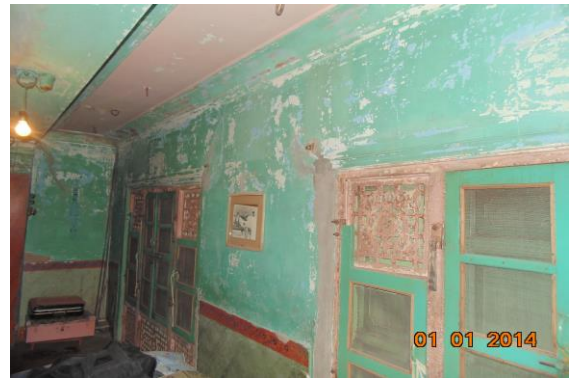
Photo 77
Peeling of Plaster on Wall No. 1 of Second Floor

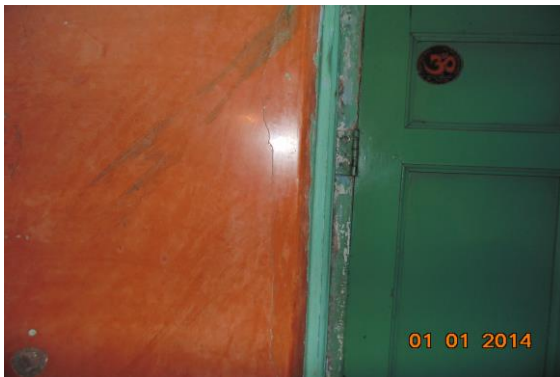
Photo 78
Plaster Crack on Wall No. 4 of Second Floor

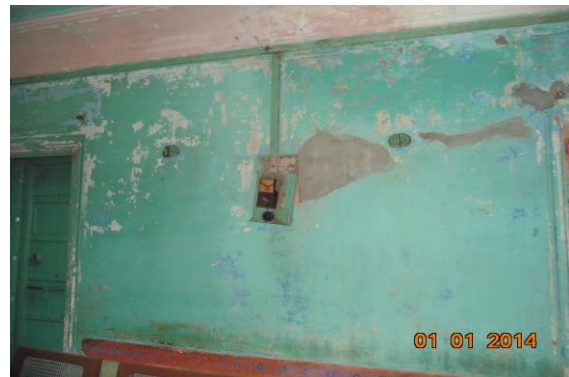
Photo 79
Dampness/Seepage on Wall No. 2 of Second Floor

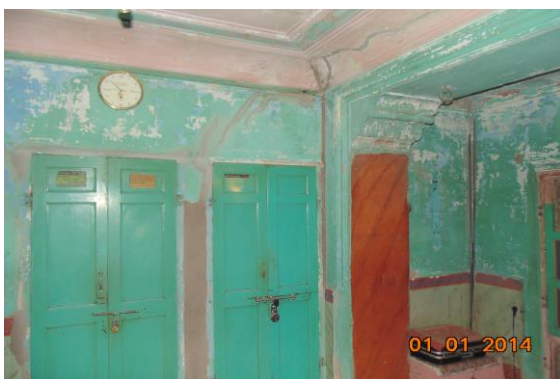
Photo 80
Dampness/Seepage on Wall No. 3 of Second Floor

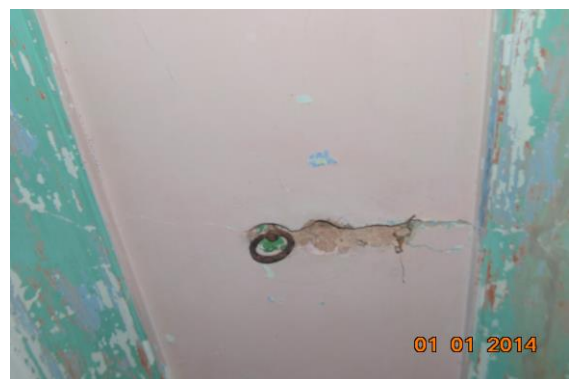
Photo 81
Peeling of Plaster on Roof of Second Floor

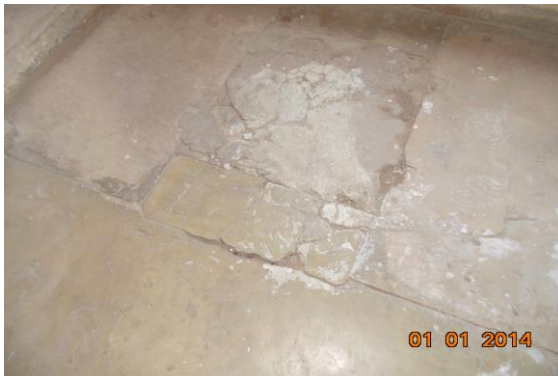
Photo 82
Peeling of Plaster on Floor of Lobby Wall No.1 of Second Floor

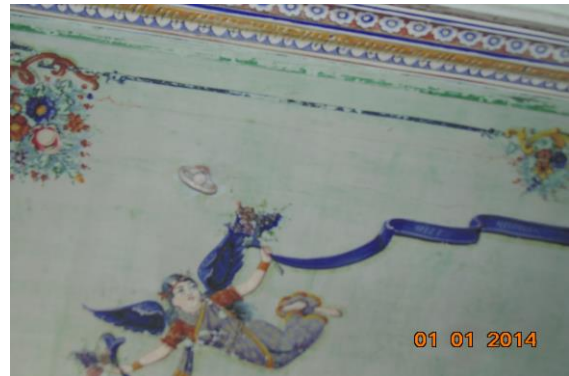
Photo 83
Plaster Crack on Roof of Hall No. 1 of Second Floor

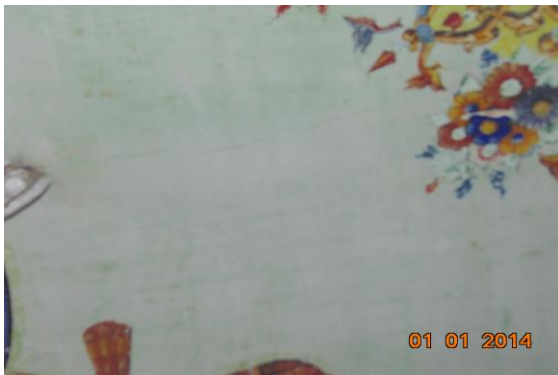
Photo 84
Plaster Crack on Roof of Hall No. 1 of Second Floor

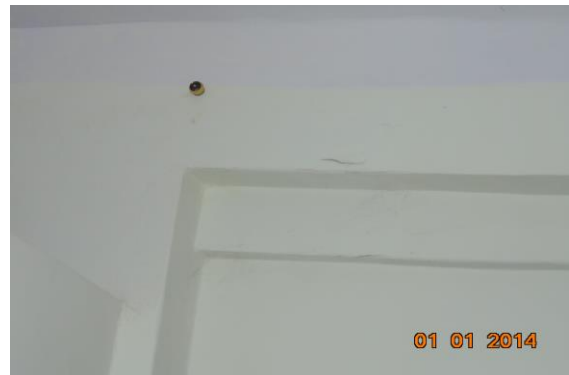
Photo 85
Peeling of Plaster on Wall No. 4 of Room No. 3 of Second Floor

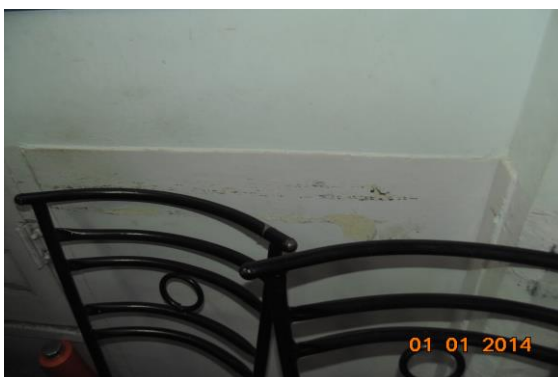
Photo 86
Peeling of Plaster on Wall No. 3 of Hall No. 1 of Second Floor

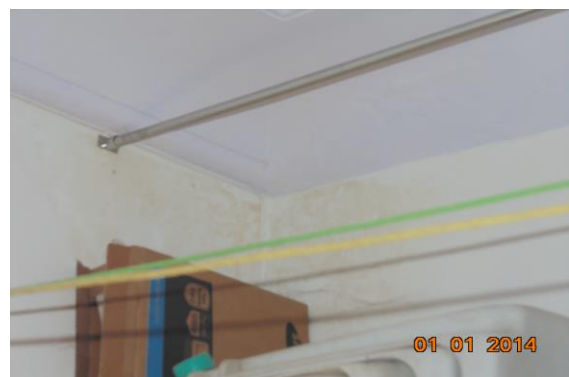
Photo 87
Dampness/Seepage on Wall No. 2 & 4 of Room No. 4 of Second Floor

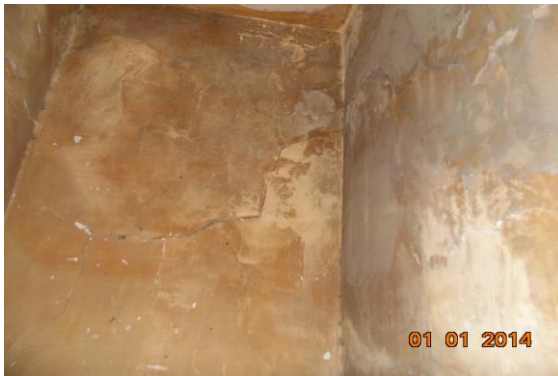
Photo 88
Damaged Portion on Wall No. 2 of Stair SF to TF of Third Floor

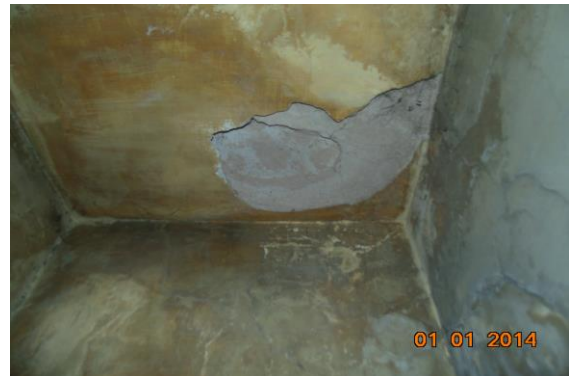
Photo 89
Peeling of Plaster on Roof of Third Floor

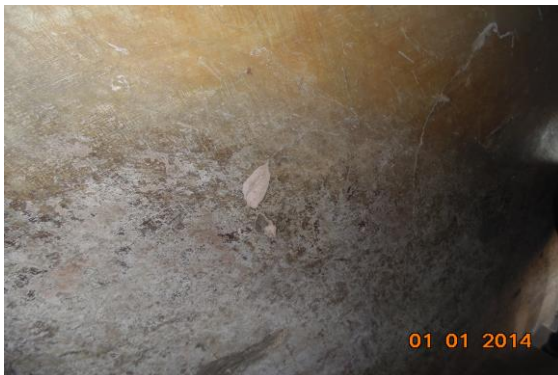
Photo 90
Peeling of Plaster on Wall No. 4 of Third Floor

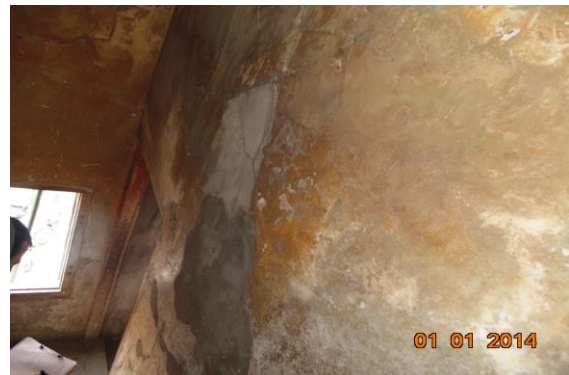
Photo 91
Damaged Portion on Wall No. 3 of Third Floor

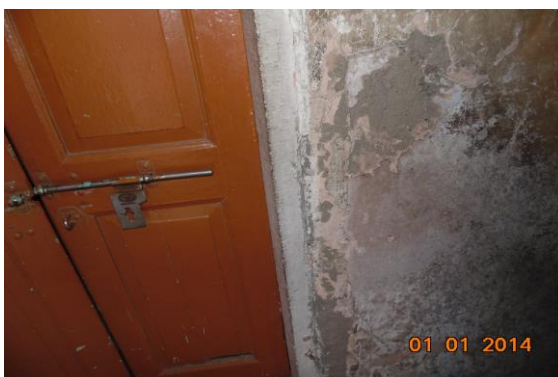
Photo 92
Peeling of Plaster on Wall No. 4 of Third Floor

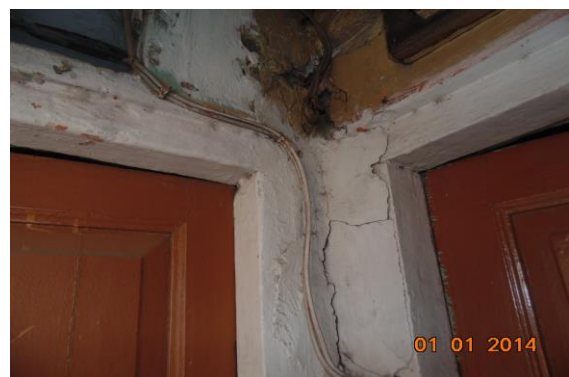
Photo 93
Peeling of Plaster on Wall No. 4 of Third Floor

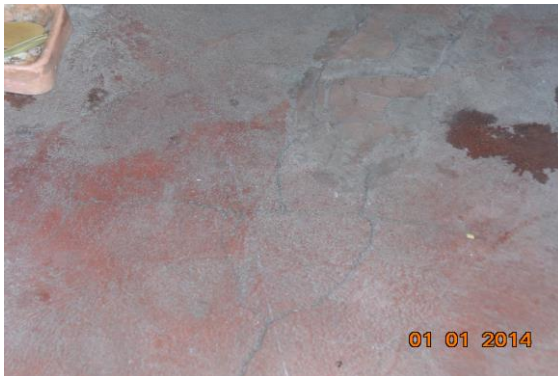
Photo 94
Plaster Crack on Floor of Bathroom No. 1 of Third Floor

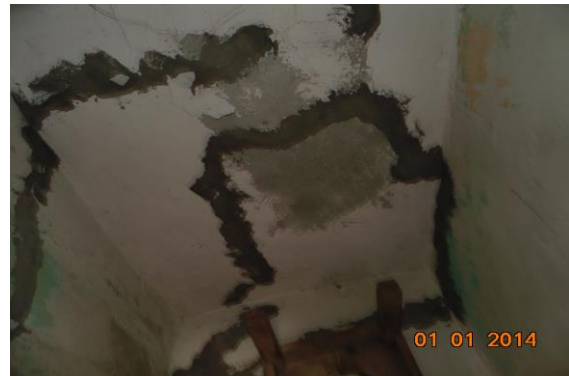
Photo 95
Peeling of Plaster on Roof of Toilet No. 1 of Third Floor

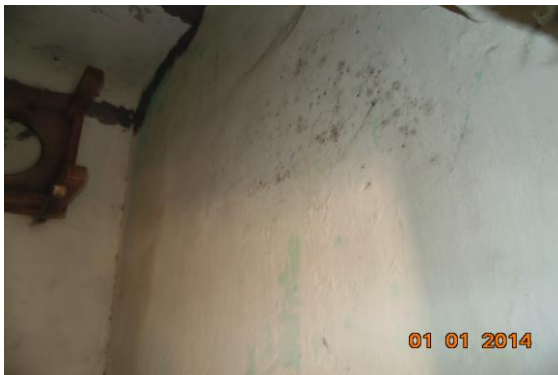
Photo 96
Dampness/Seepage on Wall No. 2 of Third Floor

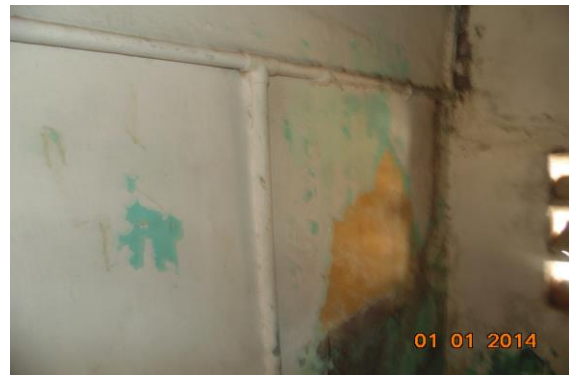
Photo 97
Dampness/Seepage on Wall No. 1 & 4 of Third Floor

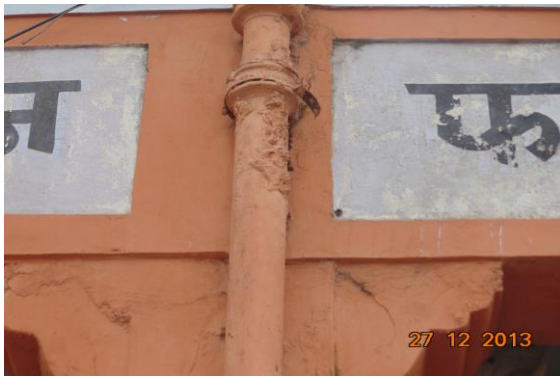
Photo 100
Peeling of Plaster on Roof & Wall No.1 of Third Floor

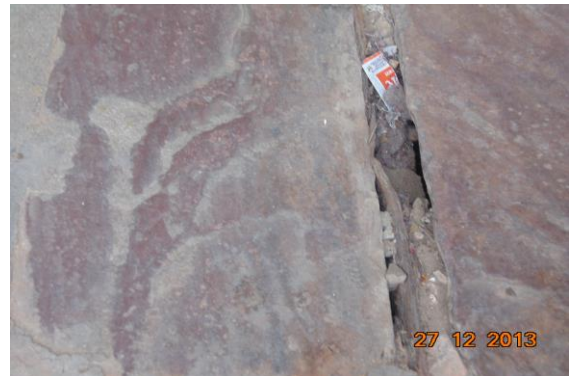
Photo 101
Plaster Crack on Roof of Kitchen of Third Floor

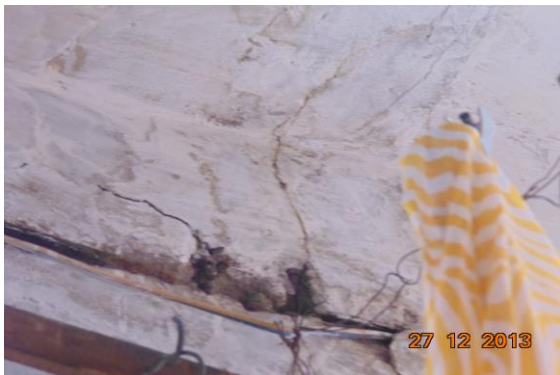
Photo 102
Plaster Crack on Roof of Kitchen of Third Floor

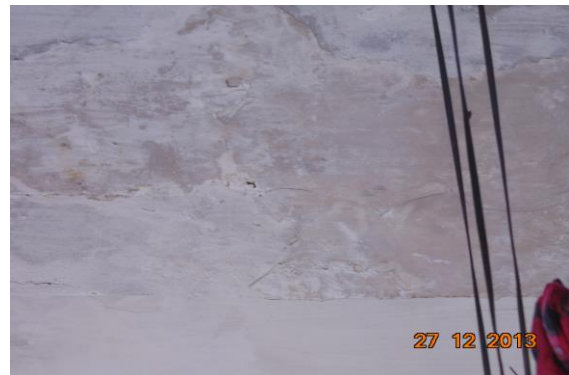
Photo 103
Peeling of Plaster on Wall No. 4 of Kitchen of Third Floor

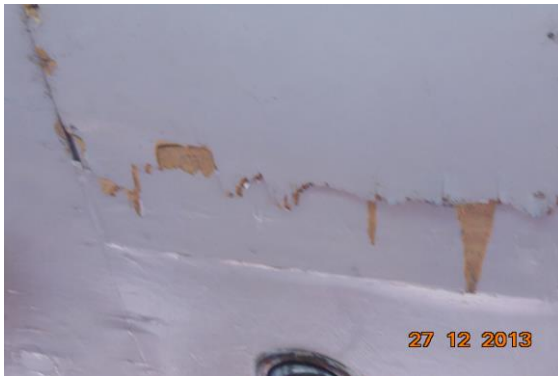
Photo 106
Peeling of Plaster on Wall No. 4 of Third Floor

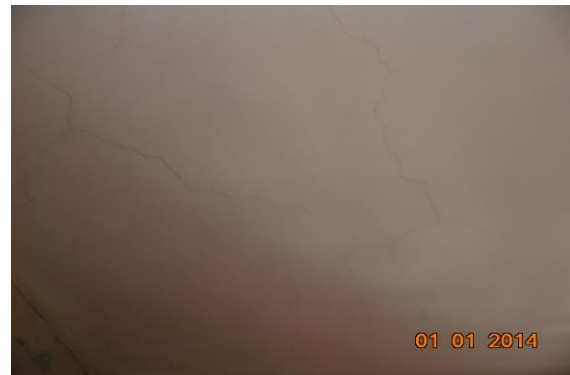
Photo 109
Plaster Crack on Roof of Third Floor

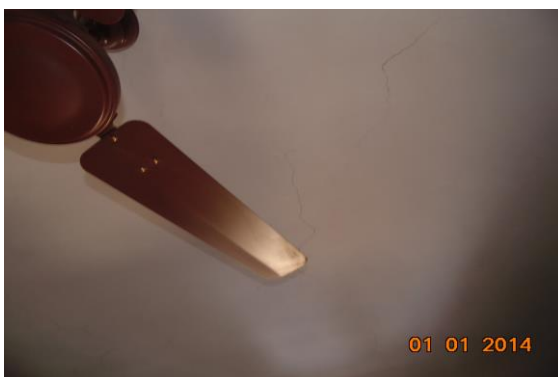
Photo 110
Plaster Crack on Roof of Third Floor

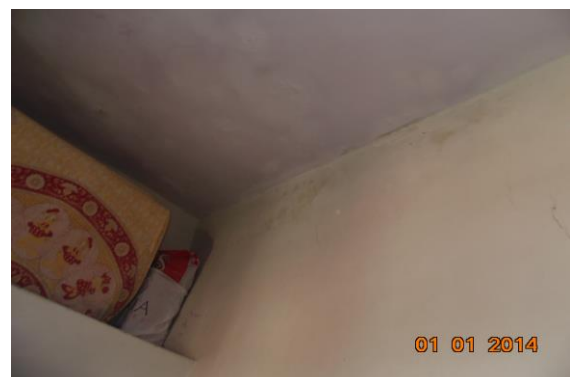
Photo 111
Dampness/Seepage on Wall No. 1 of Third Floor

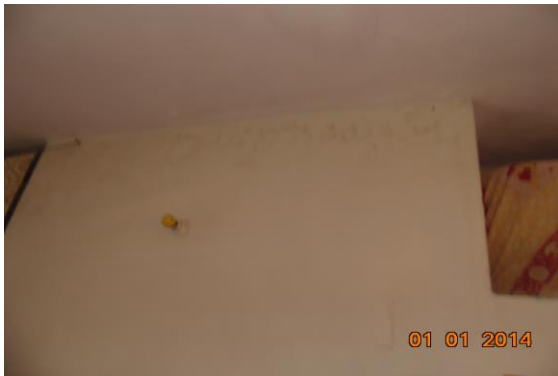
Photo 112
Dampness/Seepage on Wall No. 3 of Third Floor

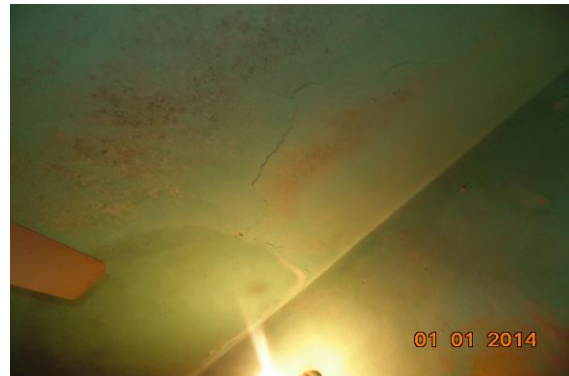
Photo 113
Plaster Crack on Roof of Room No. 2 of Third Floor

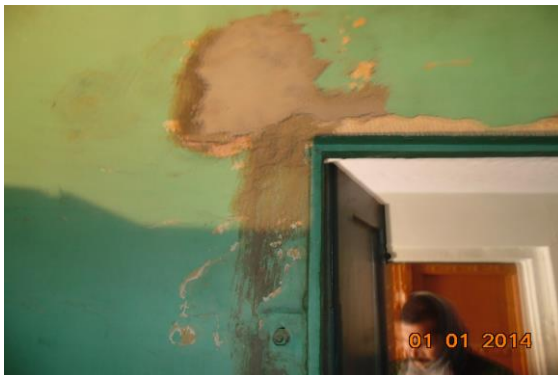
Photo 114
Peeling of Plaster on Wall No. 3 of Third Floor

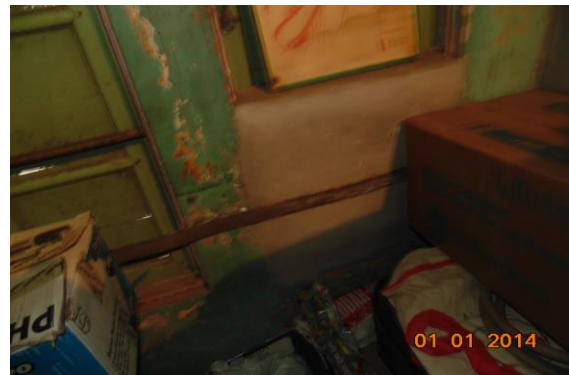
Photo 115
Peeling of Plaster on Wall No. 4 of Third Floor

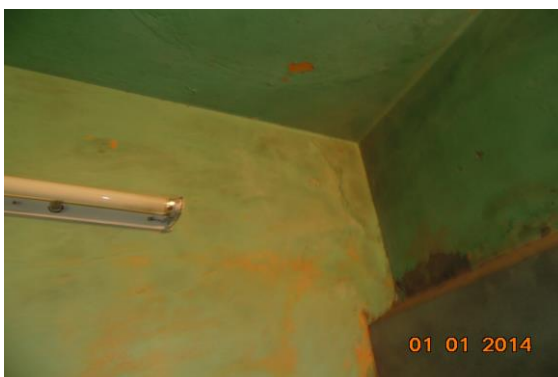
Photo 116
Dampness/Seepage on Wall No. 4 of Third Floor

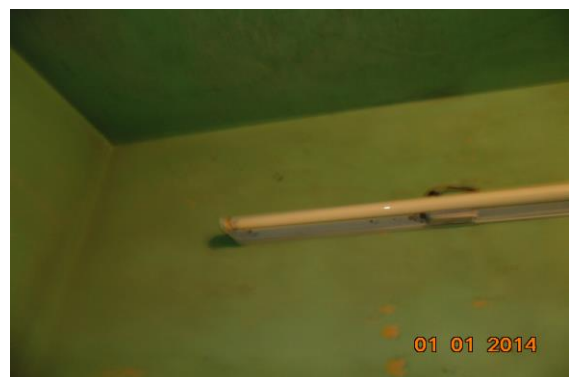
Photo 117
Dampness/Seepage on Wall No. 4 of Third Floor

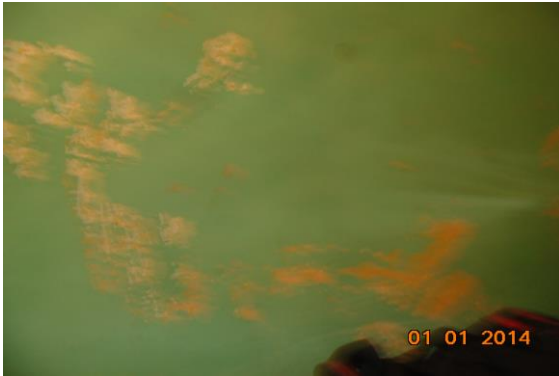
Photo 118
Peeling of Plaster on Wall No. 1 of Third Floor

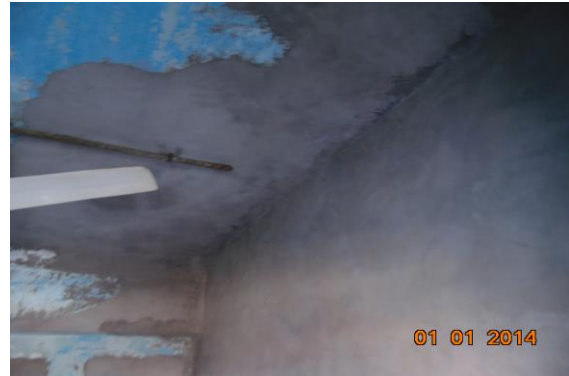
Photo 119
Peeling of Plaster on Roof & Wall No.2 of Room No. 3 of Third Floor

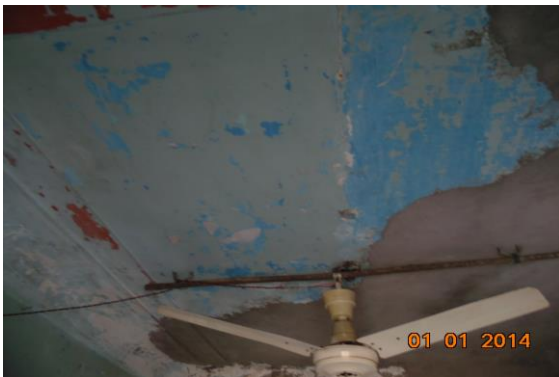
Photo 120
Dampness/Seepage on Roof of Third Floor

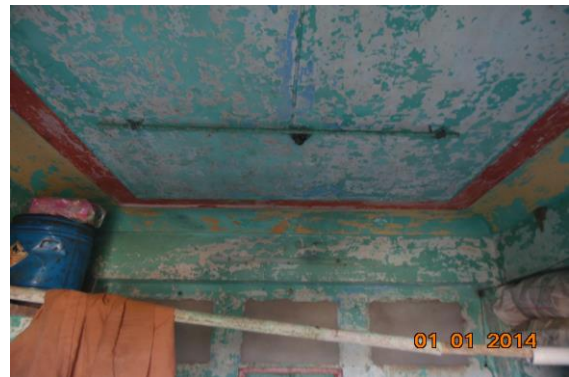
Photo 121
Dampness/Seepage of Third Floor

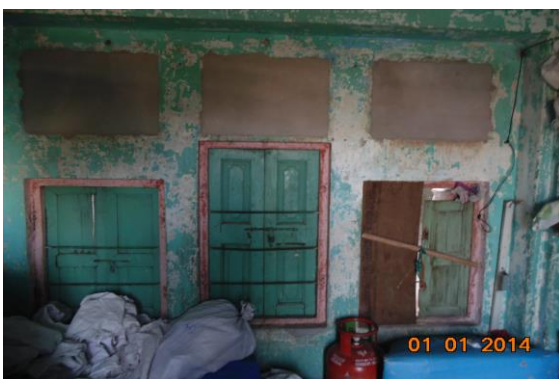
Photo 122
Dampness/Seepage on Roof & Wall No. 4 of Room No. 4 of Third Floor

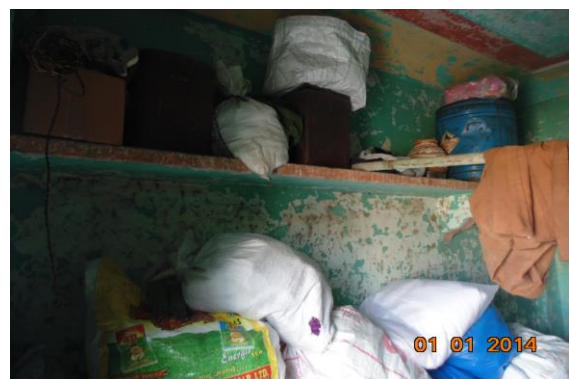
Photo 123
Dampness/Seepage on Wall No. 4 of Third Floor

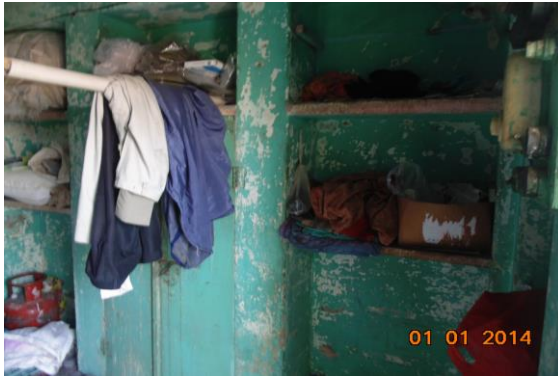
Photo 124
Dampness/Seepage on Wall No. 1 of Third Floor

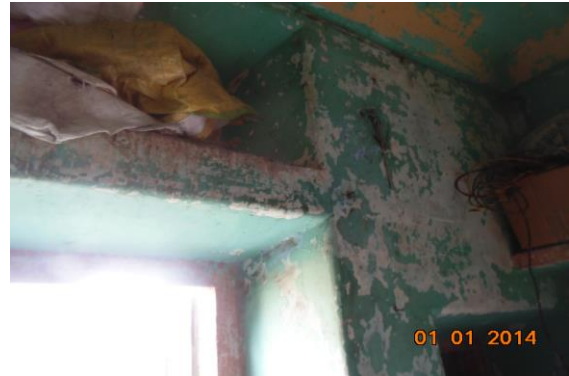
Photo 125
Dampness/Seepage on Wall No. 2 of Third Floor

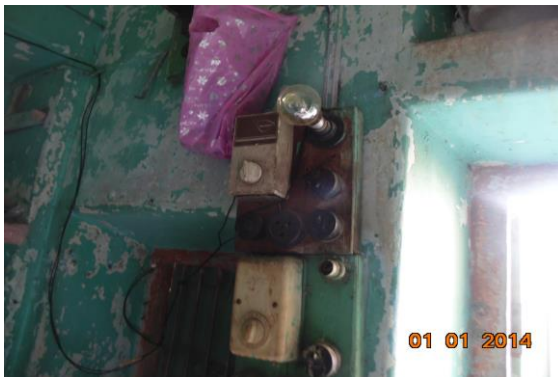
Photo 126
Dampness/Seepage on Wall No. 3 of Third Floor

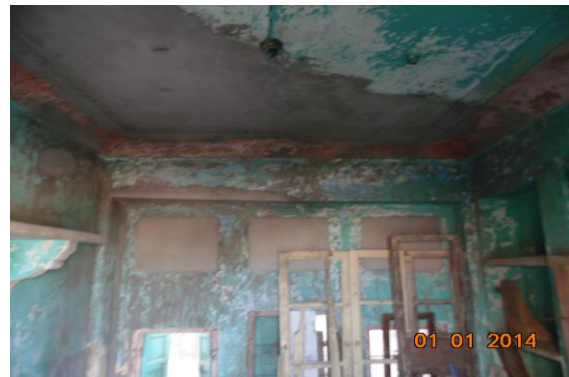
Photo 127
Dampness/Seepage on Wall No. 3 of Third Floor

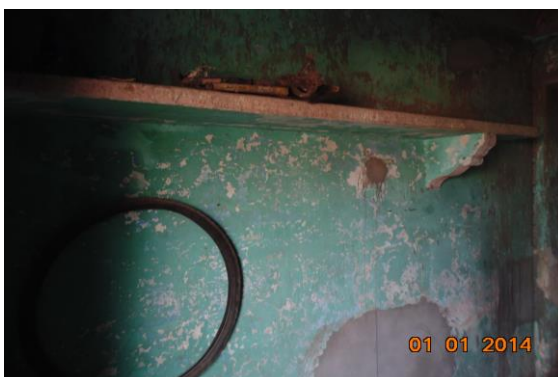
Photo 128
Dampness/Seepage on Roof & Wall No. 4 of Room No. 5 of Third Floor

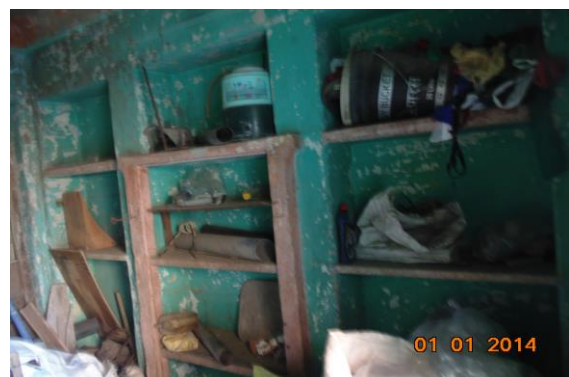
Photo 129
Dampness/Seepage on Wall No. 1 of Third Floor

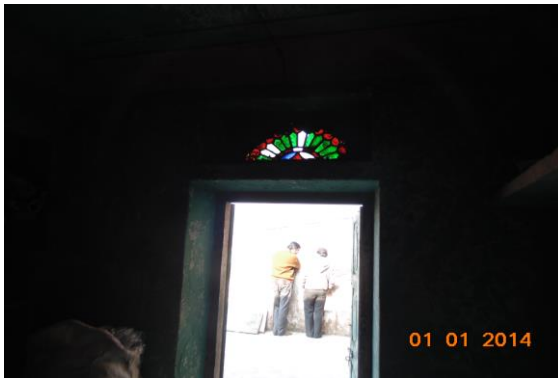
Photo 130
Dampness/Seepage on Wall No. 2 of Third Floor

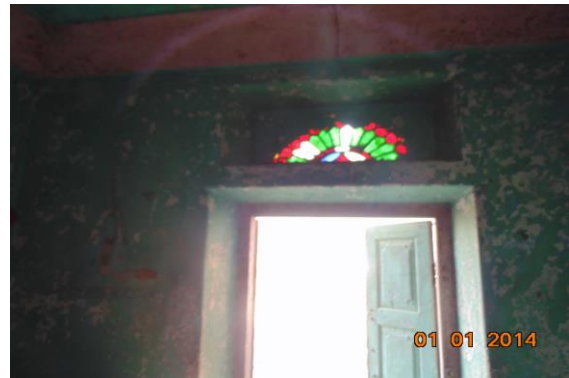
Photo 131
Dampness/Seepage on Wall No. 3 of Third Floor

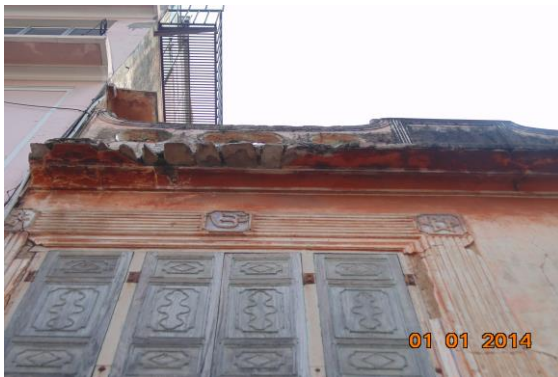
Photo 132
Damaged Portion on Outer Wall of FF External Façade

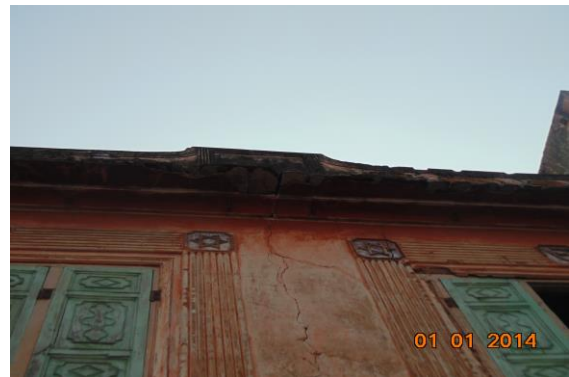
Photo 133
Damaged Portion on Outer Wall of FF External Façade

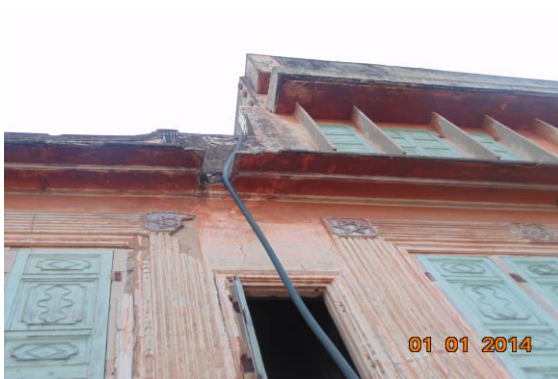
Photo 134
Damaged Portion on Outer Wall of FF External Façade

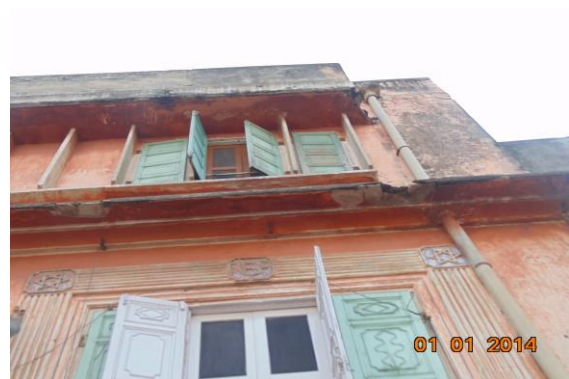
Photo 135
Damaged Portion on Outer Wall of FF External Façade

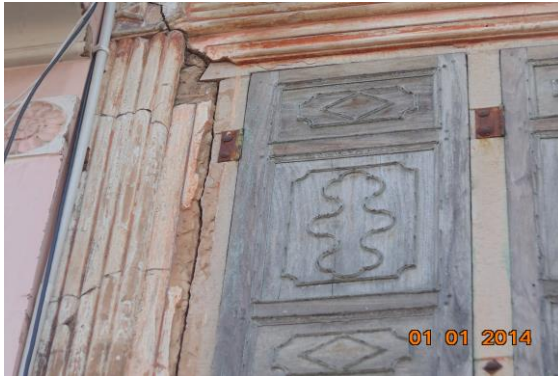
Photo 136
Peeling of Plaster on Outer Wall of SF External Façade

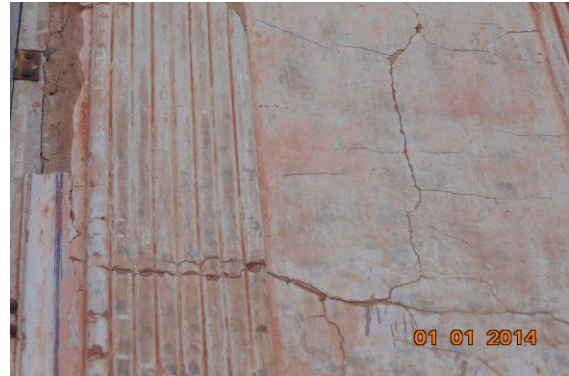
Photo 137
Peeling of Plaster on Outer Wall of SF External Façade

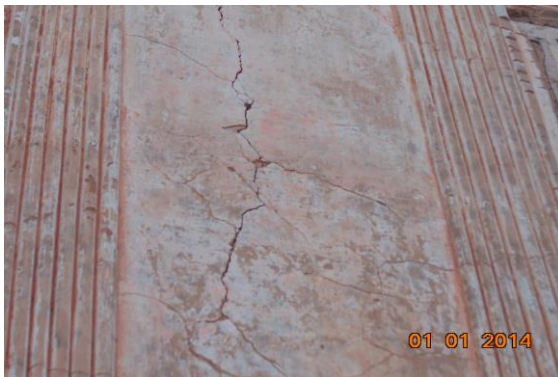
Photo 138
Peeling of Plaster on Outer Wall of SF External Façade

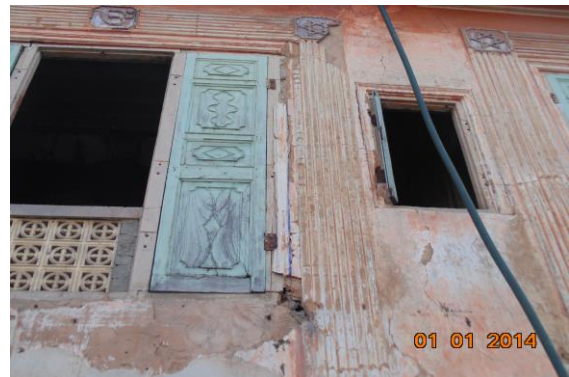
Photo 139
Peeling of Plaster on Outer Wall of SF External Façade

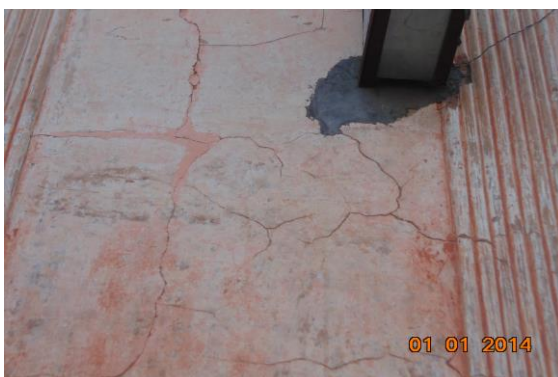
Photo 140
Peeling of Plaster on Outer Wall of SF External Façade

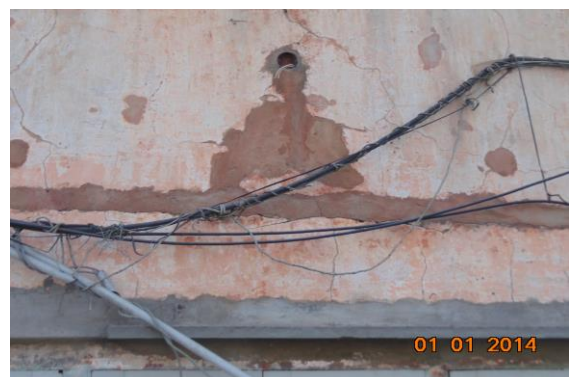
Photo 141
Peeling of Plaster on Outer Wall of FF External Façade

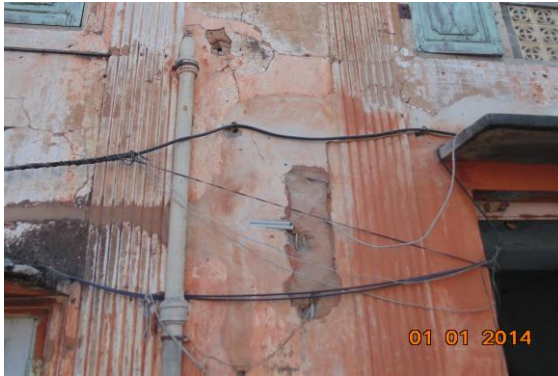
Photo 142
Peeling of Plaster on Outer Wall of FF External Façade

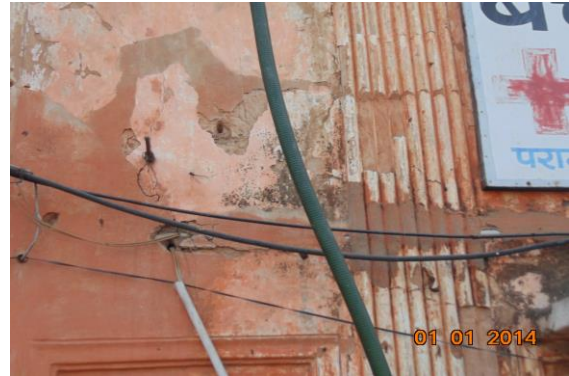
Photo 143
Peeling of Plaster on Outer Wall of FF External Façade

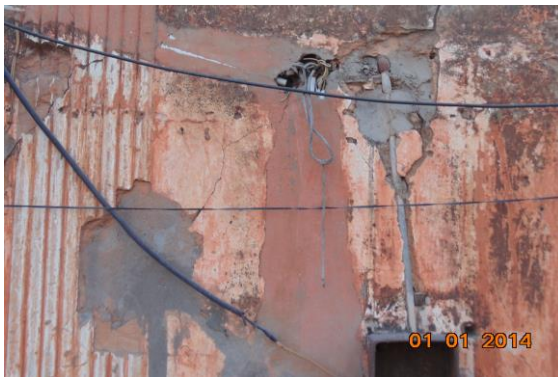
Photo 144
Peeling of Plaster on Outer Wall of FF External Façade

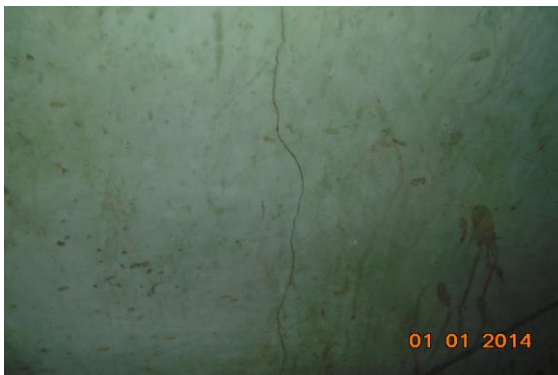
Photo 9
Inclined Crack on Wall No. 1 of House No. 458, First Floor
Approx. Width = 1mm, Approx. Length = 1.2m.
Distance from Wall No. 3 = 1.1m, Height from Floor = 1m.

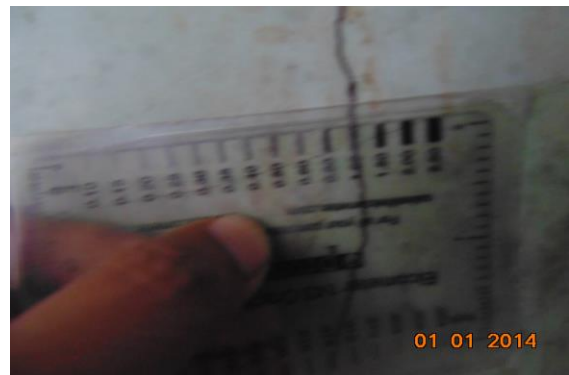
Photo 9A
Inclined Crack on Wall No. 1 of House No. 458, First Floor
Approx. Width = 1mm, Approx. Length = 1.2m.
Distance from Wall No. 3 = 1.1m, Height from Floor = 1m.

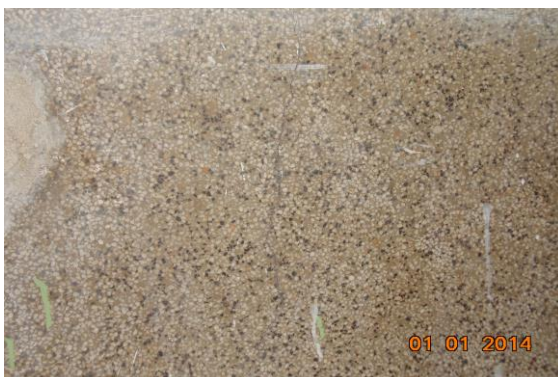
Photo 10
Inclined Crack on Wall No. 4 of House No. 458, First Floor
Approx. Width = 0.4mm, Approx. Length = 1.5m.
Distance from Wall No. 1 = 0.6m, Height from Floor = 0m.

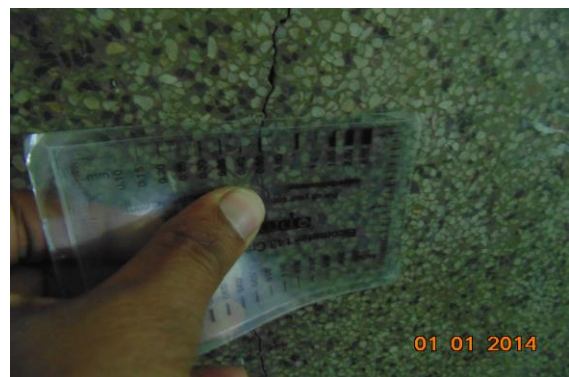
Photo 10A
Inclined Crack on Wall No. 4 of House No. 458, First Floor
Approx. Width = 0.4mm, Approx. Length = 1.5m.
Distance from Wall No. 1 = 0.6m, Height from Floor = 0m.

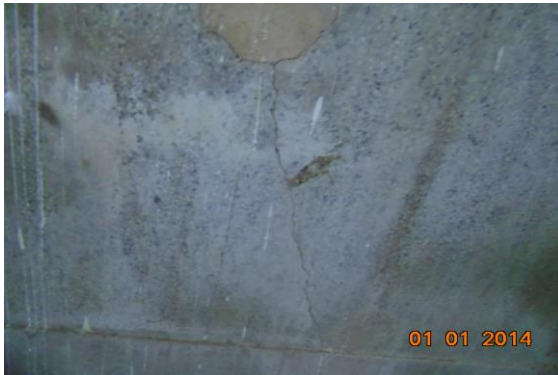
Photo 11

Inclined Crack on Wall No. 1 of House No. 458, First Floor
Approx. Width = 0.6mm, Approx. Length = 0.8m.
Distance from Wall No. 4 = 0.35m, Height from Floor = 0.1m.

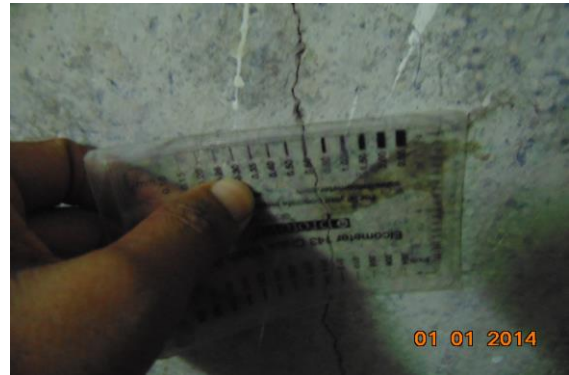
Photo 11A

Inclined Crack on Wall No. 1 of House No. 458, First Floor
Approx. Width = 0.6mm, Approx. Length = 0.8m.
Distance from Wall No. 4 = 0.35m, Height from Floor = 0.1m.

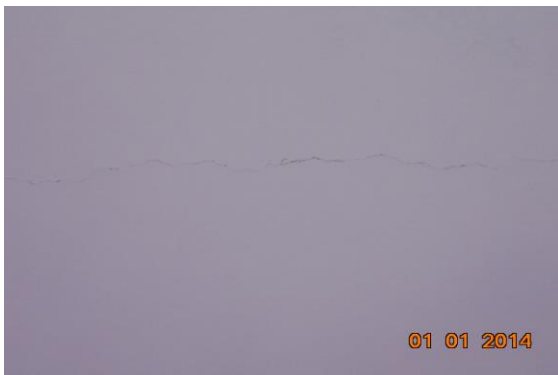
Photo 11A

Inclined Crack on Wall No. 1 of House No. 458, First Floor
Approx. Width = 0.6mm, Approx. Length = 0.8m.
Distance from Wall No. 4 = 0.35m, Height from Floor = 0.1m.

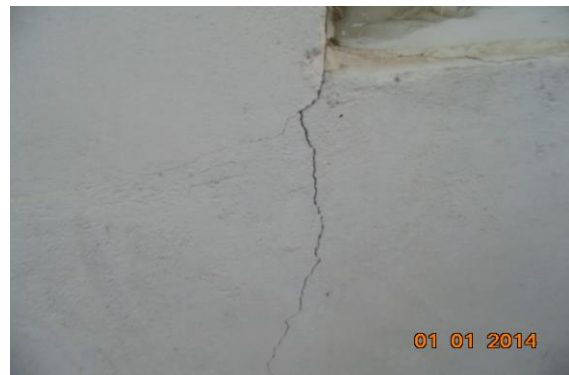
Photo 12

Inclined Crack on Wall No. 1 of Balcony 1, Fourth Floor
Approx. Width = 1mm, Approx. Length = 0.5m.
Distance from Wall No. 1 = 1.5m, Height from Floor = 0m.

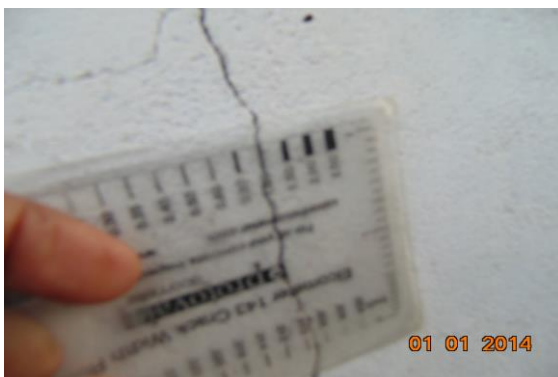
Photo 12A

Inclined Crack on Wall No. 1 of Balcony 1, Fourth Floor
Approx. Width = 1mm, Approx. Length = 0.5m.
Distance from Wall No. 1 = 1.5m, Height from Floor = 0m.

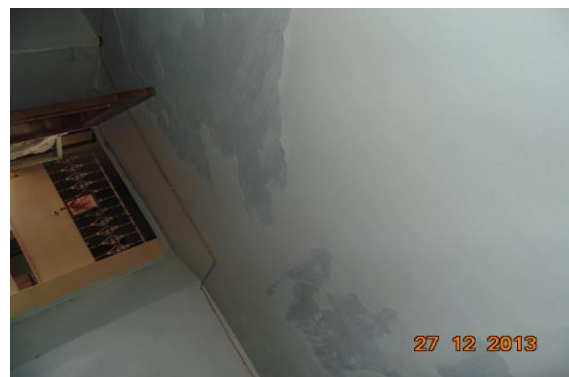
Photo 13

Peeling of Plaster on Roof of Part D of Shop No.67 of Ground Floor

Summary of Defects Other Than Crack			
Defect ID	Location	Description	Photo No.
5	Roof Part D of Shop No.67 Ground Floor	Peeling of Plaster	13
6	Rightside External Column Outer Shop No.68 Ground Floor	Peeling of Plaster	14
7	Wall No. 2 Store 1 House No. 458, First Floor	Dampness/Seepage	15
8	Wall No. 1 House No. 458, First Floor	Dampness/Seepage	16
9	Roof House No. 458, First Floor	Dampness/Seepage	17
10	Balcony Shed House No. 458, First Floor	Dampness/Seepage	18
11	Balcony Shed House No. 458, First Floor	Dampness/Seepage	19
12	Roof Stair FF to SF House No. 458, First Floor	Dampness/Seepage	20
13	Wall No. 2 House No. 458, First Floor	Plaster Crack	21
14	Wall No. 2 House No. 458, First Floor	Plaster Crack	22
15	Wall No. 1 House No. 458, First Floor	Plaster Crack	23
16	Wall No. 1 House No. 458, First Floor	Plaster Crack	24
17	Roof Bathroom House No. 458, Upper First Floor	Dampness/Seepage	25
18	Roof Bathroom House No. 458, Upper First Floor	Dampness/Seepage	26

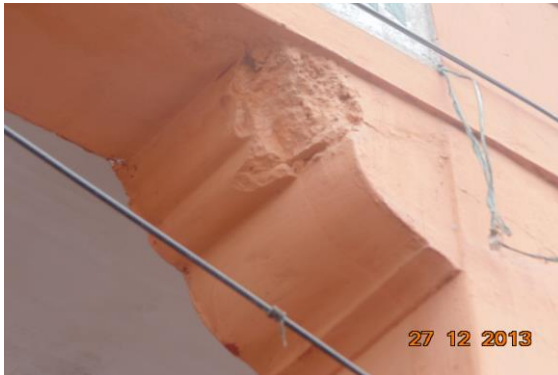
Photo 14

Peeling of Plaster on Rightside External Column Outer of Shop No.68 of Ground Floor

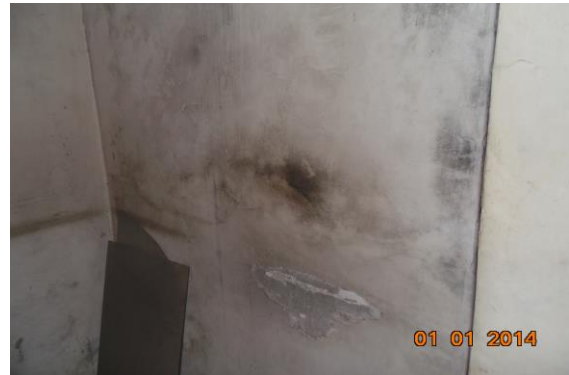
Photo 15

Dampness/Seepage on Wall No. 2 of Store 1 of House No. 458, First Floor

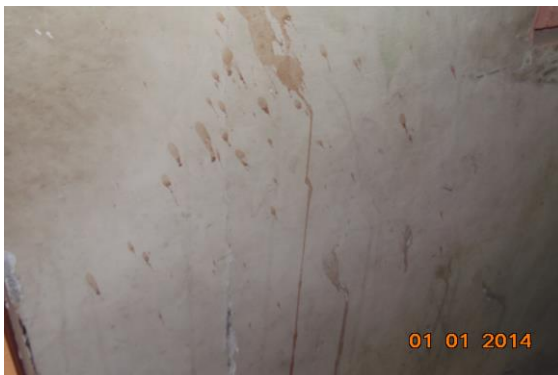
Photo 16

Dampness/Seepage on Wall No. 1 of House No. 458, First Floor

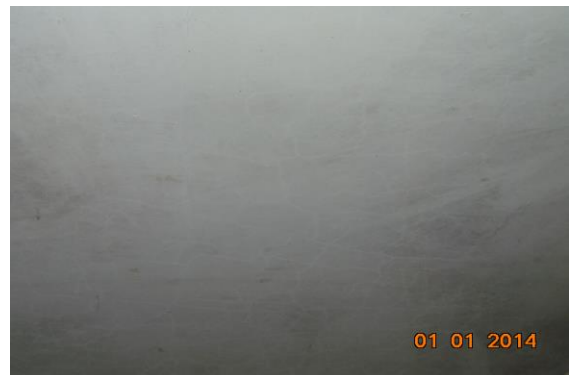
Photo 17

Dampness/Seepage on Roof of House No. 458, First Floor

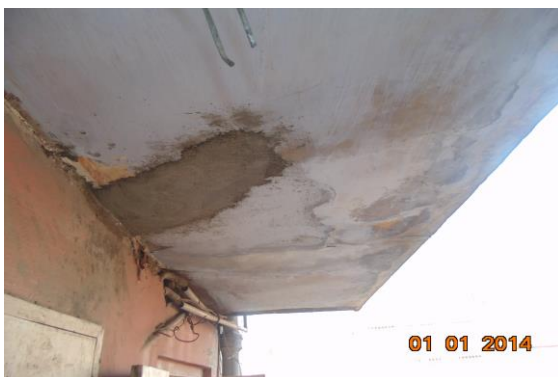
Photo 18

Dampness/Seepage on Balcony Shed of House No. 458, First Floor

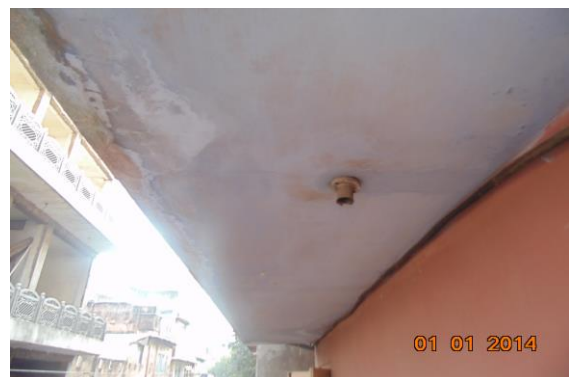
Photo 19

Dampness/Seepage on Balcony Shed of House No. 458, First Floor

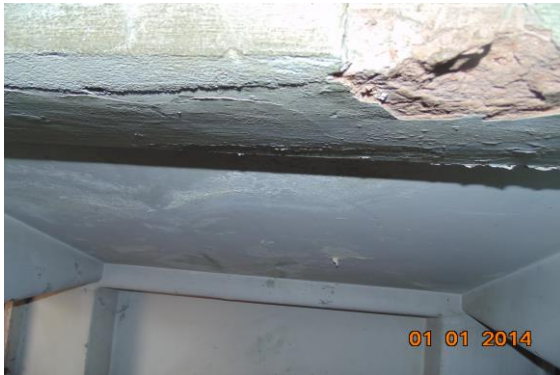
Photo 20

Dampness/Seepage on Roof of Stair FF to SF of House No. 458, First Floor

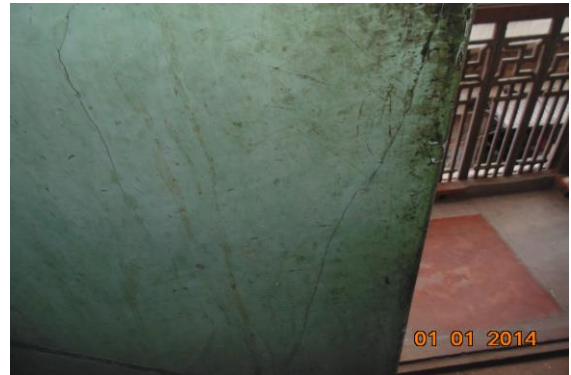
Photo 21

Plaster Crack on Wall No. 2 of House No. 458, First Floor

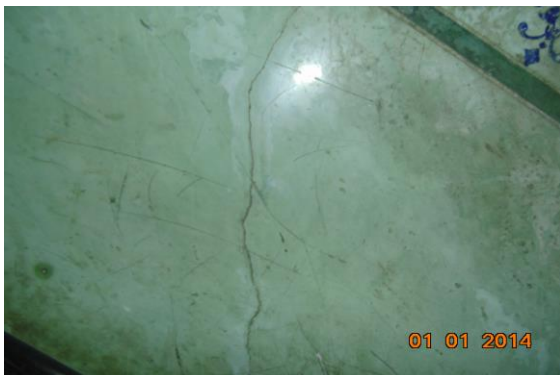
Photo 22

Plaster Crack on Wall No. 2 of House No. 458, First Floor

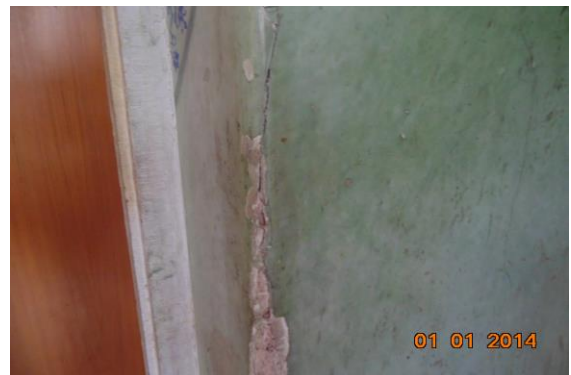
Photo 23

Plaster Crack on Wall No. 1 of House No. 458, First Floor

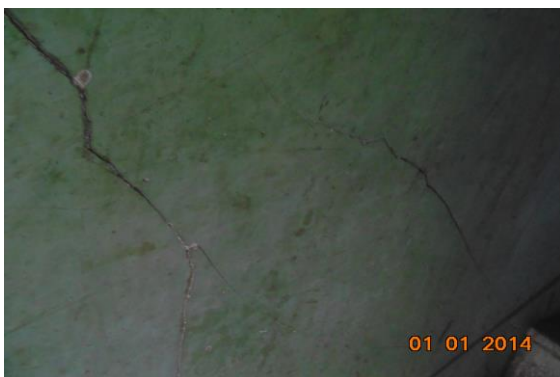
Photo 24

Plaster Crack on Wall No. 1 of House No. 458, First Floor

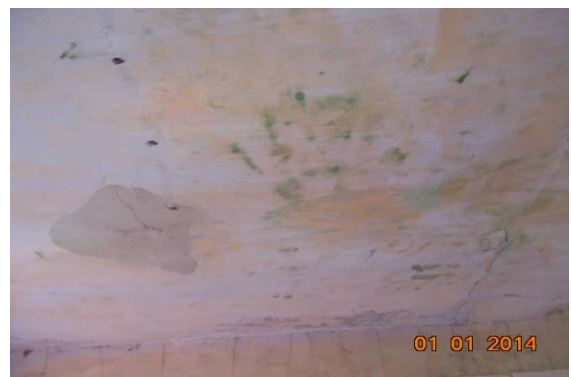
Photo 25

Dampness/Seepage on Roof of Bathroom of House No. 458, Upper First Floor

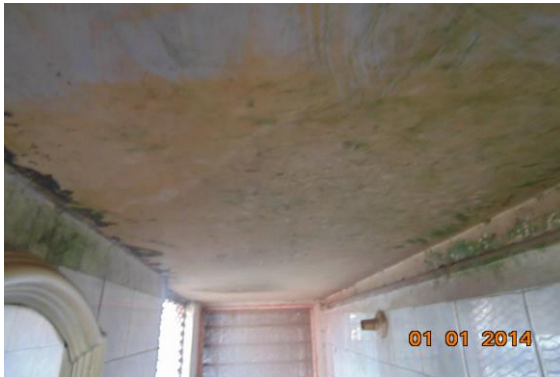
Photo 26

Dampness/Seepage on Roof of Bathroom of House No. 458, Upper First Floor

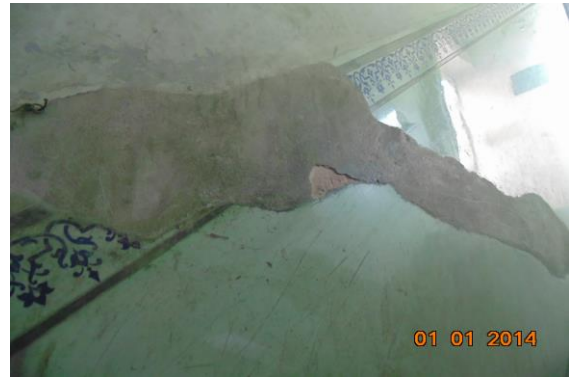
Photo 27

Peeling of Plaster on Wall No. 1 of Stair FF to SF

19	Wall No. 1 Stair FF to SF	Peeling of Plaster	27
20	Wall No. 1 & 3 Gallery 1 House No. 458, First Floor	Dampness/Seepage	28
21	Wall No. 1 & 4 Gallery 3 House No. 458, First Floor	Dampness/Seepage	29
22	Wall No. 4 Gallery 4 House No. 458, First Floor	Plaster Crack	30
23	Wall No. 3 House No. 458, First Floor	Peeling of Plaster	31
24	Wall No. 2 House No. 458, First Floor	Plaster Crack	32
25	Floor House No. 458, First Floor	Plaster Crack	33
26	Toilet No. 1 House No. 458, First Floor	Peeling of Plaster	34
27	Wall No. 2, 3 & Roof Balcony House No. 458, Second Floor	Dampness/Seepage	35
28	Roof Hall No. 1 House No. 458, Second Floor	Dampness/Seepage	36
29	Roof House No. 458, Second Floor	Peeling of Plaster	37
30	Wall No. 2 House No. 458, Second Floor	Peeling of Plaster	38
31	Wall No. 3 House No. 458, Second Floor	Peeling of Plaster	39
32	Wall No. 4 House No. 458, Second Floor	Dampness/Seepage	40
33	Floor House No. 458, Second Floor	Peeling of Plaster	41
