Pre Building Condition Survey Report

Name and Address of Structure :	Badi Chopar to Ramp Area (Down Line)
---------------------------------	--------------------------------------

Name of the Project	Contract JMRC-UG1B “Design and Construction of Tunnel between Chandpole and Badi Chouper and reverse line by Shield TBM, Underground Metro Stations at Choti Chouper and Badi Chouper by Cut and Cover Methods on East West Corridor of Jaipur Metro Rail Corporation Limited .”	
Owner :

Pre - Condition Building Survey for Construction of Underground Stations from Chandpole to Bari Chouper and reversal line

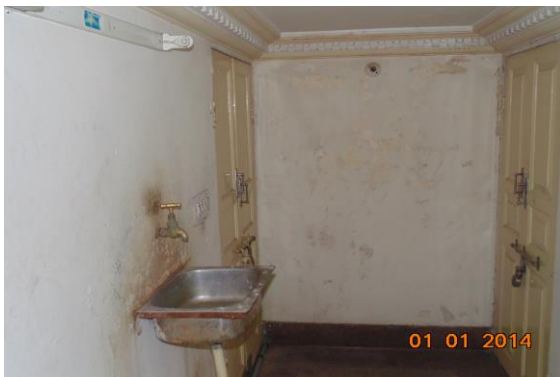
Photo 28

Dampness/Seepage on Wall No. 1 & 3 of Gallery 1 of House No. 458, First Floor

19	Wall No. 1 Stair FF to SF	Peeling of Plaster	27
20	Wall No. 1 & 3 Gallery 1 House No. 458, First Floor	Dampness/Seepage	28
21	Wall No. 1 & 4 Gallery 3 House No. 458, First Floor	Dampness/Seepage	29
22	Wall No. 4 Gallery 4 House No. 458, First Floor	Plaster Crack	30
23	Wall No. 3 House No. 458, First Floor	Peeling of Plaster	31
24	Wall No. 2 House No. 458, First Floor	Plaster Crack	32
25	Floor House No. 458, First Floor	Plaster Crack	33
26	Toilet No. 1 House No. 458, First Floor	Peeling of Plaster	34
27	Wall No. 2, 3 & Roof Balcony House No. 458, Second Floor	Dampness/Seepage	35
28	Roof Hall No. 1 House No. 458, Second Floor	Dampness/Seepage	36
29	Roof House No. 458, Second Floor	Peeling of Plaster	37
30	Wall No. 2 House No. 458, Second Floor	Peeling of Plaster	38
31	Wall No. 3 House No. 458, Second Floor	Peeling of Plaster	39
32	Wall No. 4 House No. 458, Second Floor	Dampness/Seepage	40
33	Floor House No. 458, Second Floor	Peeling of Plaster	41

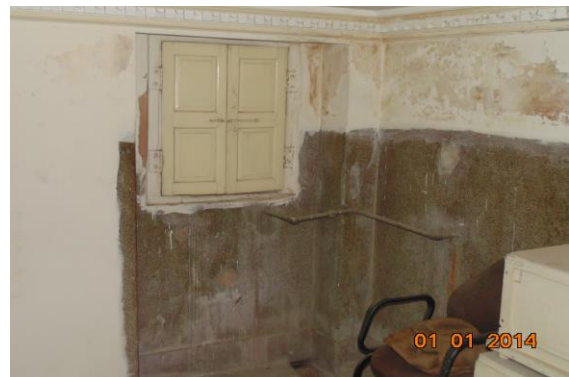
Photo 29

Dampness/Seepage on Wall No. 1 & 4 of Gallery 3 of House No. 458, First Floor

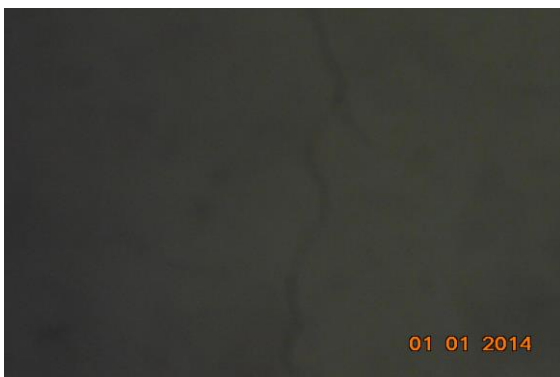
Photo 30

Plaster Crack on Wall No. 4 of Gallery 4 of House No. 458, First Floor

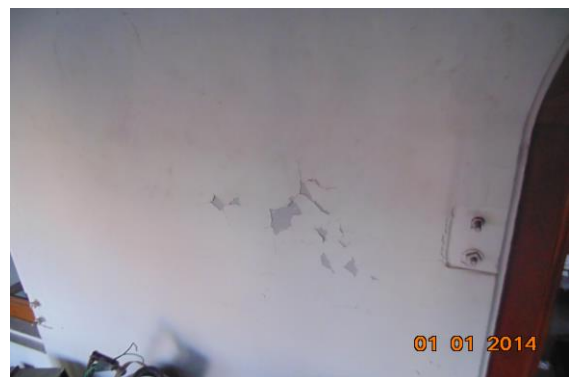
Photo 31

Peeling of Plaster on Wall No. 3 of House No. 458, First Floor

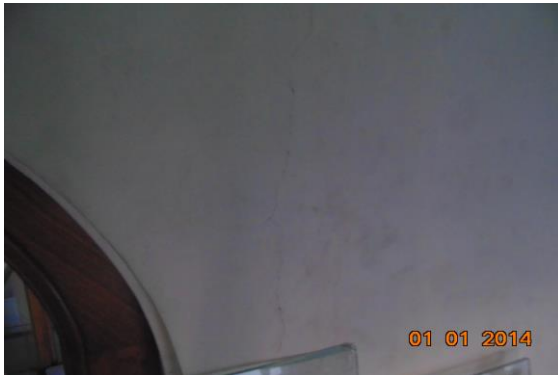
Photo 32

Plaster Crack on Wall No. 2 of House No. 458, First Floor

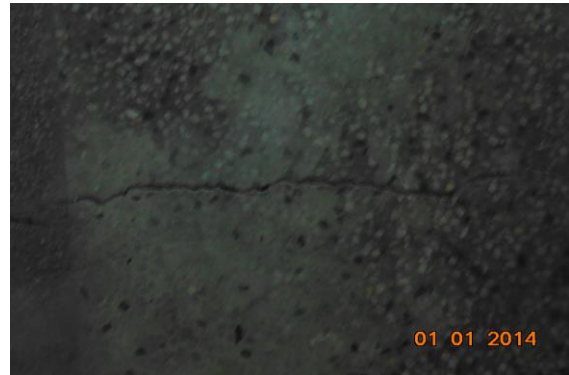
Photo 33

Plaster Crack on Floor of House No. 458, First Floor

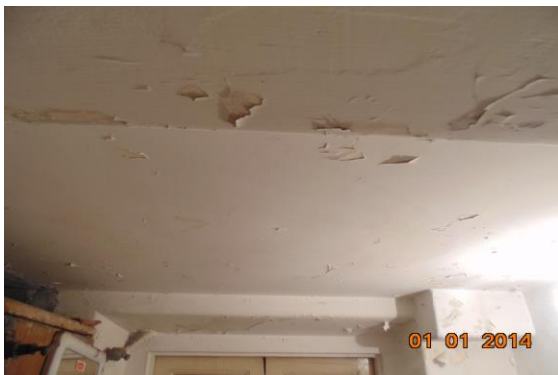
Photo 34

Peeling of Plaster on Toilet No. 1 of House No. 458, First Floor

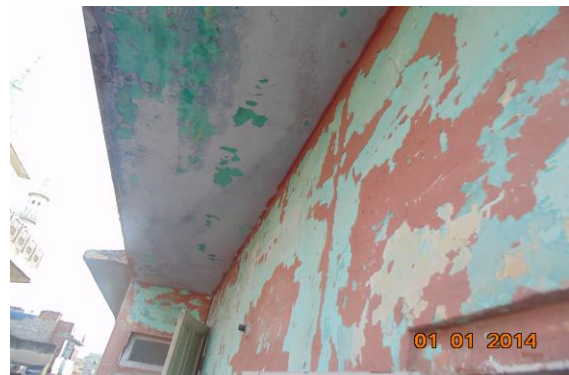
Photo 35

Dampness/Seepage on Wall No. 2, 3 & Roof of Balcony of House No. 458, Second Floor

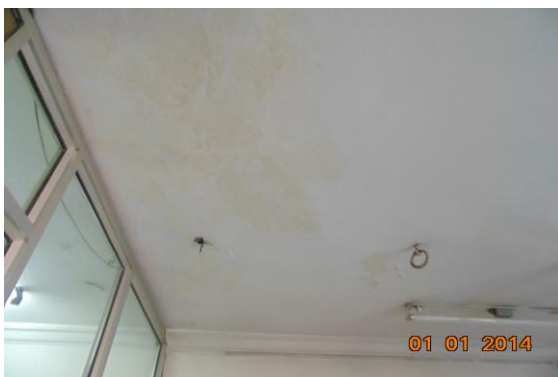
Photo 36

Dampness/Seepage on Roof of Hall No. 1 of House No. 458, Second Floor

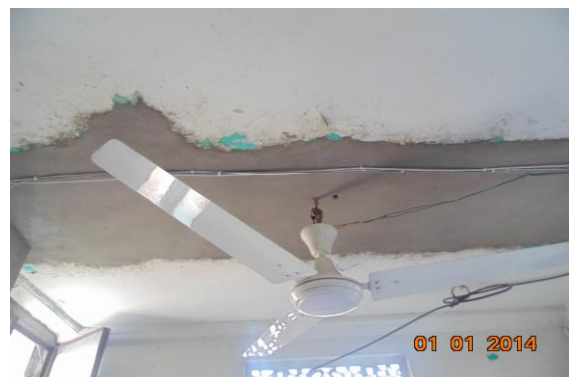
Photo 37

Peeling of Plaster on Roof of House No. 458, Second Floor

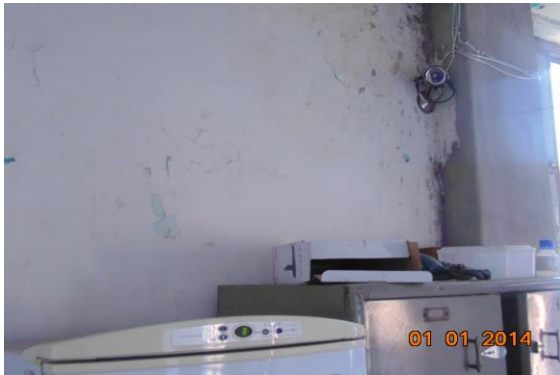
Photo 38

Peeling of Plaster on Wall No. 2 of House No. 458, Second Floor

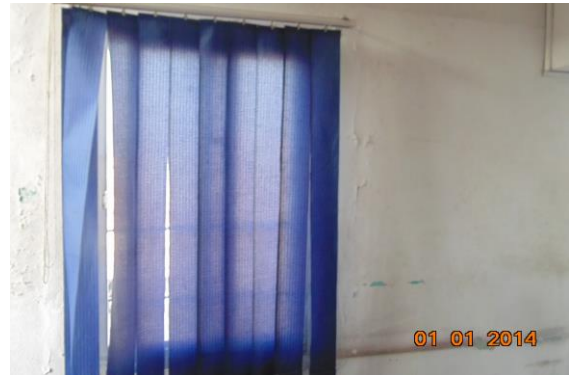
Photo 39

Peeling of Plaster on Wall No. 3 of House No. 458, Second Floor

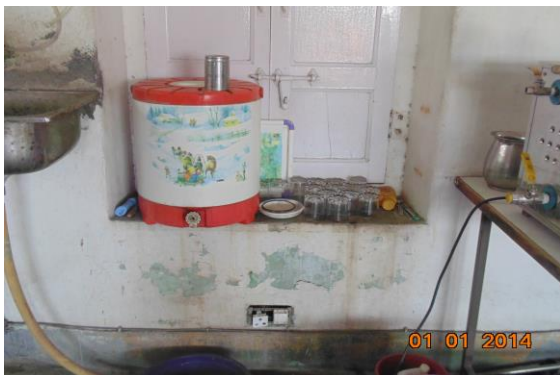
Photo 40

Dampness/Seepage on Wall No. 4 of House No. 458, Second Floor

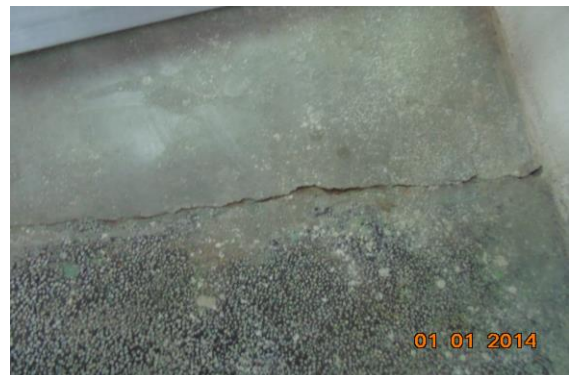
Photo 41

Peeling of Plaster on Floor of House No. 458, Second Floor

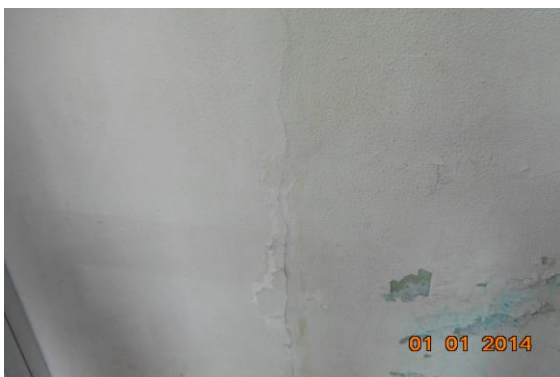
Photo 42

Plaster Crack on Wall No. 2 of House No. 458, Second Floor

34	Wall No. 2 House No. 458, Second Floor	Plaster Crack	42
35	Wall No. 4 Hall No. 1 Third Floor	Dampness/Seepage	43
36	Roof Stair TF to 4th Floor	Plaster Crack	44
37	Wall No. 1 Third Floor	Dampness/Seepage	45
38	Wall No. 1 Hall No. 1 Fourth Floor	Dampness/Seepage	46

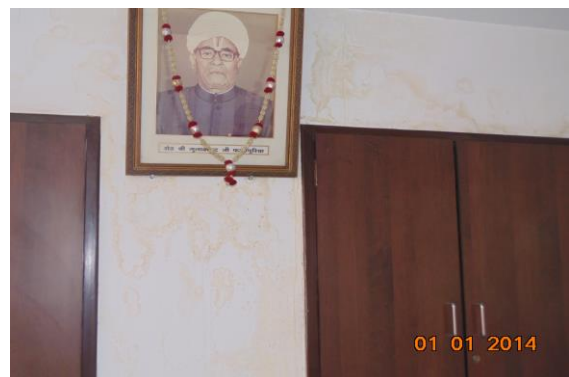
Photo 43

Dampness/Seepage on Wall No. 4 of Hall No. 1 of Third Floor

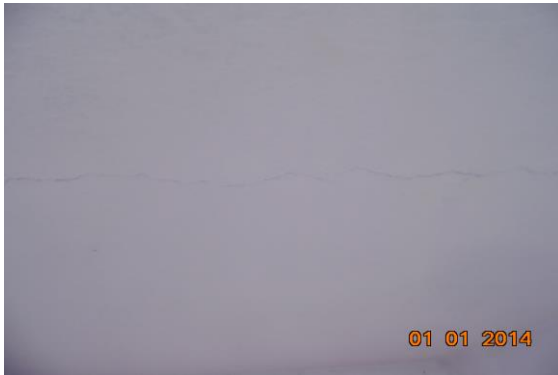
Photo 44
Plaster Crack on Roof of Stair TF to 4Th Floor

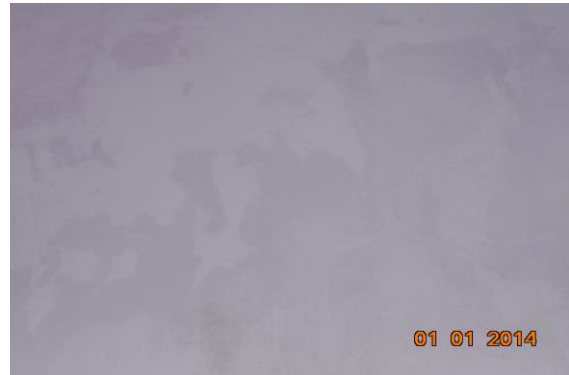
Photo 45
Dampness/Seepage on Wall No. 1 of Third Floor

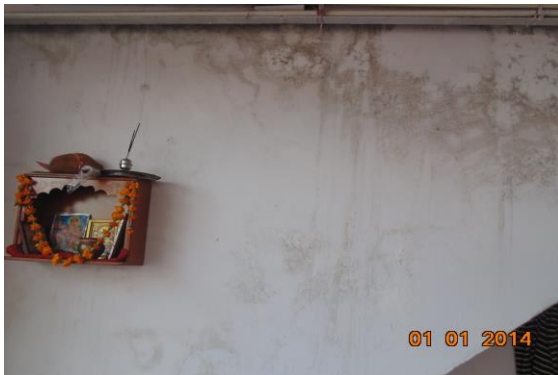
Photo 46
Dampness/Seepage on Wall No. 1 of Hall No. 1 of Fourth Floor

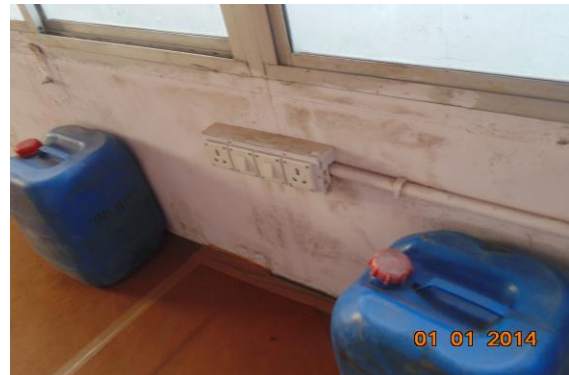
Photo 47
Dampness/Seepage on Wall No. 3 of Fourth Floor

39	Wall No. 3 Fourth Floor	Dampness/Seepage	47
40	Wall No. 3 Fourth Floor	Dampness/Seepage	48
41	Wall No. 4 Balcony 2 Fourth Floor	Plaster Crack	49
42	External Wall SF External Hazard	Plaster Crack	50
43	External Wall FF External Hazard	Peeling of Plaster	51
44	External Wall	Peeling of Plaster	52
45	Back Side Shed Second Floor	Peeling of Plaster	53
46	Left Side Shed First Floor	Peeling of Plaster	54
47	Left Side Shed Ground Floor	Peeling of Plaster	55

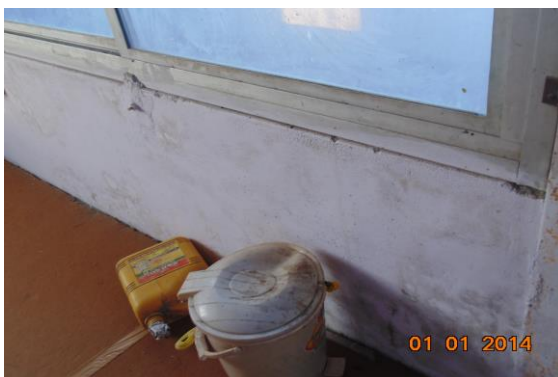
Photo 48
Dampness/Seepage on Wall No. 3 of Fourth Floor

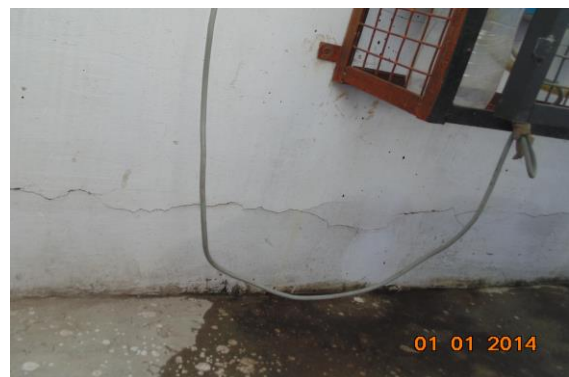
Photo 49
Plaster Crack on Wall No. 4 of Balcony 2 of Fourth Floor

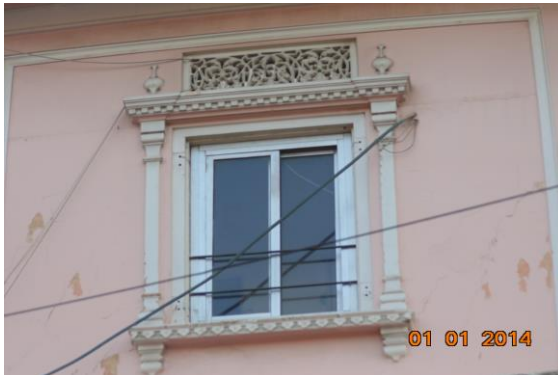
Photo 50
Plaster Crack on External Wall of SF External Hazard

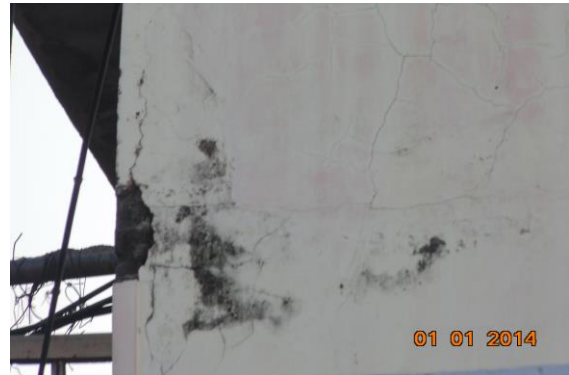
Photo 51
Peeling of Plaster on External Wall of FF External Hazard

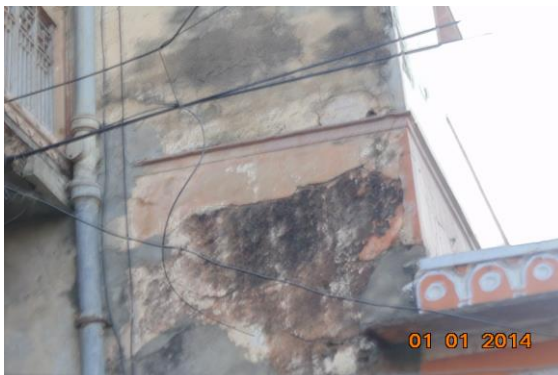
Photo 52
Peeling of Plaster on External Wall

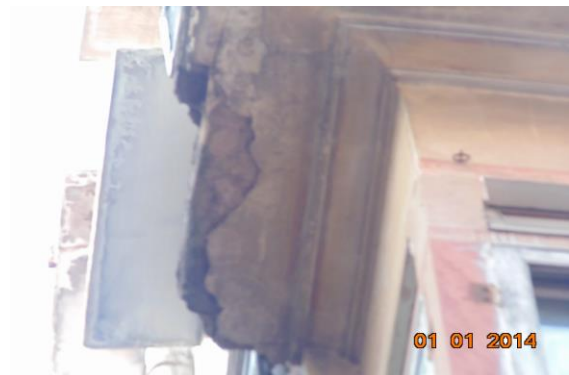
Photo 53
Peeling of Plaster on Back Side Shed of Second Floor

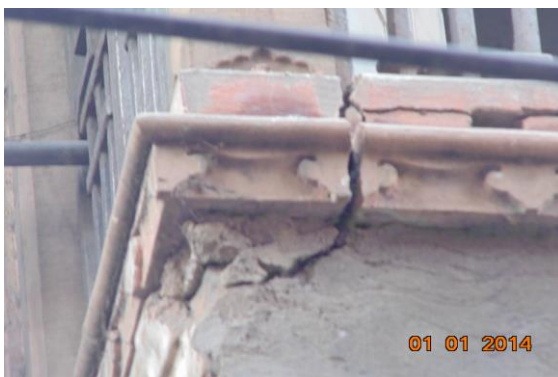
Photo 54
Peeling of Plaster on Left Side Shed of First Floor

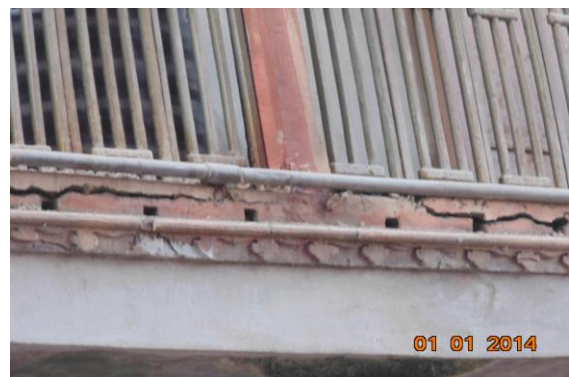
Photo 55
Peeling of Plaster on Left Side Shed of Ground Floor

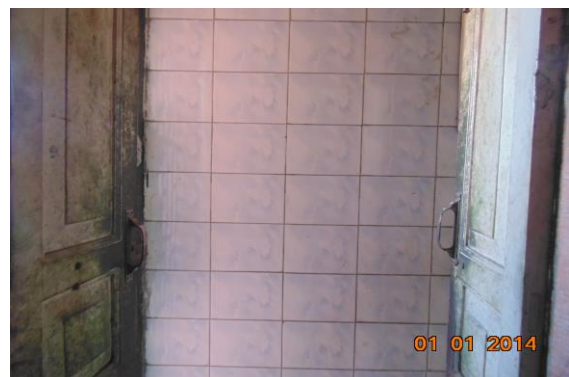
Photo 61

Wall No. 2, 4 & 3 of Bathroom of House No. 458, Upper First Floor Covered with Tiles

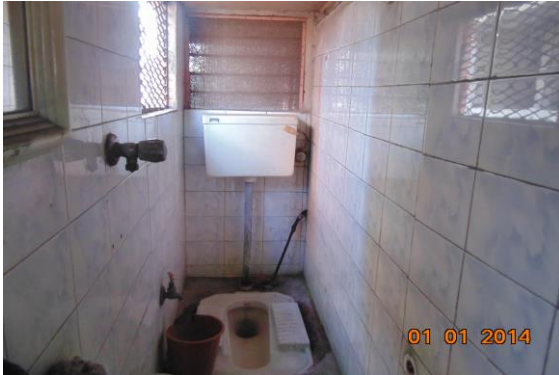
Photo 62

Wall No. 2, 4 & 3 of Bathroom of House No. 458, Upper First Floor
Covered with Tiles

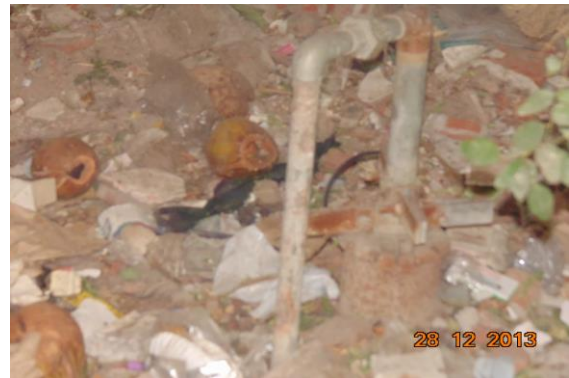
Photo 2
Borewell Main View, Ground Floor

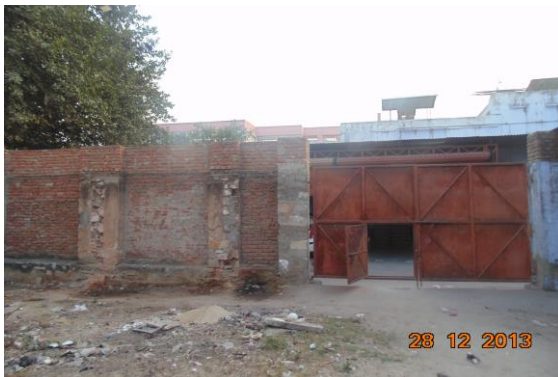
Photo 3
Peeling of Plaster on Wall No. 3 of Open Sky of House No. 61 of Ground Floor

Summary of Defects Other Than Crack			
Defect ID	Location	Description	Photo No.
1	Wall No. 3 Open Sky of House No. 61 Ground Floor	Peeling of Plaster	3
2	Wall No. 2 Open Sky of House No. 61 Ground Floor	Peeling of Plaster	4
3	Wall No. 4 Open Sky of House No. 61 Ground Floor	Peeling of Plaster	5
4	All Wall & roof Toilet No. 1 House No. 61,Ground Floor	Dampness/Seepage	6
5	All Wall Toilet No. 1 House No. 61,Ground Floor	Dampness/Seepage	7
6	Wall No. 1 Toilet No. 1 House No. 61,Ground Floor	Peeling of Plaster	8
7	Wall No. 4 Room No. 2 House No. 61,Ground Floor	Dampness/Seepage	9
8	Wall No. 4 House No. 61 Ground Floor	Dampness/Seepage	10
9	Wall No. 3 External Façade of House No. 61 Ground Floor	Peeling of Plaster	11
10	Wall No. 3 External Façade of House No. 61 Ground Floor	Peeling of Plaster	12

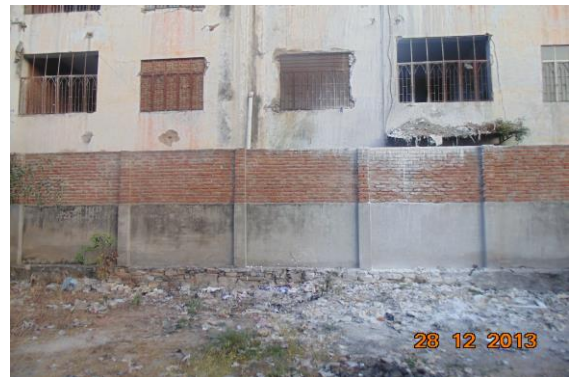
Photo 4
Peeling of Plaster on Wall No. 2 of Open Sky of House No. 61 of Ground Floor

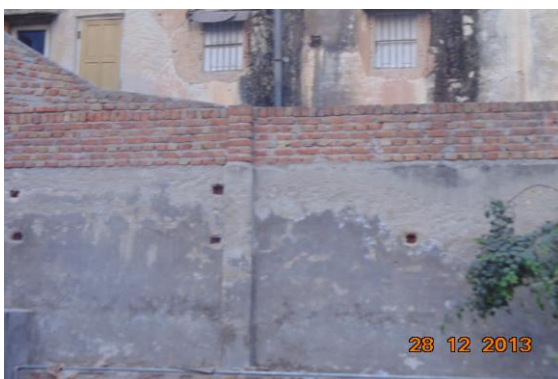
Photo 5
Peeling of Plaster on Wall No. 4 of Open Sky of House No. 61 of Ground Floor

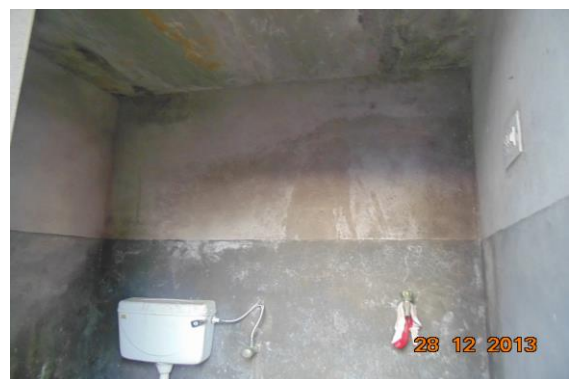
Photo 6
Dampness/Seepage on All Wall & roof of Toilet No. 1 of House No. 61, Ground Floor

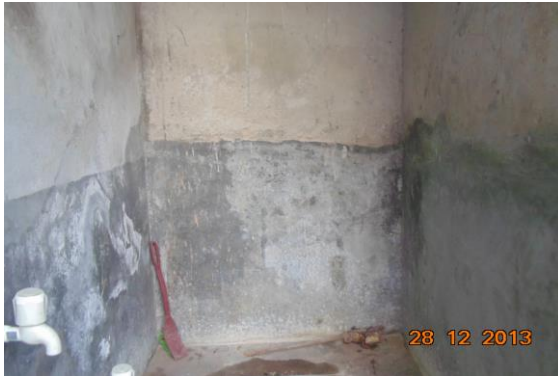
Photo 7

Dampness/Seepage on All Wall of Toilet No. 1 of House No. 61, Ground Floor

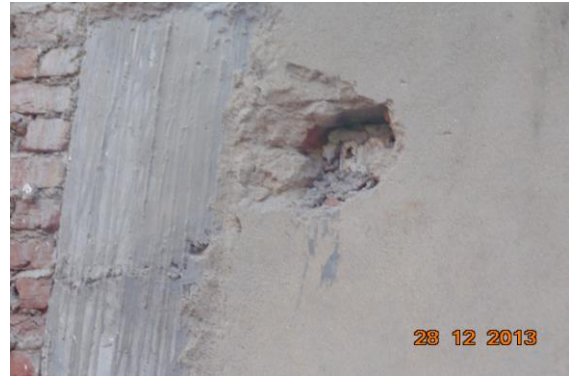
Photo 8

Peeling of Plaster on Wall No. 1 of Toilet No. 1 of House No. 61, Ground Floor

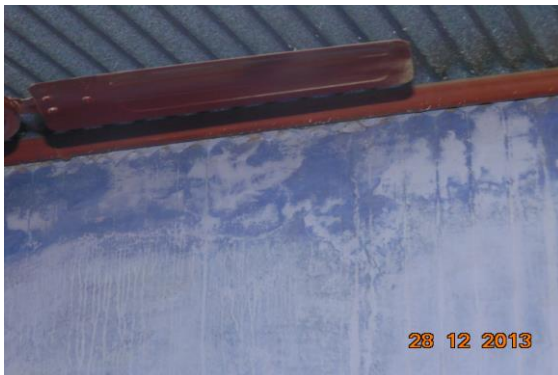
Photo 9

Dampness/Seepage on Wall No. 4 of Room No. 2 of House No. 61, Ground Floor

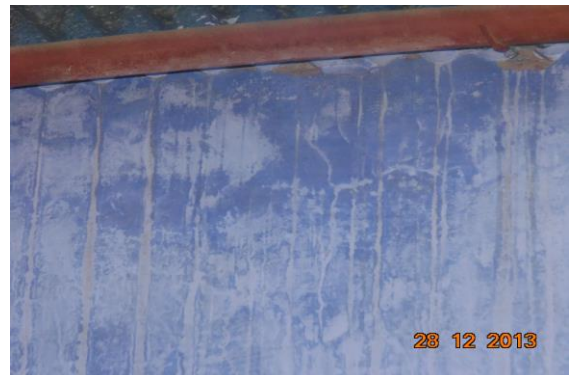
Photo 10

Dampness/Seepage on Wall No. 4 of House No. 61 of Ground Floor

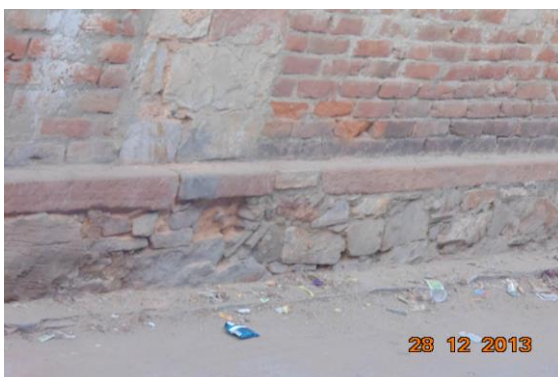
Photo 11

Peeling of Plaster on Wall No. 3 of External Façade of House No. 61 of Ground Floor

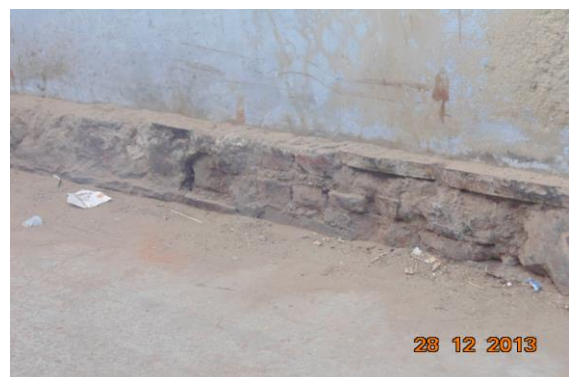
Photo 12

Peeling of Plaster on Wall No. 3 of External Façade of House No. 61 of Ground Floor

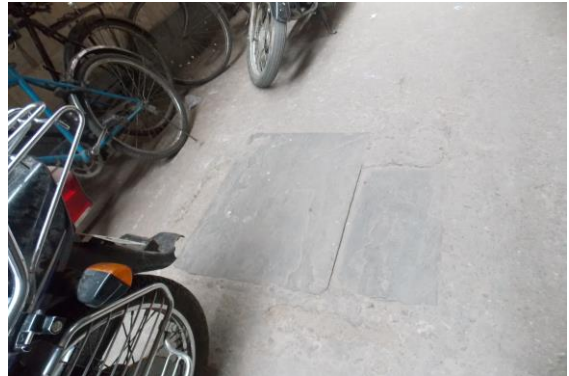
Photo 4
View of Borewell, Ground Floor

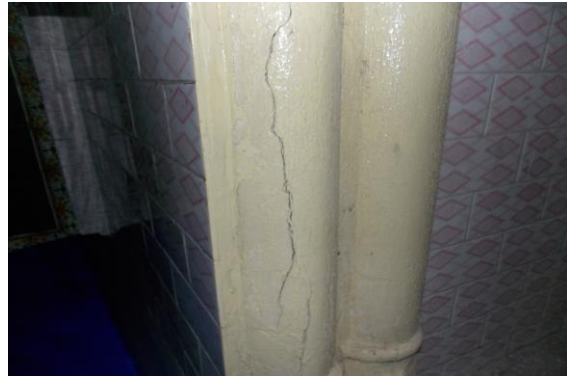
Photo 8
Inclined Crack on Wall No. 3 of Open Sky, Ground Floor
Approx. Width = 1.5mm, Approx. Length = 0.9m.
Distance from Wall no.8 = 0.05m, Height from Floor = 0m.

Summary of Cracks						
Defect ID	Location	Orientation	Appx. Width (mm)	Appx. Length (m)	Category	Photo No.
1	Wall No. 3 Open Sky Ground Floor	Inclined	1.5	0.9	Slight	8, 8A
2	Wall No. 3 Hall No. 1 Second Floor	Inclined	8	1.6	Moderate	9, 9A
3	Wall No. 2 Open Area Third Floor	Inclined	2.5	1.2	Slight	10, 10A

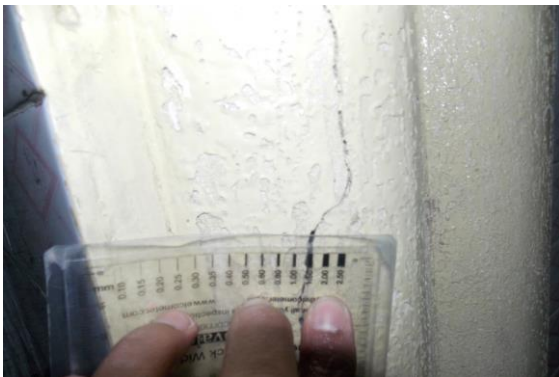
Photo 8A
Inclined Crack on Wall No. 3 of Open Sky, Ground Floor
Approx. Width = 1.5mm, Approx. Length = 0.9m.
Distance from Wall no.8 = 0.05m, Height from Floor = 0m.

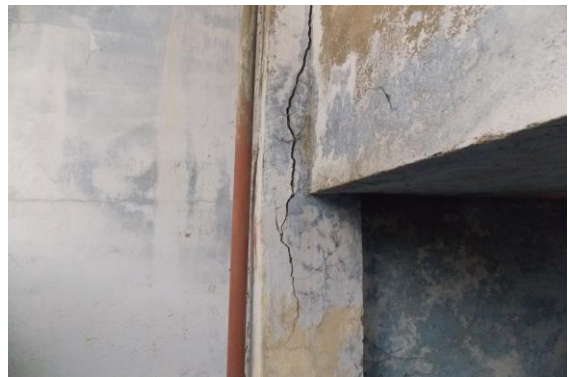
Photo 9
Inclined Crack on Wall No. 3 of Hall No. 1, Second Floor
Approx. Width = 8mm, Approx. Length = 1.6m.
Distance from Wall no.2 = 0.7m, Height from Floor = 1m.

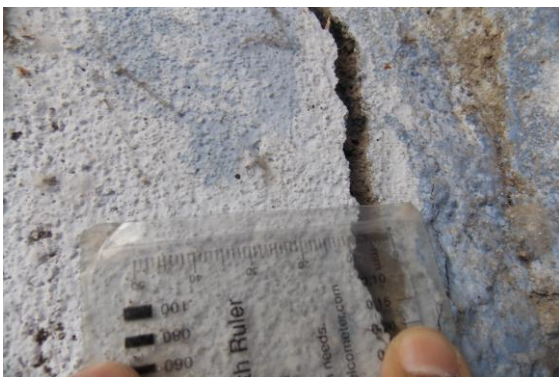
Photo 9A
Inclined Crack on Wall No. 3 of Hall No. 1, Second Floor
Approx. Width = 8mm, Approx. Length = 1.6m.
Distance from Wall no.2 = 0.7m, Height from Floor = 1m.

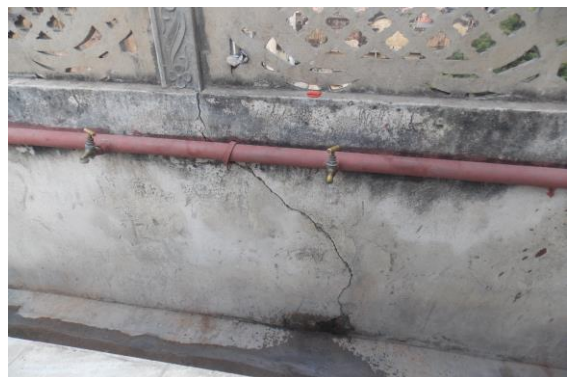
Photo 10
Inclined Crack on Wall No. 2 of Open Area, Third Floor
Approx. Width = 2.5mm, Approx. Length = 1.2m.
Distance from Wall No.4 = 3.5m, Height from Floor = 0m.

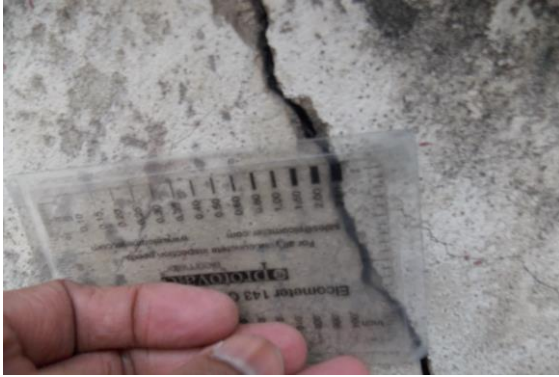
Photo 10A

Inclined Crack on Wall No. 2 of Open Area, Third Floor
Approx. Width = 2.5mm, Approx. Length = 1.2m.
Distance from Wall No.4 = 3.5m, Height from Floor = 0m.

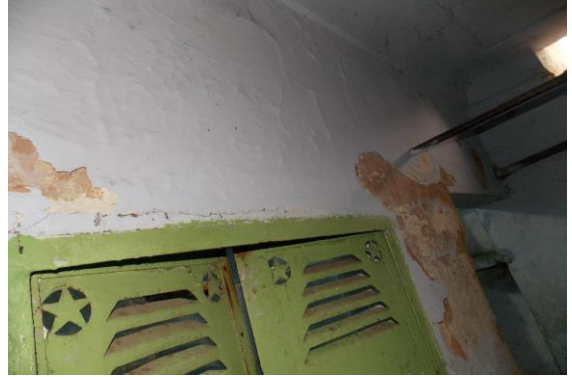
Photo 11

Peeling of Plaster on Wall No. 1 of Passage of Ground Floor

Summary of Defects Other Than Crack			
Defect ID	Location	Description	Photo No.
4	Wall No. 1 Passage Ground Floor	Peeling of Plaster	11
5	Wall No. 4 Passage Ground Floor	Dampness/Seepage	12
6	Wall No. 3 open sky Ground Floor	Peeling of Plaster	13
7	Wall No. 4 & 2 Bathroom No. Ground Floor	Damaged Portion	14
8	Wall No. 1 Hall No. 1 Ground Floor	Peeling of Plaster	15
9	Wall No. 1 open sky Ground Floor	Dampness/Seepage	16
10	Wall No. 5 & 6 open sky Ground Floor	Dampness/Seepage	17
11	Wall No. 4 Hall No. 1 First Floor	Dampness/Seepage	18
12	Wall No. 4 Staircase FF to SF First Floor	Dampness/Seepage	19
13	Wall No. 2 Staircase FF to SF First Floor	Dampness/Seepage	20
14	Roof Hall No. 1 Second Floor	Peeling of Plaster	21
15	Wall No. 4 Hall No. 1 Second Floor	Dampness/Seepage	22
16	Wall No. 3 Hall No. 1 Second Floor	Dampness/Seepage	23
17	Wall No. 2 & 4 Staircase SF to TF Second Floor	Dampness/Seepage	24
18	Roof Staircase SF to TF Second Floor	Dampness/Seepage	25

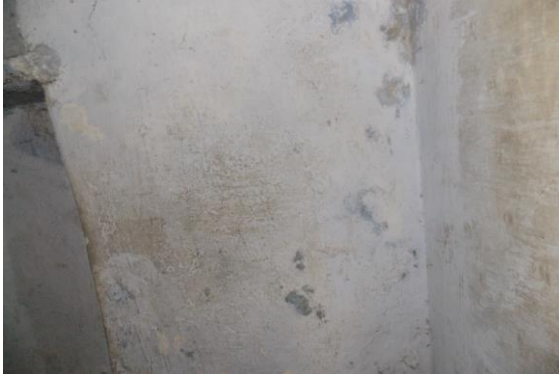
Photo 12

Dampness/Seepage on Wall No. 4 of Passage of Ground Floor

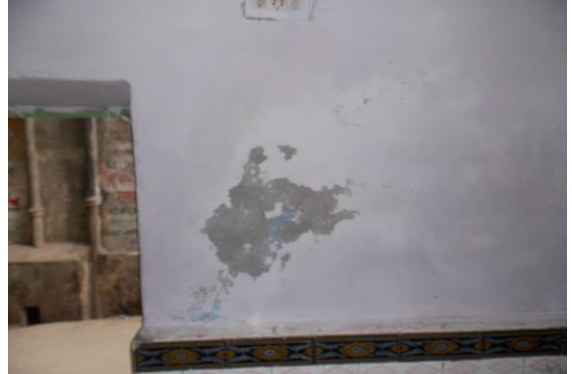
Photo 13

Peeling of Plaster on Wall No. 3 of open sky of Ground Floor

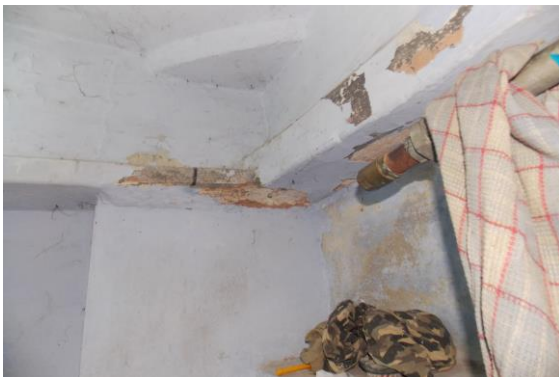
Photo 14

Damaged Portion on Wall No. 4 & 2 of Bathroom No. of Ground Floor

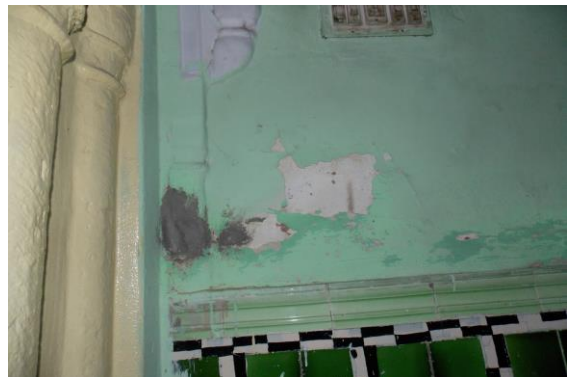
Photo 15

Peeling of Plaster on Wall No. 1 of Hall No. 1 of Ground Floor

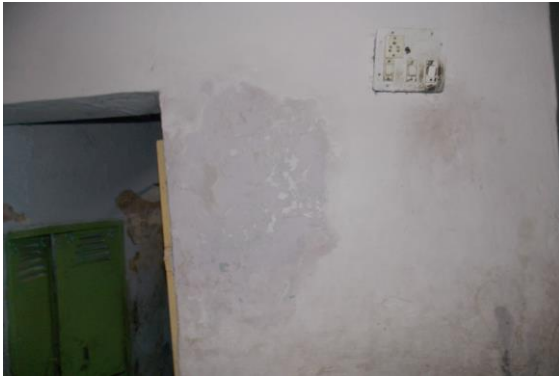
Photo 16

Dampness/Seepage on Wall No. 1 of open sky of Ground Floor

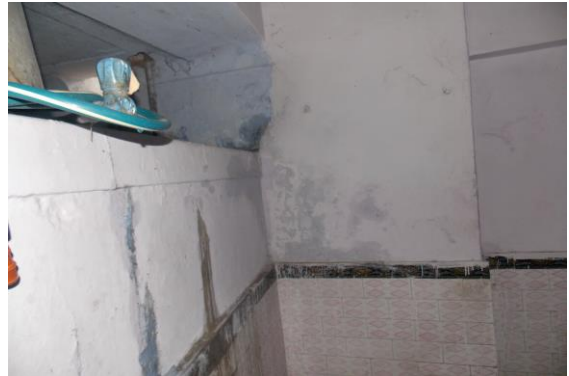
Photo 17

Dampness/Seepage on Wall No. 5 & 6 of open sky of Ground Floor

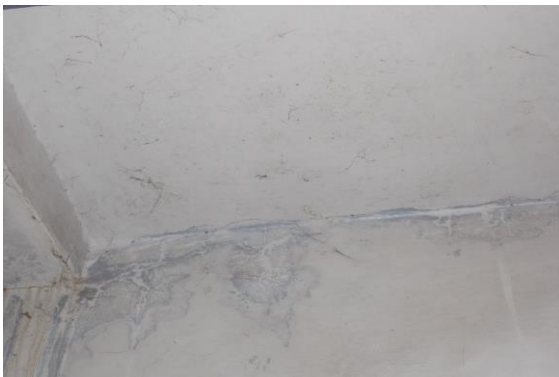
Photo 18

Dampness/Seepage on Wall No. 4 of Hall No. 1 of First Floor

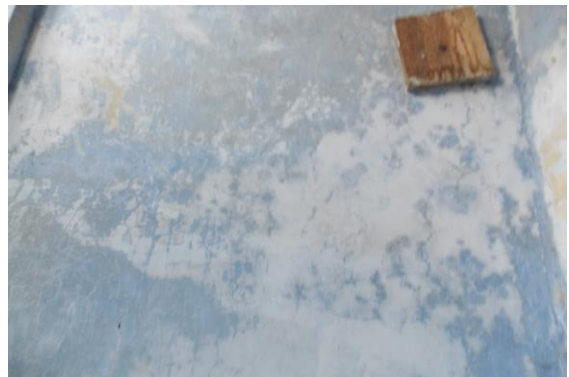
Photo 19

Dampness/Seepage on Wall No. 4 of Staircase FF to SF of First Floor

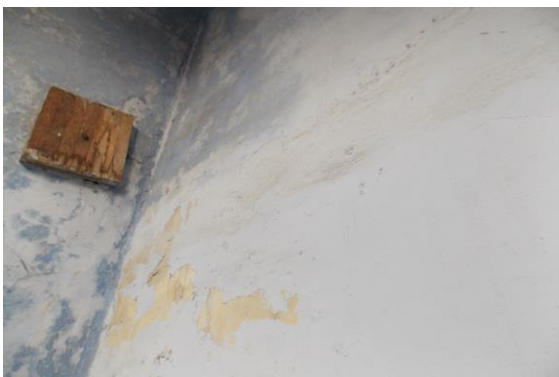
Photo 20

Dampness/Seepage on Wall No. 2 of Staircase FF to SF of First Floor

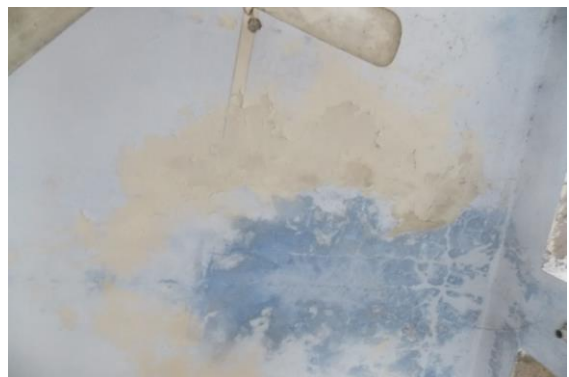
Photo 21

Peeling of Plaster on Roof of Hall No. 1 of Second Floor

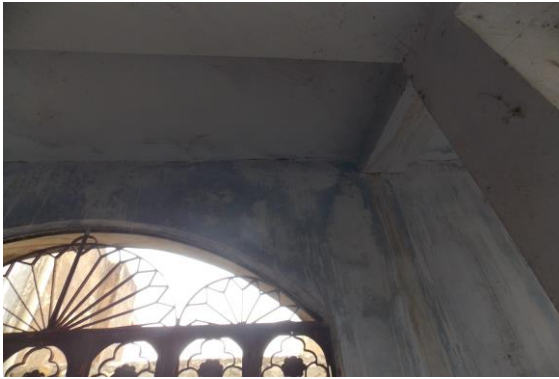
Photo 22

Dampness/Seepage on Wall No. 4 of Hall No. 1 of Second Floor

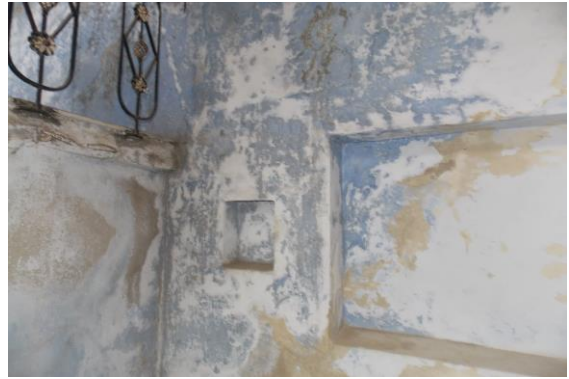
Photo 23

Dampness/Seepage on Wall No. 3 of Hall No. 1 of Second Floor

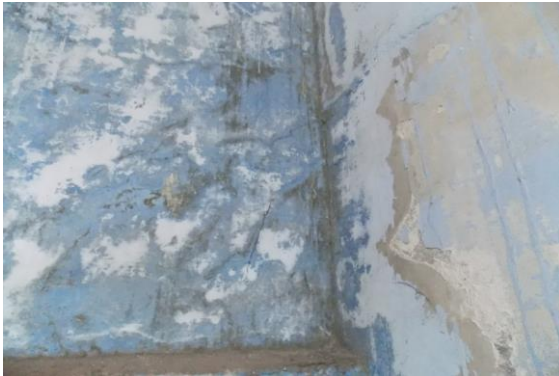
Photo 24

Dampness/Seepage on Wall No. 2 & 4 of Staircase SF to TF of Second Floor

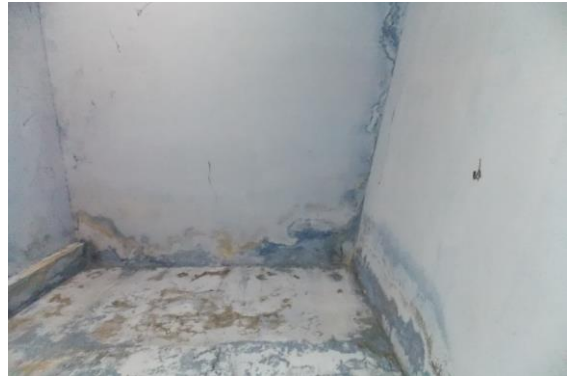
Photo 25

Dampness/Seepage on Roof of Staircase SF to TF of Second Floor

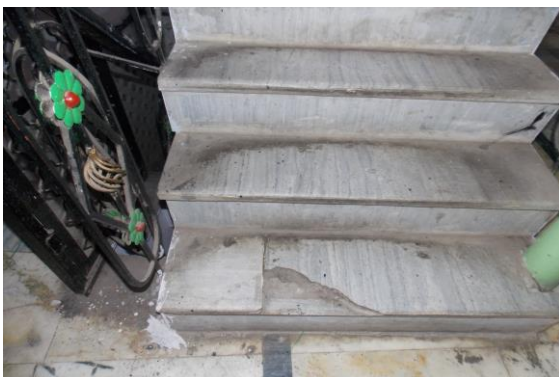
Photo 26

Steps of Staircase FF to SF of Second Floor

19	Steps Staircase FF to SF Second Floor	Peeling of Plaster	26
20	Wall No. 1 Hall No. 1 Third Floor	Dampness/Seepage	27
21	Wall No. 4 & Roof Hall No. 1 Third Floor	Dampness/Seepage	28
22	Floor Open Area Third Floor	Peeling of Plaster	29
23	Floor Terrace	Peeling of Plaster	30
24	Backside Outer Wall Building Ground Floor	Damaged Portion	31

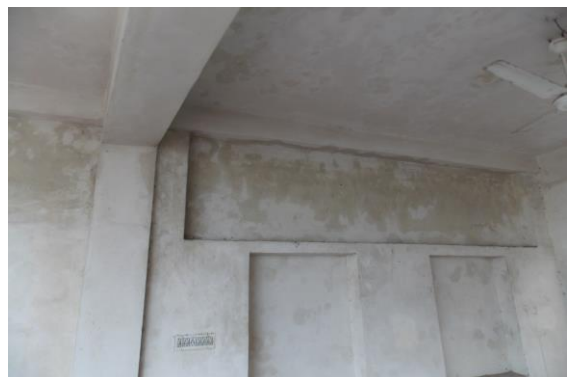
Photo 27

Dampness/Seepage on Wall No. 1 of Hall No. 1 of Third Floor

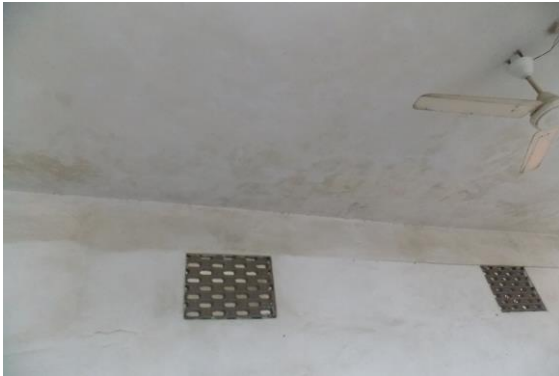
Photo 28

Dampness/Seepage on Wall No. 4 & Roof of Hall No. 1 of Third Floor

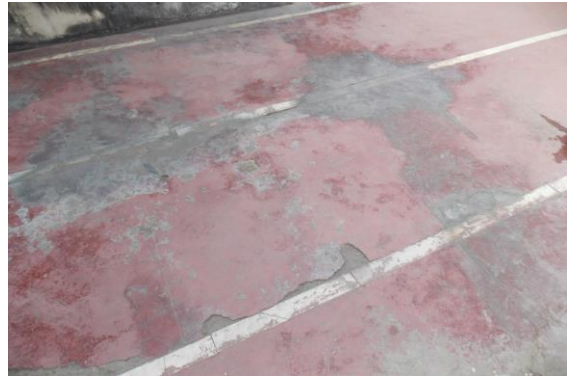
Photo 29

Peeling of Plaster on Floor of Open Area of Third Floor

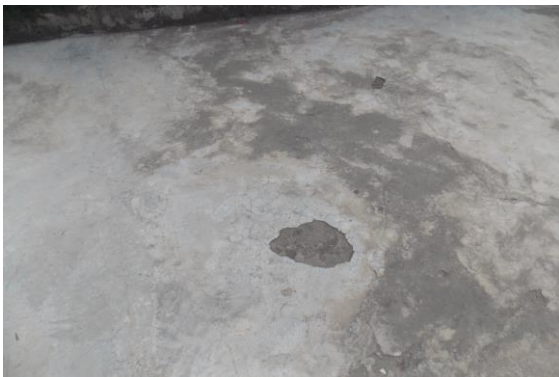
Photo 30

Peeling of Plaster on Floor of Terrace

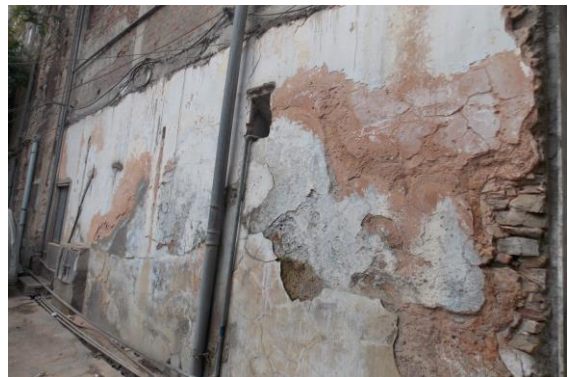
Photo 31

Damaged Portion on Backside Outer Wall of Building of Ground Floor

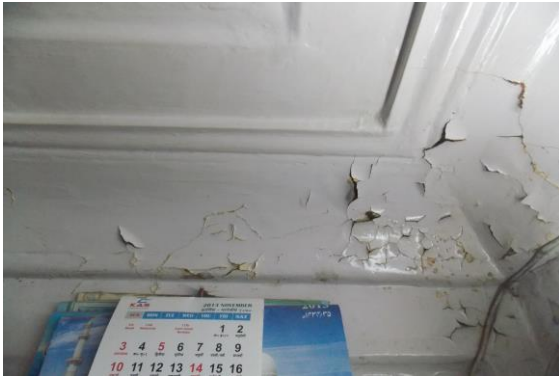
Photo 9
Peeling of Plaster on Wall No. 3 of Shop No.1 of Ground Floor

Summary of Defects Other Than Crack			
Defect ID	Location	Description	Photo No.
1	Wall No. 3 Shop No.1 Ground Floor	Peeling of Plaster	9
2	Wall No. 3 & Roof Shop No.1 Ground Floor	Damaged Portion	10
3	Roof Shop No.1 Ground Floor	Plaster Crack	11
4	Wall No. 3 & Sunshade Shop No.1 Ground Floor	Damaged Portion	12
5	Wall No. 3 & Sunshade Shop No.1 Ground Floor	Peeling of Plaster	13
6	Wall No. 3 Shop No.1 Ground Floor	Peeling of Plaster	14
7	Wall No. 2 Shop No.3 Ground Floor	Peeling of Plaster	15

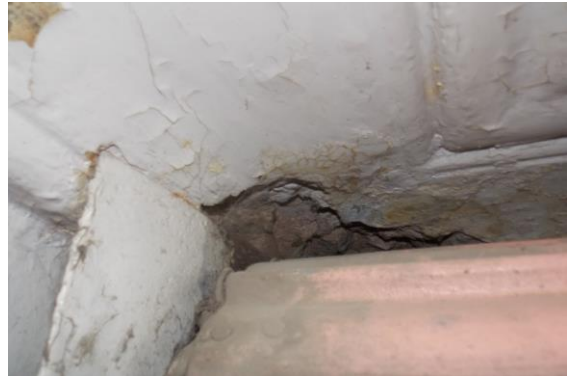
Photo 10
Damaged Portion on Wall No. 3 & Roof of Shop No.1 of Ground Floor

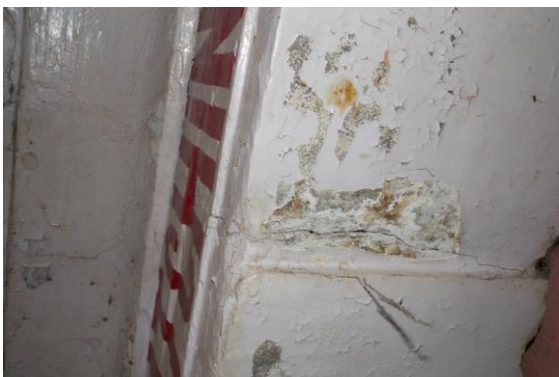
Photo 11
Plaster Crack on Roof of Shop No.1 of Ground Floor

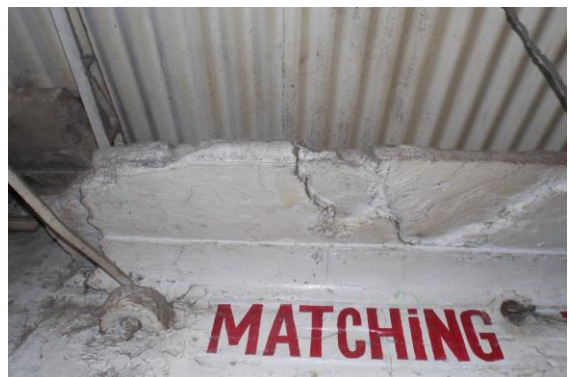
Photo 12
Damaged Portion on Wall No. 3 & Sunshade of Shop No.1 of Ground Floor

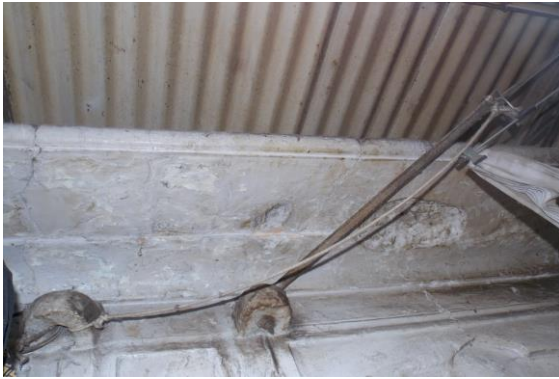
Photo 13

Peeling of Plaster on Wall No. 3 & Sunshade of Shop No.1 of Ground Floor

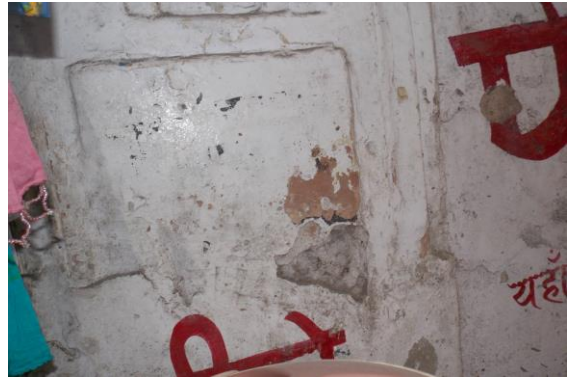
Photo 14

Peeling of Plaster on Wall No. 3 of Shop No.1 of Ground Floor

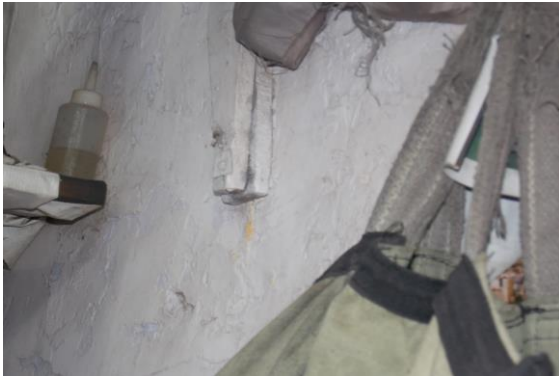
Photo 15

Peeling of Plaster on Wall No. 2 of Shop No.3 of Ground Floor

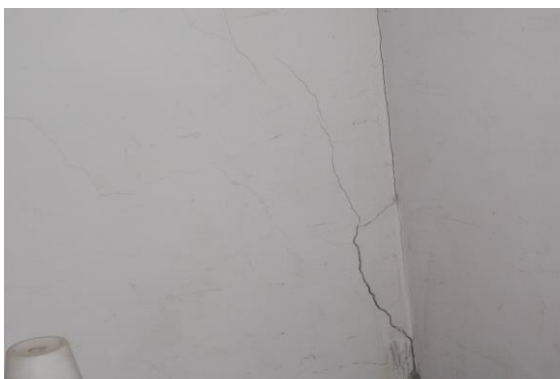
Photo 5

Inclined Crack on Wall No. 1 of Hall No. 1, First Floor
Approx. Width = 0.5mm, Approx. Length = 2m.

Summary of Cracks						
Defect ID	Location	Orientation	Appx. Width (mm)	Appx. Length (m)	Category	Photo No.
1	Wall No. 1 Hall No. 1 First Floor	Inclined	0.5	2	Very Slight	5
2	Roof Varanda Ground Floor	Horizontal	0.2	2.5	Very Slight	6
3	Parapet Wall Varanda External Façade	Inclined	1	1	Slight	7
4	Beam External Varanda Ground Floor	Inclined	0.35	0.6	Very Slight	8, 8A
5	Right side Wall Building First Floor	Vertical	1	1	Slight	9
6	Sun Shade Building Second Floor	Horizontal	0.8	1.1	Very Slight	10
7	Roof Varanda Ground Floor	Inclined	0.5	2	Very Slight	11
8	Wall No. 1 Shop No.70 Ground Floor	Inclined	0.5	2.3	Very Slight	12, 12A
9	Wall No. 1 Shop No.70 Ground Floor	Vertical	0.4	1.1	Very Slight	13, 13A
10	Wall No. 1 Shop No.70 Ground Floor	Inclined	0.35	2	Very Slight	14
11	Wall No. 4 Shop No.70 Ground Floor	Inclined	0.5	1.5	Very Slight	15
12	Roof Shop No.70 Ground Floor	Horizontal	0.2	1	Very Slight	16
13	Wall No. 2 Shop No.70 Ground Floor	Vertical	0.3	1.5	Very Slight	17

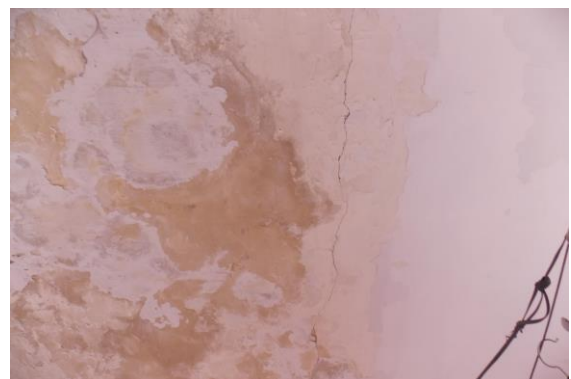
Photo 6

Horizontal Crack on Roof of Varanda, Ground Floor
Approx. Width = 0.2mm, Approx. Length = 2.5m.
Distance from Leftside External Column = 0m, Height from Floor = 3m.

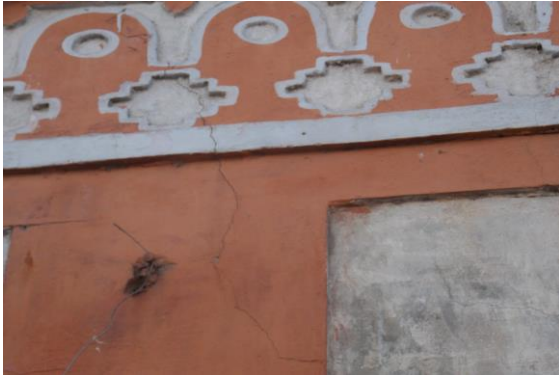
Photo 7

Inclined Crack on Parapet Wall of Varanda, External Façade
Approx. Width = 1mm, Approx. Length = 1m.

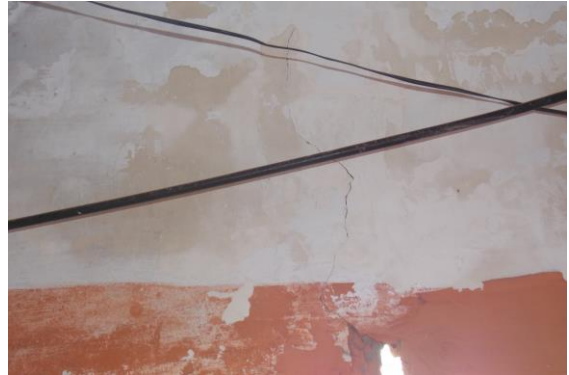
Photo 8

Inclined Crack on Beam External of Varanda, Ground Floor
Approx. Width = 0.35mm, Approx. Length = 0.6m.
Distance from Backside of Leftside External Column = 0.25m, Height from Floor = 2.5m

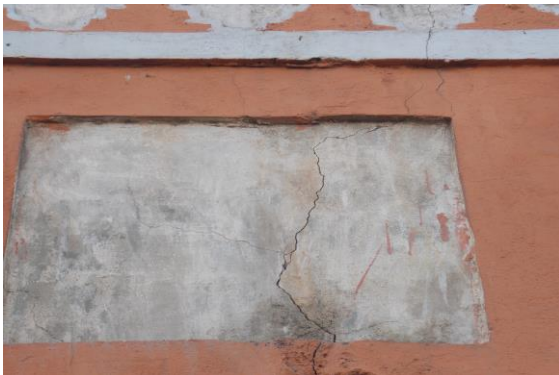
Photo 8A

Inclined Crack on Beam External of Varanda, Ground Floor
Approx. Width = 0.35mm, Approx. Length = 0.6m.
Distance from Backside of Leftside External Column = 0.25m, Height from Floor = 2.5m

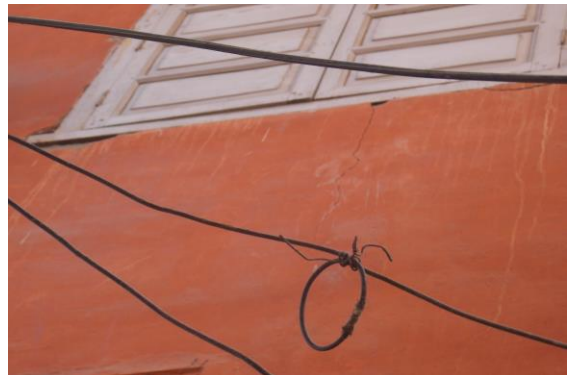
Photo 9

Vertical Crack on Wall No. Right side Wall of Building, First Floor
Approx. Width = 1mm, Approx. Length = 1m.
Distance from Backside Wall = 1.5m, Height from Floor = 4.3m.

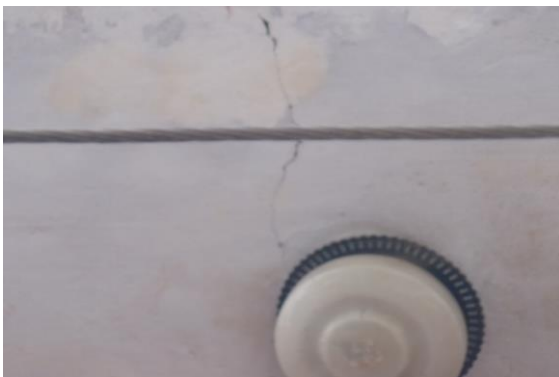
Photo 10

Horizontal Crack on Sun Shade of Building, Second Floor
Approx. Width = 0.8mm, Approx. Length = 1.1m.
Distance from Backside Wall = 2.5m, Height from Floor = 10m.

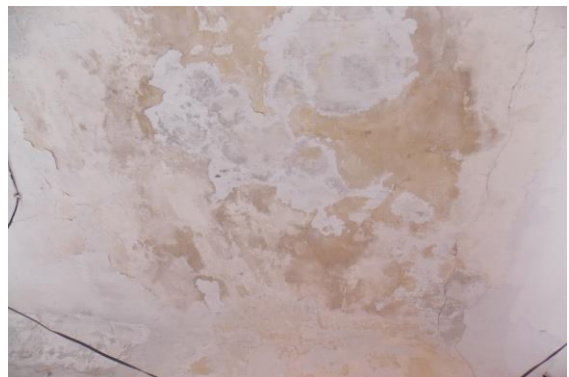
Photo 11

Inclined Crack on Roof of Varanda, Ground Floor
Approx. Width = 0.5mm, Approx. Length = 2m.

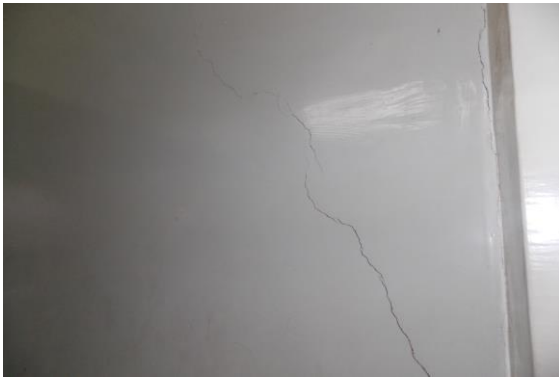
Photo 12

Inclined Crack on Wall No. 1 of Shop No.70, Ground Floor
Approx. Width = 0.5mm, Approx. Length = 2.3m.
Distance from Wall No.3 = 2m, Height from Floor = 0.1m.

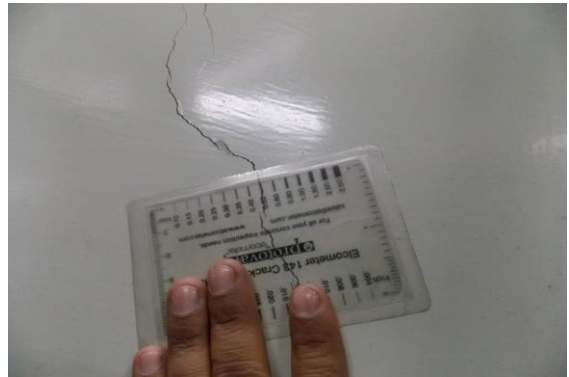
Photo 12A

Inclined Crack on Wall No. 1 of Shop No.70, Ground Floor
Approx. Width = 0.5mm, Approx. Length = 2.3m.
Distance from Wall No.3 = 2m, Height from Floor = 0.1m.

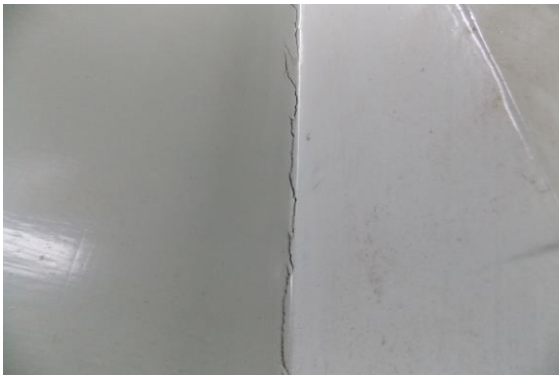
Photo 13

Vertical Crack on Wall No. 1 of Shop No.70, Ground Floor
Approx. Width = 0.4mm, Approx. Length = 1.1m.
Distance from Wall No.3 = 2m, Height from Floor = 1.5m.

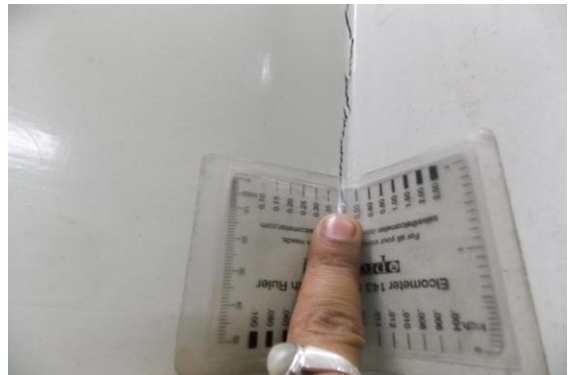
Photo 13A

Vertical Crack on Wall No. 1 of Shop No.70, Ground Floor
Approx. Width = 0.4mm, Approx. Length = 1.1m.
Distance from Wall No.3 = 2m, Height from Floor = 1.5m.

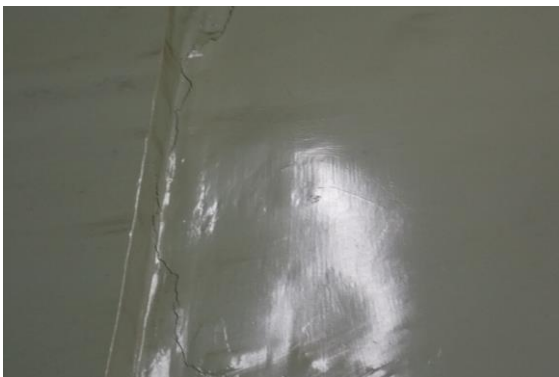
Photo 14

Inclined Crack on Wall No. 1 of Shop No.70, Ground Floor
Approx. Width = 0.35mm, Approx. Length = 2m.
Distance from Wall No.3 = 3m, Height from Floor = 2m.
