Pre Building Condition Survey Report

Name and Address of Structure :	Badi Chopar to Ramp Area (Down Line)
---------------------------------	--------------------------------------

Name of the Project	Contract JMRC-UG1B “Design and Construction of Tunnel between Chandpole and Badi Chouper and reverse line by Shield TBM, Underground Metro Stations at Choti Chouper and Badi Chouper by Cut and Cover Methods on East West Corridor of Jaipur Metro Rail Corporation Limited .”	
Owner :

Pre - Condition Building Survey for Construction of Underground Stations from Chandpole to Bari Chouper and reversal line

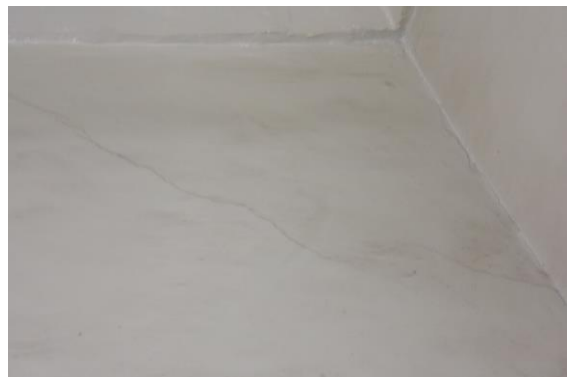
Photo 15

Inclined Crack on Wall No. 4 of Shop No.70, Ground Floor
Approx. Width = 0.5mm, Approx. Length = 1.5m.
Distance from Wall No.2 = 0m, Height from Floor = 2.5m.

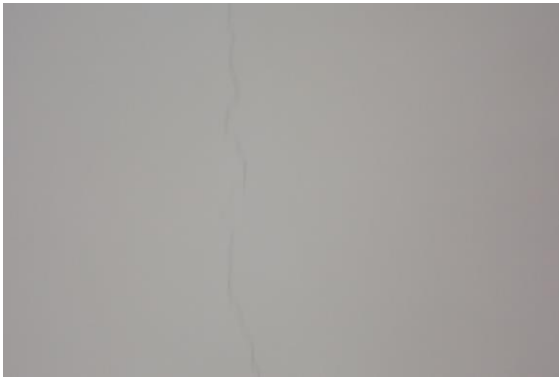
Photo 16

Horizontal Crack on Roof of Shop No.70, Ground Floor
Approx. Width = 0.2mm, Approx. Length = 1m.
Distance from Wall No.2 = 1.5m, Height from Floor = 4m.

Summary of Cracks						
Defect ID	Location	Orientation	Appx. Width (mm)	Appx. Length (m)	Category	Photo No.
1	Wall No. 1 Hall No. 1 First Floor	Inclined	0.5	2	Very Slight	5
2	Roof Varanda Ground Floor	Horizontal	0.2	2.5	Very Slight	6
3	Parapet Wall Varanda External Façade	Inclined	1	1	Slight	7
4	Beam External Varanda Ground Floor	Inclined	0.35	0.6	Very Slight	8, 8A
5	Right side Wall Building First Floor	Vertical	1	1	Slight	9
6	Sun Shade Building Second Floor	Horizontal	0.8	1.1	Very Slight	10
7	Roof Varanda Ground Floor	Inclined	0.5	2	Very Slight	11
8	Wall No. 1 Shop No.70 Ground Floor	Inclined	0.5	2.3	Very Slight	12, 12A
9	Wall No. 1 Shop No.70 Ground Floor	Vertical	0.4	1.1	Very Slight	13, 13A
10	Wall No. 1 Shop No.70 Ground Floor	Inclined	0.35	2	Very Slight	14
11	Wall No. 4 Shop No.70 Ground Floor	Inclined	0.5	1.5	Very Slight	15
12	Roof Shop No.70 Ground Floor	Horizontal	0.2	1	Very Slight	16
13	Wall No. 2 Shop No.70 Ground Floor	Vertical	0.3	1.5	Very Slight	17

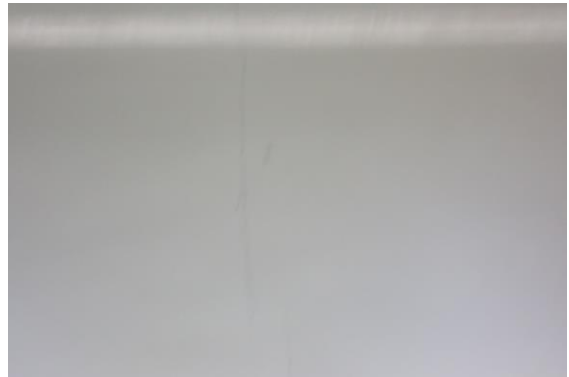
Photo 17

Vertical Crack on Wall No. 2 of Shop No.70, Ground Floor
Approx. Width = 0.3mm, Approx. Length = 1.5m.
Distance from Wall No.4 = 1.6m, Height from Floor = 2.5m.

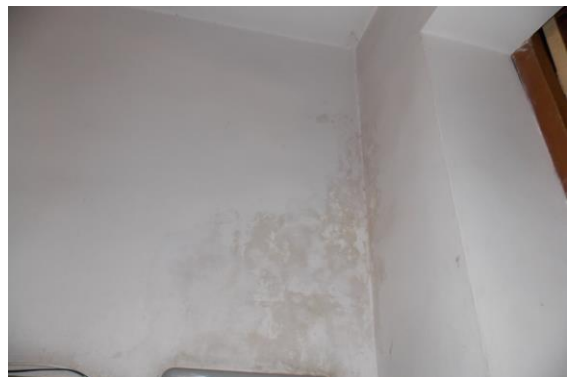
Photo 19

Dampness/Seepage on Wall No. 3 of Hall No. 1 of First Floor

Summary of Defects Other Than Crack			
Defect ID	Location	Description	Photo No.
15	Wall No. 3 Hall No. 1 First Floor	Dampness/Seepage	19
16	Wall No. 1 & 4 Hall No. 1 First Floor	Dampness/Seepage	20
17	Wall No. 1, 2, 3 & Roof Staircase GF to FF	Dampness/Seepage	21
18	Roof Varanda Ground Floor	Dampness/Seepage	22
19	Sun Shade Building Ground Floor	Peeling of Plaster	23
20	Backside Wall Building First Floor	Peeling of Plaster	24
21	Backside Wall Building Ground Floor	Damaged Portion	25
22	Roof Varanda of Shop No.69 Ground Floor	Dampness/Seepage	26
23	Varanda of Shop No.69 Ground Floor	Peeling of Plaster	27
24	Roof Varanda of Shop No.70 Ground Floor	Dampness/Seepage	28
25	Roof Varanda of Shop No.70 Ground Floor	Peeling of Plaster	29
26	Wall No. 2 Shop No.70 Ground Floor	Peeling of Plaster	30
27	Wall No. 2 Shop No.70 Ground Floor	Peeling of Plaster	31

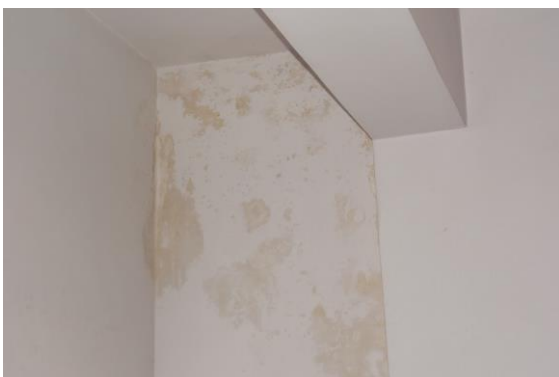
Photo 20

Dampness/Seepage on Wall No. 1 & 4 of Hall No. 1 of First Floor

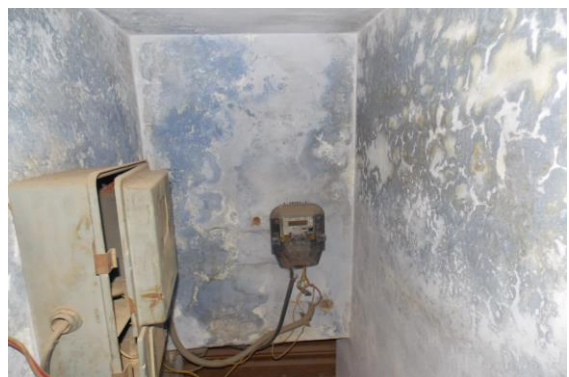
Photo 21

Dampness/Seepage on Wall No. 1, 2, 3 & Roof of Staircase GF to FF

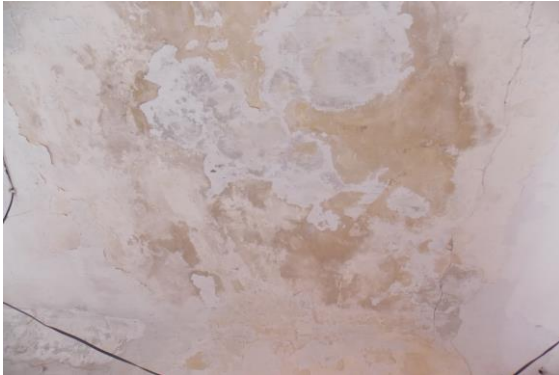
Photo 22
Dampness/Seepage on Roof of Varanda of Ground Floor

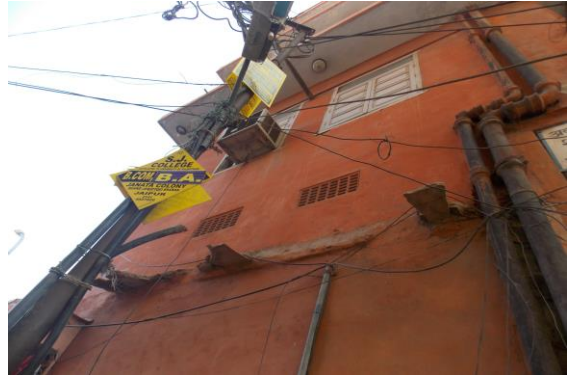
Photo 23
Peeling of Plaster on Sun Shade of Building of Ground Floor

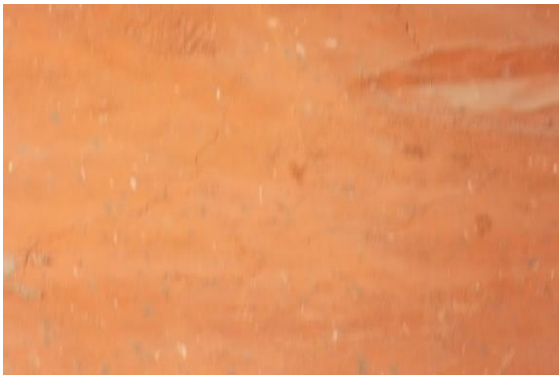
Photo 24
Peeling of Plaster on Backside Wall of Building of First Floor

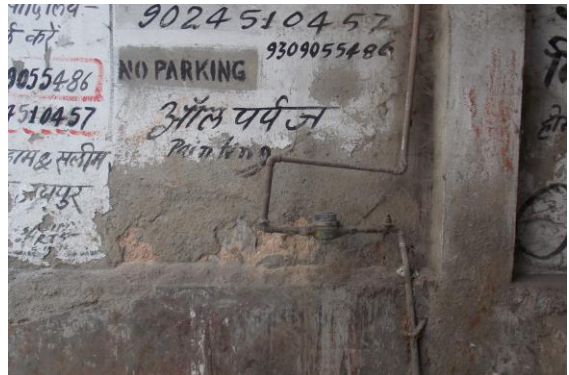
Photo 25
Damaged Portion on Backside Wall of Building of Ground Floor

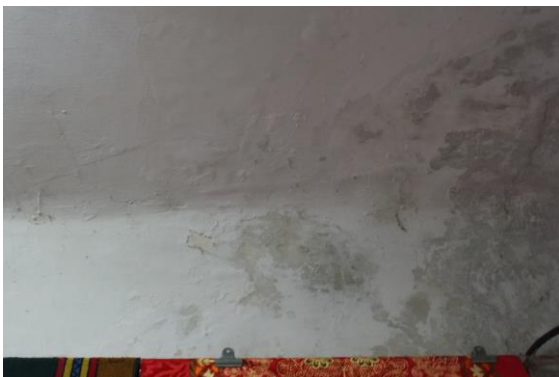
Photo 26
Dampness/Seepage on Roof of Varanda of Shop No.69 of Ground Floor

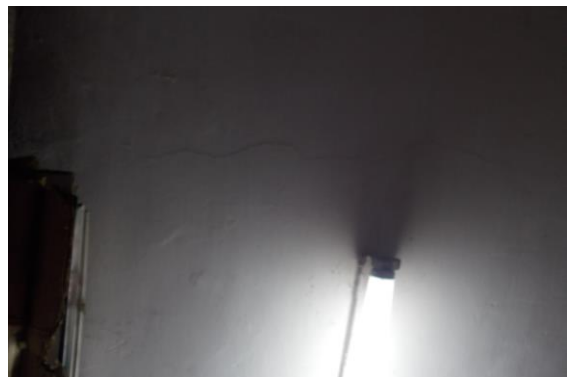
Photo 27
Peeling of Plaster on Varanda of Shop No.69 of Ground Floor

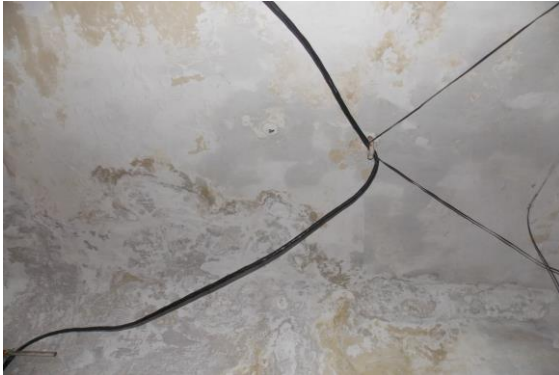
Photo 28

Dampness/Seepage on Roof of Varanda of Shop No.70 of Ground Floor

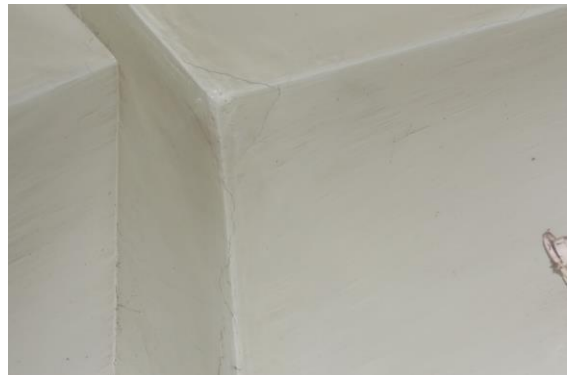
Photo 30

Peeling of Plaster on Wall No. 2 of Shop No.70 of Ground Floor

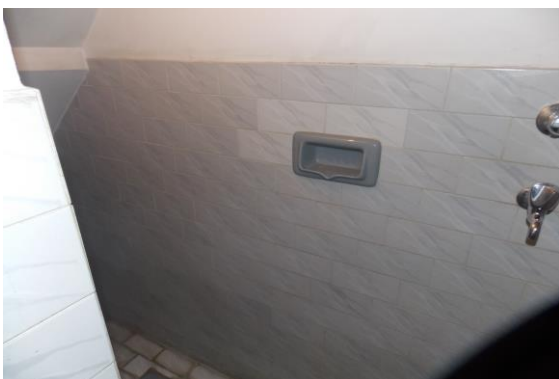
Photo 31

Peeling of Plaster on Wall No. 2 of Shop No.70 of Ground Floor

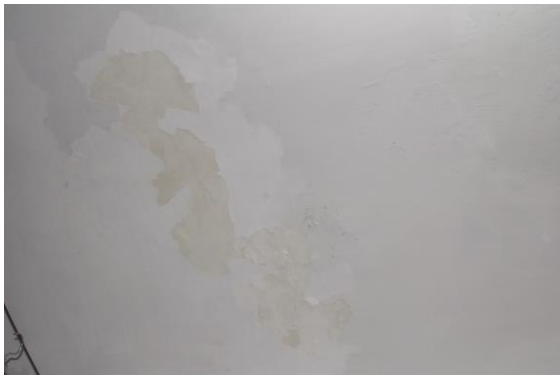
Photo 3
Peeling of Plaster on Roof of Varanda of Shop No.71 of Ground Floor

Summary of Defects Other Than Crack			
Defect ID	Location	Description	Photo No.
1	Roof Varanda of Shop No.71 Ground Floor	Peeling of Plaster	3

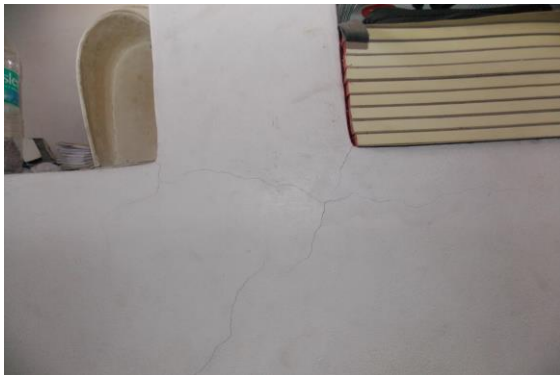
Photo 3
Inclined Crack on Wall No. 4 of Room No. 1, First Floor
Approx. Width = 0.1mm, Approx. Length = 2m.

Summary of Cracks						
Defect ID	Location	Orientation	Appx. Width (mm)	Appx. Length (m)	Category	Photo No.
1	Wall No. 4 Room No. 1 First Floor	Inclined	0.1	2	Very Slight	3
2	Roof Room No. 1 First Floor	Horizontal	0.35	2.7	Very Slight	4
3	Wall No. 2 Room No. 1 First Floor	Inclined	0.3	2	Very Slight	5
4	Wall No. 4 Room No. 2 First Floor	Inclined	0.1	3	Very Slight	6
5	Wall No. 3 Room No. 1 First Floor	Inclined	0.5	0	Very Slight	7, 7A
6	Roof Staircase FF to SF	Inclined	0.1	2	Very Slight	8
7	Wall No. 1 Room No. 1 Second Floor	Inclined	0.1	2	Very Slight	9
8	Wall No. 1 Staircase GF to FF	Inclined	4	2	Slight	10

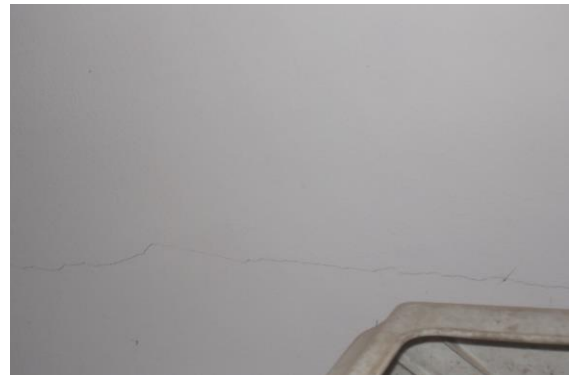
Photo 4
Horizontal Crack on Roof of Room No. 1, First Floor
Approx. Width = 0.35mm, Approx. Length = 2.7m.
Distance from Wall no.4 = 0.15m, Height from Floor = 2.5m.

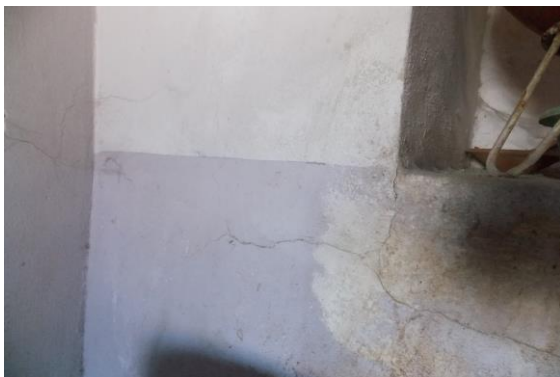
Photo 5
Inclined Crack on Wall No. 2 of Room No. 1, First Floor
Approx. Width = 0.3mm, Approx. Length = 2m.

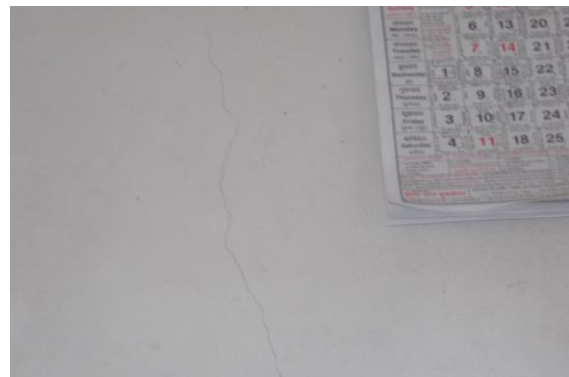
Photo 6
Inclined Crack on Wall No. 4 of Room No. 2, First Floor
Approx. Width = 0.1mm, Approx. Length = 3m.

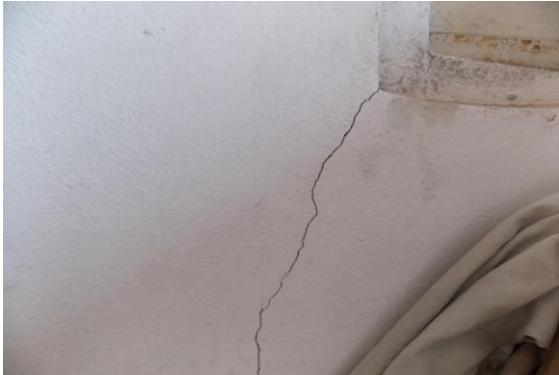
Photo 7

Inclined Crack on Wall No. 3 of Room No. 1, First Floor
Approx. Width = 0.5mm, Approx. Length = 0m.
Distance from Wall No.1 = 0.45m, Height from Floor = 0.4m.

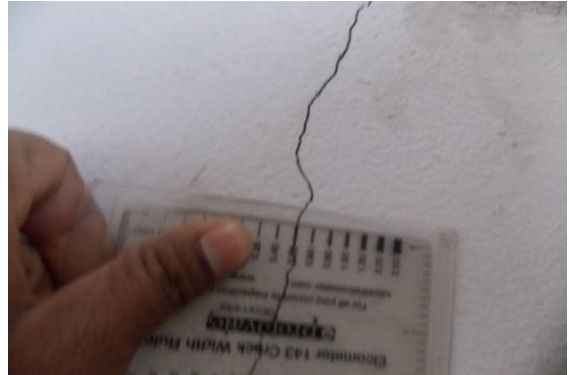
Photo 7A

Inclined Crack on Wall No. 3 of Room No. 1, First Floor
Approx. Width = 0.5mm, Approx. Length = 0m.
Distance from Wall No.1 = 0.45m, Height from Floor = 0.4m.

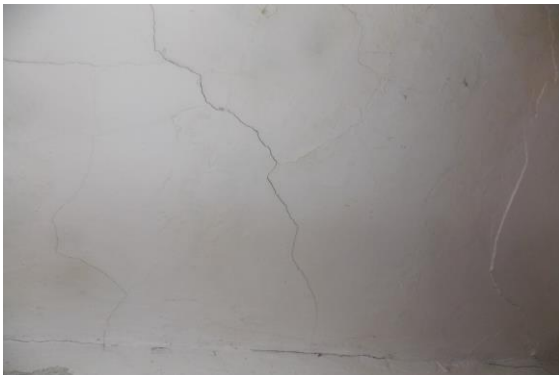
Photo 8

Inclined Crack on Roof of Staircase FF to SF
Approx. Width = 0.1mm, Approx. Length = 2m.

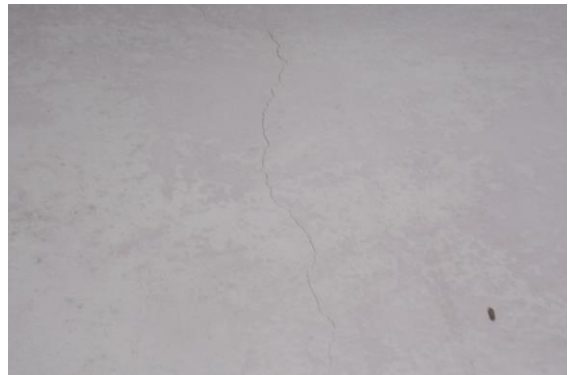
Photo 9

Inclined Crack on Wall No. 1 of Room No. 1, Second Floor
Approx. Width = 0.1mm, Approx. Length = 2m.

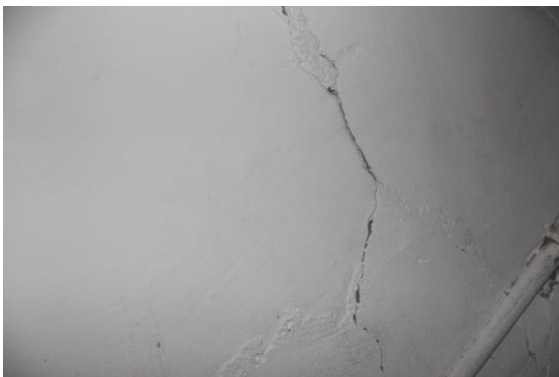
Photo 10

Inclined Crack on Wall No. 1 of Staircase GF to FF
Approx. Width = 4mm, Approx. Length = 2m.

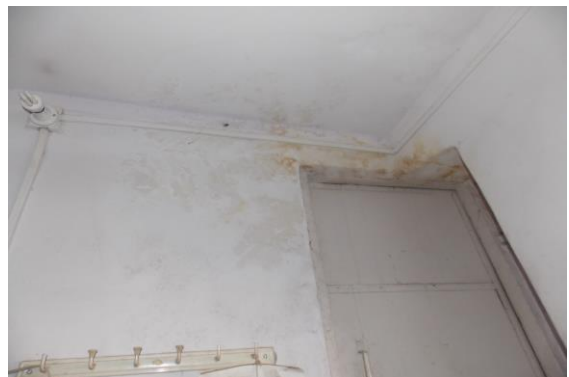
Photo 11

Dampness/Seepage on Wall No. 3 of Room No. 1 of First Floor

Summary of Defects Other Than Crack			
Defect ID	Location	Description	Photo No.
9	Wall No. 3 Room No. 1 First Floor	Dampness/Seepage	11
10	Wall No. 1 Room No. 2 First Floor	Dampness/Seepage	12
11	Steps Staircase FF to SF	Damaged Portion	13
12	Wall No. 2 Staircase FF to SF	Damaged Portion	14
13	Wall No. 2 Staircase FF to SF	Dampness/Seepage	15
14	Wall No. 3 Staircase FF to SF	Damaged Portion	16
15	Wall No. 1 Staircase FF to SF	Dampness/Seepage	17
16	Roof Room No. 1 Second Floor	Dampness/Seepage	18
17	Wall No. 4 Room No. 1 Second Floor	Dampness/Seepage	19
18	Wall No. 1 & Roof Staircase GF to FF	Peeling of Plaster	20
19	Wall No. 1 Staircase GF to FF	Peeling of Plaster	21
20	Roof Varanda Ground Floor	Peeling of Plaster	22
21	Frontwall of Building First Floor	Dampness/Seepage	23
22	Backside Wall Ground Floor	Damaged Portion	24
23	Backside Wall Second Floor	Damaged Portion	25
24	Roof Varanda of Shop No.72 Ground Floor	Peeling of Plaster	26

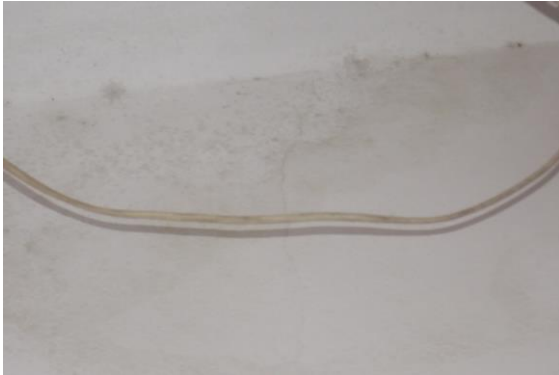
Photo 12
Dampness/Seepage on Wall No. 1 of Room No. 2 of First Floor

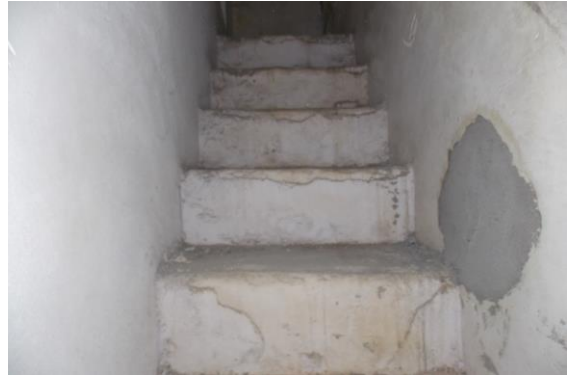
Photo 13
Damaged Portion on Wall No. Steps of Staircase FF to SF

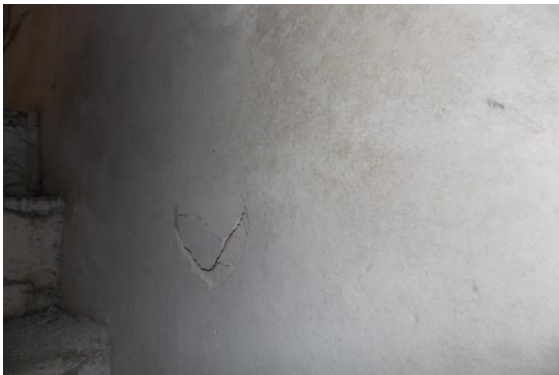
Photo 14
Damaged Portion on Wall No. 2 of Staircase FF to SF

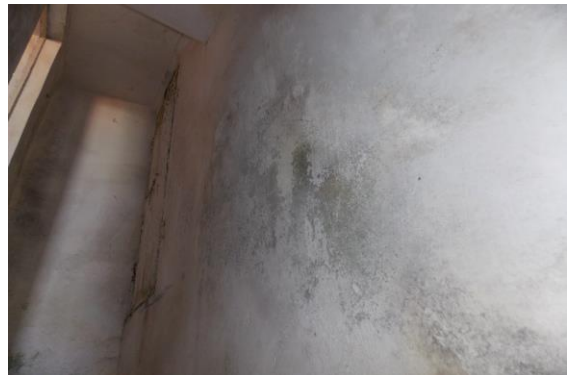
Photo 15
Dampness/Seepage on Wall No. 2 of Staircase FF to SF

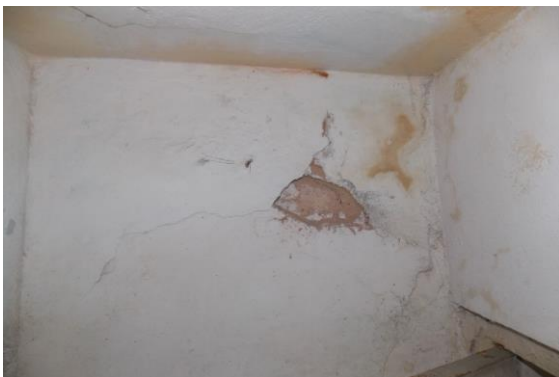
Photo 16
Damaged Portion on Wall No. 3 of Staircase FF to SF

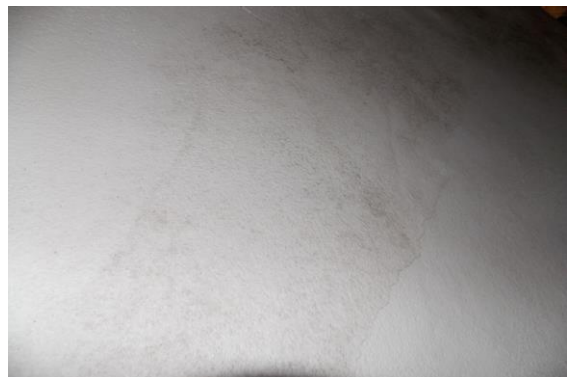
Photo 17
Dampness/Seepage on Wall No. 1 of Staircase FF to SF

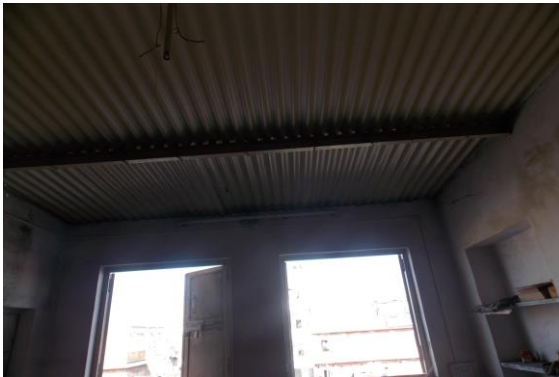
Photo 18
Dampness/Seepage on Roof of Room No. 1 of Second Floor

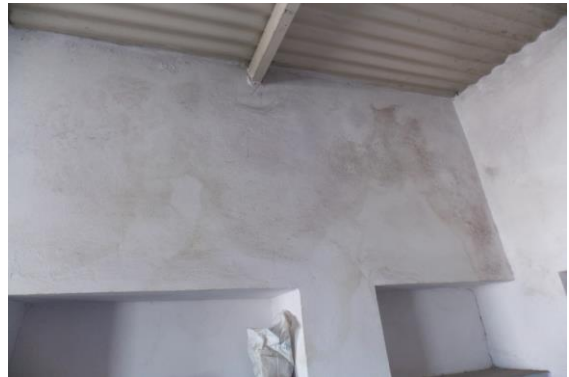
Photo 19
Dampness/Seepage on Wall No. 4 of Room No. 1 of Second Floor

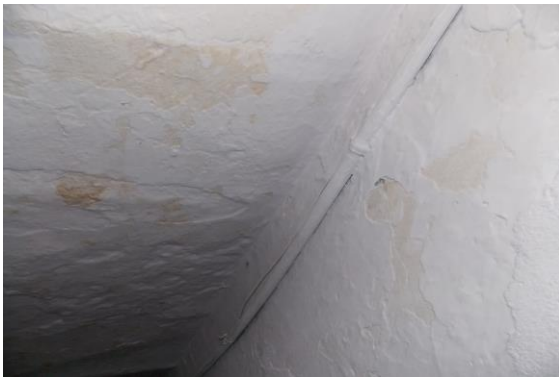
Photo 20
Peeling of Plaster on Wall No. 1 & Roof of Staircase GF to FF

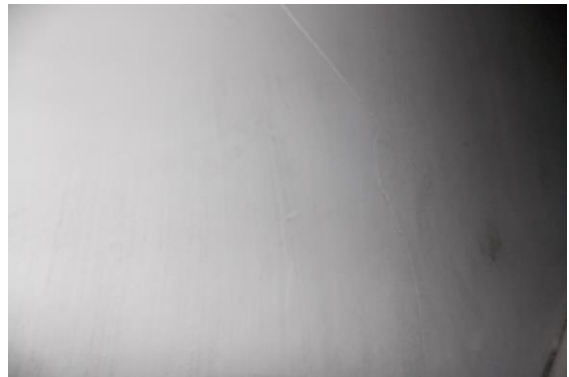
Photo 21
Peeling of Plaster on Wall No. 1 of Staircase GF to FF

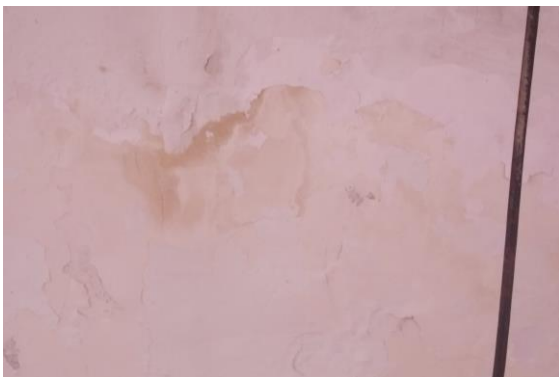
Photo 22
Peeling of Plaster on Roof of Varanda of Ground Floor

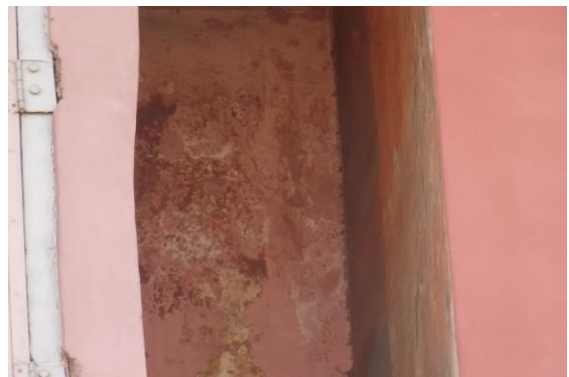
Photo 23
Dampness/Seepage on Frontwall of Building of First Floor

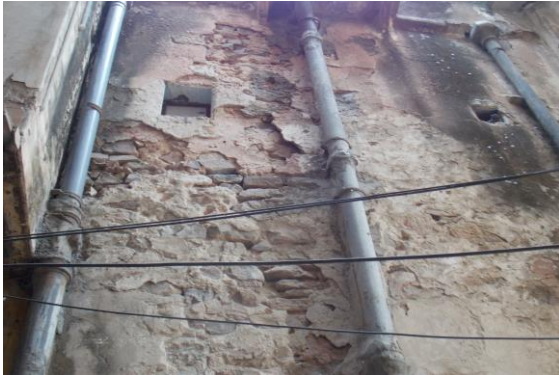
Photo 24
Damaged Portion on Backside Wall of Ground Floor

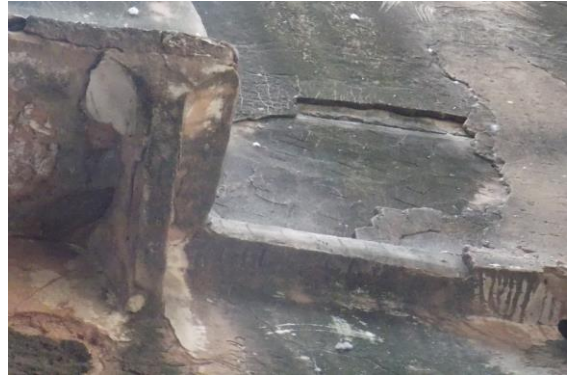
Photo 25
Damaged Portion on Backside Wall of Second Floor

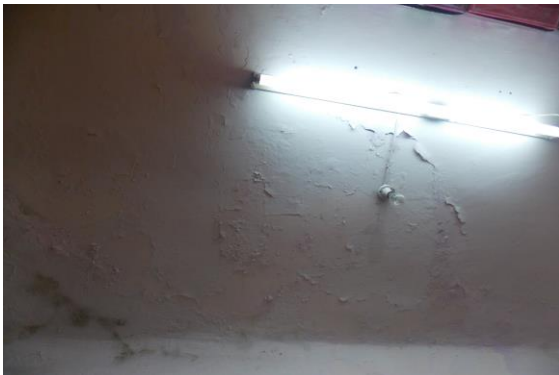
Photo 26
Peeling of Plaster on Roof of Varanda of Shop No.72 of Ground Floor

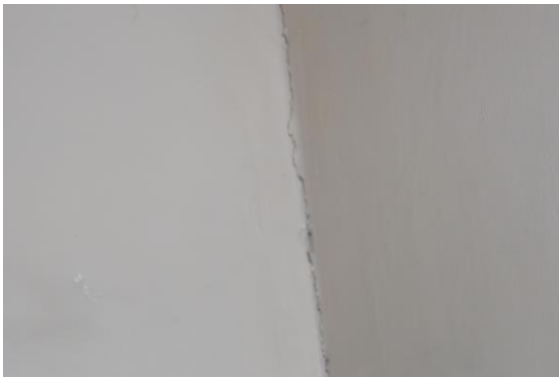
Photo 3
Inclined Crack on Wall No. 2, 4 & joint Crack of Store , Second Floor
Approx. Width = 1mm, Approx. Length = 2m.

Summary of Cracks						
Defect ID	Location	Orientation	Appx. Width (mm)	Appx. Length (m)	Category	Photo No.
1	Wall No. 2, 4 & joint Crack Store Second Floor	Inclined	1	2	Slight	3
2	Wall No. 1 Staircase FF to SF	Inclined	0.1	2	Very Slight	4
3	Steps Staircase TF to Terrace	Inclined	0.2	3	Very Slight	5
4	Roof Varanda of Shop No.73 Ground Floor	Horizontal	0.25	2.5	Very Slight	6

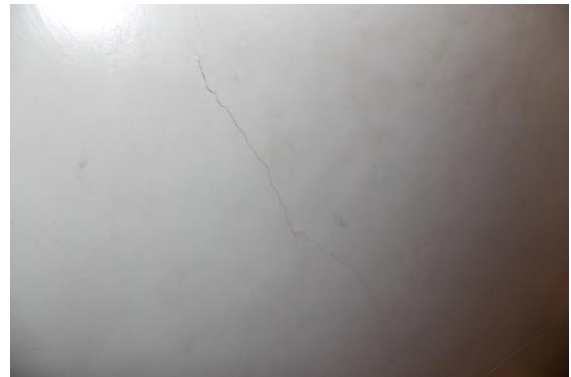
Photo 4
Inclined Crack on Wall No. 1 of Staircase FF to SF

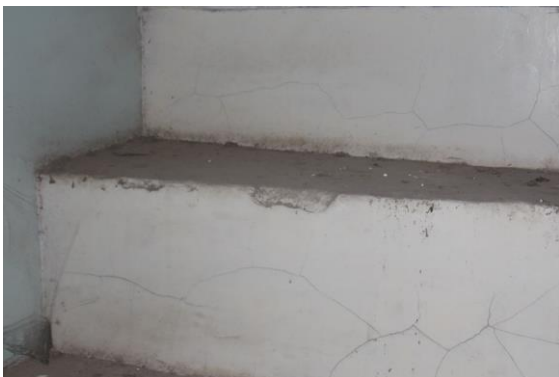
Photo 5
Inclined Crack on Steps of Staircase TF to Terrace
Approx. Width = 0.2mm, Approx. Length = 3m.

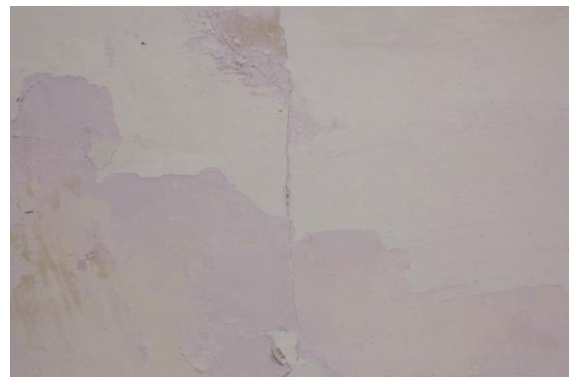
Photo 6
Horizontal Crack on Roof of Varanda of Shop No.73, Ground Floor
Approx. Width = 0.25mm, Approx. Length = 2.5m.
Height from Floor = 3m.

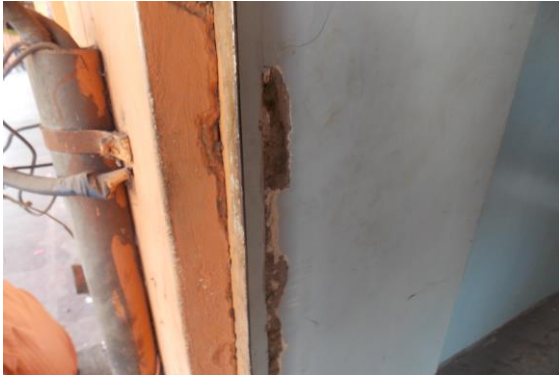
Photo 7
Damaged Portion on Wall No. 1 of Staircase GF to FF

Summary of Defects Other Than Crack			
Defect ID	Location	Description	Photo No.
5	Wall No. 1 Staircase GF to FF	Damaged Portion	7
6	Wall No. 1 Staircase GF to FF	Peeling of Plaster	8
7	Wall No. 1 Toilet No. 1 First Floor	Dampness/Seepage	9
8	Wall No. 1 & 4 Toilet No. 1 First Floor	Dampness/Seepage	10
9	Wall No. 3 & Roof Room No. 1 Second Floor	Dampness/Seepage	11
10	Wall No. 2, 3 & Roof Room No. 1 Second Floor	Dampness/Seepage	12
11	Wall No. 1 Staircase FF to SF	Peeling of Plaster	13
12	Wall No. 4 Room No. 2 Third Floor	Peeling of Plaster	14
13	Roof Varanda of Shop No.73 Ground Floor	Peeling of Plaster	15

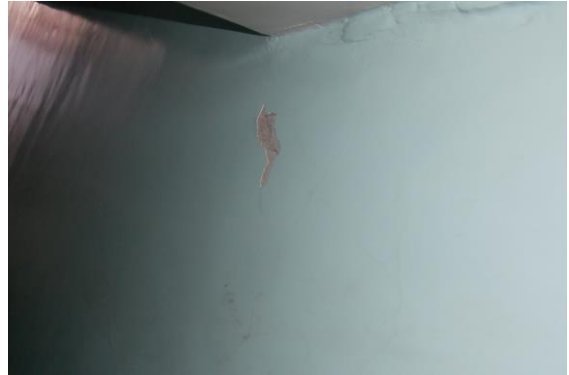
Photo 8
Peeling of Plaster on Wall No. 1 of Staircase GF to FF

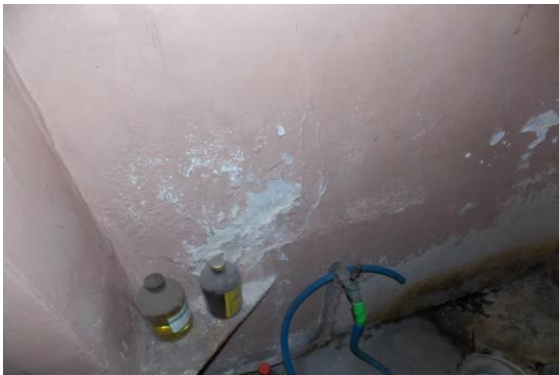
Photo 9
Dampness/Seepage on Wall No. 1 of Toilet No. 1 of First Floor

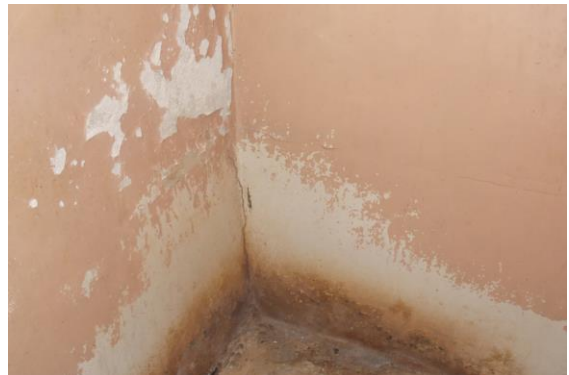
Photo 10
Dampness/Seepage on Wall No. 1 & 4 of Toilet No. 1 of First Floor

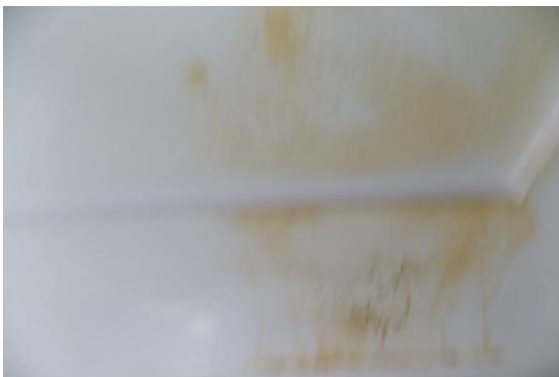
Photo 11
Dampness/Seepage on Wall No. 3 & Roof of Room No. 1 of Second Floor

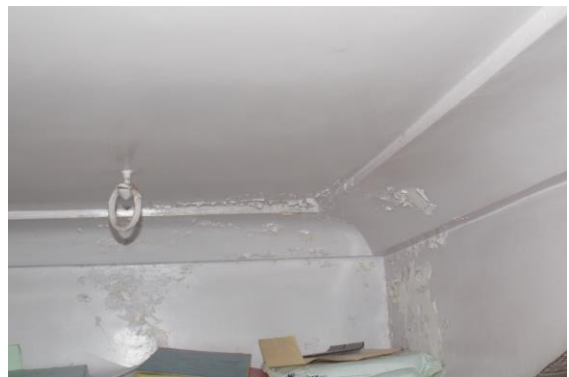
Photo 12
Dampness/Seepage on Wall No. 2, 3 & Roof of Room No. 1 of Second Floor

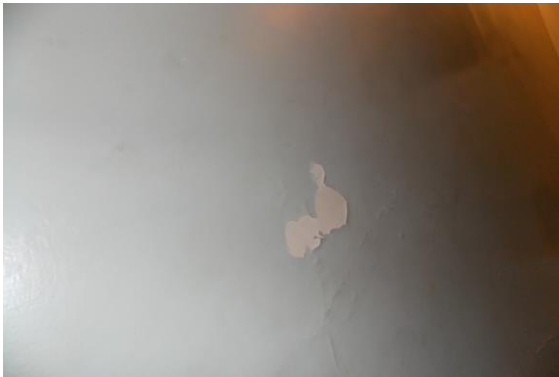
Photo 13

Peeling of Plaster on Wall No. 1 of Staircase FF to SF

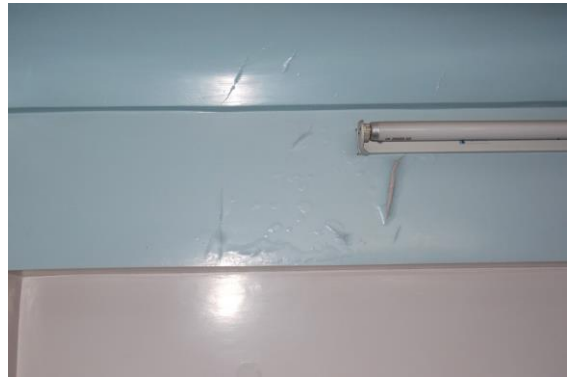
Photo 14

Peeling of Plaster on Wall No. 4 of Room No. 2 of Third Floor

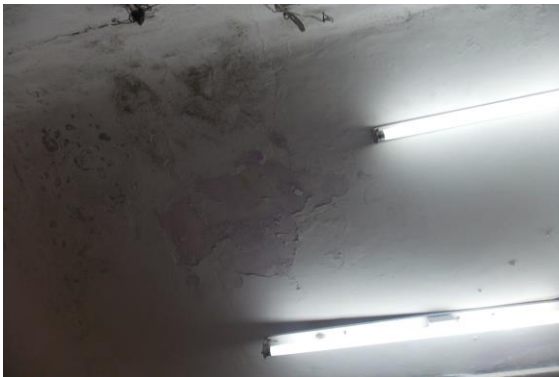
Photo 15

Peeling of Plaster on Roof of Varanda of Shop No.73 of Ground Floor

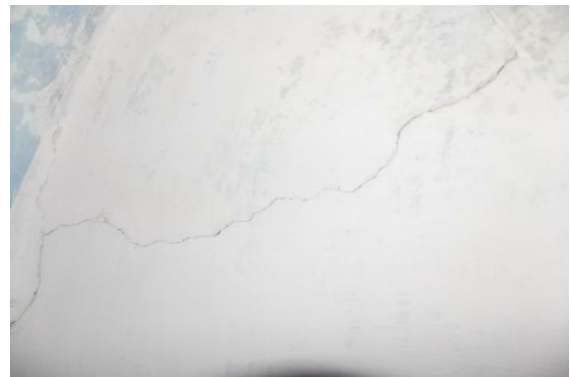
Photo 4

Inclined Crack on Wall No. 1 of Staircase SF to TF, Second Floor,
Approx. Width = 0.25mm, Approx. Length = 2m.
Distance from = m, Height from Floor = m.

Summary of Cracks						
Defect ID	Location	Orientation	Appx. Width (mm)	Appx. Length (m)	Category	Photo No.
1	Wall No. 1 Staircase SF to TF Second Floor	Inclined	0.25	2	Very Slight	4, 4A
2	Wall No. 4 Room No. 1 Above Shop No. 74, Third Floor	Inclined	0.6	1	Very Slight	5, 5A
3	Wall No. 4 Open Area Third Floor	Inclined	1.2	1.5	Slight	6, 6A
4	Wall No. 4 Open Area Third Floor	Inclined	0.6	1.5	Very Slight	7, 7A
5	Wall No. 1 Room No. 2 First Floor	Inclined	0.25	1.5	Very Slight	8, 8A
6	External Beam Varanda Above Shop No. 74, Ground Floor	Inclined	0.5	1.7	Very Slight	9
7	Wall No. External Beam Varanda Above Shop No. 74, Ground Floor	Inclined	1	1.7	Slight	10

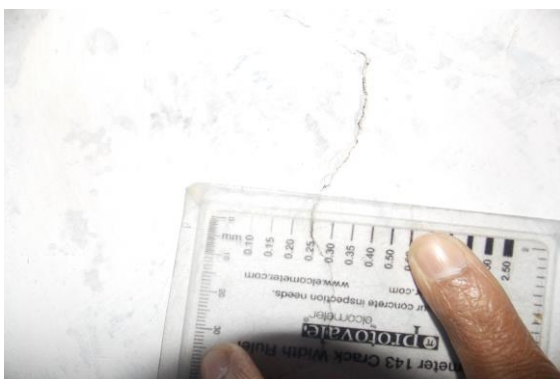
Photo 4A

Inclined Crack on Wall No. 1 of Staircase SF to TF, Second Floor
Approx. Width = 0.25mm, Approx. Length = 2m.
Distance from = m, Height from Floor = m.

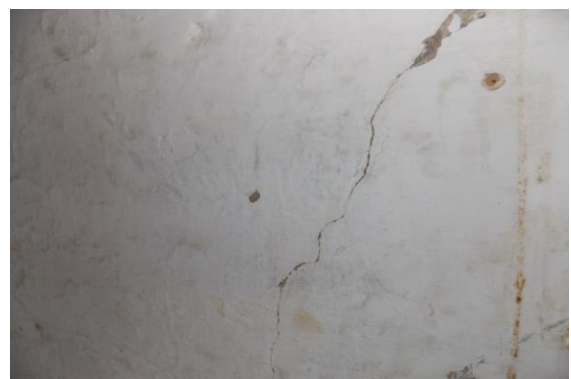
Photo 5

Inclined Crack on Wall No. 4 of Room No. 1, Above Shop No. 74, Third Floor, Approx. Width = 0.6mm, Approx. Length = 1m. Distance from = 0.7m, Height from Floor = 0.6m.

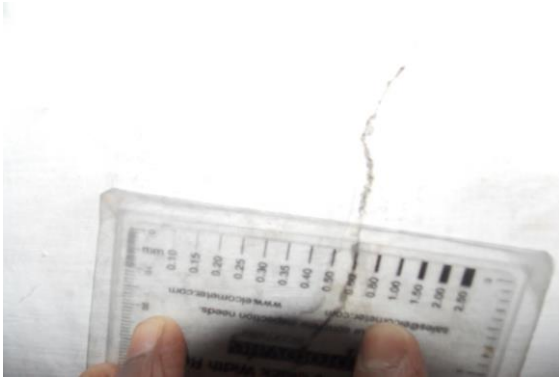
Photo 5A

Inclined Crack on Wall No. 4 of Room No. 1, Above Shop No. 74, Third Floor, Approx. Width = 0.6mm, Approx. Length = 1m.
Distance from = 0.7m, Height from Floor = 0.6m.

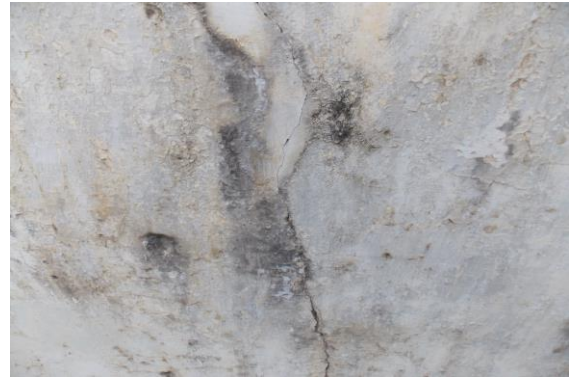
Photo 6

Inclined Crack on Wall No. 4 of Open Area, Third Floor, Approx. Width = 1.2mm, Approx. Length = 1.5m.
Distance from = 1.6m, Height from Floor = 0m.

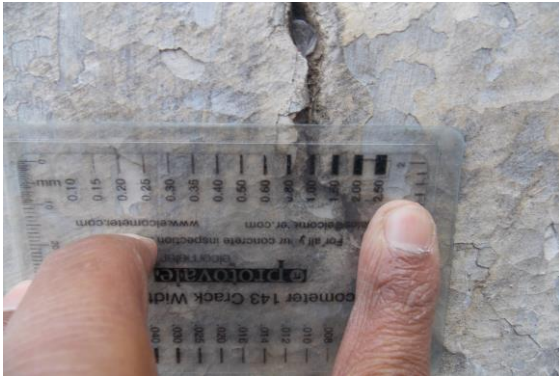
Photo 6A

Inclined Crack on Wall No. 4 of Open Area, Third Floor, Approx. Width = 1.2mm, Approx. Length = 1.5m.
Distance from = 1.6m, Height from Floor = 0m.

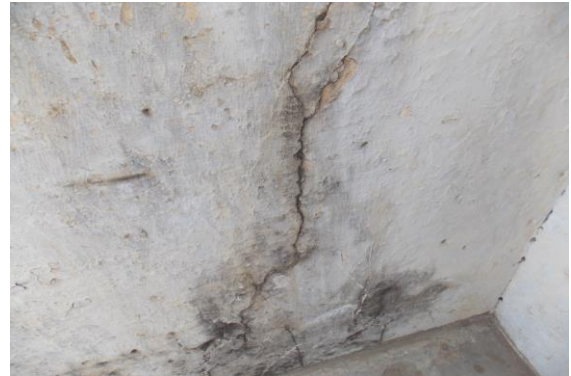
Photo 7

Inclined Crack on Wall No. 4 of Open Area, Third Floor, Approx. Width = 0.6mm, Approx. Length = 1.5m.
Distance from Wall No. 1 = 0.7m, Height from Floor = 0m.

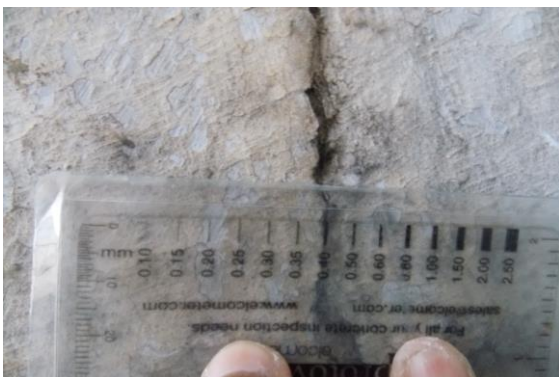
Photo 7A

Inclined Crack on Wall No. 4 of Open Area, Third Floor, Approx. Width = 0.6mm, Approx. Length = 1.5m.
Distance from Wall No. 1 = 0.7m, Height from Floor = 0m.

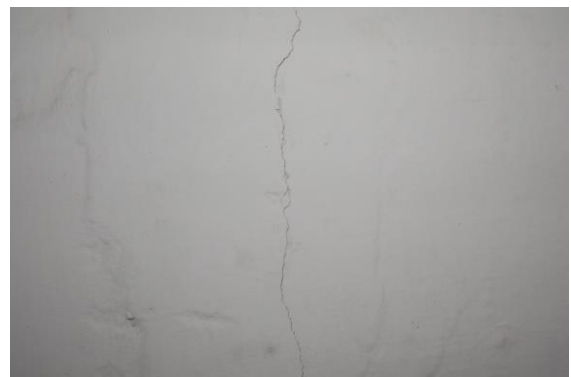
Photo 8

Inclined Crack on Wall No. 1 of Room No. 2, First Floor, Approx. Width = 0.25mm, Approx. Length = 1.5m.
Distance from = 0.3m, Height from Floor = 0.5m.

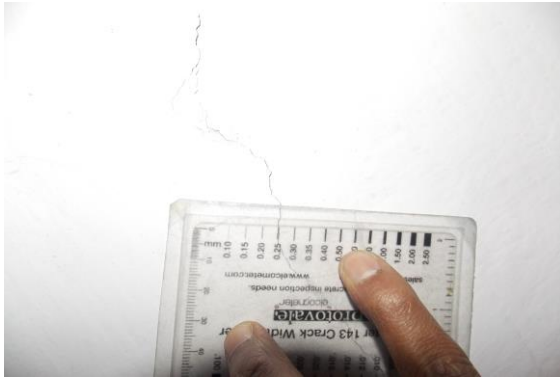
Photo 8A

Inclined Crack on Wall No. 1 of Room No. 2, First Floor, Approx. Width = 0.25mm, Approx. Length = 1.5m.
Distance from = 0.3m, Height from Floor = 0.5m.

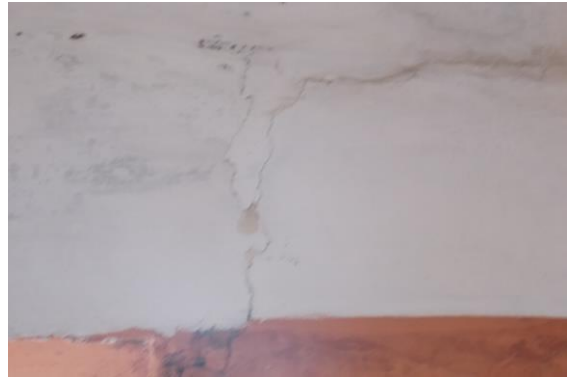
Photo 9

Inclined Crack on External Beam of Varanda, Above Shop No. 74, Ground Floor, Approx. Width = 0.5mm, Approx. Length = 1.7m., Distance from = Right side External Column, Height from Floor = 2.3m.

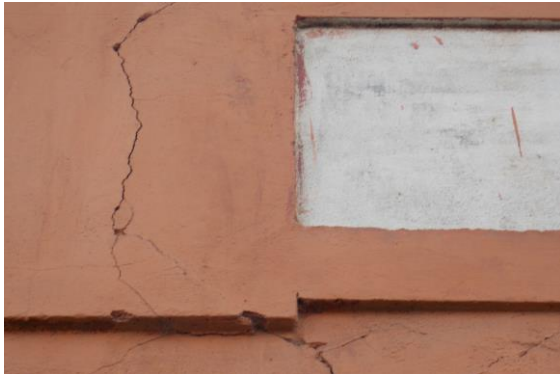
Photo 10

Inclined Crack on External Beam of Varanda, Above Shop No. 74, Ground Floor, Approx. Width = 1mm, Approx. Length = 1.7m., Distance from = Right side External Column, Height from Floor = 2.3m.

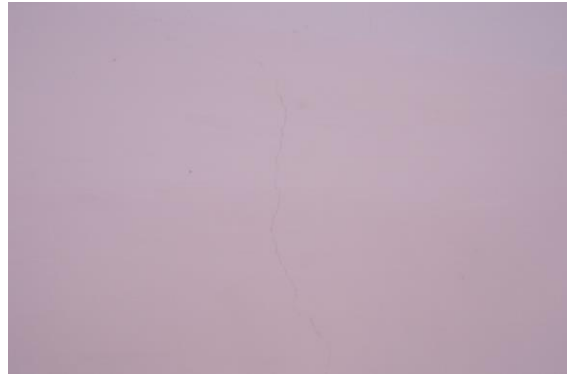
Photo 11

Peeling of Plaster on Roof of Room No. 1 of Above Shop No. 74, Second Floor

Summary of Defects Other Than Crack			
Defect ID	Location	Description	Photo No.
8	Roof Room No. 1 Above Shop No. 74, Second Floor	Peeling of Plaster	11
9	Wall No. 2 Room No. 1 Above Shop No. 74, Second Floor	Peeling of Plaster	12
10	Wall No. 4 Lobby Second Floor	Dampness/Seepage	13
11	Wall No. 2 Lobby Second Floor	Peeling of Plaster	14
12	Wall No. 2 Staircase SF to TF Second Floor	Dampness/Seepage	15
13	Roof Staircase SF to TF Second Floor	Dampness/Seepage	16
14	Wall No. 4 Room No. 1 Above Shop No. 74, Third Floor	Peeling of Plaster	17
15	Roof Room No. 1 Above Shop No. 74, Third Floor	Dampness/Seepage	18
16	Wall No. 3 Room No. 1 Above Shop No. 74, Third Floor	Peeling of Plaster	19
17	Wall No. 2 Room No. 1 Above Shop No. 74, Third Floor	Dampness/Seepage	20
18	Steps Staircase area Third Floor	Peeling of Plaster	21
19	Roof Toilet No. 1 Above Shop No. 74, First Floor	Peeling of Plaster	22
20	Wall No. 1 Toilet No. 1 Above Shop No. 74, First Floor	Dampness/Seepage	23

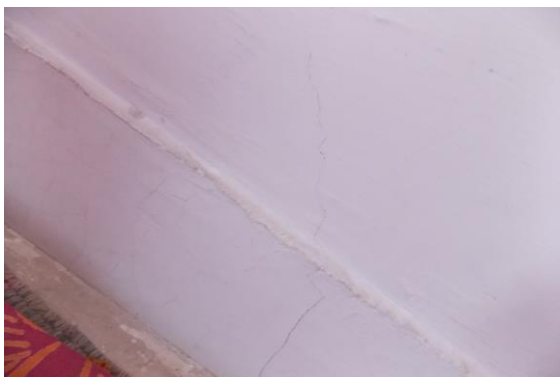
Photo 12

Peeling of Plaster on Wall No. 2 of Room No. 1 of Above Shop No. 74, Second Floor

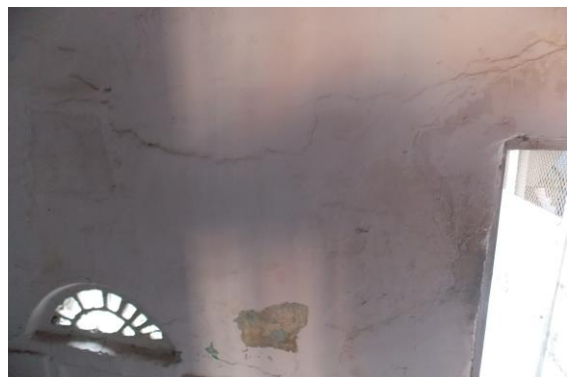
Photo 13

Dampness/Seepage on Wall No. 4 of Lobby of Second Floor

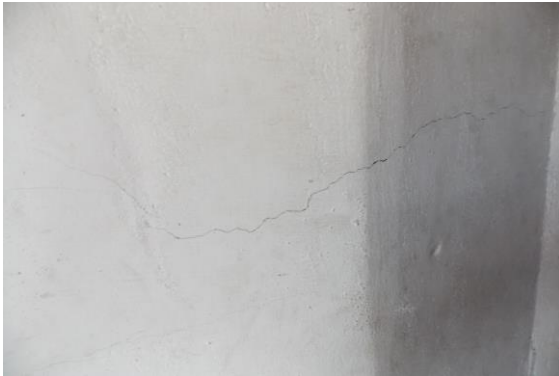
Photo 14
Peeling of Plaster on Wall No. 2 of Lobby of Second Floor

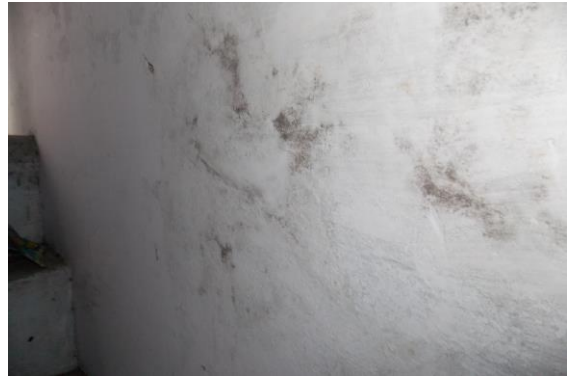
Photo 15
Dampness/Seepage on Wall No. 2 of Staircase SF to TF of Second Floor

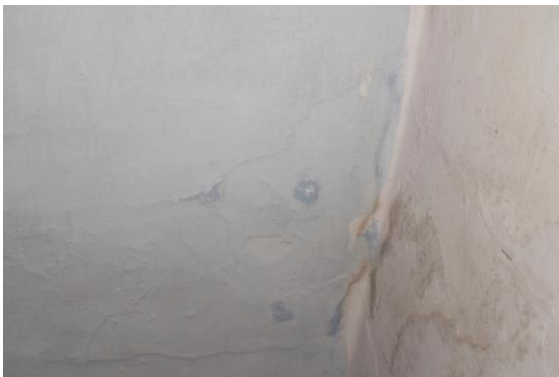
Photo 16
Dampness/Seepage on Roof of Staircase SF to TF of Second Floor

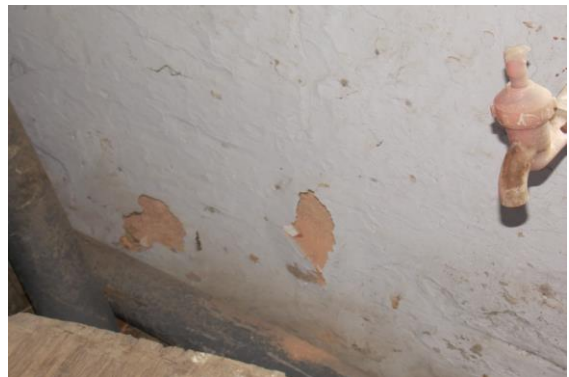
Photo 17
Peeling of Plaster on Wall No. 4 of Room No. 1 of Above Shop No. 74, Third Floor

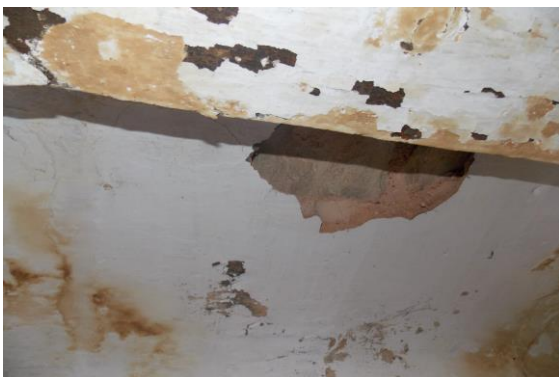
Photo 18
Dampness/Seepage on Roof of Room No. 1 of Above Shop No. 74, Third Floor

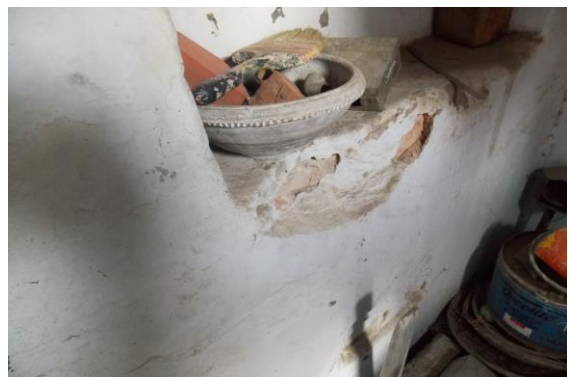
Photo 19
Peeling of Plaster on Wall No. 3 of Room No. 1 of Above Shop No. 74, Third Floor

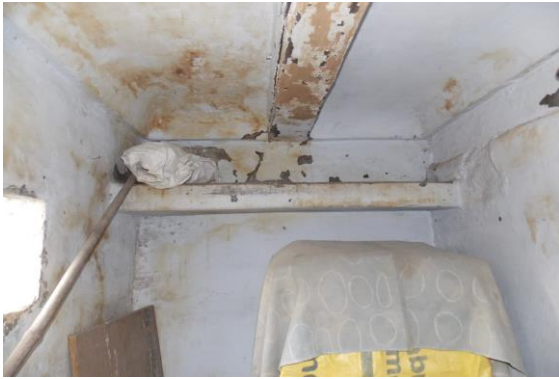
Photo 20

Dampness/Seepage on Wall No. 2 of Room No. 1 of Above Shop No. 74, Third Floor

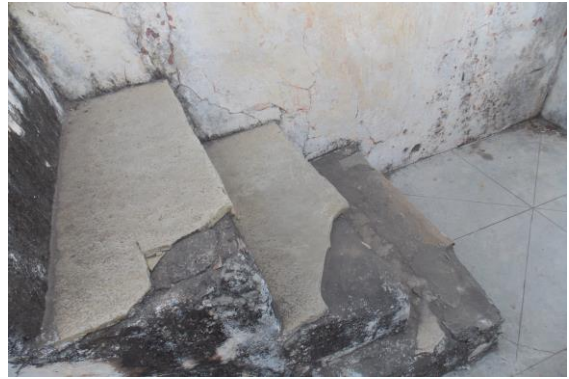
Photo 21

Peeling of Plaster on Steps of Staircase area of Third Floor

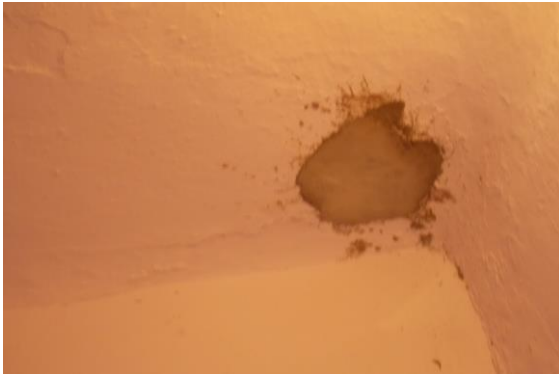
Photo 22

Peeling of Plaster on Roof of Toilet No. 1 of Above Shop No. 74, First Floor

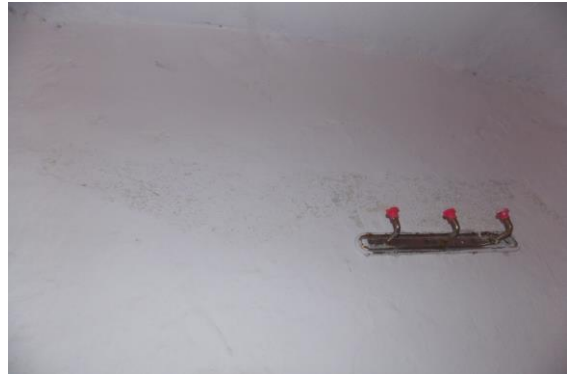
Photo 23

Dampness/Seepage on Wall No. 1 of Toilet No. 1 of Above Shop No. 74, First Floor

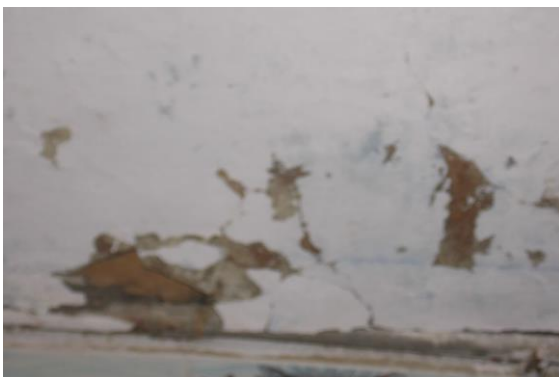
Photo 24

Peeling of Plaster on Wall No. 2 of Toilet No. 1 of Above Shop No. 74, First Floor

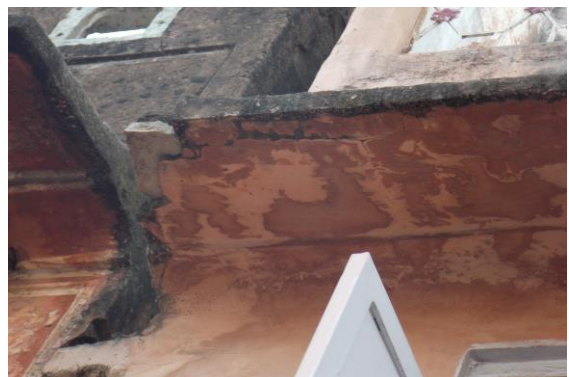
Photo 25

Dampness/Seepage on Roof Sun Shade of Above Shop No. 74 of First Floor

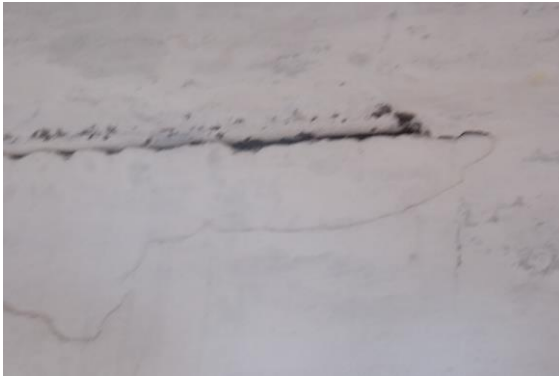
Photo 26

Peeling of Plaster on External Beam of Varanda of Above Shop No. 74, Ground Floor

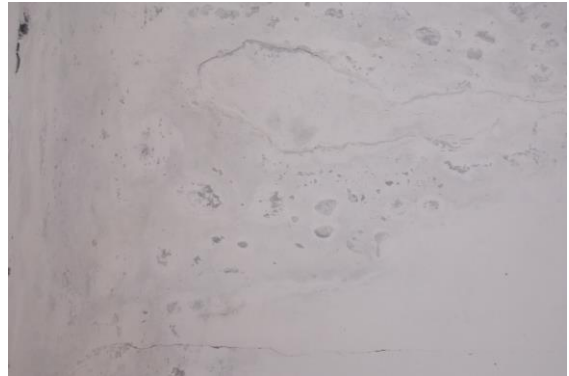
Photo 27

Dampness/Seepage on Roof of Varanda of Above Shop No. 74, Ground Floor

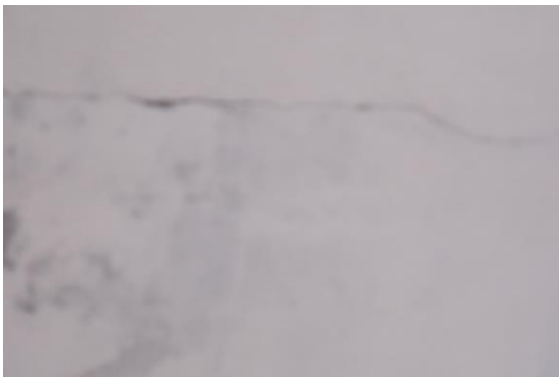
Photo 28

Peeling of Plaster on Roof of Varanda of Above Shop No. 74, Ground Floor

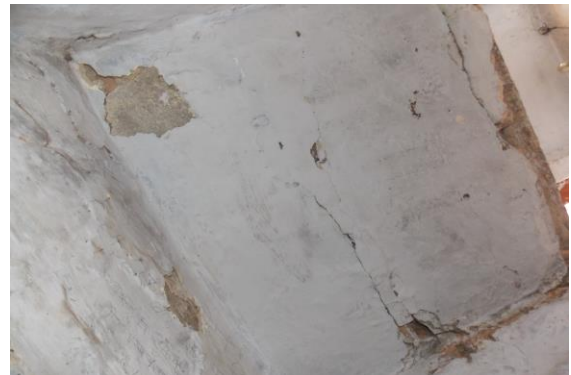
Photo 4
Inclined Crack on Roof of Staircase GF to FF
Approx. Width = 20mm, Approx. Length = 1m.

Summary of Cracks						
Defect ID	Location	Orientation	Appx. Width (mm)	Appx. Length (m)	Category	Photo No.
1	Roof Staircase GF to FF	Inclined	20	1	Severe	4
2	Wall No. 4 Staircase GF to FF	Vertical	2.5	0.5	Slight	5
3	Wall No. 2 & 3 Open area Third Floor	Vertical	20	2.5	Severe	6, 6A
4	Open area Third Floor	Vertical	2.5	2	Slight	7, 7A
5	Floor Open area Third Floor	Inclined	2	2	Slight	8
6	Outside Wall External Façade	Inclined	5	1	Moderate	9
7	Outside Wall External Façade	Inclined	1	3	Slight	10
8	Leftside External Column Varanda of Shop No.76 Ground Floor	Inclined	0.35	1.5	Very Slight	11

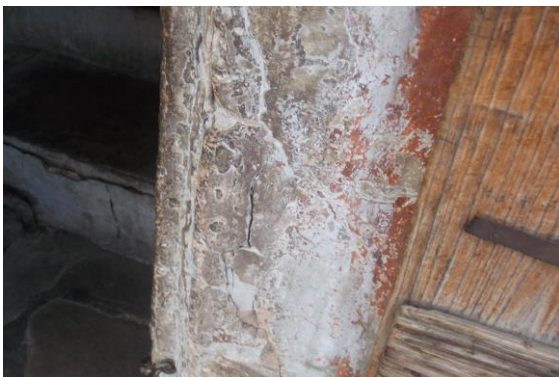
Photo 5
Vertical Crack on Wall No. 4 of Staircase GF to FF
Approx. Width = 2.5mm, Approx. Length = 0.5m.
