Pre Building Condition Survey Report

Name and Address of Structure :	Badi Chopar to Ramp Area (Down Line)
---------------------------------	--------------------------------------

Name of the Project	Contract JMRC-UG1B “Design and Construction of Tunnel between Chandpole and Badi Chouper and reverse line by Shield TBM, Underground Metro Stations at Choti Chouper and Badi Chouper by Cut and Cover Methods on East West Corridor of Jaipur Metro Rail Corporation Limited .”	
Owner :

Pre - Condition Building Survey for Construction of Underground Stations from Chandpole to Bari Chouper and reversal line

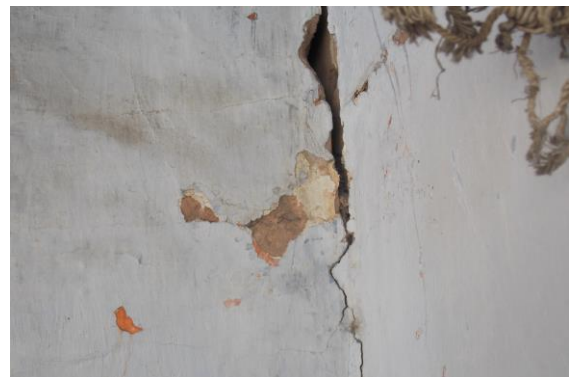
Photo 6
Vertical Crack on Wall No. 2 & 3 of Open area, Third Floor
Approx. Width = 20mm, Approx. Length = 2.5m.
Height from Floor = 0m.

Summary of Cracks						
Defect ID	Location	Orientation	Appx. Width (mm)	Appx. Length (m)	Category	Photo No.
1	Roof Staircase GF to FF	Inclined	20	1	Severe	4
2	Wall No. 4 Staircase GF to FF	Vertical	2.5	0.5	Slight	5
3	Wall No. 2 & 3 Open area Third Floor	Vertical	20	2.5	Severe	6, 6A
4	Open area Third Floor	Vertical	2.5	2	Slight	7, 7A
5	Floor Open area Third Floor	Inclined	2	2	Slight	8
6	Outside Wall External Façade	Inclined	5	1	Moderate	9
7	Outside Wall External Façade	Inclined	1	3	Slight	10
8	Leftside External Column Varanda of Shop No.76 Ground Floor	Inclined	0.35	1.5	Very Slight	11

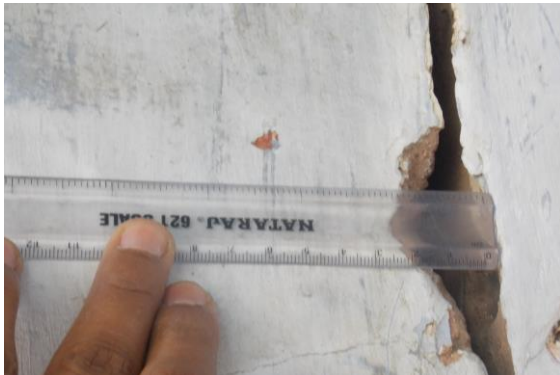
Photo 6A

Vertical Crack on Wall No. 2 & 3 of Open area, Third Floor
Approx. Width = 20mm, Approx. Length = 2.5m.
Height from Floor = 0m.

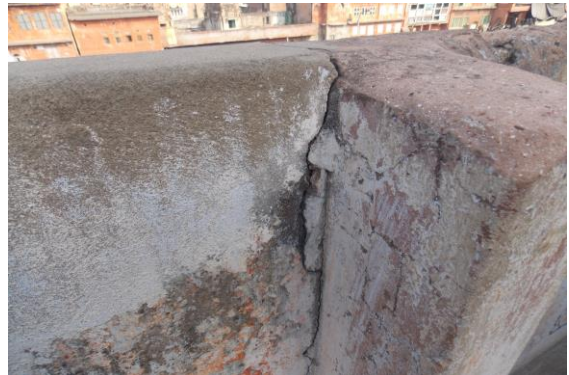
Photo 7

Vertical Crack on Open area, Third Floor
Approx. Width = 2.5mm, Approx. Length = 2m.
Distance from Wall no.2 = 1.7m, Height from Floor = 0.4m.

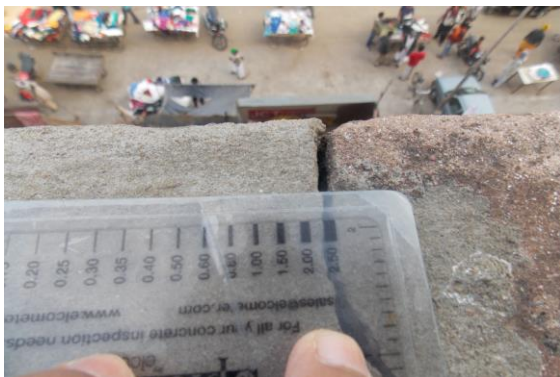
Photo 7A

Vertical Crack on Open area, Third Floor
Approx. Width = 2.5mm, Approx. Length = 2m.
Distance from Wall no.2 = 1.7m, Height from Floor = 0.4m.

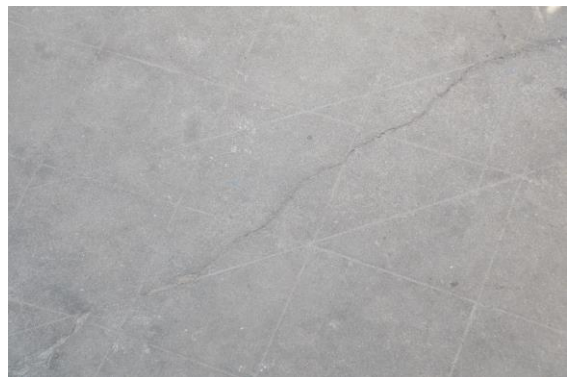
Photo 8

Inclined Crack on Floor of Open area, Third Floor
Approx. Width = 2mm, Approx. Length = 2m.

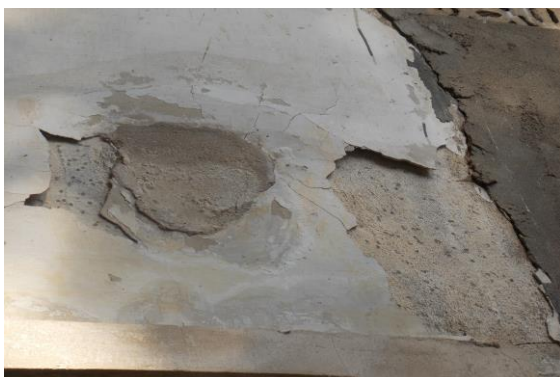
Photo 9

Inclined Crack on Outside Wall of External Façade,
Approx. Width = 5mm, Approx. Length = 1m.

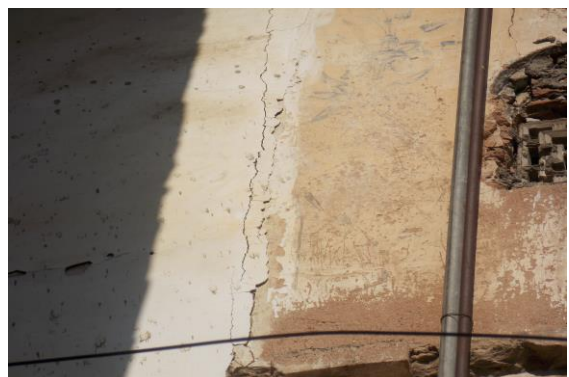
Photo 10

Inclined Crack on Outside Wall of External Façade,
Approx. Width = 1mm, Approx. Length = 3m.

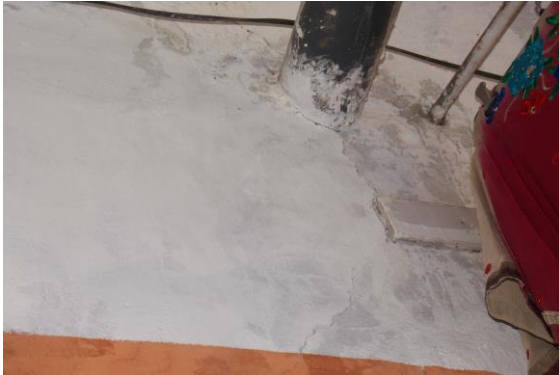
Photo 11

Inclined Crack on Leftside External Column of Varanda of Shop No.76,
Ground Floor
Approx. Width = 0.35mm, Approx. Length = 1.5m.
Distance from Leftside External Column = Racksidem Height from Floor

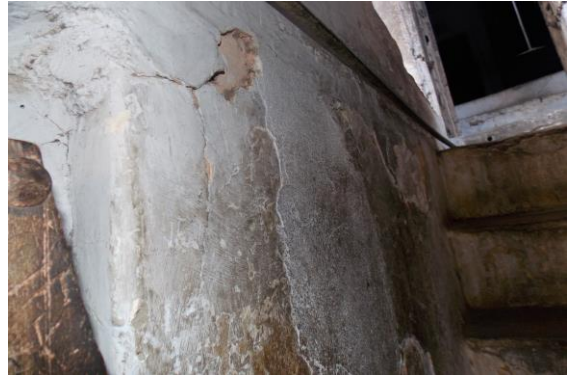
Photo 12

Damaged Portion on Wall No. 1 of Staircase GF to FF

Summary of Defects Other Than Crack			
Defect ID	Location	Description	Photo No.
9	Wall No. 1 Staircase GF to FF	Damaged Portion	12
10	Wall No. 2 Staircase GF to FF	Damaged Portion	13
11	Wall No. Steps Staircase GF to FF	Damaged Portion	14
12	Wall No. 1 Room No. 1 First Floor	Peeling of Plaster	15
13	Wall No. 4 Room No. 1 First Floor	Peeling of Plaster	16
14	Wall No. 3 Room No. 1 First Floor	Peeling of Plaster	17
15	Roof Room No. 1 First Floor	Damaged Portion	18
16	Wall No. 1 Room No. 2 First Floor	Peeling of Plaster	19
17	Wall No. 4 Room No. 2 First Floor	Damaged Portion	20
18	Roof Room No. 2 First Floor	Damaged Portion	21
19	Wall No. 3 Lobby First Floor	Peeling of Plaster	22
20	Wall No. 1 Lobby First Floor	Peeling of Plaster	23
21	Roof Lobby First Floor	Peeling of Plaster	24
22	Wall No. 4 Lobby First Floor	Peeling of Plaster	25
23	Wall No. 4 Passage First Floor	Peeling of Plaster	26
24	Wall No. 2 Passage First Floor	Peeling of Plaster	27

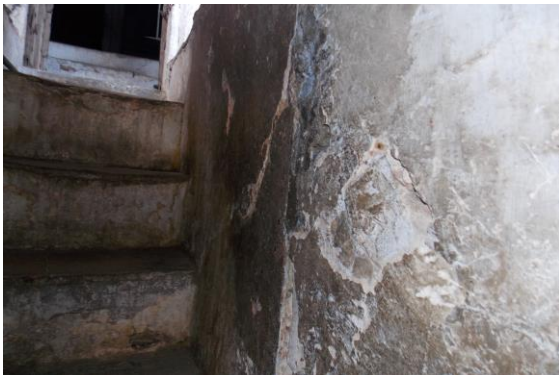
Photo 13

Damaged Portion on Wall No. 2 of Staircase GF to FF

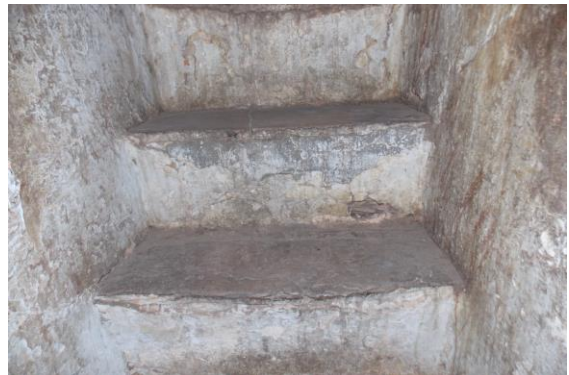
Photo 14

Damaged Portion on Steps of Staircase GF to FF

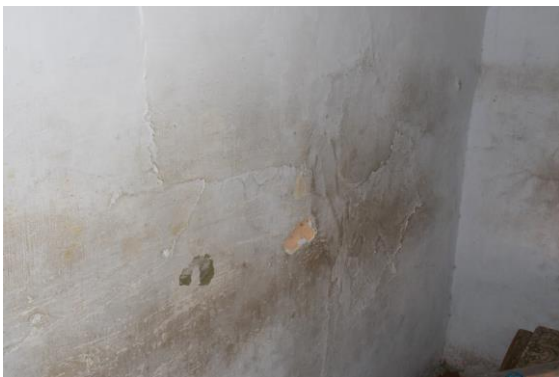
Photo 15

Peeling of Plaster on Wall No. 1 of Room No. 1 of First Floor

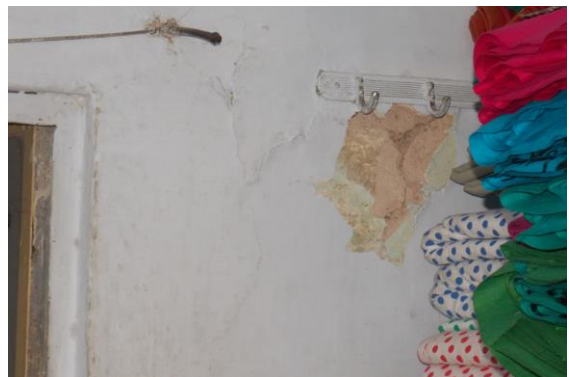
Photo 16

Peeling of Plaster on Wall No. 4 of Room No. 1 of First Floor

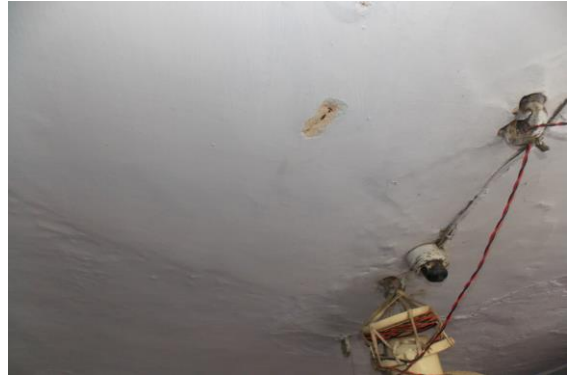
Photo 18

Damaged Portion on Roof of Room No. 1 of First Floor

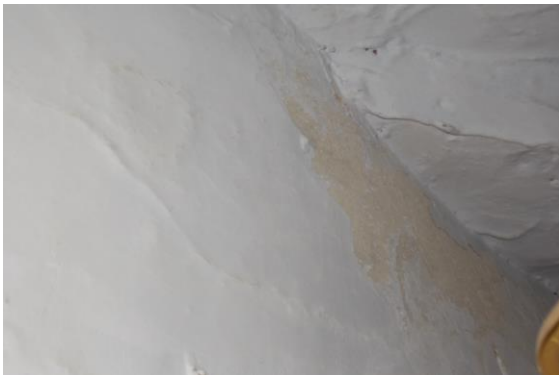
Photo 19

Peeling of Plaster on Wall No. 1 of Room No. 2 of First Floor

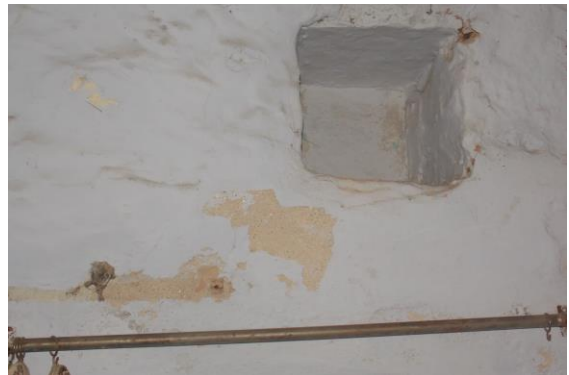
Photo 20

Damaged Portion on Wall No. 4 of Room No. 2 of First Floor

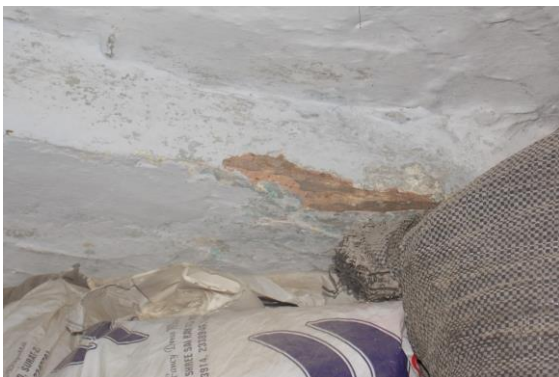
Photo 21

Damaged Portion on Roof of Room No. 2 of First Floor

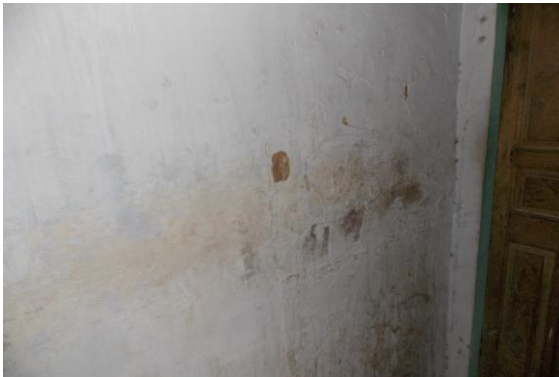
Photo 23
Peeling of Plaster on Wall No. 1 of Lobby of First Floor

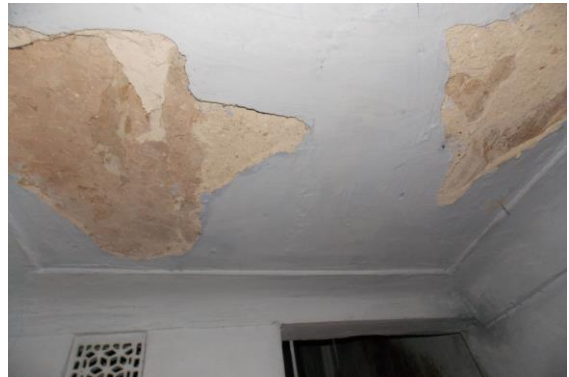
Photo 24
Peeling of Plaster on Roof of Lobby of First Floor

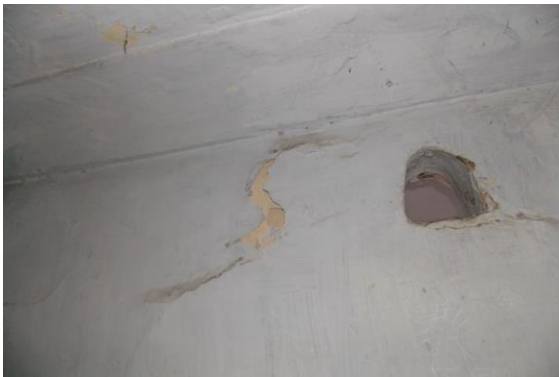
Photo 25
Peeling of Plaster on Wall No. 4 of Lobby of First Floor

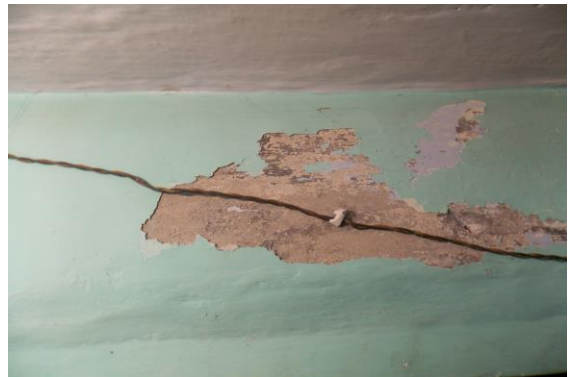
Photo 26
Peeling of Plaster on Wall No. 4 of Passage of First Floor

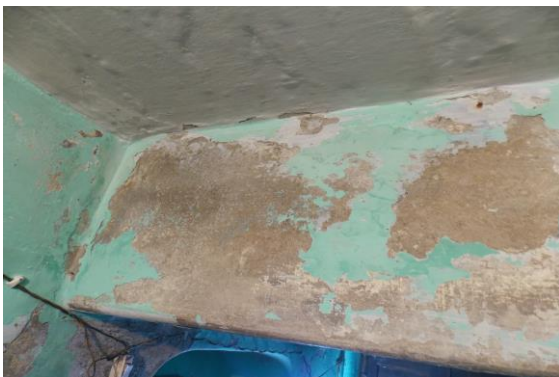
Photo 27
Peeling of Plaster on Wall No. 2 of Passage of First Floor

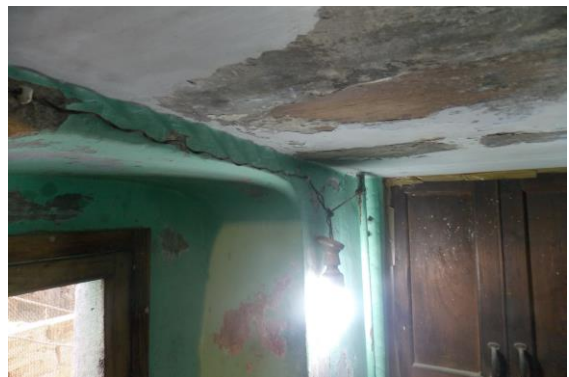
Photo 28
Peeling of Plaster on Wall No. 1, 4 & Roof of Kitchen of First Floor

25	Wall No. 1, 4 & Roof Kitchen First Floor	Peeling of Plaster	28
26	Floor Lobby First Floor	Peeling of Plaster	29
27	Wall No. 4 Room No. 2 Second Floor	Peeling of Plaster	30
28	Roof Room No. 2 Second Floor	Damaged Portion	31
29	Roof Room No. 2 Second Floor	Peeling of Plaster	32
30	Roof Room No. 4 Second Floor	Peeling of Plaster	33
31	Wall No. 1 Room No. 4 Second Floor	Peeling of Plaster	34
32	Wall No. 1 & 4 Room No. 4 Second Floor	Peeling of Plaster	35
33	Roof Room No. 4 Second Floor	Peeling of Plaster	36
34	Wall No. 3 Room No. 4 Second Floor	Peeling of Plaster	37
35	Roof Room No. 3 Second Floor	Peeling of Plaster	38
36	Wall No. 4 Open Area Second Floor	Dampness/Seepage	39
37	Wall No. 1, 3 & Roof Open Area Second Floor	Dampness/Seepage	40
38	Wall No. 4 & Roof Kitchen Second Floor	Dampness/Seepage	41
39	Roof Room No. 1 Third Floor	Peeling of Plaster	42

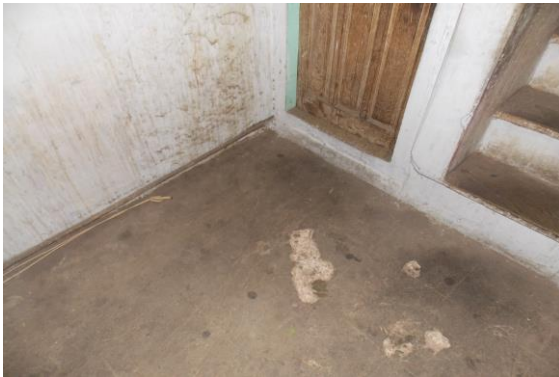
Photo 29
Peeling of Plaster on Floor of Lobby of First Floor

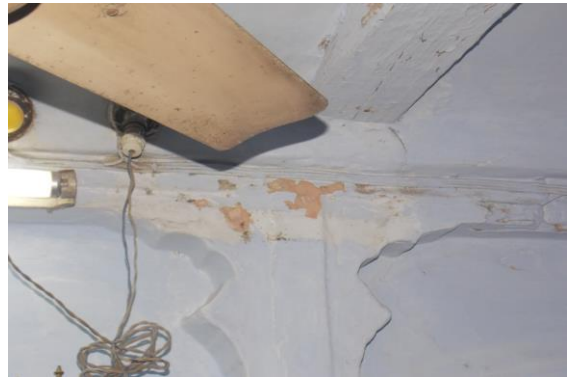
Photo 30
Peeling of Plaster on Wall No. 4 of Room No. 2 of Second Floor

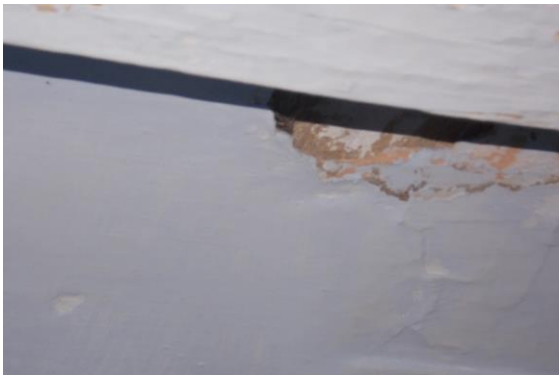
Photo 31
Damaged Portion on Roof of Room No. 2 of Second Floor

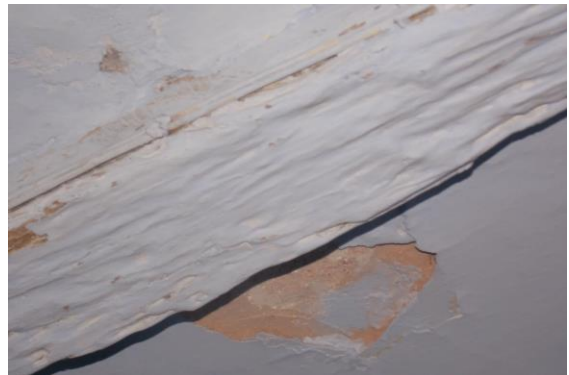
Photo 32
Peeling of Plaster on Roof of Room No. 2 of Second Floor

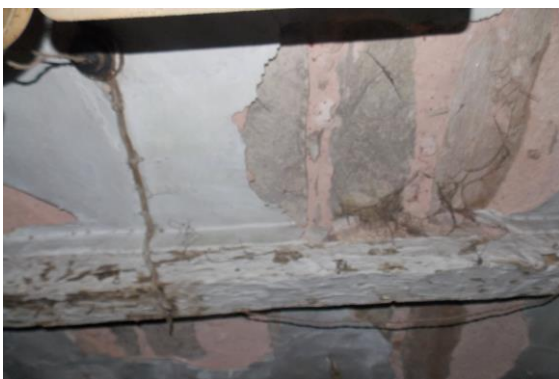
Photo 33
Peeling of Plaster on Roof of Room No. 4 of Second Floor

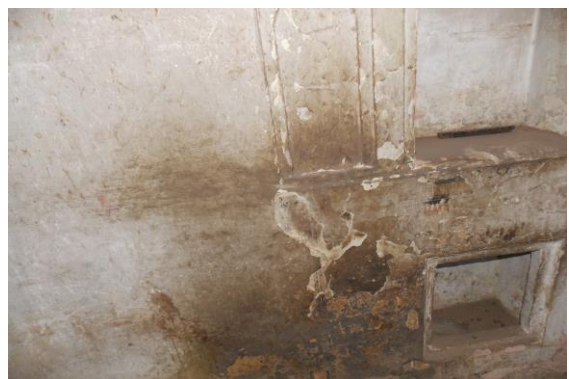
Photo 34
Peeling of Plaster on Wall No. 1 of Room No. 4 of Second Floor

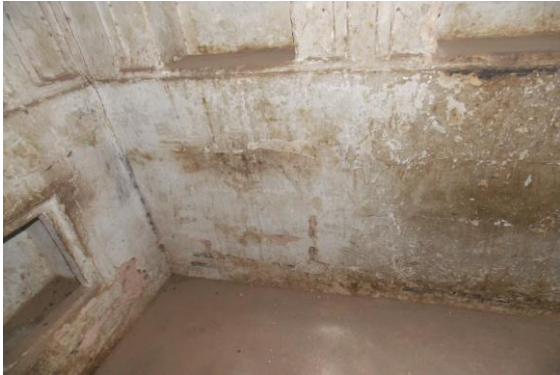
Photo 35

Peeling of Plaster on Wall No. 1 & 4 of Room No. 4 of Second Floor

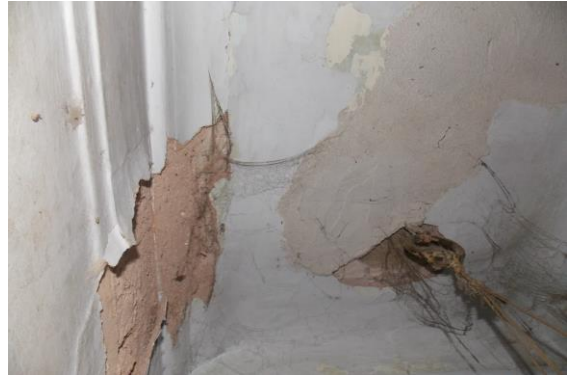
Photo 36

Peeling of Plaster on Wall No. Roof of Room No. 4 of Second Floor

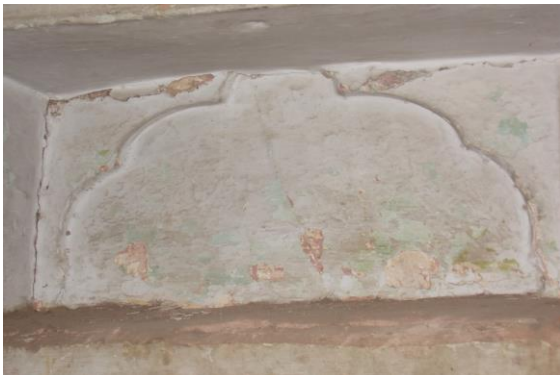
Photo 37

Peeling of Plaster on Wall No. 3 of Room No. 4 of Second Floor

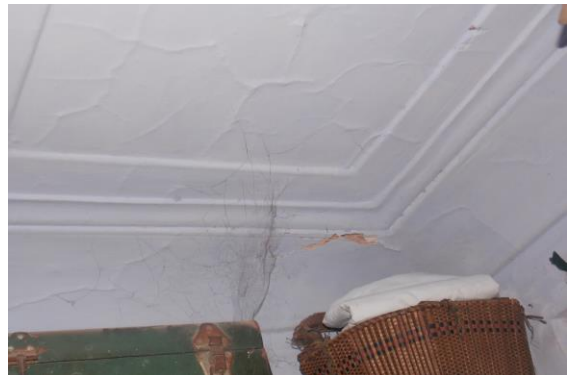
Photo 38

Peeling of Plaster on Roof of Room No. 3 of Second Floor

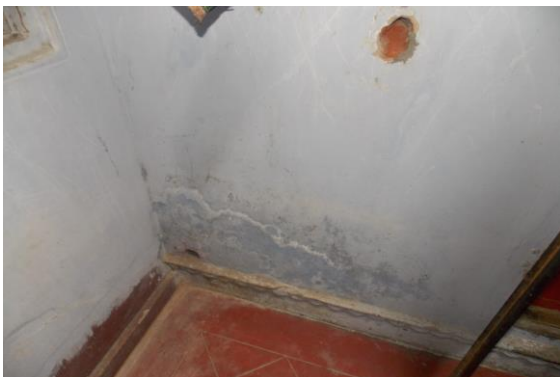
Photo 39

Dampness/Seepage on Wall No. 4 of Open Area of Second Floor

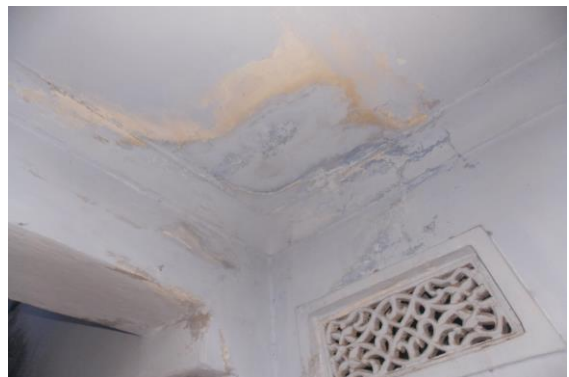
Photo 40

Dampness/Seepage on Wall No. 1, 3 & Roof of Open Area of Second Floor

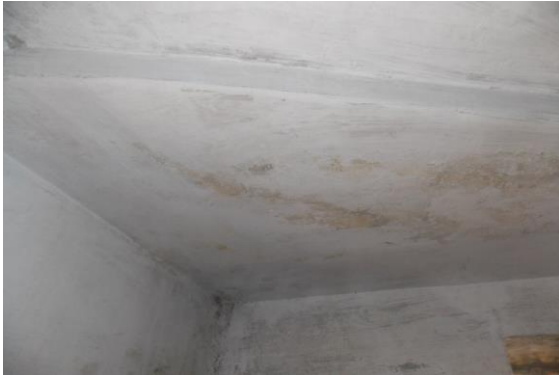
Photo 41

Dampness/Seepage on Wall No. 4 & Roof of Kitchen of Second Floor

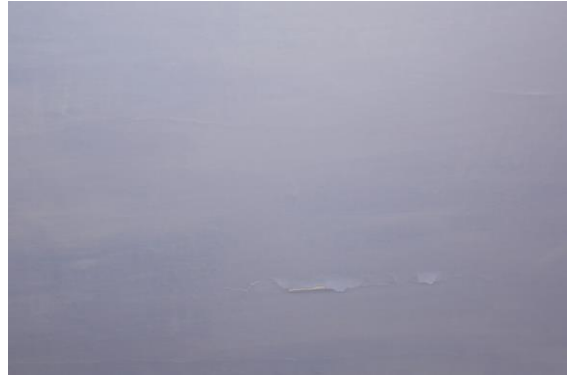
Photo 42

Peeling of Plaster on Roof of Room No. 1 of Third Floor

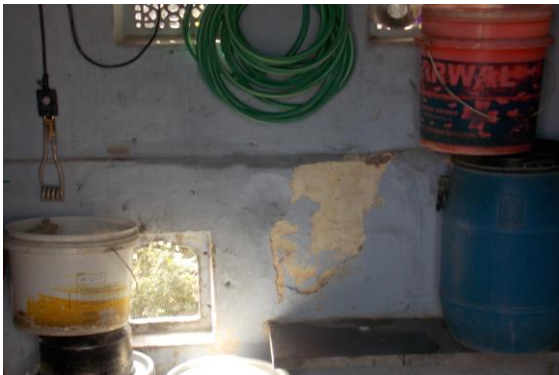
Photo 43

Peeling of Plaster on Wall No. 4 of Kitchen of Third Floor

40	Wall No. 4 Kitchen Third Floor	Peeling of Plaster	43
41	Roof Kitchen Third Floor	Damaged Portion	44
42	Wall No. 2 & Roof Kitchen Third Floor	Dampness/Seepage	45
43	Wall No. 2 Kitchen Third Floor	Peeling of Plaster	46
44	Wall No. 1 Open area Third Floor	Damaged Portion	47
45	Wall No. 1 Open area Third Floor	Damaged Portion	48
46	Wall No. 3 Open area Third Floor	Damaged Portion	49
47	Wall No. 3 Open area Third Floor	Damaged Portion	50
48	Wall No. 4 Open area Third Floor	Damaged Portion	51
49	Wall No. 2 Open area Third Floor	Damaged Portion	52
50	Staircase TF to Terrace	Peeling of Plaster	53
51	Outerwall Sun Shade Second Floor	Damaged Portion	54
52	Outerwall Sun Shade Second Floor	Damaged Portion	55
53	Outside Wall External Façade	Peeling of Plaster	57
54	Outside Wall External Façade	Damaged Portion	58
55	Outside Wall External Façade	Damaged Portion	59
56	Chajja External Façade	Damaged Portion	60
57	Roof Varanda of Shop No.75 Ground Floor	Peeling of Plaster	61

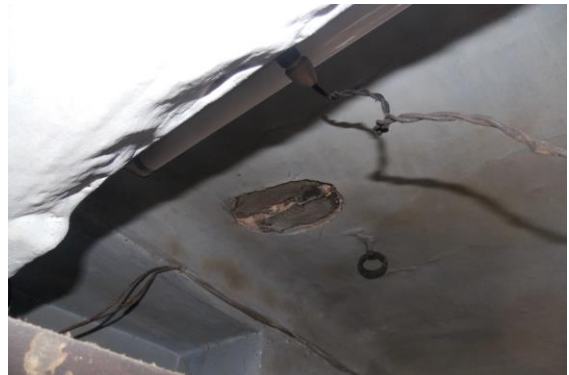
Photo 44

Damaged Portion on Roof of Kitchen of Third Floor

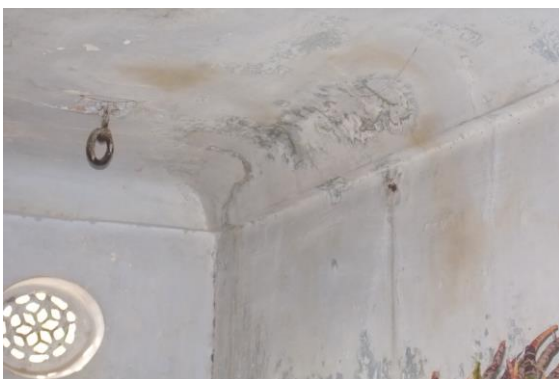
Photo 45

Dampness/Seepage on Wall No. 2 & Roof of Kitchen of Third Floor

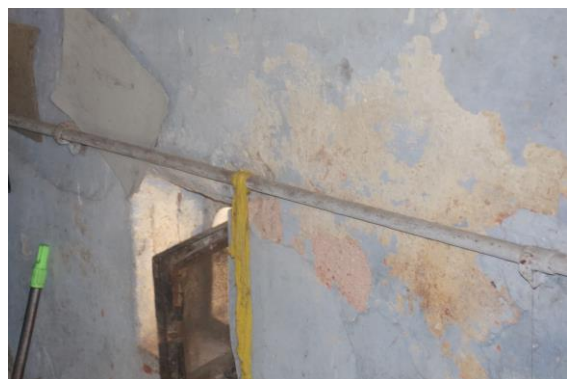
Photo 46

Peeling of Plaster on Wall No. 2 of Kitchen of Third Floor

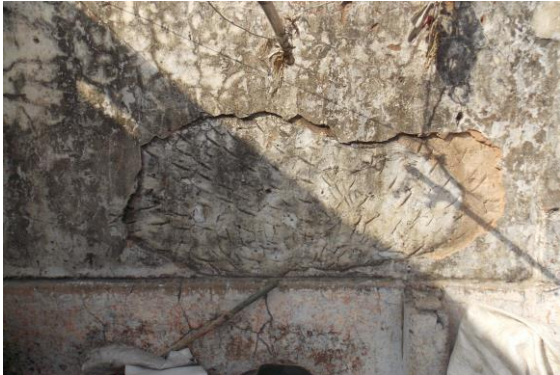
Photo 47

Damaged Portion on Wall No. 1 of Open area of Third Floor

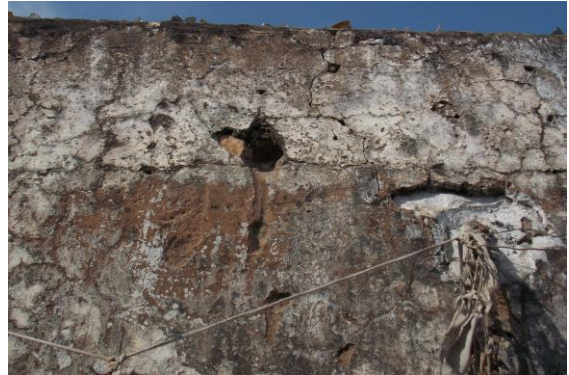
Photo 48

Damaged Portion on Wall No. 1 of Open area of Third Floor

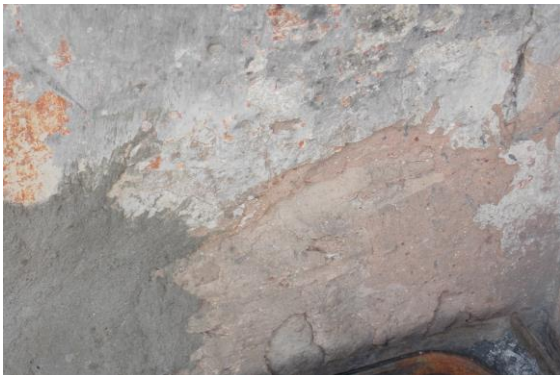
Photo 49

Damaged Portion on Wall No. 3 of Open area of Third Floor

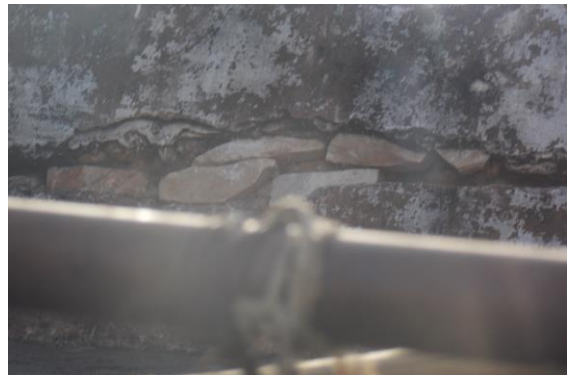
Photo 50

Damaged Portion on Wall No. 3 of Open area of Third Floor

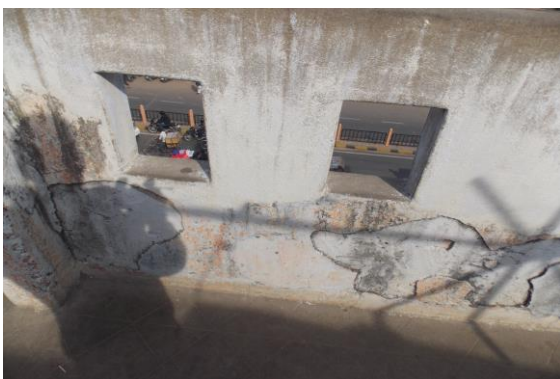
Photo 51

Damaged Portion on Wall No. 4 of Open area of Third Floor

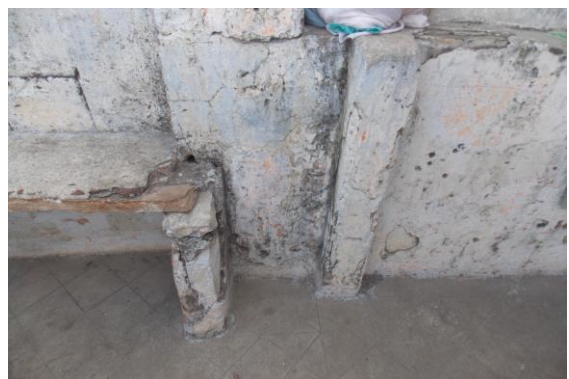
Photo 52

Damaged Portion on Wall No. 2 of Open area of Third Floor

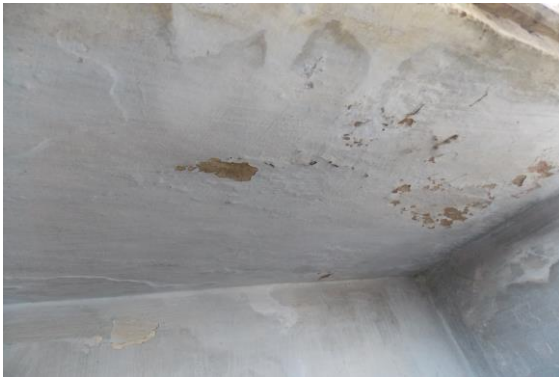
Photo 53
Peeling of Plaster on Staircase TF to Terrace

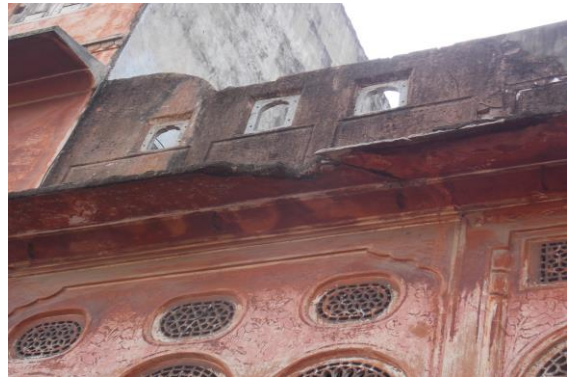
Photo 54
Damaged Portion on Outerwall Sun Shade of Second Floor

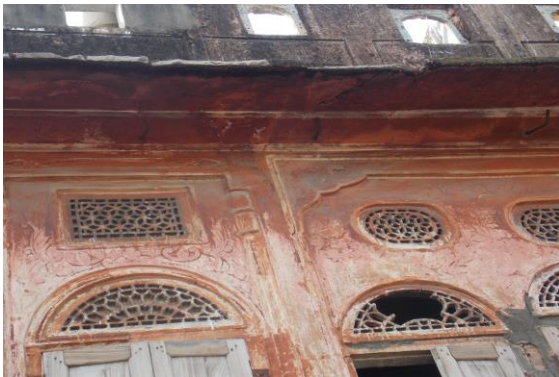
Photo 55
Damaged Portion on Outerwall Sun Shade of Second Floor

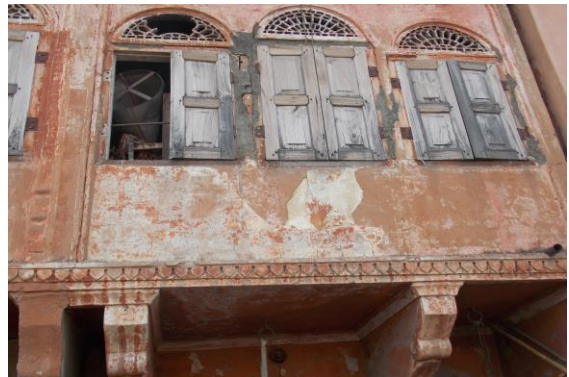
Photo 56
Peeling of Plaster

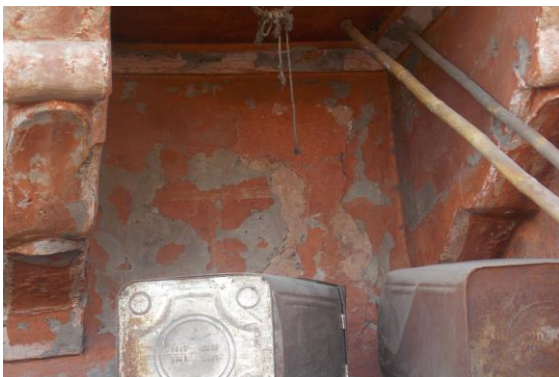
Photo 57
Peeling of Plaster on Outside Wall of External Façade

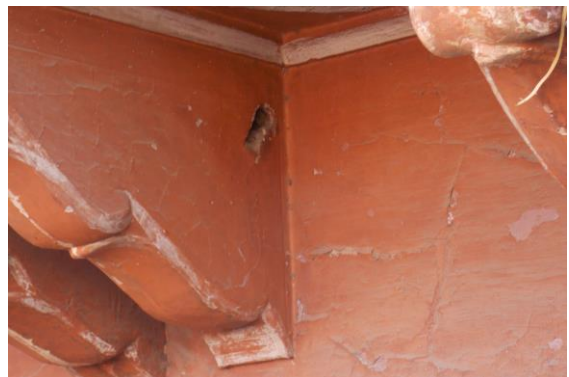
Photo 58
Damaged Portion on Outside Wall of External Façade

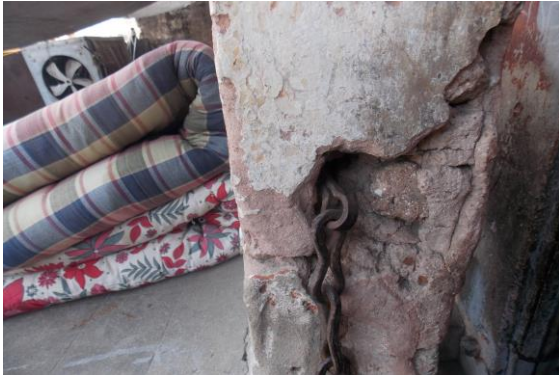
Photo 59
Damaged Portion on Outside Wall of External Façade

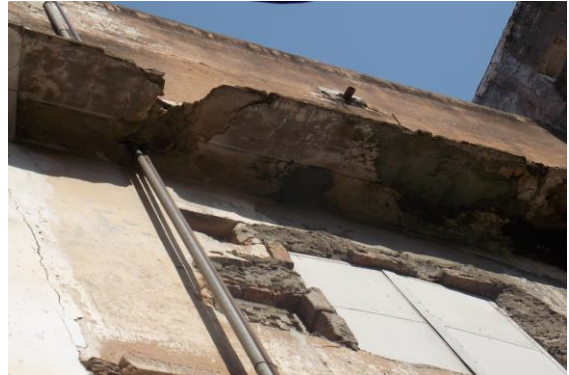
Photo 60
Damaged Portion on Chajja of External Façade

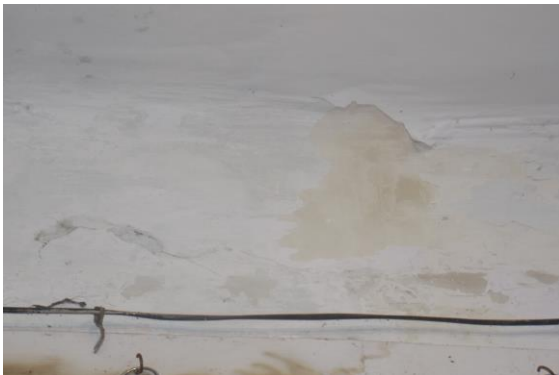
Photo 61
Peeling of Plaster on Roof of Varanda of Shop No.75 of Ground Floor

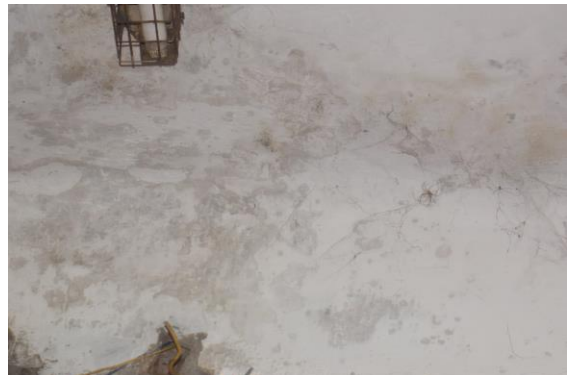
Photo 62
Dampness/Seepage on Beam of Varanda of Shop No.75 of Ground Floor

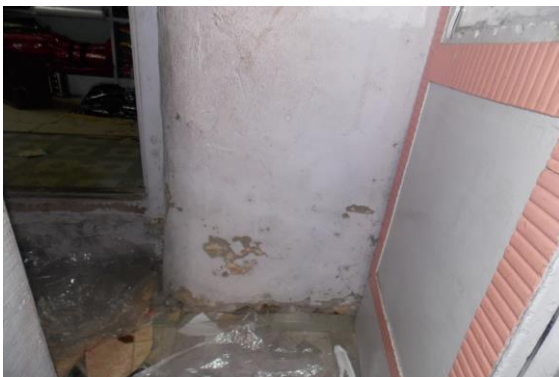
Photo 63
Peeling of Plaster on Wall No. 4 of Part A of Shop No.76 of Ground Floor

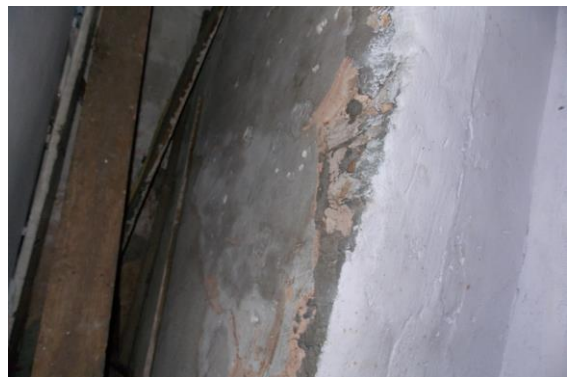
Photo 64
Peeling of Plaster on Wall No. 4 of Part A of Shop No.76 of Ground Floor

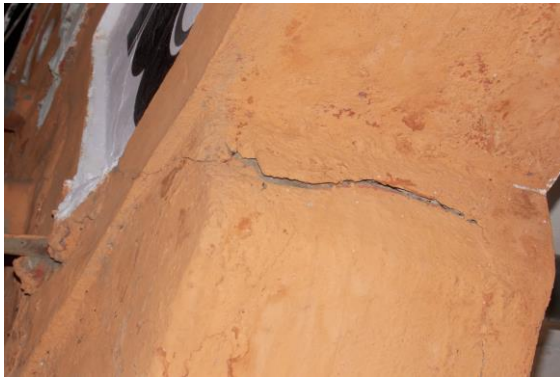
Photo 65

Peeling of Plaster on Leftside External Column of Varanda of Shop No.76 of Ground Floor

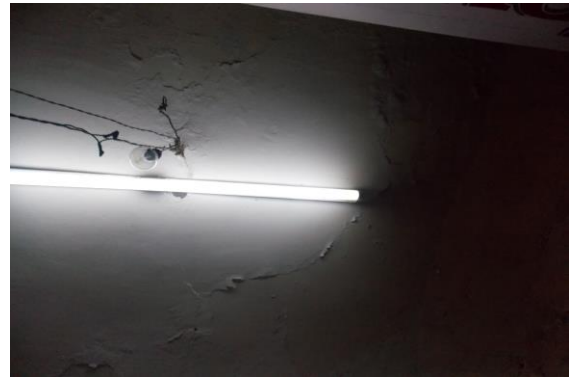
Photo 66

Peeling of Plaster on Roof of Varanda of Shop No.76 of Ground Floor

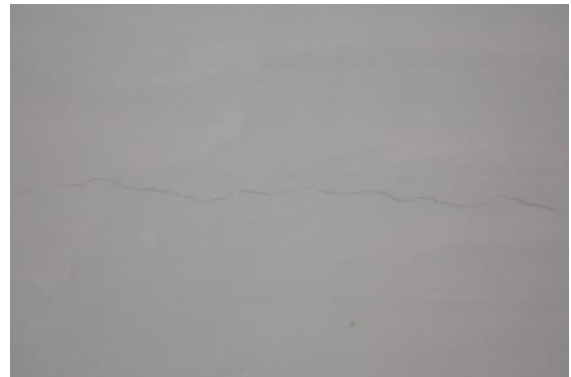
Photo 4

Inclined Crack on Wall No. 1 of Room No. 1, First Floor
Approx. Width = 0.3mm, Approx. Length = 2m.

Summary of Cracks						
Defect ID	Location	Orientation	Appx. Width (mm)	Appx. Length (m)	Category	Photo No.
1	Wall No. 1 Room No. 1 First Floor	Inclined	0.3	2	Very Slight	4
2	Wall No. 2 Room No. 2 First Floor	Inclined	0.1	3	Very Slight	5
3	Wall No. 1 Room No. 1 Second Floor	Inclined	0.3	2	Very Slight	6
4	Wall No. 1 Room No. 1 Second Floor	Inclined	0.15	1.5	Very Slight	7, 7A
5	Wall No. 1 Staircase GF to FF	Inclined	1	1.5	Slight	8, 8A
6	Roof Varanda Ground Floor	Horizontal	0.3	2.5	Very Slight	9
7	Internal Beam Varanda Ground Floor	Inclined	0.6	1.2	Very Slight	10
8	Rightside External Column Varanda of Shop No.78 Ground Floor	Inclined	0.4	1.3	Very Slight	11
9	Roof Varanda of Shop No.78 Ground Floor	Horizontal	0.25	2	Very Slight	12

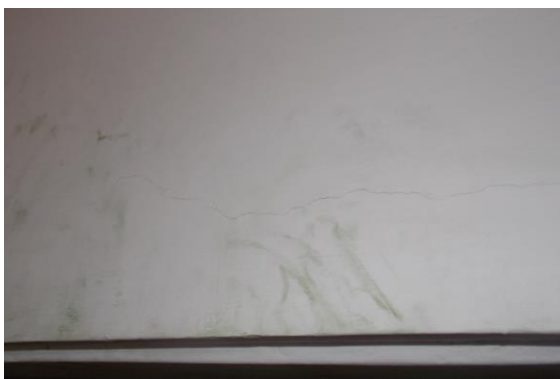
Photo 5

Inclined Crack on Wall No. 2 of Room No. 2, First Floor
Approx. Width = 0.1mm, Approx. Length = 3m.

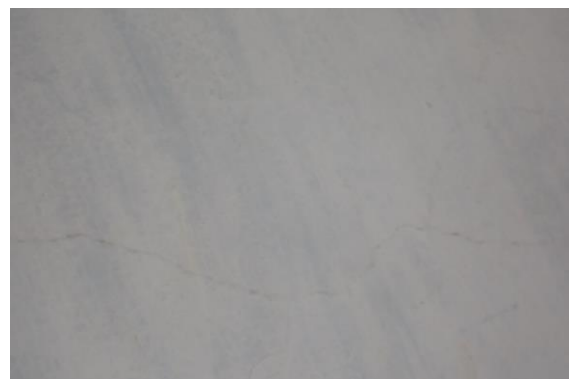
Photo 6

Inclined Crack on Wall No. 1 of Room No. 1, Second Floor
Approx. Width = 0.3mm, Approx. Length = 2m.

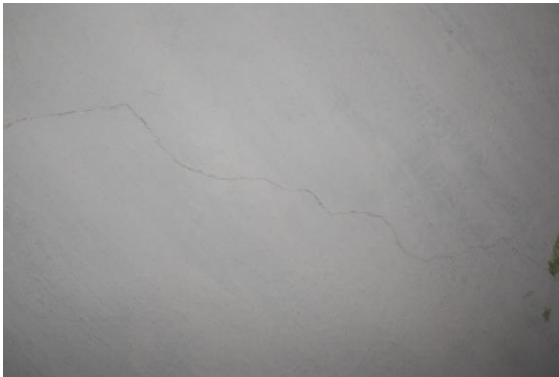
Photo 7

Inclined Crack on Wall No. 1 of Room No. 1, Second Floor
Approx. Width = 0.15mm, Approx. Length = 1.5m.
Distance from Wall no.4 = 0.2m, Height from Floor = 0m.

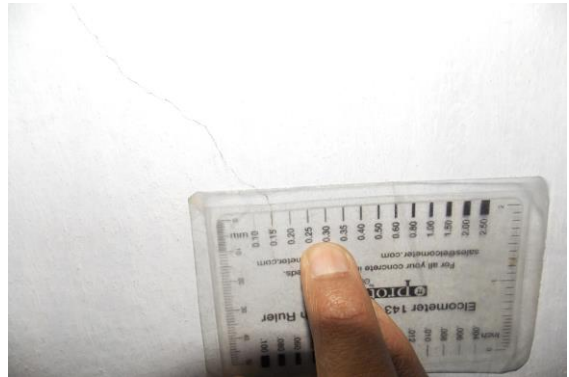
Photo 7A

Inclined Crack on Wall No. 1 of Room No. 1, Second Floor
Approx. Width = 0.15mm, Approx. Length = 1.5m.
Distance from Wall no.4 = 0.2m, Height from Floor = 0m.

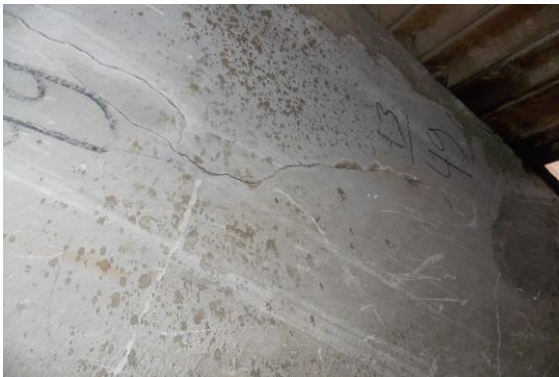
Photo 8

Inclined Crack on Wall No. 1 of Staircase GF to FF
Approx. Width = 1mm, Approx. Length = 1.5m.
Distance from Wall no.3 = 0.3m, Height from Floor = 0.05m.

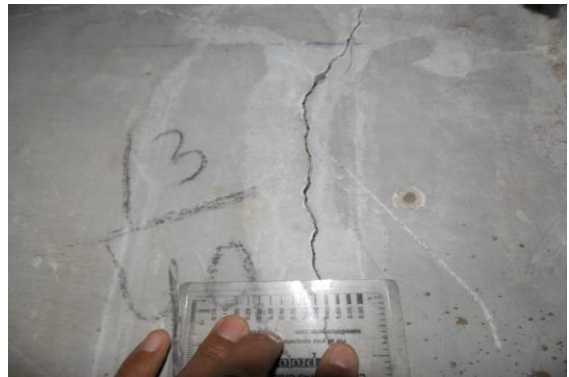
Photo 8A

Inclined Crack on Wall No. 1 of Staircase GF to FF
Approx. Width = 1mm, Approx. Length = 1.5m.
Distance from Wall no.3 = 0.3m, Height from Floor = 0.05m.

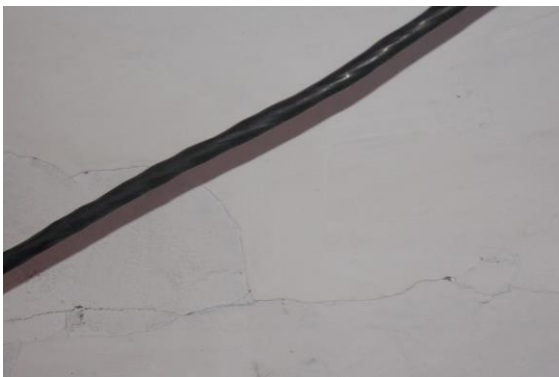
Photo 9

Horizontal Crack on Roof of Varanda, Ground Floor
Approx. Width = 0.3mm, Approx. Length = 2.5m.
Distance from leftside external Column = 0m, Height from Floor = 3.5m.

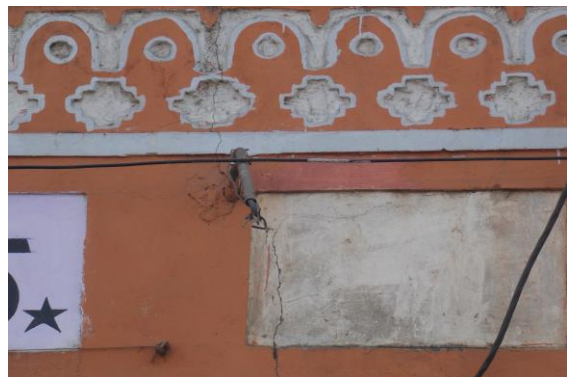
Photo 10

Inclined Crack on Internal Beam of Varanda, Ground Floor
Approx. Width = 0.6mm, Approx. Length = 1.2m.
Distance from leftside external Column = 0m, Height from Floor = 2.5m.

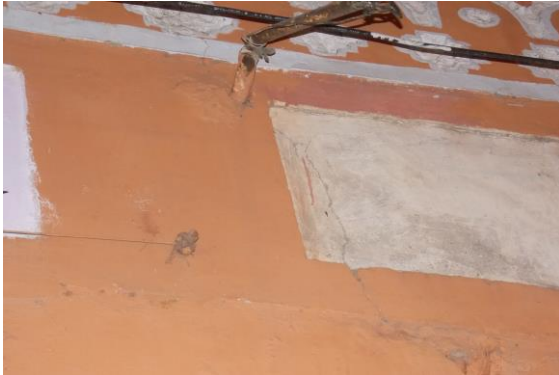
Photo 11

Inclined Crack on Rightside External Column of Varanda of Shop No.78, Ground Floor

Approx. Width = 0.4mm, Approx. Length = 1.3m.

Distance from Rightside external Column = 0m Height from Floor =

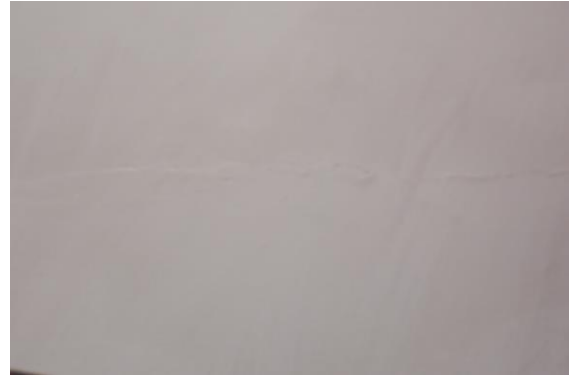
Photo 12

Horizontal Crack on Roof of Varanda of Shop No.78, Ground Floor

Approx. Width = 0.25mm, Approx. Length = 2m.

Height from Floor = 3m.

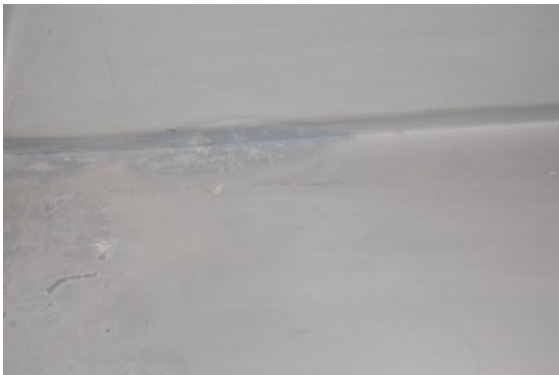
Photo 13

Dampness/Seepage on Wall No. 4 of Room No. 1 of First Floor

Summary of Defects Other Than Crack			
Defect ID	Location	Description	Photo No.
10	Wall No. 4 Room No. 1 First Floor	Dampness/Seepage	13
11	Wall No. 4 Room No. 2 First Floor	Dampness/Seepage	14
12	Wall No. 4 & 5 Room No. 2 First Floor	Dampness/Seepage	15
13	Wall No. 1 Staircase FF to SF	Dampness/Seepage	16
14	Wall No. 4 Staircase FF to SF	Dampness/Seepage	17
15	Wall No. 2 & 4 Toilet No. 1 Second Floor	Dampness/Seepage	18
16	Roof Staircase Area Second Floor	Peeling of Plaster	19
17	Wall No. 4 Room No. 1 Second Floor	Dampness/Seepage	20
18	Wall No. 4 & 1 Room No. 1 Third Floor	Dampness/Seepage	21
19	Wall No. 2 Staircase SF to TF	Dampness/Seepage	22
20	Wall No. 3 Staircase GF to FF	Peeling of Plaster	23
21	Steps Staircase GF to FF	Damaged Portion	24
22	Wall No. 1 Staircase GF to FF	Damaged Portion	25
23	Beam Varanda Ground Floor	Damaged Portion	26
24	Roof Varanda of Shop No.77 Ground Floor	Peeling of Plaster	27

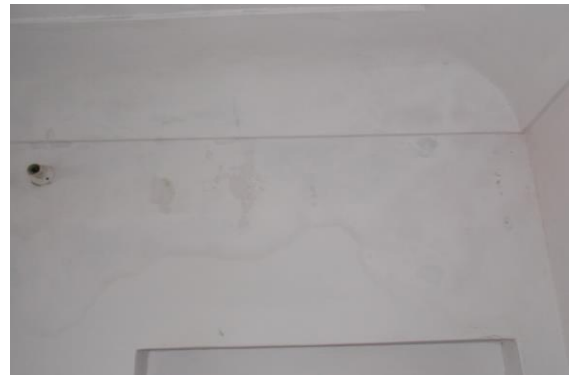
Photo 14

Dampness/Seepage on Wall No. 4 of Room No. 2 of First Floor

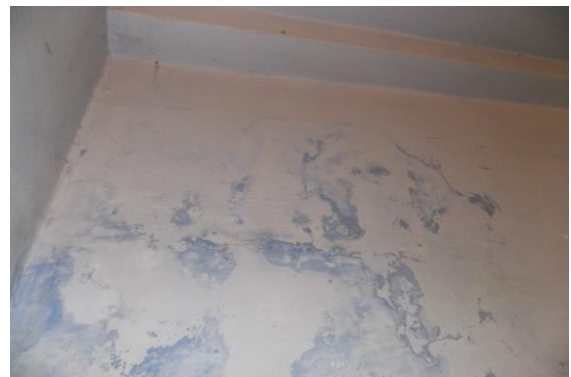
Photo 15

Dampness/Seepage on Wall No. 4 & 5 of Room No. 2 of First Floor

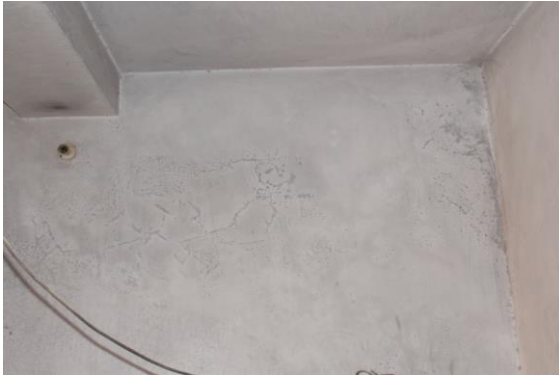
Photo 17
Dampness/Seepage on Wall No. 4 of Staircase FF to SF

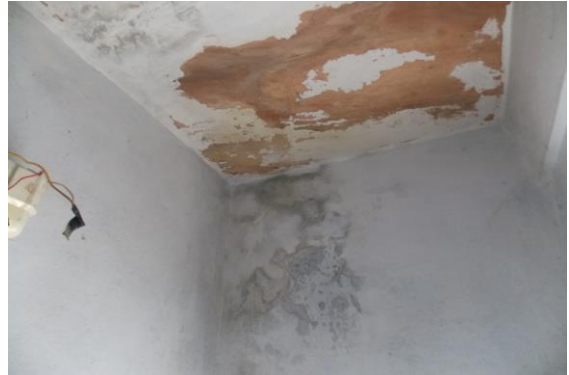
Photo 18
Dampness/Seepage on Wall No. 2 & 4 of Toilet No. 1 of Second Floor

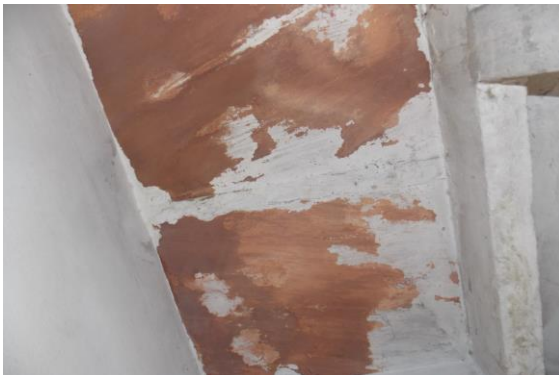
Photo 19
Peeling of Plaster on Roof of Staircase Area of Second Floor

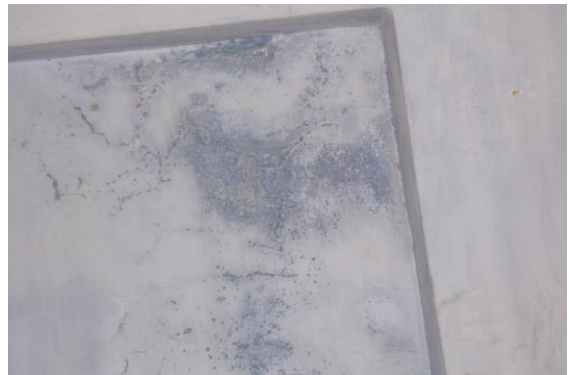
Photo 20
Dampness/Seepage on Wall No. 4 of Room No. 1 of Second Floor

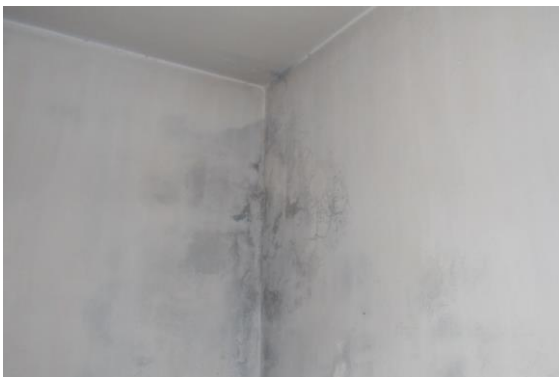
Photo 21
Dampness/Seepage on Wall No. 4 & 1 of Room No. 1 of Third Floor

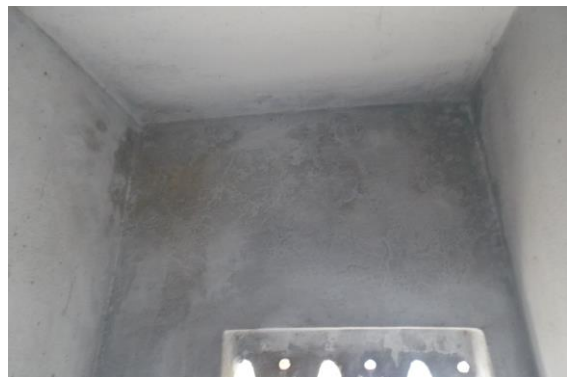
Photo 22
Dampness/Seepage on Wall No. 2 of Staircase SF to TF

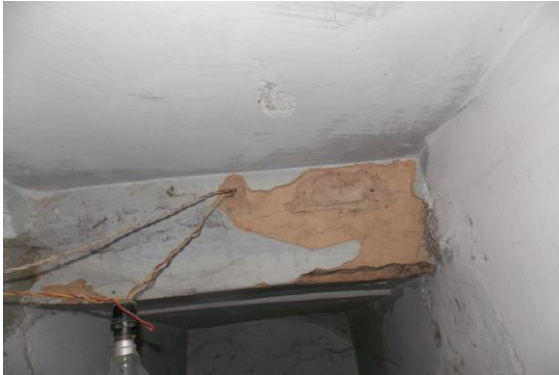
Photo 23
Peeling of Plaster on Wall No. 3 of Staircase GF to FF

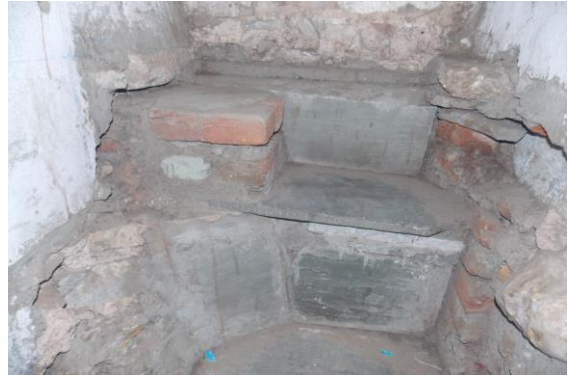
Photo 24
Damaged Portion on Steps of Staircase GF to FF

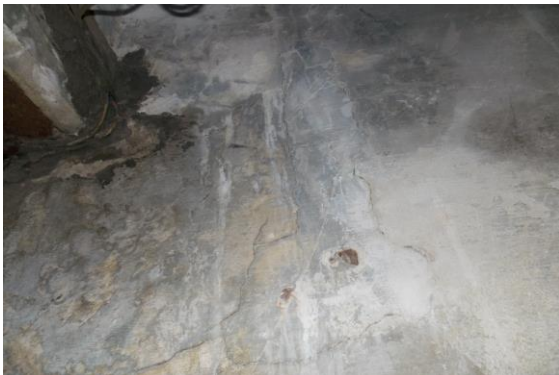
Photo 25
Damaged Portion on Wall No. 1 of Staircase GF to FF

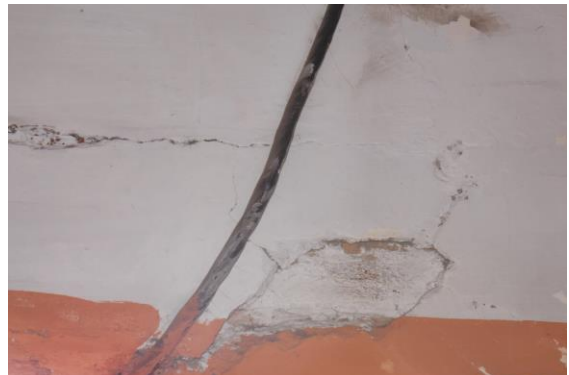
Photo 26
Damaged Portion on Beam of Varanda of Ground Floor

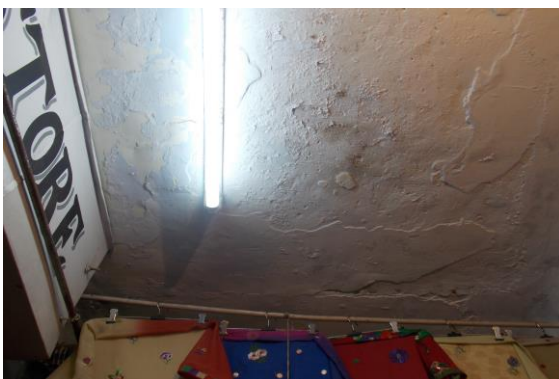
Photo 27
Peeling of Plaster on Roof of Varanda of Shop No.77 of Ground Floor

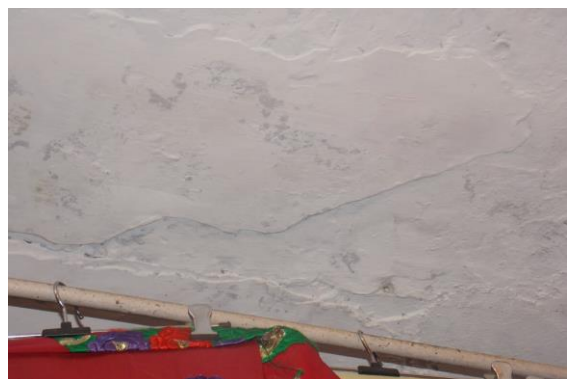
Photo 28
Peeling of Plaster on Roof of Varanda of Shop No.77 of Ground Floor

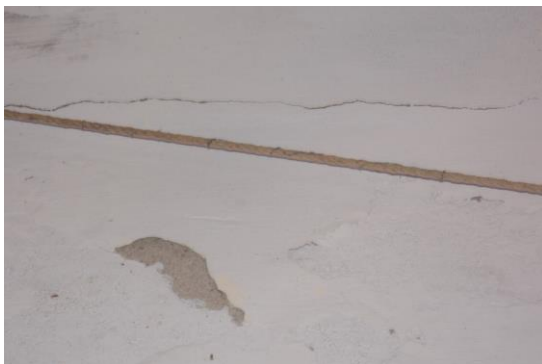
Photo 3

Inclined Crack on Beam of Varanda of Shop, Ground Floor
Approx. Width = 0.3mm, Approx. Length = 1m.
Distance from = m, Height from Floor = m.

Summary of Cracks						
Defect ID	Location	Orientation	Appx. Width (mm)	Appx. Length (m)	Category	Photo No.
1	Beam Varanda of Shop Ground Floor	Inclined	0.3	1	Very Slight	3
2	Floor Shop No.79 Ground Floor	Inclined	2	1	Slight	4
3	Roof Varanda of Shop Ground Floor	Horizontal	0.8	2.5	Very Slight	5
4	Wall No. 1 Staircase GF to FF First Floor	Inclined	5	1	Moderate	6
5	Roof Room No. 2 First Floor	Inclined	1	1	Slight	7
6	Wall No. 2 Toilet No. 1 First Floor	Inclined	2	2	Slight	8
7	Wall No. 3 Room No. 1 Second Floor	Inclined	0.25	0.4	Very Slight	9, 9A
8	Wall No. 3 & Roof H.No.642 Second Floor	Inclined	2.5	3.3	Slight	10, 10A
9	Wall No. 3 Room No. 2 Second Floor	Inclined	0.5	1	Very Slight	11
10	Wall No. 4 Room No. 2 Second Floor	Inclined	0.3	1	Very Slight	12
11	Roof Room No. 2 Second Floor	Horizontal	0.6	1.3	Very Slight	13
12	Wall No. 3 Room No. 2 Second Floor	Inclined	0.4	1	Very Slight	14, 14A
13	Boundary Wall Terrace	Inclined	3.5	1	Slight	15
