Pre Building Condition Survey Report

Name and Address of Structure :	Badi Chopar to Ramp Area (Down Line)
---------------------------------	--------------------------------------

Name of the Project	Contract JMRC-UG1B “Design and Construction of Tunnel between Chandpole and Badi Chouper and reverse line by Shield TBM, Underground Metro Stations at Choti Chouper and Badi Chouper by Cut and Cover Methods on East West Corridor of Jaipur Metro Rail Corporation Limited .”	
Owner :

Pre - Condition Building Survey for Construction of Underground Stations from Chandpole to Bari Chouper and reversal line

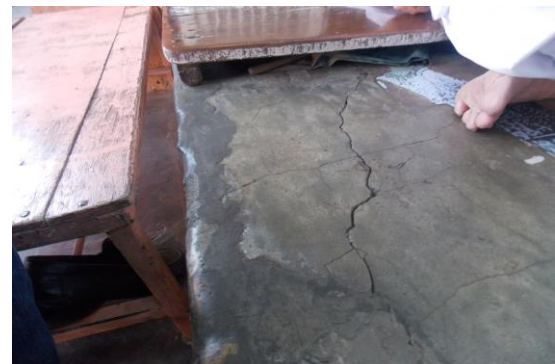
Photo 4

Inclined Crack on Floor of Shop No.79, Ground Floor
Approx. Width = 2mm, Approx. Length = 1m.

Summary of Cracks						
Defect ID	Location	Orientation	Appx. Width (mm)	Appx. Length (m)	Category	Photo No.
1	Beam Varanda of Shop Ground Floor	Inclined	0.3	1	Very Slight	3
2	Floor Shop No.79 Ground Floor	Inclined	2	1	Slight	4
3	Roof Varanda of Shop Ground Floor	Horizontal	0.8	2.5	Very Slight	5
4	Wall No. 1 Staircase GF to FF First Floor	Inclined	5	1	Moderate	6
5	Roof Room No. 2 First Floor	Inclined	1	1	Slight	7
6	Wall No. 2 Toilet No. 1 First Floor	Inclined	2	2	Slight	8
7	Wall No. 3 Room No. 1 Second Floor	Inclined	0.25	0.4	Very Slight	9, 9A
8	Wall No. 3 & Roof H.No.642 Second Floor	Inclined	2.5	3.3	Slight	10, 10A
9	Wall No. 3 Room No. 2 Second Floor	Inclined	0.5	1	Very Slight	11
10	Wall No. 4 Room No. 2 Second Floor	Inclined	0.3	1	Very Slight	12
11	Roof Room No. 2 Second Floor	Horizontal	0.6	1.3	Very Slight	13
12	Wall No. 3 Room No. 2 Second Floor	Inclined	0.4	1	Very Slight	14, 14A
13	Boundary Wall Terrace	Inclined	3.5	1	Slight	15

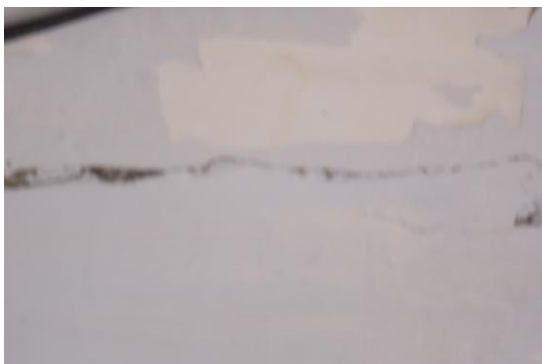
Photo 5

Horizontal Crack on Roof of Varanda of Shop, Ground Floor
Approx. Width = 0.8mm, Approx. Length = 2.5m.
Distance from = Backside Rightside External Column, Height from Floor = 3m.

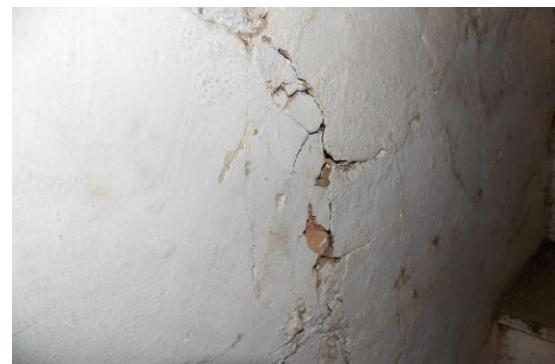
Photo 6

Inclined Crack on Wall No. 1 of Staircase GF to FF
Approx. Width = 5mm, Approx. Length = 1m

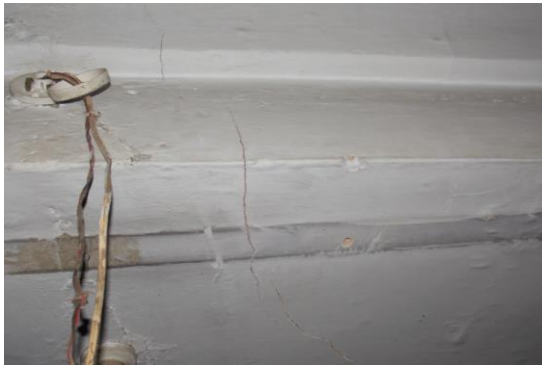
Photo 7

Inclined Crack on Roof of Room No. 2, First Floor
Approx. Width = 1mm, Approx. Length = 1m.
Distance from Wall No.4 = 1.3m, Height from Floor = 2.2m.

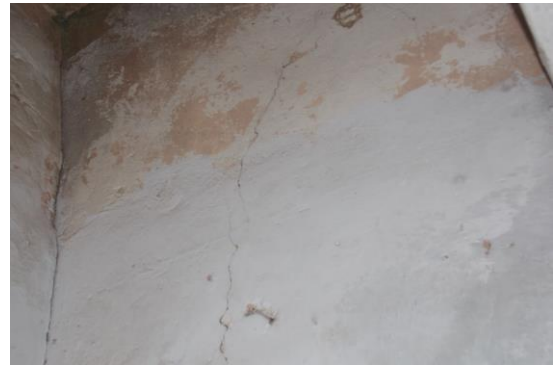
Photo 8

Inclined Crack on Wall No. 2 of Toilet No. 1, First Floor
Approx. Width = 2mm, Approx. Length = 2m.

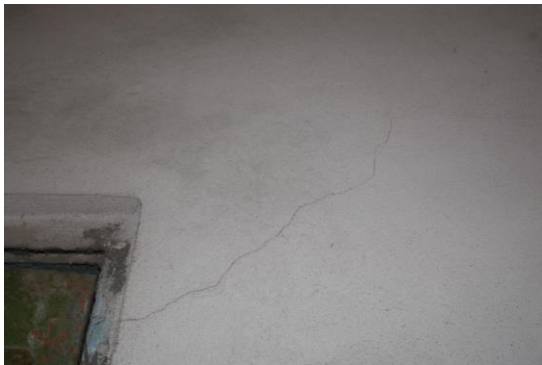
Photo 9

Inclined Crack on Wall No. 3 of Room No. 1, Second Floor
Approx. Width = 0.25mm, Approx. Length = 0.4m.
Distance from Wall no.2 = 0.6m, Height from Floor = 1.9m.

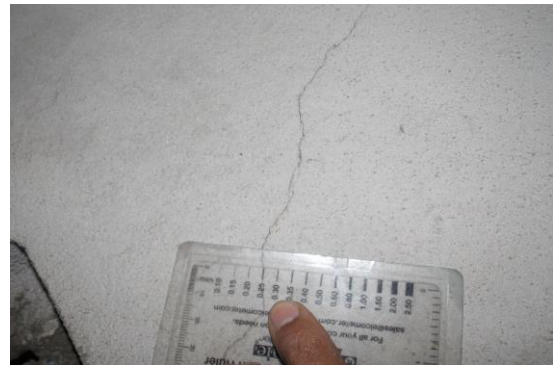
Photo 9A

Inclined Crack on Wall No. 3 of Room No. 1, Second Floor
Approx. Width = 0.25mm, Approx. Length = 0.4m.
Distance from Wall no.2 = 0.6m, Height from Floor = 1.9m.

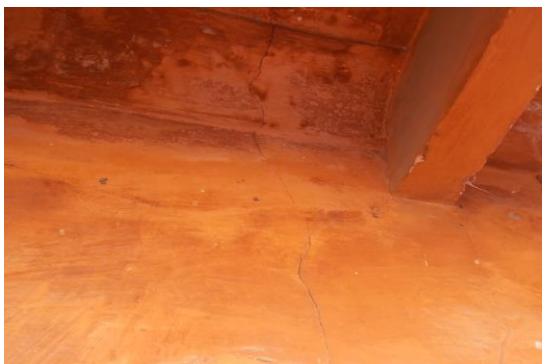
Photo 10

Inclined Crack on Wall No. 3 & Roof of H.No.642, Second Floor
Approx. Width = 2.5mm, Approx. Length = 3.3m.
Distance from Wall no.1 = 2.6m, Height from Floor = 0m.

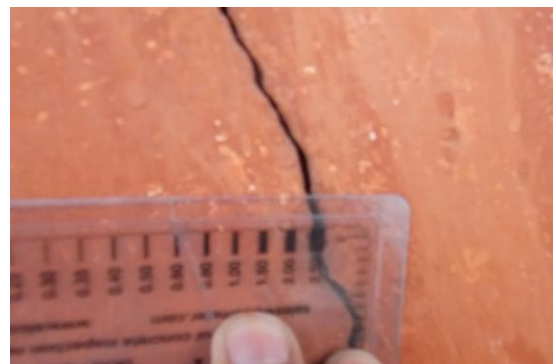
Photo 10A

Inclined Crack on Wall No. 3 & Roof of H.No.642, Second Floor
Approx. Width = 2.5mm, Approx. Length = 3.3m.
Distance from Wall no.1 = 2.6m, Height from Floor = 0m.

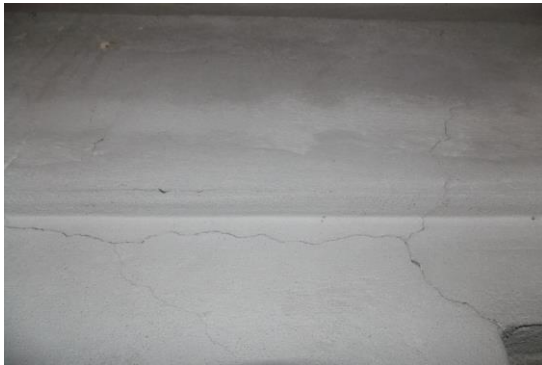
Photo 11

Inclined Crack on Wall No. 3 of Room No. 2, Second Floor
Approx. Width = 0.5mm, Approx. Length = 1m.

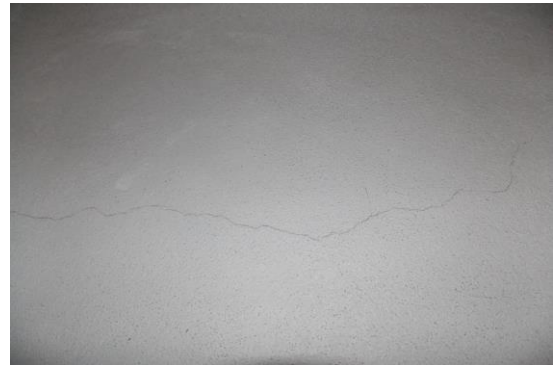
Photo 12

Inclined Crack on Wall No. 4 of Room No. 2, Second Floor
Approx. Width = 0.3mm, Approx. Length = 1m.

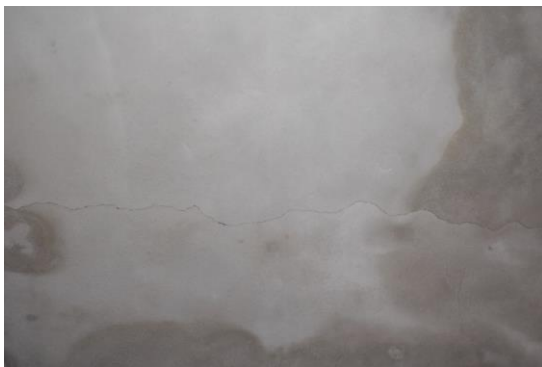
Photo 13

Horizontal Crack on Roof of Room No. 2, Second Floor
Approx. Width = 0.6mm, Approx. Length = 1.3m.
Distance from Wall no.4 = 1.5m, Height from Floor = 3m.

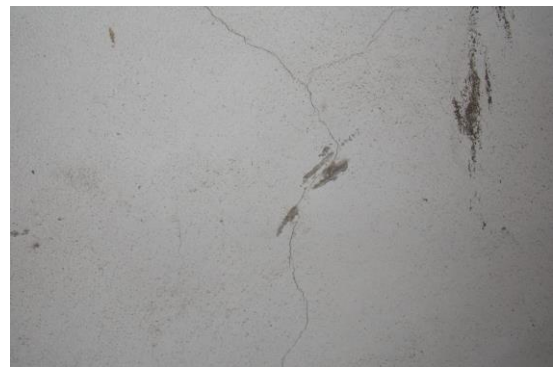
Photo 14

Inclined Crack on Wall No. 3 of Room No. 2, Second Floor
Approx. Width = 0.4mm, Approx. Length = 1m.
Distance from Wall no.2 = 1.3m, Height from Floor = 0m.

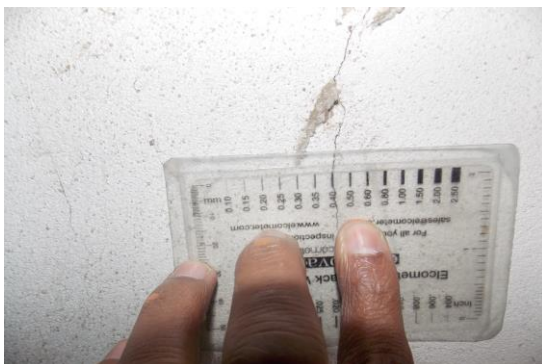
Photo 14A

Inclined Crack on Wall No. 3 of Room No. 2, Second Floor
Approx. Width = 0.4mm, Approx. Length = 1m.
Distance from Wall no.2 = 1.3m, Height from Floor = 0m.

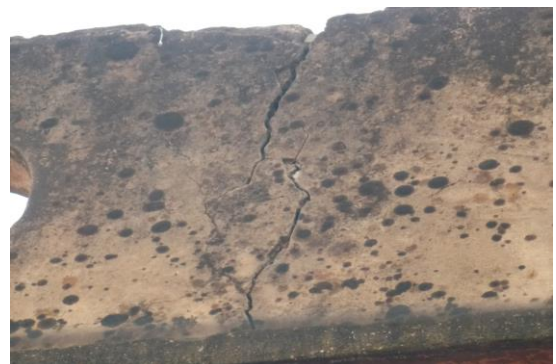
Photo 15

Inclined Crack on Wall No. Boundary Wall of Terrace
Approx. Width = 3.5mm, Approx. Length = 1m.
Distance from Right side External Column = 2.5m, Height from Floor = 10m

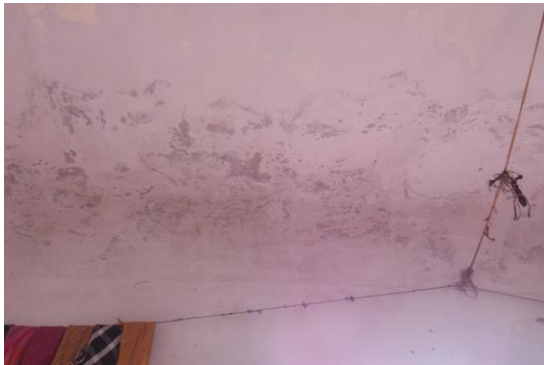
Photo 16
Dampness/Seepage on Roof of Varanda of Shop of Ground Floor

Summary of Defects Other Than Crack			
Defect ID	Location	Description	Photo No.
14	Roof Varanda of Shop Ground Floor	Dampness/Seepage	16
15	Roof Varanda of Shop Ground Floor	Peeling of Plaster	17
16	Roof Varanda of Shop Ground Floor	Damaged Portion	18
17	Wall No. 2 Staircase GF to FF First Floor	Peeling of Plaster	19
18	Wall No. 1 Staircase GF to FF First Floor	Damaged Portion	20
19	Roof Room No. 1 First Floor	Peeling of Plaster	21
20	Wall No. 1 Room No. 1 First Floor	Damaged Portion	22
21	Wall No. 3 Room No. 1 First Floor	Damaged Portion	23
22	Wall No. 4 Room No. 2 First Floor	Peeling of Plaster	24
23	Roof Room No. 2 First Floor	Peeling of Plaster	25
24	Wall No. 2 Room No. 2 First Floor	Peeling of Plaster	26
25	Wall No. 3 Room No. 2 First Floor	Peeling of Plaster	27
26	Wall No. 4 Store First Floor	Damaged Portion	28
27	Wall No. 1 Store First Floor	Damaged Portion	29
28	Wall No. 2 Store First Floor	Damaged Portion	30

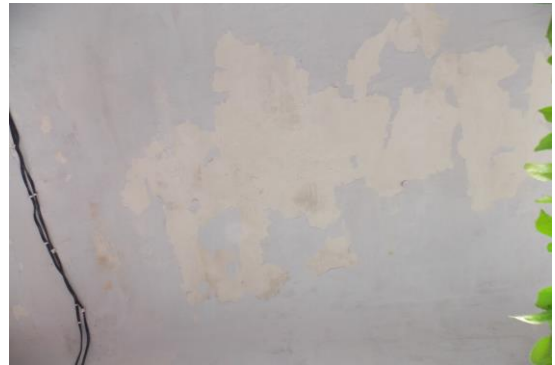
Photo 17
Peeling of Plaster on Roof of Varanda of Shop of Ground Floor

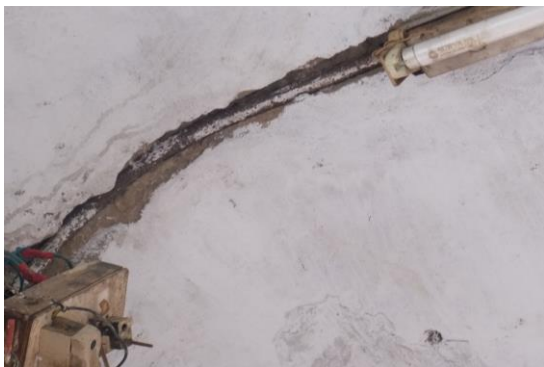
Photo 18
Damaged Portion on Roof of Varanda of Shop of Ground Floor

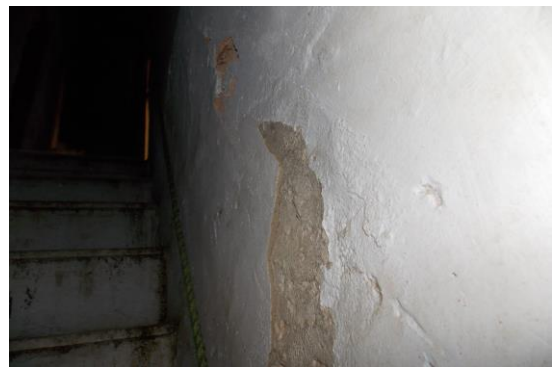
Photo 19
Peeling of Plaster on Wall No. 2 of Staircase GF to FF

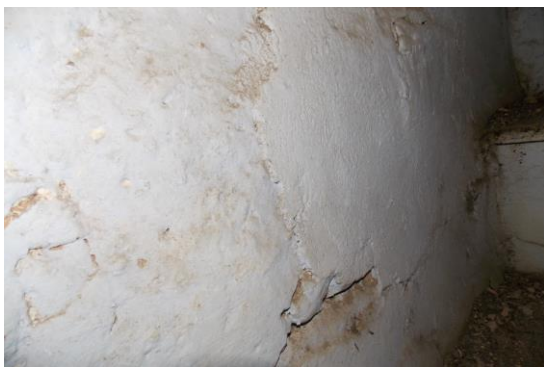
Photo 20
Damaged Portion on Wall No. 1 of Staircase GF to FF

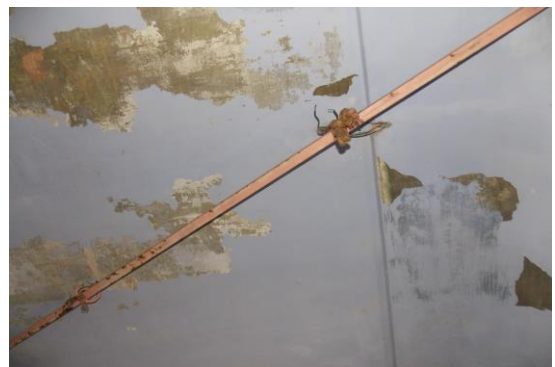
Photo 21
Peeling of Plaster on Roof of Room No. 1 of First Floor

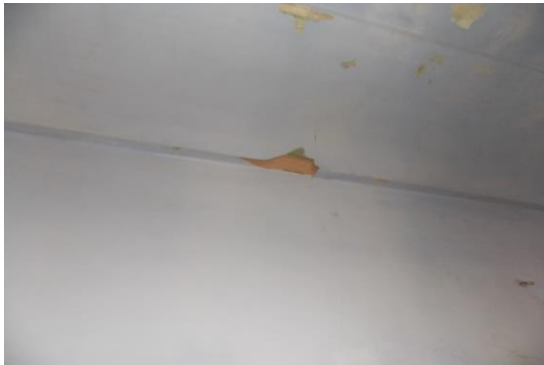
Photo 22
Damaged Portion on Wall No. 1 of Room No. 1 of First Floor

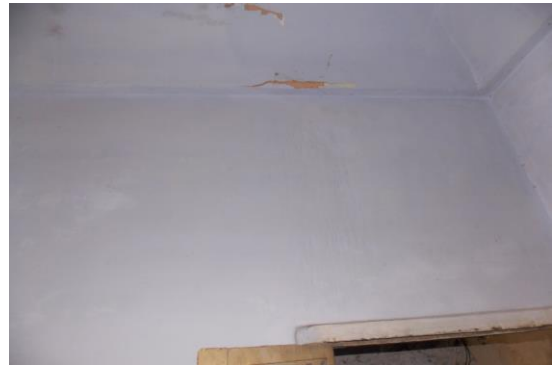
Photo 23
Damaged Portion on Wall No. 3 of Room No. 1 of First Floor

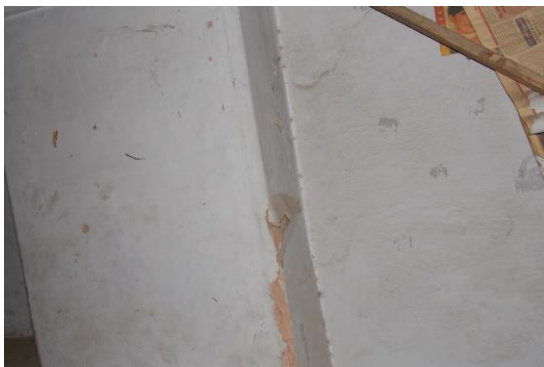
Photo 24
Peeling of Plaster on Wall No. 4 of Room No. 2 of First Floor

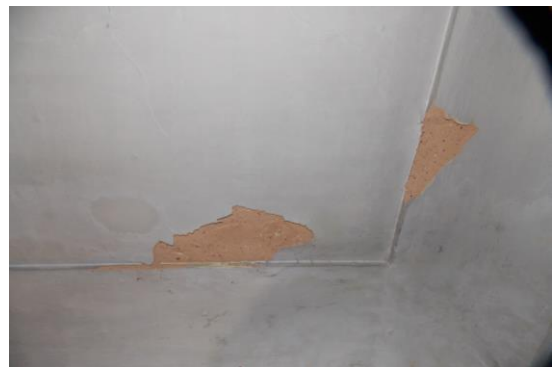
Photo 25
Peeling of Plaster on Roof of Room No. 2 of First Floor

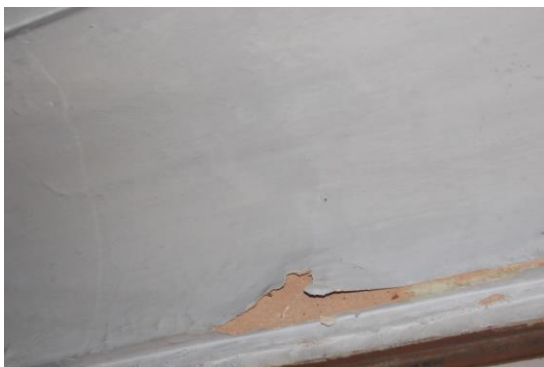
Photo 26
Peeling of Plaster on Wall No. 2 of Room No. 2 of First Floor

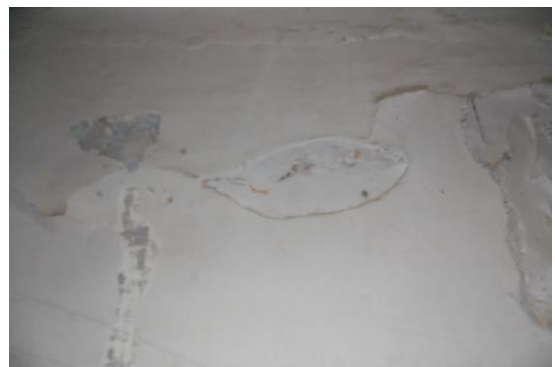
Photo 27
Peeling of Plaster on Wall No. 3 of Room No. 2 of First Floor

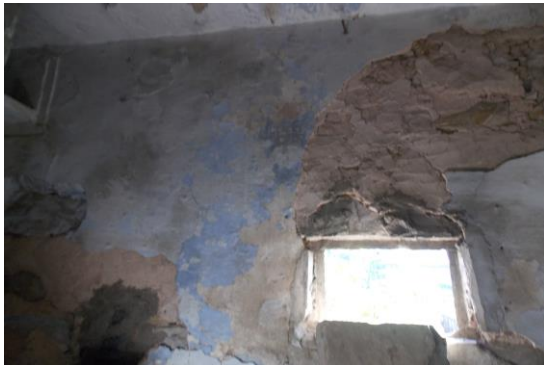
Photo 28
Damaged Portion on Wall No. 4 of Store of First Floor

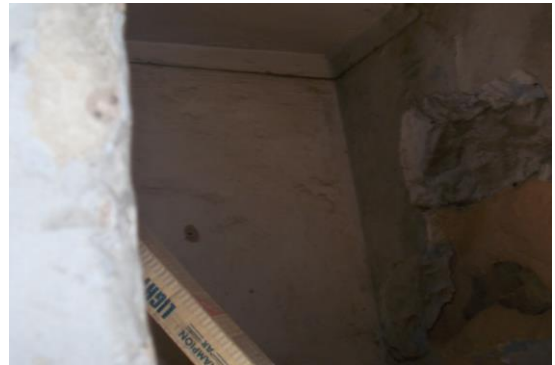
Photo 29
Damaged Portion on Wall No. 1 of Store of First Floor

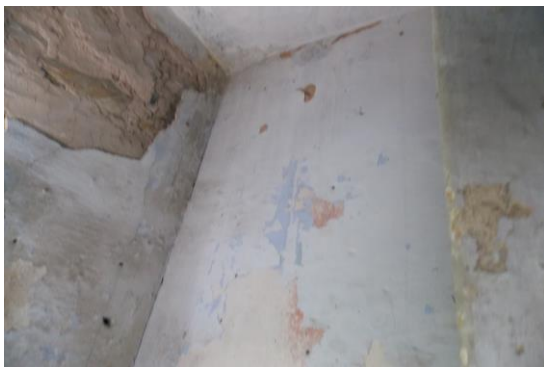
Photo 30
Damaged Portion on Wall No. 2 of Store of First Floor

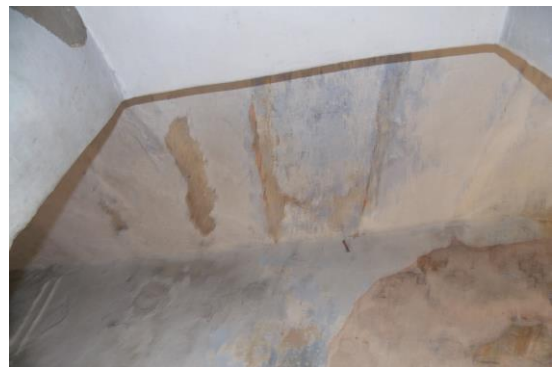
Photo 31
Peeling of Plaster on Roof of Store of First Floor

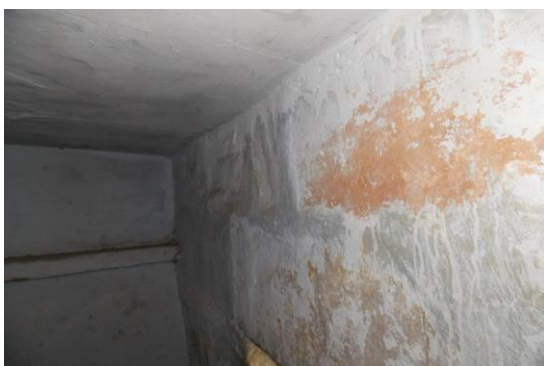
Photo 32
Peeling of Plaster on Wall No. 2 of Toilet No. 1 of First Floor

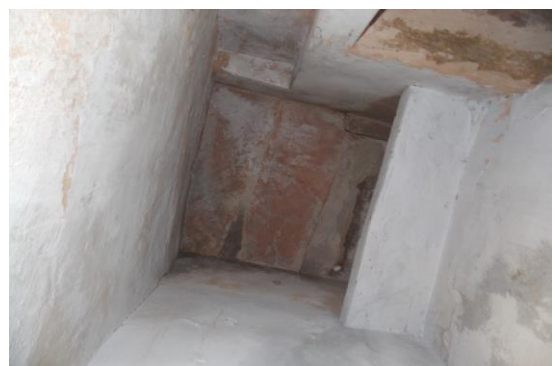
Photo 33
Peeling of Plaster on Roof of Toilet No. 1 of First Floor

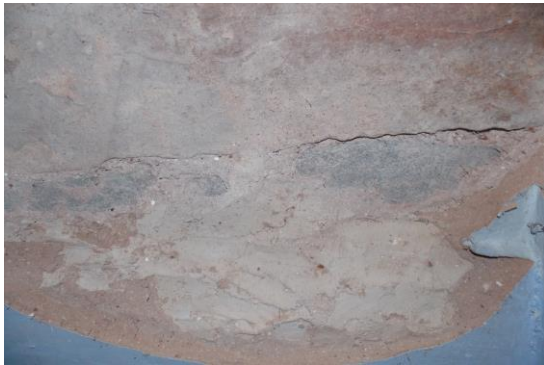
Photo 34
Peeling of Plaster on Roof of Lobby of First Floor

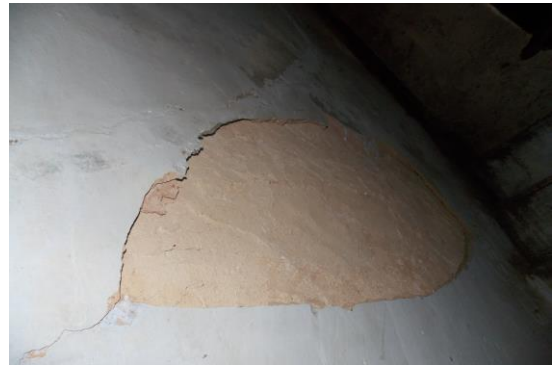
Photo 35
Peeling of Plaster on Wall No. 1 of Staircase FF to SF

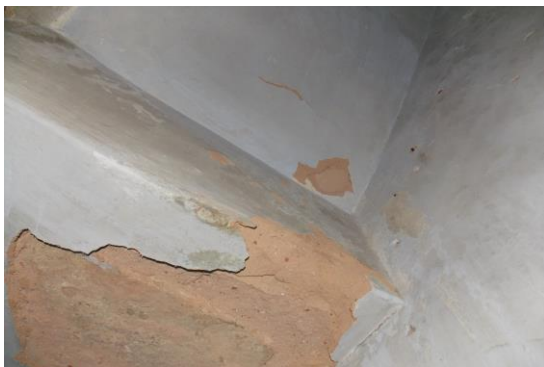
Photo 36
Peeling of Plaster on Roof of Staircase FF to SF

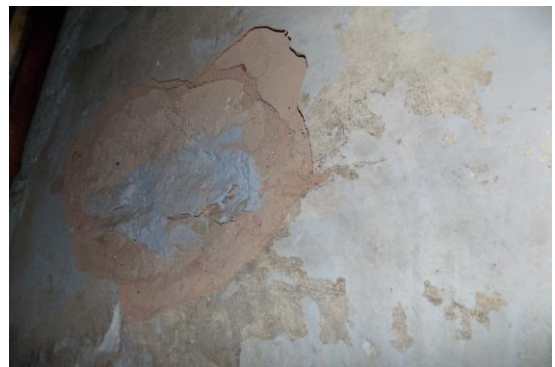
Photo 37
Peeling of Plaster on Wall No. 2 of Staircase FF to SF

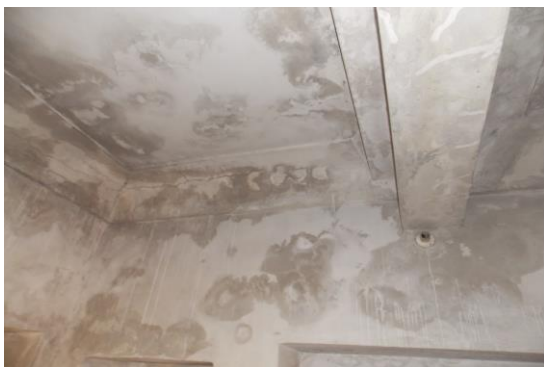
Photo 38
Dampness/Seepage on Wall No. 4 & Roof of Room No. 1 of Second Floor

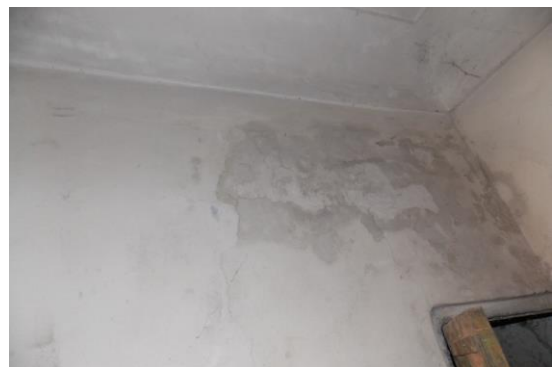
Photo 39
Dampness/Seepage on Wall No. 3 of Room No. 1 of Second Floor

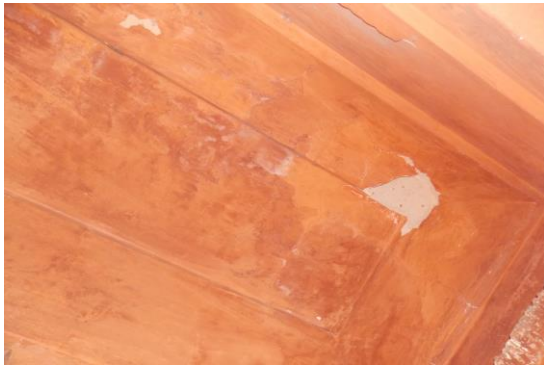
Photo 40
Peeling of Plaster on Roof of Balcony of Second Floor

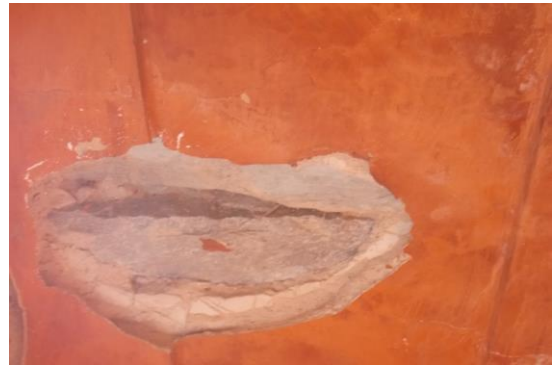
Photo 41
Peeling of Plaster on Roof of Balcony of Second Floor

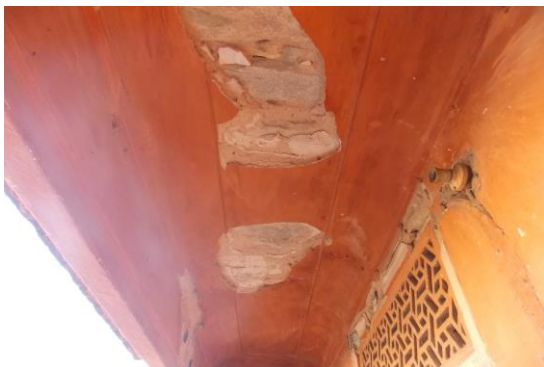
Photo 42
Peeling of Plaster on Roof of Balcony of Second Floor

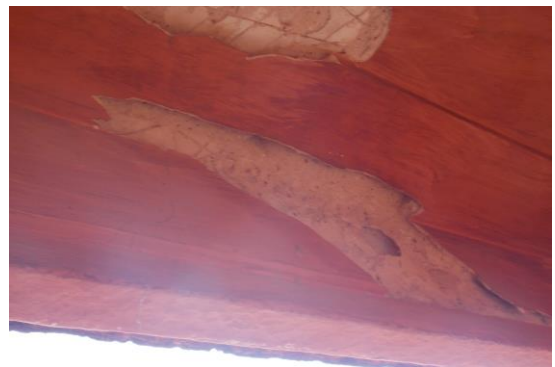
Photo 43
Peeling of Plaster on Wall No. 4 of Balcony of Second Floor

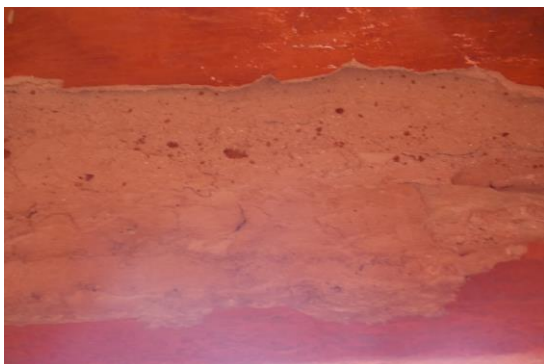
Photo 44
Peeling of Plaster on Wall No. 4 of Balcony of Second Floor

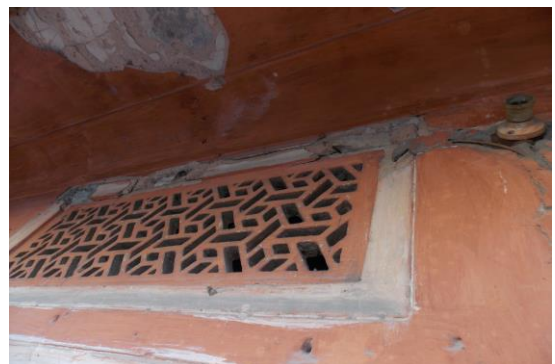
Photo 45
Peeling of Plaster on Wall No. 3 of Balcony of Second Floor

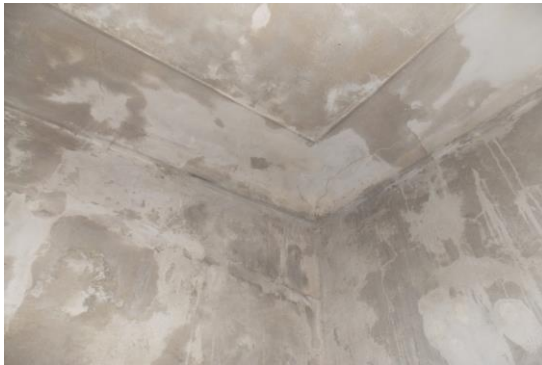
Photo 46

Dampness/Seepage on Wall No. 2 & 3 of Room No. 2 of Second Floor

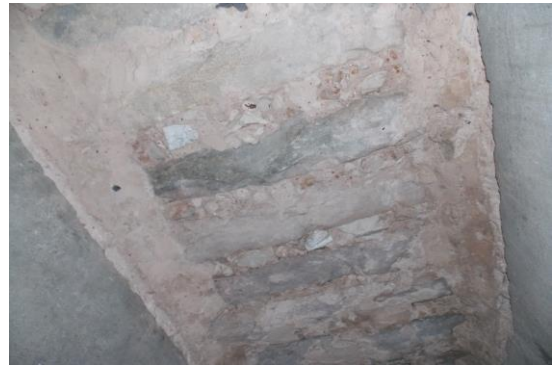
Photo 47

Peeling of Plaster on Roof of Room No. 3 of Second Floor

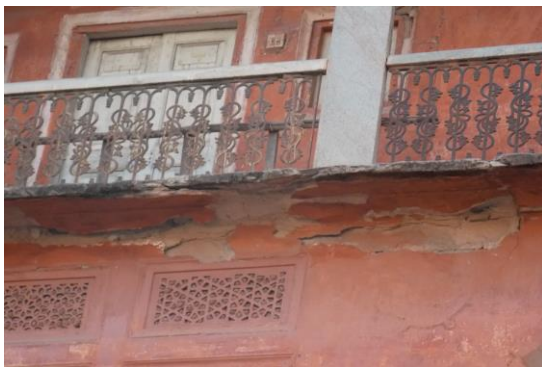
Photo 48

Peeling of Plaster on Frontside Wall Sun shade of First Floor

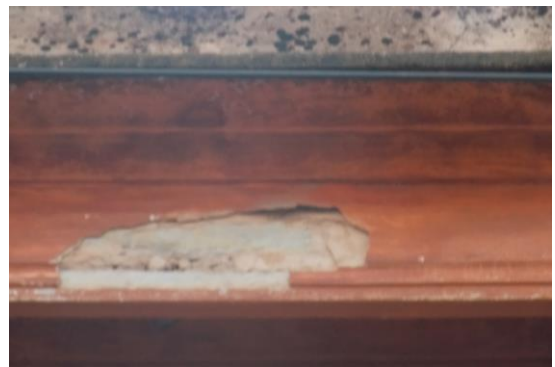
Photo 49

Peeling of Plaster on Frontside Wall of Second Floor

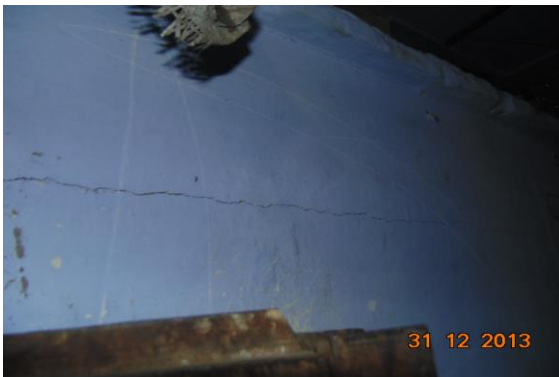
Photo 3

Horizontal Crack on Wall No. 3 of Room No. 1, First Floor, Approx.
Width = 0.8mm, Approx. Length = 2m.
Distance from Wall No. 2 = 0m, Height from Floor = 1.7m.

Summary of Cracks						
Defect ID	Location	Orientation	Appx. Width (mm)	Appx. Length (m)	Category	Photo No.
1	Wall No. 3 Room No. 1 First Floor	Horizontal	0.8	2	Very Slight	3, 3A

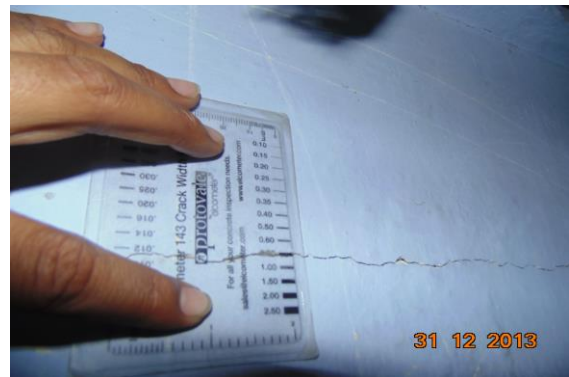
Photo 3A

Horizontal Crack on Wall No. 3 of Room No. 1, First Floor, Approx.
Width = 0.8mm, Approx. Length = 2m.
Distance from Wall No. 2 = 0m, Height from Floor = 1.7m.

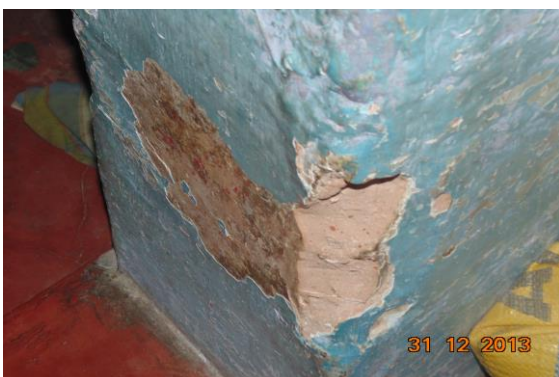
Photo 4

Peeling of Plaster on Wall No. 3 of Varandah of Second Floor

Summary of Defects Other Than Crack			
Defect ID	Location	Description	Photo No.
2	Wall No. 3 Varandah Second Floor	Peeling of Plaster	4
3	Roof Room No. 1 Second Floor	Peeling of Plaster	5
4	Wall No. 2 Room No. 1 Second Floor	Peeling of Plaster	6
5	Wall No. 4 Toilet No. 1 Second Floor	Peeling of Plaster	7
6	Roof Store Third Floor	Dampness/Seepage	8
7	Wall No. 4 Third Floor	Peeling of Plaster	9
8	Wall No. 3 Third Floor	Peeling of Plaster	10
9	Wall No. 2 & 4 Room No. 1 Third Floor	Dampness/Seepage	11
10	Roof Varandah Third Floor	Dampness/Seepage	12
11	Stair Step SF to TF	Peeling of Plaster	13
12	Wall No. 2 Stair SF to TF	Damaged Portion	14
13	Wall No. 1, 2 & 3 Stair FF to SF	Dampness/Seepage	15
14	Wall No. 2 Passage Second Floor	Peeling of Plaster	16
15	Wall No. 4, 2 & Roof Toilet No. 1 First Floor	Dampness/Seepage	17
16	Roof Room No. 1 First Floor	Dampness/Seepage	18
17	Roof Room No. 1 First Floor	Peeling of Plaster	19

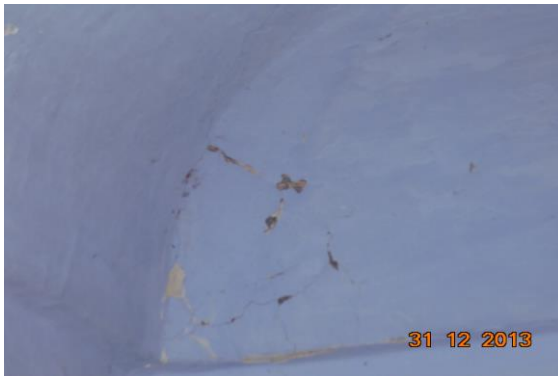
Photo 6
Peeling of Plaster on Wall No. 2 of Room No. 1 of Second Floor

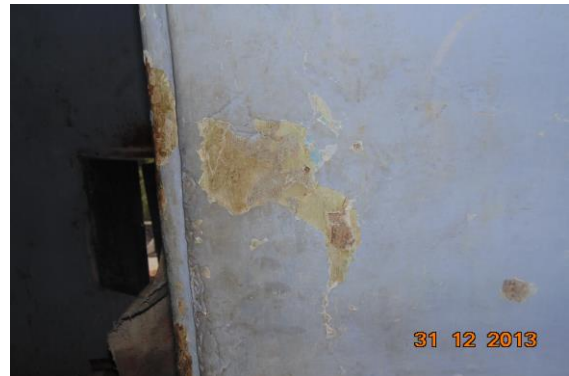
Photo 7
Peeling of Plaster on Wall No. 4 of Toilet No. 1 of Second Floor

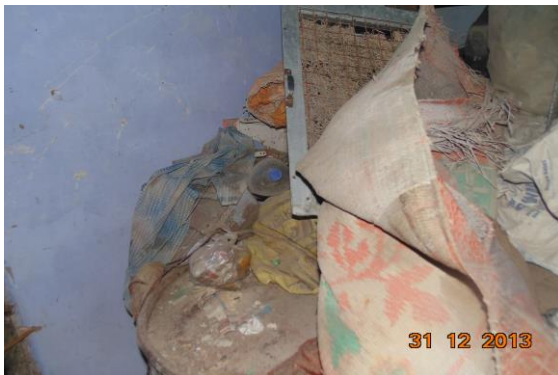
Photo 8
Dampness/Seepage on Roof of Store of Third Floor

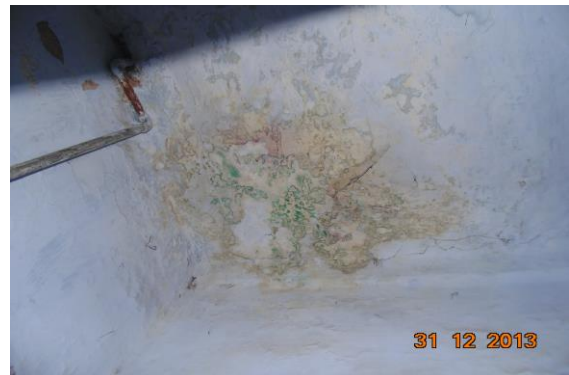
Photo 9
Peeling of Plaster on Wall No. 4 of Third Floor

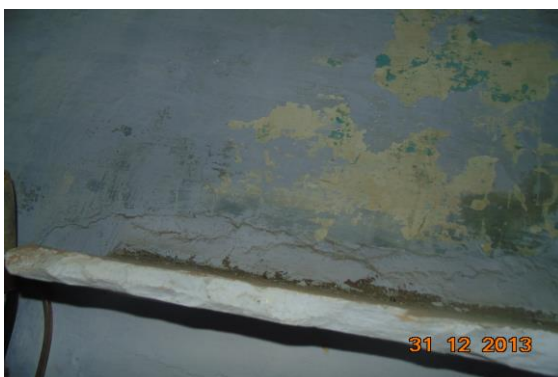
Photo 10
Peeling of Plaster on Wall No. 3 of Third Floor

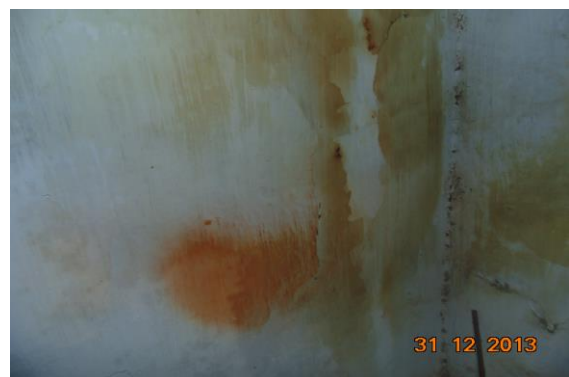
Photo 11
Dampness/Seepage on Wall No. 2 & 4 of Room No. 1 of Third Floor

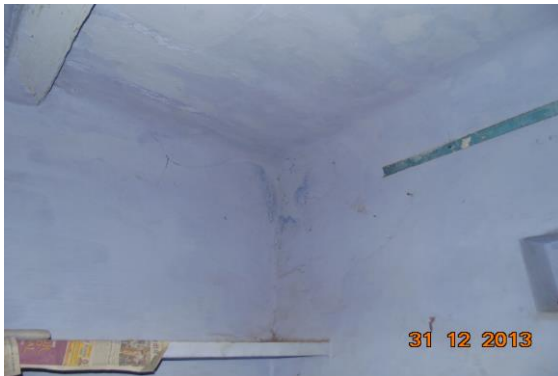
Photo 12
Dampness/Seepage on Roof of Varandah of Third Floor

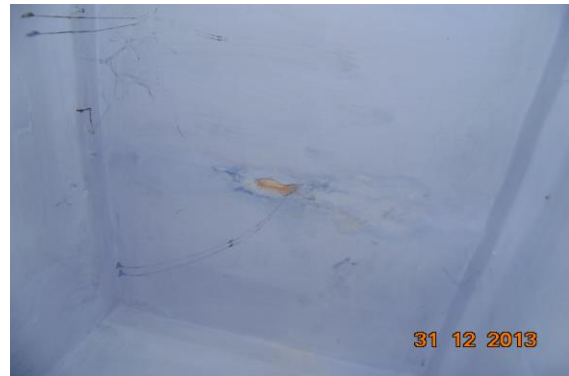
Photo 13
Peeling of Plaster on Stair Step SF to TF of

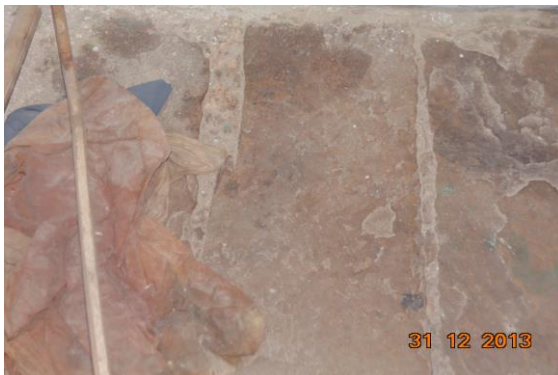
Photo 14
Damaged Portion on Wall No. 2 of Stair SF to TF

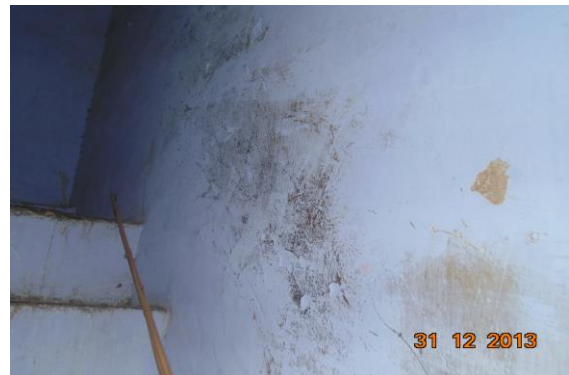
Photo 15
Dampness/Seepage on Wall No. 1, 2 & 3 of Stair FF to SF

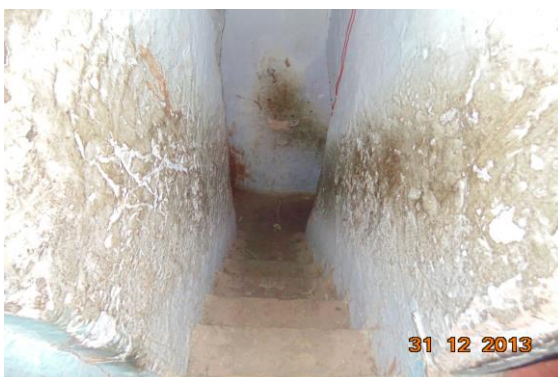
Photo 16
Peeling of Plaster on Wall No. 2 of Passage of Second Floor

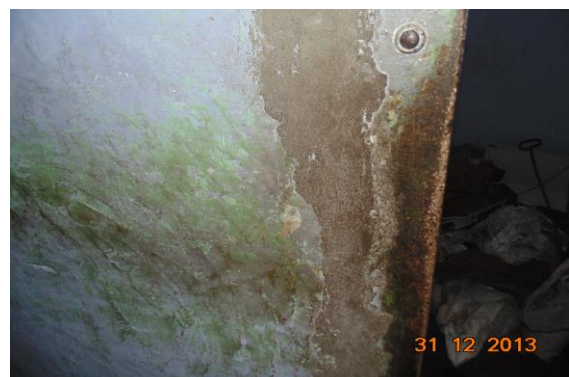
Photo 17
Dampness/Seepage on Wall No. 4, 2 & Roof of Toilet No. 1 of First Floor

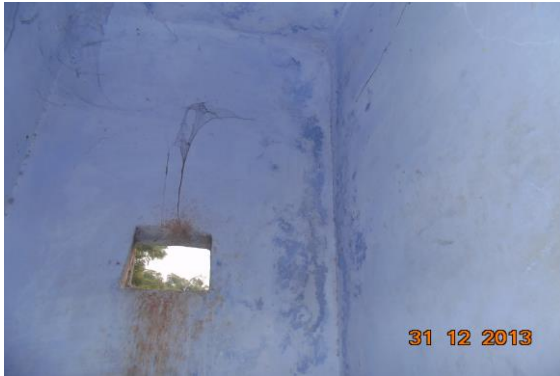
Photo 18
Dampness/Seepage on Roof of Room No. 1 of First Floor

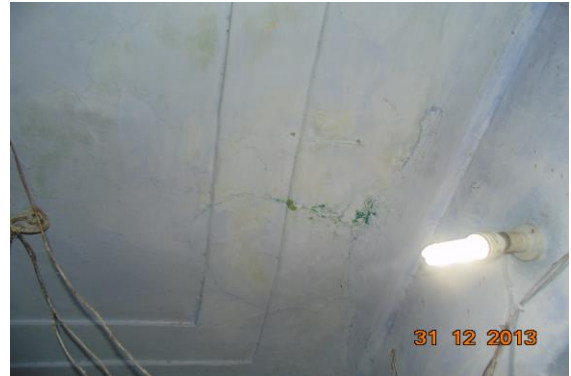
Photo 19
Peeling of Plaster on Roof of Room No. 1 of First Floor

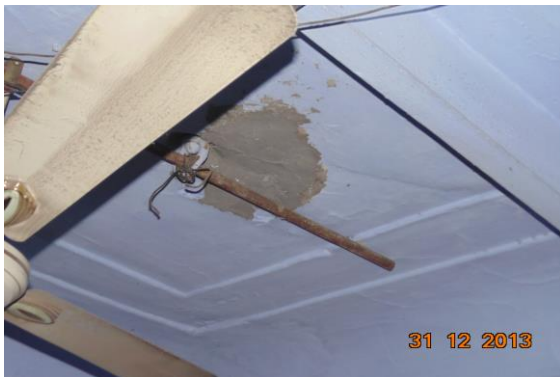
Photo 20
Peeling of Plaster on Roof of Room No. 1 of First Floor

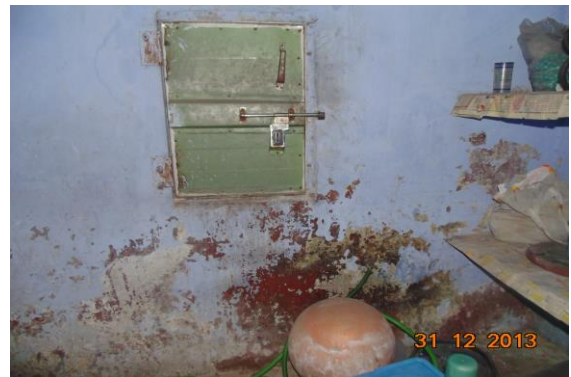
Photo 21
Peeling of Plaster on Wall No. 4 of Bathroom of First Floor

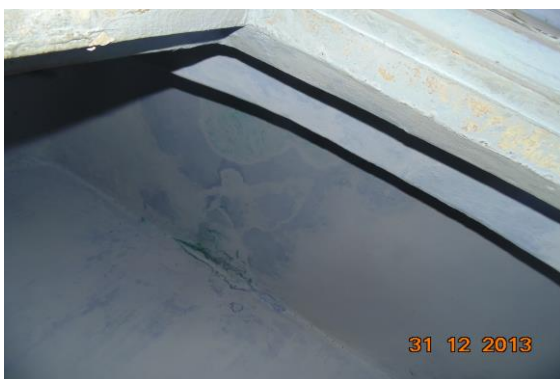
Photo 22
Dampness/Seepage on Roof of First Floor

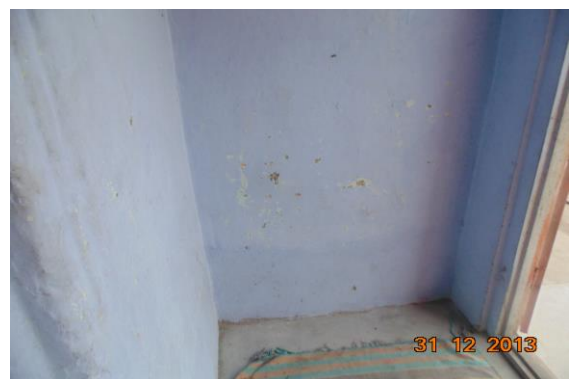
Photo 23
Peeling of Plaster on Wall No. 1 of Varandah of First Floor

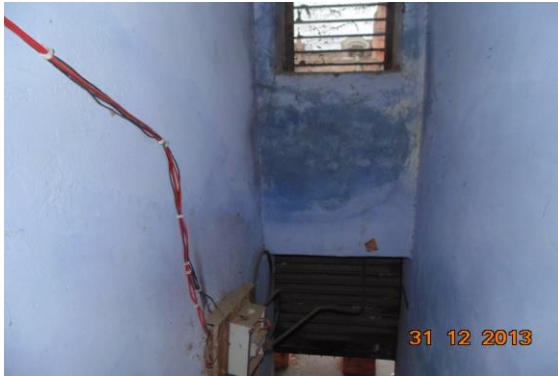
Photo 24
Dampness/Seepage on Wall No. 3 of Stair GF to FF

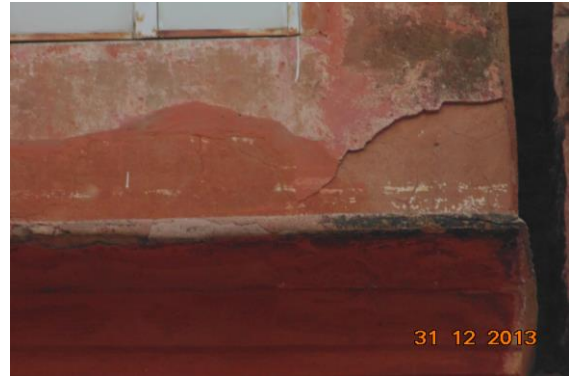
Photo 25
Peeling of Plaster on Front Wall of Third Floor

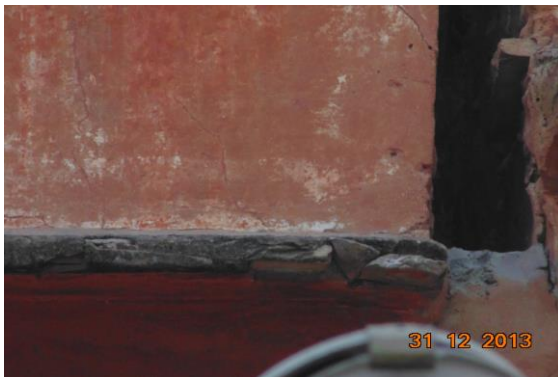
Photo 26
Damaged Portion on Front Wall of Shed of First Floor

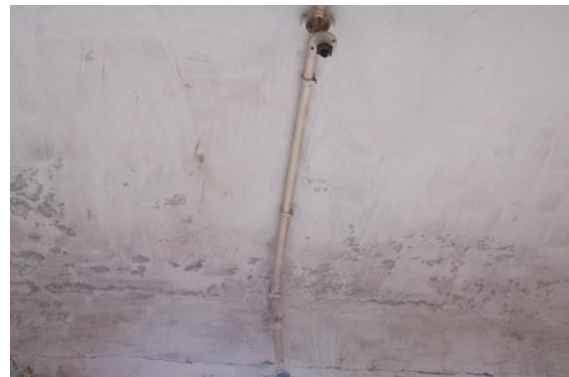
Photo 27
Dampness/Seepage on Roof of Varanda of Ground Floor

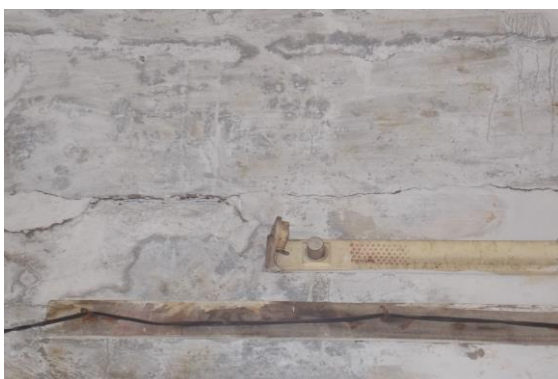
Photo 28
Peeling of Plaster on External Beam of Varanda of Ground Floor

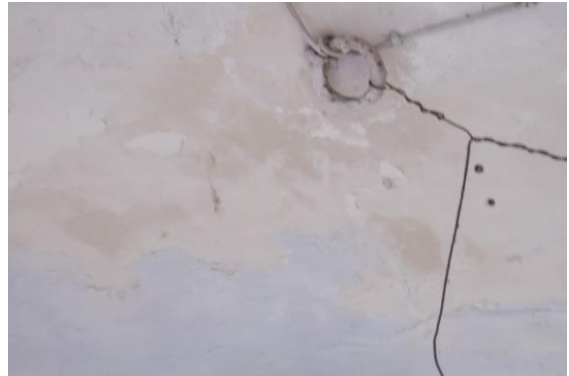
Photo 2
Peeling of Plaster on Roof of Varanda of Ground Floor

Summary of Defects Other Than Crack			
Defect ID	Location	Description	Photo No.
1	Roof Varanda Ground Floor	Peeling of Plaster	2

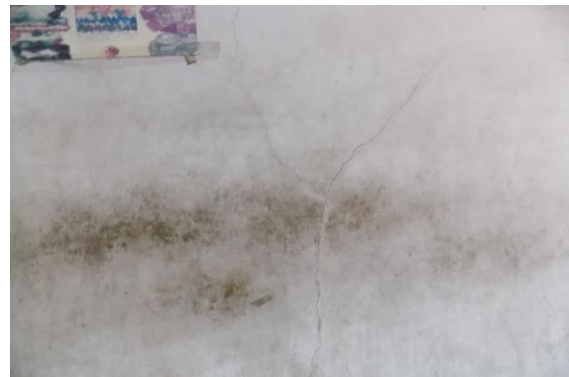
Photo 4
Inclined Crack on Wall No. 2 of Shop No. 84, Ground Floor
Approx. Width = 0.3mm, Approx. Length = 2m.
Distance from Wall No. 3 = 1.2m, Height from Floor = 0m.

Summary of Cracks						
Defect ID	Location	Orientation	Appx. Width (mm)	Appx. Length (m)	Category	Photo No.
1	Wall No. 2 Shop No. 84 Ground Floor	Inclined	0.3	2	Very Slight	4, 4A
2	Wall No. 4 Room No. 1 House No. 672, First Floor	Vertical	0.3	1	Very Slight	5

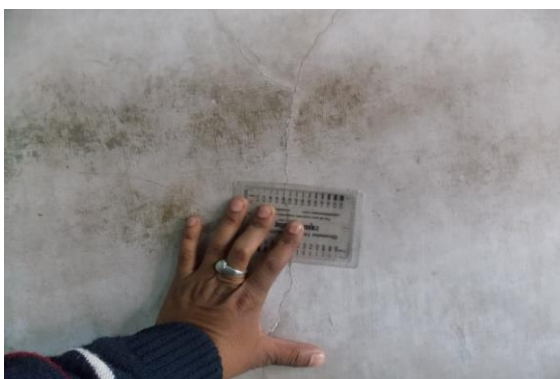
Photo 4A
Inclined Crack on Wall No. 2 of Shop No. 84, Ground Floor
Approx. Width = 0.3mm, Approx. Length = 2m.
Distance from Wall No. 3 = 1.2m, Height from Floor = 0m.

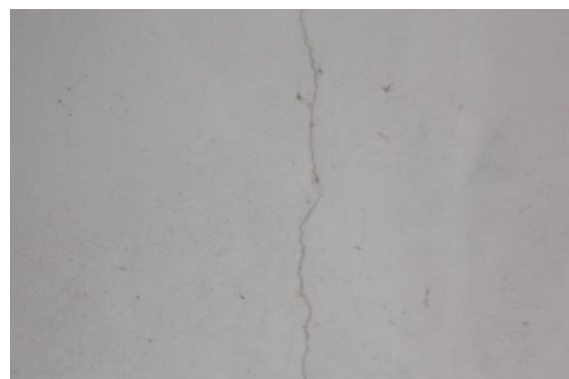
Photo 5
Vertical Crack on Wall No. 4 of Room No. 1, House No. 672, First Floor
Approx. Width = 0.3mm, Approx. Length = 1m. Distance from Wall No. 1 = 0.3m, Height from Floor = 2m.

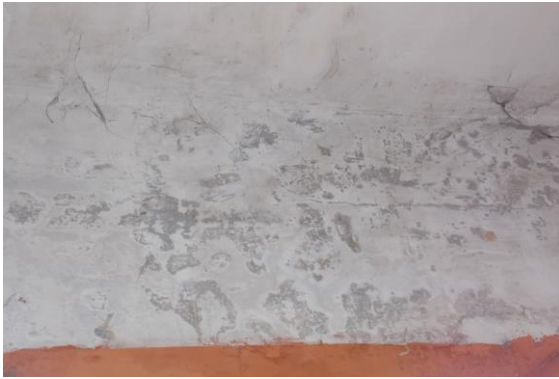
Photo 6

Dampness/Seepage on Beam of Varanda of Shop No. 84 of Ground Floor

Summary of Defects Other Than Crack			
Defect ID	Location	Description	Photo No.
3	Beam Varanda of Shop No. 84 Ground Floor	Dampness/Seepage	6
4	Roof Varanda of Shop No. 84 Ground Floor	Peeling of Plaster	7
5	Varanda of Shop No. 84 Ground Floor	Damaged Portion	8
6	Wall No. 2 & Roof Shop No. 84 Ground Floor	Dampness/Seepage	9
7	Wall No. 2 Shop No. 84 Ground Floor	Peeling of Plaster	10
8	Wall No. 1 & 4 Shop No. 84 Ground Floor	Peeling of Plaster	11
9	Roof Staircase First Floor to Second Floor of House No. 672 First Floor	Dampness/Seepage	12
10	Wall No. 4 Toilet No. 1 House No. 672, Second Floor	Plaster Crack	13
11	Wall No. 3 Room No. 1 Teen Shade Room of House No. 672, Second Floor	Dampness/Seepage	14
12	Wall No. 1 Staircase Ground Floor to Second Floor of House No. 672 Second Floor	Plaster Crack	15
13	Staircase First Floor to Second Floor of House No. 672 First Floor	Peeling of Plaster	16

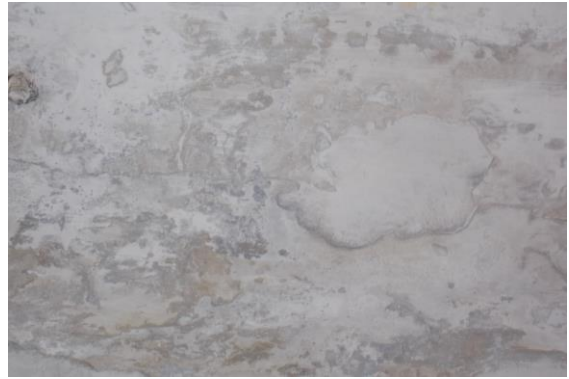
Photo 7

Peeling of Plaster on Roof of Varanda of Shop No. 84 of Ground Floor

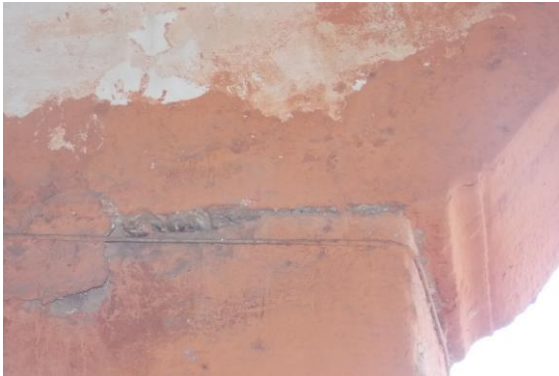
Photo 8

Damaged Portion on Varanda of Shop No. 84 of Ground Floor

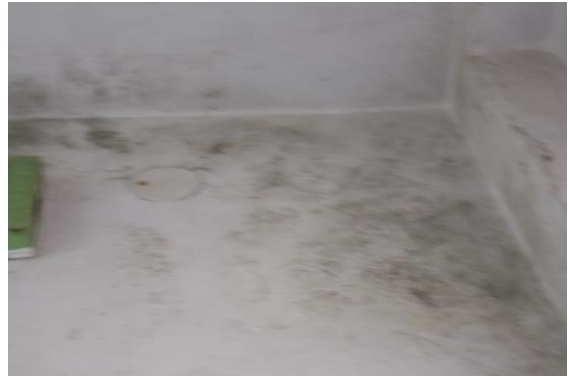
Photo 9

Dampness/Seepage on Wall No. 2 & Roof of Shop No. 84 of Ground Floor

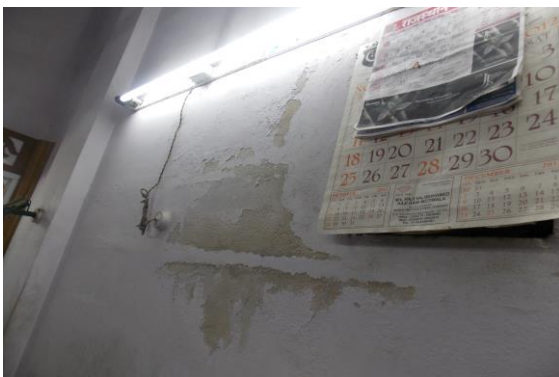
Photo 10

Peeling of Plaster on Wall No. 2 of Shop No. 84 of Ground Floor

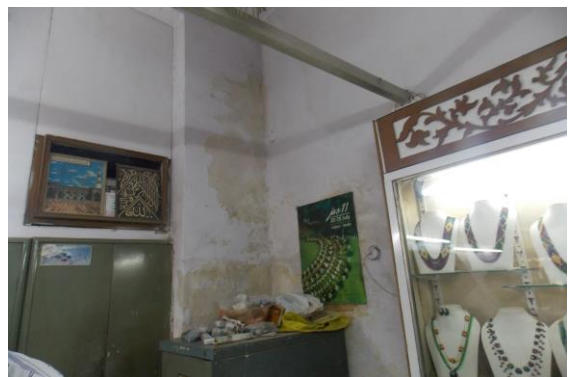
Photo 11

Peeling of Plaster on Wall No. 1 & 4 of Shop No. 84 of Ground Floor

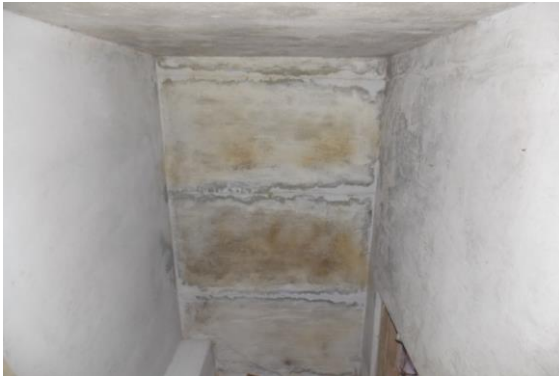
Photo 12

Dampness/Seepage on Roof of Staircase First Floor to Second Floor of House No. 672 of First Floor

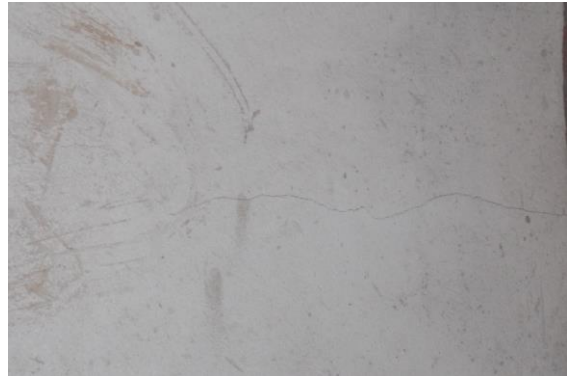
Photo 13

Plaster Crack on Wall No. 4 of Toilet No. 1 of House No. 672, Second Floor

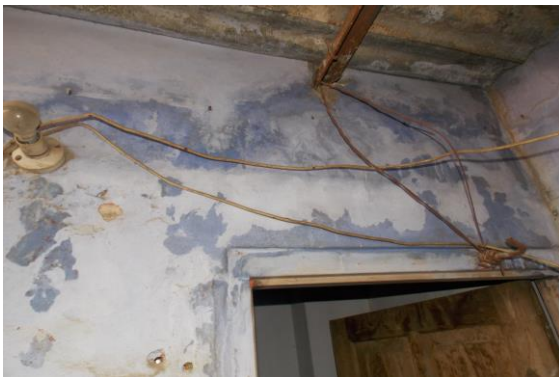
Photo 14

Dampness/Seepage on Wall No. 3 of Room No. 1 of Teen Shade Room of House No. 672, Second Floor

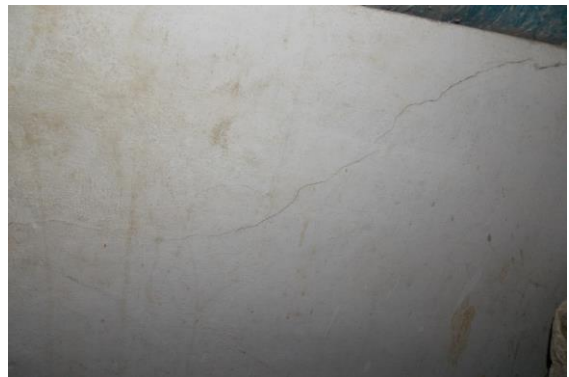
Photo 15

Plaster Crack on Wall No. 1 of Staircase Ground Floor to Second Floor of House No. 672 of Second Floor

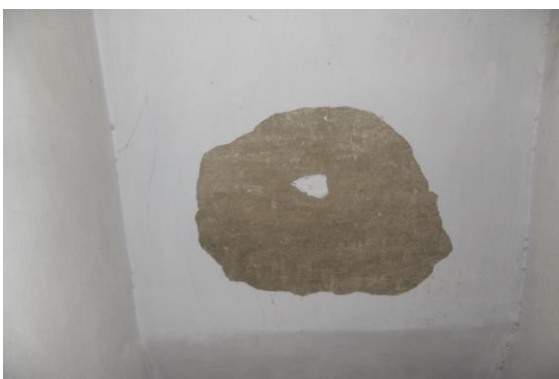
Photo 16

Peeling of Plaster on of Staircase First Floor to Second Floor of House No. 672 of First Floor

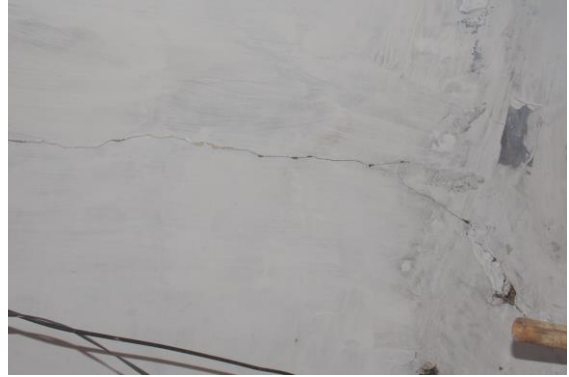
Photo 14
Inclined Crack on Roof & R/S External column of Varanda, Shop No. 90 & 91, G/F Approx. Width = 1.5mm, Approx. Length = 3m. Distance from R/s External column = 0m, Height from Floor = 2.8m.

Summary of Cracks						
Defect ID	Location	Orientation	Appx. Width (mm)	Appx. Length (m)	Category	Photo No.
1	Roof & Right side External column Varanda Shop No. 90 & 91, Ground Floor	Inclined	1.5	3	Slight	14
2	External Column Varanda Shop No. 93, Ground Floor	Vertical	0.8	3.5	Very Slight	15
3	External Column Varanda Shop No. 93, Ground Floor	Vertical	0.8	3.5	Very Slight	16

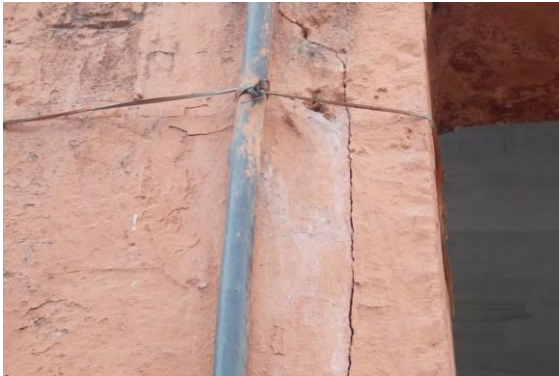
Photo 15
Vertical Crack on External Column of Varanda , Shop No. 93, Ground Floor, Approx. Width = 0.8mm, Approx. Length = 3.5m. Distance from External Column = 0m, Height from Floor = 0m.
