Pre Building Condition Survey Report

Name and Address of Structure :	Badi Chopar to Ramp Area (Down Line)
---------------------------------	--------------------------------------

Name of the Project	Contract JMRC-UG1B “Design and Construction of Tunnel between Chandpole and Badi Chouper and reverse line by Shield TBM, Underground Metro Stations at Choti Chouper and Badi Chouper by Cut and Cover Methods on East West Corridor of Jaipur Metro Rail Corporation Limited .”	
Owner :

Pre - Condition Building Survey for Construction of Underground Stations from Chandpole to Bari Chouper and reversal line

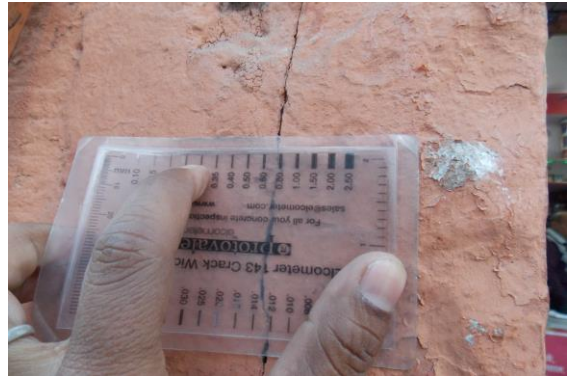
Photo 16
Vertical Crack on External Column of Varanda, Shop No. 93, Ground Floor, Approx. Width = 0.8mm, Approx. Length = 3.5m. Distance from External Column = 0m, Height from Floor = 0m.

Summary of Cracks						
Defect ID	Location	Orientation	Appx. Width (mm)	Appx. Length (m)	Category	Photo No.
1	Roof & Right side External column Varanda Shop No. 90 & 91, Ground Floor	Inclined	1.5	3	Slight	14
2	External Column Varanda Shop No. 93, Ground Floor	Vertical	0.8	3.5	Very Slight	15
3	External Column Varanda Shop No. 93, Ground Floor	Vertical	0.8	3.5	Very Slight	16

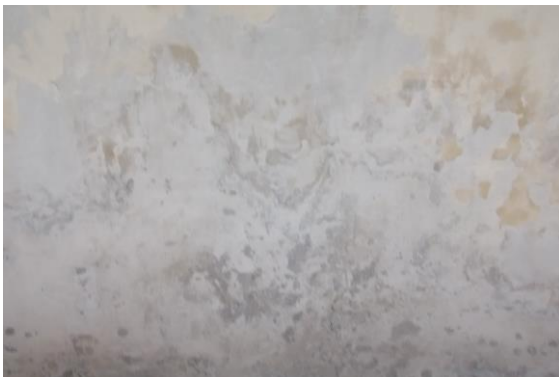
Photo 17
Dampness/Seepage on Roof of Varanda of Shop No. 85, Ground Floor

Summary of Defects Other Than Crack			
Defect ID	Location	Description	Photo No.
4	Roof Varanda Shop No. 85, Ground Floor	Dampness/Seepage	17
5	Beam Varanda Shop No. 85, Ground Floor	Peeling of Plaster	18
6	Roof Varanda Shop No. 86, Ground Floor	Peeling of Plaster	19
7	Roof Part B Shop No. 86, Ground Floor	Dampness/Seepage	20
8	Wall No. 2 Part B Shop No. 86, Ground Floor	Peeling of Plaster	21
9	Wall No. 2 Part B Shop No. 86, Ground Floor	Peeling of Plaster	22
10	Roof Varanda Shop No. 90 & 91, Ground Floor	Dampness/Seepage	23
11	Roof Shop No. 90 & 91 Ground Floor	Dampness/Seepage	24
12	External Beam Front Side Shop No. 96 Ground Floor	Peeling of Plaster	25
13	Roof Varanda Shop No. 96, Ground Floor	Dampness/Seepage	26
14	Left side external Column Varanda Shop No. 96, Ground Floor	Peeling of Plaster	27
15	Outer wall Front side Varanda Shop No. 96, Ground Floor	Peeling of Plaster	28
16	Roof Room No. 1 Shop No. 96, Ground Floor	Peeling of Plaster	29

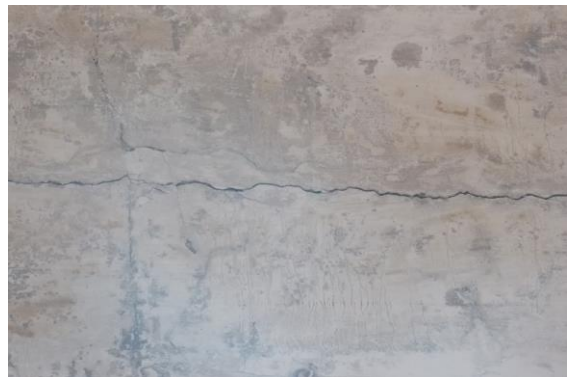
Photo 18
Peeling of Plaster on Beam of Varanda of Shop No. 85, Ground Floor

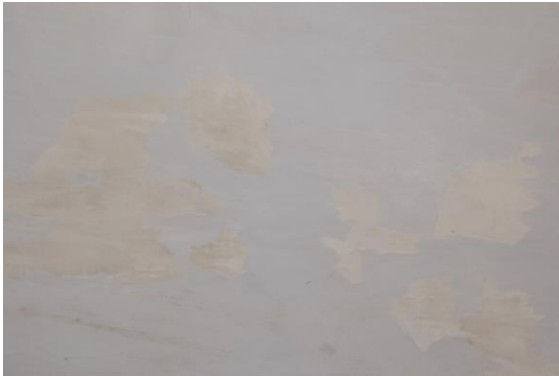
Photo 19

Peeling of Plaster on Roof of Varanda of Shop No. 86, Ground Floor

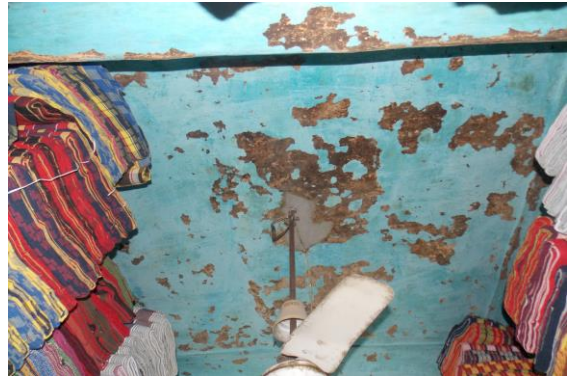
Photo 20

Dampness/Seepage on Roof of Part B of Shop No. 86, Ground Floor

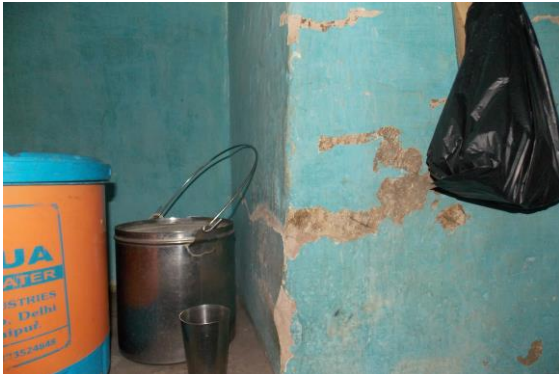
Photo 21

Peeling of Plaster on Wall No. 2 of Part B of Shop No. 86, Ground Floor

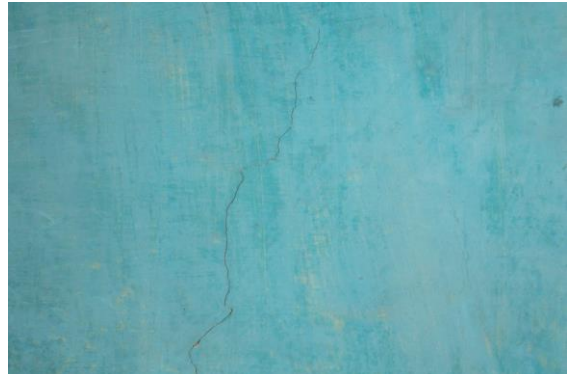
Photo 22

Peeling of Plaster on Wall No. 2 of Part B of Shop No. 86, Ground Floor

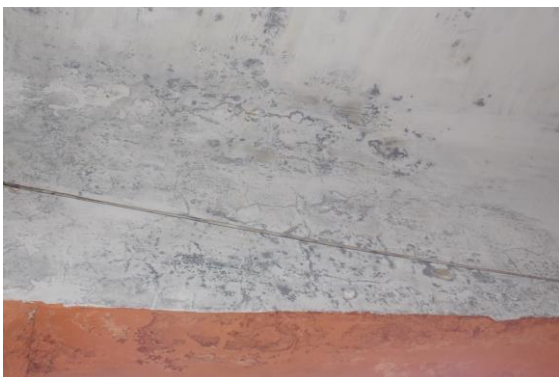
Photo 23

Dampness/Seepage on Roof of Varanda of Shop No. 90 & 91, Ground Floor

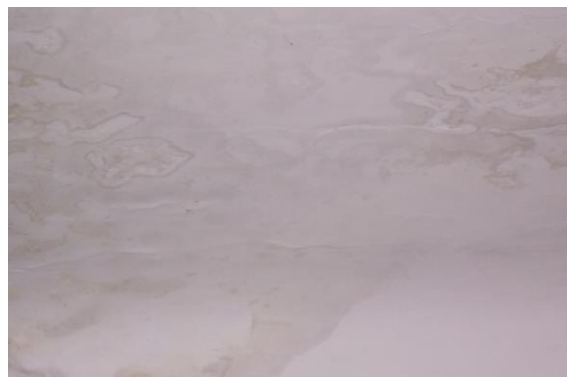
Photo 24

Dampness/Seepage on Roof of Shop No. 90 & 91 of Ground Floor

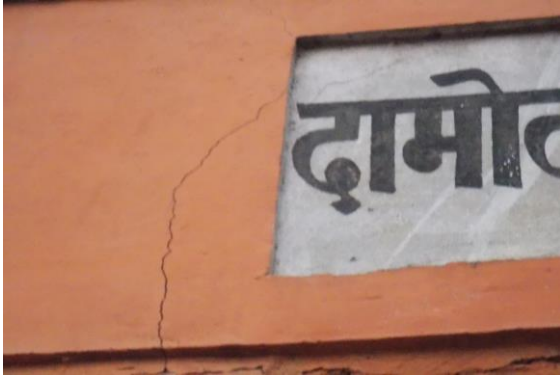
Photo 25

Peeling of Plaster on External Beam Front Side of Shop No. 96 of Ground Floor

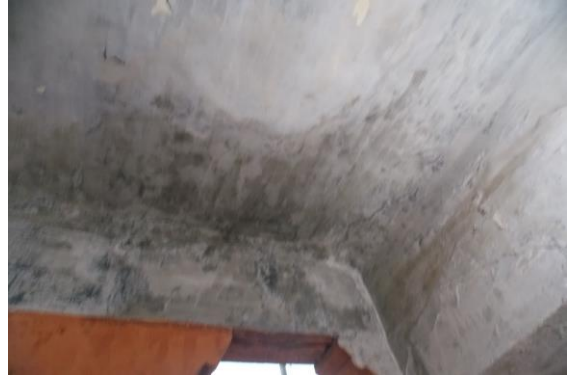
Photo 26

Dampness/Seepage on Roof of Varanda of Shop No. 96, Ground Floor

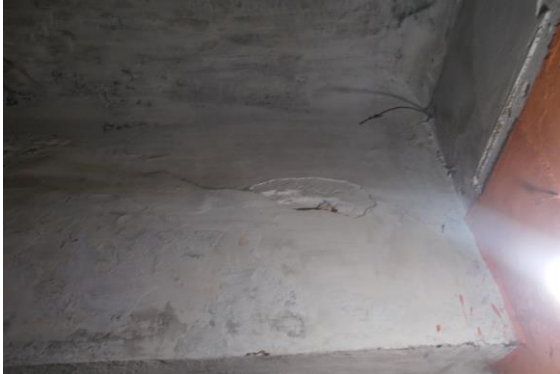
Photo 27

Peeling of Plaster on Left side external Column of Varanda of Shop No. 96, Ground Floor

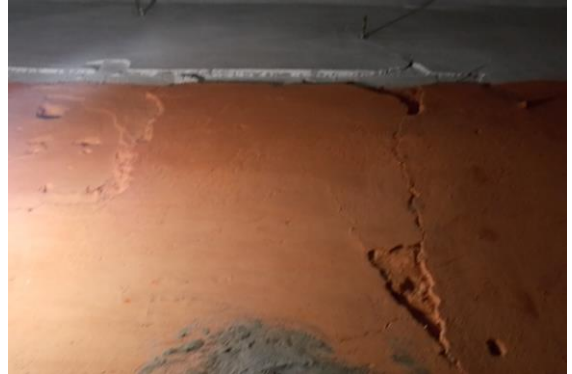
Photo 28

Peeling of Plaster on Outer wall Front side of Varanda of Shop No. 96, Ground Floor

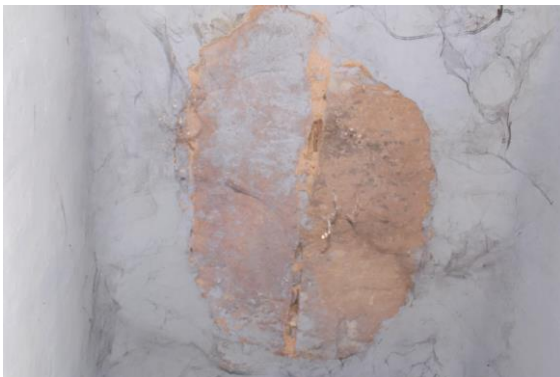
Photo 29

Peeling of Plaster on Roof of Room No. 1 of Shop No. 96, Ground Floor

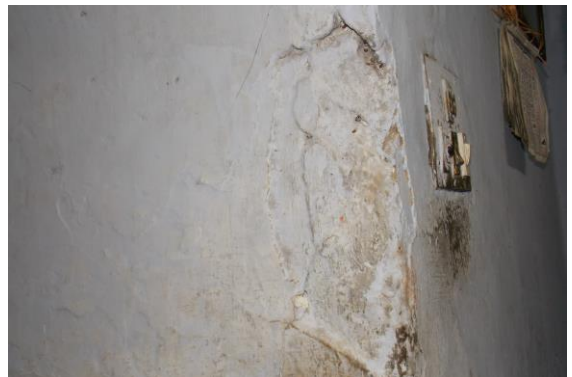
Photo 30

Peeling of Plaster on Wall No. 6 of Shop No. 96 of Ground Floor

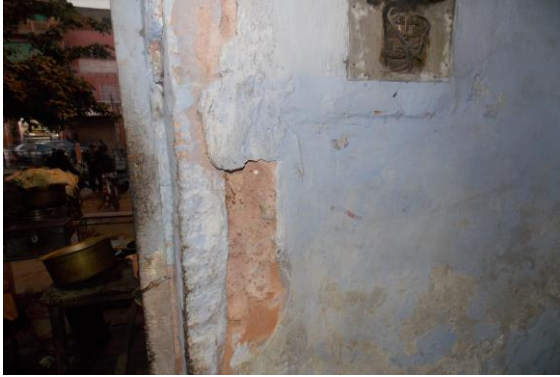
Photo 31

Peeling of Plaster on Wall No. 3 of Shop No. 96 of Ground Floor

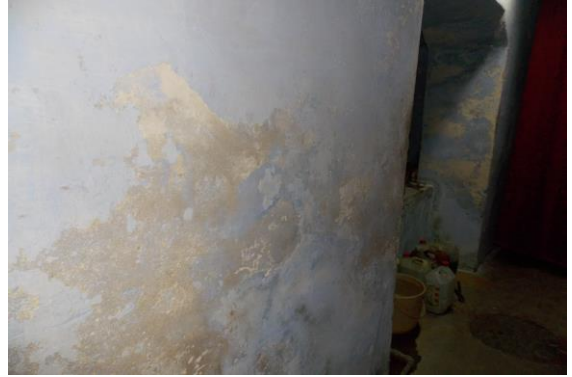
Photo 32

Dampness/Seepage on Wall No. 3 of Shop No. 96 of Ground Floor

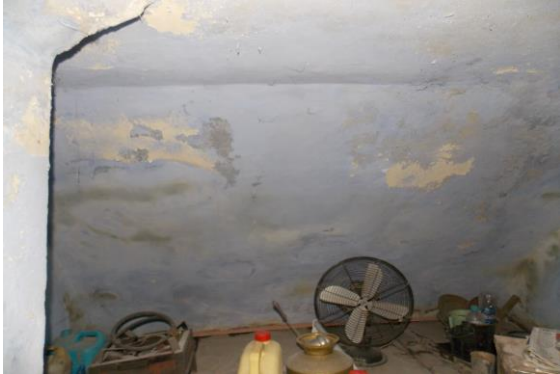
Photo 33

Dampness/Seepage on Wall No. 15 of Shop No. 96 of Ground Floor

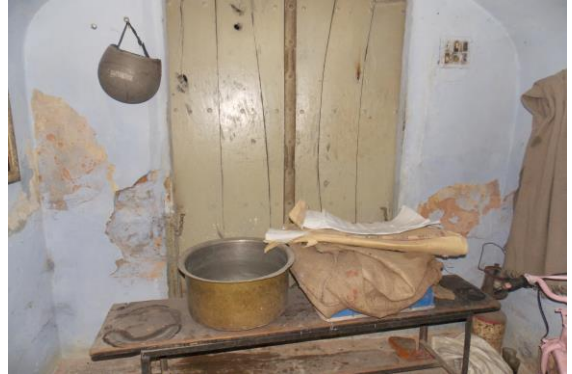
Photo 34

Peeling of Plaster on Wall No. 10 of Shop No. 96 of Ground Floor

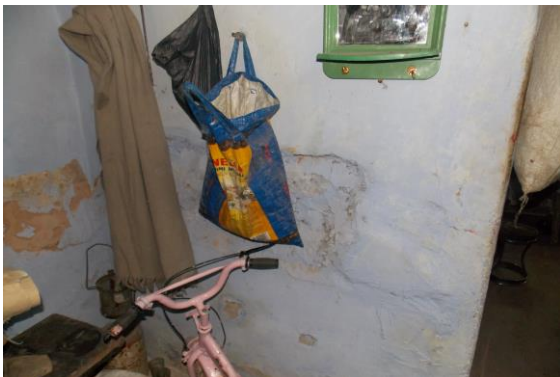
Photo 35

Peeling of Plaster on Wall No. 9 of Shop No. 96 of Ground Floor

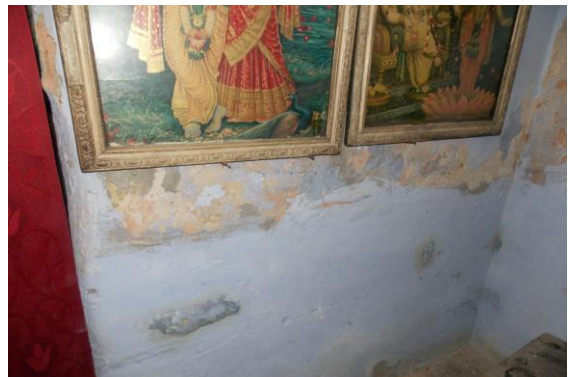
Photo 36

Peeling of Plaster on Wall No. 11 of Shop No. 96 of Ground Floor

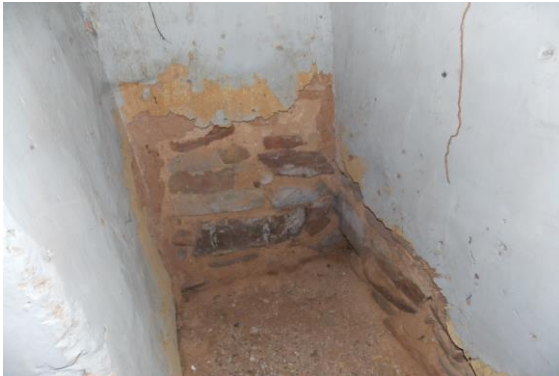
Photo 37

Peeling of Plaster on Wall No. 1, 3 & 4 of Shop No. 96 of Ground Floor

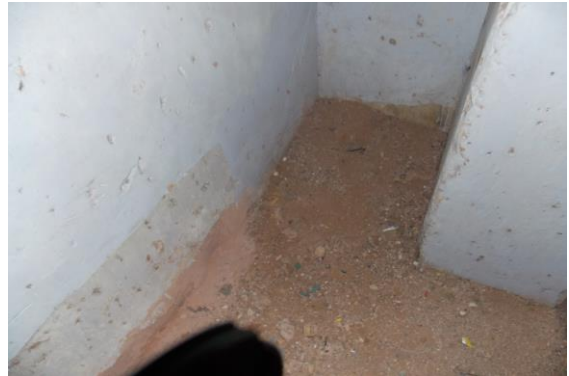
Photo 38

Peeling of Plaster on Floor of Store No. 2 of Ground Floor

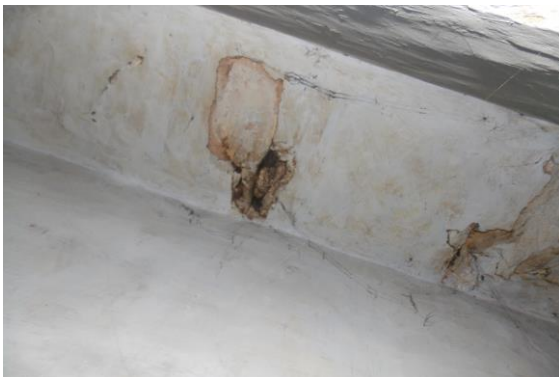
Photo 39

Peeling of Plaster on Roof of Store No. 2 of Ground Floor

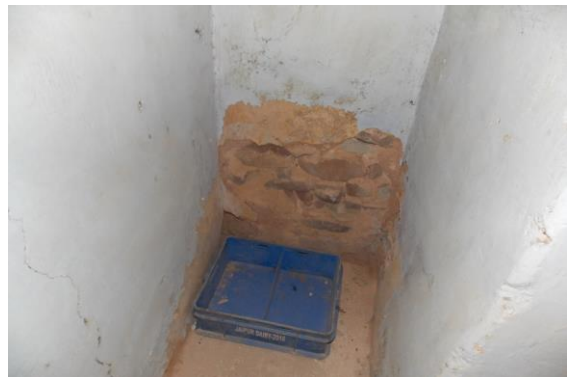
Photo 40

Peeling of Plaster on Wall No. 2, 3 & 4 of Store No. 1 of Ground Floor

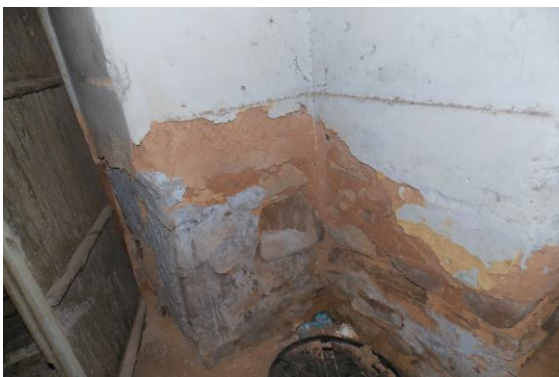
Photo 41

Peeling of Plaster on Wall No. 1 & 3 of Room No. 2 of Shop No. 96, Ground Floor

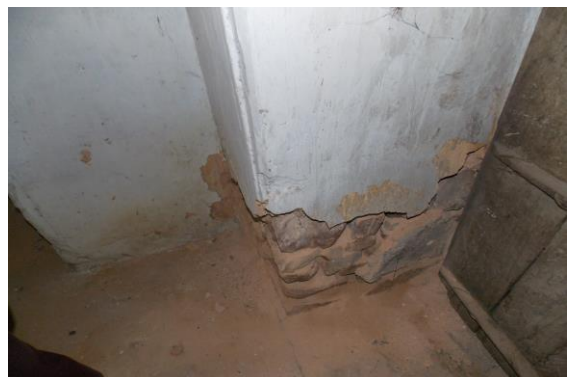
Photo 42

Peeling of Plaster on Wall No. 2 & 3 of Room No. 2 of Shop No. 96, Ground Floor

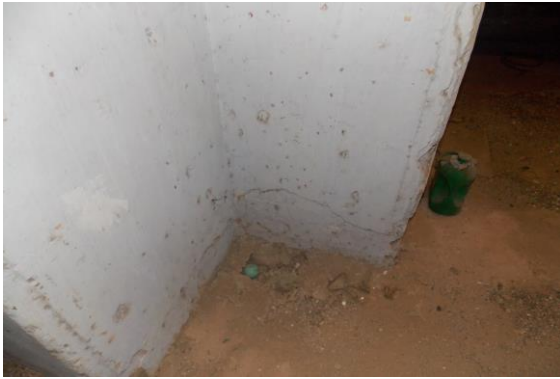
Photo 43

Peeling of Plaster on Wall No. 4 of Room No. 2 of Shop No. 96, Ground Floor

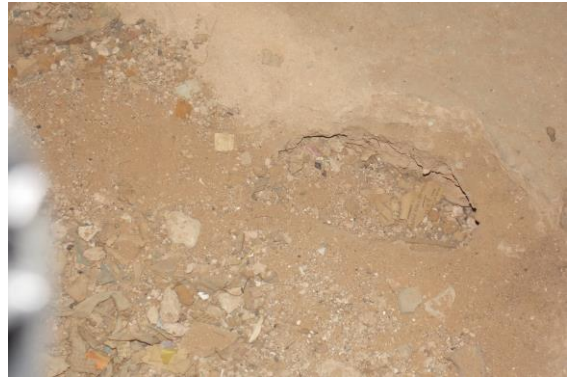
Photo 44

Peeling of Plaster on Floor of Room No. 2 of Shop No. 96, Ground Floor

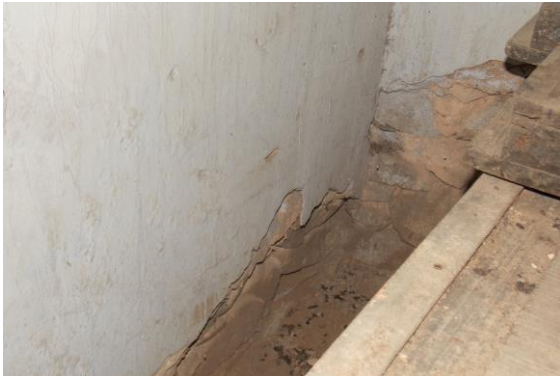
Photo 45

Peeling of Plaster on Wall No. 1 & 4 of Room No. 3 of Shop No. 96, Ground Floor

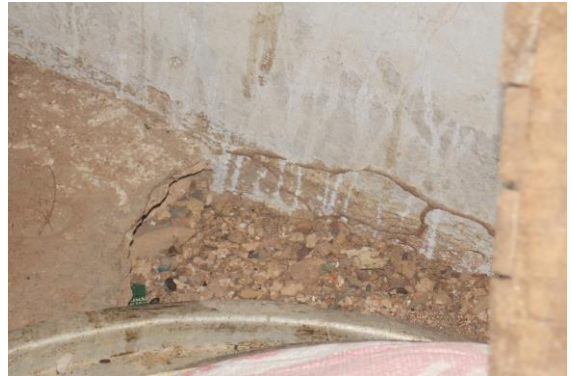
Photo 46

Peeling of Plaster on Wall No. 2 & Floor & Room No. 3 of Shop No. 96, Ground Floor

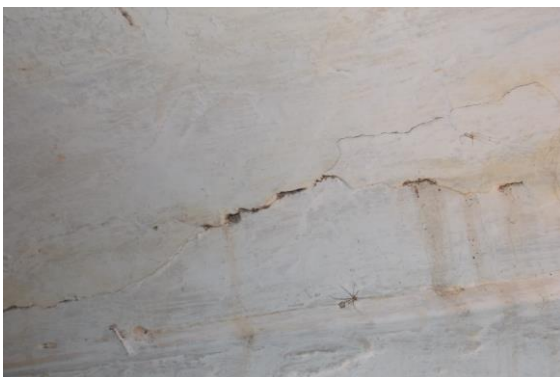
Photo 47

Peeling of Plaster on Wall No. 3 of Room No. 3 of Shop No. 96, Ground Floor

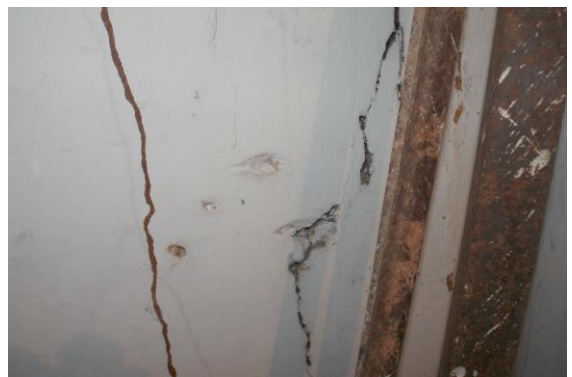
Photo 48

Peeling of Plaster on Wall No. 2 of Room No. 3 of Shop No. 96, Ground Floor

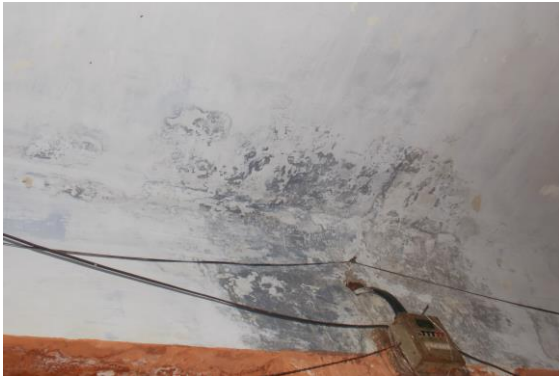
Photo 49

Dampness/Seepage on Roof & External Beam of Varanda of Shop No. 97 & 98, Ground Floor

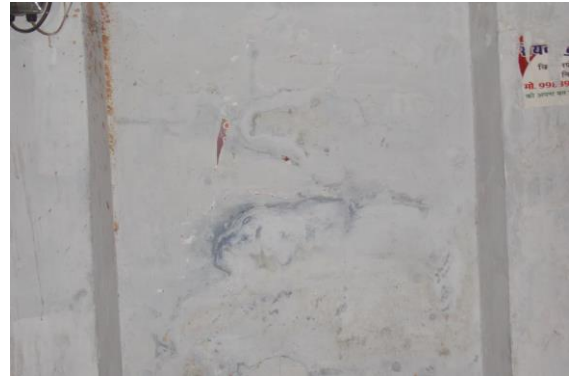
Photo 50

Dampness/Seepage on Outer wall Right Hand Side of Varanda of Shop No. 97 & 98, Ground Floor

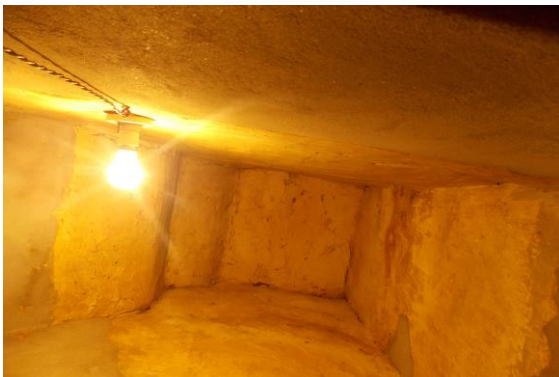
Photo 51

Peeling of Plaster on Roof of Toilet No. 1 of Shop No. 96, Ground Floor

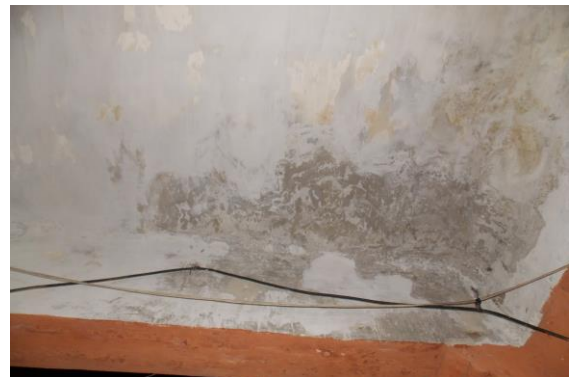
Photo 52

Dampness/Seepage on Roof of Varanda of Shop No. 100, Ground Floor

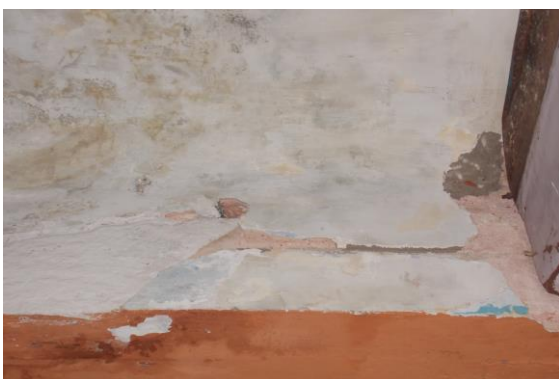
Photo 53

Peeling of Plaster on External Beam of Varanda of Shop No. 100, Ground Floor

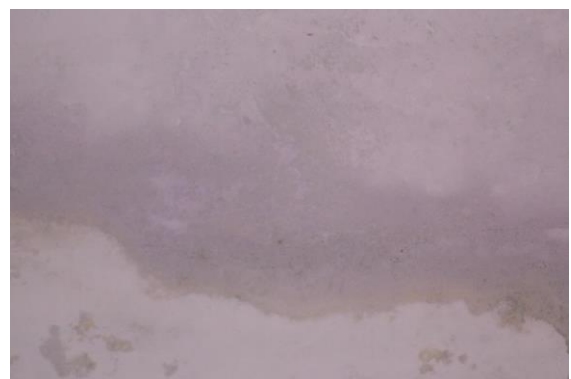
Photo 54

Dampness/Seepage on Wall No. 4 of Shop No. 100 of Ground Floor

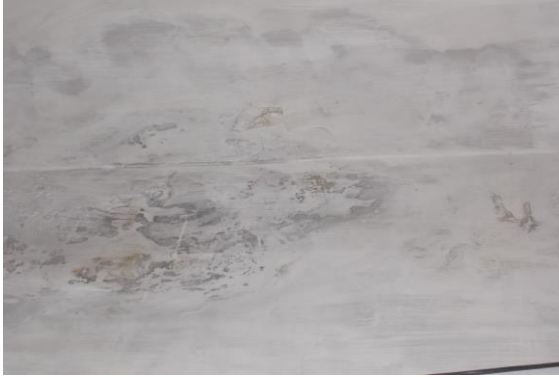
Photo 55

Dampness/Seepage on Roof of Varanda of Shop No. 93, Ground Floor

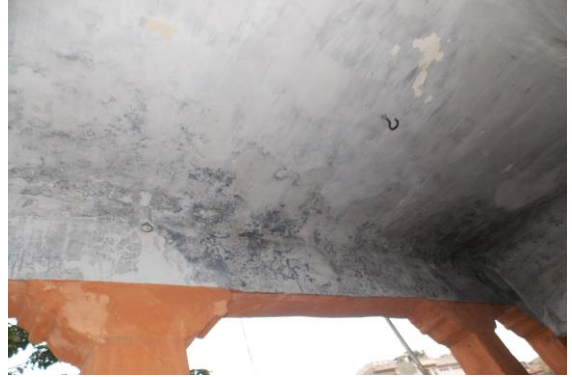
Photo 56

Dampness/Seepage on Roof of Varanda of Shop No. 94 & 95, Ground Floor

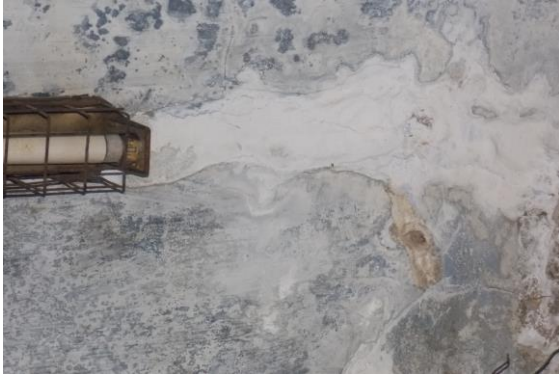
Photo 57

Peeling of Plaster on Roof of Varanda of Shop No. 94 & 95, Ground Floor

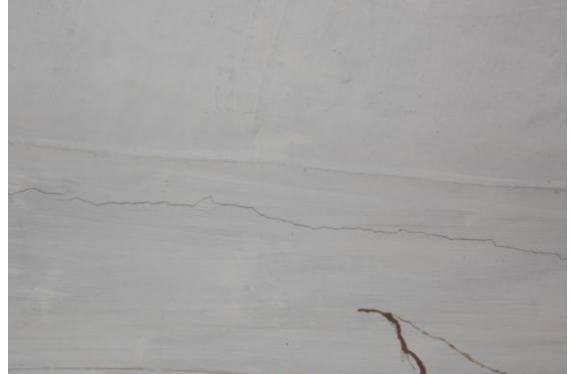
Photo 58

Peeling of Plaster on Roof of Part F of Shop No. 94 & 95, Ground Floor

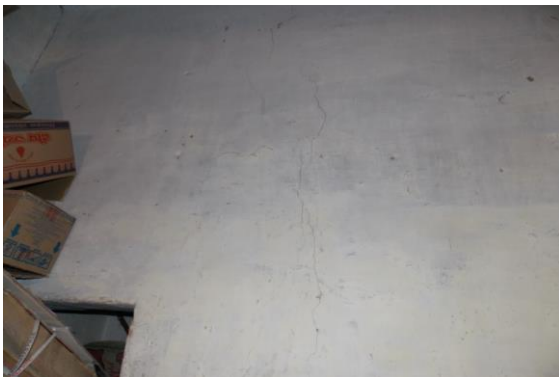
Photo 59

Peeling of Plaster on Wall No. 4 of Part F of Shop No. 94 & 95, Ground Floor

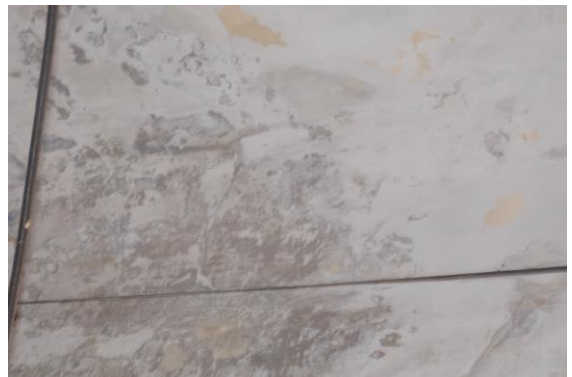
Photo 60

Dampness/Seepage on Roof of Varanda of Shop No.99 of Ground Floor

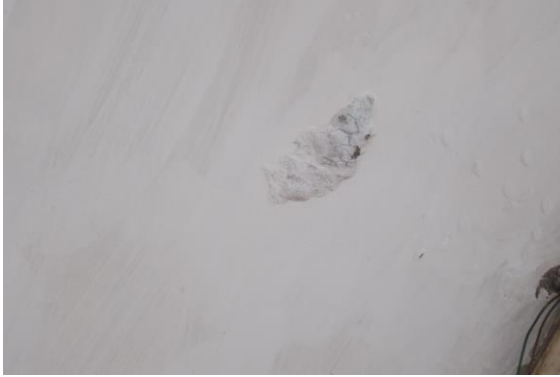
Photo 61

Peeling of Plaster on Roof of Varanda of Shop No.99 of Ground Floor

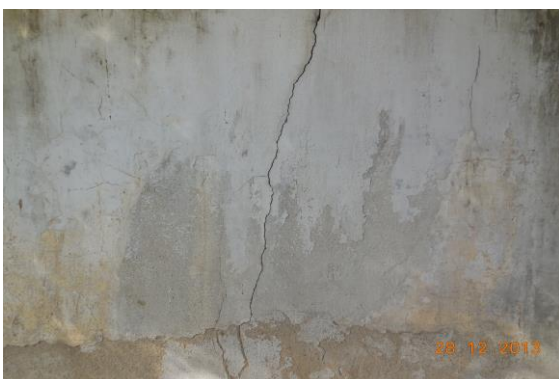
Photo 17
Inclined Crack on Wall No. 4 of Open Area 1 of Navjeevan Chikitsalaya, Ground Floor Approx. Width = 2mm, Approx. Length = 1.3m. Distance from Wall No.2 = 5m, Height from Floor = 1m.

Summary of Cracks						
Defect ID	Location	Orientation	Appx. Width (mm)	Appx. Length (m)	Category	Photo No.
1	Wall No. 4 Open Area 1 of Navjeevan Chikitsalaya Ground Floor	Inclined	2	1.3	Slight	17, 17A
2	Wall No. 1 Open Area 1 of Navjeevan Chikitsalaya Ground Floor	Inclined	4	1.5	Slight	18, 18A
3	Wall No. 1 Room No. 9 Part A of Navjeevan Chikitsalaya, Ground Floor	Inclined	0.35	1.5	Very Slight	19, 19A
4	Wall No. 4 & Roof Room No. 9 Part B of Navjeevan Chikitsalaya, Ground Floor	Inclined	0.35	3	Very Slight	20
5	Wall No. 3 Room No. 8 Part A of Navjeevan Chikitsalaya, Ground Floor	Vertical	0.5	1	Very Slight	21
6	Wall No. 4 Room No. 8 Part B of Navjeevan Chikitsalaya, Ground Floor	Inclined	0.3	1.5	Very Slight	22
7	Wall No. 3 Room No. 8 Part B of Navjeevan Chikitsalaya, Ground Floor	Inclined	0.25	4	Very Slight	23, 23A
8	Wall No. 3 Room No. 11 Navjeevan Chikitsalaya, Ground Floor	Vertical	0.5	1.5	Very Slight	24, 24A

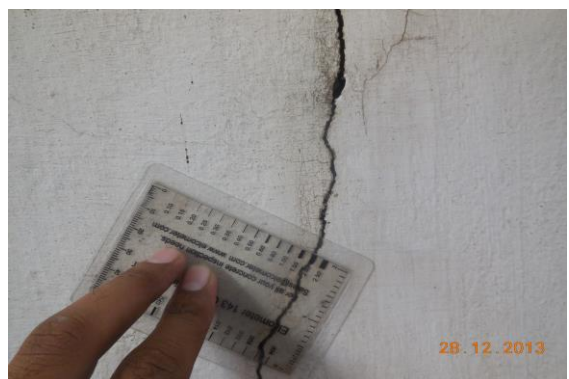
Photo 17A
Inclined Crack on Wall No. 4 of Open Area 1 of Navjeevan Chikitsalaya, Ground Floor Approx. Width = 2mm, Approx. Length = 1.3m. Distance from Wall No.2 = 5m, Height from Floor = 1m.

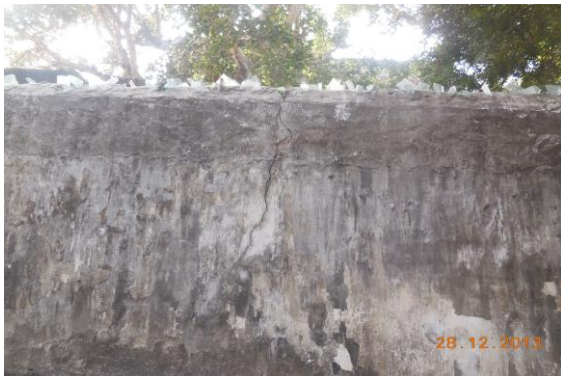
Photo 18

Inclined Crack on Wall No. 1 of Open Area 1 of Navjeevan Chikitsalaya, Ground Floor Approx. Width = 4mm, Approx. Length = 1.5m. Distance from Wall No.4 = 4m, Height from Floor = 1m.

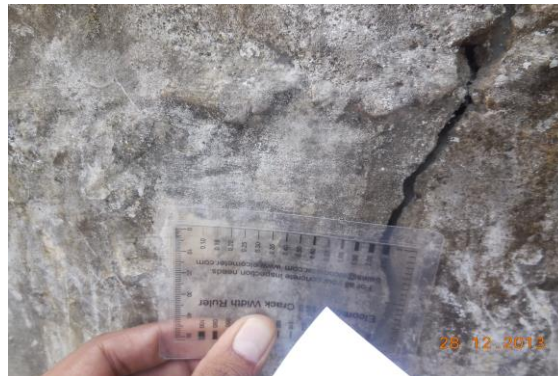
Photo 18A

Inclined Crack on Wall No. 1 of Open Area 1 of Navjeevan Chikitsalaya, Ground Floor Approx. Width = 4mm, Approx. Length = 1.5m. Distance from Wall No.4 = 4m, Height from Floor = 1m.

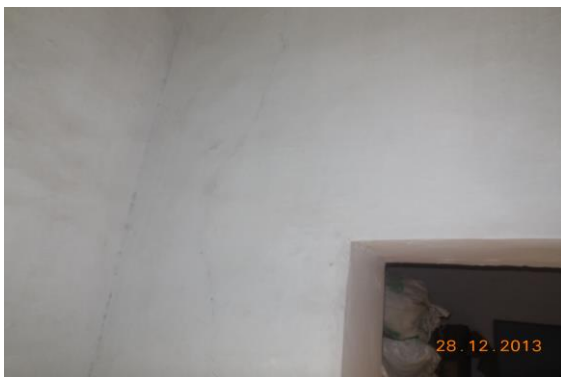
Photo 19

Inclined Crack on Wall No. 1 of Room No. 9, Part A of Navjeevan Chikitsalaya, Ground Floor Approx. Width = 0.35mm, Approx. Length = 1.5m. Distance from Wall No.3 = 0.25m, Height from Floor = 1.6m.

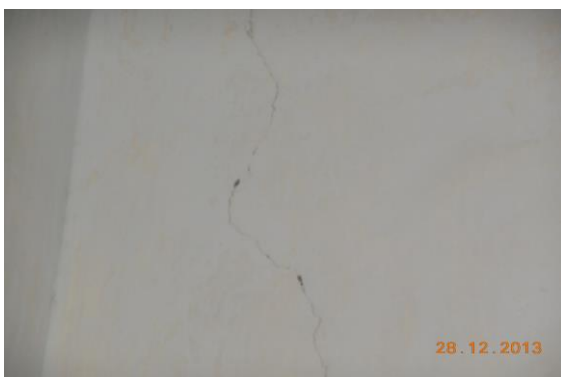
Photo 19A

Inclined Crack on Wall No. 1 of Room No. 9, Part A of Navjeevan Chikitsalaya, Ground Floor Approx. Width = 0.35mm, Approx. Length = 1.5m. Distance from Wall No.3 = 0.25m, Height from Floor = 1.6m.

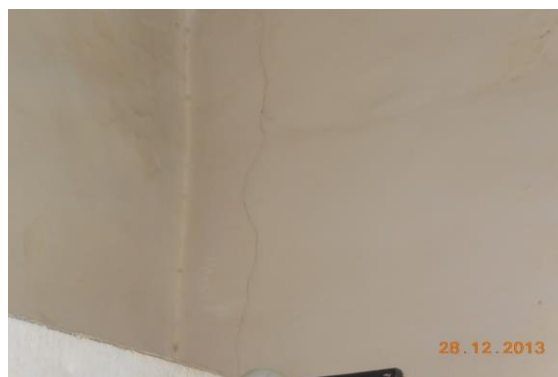
Photo 20

Inclined Crack on Wall No.4 & Roof of Room No. 9, Part B of Navjeevan Chikitsalaya, G/F Approx. Width = 0.35mm, Approx. Length = 3m. Distance from Wall No.1 = 2m, Height from Floor=2m.

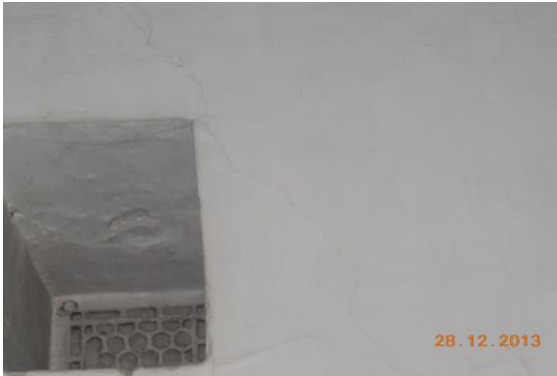
Photo 21

Vertical Crack on Wall No. 3 of Room No. 8, Part A of Navjeevan Chikitsalaya, G/F Approx. Width = 0.5mm, Approx. Length = 1m. Distance from Wall No.2 = 0.15m, Height from Floor = 2m.

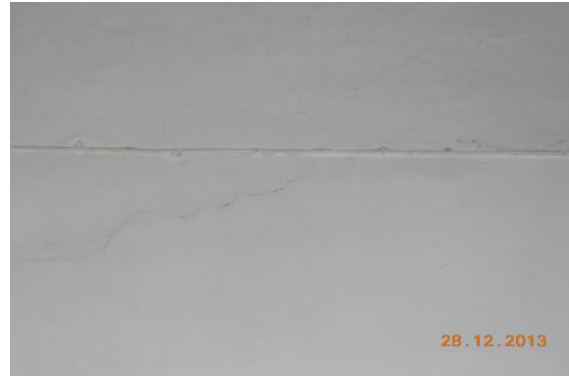
Photo 22

Inclined Crack on Wall No. 4 of Room No. 8, Part B of Navjeevan Chikitsalaya, G/F Approx. Width = 0.3mm, Approx. Length = 1.5m. Distance from Wall No.2 = 0.8m, Height from Floor = 2m.

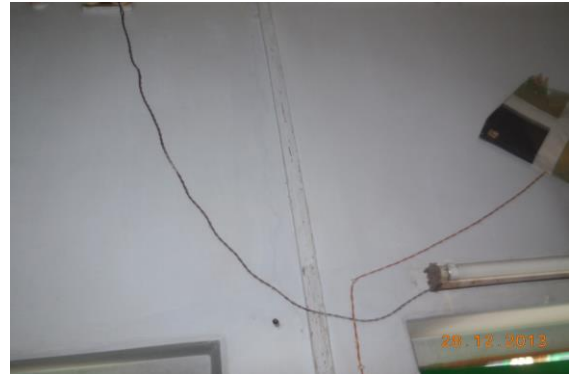
Photo 23A

Inclined Crack on Wall No. 3 of Room No. 8, Part B of Navjeevan Chikitsalaya, G/F r Approx. Width = 0.25mm, Approx. Length = 4m. Distance from Wall No.2 = 0.3m, Height from Floor = 0.4m.

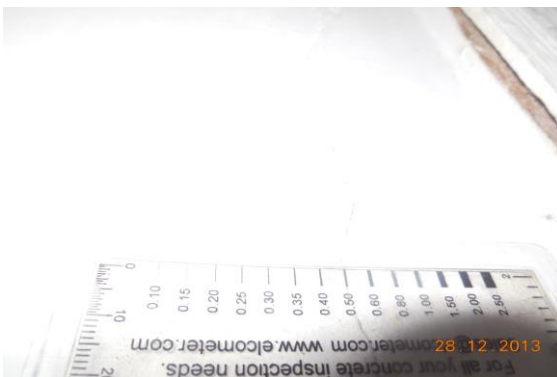
Photo 24

Vertical Crack on Wall No. 3 of Room No. 11, Navjeevan Chikitsalaya, G/F Approx. Width = 0.5mm, Approx. Length = 1.5m. Distance from Wall No.1 = 2m, Height from Floor = 1.5m.

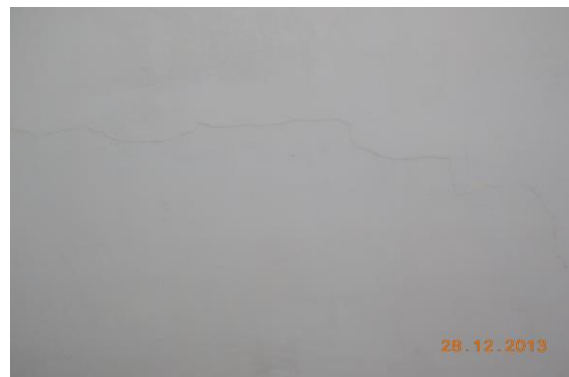
Photo 24A

Vertical Crack on Wall No. 3 of Room No. 11, Navjeevan Chikitsalaya, G/F Approx. Width = 0.5mm, Approx. Length = 1.5m. Distance from Wall No.1 = 2m, Height from Floor = 1.5m.

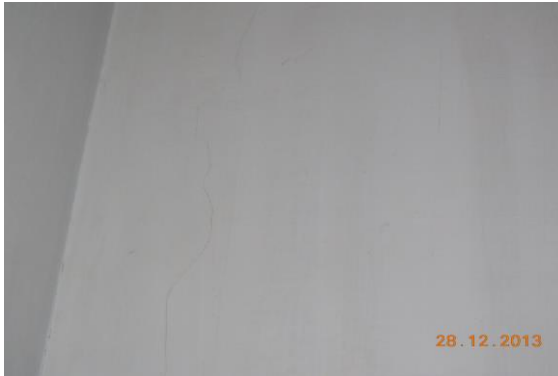
Photo 25

Horizontal Crack on Roof of Room No. 11, Navjeevan Chikitsalaya, Ground Floor Approx. Width = 0.5mm, Approx. Length = 1m. Distance from Wall No.1 = 0.7m, Height from Floor = 3.3m.

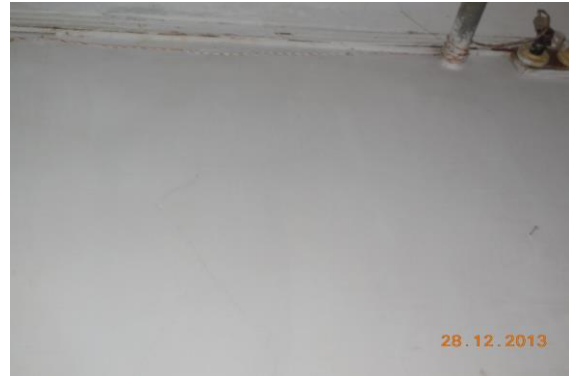
Photo 26

Inclined Crack on Wall No. 4 of Room No. 11, Navjeevan Chikitsalaya, G/F Approx. Width = 0.35mm, Approx. Length = 1.5m. Distance from Wall No.1 = 0.15m, Height from Floor = 2m.

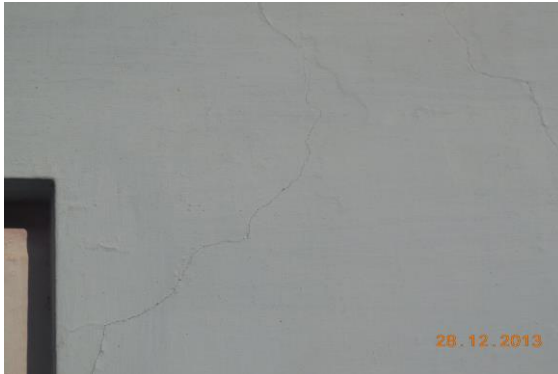
Photo 27

Inclined Crack on Wall No. 3 of Room No. 11, Navjeevan Chikitsalaya, G/F Approx. Width = 0.25mm, Approx. Length = 2m. Distance from Wall No.2 = 1.8m, Height from Floor = 2m.

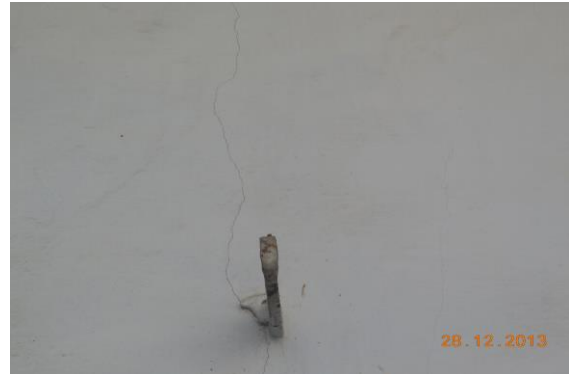
Photo 28

Inclined Crack on Wall No. 3 of Open Varanda of Navjeevan Chikitsalaya, G/F Approx. Width = 0.2mm, Approx. Length = 1.4m. Distance from Wall No.2 = 4m, Height from Floor = 1.8m.

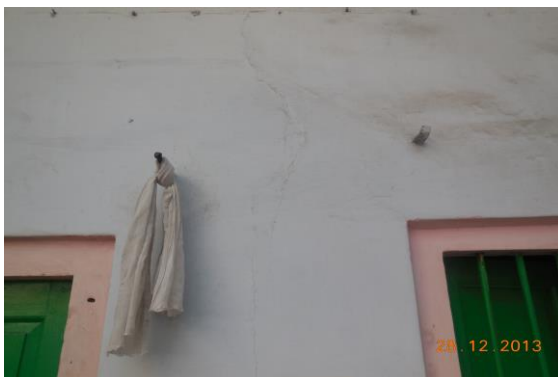
Photo 29

Inclined Crack on Wall No. 4 of Open Varanda of Navjeevan Chikitsalaya, G/F Approx. Width = 0.35mm, Approx. Length = 1.6m. Distance from Wall No.1 = 4.2m, Height from Floor = 1.6m.

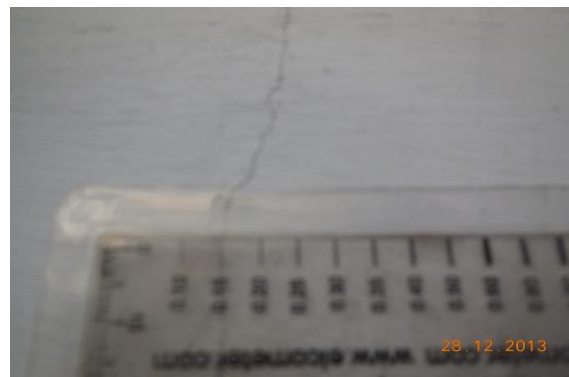
Photo 30

Inclined Crack on Wall No. 1 of Open Varanda of Navjeevan Chikitsalaya, G/F Approx. Width = 0.15mm, Approx. Length = 2.5m. Distance from Wall No.4 = 3.3m, Height from Floor = 0.7m.

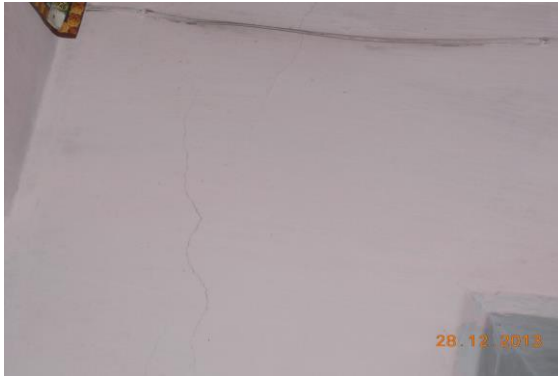
Photo 30A

Inclined Crack on Wall No. 1 of Open Varanda of Navjeevan Chikitsalaya, G/F Approx. Width = 0.15mm, Approx. Length = 2.5m. Distance from Wall No.4 = 3.3m, Height from Floor = 0.7m.

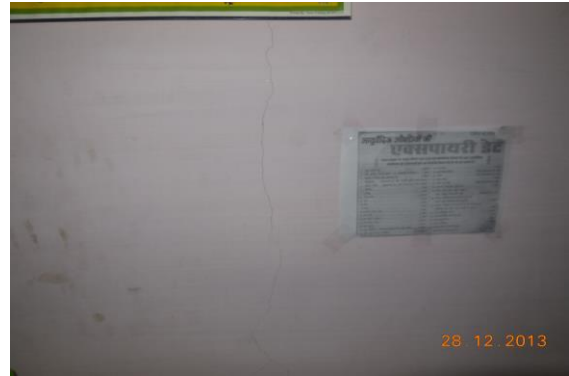
Photo 31

Inclined Crack on Wall No. 4 of Part-A of Shop of Navjeevan Chikitsalaya, G/F Approx. Width = 0.2mm, Approx. Length = 1.5m. Distance from Wall No.1 = 0.15m, Height from Floor = 1.8m.

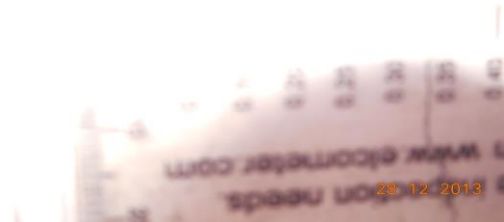
Photo 32A

Inclined Crack on Wall No. 2 of Part-A of Shop of Navjeevan Chikitsalaya, G/F Approx. Width = 0.35mm, Approx. Length = 2m. Distance from Wall No.4 = 3m, Height from Floor = 0m.

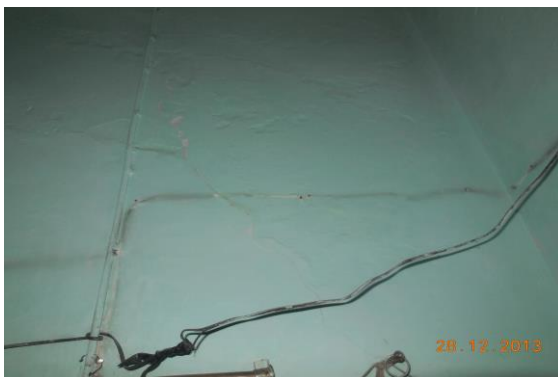
Photo 32A

Inclined Crack on Wall No. 2 of Part-A of Shop of Navjeevan Chikitsalaya, G/F Approx. Width = 0.35mm, Approx. Length = 2m. Distance from Wall No.4 = 3m, Height from Floor = 0m.

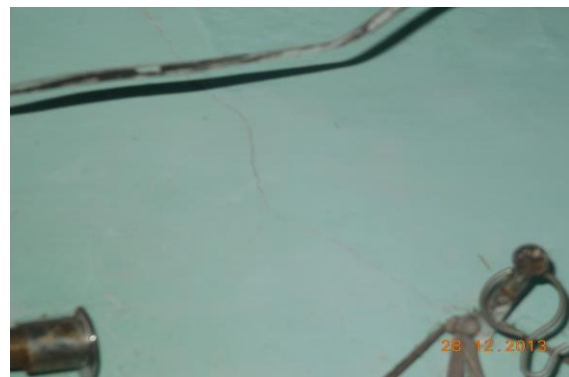
Photo 33

Inclined Crack on Wall No. 2 of Part-B of Shop of Navjeevan Chikitsalaya, G/F Approx. Width = 0.3mm, Approx. Length = 0.6m. Distance from Wall No.3 = 0.25m, Height from Floor = 1.9m.

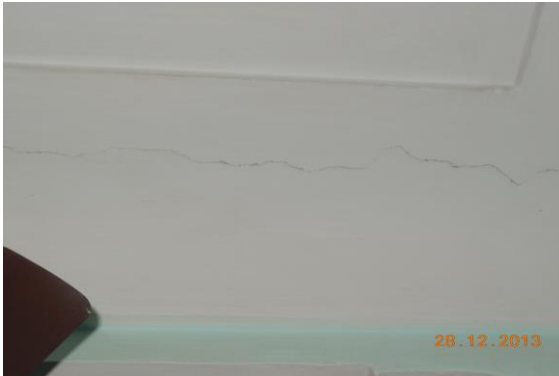
Photo 33A

Inclined Crack on Wall No. 2 of Part-B of Shop of Navjeevan Chikitsalaya, G/F Approx. Width = 0.3mm, Approx. Length = 0.6m. Distance from Wall No.3 = 0.25m, Height from Floor = 1.9m.

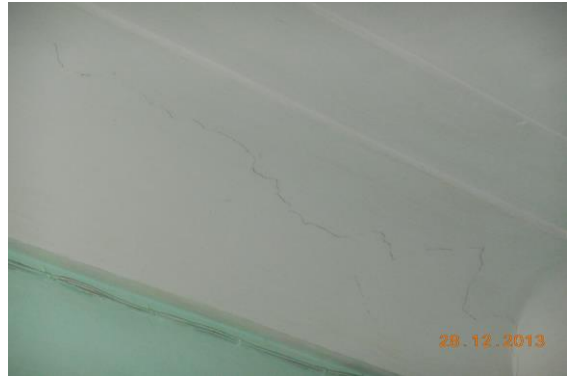
Photo 34

Horizontal Crack on Roof of Room No. 13, Navjeevan Chikitsalaya, G/F
Approx. Width = 0.6mm, Approx. Length = 3m. Distance from Wall No.1 = 0m, Height from Floor = 3.3m.

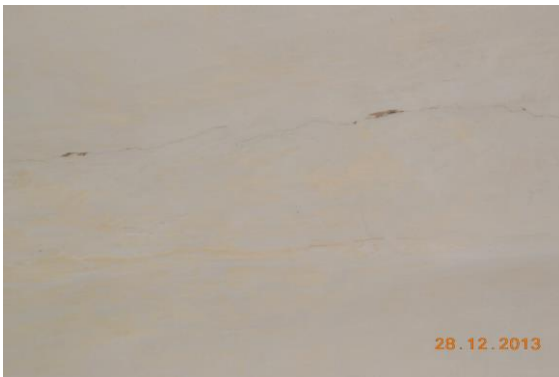
Photo 35

Horizontal Crack on Roof of Room No. 13, Navjeevan Chikitsalaya, G/F
Approx. Width = 0.5mm, Approx. Length = 1.5m.
Distance from Wall No.4 = 0m, Height from Floor = 3.3m.

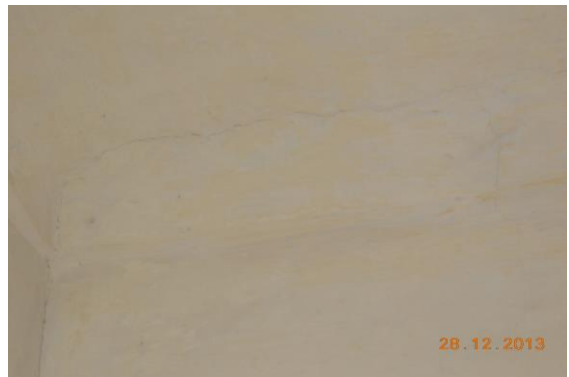
Photo 36

Horizontal Crack on Roof of Room No. 14, Part A of Navjeevan Chikitsalaya, G/F
Approx. Width = 0.4mm, Approx. Length = 1.8m.
Distance from Wall No.3 = 0m, Height from Floor = 3.3m.

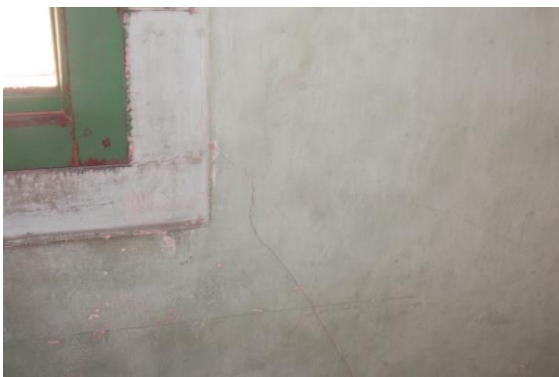
Photo 37

Horizontal Crack on Roof of Room No. 14, Part B of Navjeevan Chikitsalaya, G/F
Distance from Wall No.4 = 0m, Height from Floor = 3.3m.

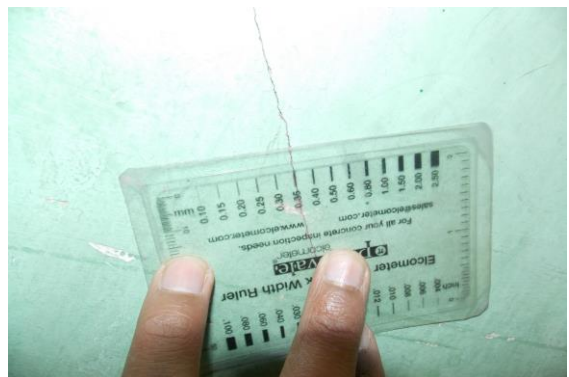
Photo 38

Inclined Crack on Wall No. 1 of Room No. 2, Navjeevan Chikitsalaya, First Floor
Approx. Width = 0.35mm, Approx. Length = 1m. Distance from Wall No.4 = 0.6m, Height from Floor = 0m.

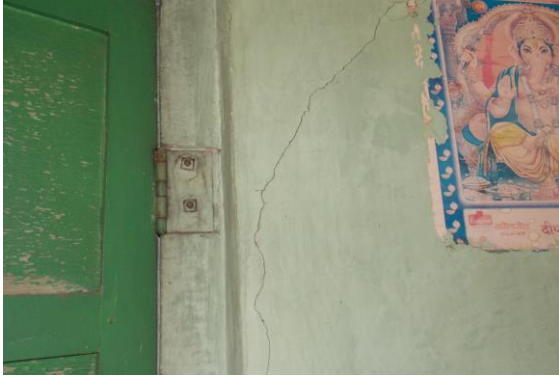
Photo 38A

Inclined Crack on Wall No. 1 of Room No. 2, Navjeevan Chikitsalaya, First Floor
Approx. Width = 0.35mm, Approx. Length = 1m. Distance from Wall No.4 = 0.6m, Height from Floor = 0m.

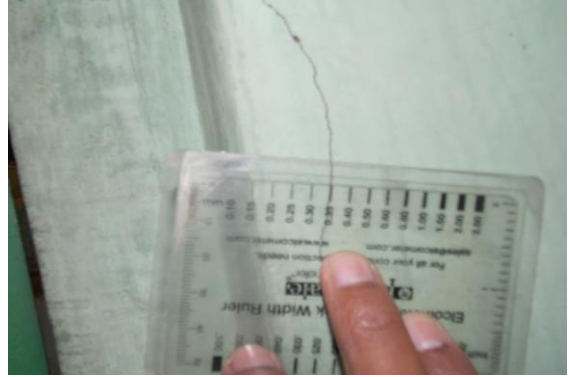
Photo 39

Inclined Crack on Wall No. 4 of Room No. 2, Navjeevan Chikitsalaya, First Floor Approx. Width = 0.35mm, Approx. Length = 1.3m. Distance from Wall No.2 = 0.7m, Height from Floor = 1.2m.

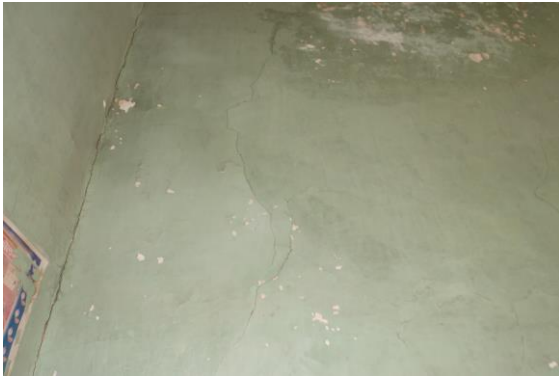
Photo 39A

Inclined Crack on Wall No. 4 of Room No. 2, Navjeevan Chikitsalaya, First Floor Approx. Width = 0.35mm, Approx. Length = 1.3m. Distance from Wall No.2 = 0.7m, Height from Floor = 1.2m.

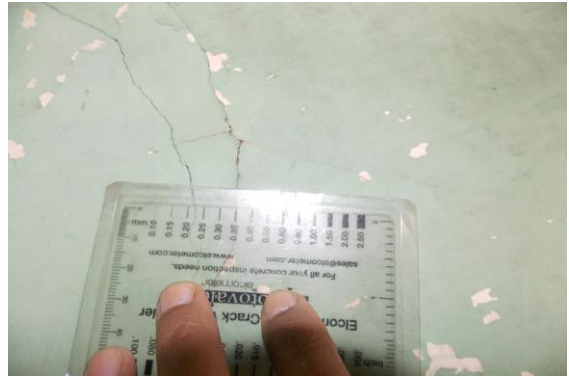
Photo 40

Inclined Crack on Wall No. 2 of Room No. 2, Navjeevan Chikitsalaya, First Floor Approx. Width = 0.35mm, Approx. Length = 2.1m. Distance from Wall No.4 = 0.1m, Height from Floor = 1.5m.

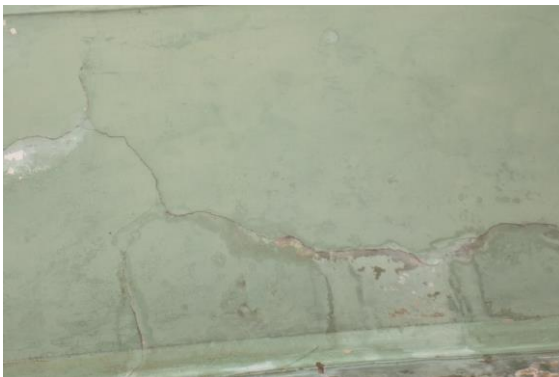
Photo 40A

Inclined Crack on Wall No. 2 of Room No. 2, Navjeevan Chikitsalaya, First Floor Approx. Width = 0.35mm, Approx. Length = 2.1m. Distance from Wall No.4 = 0.1m, Height from Floor = 1.5m.

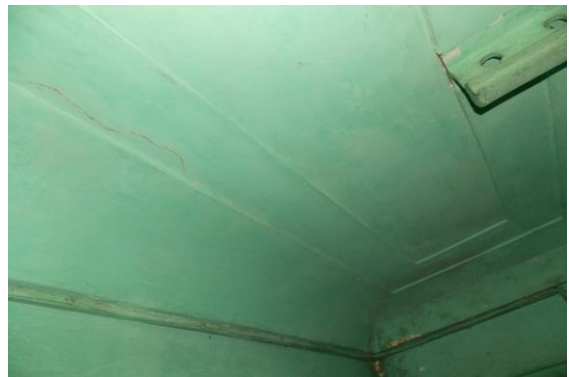
Photo 41

Inclined Crack on Roof of Room No. 2, Navjeevan Chikitsalaya, First Floor Approx. Width = 0.8mm, Approx. Length = 2m. Distance from Wall No.2 = 0.15m, Height from Floor = 3m.

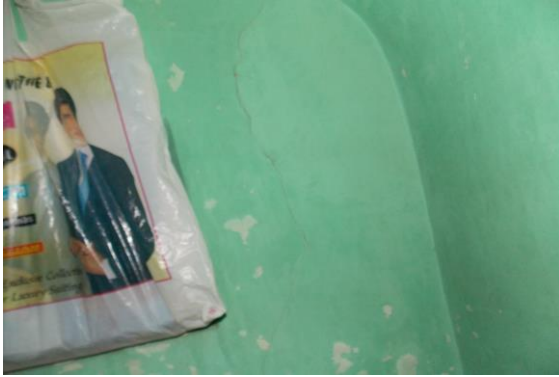
Photo 42

Inclined Crack on Wall No. 1 & Roof of Room No. 1, Navjeevan Chikitsalaya, M/Floor Approx. Width = 1mm, Approx. Length = 2.5m. Distance from Wall No.3 = 0.1m, Height from Floor = 1m.

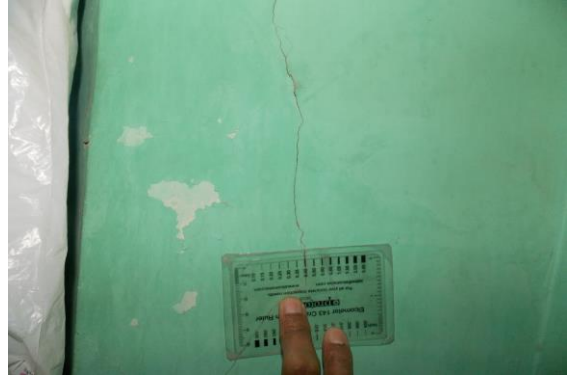
Photo 43

Inclined Crack on Wall No. 1 of Room No. 1, Navjeevan Chikitsalaya, M/Floor Approx. Width = 0.4mm, Approx. Length = 1.2m. Distance from Wall No.3 = 0.7m, Height from Floor = 0.7m.

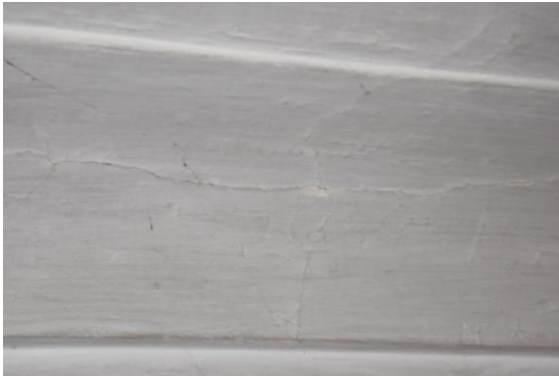
Photo 43A

Inclined Crack on Wall No. 1 of Room No. 1, Navjeevan Chikitsalaya, M/Floor Approx. Width = 0.4mm, Approx. Length = 1.2m. Distance from Wall No.3 = 0.7m, Height from Floor = 0.7m.

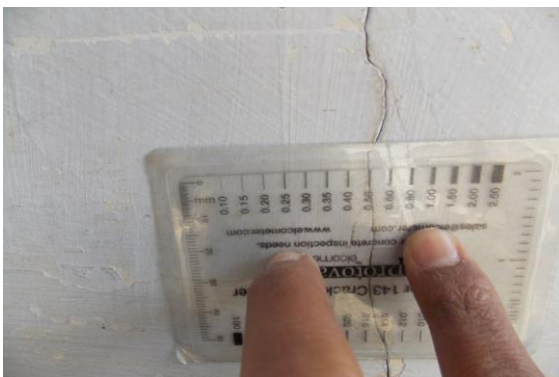
Photo 45

Inclined Crack on Wall No. 1 of Passage 1 of Navjeevan Chikitsalaya, First Floor Approx. Width = 0.5mm, Approx. Length = 1.5m. Distance from Wall No.4 = 2.7m, Height from Floor = 0m.

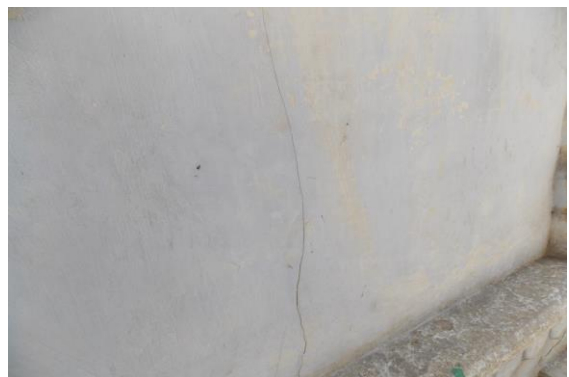
Photo 45A

Inclined Crack on Wall No. 1 of Passage 1 of Navjeevan Chikitsalaya, First Floor Approx. Width = 0.5mm, Approx. Length = 1.5m. Distance from Wall No.4 = 2.7m, Height from Floor = 0m.

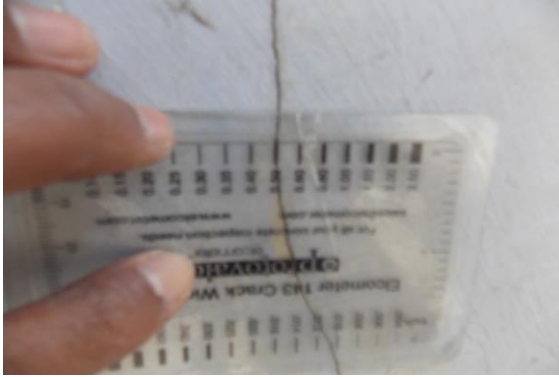
Photo 46

Inclined Crack on Wall No. 1 of Passage 1 of Navjeevan Chikitsalaya, First Floor Approx. Width = 0.5mm, Approx. Length = 1.7m. Distance from Wall No.4 = 1.5m, Height from Floor = 0m.

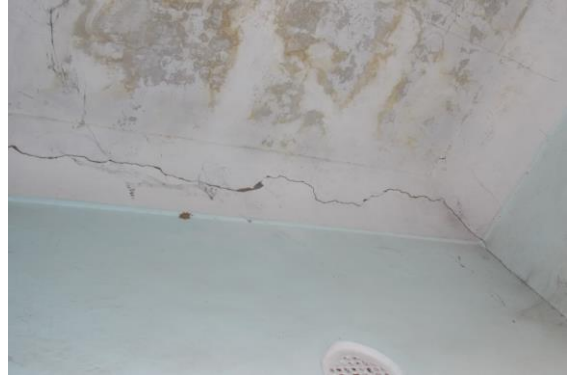
Photo 46A

Inclined Crack on Wall No. 1 of Passage 1 of Navjeevan Chikitsalaya, First Floor Approx. Width = 0.5mm, Approx. Length = 1.7m. Distance from Wall No.4 = 1.5m, Height from Floor = 0m.

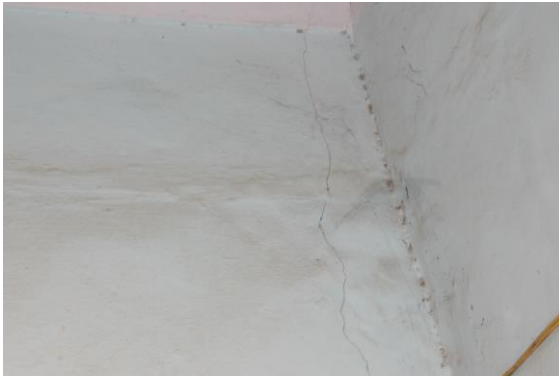
Photo 47

Inclined Crack on Wall No. 4 & Roof of Lobby of Navjeevan Chikitsalaya, First Floor Approx. Width = 3mm, Approx. Length = 3.6m. Distance from Wall No.1 & 4 = 0m, Height from Floor = 2.4m.
