Pre Building Condition Survey Report

Name and Address of Structure :	Badi Chopar to Ramp Area (Down Line)
---------------------------------	--------------------------------------

Name of the Project	Contract JMRC-UG1B “Design and Construction of Tunnel between Chandpole and Badi Chouper and reverse line by Shield TBM, Underground Metro Stations at Choti Chouper and Badi Chouper by Cut and Cover Methods on East West Corridor of Jaipur Metro Rail Corporation Limited .”	
Owner :

Pre - Condition Building Survey for Construction of Underground Stations from Chandpole to Bari Chouper and reversal line

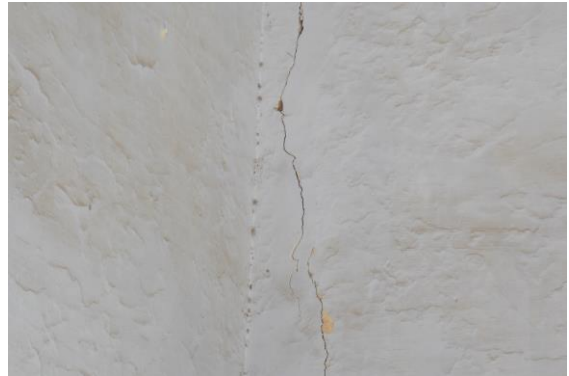
Photo 49

Inclined Crack on Wall No. 4 of Varanda 1 of Navjeevan Chikitsalaya, First Floor

Approx. Width = 5mm, Approx. Length = 2.3m.
Distance from Wall No 1 = 0.3m Height from Floor = 2.5m

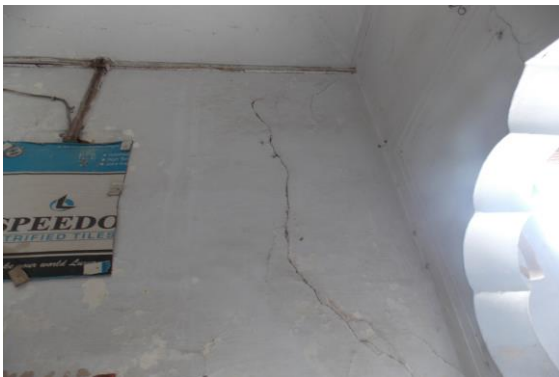
Photo 50

Inclined Crack on Wall No. 2 of Varanda 2 of Navjeevan Chikitsalaya, First Floor Approx. Width = 1mm, Approx. Length = 2m. Distance from Wall No.3 = 0m, Height from Floor = 1.9m.

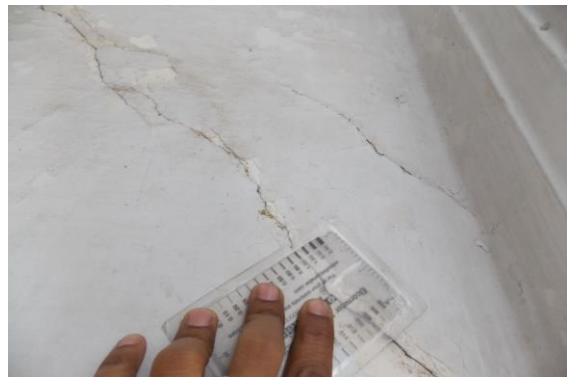
Photo 50A

Inclined Crack on Wall No. 2 of Varanda 2 of Navjeevan Chikitsalaya, First Floor Approx. Width = 1mm, Approx. Length = 2m. Distance from Wall No.3 = 0m, Height from Floor = 1.9m.

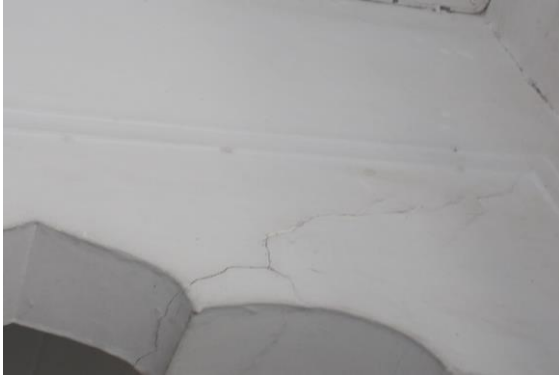
Photo 51

Inclined Crack on Wall No. 4 of Varanda 2 of Navjeevan Chikitsalaya, First Floor Approx. Width = 0.6mm, Approx. Length = 1m. Distance from Wall No.2 = 0.4m, Height from Floor = 2.2m.

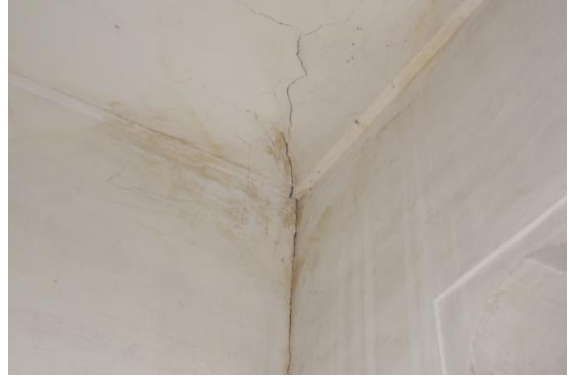
Photo 52

Inclined Crack on Wall No. 2 & 3 of Room No. 5, Navjeevan Chikitsalaya, First Floor Approx. Width = 2mm, Approx. Length = 2.5m. Distance from Wall No.2 & 3 = 0m, Height from Floor = 1.1m.

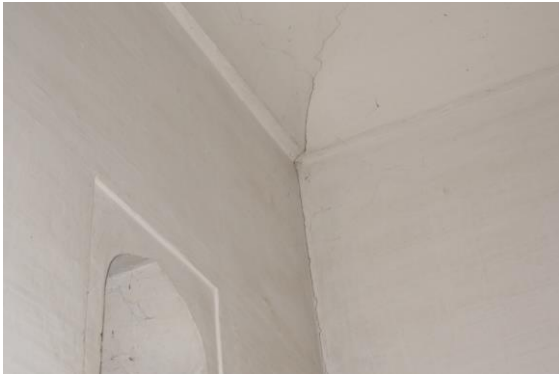
Photo 53

Inclined Crack on Wall No. 1 & 3 of Navjeevan Chikitsalaya, First Floor Approx. Width = 1.5mm, Approx. Length = 2.5m. Distance from Wall No.1 & 3 = 0m, Height from Floor = 2m.

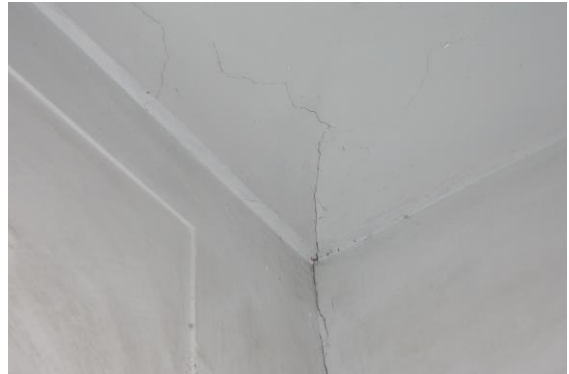
Photo 54

Inclined Crack on Wall No. 4 & Roof of Room No. 6, Navjeevan Chikitsalaya, First Floor Approx. Width = 0.8mm, Approx. Length = 5.5m. Distance from Wall No 2 = 2.5m Height from Floor = 1.2m

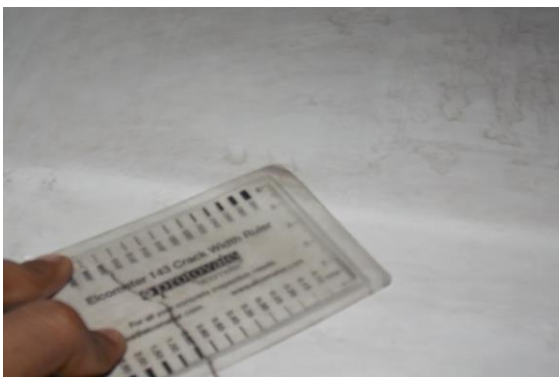
Photo 54A

Inclined Crack on Wall No. 4 & Roof of Room No. 6, Navjeevan Chikitsalaya, First Floor Approx. Width = 0.8mm, Approx. Length = 5.5m. Distance from Wall No.2 = 2.5m, Height from Floor = 1.2m.

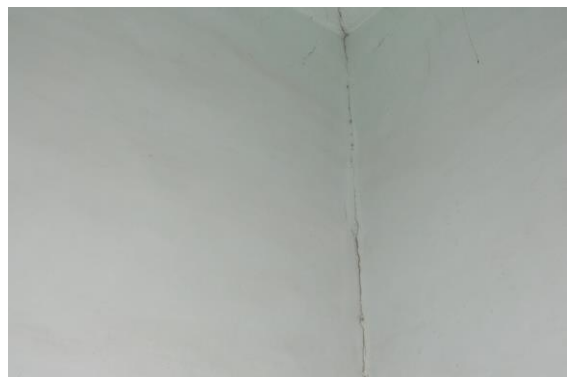
Photo 55

Inclined Crack on Wall No. 4 & Roof of Store 2 of Navjeevan Chikitsalaya, First Floor Approx. Width = 0.8mm, Approx. Length = 5.5m. Distance from Wall No.1 = 0.6m, Height from Floor = 0.4m.

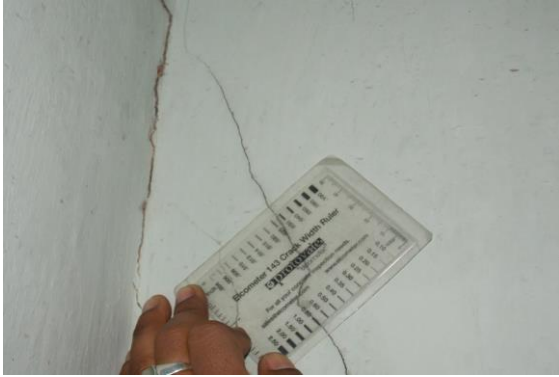
Photo 55A

Inclined Crack on Wall No. 4 & Roof of Store 2 of Navjeevan Chikitsalaya, First Floor Approx. Width = 0.8mm, Approx. Length = 5.5m. Distance from Wall No.1 = 0.6m, Height from Floor = 0.4m.

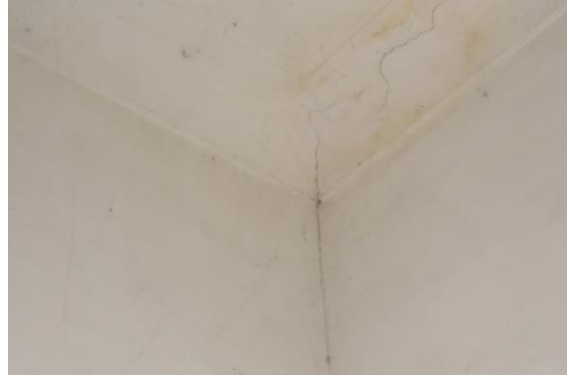
Photo 55A

Inclined Crack on Wall No. 4 & Roof of Store 2 of Navjeevan Chikitsalaya, First Floor Approx. Width = 0.8mm, Approx. Length = 5.5m. Distance from Wall No.1 = 0.6m, Height from Floor = 0.4m.

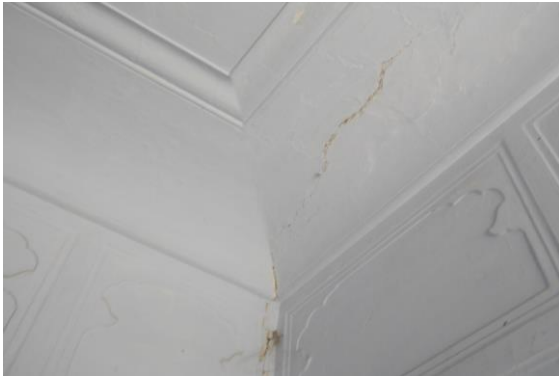
Photo 56

Inclined Crack on Wall No. 4 & Roof of Varanda 4 of Navjeevan Chikitsalaya, First Floor Approx. Width = 3mm, Approx. Length = 2.1m. Distance from Wall No.2 = 0.05m, Height from Floor = 3m.

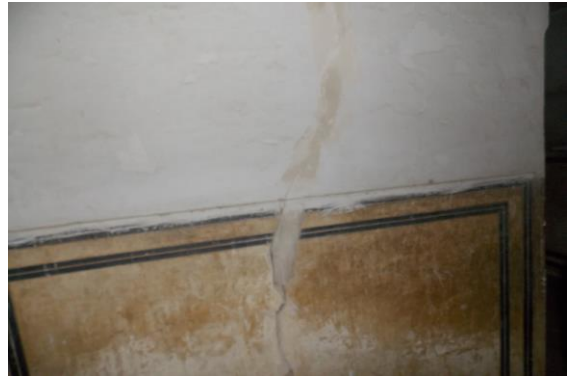
Photo 57

Inclined Crack on Wall No. 2 & Roof of Varanda 7 of Navjeevan Chikitsalaya, First Floor Approx. Width = 2mm, Approx. Length = 5m. Distance from Wall No.3 = 0.6m, Height from Floor = 0m.

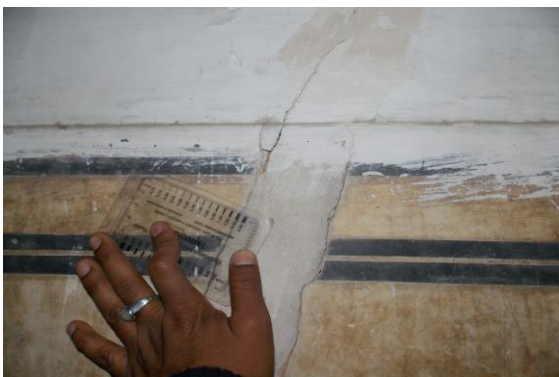
Photo 57A

Inclined Crack on Wall No. 2 & Roof of Varanda 7 of Navjeevan Chikitsalaya, First Floor Approx. Width = 2mm, Approx. Length = 5m. Distance from Wall No.3 = 0.6m, Height from Floor = 0m.

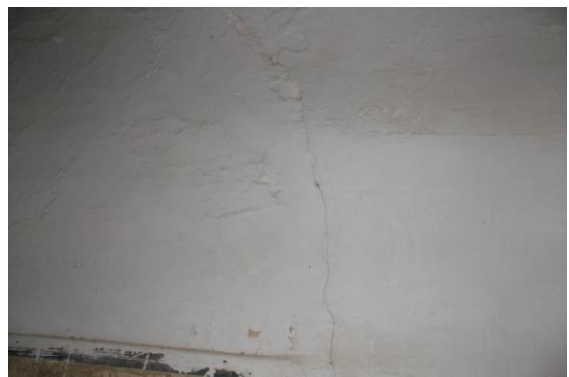
Photo 58

Inclined Crack on Wall No. 1 & Roof of Varanda 7 of Navjeevan Chikitsalaya, First Floor Approx. Width = 0.35mm, Approx. Length = 5m. Distance from Wall No.3 = 1m, Height from Floor = 0m.

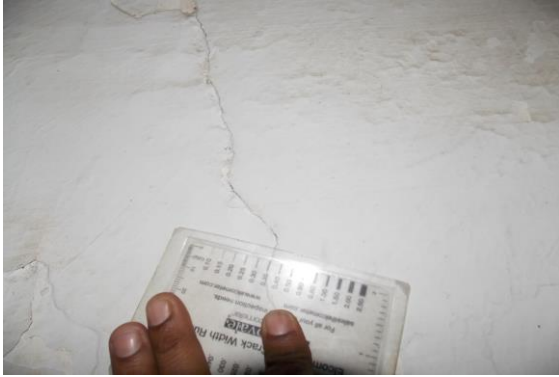
Photo 58A

Inclined Crack on Wall No. 1 & Roof of Varanda 7 of Navjeevan Chikitsalaya, First Floor Approx. Width = 0.35mm, Approx. Length = 5m. Distance from Wall No.3 = 1m, Height from Floor = 0m.

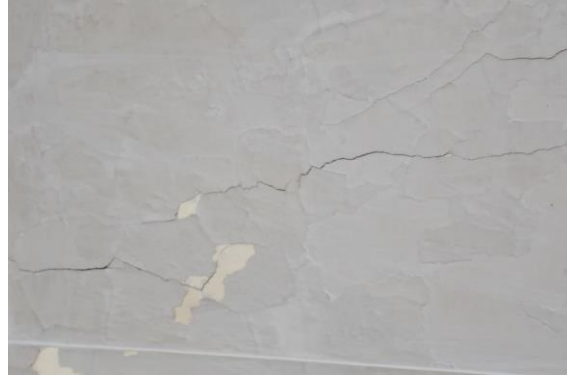
Photo 59

Inclined Crack on Roof of Varanda 8 of Navjeevan Chikitsalaya, First Floor Approx. Width = 1.5mm, Approx. Length = 3m. Distance from Wall No.3 = 1.5m, Height from Floor = 4m.

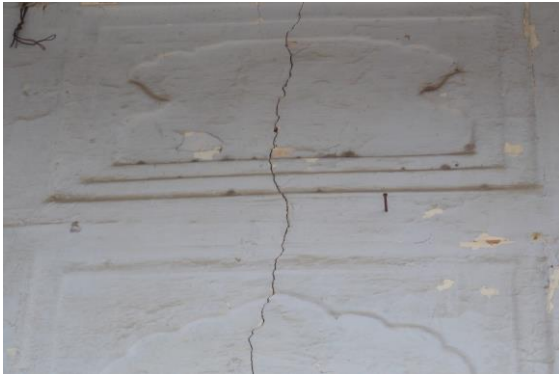
Photo 60

Inclined Crack on Wall No. 3 & Sunshade of Open Sky of Navjeevan Chikitsalaya, First Floor
Approx. Width = 1mm, Approx. Length = 2.5m.
Distance from Wall No 2 = 1.7m Height from Floor = 2.1m

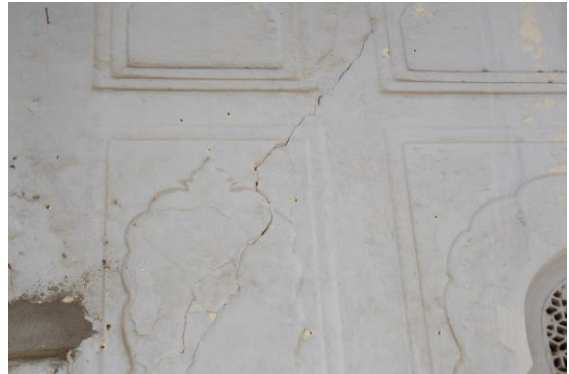
Photo 61

Inclined Crack on Wall No. 2 of Open Sky of Navjeevan Chikitsalaya, First Floor
Approx. Width = 1.5mm, Approx. Length = 2m.
Distance from Wall No 3 = 1.8m Height from Floor = 2m

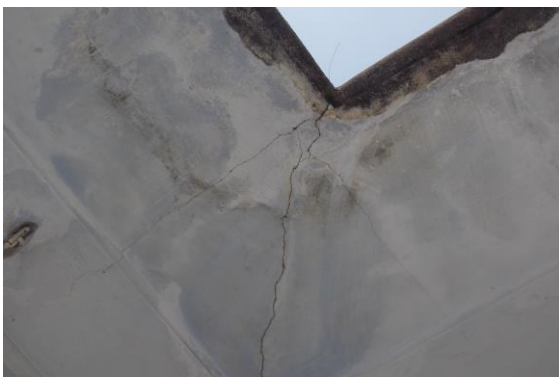
Photo 62

Horizontal Crack on Sunshade of Open Sky of Navjeevan Chikitsalaya, First Floor Approx. Width = 0.4mm, Approx. Length = 1m. Distance from Wall No.2 & 3 = 0m, Height from Floor = 3.5m.

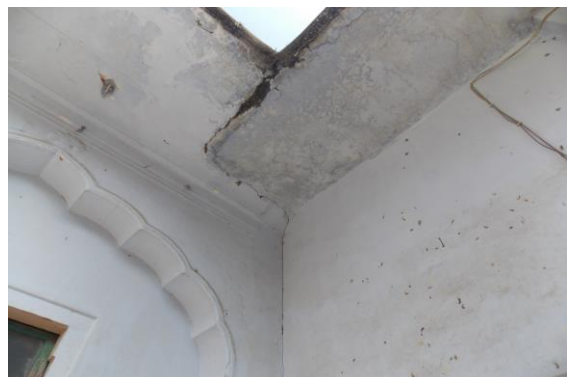
Photo 63

Inclined Crack on Wall No. 3 & Shade of Open Sky of Navjeevan Chikitsalaya, F/F Approx. Width = 1.5mm, Approx. Length = 1.7m. Distance from Wall No.3 = 0.15m, Height from Floor = 3.5m.

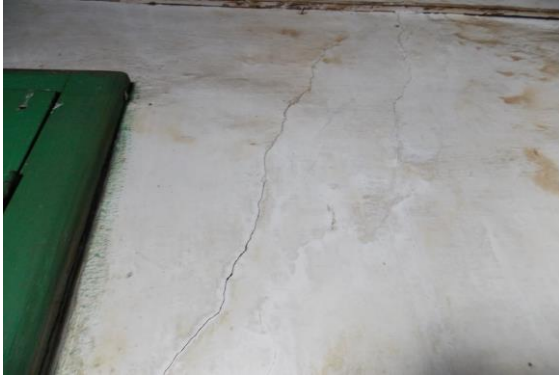
Photo 64

Inclined Crack on Wall No. 4 of Room No. 10, Navjeevan Chikitsalaya, First Floor Approx. Width = 0.6mm, Approx. Length = 2.7m. Distance from Wall No.2 = 2.7m, Height from Floor = 1.6m.

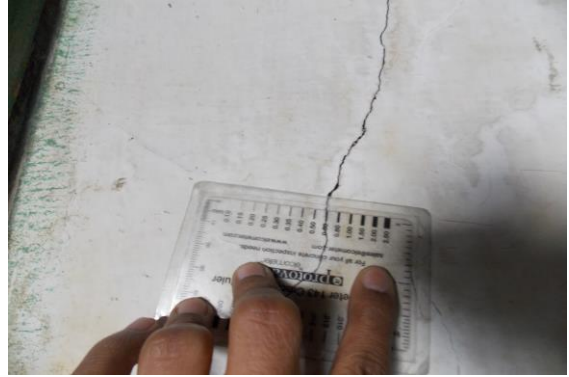
Photo 64A

Inclined Crack on Wall No. 4 of Room No. 10, Navjeevan Chikitsalaya, First Floor Approx. Width = 0.6mm, Approx. Length = 2.7m. Distance from Wall No.2 = 2.7m, Height from Floor = 1.6m.

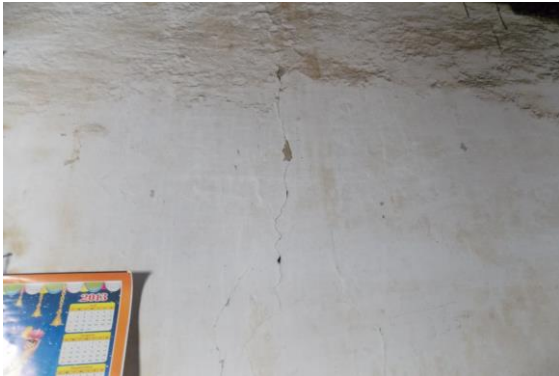
Photo 65

Inclined Crack on Wall No. 4 of Room No. 10, Navjeevan Chikitsalaya, First Floor Approx. Width = 0.8mm, Approx. Length = 3m. Distance from Wall No.2 = 1.8m, Height from Floor = 1m.

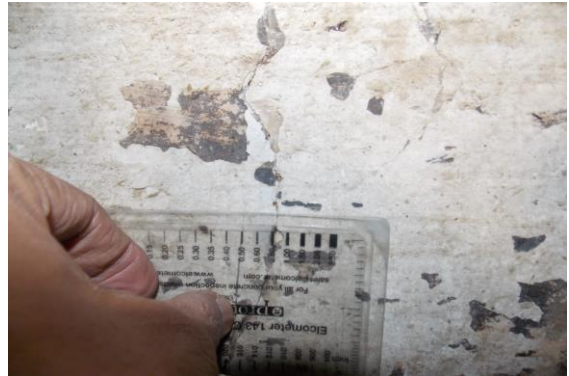
Photo 65A

Inclined Crack on Wall No. 4 of Room No. 10, Navjeevan Chikitsalaya, First Floor Approx. Width = 0.8mm, Approx. Length = 3m. Distance from Wall No.2 = 1.8m, Height from Floor = 1m.

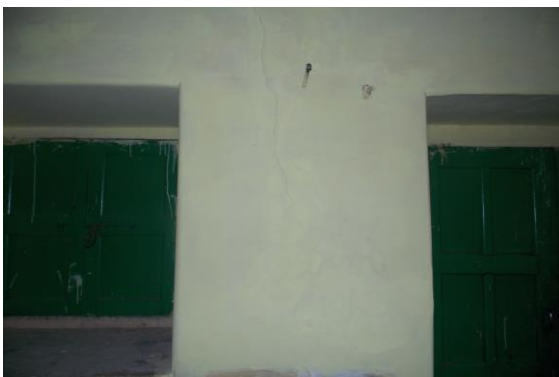
Photo 66

Inclined Crack on Wall No. 3 of Hall 1 of Navjeevan Chikitsalaya, First Floor Approx. Width = 0.4mm, Approx. Length = 4.2m. Distance from Wall No.2 = 5m, Height from Floor = 0m.

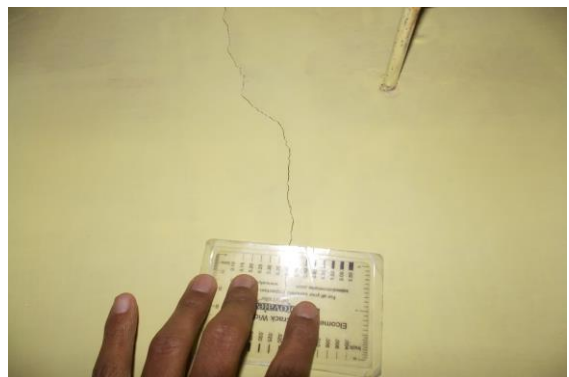
Photo 66A

Inclined Crack on Wall No. 3 of Hall 1 of Navjeevan Chikitsalaya, First Floor Approx. Width = 0.4mm, Approx. Length = 4.2m. Distance from Wall No.2 = 5m, Height from Floor = 0m.

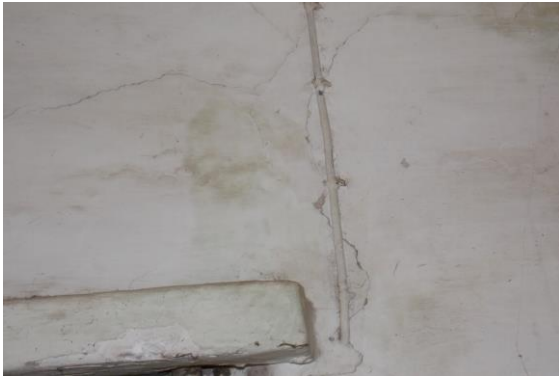
PHOTO 67

Inclined Crack on Wall No. 4 of Room No. 15, Navjeevan Chikitsalaya, First Floor

Approx. Width = 2mm, Approx. Length = 1.6m.
Distance from Wall No 2 = 0.7m Height from Floor = 1m

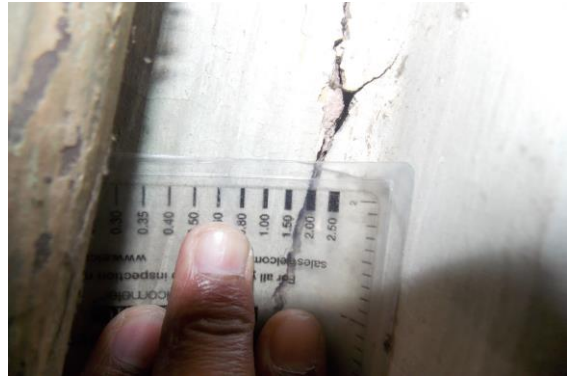
PHOTO 67A

Inclined Crack on Wall No. 4 of Room No. 15, Navjeevan Chikitsalaya, First Floor

Approx. Width = 2mm, Approx. Length = 1.6m.
Distance from Wall No 2 = 0.7m Height from Floor = 1m

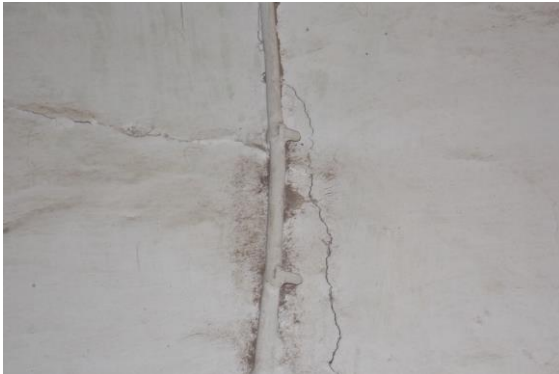
Photo 68

Inclined Crack on Wall No. 3 of Room No. 15, Navjeevan Chikitsalaya, First Floor Approx. Width = 0.4mm, Approx. Length = 1.8m. Distance from Wall No.2 = 0.7m, Height from Floor = 1m.

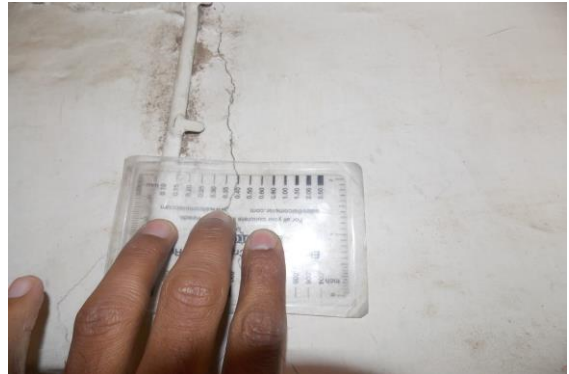
Photo 68A

Inclined Crack on Wall No. 3 of Room No. 15, Navjeevan Chikitsalaya, First Floor Approx. Width = 0.4mm, Approx. Length = 1.8m. Distance from Wall No.2 = 0.7m, Height from Floor = 1m.

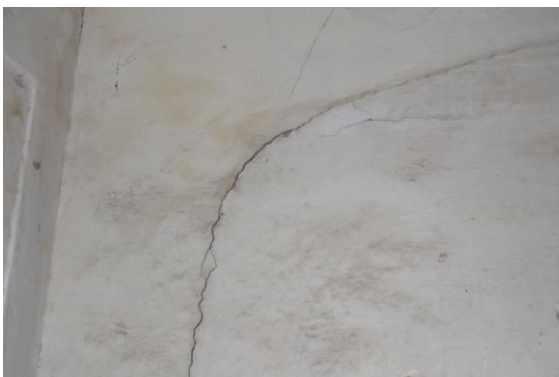
Photo 69

Inclined Crack on Wall No. 1 of Room No. 16, Navjeevan Chikitsalaya, First Floor Approx. Width = 1.5mm, Approx. Length = 1.7m. Distance from Wall No.3 = 0m, Height from Floor = 1.1m.

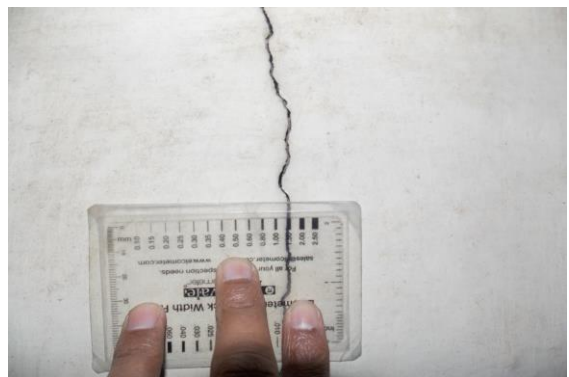
Photo 69A

Inclined Crack on Wall No. 1 of Room No. 16, Navjeevan Chikitsalaya, First Floor Approx. Width = 1.5mm, Approx. Length = 1.7m. Distance from Wall No.3 = 0m, Height from Floor = 1.1m.

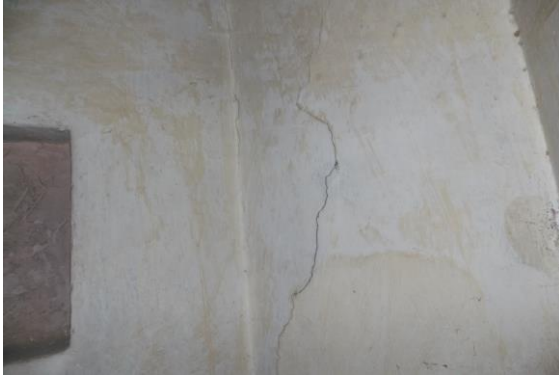
Photo 70

Inclined Crack on Wall No. 2 of Tomb 1 of Navjeevan Chikitsalaya, First Floor Approx. Width = 0.8mm, Approx. Length = 2m. Distance from Wall No.3 = 0.3m, Height from Floor = 0m.

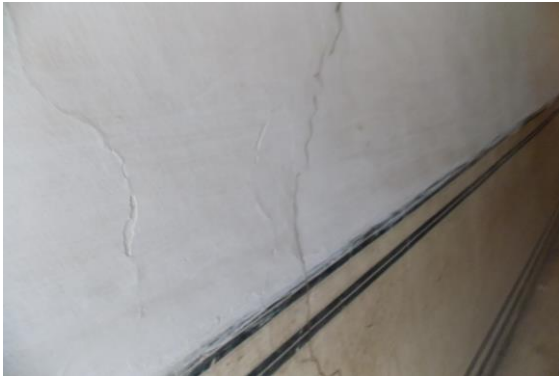
Photo 71

Inclined Crack on Wall No. 1 & Roof of Store 4 of Navjeevan Chikitsalaya, First Floor Approx. Width = 1.5mm, Approx. Length = 5m. Distance from Wall No.3 = 2m, Height from Floor = 0m.

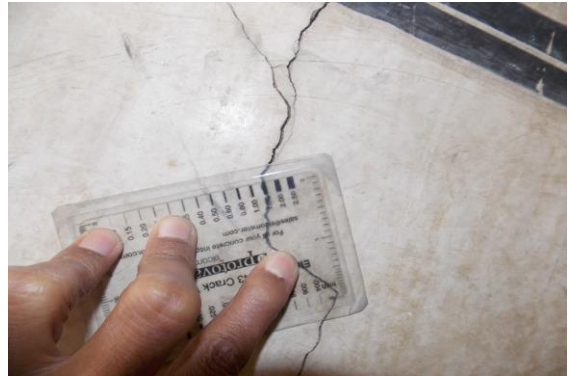
Photo 71A

Inclined Crack on Wall No. 1 & Roof of Store 4 of Navjeevan Chikitsalaya, First Floor Approx. Width = 1.5mm, Approx. Length = 5m. Distance from Wall No.3 = 2m, Height from Floor = 0m.

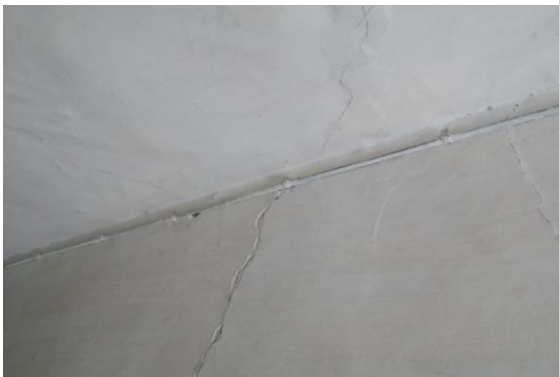
Photo 71A

Inclined Crack on Wall No. 1 & Roof of Store 4 of Navjeevan Chikitsalaya, First Floor Approx. Width = 1.5mm, Approx. Length = 5m. Distance from Wall No.3 = 2m, Height from Floor = 0m.

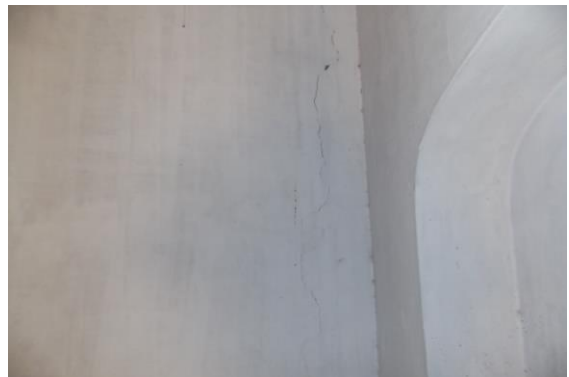
Photo 72

Inclined Crack on Wall No. 4 of Kitchen of Navjeevan Chikitsalaya, First Floor Approx. Width = 0.6mm, Approx. Length = 2.8m. Distance from Wall No.1 = 2.5m, Height from Floor = 0m.

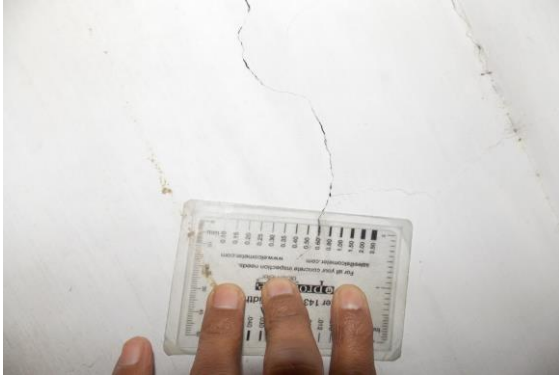
Photo 72A

Inclined Crack on Wall No. 4 of Kitchen of Navjeevan Chikitsalaya, First Floor Approx. Width = 0.6mm, Approx. Length = 2.8m. Distance from Wall No.1 = 2.5m, Height from Floor = 0m.

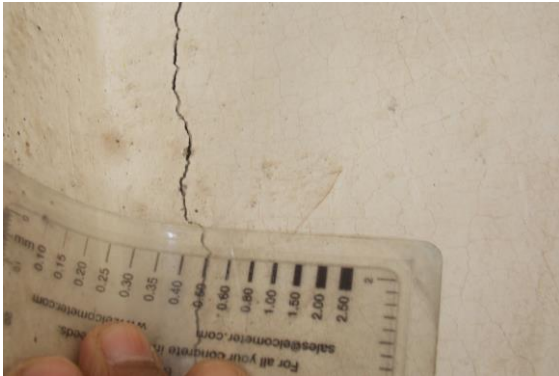
Photo 73

Inclined Crack on Wall No. 4 of Varanda 11 of Navjeevan Chikitsalaya, First Floor Approx. Width = 0.5mm, Approx. Length = 2m. Distance from Wall No.1 = 0m, Height from Floor = 0m.

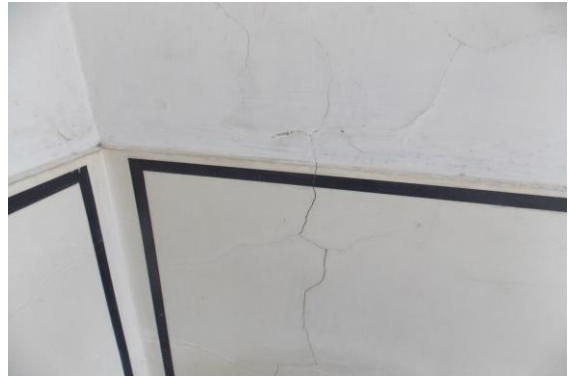
Photo 73A

Inclined Crack on Wall No. 4 of Varanda 11 of Navjeevan Chikitsalaya, First Floor Approx. Width = 0.5mm, Approx. Length = 2m. Distance from Wall No.1 = 0m, Height from Floor = 0m.

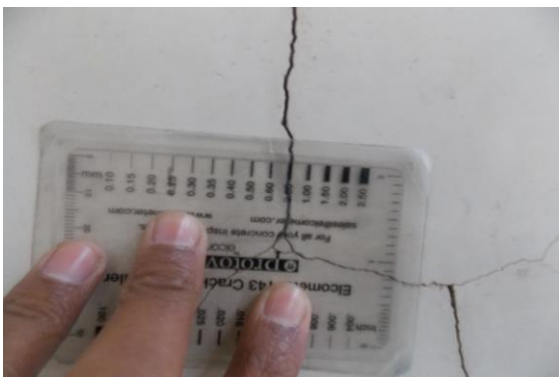
Photo 74

Inclined Crack on Wall No. 2 of Varanda 12 of Navjeevan Chikitsalaya, First Floor Approx. Width = 0.8mm, Approx. Length = 2m. Distance from Wall No.3 = 0.3m, Height from Floor = 0m.

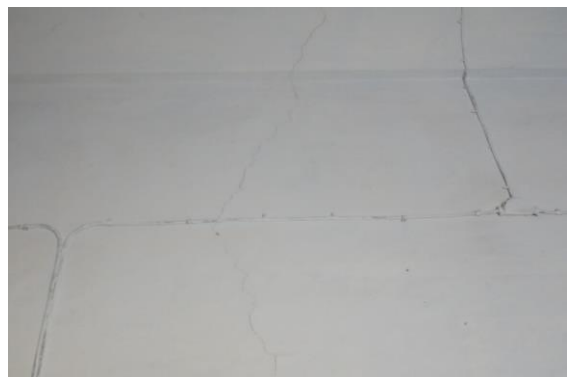
Photo 74A

Inclined Crack on Wall No. 2 of Varanda 12 of Navjeevan Chikitsalaya, First Floor Approx. Width = 0.8mm, Approx. Length = 2m. Distance from Wall No.3 = 0.3m, Height from Floor = 0m.

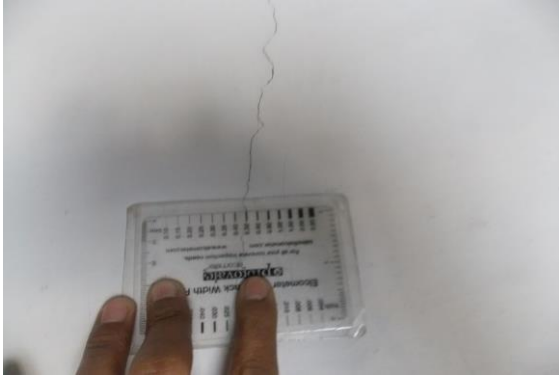
Photo 75

Inclined Crack on Wall No. 4 & Roof of Room No. 17, Navjeevan Chikitsalaya, First Floor Approx. Width = 0.5mm, Approx. Length = 2.3m. Distance from Wall No.1 = 3m, Height from Floor = 0m.

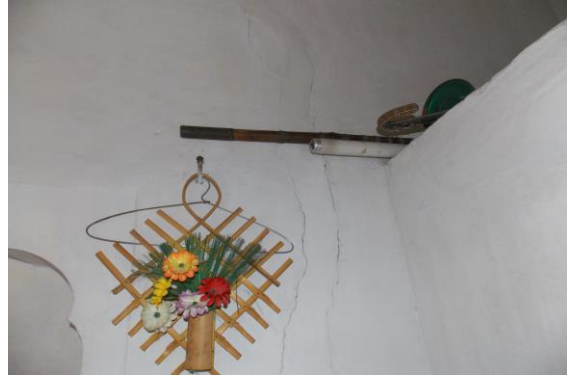
Photo 75A

Inclined Crack on Wall No. 4 & Roof of Room No. 17, Navjeevan Chikitsalaya, First Floor Approx. Width = 0.5mm, Approx. Length = 2.3m. Distance from Wall No.1 = 3m, Height from Floor = 0m.

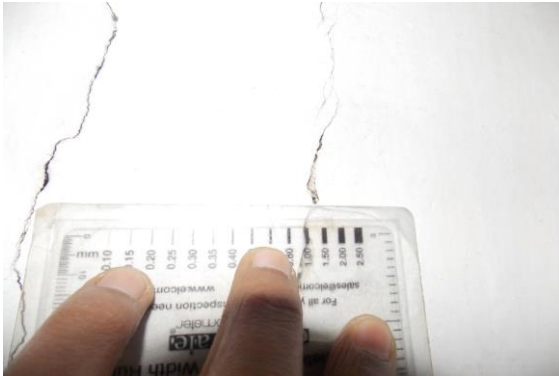
Photo 76

Inclined Crack on Wall No. 4 of Room No. 17, Navjeevan Chikitsalaya, First Floor Approx. Width = 1mm, Approx. Length = 3.5m. Distance from Wall No.2 = 0m, Height from Floor = 0.8m.

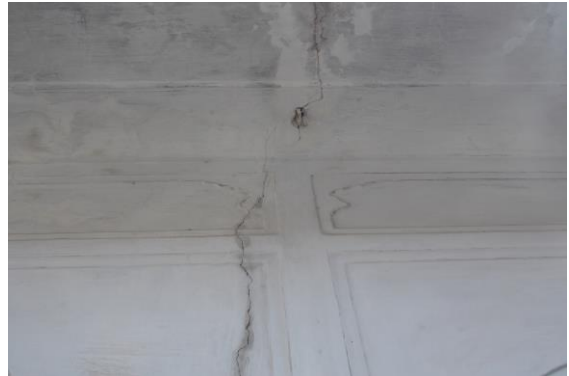
Photo 76A

Inclined Crack on Wall No. 4 of Room No. 17, Navjeevan Chikitsalaya, First Floor Approx. Width = 1mm, Approx. Length = 3.5m. Distance from Wall No.2 = 0m, Height from Floor = 0.8m.

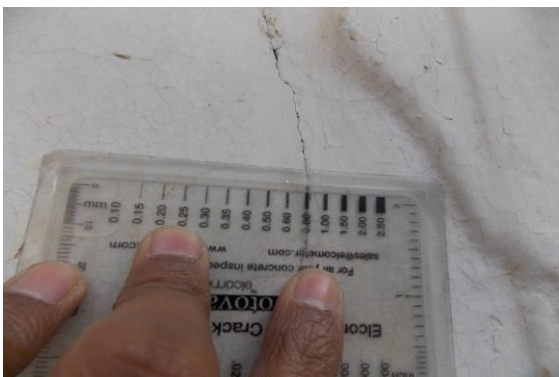
Photo 77

Inclined Crack on Wall No. 2 of Open Sky 3 of Navjeevan Chikitsalaya, First Floor Approx. Width = 0.8mm, Approx. Length = 2.8m. Distance from Wall No.4 = 2.5m, Height from Floor = 1.7m.

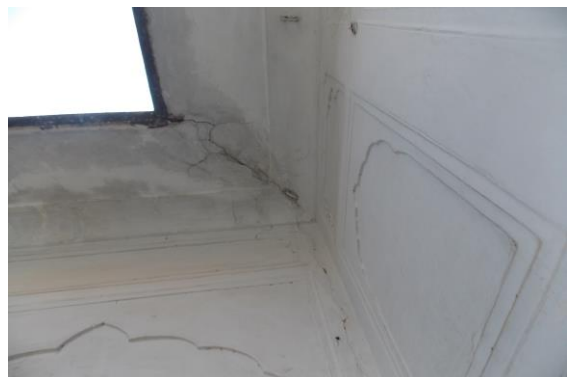
Photo 77A

Inclined Crack on Wall No. 2 of Open Sky 3 of Navjeevan Chikitsalaya, First Floor Approx. Width = 0.8mm, Approx. Length = 2.8m. Distance from Wall No.4 = 2.5m, Height from Floor = 1.7m.

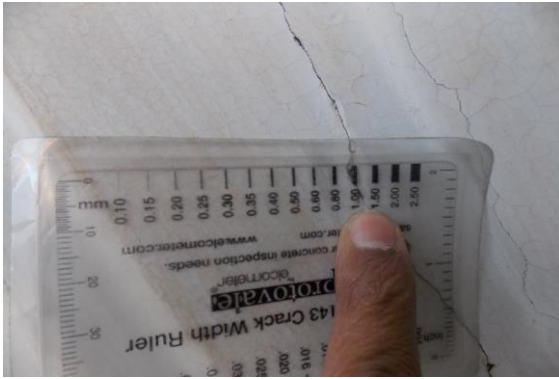
Photo 78

Inclined Crack on Wall No. 3 of Open Sky 3 of Navjeevan Chikitsalaya, First Floor Approx. Width = 1mm, Approx. Length = 4m. Distance from Wall No.1 = 0m, Height from Floor = 0m.

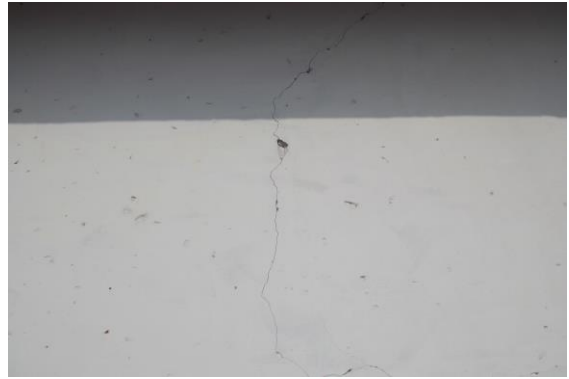
Photo 78A

Inclined Crack on Wall No. 3 of Open Sky 3 of Navjeevan Chikitsalaya, First Floor Approx. Width = 1mm, Approx. Length = 4m. Distance from Wall No.1 = 0m, Height from Floor = 0m.

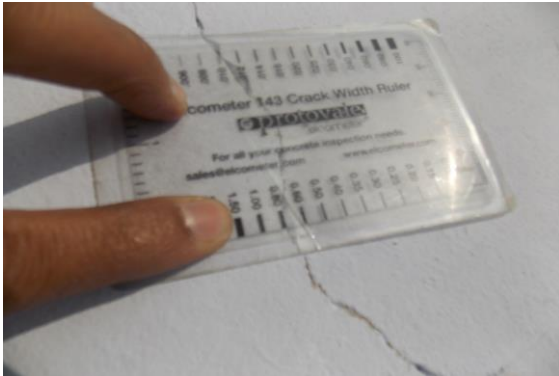
Photo 79

Inclined Crack on External Faccade, Back Side of Navjeevan Chikitsalaya, G/F Approx. Width = 0.8mm, Approx. Length = 3m. Distance from Right Side Wall = 11m, Height from Floor = 2m.

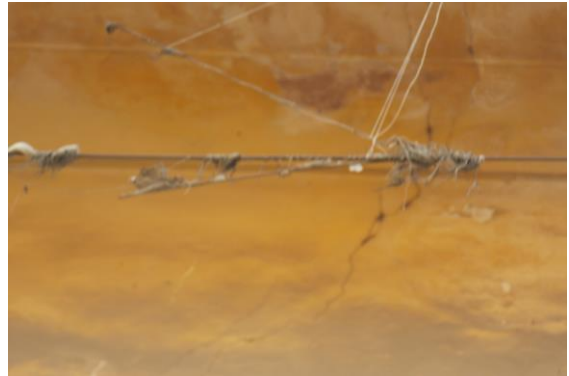
Photo 79A

Inclined Crack on External Faccade, Back Side of Navjeevan Chikitsalaya, Ground Floor Approx. Width = 0.8mm, Approx. Length = 3m. Distance from Right Side Wall = 11m, Height from Floor = 2m.

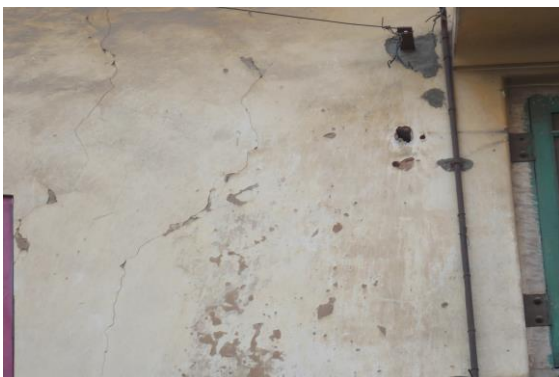
Photo 80

Inclined Crack on Wall No. 2 of External Faccade, R/S of Navjeevan Chikitsalaya, F/F Approx. Width = 1.5mm, Approx. Length = 3m. Dist. from Wall No.3 = 13m, Height from Floor = 5m.

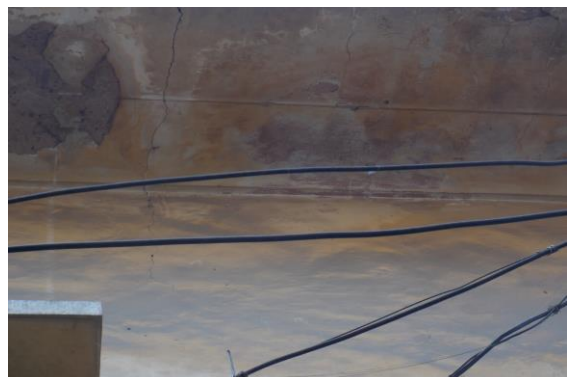
Photo 81

Inclined Crack on Wall No. 2 of External Faccade, R/S of Navjeevan Chikitsalaya, F/F Approx. Width = 0.8mm, Approx. Length = 2.1m. Dist. from Wall No.3 = 13m, Height from Floor = 4m.

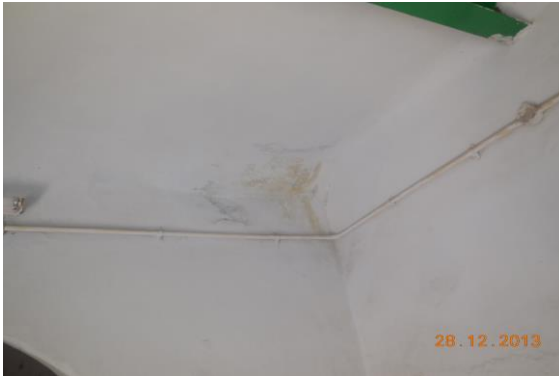
Photo 82

Inclined Crack on Wall No. 2 of External Faccade, R/S of Navjeevan Chikitsalaya, First Floor Approx. Width = 1mm, Approx. Length = 4m. Dist. from Wall No.3 = 6m, Height from Floor = 4m.

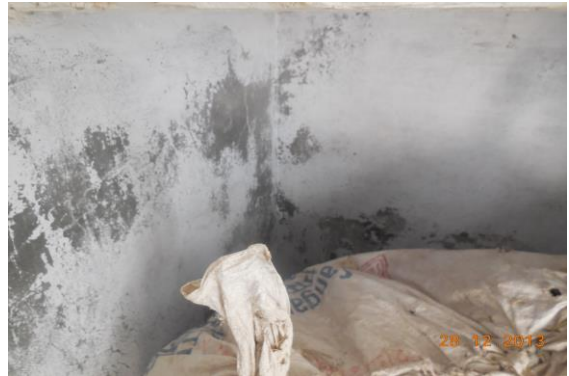
Photo 83

Dampness/Seepage on Wall No. 4 & Roof of Room No. 1 of Part A of Navjeevan Chikitsalaya, Ground Floor

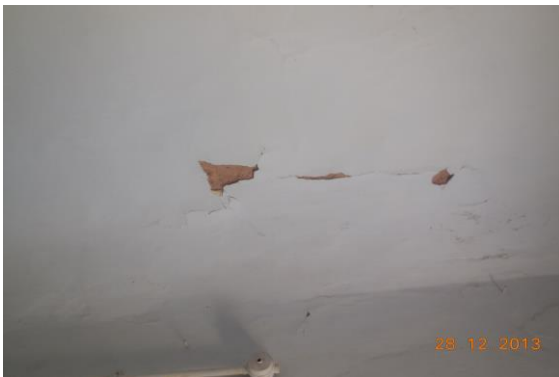
Photo 84

Dampness/Seepage on Wall No. 2 & 4 of Room No. 1 of Part A of Navjeevan Chikitsalaya, Ground Floor

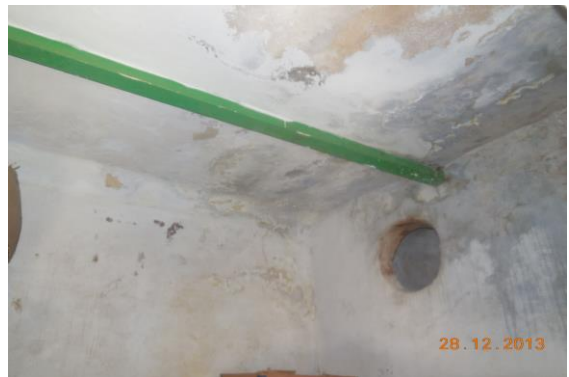
Photo 85

Peeling of Plaster on Wall No. 2 & 4 of Room No. 1 of Part A of Navjeevan Chikitsalaya, Ground Floor

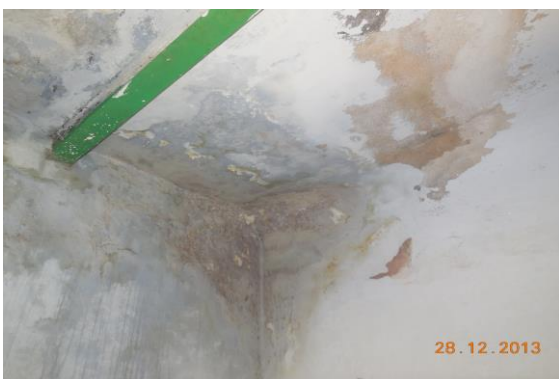
Photo 86

Dampness/Seepage on Wall No. 2, 4 & Roof of Room No. 1 of Part A of Navjeevan Chikitsalaya, Ground Floor

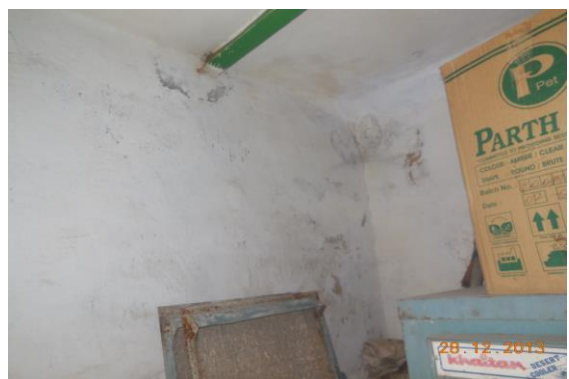
Photo 87

Dampness/Seepage on Wall No. 2, 3 & Roof of Room No. 1 of Part A of Navjeevan Chikitsalaya, Ground Floor

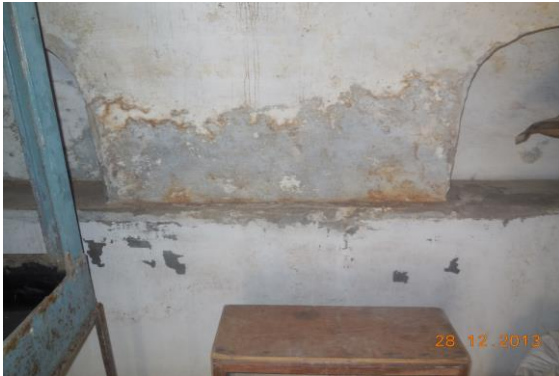
Photo 88

Dampness/Seepage on Wall No. 1 of Room No. 1 of Part A of Navjeevan Chikitsalaya, Ground Floor

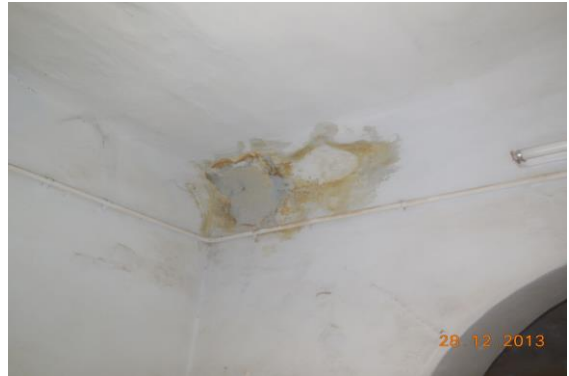
Photo 89

Dampness/Seepage on Wall No. 4 of Room No. 1 of Part A of Navjeevan Chikitsalaya, Ground Floor

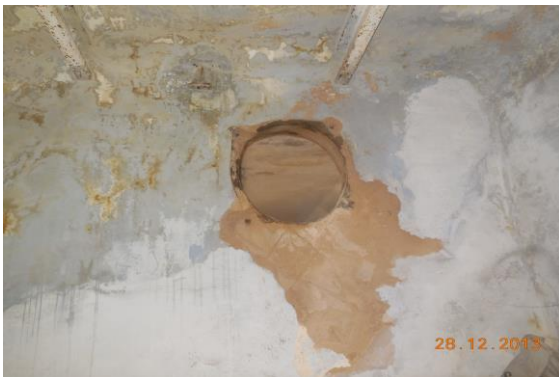
Photo 90

Dampness/Seepage on Wall No. 4 & Roof of Room No. 2 of Part A of Navjeevan Chikitsalaya, Ground Floor

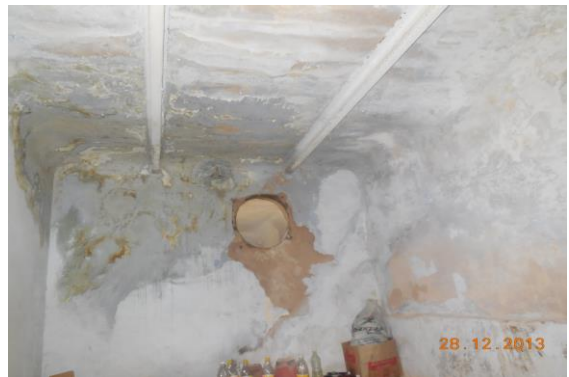
Photo 91

Peeling of Plaster on Wall No. 2 of Room No. 2 of Part A of Navjeevan Chikitsalaya, Ground Floor

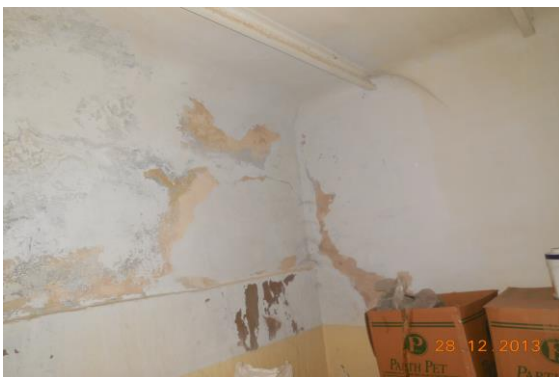
Photo 92

Dampness/Seepage on Wall No. 1, 3, 4 & Roof of Room No. 2 of Part A of Navjeevan Chikitsalaya, Ground Floor

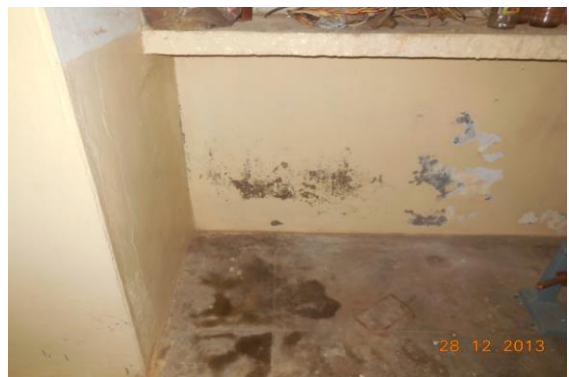
Photo 93

Peeling of Plaster on Wall No. 2 & 4 of Room No. 2 of Part A of Navjeevan Chikitsalaya, Ground Floor

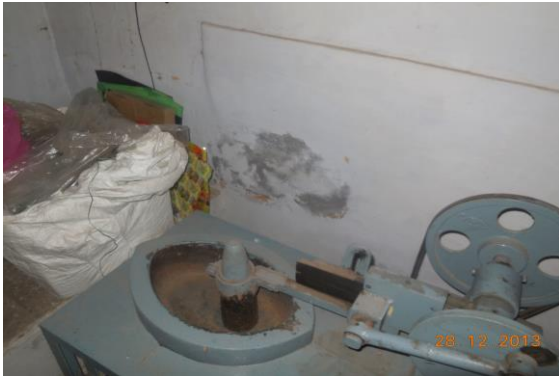
Photo 94

Dampness/Seepage on Wall No. 1 of Room No. 2 of Part A of Navjeevan Chikitsalaya, Ground Floor

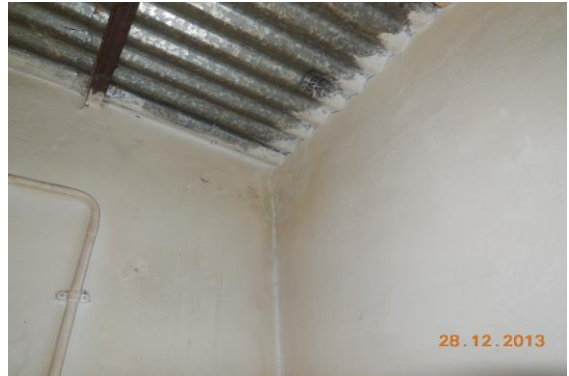
Photo 95
Dampness/Seepage on Wall No. 2 of Room No. 3 of Part A of Navjeevan Chikitsalaya, Ground Floor

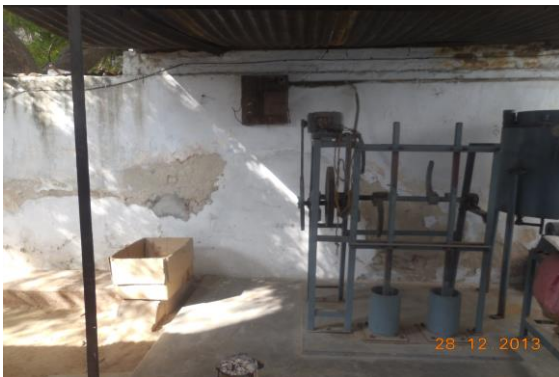
Photo 96
Dampness/Seepage on Wall No. 1 & 3 of Room No. 4 of Part A of Navjeevan Chikitsalaya, Ground Floor

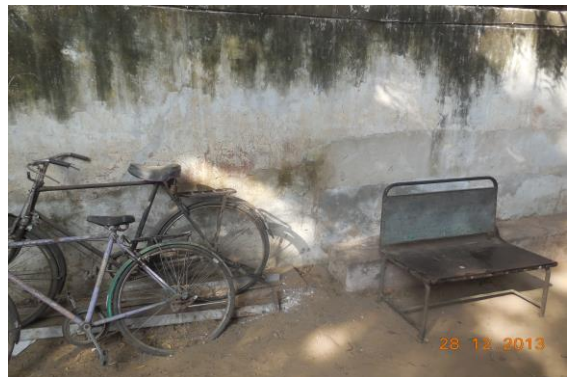
Photo 97
Peeling of Plaster on Wall No. 4 of Open Area 1 of Navjeevan Chikitsalaya of Ground Floor

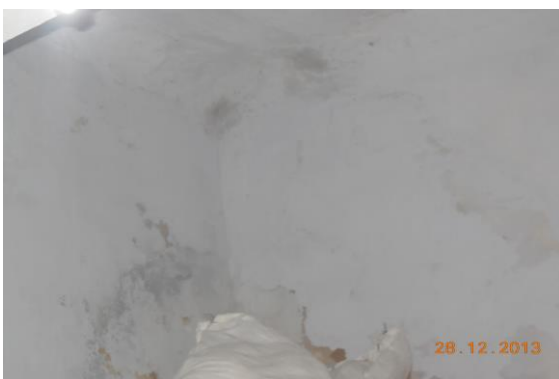
Photo 98
Peeling of Plaster on Wall No. 4 of Open Area 1 of Navjeevan Chikitsalaya of Ground Floor

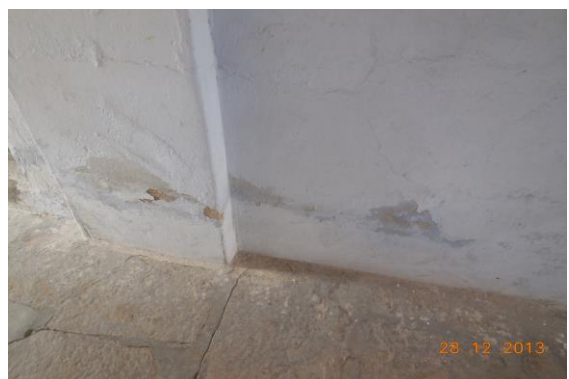
Photo 99
Dampness/Seepage on Wall No. 1, 4 & Roof of Room No. 9 of Part D of Navjeevan Chikitsalaya, Ground Floor

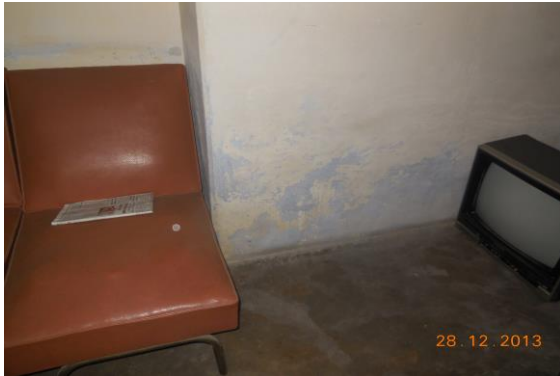
Photo 100
Dampness/Seepage on Wall No. 2 of Passage 2 of Navjeevan Chikitsalaya of Ground Floor

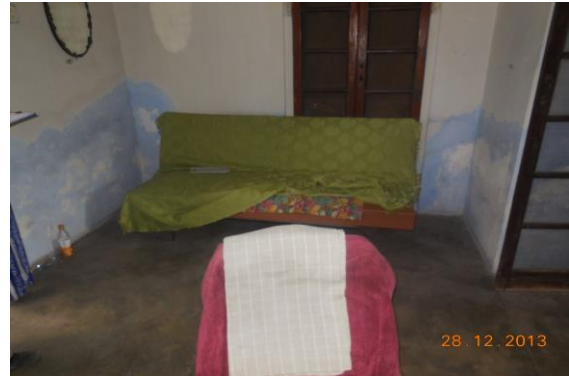
Photo 101

Peeling of Plaster on Wall No. 4 of Room No. 8 of Part A of Navjeevan Chikitsalaya, Ground Floor

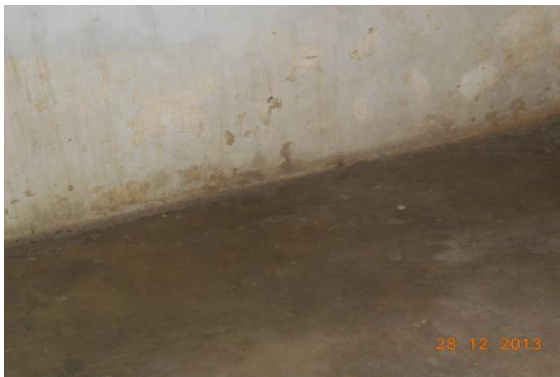
Photo 102

Peeling of Plaster on Wall No. 3 & 4 of Room No. 8 of Part A of Navjeevan Chikitsalaya, Ground Floor

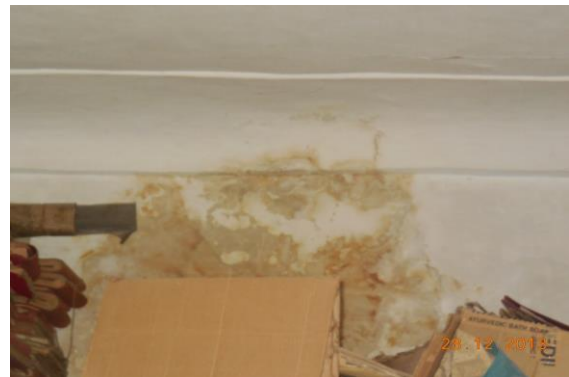
Photo 103

Dampness/Seepage on Wall No. 4 of Room No. 8 of Part B of Navjeevan Chikitsalaya, Ground Floor

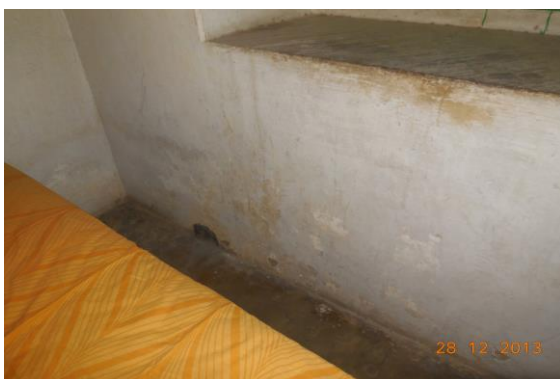
Photo 104

Dampness/Seepage on Wall No. 2 of Room No. 8 of Part B of Navjeevan Chikitsalaya, Ground Floor

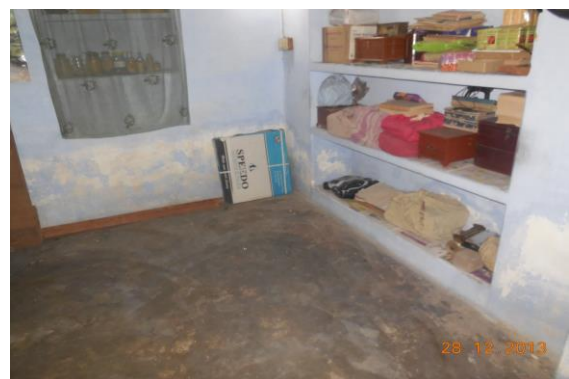
Photo 106

Peeling of Plaster on Wall No. 2 & 4 of Room No. 12 of Part B of Navjeevan Chikitsalaya, Ground Floor

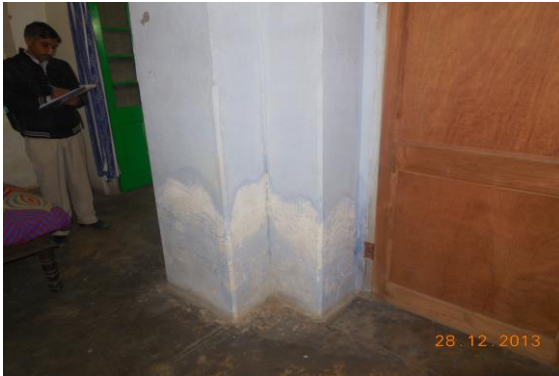
Photo 107

Peeling of Plaster on Wall No. 1 & 3 of Room No. 12 of Part B of Navjeevan Chikitsalaya, Ground Floor

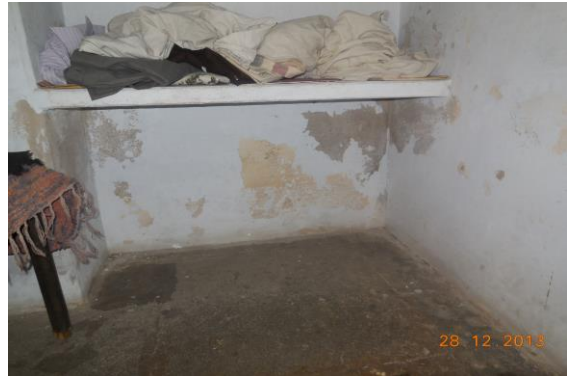
Photo 108

Dampness/Seepage on Wall No. 2 & 4 of Room No. 11 of Navjeevan Chikitsalaya, Ground Floor

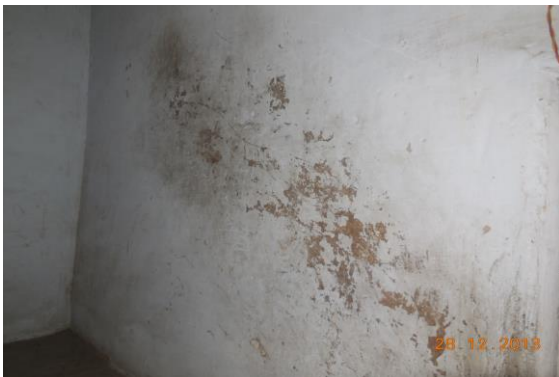
Photo 109

Dampness/Seepage on Wall No. 3 of Stair Case of Navjeevan Chikitsalaya of Ground Floor

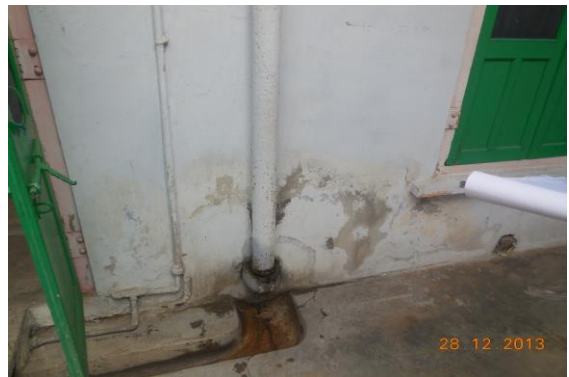
Photo 110

Dampness/Seepage on Wall No. 3 of Open Varanda of Navjeevan Chikitsalaya of Ground Floor

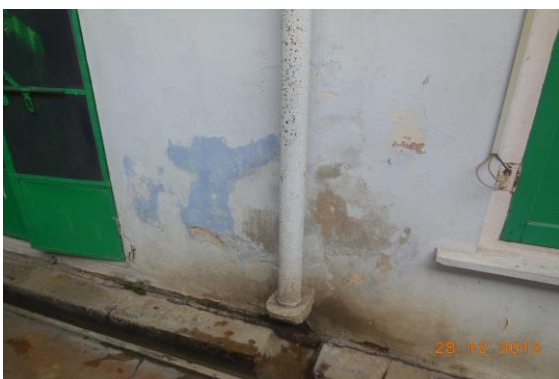
Photo 111

Dampness/Seepage on Wall No. 3 of Open Varanda of Navjeevan Chikitsalaya of Ground Floor

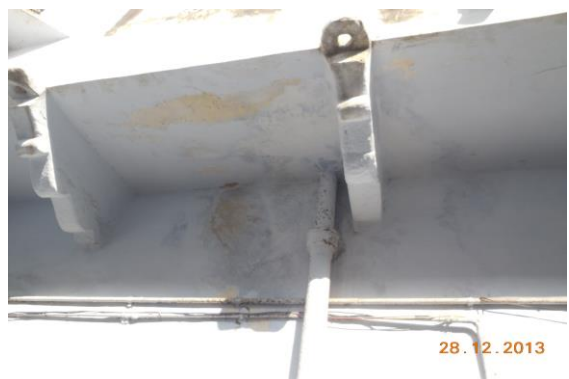
Photo 112

Dampness/Seepage on Wall No. 3 & Roof of Open Varanda of Navjeevan Chikitsalaya of Ground Floor

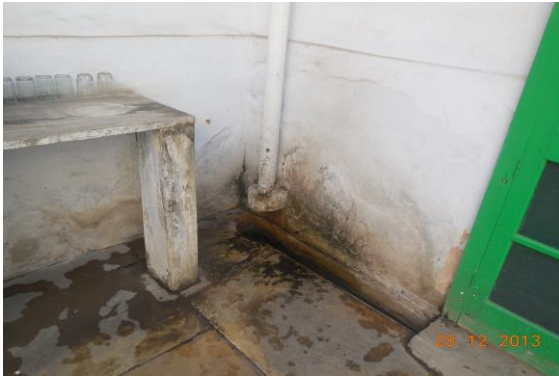
Photo 113

Dampness/Seepage on Wall No. 1 & 4 of Open Varanda of Navjeevan Chikitsalaya of Ground Floor

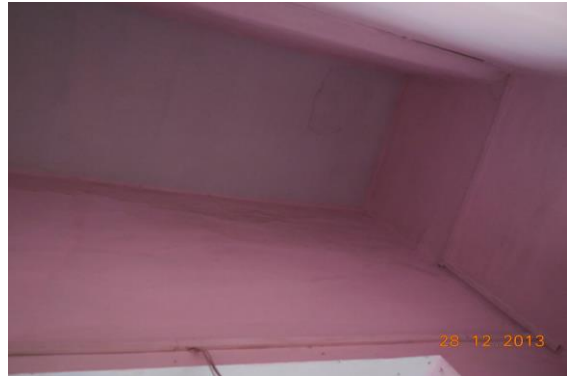
Photo 114

Peeling of Plaster on Wall No. 3 & Roof of Part-B of Shop of Navjeevan Chikitsalaya of Ground Floor

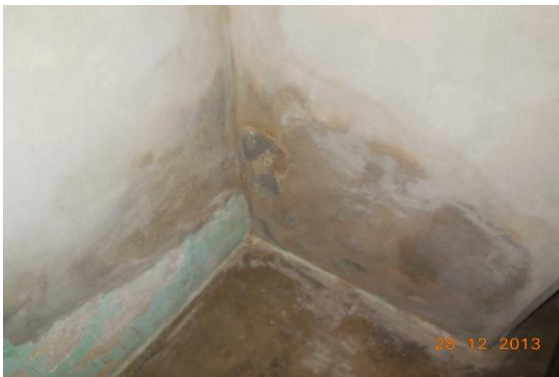
Photo 115

Dampness/Seepage on Wall No. 2 & 3 of Room No. 13 of Navjeevan Chikitsalaya, Ground Floor
