Pre Building Condition Survey Report

Name and Address of Structure :	Badi Chopar to Ramp Area (Down Line)
---------------------------------	--------------------------------------

Name of the Project	Contract JMRC-UG1B “Design and Construction of Tunnel between Chandpole and Badi Chouper and reverse line by Shield TBM, Underground Metro Stations at Choti Chouper and Badi Chouper by Cut and Cover Methods on East West Corridor of Jaipur Metro Rail Corporation Limited .”	
Owner :

Pre - Condition Building Survey for Construction of Underground Stations from Chandpole to Bari Chouper and reversal line

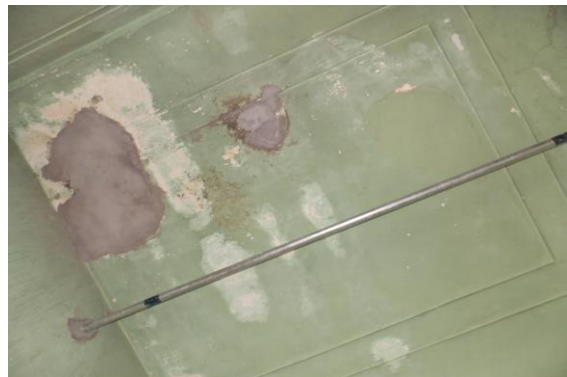
Photo 116

Peeling of Plaster on Roof of Room No. 2 of Navjeevan Chikitsalaya, First Floor

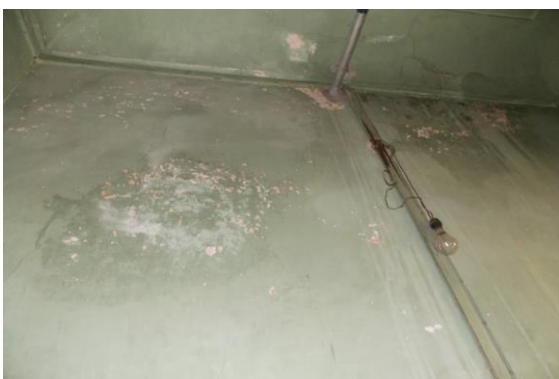
Photo 117

Dampness/Seepage on Wall No. 2 of Room No. 2 of Navjeevan Chikitsalaya, First Floor

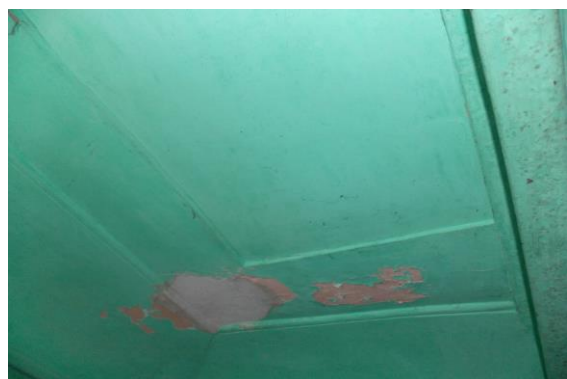
Photo 118

Peeling of Plaster on Roof of Room No. 1 of Navjeevan Chikitsalaya, Mezanine Floor

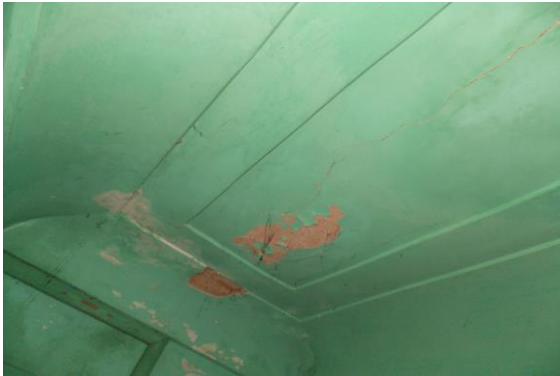
Photo 119

Peeling of Plaster on Roof of Room No. 1 of Navjeevan Chikitsalaya, Mezanine Floor

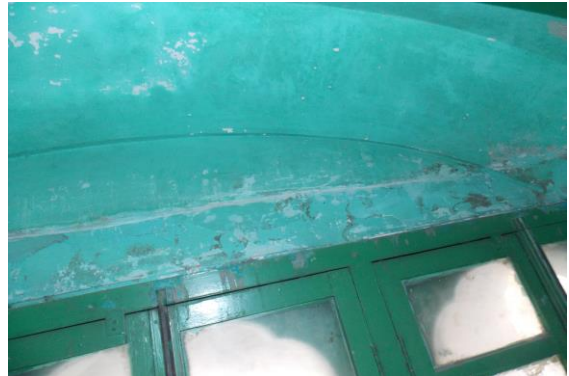
Photo 120

Peeling of Plaster on Wall No. 2 of Room No. 1 of Navjeevan Chikitsalaya, Mezanine Floor

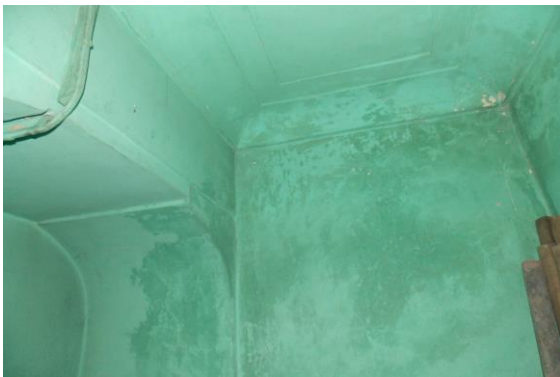
Photo 121

Dampness/Seepage on Wall No. 3 of Room No. 1 of Navjeevan Chikitsalaya, Mezanine Floor

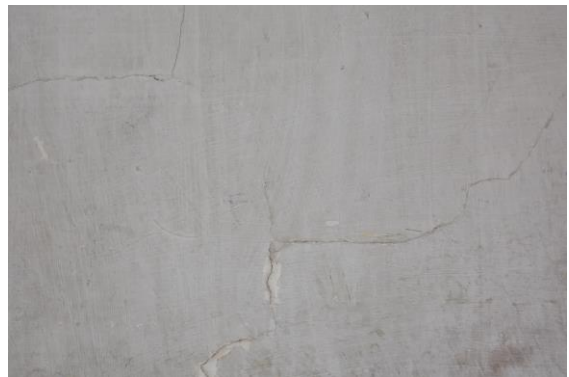
Photo 122

Plaster Crack on Wall No. 1 of Store Room of Navjeevan Chikitsalaya of First Floor

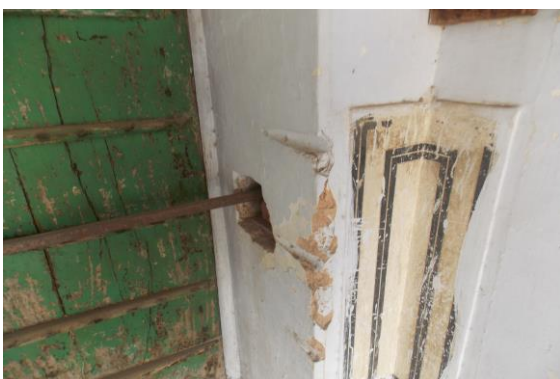
Photo 123

Peeling of Plaster on Wall No. 3 of Passage 1 of Navjeevan Chikitsalaya of First Floor

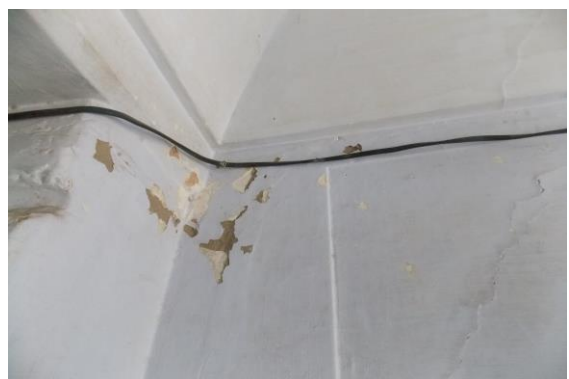
Photo 124

Peeling of Plaster on Wall No. 1 & 3 of Passage 1 of Navjeevan Chikitsalaya of First Floor

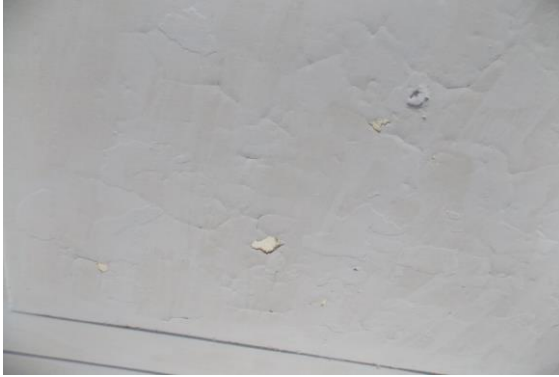
Photo 125

Peeling of Plaster on Wall No. 4 of Passage 1 of Navjeevan Chikitsalaya of First Floor

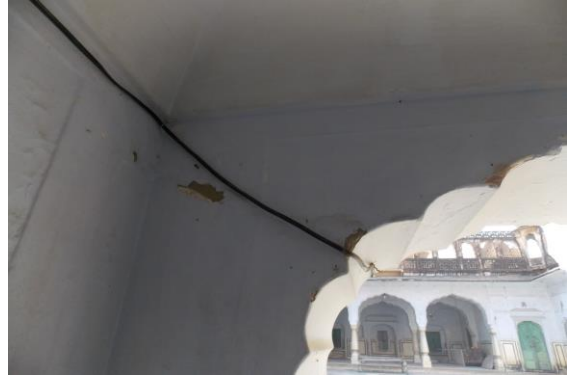
Photo 126

Peeling of Plaster on Roof of Passage 1 of Navjeevan Chikitsalaya of First Floor

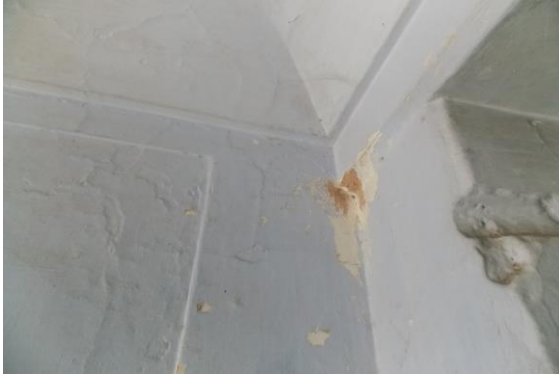
Photo 127

Peeling of Plaster on Wall No. 2 & 3 of Passage 1 of Navjeevan Chikitsalaya of First Floor

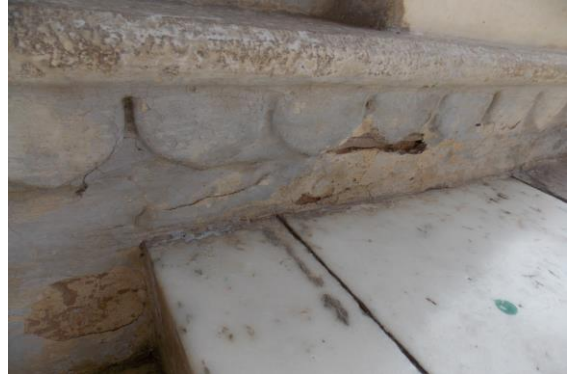
Photo 128

Peeling of Plaster on Wall No. 1 of Passage 1 of Navjeevan Chikitsalaya of First Floor

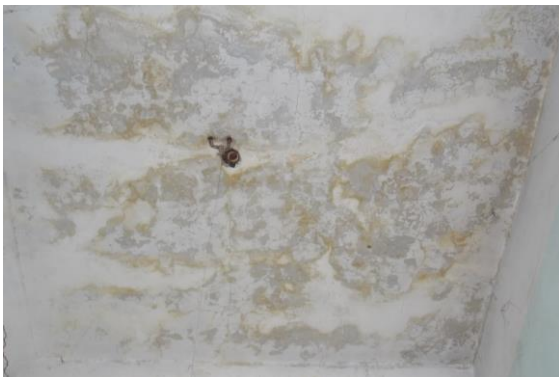
Photo 129

Dampness/Seepage on Roof of Lobby of Navjeevan Chikitsalaya of First Floor

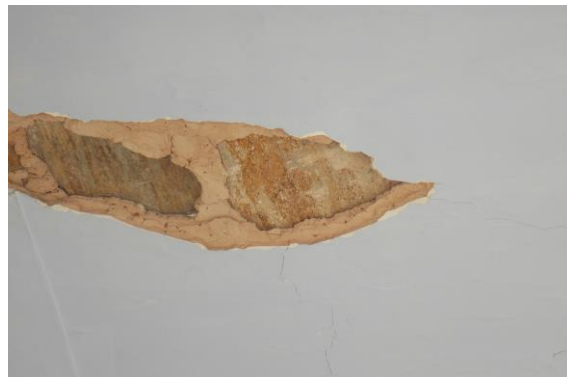
Photo 130

Peeling of Plaster on Roof of Varanda 1 of Navjeevan Chikitsalaya of First Floor

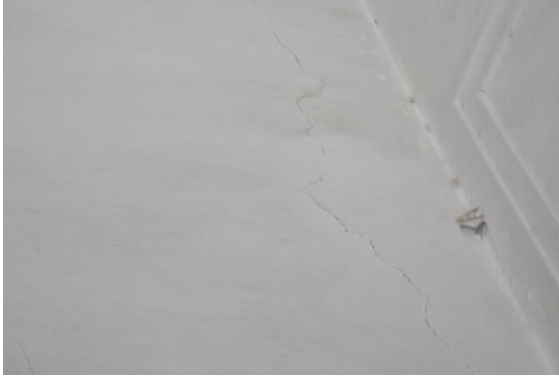
Photo 131

Peeling of Plaster on Wall No. 2 of Varanda 3 of Navjeevan Chikitsalaya of First Floor

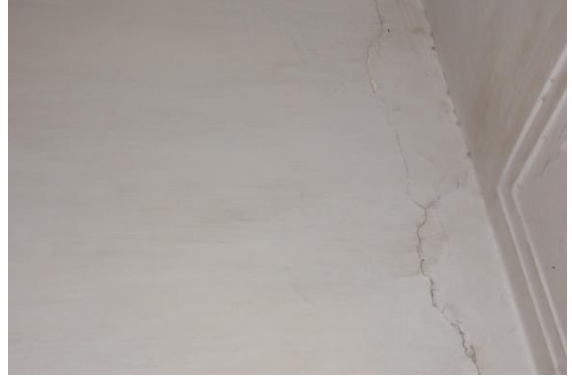
Photo 132

Peeling of Plaster on Wall No. 2 of Varanda 3 of Navjeevan Chikitsalaya of First Floor

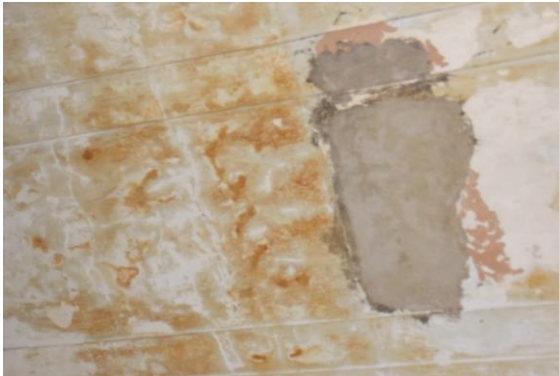
Photo 133

Dampness/Seepage on Roof of Varanda 2 of Navjeevan Chikitsalaya of First Floor

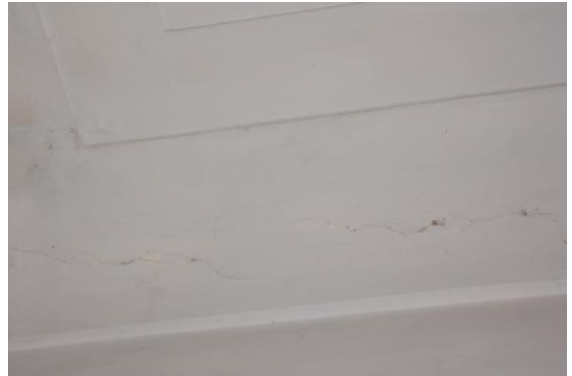
Photo 134

Plaster Crack on Roof of Varanda 3 of Navjeevan Chikitsalaya of First Floor

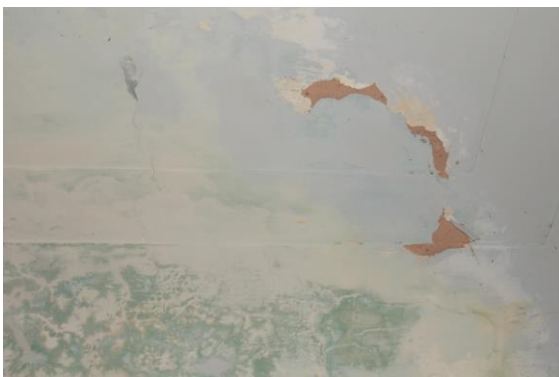
Photo 135

Dampness/Seepage on Roof of Room No. 6 of Navjeevan Chikitsalaya, First Floor

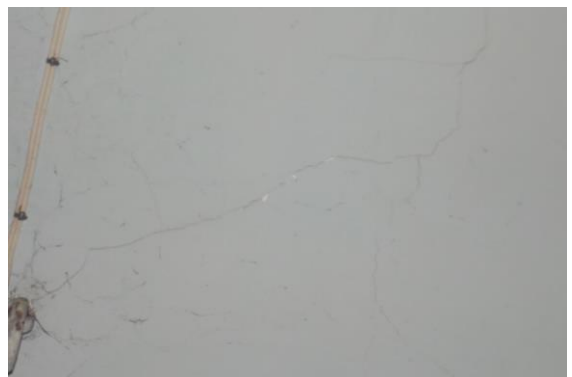
Photo 136

Plaster Crack on Roof of Room No. 6 of Navjeevan Chikitsalaya, First Floor

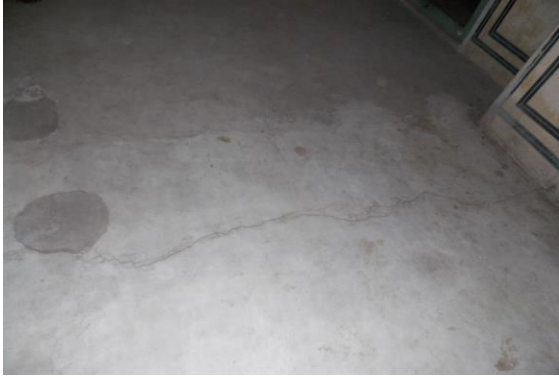
Photo 137

Plaster Crack on Floor of Room No. 6 of Navjeevan Chikitsalaya, First Floor

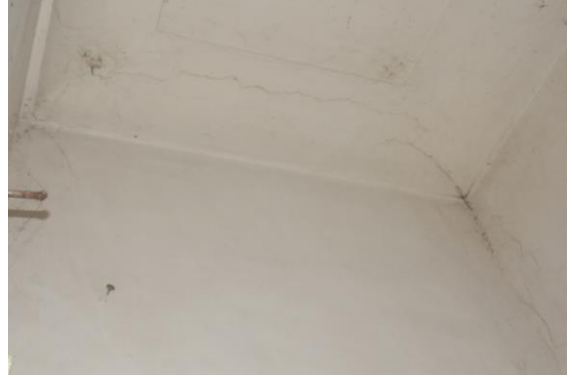
Photo 138

Plaster Crack on Wall No. 1 of Store 3 of Navjeevan Chikitsalaya of First Floor

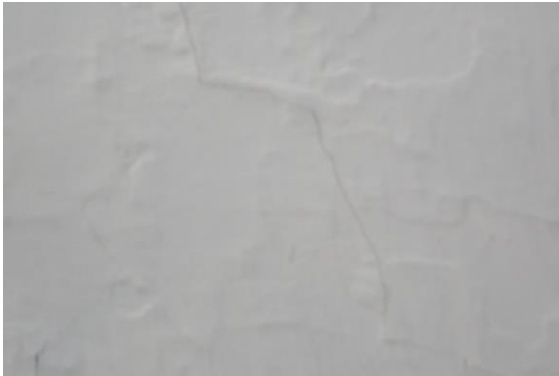
Photo 139

Plaster Crack on Roof of Varanda 4 of Navjeevan Chikitsalaya of First Floor

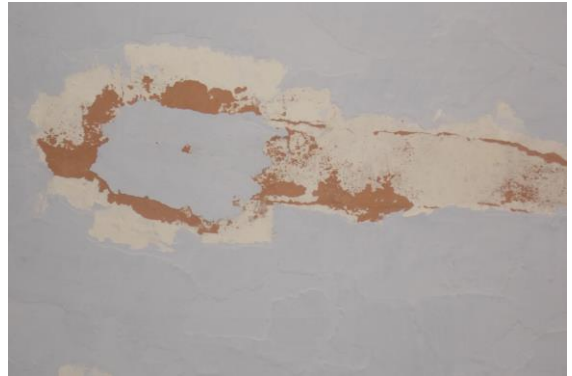
Photo 140

Peeling of Plaster on Roof of Varanda 4 of Navjeevan Chikitsalaya of First Floor

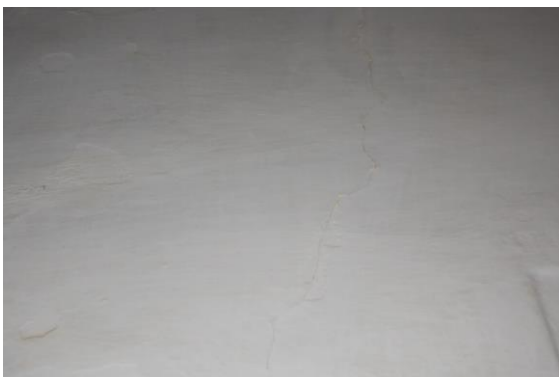
Photo 141

Plaster Crack on Wall No. 1 of Varanda 5 of Navjeevan Chikitsalaya of First Floor

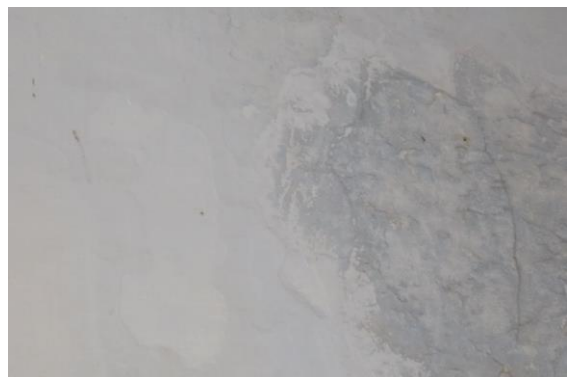
Photo 142

Dampness/Seepage on Wall No. 1 of Varanda 6 of Navjeevan Chikitsalaya of First Floor

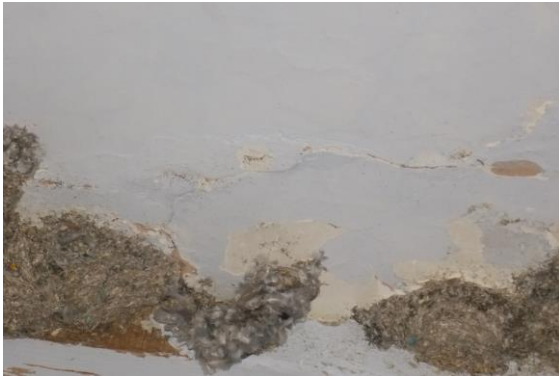
Photo 143

Peeling of Plaster on Roof of Varanda 6 of Navjeevan Chikitsalaya of First Floor

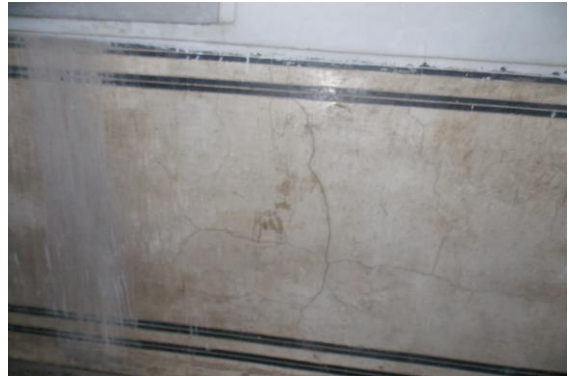
Photo 144

Damaged Portion on Wall No. 1 of Varanda 7 of Navjeevan Chikitsalaya of First Floor

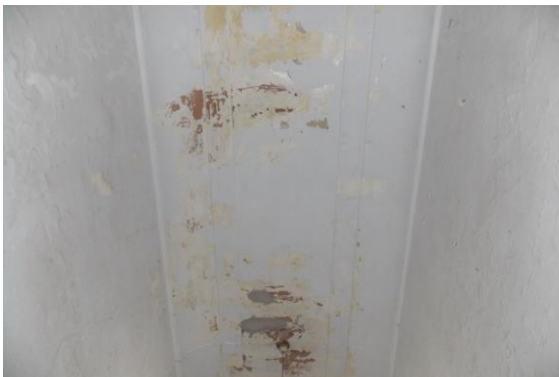
Photo 145

Peeling of Plaster on Roof of Varanda 7 of Navjeevan Chikitsalaya of First Floor

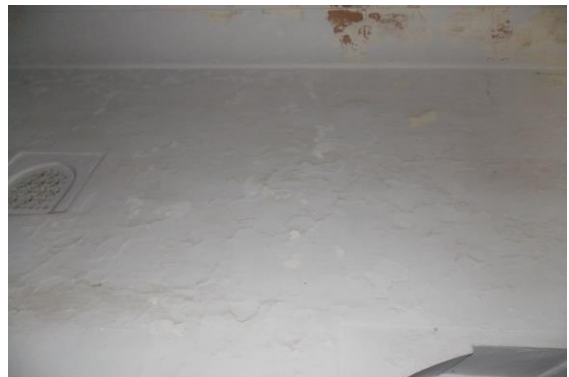
Photo 146

Peeling of Plaster on Wall No. 1 of Varanda 7 of Navjeevan Chikitsalaya of First Floor

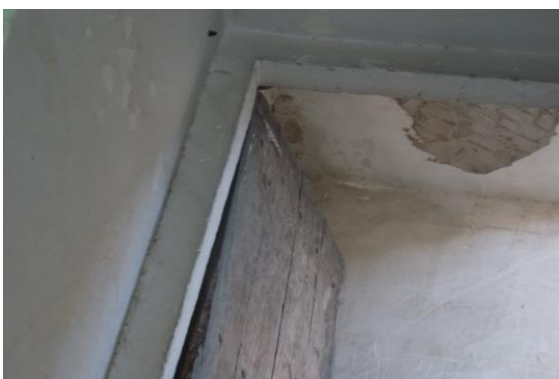
Photo 147

Peeling of Plaster on Roof of Stair Case 3 of Navjeevan Chikitsalaya of First Floor

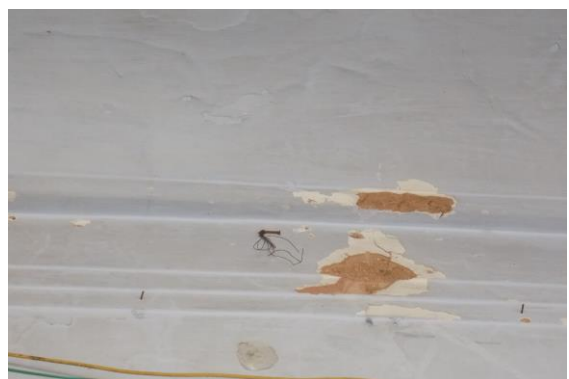
Photo 148

Peeling of Plaster on Wall No. 4 of Varanda 8 of Navjeevan Chikitsalaya of First Floor

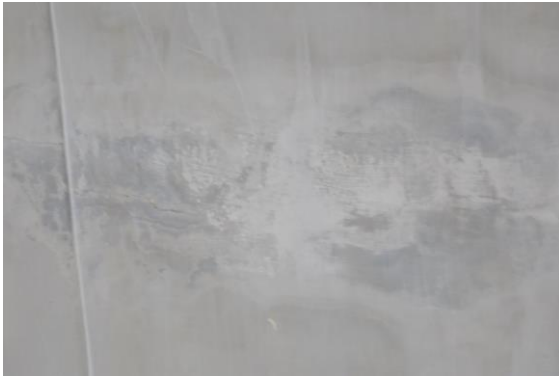
Photo 149

Dampness/Seepage on Roof of Varanda 8 of Navjeevan Chikitsalaya of First Floor

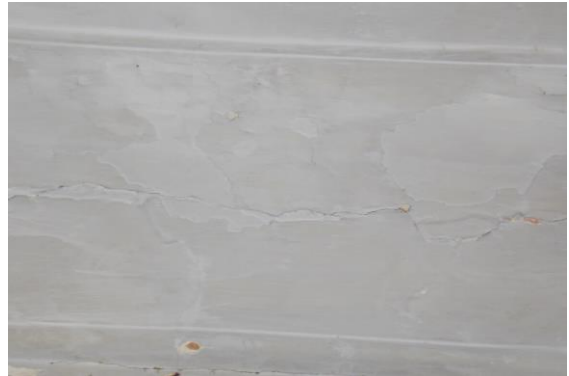
Photo 150

Peeling of Plaster on Roof of Varanda 8 of Navjeevan Chikitsalaya of First Floor

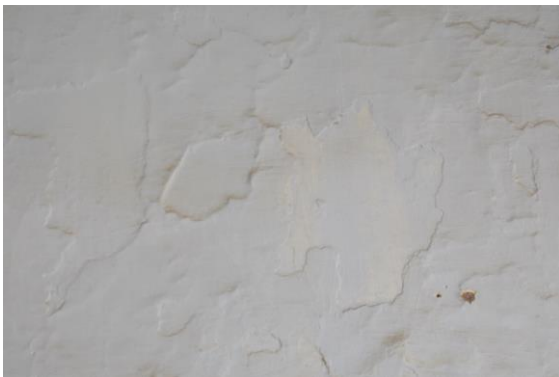
Photo 151

Peeling of Plaster on Wall No. 2 of Varanda 8 of Navjeevan Chikitsalaya of First Floor

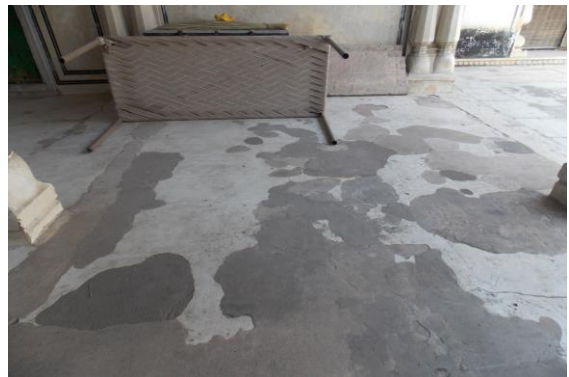
Photo 152

Peeling of Plaster on Floor of Varanda 8 of Navjeevan Chikitsalaya of First Floor

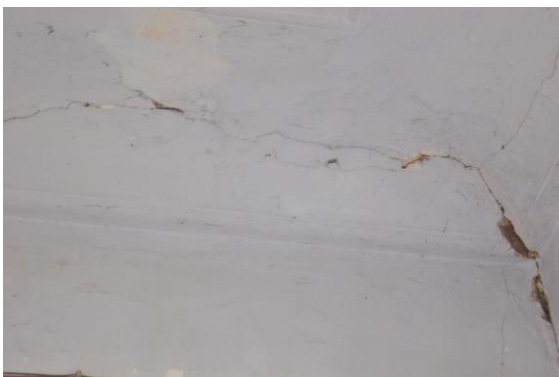
Photo 153

Damaged Portion on Roof of Varanda 9 of Navjeevan Chikitsalaya of First Floor

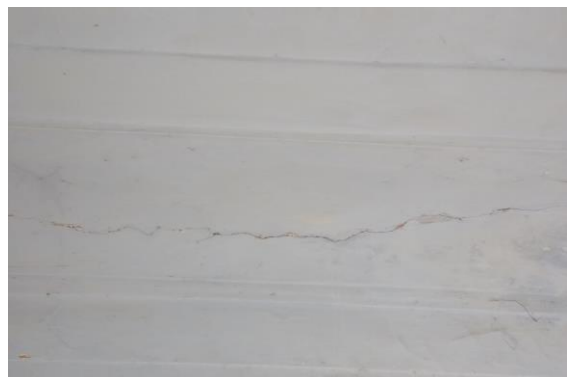
Photo 154

Plaster Crack on Roof of Varanda 9 of Navjeevan Chikitsalaya of First Floor

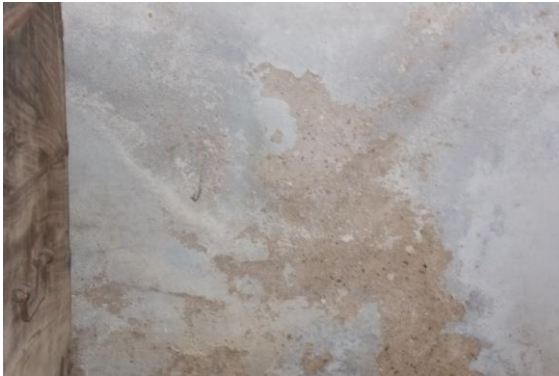
Photo 155

Peeling of Plaster on Wall No. 1 of Varanda 9 of Navjeevan Chikitsalaya of First Floor

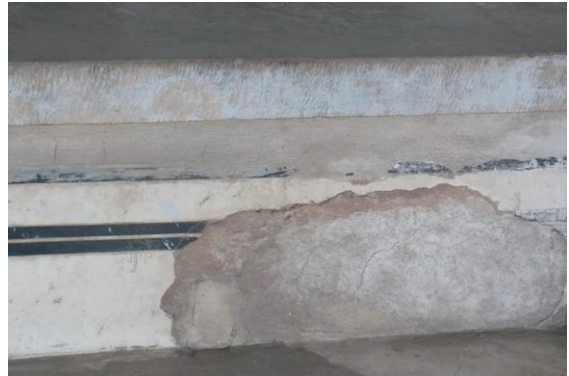
Photo 156

Peeling of Plaster on Wall No. 4 of Varanda 9 of Navjeevan Chikitsalaya of First Floor

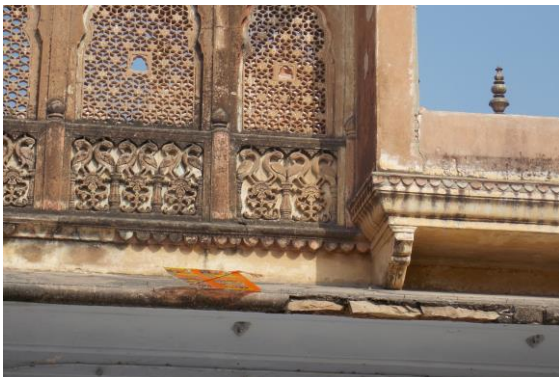
Photo 157

Damaged Portion on Wall No. 3 of Open Sky of Navjeevan Chikitsalaya of First Floor

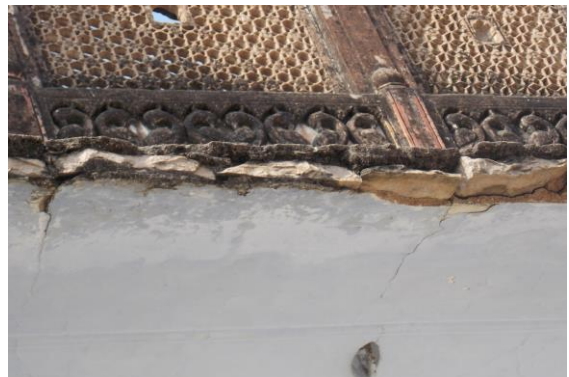
Photo 158

Damaged Portion on Wall No. 2 of Open Sky of Navjeevan Chikitsalaya of First Floor

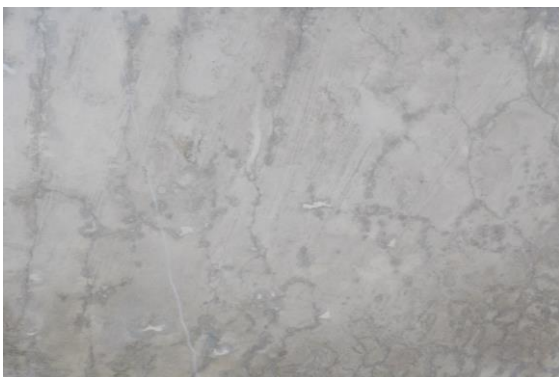
Photo 159

Dampness/Seepage on Wall No. 1 & Sunshade of Open Sky of Navjeevan Chikitsalaya of First Floor

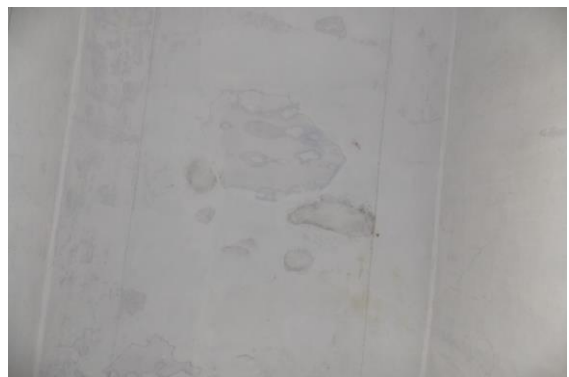
Photo 160

Dampness/Seepage on Roof of Room No. 9 of Navjeevan Chikitsalaya, First Floor

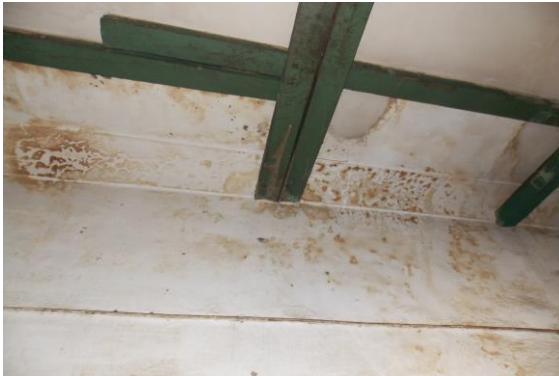
Photo 161

Dampness/Seepage on Wall No. 4 & Roof of Room No. 10 of Navjeevan Chikitsalaya, First Floor

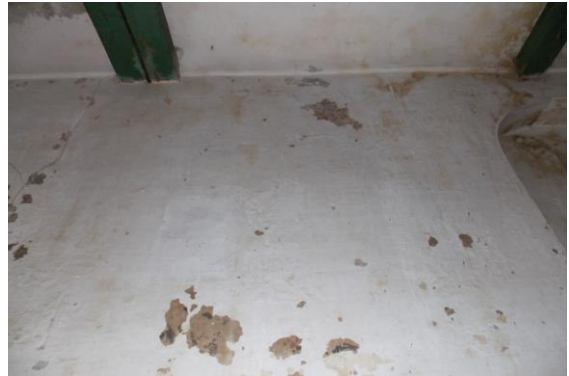
Photo 162

Peeling of Plaster on Wall No. 3 of Room No. 10 of Navjeevan Chikitsalaya, First Floor

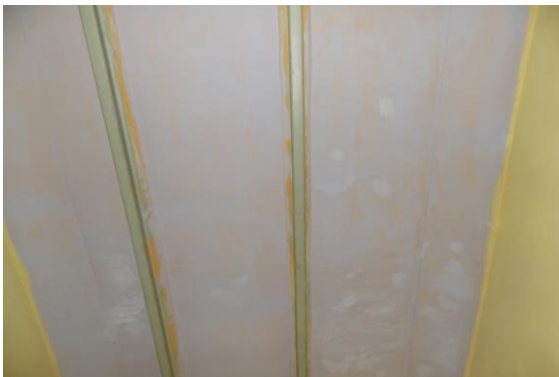
Photo 163

Dampness/Seepage on Roof of Hall 1 of Navjeevan Chikitsalaya of First Floor

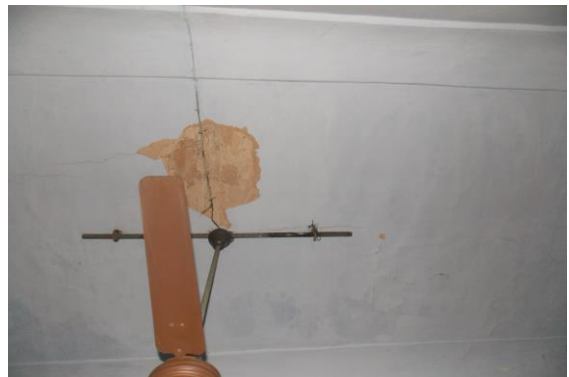
Photo 164

Peeling of Plaster on Roof of Hall 2 of Navjeevan Chikitsalaya of First Floor

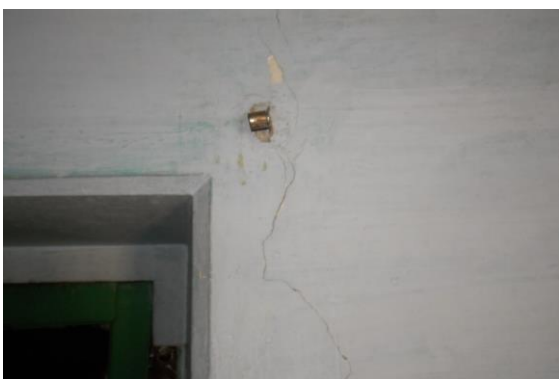
Photo 165

Plaster Crack on Wall No. 4 of Hall 2 of Navjeevan Chikitsalaya of First Floor

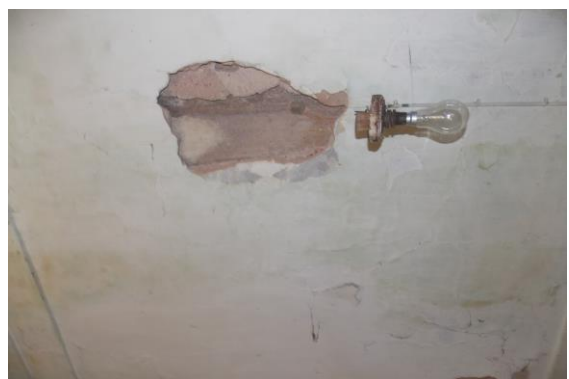
Photo 166

Peeling of Plaster on Roof of Room No. 15 of Navjeevan Chikitsalaya, First Floor

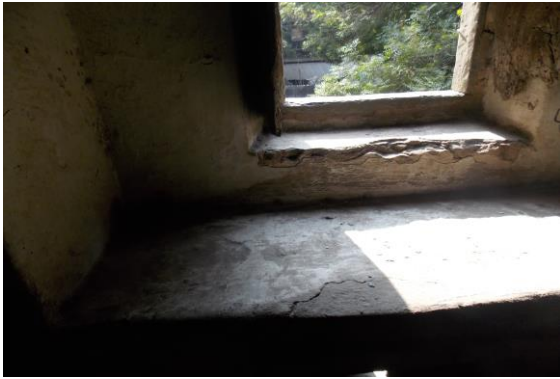
Photo 167
Peeling of Plaster on Wall No. 1 of Room No. 15 of Navjeevan Chikitsalaya, First Floor

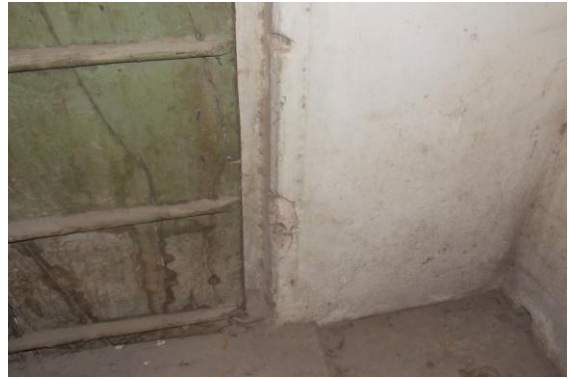
Photo 168
Peeling of Plaster on Wall No. 4 of Room No. 15 of Navjeevan Chikitsalaya, First Floor

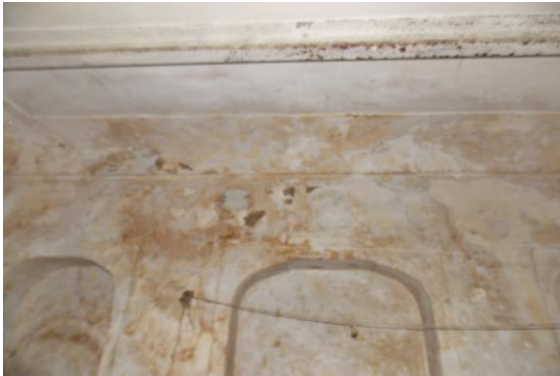
Photo 169
Dampness/Seepage on Wall No. 4 & Roof of Room No. 16 of Navjeevan Chikitsalaya, First Floor

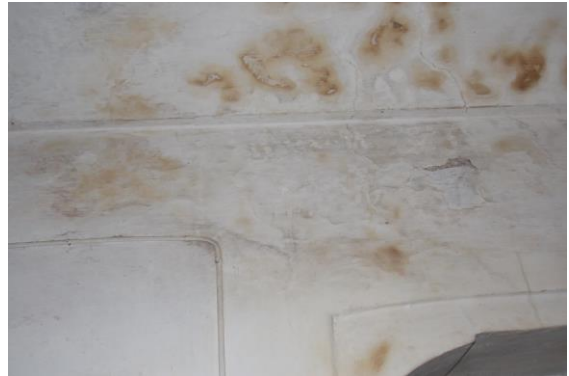
Photo 170
Dampness/Seepage on Wall No. 3 & Roof of Room No. 16 of Navjeevan Chikitsalaya, First Floor

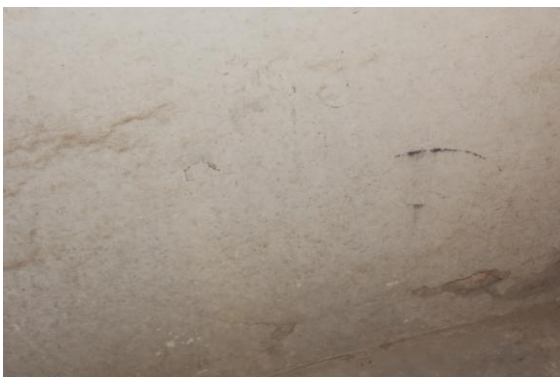
Photo 171
Peeling of Plaster on Wall No. 2 of Room No. 16 of Navjeevan Chikitsalaya, First Floor

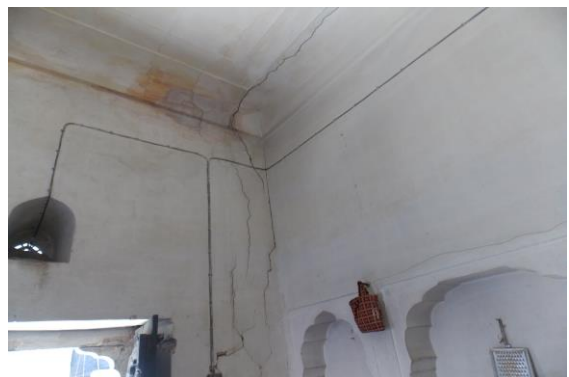
Photo 172
Damaged Portion on Wall No. 3, 4 & Roof of Room No. 18 of Navjeevan Chikitsalaya, First Floor

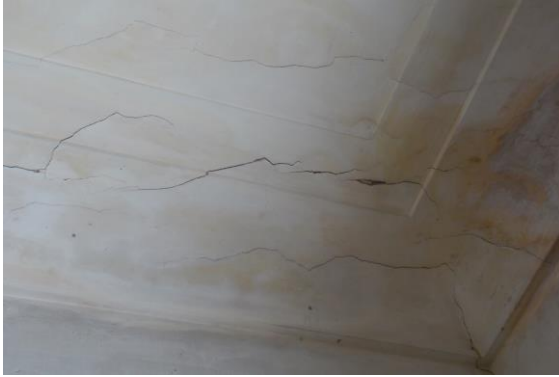
Photo 173

Damaged Portion on Wall No. 3, 4 & Roof of Room No. 18 of Navjeevan Chikitsalaya, First Floor

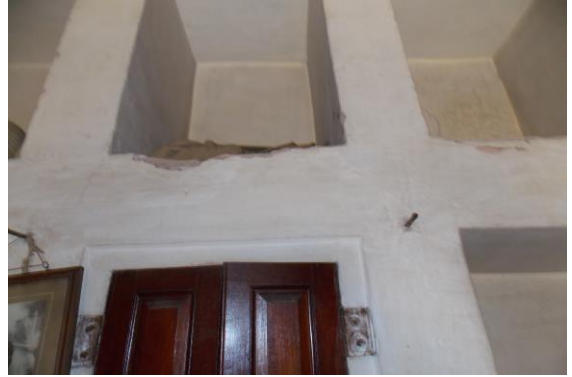
Photo 174

Peeling of Plaster on Wall No. 4 of Room No. 18 of Navjeevan Chikitsalaya, First Floor

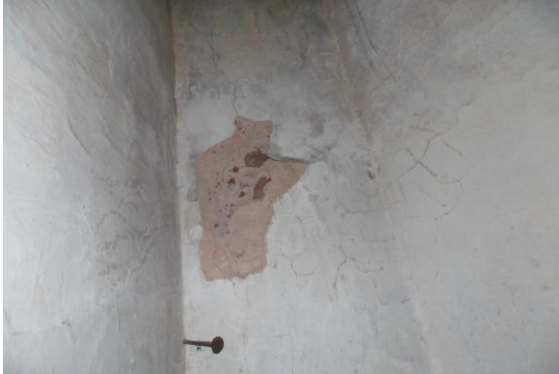
Photo 175

Peeling of Plaster on Wall No. 1 of Tomb 1 of Navjeevan Chikitsalaya of First Floor

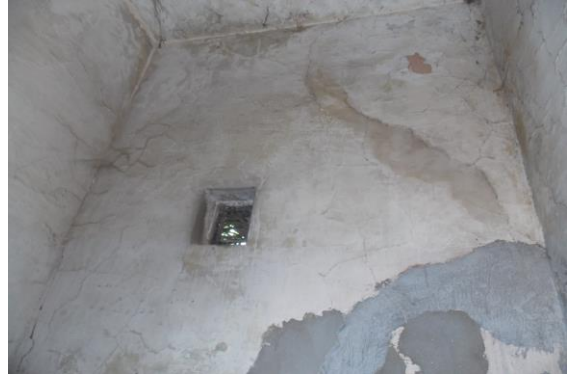
Photo 176

Damaged Portion on Wall No. 4 & Roof of Store 4 of Navjeevan Chikitsalaya of First Floor

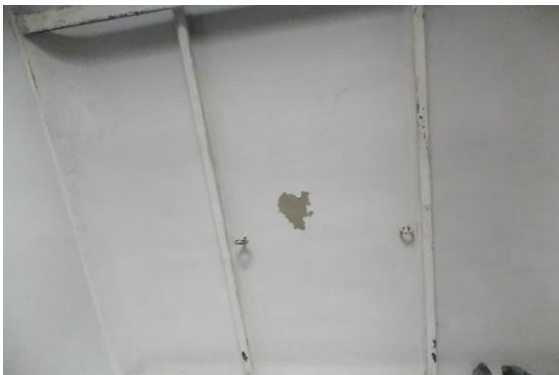
Photo 177

Peeling of Plaster on Roof of Kitchen of Navjeevan Chikitsalaya of First Floor

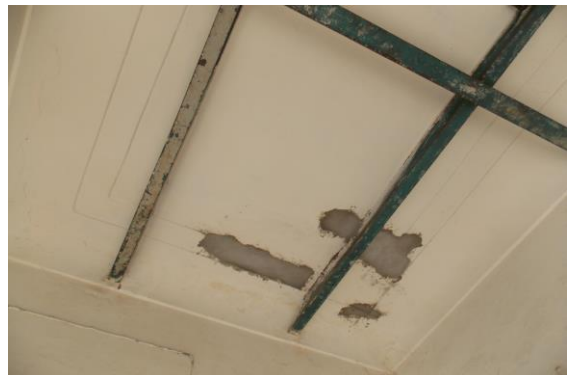
Photo 178

Peeling of Plaster on Roof of Varanda 11 of Navjeevan Chikitsalaya of First Floor

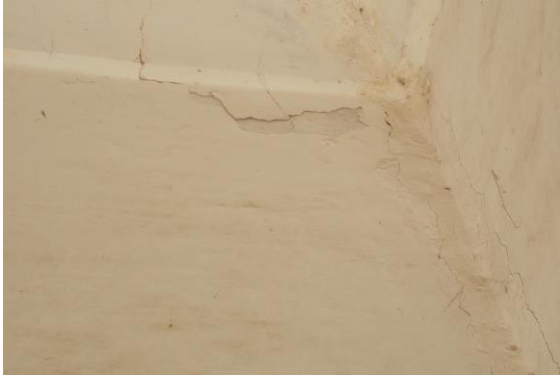
Photo 179
Peeling of Plaster on Wall No. 1 of Varanda 11 of Navjeevan Chikitsalaya of First Floor

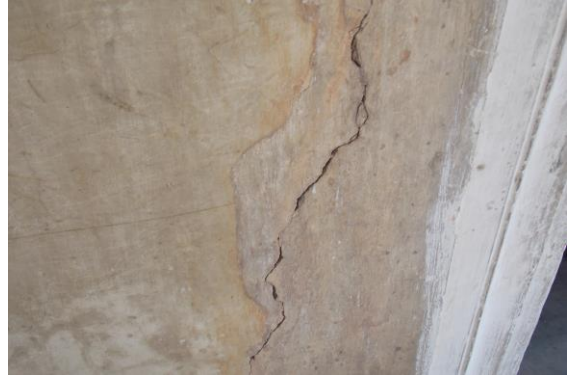
Photo 180
Damaged Portion on Wall No. 2 of Varanda 11 of Navjeevan Chikitsalaya of First Floor

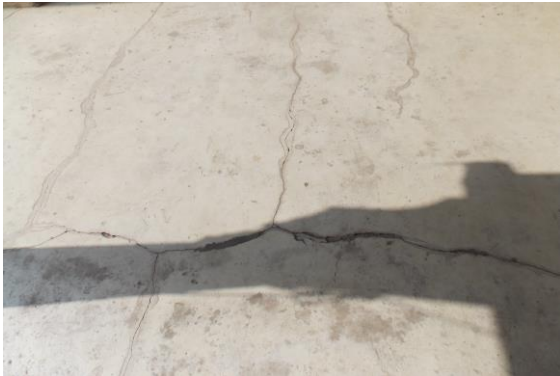
Photo 181
Plaster Crack on Floor of Varanda 10 of Navjeevan Chikitsalaya of First Floor

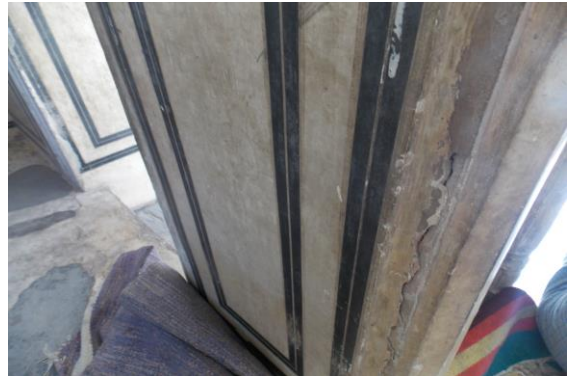
Photo 182
Peeling of Plaster on Wall No. 3 of Varanda 10 of Navjeevan Chikitsalaya of First Floor

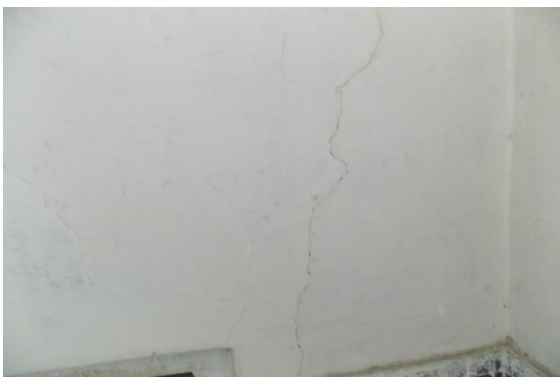
Photo 183
Plaster Crack on Wall No. 2 of Varanda 10 of Navjeevan Chikitsalaya of First Floor

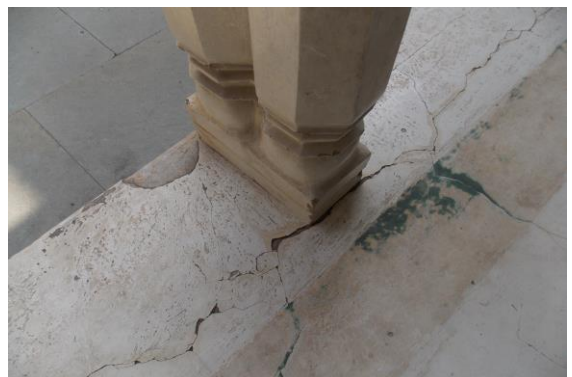
Photo 184
Plaster Crack on Floor of Varanda 12 of Navjeevan Chikitsalaya of First Floor

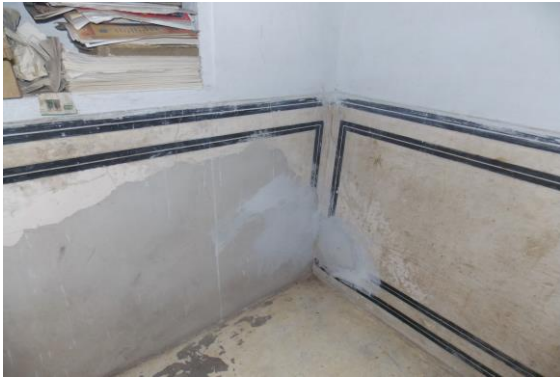
Photo 185

Peeling of Plaster on Wall No. 2 of Room No. 17 of Navjeevan Chikitsalaya, First Floor

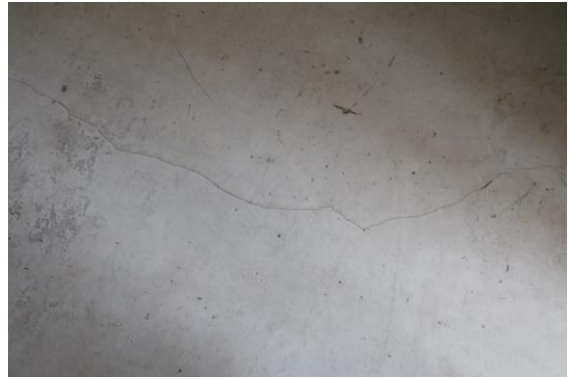
Photo 186

Plaster Crack on Floor of Room No. 17 of Navjeevan Chikitsalaya, First Floor

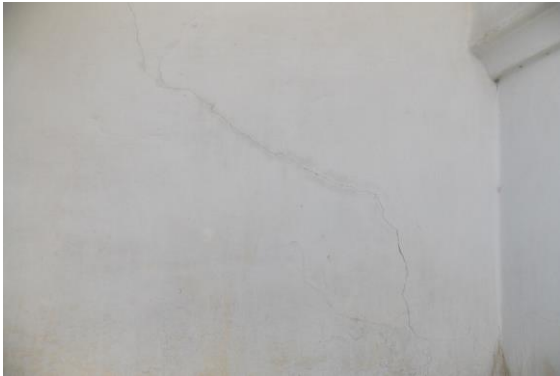
Photo 187

Plaster Crack on Wall No. 3 of Open Sky 3 of Navjeevan Chikitsalaya of First Floor

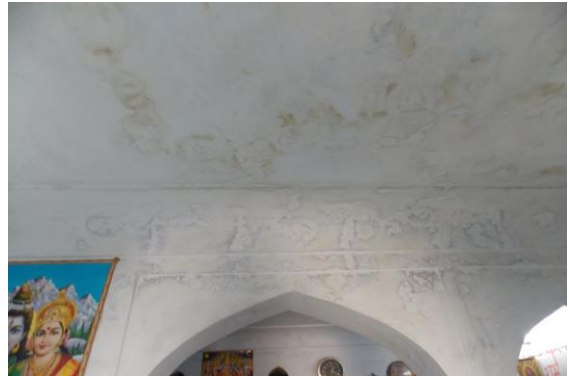
Photo 188

Dampness/Seepage on Wall No. 4 & Roof of Temple of Navjeevan Chikitsalaya of Ground Floor

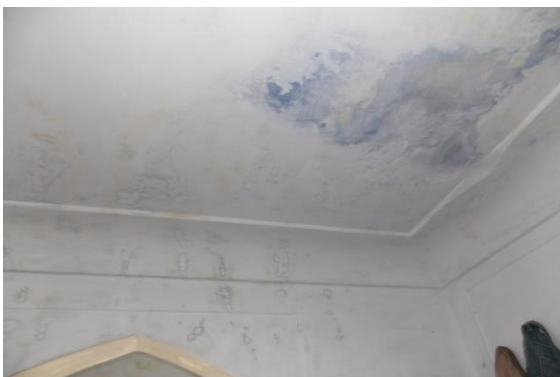
Photo 189

Dampness/Seepage on Wall No. 3 & Roof of Varanda 2 of Navjeevan Chikitsalaya of Ground Floor

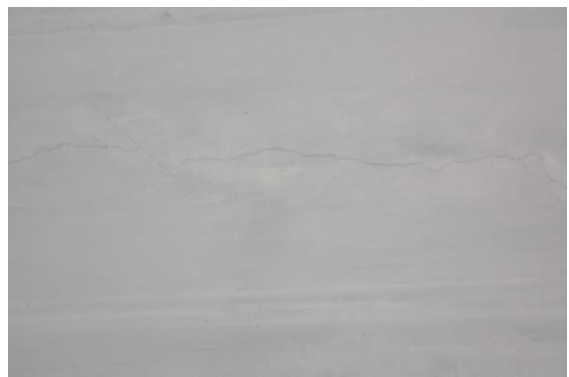
Photo 190

Plaster Crack on Roof of Passage 1 of Navjeevan Chikitsalaya of Ground Floor

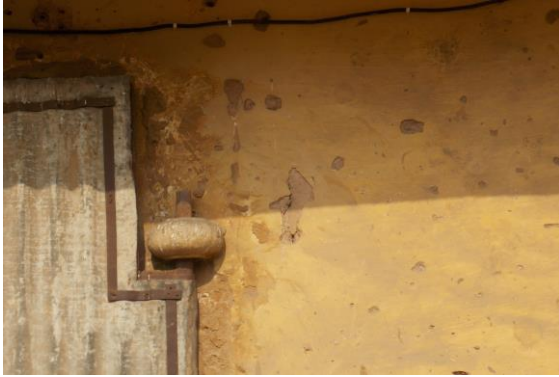
Photo 191

Peeling of Plaster on of External Faccade,Back Side of Navjeevan Chikitsalaya of Ground Floor

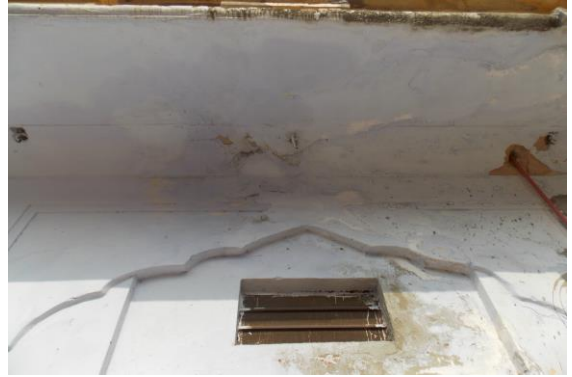
Photo 192

Dampness/Seepage on Sunshade of External Faccade,Back Side of Navjeevan Chikitsalaya of Ground Floor

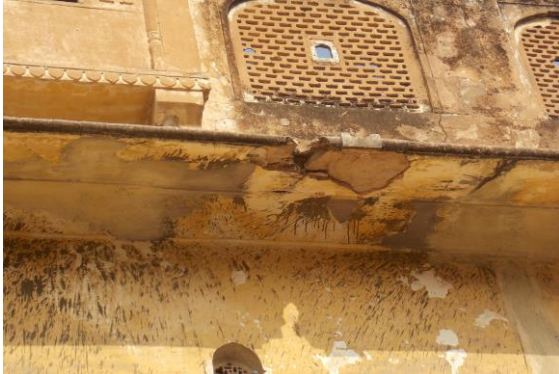
Photo 193

Damaged Portion on Sunshade of External Faccade,Back Side of Navjeevan Chikitsalaya of First Floor

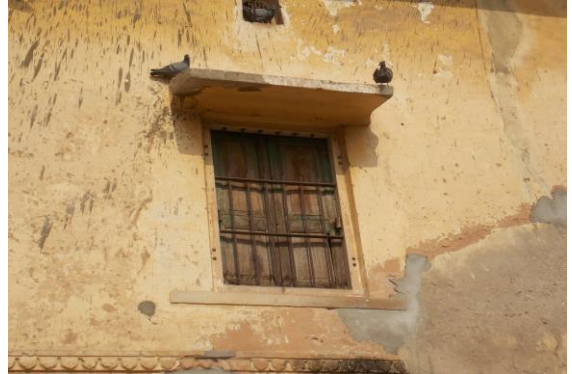
Photo 194

Peeling of Plaster on Back Side Wall of External Faccade,Back Side of Navjeevan Chikitsalaya of First Floor

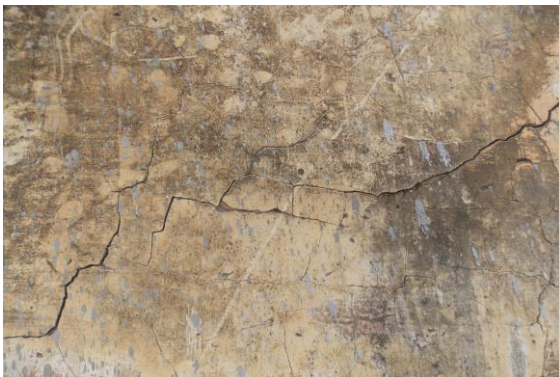
Photo 195

Damaged Portion on Back Side Wall of External Faccade,Back Side of Navjeevan Chikitsalaya of Ground Floor

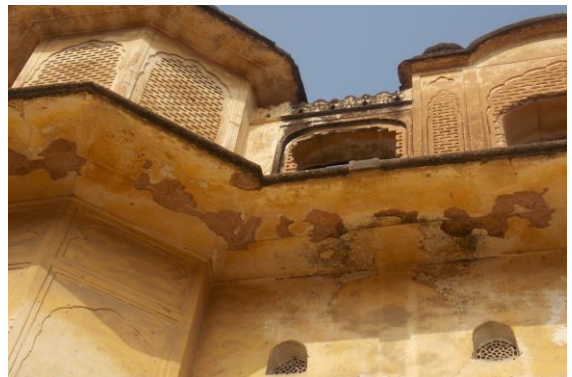
Photo 196

Peeling of Plaster on Sunshade of External Faccade,Back Side of Navjeevan Chikitsalaya of Second Floor

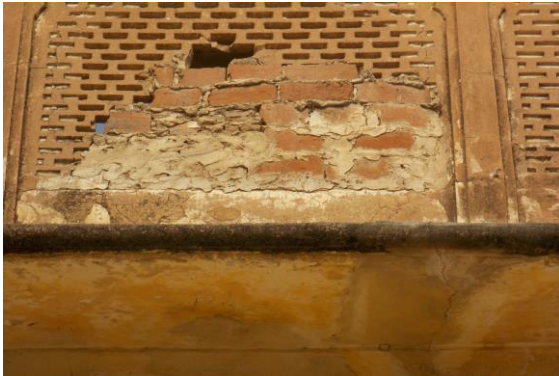
Photo 197

Peeling of Plaster on Sunshade of External Faccade,Back Side of Navjeevan Chikitsalaya of Second Floor

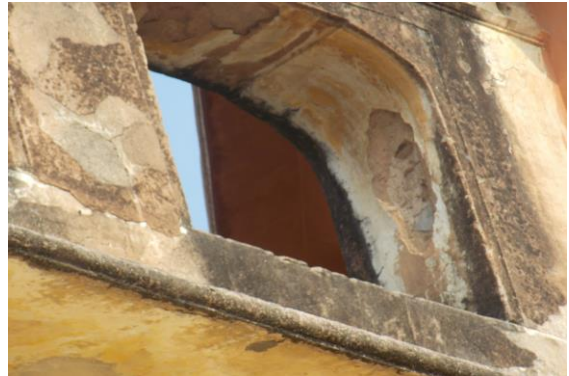
Photo 198

Peeling of Plaster on Back Side Wall of External Faccade,Back Side of Navjeevan Chikitsalaya of Terrace

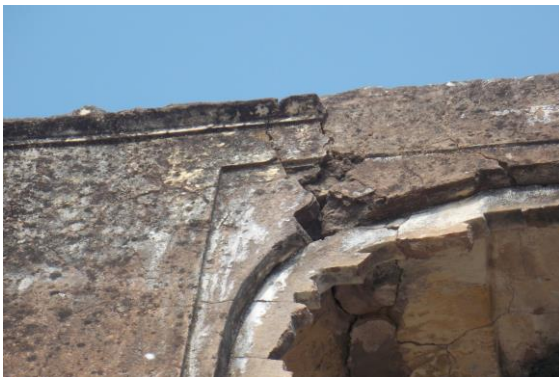
Photo 199

Damaged Portion on Back Side Wall of External Faccade,Back Side of Navjeevan Chikitsalaya of Terrace

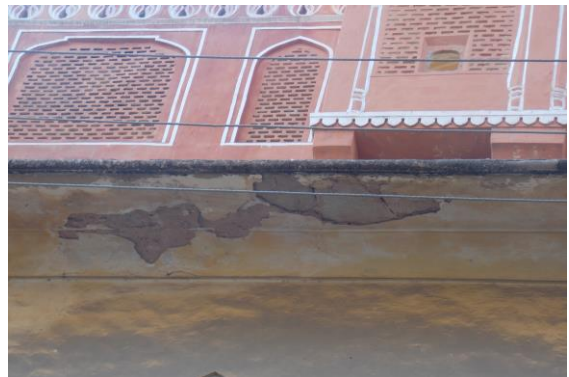
Photo 200

Peeling of Plaster on Sunshade of External Faccade,Right Side of Navjeevan Chikitsalaya of First Floor

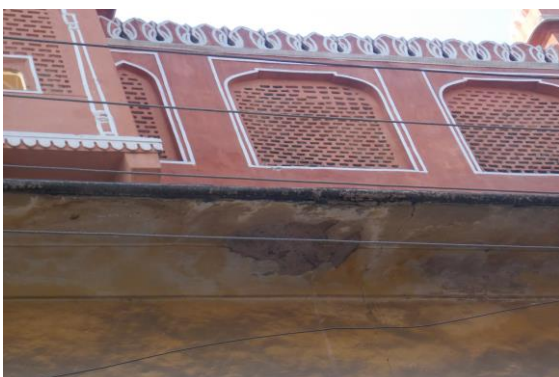
Photo 201

Peeling of Plaster on Sunshade of External Faccade,Right Side of Navjeevan Chikitsalaya of First Floor

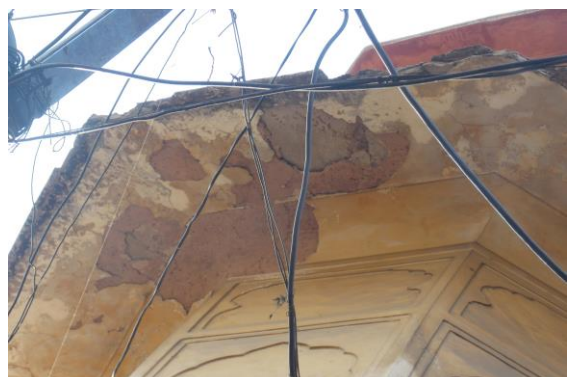
Photo 202

Peeling of Plaster on Sunshade of External Faccade,Right Side of Navjeevan Chikitsalaya of First Floor

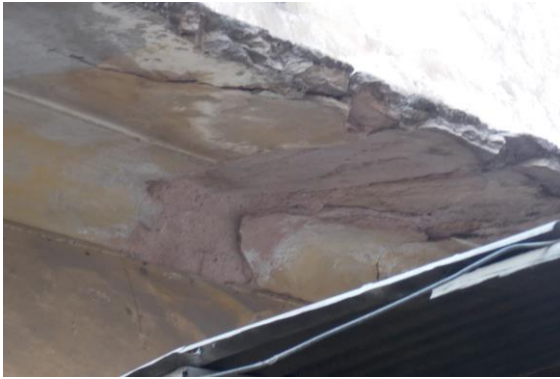
Photo 203

Damaged Portion on Sunshade of External Faccade, Right Side of Navjeevan Chikitsalaya of Ground Floor

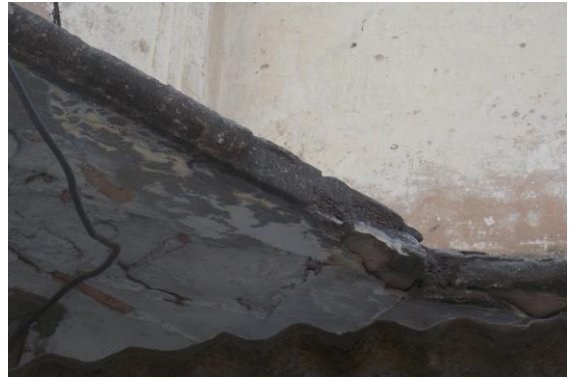
Photo 204

Damaged Portion on Sunshade of External Faccade, Right Side of Navjeevan Chikitsalaya of Ground Floor

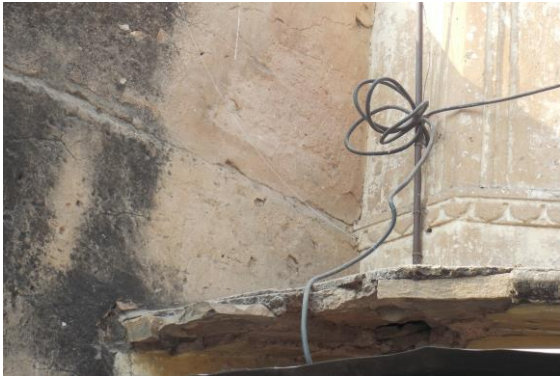
Photo 205

Damaged Portion on Sunshade of External Faccade, Right Side of Navjeevan Chikitsalaya of Ground Floor

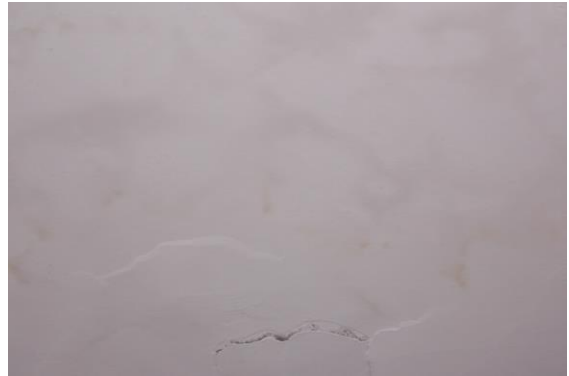
Photo 206

Dampness/Seepage on Roof of Varanda 13 of Navjeevan Chikitsalaya of First Floor

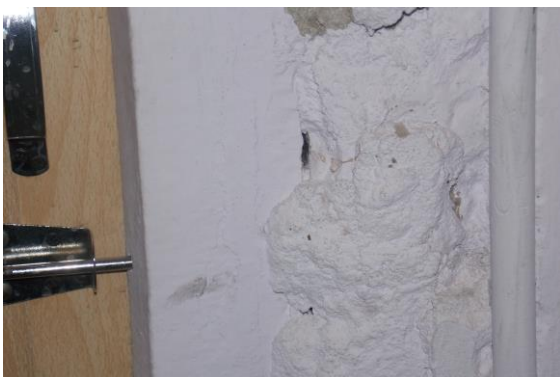
Photo 207

Peeling of Plaster on Wall No. 4 of Lobby of Navjeevan Chikitsalaya of First Floor

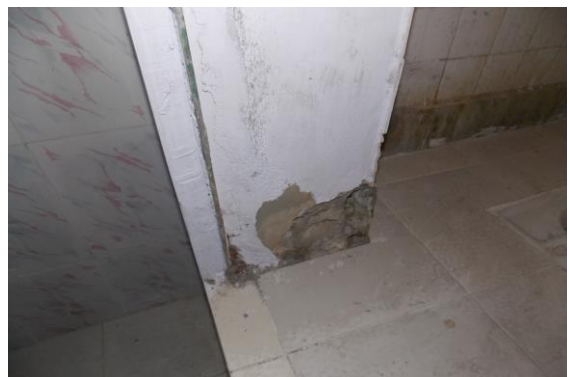
Photo 208

Peeling of Plaster on Wall No. 1 of Toilet No. 1 of Navjeevan Chikitsalaya, First Floor

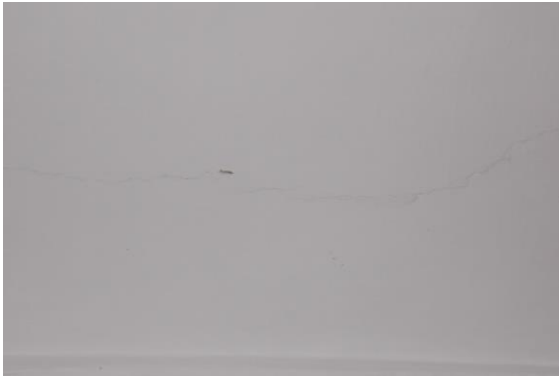
Photo 209

Peeling of Plaster on Roof of Hall 3 of Navjeevan Chikitsalaya of First Floor

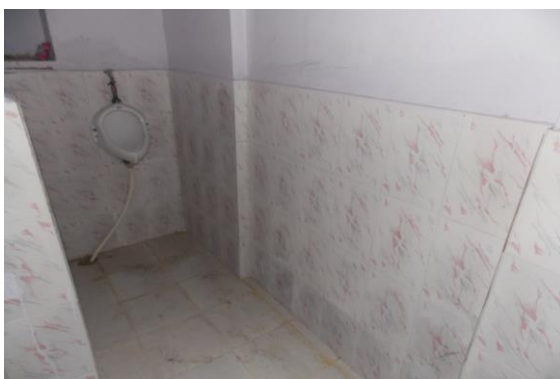
Photo 231
All Wall of Toilet No. 1 of Navjeevan Chikitsalaya, First Floor Covered With Tiles
