Pre Building Condition Survey Report

Name and Address of Structure :	Badi Chopar to Ramp Area (Down Line)
---------------------------------	--------------------------------------

Name of the Project	Contract JMRC-UG1B “Design and Construction of Tunnel between Chandpole and Badi Chouper and reverse line by Shield TBM, Underground Metro Stations at Choti Chouper and Badi Chouper by Cut and Cover Methods on East West Corridor of Jaipur Metro Rail Corporation Limited .”	
Owner :

Pre - Condition Building Survey for Construction of Underground Stations from Chandpole to Bari Chouper and reversal line

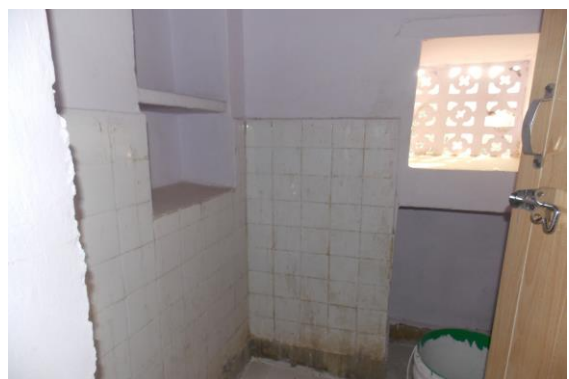
Photo 232
All Wall of Toilet No. 2 of Navjeevan Chikitsalaya, First Floor Covered With Tiles

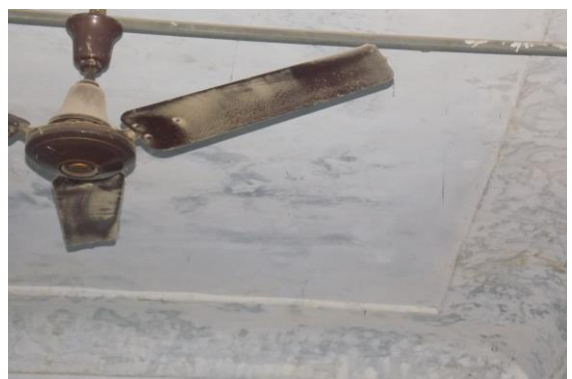
Photo 12
Dampness/Seepage on Roof of Shop No.4, Part C of Ground Floor

Summary of Defects Other Than Crack			
Defect ID	Location	Description	Photo No.
1	Roof Shop No.4,Part C Ground Floor	Dampness/Seepage	12

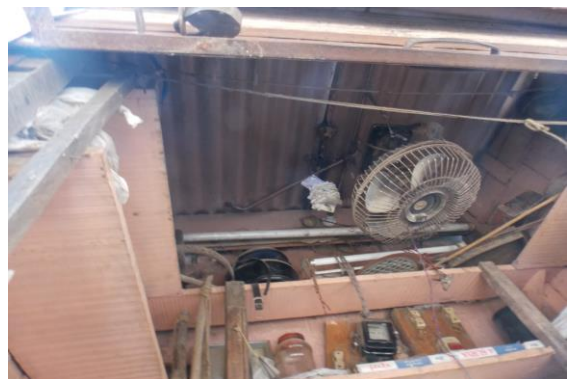
Photo 18

Roof of Shop No.5 of Ground Floor Tinsed

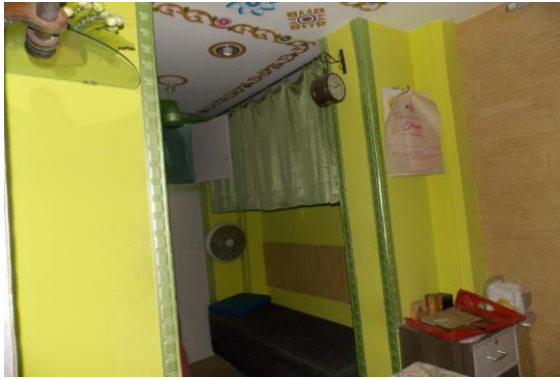
Photo 19

All Wall of Shop No.6,Part C of Ground Floor Covered With Marble

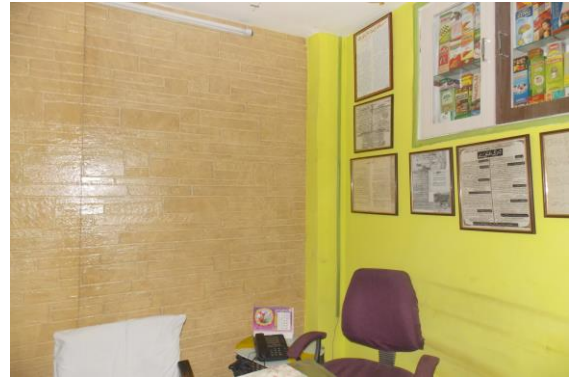
Photo 20

All Wall of Shop No.6,Part C of Ground Floor Covered With Marble

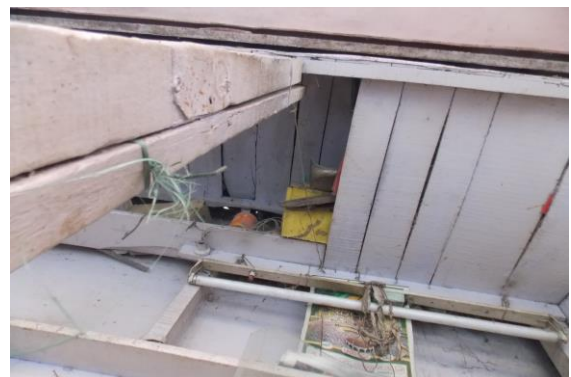
Photo 24

Roof of Shop No.3 of Ground Floor Tin Shade

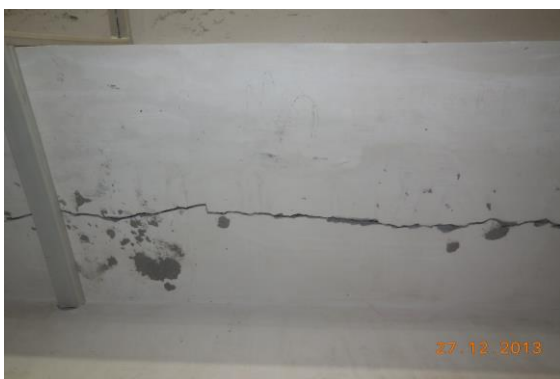
Photo 107
Horizontal Crack on Roof of Part -II of Shop No.27 & 36, Second Floor, Approx. Width = 3mm, Approx. Length = 2.5m. Distance from Wall no.1 = 0m, Height from Floor = 2.3m.

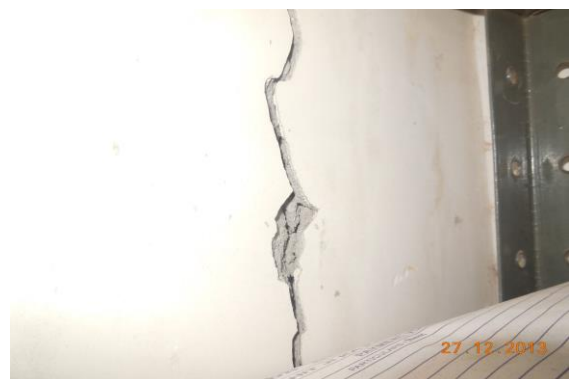
Photo 108
Vertical Crack on Wall No. 2 of Part -II of Shop No.27 & 36, Second Floor
Approx. Width = 5mm, Approx. Length = 2.3m.
Distance from Wall no.3 = 0.1m Height from Floor = 0m

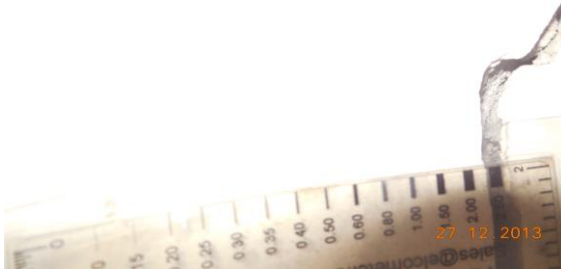
Photo 108A

Vertical Crack on Wall No. 2 of Part -II of Shop No.27 & 36, Second Floor, Approx. Width = 5mm, Approx. Length = 2.3m.
Distance from Wall no.3 = 0.1m, Height from Floor = 0m.

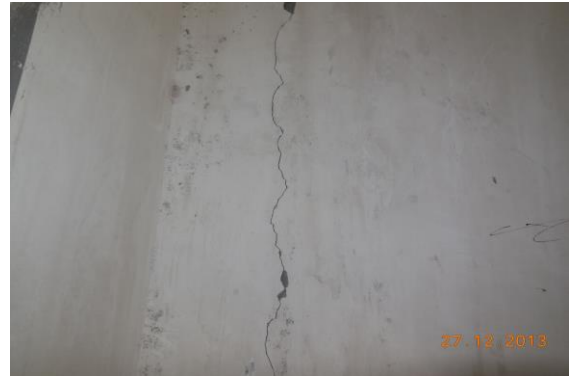
Photo 109

Vertical Crack on Wall No. 1 of Part -II of Shop No.27 & 36, Second Floor, Approx. Width = 1mm, Approx. Length = 2.3m.
Distance from Wall No.3 = 0.15m, Height from Floor = 0m.

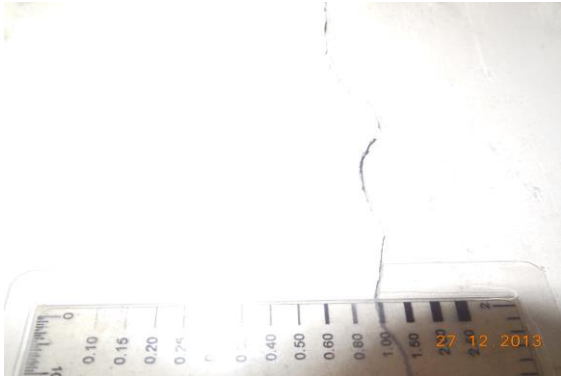
Photo 109A

Vertical Crack on Wall No. 1 of Part -II of Shop No.27 & 36, Second Floor, Approx. Width = 1mm, Approx. Length = 2.3m.
Distance from Wall No.3 = 0.15m, Height from Floor = 0m.

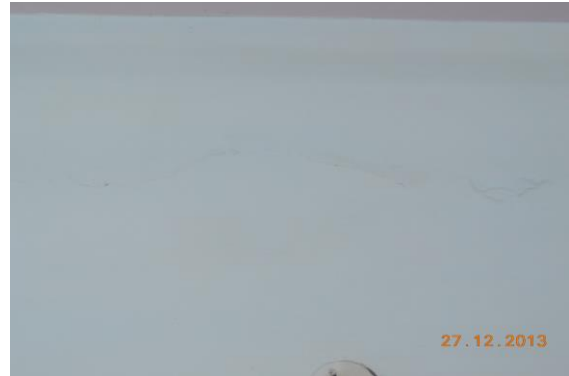
Photo 110

Horizontal Crack on Wall No. 1 of Shop No.26 & 37, Second Floor, Approx. Width = 0.35mm, Approx. Length = 5m.
Distance from Wall no.3 = 0m, Height from Floor = 2.4m.

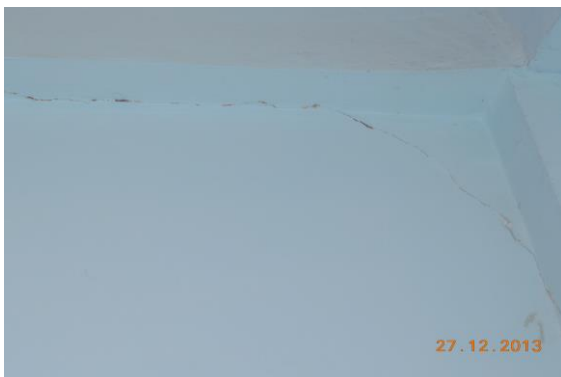
Photo 111

Inclined Crack on Wall No. 4 of Shop No.26 , Second Floor, Approx. Width = 0.4mm, Approx. Length = 2.5m.
Distance from Wall no.2 = 0.1m, Height from Floor = 2.2m.

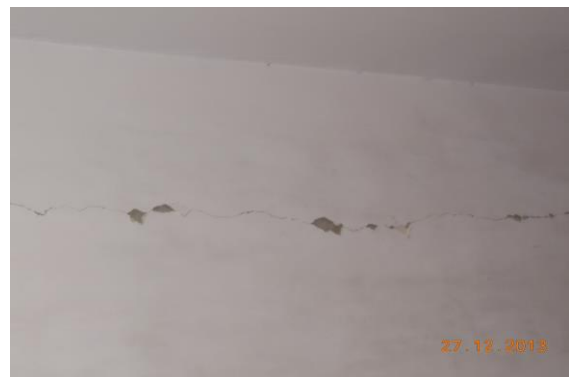
Photo 112

Horizontal Crack on Wall No. 1 of Shop No.37, Second Floor, Approx. Width = 0.4mm, Approx. Length = 3.2m.
Distance from Wall no.3 = 0m, Height from Floor = 2.4m.

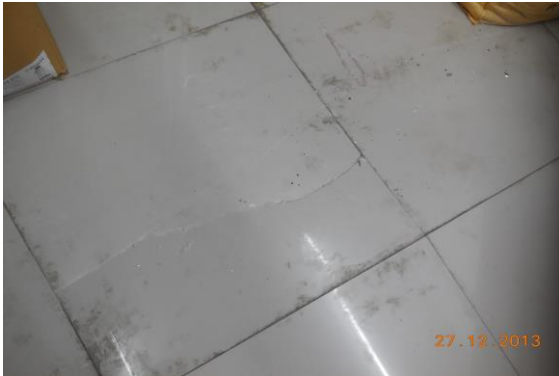
Photo 113

Horizontal Crack on Floor of Shop No.S-25, Second Floor,Approx.
Width = 0.8mm, Approx. Length = 0m.
Distance from 0Wall no.2 = 2m, Height from Floor = 0m.

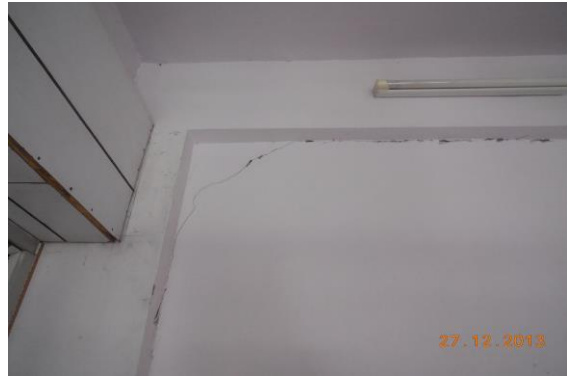
Photo 114

Inclined Crack on of Shop No.12, Second Floor,Approx. Width =
0.5mm, Approx. Length = 2.5m.
Distance from Wall No.3 = 0.2m, Height from Floor = 1.3m.

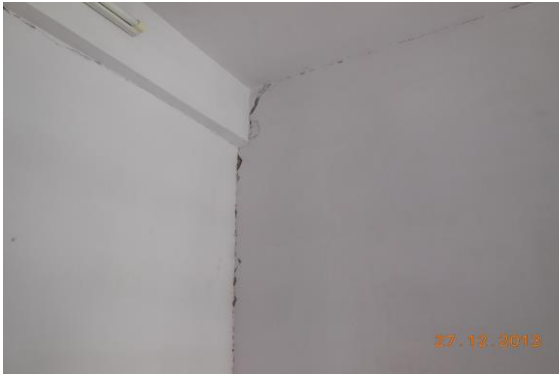
Photo 115

Vertical Crack on of Shop No.12, Second Floor,Approx. Width =
0.4mm, Approx. Length = 2.4m.
Distance from = Corner Wall no.4 & 2m, Height from Floor = 0m.

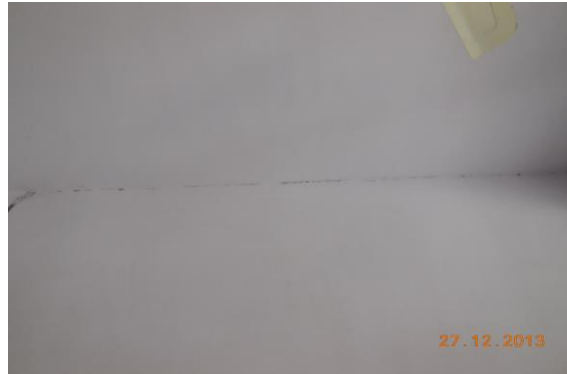
Photo 116

Horizontal Crack on of Shop No.12, Second Floor,Approx. Width =
0.5mm, Approx. Length = 2.4m.
Distance from Wall No.4 = 0m, Height from Floor = 2.8m.

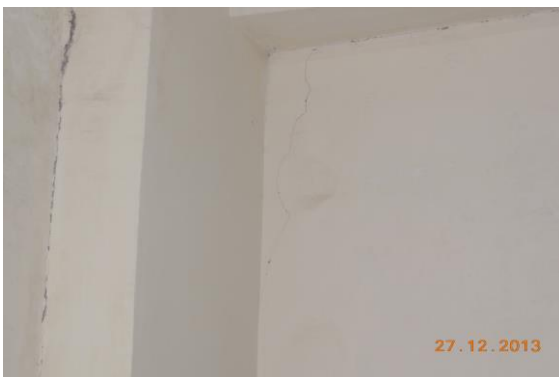
Photo 117

Inclined Crack on Wall No. 4 of Shop No.14, Second Floor,Approx.
Width = 0.25mm, Approx. Length = 0.65m.
Distance from Wall No.1 = 0m, Height from Floor = 1.8m.

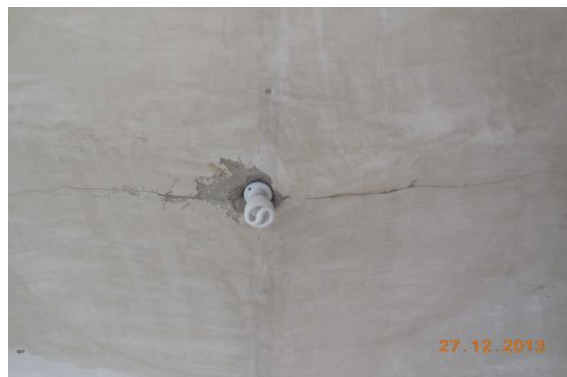
Photo 118

Horizontal Crack on Roof of Varanda, Shop No.S-22, Second Floor
Approx. Width = 0.5mm, Approx. Length = 2m.
Distance from = Passage Between shop No.21 & 22m, Height from
Floor = 2.8m

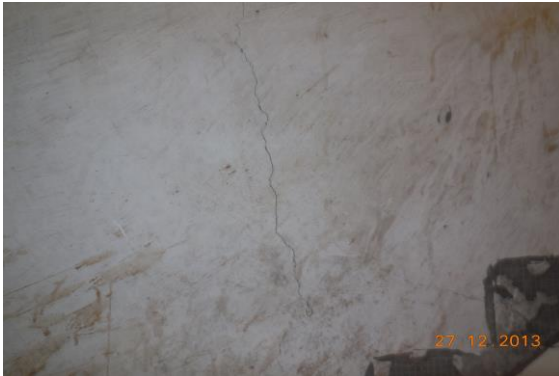
Photo 119

Vertical Crack on Wall No. 1 & 4 of Staircase GF to FF, Second Floor, Approx. Width = 0.5mm, Approx. Length = 0.6m. Distance from Wall No.1 = 1.9m, Height from Floor = 1m.

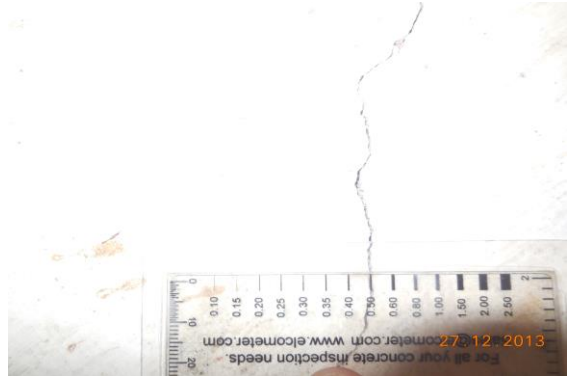
Photo 119A

Vertical Crack on Wall No. 1 & 4 of Staircase GF to FF, Second Floor, Approx. Width = 0.5mm, Approx. Length = 0.6m. Distance from Wall No.1 = 1.9m, Height from Floor = 1m.

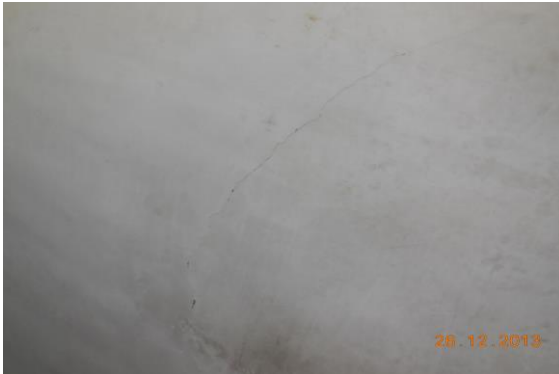
Photo 120

Inclined Crack on Wall No. 4 of Shop No. F 48, First Floor, Approx. Width = 0.3mm, Approx. Length = 1.5m. Distance from Wall No. 1 = 0.3m, Height from Floor = 0.8m.

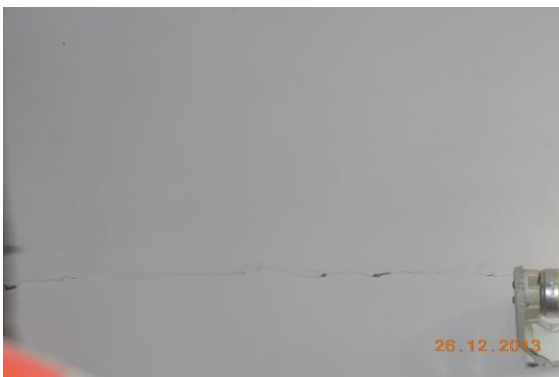
Photo 120A

Inclined Crack on Wall No. 4 of Shop No. F 48, First Floor, Approx. Width = 0.3mm, Approx. Length = 1.5m. Distance from Wall No. 1 = 0.3m, Height from Floor = 0.8m.

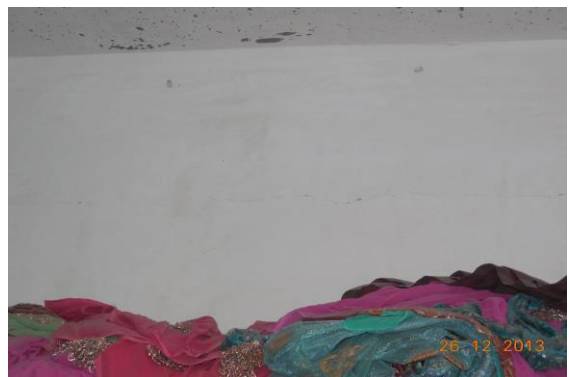
Photo 121

Horizontal Crack on Wall No. 1 & 4 of Part A, Shop No. F 26, First Floor, Approx. Width = 0.5mm, Approx. Length = 2m. Distance from Wall No. 1 = 0m, Height from Floor = 2.6m.

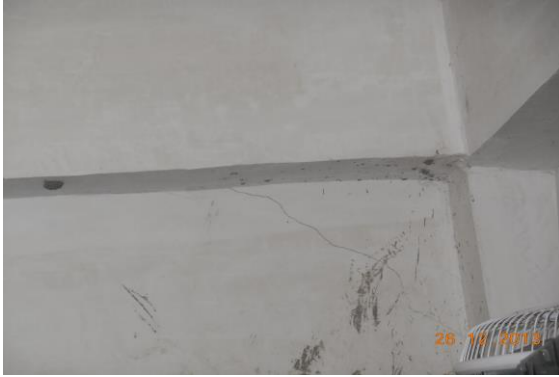
Photo 122

Horizontal Crack on Beam of Part A & B, Shop No. F 23, First Floor, Approx. Width = 0.2mm, Approx. Length = 10m. Distance from Wall No. 4 = 0m, Height from Floor = 2.4m.

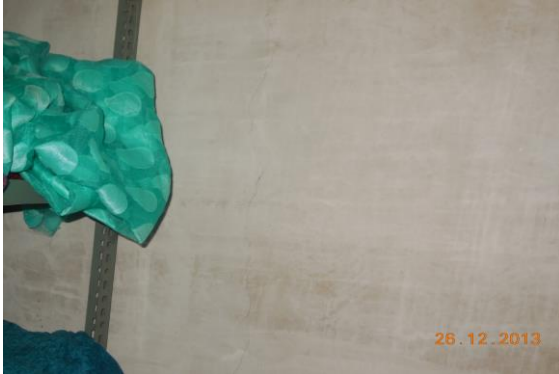
Photo 124

Horizontal Crack on Wall No. 1 of Shop No. F 22, First Floor
Approx. Width = 0.3mm, Approx. Length = 5m.
Distance from Wall No. 3 = 5.2m, Height from Floor = 2.5m.

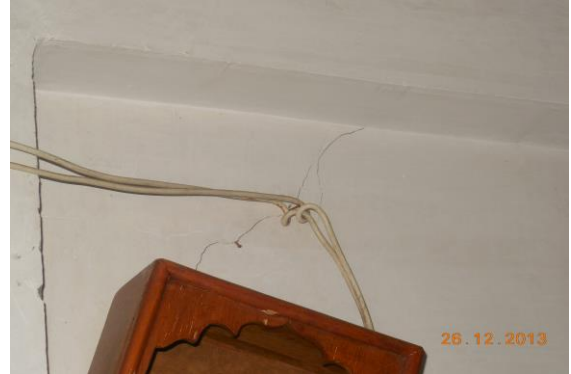
Photo 125

Vertical Crack on Wall No. 1 of Shop No. F 23, First Floor
Approx. Width = 0.25mm, Approx. Length = 2.4m.
Distance from Wall No. 3 = 5.2m, Height from Floor = 0m.

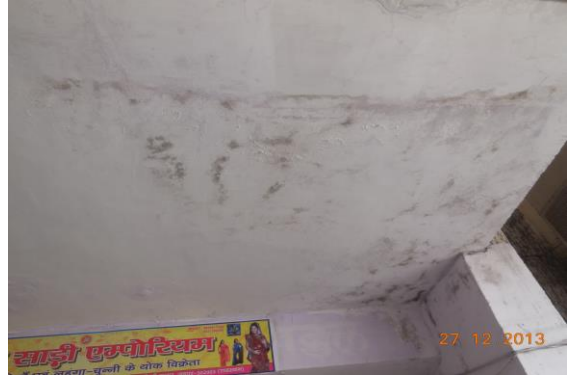
Photo 128

Dampness/Seepage on Roof of Varanda of Shop No.37 of Second Floor

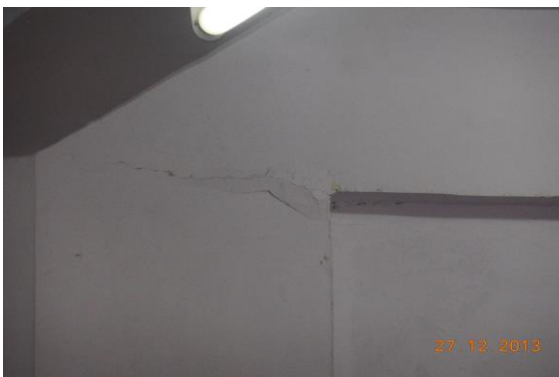
Photo 131

Dampness/Seepage on Wall No. 1 of Shop No.S-9 of Second Floor

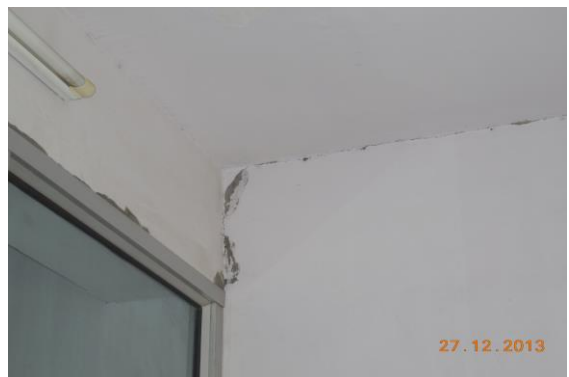
Photo 132

Peeling of Plaster on Wall No. 4 of shop No.2 & 1 of Second Floor

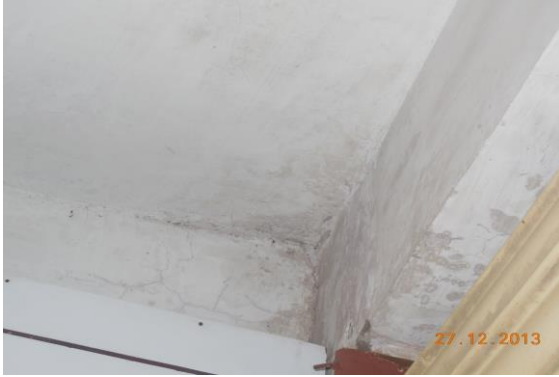
Photo 133

Peeling of Plaster on Wall No. 1 & 4 of Shop No.12 of Second Floor

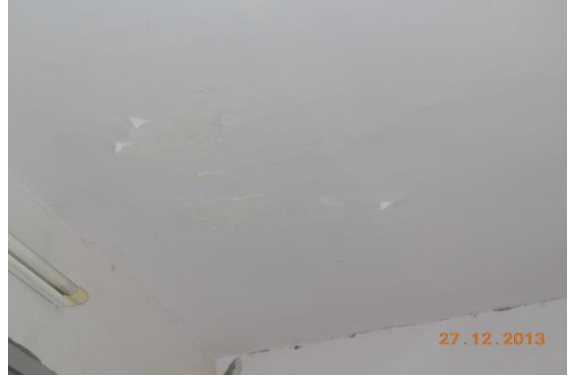
Photo 134

Dampness/Seepage on Wall No. 3, 2 & Roof of Shop No.12 of Second Floor

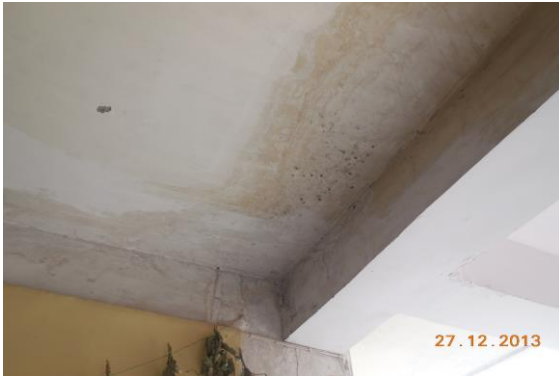
Photo 135

Peeling of Plaster on Roof of Shop No.12 of Second Floor

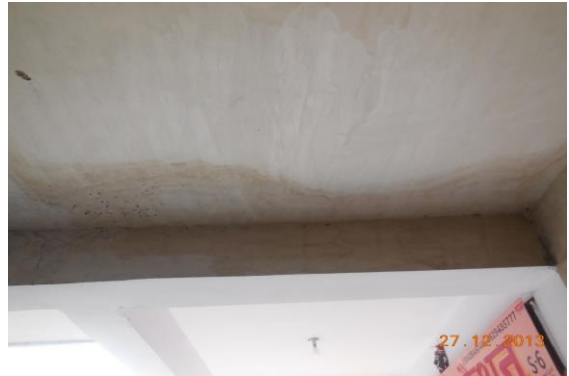
Photo 136

Dampness/Seepage on Roof of Passage, Shop No.12 of Second Floor

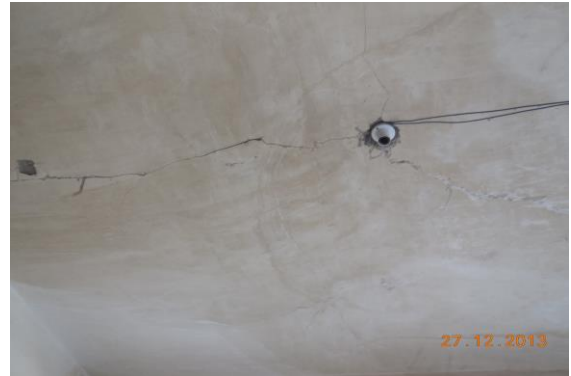
Photo 140

Dampness/Seepage on Roof of Varanda, Shop No.S-22 of Second Floor

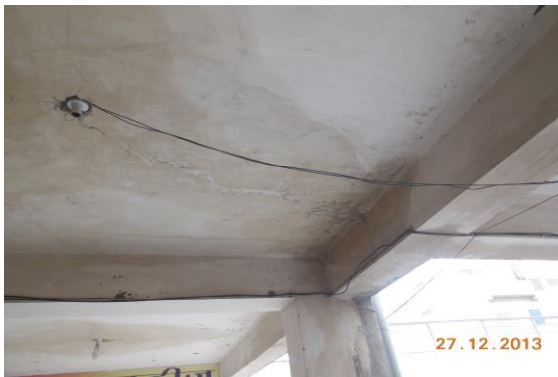
Photo 141

Peeling of Plaster on Roof of Varanda, Shop No.S-22 of Second Floor

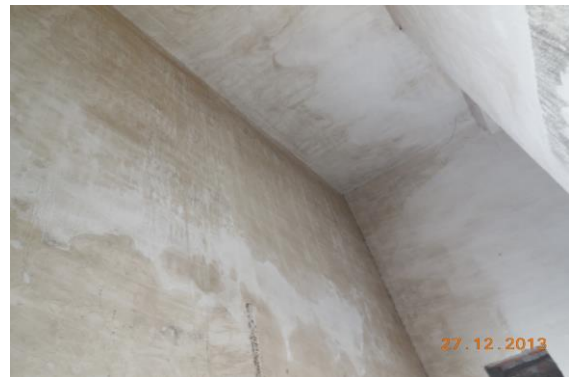
Photo 142

Dampness/Seepage on Roof of Varanda, Shop No.S-22 of Second Floor

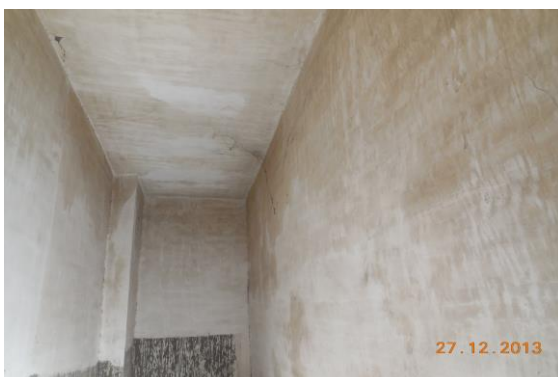
Photo 143

Dampness/Seepage on All walls & Roof of Staircase SF to Terrace of Second Floor

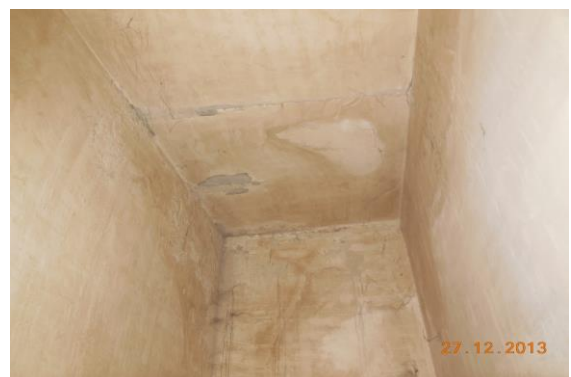
Photo 144

Dampness/Seepage on All walls & Roof of Staircase SF to Terrace of Second Floor

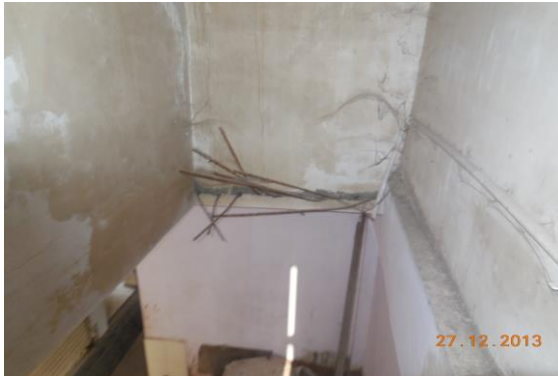
Photo 145

Dampness/Seepage on All walls & Roof of Staircase FF to SF of Second Floor

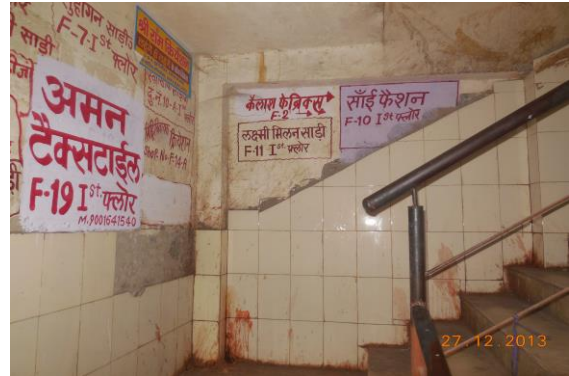
Photo 146

Exposed Reinforcement on Wall No. 3 of Staircase FF to SF of Second Floor

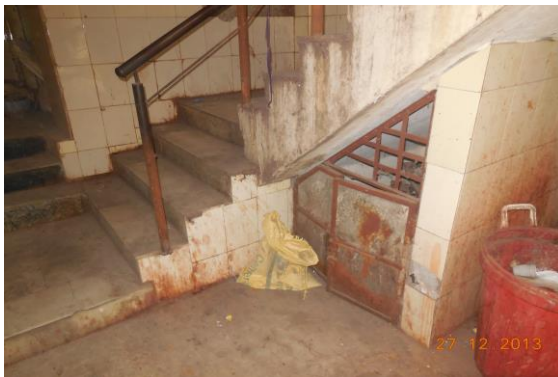
Photo 147

Peeling of Plaster on Wall No. 1 & 4 of Staircase GF to FF of Second Floor

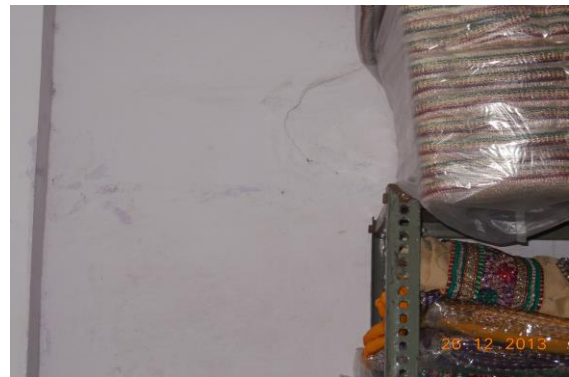
Photo 148

Peeling of Plaster on Under Roof of Staircase GF to FF of Second Floor

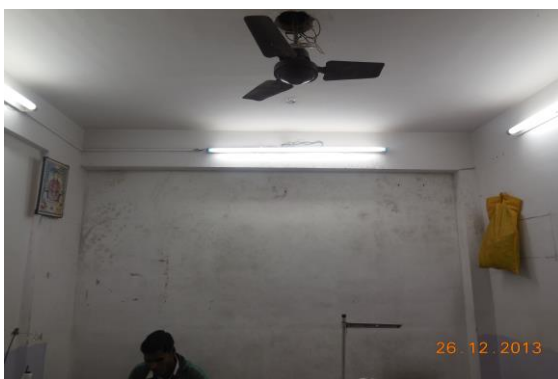
Photo 149

Dampness/Seepage on Wall No. 4 of Shop No. F 47 of First Floor

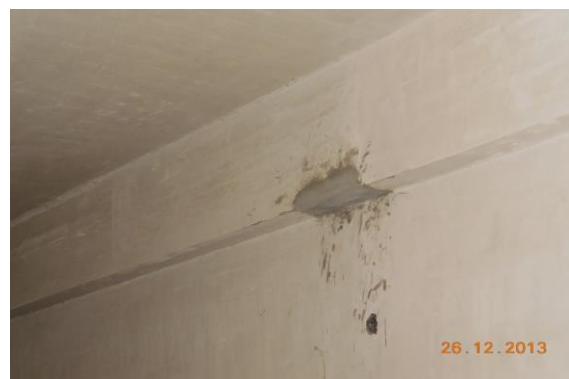
Photo 150

Dampness/Seepage on Wall No. 4 of Shop No. F 48 of First Floor

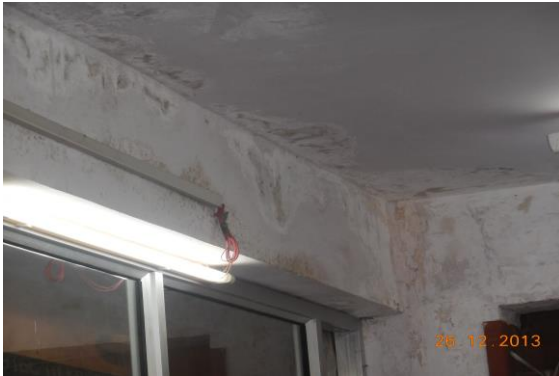
Photo 151

Peeling of Plaster on Wall No. 2 of Shop No. F 8 of First Floor

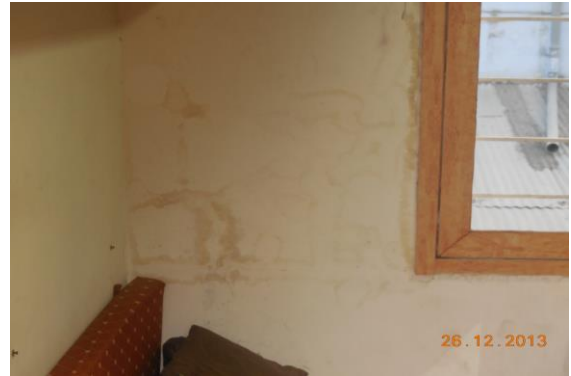
Photo 152
Dampness/Seepage on Wall No. 1 & 4 of Shop No. F 13 of First Floor

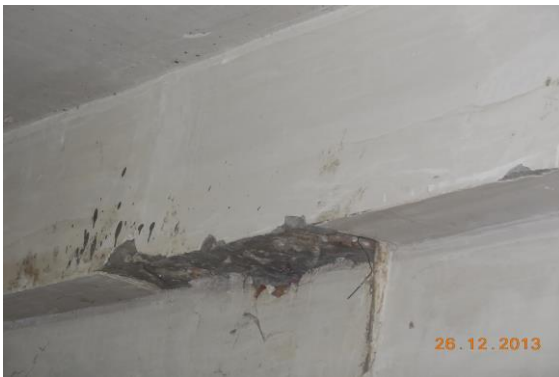
Photo 153
Dampness/Seepage on Wall No. 4 of Shop No. F 13 of First Floor

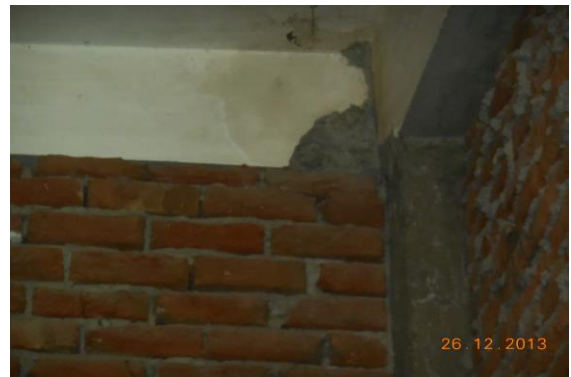
Photo 154
Peeling of Plaster on Wall No. 2 of Shop No. F 1 of First Floor

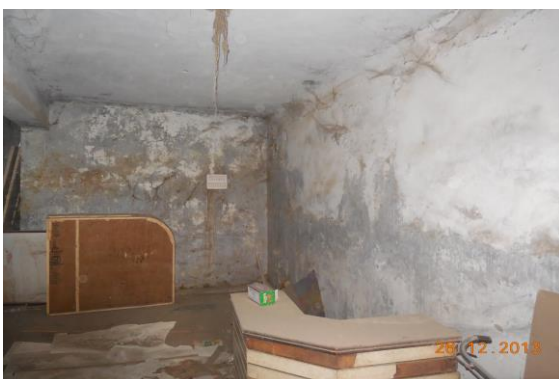
Photo 155
Peeling of Plaster on Entry Gate & 4 of Shopping Complex of Basement

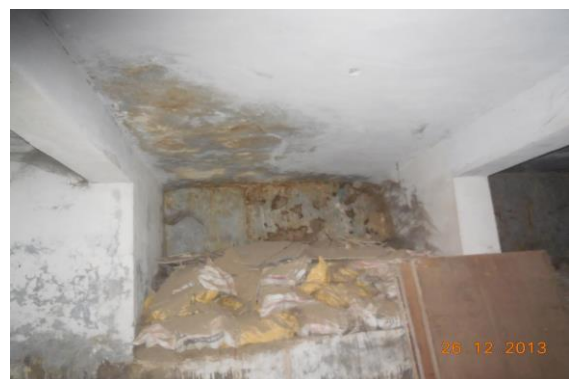
Photo 156
Dampness/Seepage on Wall No. 4 of Shopping Complex of Basement

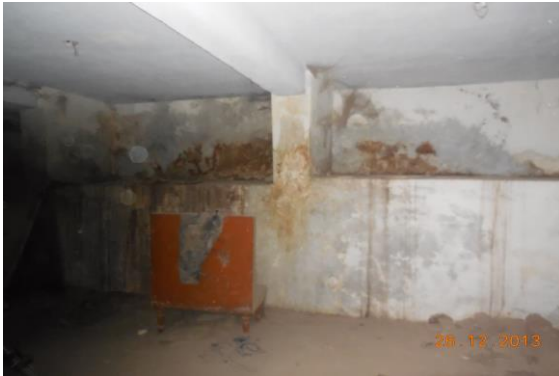
Photo 157
Dampness/Seepage on Wall No. 4 & Roof of Shopping Complex of Basement

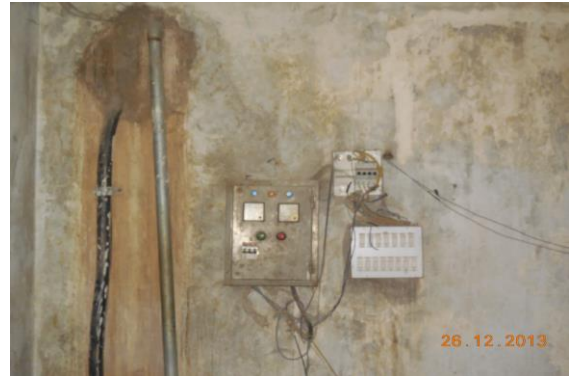
Photo 158

Dampness/Seepage on Wall No. 4 & Roof of Shopping Complex of Basement

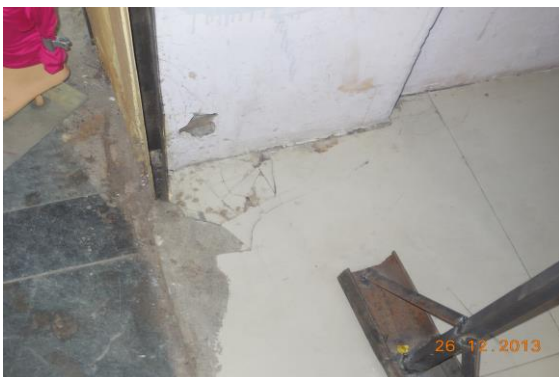
Photo 161

Peeling of Plaster on Floor & Tiles Crack of Shop No. G 21 of Ground Floor

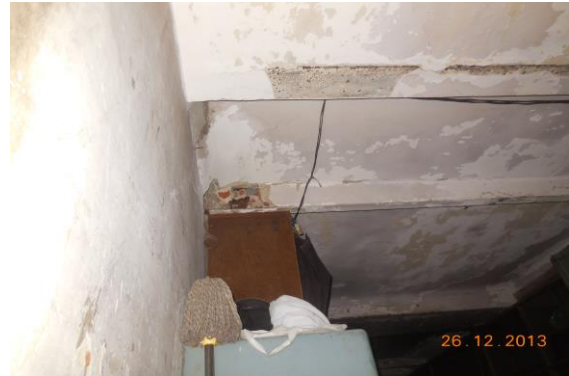
Photo 164

Peeling of Plaster on Roof of Harsh Jewellers of Upper Ground Floor

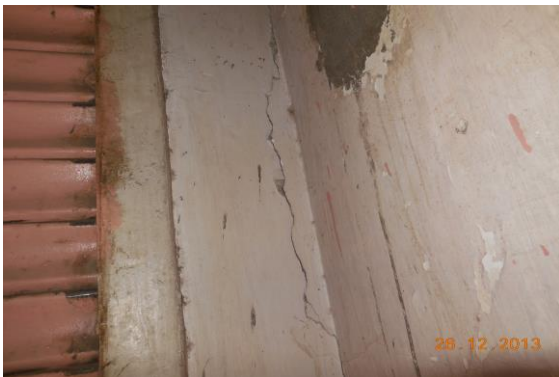
Photo 165

Peeling of Plaster on Roof of Harsh Jewellers of Upper Ground Floor

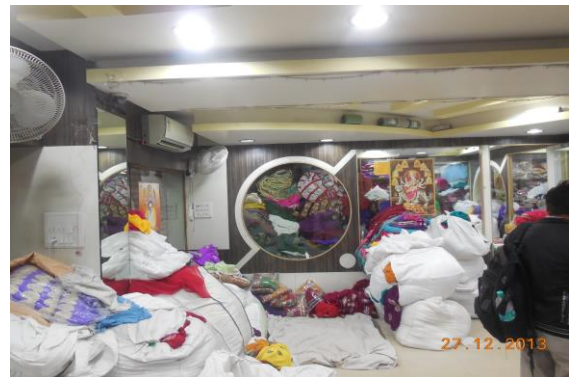
Photo 166

Peeling of Plaster on Wall No. 3 of Harsh Jewellers of Upper Ground Floor

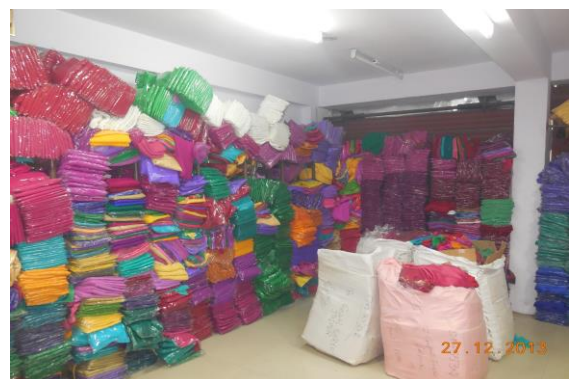
Photo 199
Wall No. 1 of shop No.2 & 1 of Second Floor Covered with Material

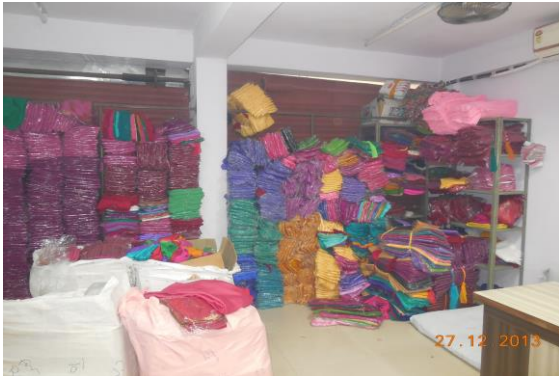
Photo 200

Wall No. 4 of shop No.2 & 1 of Second Floor Covered with Material

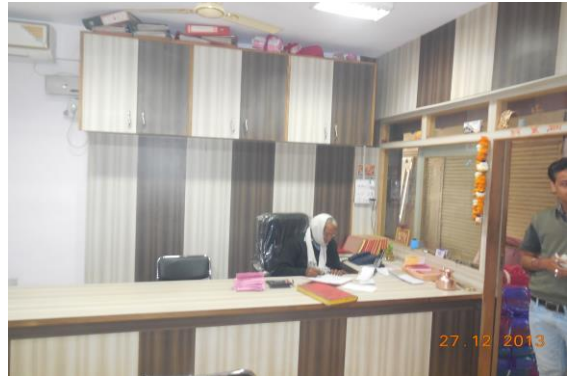
Photo 201

Wall No. 2 of shop No.2 & 1 of Second Floor Covered with Wooden work

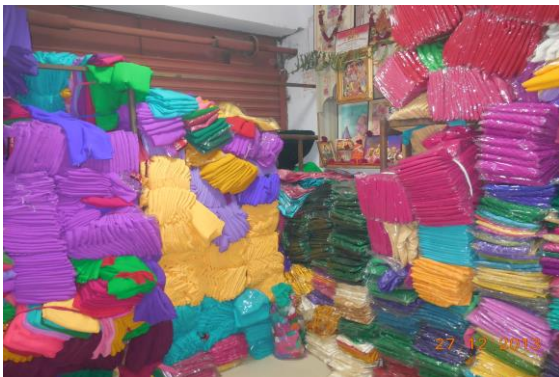
Photo 202

Wall No. 1 & 3 of shop No.2 & 1 of Second Floor Covered with Material

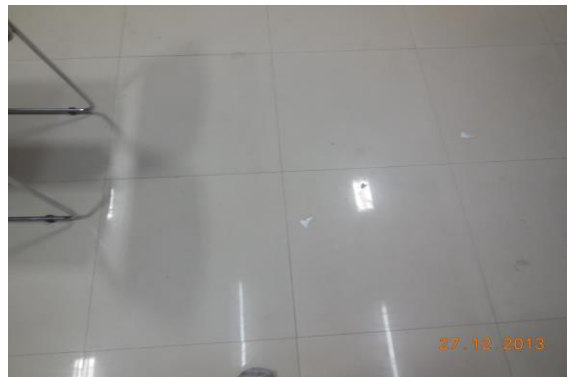
Photo 203

Floor of shop No.2 & 1 of Second Floor Covered with Tiles

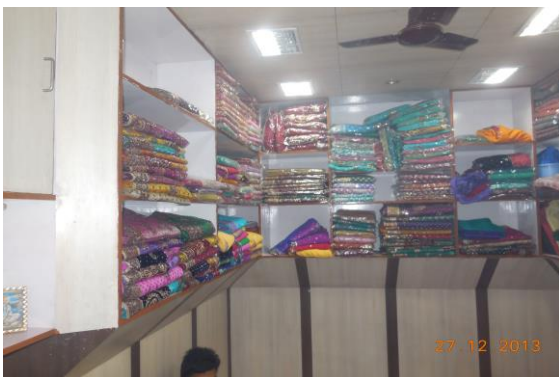
Photo 204

Wall No. 1 & 4 of Shop No.13A of Second Floor Covered with Wooden work & Material

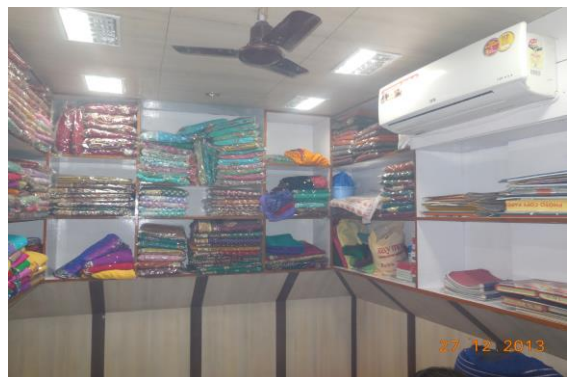
Photo 205

Wall No. 2 & 4 of Shop No.13A of Second Floor Covered with Wooden work & Material

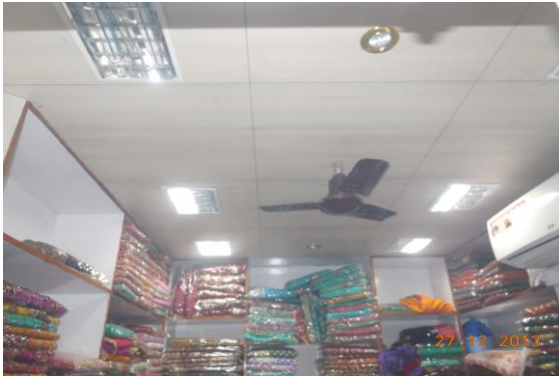
Photo 206
Roof of Shop No.13A of Second Floor Covered with Falls Ceiling

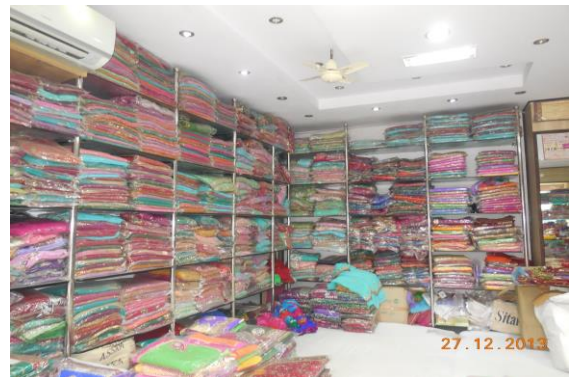
Photo 209
Wall No. 1 & 4 of Shop No.16 & 17 of Second Floor Covered with Material

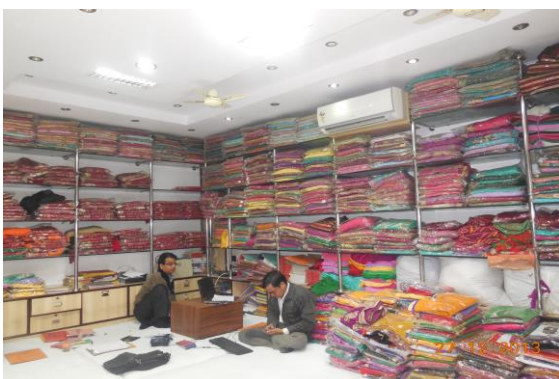
Photo 210
Wall No. 2 & 4 of Shop No.16 & 17 of Second Floor Covered with Material

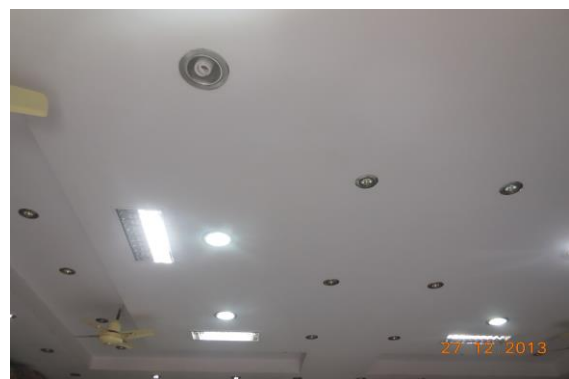
Photo 211
Roof of Shop No.16 & 17 of Second Floor Covered with Falls Ceiling

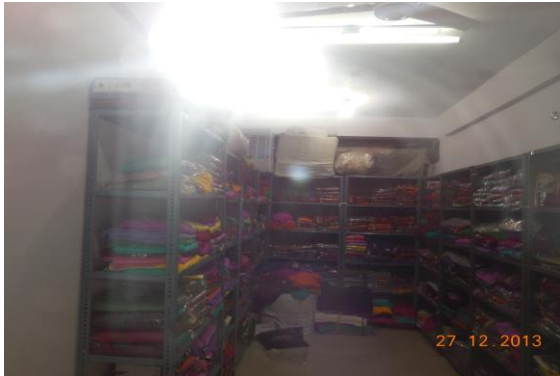
Photo 212

Wall No. 1 & 4 of Shop No.S-11 of Second Floor Covered with Material

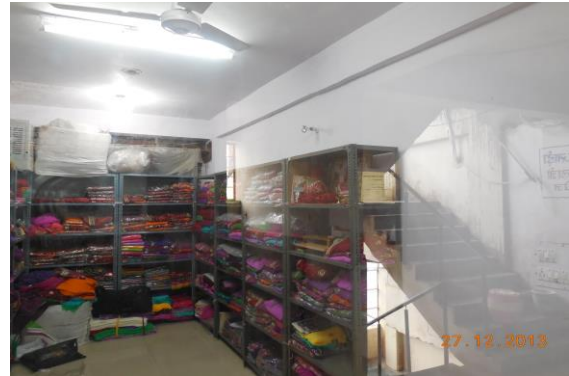
Photo 213

Wall No. 2 & 4 of Shop No.S-11 of Second Floor Covered with Material

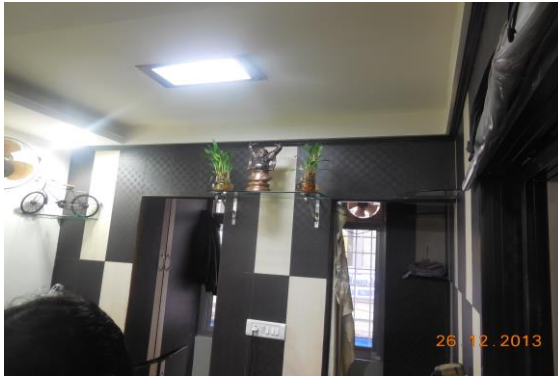
Photo 230

Wall No. 2 of Shop No. F 32 & 33 of First Floor Covered with Wooden work

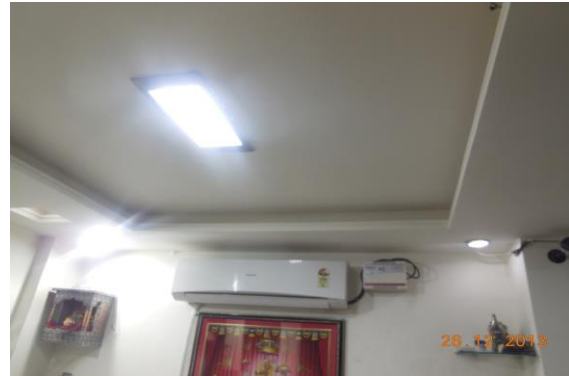
Photo 231

Roof of Shop No. F 32 & 33 of First Floor Covered with False Ceiling

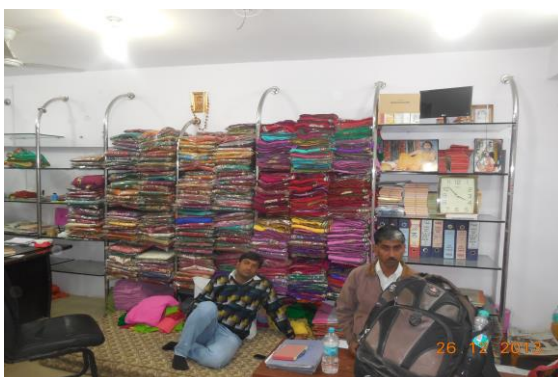
Photo 234

Wall No. 4 of Shop No. F 36 of First Floor Covered with Material

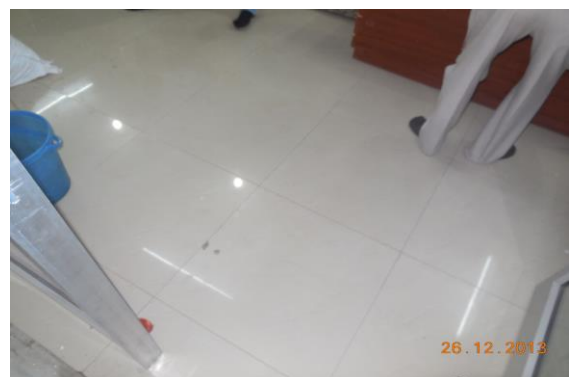
Photo 235

Floor of Shop No. F 36 of First Floor Covered with Tiles

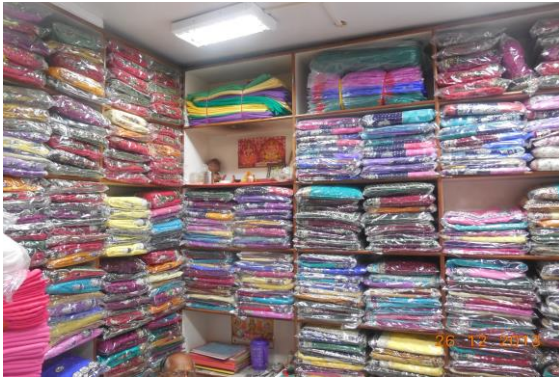
Photo 236

Wall No. 1 & 4 of Shop No. F 46 of First Floor Covered with Material

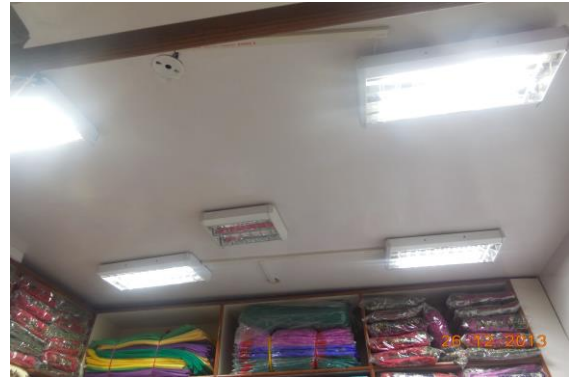
Photo 237

Roof of Shop No. F 46 of First Floor Covered with False Ceiling

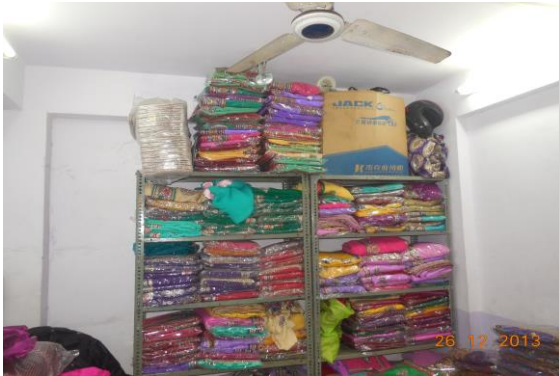
Photo 238

Wall No. 4 of Shop No. F 47 of First Floor Covered with Material

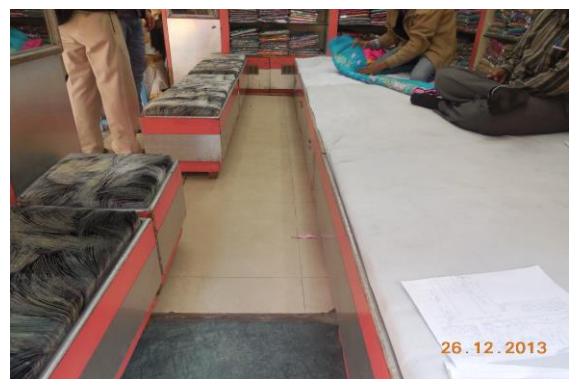
Photo 319

Floor of Shop of Ground Floor Covered With Tiles

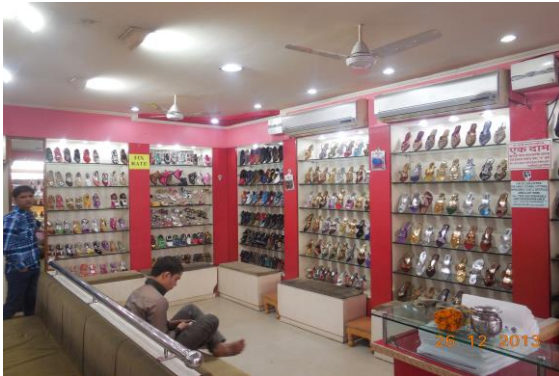
Photo 320

Wall No. 2 & 4 of Part A of Ground Floor Covered With Material

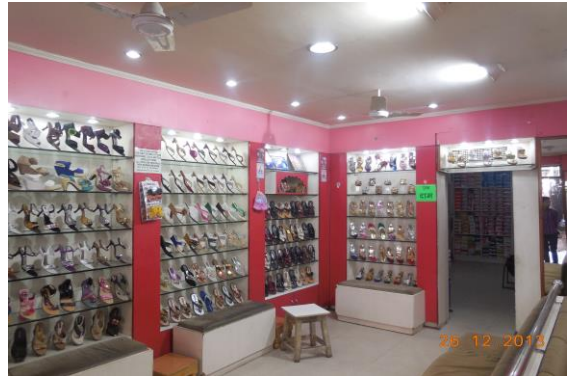
Photo 321

Wall No. 1 & 4 of Part A of Ground Floor Covered With Material

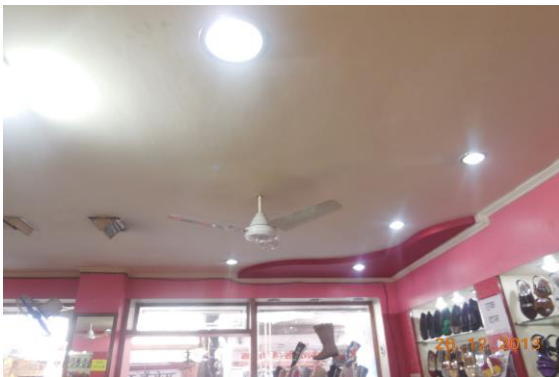
Photo 322

Roof of Part A of Ground Floor Covered With Material

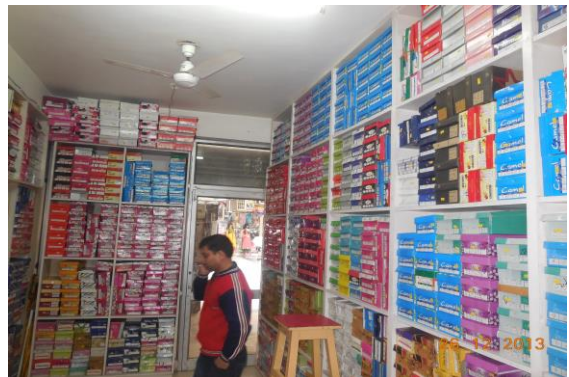
Photo 323

Wall No. 2 & 4 of Part B of Ground Floor Covered With Material

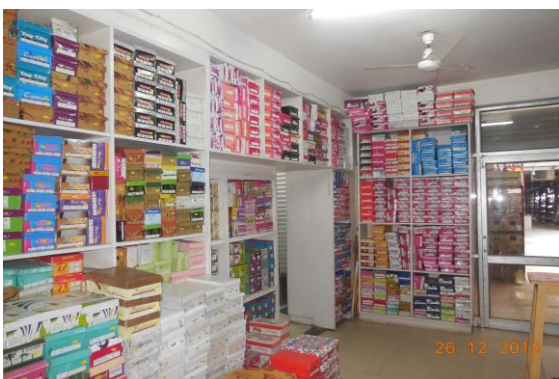
Photo 324

Wall No. 1 & 4 of Part B of Ground Floor Covered With Material

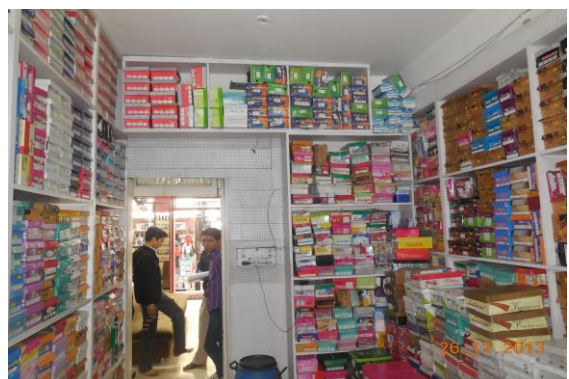
Photo 325

Wall No. 3 of Part B of Ground Floor Covered With Material

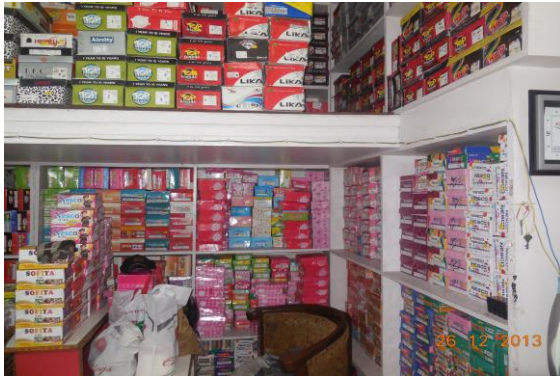
Photo 326

Wall No. 2 & 4 of Part C of Ground Floor Covered With Material

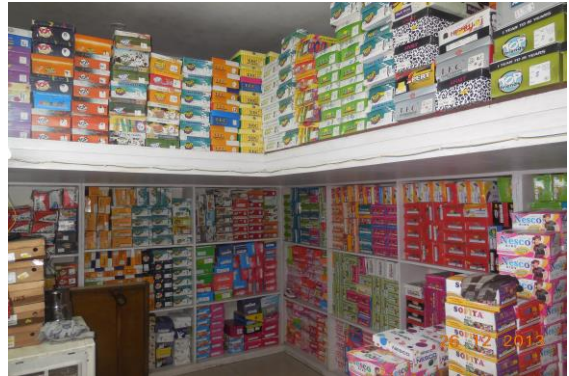
Photo 327

Wall No. 2 & 4 of Part C of Ground Floor Covered With Material

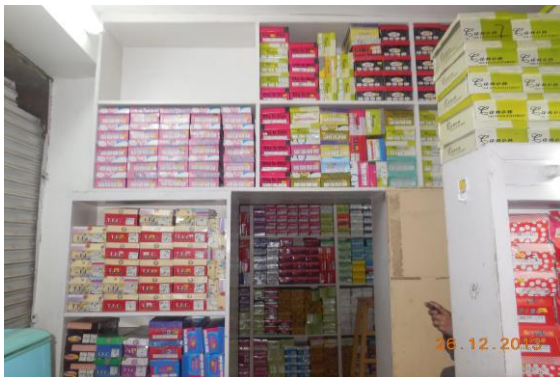
Photo 328

Wall No. 3 of Part C of Ground Floor Covered With Material

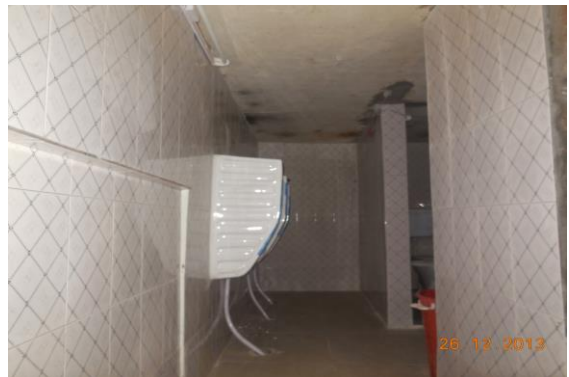
Photo 329

of Toilet No. 1 of Ground Floor Covered With Tiles

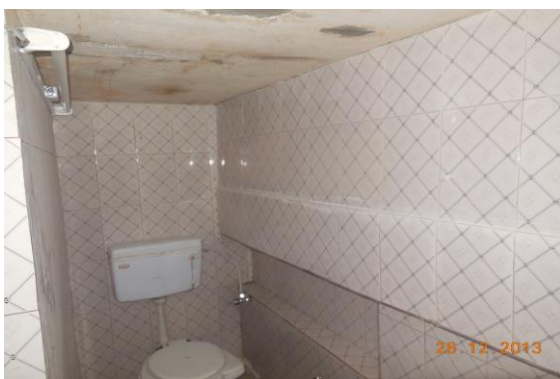
Photo 330

Toilet No. 1 of Ground Floor Covered With Tiles

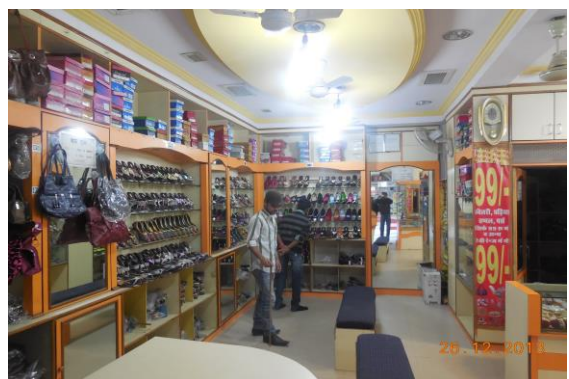
Photo 331

Wall No. 1 & 4 of Shop No. G 6 & 7 of Ground Floor Covered With Material

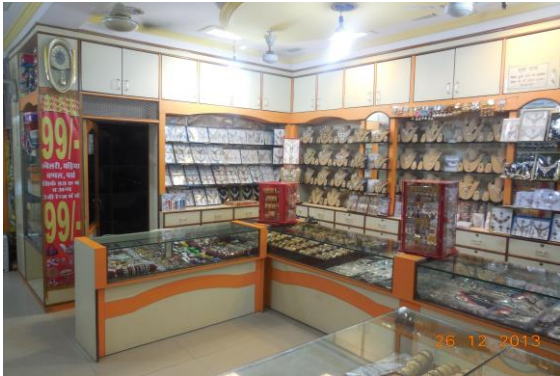
Photo 332

Wall No. 2 & 4 of Shop No. G 6 & 7 of Ground Floor Covered With Material

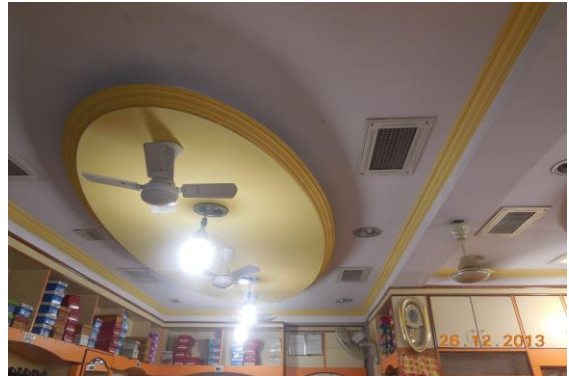
Photo 333

Roof of Shop No. G 6 & 7 of Ground Floor Covered With Falls Ceiling

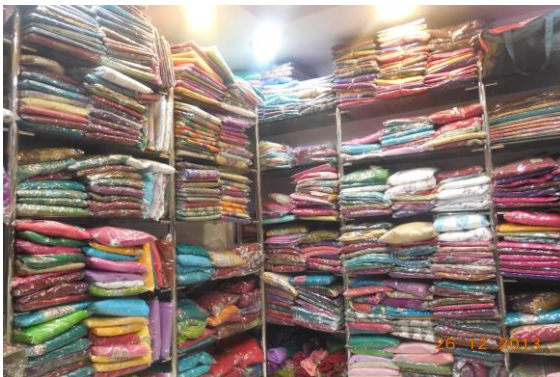
Photo 334

Wall No. 1 & 4 of Shop No. G 22 of Ground Floor Covered With Material

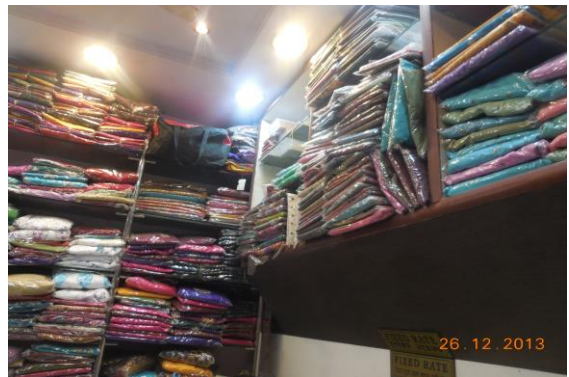
Photo 335

Wall No. 2 & 4 of Shop No. G 22 of Ground Floor Covered With Material
