Pre Building Condition Survey Report

Name and Address of Structure :	Badi Chopar to Ramp Area (Down Line)
---------------------------------	--------------------------------------

Name of the Project	Contract JMRC-UG1B “Design and Construction of Tunnel between Chandpole and Badi Chouper and reverse line by Shield TBM, Underground Metro Stations at Choti Chouper and Badi Chouper by Cut and Cover Methods on East West Corridor of Jaipur Metro Rail Corporation Limited .”	
Owner :

Pre - Condition Building Survey for Construction of Underground Stations from Chandpole to Bari Chouper and reversal line

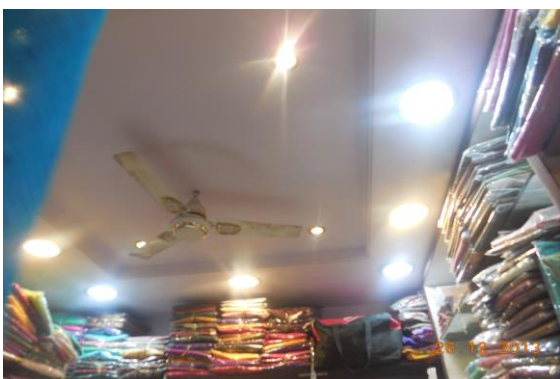
Photo 336

Roof of Shop No. G 22 of Ground Floor Covered With Falls Ceiling

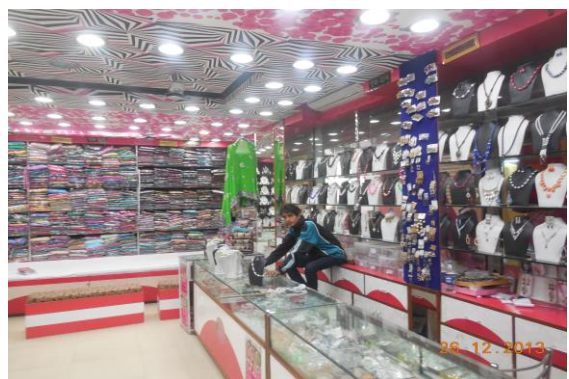
Photo 337

Wall No. 2 & 4 of Shop No. 11, 12 & 13 of Ground Floor Covered With Material

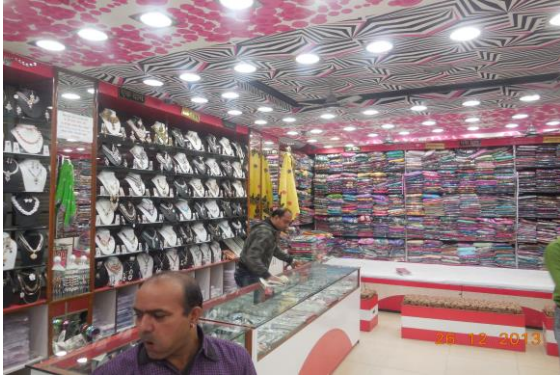
Photo 338

Wall No. 1 & 4 of Shop No. 11,12 & 13 of Ground Floor Covered With Material

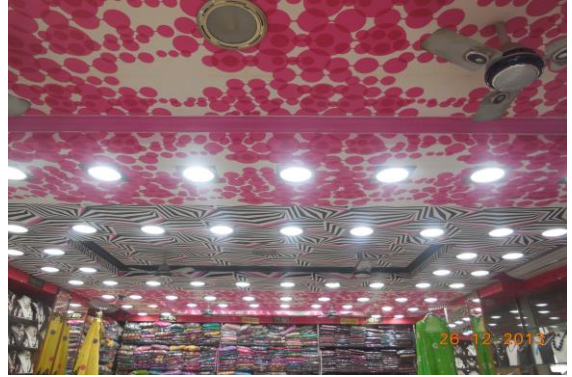
Photo 339

Roof of Shop No. 11,12 & 13 of Ground Floor Covered With Falls Celling

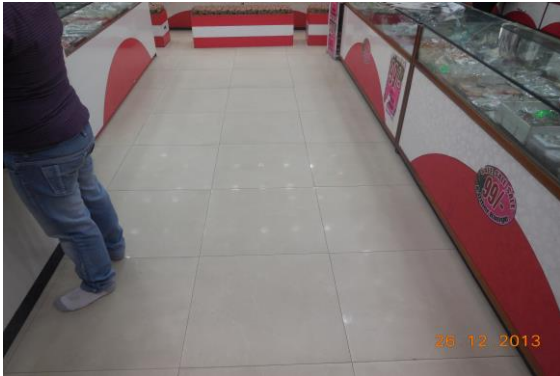
Photo 340

Floor of Shop No. 11,12 & 13 of Ground Floor Covered With Tiles

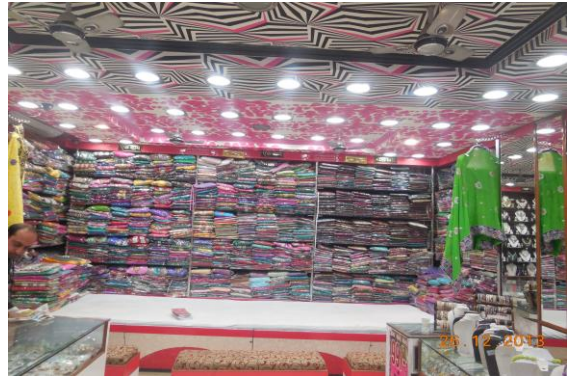
Photo 341

Wall No. 4 of Shop No. 11,12 & 13 of Ground Floor Covered With Material

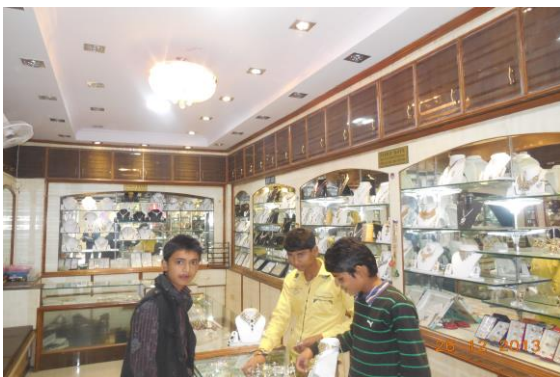
Photo 342

Wall No. 2 & 4 of Shop No. G 9 of Ground Floor Covered With Material

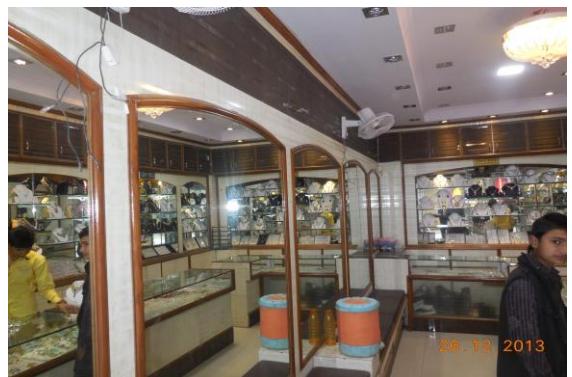
Photo 343

Wall No. 1 of Shop No. G 9 of Ground Floor Covered With Material

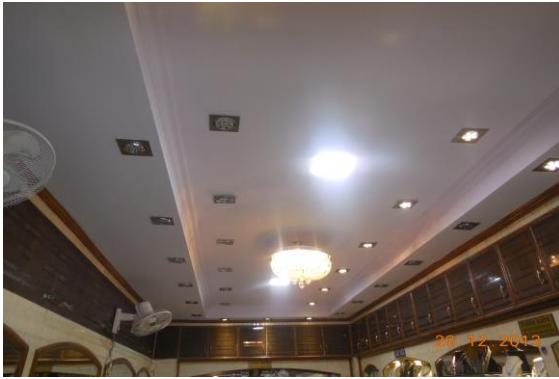
Photo 344

Roof of Shop No. G 9 of Ground Floor Covered With Falls Ceiling

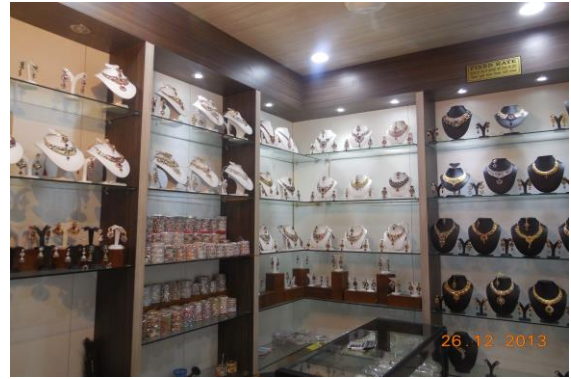
Photo 345

Wall No. 2 & 4 of Shop No. G 21 of Ground Floor Covered With Material

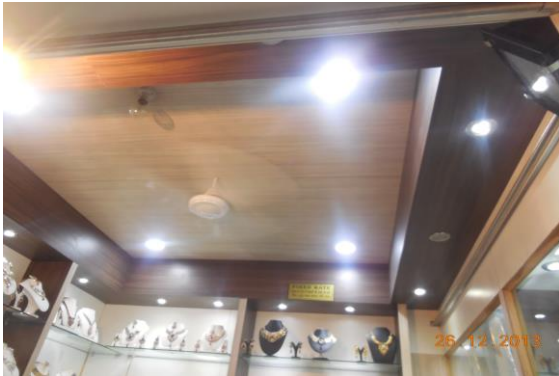
Photo 346

Roof of Room No. 6 of Ground Floor Covered With Falls Ceiling

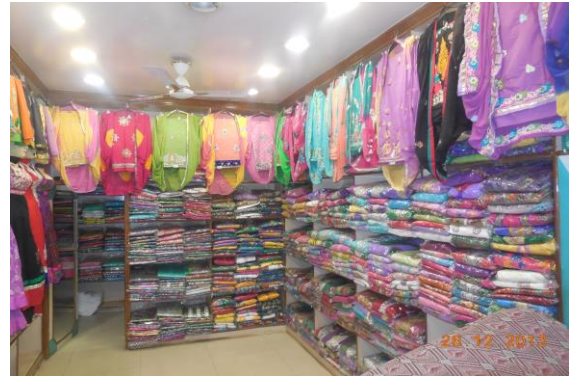
Photo 347

Wall No. 2 & 4 of Shop No. 17 of Ground Floor Covered With Material

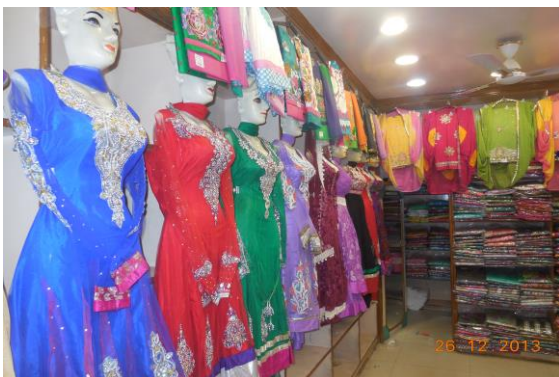
Photo 348

Wall No. 1 of Shop No. 17 of Ground Floor Covered With Material

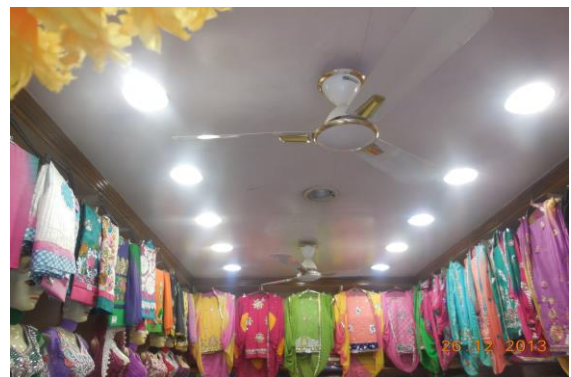
Photo 349

Roof of Shop No. 17 of Ground Floor Covered With Falls Ceiling

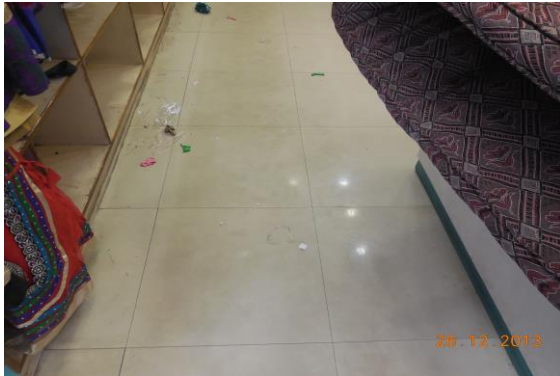
Photo 350

Floor of Shop No. 17 of Ground Floor Covered With Tiles

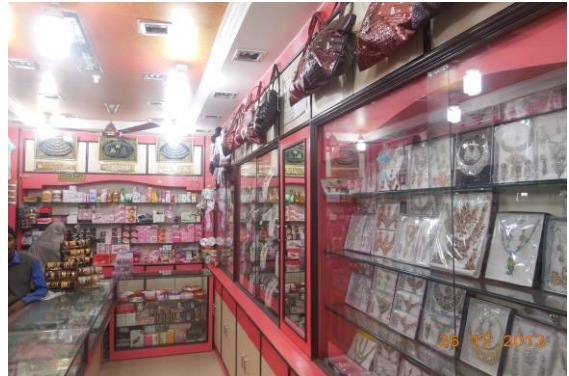
Photo 351

Wall No. 2 & 4 of Shop No. 16 of Ground Floor Covered With Material

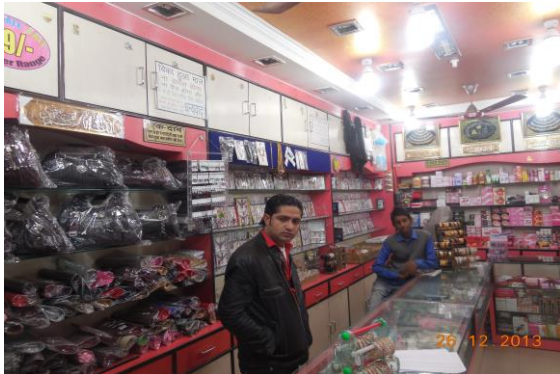
Photo 352

Wall No. 1 of Shop No. 16 of Ground Floor Covered With Material

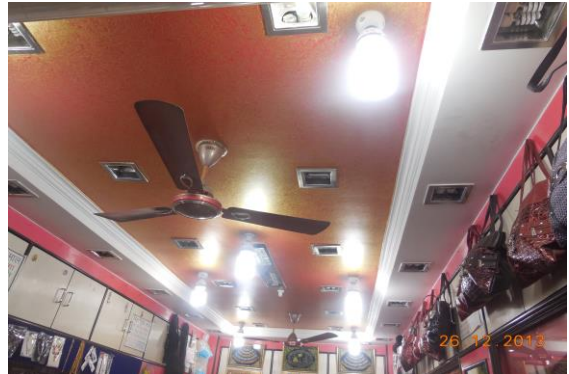
Photo 353

Roof of Shop No. 16 of Ground Floor Covered With Falls Ceiling

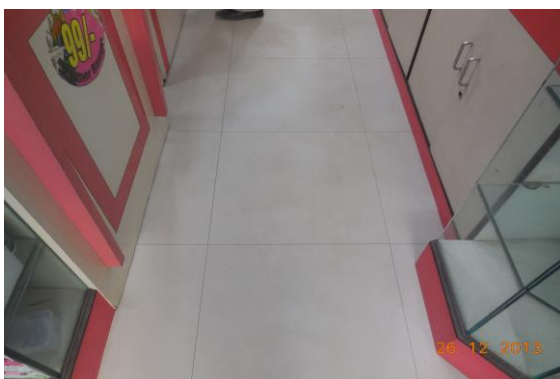
Photo 354

Floor of Shop No. 16 of Ground Floor Covered With Tiles

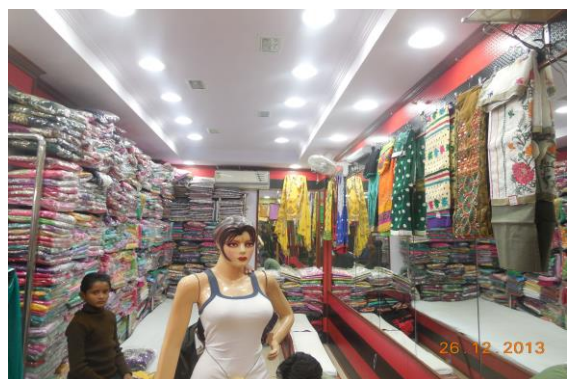
Photo 355

Wall No. 1, 2 & 4 of Shop No. G 14 & 14A of Ground Floor Covered With Material

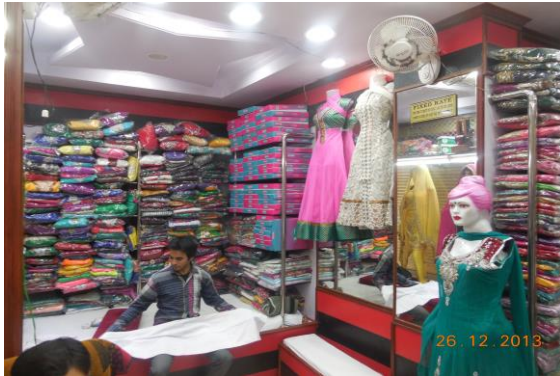
Photo 356

Wall No. 5 & 6 of Shop No. G 14 & 14A of Ground Floor Covered With Material

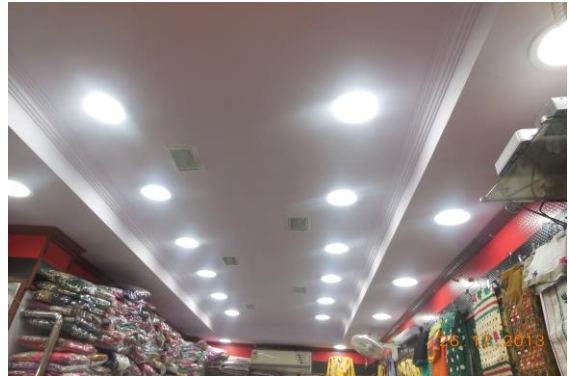
Photo 357

Roof of Shop No. G 14 & 14A of Ground Floor Covered With Falls Celling

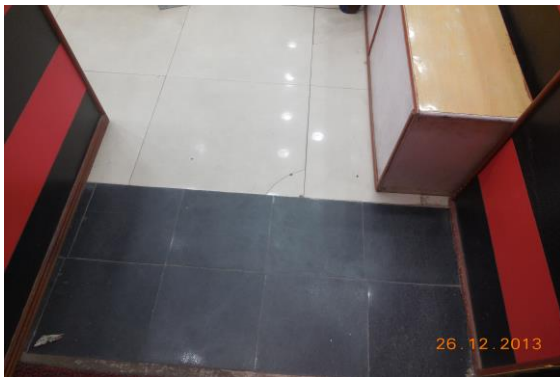
Photo 358

Floor of Shop No. G 14 & 14A of Ground Floor Covered With Tiles

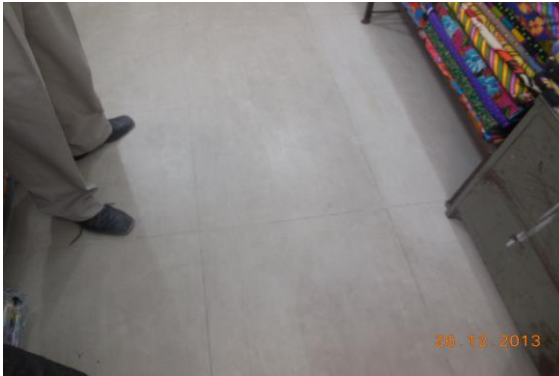
Photo 440

Floor of R.K.Fabs of Ground Floor Covered with Tiles

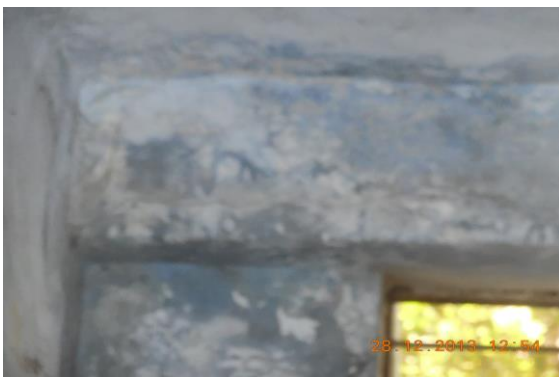
Photo 59
Horizontal Crack on Wall No. 4 of Toilet No. 2, Sarraf Katla, Ground Floor Approx. Width = 0.8mm, Approx. Length = 0.5m. Distance from Wall No. 1 = 0m, Height from Floor = 2.8m.

Summary of Cracks						
Defect ID	Location	Orientation	Appx. Width (mm)	Appx. Length (m)	Category	Photo No.
1	Wall No. 4 Toilet No. 2 Sarraf Katla,Ground Floor	Horizontal	0.8	0.5	Very Slight	59

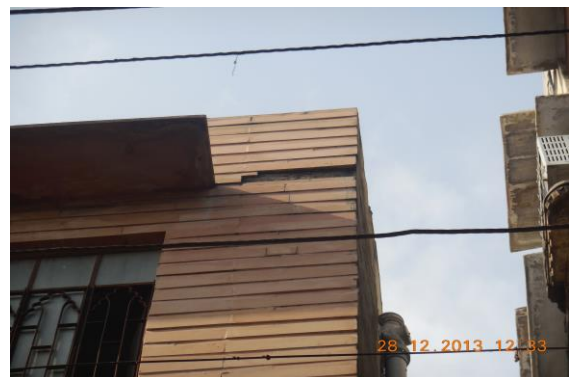
Photo 60
Damaged Portion on External Wall of Passage-2 of Sarraf Katla of Ground Floor

Summary of Defects Other Than Crack			
Defect ID	Location	Description	Photo No.
2	External Wall Passage-2 of Sarraf Katla Ground Floor	Damaged Portion	60
3	External Wall & Sunshade Passage-2 of Sarraf Katla Second Floor	Peeling of Plaster	61
4	Wall No. 4 Toilet No. 2 Sarraf Katla,Ground Floor	Dampness/Seepage	62
5	Wall No. 1 Toilet No. 2 Sarraf Katla,Ground Floor	Peeling of Plaster	63
6	Wall No. 2 Shop No. 114 of Sarraf Katla Ground Floor	Peeling of Plaster	64
7	Wall No. 4 Shop No. 103 of Sarraf Katla Ground Floor	Peeling of Plaster	65
8	Wall No. 2 & 4 Shop No. 3 & 4 of Sarraf Katla Basement	Dampness/Seepage	66
9	Wall No. 1 Shop No. 212 of Sarraf Katla First Floor	Peeling of Plaster	67
10	Wall No. 4 Shop No. 212 of Sarraf Katla First Floor	Peeling of Plaster	68
11	Wall No. 4 Shop No. 201 of Sarraf Katla First Floor	Dampness/Seepage	69
12	Wall No. 2 Toilet No. 2 Passage-2 of Sarraf Katla,First Floor	Damaged Portion	70

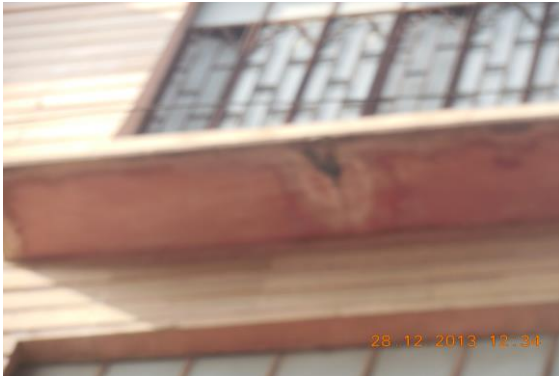
Photo 61

Peeling of Plaster on External Wall & Sunshade of Passage-2 of Sarraf Katla of Second Floor

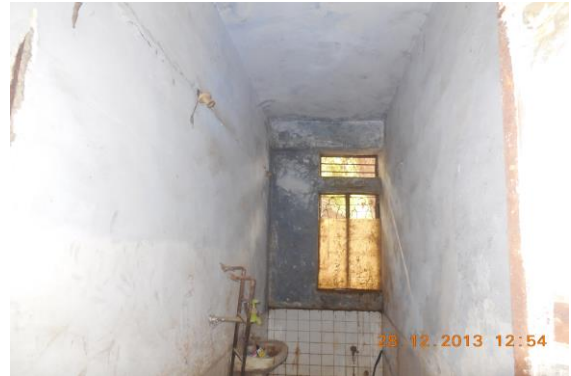
Photo 62

Dampness/Seepage on Wall No. 4 of Toilet No. 2 of Sarraf Katla, Ground Floor

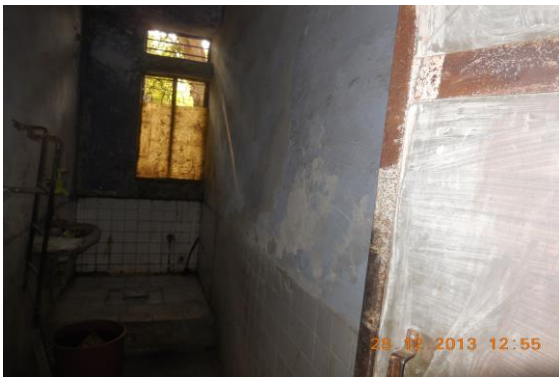
Photo 63

Peeling of Plaster on Wall No. 1 of Toilet No. 2 of Sarraf Katla, Ground Floor

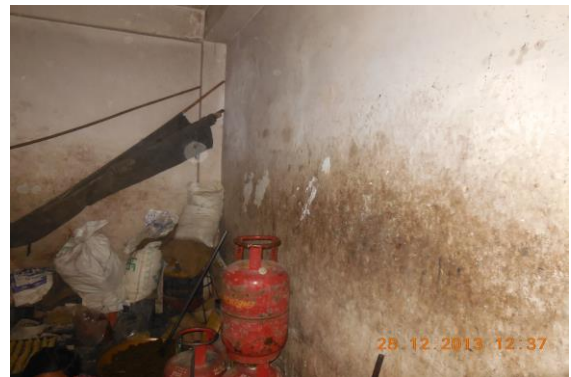
Photo 64

Peeling of Plaster on Wall No. 2 of Shop No. 114 of Sarraf Katla of Ground Floor

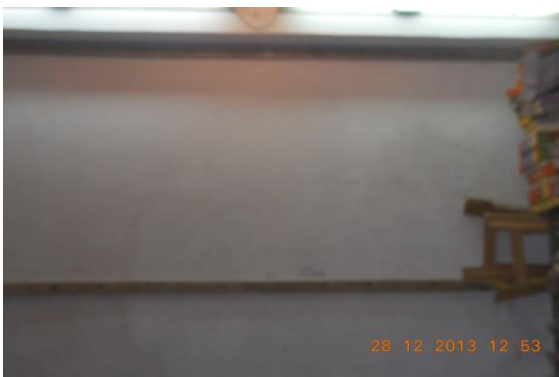
Photo 65

Peeling of Plaster on Wall No. 4 of Shop No. 103 of Sarraf Katla of Ground Floor

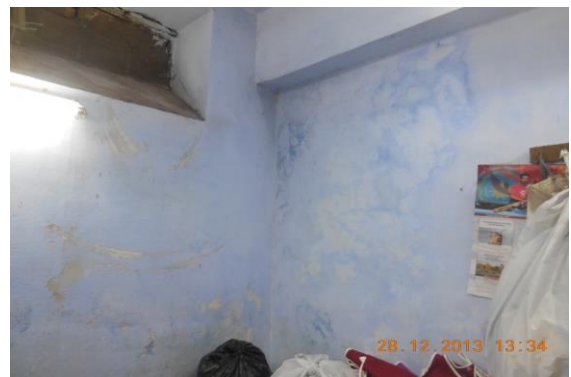
Photo 66

Dampness/Seepage on Wall No. 2 & 4 of Shop No. 3 & 4 of Sarraf Katla of Basement

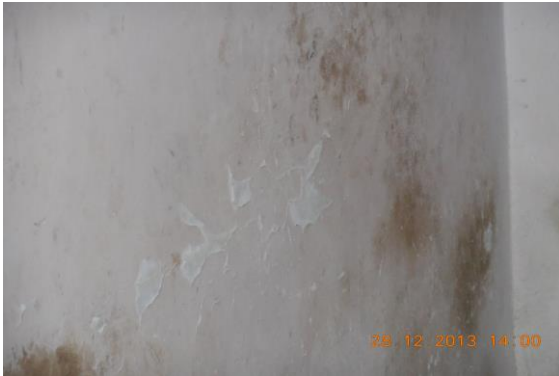
Photo 67

Peeling of Plaster on Wall No. 1 of Shop No. 212 of Sarraf Katla of First Floor

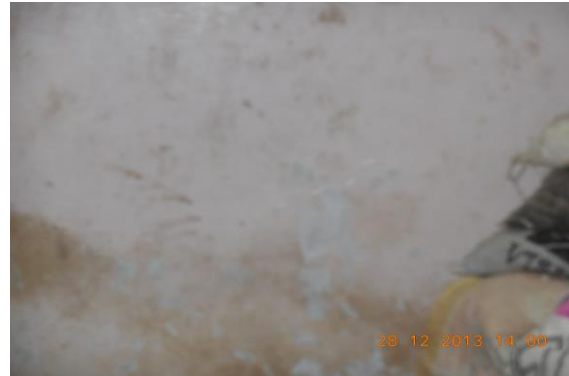
Photo 68

Peeling of Plaster on Wall No. 4 of Shop No. 212 of Sarraf Katla of First Floor

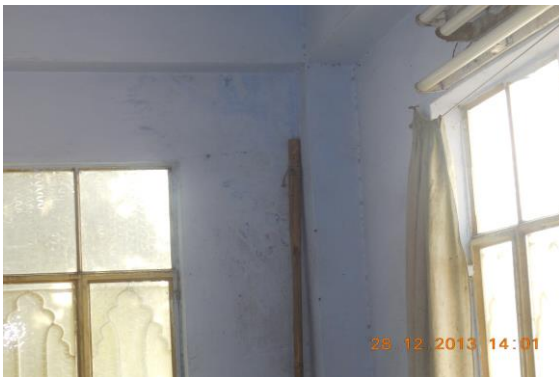
Photo 69

Dampness/Seepage on Wall No. 4 of Shop No. 201 of Sarraf Katla of First Floor

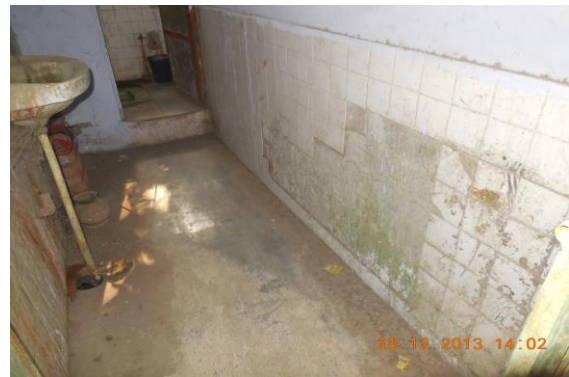
Photo 70

Damaged Portion on Wall No. 2 of Toilet No. 2 of Passage-2 of Sarraf Katla, First Floor

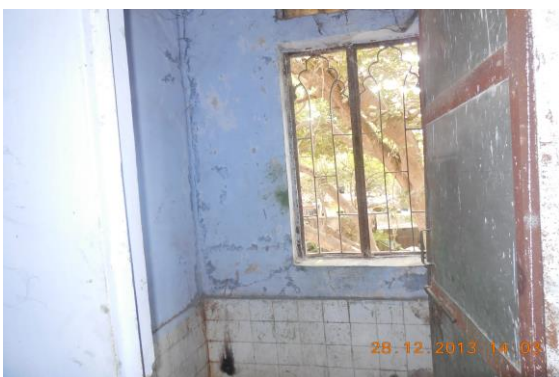
Photo 71

Dampness/Seepage on Wall No. 4 of Toilet No. 2 of Passage-2 of Sarraf Katla, First Floor

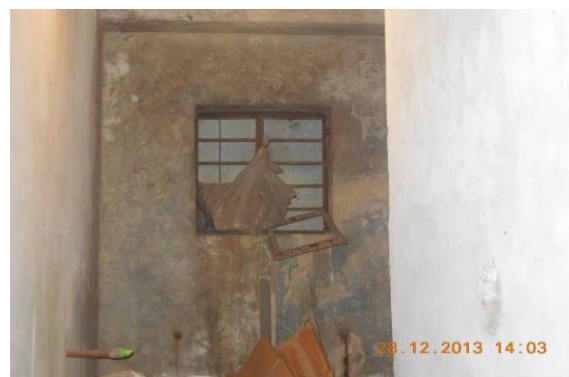
Photo 72

Dampness/Seepage on Wall No. 1 of Toilet No. 1 of Passage-1 of Sarraf Katla, First Floor

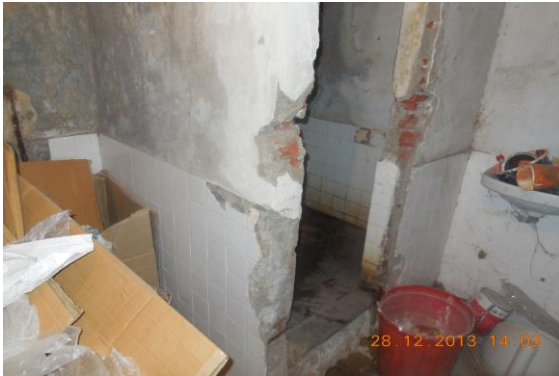
Photo 73

Peeling of Plaster on Wall No. 5 & 6 of Toilet No. 1 of Passage-1 of Sarraf Katla, First Floor

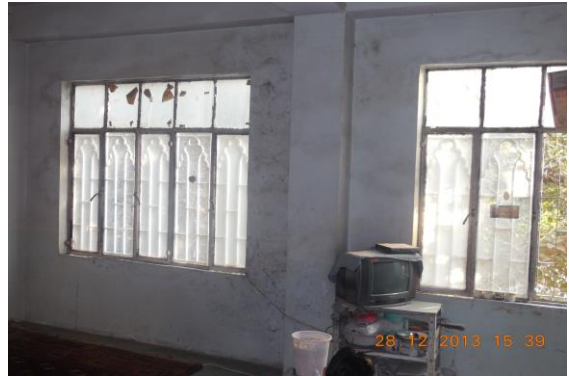
Photo 74

Dampness/Seepage on Wall No. 4 of Shop No. 302 & 303 of Sarraf Katla of Second Floor

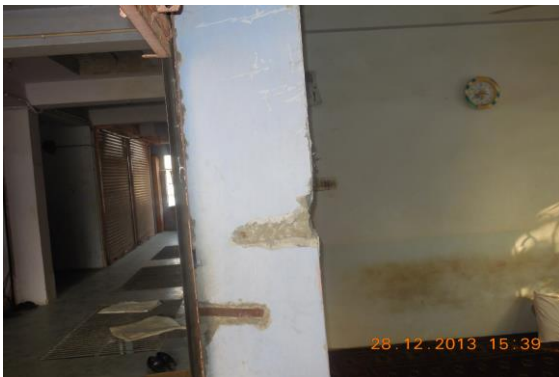
Photo 75

Peeling of Plaster on Wall No. 3 of Shop No. 302 & 303 of Sarraf Katla of Second Floor

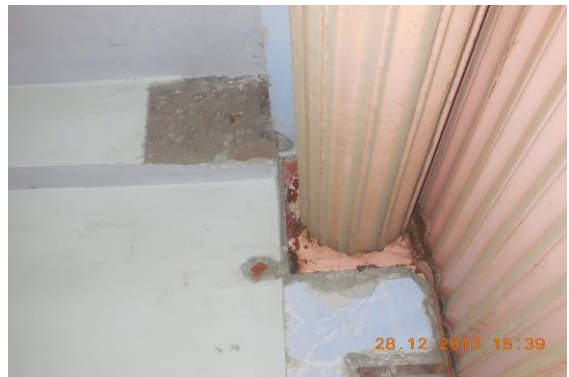
Photo 76

Peeling of Plaster on Wall No. 2 of Shop No. 302 & 303 of Sarraf Katla of Second Floor

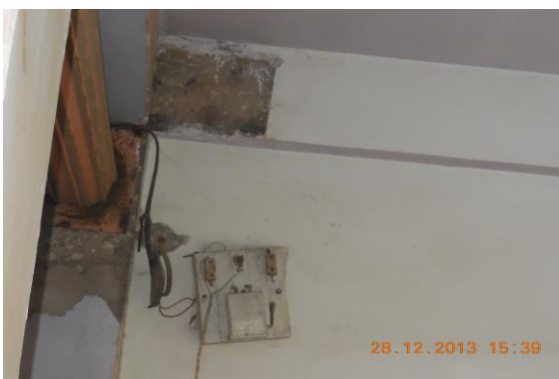
Photo 77

Peeling of Plaster on Wall No. 1 & 3 of Shop No. 302 & 303 of Sarraf Katla of Second Floor

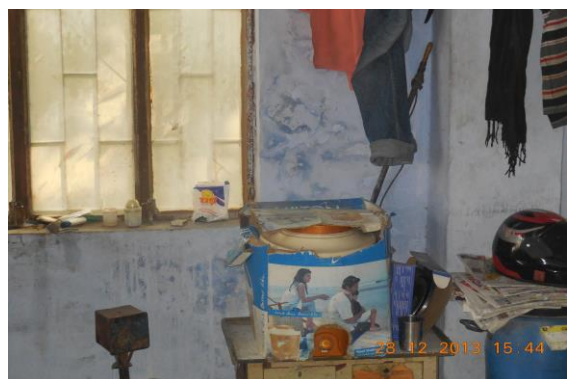
Photo 78

Dampness/Seepage on Wall No. 4 of Shop No. 306 & 307 of Sarraf Katla of Second Floor

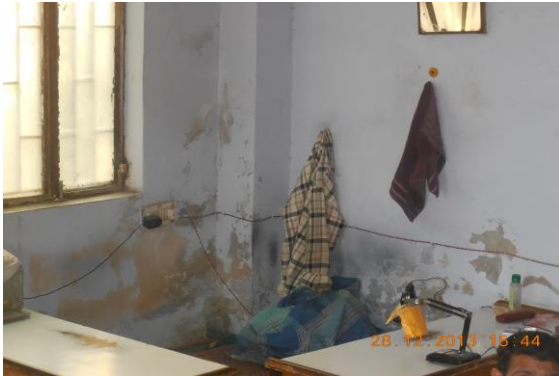
Photo 79

Dampness/Seepage on Wall No. 2 & 4 of Shop No. 306 & 307 of Sarraf Katla of Second Floor

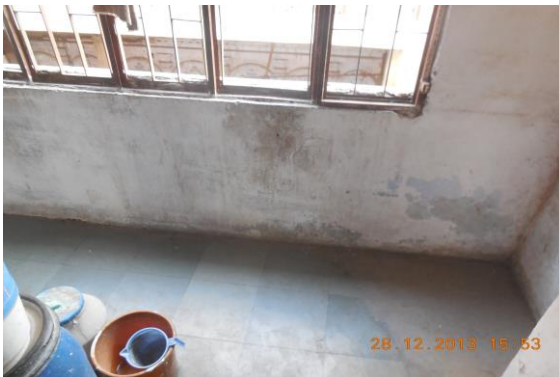
Photo 80

Dampness/Seepage on Wall No. 4 of Shop No. 306 & 307 of Sarraf Katla of Second Floor

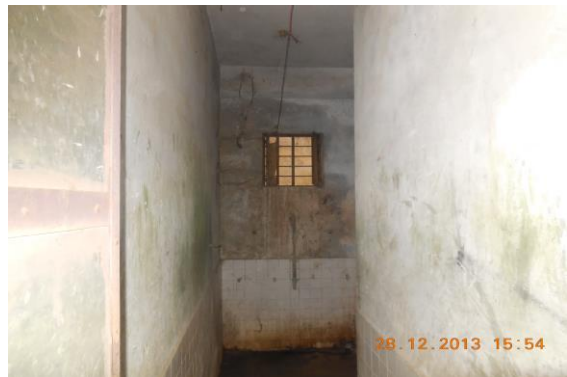
Photo 81

Dampness/Seepage on Wall No. 2 & 3 of Passage-1 of Sarraf Katla of Second Floor

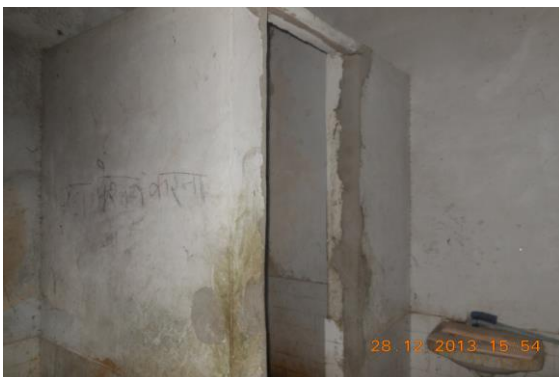
Photo 82

Dampness/Seepage on Wall No. 4 of Toilet No. 1 of Sarraf Katla, Second Floor

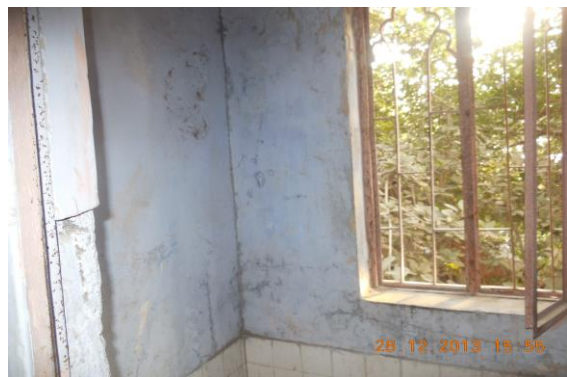
Photo 83

Peeling of Plaster on Wall No. 5 & 6 of Toilet No. 1 of Sarraf Katla, Second Floor

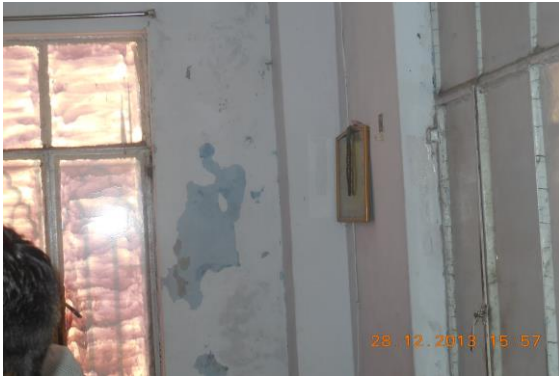
Photo 84

Dampness/Seepage on Wall No. 1 & 4 of Toilet No. 2 of Sarraf Katla, Second Floor

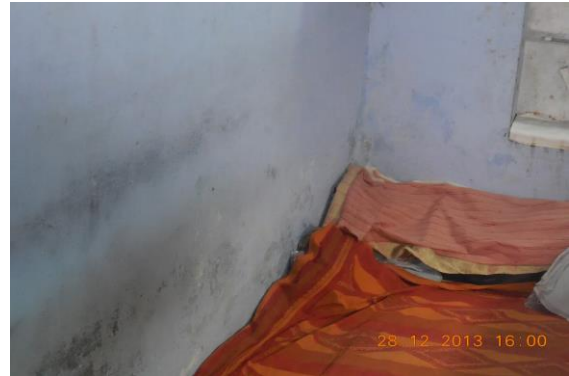
Photo 85

Peeling of Plaster on Wall No. 4 of Shop No. 401 of Sarraf Katla of Third Floor

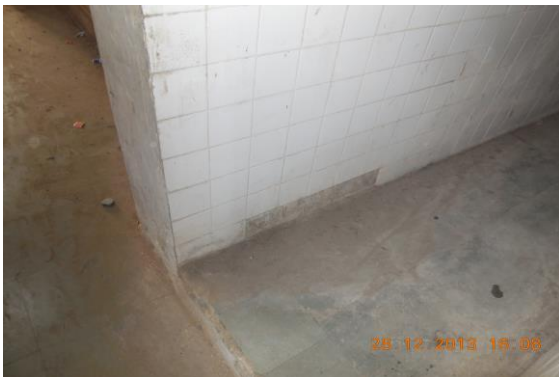
Photo 86

Dampness/Seepage on Wall No. 1 & 4 of Shop No. 405 of Sarraf Katla of Third Floor

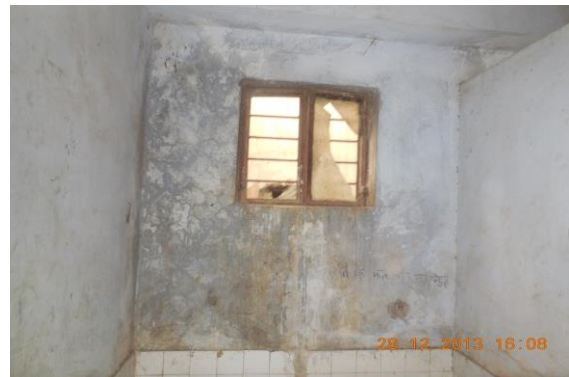
Photo 87

Damaged Portion on Wall No. 1 of Toilet No. 1 of Passage-1 of Sarraf Katla, Third Floor

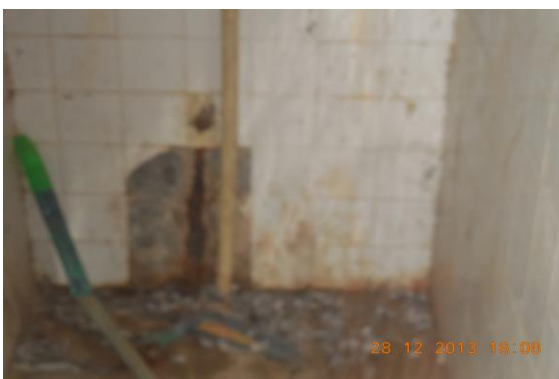
Photo 88

Dampness/Seepage on Wall No. 4 of Toilet No. 1 of Passage-1 of Sarraf Katla, Third Floor

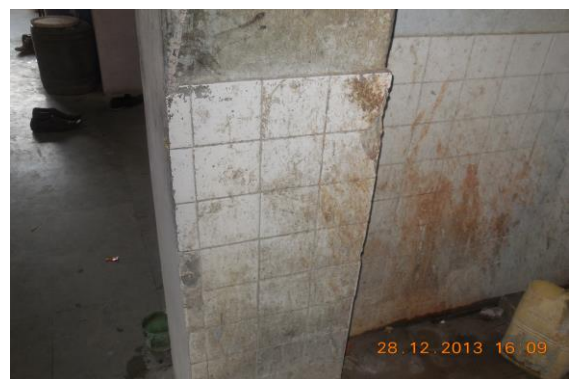
Photo 89

Damaged Portion on Wall No. 7 of Toilet No. 1 of Passage-1 of Sarraf Katla, Third Floor

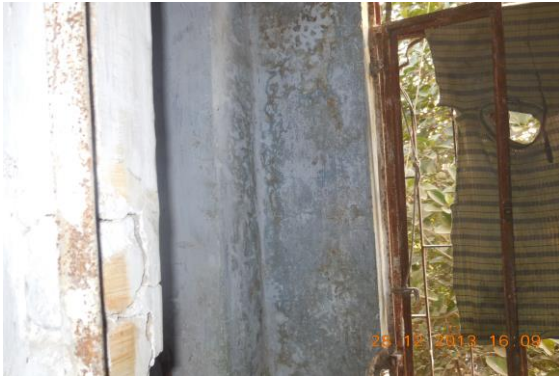
Photo 90

Damaged Portion on Wall No. 1 of Toilet No. 2 of Passage-1 of Sarraf Katla, Third Floor

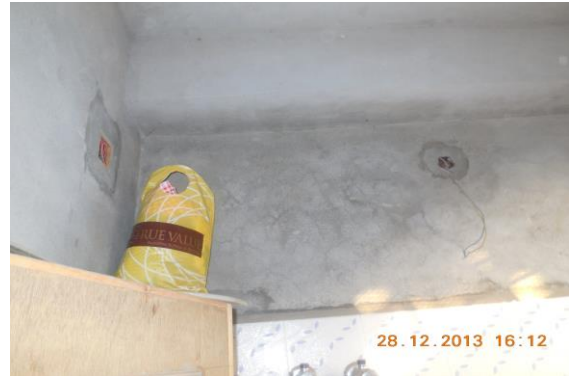
Photo 91

Dampness/Seepage on Wall No. 1 & 4 of Toilet No. 2 of Passage-1 of Sarraf Katla, Third Floor

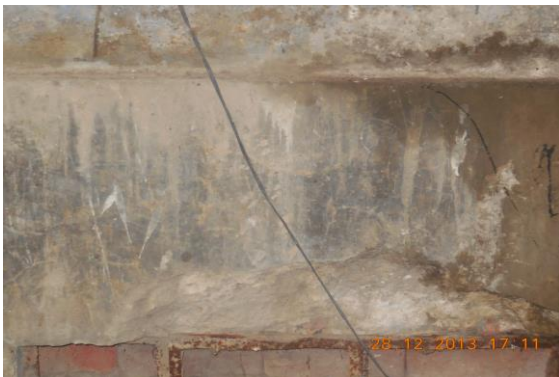
Photo 92

Dampness/Seepage on Wall No. 4 of Toilet No. 1 of Sarraf Katla, Fourth Floor

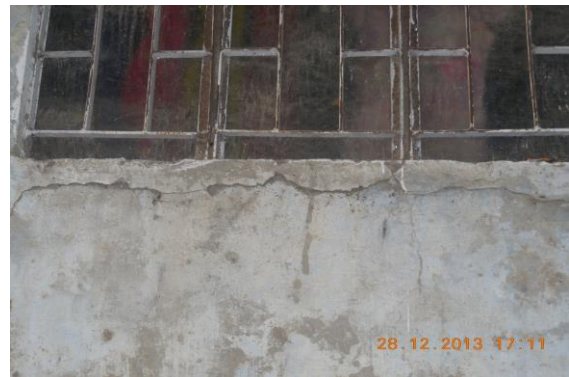
Photo 93

Peeling of Plaster on Left Side View of Sarraf Katla of Ground Floor

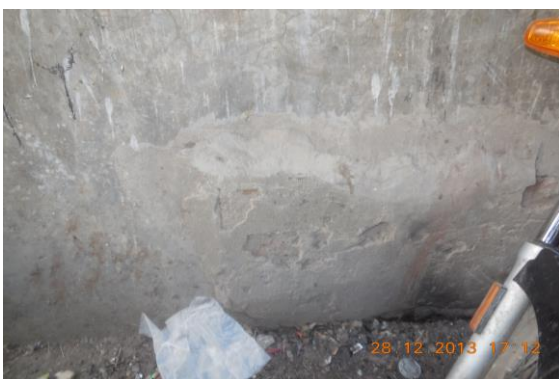
Photo 94

Peeling of Plaster on Left Side View of Sarraf Katla of Ground Floor

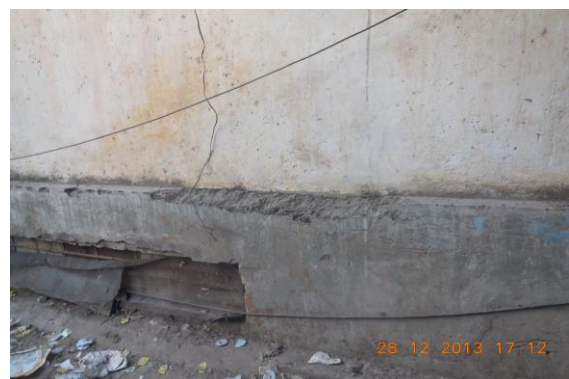
Photo 95

Peeling of Plaster on Left Side View of Sarraf Katla of Ground Floor

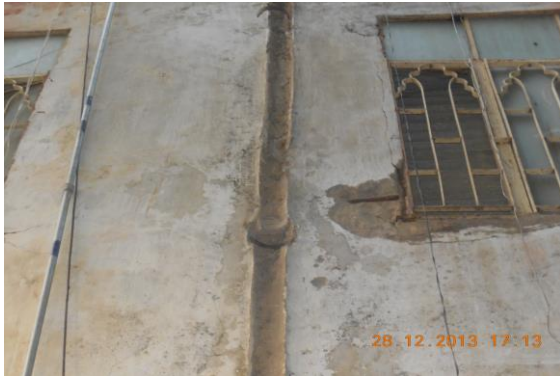
Photo 96

Peeling of Plaster on Left Side View of Sarraf Katla of Ground Floor

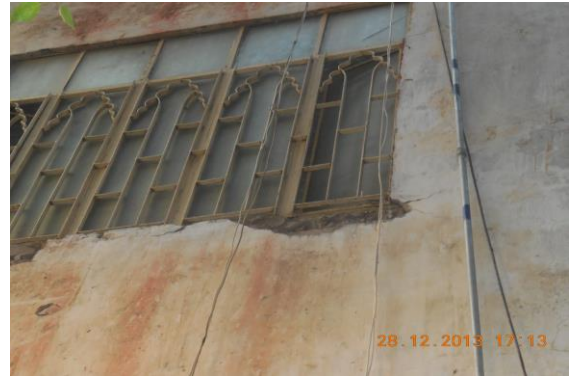
Photo 97

Peeling of Plaster on of Left Side View of Sarraf Katla of First Floor

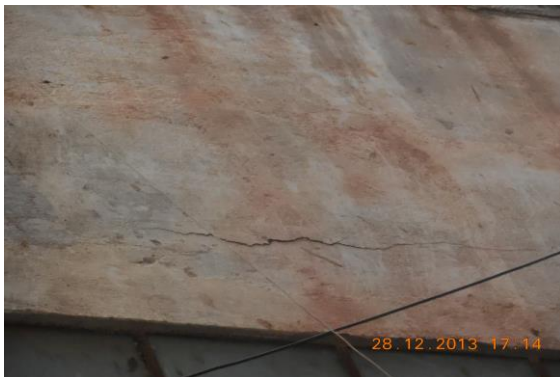
Photo 98

Peeling of Plaster on of Left Side View of Sarraf Katla of First Floor

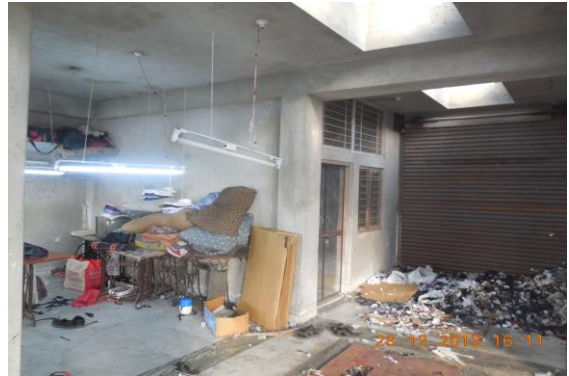
Photo 199
Shop No. 425 of Sarraf Katla of Third Floor Locked

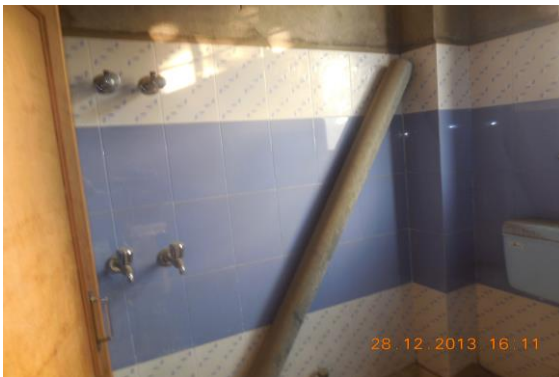
Photo 200
Room No. 2 of Sarraf Katla, Fourth Floor Locked

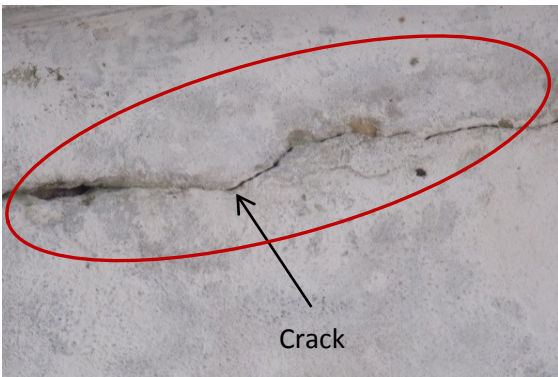
Photo 3

Horizontal Crack on Roof of Varandah of House above Shop No. 82, Ground Floor, Approx. Width = 1.5mm, Approx. Length = 2.8m. Distance from R.H.S. Col. = 0m, Height from Floor = 3m.

Summary of Cracks						
Defect ID	Location	Orientation	Appx. Width (mm)	Appx. Length (m)	Category	Photo No.
1	Roof of Varandah of House above Shop No. 82, Ground Floor	Horizontal	1.5	2.8	Slight	3
2	Wall No. 2 of Stair GF to FF of House above Shop No.82, Ground floor	Inclined	0.25	0.8	Very Slight	4A & 4B
3	Wall No. 1 to 3 of Stair GF to FF of House above Shop No.82, First floor	Inclined	0.35	2.7	Very Slight	5
4	Wall No. 3 of Stair GF to FF of House above Shop No.82, First floor	Horizontal	1	0.7	Slight	6
5	Wall No. 1 of Stair FF to SF of House above Shop No.82, First floor	Inclined	0.25	1.2	Very Slight	7A & 7B
6	Wall no. 4 of Lobby of House above Shop No.82,Second Floor	Horizontal	2.5	1.8	Very Slight	8A & 8B
Summary of Defects Other Than Crack						
Defect ID	Location	Description				Photo No.
1	Roof of Varandah of House above Shop No. 82, Ground Floor	Plaster Removal				9
2	Roof of Varandah of House above Shop No. 82, Ground Floor	Plaster Crack				10

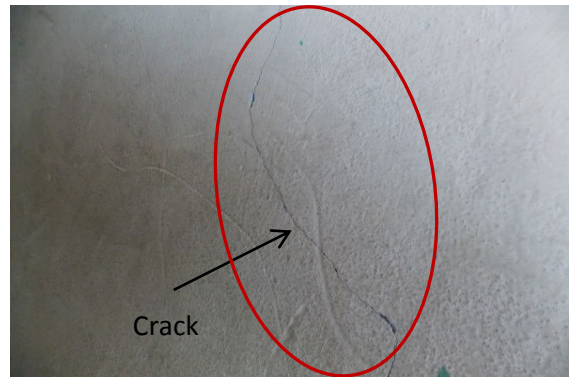
Photo 4A

Inclined Crack on Wall No.2 of Stair GF to FF of House above Shop No.82 Ground floor, Approx. Width = .25mm, Approx. Length = .8m. Distance from Wall No.3 = 3m, Height from Floor = 1.2m.

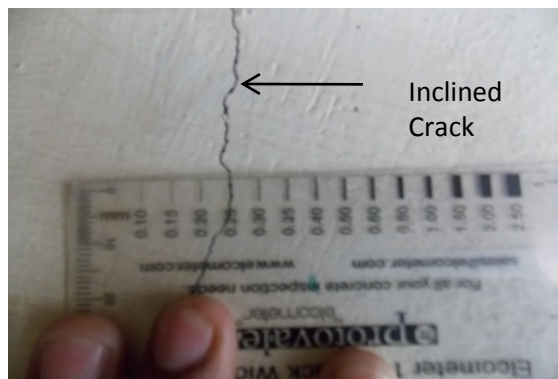
Photo 4B

Inclined Crack on Wall No.2 of Stair GF to FF of House above Shop No.82 Ground floor, Approx. Width = .25mm, Approx. Length = .8m. Distance from Wall No.3 = 3m, Height from Floor = 1.2m.

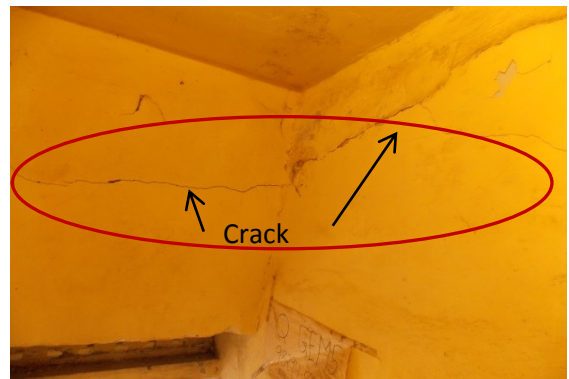
Photo 5

Inclined Crack on Wall No.1 to 3 of Stair GF to FF of House above Shop No.82, First floor, Approx. Width = 0.35mm, Approx. Length = 2.7m. Distance from Wall No. 3 = 0m, Height from Floor = 1.2m.

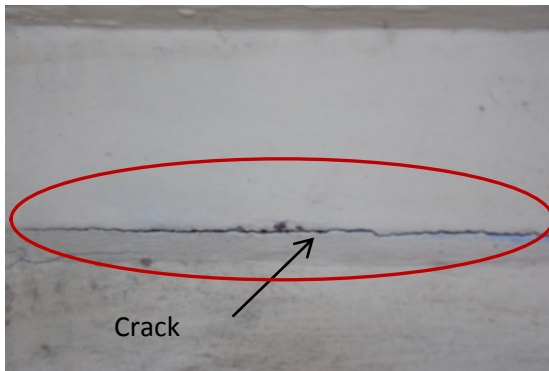
Photo 6

Horizontal Crack on Wall No. 3 of Stair GF to FF of House above Shop No.82, First floor, Approx. Width = 1mm, Approx. Length = 0.70m. Distance from Wall No. 3 = 0m, Height from Floor = 2m.

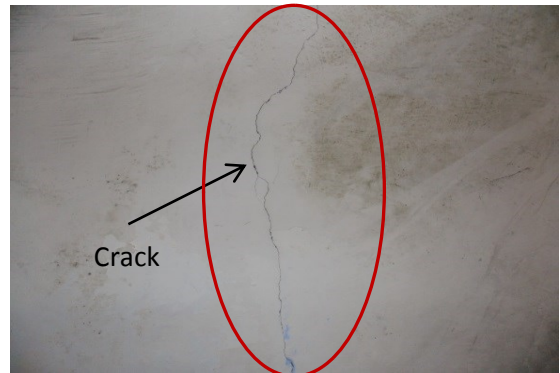
Photo 7A

Inclined Crack on Wall No. 1 of Stair FF to SF of House above Shop No.82, First floor, Approx. Width = 0.25mm, Approx. Length = 1.20m. Distance from Wall No. 4= 2.50m, Height from Floor = 1m.

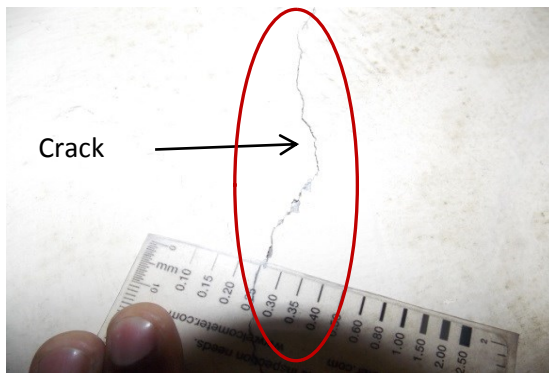
Photo 7B

Inclined Crack on Wall No. 1 of Stair FF to SF of House above Shop No.82, First floor, Approx. Width = 0.25mm, Approx. Length = 1.20m. Distance from Wall No. 4= 2.50m, Height from Floor = 1m.

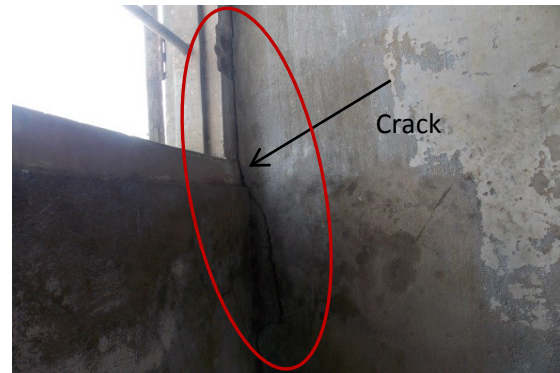
Photo 8A

Inclined Crack on Wall no. 4 of Lobby of House above Shop No.82, Second Floor, Approx. Width = 2.5mm, Approx. Length = 1.80m. Distance from Wall No.3= 1m, Height from Floor = 0m.

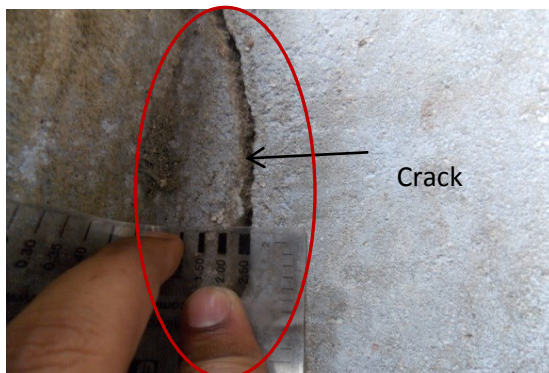
Photo 8B

Inclined Crack on Wall no. 4 of Lobby of House above Shop No.82, Second Floor, Approx. Width = 2.5mm, Approx. Length = 1.80m. Distance from Wall No.3= 1m, Height from Floor = 0m.

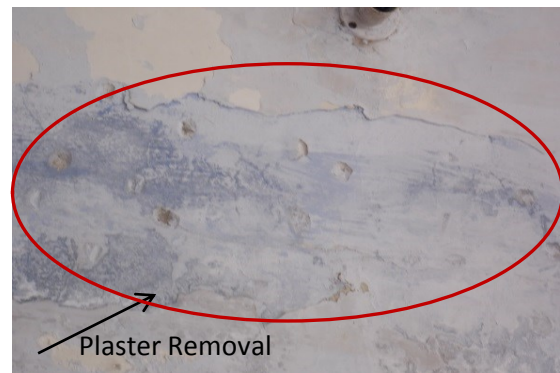
Photo 9

Plaster Removal on Roof of Varandah of House above Shop No. 82, Ground Floor

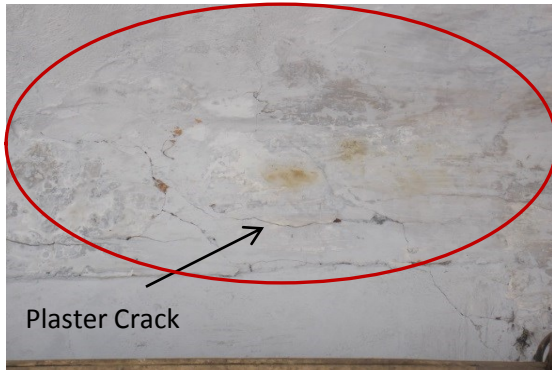
Photo 10

Plaster Crack on Roof of Varandah of House above Shop No. 82, Ground Floor

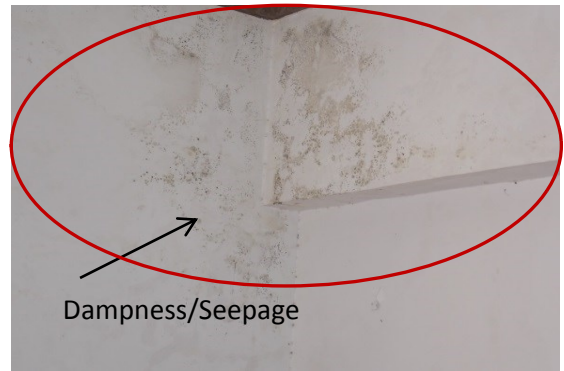
Photo 11

Dampness/Seepage on Wall No. 1 & 4 of Room of House above Shop No.82, First floor

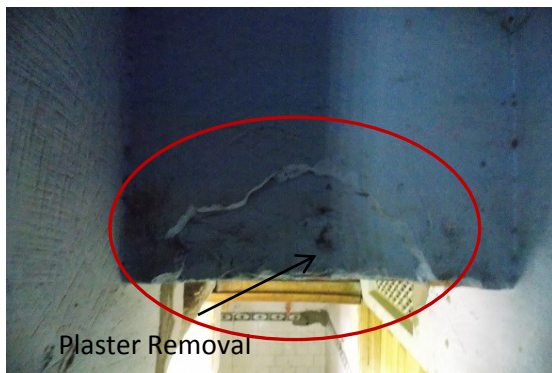
Photo 12

Plaster Removal on Wall No. 3 of Stair SF to TF of House above Shop No.82, Second Floor

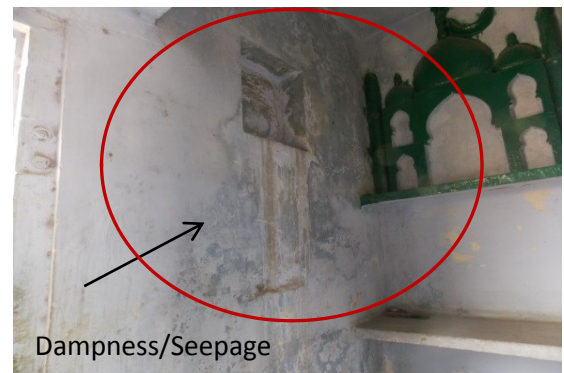
Photo 13

Dampness/Seepage on Wall No.1 of Lobby of House above Shop No.82, Third Floor

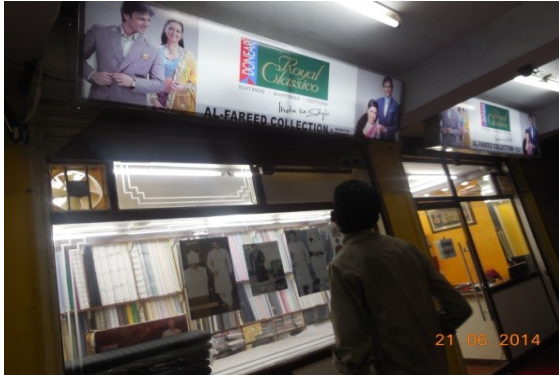
Photo 1

Front View of Shop No.B 8 & B9,Al-Fareed Collection,Basement

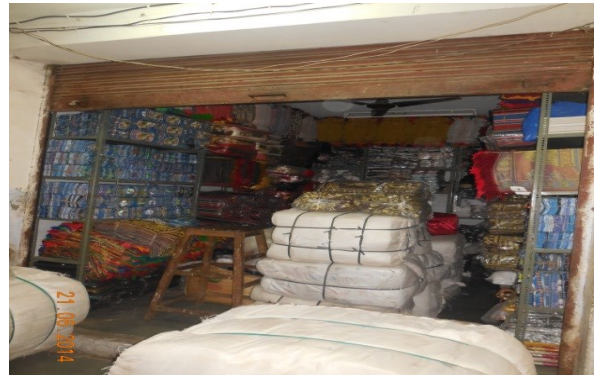
Photo 2

Front View of Shop No. 111, F.M.Lungi Centre,Ground Floor

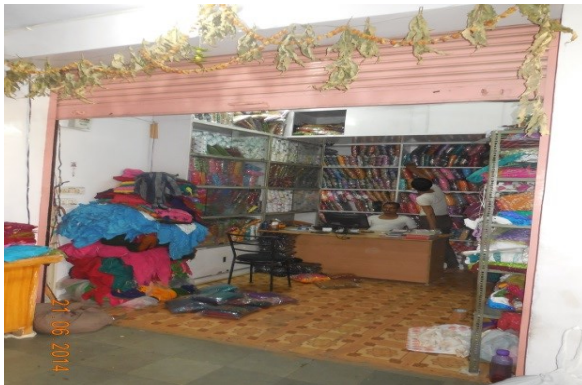
Photo 3

Front View of Shop No. 216,Manisha Textiles Godown, First Floor

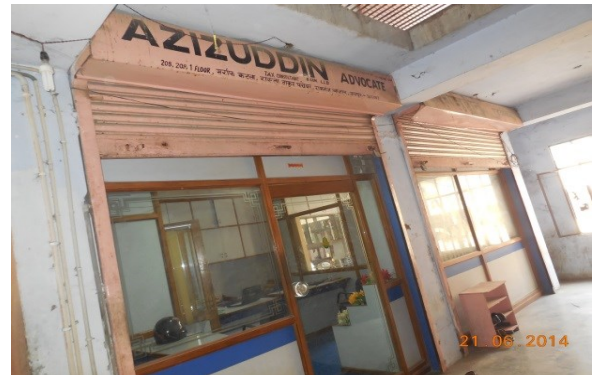
Photo 4

Front View of Shop No. 208 & 209,Azizuddin Advocate, First Floor

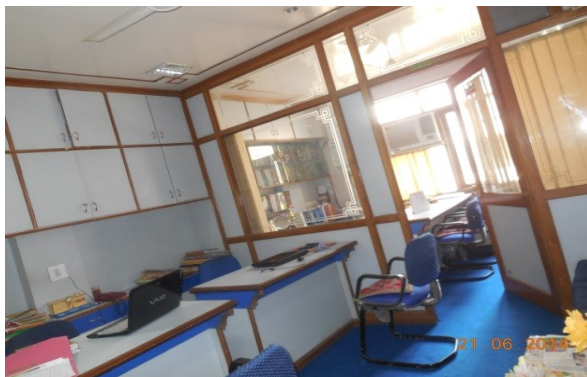
Photo 5

General View of Shop No. 208 & 209,Azizuddin Advocate, First Floor

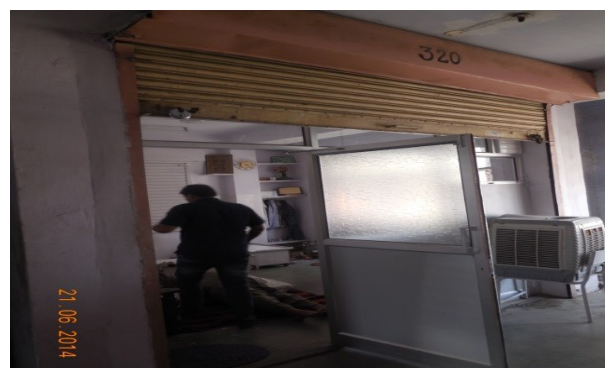
Photo 6

Front View of Shop No.320,Galaxy Gems & Enterprises, Second Floor

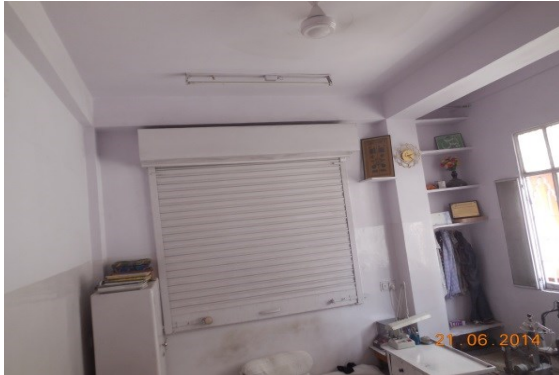
Photo 7

General View of Shop No.320, Galaxy Gems & Enterprises, Second Floor

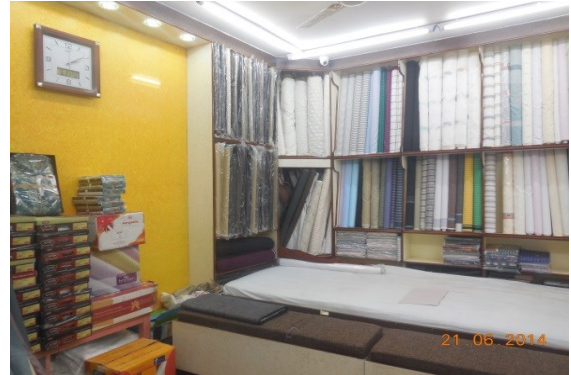
Photo 8

Covered With Materials, All Walls of Shop No. B-08 & 09, Al-Fareed Collection, Basement

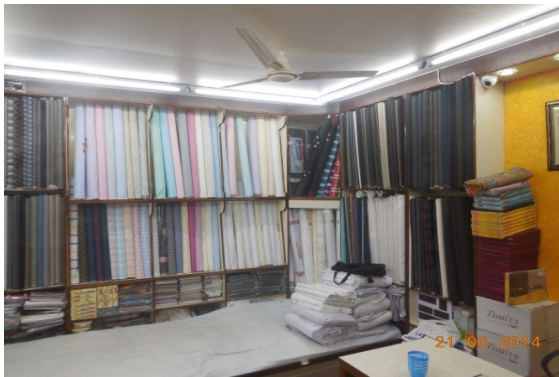
Photo 9

Covered With Materials, All Walls of Shop No. B-08 & 09, Al-Fareed Collection, Basement

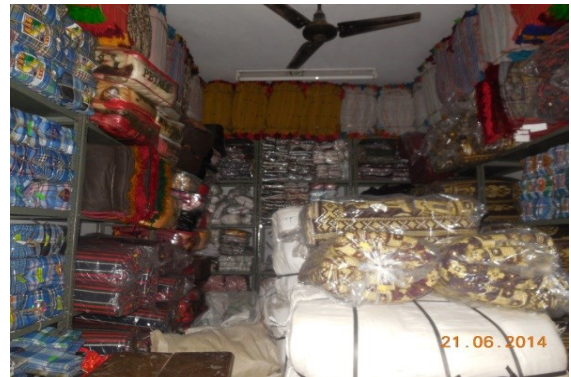
Photo 10

Covered With Materials, All Walls of Shop No.111, F.M.Lungi Centre, Ground Floor

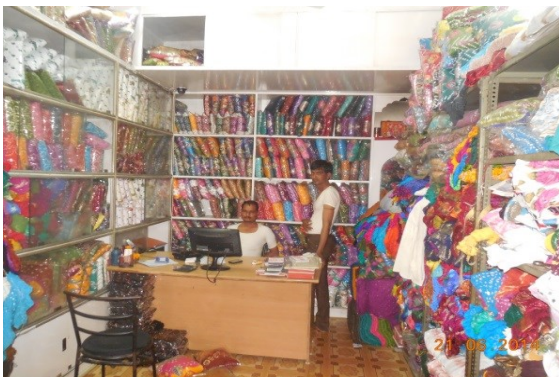
Photo 11

Covered With Materials, All Walls of Shop No. 216, Manisha Textiles Godown, First Floor
