Pre Building Condition Survey Report

Name and Address of Structure :	Badi Chopar to Ramp Area (Down Line)
---------------------------------	--------------------------------------

Name of the Project	Contract JMRC-UG1B “Design and Construction of Tunnel between Chandpole and Badi Chouper and reverse line by Shield TBM, Underground Metro Stations at Choti Chouper and Badi Chouper by Cut and Cover Methods on East West Corridor of Jaipur Metro Rail Corporation Limited .”	
Owner :

Pre - Condition Building Survey for Construction of Underground Stations from Chandpole to Bari Chouper and reversal line

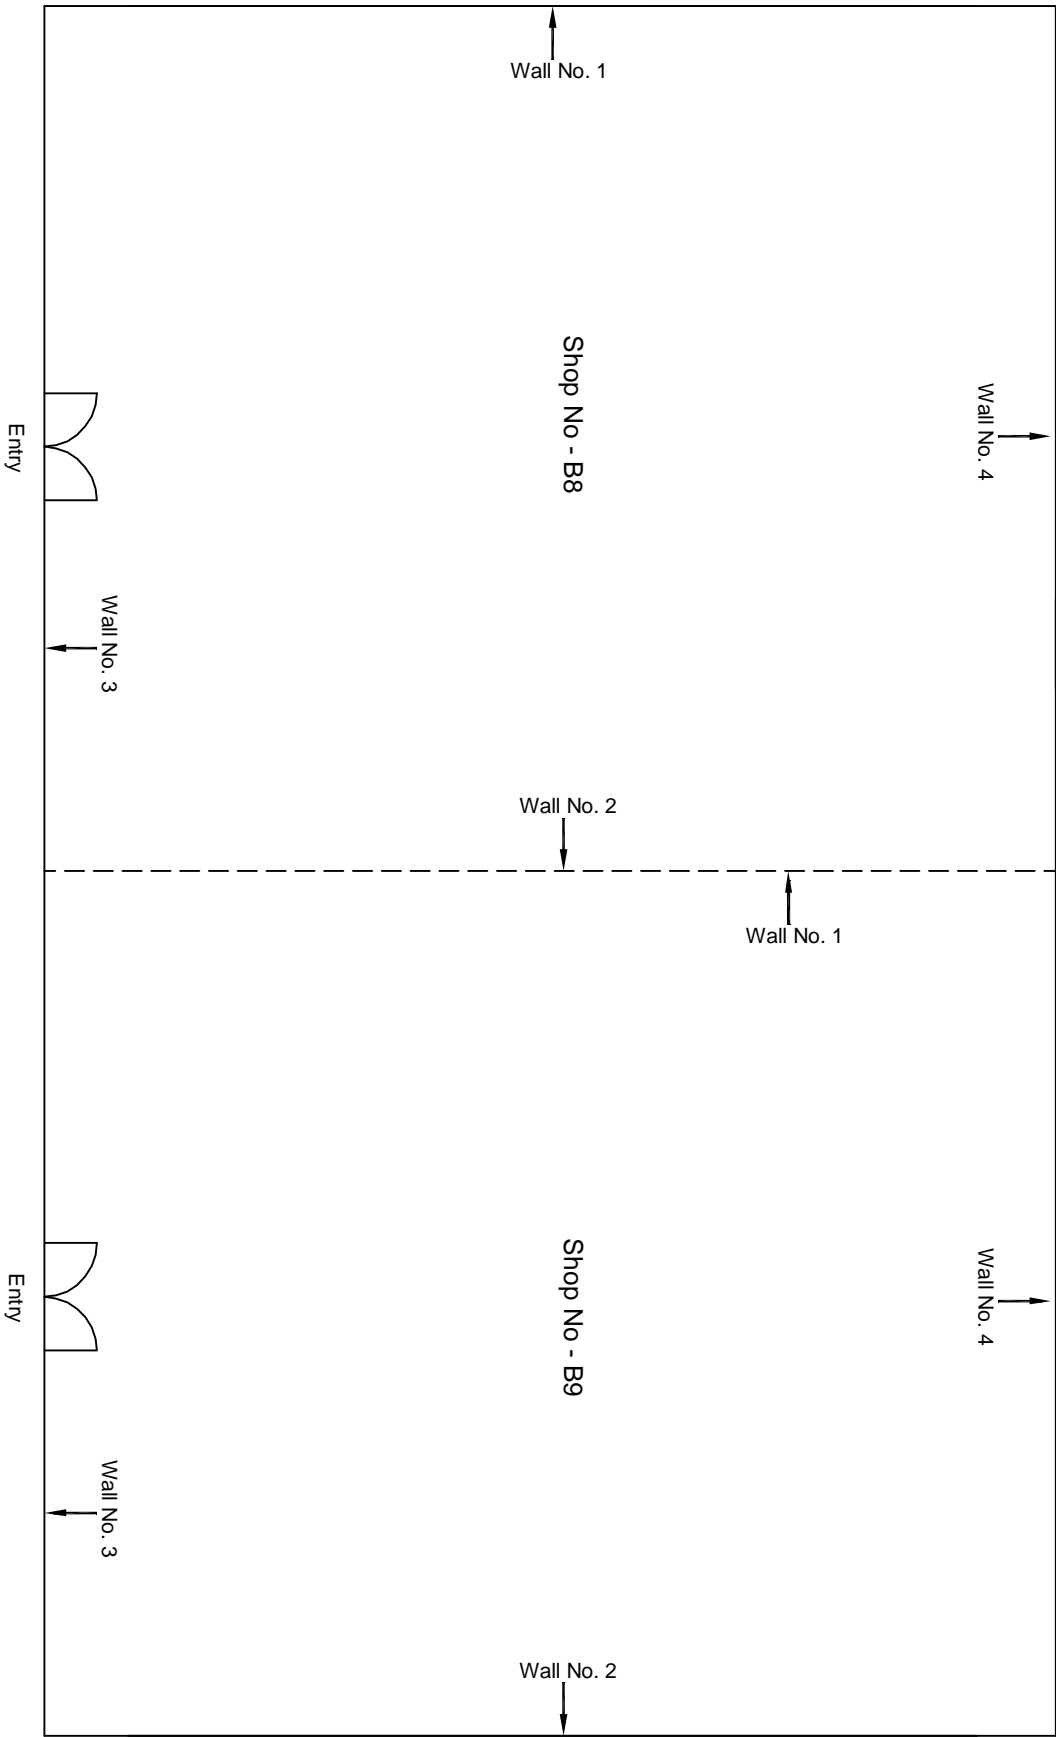
Basement Floor Plan

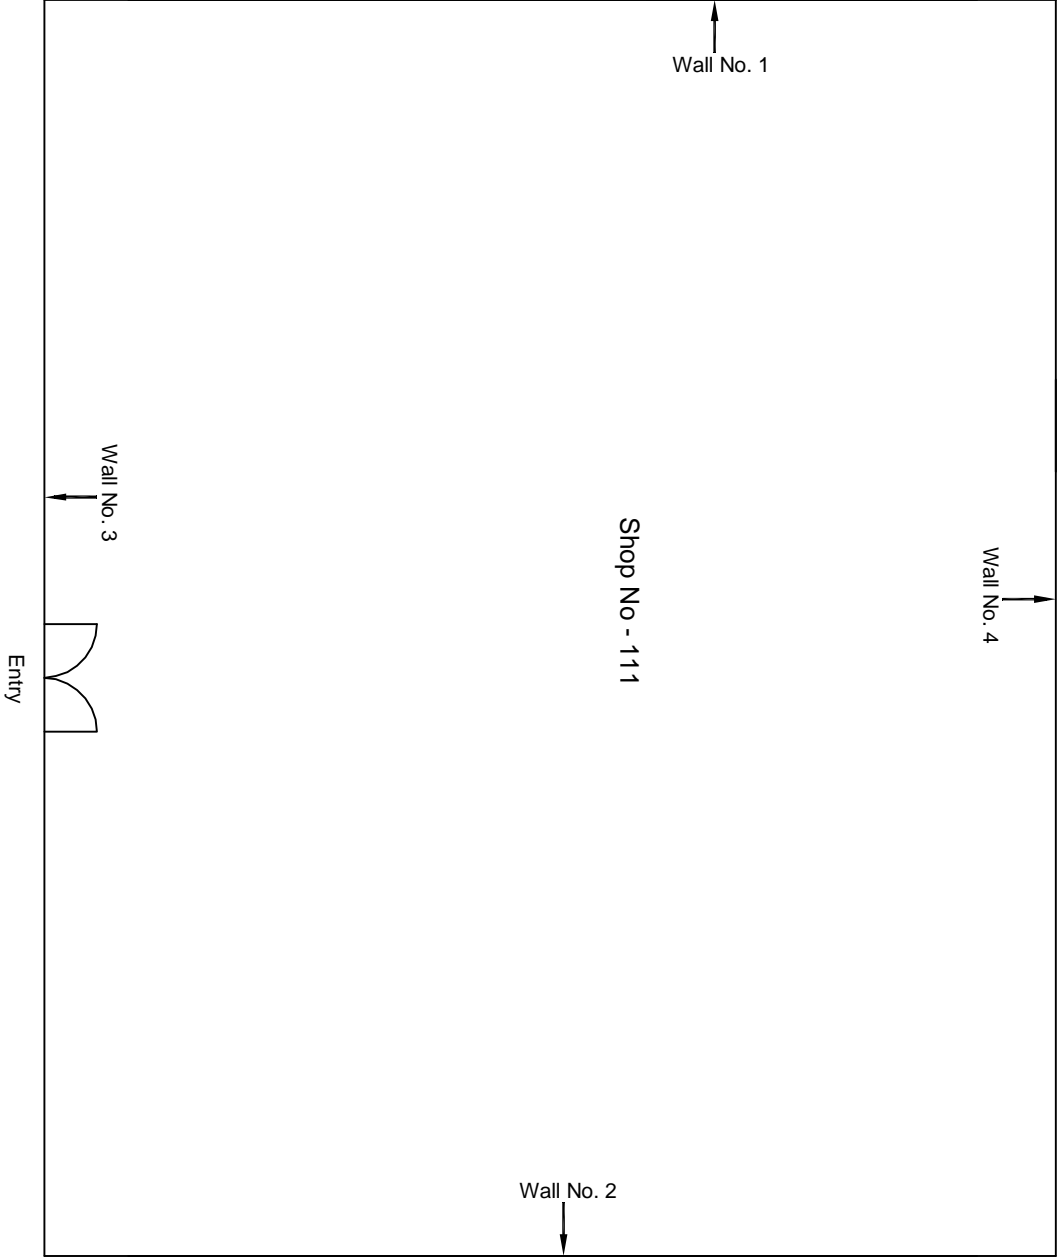
Ground Floor Plan

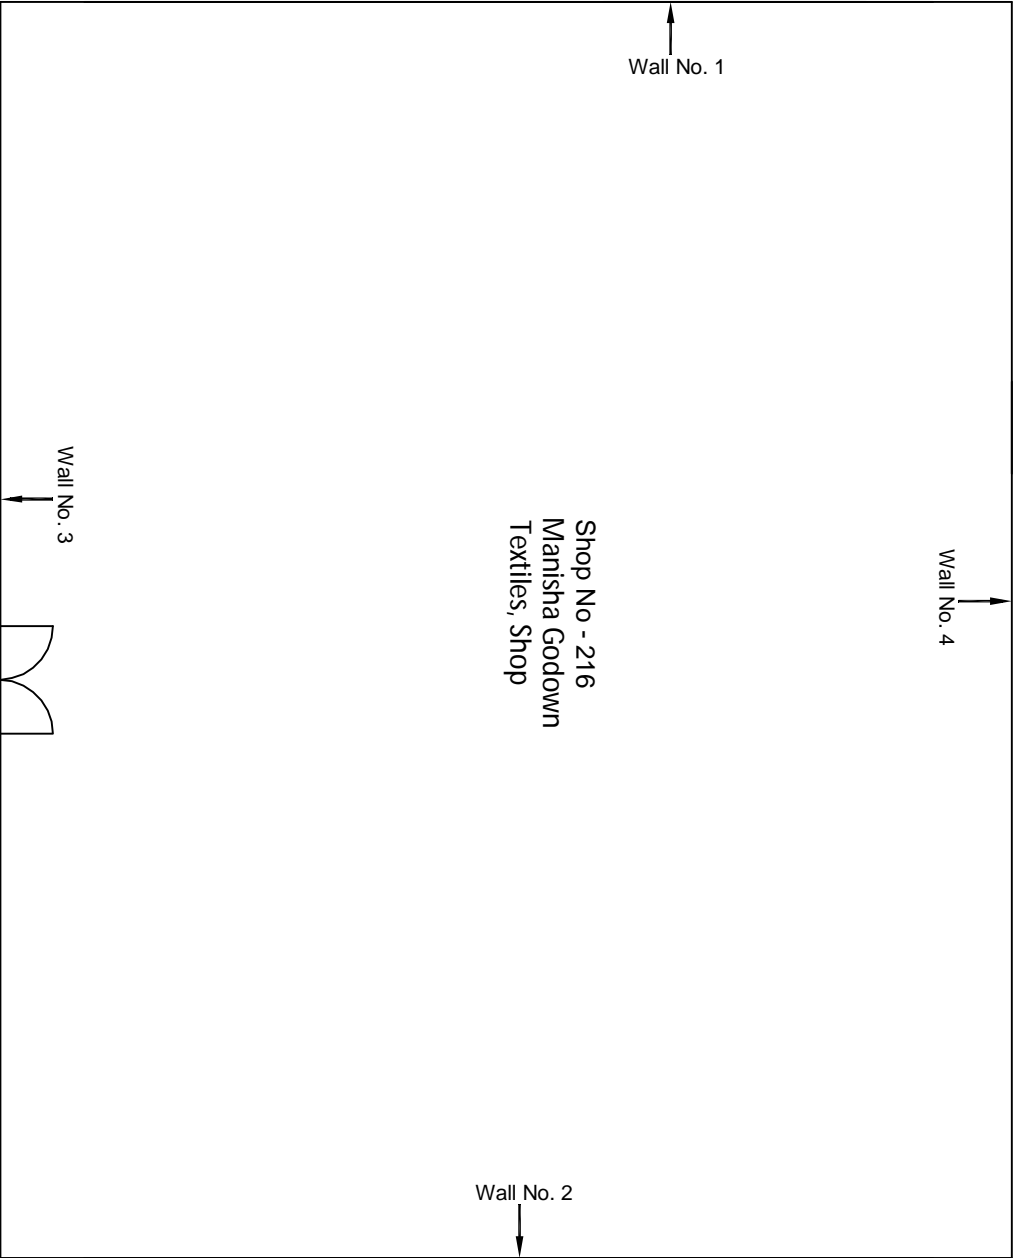
First Floor Plan

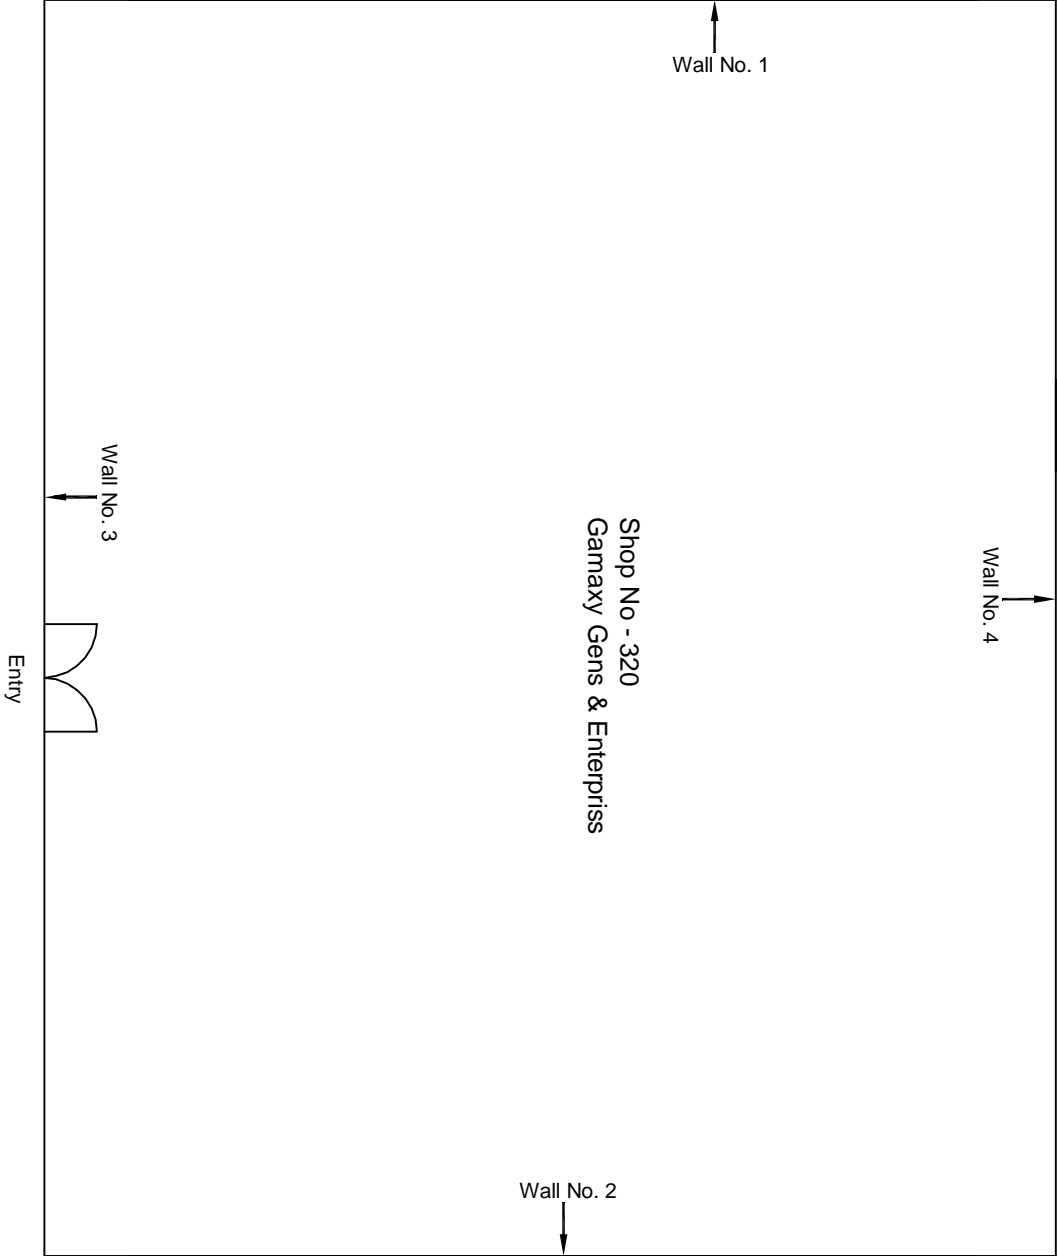
Second Floor Plan
