Environmental and Social Monitoring Report

Thirteenth Quarterly Report
(January 2018 - March 2018)

India: Jaipur Metro Rail Line 1-Phase B Project

Prepared by: Jaipur Metro Rail Corporation Limited for the Asian Development Bank

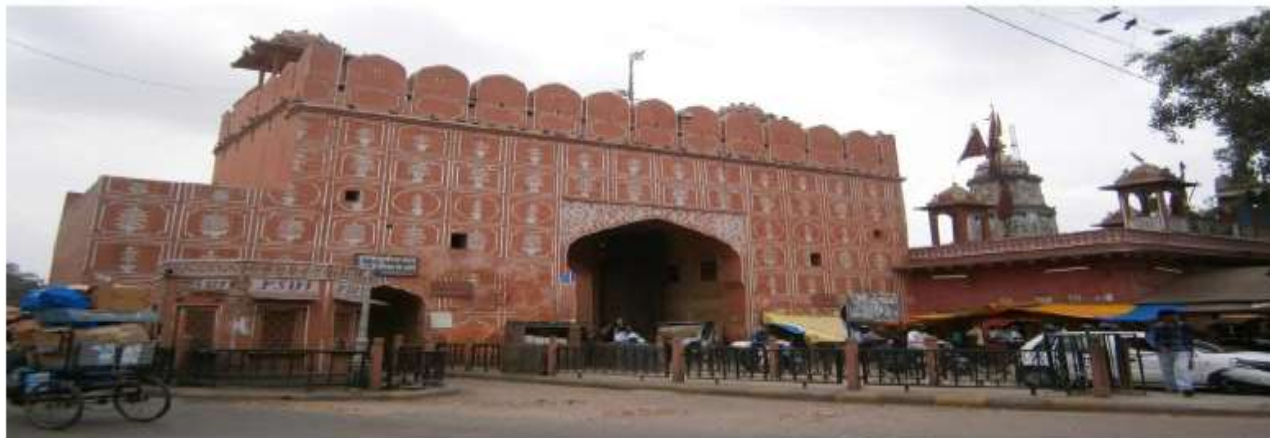
Chandpole Gate Tunnel Underpass Scheme

22. Chandpole Gate is coming right in the center of alignment, attracting maximum settlement, but original drawings relating to its foundation were not available. Therefore, the foundation of Chandpole Gate has been physically examined by a team of engineers, by making several trial pits around the gate.

23. For the determination of the structure's foundation, special survey was carried out by CEC and nine trial pits were executed in certain locations near the gate. The foundation of Chandpole Gate has been found to be in a sound condition which can sustain the impact of tunnel-making underneath. To assess the ground settlement due to tunneling by TBM & its effect on structural safety of Chandpole Gate, a detailed 3D analysis has been carried out by M/s Omikron Kappa – Indus Consultant JV and a detailed report submitted.

28. Now both TBMs have crossed underneath Chandpole Gate, the gate sustained no damage during the tunneling process. Monitoring Results for all Geotechnical instruments installed during the passing of TBMs under Chandpole gate were within the design limits. The maximum observed settlements under Chandpole Gate was -3 mm.

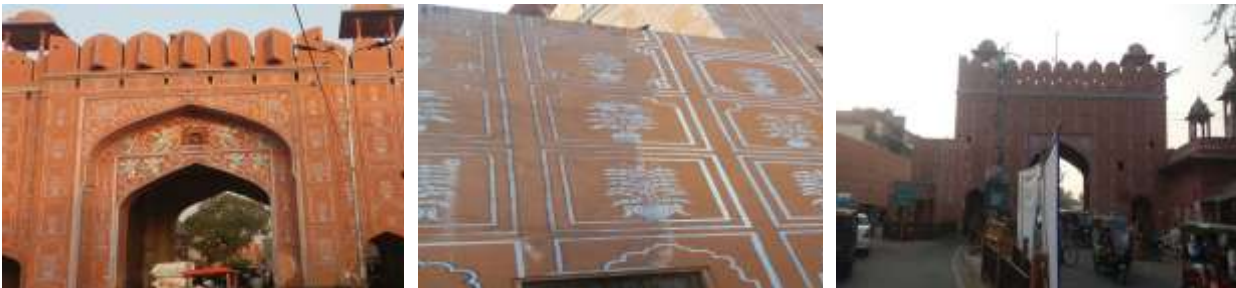
29. As a part of precautionary measure and to ensure that the strength of the Chandpole gate is not compromised, JMRC has got done repairing of pre-existing defects in the gate using plaster, lime kada etc. Alongwith improving the strength of the Gate, the work will also enhance the aesthetics of the historic Gate.

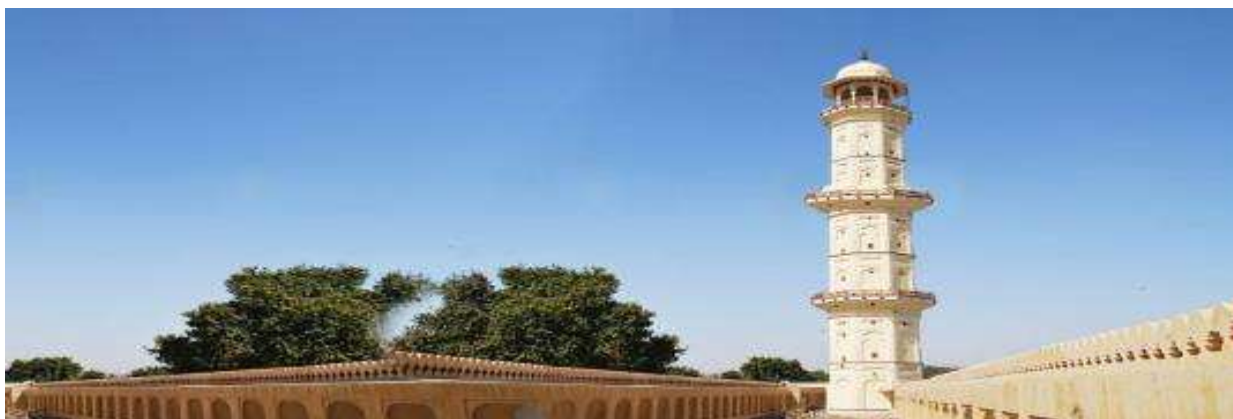
Isarlat Side Pass Scheme

30. As per report of structural expert of Heritage Consultants, Abha Narain Lambah Associates & Shashank Mehendale & Associates (JV), physical condition of Isarlat is found to be

generally sound and it is located at safe distance from the tunnel axis. There will be no adverse impact on the Isarlat during tunnel construction.

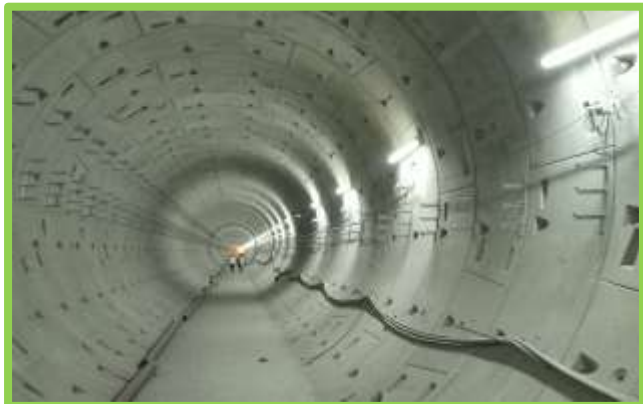
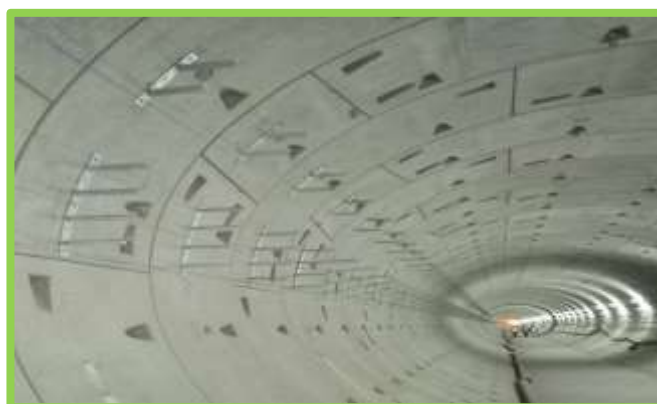
**View of tunnel towards Badi Chaupar and Chandpole**

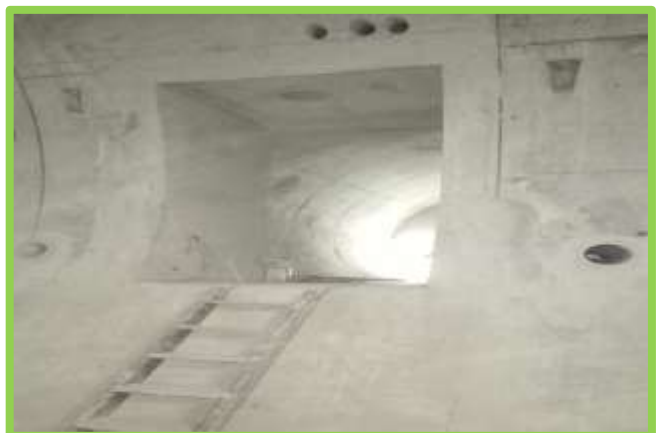
**Regular Housekeeping in the stations****View of cross passage no.-5, TBM-2**

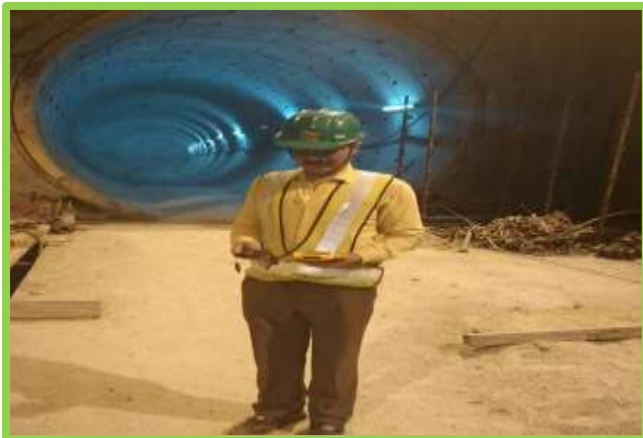
**Illumination testing**

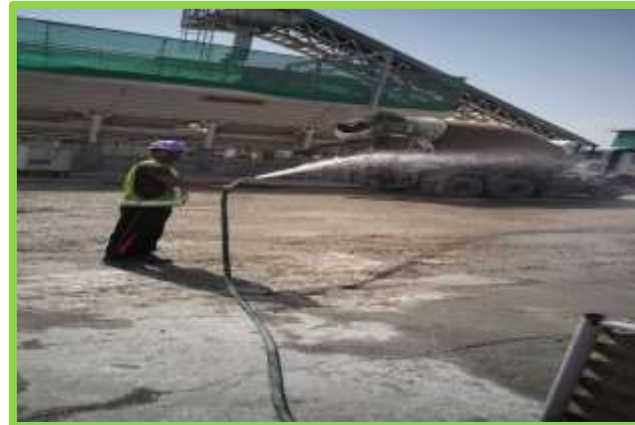
**Water sprinkling for dust suppression at site**

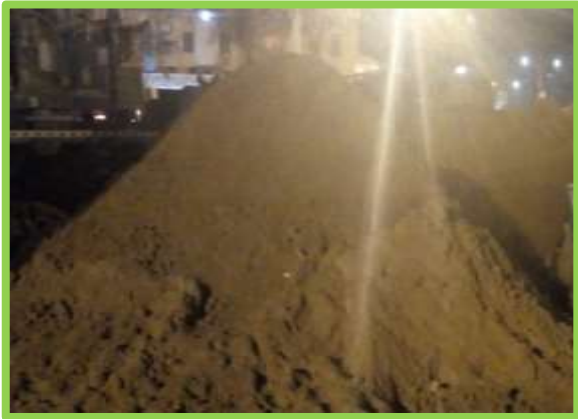
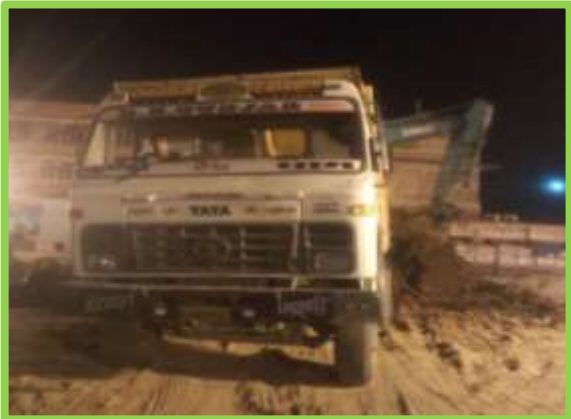
Excavated muck stored at site	Excavated muck stored at surface level	Muck loading into dumper by excavator

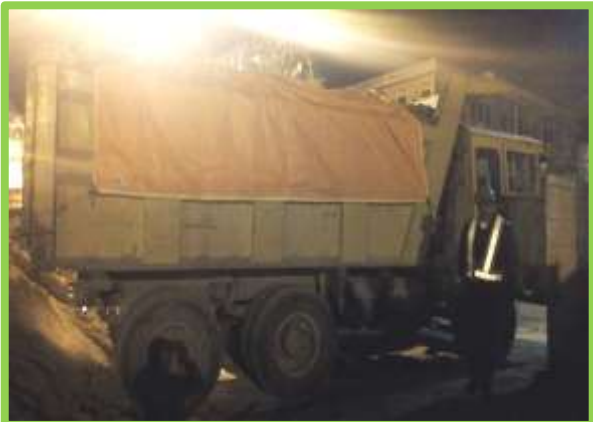
Loaded dumper properly covered by tarpaulin	Loaded dumper is going through public road for muck disposal	Road marshal deployed for safe entry/exit of vehicle
