Pre Building Condition Survey Report

Name of the Project	Contract JMRC-UG1B "Design and Construction of Tunnel between Chandpole and Badi Chouper and reverse line by Shield TBM, Underground Metro Stations at Choti Chouper and Badi Chouper by Cut and Cover Methods on East West Corridor of Jaipur Metro Rail Corporation Limited ."		
Owner :	JAIPUR METRO	Jaipur Metro Rail Corporation	
Contractor :	VUV	Continental Engineering Corporation	
Survey Agency :	Aimil I Instrumentation	tion & Technologies

Pre Building Condition Survey Report Chand Pole to Choti Chopar (UP Line)

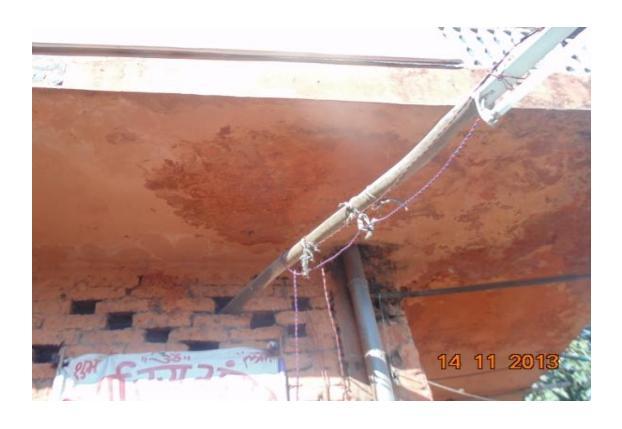
Summary of Defects Other Than Crack			
Defect ID	Location	Description	
3	Front Shed Temple Sh. Bhomia Ji Maharaj	Dampness/Seepage	2
4	External Wall No. 3 Temple Sh. Bhomia Ji Maharaj	Peeling of Plaster	3
5	Wall No. 2 Temple Sh. Bhomia Ji Maharaj	Peeling of Plaster	4
6	Roof Temple Sh. Bhomia Ji Maharaj	Peeling of Plaster	6
7	Wall No. 4 Temple Sh. Bhomia Ji Maharaj Stair Area	Dampness/Seepage	7
8	External Wall No. 2 Temple Sh. Bhomia Ji Maharaj	Peeling of Plaster	10
9	External Wall No. 2 Temple Sh. Bhomia Ji Maharaj	Peeling of Plaster	11
10	External Wall No. 2 Temple Sh. Bhomia Ji Maharaj	Peeling of Plaster	12

Photo 2 Dampness/Seepage on Front Shed of Temple Sh. Bhomia Ji Maharaj

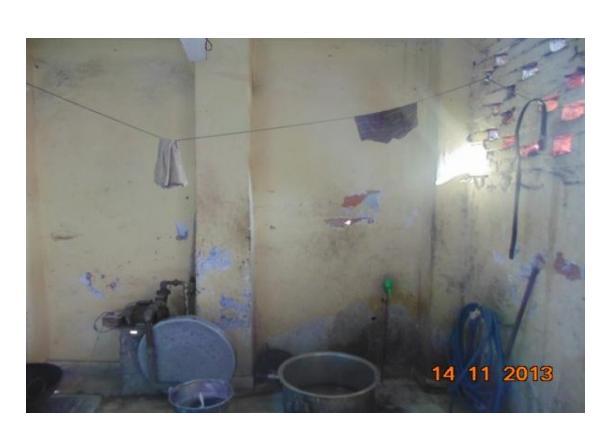
Photo 3 Peeling of Plaster on External Wall No. 3 of Temple Sh. Bhomia Ji Maharaj

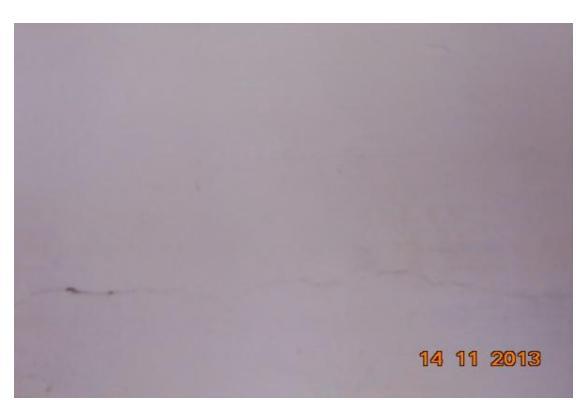
Summary of Cracks					
Defect ID Location Orientation Appx. Width Appx. Length (mm) (m) Categor					Category	Photo No.
1	Wall No. 4 Temple Sh. Bhomia Ji Maharaj Ground Floor	Horizontal	0.25	1.3	Very Slight	5
2	Roof Temple Sh. Bhomia Ji Maharaj Ground Floor	Horizontal	0.2	2	Very Slight	8

Photo 5 Horizontal Crack on Wall No. 4 of Temple Sh. Bhomia Ji Maharaj, Approx. Width = 0.25mm, Approx. Length = 1.3m. Distance from Wall No. 1 = 0m, Height from Floor = 0.2m.

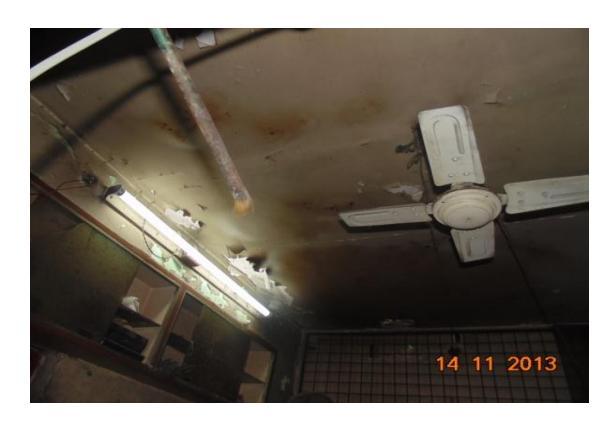
Photo 6 Peeling of Plaster on Roof of Temple Sh. Bhomia Ji Maharaj

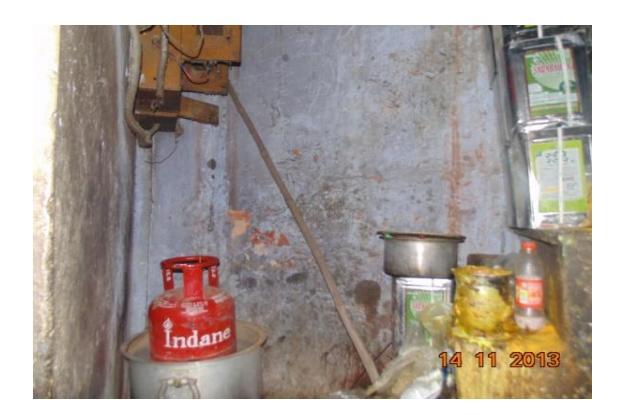
Photo 7 Dempness/Seepage on Wall No. 4 of Staircase Area Temple Sh. Bhomia Ji Maharaj

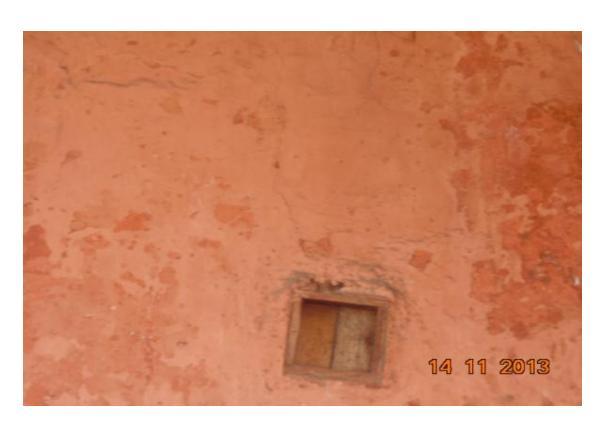
Photo 9 Demage External Wall No. 2 of Temple Sh. Bhomia Ji Maharaj

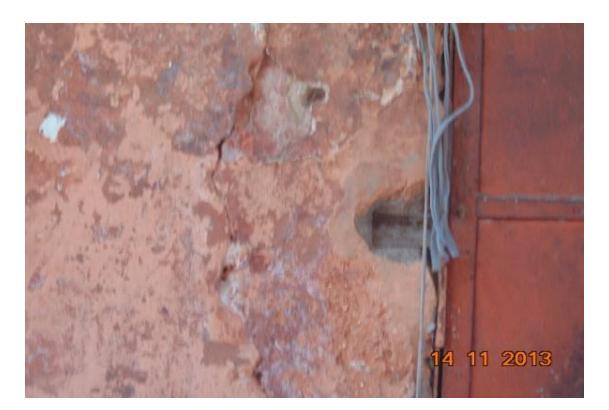
Photo 11 Peeling of Plaster on External Wall No. 2 of Temple Sh. Bhomia Ji Maharaj

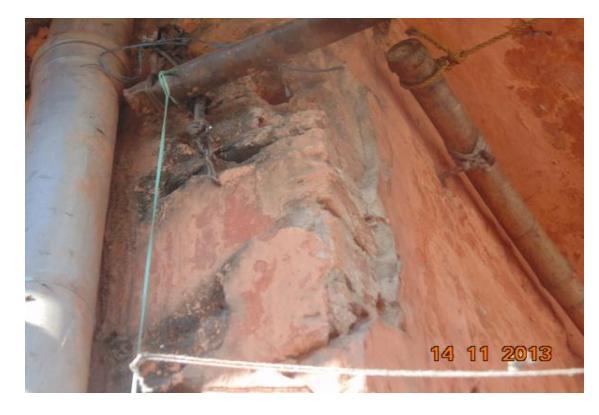
Photo 12 Peeling of Plaster on External Wall No. 2 of Temple Sh. Bhomia Ji Maharaj

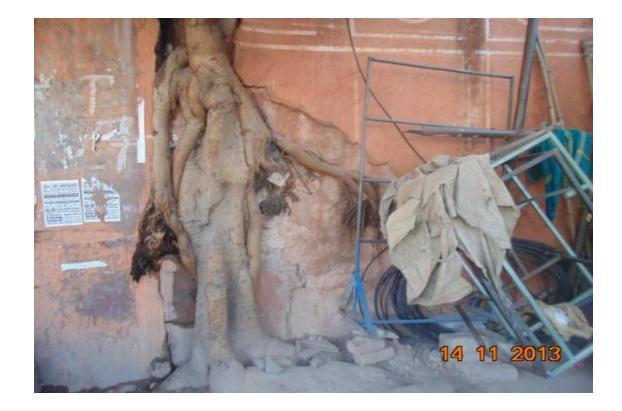
Photo 15 External Wall of Temple Sh. Bhomia Ji Maharj Demaged

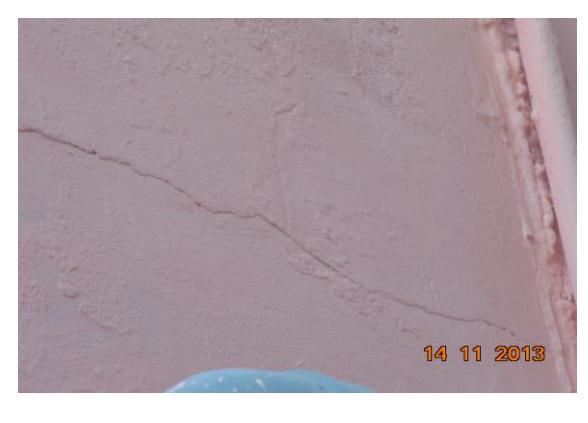
Summary of Cracks						
Defect ID	Location	Orientation	Appx. Width (mm)	Appx. Length (m)	Category	Photo No.
1	Wall No. Outer Wall Shop No. 13 Ground floor	Inclined	5	3.5	Moderate	3
2	Wall No. Outer Wall, 2 & 4 Shop No. 13 Ground floor	Horizontal	0.5	3.5	Very Slight	4

Photo 3 Inclined Crack on Wall No. Outer Wall of Shop No. 13, Ground floor Approx. Width = 5mm, Approx. Length = 3.5m. Distance from W3 = 0.7m, Height from Floor = 3m.

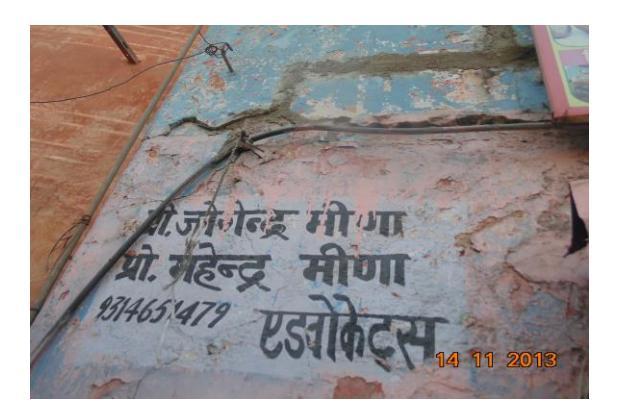
Photo 4

Peeling of Plaster on Wall No.3 & OuterWall of Mashoor Lala Ram

Pakodi Wale of Ground Floor

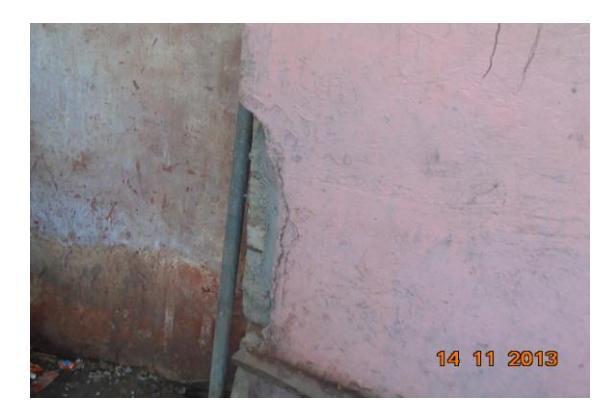
Photo 5 Damaged Portion on Wall No.3 & OuterWall of Mashoor Lala Ram Pakodi Wale of Ground Floor

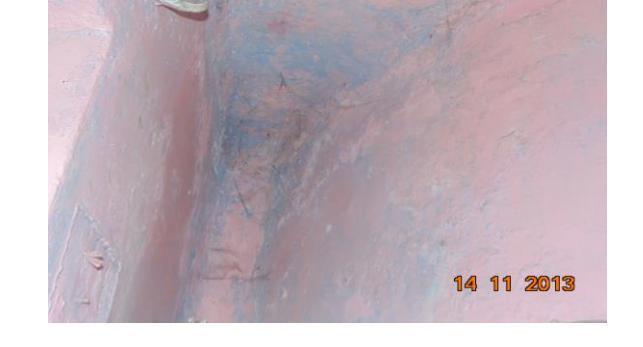
Photo 6 Dampness/Seepage on Wall No. 1, 5 & 4 of Mashoor Lala Ram Pakodi Wale of Ground Floor

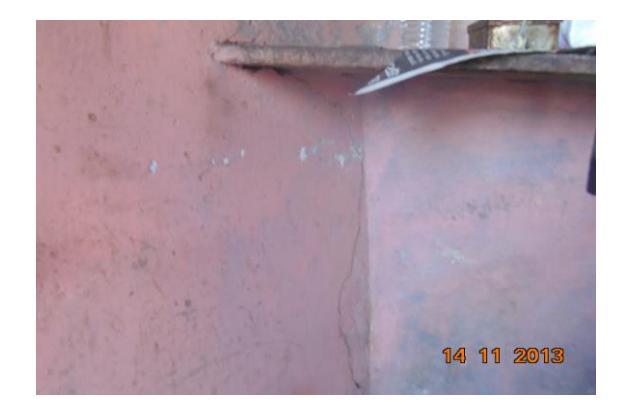
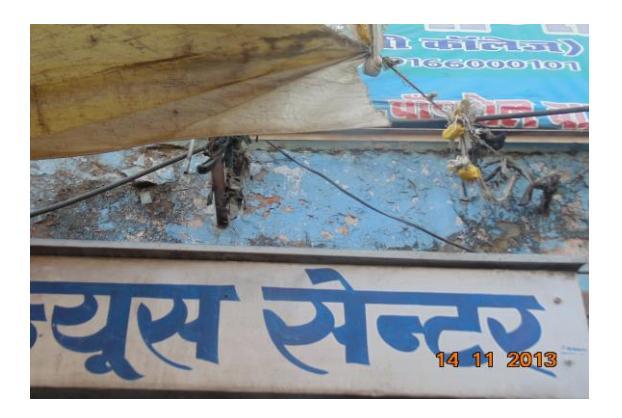
Photo 7
 Photo 8

Peeling of Plaster on Wall No. 5 & 4 of Mashoor Lala Ram Pakodi Wale
 Dampness/Seepage on Wall No.3 & Outer Wall of Ravi Shankar Juice of Ground Floor

Wala of Ground Floor
 Wala of Ground Floor

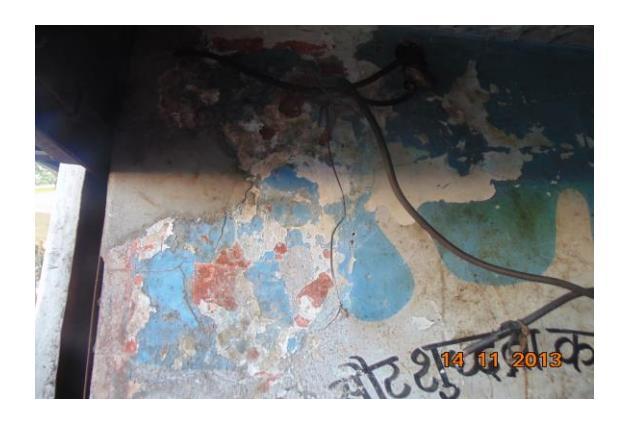
Photo 9 Peeling of Plaster on Wall No.3 & Outer Wall of Ravi Shankar Juice Wala of Ground Floor

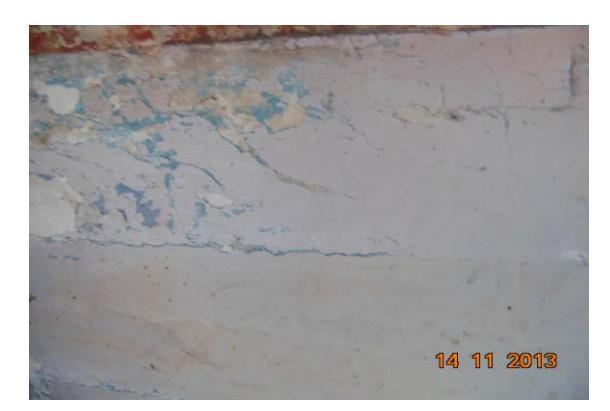
Photo 1 Peeling of Plaster on Roof of Kiran Juice Centre of Ground Floor

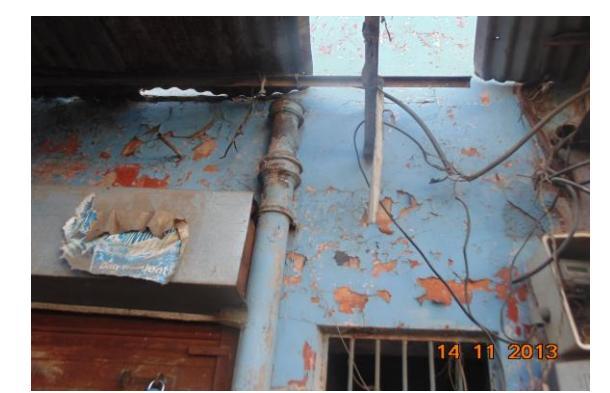
Photo 12 Peeling of Plaster on Wall No.3 & Outer Wall of Kiran Juice Centre of Ground Floor

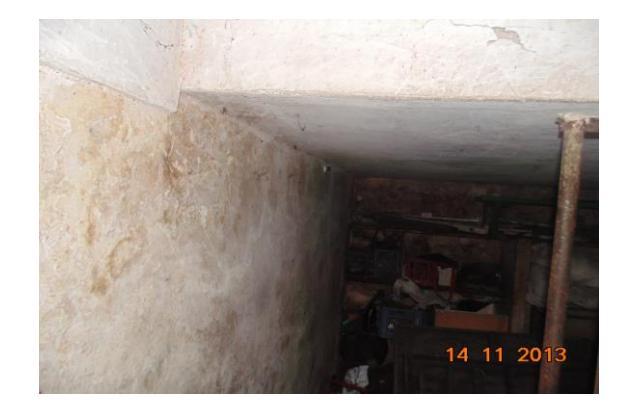
Photo 13 Dampness/Seepage on All Wall of Kiran Juice Centre of Basement

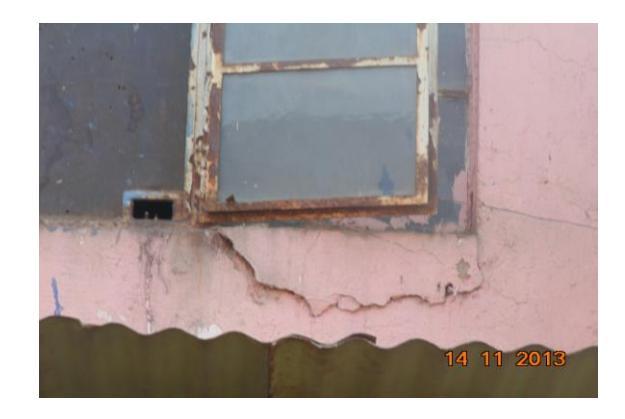
Photo 2 Peeling of Plaster on Outer Wall No.3 of Sheesh Mahal Hotel of Ground Floor

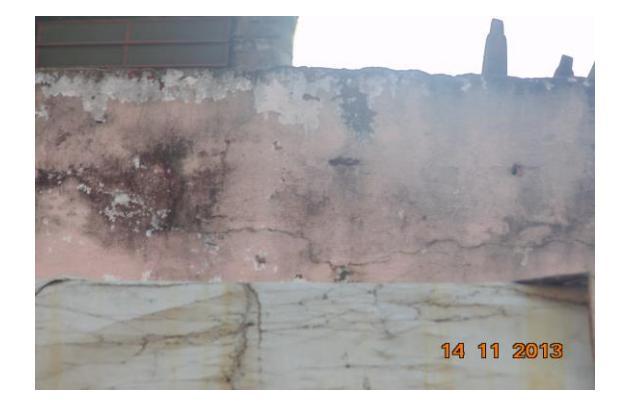
Photo 3 Dampness/Seepage on Outer Wall No.3 of Sheesh Mahal Hotel of Ground Floor

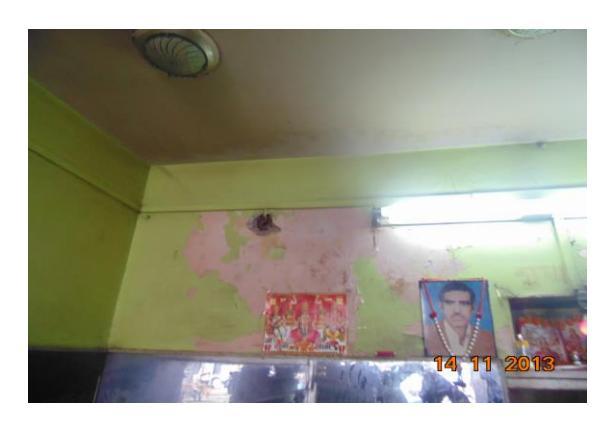
Photo 4 Peeling of Plaster on Wall No. 4 of Sheesh Mahal Hotel of Ground Floor

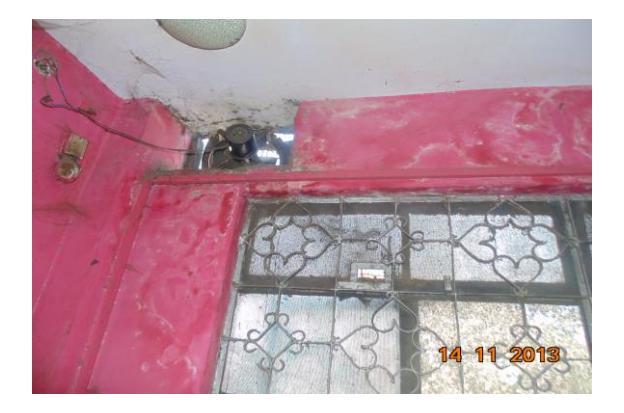
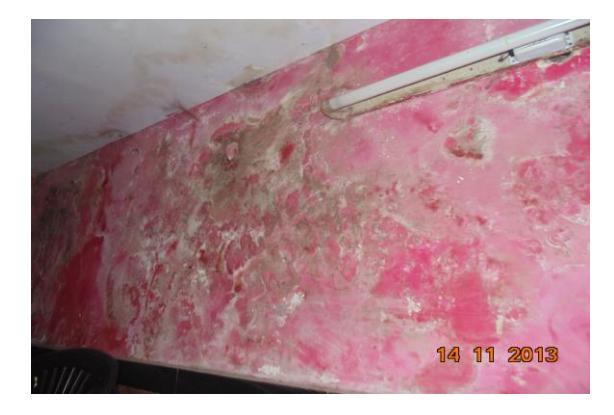
Photo 5 Dampness/Seepage on Wall No. 4 of Sheesh Mahal Hotel of First Floor Dampness/Seepage on Wall No. 1 of Sheesh Mahal Hotel of First Floor

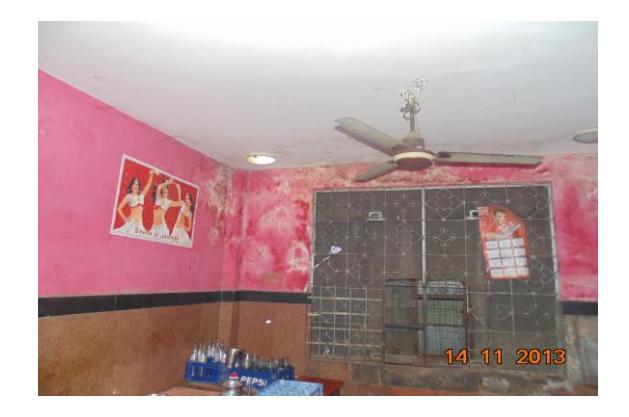
Photo 7 Dampness/Seepage on Wall No. 2 & 3 of Sheesh Mahal Hotel of First Floor

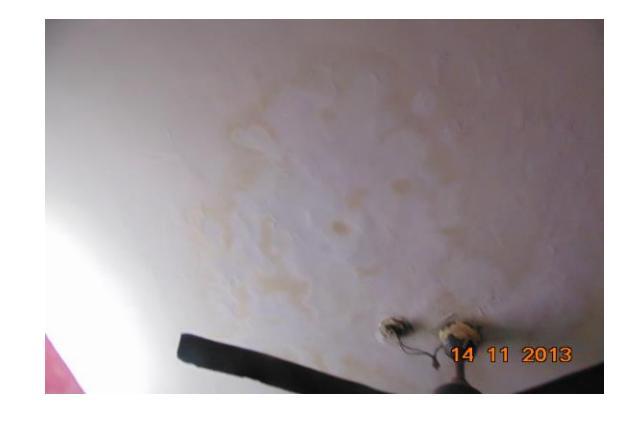
Photo 8 Dampness/Seepage on Roof of Sheesh Mahal Hotel of First Floor

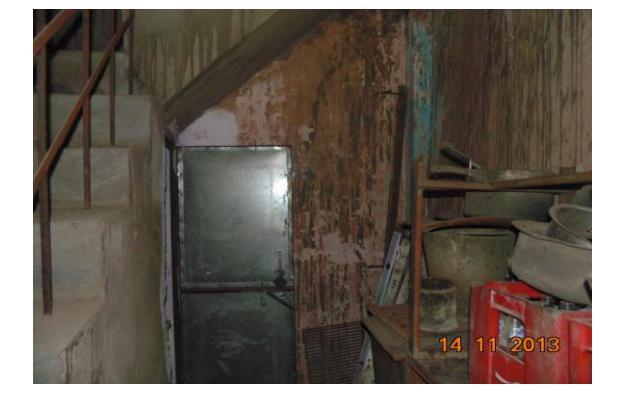
Summary of Defects Other Than Crack				
Defect ID	Location	Description	Photo No.	
1	Wall No. 2 Hall No. 1 First Floor	Peeling of Plaster	5	
2	Wall No. 3 Hall No. 1 First Floor	Peeling of Plaster	6	
3	Staircase area FF to SF First Floor	Peeling of Plaster	7	
4	Wall No. 1 Hall No. 1 Second Floor	Peeling of Plaster	8	
5	Wall No. 1, 3 & Corner Hall No. 1 Second Floor	Exposed Reinforcement	9

Photo 6 Peeling of Plaster on Wall No. 3 of Hall No. 1 of First Floor

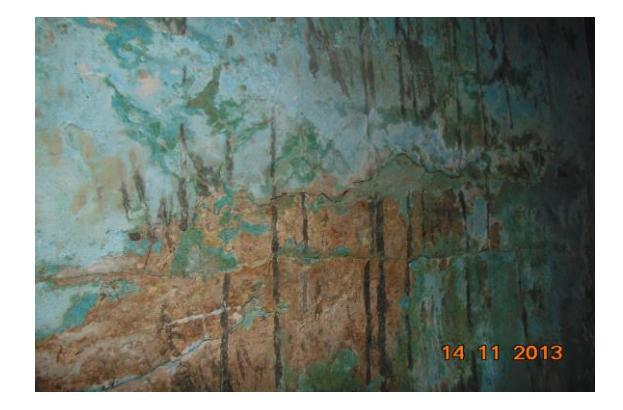
Photo 7 Peeling of Plaster on Staircase area FF to SF of First Floor

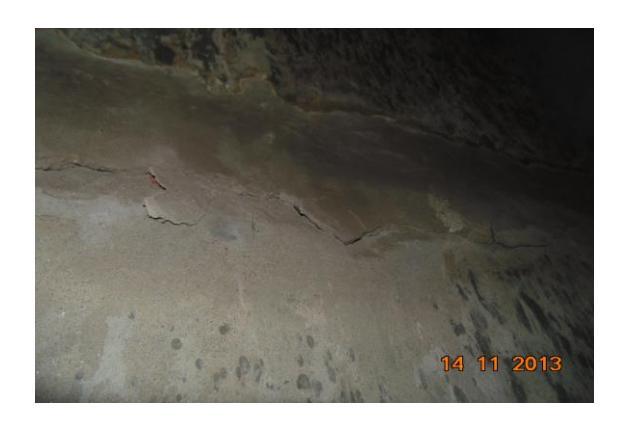
Photo 8 Peeling of Plaster on Wall No. 1 of Hall No. 1 of Second Floor

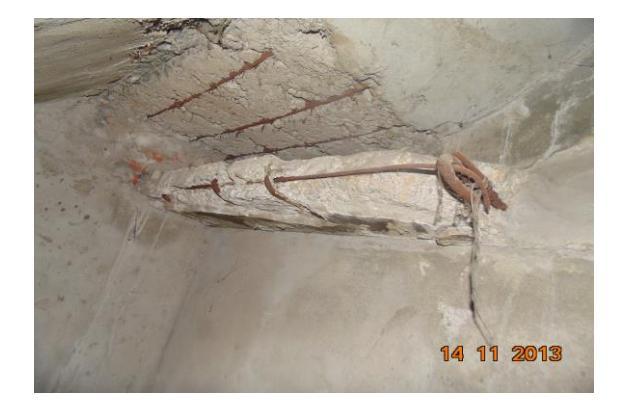
Photo 9 Exposed Reinforcement on Wall No. 1, 3 & Corner of Hall No. 1 of Second Floor

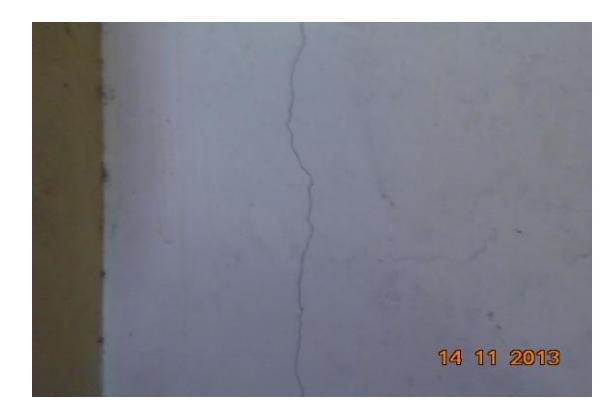
Summary of Cracks						
Defect ID	Location	Orientation	Appx. Width (mm)	Appx. Length (m)	Category	Photo No.
1	Wall No. 3 Hall No. 1 First Floor	Vertical	0.35	1.8	Very Slight	3, 3A
2	Wall No. 4 Toilet No. 1 Second Floor	Vertical	0.4	0.9	Very Slight	4, 4A

Photo 3 Vertical Crack on Wall No. 3 of Hall No. 1, First Floor Approx. Width = 0.35mm, Approx. Length = 1.8m. Distance from Wall no.2 = 0.2m, Height from Floor = 0.5m.

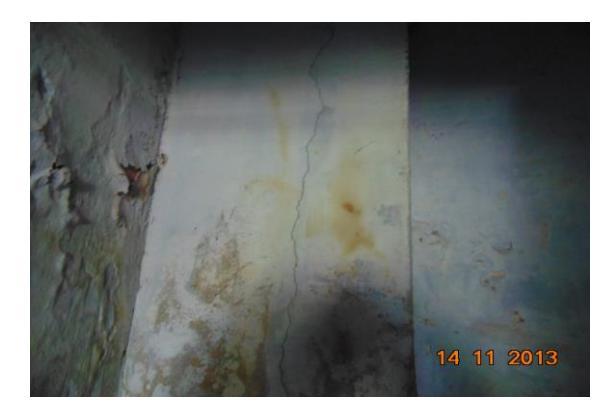
Photo 4 Vertical Crack on Wall No. 4 of Toilet No. 1, Second Floor Approx. Width = 0.4mm, Approx. Length = 0.9m. Distance from Wall no.1 = 0.2m, Height from Floor = 1.4m.

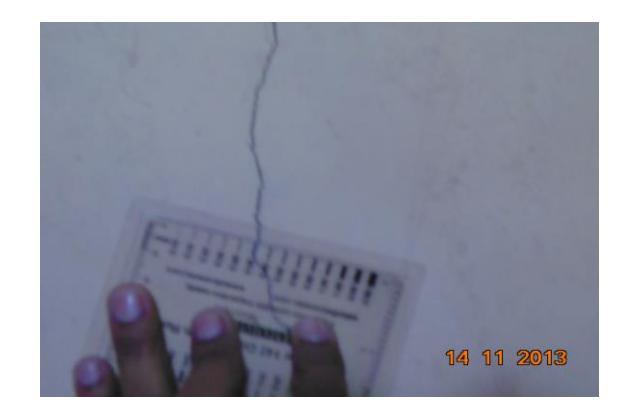
Photo 3A Vertical Crack on Wall No. 3 of Hall No. 1, First Floor Approx. Width = 0.35mm, Approx. Length = 1.8m. Distance from Wall no.2 = 0.2m, Height from Floor = 0.5m.

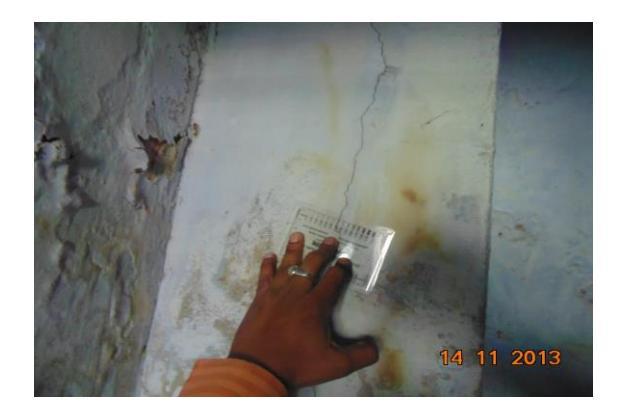
Photo 4A Vertical Crack on Wall No. 4 of Toilet No. 1, Second Floor Approx. Width = 0.4mm, Approx. Length = 0.9m. Distance from Wall no.1 = 0.2m, Height from Floor = 1.4m.

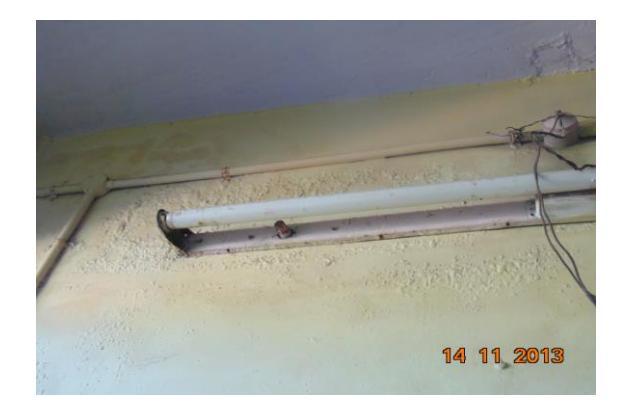
Photo 5 Dampness/Seepage on Wall No. 2 of Hall No. 1 of First Floor

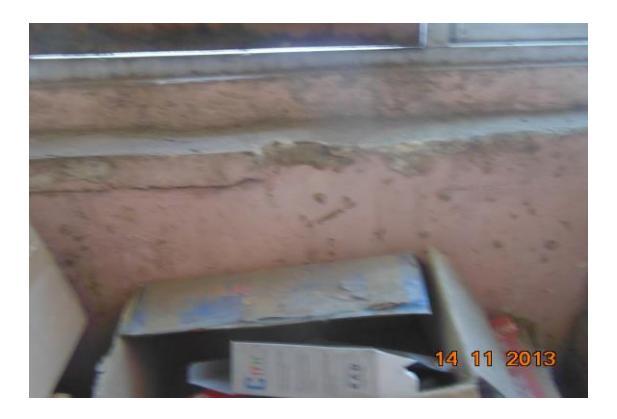
Photo 6 Peeling of Plaster on Wall No. 4 of Hall No. 1 of First Floor

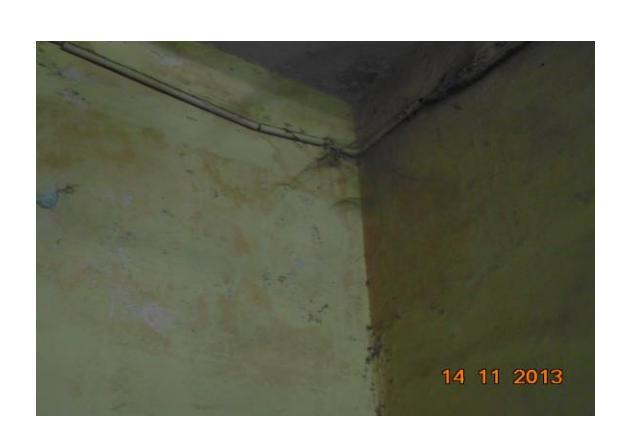
Photo 7 Dampness/Seepage on Roof of Hall No. 1 of First Floor

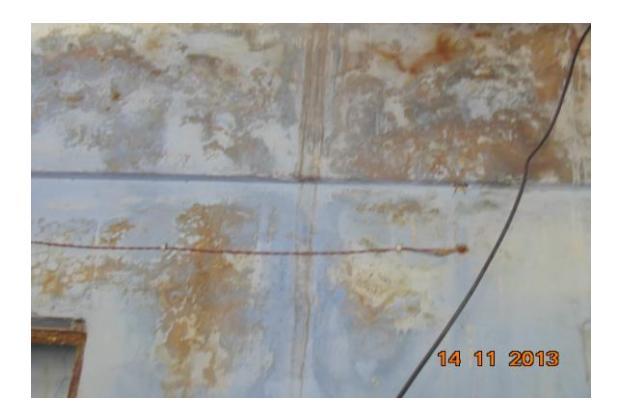
Photo 9 Dampness/Seepage on Wall No. 2 of Hall No. 1 of Second Floor

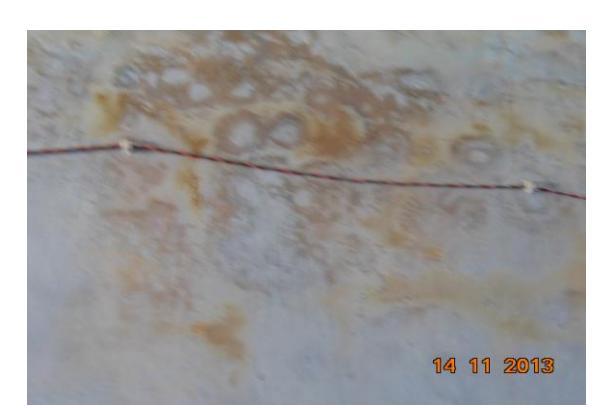
Photo 8

Dampness/Seepage on Wall No. 3 of Hall No. 1 of First Floor

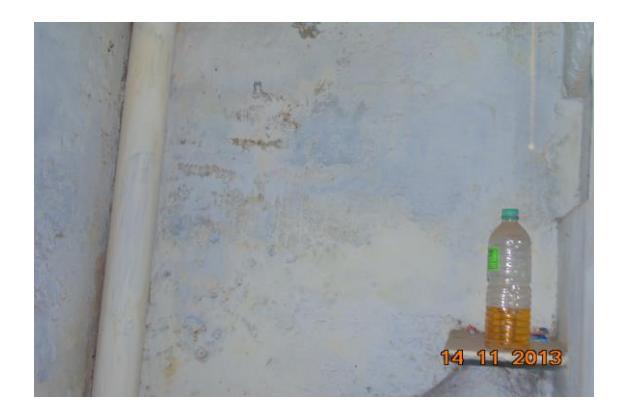
Photo 11 Dampness/Seepage on Wall No. 3 of Hall No. 1 of Second Floor

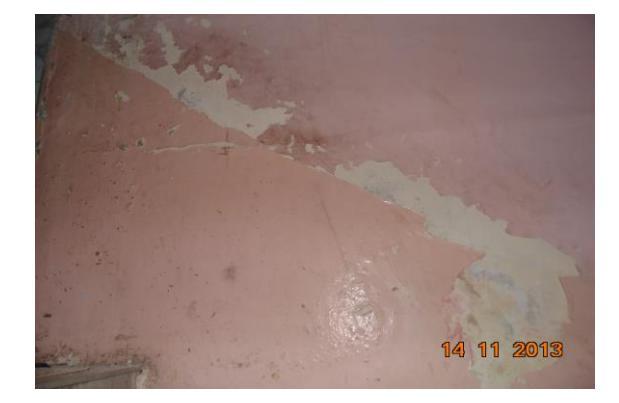
Photo 3 Peeling of Plaster on Wall No. 1 of Hall No. 1 of First Floor

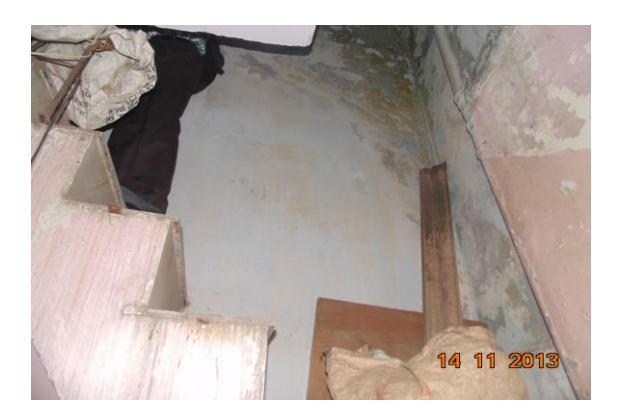
Photo 5 Dampness/Seepage on Roof, 2 & 4 of Staircase FF to SF of First Floor

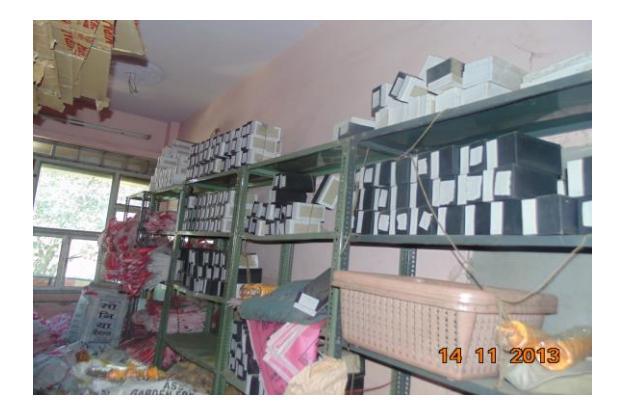
Photo 4 Peeling of Plaster on Wall No. 2 of Hall No. 1 of First Floor

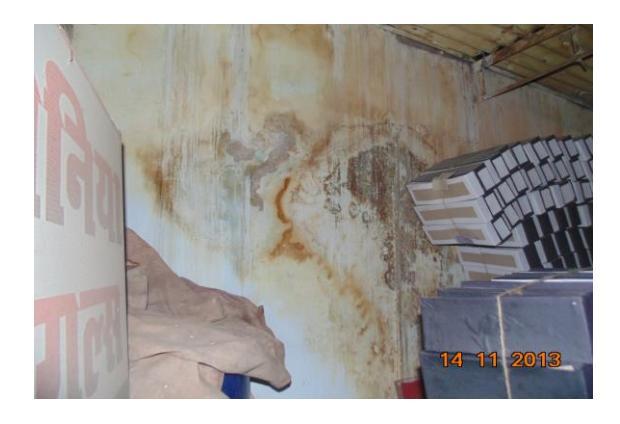
Photo 6 Dampness/Seepage on Wall No. 1 of Hall No. 1 of Second Floor

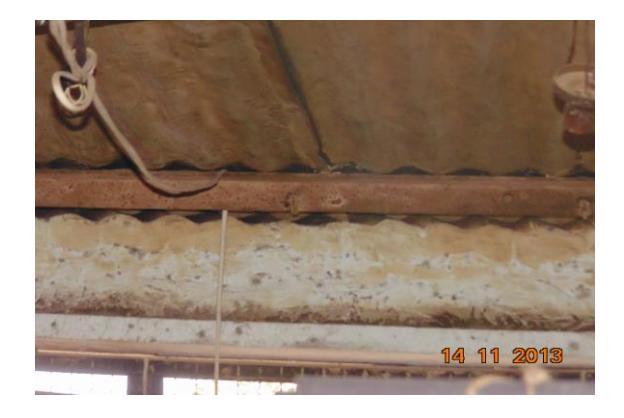
Photo 7 Dampness/Seepage on Wall No. 4 of Hall No. 1 of Second Floor

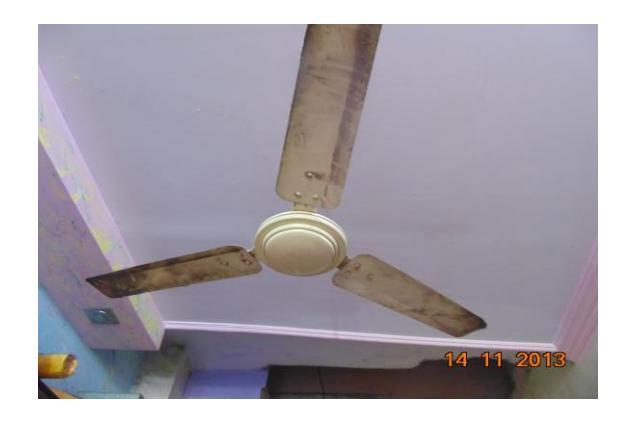
Photo 8 Dampness/Seepage on Roof of Staircase FF to SF of Second Floor

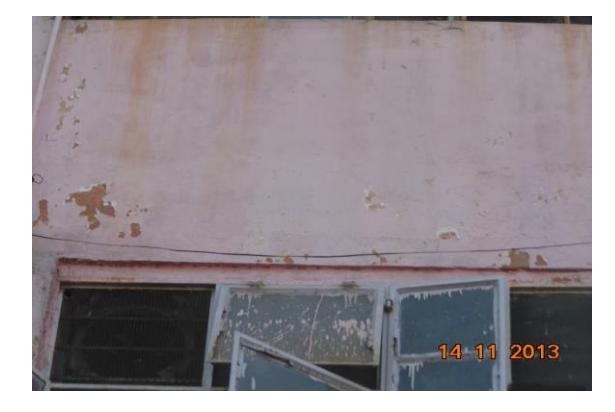
Photo 3 Peeling of Plaster on Wall No. 3 & OuterWall of shop of Jai Jagdamba Hotel of First Floor

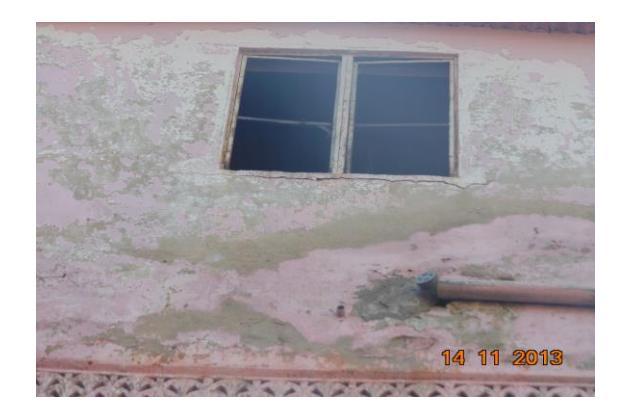
Photo 4 Peeling of Plaster on Wall No. 3 & OuterWall of shop of Jai Jagdamba Hotel of Second Floor

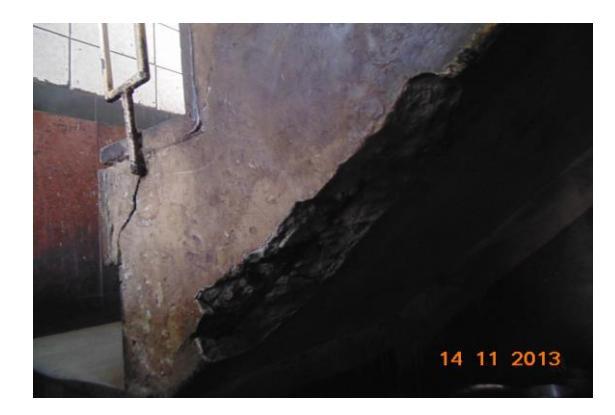
Photo 5 Exposed Reinforcement on Wall No. Staircase Area of Jai Jagdamba Hotel of Ground Floor

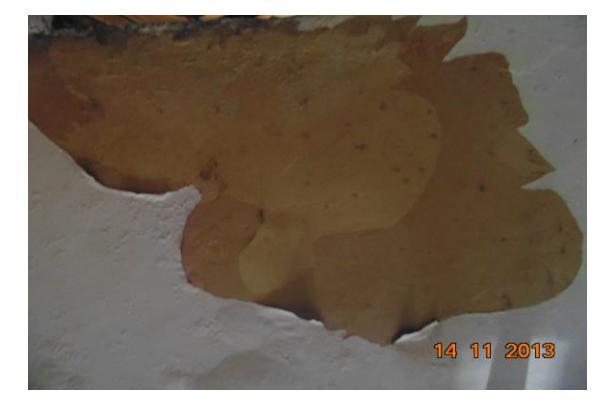
Photo 6 Peeling of Plaster on Roof of Hall No. 1 of First Floor

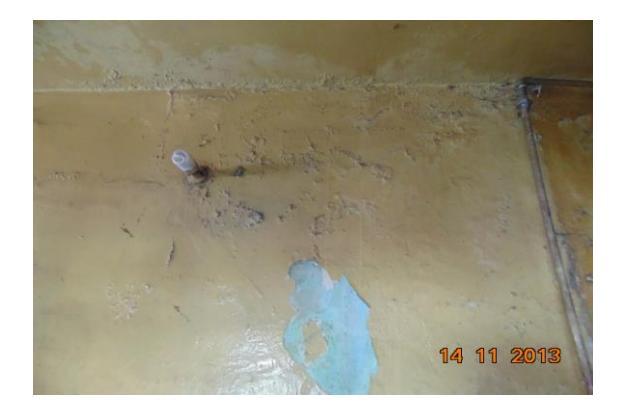
Photo 7 Dampness/Seepage on Wall No. 2 of Hall No. 1 of Second Floor

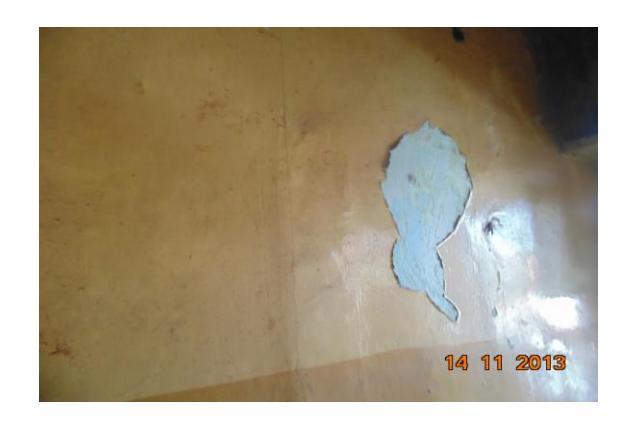
Photo 8 Peeling of Plaster on Wall No. 1 of Hall No. 1 of Second Floor

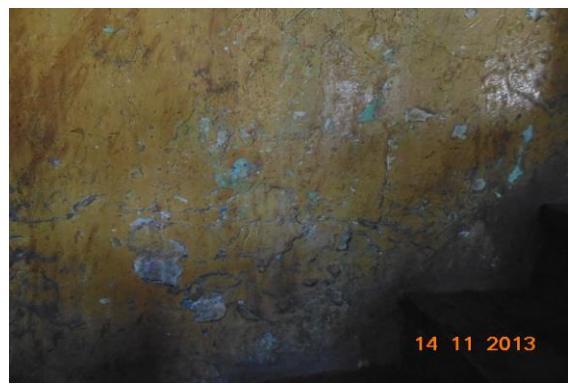
Photo 9 Dampness/Seepage on Roof of Hall No. 1 of Second Floor

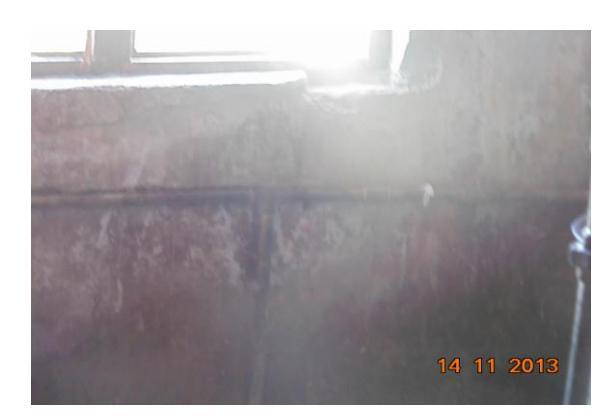
<u>Photo 1</u>1 Dampness/Seepage on Wall No. 4 of Hall No. 1 of Third Floor

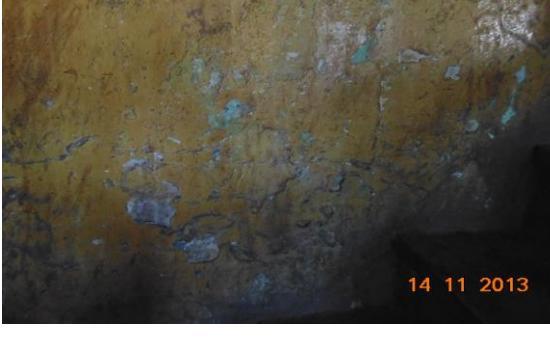
Photo 10 Dampness/Seepage on Wall No. 1 of Hall No. 1 of Third Floor

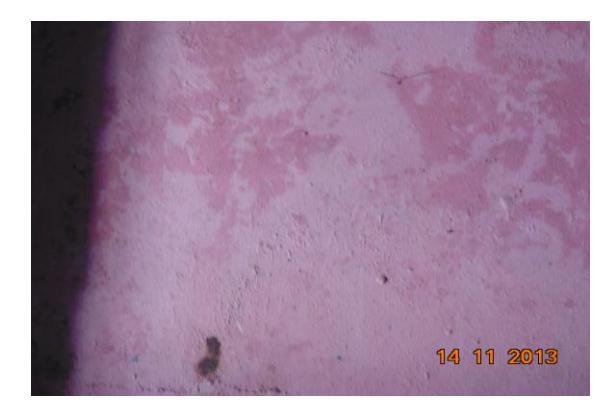
Photo 12 Dampness/Seepage on Wall No. 2 of Hall No. 1 of Third Floor

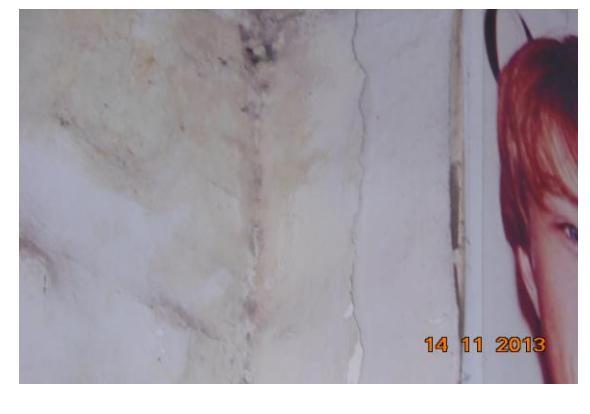
Photo 4 Vertical Crack on Wall No. 1 of Billu Saloon , Ground Floor Approx. Width = 0.25mm, Approx. Length = 0.4m. Distance from Wall No.3 = 1.5m, Height from Floor = 2m.

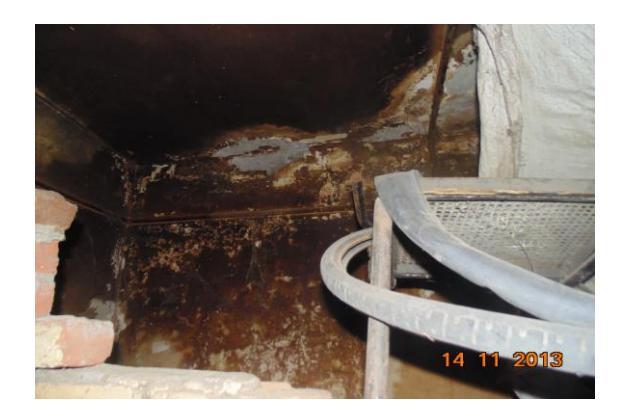
Photo 7 Dampness/Seepage on Wall No. 1 & 4 of Hussain Cycle Works of Ground Floor

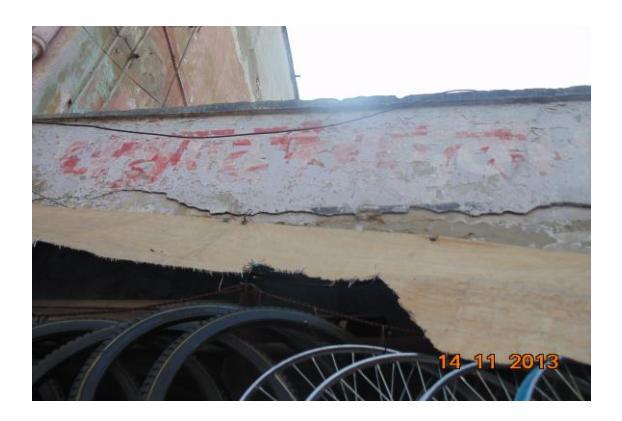
Photo 8 Peeling of Plaster on Wall No. 3 & Outside Wall of Hussain Cycle Works of Ground Floor

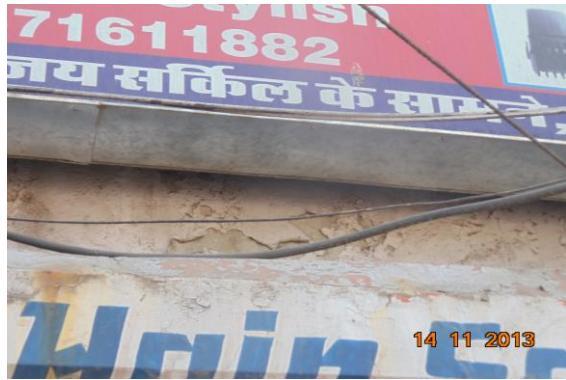
Photo 9 Peeling of Plaster on Wall No. 3 & Outside Wall of Billu Saloon of Ground Floor

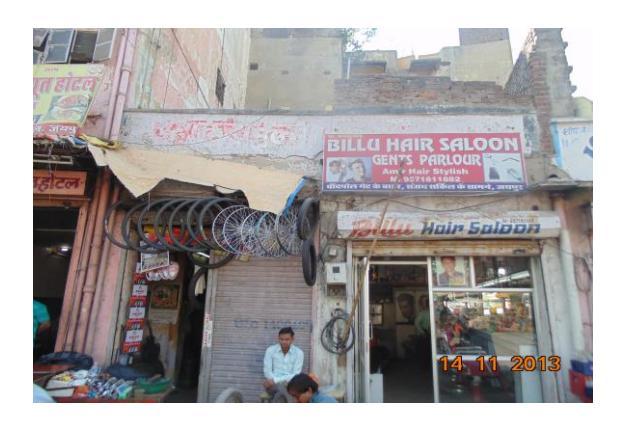
Photo 11 Damaged Portion on Wall No. 3 & Outside Wall of Shop of Ground Floor

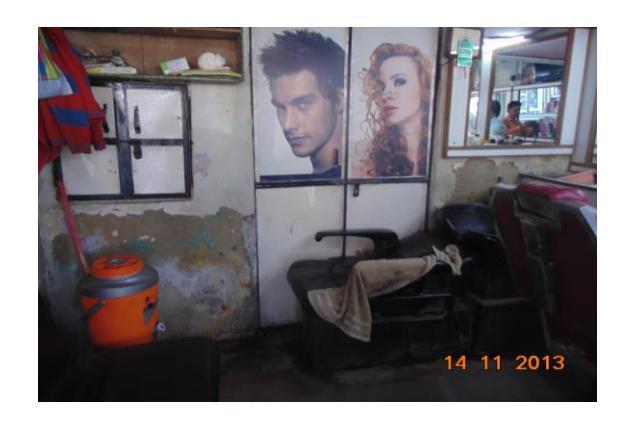
Photo 12

Wall No. 2 of Billu Saloon of Ground Floor Covered With Glass

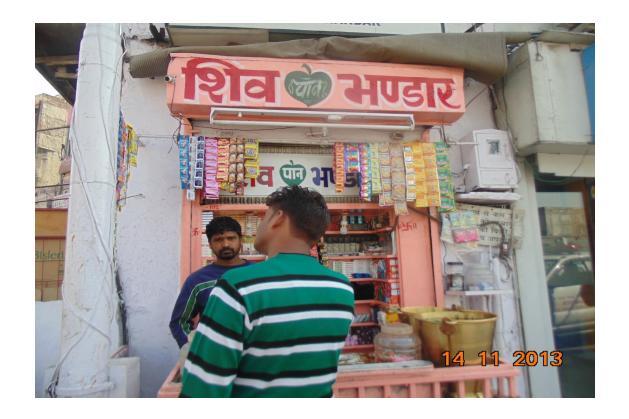
Photo 1 View of Shop No. 12 Shiv Pan Bhandar

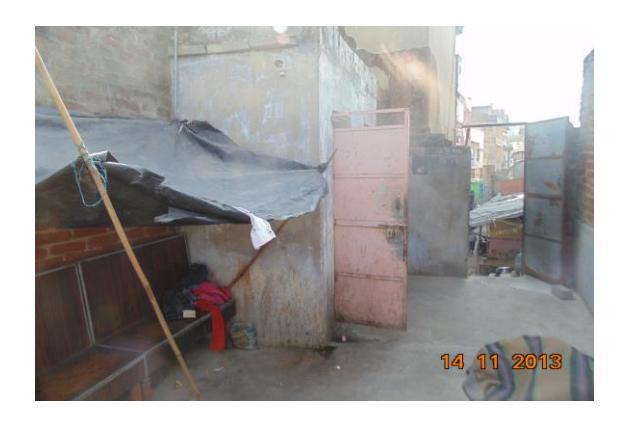
Photo 2 View of Terrace, First Floor

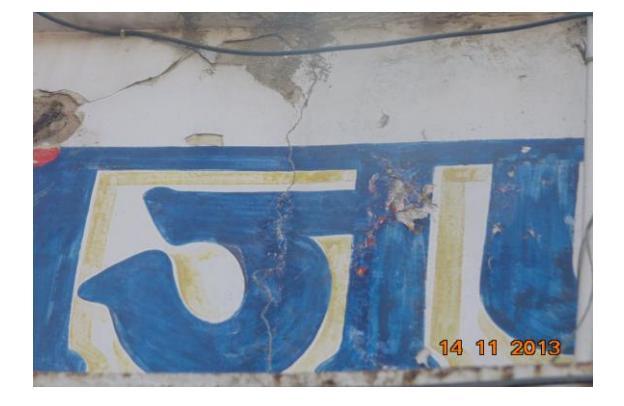
Photo 3 Vertical Crack on Outer Wall of Shop No. 11 & 12, Ground Floor,Approx. Width = 1mm, Approx. Length = 2m.

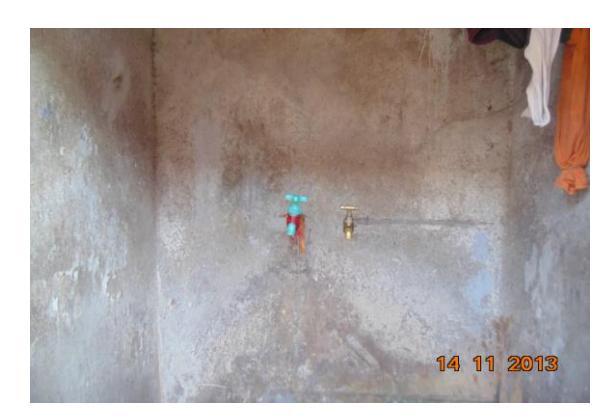
Photo 5 Dampness/Seepage on All Walls of Bathroom of Shop No. 11 & 12, First Floor

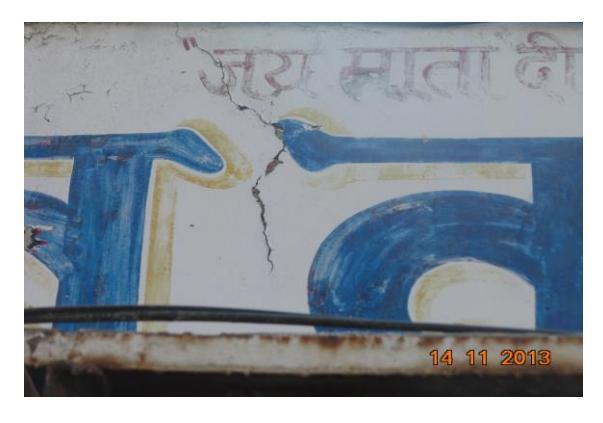
Photo 4 Inclined Crack on Outer Wall of Shop No. 11 & 12, Ground Floor,Approx. Width = 2mm, Approx. Length = 1m.

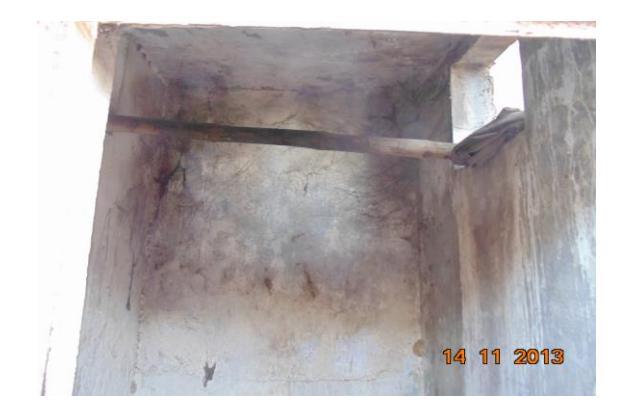
Photo 6 Dampness/Seepage on All Walls of Toilet No. 1 of Shop No. 11 & 12, First Floor

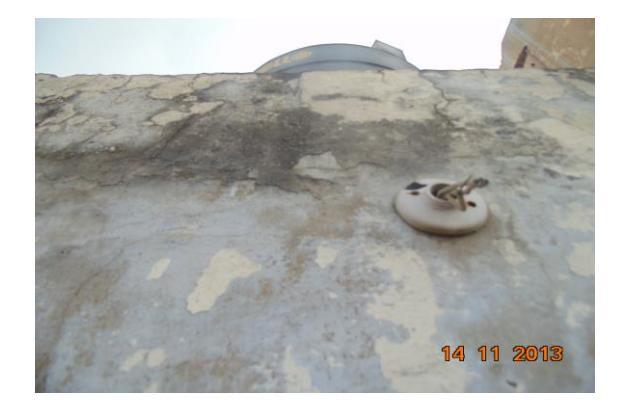
Photo 7 Dampness/Seepage on Outer Wall of Bathroom of Shop No. 11 & 12, First Floor

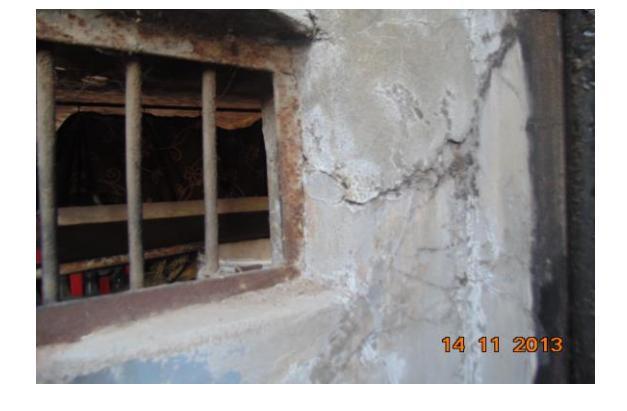
Photo 8 Damaged Portion on Backside Wall of Shop No. 11 & 12 of Ground Floor

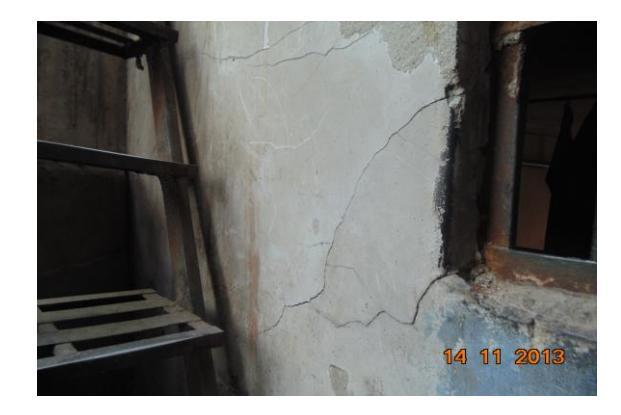
Photo 9 Damaged Portion on Backside Wall of Shop No. 11 & 12 of Ground Floor

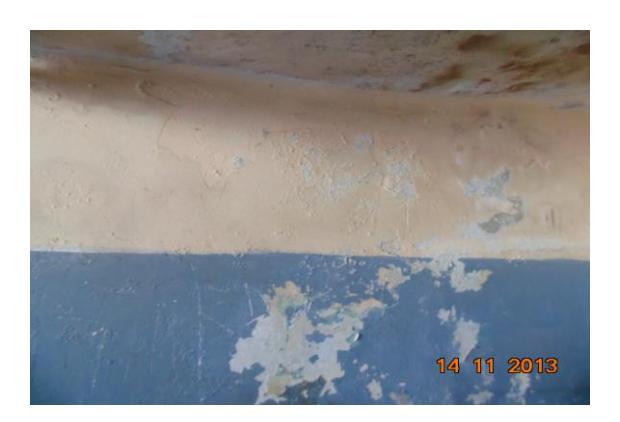
Photo 11 Dampness/Seepage on Wall No. 1 of Part 1 of Shop No. 11, Ground Floor

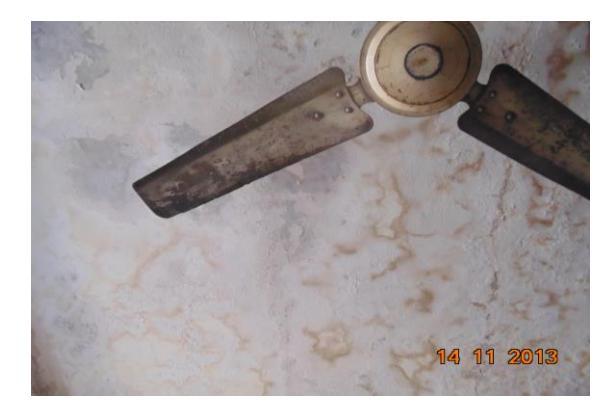
Photo 12 Dampness/Seepage on Roof of Part 1 of Shop No. 11, Ground Floor

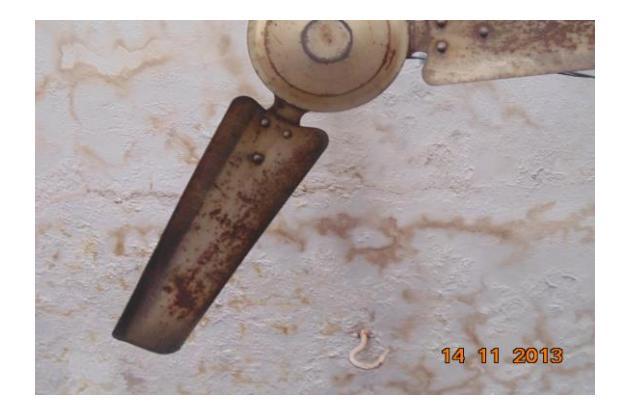
Photo 13 Plaster Crack on Roof of Part 1 of Shop No. 11, Ground Floor

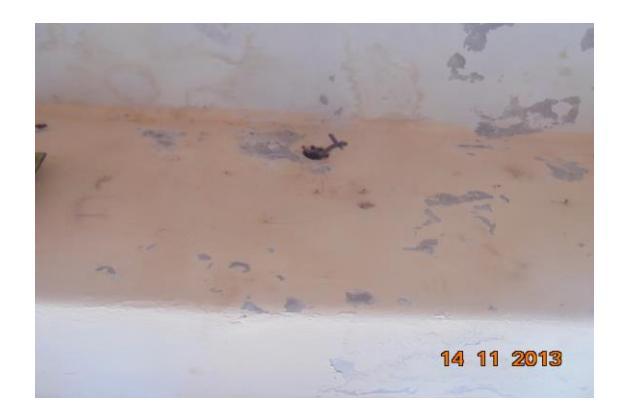
Photo 14 Peeling of Plaster on Wall No. 3 of Part 1 of Shop No. 11, Ground Floor

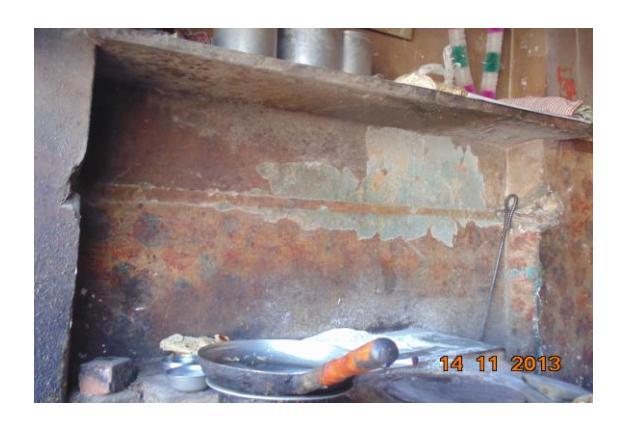
Photo 15 Dampness/Seepage on Roof of Part 2 of Shop No. 11, Ground Floor

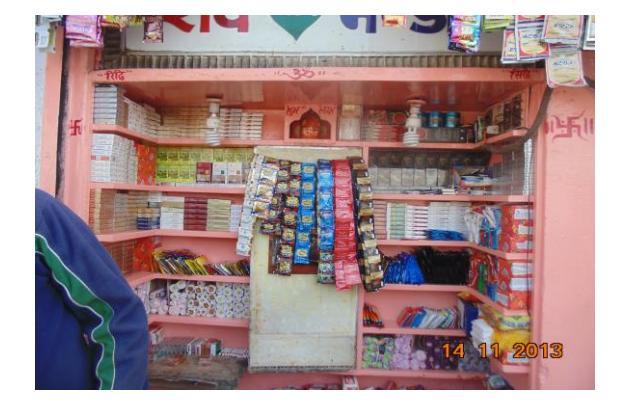
Photo 17 All Walls of Shop No. 12 of Ground Floor Covered With Material

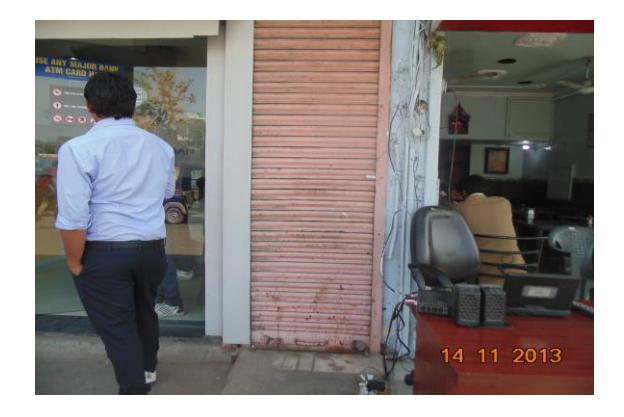
Photo 6 Office of Ground floor Locked

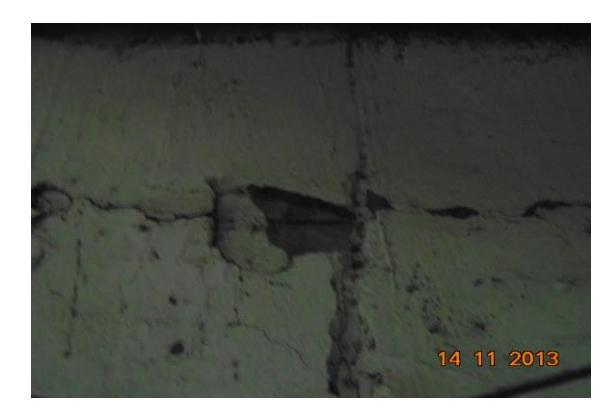
Horizontal Crack on Wall No. 2 of Toilet No. 2, House No. D-10, Second Horizontal Crack on Wall No. 2 of Toilet No. 2, House No. D-10, Second Floor, Approx. Width = 0.3mm, Approx. Length = 1m.Distance from Wall No. 3 = 1m, Height from Floor = 2m. No. 3 = 1m, Height from Floor = 2m.

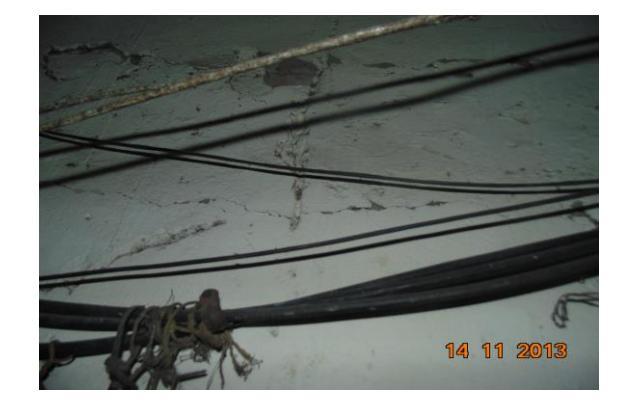
Photo 18 Vertical Crack on Wall No.3 & Outer Wall , House No. D-10, Ground Floor,Approx. Width = 5mm, Approx. Length = 2m.Distance from Wall No. 4 = 0.5m, Height from Floor = 0m.
