Pre Building Condition Survey Report

Name of the Project	Contract JMRC-UG1B "Design and Construction of Tunnel between Chandpole and Badi Chouper and reverse line by Shield TBM, Underground Metro Stations at Choti Chouper and Badi Chouper by Cut and Cover Methods on East West Corridor of Jaipur Metro Rail Corporation Limited ."		
Owner :	JAIPUR METRO	Jaipur Metro Rail Corporation	
Contractor :	VUV	Continental Engineering Corporation	
Survey Agency :	Aimil I Instrumentation	tion & Technologies

Pre Building Condition Survey Report Chand Pole to Choti Chopar (UP Line)

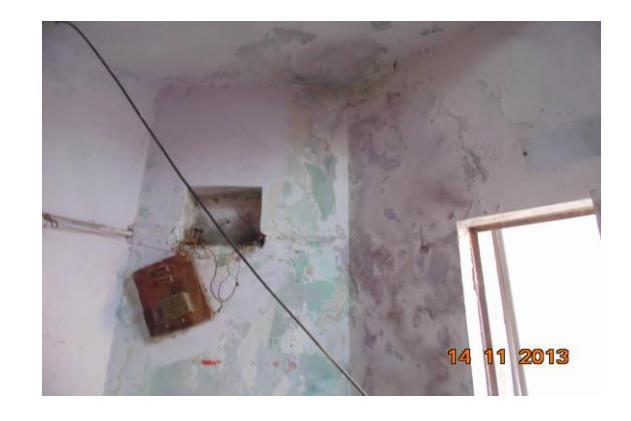
Photo 19 Inclined Crack on Wall No. 3 & Outer Wall of , House No. D-10, Ground Floor,Approx. Width = 1.5mm, Approx. Length = 2m.Distance from Wall No. 4 = 0.5m, Height from Floor = 1.8m.

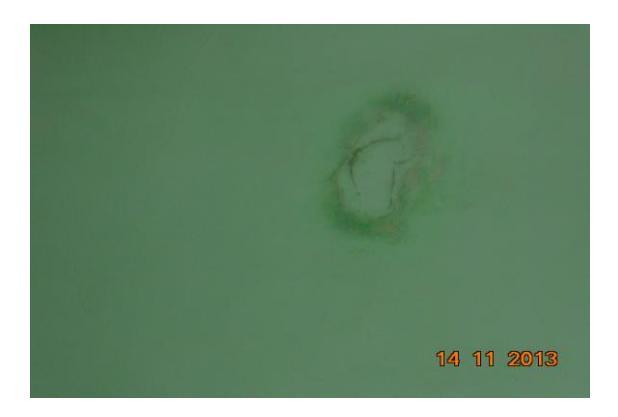
Photo 20 Dampness/Seepage on Wall No. 4 of Stair Area of House No. D-10, First Floor

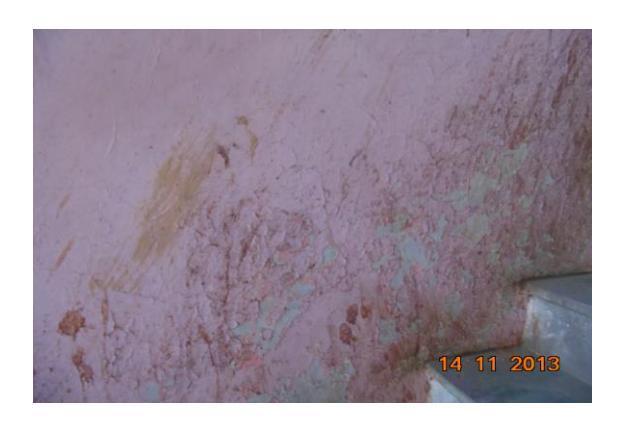
Photo 21 Dampness/Seepage on Wall No. 2 of Room No. 2 of House No. D-10, First Floor

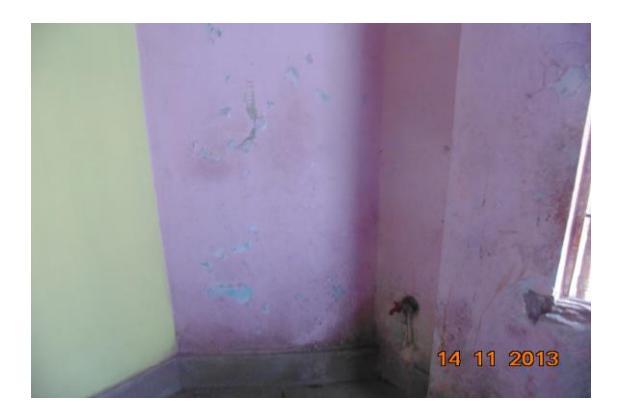
Photo 22 Peeling of Plaster on Wall No. 2 of Stair of House No. D-10, First Floor

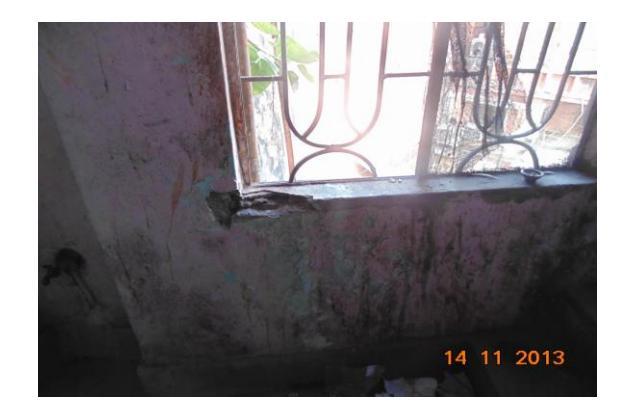
Photo 23 Dampness/Seepage on Wall No. 4 of Stair of House No. D-10, Second Floor

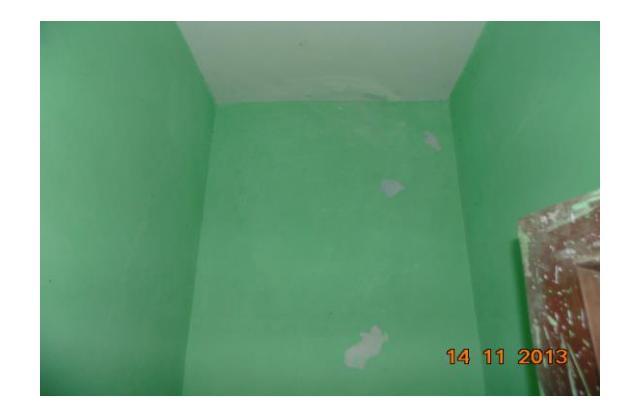
Photo 25 Peeling of Plaster on Roof of Toilet No. 3 of House No. D-10, Second Floor

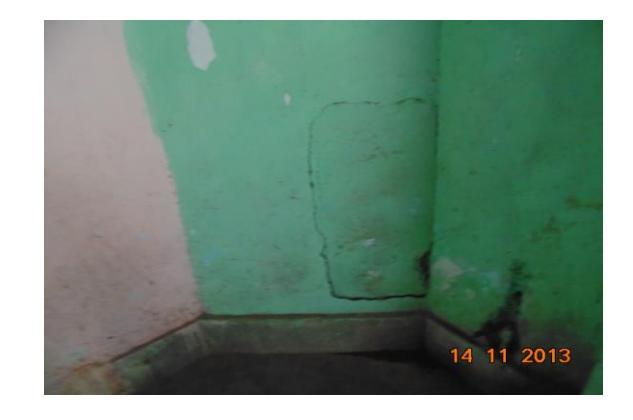
Photo 26 Peeling of Plaster on Wall No. 4 of Stair of House No. D-10, Third Floor

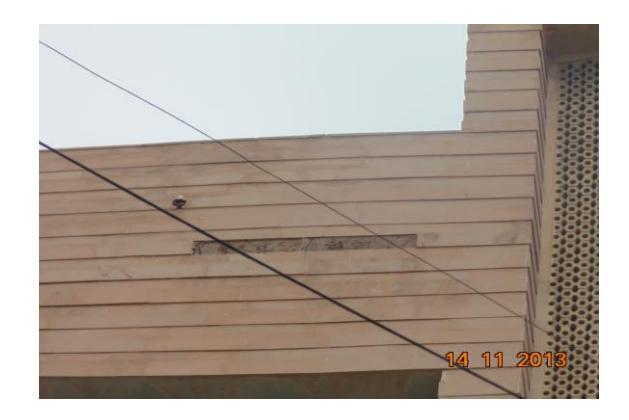
Photo 31 Damaged Portion on Wall No. 3 & Outer Wall of House No. D-10, Ground Floor

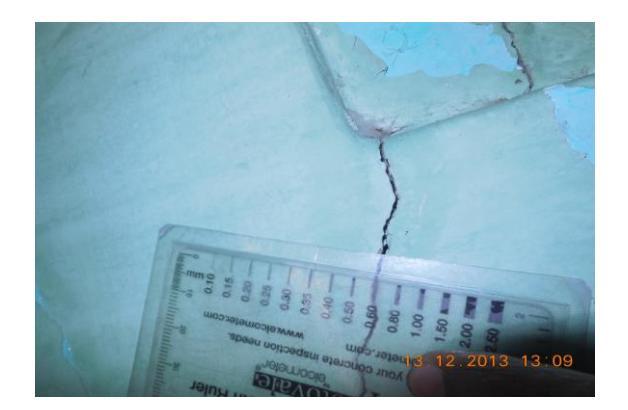
$\label{eq:photo12} \frac{Photo \ 12}{Photo \ 12}$ Horizontal Crack on Wall No. 1 & Roof of Room, First Floor, Approx. Width = 0.6mm, Approx. Length = 0.7m. Distance from Wall No. 1 = 0.7m, Height from Floor = 2m.

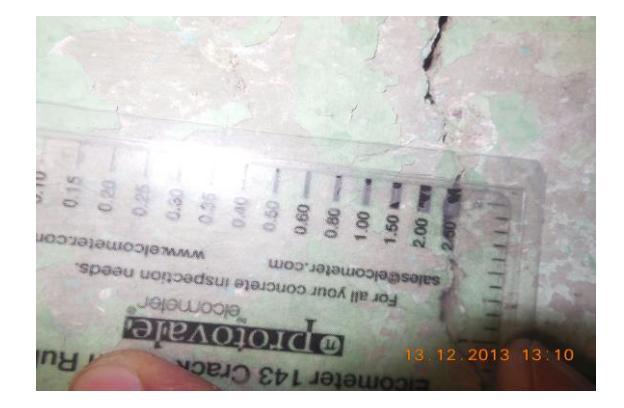
$\label{eq:photo12A} \frac{Photo12A}{Photo12A} Horizontal Crack on Wall No. 1 & Roof of Room, First Floor, Approx. Width = 0.6mm, Approx. Length = 0.7m. \\ Distance from Wall No. 1 = 0.7m, Height from Floor = 2m. \\ \end{array}$

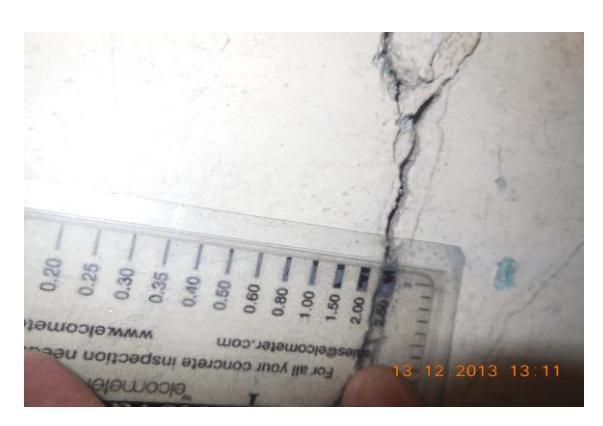
Photo 13A Horizontal Crack on Room, First Floor, Approx. Width = 250mm, Approx. Length = 0.8m. Distance from Wall No. 1 = 0.8m, Height from Floor = 0.5m.

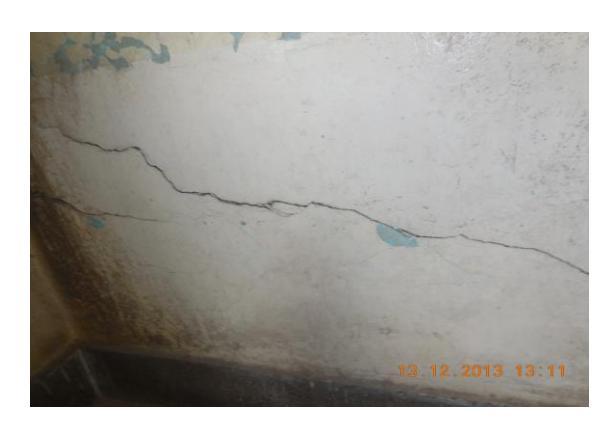
Photo 13 Horizontal Crack on Room, First Floor, Approx. Width = 250mm, Approx. Length = 0.8m. Distance from Wall No. 1 = 0.8m, Height from Floor = 0.5m.

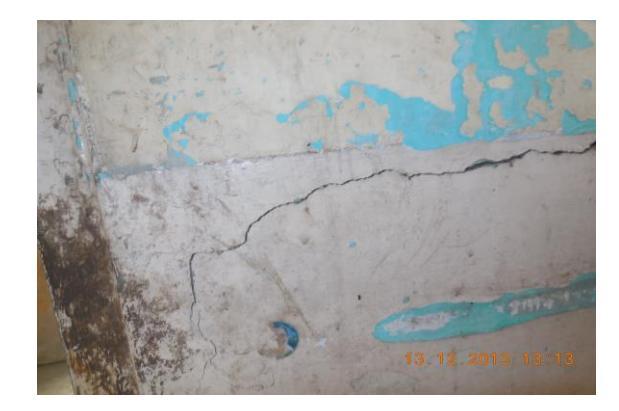
Photo 14 Inclined Crack on Bathroom, First Floor, Approx. Width = 2.5mm, Approx. Length = 1.3m. Distance from Wall No. 4 = 0m, Height from Floor = 0m.

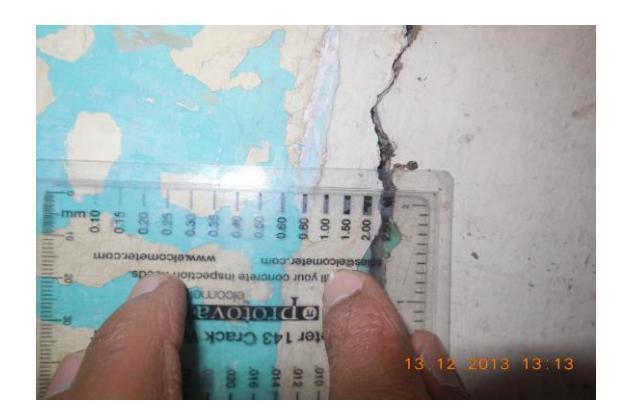
Photo 15A Inclined Crack on All Walls of Bathroom, First Floor, Approx. Width = 2.5mm, Approx. Length = 0.35m. Distance from Wall No. 4 = 0m, Height from Floor = 0.3m.

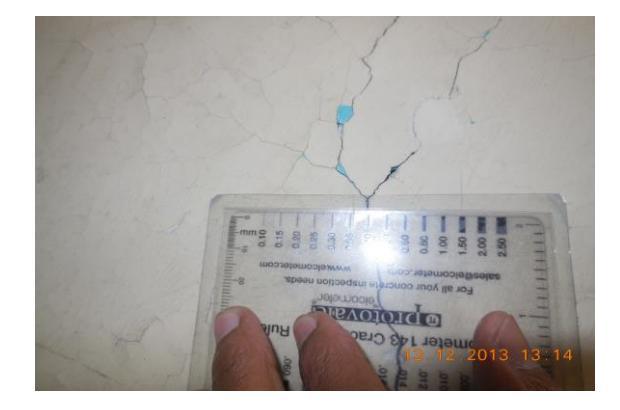
Photo 16A Inclined Crack on Bathroom, First Floor, Approx. Width = 0.4mm, Approx. Length = 0.8m. Distance from Wall No. 4 = 0.4m, Height from Floor = 1.7m.

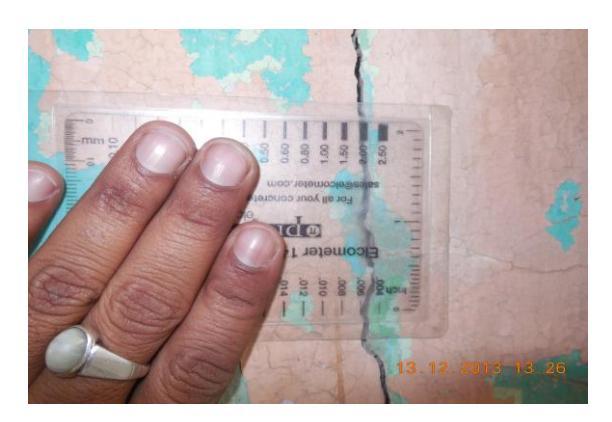
Photo 17A Inclined Crack on Roof of Hall No. 1, Second Floor, Approx. Width = 2mm, Approx. Length = 1.3m. Distance from Wall No. 4 = 0.1m, Height from Floor = 1.5m.

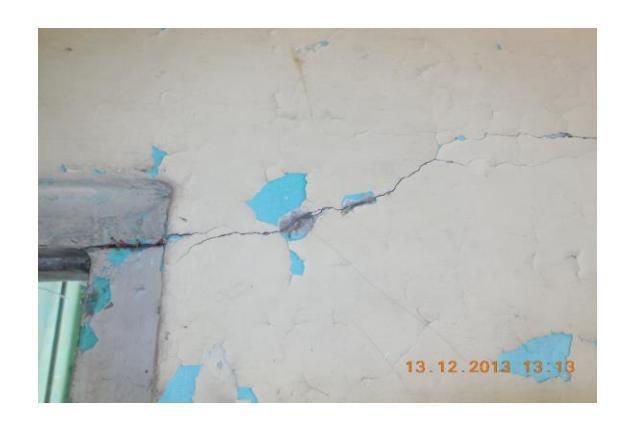
Photo 16 Inclined Crack on Bathroom, First Floor, Approx. Width = 0.4mm, Approx. Length = 0.8m. Distance from Wall No. 4 = 0.4m, Height from Floor = 1.7m.

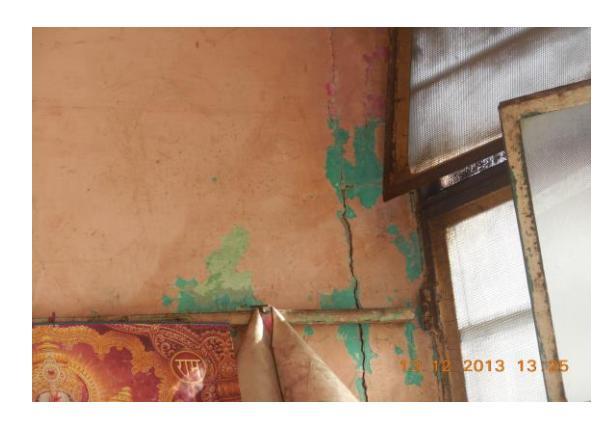
Photo 17 Inclined Crack on Roof of Hall No. 1, Second Floor, Approx. Width = 2mm, Approx. Length = 1.3m. Distance from Wall No. 4 = 0.1m, Height from Floor = 1.5m.

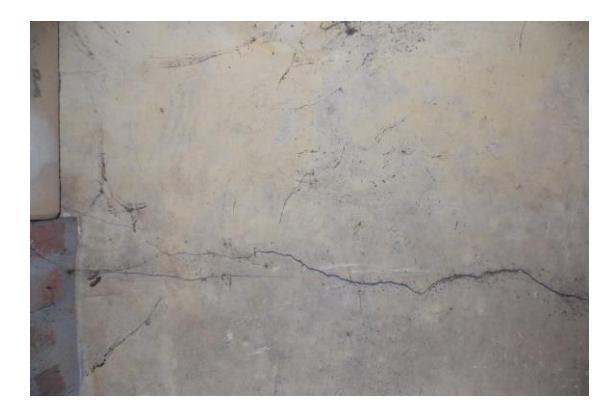
Photo 18 Horizontal Crack on All Walls of Room No. 1, Ground Floor Special D5 Approx. Width = 2.5mm, Approx. Length = 2m. Distance from Wall 1 = 1.5m, Height from Floor = 1m.

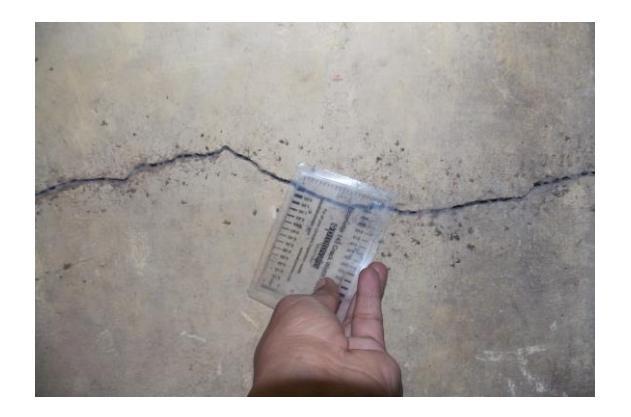
Photo 18A Horizontal Crack on All Walls of Room No. 1, Ground Floor Special D5 Approx. Width = 2.5mm, Approx. Length = 2m. Distance from Wall 1 = 1.5m, Height from Floor = 1m.

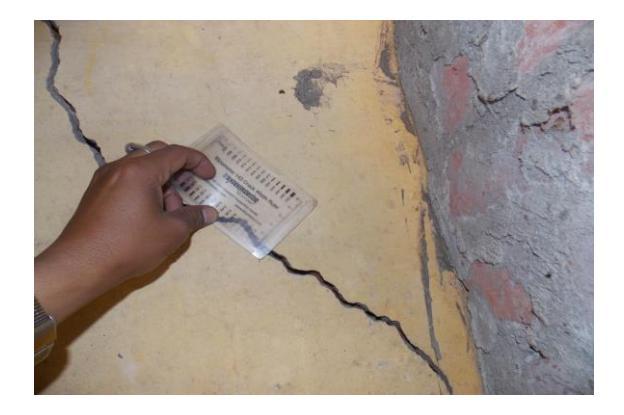
Photo 19A Inclined Crack on Room No. 1, Ground Floor , Approx. Width = 5mm, Approx. Length = 2.5m. Distance from Wall 1 = 1m, Height from Floor = 0.7m.

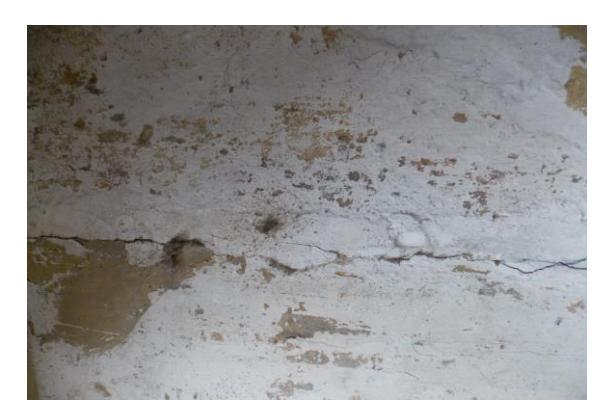
Photo 21 Inclined Crack on of Room No. 1, Ground Floor, Approx. Width = 0.5mm, Approx. Length = 2.5m. Distance from Wall 4 = 0m, Height from Floor = 2.2m.

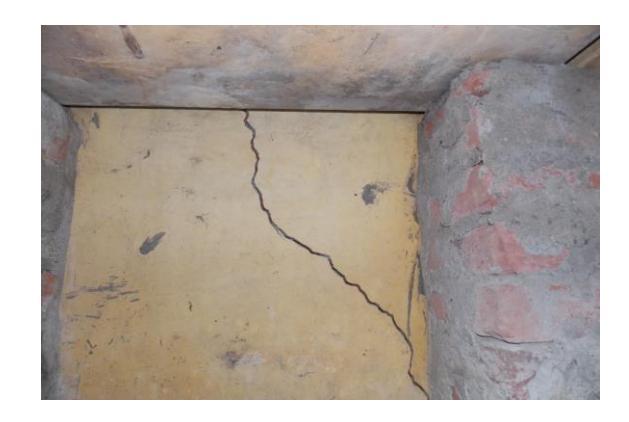
Photo 19 Inclined Crack on Room No. 1, Ground Floor, Approx. Width = 5mm, Approx. Length = 2.5m. Distance from Wall 1 = 1m, Height from Floor = 0.7m.

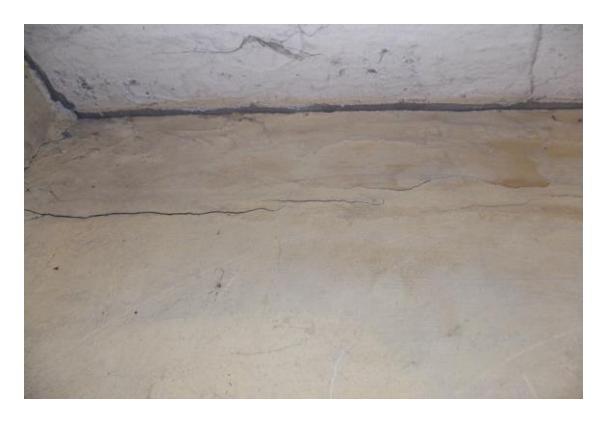
Photo 20 Inclined Crack on of Room No. 1, Ground Floor , Approx. Width = 0.8mm, Approx. Length = 1.5m. Distance from Wall 3 = 0m, Height from Floor = 2m.

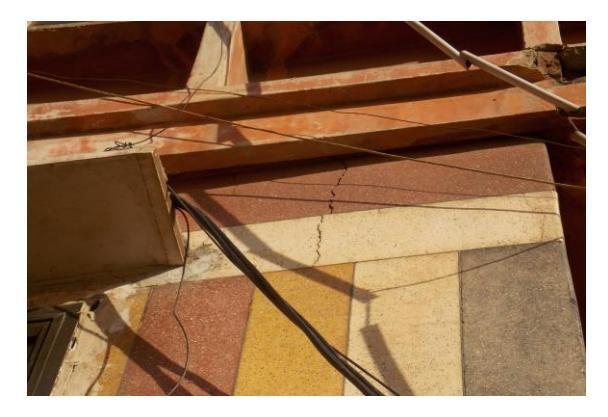
Photo 22 Vertical Crack on Outside Wall No. 1 of Electrical Hazard, Ground Upper Floor Approx. Width = 2mm, Approx. Length = 2m. Distance from Wall No. 2 = 0m, Height from Floor = 2.5m.

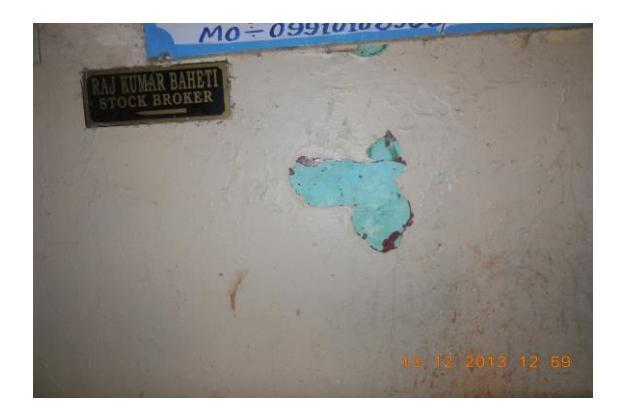
Photo 23 Peeling of Plaster on House No. 5 of Mezzanine Floor

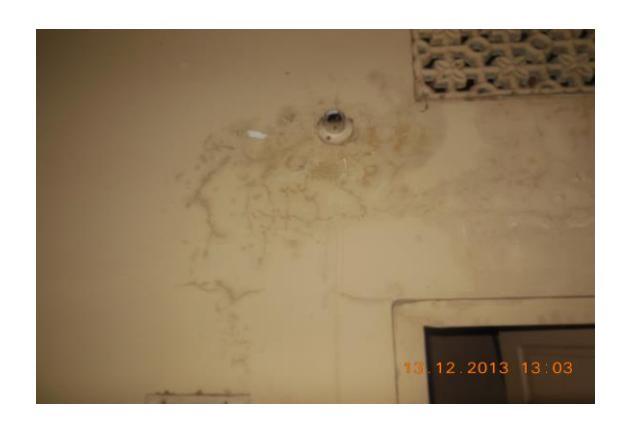
Photo 24 Dampness/Seepage on Lobby of First Floor

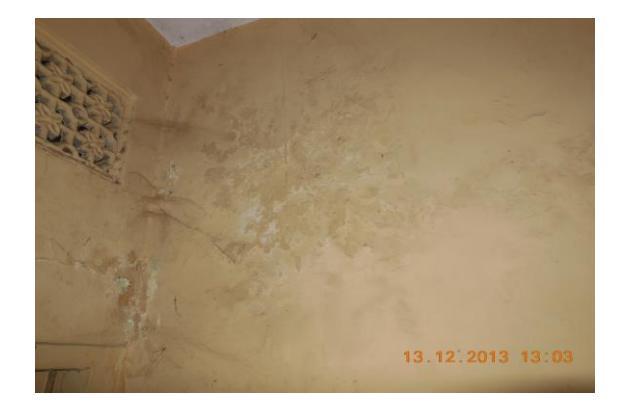
Photo 25 Peeling of Plaster on Lobby of First Floor

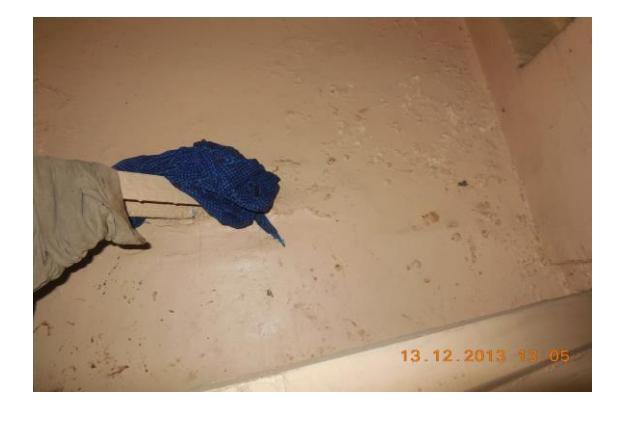
Photo 26 Peeling of Plaster on Bathroom of First Floor

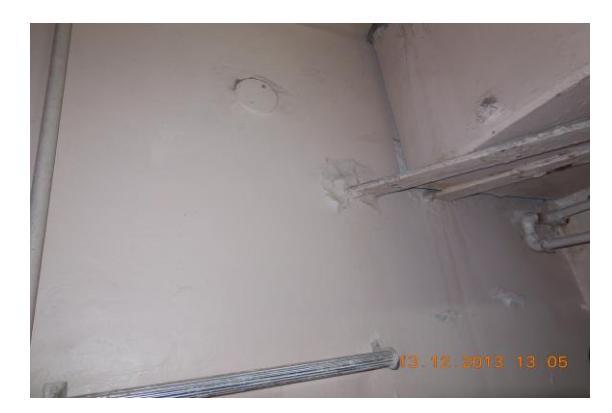
Photo 27 Peeling of Plaster on Room of First Floor

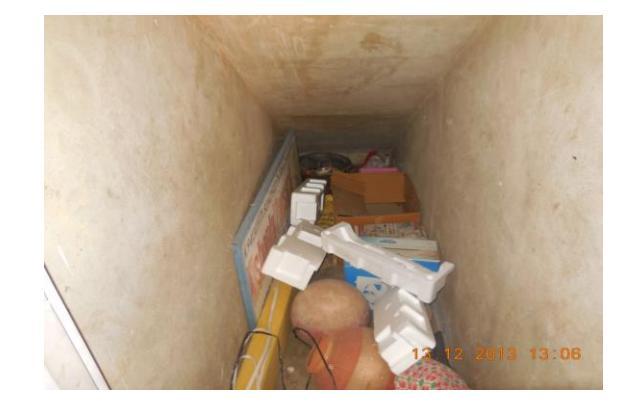
Photo 28 Peeling of Plaster on Store of First Floor

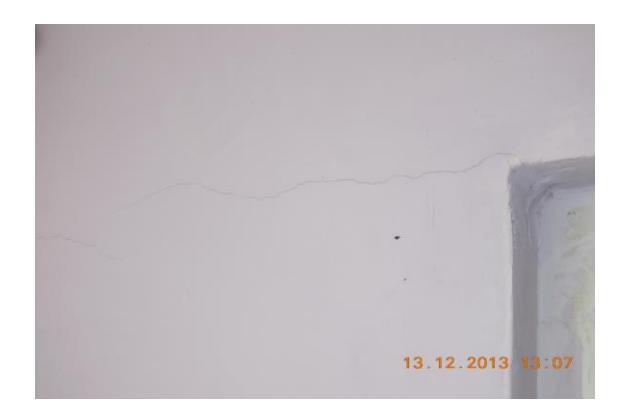
Photo 29 Plaster Crack on Hall No. 2 of First Floor

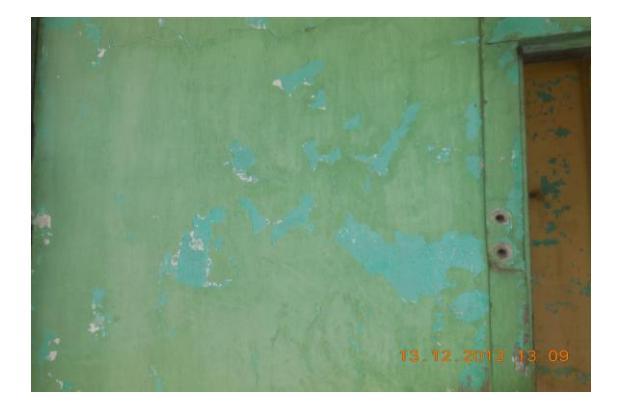
Photo 30 Peeling of Plaster on Wall No. 1 & Roof of Bathroom of First Floor

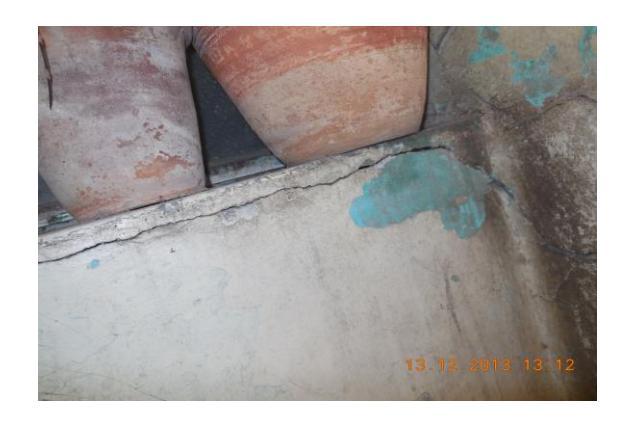
Photo 31 Peeling of Plaster on Wall No. 1 & Roof of Bathroom of First Floor

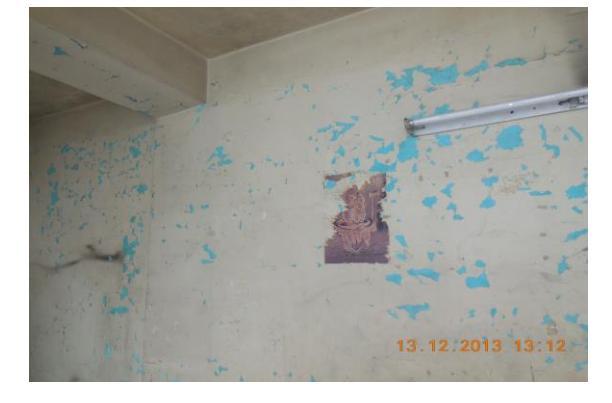
Photo 33 Peeling of Plaster on All Walls of Bathroom of First Floor

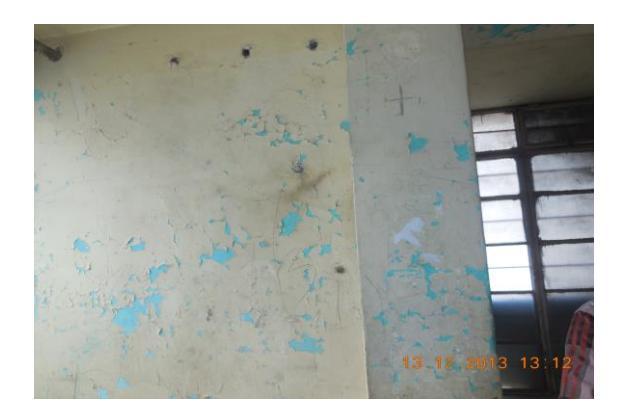
Photo 34 Peeling of Plaster on All Walls of Bathroom of First Floor

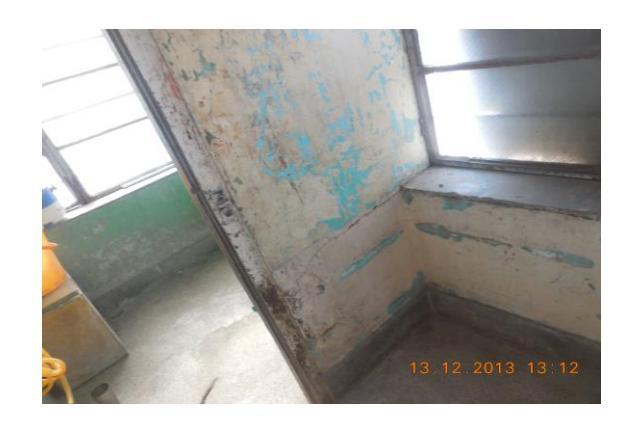
Photo 35 Peeling of Plaster on All Walls of Bathroom of First Floor

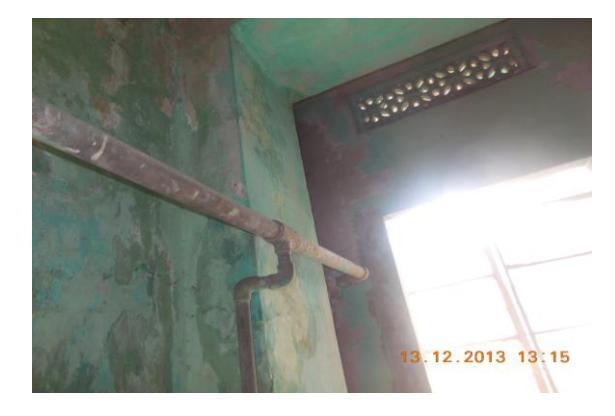
Photo 36 Peeling of Plaster on All Walls of Bathroom of First Floor

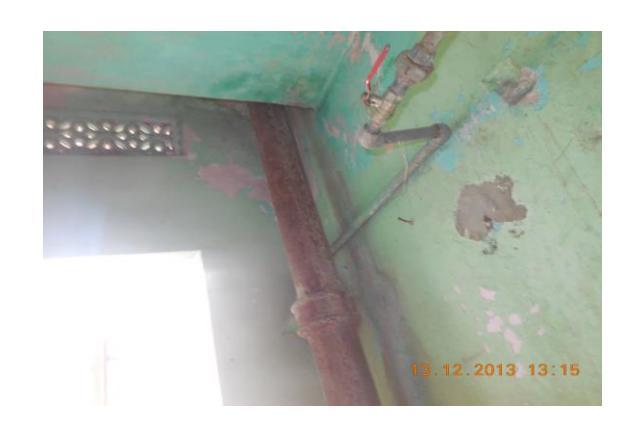
Photo 37 Dampness/Seepage on Roof & Wall No.1 of House No. 5 of First Floor Dampness/Seepage on Roof & Wall No.1 of House No. 5 of First Floor

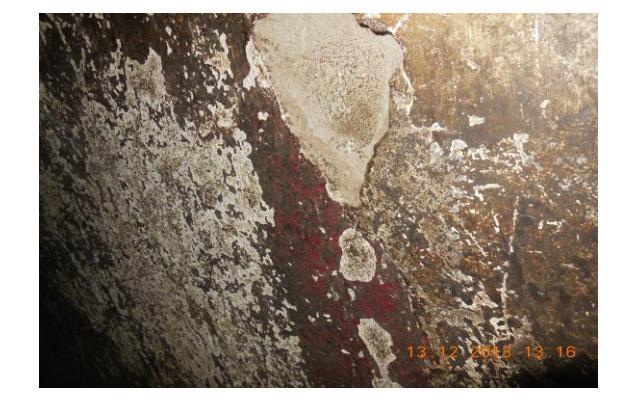
Photo <u>3</u>9 Damaged Portion on Roof & Wall No.1 of Stair Case of First Floor

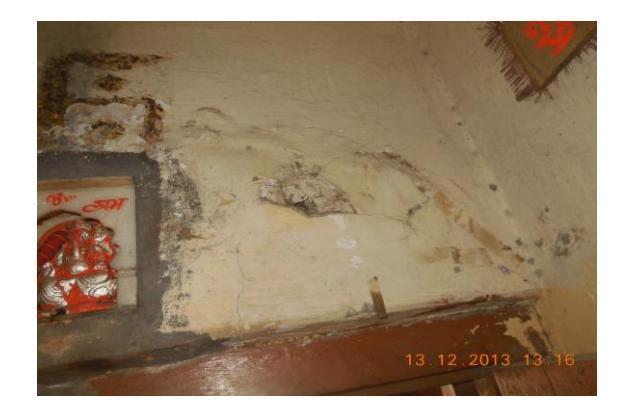
Photo 40 Damaged Portion on Roof & Wall No.1 of Stair Case of First Floor

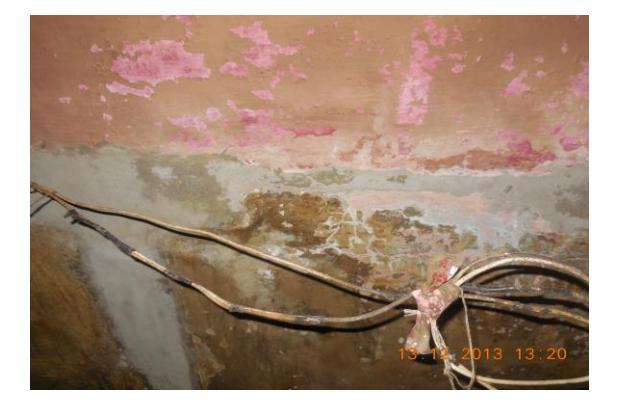
Photo 41 Damaged Portion on Roof & Wall No.1 of Stair Case of First Floor

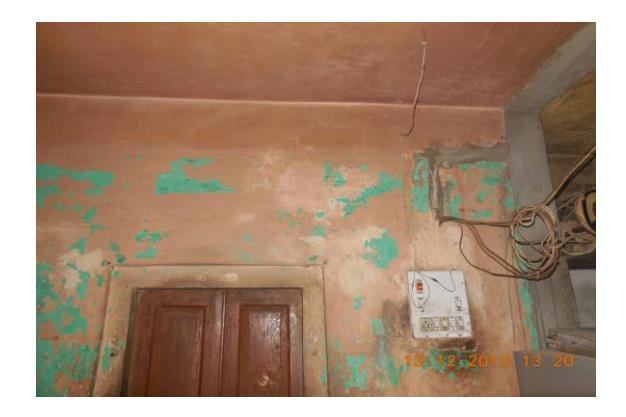
Photo 43 Peeling of Plaster on Roof of House No. 5 of Second Floor

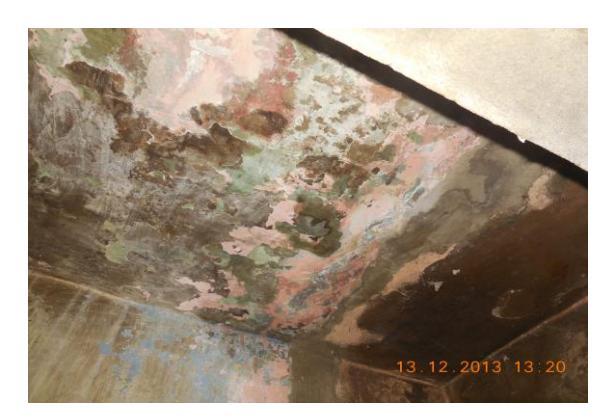
Photo 45 Peeling of Plaster on Roof of House No. 5 of Second Floor

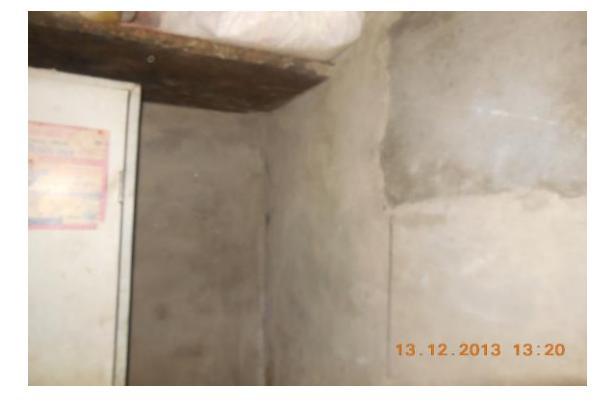
Photo 44 Peeling of Plaster on Roof of House No. 5 of Second Floor

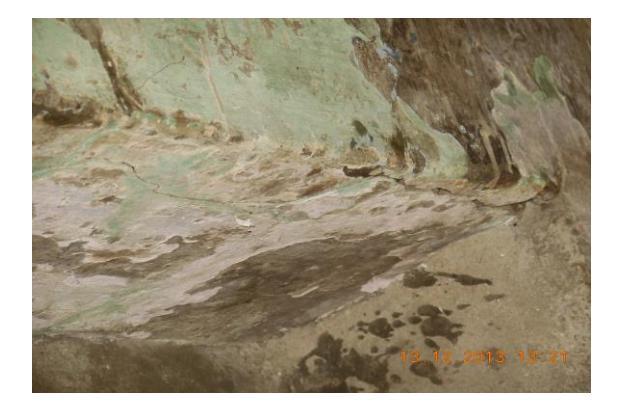
Photo 46 Peeling of Plaster on Roof of House No. 5 of Second Floor

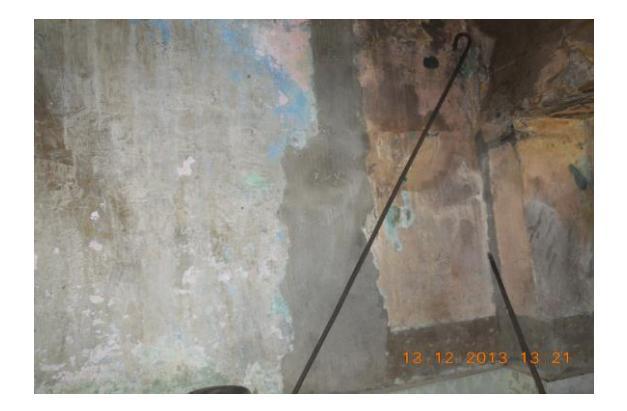
Photo 47 Peeling of Plaster on Roof of House No. 5 of Second Floor

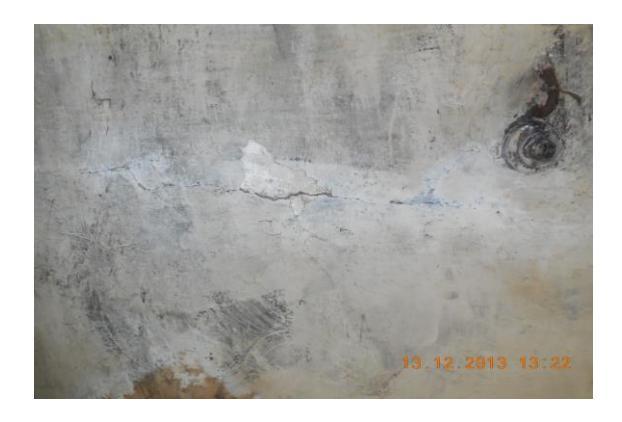
Photo 48 Peeling of Plaster on Roof of House No. 5 of Second Floor

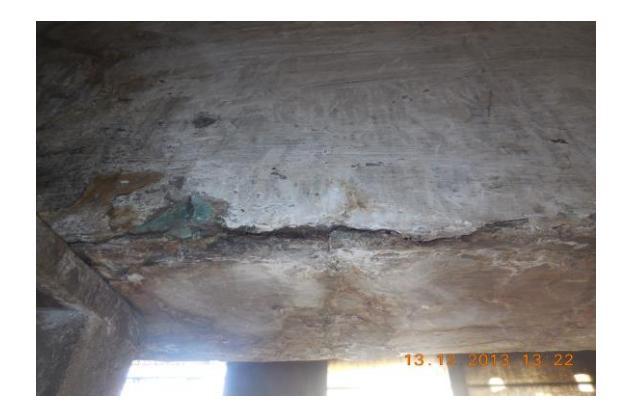
Photo 49 Peeling of Plaster on Roof of House No. 5 of Second Floor

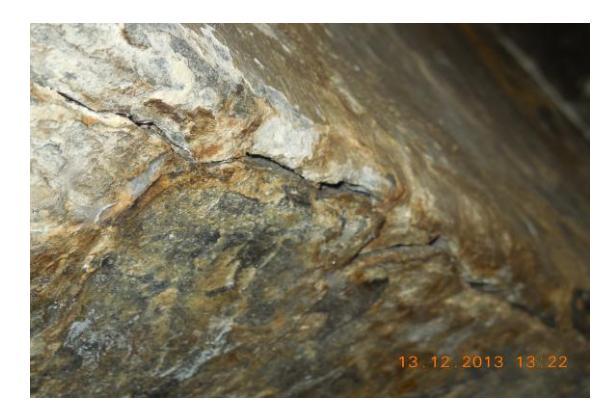
Photo 51 Peeling of Plaster on Roof of House No. 5 of Second Floor

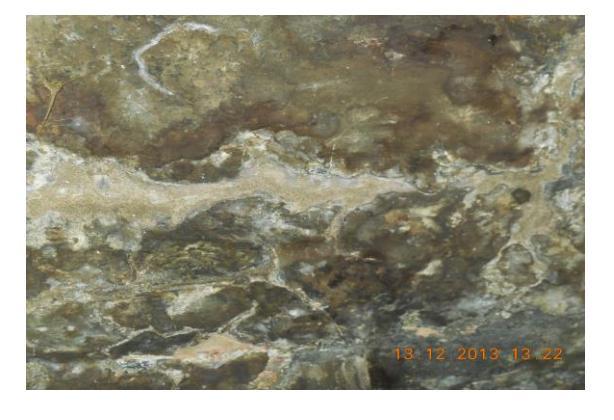
Photo 50 Peeling of Plaster on Roof of House No. 5 of Second Floor

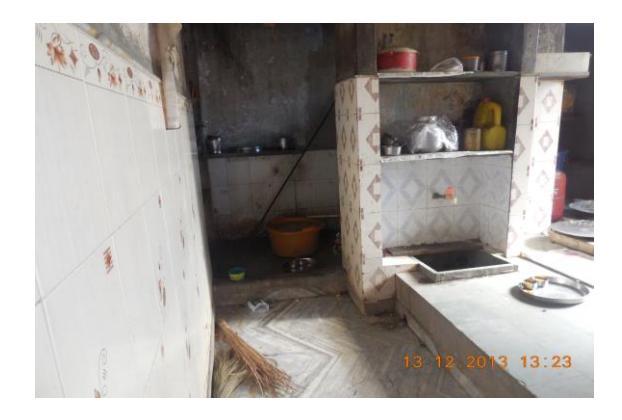
Photo 52 Peeling of Plaster on Roof of House No. 5 of Second Floor

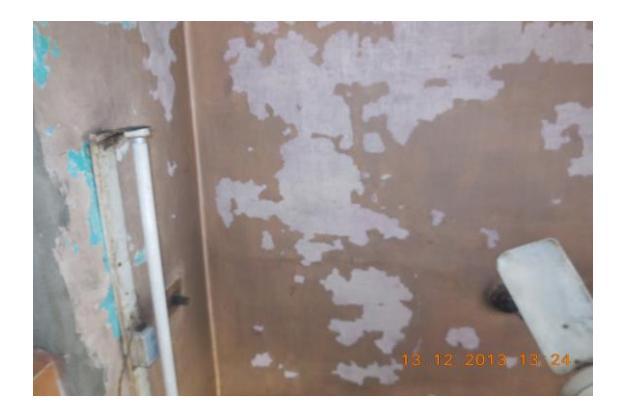
Photo 53 Peeling of Plaster on Roof of House No. 5 of Second Floor

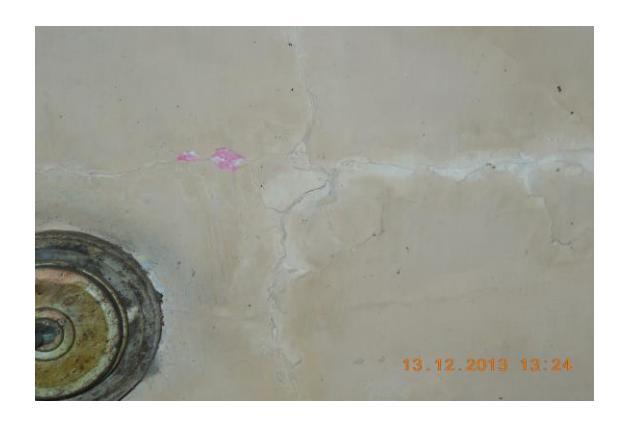
Photo 54 Plaster Crack on Roof of House No. 5 of Second Floor

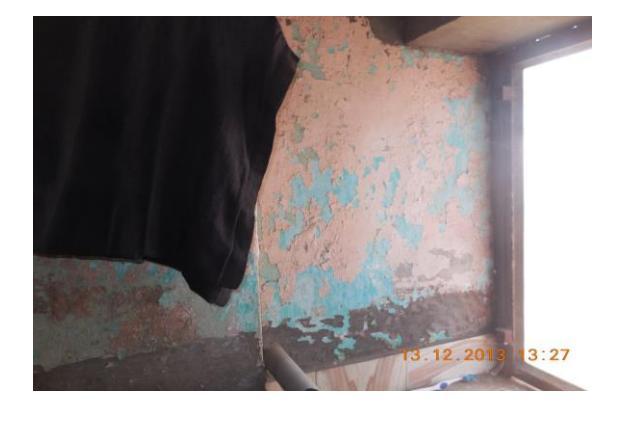
Photo 55 Peeling of Plaster on Tample Wall & Wall No.1 of House No. 5 of Second Floor

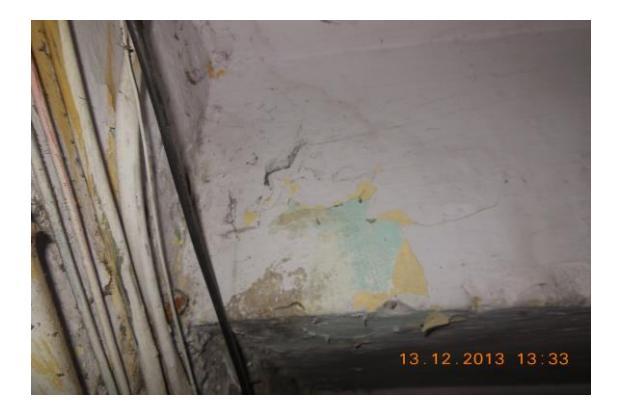
Photo 57 Peeling of Plaster on Roof of Stair Case of Second Floor

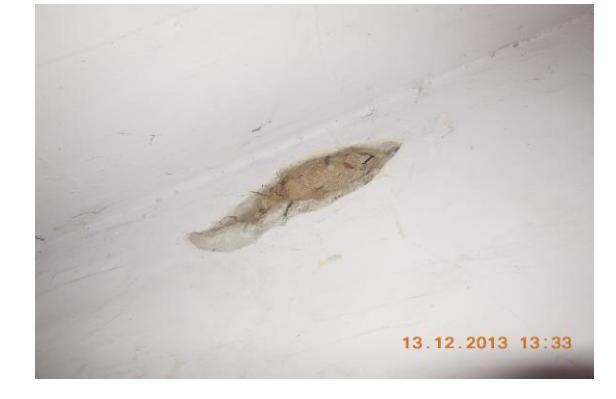
Photo 58 Peeling of Plaster on Roof & Wall No. 1 of Stair Case of Second Floor

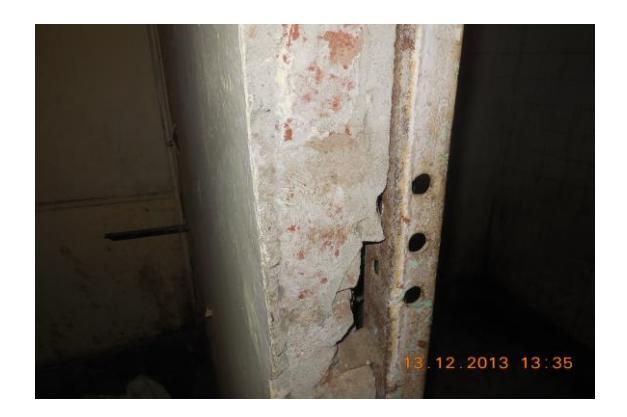
Photo 59 Damaged Portion on Bathroom of Third Floor

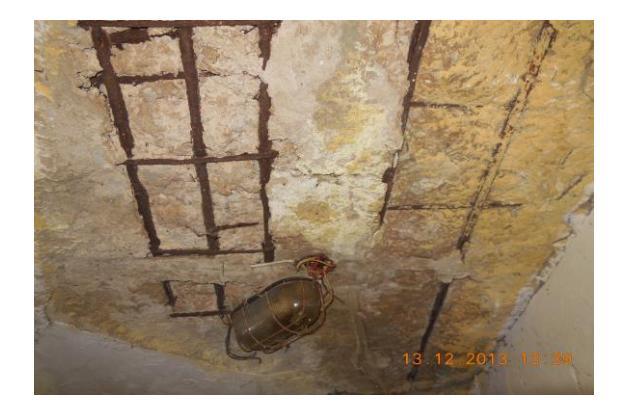
Photo 61 Damaged Portion on Roof of Toilet No. 2 of Third Floor

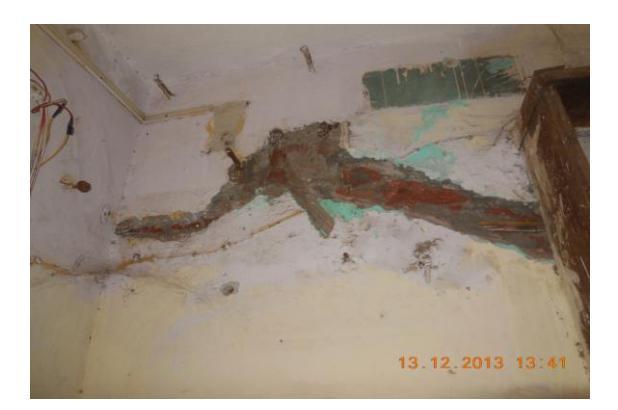
Photo 63 Damaged Portion on Roof of Passage of Third Floor

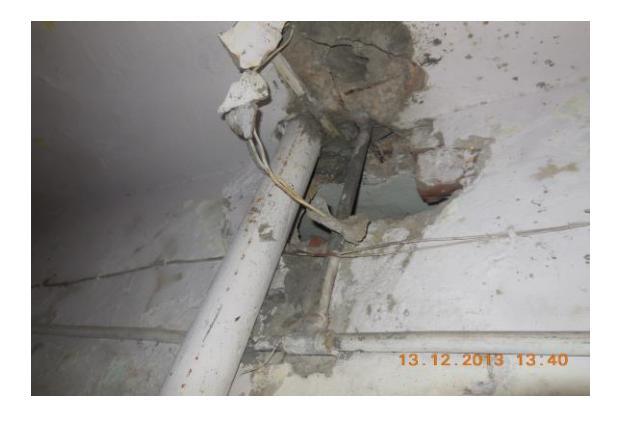
Photo 62 Damaged Portion on Roof of Lobby 3 of Third Floor

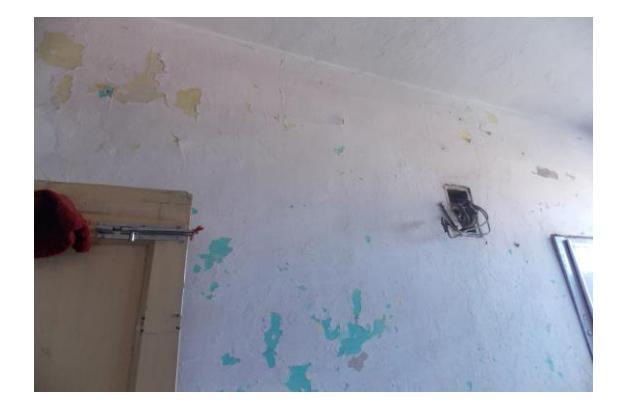
Photo 64 Peeling of Plaster on Roof & Wall No1 of Lobby 2 of Third Floor

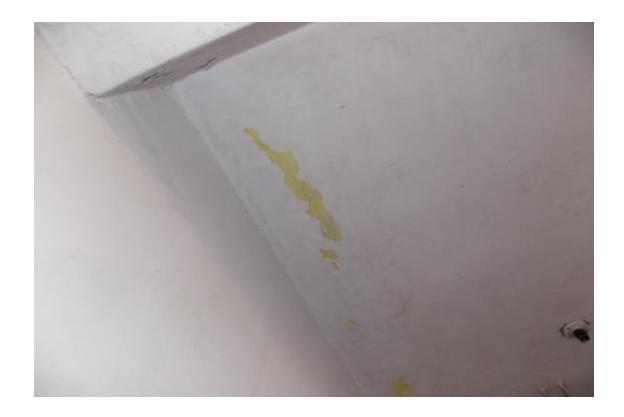
Photo 65 Peeling of Plaster on Roof of Lobby 3 of Third Floor

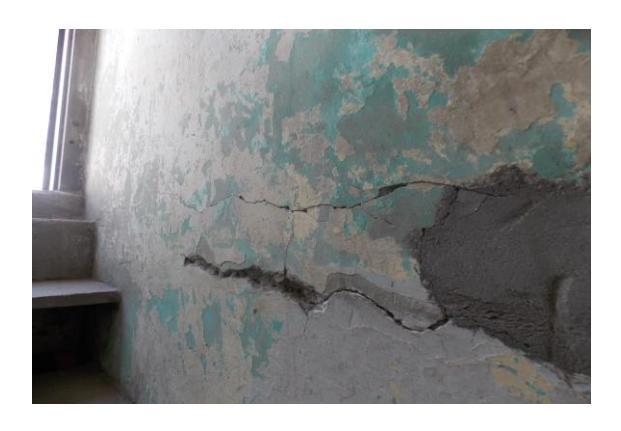
Photo 6 Peeling of Plaster on Roof of Stair Case of Third Floor

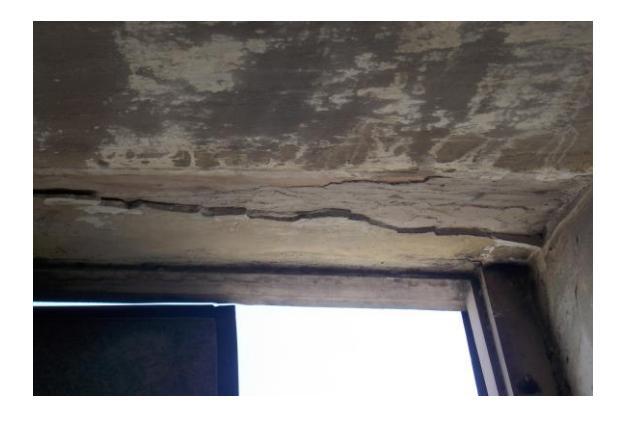
Photo 67 Peeling of Plaster on Roof of House No. 5 of Third Floor

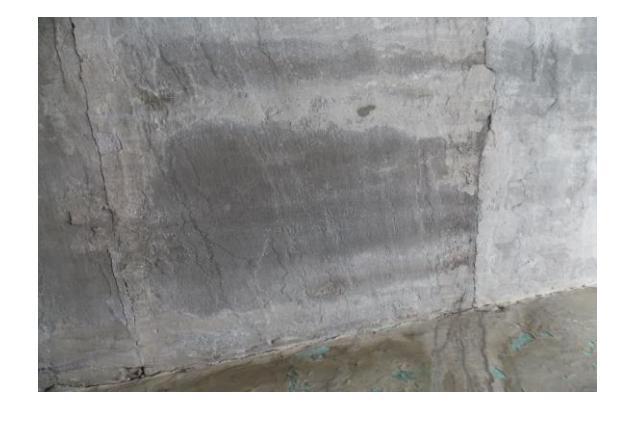
Photo 68 Plaster Crack on Roof of House No. 5 of Third Floor

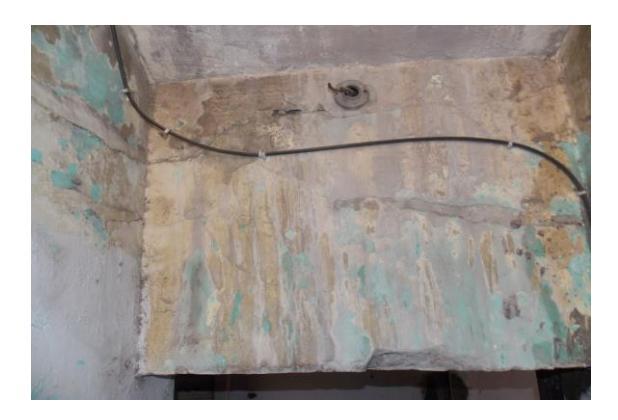
Photo 69 Peeling of Plaster on Wall No. 3 & Roof of House No. 5 of Third Floor

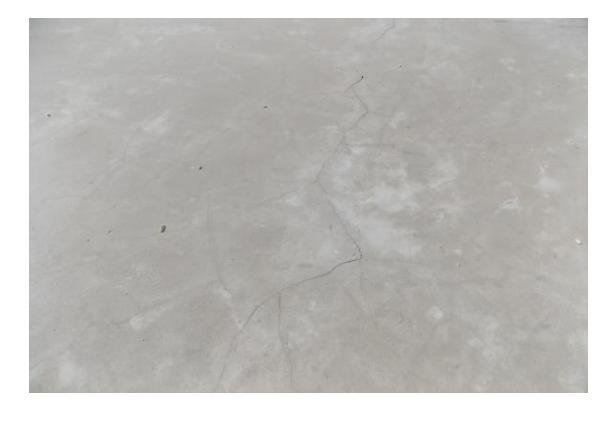
Photo 70 Plaster Crack on Floor of Tarrace Floor of Third Floor

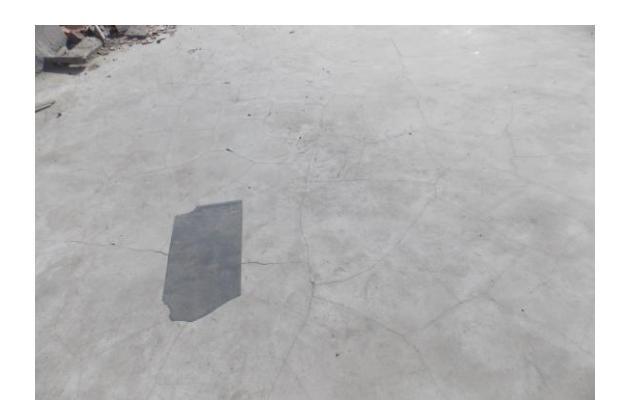
Photo 71
Plaster Crack on Floor of Tarrace Floor of Third Floor

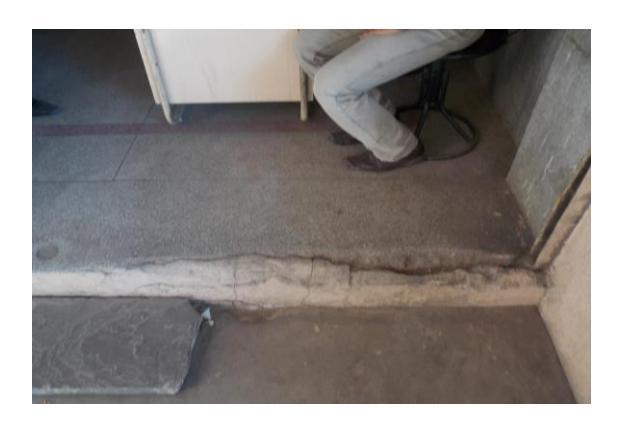
Photo 73 Plaster Crack on House No. Special D 5 of Ground Floor

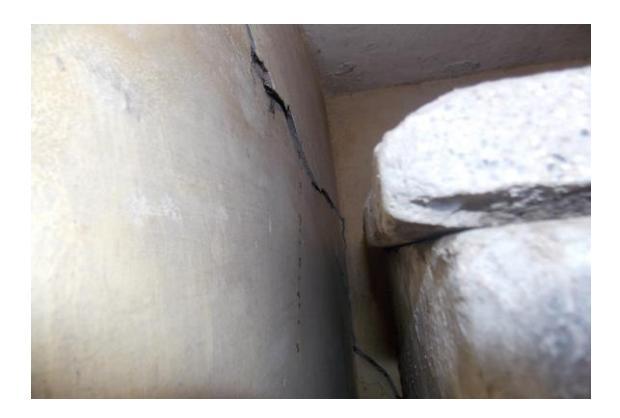
Photo 75 Damaged Portion on Room No. 1 of Ground Floor

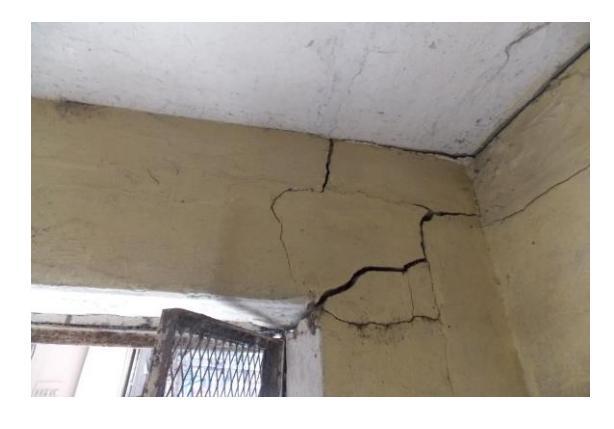
Photo 76 Damaged Portion on Room No. 1 of Ground Floor

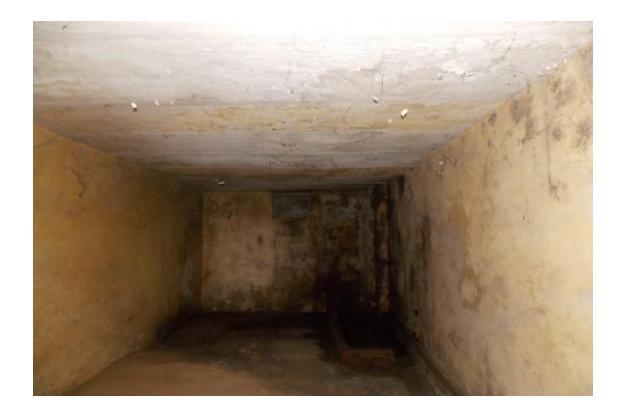
Photo 77 Dampness/Seepage on Room No. 1 of Ground Floor

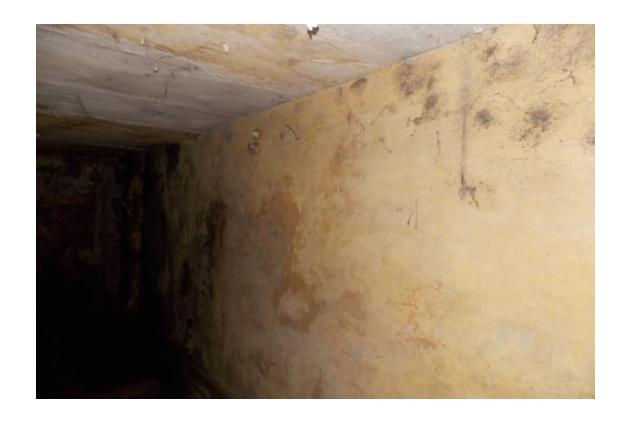
Photo 78 Dampness/Seepage on Room No. 1 of Ground Floor

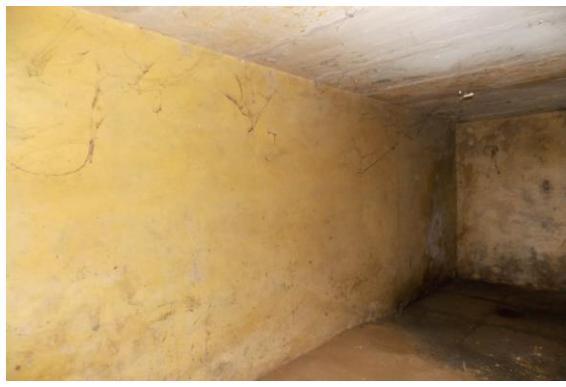
Photo 79 Dampness/Seepage on Room No. 1 of Ground Floor

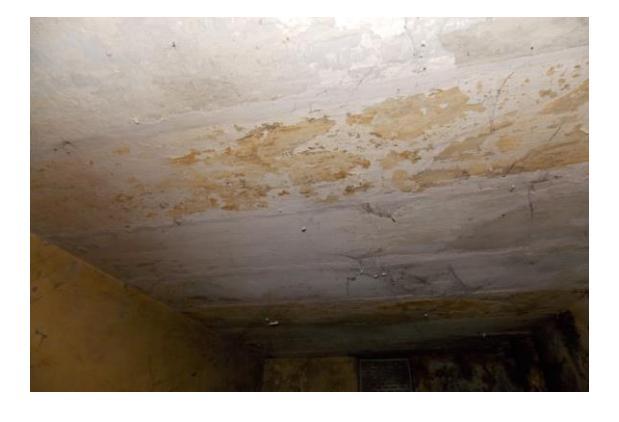
Photo 80 Dampness/Seepage on Roof of Room No. 1 of Ground Floor

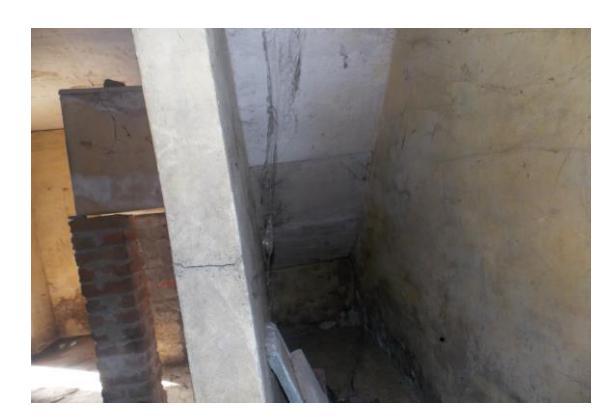
Photo 81 Dampness/Seepage on Toilet No. 1 of Ground Floor

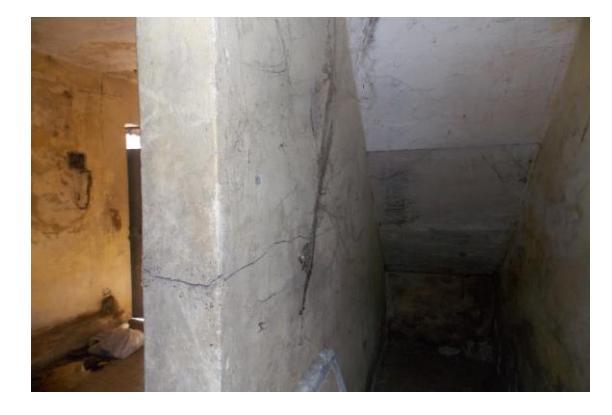
Photo 82 Damaged Portion on Toilet No. 1 of Ground Floor

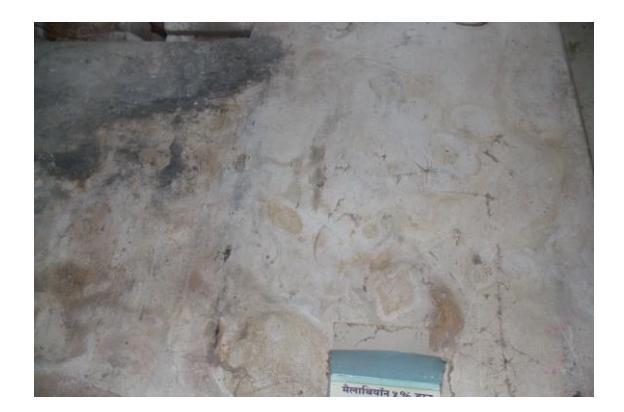
Photo 83 Damaged Portion on Wall No. 2 of Hall No. 1 of Basement

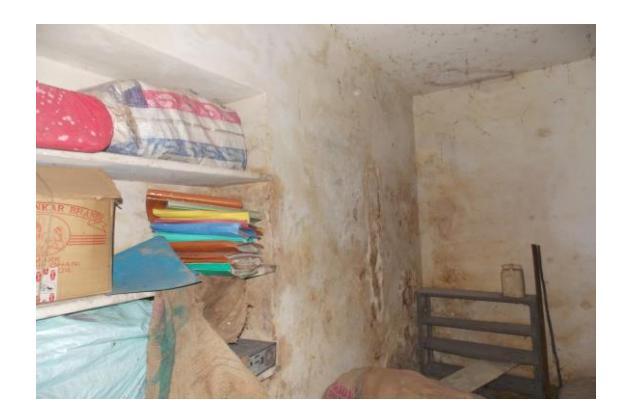
Photo 84 Dampness/Seepage on Stair Case of Basement

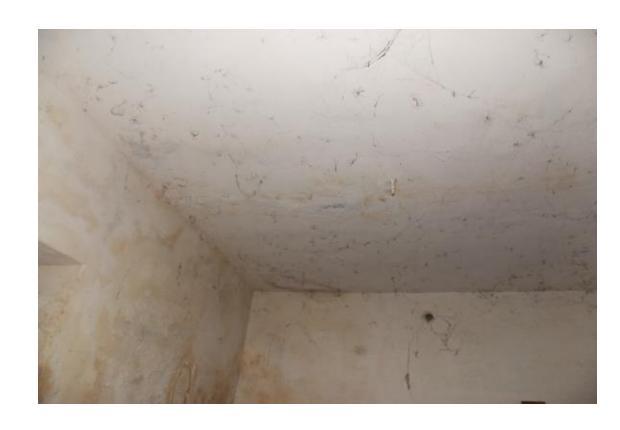
Photo 85 Dampness/Seepage on Wall No. 4 of Hall No. 2 of Basement
