Pre Building Condition Survey Report

Name of the Project	Contract JMRC-UG1B "Design and Construction of Tunnel between Chandpole and Badi Chouper and reverse line by Shield TBM, Underground Metro Stations at Choti Chouper and Badi Chouper by Cut and Cover Methods on East West Corridor of Jaipur Metro Rail Corporation Limited ."		
Owner :	JAIPUR METRO	Jaipur Metro Rail Corporation	
Contractor :	VUV	Continental Engineering Corporation	
Survey Agency :	Aimil I Instrumentation	tion & Technologies

Pre Building Condition Survey Report Chand Pole to Choti Chopar (UP Line)

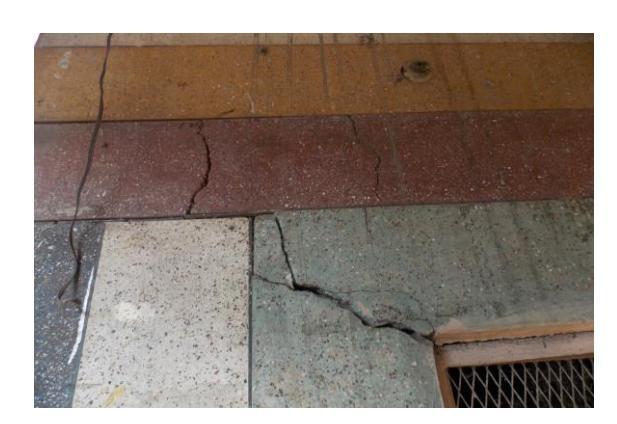
Photo 87 Damaged Portion on Outside Wall No. 1 of Electrical Hazard of Ground Floor

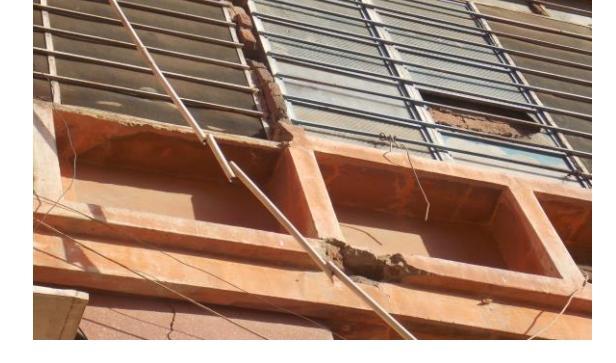
Photo 88 Damaged Portion on Outside Wall No. 1 of Electrical Hazard of First Floor

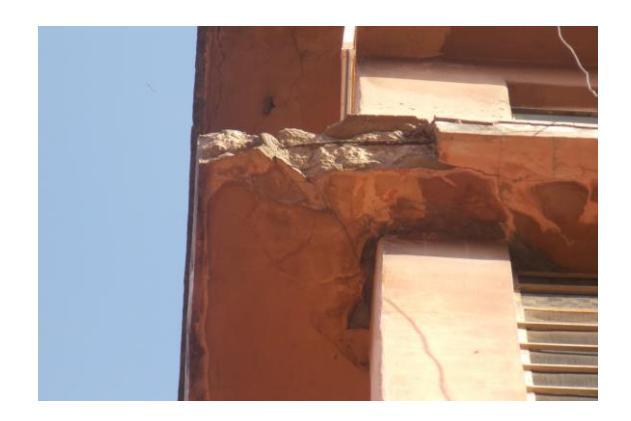
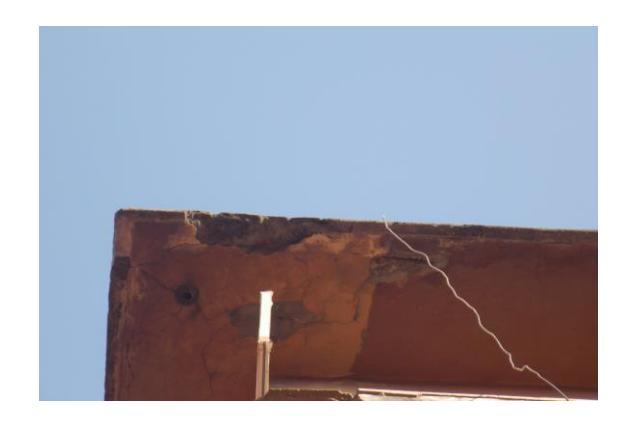
Photo 89 Damaged Portion on Roof of Shade Electrical Hazard of Second Floor

Photo 90 Damaged Portion on Roof of Shade Electrical Hazard of Third Floor

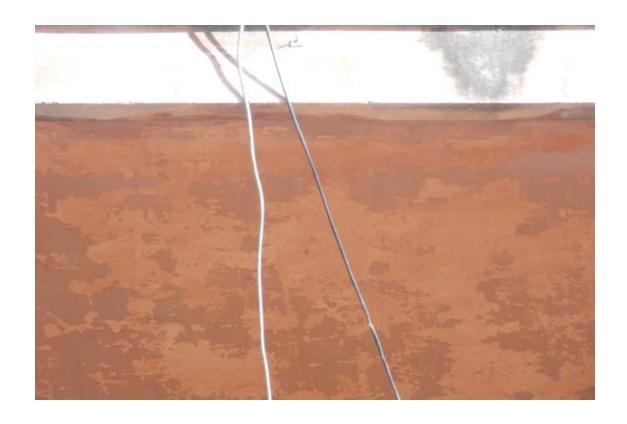
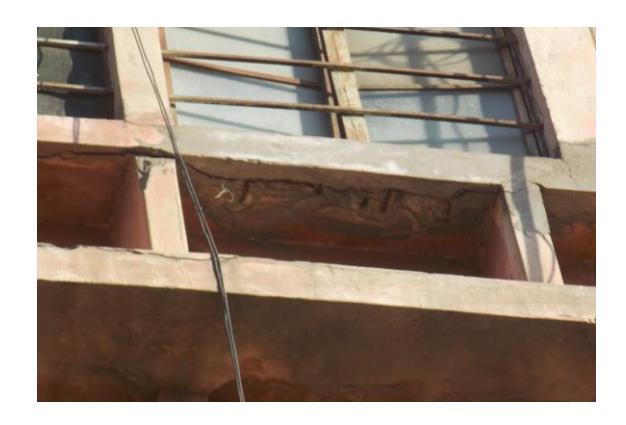
Photo 91 Dampness/Seepage on Electrical Hazard Upper Floor of Ground Upper Floor Peeling of Plaster on Floor of Electrical Hazard Front Wall of Basement

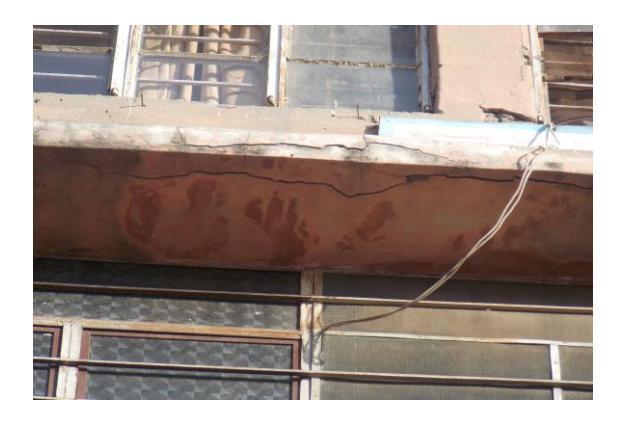
Photo 93 Damaged Portion on Floor of Electrical Hazard Sunshade of Third Floor

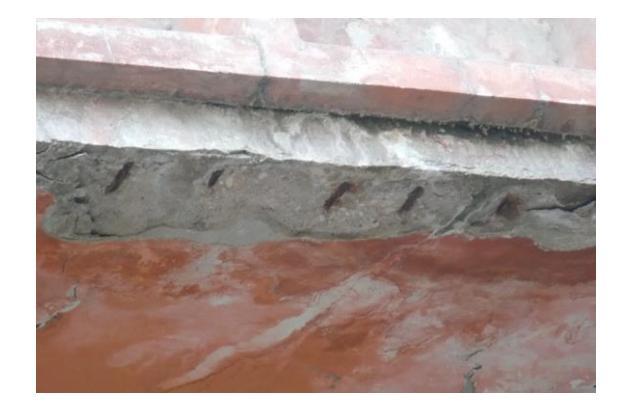
Photo 95 Peeling of Plaster on Electrical Hazard Third Floor Sunshade of Third Floor

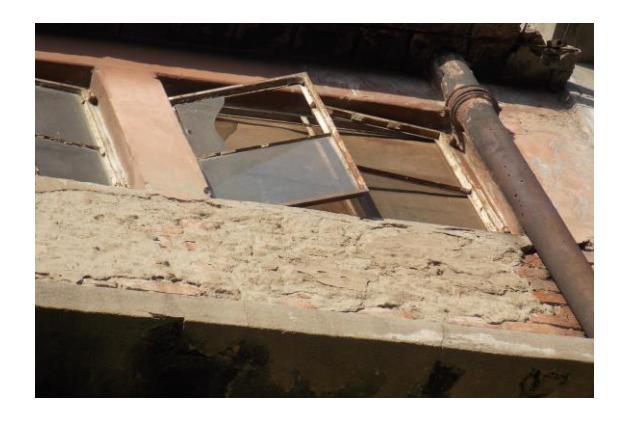
Photo 96 Damaged Portion on Floor of Electrical Hazard Ground Floor of Basement

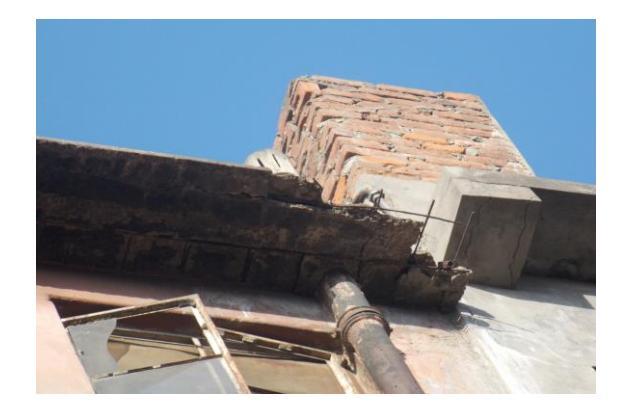
Photo 97 Damaged Portion on Electrical Hazard of Third Floor

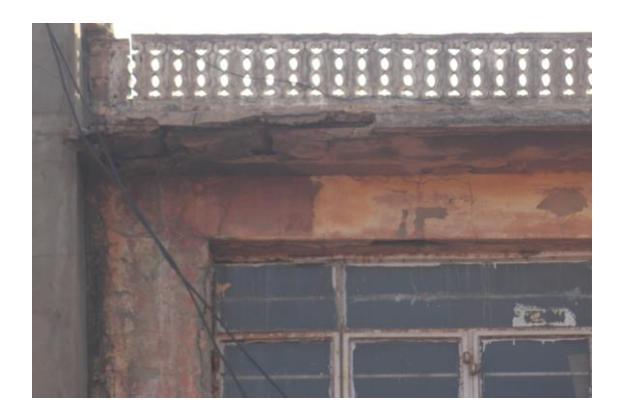
Photo 99 Damaged Portion on Floor of Electrical Hazard Third Floor of Third Floor

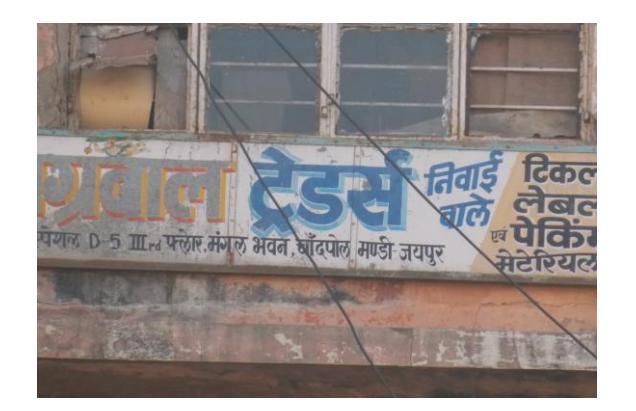
Photo 101 Dampness/Seepage on Floor of Electrical Hazard Second Floor Sunshade of Second Floor

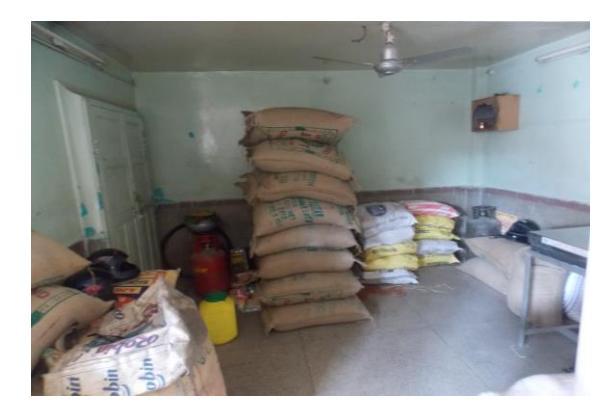
Photo 124 House No. Special D 5 of Ground Floor Covered with Materials

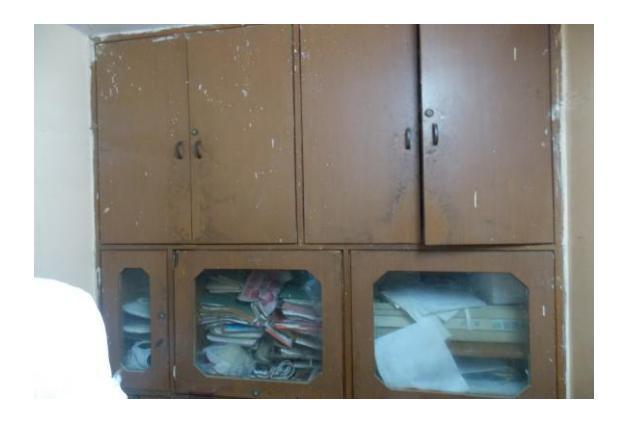
Photo 125 Floor of Shop Part B of Ground Floor Special D5 Covered with Materials

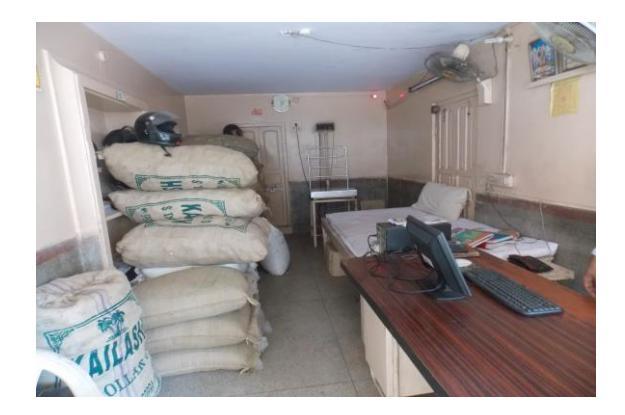
Photo 127 All Walls of Shop Part A of Ground Floor Special D5 Covered with Materials

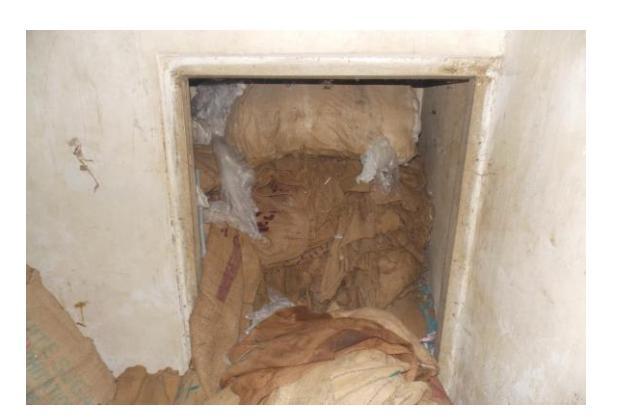
Photo 129 All Walls of Room No. 1 of Basement Covered with Material

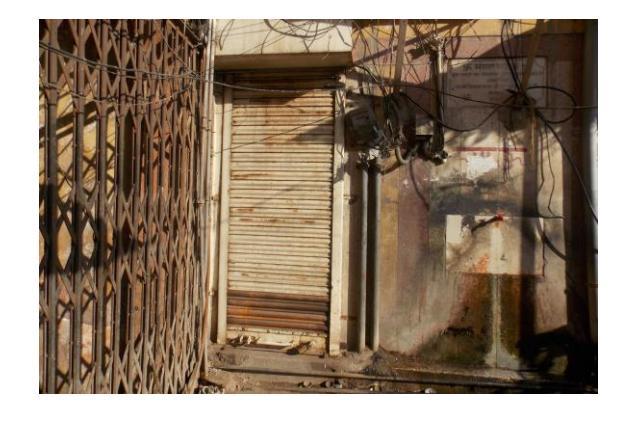
Photo 128 House No. Special D 5 of Ground Floor Locked

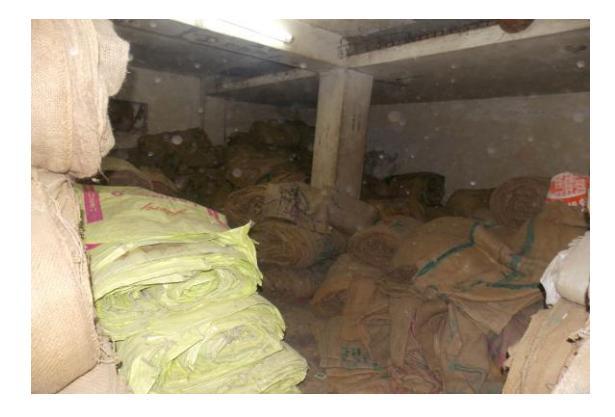
Photo 130 All Walls of Hall No. 1 of Basement Covered with Material

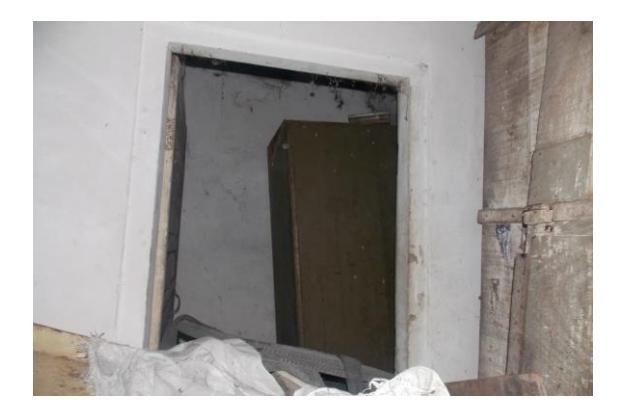
Photo 131 Store of Basement Not in Approach

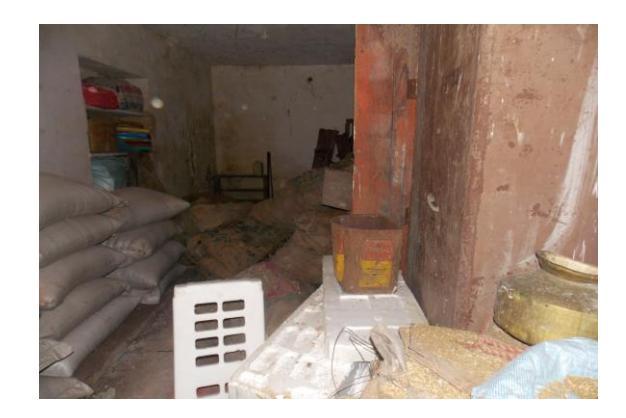
Photo 132 All Walls of Basement Covered with Materials

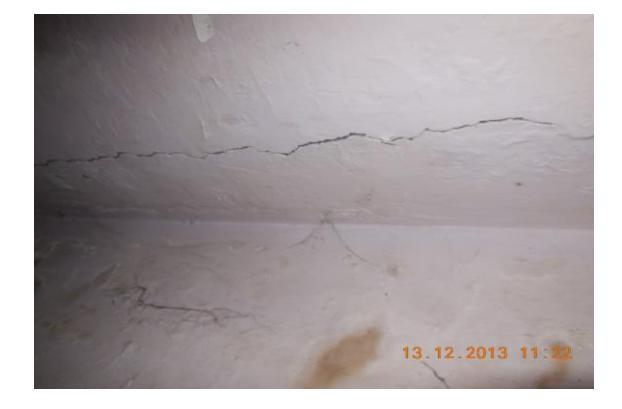
Photo 3 Horizontal Crack on Roof of Passage, Ground Floor, Approx. Width = 4mm, Approx. Length = 4m. Distance from Wall No. 4 = 0.3m, Height from Floor = 1.9m.

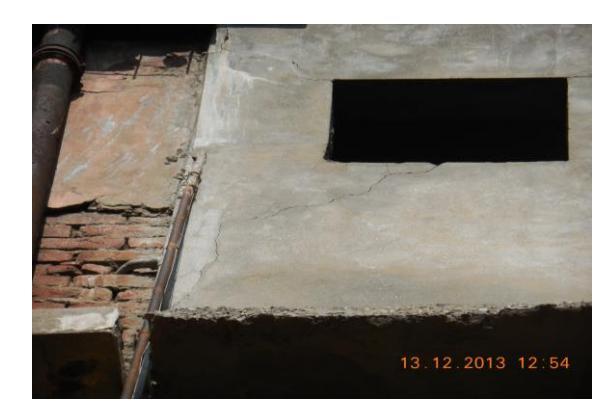
Photo 4 Inclined Crack on Outter Wall of External Hazard, Third Floor Approx. Width = 1.5mm, Approx. Length = 2m. Distance from Left Side = 0m, Height from Floor = 11m.

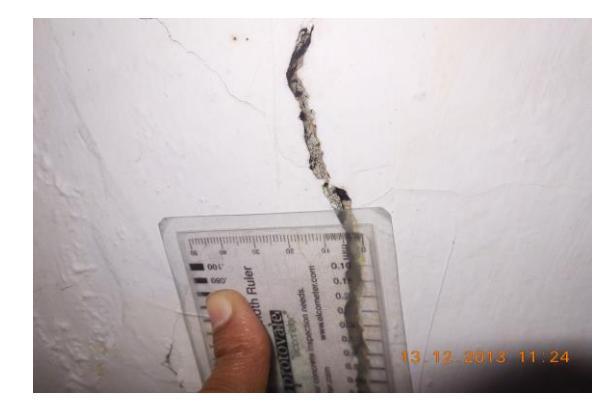
Photo 3A Horizontal Crack on Roof of Passage, Ground Floor, Approx. Width = 4mm, Approx. Length = 4m. Distance from Wall No. 4 = 0.3m, Height from Floor = 1.9m.

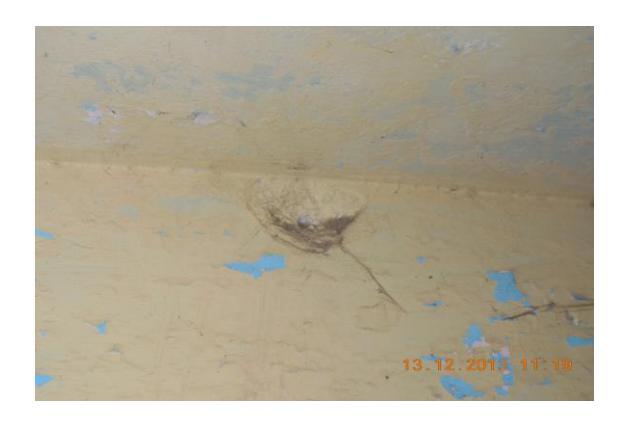
Photo 7 Damaged Portion on Roof of Stair Case of Ground Floor

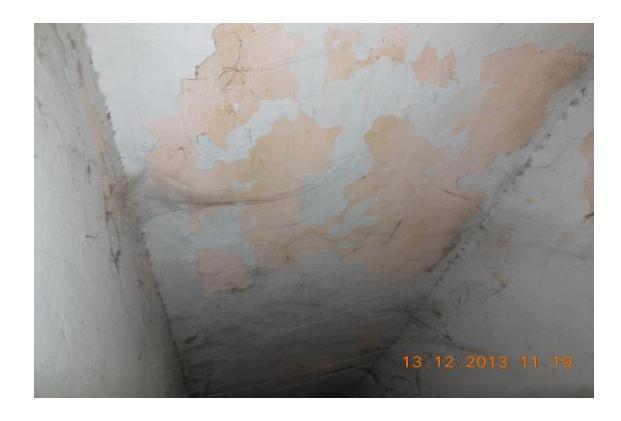
Photo 8 Peeling of Plaster on Roof of Passage of Ground Floor

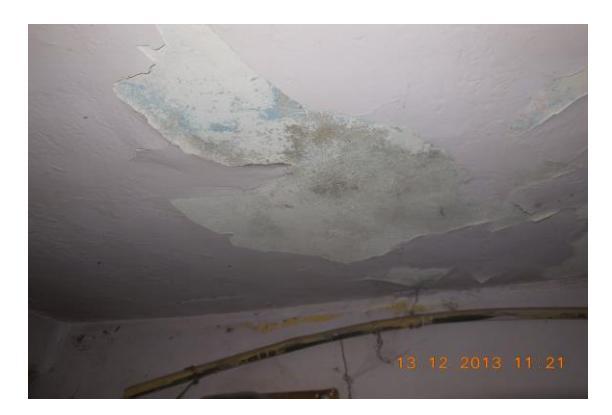
Photo 10 Dampness/Seepage on Roof of Passage of Ground Floor

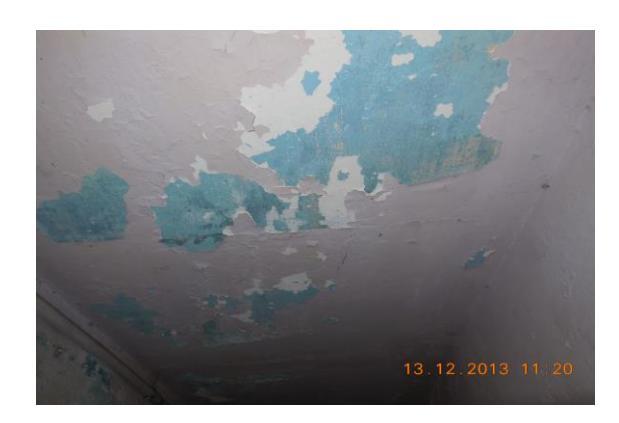
Photo 9 Peeling of Plaster on Roof of Stair Case of Ground Floor

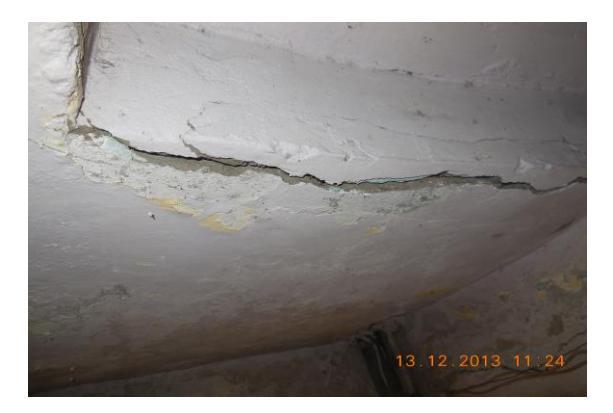
Photo 11 Damaged Portion on Roof of Passage of Ground Floor

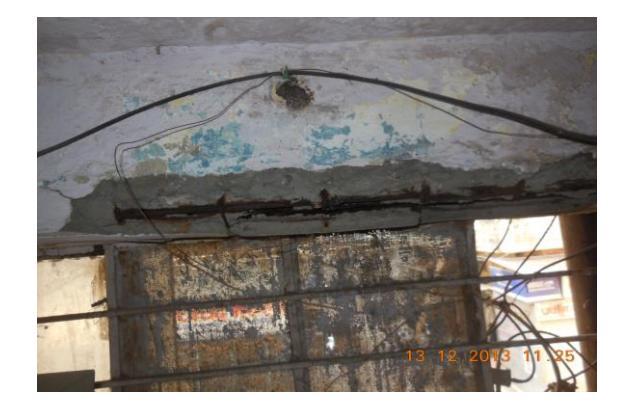
Photo 12 Damaged Portion on Roof of Passage of Ground Floor

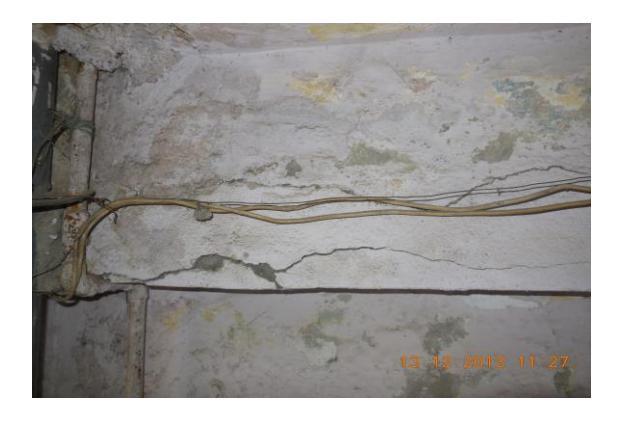
Photo 13 Damaged Portion on Roof of Passage of Ground Floor

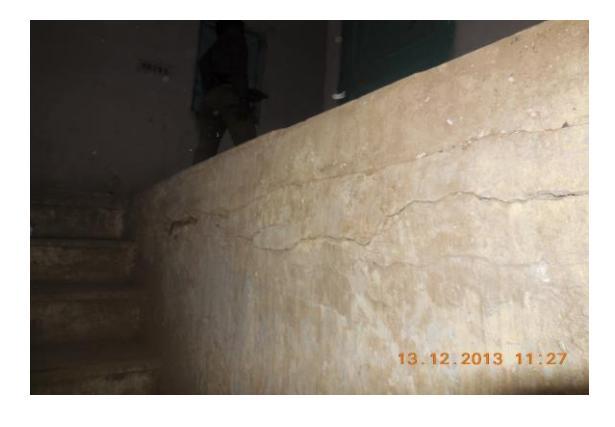
Photo 14 Damaged Portion on Roof of Passage of Ground Floor

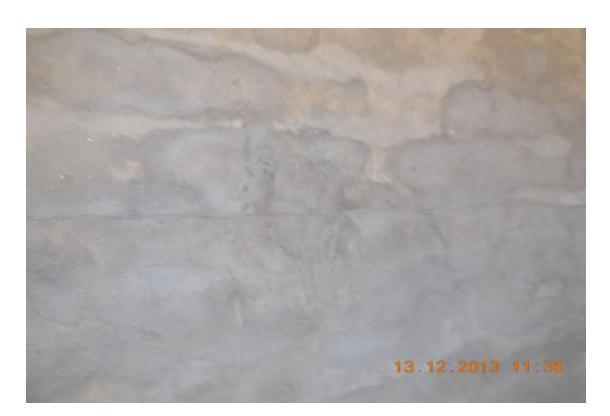
Photo 16 Plaster Crack on Hall No. 1 of Third Floor

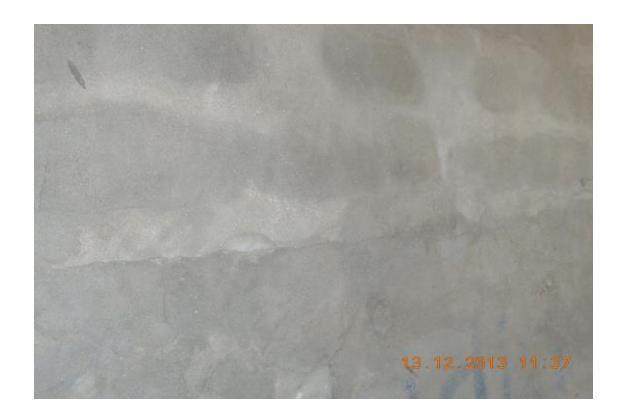
Photo 17 Plaster Crack on Hall No. 1 of Third Floor

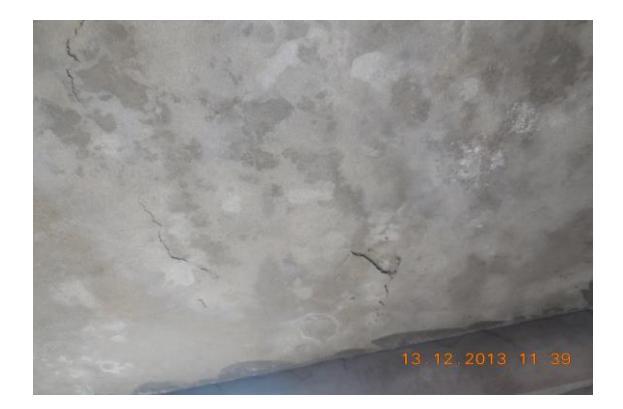
Photo 18 Peeling of Plaster on Roof of Hall No. 1 of Second Floor

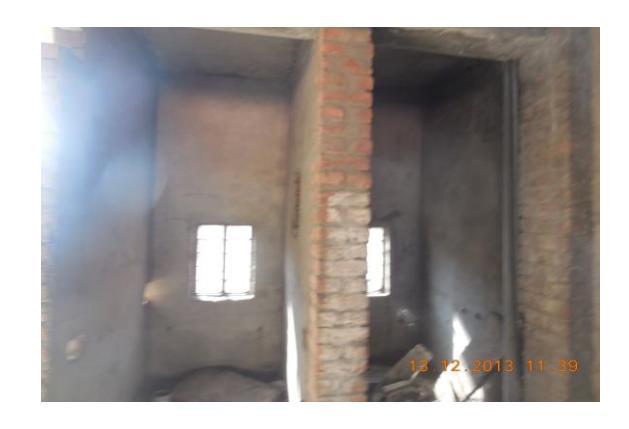
Photo 19 Peeling of Plaster on Roof of Toilet No. 1 of Third Floor

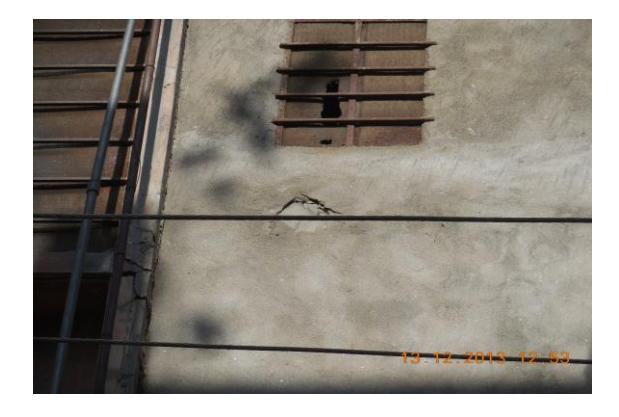
Photo 20 Peeling of Plaster on Roof of Hall No. 1 of Third Floor

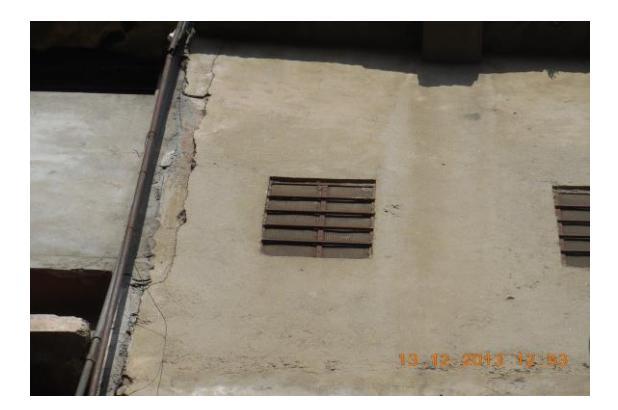
Photo 22 Peeling of Plaster on Outter Wall of External Hazard of Second Floor

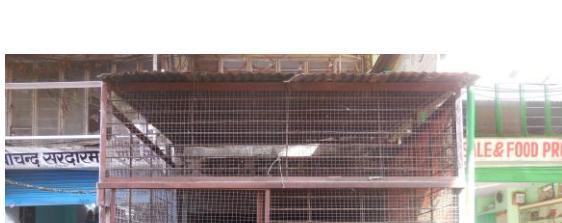
Photo 21
Peeling of Plaster on Outter Wall of External Hazard of First Floor

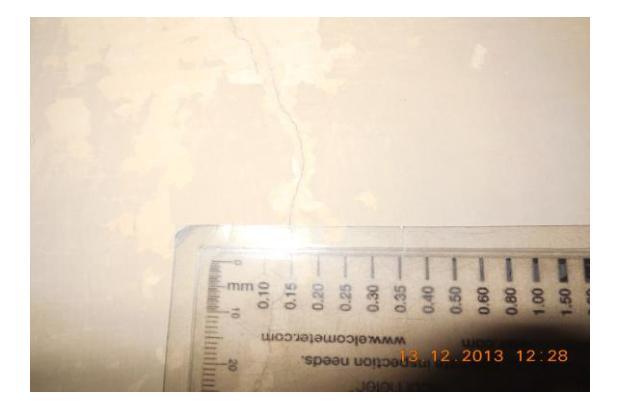
Photo 8A Horizontal Crack on Roof of Hall No. 1, Second Floor, Approx. Width = 0.15mm, Approx. Length = 0.8m. Distance from W1 = 1.6m, Height from Floor = 1.7m.

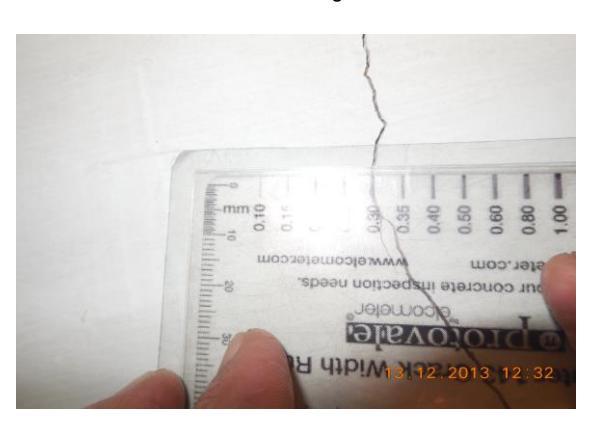
$\label{eq:photo_9A} \frac{Photo \ 9A}{Photo \ 9A} \\ \mbox{Horizontal Crack on Roof of Room No. 1, Second Floor, Approx. Width} \\ = 0.3mm, \ Approx. \ Length = 0.6m. \\ \mbox{Distance from W2} = 0.6m, \ Height from Floor = 1.5m. \\ \mbox{Horizontal Crack on Roof of R$

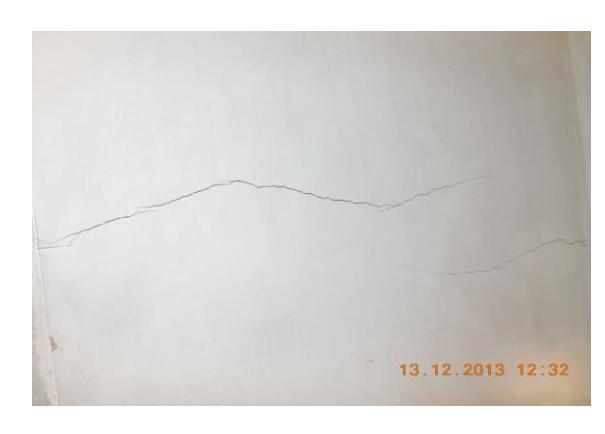
$\label{eq:photo 9} \frac{Photo 9}{Photo 1} \\ \mbox{Horizontal Crack on Roof of Room No. 1, Second Floor, Approx. Width} \\ = 0.3mm, Approx. Length = 0.6m. \\ \mbox{Distance from W2 = 0.6m, Height from Floor = 1.5m.} \\ \mbox{Horizontal Crack on Roof of Room Photon P$

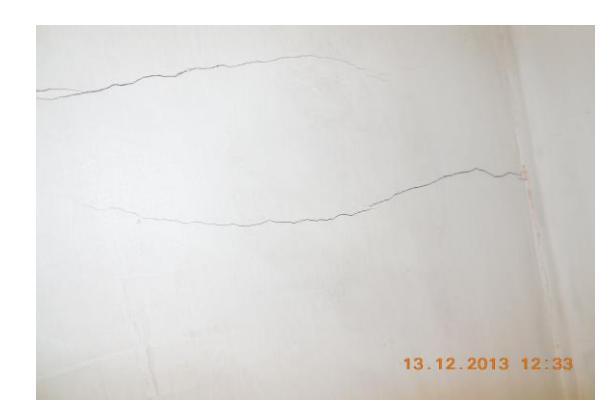
Photo 10 Horizontal Crack on Room No. 1, Second Floor, Approx. Width = 0.3mm, Approx. Length = 0.5m. Distance from W2 = 0m, Height from Floor = 1.3m.

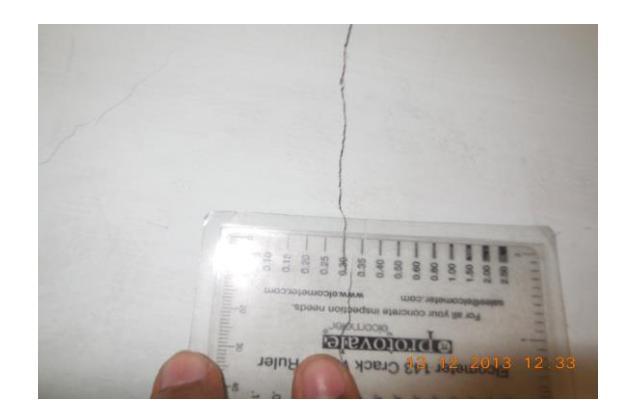
Photo 10A Horizontal Crack on Room No. 1, Second Floor, Approx. Width = 0.3mm, Approx. Length = 0.5m. Distance from W2 = 0m, Height from Floor = 1.3m.

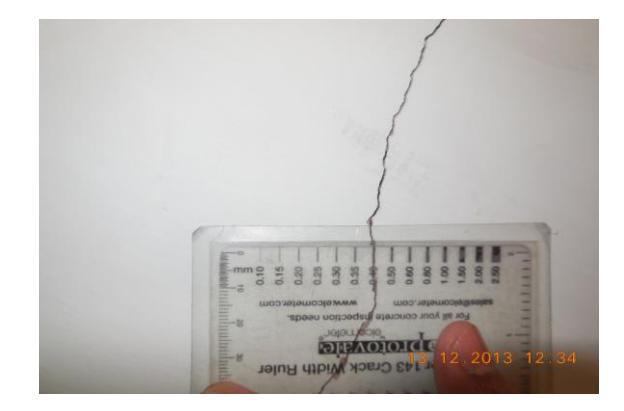
$\label{eq:hoto_11A} \frac{Photo_11A}{Photoonuclean}$ Horizontal Crack on Roof of Room No. 1, Approx. Width = 0.4mm, Approx. Length = 0.5m. Distance from W1 = 0m, Height from Floor = 1.5m.

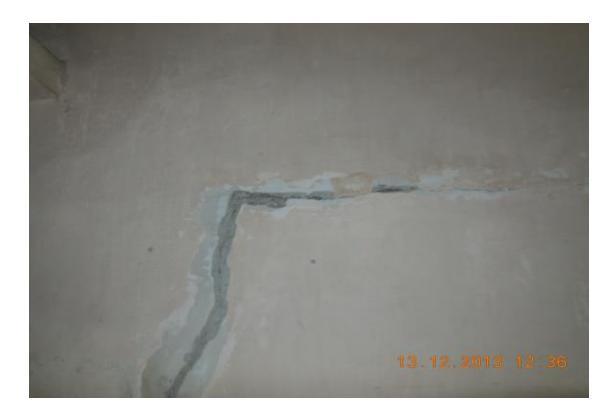
Photo 13 Inclined Crack on Roof, 2 & 4 of Open Area, Approx. Width = 2.5mm, Approx. Length = 3.5m. Distance from W4 = 0m, Height from Floor = 1.3m.

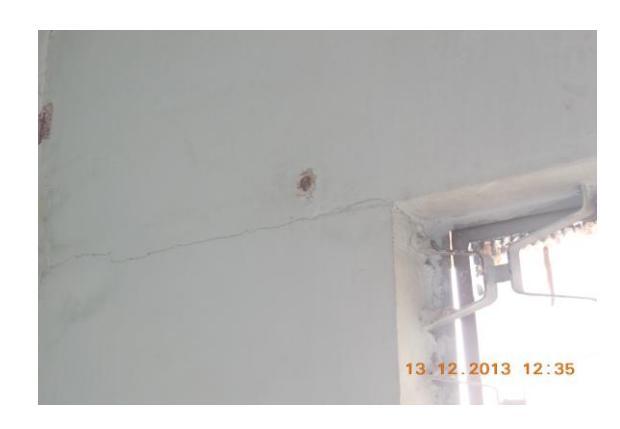
Photo 12 Horizontal Crack on Roof, 2 & 4 of Room No. 2, Approx. Width = 0.4mm, Approx. Length = 0.7m. Distance from W1 = 0m, Height from Floor = 1.5m.

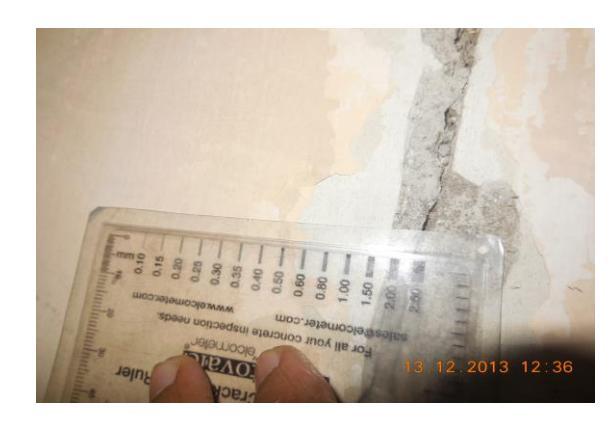
Photo 13A Inclined Crack on Roof, 2 & 4 of Open Area, Approx. Width = 2.5mm, Approx. Length = 3.5m. Distance from W4 = 0m, Height from Floor = 1.3m.

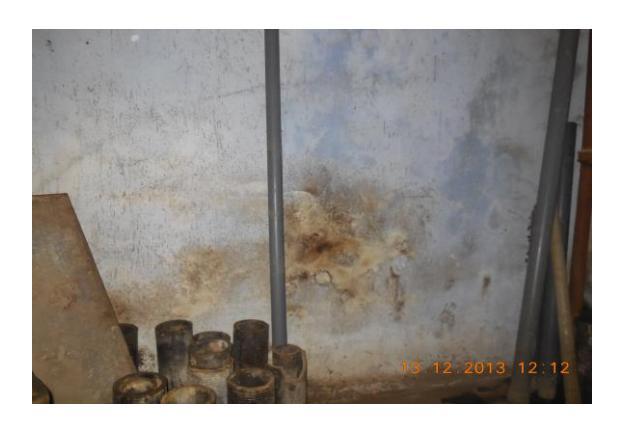
Photo 17 Dampness/Seepage on Part B of Ganesh Lal Jai Kumar & Sons of Ground Floor

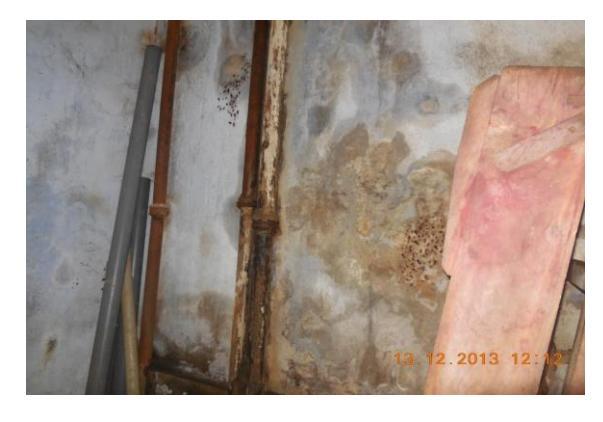
Photo 18 Dampness/Seepage on Part B of Ganesh Lal Jai Kumar & Sons of Ground Floor

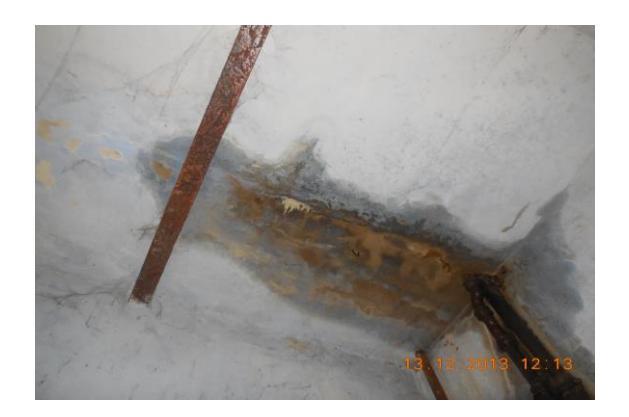
Photo 19 Dampness/Seepage on Roof of Part B of Ganesh Lal Jai Kumar & Sons of Ground Floor

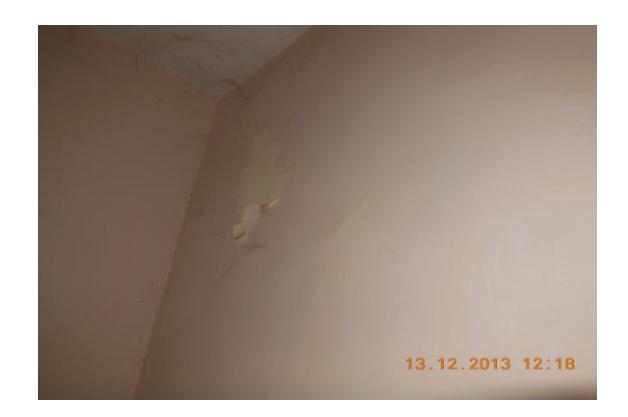
Photo 20 Dampness/Seepage on Room No. 3 of Mazanine Floor

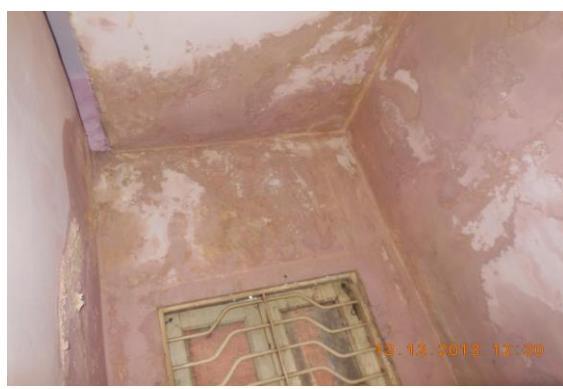
Photo 21 Dampness/Seepage on Toilet No. 1 of First Floor

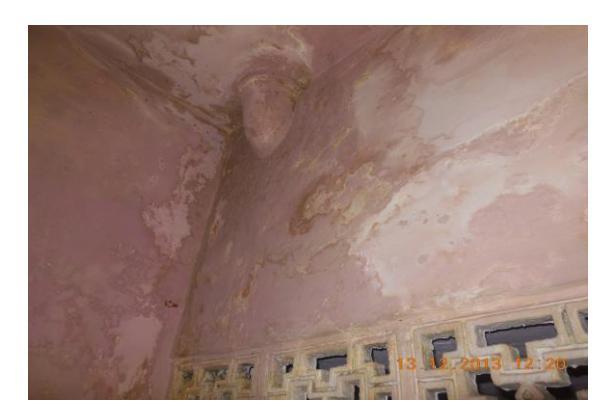
Photo 23 Dampness/Seepage on Roof & All Walls of of First Floor

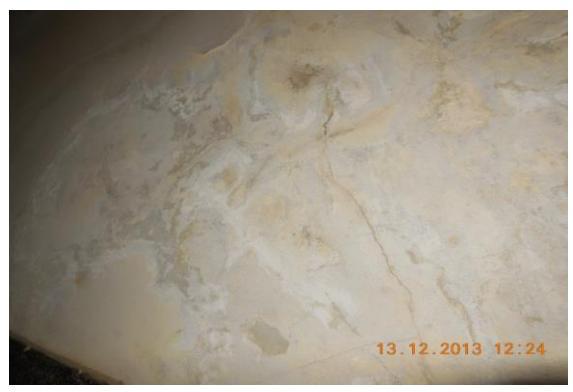
Photo 24 Peeling of Plaster on Stair Case FF to SF of Second Floor

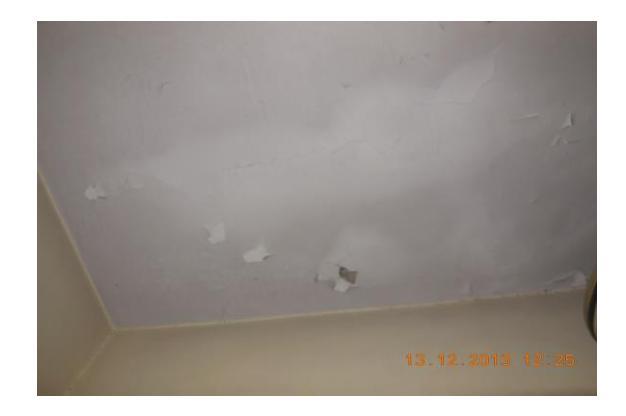
Photo 25 Peeling of Plaster on Roof of Stair Case FF to SF of Second Floor

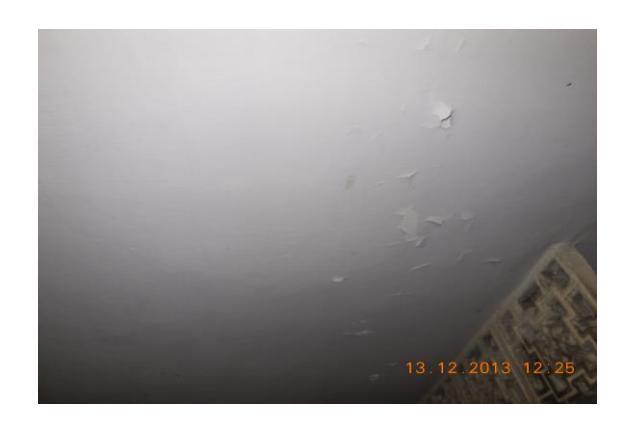
Photo 26 Peeling of Plaster on Roof of Passage of Second Floor

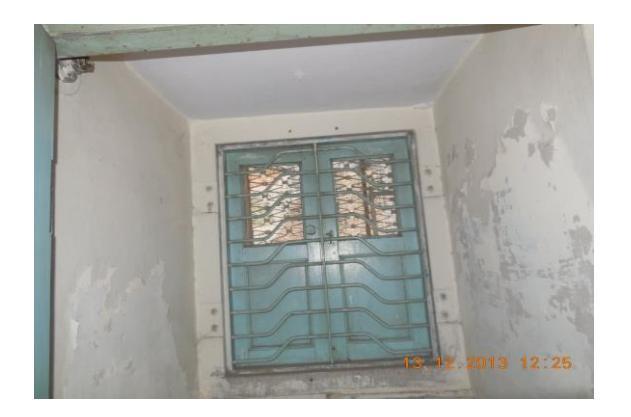
Photo 27 Peeling of Plaster on Roof, Wall No. 1 & 2 of Toilet No. 1 of Second Floor

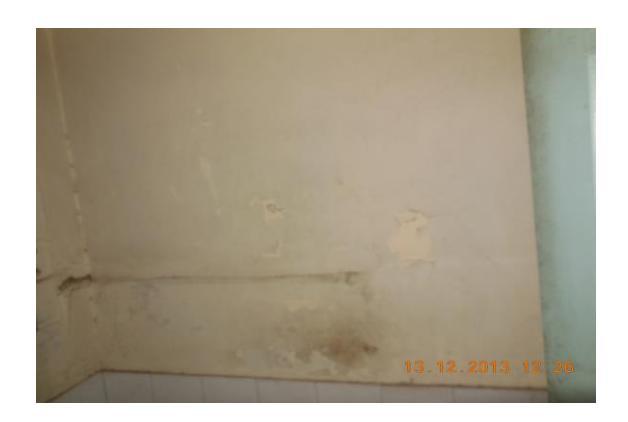
Photo 29 Peeling of Plaster on Roof & Wall No. 1 of Toilet No. 1 of Second Floor

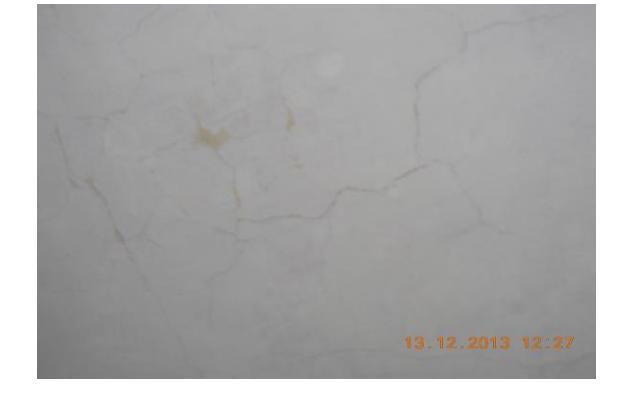
Photo 30 Plaster Crack on Roof of Hall No. 1 of Second Floor

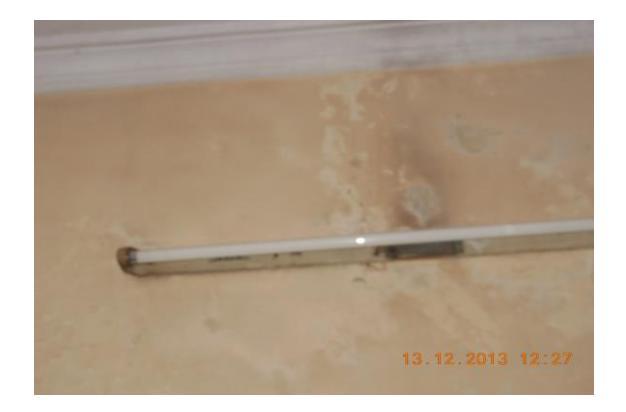
Photo 31 Peeling of Plaster on Roof of Hall No. 1 of Second Floor

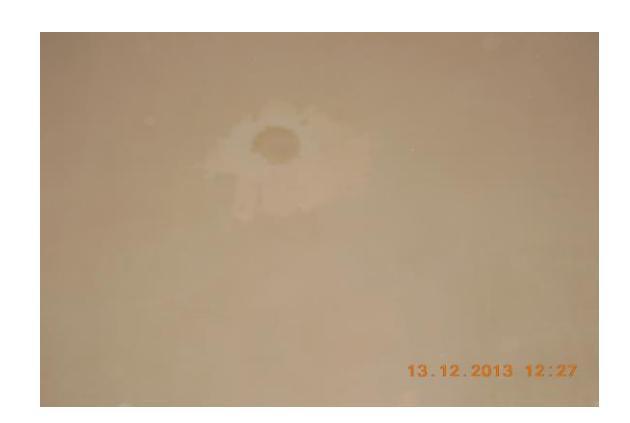
Photo 32 Peeling of Plaster on Roof of Hall No. 1 of Second Floor

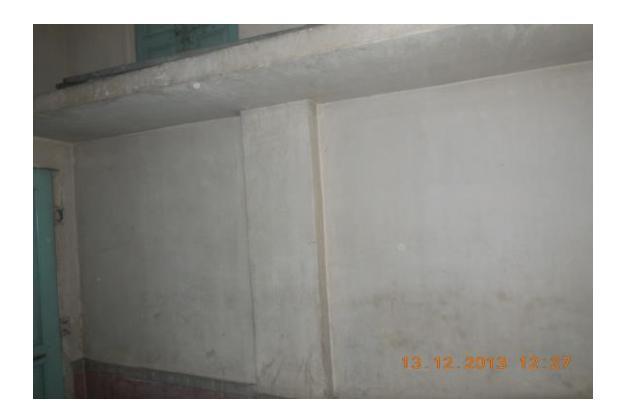
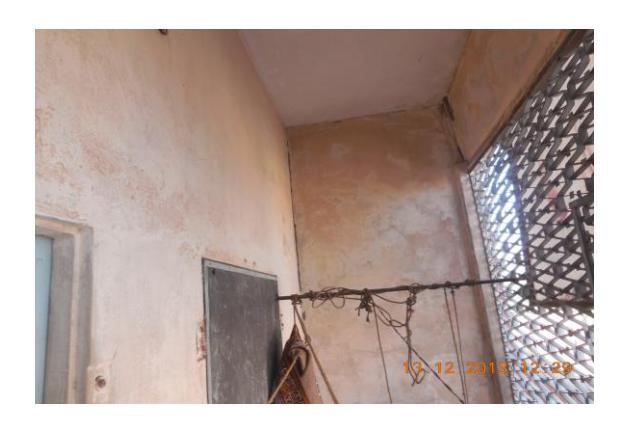
Photo 33 Peeling of Plaster on Roof of Hall No. 1 of Second Floor

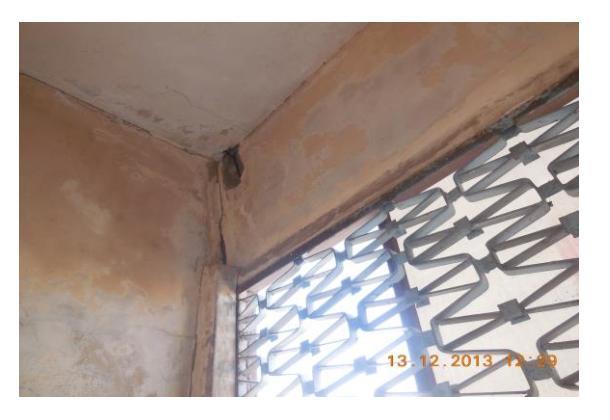
Photo 35 Peeling of Plaster on Balcony of Second Floor

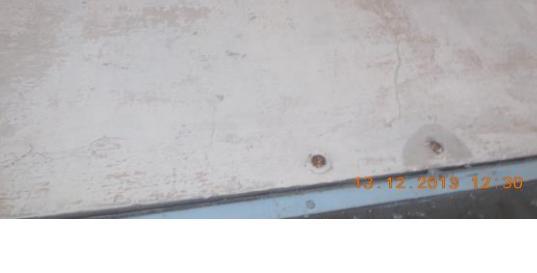
Photo 36 Plaster Crack on Balcony of Second Floor

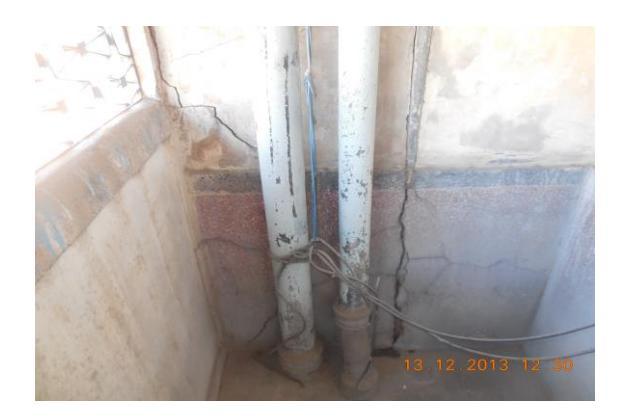
Photo 37 Damaged Portion on Balcony of Second Floor

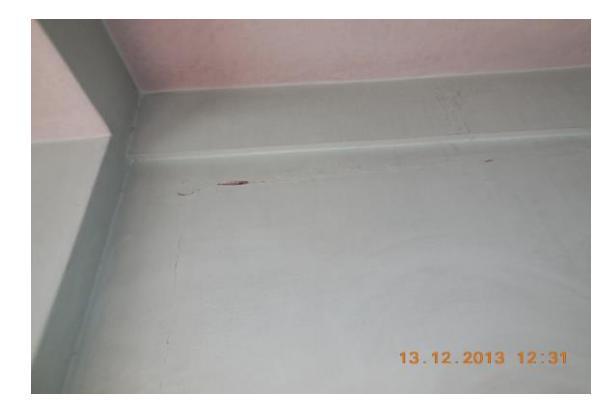
Photo 39 Peeling of Plaster on Roof of Room No. 1 of Second Floor

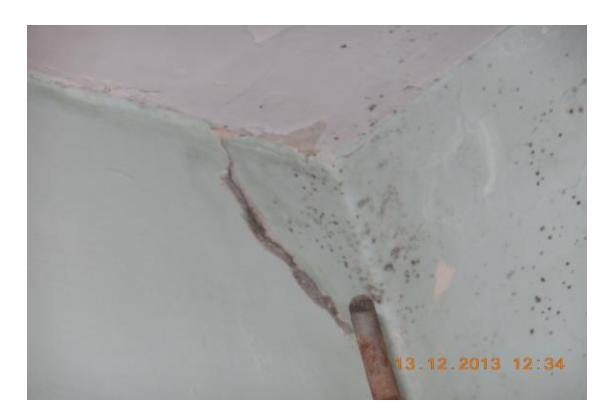
Photo 41 Peeling of Plaster on Roof, Wall No. 2 & 4 of Room No. 2

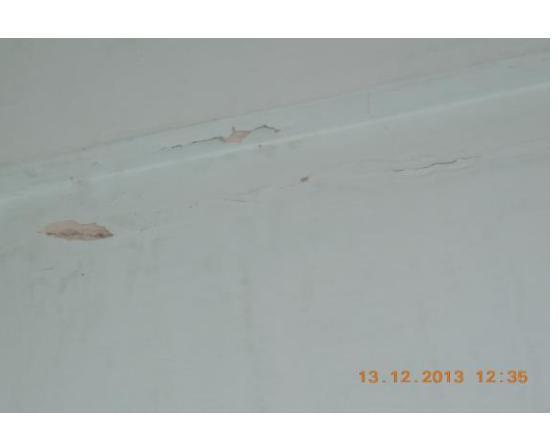
Photo 42 Peeling of Plaster on Roof, Wall No. 2 & 4 of Room No. 2

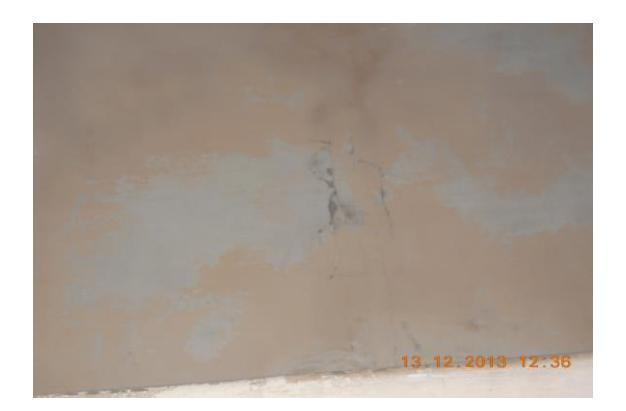
Photo 43 Peeling of Plaster on Open Area

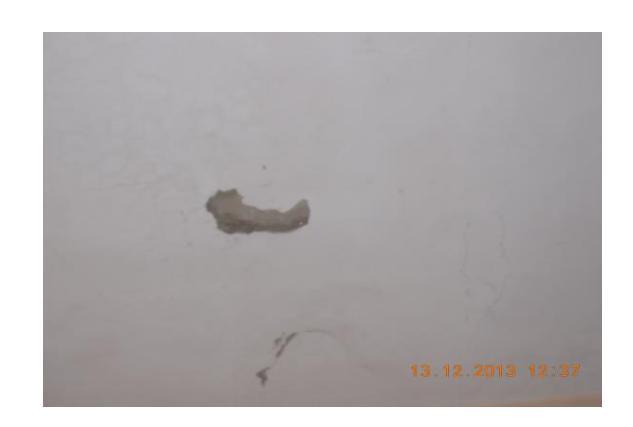
Photo 44 Peeling of Plaster on Roof of Open Area

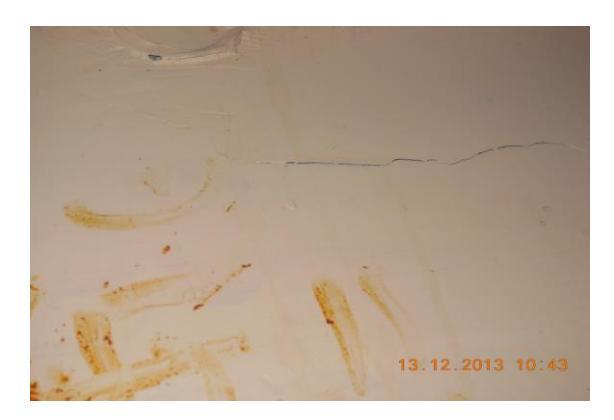
Photo 5

Horizontal Crack on Wall No. 4 of Rajesh Enterprises, Part A, House No. SPL D 2,Ground Floor,Approx. Width = 0.2mm, Approx. Length = 1m.Distance from Wall No. 2 = 1m, Height from Floor = 2m.

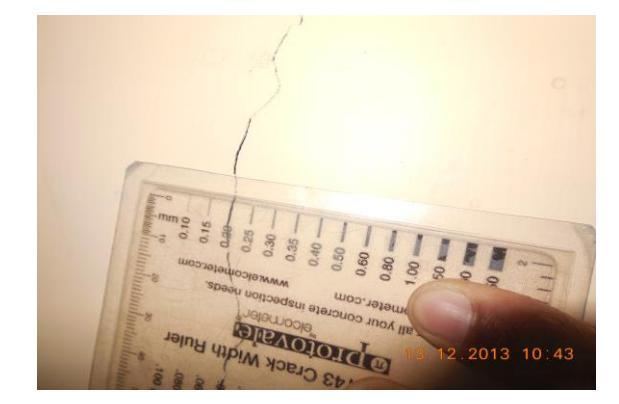
Photo 5A Horizontal Crack on Wall No. 4 of Rajesh Enterprises, Part A, House No. SPL D 2,G.F.,Approx. Width = 0.2mm, Approx. Length = 1m.Distance from Wall No. 2 = 1m, Height from Floor = 2m.

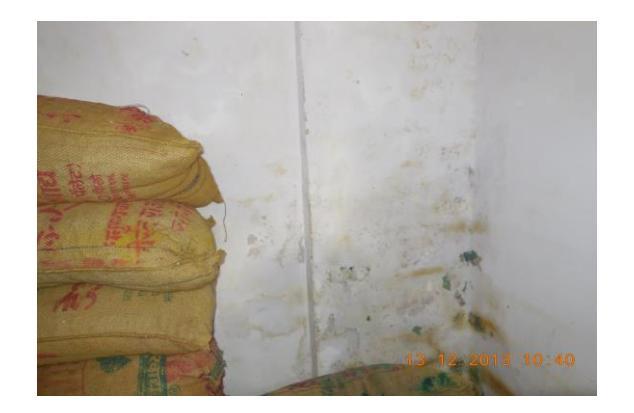
Photo 6 Dampness/Seepage on Wall No. 4 of House No. SPL D 2 of Ground Floor

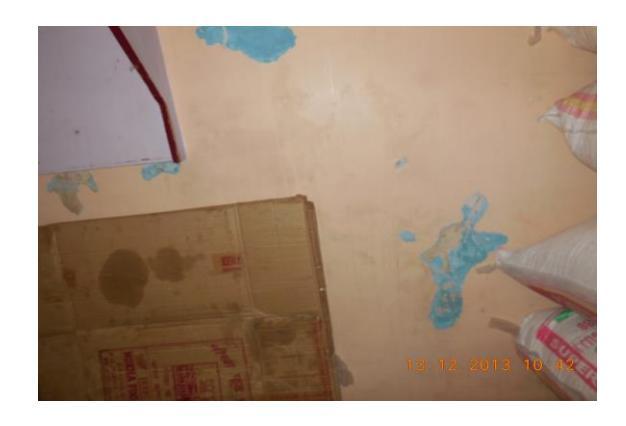
Photo 7 Peeling of Plaster on Wall No. 2 of Rajesh Enterprises, Part A of House No. SPL D 2, Ground Floor

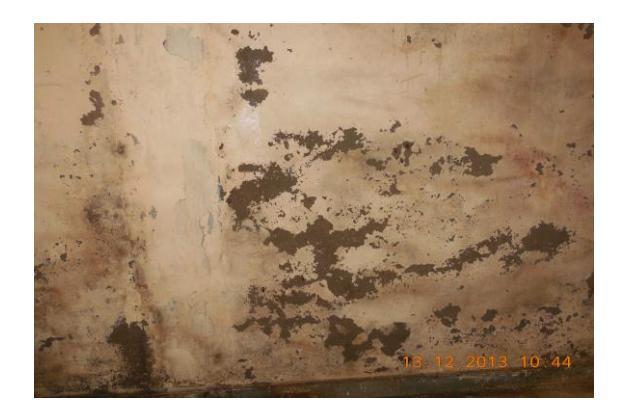
Photo 10 Peeling of Plaster on Wall No. 1 of Rajesh Enterprises, Part B of Tin Shade Room of House No. SPL D 2, Ground Floor

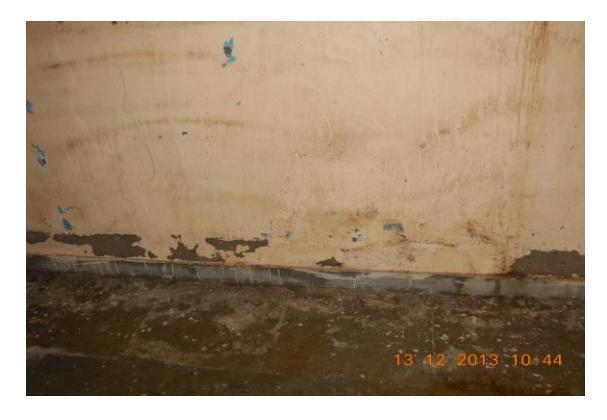
<u>Photo 1</u>1 Peeling of Plaster on Wall No. 4 of Rajesh Enterprises, Part B of Tin Shade Room of House No. SPL D 2, Ground Floor

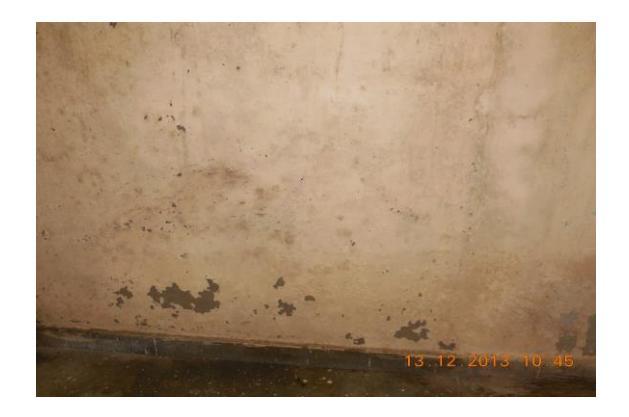
Photo 12 Peeling of Plaster on Wall No. 2 of Rajesh Enterprises, Part B of Tin Shade Room of House No. SPL D 2,Ground Floor

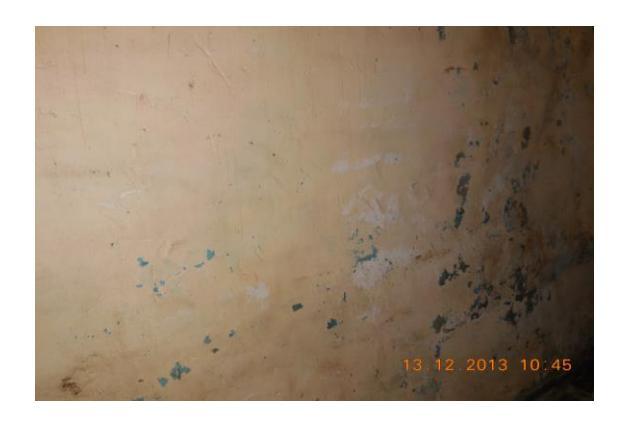
Photo 13 Peeling of Plaster on Wall No. 3 of Rajesh Enterprises, Part B of Tin Shade Room of House No. SPL D 2,Ground Floor

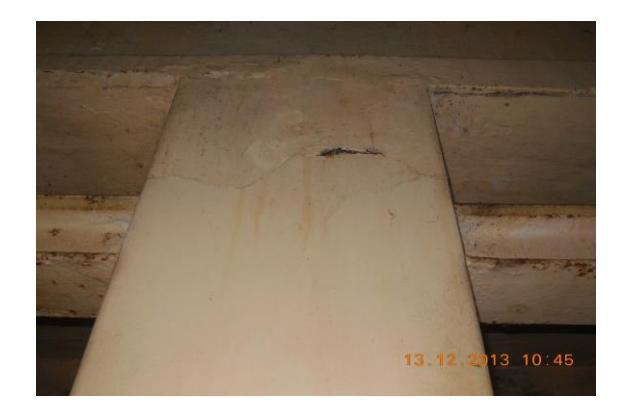
Photo 14 Peeling of Plaster on Column of Rajesh Enterprises, Part B of Tin Shade Room of House No. SPL D 2,Ground Floor

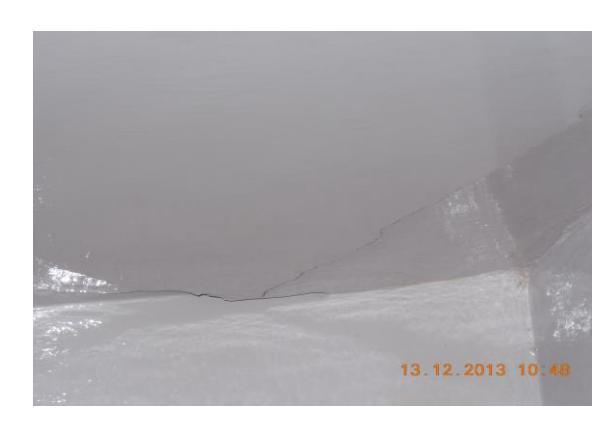
Photo 15 Peeling of Plaster on Roof of Bathroom of House No. SPL D 2,First Floor
