Pre Building Condition Survey Report

Name of the Project	Contract JMRC-UG1B "Design and Construction of Tunnel between Chandpole and Badi Chouper and reverse line by Shield TBM, Underground Metro Stations at Choti Chouper and Badi Chouper by Cut and Cover Methods on East West Corridor of Jaipur Metro Rail Corporation Limited ."		
Owner :	JAIPUR METRO	Jaipur Metro Rail Corporation	
Contractor :	VUV	Continental Engineering Corporation	
Survey Agency :	Aimil I Instrumentation	tion & Technologies

Pre Building Condition Survey Report Chand Pole to Choti Chopar (UP Line)

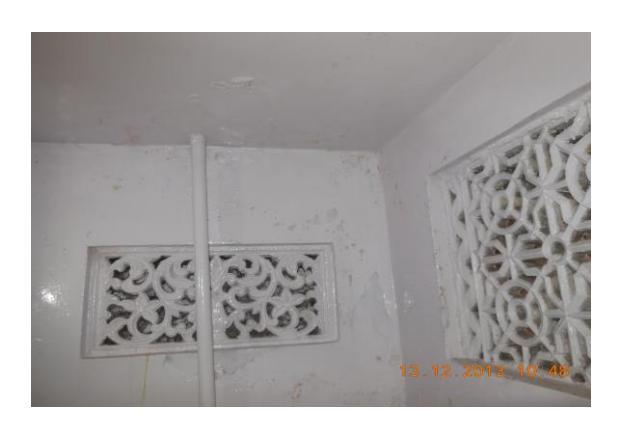
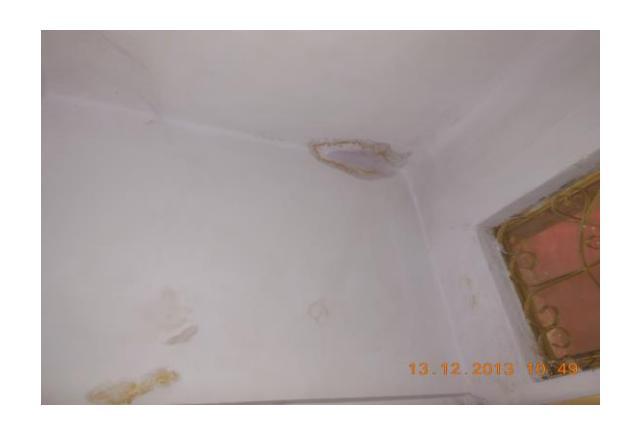
Photo 16
 Photo 17

Peeling of Plaster on Wall No.4& Roof of Toilet No. 1 of House No. SPL
 Dampness/Seepage on Wall No. 1 & 3 of Hall No. 1 of House No. SPL

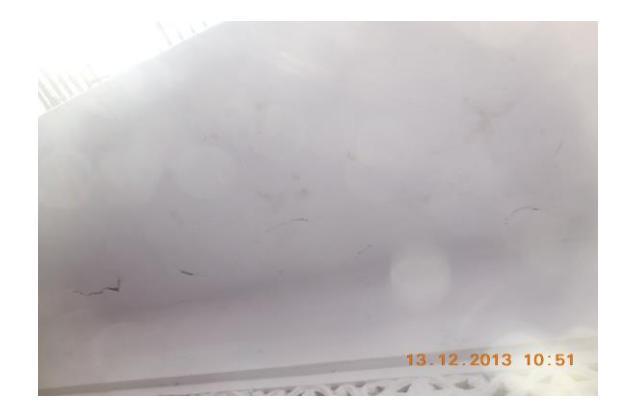
Photo 18 Peeling of Plaster on Roof of Lobby of House No. SPL D 2,First Floor

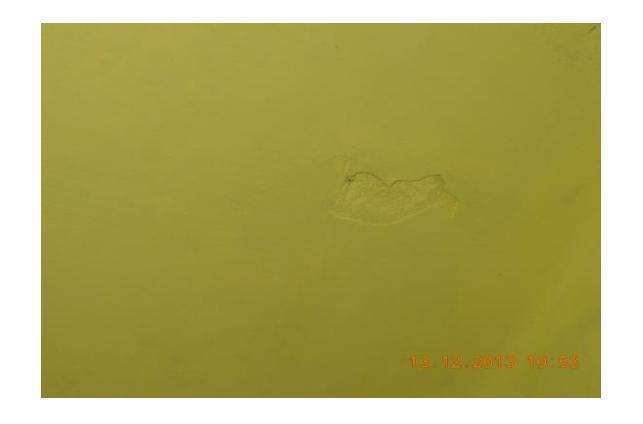
Photo 19 Peeling of Plaster on Roof of Lobby of House No. SPL D 2, Second Floor

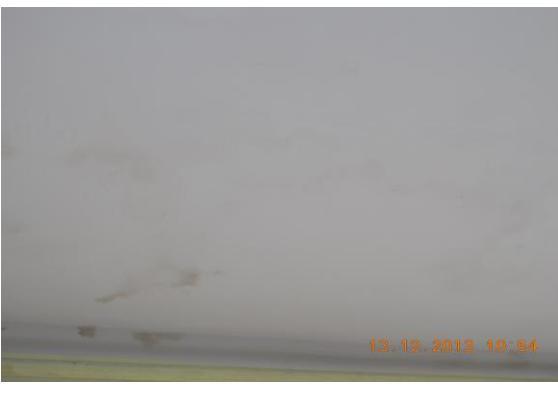
Photo 20 Dampness/Seepage on Roof of Store of House No. SPL D 2, Second Floor

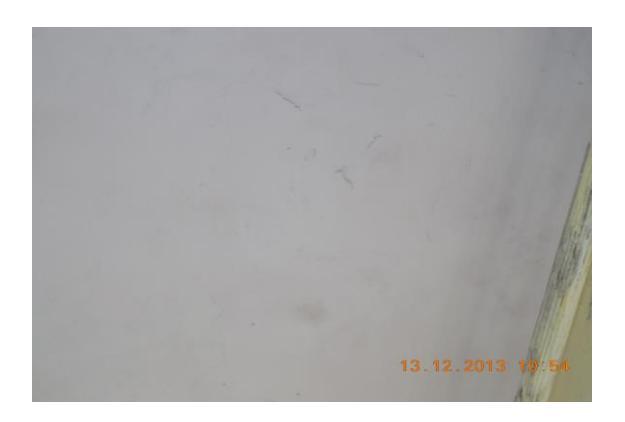
Photo 22 Peeling of Plaster on Roof of Toilet No. 1 of Second Floor

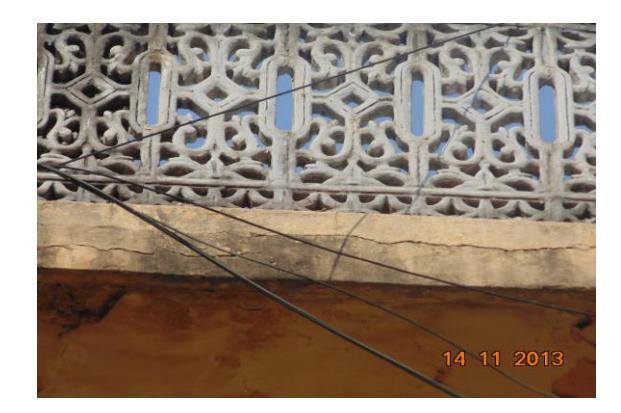
Photo 6 Horizontal Crack on Wall No. 3 &Outer Wall of Main Gate, House No. D-1, Ground Floor,Approx. Width = 2.5mm, Approx. Length = 8m.Distance from Outer Wall No. 1 = 0m, Height from Floor = 8m.

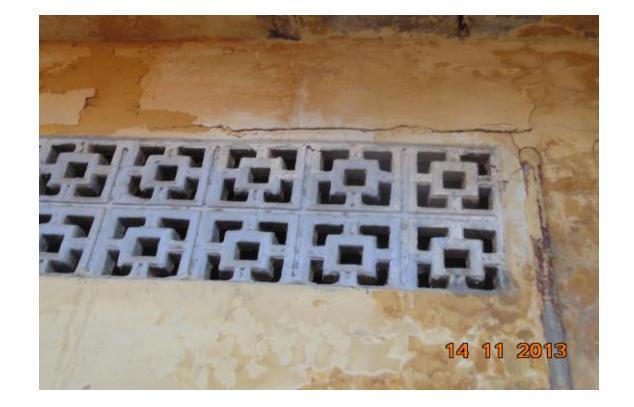
Photo 7

Horizontal Crack on Wall No. 3 of Varanda, House No. D-1, Second Floor, Approx. Width = 3mm, Approx. Length = 0.6m. Distance from Wall Floor, Approx. Width = 2mm, Approx. Length = 1.2m. Distance from Wall No. 2 = 0.6m, Height from Floor = 2.45m.

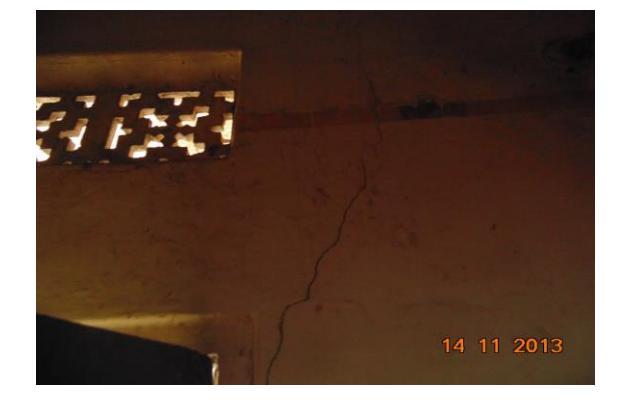
Photo 8

Inclined Crack on Wall No. 3 of Room No. 1, House No. D-1, Second No. 2 = 0.7m, Height from Floor = 1.9m.

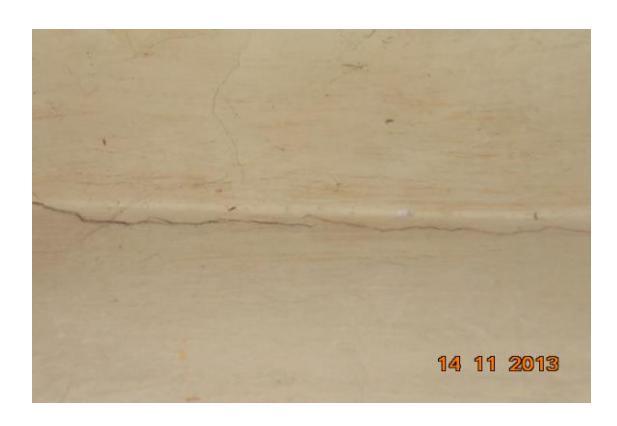
Photo 9

Inclined Crack on Wall No. 3 of Room No. 1, House No. D-1, Second Floor, Approx. Width = 2mm, Approx. Length = 1.2m. Distance from Wall Floor, Approx. Width = 2mm, Approx. Length = 0.5m. Distance from Wall No. 2 = 0.7m, Height from Floor = 1..9m.

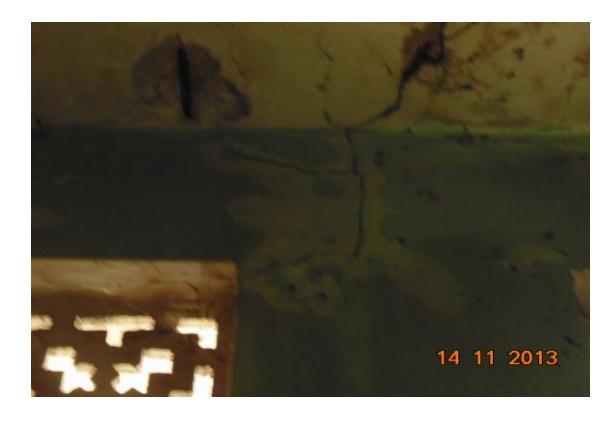
<u>Photo 1</u>1 Vertical Crack on Wall No. 3 of Room No. 2, House No. D-1, Second Floor, Approx. Width = 1.5mm, Approx. Length = 0.25m. Distance from Wall No. 2 = 1m, Height from Floor = 2.75m.

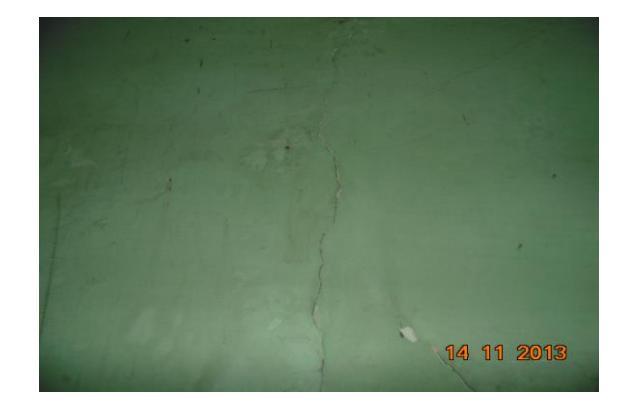
Photo 12

Vertical Crack on Wall No. 4 of Room No. 2, House No. D-1, Second Floor,Approx. Width = 0.4mm, Approx. Length = 1.2m.Distance from Wall No. 1 = 1.3m, Height from Floor = 1.8m.

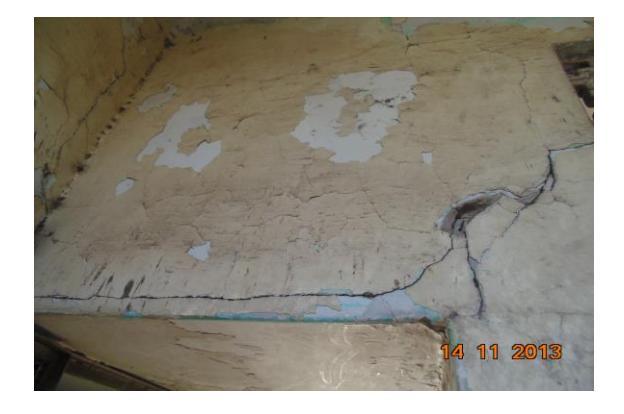
<u>Photo 1</u>3

Inclined Crack on Wall No. 3 of Room No. 2, House No. D-1, Second Floor, Approx. Width = 2.5mm, Approx. Length = 1m.Distance from Wall No. 2 = 0m, Height from Floor = 2m.

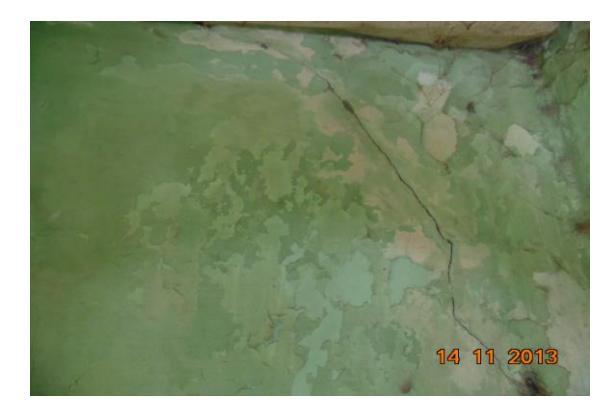
Photo 15 Inclined Crack on Wall No. 1 of Room No. 3, House No. D-1, Second Floor,Approx. Width = 1.5mm, Approx. Length = 0.5m.Distance from Wall No. 3 = 0m, Height from Floor = 1.6m.

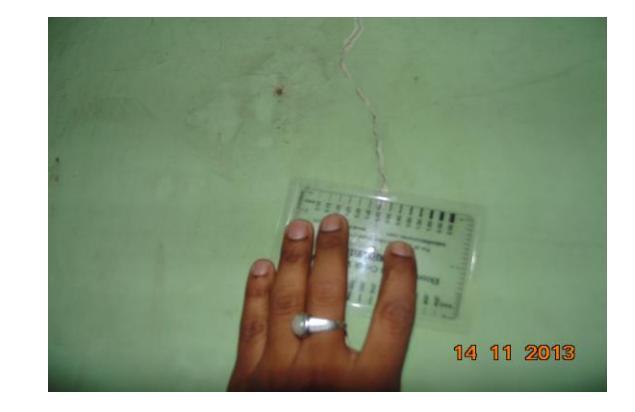
Photo 12A Vertical Crack on Wall No. 4 of Room No. 2, House No. D-1, Second Floor,Approx. Width = 0.4mm, Approx. Length = 1.2m.Distance from Wall No. 1 = 1.3m, Height from Floor = 1.8m.

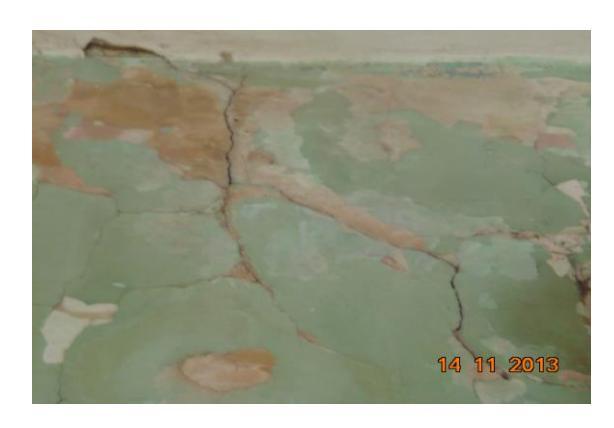
Photo 14

Inclined Crack on Wall No. 3 of Room No. 3, House No. D-1, Second Floor, Approx. Width = 0.8mm, Approx. Length = 0.5m. Distance from Wall No. 1 = 0.6m, Height from Floor = 2.5m.

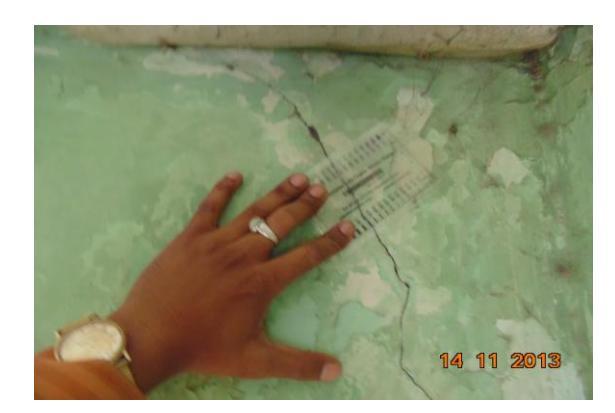
Photo 15A Inclined Crack on Wall No. 1 of Room No. 3, House No. D-1, Second Floor,Approx. Width = 1.5mm, Approx. Length = 0.5m.Distance from Wall No. 3 = 0m, Height from Floor = 1.6m.

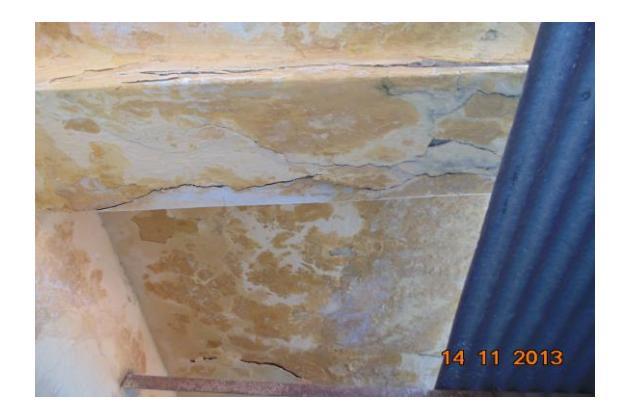
Photo 16 Inclined Crack on Roof of Varanda, House No. D-1, Second Floor, Approx. Width = 3mm, Approx. Length = 1m. Distance from Wall No. 3 = 0m, Height from Floor = 2.6m.

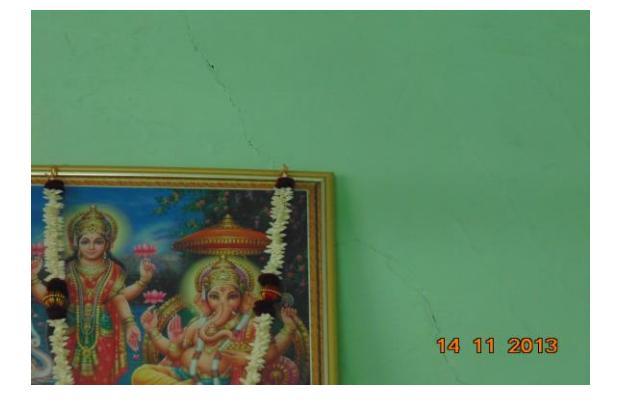
Photo 17

Inclined Crack on Wall No. 4 of Room No. 6, House No. D-1, Second Floor, Approx. Width = 0.4mm, Approx. Length = 1.4m. Distance from Wall No. 2 = 0m, Height from Floor = 1.8m.

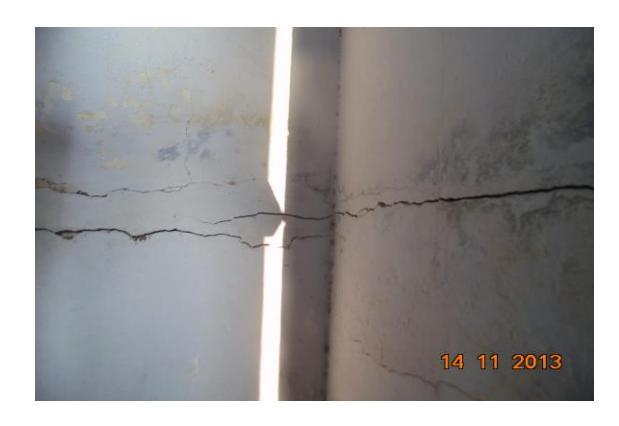
<u>Photo 1</u>9 Horizontal Crack on All wall of Stair, House No. D-1, Second Floor, Approx. Width = 10mm, Approx. Length = 6m. Distance from Wall

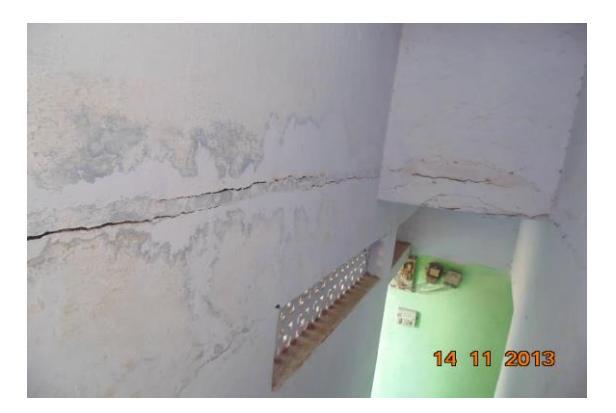
Horizontal Crack on Wall No. 3 of Varanda 3, House No. D-1, Second Floor, Approx. Width = 10mm, Approx. Length = 2.5m. Distance from = m, Height from Floor = 2.7m.

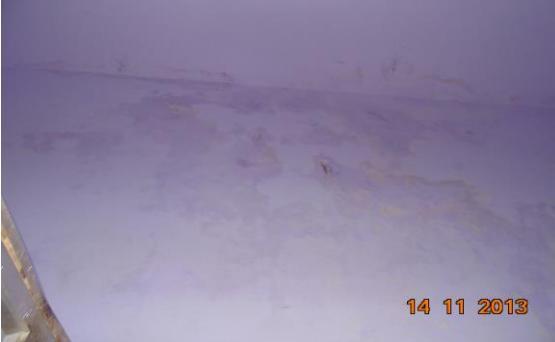
Photo 20 Horizontal Crack on All wall of Stair, House No. D-1, Second Floor, Approx. Width = 10mm, Approx. Length = 6m. Distance from Wall No. 3 = 0m, Height from Floor = 0.9m.

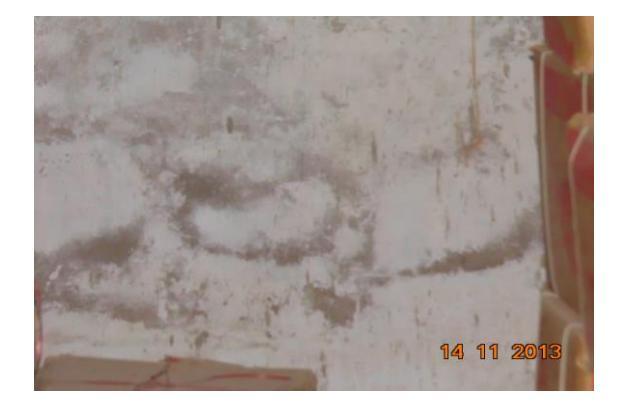
Photo 22 Dampness/Seepage on Wall No. 2 of Hall No. 2 of House No. D-1, Ground Floor

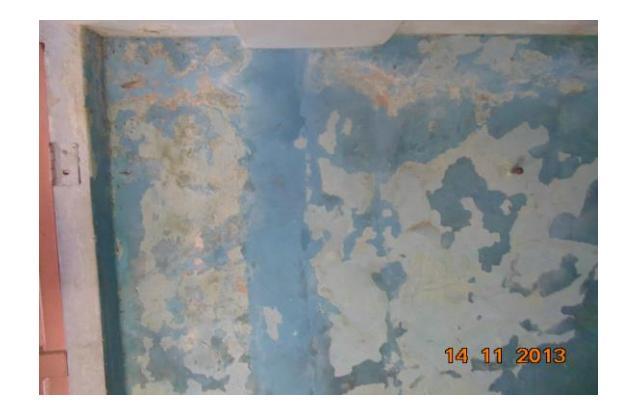
Photo 23 Dampness/Seepage on Wall No. 1 of Room No. 3 of House No. D-1, First Floor

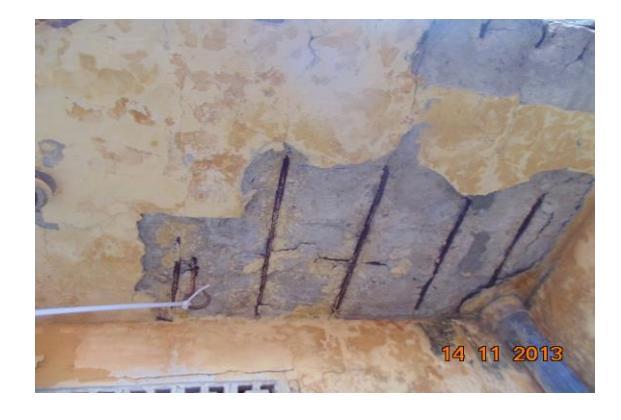
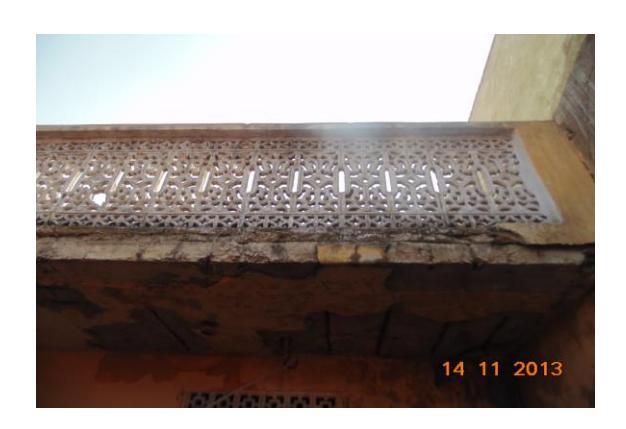
Photo 24
 Photo 25

Exposed Reinforcement on Roof of Varanda of House No. D-1, Second
 Exposed Reinforcement on Roof of Varanda of House No. D-1, Second

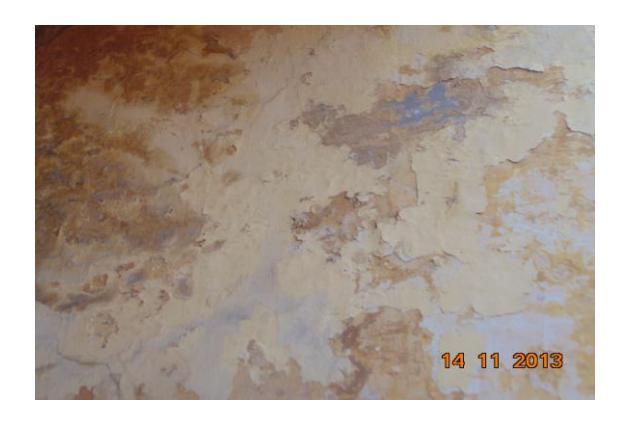
Photo 26 Dampness/Seepage on Wall No. 3 of Varanda of House No. D-1, Second Floor

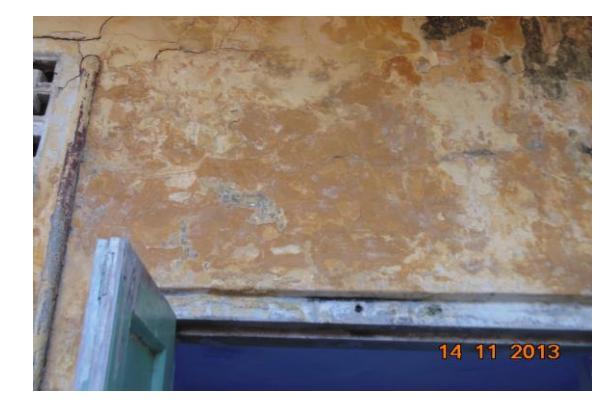
Photo 27 Dampness/Seepage on Wall No. 3 of Varanda of House No. D-1, Second Floor

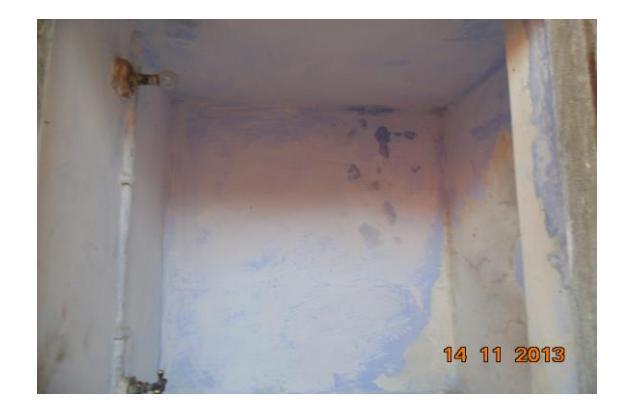
Photo 28 Peeling of Plaster on All wall of Bathroom of House No. D-1, Second Floor

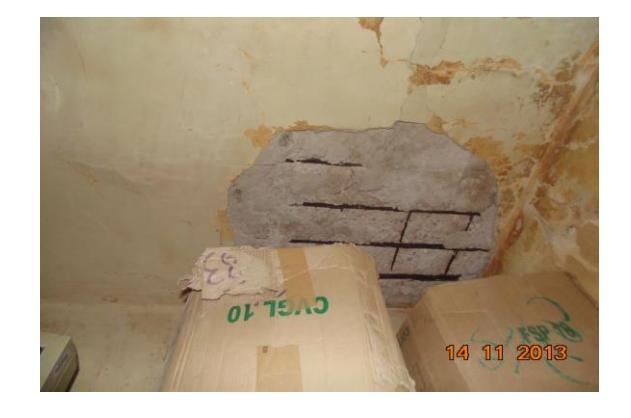
Photo 29 Exposed Reinforcement on Roof of Room No. 1 of House No. D-1, Second Floor

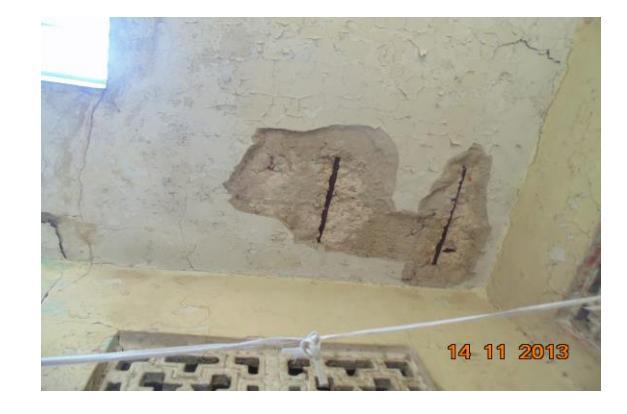
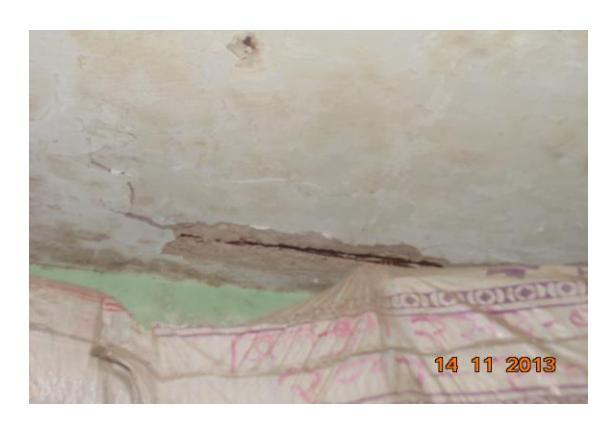
Photo 30
 Photo 31

Exposed Reinforcement on Wall No. 3 of Room No. 1 of House No. D-1, Exposed Reinforcement on Wall No. 2 & Roof of Room No. 2 of House Second Floor
 No. D-1, Second Floor

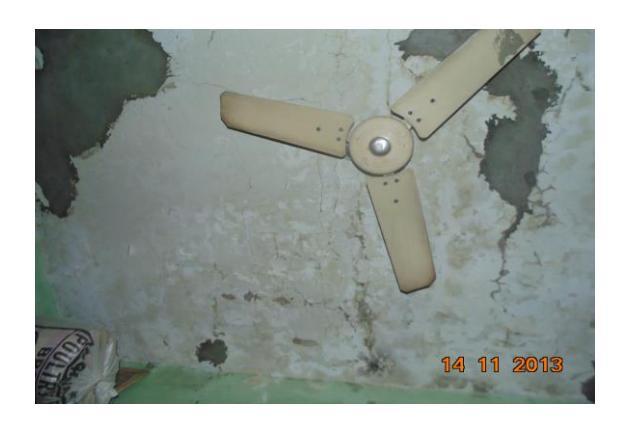
Photo 32 Damaged Portion on Roof of Room No. 2 of House No. D-1, Second Floor

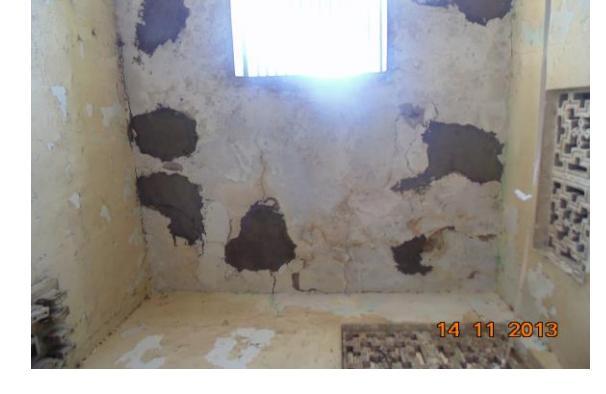
Photo 33 Damaged Portion on Roof of Room No. 2 of House No. D-1, Second Floor

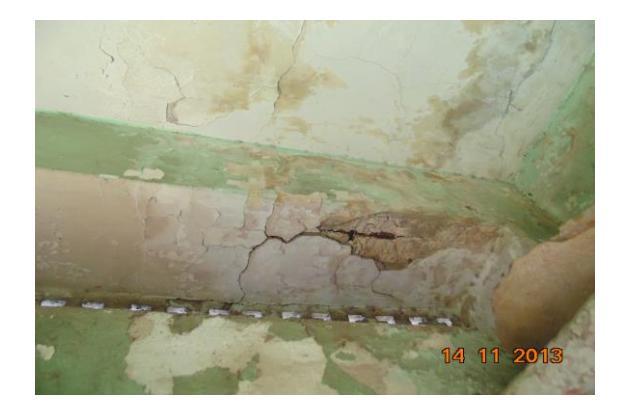
Photo 34 Damaged Portion on Wall No. 3 of Room No. 3 of House No. D-1, Second Floor

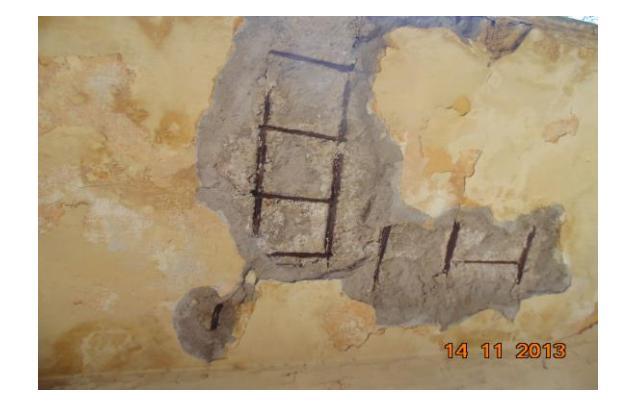
Photo 36 Exposed Reinforcement on Roof of Balcony of House No. D-1, Second Exposed Reinforcement on Roof of Balcony of House No. D-1, Second Floor Floor

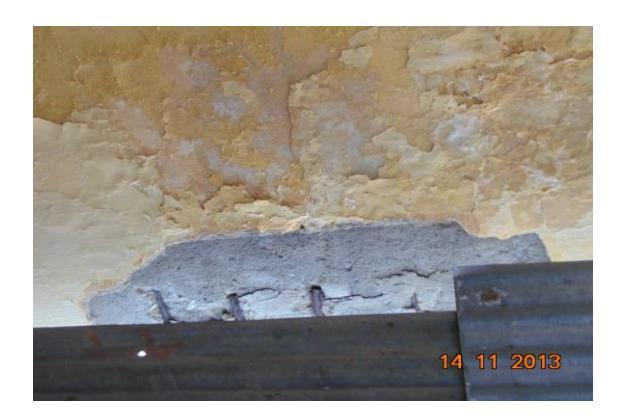
Photo 38 Exposed Reinforcement on Roof of Varanda of House No. D-1, Second Floor

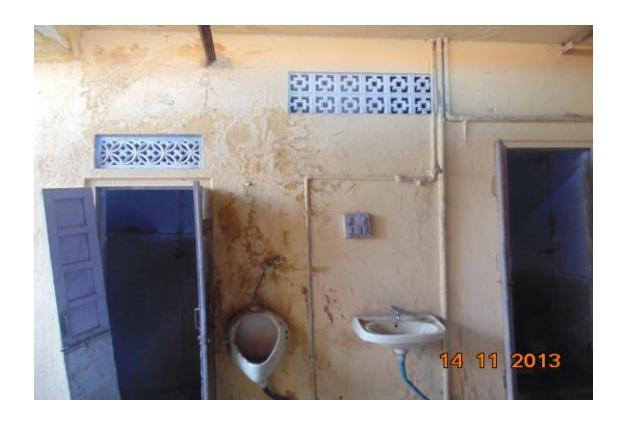
Photo 39 Dampness/Seepage on Wall No. 3 of Varanda of House No. D-1, Second Floor

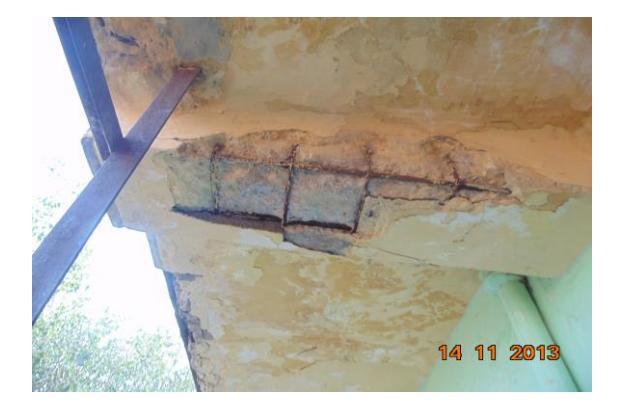
Photo 40 Damaged Portion on Roof of Varanda of House No. D-1, Second Floor

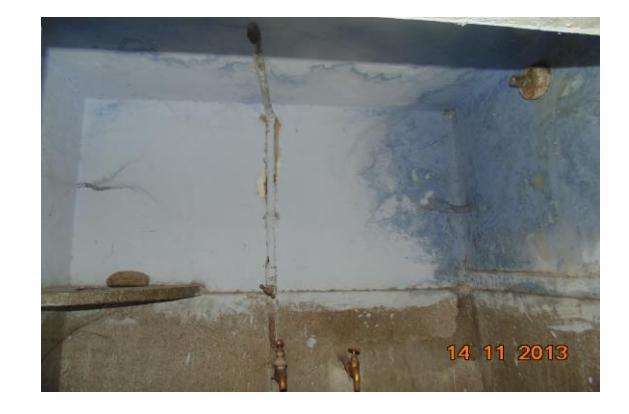
Photo 41 Dampness/Seepage on Wall No. 4, 2 & Roof of Bathroom of House No. D-1, Second Floor

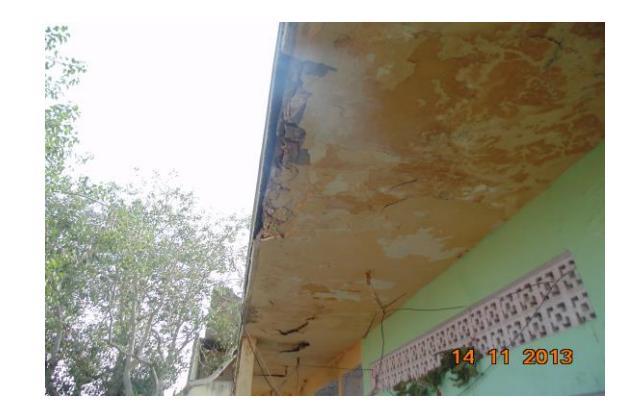
Photo 42 Damaged Portion on Shade of Varanda 3 of House No. D-1, Second Floor

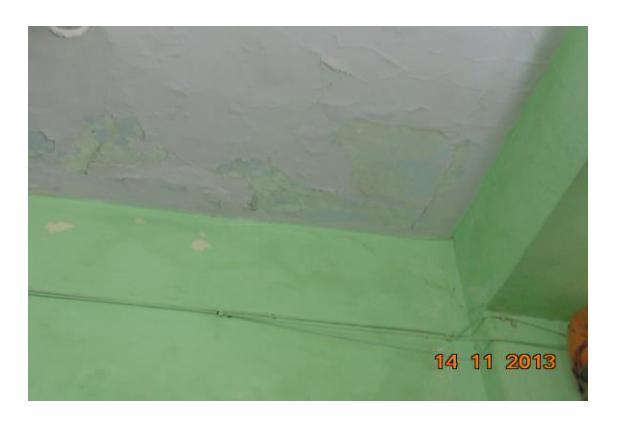
Photo 44 Dampness/Seepage on Roof of Room No. 6 of House No. D-1, Second Floor

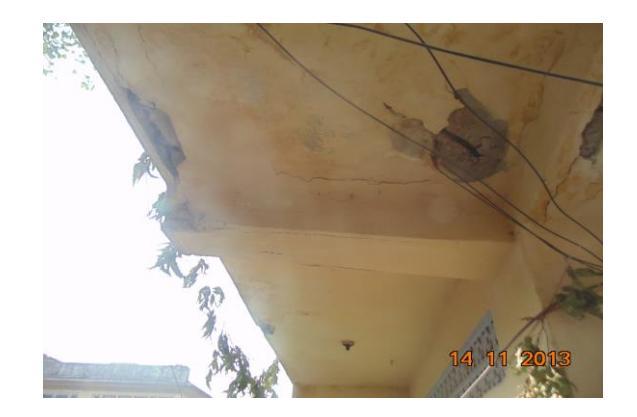
Photo 46 Damaged Portion on Roof of Balcony 2 of House No. D-1, Second Floor

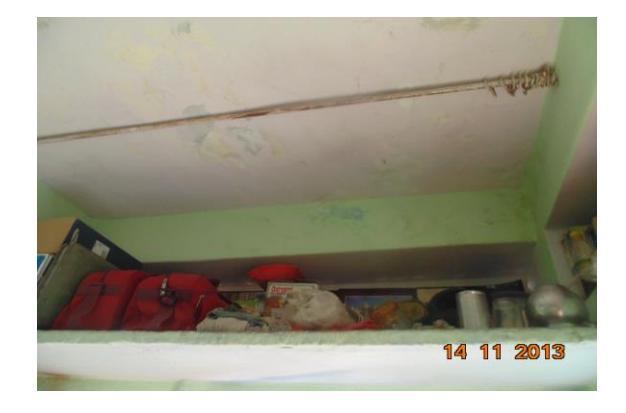
Photo 48 Dampness/Seepage on Wall No. 3 & Roof of Room No. 4 of House No. D-1, Second Floor

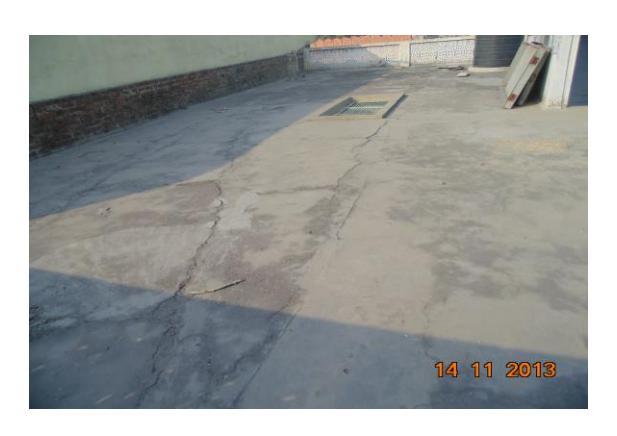
Photo 49

Plaster Crack on Floor of Terrace of House No. D-1, Terrace

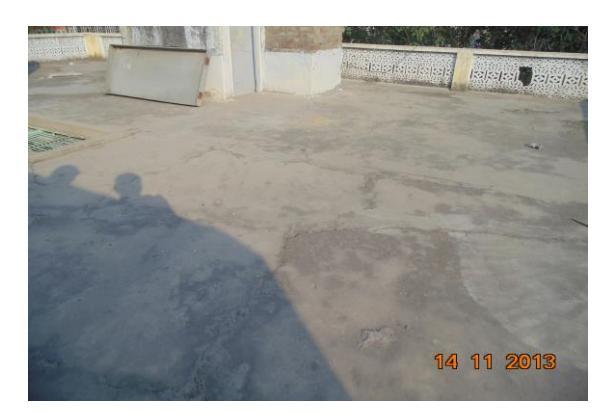
Photo 50 Plaster Crack on Floor of Terrace of House No. D-1, Terrace

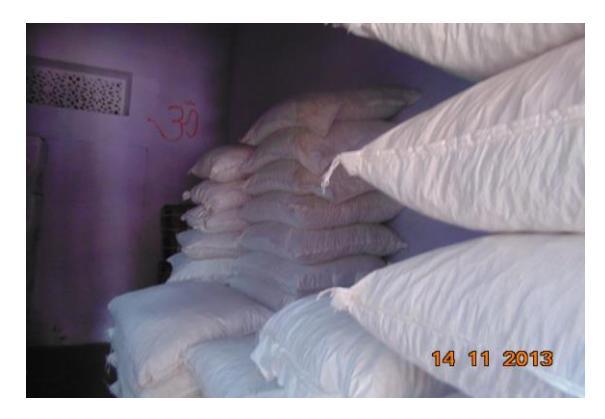
Photo 51 Wall No. 2 of Room No. 2 of House No. D-1, Ground Floor Covered with Material

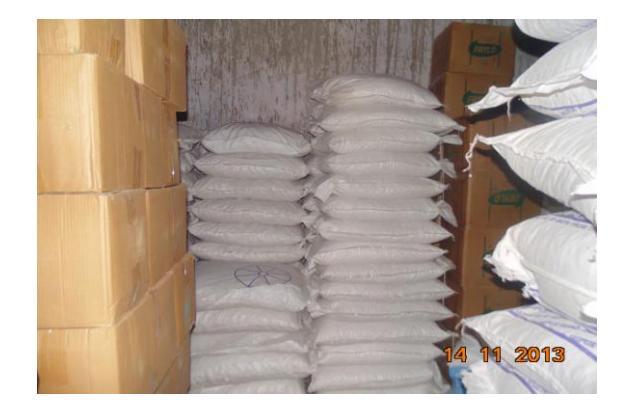
Photo 52 All wall of Hall No. 2 of House No. D-1, Ground Floor Covered with Material

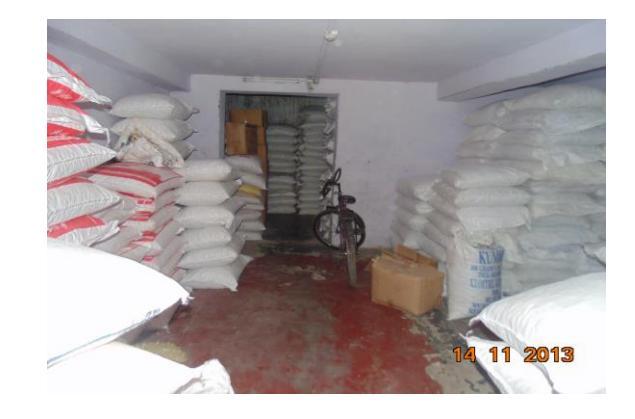
Photo 53 Wall No. 1 & 2 of Room No. 4 of House No. D-1, Ground Floor Covered with Material

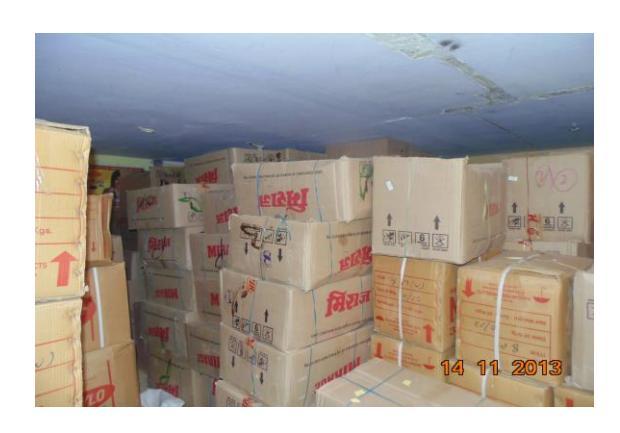
Photo 54 Wall No. 1 & 2 of Hall No. 1 of House No. D-1, Ground Floor Covered with Material

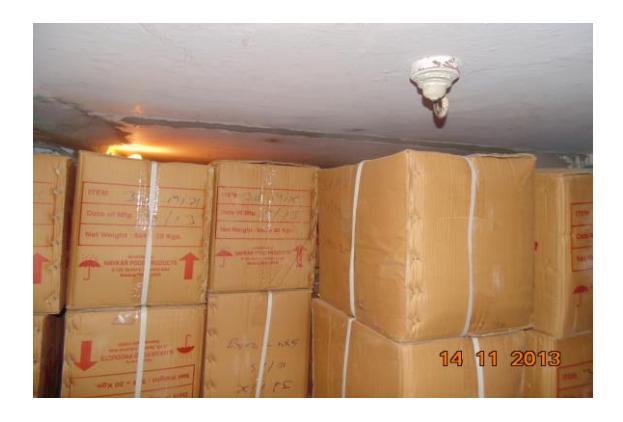
Photo 56 All wall of Lobby of House No. D-1, First Floor Covered with Material

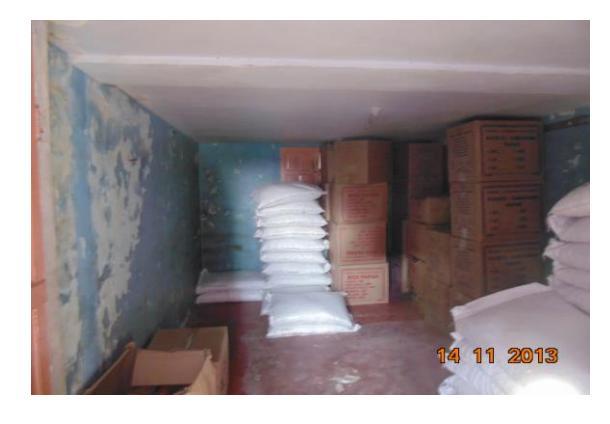
Photo 57 All wall of Room No. 3 of House No. D-1, First Floor Covered with Material

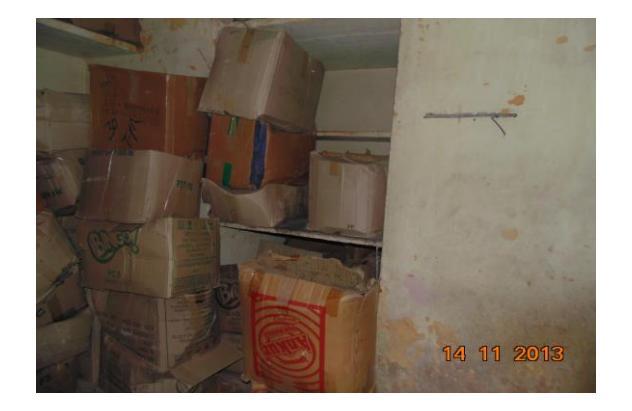
Photo 58 Wall No. 4 of Room No. 1 of House No. D-1, Second Floor Covered with Material

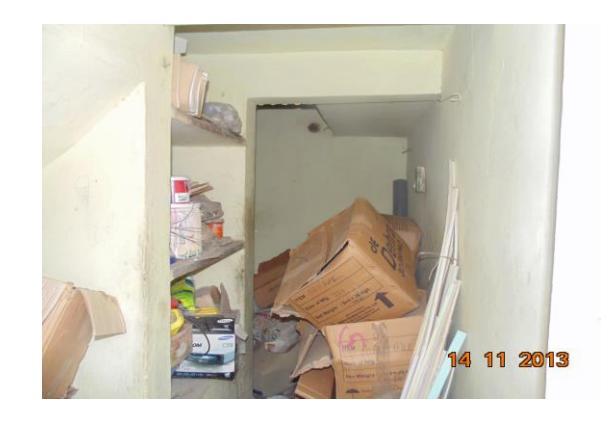
Photo 59 Store of House No. D-1, Second Floor Covered with Material

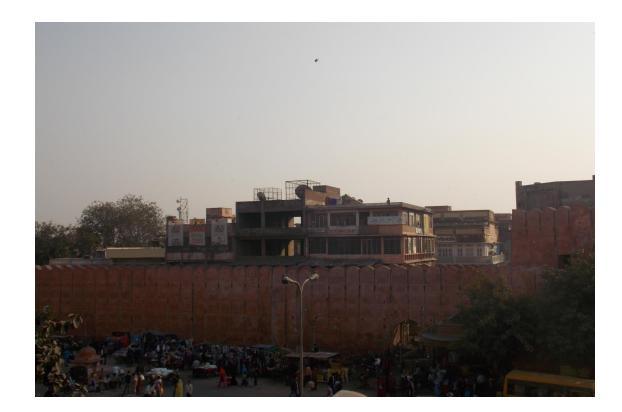
Photo 1 R/S Compound wall (towards CP to CC)

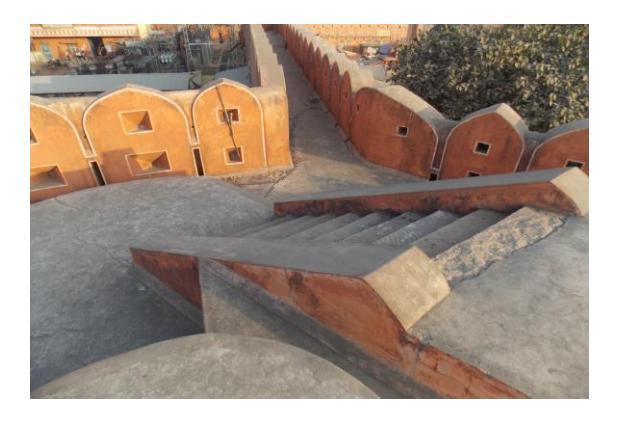
Photo 2 General View of Terrace of left side compound Wall Towards CP To CC, Terrace of G/F (L/S Compound Wall)

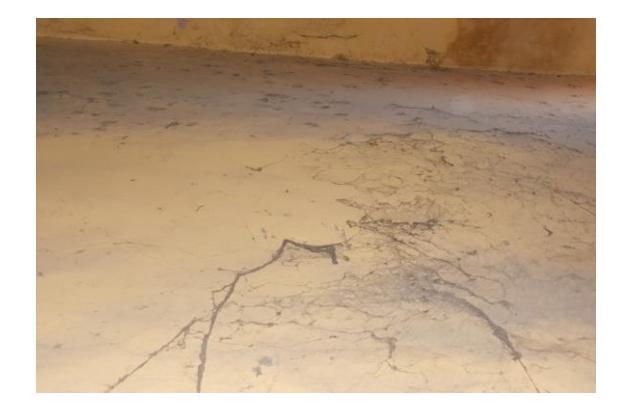
Photo 7 Wall No. 4 of Stair Case is Tilted according to normal Verticality, Terrace of G/F (L/S Compound Wall)

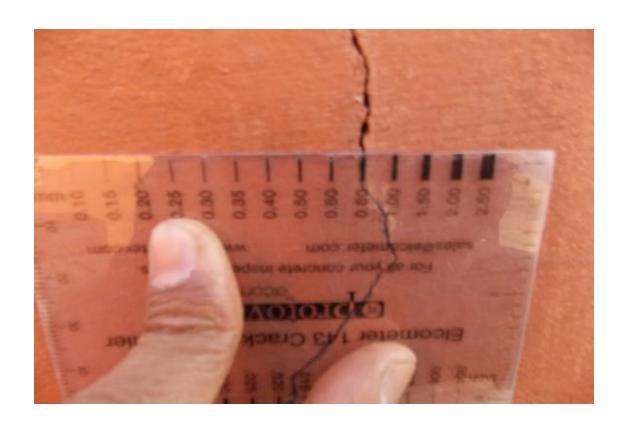
Photo 10A

Inclined Crack on of L/s Vertical Slab No.63, Terrace of G/F (L/S Compound Wall), Approx. Width = 0.8mm, Approx. Length = 1.6m. Distance from Slab No.62 = 1.38m, Height from Floor = 0m.

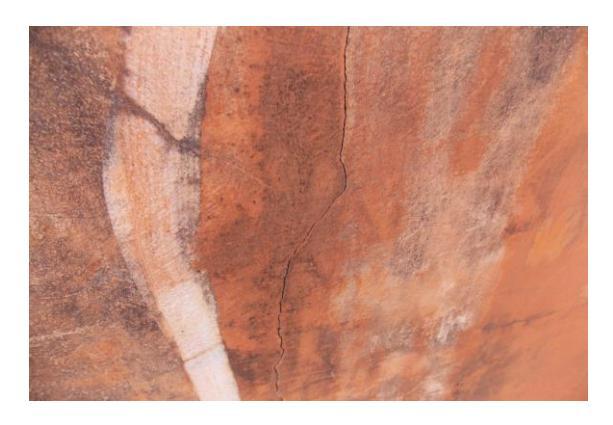
Photo 11 Inclined Crack on of L/S Vertical Slab No.76, Terrace of G/F (L/S Compound Wall),Approx. Width = 0.6mm, Approx. Length = 1.3m. Distance from Slab No. 75 = 0.13m, Height from Floor = 0m.

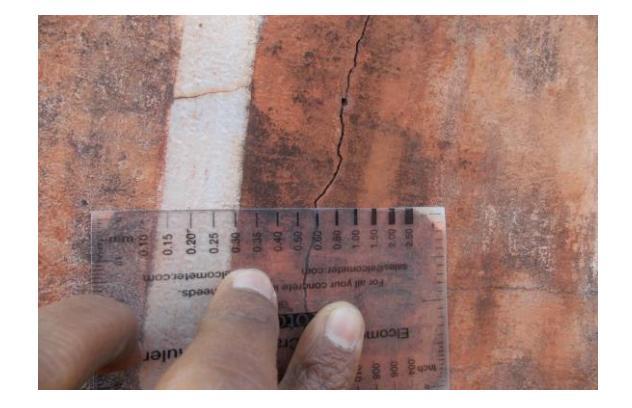
Photo 11A

Inclined Crack on of L/S Vertical Slab No.76, Terrace of G/F (L/S Compound Wall), Approx. Width = 0.6mm, Approx. Length = 1.3m. Distance from Slab No. 75 = 0.13m, Height from Floor = 0m.

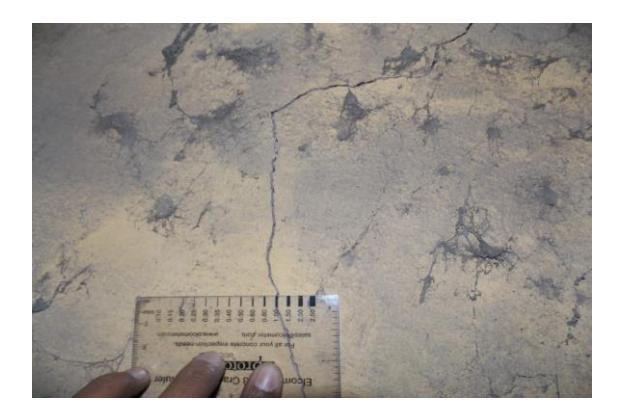
Photo 13A

Inclined Crack on of Stair Case GF to Terrace, Terrace of G/F (L/S Compound Wall),Approx. Width = 1mm, Approx. Length = 3m. Distance from Wall 2 = 2.5m, Height from Floor = 0.8m.

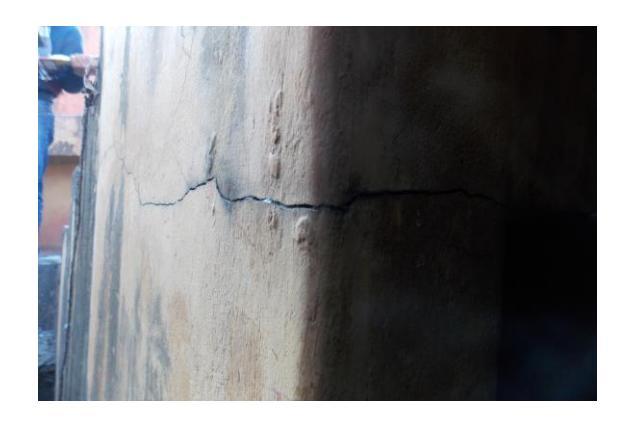
Photo 12 Horizontal Crack on of Stair Case GF to Terrace, Terrace of G/F (L/S Compound Wall),Approx. Width = 0.5mm, Approx. Length = 1.1m. Distance from Wall 7 = 1.42m, Height from Floor = 1.6m.

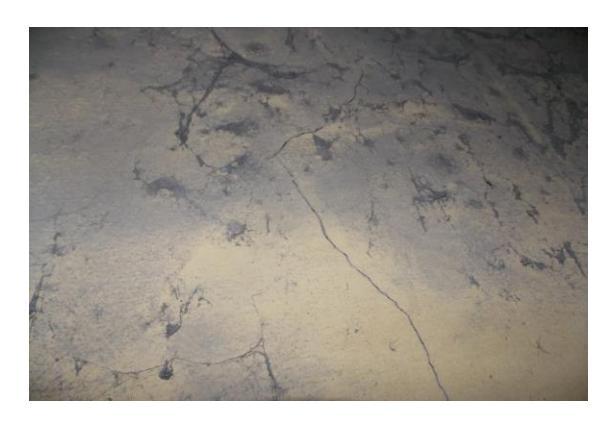
Photo 13

Inclined Crack on of Stair Case GF to Terrace, Terrace of G/F (L/S Compound Wall), Approx. Width = 1mm, Approx. Length = 3m. Distance from Wall 2 = 2.5m, Height from Floor = 0.8m.

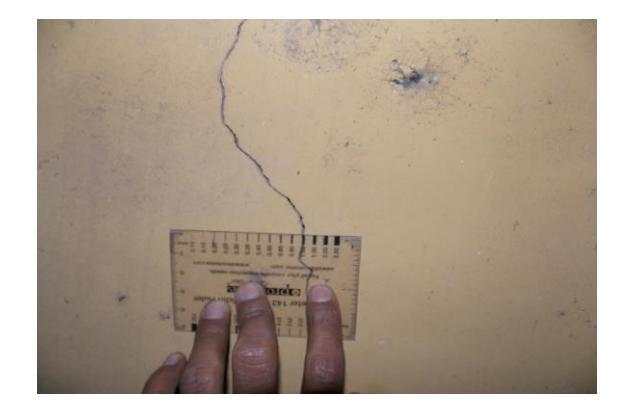
Photo 14A Inclined Crack on of Stair Case GF to Terrace, Terrace of G/F (L/S Compound Wall),Approx. Width = 1mm, Approx. Length = 3m. Distance from Wall 15 = 1.48m, Height from Floor = 0m.

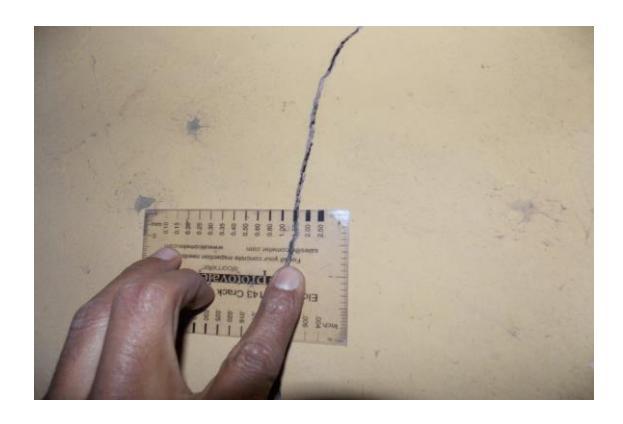
Photo 15A

Inclined Crack on of Stair Case GF to Terrace, Terrace of G/F (L/S Compound Wall), Approx. Width = 1.5mm, Approx. Length = 2.2m. Distance from Wall 15 = 1.6m, Height from Floor = 0m.

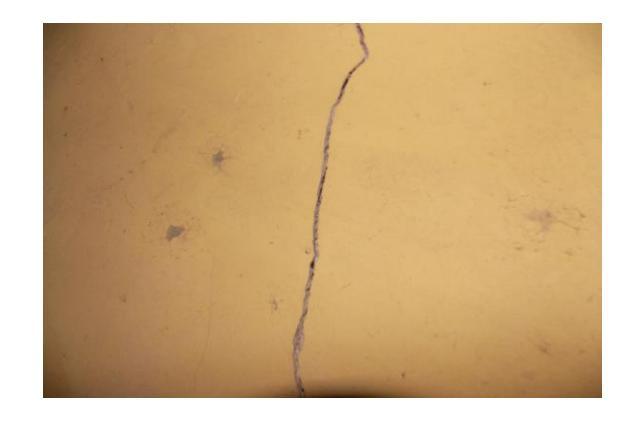
Photo 15 Inclined Crack on of Stair Case GF to Terrace, Terrace of G/F (L/S Compound Wall),Approx. Width = 1.5mm, Approx. Length = 2.2m. Distance from Wall 15 = 1.6m, Height from Floor = 0m.

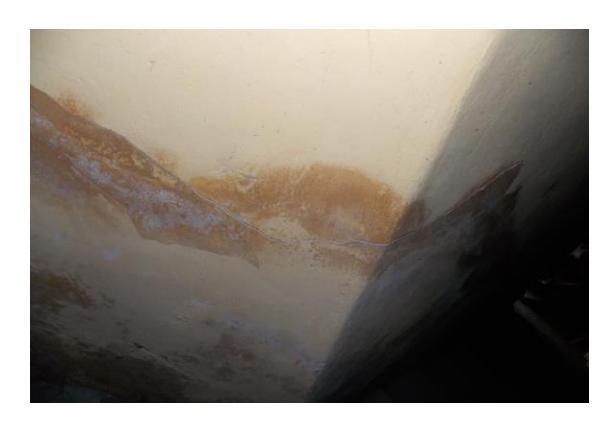
Photo 16

Inclined Crack on of Stair Case GF to Terrace, Terrace of G/F (L/S Compound Wall), Approx. Width = 1.5mm, Approx. Length = 2.2m. Distance from Wall 15 = 2.2m, Height from Floor = 0.9m.

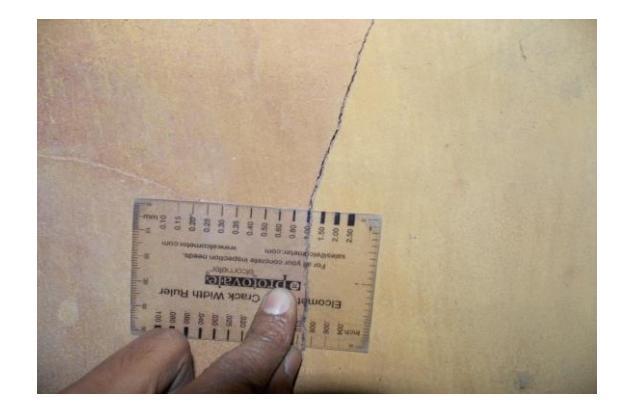
Photo 17A Inclined Crack on of Stair Case GF to Terrace, Terrace of G/F (L/S Compound Wall) Approx. Width = 1mm, Approx. Length = 2.4m. Distance from Wall 15 = 0.25m, Height from Floor = 0m.

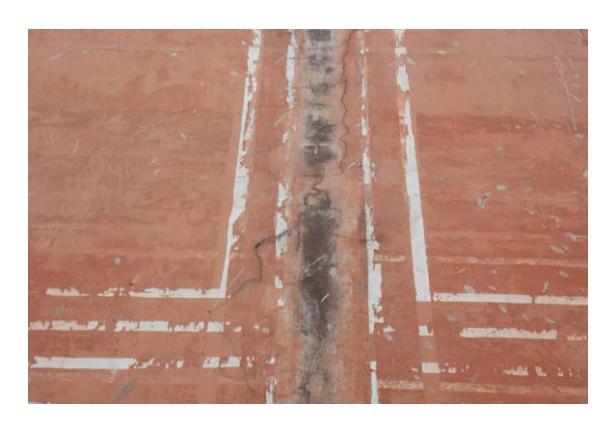
Photo 20 Inclined Crack on of Vertical Slab no.1&2, Approx. Width = 0.8mm, Approx. Length = 4.5m. Distance from Slab No. 2 = 0.1m, Height from Floor = 2m.

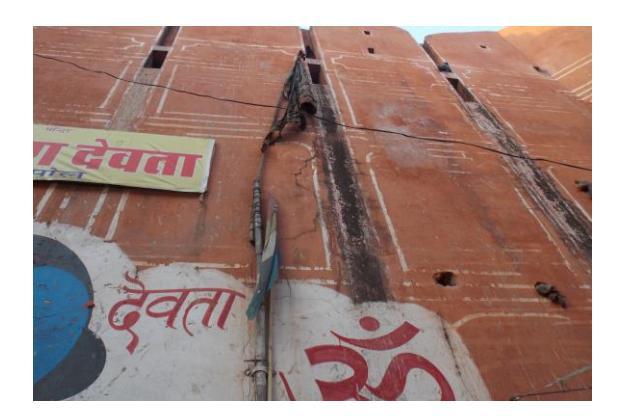
Photo 21 Inclined Crack on of Vertical Slab no.5, Approx. Width = 1mm, Approx. Length = 4m. Distance from Slab No. 6 = 0.5m, Height from Floor = 2m.

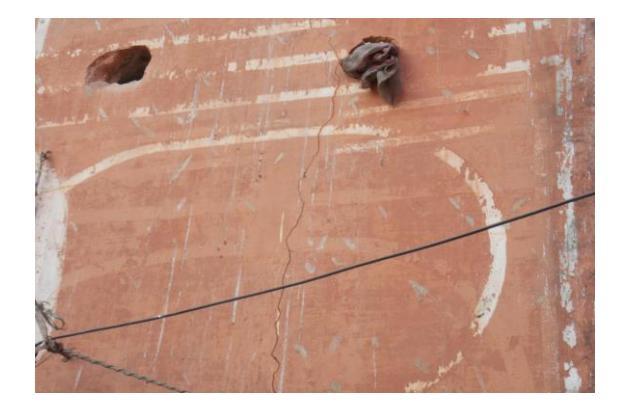
Photo 22 Inclined Crack on of Vertical Slab no.6, Approx. Width = 0.6mm, Approx. Length = 1.5m. Distance from Slab No.7 = 0.6m, Height from Floor = 2m.

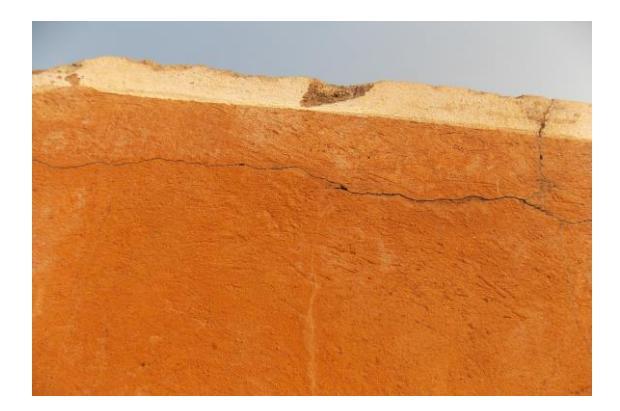
Photo 43 Plaster Crack on of L/s Vertical Slab No.42 of Terrace of G/F (L/S Compound Wall)

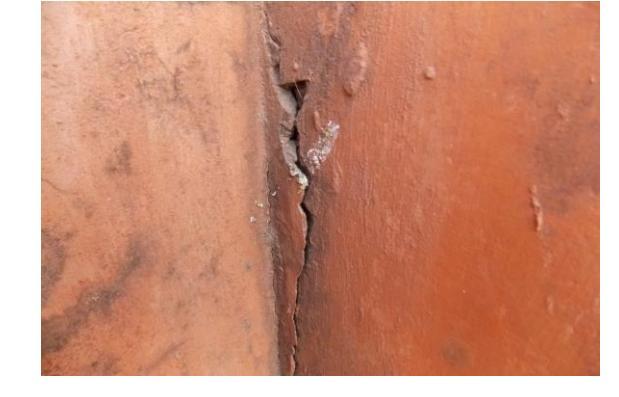
Photo 44 Plaster Crack on of L/s Vertical Slab No.44 of Terrace of G/F (L/S Compound Wall)

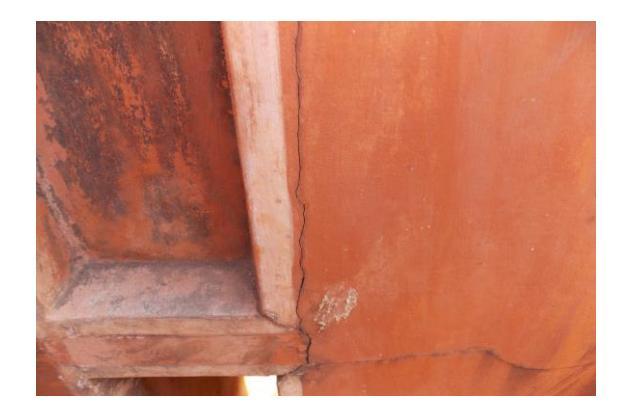
Photo 45 Damaged Portion on of L/s Vertical Slab No.45 (Joint Opening) of Terrace of G/F (L/S Compound Wall)

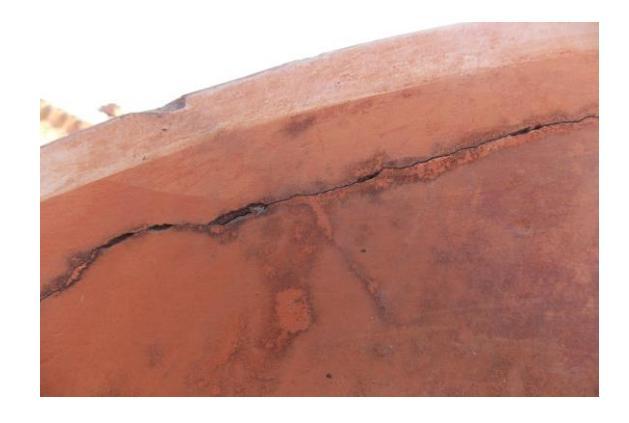
Photo 46 Plaster Crack on of L/s Vertical Slab No.46 of Terrace of G/F (L/S Compound Wall)

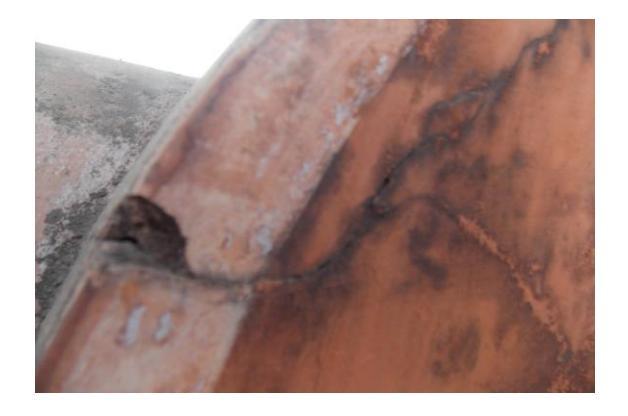
Photo 47 Plaster Crack on of L/s Vertical Slab No.47 of Terrace of G/F (L/S Compound Wall)

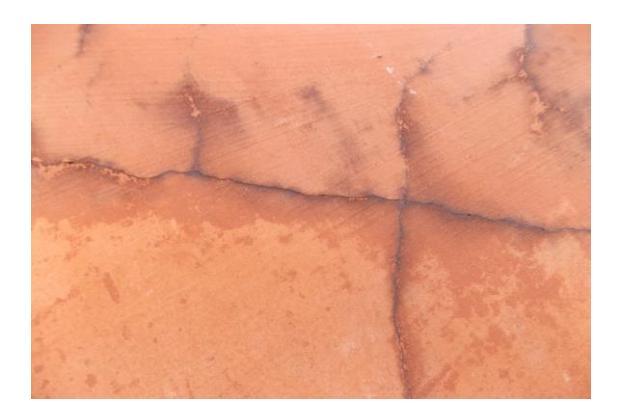
Photo 49 Plaster Crack on of L/s Vertical Slab No.50 of Terrace of G/F (L/S Compound Wall)

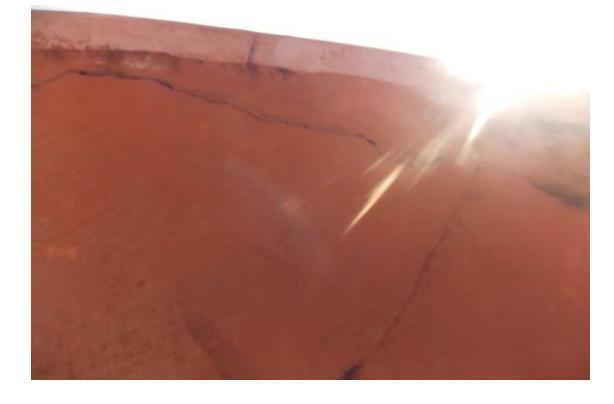
Photo 50 Plaster Crack on of L/s Vertical Slab No.51 of Terrace of G/F (L/S Compound Wall)
