Pre Building Condition Survey Report

Name of the Project	Contract JMRC-UG1B "Design and Construction of Tunnel between Chandpole and Badi Chouper and reverse line by Shield TBM, Underground Metro Stations at Choti Chouper and Badi Chouper by Cut and Cover Methods on East West Corridor of Jaipur Metro Rail Corporation Limited ."		
Owner :	JAIPUR METRO	Jaipur Metro Rail Corporation	
Contractor :	VUV	Continental Engineering Corporation	
Survey Agency :	Aimil I Instrumentation	tion & Technologies

Pre Building Condition Survey Report Chand Pole to Choti Chopar (UP Line)

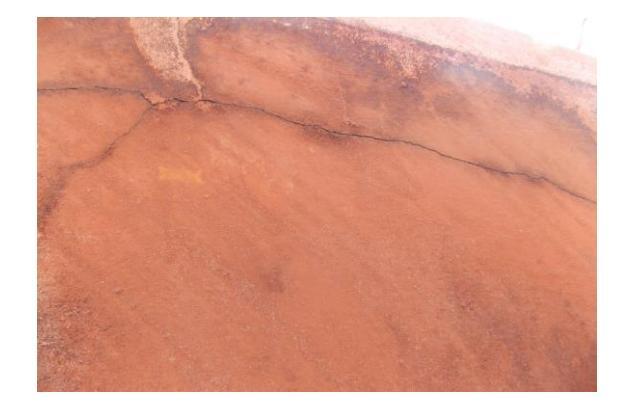
Photo 51 Plaster Crack on of L/s Vertical Slab No.52 of Terrace of G/F (L/S Compound Wall)

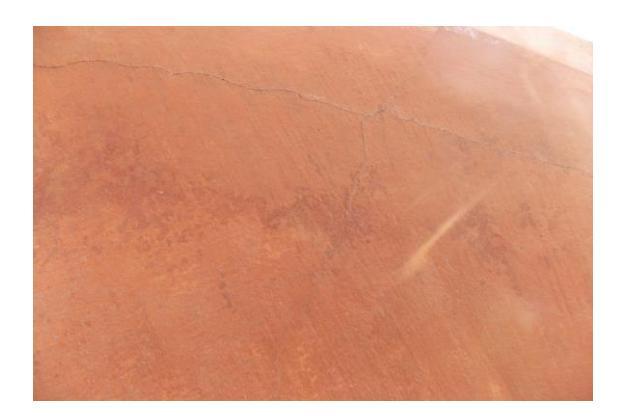
Photo 55 Plaster Crack on of L/s Vertical Slab No.63 of Terrace of G/F (L/S Compound Wall)

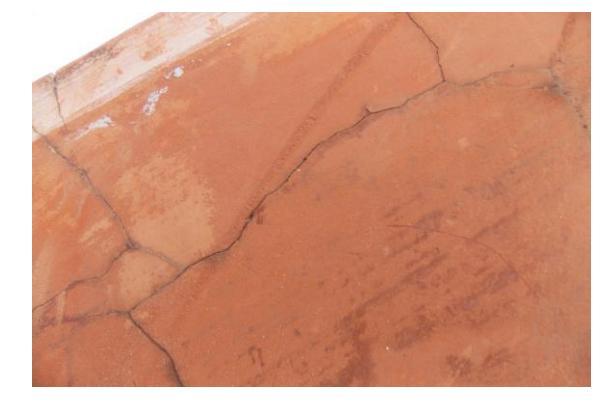
Photo 56 Plaster Crack on of L/s Vertical Slab No.64 of Terrace of G/F (L/S Compound Wall)

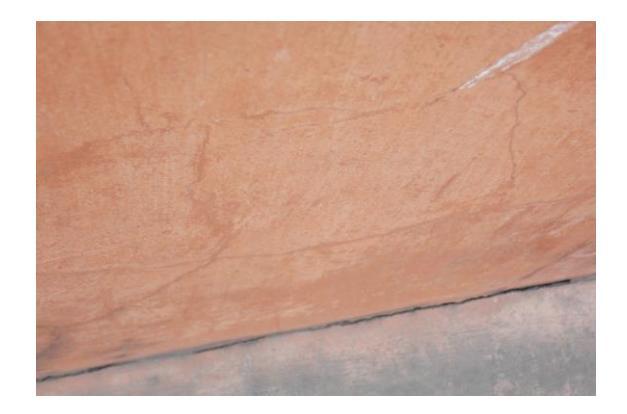
Photo 57 Plaster Crack on of L/s Vertical Slab No.65 of Terrace of G/F (L/S Compound Wall)

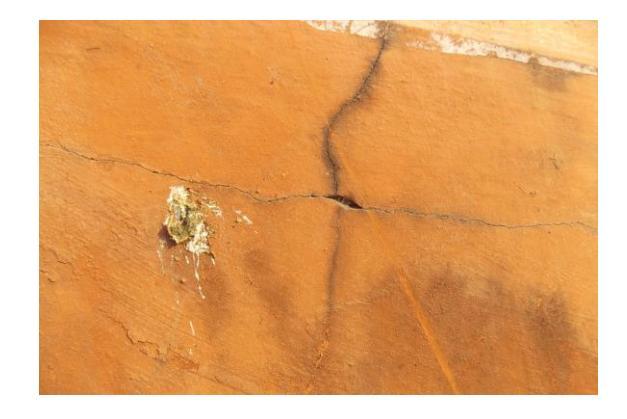
Photo 58 Damaged Portion on of L/s Vertical Slab No.65 (Joint Opening) of Terrace of G/F (L/S Compound Wall)

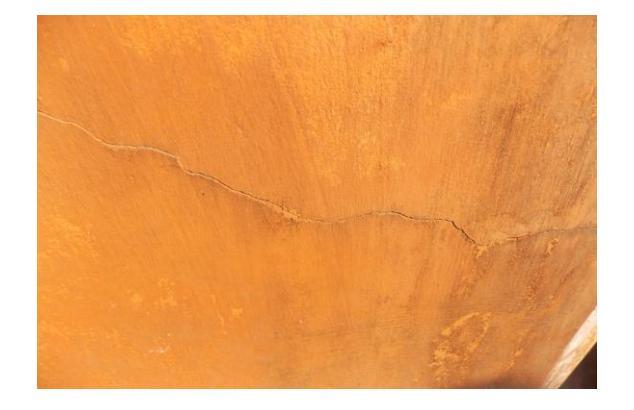
Photo 59 Plaster Crack on of L/s Vertical Slab No.66 of Terrace of G/F (L/S Compound Wall)

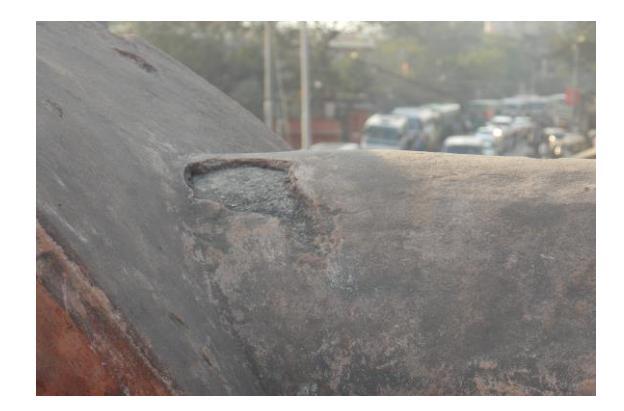
Photo 61 Plaster Crack on of L/s Vertical Slab No.68 of Terrace of G/F (L/S Compound Wall)

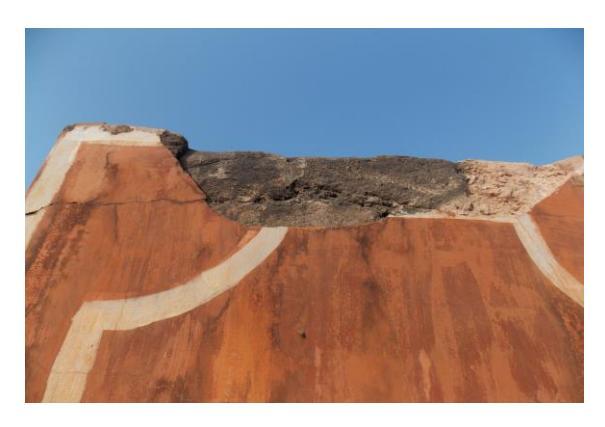
Photo 62 Peeling of Plaster on Top of Slab No. 72 & 73 of Terrace of G/F (L/S Compound Wall)

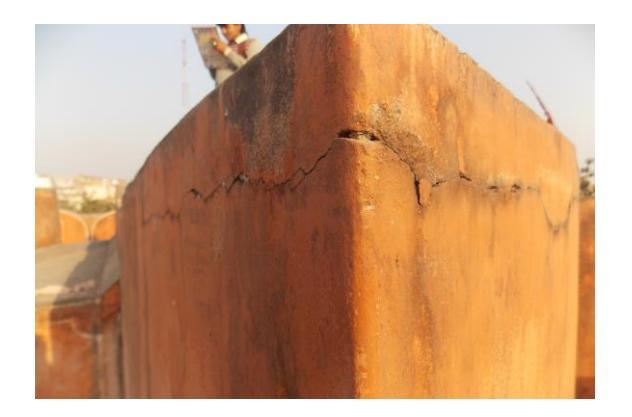
Photo 64 Plaster Crack on Center pillar outer wall 5&6 of Terrace of G/F (L/S Compound Wall)

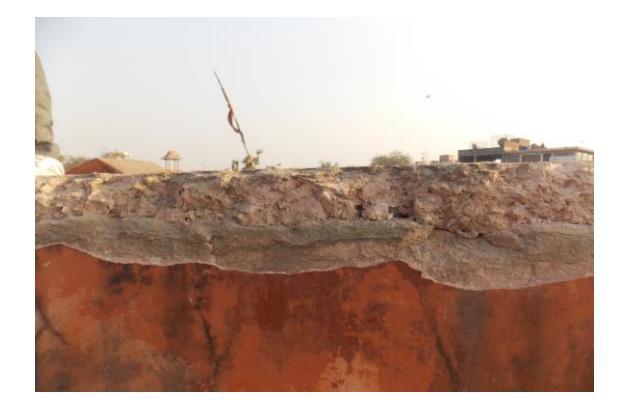
Photo 65 Peeling of Plaster on Center pillar Wall 6 of Terrace of G/F (L/S Compound Wall)

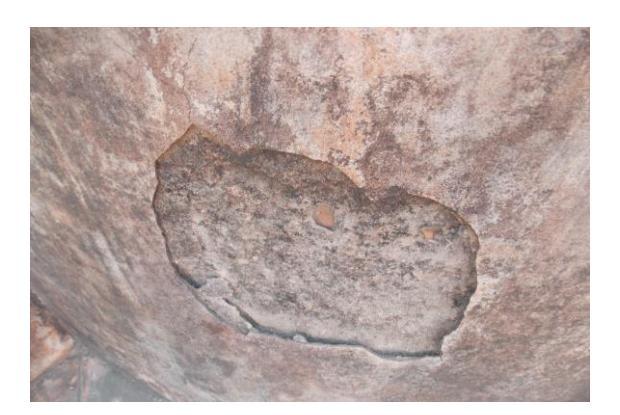
Photo 68 Peeling of Plaster on Center pillar wall 12 of Terrace of G/F (L/S Compound Wall)

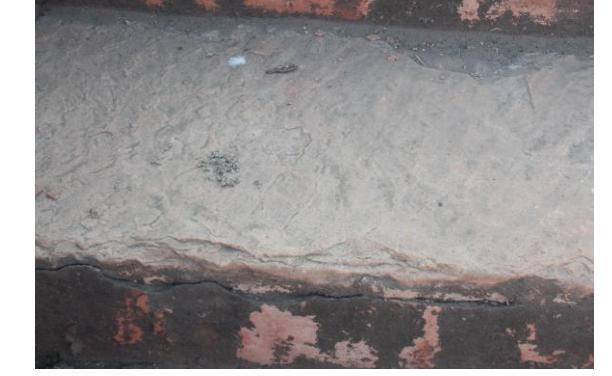
Photo 69 Peeling of Plaster on Stair Step from Terrace to top of Center pillar of Terrace of G/F (L/S Compound Wall)

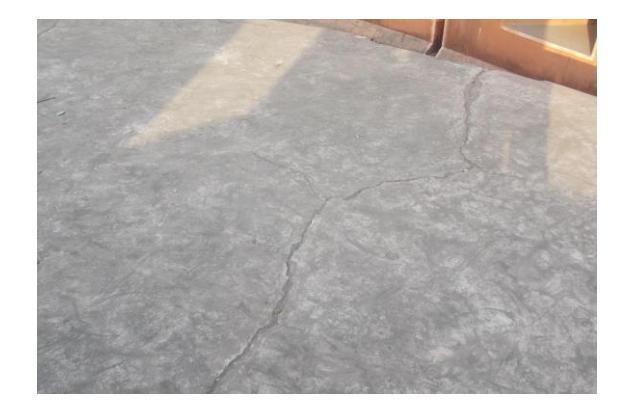
Photo 70 Peeling of Plaster on Floor of center pillar of Terrace of G/F (L/S Compound Wall)

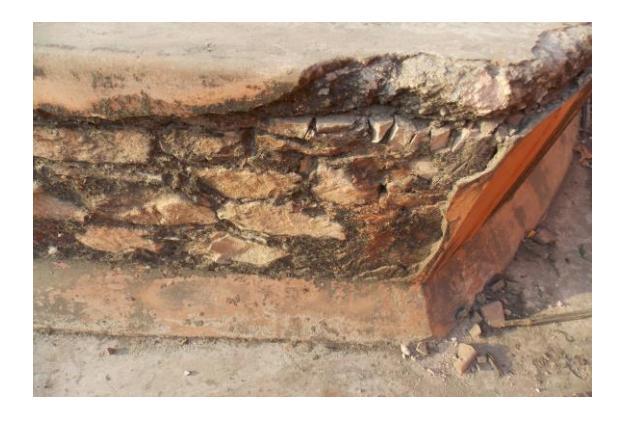
Photo 71
Peeling of Plaster on Pillar 1 outer Wall of Terrace of G/F (L/S
Compound Wall)

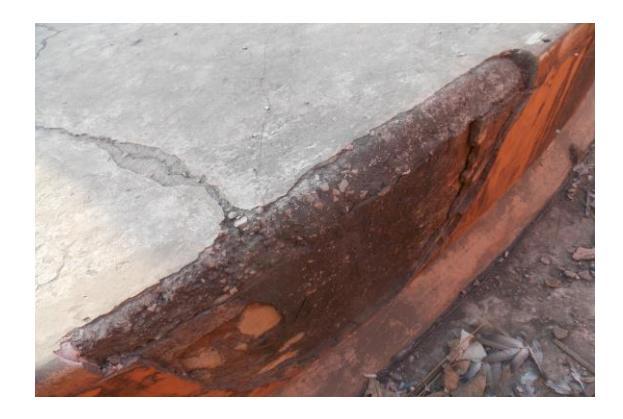
Peeling of Plaster on Pillar 1 outer Wall of Terrace of G/F (L/S Compound Wall)

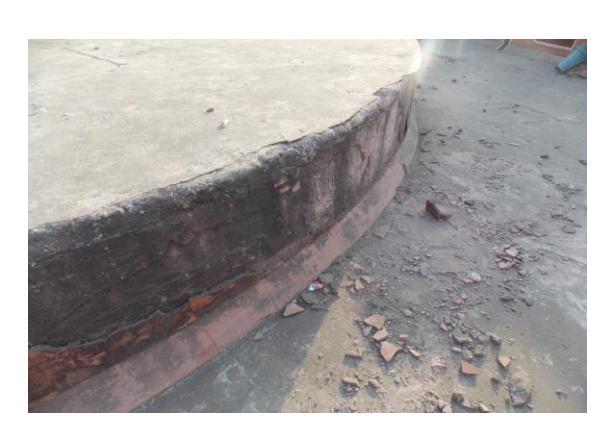
Photo 73 Peeling of Plaster on Pillar 1 outer Wall of Terrace of G/F (L/S Compound Wall)

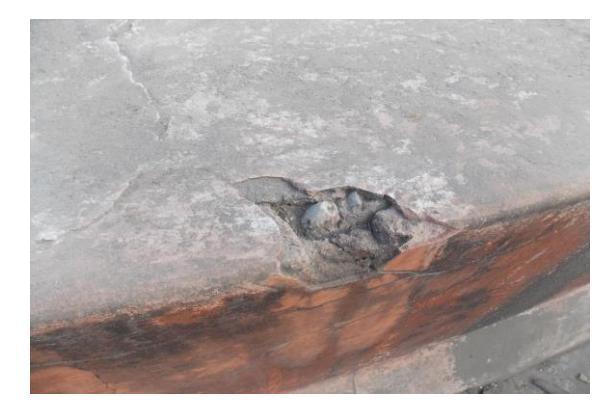
Photo 74 Peeling of Plaster on Pillar 1 outer Wall of Terrace of G/F (L/S Compound Wall)

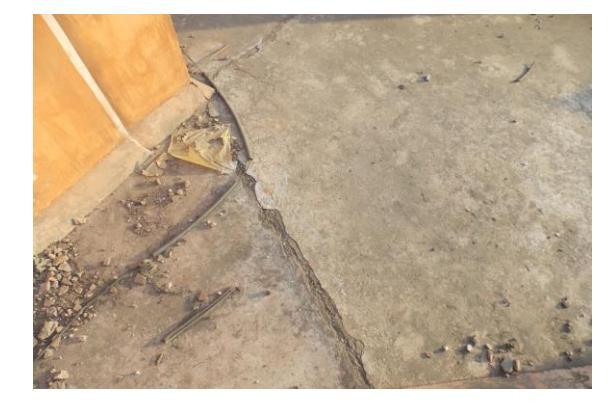
Photo 75 Damaged Portion on Floor of Floor of terrace of Terrace of G/F (L/S Compound Wall)

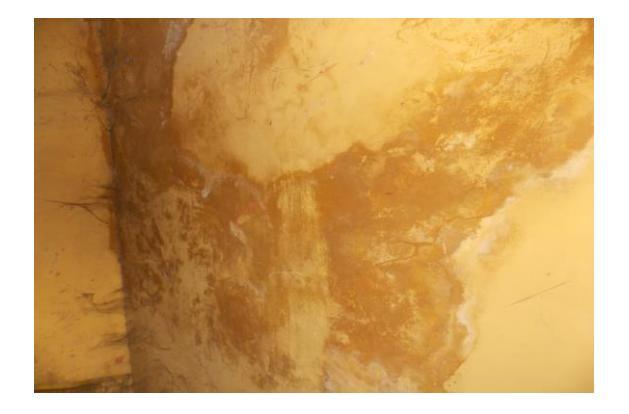
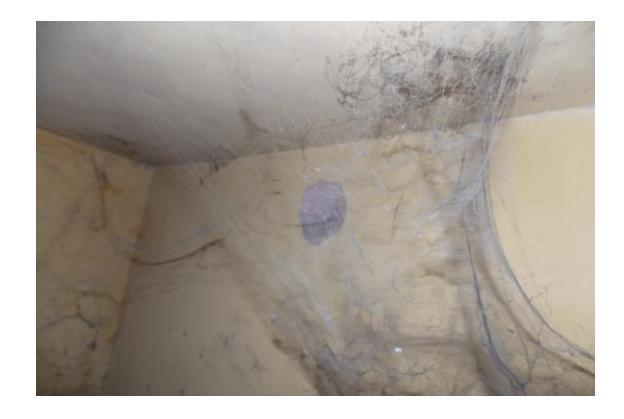
Photo 76
 Photo 7

Dampness/Seepage on Floor of Stair case GF to Terrace of Terrace of Terrace of Peeling of Plaster on Floor of Stair case GF to Terrace of G/F
 G/F (L/S Compound Wall)

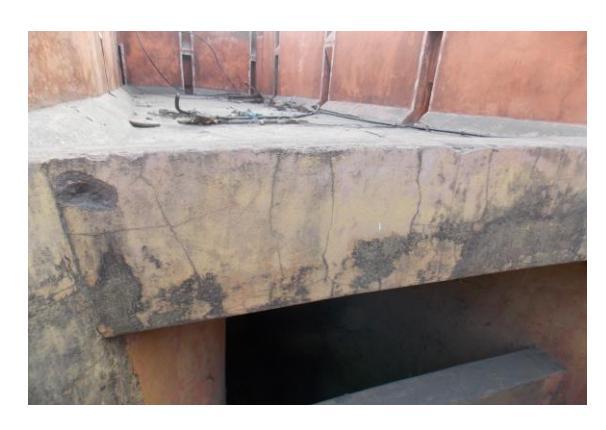
Photo 78 Plaster Crack on of Stair Case GF to Terrace of Terrace of G/F (L/S Compound Wall)

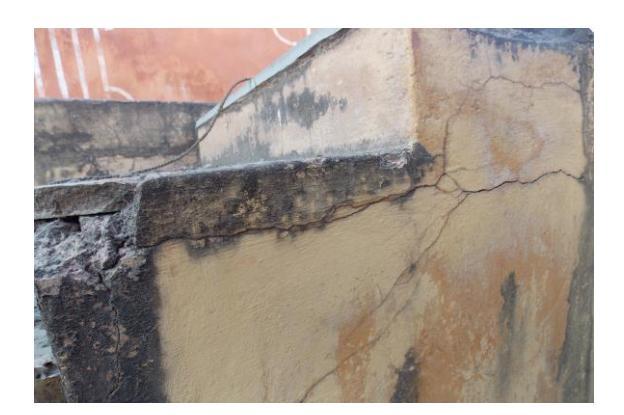
Photo 80 Plaster Crack on Stair Case GF to Terrace of G/F (L/S Compound Wall)

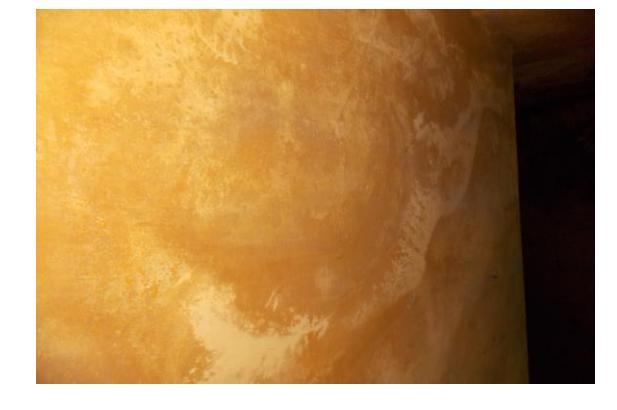
Photo 81 Dampness/Seepage on Stair Case GF to Terrace of Terrace of G/F (L/S Compound Wall)

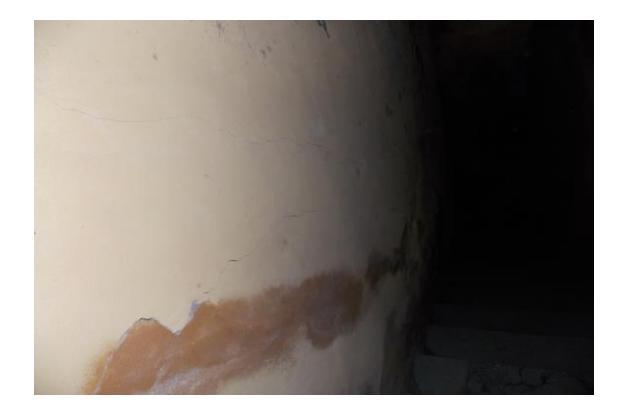
Photo 82 Dampness/Seepage on Stair Case GF to Terrace of Terrace of G/F (L/S Compound Wall)

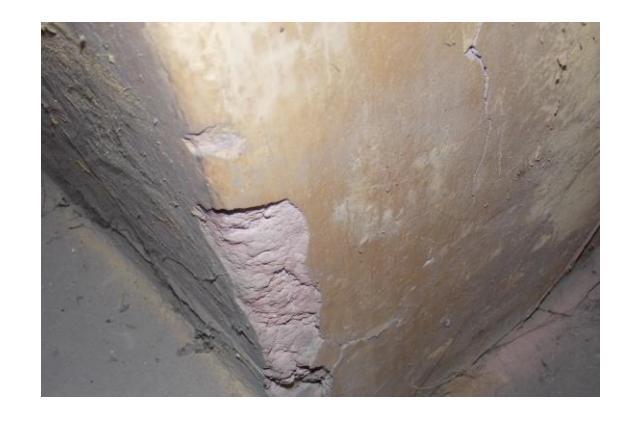
Photo 83 Peeling of Plaster on Stair Case GF to Terrace of G/F (L/S Compound Wall)

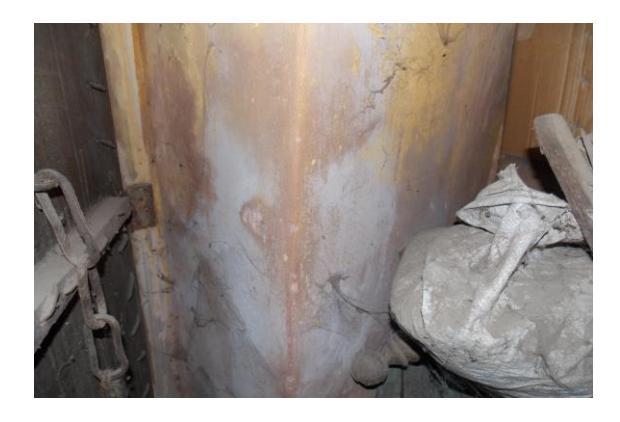
Photo 85 Dampness/Seepage on Roof of Stair Case GF to Terrace of Terrace of G/F (L/S Compound Wall)

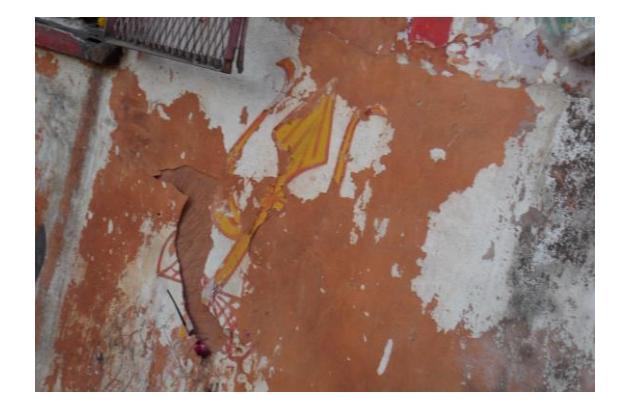
Photo 88 Peeling of Plaster on Vertical Slab no. 5

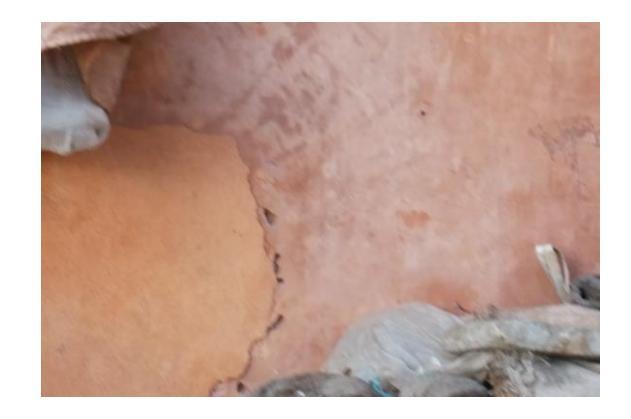
Photo 89 Peeling of Plaster on Vertical Slab no.7

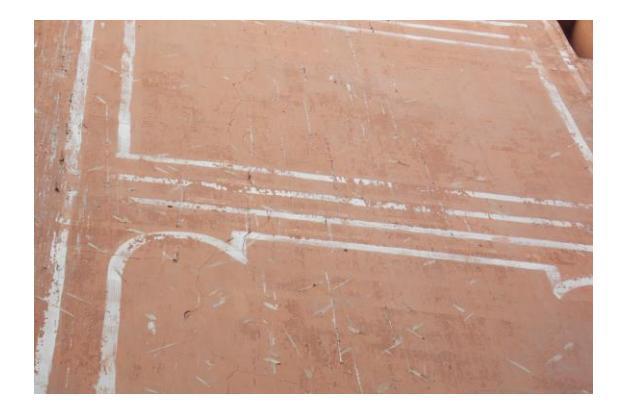
Photo 90 Plaster Crack on Vertical Slab no. 8 & 9

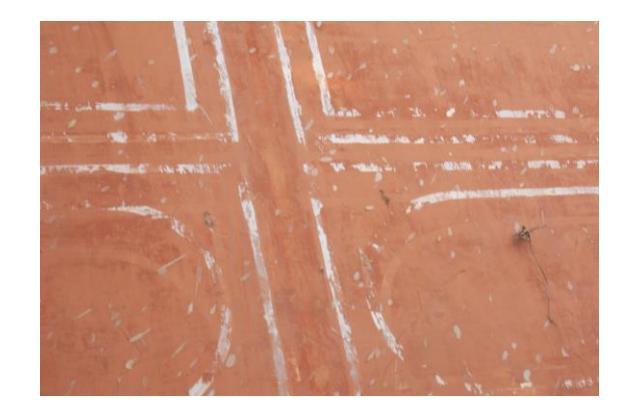
Photo 93 Plaster Crack on Vertical Slab no.15&16

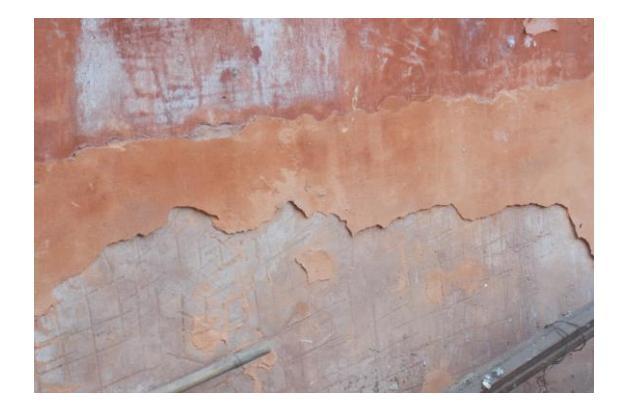
Photo 94 Peeling of Plaster on Vertical Slab no.17&18

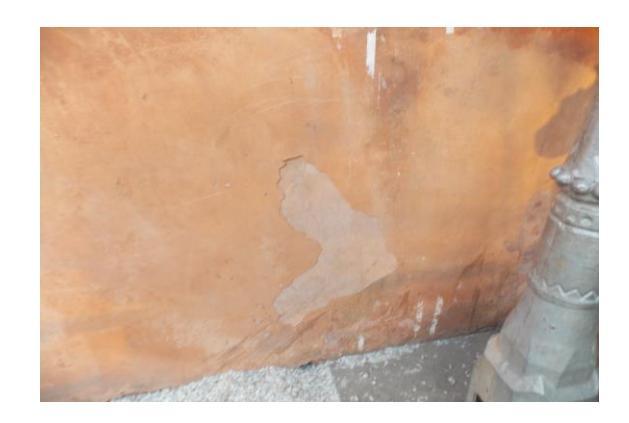
Photo 95 Peeling of Plaster on Vertical Slab no.20

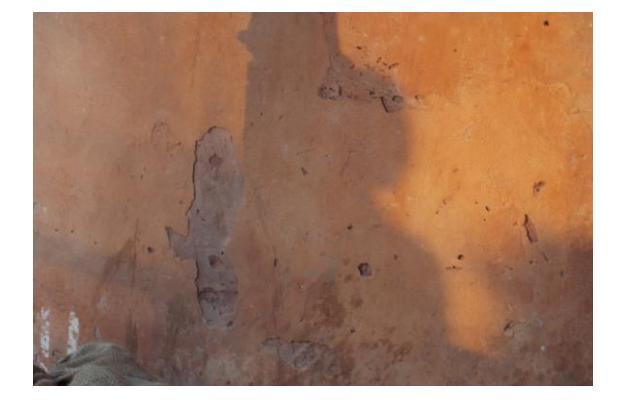
Photo 96 Peeling of Plaster on Vertical Slab no.21

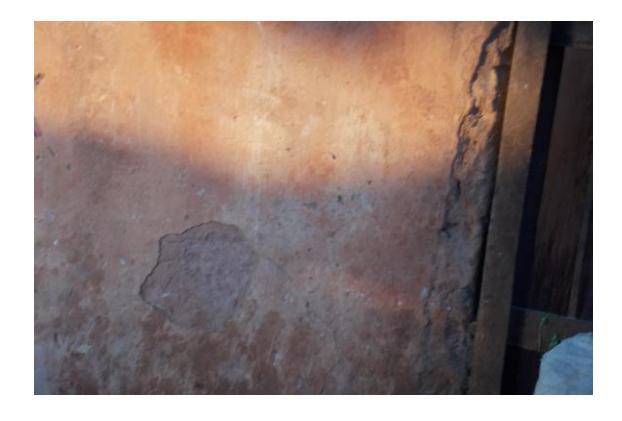
Photo 97 Peeling of Plaster on Vertical Slab no.22

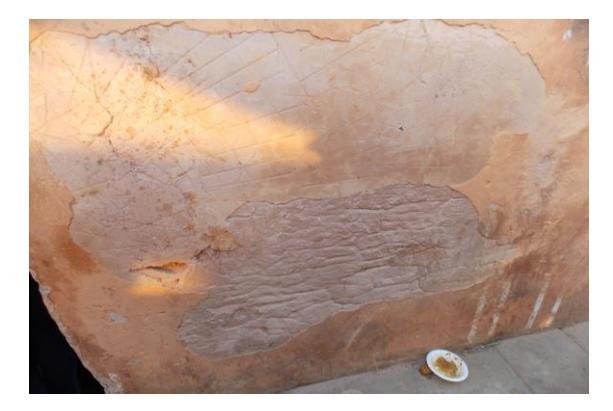
Photo 98 Peeling of Plaster on Vertical Slab no.24

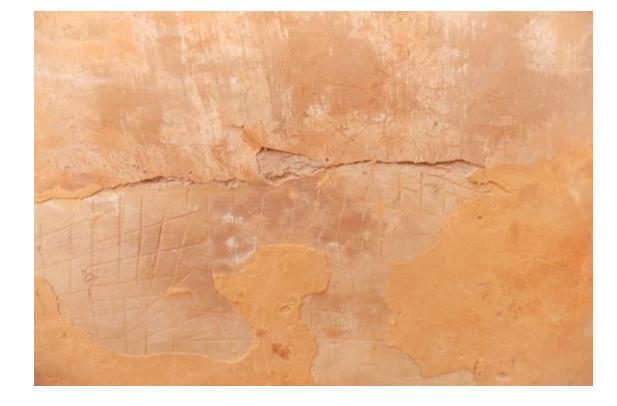
Photo 99 Peeling of Plaster on Vertical Slab no.25

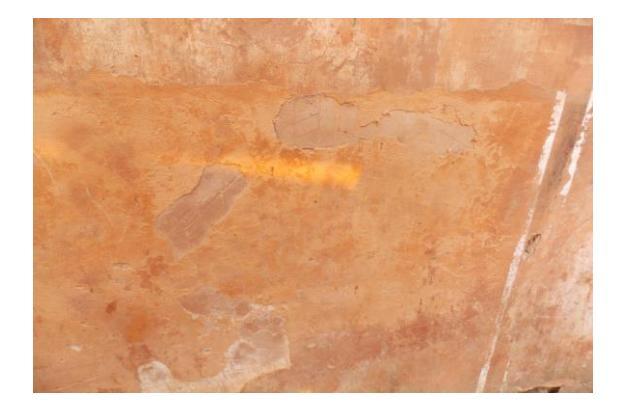
Photo 100 Peeling of Plaster on Vertical Slab no.26

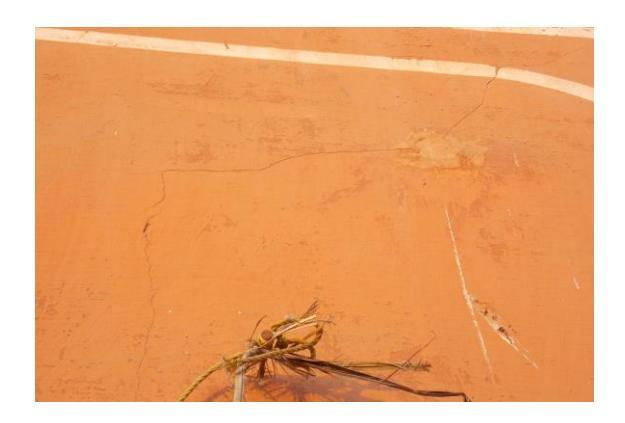
Photo 101 Plaster Crack on Vertical Slab no.26

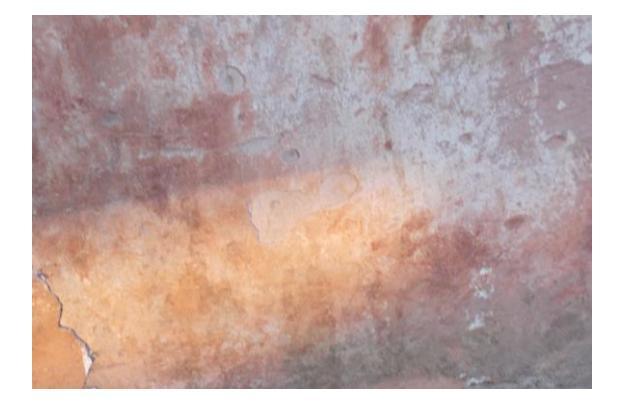
Photo 102 Peeling of Plaster on Vertical Slab no.27

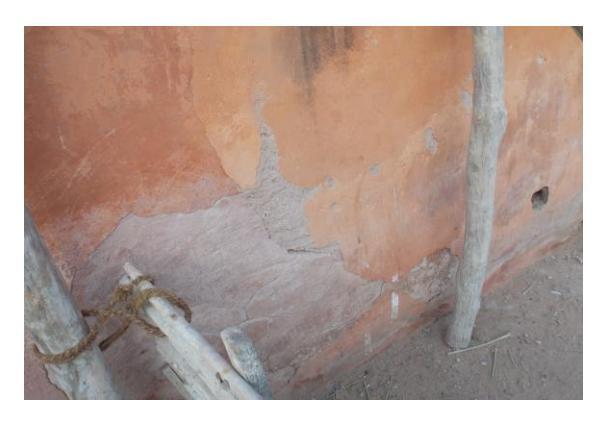
Photo 103 Peeling of Plaster on Vertical Slab no. 28 & 29

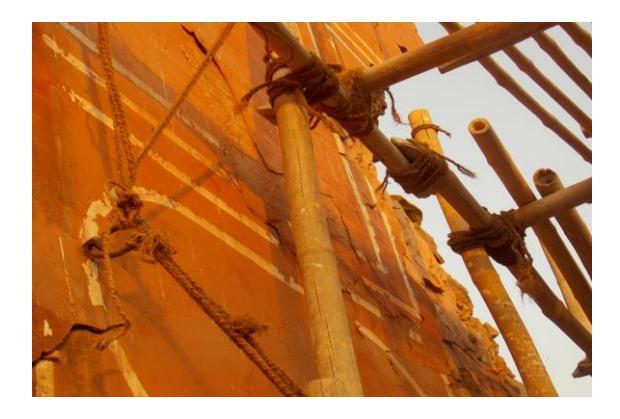
Photo 104 Peeling of Plaster on Vertical Slab no.29

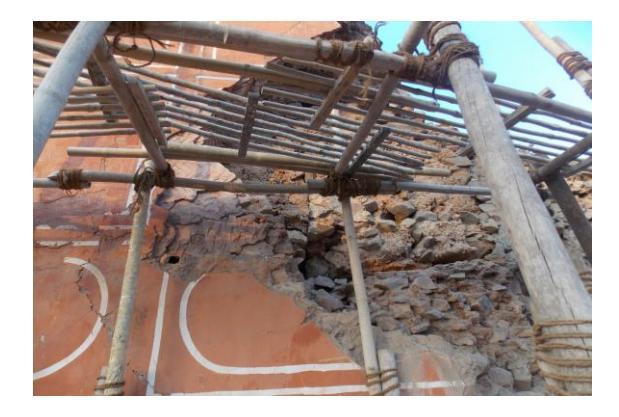
Photo 105 Dampness/Seepage on Vertical Slab no.30

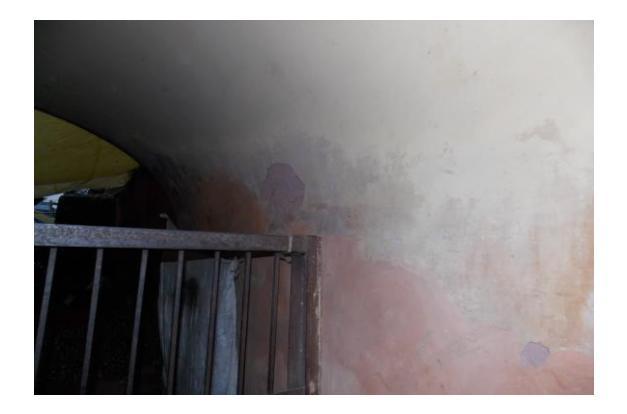
Photo 106 Peeling of Plaster on Gate at Left Side

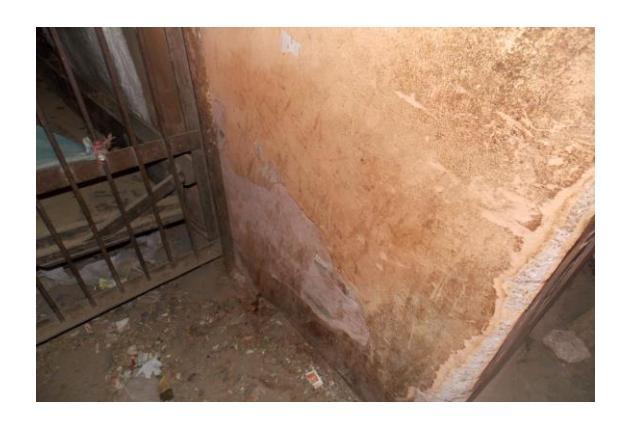
Photo 107 Peeling of Plaster on Gate at Left Side

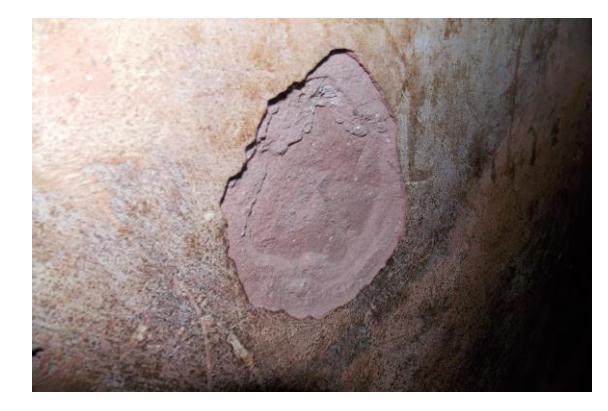
Photo 108 Peeling of Plaster on Gate L/s

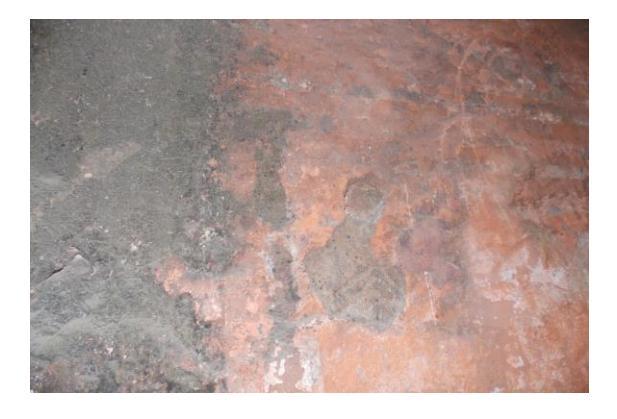
Photo 109 Peeling of Plaster on inside L/s Gate

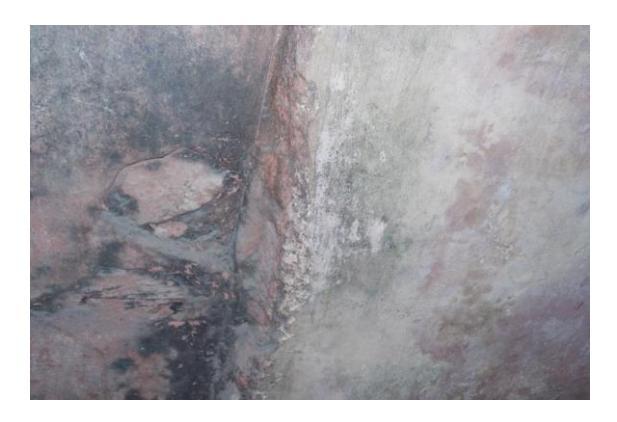
Photo 110 Peeling of Plaster on inside/ Back Side L/s Gate

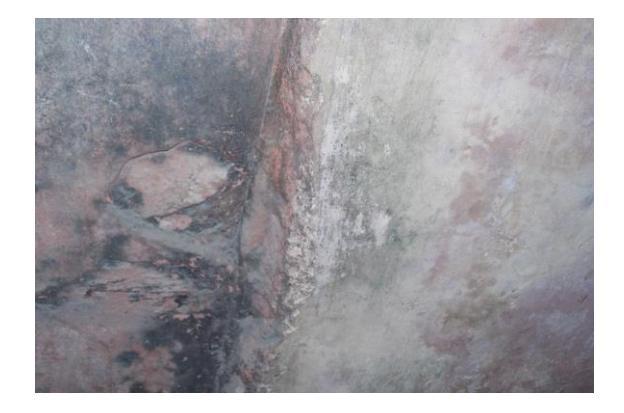
Photo 111 Peeling of Plaster on inside/ Back Side L/s Gate

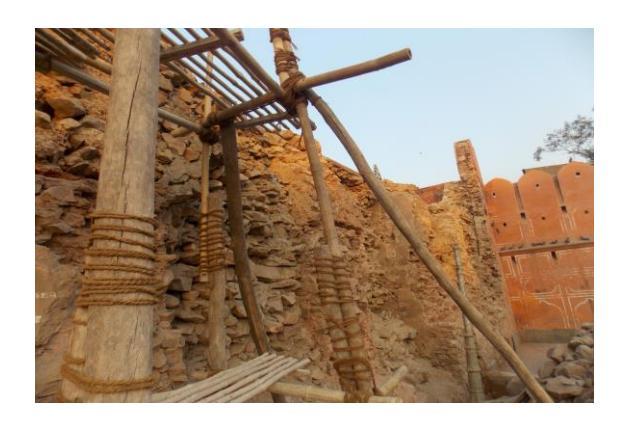
Photo 2 Damaged Portion on of Vertical Slabs/ Wall

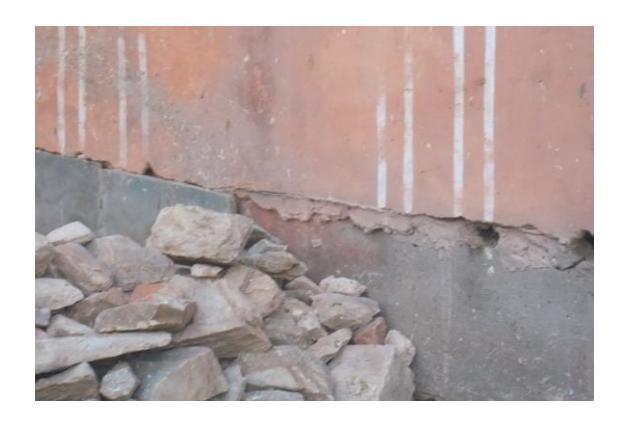
Photo 2 Peeling of Plaster on of Vertical Slab No. 64

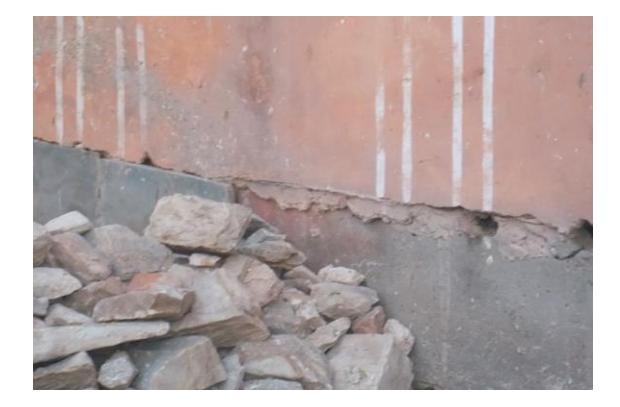
Peeling of Plaster on of Vertical Slab No. 63

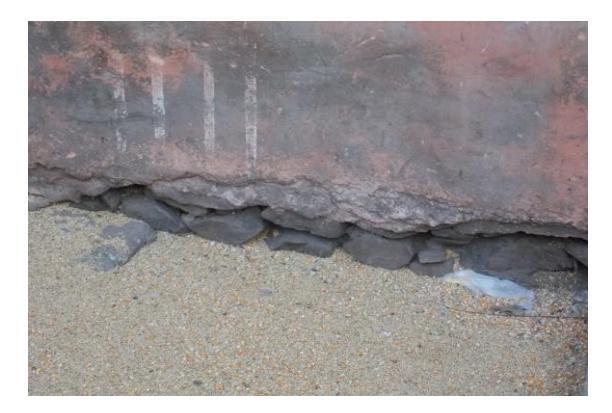
Photo 5 Peeling of Plaster on of Vertical Slab No. 61

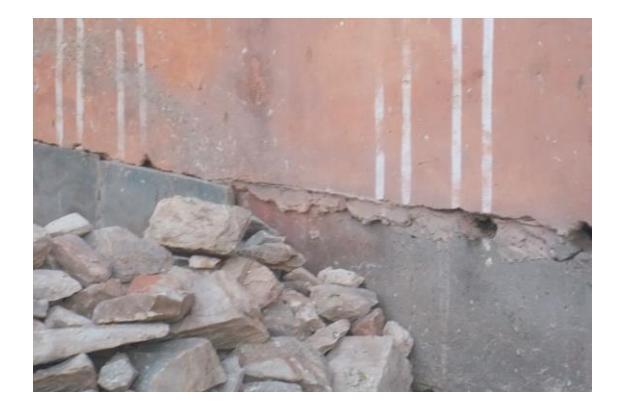
Peeling of Plaster on of Vertical Slab No. 62

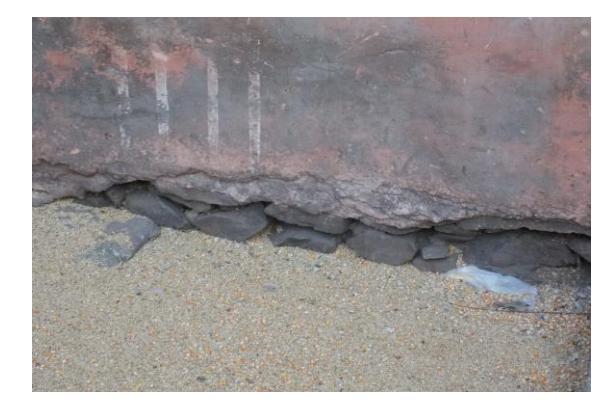
Photo 6 Peeling of Plaster on of Vertical Slab No. 60

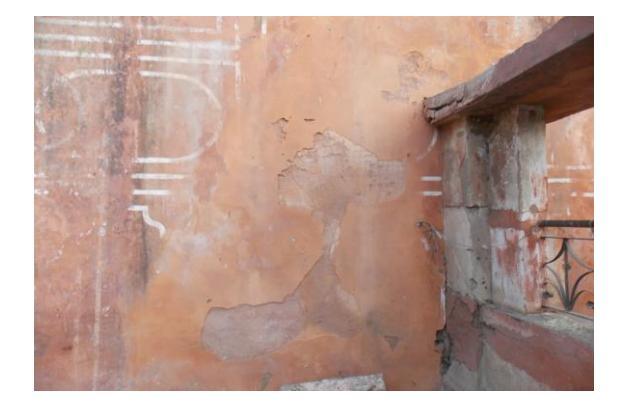
Photo 7 Peeling of Plaster on of Vertical Slab No.57 &58

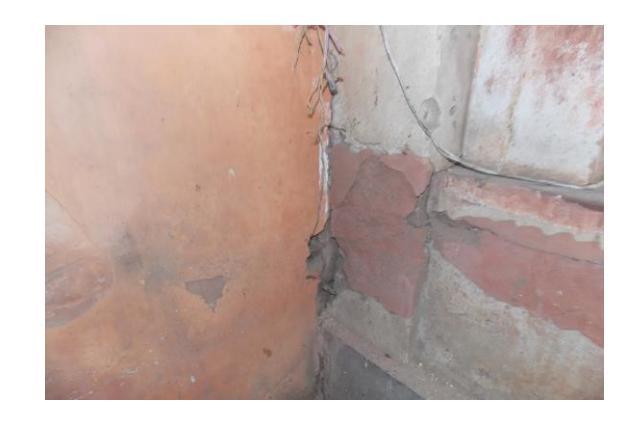
Photo 8 Peeling of Plaster on of Vertical Slab No.57

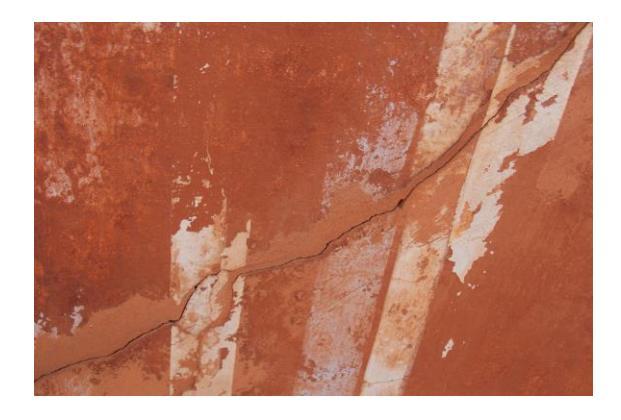
Photo 3 Inclined Crack on Sky open Area on Terrace of G/F (R/S Compound Wall),Approx. Width = 1mm, Approx. Length = 2m

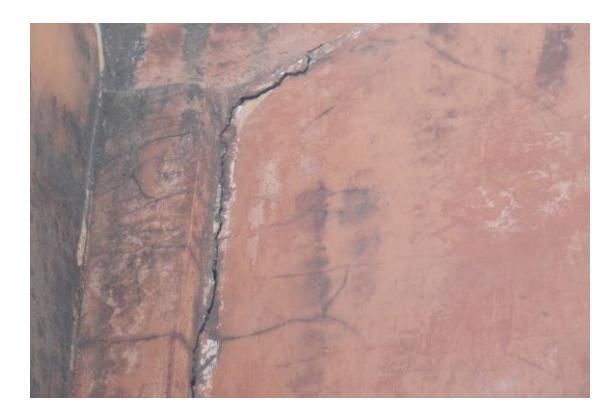
Photo 5 Inclined Crack on Outer Side of Slab No. 5, Terrace of G/F (R/S Compound Wall), Approx. Width = 3mm, Approx. Length = 1.5m.Distance from Slab No. 4 = 0m, Height from Floor = 8m.

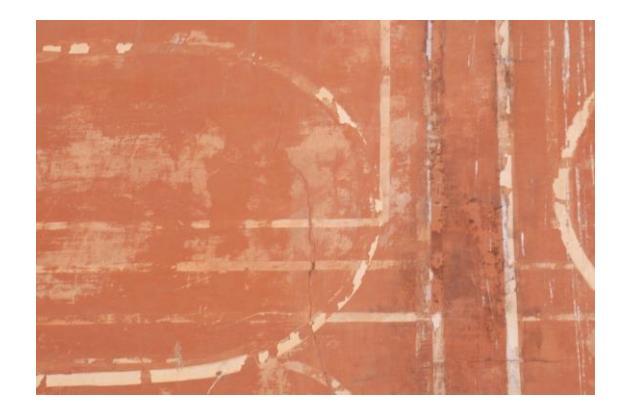
Photo 6

Inclined Crack on Outer Side of Slab No. 7, Terrace of G/F (R/S Compound Wall),Approx. Width = 0.5mm, Approx. Length = 3m.Distance from Slab No. 8 = 0.2m, Height from Floor = 1.5m.

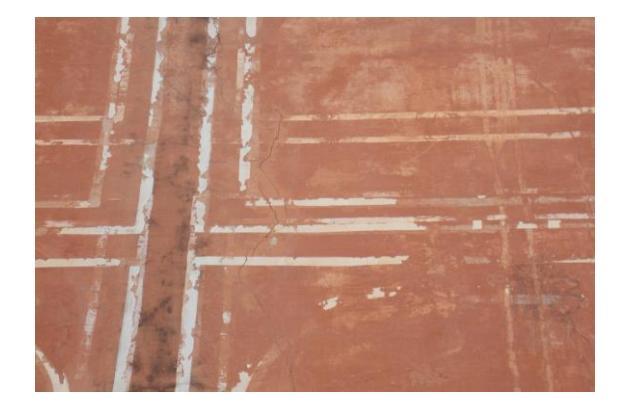
Photo 7

Inclined Crack on Outer Side Slab No. 16, Terrace of G/F (R/S Compound Wall),Approx. Width = 0.5mm, Approx. Length = 5m.Distance from Slab No.15 = 0.05m, Height from Floor = 1.5m.

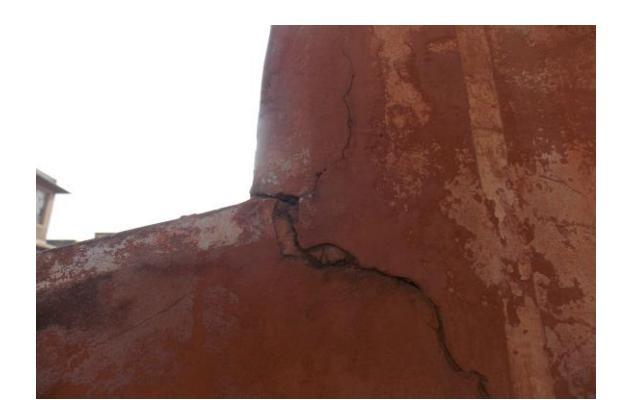
Photo 9 Plaster Crack on Vertical Slab no. 1 on Terrace of G/F (R/S Compound Wall)

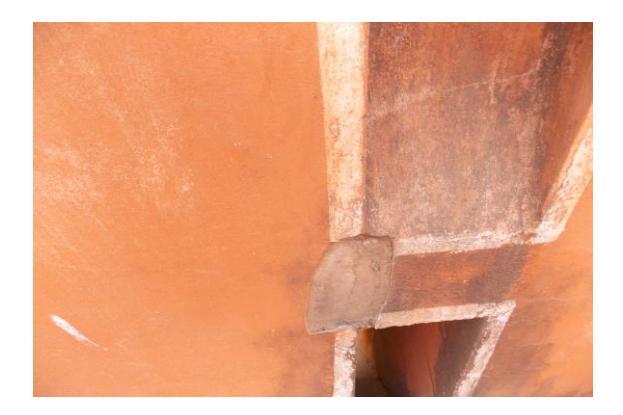
Photo 11 Peeling of Plaster on L/s Vertical Slab no. 7 of Terrace of G/F (R/S Compound Wall)

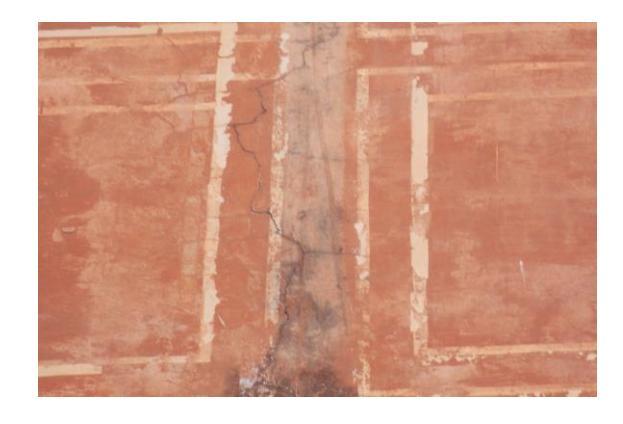
Photo 8

Inclined Crack on Outer Side Slab No. 20, Terrace of G/F (R/S Compound Wall), Approx. Width = 0.6mm, Approx. Length = 3.5m.Distance from Slab No. 19 = 0.25m, Height from Floor = 3m.

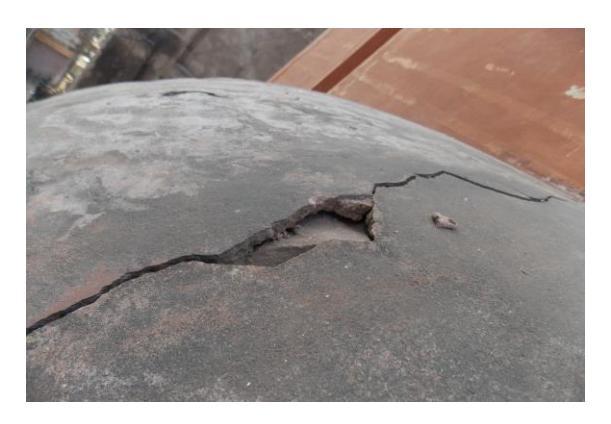
Photo 10 Peeling of Plaster on Top of Slab No.1 on Terrace of G/F (R/S Compound Wall)

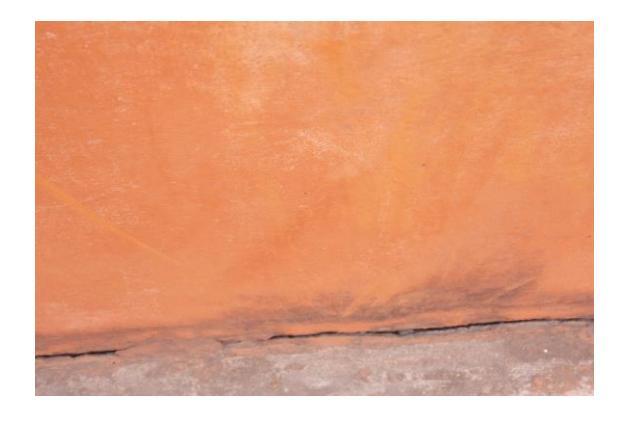
Photo 12 Damaged Portion on L/s Vertical Slab No.7 & Floor (Joint Opening) of Terrace of G/F (R/S Compound Wall)

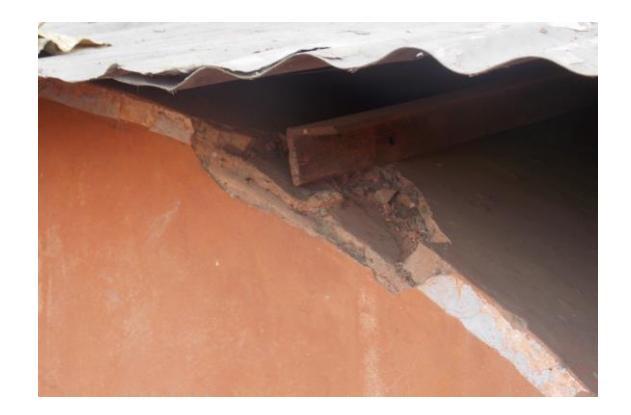
Photo 13 Peeling of Plaster on L/s Vertical Slab no.11 of Terrace of G/F (R/S Compound Wall)

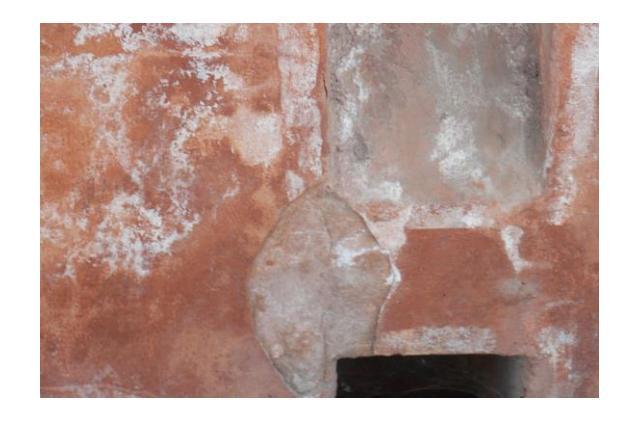
Photo 14 Peeling of Plaster on L/s Vertical Slab No.11 of Terrace of G/F (R/S Compound Wall)

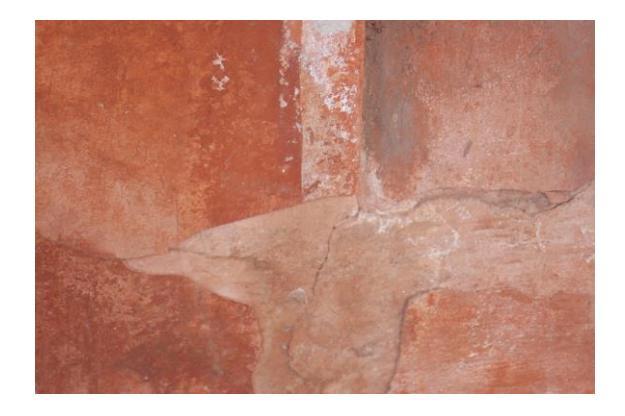
Photo 15 Peeling of Plaster on L/s Vertical Slab No.12 of Terrace of G/F (R/S Compound Wall)

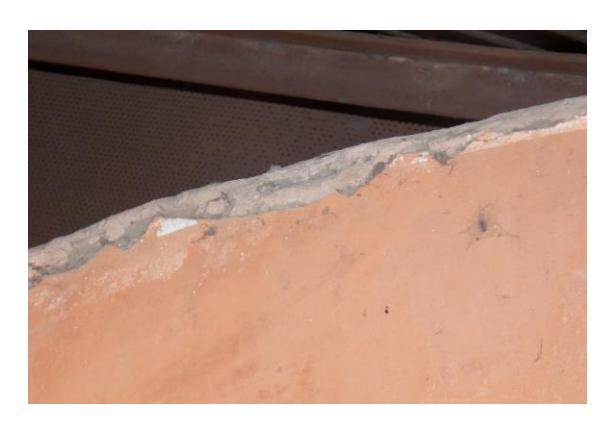
Photo 16 Peeling of Plaster on L/s Vertical Slab No.13 of Terrace of G/F (R/S Compound Wall)

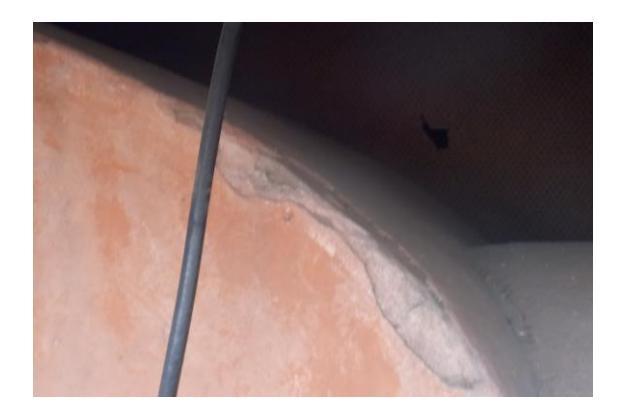
Photo 17 Peeling of Plaster on L/s Vertical Slab No.13 of Terrace of G/F (R/S Compound Wall)

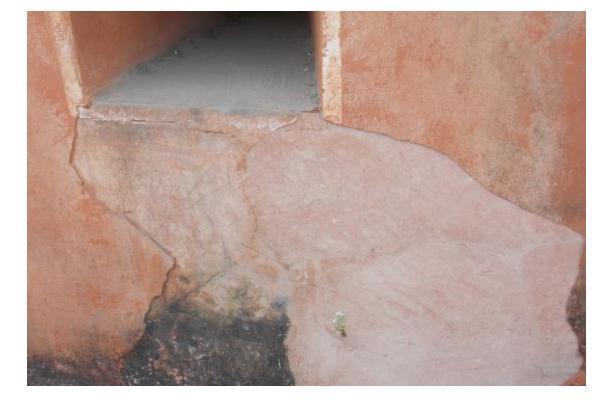
Photo 18 Peeling of Plaster on L/s Vertical Slab No.14 of Terrace of G/F (R/S Compound Wall)

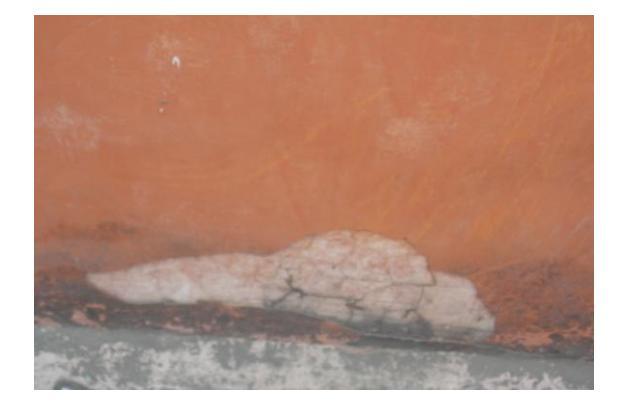
Photo 19 Peeling of Plaster on L/s Vertical Slab No.15 of Terrace of G/F (R/S Compound Wall)

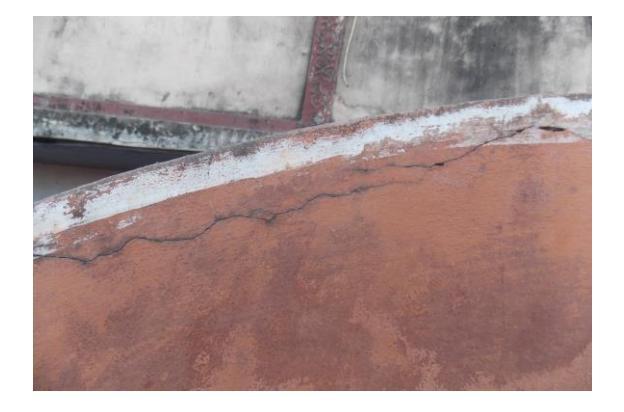
Photo 20 Plaster Crack on L/s Vertical Slab No. 20 of Terrace of G/F (R/S Compound Wall)

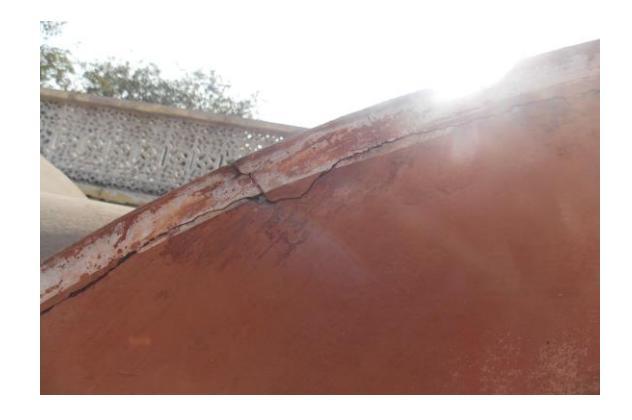
Photo 21 Plaster Crack on L/s Vertical Slab No. 21 of Terrace of G/F (R/S Compound Wall)

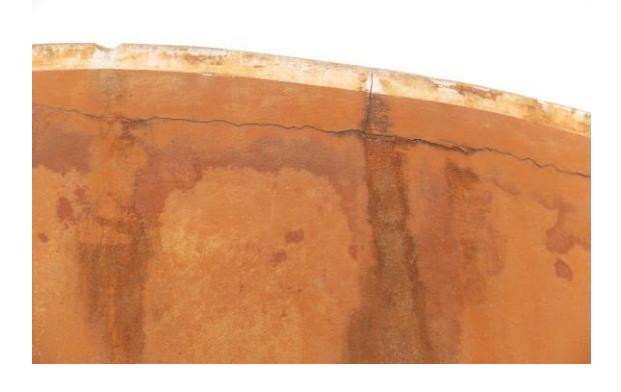
Photo 22 Plaster Crack on R/s Vertical Slab No. 37 of Terrace of G/F (R/S Compound Wall)

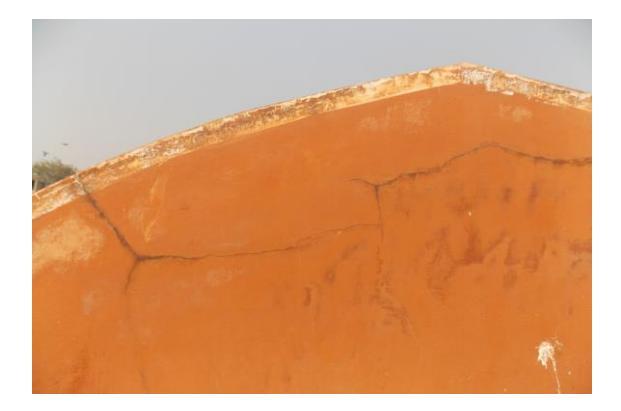
Photo 23 Plaster Crack on R/s Vertical Slab No. 35 of Terrace of G/F (R/S Compound Wall)

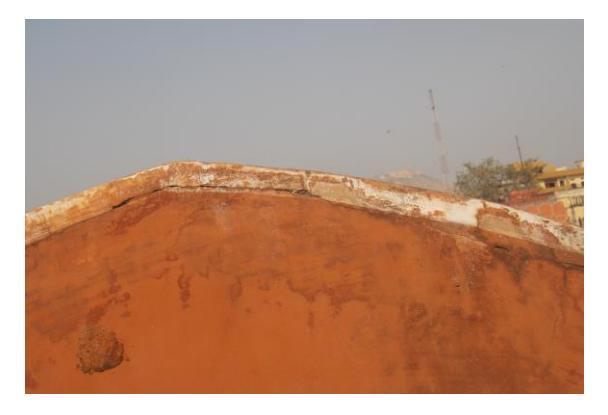
Photo 24 Plaster Crack on R/s Vertical Slab No. 34 of Terrace of G/F (R/S Compound Wall)

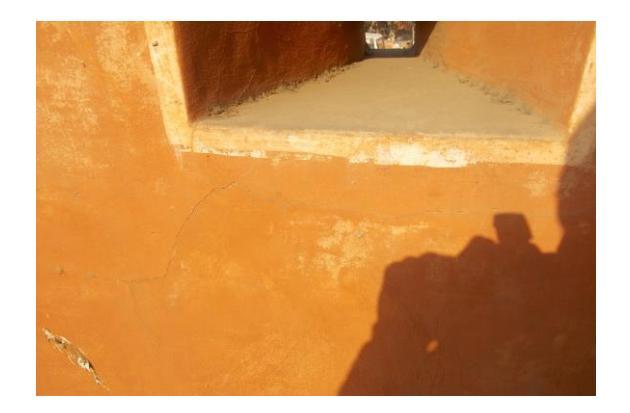
Photo 25 Plaster Crack on R/s Vertical Slab No. 31 of Terrace of G/F (R/S Compound Wall)

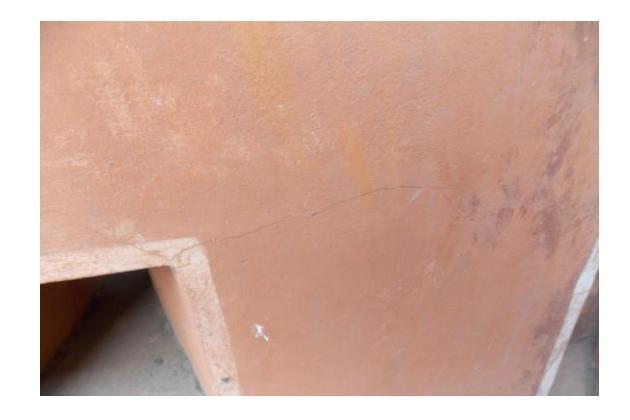
Photo 26 Plaster Crack on R/s Vertical Slab No. 30 of Terrace of G/F (R/S Compound Wall)

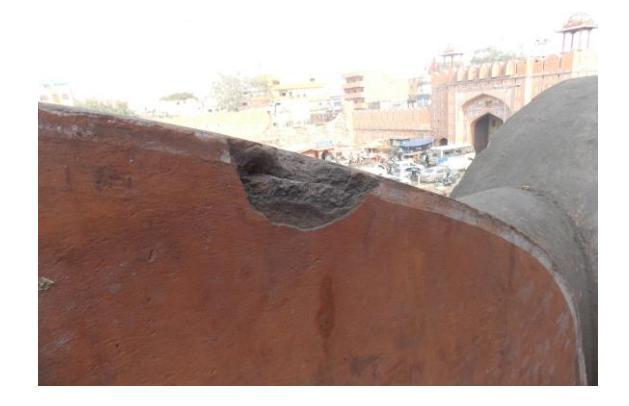
Photo 27 Peeling of Plaster on R/s Vertical Slab No. 27 of Terrace of G/F (R/S Compound Wall)

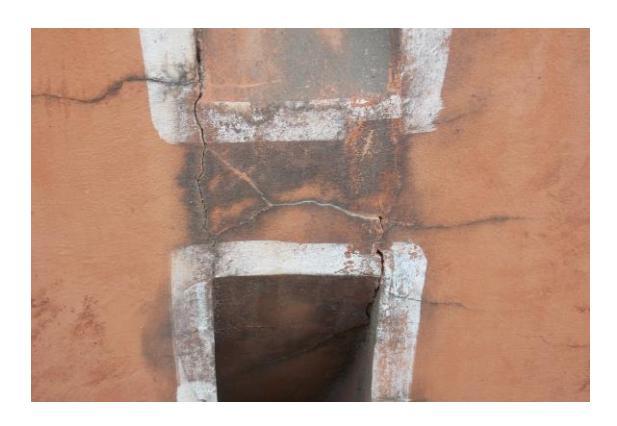
Photo 28 Plaster Crack on R/s Vertical Slab No. 21&22 of Terrace of G/F (R/S Compound Wall)
