Pre Building Condition Survey Report

Name of the Project	Contract JMRC-UG1B "Design and Construction of Tunnel between Chandpole and Badi Chouper and reverse line by Shield TBM, Underground Metro Stations at Choti Chouper and Badi Chouper by Cut and Cover Methods on East West Corridor of Jaipur Metro Rail Corporation Limited ."		
Owner :	JAIPUR METRO	Jaipur Metro Rail Corporation	
Contractor :	VUV	Continental Engineering Corporation	
Survey Agency :	Aimil I Instrumentation	tion & Technologies

Pre Building Condition Survey Report Chand Pole to Choti Chopar (UP Line)

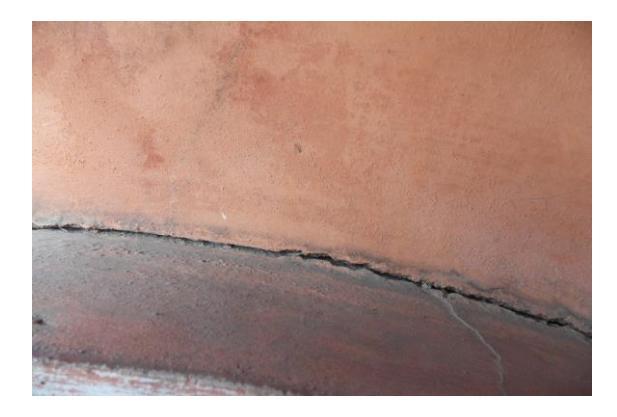
Photo 29 Damaged Portion on R/s Vertical Slab No. 1 & Gate Wall (Joint Opening) of Terrace of G/F (R/S Compound Wall)

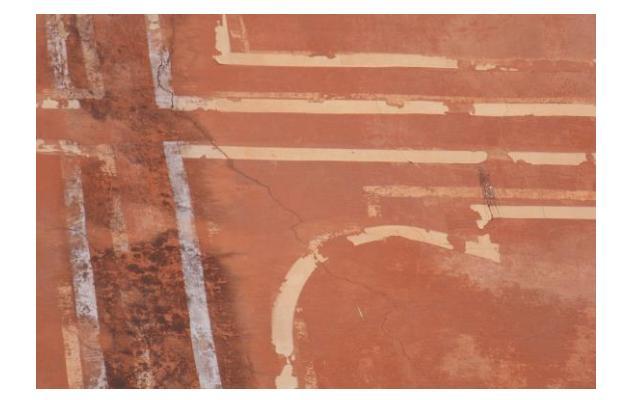
Photo 31 Plaster Crack on Outer Side Slab No. 10 of Terrace of G/F (R/S Compound Wall)

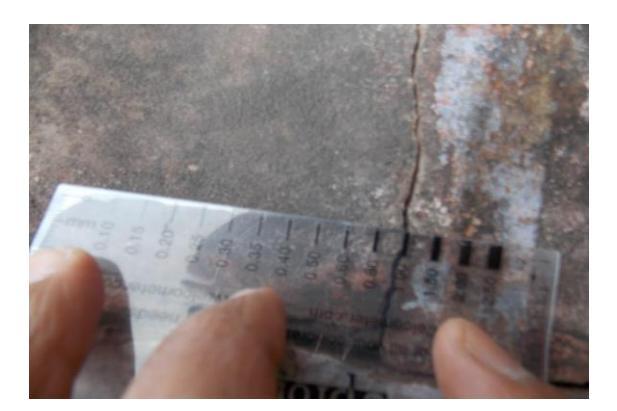
Photo 4A Inclined Crack on Vertical Slab No.6 to Vertical Slab No. 7, Terrace of F/F (R/S Compound Wall),Approx. Width = 1mm, Length = 1.8m.Distance from Slab No. 7 = 0.11m, Height from Floor = 0.8m.

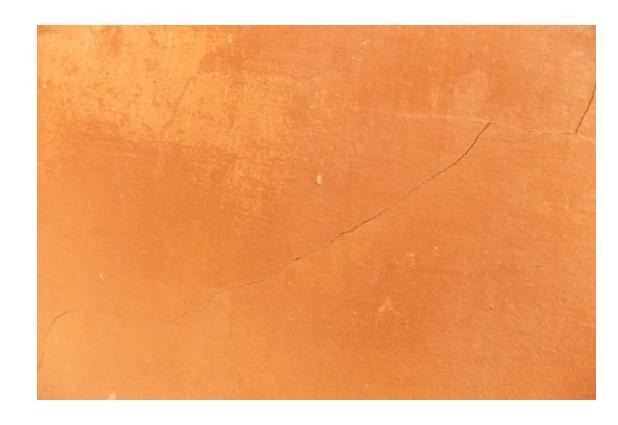
Photo 5 Inclined Crack on Vertical Slab No.20, Terrace of F/F (R/S Compound Wall),Approx. Width = 0.5mm, Approx. Length = 1.6m.Distance from Slab No.19 = 0.5m, Height from Floor = 0m.

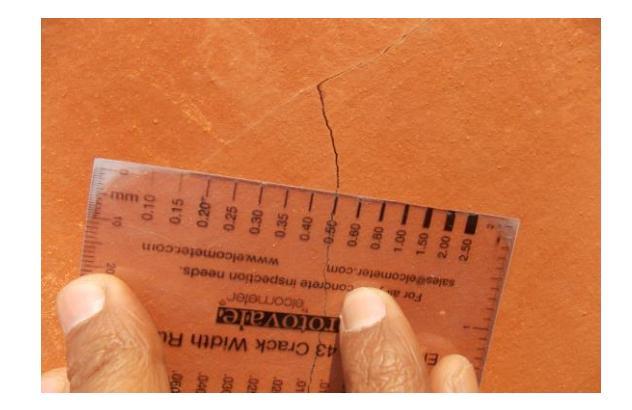
Photo 5A

Inclined Crack on Vertical Slab No.20, Terrace of F/F (R/S Compound Wall), Approx. Width = 0.5mm, Approx. Length = 1.6m. Distance from Slab No.19 = 0.5m, Height from Floor = 0m.

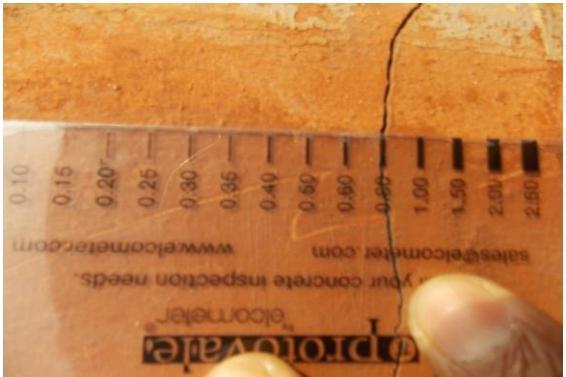
Photo 6A Inclined Crack on Vertical Slab No.21, Terrace of F/F (R/S Compound Wall), Approx. Width = 0.5mm, Approx. Length = 1.6m. Height from Floor = 0.8m.

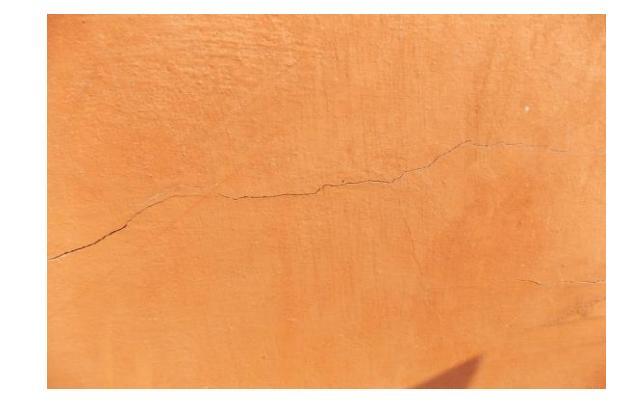
Photo 6 Inclined Crack on Vertical Slab No.21, Terrace of F/F (R/S Compound Wall), Approx. Width = 0.5mm, Approx. Length = 1.6m. Height from Floor = 0.8m.

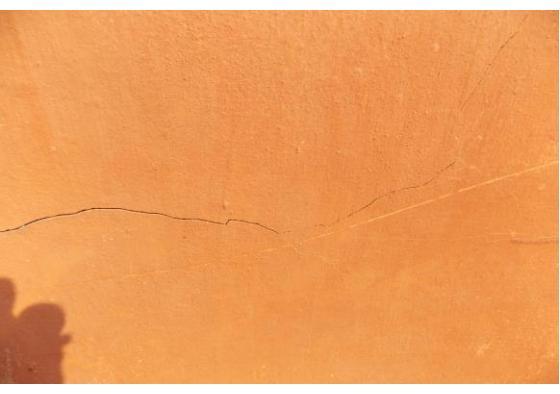
Inclined Crack on Vertical Slab No.21, Terrace of F/F (R/S Compound Wall),Approx. Width = 1mm,Length = 1.6m.Distance from Slab No.20 = 0.12m, Height from Floor = 0.55m.

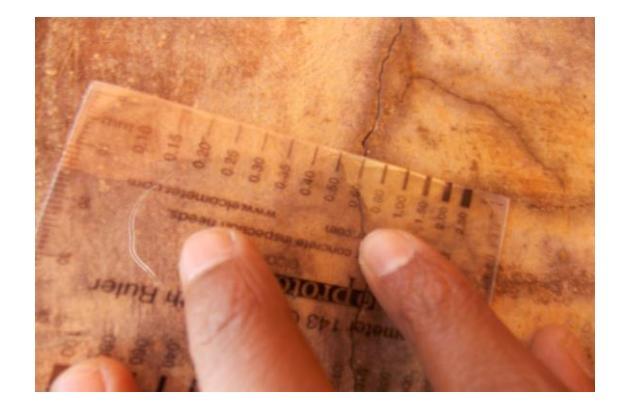
Photo 8A Horizontal Crack on Stair Case FF To Terrace, Terrace of F/F (R/S Compound Wall), Approx. Width = 0.6mm, Length = 2.5m. Distance from Last Stair Step = 0m, Height from Floor = 0.27m.

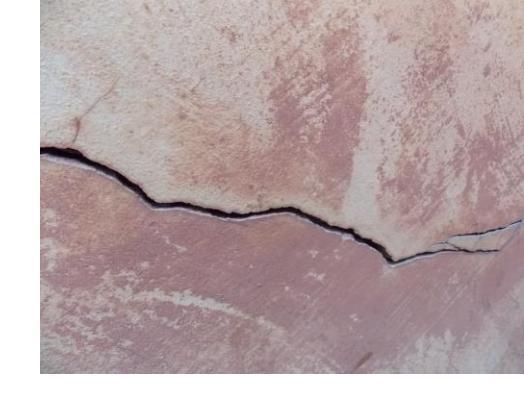
Photo 9A

Inclined Crack on Stair Case FF To Terrace, Terrace of F/F (R/S Compound Wall), Approx. Width = 4mm, Length = 1.8m. Distance from Wall 4 of stair Case = 2.07m, Height from Floor = 0.42m.

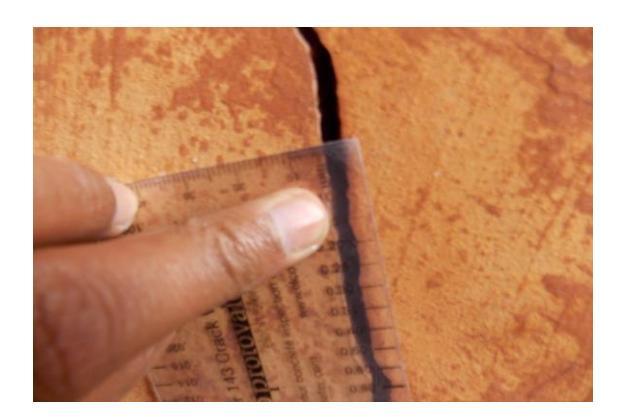
Photo 10A Inclined Crack on Stair Case FF To Terrace, Terrace of F/F (R/S Compound Wall), Approx. Width = 4mm, Length = 1.4m. Distance from Wall 4 of stair Case = 2.05m, Height from Floor = 0m.

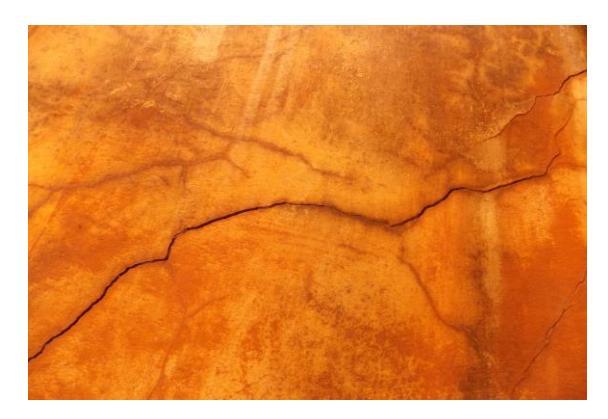
Photo 10 Inclined Crack on Stair Case FF To Terrace, Terrace of F/F (R/S Compound Wall), Approx. Width = 4mm, Length = 1.4m. Distance from Wall 4 of stair Case = 2.05m, Height from Floor = 0m.

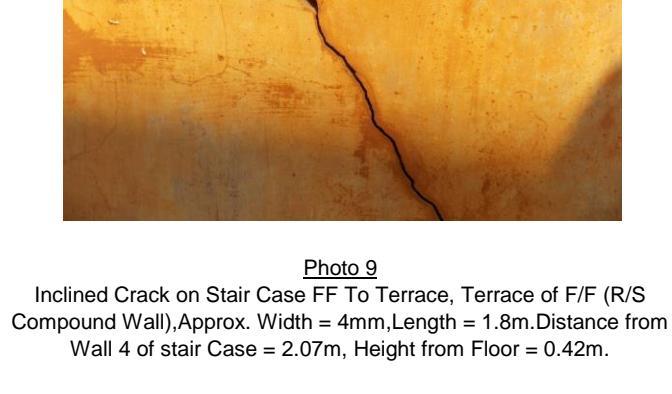
Photo 11 Inclined Crack on Stair Case FF To Terrace, Terrace of F/F (R/S Compound Wall), Approx. Width = 2mm, Length = 1.05m. Distance from Wall 3 of stair Case = 3.1m, Height from Floor = 1.13m.

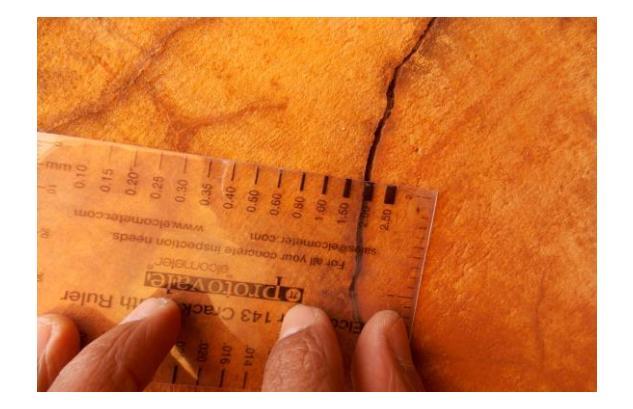
Photo 11A Inclined Crack on Stair Case FF To Terrace, Terrace of F/F (R/S Wall 3 of stair Case = 3.1m, Height from Floor = 1.13m.

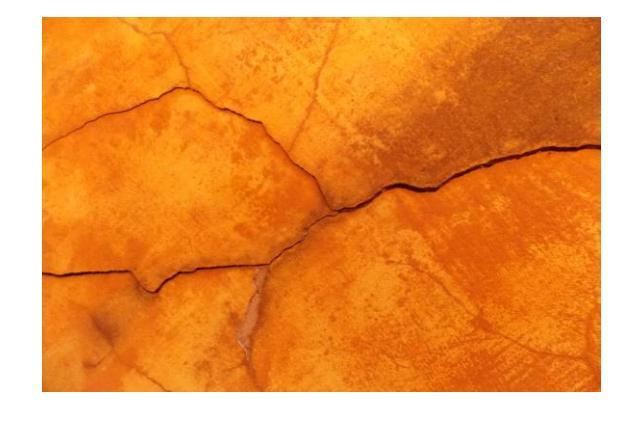
Photo 12 Inclined Crack on Stair Case FF To Terrace, Terrace of F/F (R/S Compound Wall), Approx. Width = 2mm, Length = 1.05m. Distance from Compound Wall), Approx. Width = 2.5mm, Length = 2.4m. Distance from Wall 3 of stair Case = 3.34m, Height from Floor = 0m.

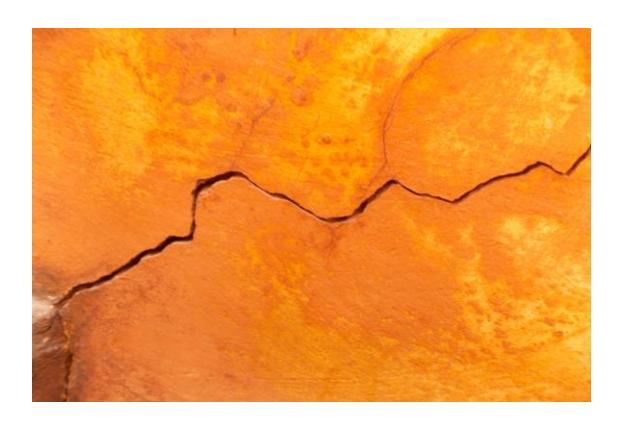
Photo 12A Inclined Crack on Stair Case FF To Terrace, Terrace of F/F (R/S Compound Wall), Approx. Width = 2.5mm, Length = 2.4m. Distance from Compound Wall), Approx. Width = 2.5mm, Length = 1.1m. Distance from Wall 3 of stair Case = 3.34m, Height from Floor = 0m.

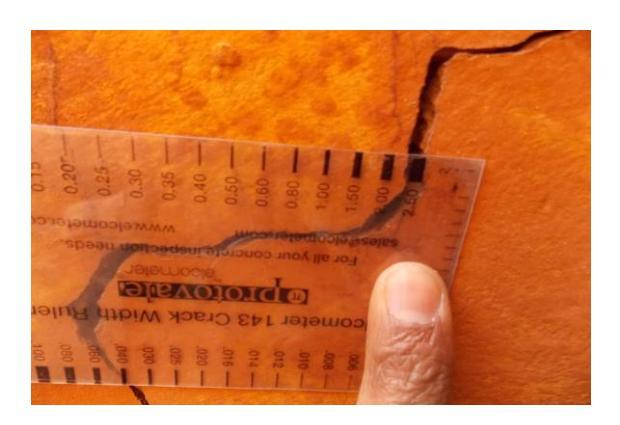
Photo 13A

Inclined Crack on Stair Case FF To Terrace, Terrace of F/F (R/S Compound Wall), Approx. Width = 2.5mm, Length = 1.1m. Distance from Wall 3 of stair Case = 3.22m, Height from Floor = 0m.

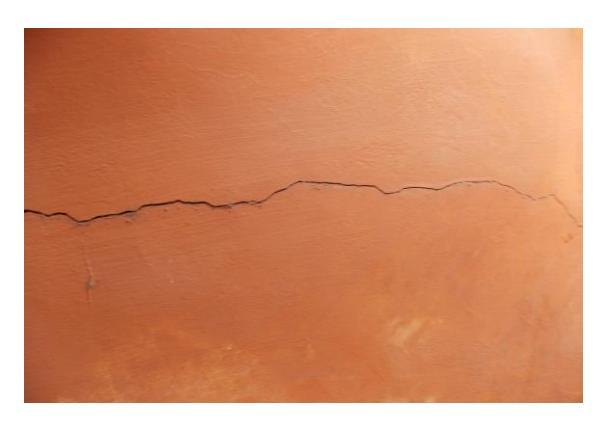
Photo 13 Inclined Crack on Stair Case FF To Terrace, Terrace of F/F (R/S Wall 3 of stair Case = 3.22m, Height from Floor = 0m.

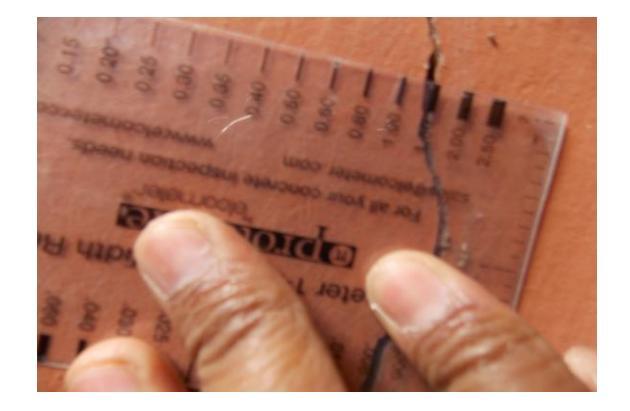
Photo 14A Inclined Crack on Stair Case FF To Terrace, Terrace of F/F (R/S Compound Wall),Approx. Width = 1.5mm, Length = 2.45m.Distance from Wall 4 of stair Case = 2.85m, Height from Floor = 0.8m.

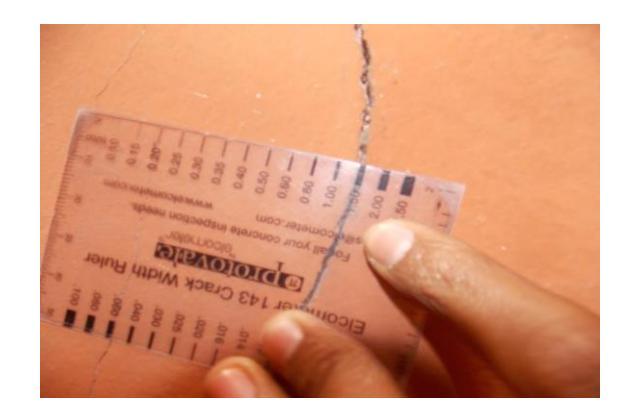
Photo 15A

Inclined Crack on Stair Case FF To Terrace, Terrace of F/F (R/S Compound Wall), Approx. Width = 1.5mm, Length = 2.55m.Distance from Wall 4 of stair Case = 4.1m, Height from Floor = 1.33m.

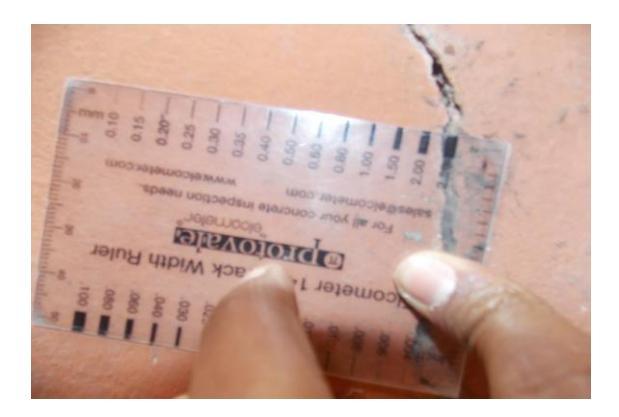
Photo 16A

Inclined Crack on Stair Case FF To Terrace, Terrace of F/F (R/S Compound Wall), Approx. Width = 2.5mm, Length = 1m.Distance from Wall 3 of Stair Case = 0m, Height from Floor = 1.7m.

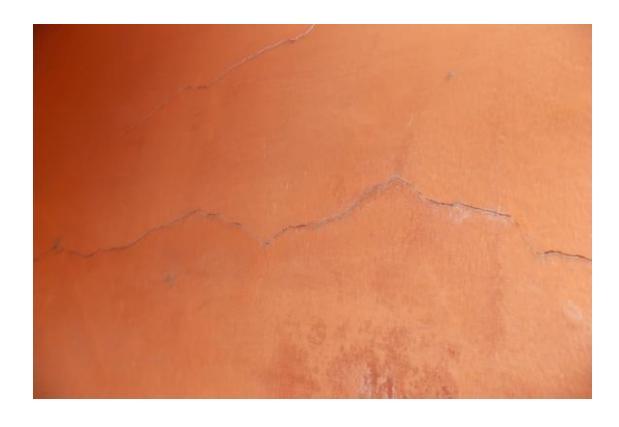
Photo 15 Inclined Crack on Stair Case FF To Terrace, Terrace of F/F (R/S Compound Wall),Approx. Width = 1.5mm, Length = 2.55m.Distance from Wall 4 of stair Case = 4.1m, Height from Floor = 1.33m.

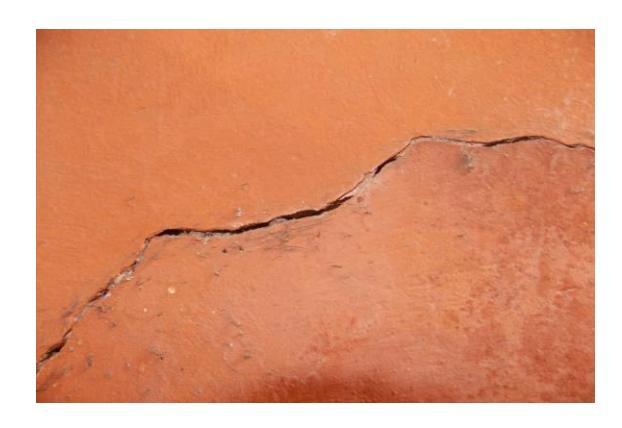
Photo 16

Inclined Crack on Stair Case FF To Terrace, Terrace of F/F (R/S Compound Wall),Approx. Width = 2.5mm, Length = 1m.Distance from Wall 3 of Stair Case = 0m, Height from Floor = 1.7m.

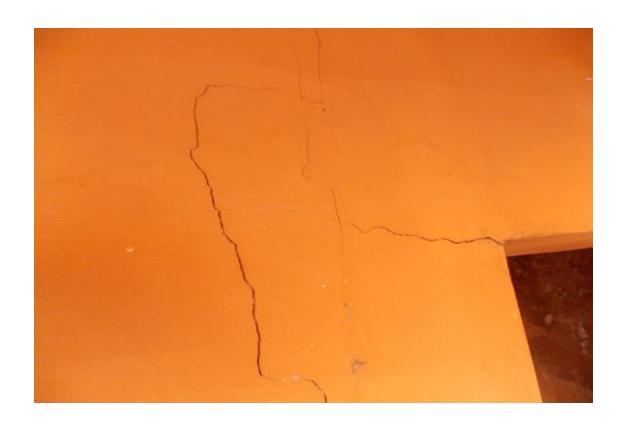
Photo 17 Inclined Crack on Stair Case FF To Terrace, Terrace of F/F (R/S Compound Wall),Approx. Width = 1mm, Approx. Length = 2m.

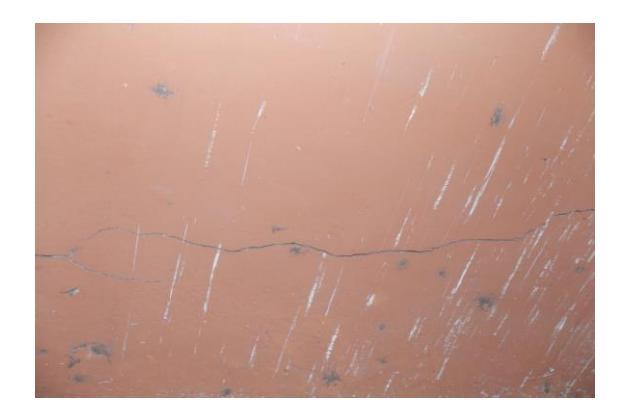
Photo 18 Inclined Crack on Gallery on F/F, Terrace of G/F (R/S Compound 3/Entry Gate = 1.8m, Height from Floor = 0.25m.

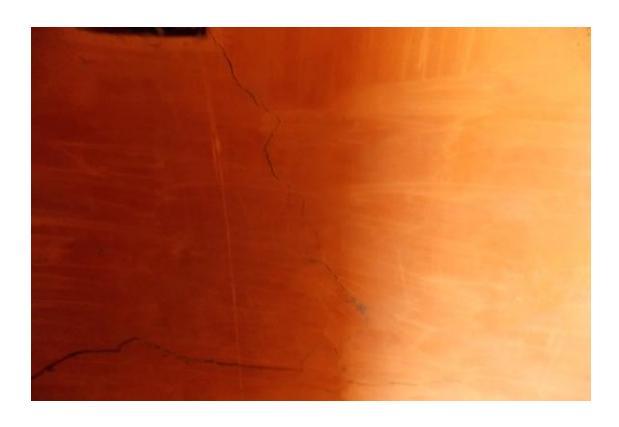
Photo 18A Inclined Crack on Gallery on F/F, Terrace of G/F (R/S Compound Wall), Approx. Width = 6mm, Approx. Length = 20m. Distance from Wall Wall), Approx. Width = 6mm, Approx. Length = 20m. Distance from Wall 3/Entry Gate = 1.8m, Height from Floor = 0.25m.

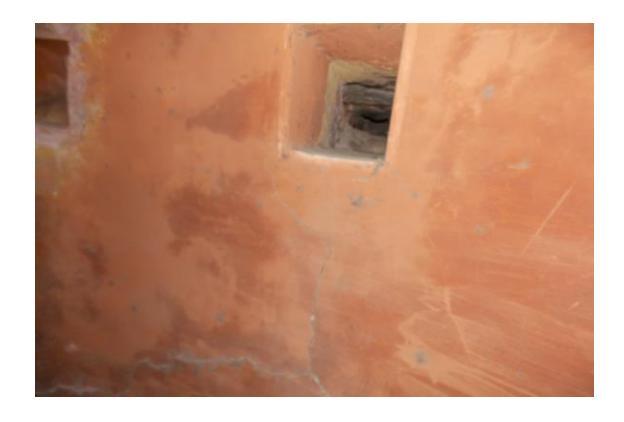
Photo 19

Inclined Crack on Gallery on F/F, Terrace of G/F (R/S Compound Wall), Approx. Width = 6mm, Length = 20m. Distance from Wall 3/Entry Gate = 1.8m, Height from Floor = 0.25m.

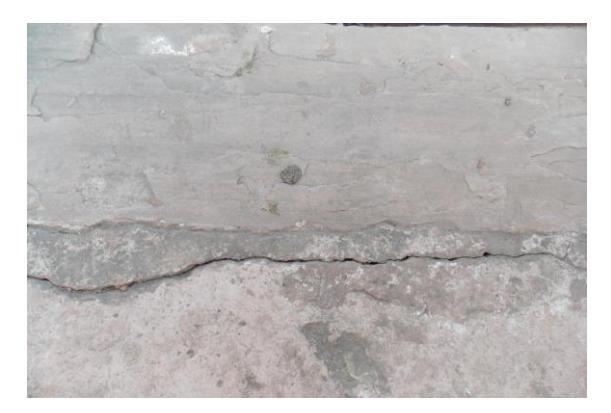
Photo 20 Horizontal Crack on , Terrace of G/F (R/S Compound Wall), Approx. Width = 2.5mm, Approx. Length = 1.1m.Distance from Wall 1 = 0.5m, Height from Floor = 0m.

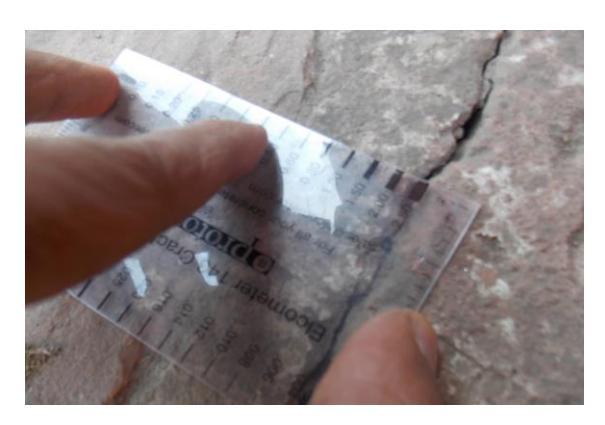
Photo 20A Horizontal Crack on , Terrace of G/F (R/S Compound Wall), Approx. Width = 2.5mm, Approx. Length = 1.1m.Distance from Wall 1 = 0.5m, Height from Floor = 0m.

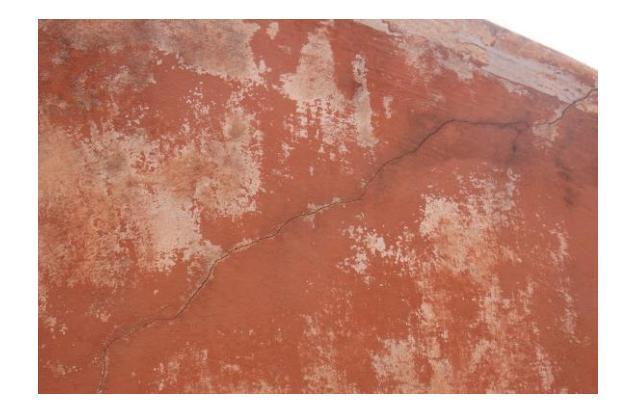
Photo 21 Plaster Crack on Vertical Slab No.3 of Terrace of F/F (R/S Compound Wall)

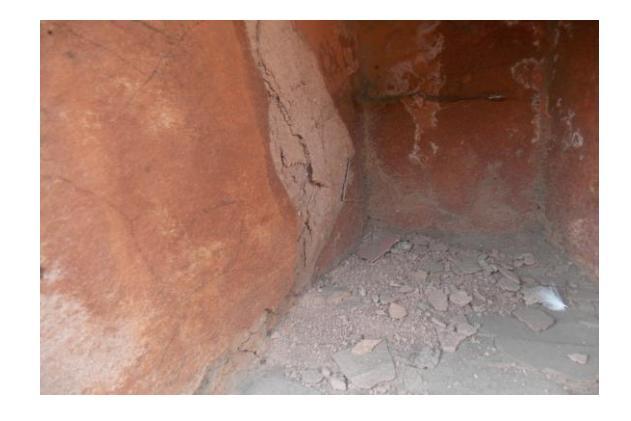
Photo 22 Peeling of Plaster on Vertical Slab N0.8 of Terrace of F/F (R/S Compound Wall)

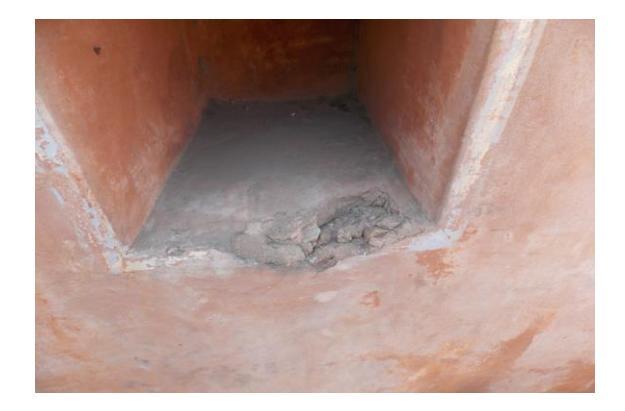
Photo 23 Peeling of Plaster on Vertical Slab No.9 of Terrace of F/F (R/S Compound Wall)

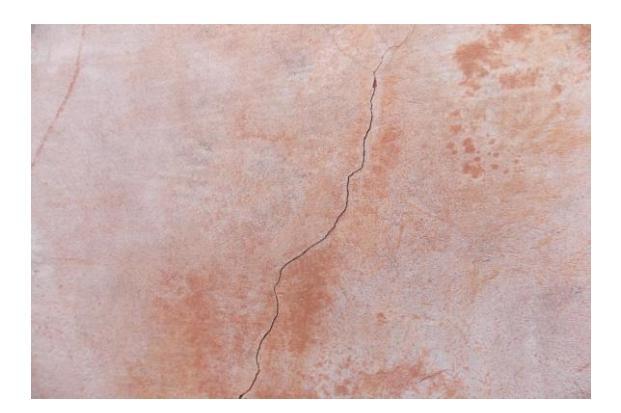
Photo 25 Plaster Crack on Vertical Slab No.9 of Terrace of F/F (R/S Compound Wall)

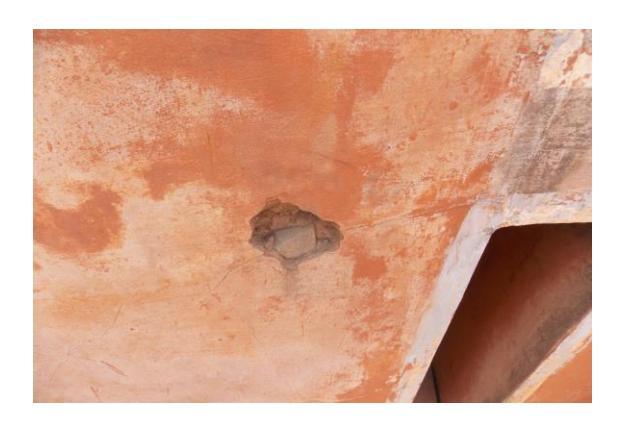
Photo 24 Peeling of Plaster on Vertical Slab No.9 of Terrace of F/F (R/S Compound Wall)

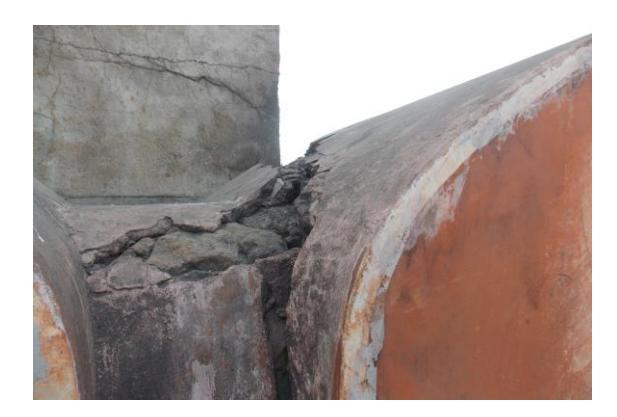
Photo 26 Dampness/Seepage on Vertical Slab 9&10 of Terrace of F/F (R/S Compound Wall)

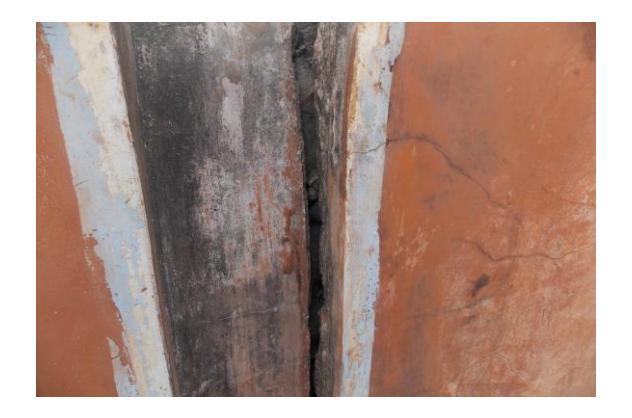
Photo 27 Dampness/Seepage on Vertical Slab 9&10 of Terrace of F/F (R/S Compound Wall)

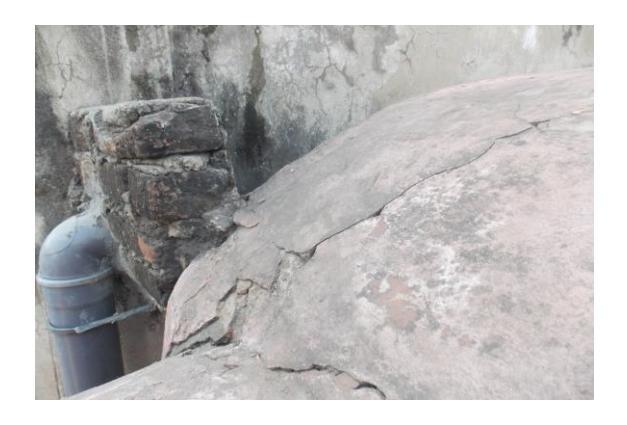
Photo 28 Dampness/Seepage on Top of Slab No.7 of Terrace of F/F (R/S Compound Wall)

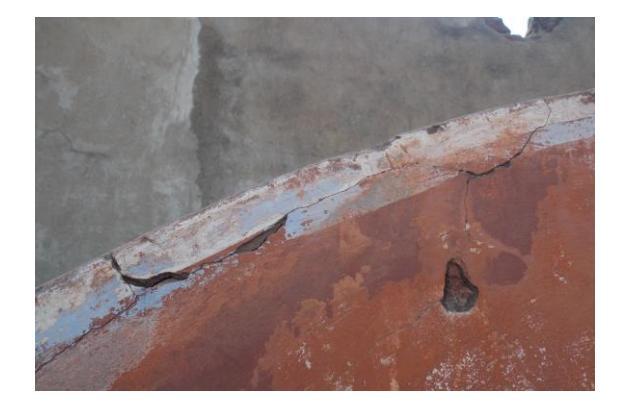
Photo 29 Peeling of Plaster on Vertical Slab No.9 of Terrace of F/F (R/S Compound Wall)

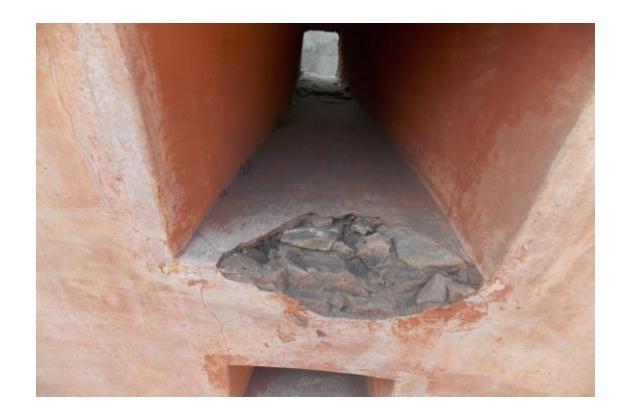
Photo 30 Peeling of Plaster on Vertical Slab No.11 of Terrace of F/F (R/S Compound Wall)

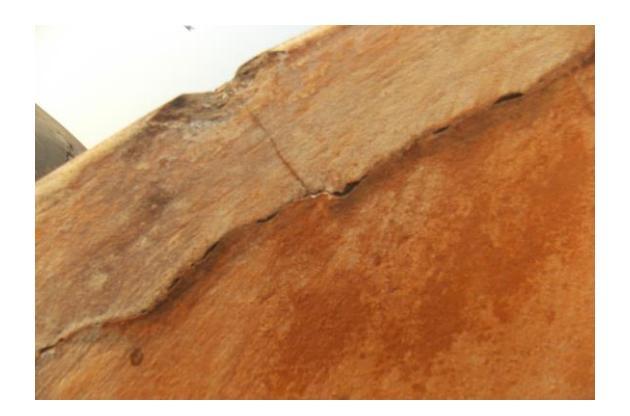
Photo 33 Plaster Crack on Vertical Slab No. 14 of Terrace of F/F (R/S Compound Wall)

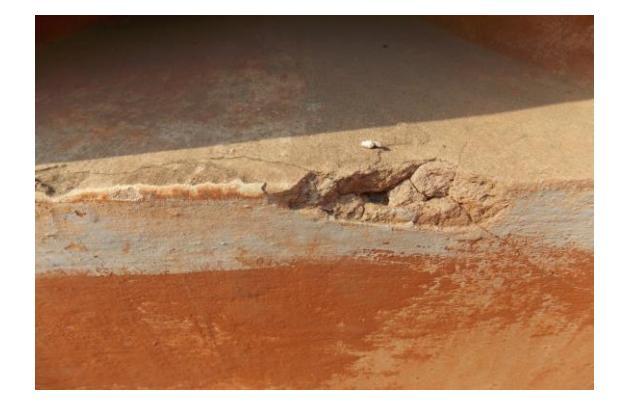
Photo 34 Peeling of Plaster on Vertical Slab No. 14 of Terrace of F/F (R/S Compound Wall)

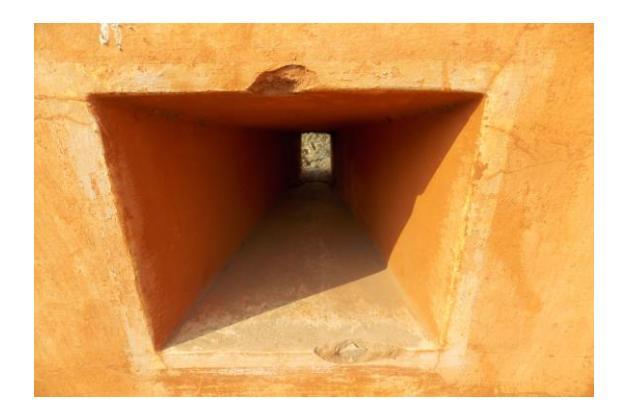
Photo 35 Peeling of Plaster on Vertical Slab No.15 of Terrace of F/F (R/S Compound Wall)

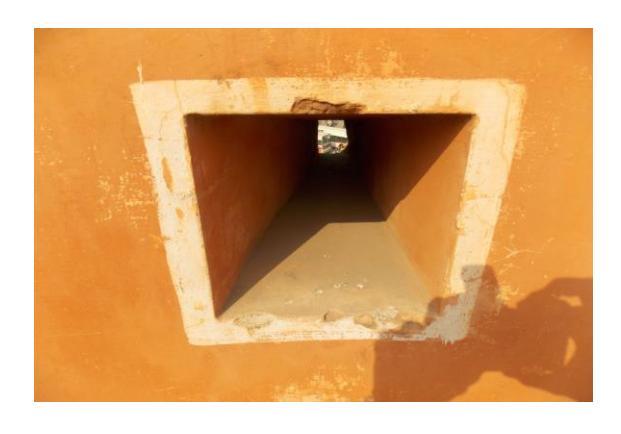
Photo 36 Peeling of Plaster on Vertical Slab No.17 of Terrace of F/F (R/S Compound Wall)

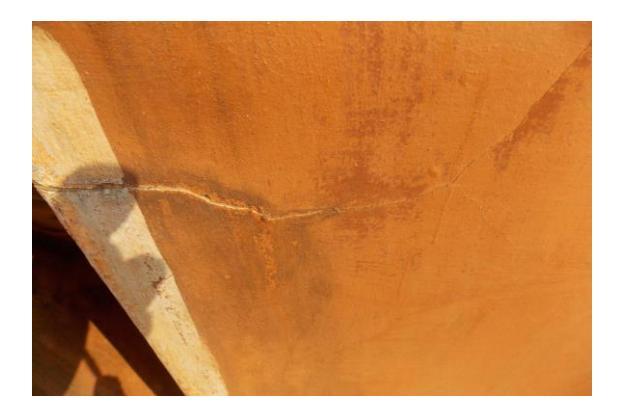
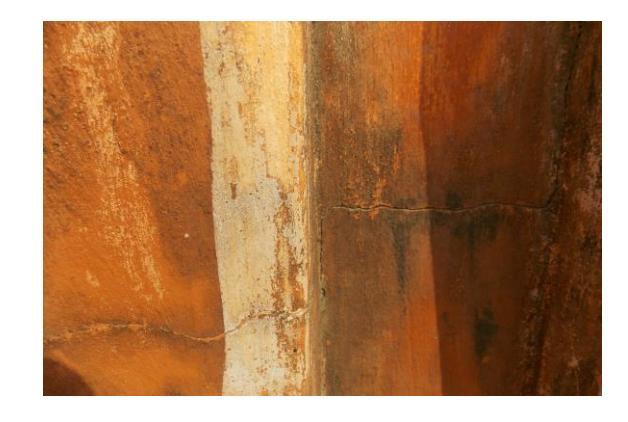
Photo 37 Plaster Crack on Vertical Slab No.20 of Terrace of F/F (R/S Compound Plaster Crack on Joint of Vertical Slab No.19&20 of Terrace of F/F (R/S Wall) Compound Wall)

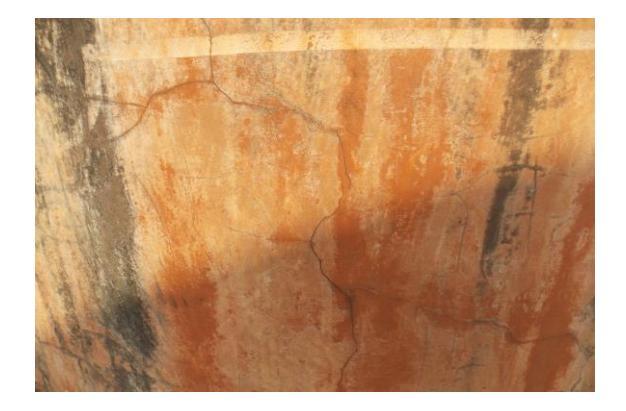
Photo 39 Plaster Crack on Center pillar on Terrace of F/F (R/S Compound Wall)

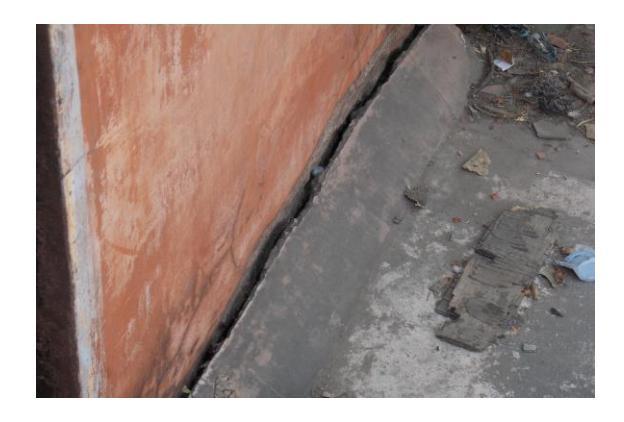
Photo 40 Peeling of Plaster on Center pillar on Terrace of F/F (R/S Compound Wall)

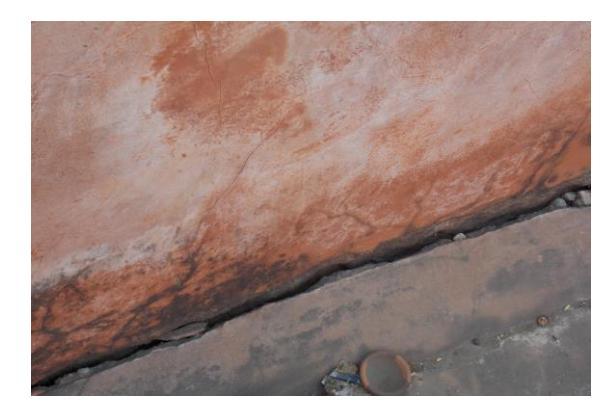
Photo 42 Damaged Portion on Between Boundary Wall & Floor (Joint Opening) of Terrace of F/F (R/S Compound Wall)

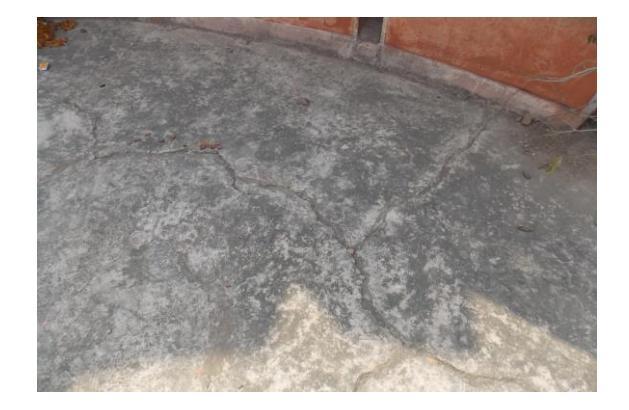
Photo 45 Plaster Crack on Terrace of F/F (R/S Compound Wall)

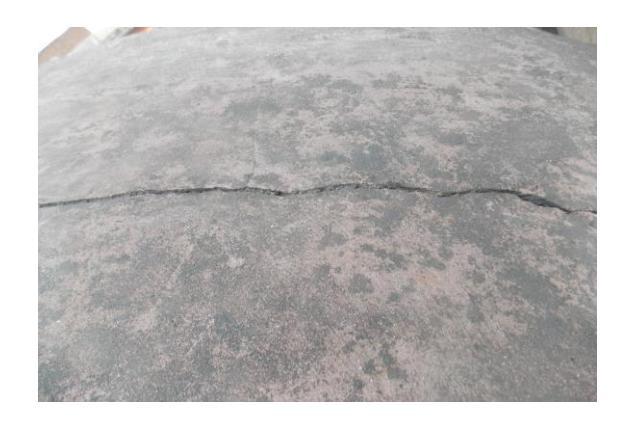
Photo 46 Plaster Crack on Top of Slab No.6 of Terrace of F/F (R/S Compound Wall)

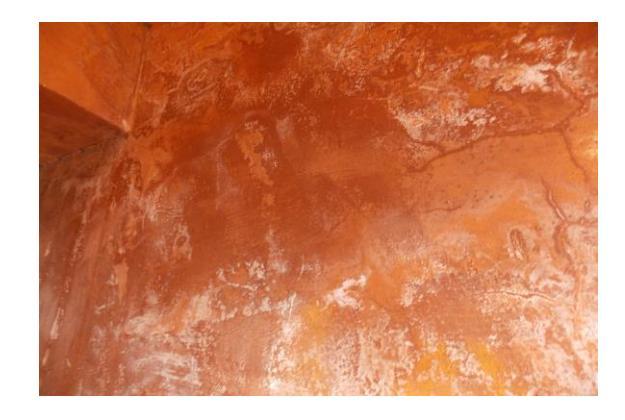
Photo 47 Peeling of Plaster on Stair Case FF To Terrace (R/S Compound Wall)

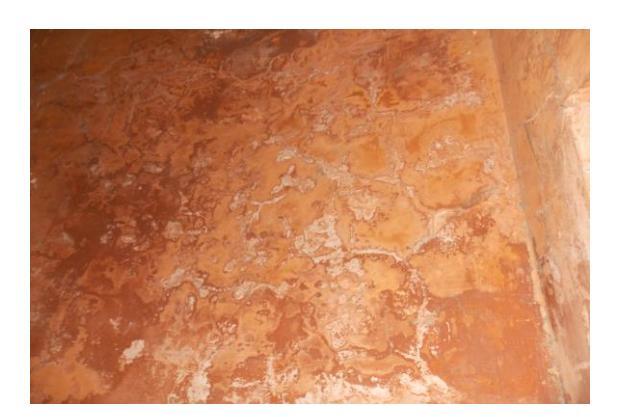
Photo 49 Dampness/Seepage on Gallery on F/F of Terrace of G/F (R/S Compound Wall)

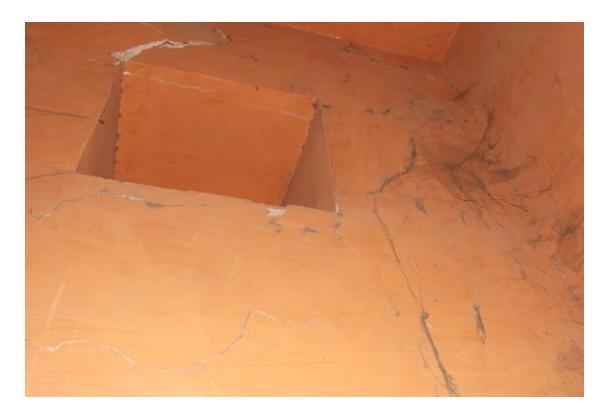
Photo 50 Dampness/Seepage on Gallery on F/F of Terrace of G/F (R/S Compound Wall)

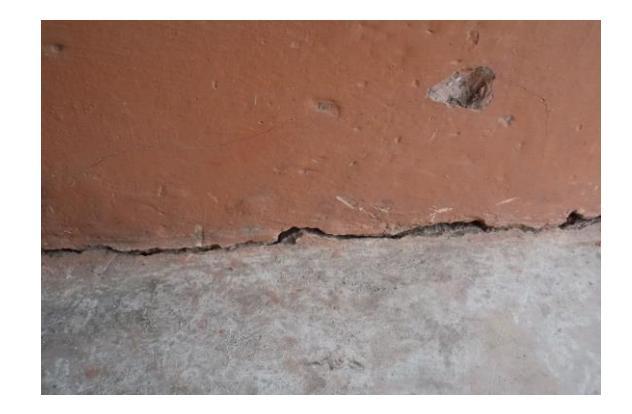
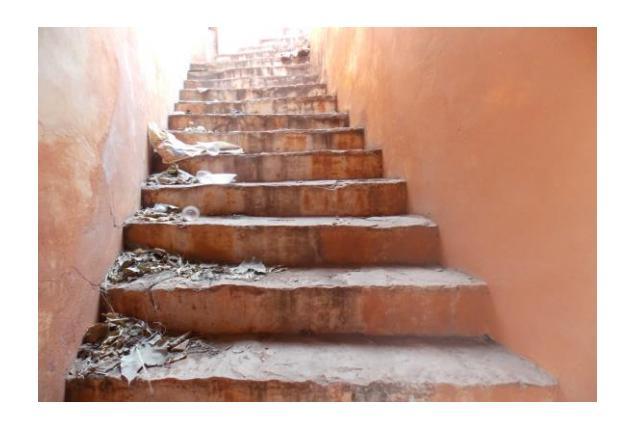
Photo 51
 Photo 52

Damaged Portion on Wall No.1& Floor of Gallery on F/F (Joint Opening) of Terrace of G/F (R/S Compound Wall)
 Peeling of Plaster on Gallery on F/F of Terrace of G/F (R/S Compound Wall)

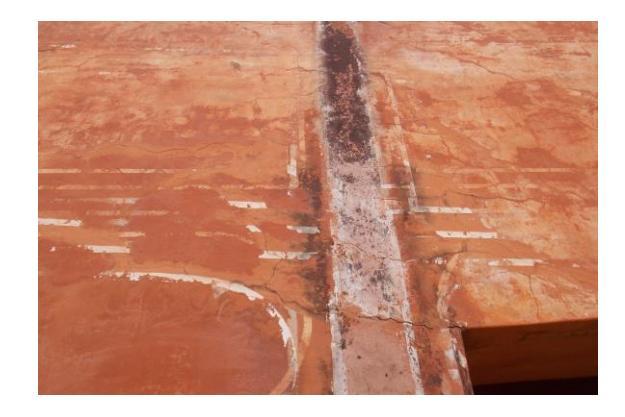
Photo 53 Plaster Crack on External F/F (Open Area Gallery of Terrace of G/F (R/S Compound Wall)

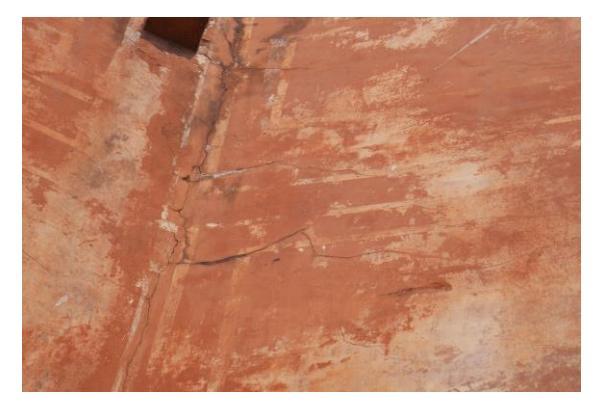
Photo 56 Plaster Crack on External F/F (Open Area Gallery of Terrace of G/F (R/S Compound Wall)

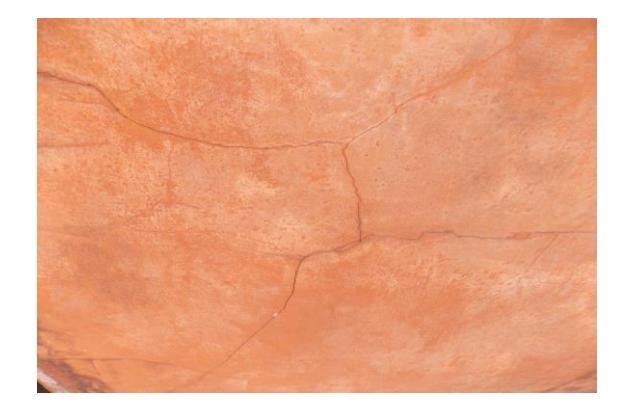
Photo 57 Plaster Crack on L/s Vertical Slab no. 2 of Terrace of G/F (R/S Compound Wall)

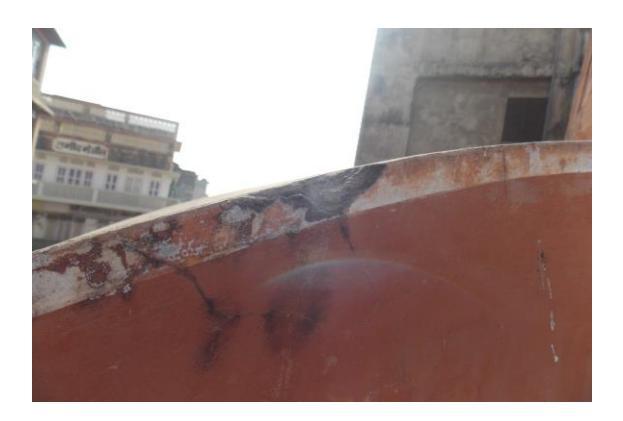
Photo 59 Peeling of Plaster on L/s Vertical Slab no. 4 of Terrace of G/F (R/S Compound Wall)

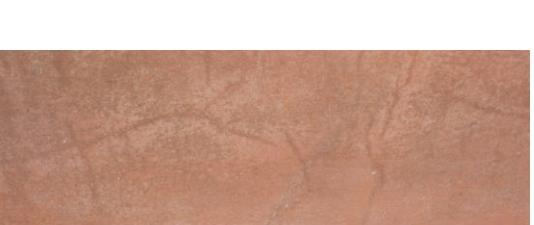
Photo 60

Peeling of Plaster on Terrace of GF (R/S Compound Wall)

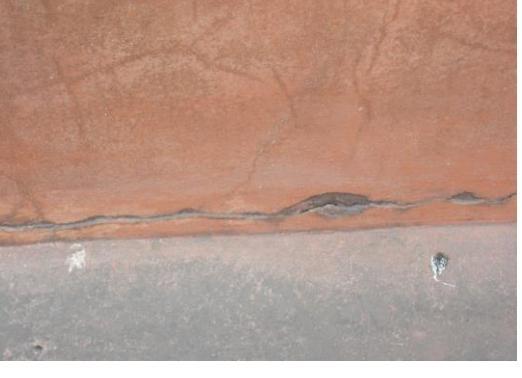
Photo 62 Peeling of Plaster on R/s Vertical Slab No. 41 of Terrace of G/F (R/S Compound Wall)

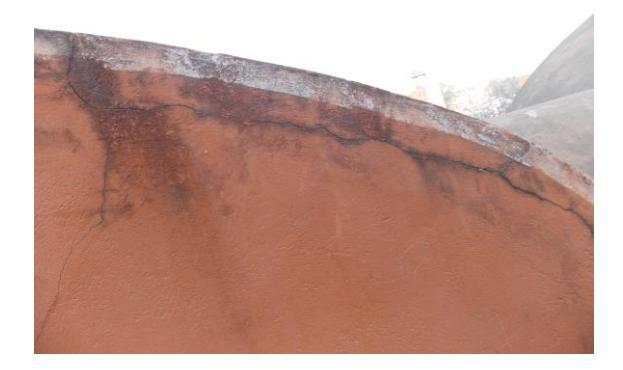
Photo 63 Plaster Crack on R/s Vertical Slab No. 40 of Terrace of G/F (R/S Compound Wall)

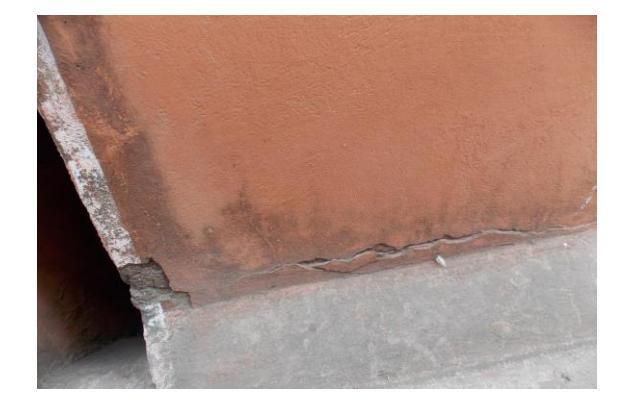
Photo 65 Peeling of Plaster on R/s Vertical Slab No. 38 of Terrace of G/F (R/S Compound Wall)

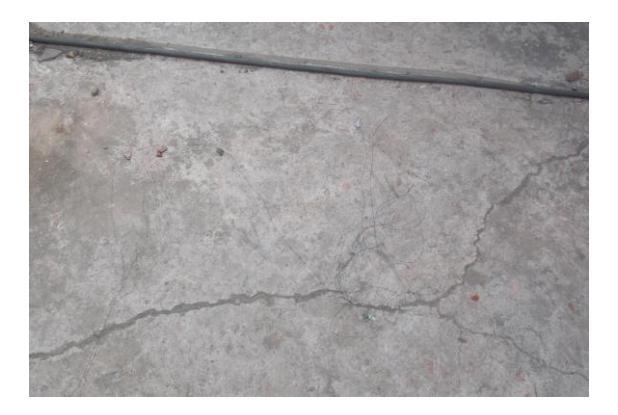
Photo 67 Plaster Crack on Floor of Terrace of G/F (R/S Compound Wall)

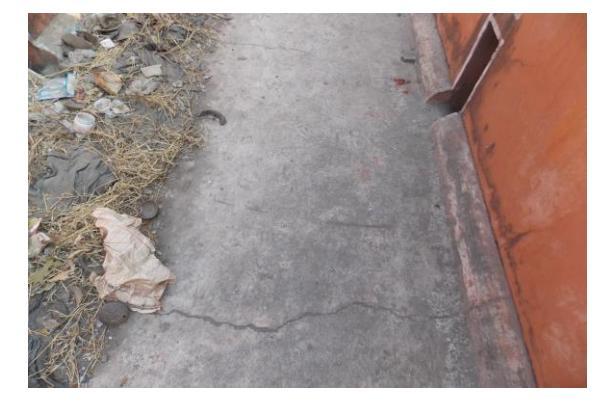
Photo 68 Plaster Crack on Floor of Terrace of G/F (R/S Compound Wall)

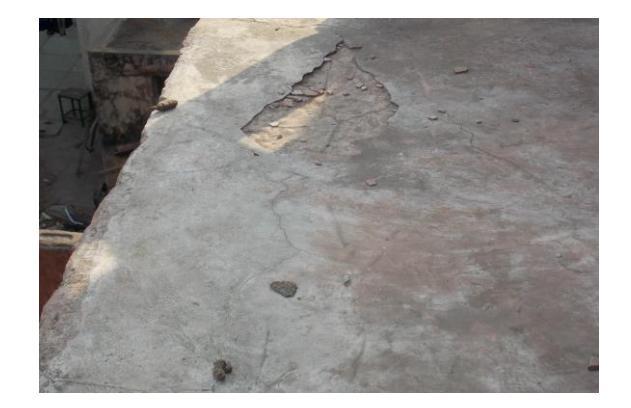
Photo 69 Peeling of Plaster on Stair 1 GF To terrace of Terrace of G/F (R/S Compound Wall)

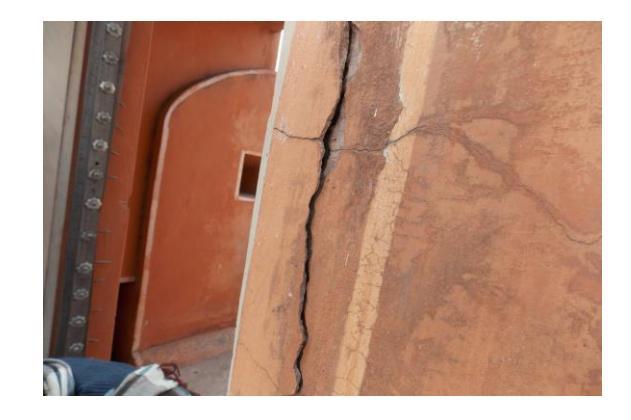
Photo 70 Dampness/Seepage on Outer wall of Gate No. 1 R/S of Terrace of G/F (R/S Compound Wall)

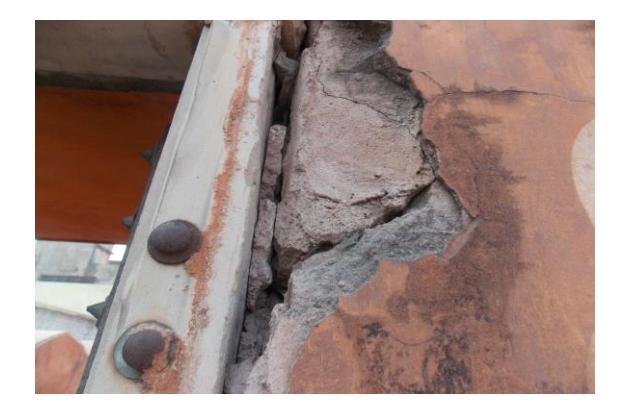
Photo 71 Dampness/Seepage on Outer wall of Gate No. 1 R/S of Terrace of G/F (R/S Compound Wall)

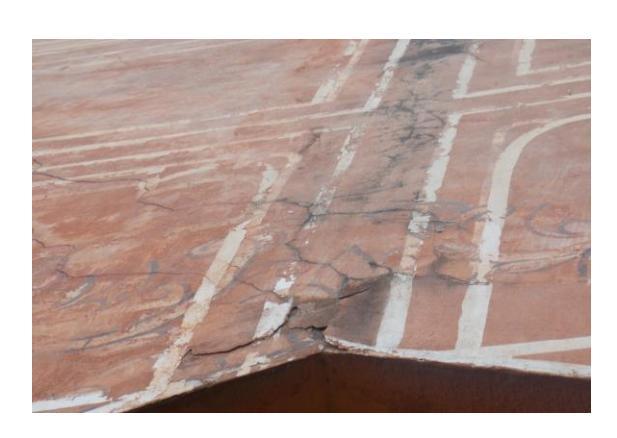
Photo 72 Peeling of Plaster on Outer wall of Gate No1 R/S Upper Portion of Terrace of G/F (R/S Compound Wall)

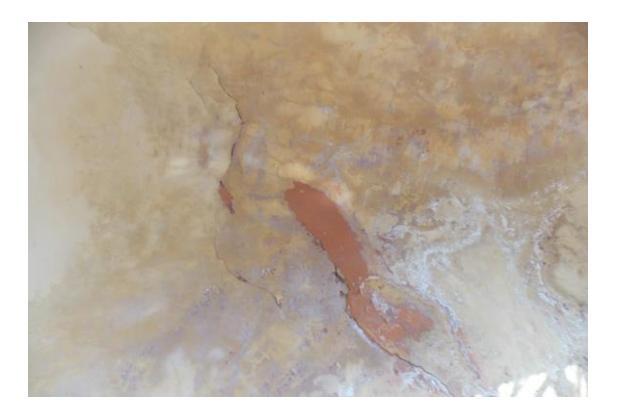
Photo 73 Dampness/Seepage on Gate on GF of Terrace (R/S Compound Wall)

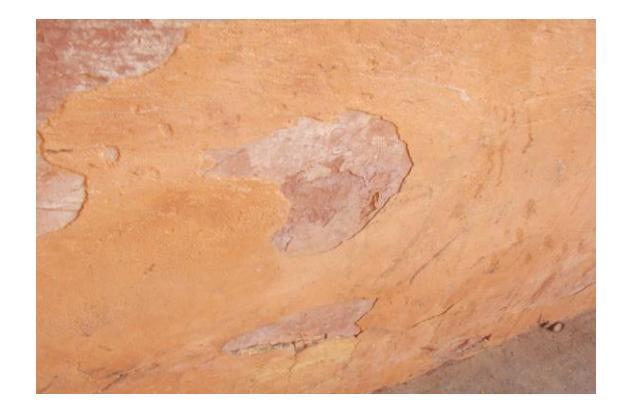
Photo 75 Peeling of Plaster on Right Side of Gate of Terrace of G/F (R/S Compound Wall)

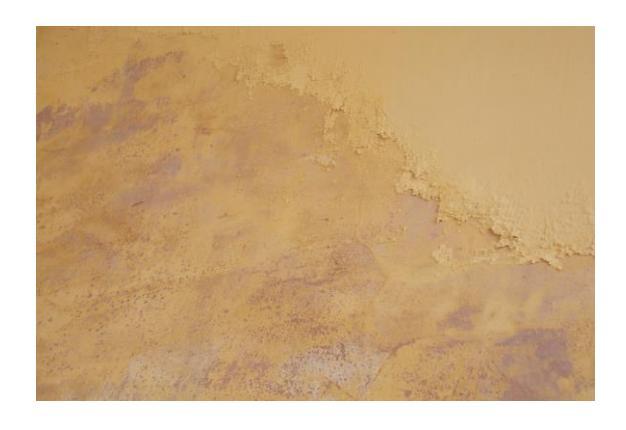
Photo 76 Dampness/Seepage on Right Side of Gate of Terrace of G/F (R/S Compound Wall)

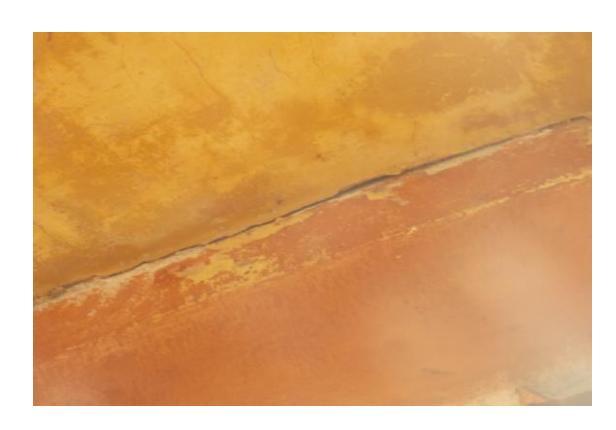
Photo 77 Dampness/Seepage on Roof of Gate on GF of Terrace of G/F (R/S Compound Wall)

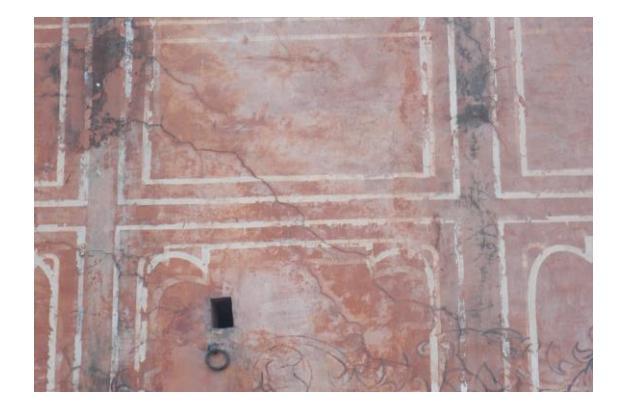
Photo 79 Peeling of Plaster on Inside of Gate of Terrace of G/F (R/S Compound Plaster Crack on Gate Front Side Upper Portion of Terrace of G/F (R/S Compound Wall) Wall)

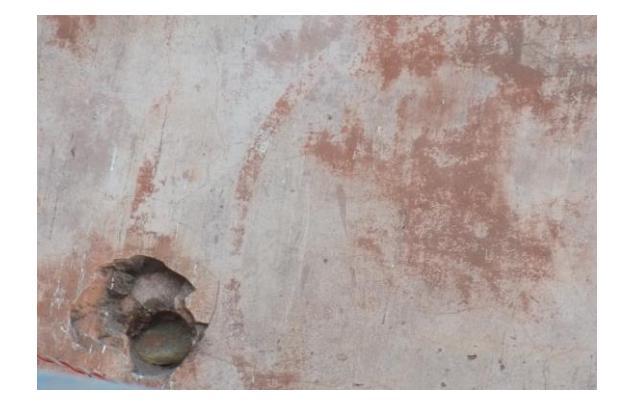
Photo 81 Peeling of Plaster on outer side of slab no. 60 of Terrace of G/F (R/S Compound Wall)
