Pre Building Condition Survey Report

Name and Address of Structure :	Choti Chopar to Badi Chopar (Down Line)
---------------------------------	---

Name of the Project	Contract JMRC-UG1B “Design and Construction of Tunnel between Chandpole and Badi Chouper and reverse line by Shield TBM, Underground Metro Stations at Choti Chouper and Badi Chouper by Cut and Cover Methods on East West Corridor of Jaipur Metro Rail Corporation Limited .”	
Owner :

Pre Building Condition Survey Report Choti Chopar to Badi Chopar (Down Line)

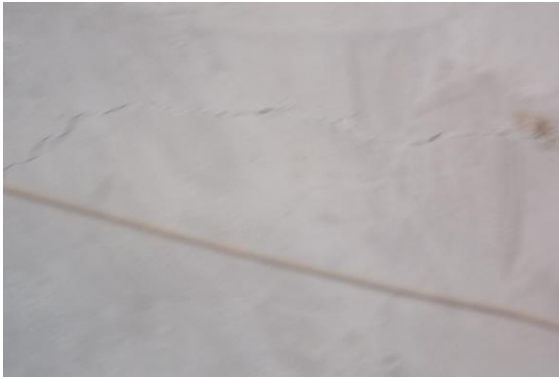
Photo 13

Inclined Crack on Roof of Varanda of Shop No. 380, Ground Floor
Approx. Width = 0.5mm, Approx. Length = 2.5m.
Distance from Rightside Column = 0.5m, Height from Floor = 3.3m.

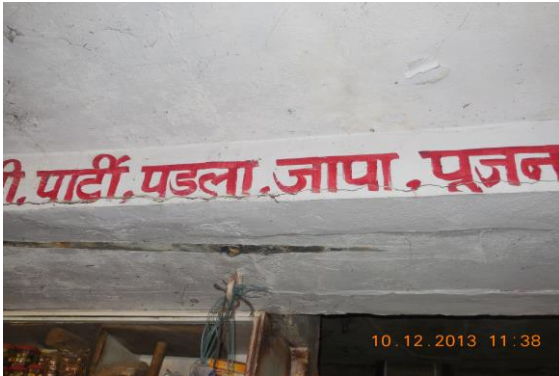
Photo 15

Inclined Crack on Wall No. 2 of Shop No. 379, Ground Floor
Approx. Width = 2.5mm, Approx. Length = 1.7m.
Distance from Wall No. 4 = 0m, Height from Floor = 0m.

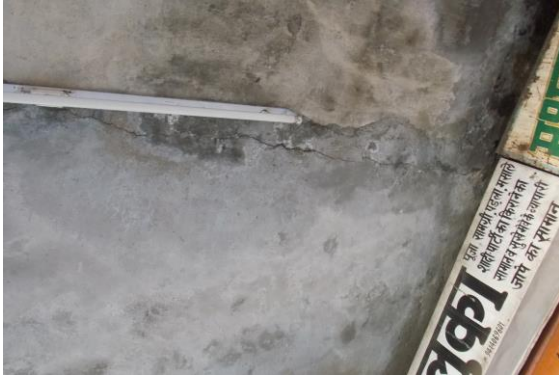
Photo 18 Horizontal Crack on Column & Between Shop No.379 & 378 of Varanda of Shop No.379, Ground Floor Approx. Width = 1.5mm, Approx. Length = 3m. Distance from Backside Right Column = 0m, Height from Floor = 3.3m.

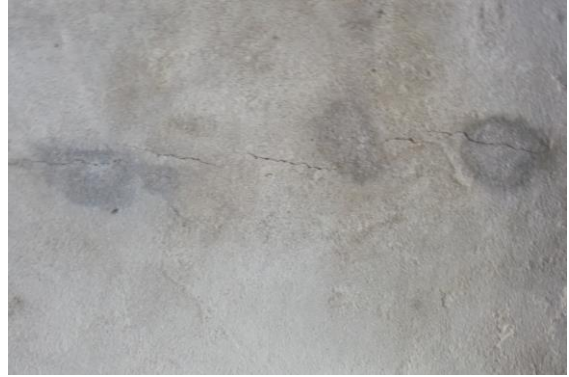
Photo 19 Horizontal Crack on Roof of Varanda of Shop No. 378, Ground Floor Approx. Width = 0.3mm, Approx. Length = 3m. Distance from Backside Left Side Column = 1.5m, Height from Floor = 3.3m.

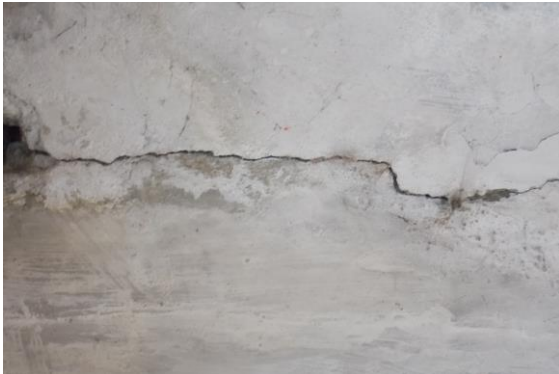
Photo 20 Horizontal Crack on Roof of Varanda of Shop No. 378, Ground Floor Approx. Width = 3mm, Approx. Length = 3m. Height from Floor = 3.3m.

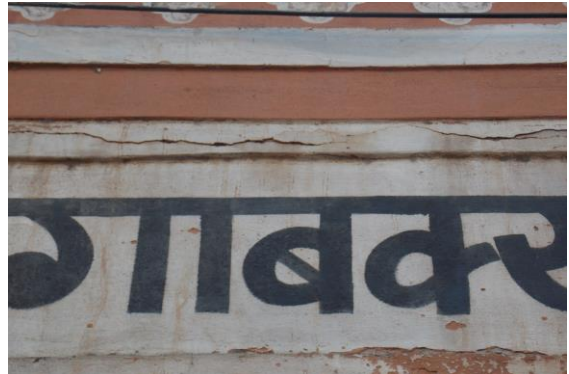
Photo 21 Horizontal Crack on Leftside Column outside of Shop No.377, Ground Floor Approx. Width = 5mm, Approx. Length = 4.5m. Between left & Right Side Column, Height from Floor = 3.3m.

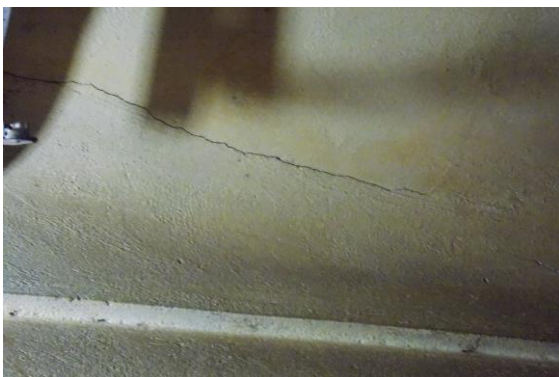
Photo 22 Horizontal Crack on Wall No. 3 of Part B of Shop No.377, Ground Floor Approx. Width = 1.5mm, Approx. Length = 1.5m. Distance from Wall No.1 = 0m, Height from Floor = 3m.

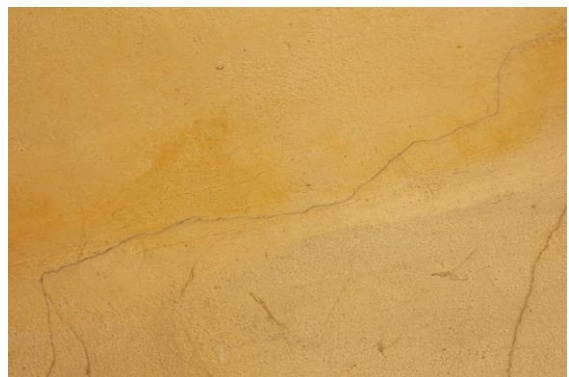
Photo 23 Inclined Crack on Wall No. 2 & Roof of Part B of Shop No.377, Ground Floor Approx. Width = 1mm, Approx. Length = 2m. Distance from Wall No.2 = 0m, Height from Floor = 2.4m.

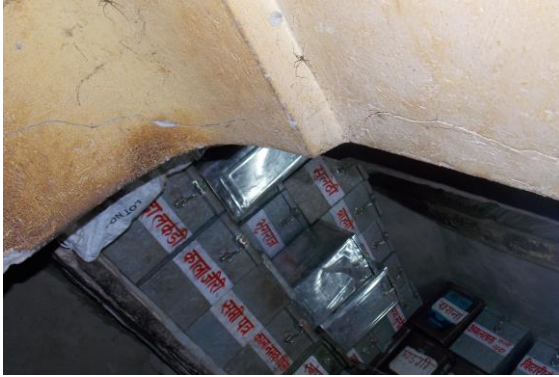
Photo 24

Inclined Crack on Wall No. 3 of Part C of Shop No.377, Ground Floor
Approx. Width = 0.8mm, Approx. Length = 1.5m. Distance from Wall No.1 = 1m, Height from Floor = 1.5m.

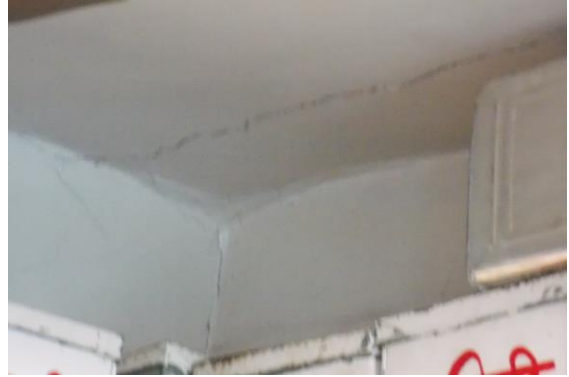
Photo 25

Horizontal Crack on Wall No. 4 of Part A of Shop No.377, Ground Floor
Approx. Width = 2mm, Approx. Length = 2.6m. Distance from Wall No.4 = 0m, Height from Floor = 2.2m.

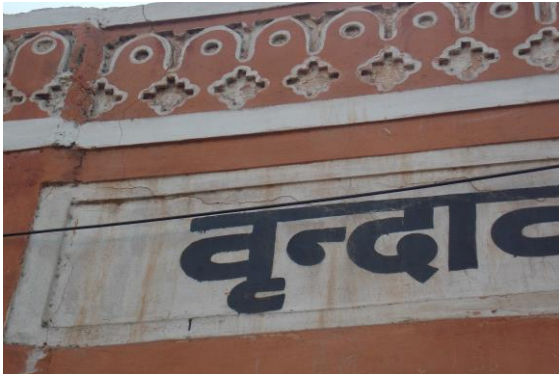
Photo 26

Inclined Crack on Wall No. Outer Shade of Frontside of Building,
Ground Floor Approx. Width = 0.4mm, Approx. Length = 3.5m. Height from Floor = 3.3m.

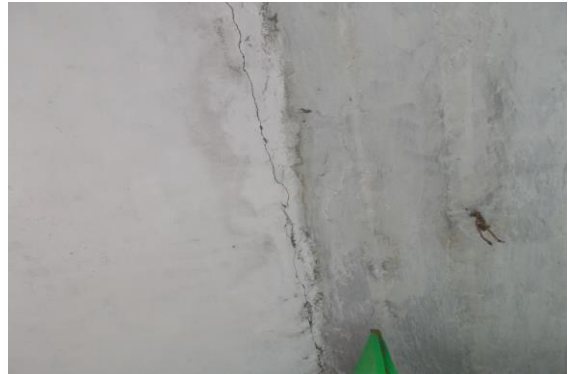
Photo 27

Horizontal Crack on Roof of Varanda of Shop No. 376, Ground Floor
Approx. Width = 1mm, Approx. Length = 2.8m. Height from Floor = 3m.

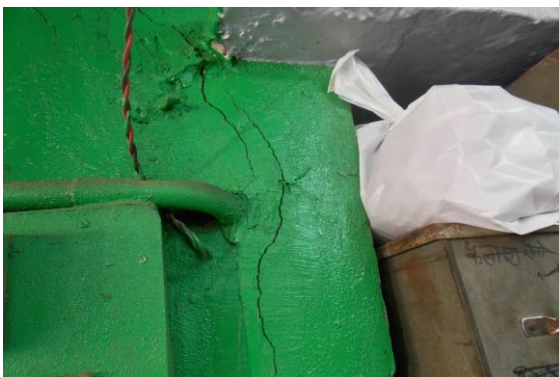
Photo 28

Inclined Crack on Wall No. 1 of Shop No. 376, Ground Floor
Approx. Width = 0.5mm, Approx. Length = 0.8m.
Distance from Wall No.3 = 0.3m, Height from Floor = 1.8m.

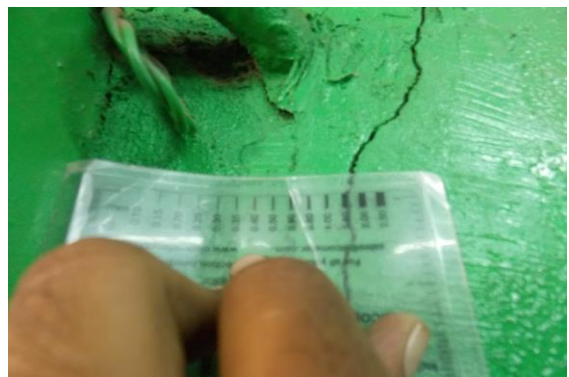
Photo 28A

Inclined Crack on Wall No. 1 of Shop No. 376, Ground Floor
Approx. Width = 0.5mm, Approx. Length = 0.8m.
Distance from Wall No.3 = 0.3m, Height from Floor = 1.8m.

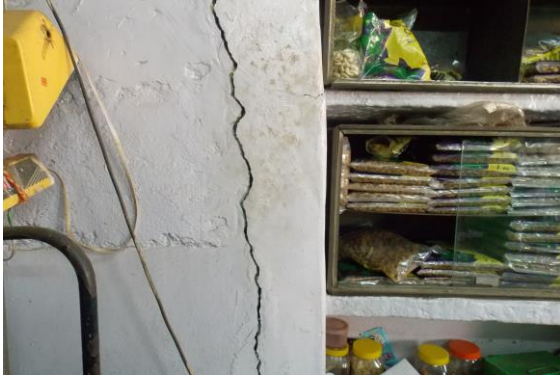
Photo 29

Vertical Crack on Wall No. 1 of Shop No. 376, Ground Floor
Approx. Width = 5mm, Approx. Length = 3m.
Distance from Wall No.3 = 2.4m, Height from Floor = 0m.

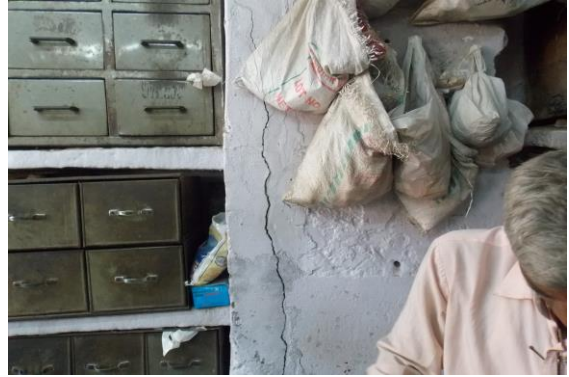
Photo 30

Vertical Crack on Wall No. 2 of Shop No. 376, Ground Floor
Approx. Width = 5mm, Approx. Length = 3m.
Distance from Wall No.3 = 2.4m, Height from Floor = 0m.

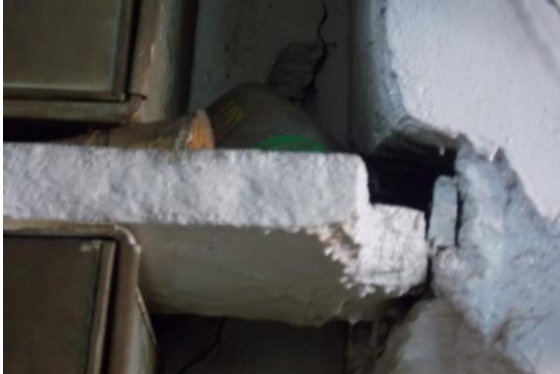
Photo 31

Inclined Crack on Wall No. 2 of Shop No. 376, Ground Floor
Approx. Width = 3mm, Approx. Length = 1m.
Distance from Wall no.3 = 0m, Height from Floor = 1.8m.

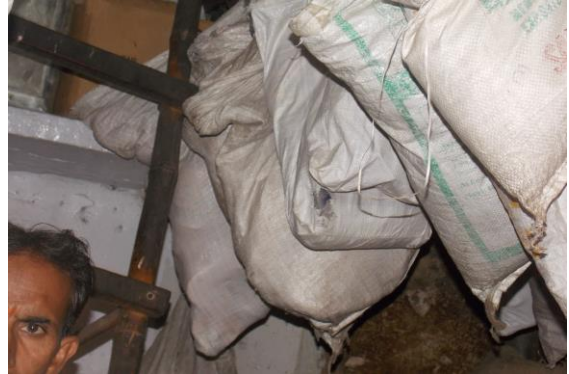
Photo 31A

Inclined Crack on Wall No. 2 of Shop No. 376, Ground Floor
Approx. Width = 3mm, Approx. Length = 1m.
Distance from Wall no.3 = 0m, Height from Floor = 1.8m.

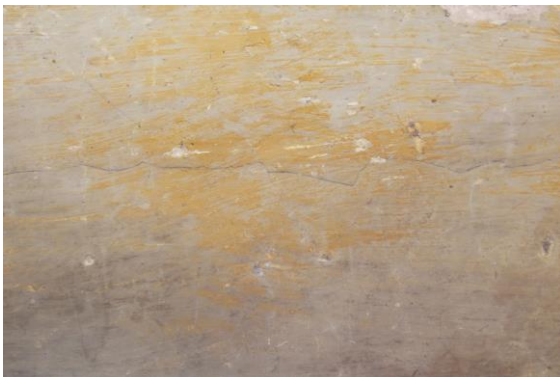
Photo 32

Horizontal Crack on Roof of Part C of Shop No. 376, Ground floor
Approx. Width = 0.5mm, Approx. Length = 1.3m.
Distance from Wall no.1 = 0m, Height from Floor = 3m.

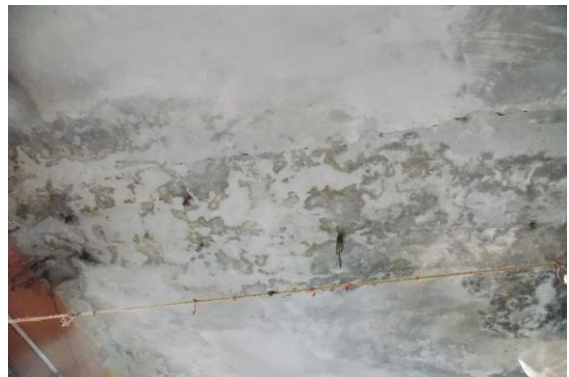
Photo 33

Dampness/Seepage on Roof of Varanda of ShopNo.380 of Ground Floor

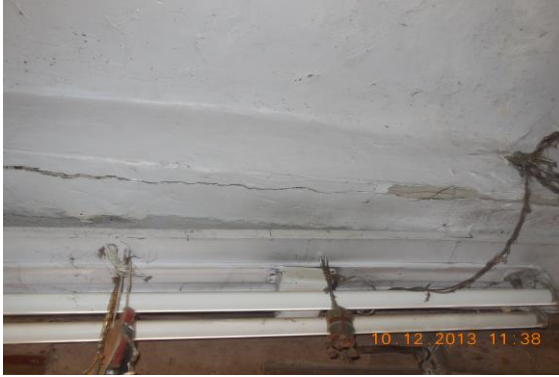
Photo 34

Dampness/Seepage on Roof & All Walls of Shop No.379 of Basement

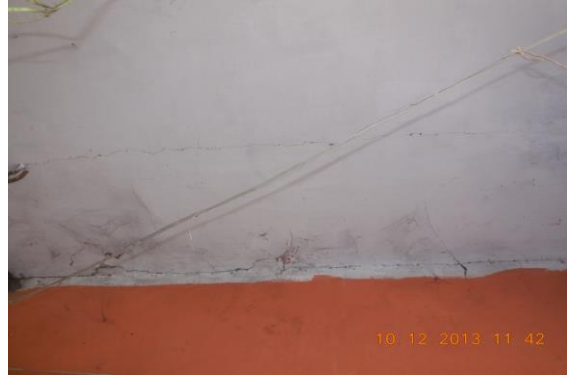
Photo 35

Dampness/Seepage on Roof & All Walls of Shop No.379 of Basement

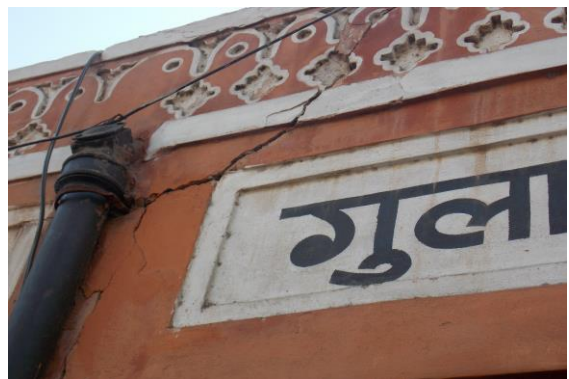
Photo 39

Peeling of Plaster on Column & Outside Left Side of Varanda of Shop No. 378 of Ground Floor

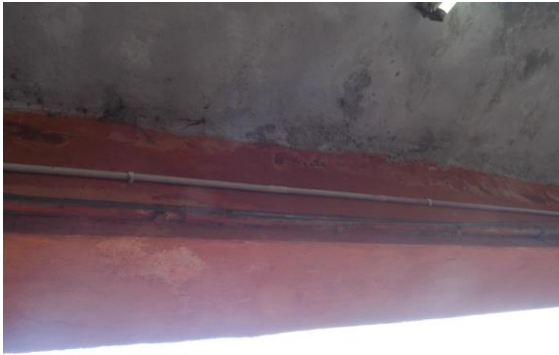
Photo 40

Dampness/Seepage on Roof of Varanda of Shop No. 378 of Ground Floor

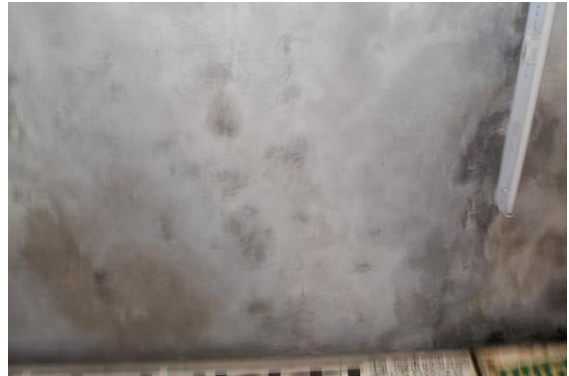
Photo 41

Dampness/Seepage on Roof of Varanda of Shop No. 378 of Ground Floor

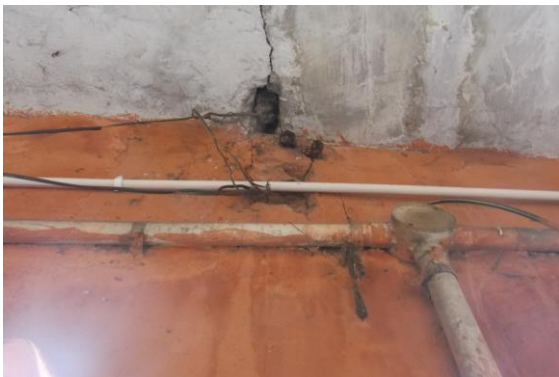
Photo 42

Peeling of Plaster on Backside Left Side Column of Shop No.378 of Ground Floor

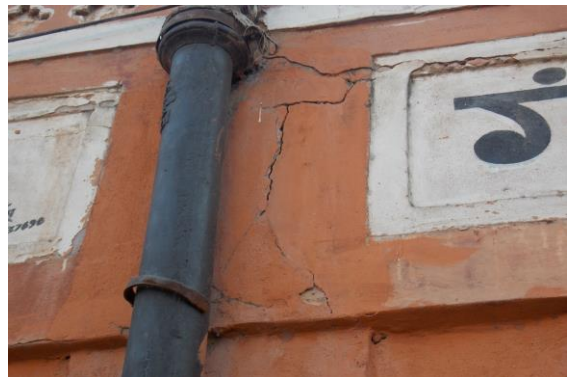
Photo 43

Peeling of Plaster on Leftside Colum outside of Shop No.377 of Ground Floor

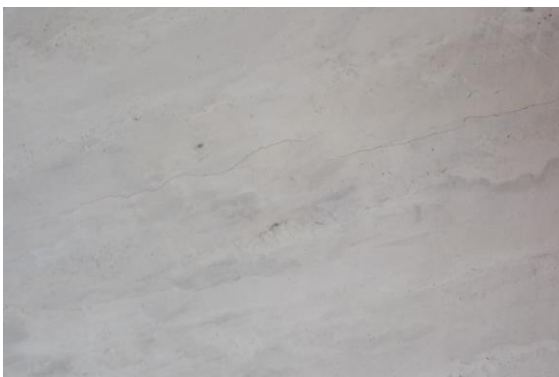
Photo 44

Peeling of Plaster on Roof of Varanda of Shop of Ground Floor

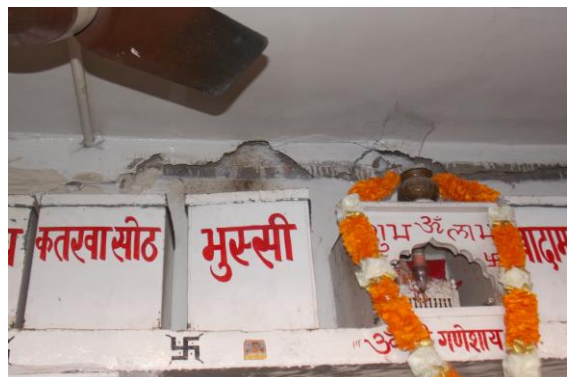
Photo 45

Peeling of Plaster on Wall No. 4 of Part A of Shop No.377 of Ground Floor

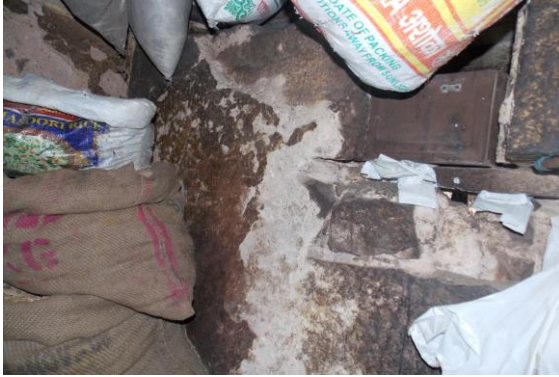
Photo 46

Peeling of Plaster on Wall No. 3 of Part C of Shop No. 376 of Ground Floor

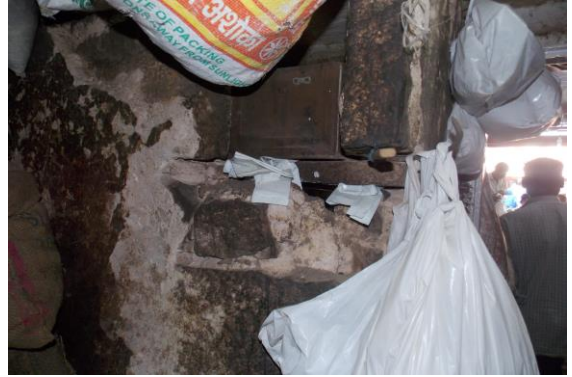
Photo 47

Peeling of Plaster on Wall No. 3 of Part C of Shop No. 376 of Ground Floor

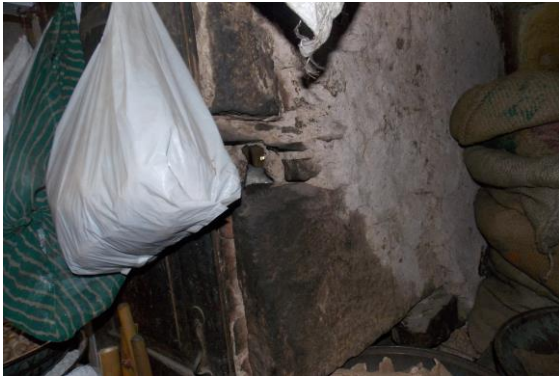
Photo 48

Peeling of Plaster on Wall No. 3 of Part C of Shop No. 376 of Ground Floor

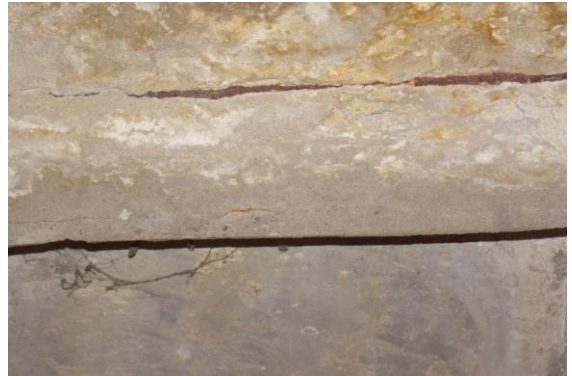
Photo 49

Peeling of Plaster on Roof of Shop No. 374 of Ground Floor

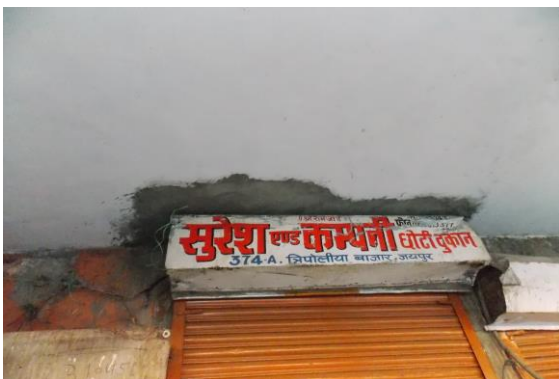
Photo 50

Peeling of Plaster on Outer Wall & 3 of Shop No. 374 of Ground Floor

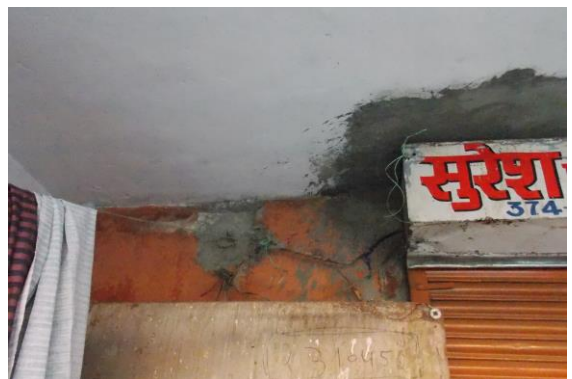
Photo 51

Peeling of Plaster on Outer Wall & 3 of Shop No. 374 of Ground Floor

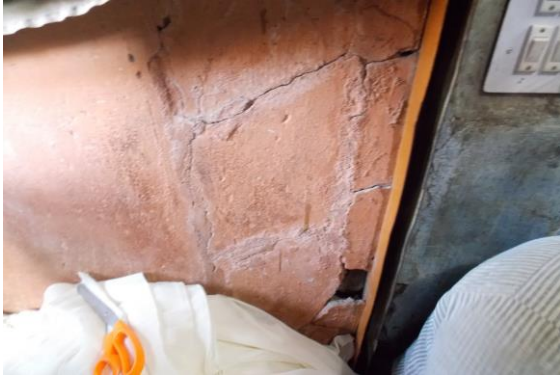
Photo 52

Peeling of Plaster on Wall No. Outer Wall & 1 of Shop No. 374 of Ground Floor

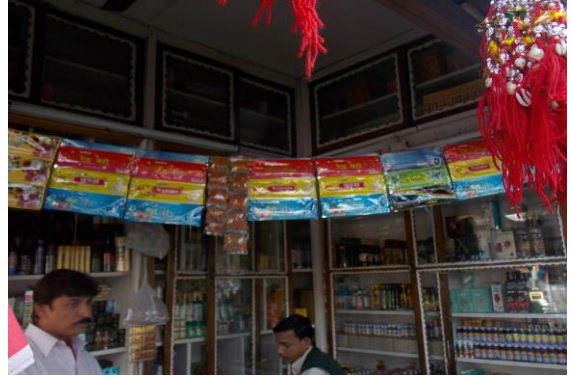
Photo 53

Wall No. 2 & 4 of Shop No. 382 of Ground Floor Covered with Material

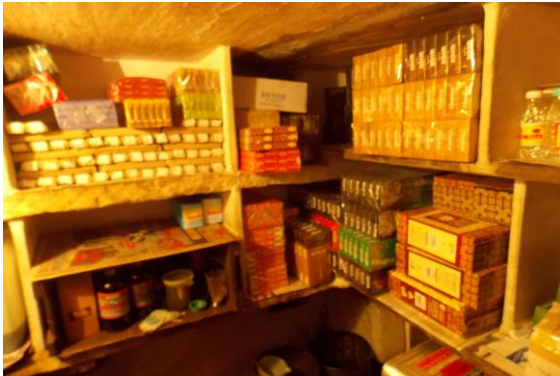
Photo 54

All Walls of Shop No. 382 of Bsaement Covered with Material

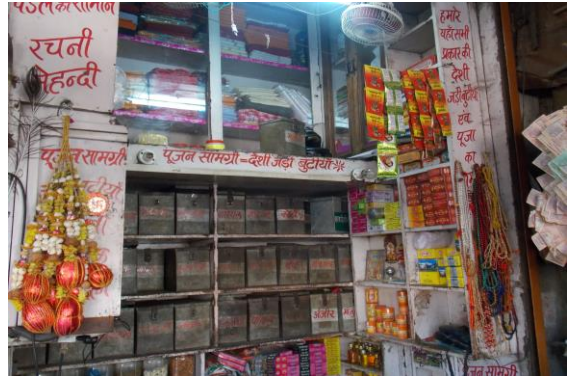
Photo 55

Wall No. 2 & 4 of Shop No 381 of Ground Floor Covered with Material

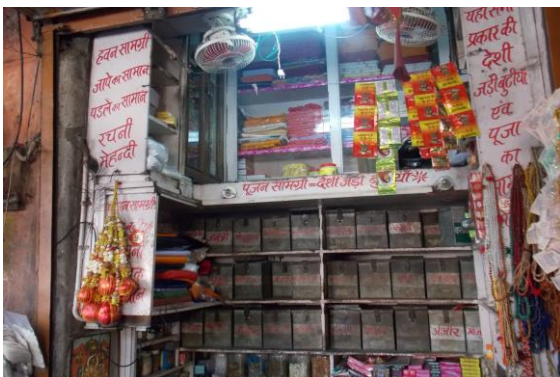
Photo 56

Wall No. 1 & 4 of Shop No 381 of Ground Floor Covered with Material

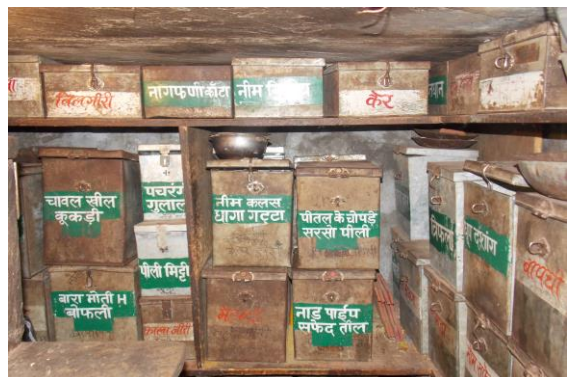
Photo 57

All Walls of Shop No 381 of Basement Covered with Material

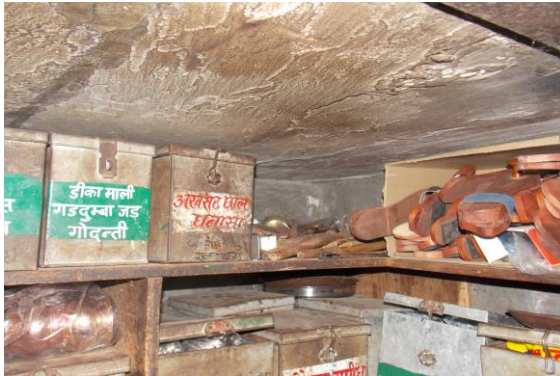
Photo 58

All Walls of Shop No 381 of Basement Covered with Material

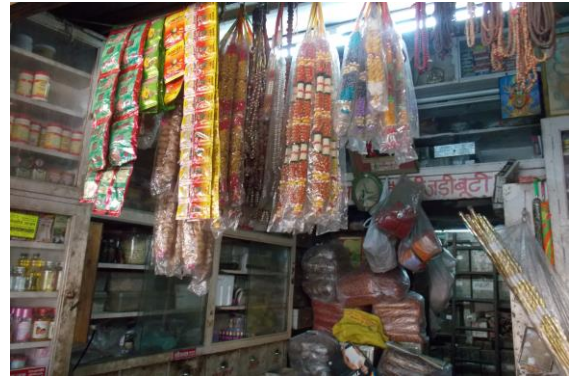
Photo 59

Wall No. 1 & 4 of Shop No. 380 of Ground Floor Covered with Material

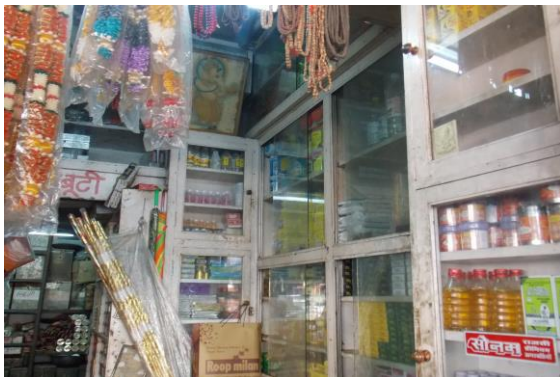
Photo 60

Wall No. 2 & 4 of Shop No. 380 of Ground Floor Covered with Material

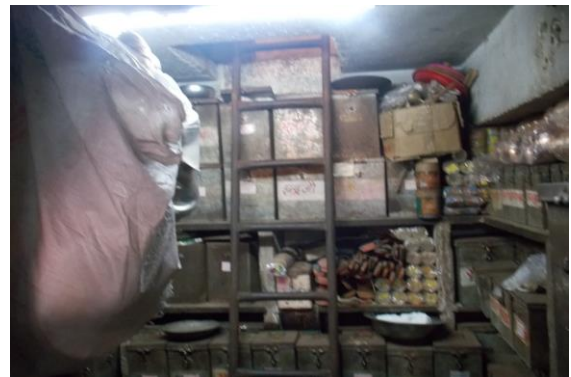
Photo 61

Wall No. 4 & 2 of Part 2 of Shop No. 380 of Ground Floor Covered with Material

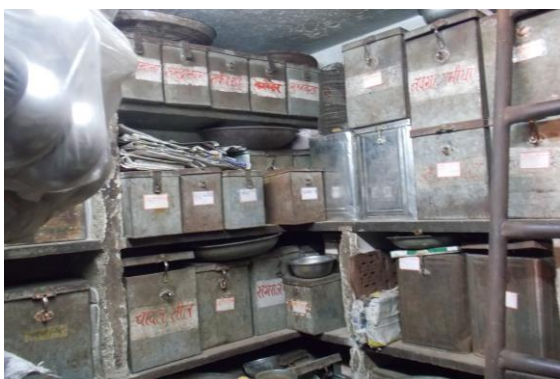
Photo 62

Wall No. 1 & 4 of Part 2 of Shop No. 380 of Ground Floor Covered with Material

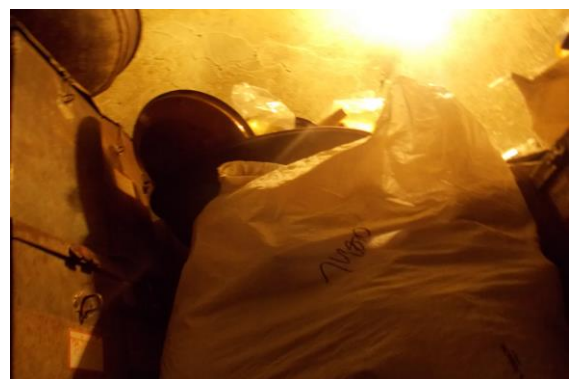
Photo 63

All Walls of UGF of Shop No. 380 of Ground Floor Covered with Material

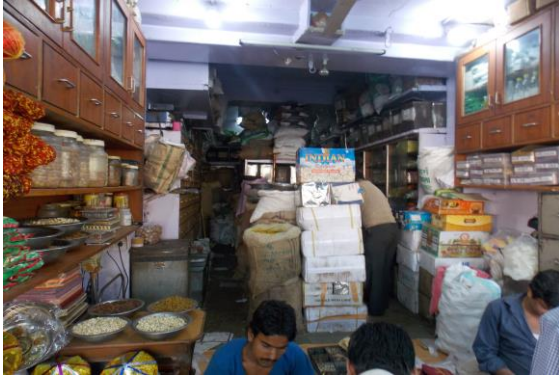
Photo 64

All Walls of Varanda of Shop No. 378 of Ground Floor Covered with material

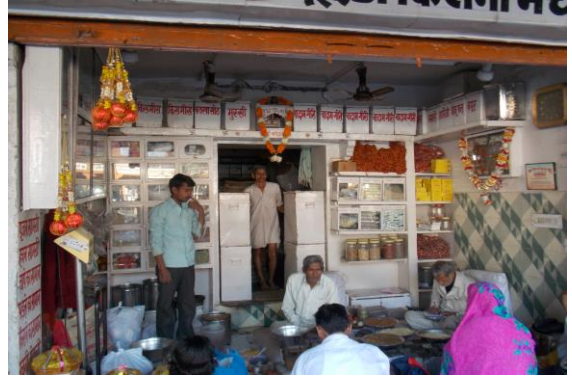
Photo 65

All Walls of Shop No.377 of Ground Floor Covered with Material

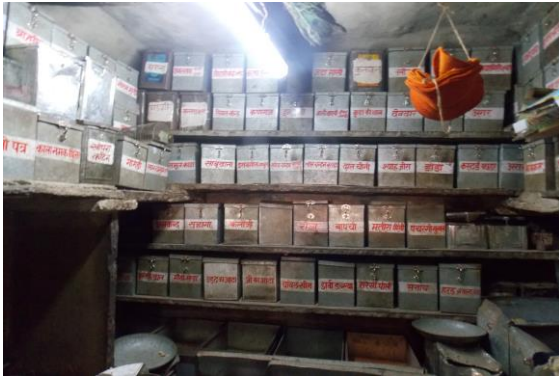
Photo 66

All Walls of Part C of Shop No.377 of Ground Floor Covered with Material

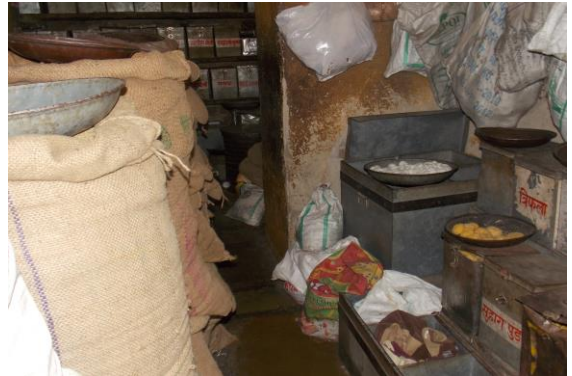
Photo 67

Wall No. 2 of Part B of Shop No.377 of Ground Floor Covered with material

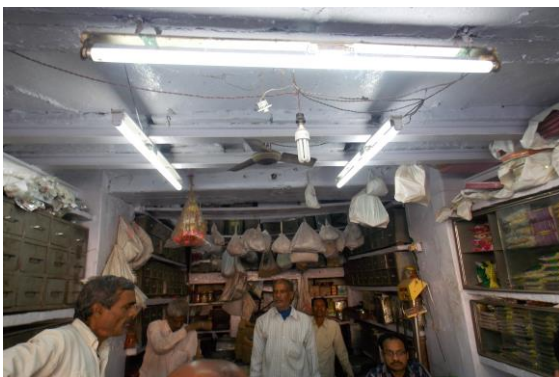
Photo 68

All Walls of Part 1 of Shop No. 376 of Ground Floor Covered with material

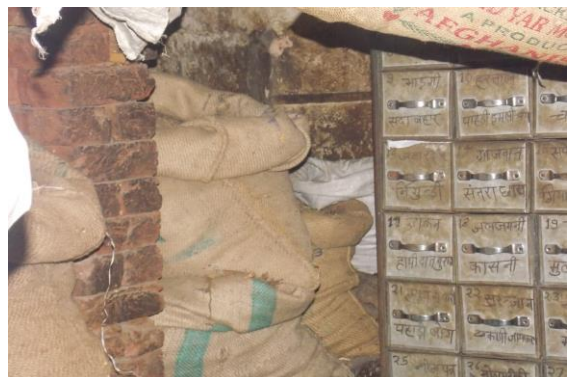
Photo 69

All Walls of Part C of Shop No. 376 of Ground Floor Covered with Material

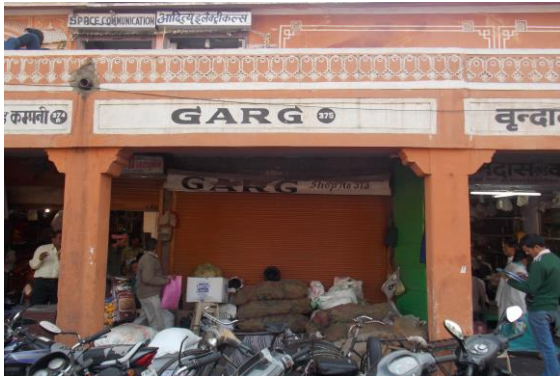
Photo 70
Shop No.375 of Ground floor Locked

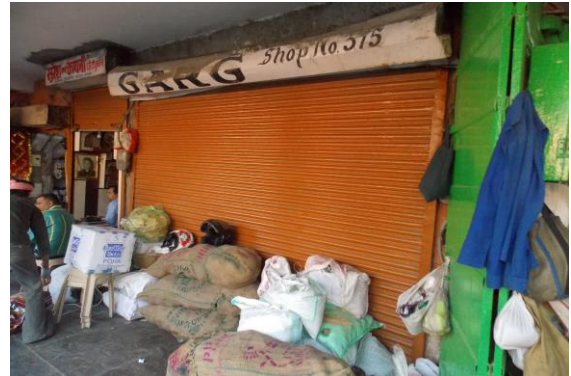
Photo 71
Shop No.375 of Ground floor Locked

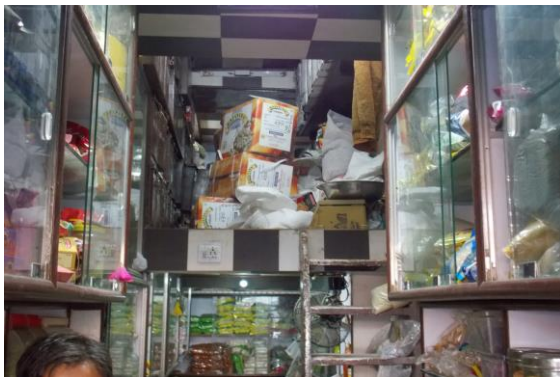
Photo 72
All Walls of Shop No. 374 A of Ground Floor Covered with material

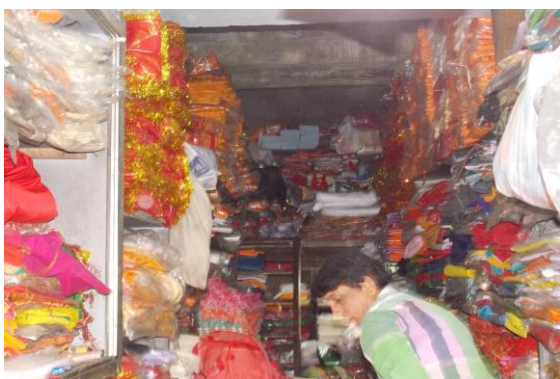
Photo 74
All Walls of Shop No. 374 of Ground Floor Covered with material

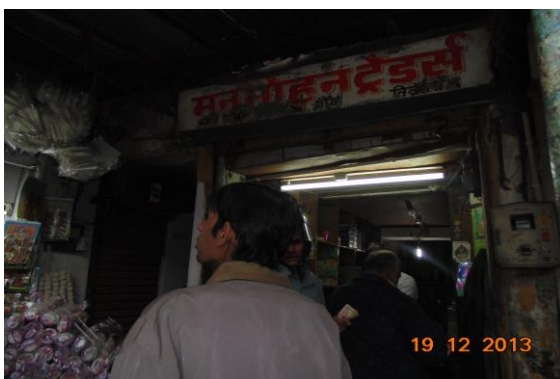
Photo 5
View of Shop Man Mohan Traders, Ground Floor

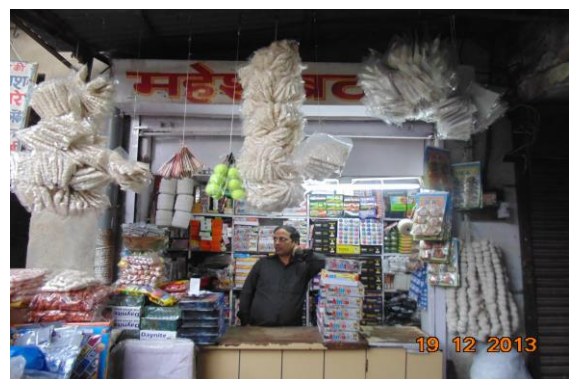
Photo 6
View of Shop Mahesh Brothers, Ground Floor

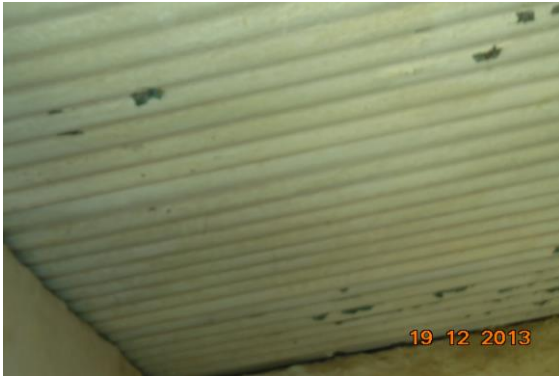
Photo 7
View of Kitchen Roof , First Floor

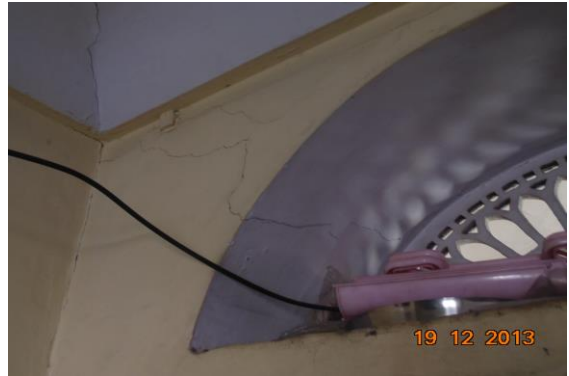
Photo 8
Inclined Crack on Wall No. 3 & Roof of Room No. 1, First Floor, Approx. Width = 1mm, Approx. Length = 3m.

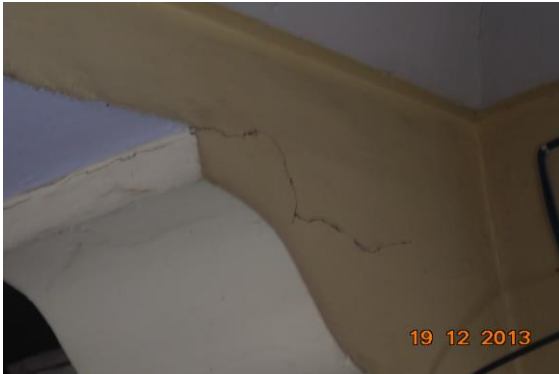
Photo 9
Inclined Crack on Wall No. 3 of Passage No. 1, First Floor, Approx. Width = 5mm, Approx. Length = 2m.

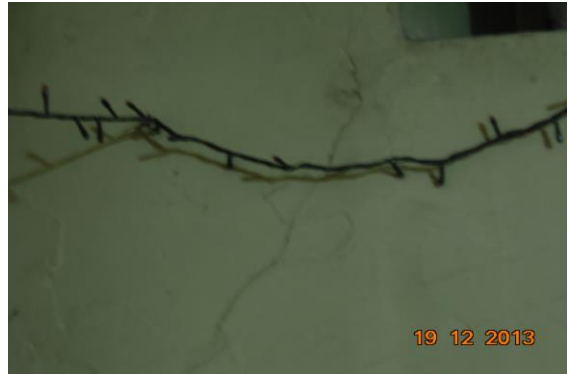
Photo 10
Inclined Crack on Wall No. 1 of Temple, First Floor, Approx. Width = 1mm, Approx. Length = 2m.

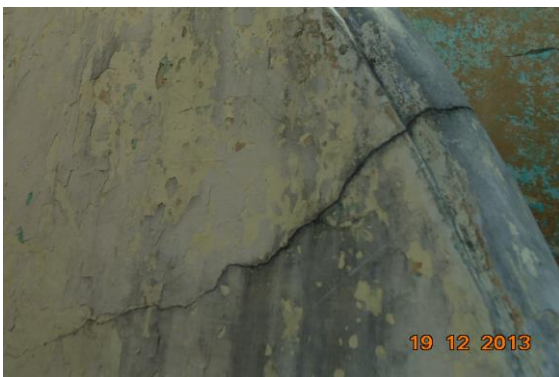
Photo 11
Inclined Crack on Wall No. 2 of Staircase First Floor to Second Floor, First Floor, Approx. Width = 1.5mm, Approx. Length = 1.5m. Distance from Wall No. 2 = 2m, Height from Floor = 1m.

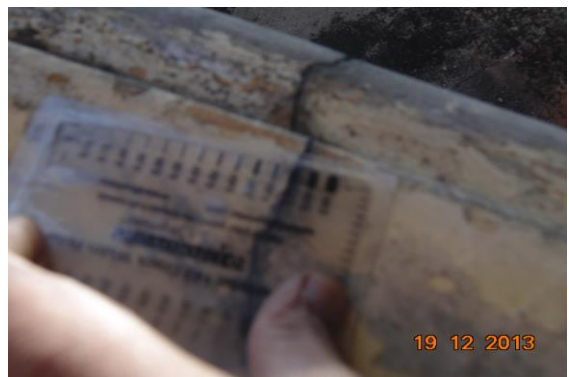
Photo 11A
Inclined Crack on Wall No. 2 of Staircase First Floor to Second Floor, First Floor, Approx. Width = 1.5mm, Approx. Length = 1.5m. Distance from Wall No. 2 = 2m, Height from Floor = 1m.

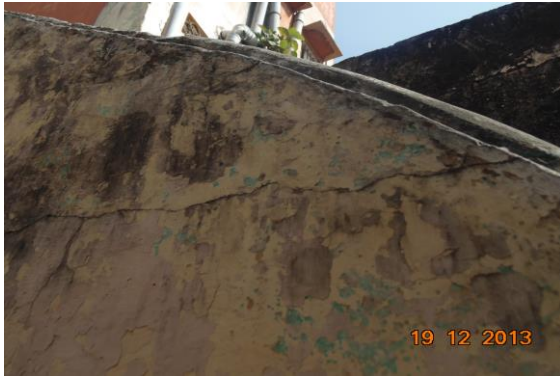
Photo 12

Inclined Crack on Wall No. 2 of Staircase First Floor to Second Floor, First Floor, Approx. Width = 1mm, Approx. Length = 1.5m. Distance from Wall No.2 = 2.5m, Height from Floor = 1.5m.

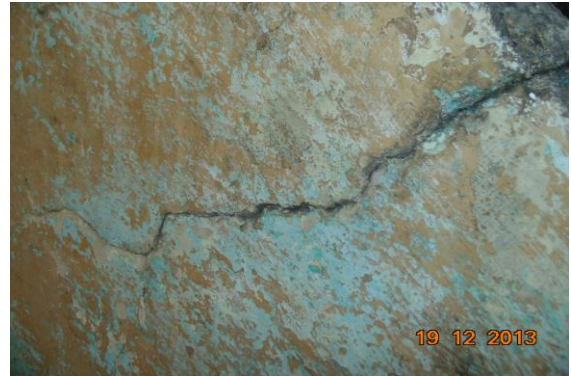
Photo 13

Inclined Crack on Wall No. 4 of Staircase First Floor to Second Floor, Second Floor, Approx. Width = 5mm, Approx. Length = 0.5m. Distance from Wall No.4 = 2m, Height from Floor = 0.2m.

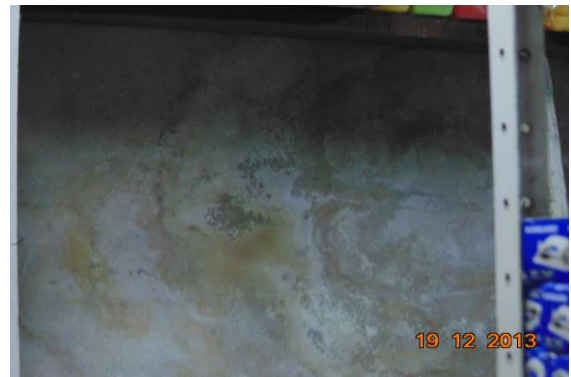
Photo 15

Dampness/Seepage on Wall No. 4 of Shop Suresh & Company of Ground Floor

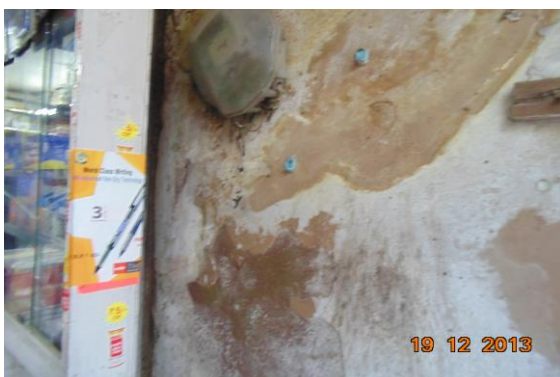
Photo 16

Dampness/Seepage on Front Side External Wall of Shop Suresh & Company of Ground Floor

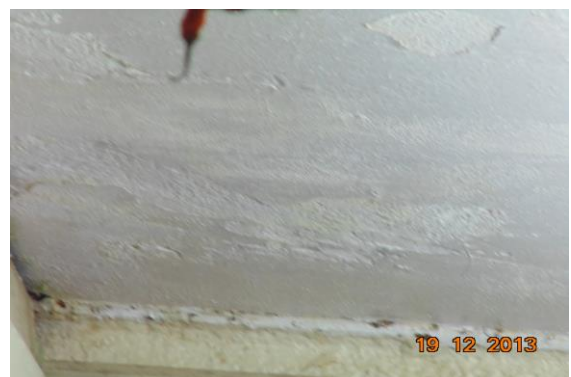
Photo 17

Dampness/Seepage on Roof of Shop Kingsons of Ground Floor

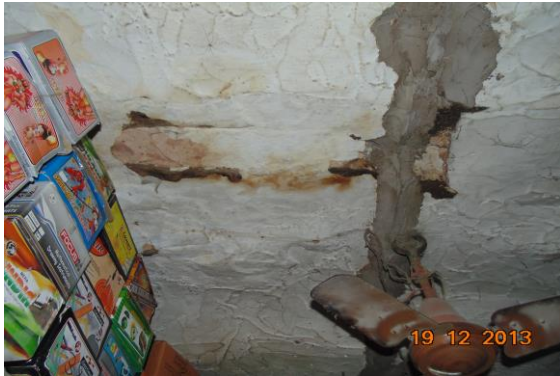
Photo 18

Peeling of Plaster on Roof of Part A of Shop Lenco of Ground Floor

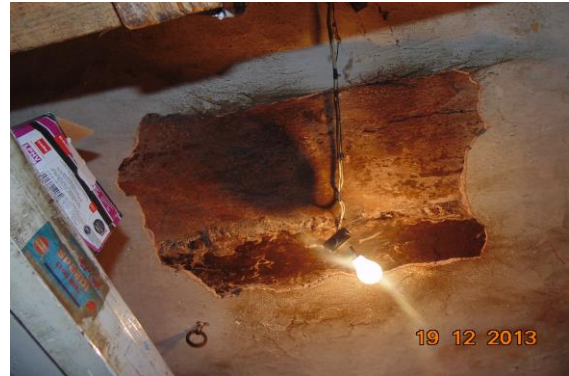
Photo 19

Peeling of Plaster on Roof of Part B of Shop Lenco of Ground Floor

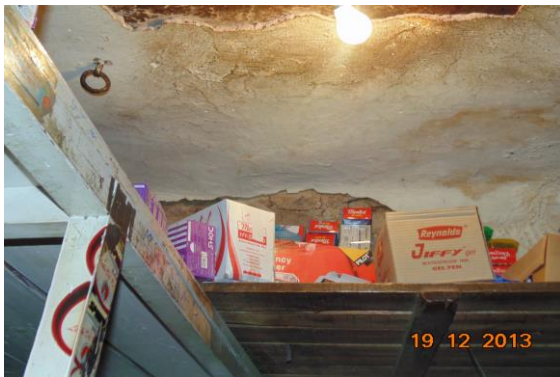
Photo 20

Peeling of Plaster on Wall No. 4 of Part B of Shop Lenco of Ground Floor

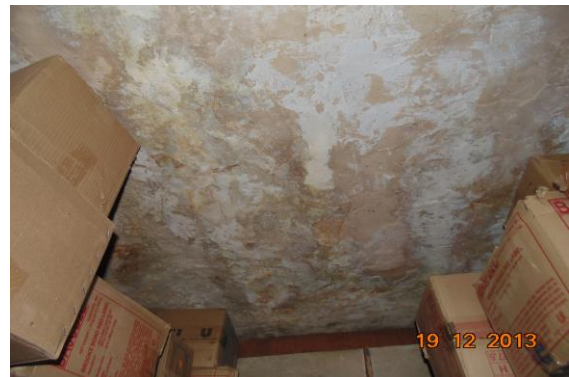
Photo 21

Peeling of Plaster on Roof of Shop Man Mohan Traders of Ground Floor

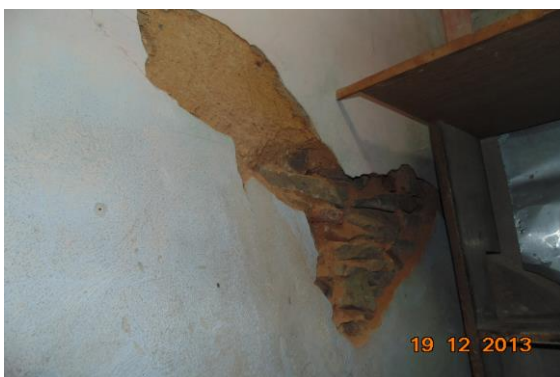
Photo 22

Damaged Portion on Wall No. 6 of Shop Man Mohan Traders of Ground Floor

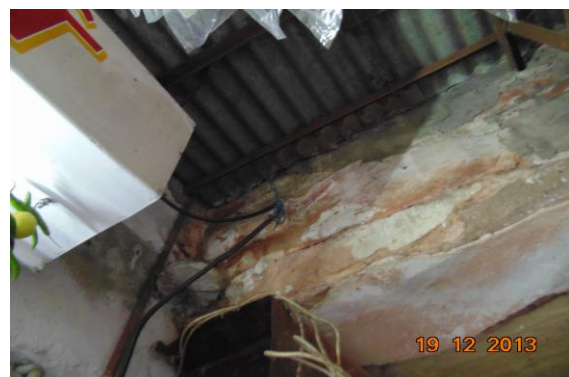
Photo 23

Damaged Portion on Front Side External Wall of Shop Mahesh Brothers of Ground Floor

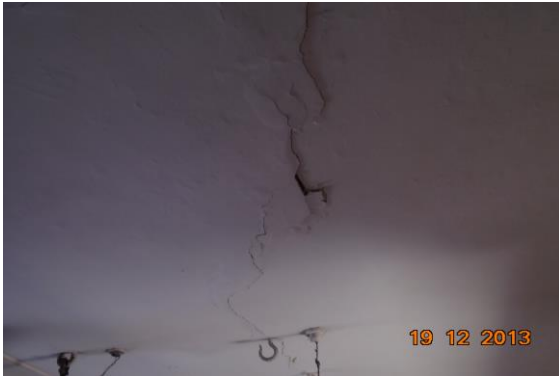
Photo 24
Damaged Portion on Roof of Room No. 1 of First Floor

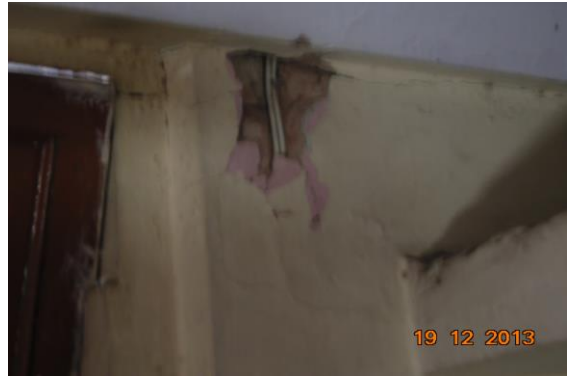
Photo 25
Peeling of Plaster on Wall No. 4 of Passage No.1 of First Floor

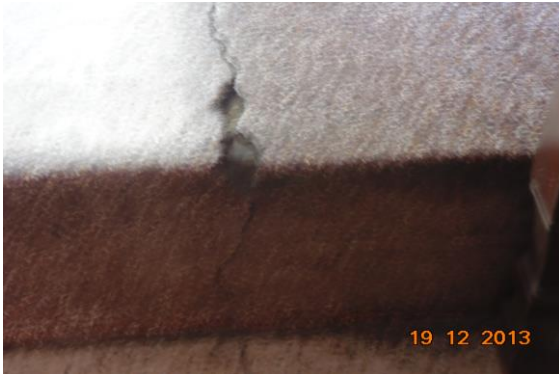
Photo 26
Damaged Portion on Floor of Passage No.1 of First Floor

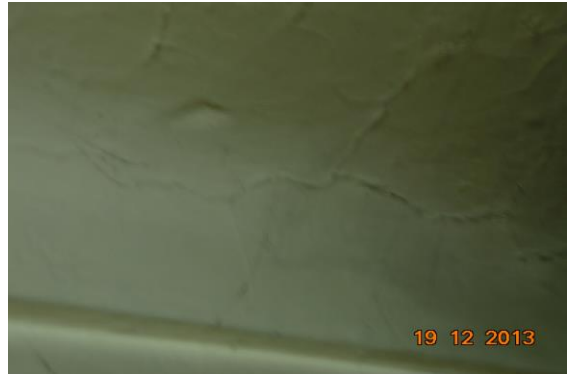
Photo 27
Peeling of Plaster on Roof of Temple of First Floor

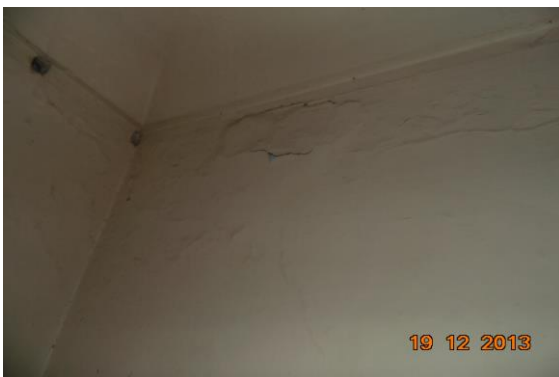
Photo 28
Peeling of Plaster on Wall No. 4 of Store No.1 of First Floor

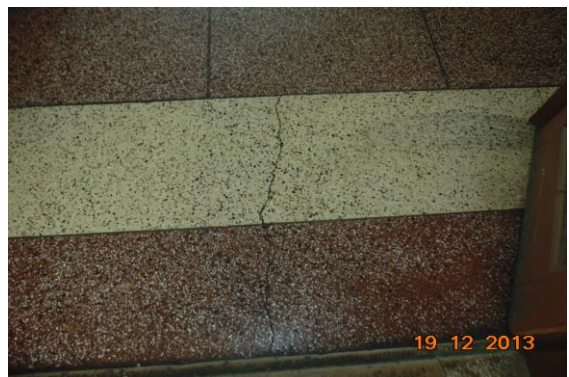
Photo 29
Peeling of Plaster on Floor of Room No. 1 of First Floor

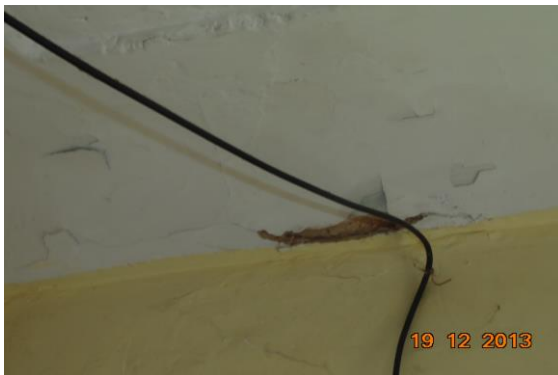
Photo 32
Peeling of Plaster on Roof of Room No. 2 of First Floor

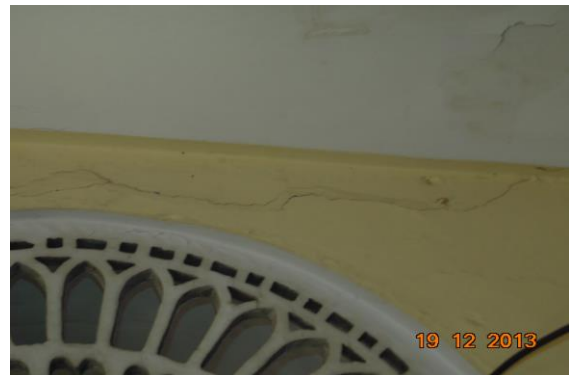
Photo 33
Peeling of Plaster on Wall No. 4 of Room No. 2 of First Floor

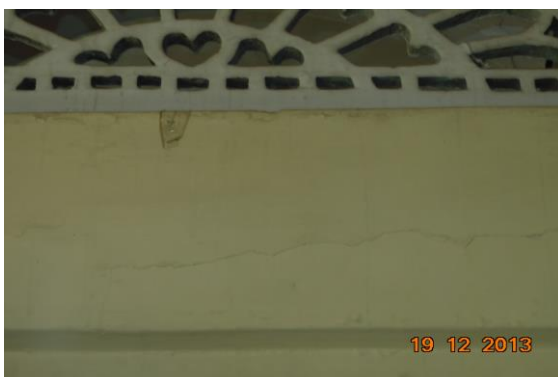
Photo 34
Peeling of Plaster on Wall No. 4 of Room No. 2 of First Floor

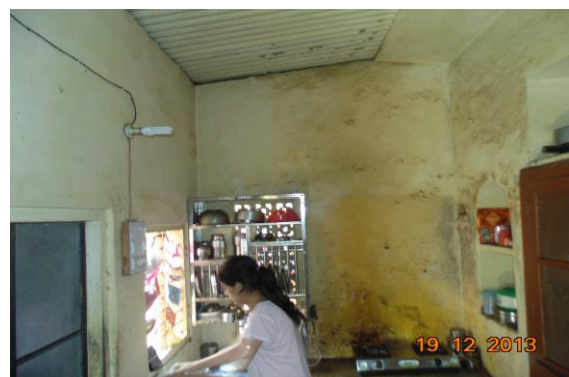
Photo 35
Dampness/Seepage on Wall No. 2 & 4 of Kitchen of First Floor

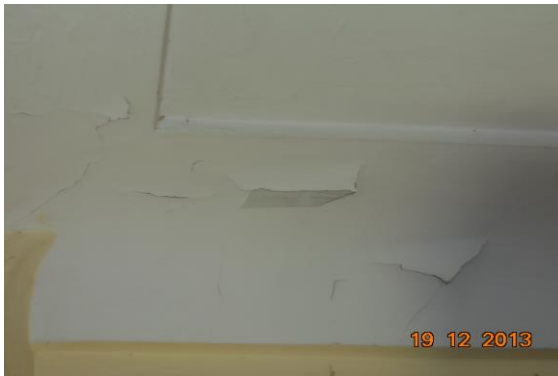
Photo 36
Peeling of Plaster on Roof of Room No. 2 of First Floor

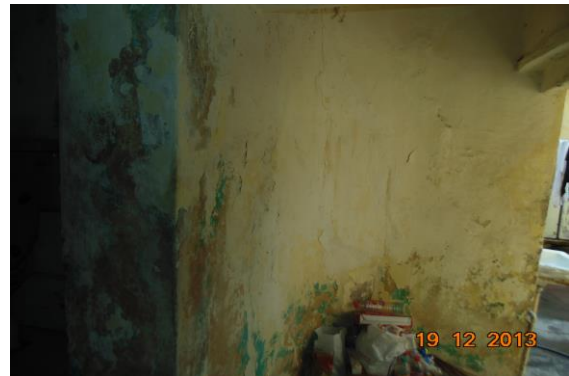
Photo 37
Dampness/Seepage on Wall No. 2 & 4 of Passage of First Floor

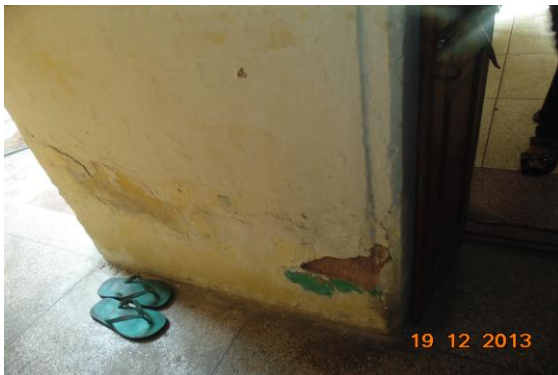
Photo 38
Dampness/Seepage on Wall No. 3 of Passage of First Floor

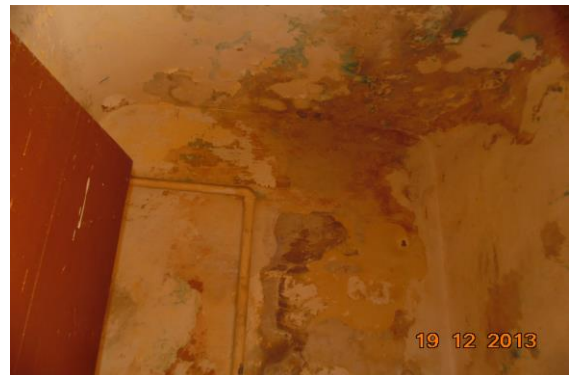
Photo 39
Dampness/Seepage on Wall No. 2, 4 & Roof of Toilet No. 1 of First Floor

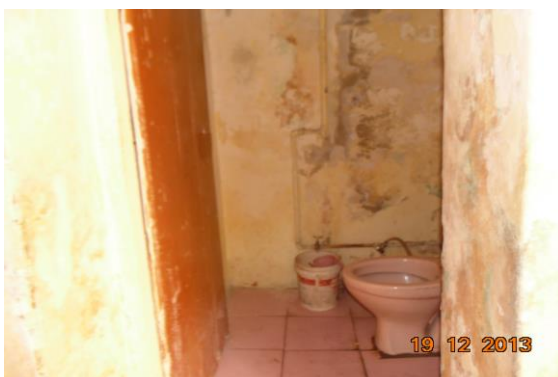
Photo 40
Dampness/Seepage on Left side Gate of Toilet No. 1 of First Floor

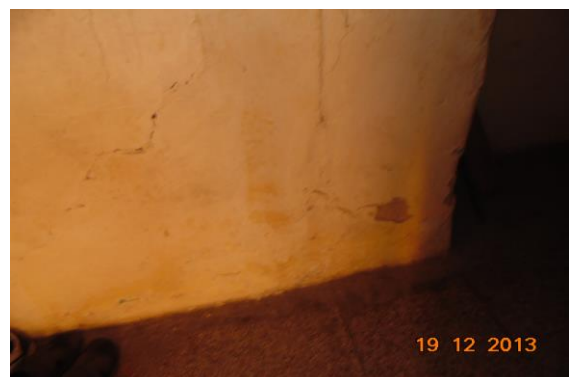
Photo 41
Damaged Portion on Wall No. 1 of Passage of First Floor

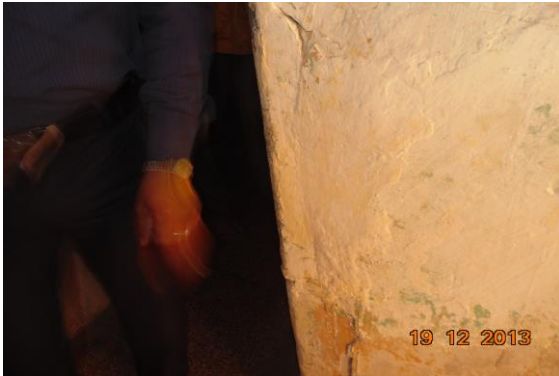
Photo 42
Damaged Portion on Wall No. 3 of Passage of First Floor

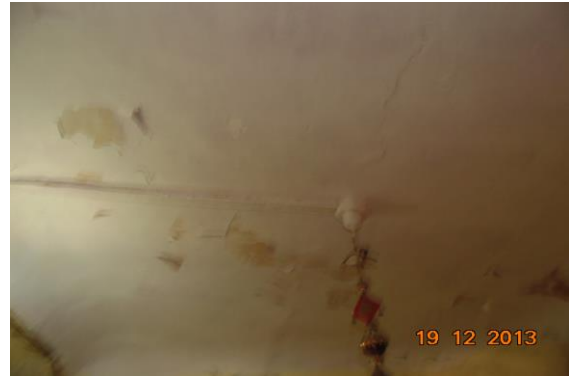
Photo 43
Peeling of Plaster on Roof of Lobby of First Floor

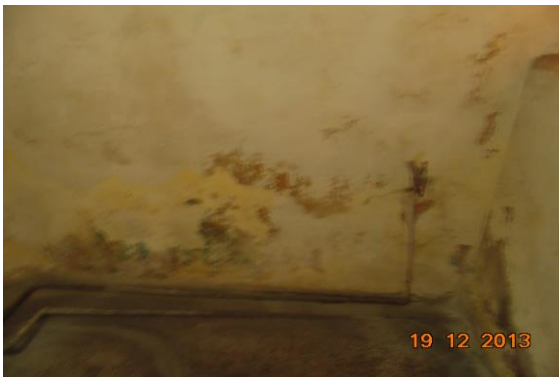
Photo 44
Dampness/Seepage on Wall No. 2 & 3 of Lobby of First Floor
